**Flood Control Project Maintenance
Levee Inspections**

Fall 2010 Levee Maintenance Deficiency Summary Report

**Flood Control Project Maintenance
Levee Inspections**
LMA District Cover Sheet
Fall 2010 Levee Inspection Results

American River Flood Control District

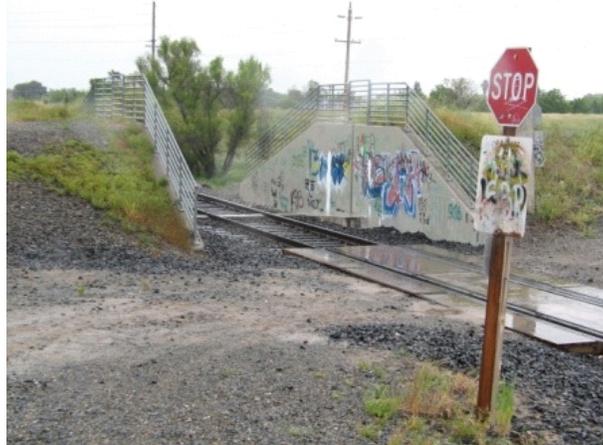
Levee Mile Report Line	1
Start Levee Mile	0.00
End Levee Mile	0.00
Location	Crown
Category	Earthen Levee
Item	Closure Structures
Stop log structure at start of unit.	
cathom_f_20100928_069.jpg

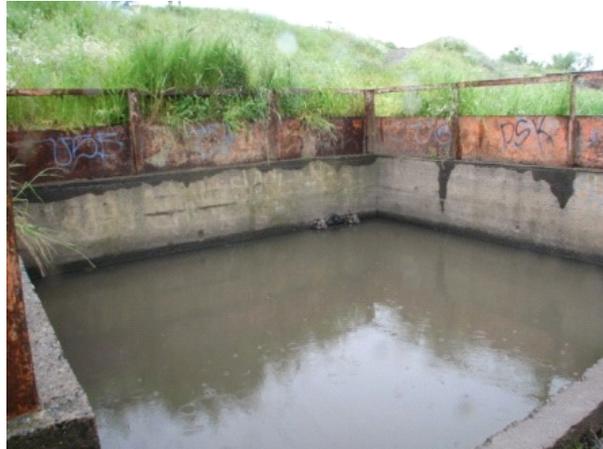
Levee Mile Report Line	2
Start Levee Mile	0.03
End Levee Mile	0.03
Location	Water Side
Category	Interior Drainage & Piping Systems
Item	Culverts: Inlets / Outlets
One of several drainage outlets to Arcade Creek at this location.	
cathom_f_20100928_068.jpg

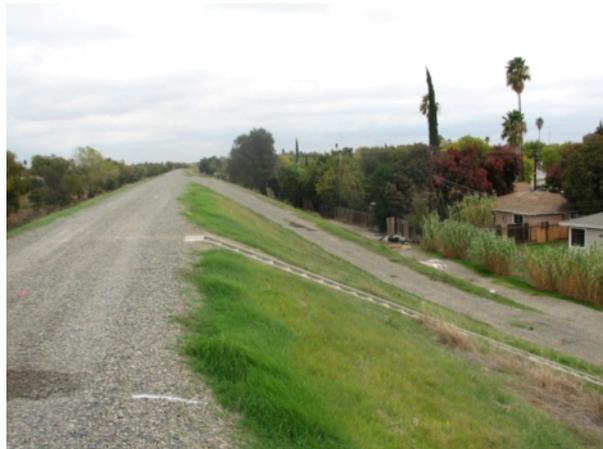
Levee Mile Report Line	3
Start Levee Mile	0.03
End Levee Mile	0.03
Location	Land Side
Category	Earthen Levee
Item	Vegetation
Levee mile 0.00, land side vegetation.	
cathom_f_20101122_214.jpg

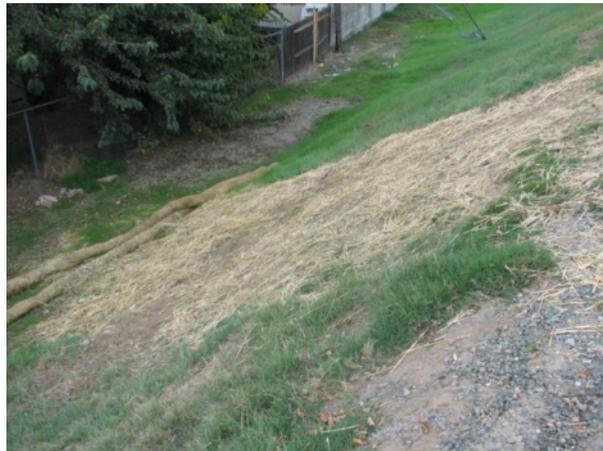
Levee Mile Report Line	10
Start Levee Mile	0.81
End Levee Mile	0.81
Location	Land Side
Category	Earthen Levee
Item	Slope Stability
Levee mile 0.81, slope repair.	
cathom_f_20101122_218.jpg

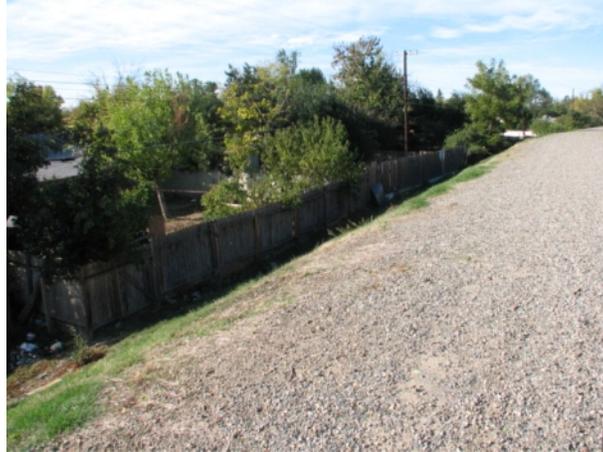
cathom_f_20100928_056.jpg

Photo of solid fences built against the levee slope.

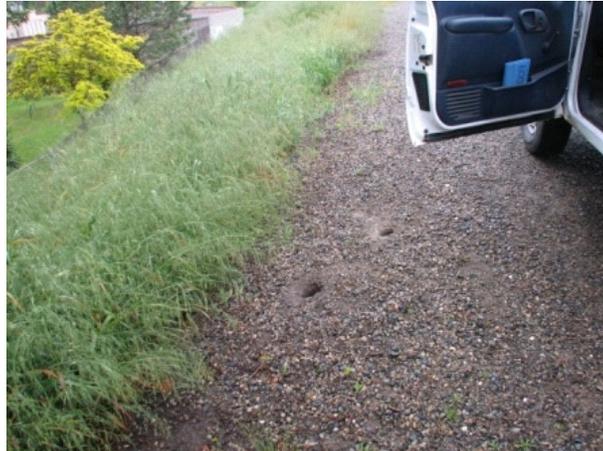
Levee Mile Report Line	16
Start Levee Mile	1.26
End Levee Mile	1.26
Location	Crown
Category	Earthen Levee
Item	Animal Control

Rodent burrows on levee crown.

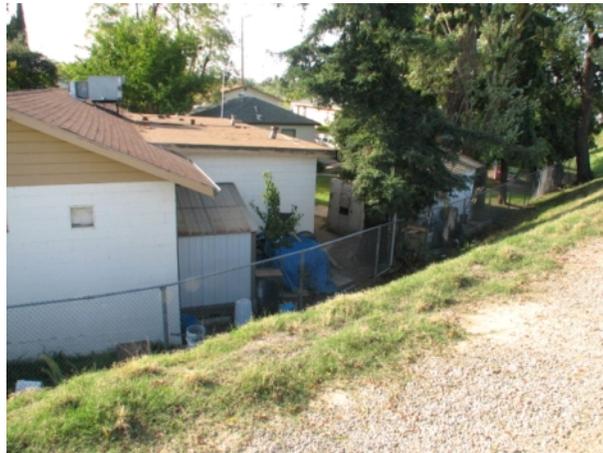
Levee Mile Report Line	17
Start Levee Mile	1.26
End Levee Mile	1.26
Location	Land Side
Category	Earthen Levee
Item	Encroachments

Fall 2009 photo: Buildings and fence near levee toe.

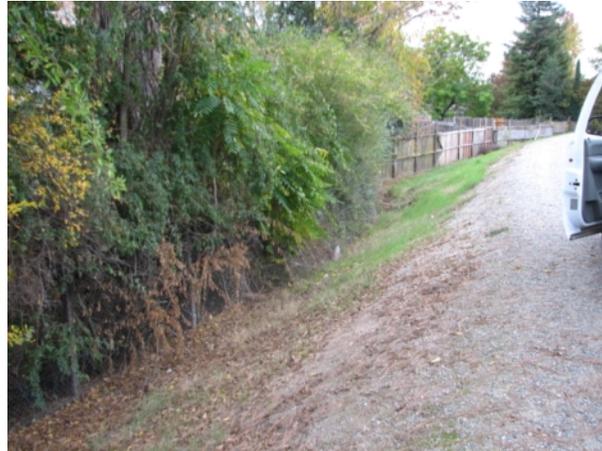
Levee Mile Report Line	26
Start Levee Mile	1.43
End Levee Mile	1.43
Location	Land Side
Category	Earthen Levee
Item	Trim / Thin Trees
Vegetation removed from slope.	
cathom_f_20101122_217.jpg

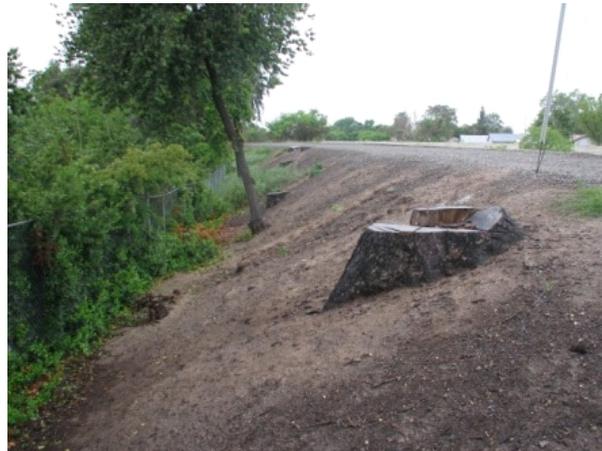
Levee Mile Report Line	28
Start Levee Mile	1.52
End Levee Mile	1.52
Location	Land Side
Category	Earthen Levee
Item	Trim / Thin Trees
Several large stumps on levee slope.	
cathom_f_20100928_065.jpg

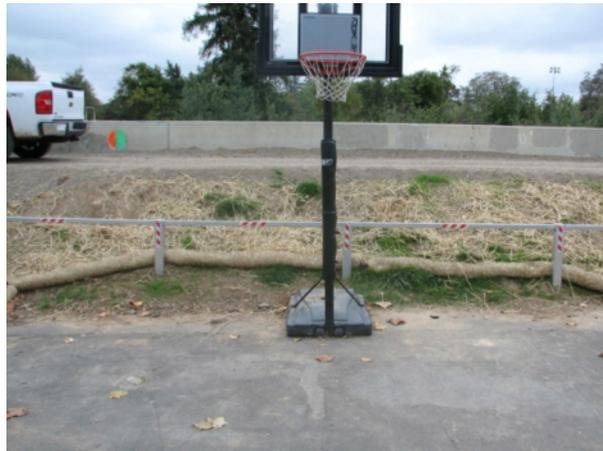
Levee Mile Report Line	47
Start Levee Mile	1.96
End Levee Mile	1.96
Location	Land Side
Category	Earthen Levee
Item	Slope Stability
Levee mile 1.96, slope stability repaired.	
cathom_f_20101122_216.jpg

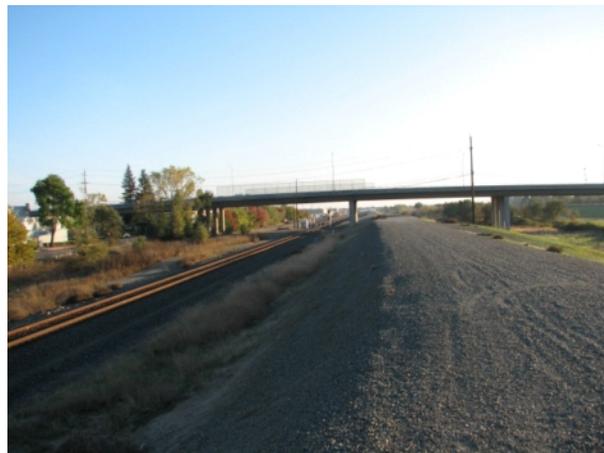
Levee Mile Report Line	7
Start Levee Mile	3.90
End Levee Mile	3.90
Location	Land Side
Category	Earthen Levee
Item	Vegetation
Levee mile 3.93, land side vegetation.	
cathom_f_20101122_209.jpg

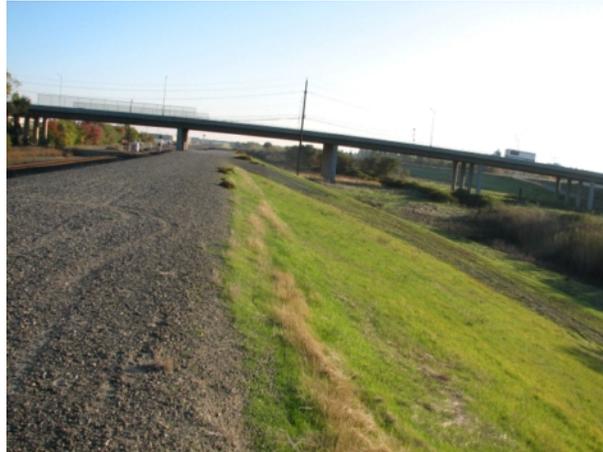
Levee Mile Report Line	8
Start Levee Mile	3.90
End Levee Mile	3.90
Location	Water Side
Category	Earthen Levee
Item	Vegetation
Levee mile 3.93, water side vegetation.	
cathom_f_20101122_210.jpg

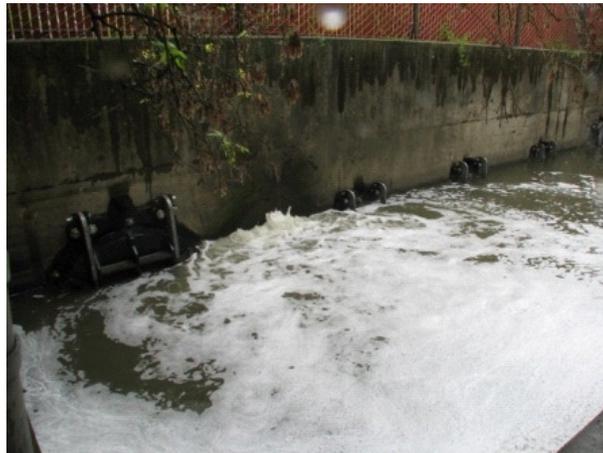
Levee Mile Report Line	2
Start Levee Mile	1.52
End Levee Mile	1.52
Location	Land Side
Category	Interior Drainage & Piping Systems
Item	Culverts: Inlets / Outlets
Drainage discharge to American River.	
cathom_f_20100928_077.jpg

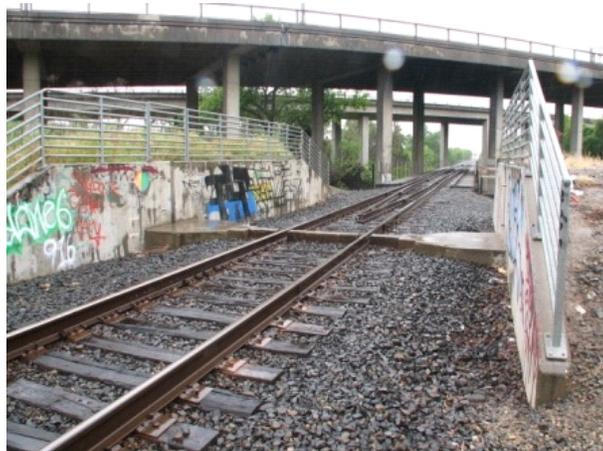
Levee Mile Report Line	7
Start Levee Mile	3.13
End Levee Mile	3.13
Location	Crown
Category	Earthen Levee
Item	Closure Structures
Stoplog closure structure at RR near Del Paso Blvd.	
cathom_f_20100928_073.jpg

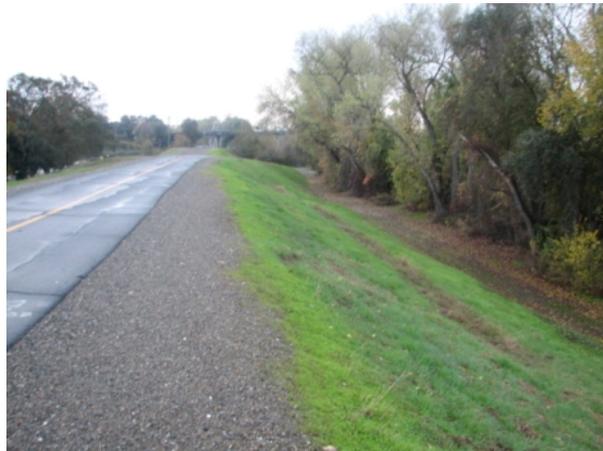
Levee Mile Report Line	11
Start Levee Mile	3.35
End Levee Mile	3.35
Location	Water Side
Category	Earthen Levee
Item	Vegetation
Levee mile 3.34, water side vegetation.	
cathom_f_20101129_229.jpg

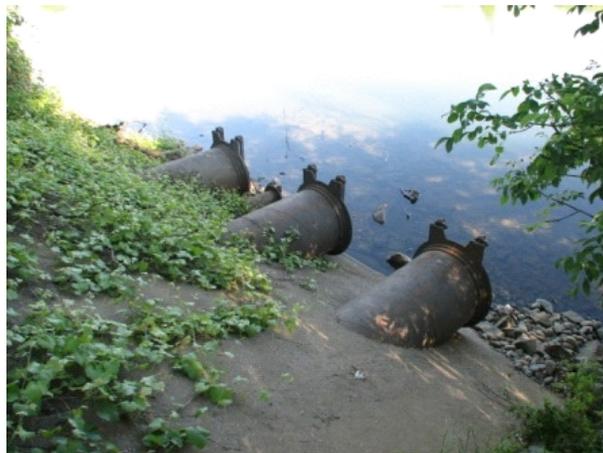
Levee Mile Report Line	6
Start Levee Mile	0.93
End Levee Mile	0.93
Location	Water Side
Category	Interior Drainage & Piping Systems
Item	Culverts: Inlets / Outlets
Outlet of storm drain to American River.	
cathom_f_20100928_085.jpg

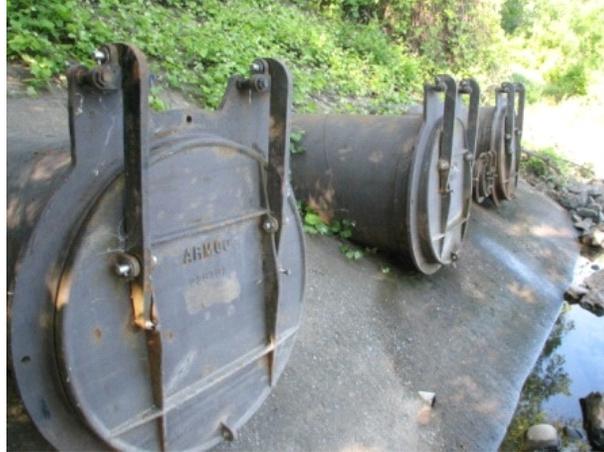
cathom_f_20100928_086.jpg

Flap gates functioning properly.

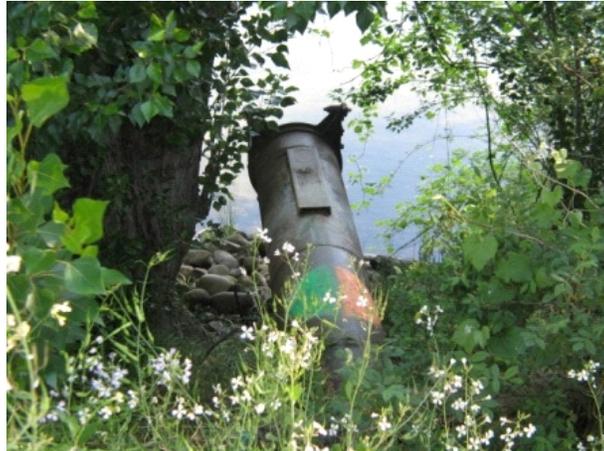
Levee Mile Report Line	7
Start Levee Mile	0.94
End Levee Mile	0.94
Location	Crown
Category	Earthen Levee
Item	Encroachments

Discharge pipe from printing into American River.

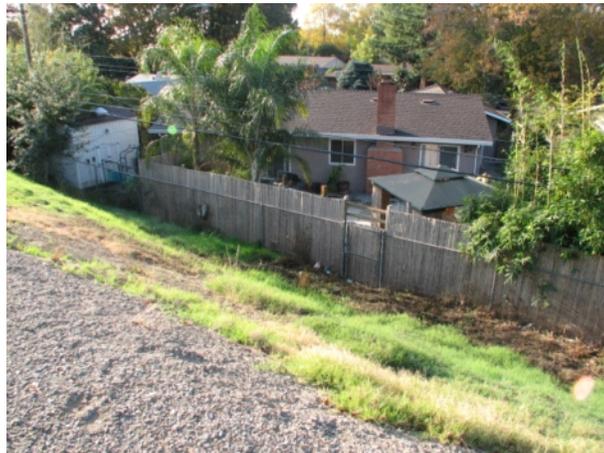
Levee Mile Report Line	17
Start Levee Mile	3.88
End Levee Mile	3.88
Location	Land Side
Category	Earthen Levee
Item	Encroachments

Fall 2009 photo: Fence and landscaping within 10-ft of levee toe obstructs access and visibility.

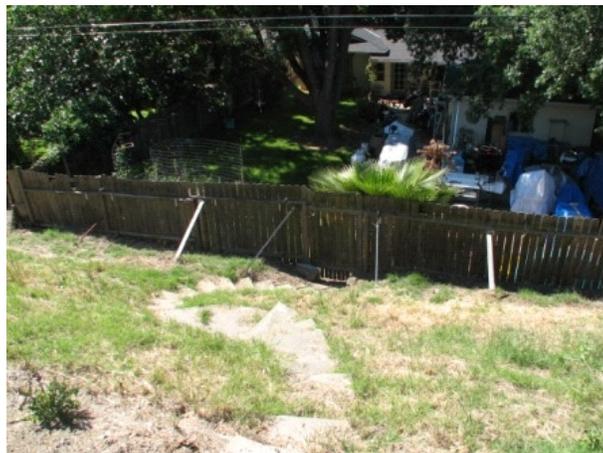
Levee Mile Report Line	82
Start Levee Mile	4.93
End Levee Mile	4.93
Location	Land Side
Category	Earthen Levee
Item	Encroachments
Wooden fence and braces obstruct access and visibility.	
cathom_f_20100928_080.jpg

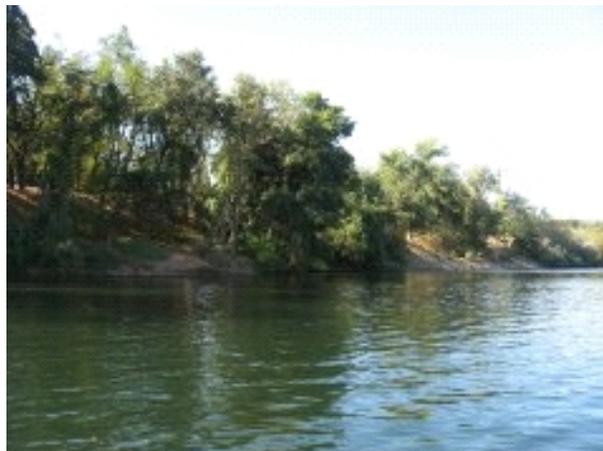
Levee Mile Report Line	173
Start Levee Mile	9.52
End Levee Mile	9.61
Location	Water Side
Category	Supplemental
Item	USACE Erosion Survey
2009: 10 ft berm, 1.5:1 slope, tree hazards, clays and silts, 8.74 ft/s [2009 SiteID:AMR_10-0_L]	
cathom_f_20100928_090.JPG

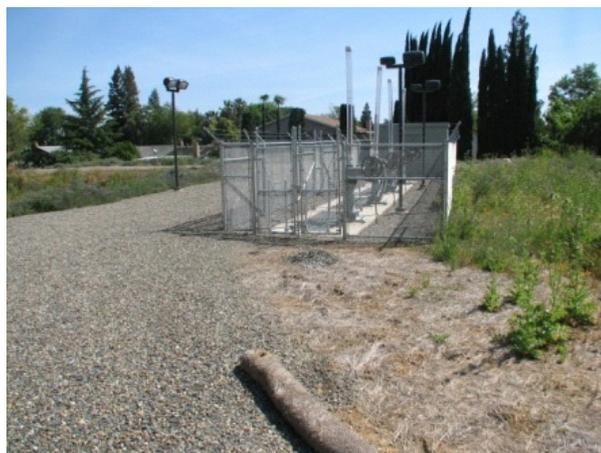
Levee Mile Report Line	210
Start Levee Mile	10.63
End Levee Mile	10.63
Location	Water Side
Category	Interior Drainage & Piping Systems
Item	Culverts: Inlets / Outlets
Mahew drain closure structure.	
cathom_f_20100928_082.jpg

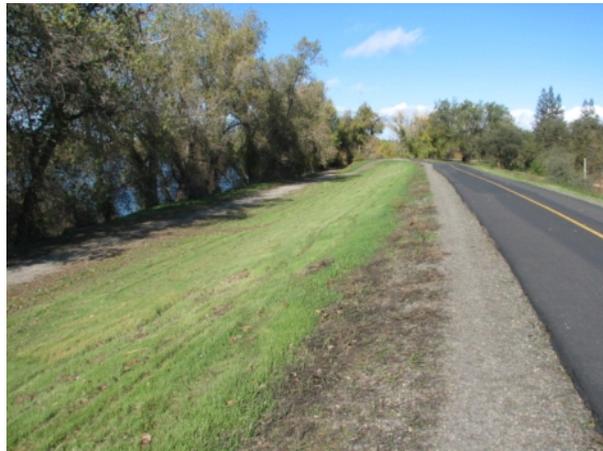
Levee Mile Report Line	4
Start Levee Mile	0.12
End Levee Mile	0.12
Location	Water Side
Category	Earthen Levee
Item	Vegetation
Levee mile 0.11, water side vegetation.	
cathom_f_20101129_231.jpg

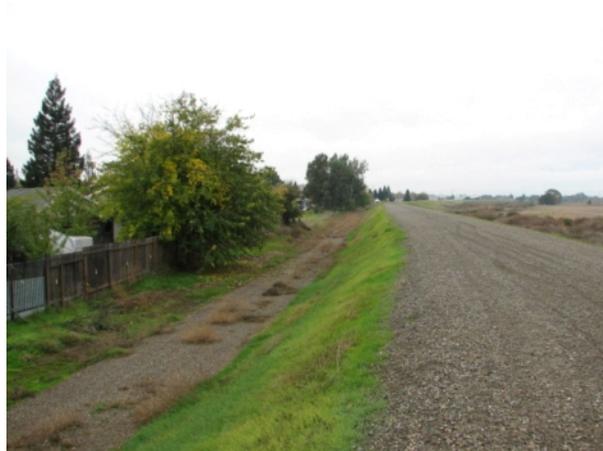
Levee Mile Report Line	3
Start Levee Mile	0.96
End Levee Mile	0.96
Location	Land Side
Category	Earthen Levee
Item	Vegetation
Levee mile 0.96, land side vegetation.	
cathom_f_20101129_226.jpg

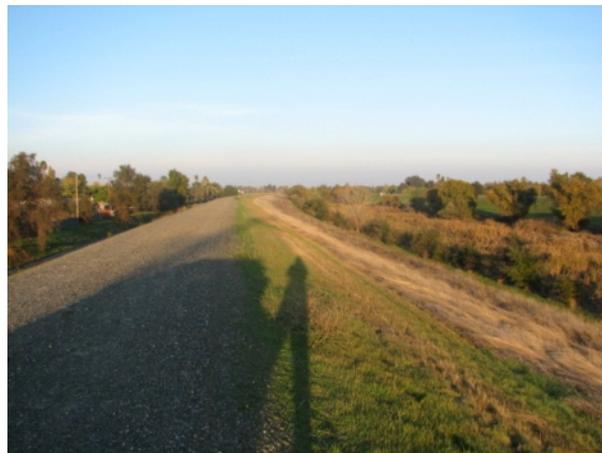
Levee Mile Report Line	3
Start Levee Mile	0.06
End Levee Mile	0.06
Location	Water Side
Category	Earthen Levee
Item	Vegetation
Levee mile 0.00, water side vegetation.	
cathom_f_20101122_213.jpg

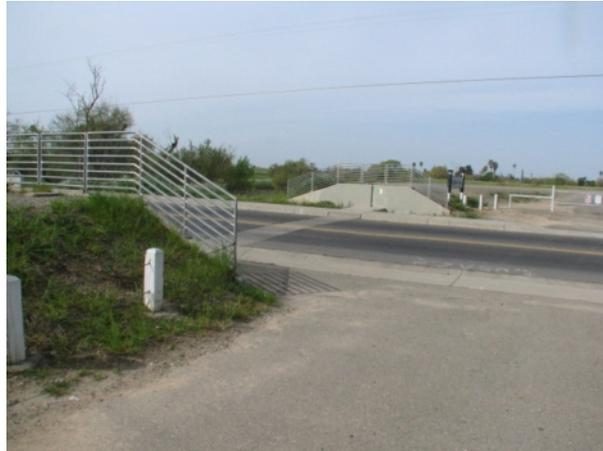
Levee Mile Report Line	6
Start Levee Mile	0.72
End Levee Mile	0.72
Location	Crown
Category	Earthen Levee
Item	Closure Structures
Stoplog structure at Norwood Ave. crossing.	
cathom_f_20100928_101.jpg

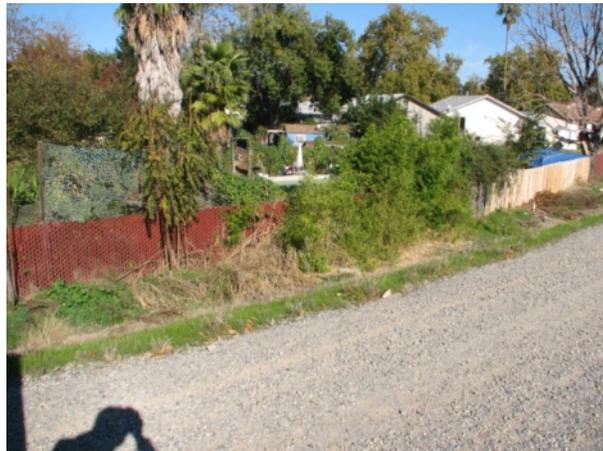
Levee Mile Report Line	10
Start Levee Mile	1.42
End Levee Mile	1.42
Location	Land Side
Category	Earthen Levee
Item	Encroachments
Fall 2009 photo of landscaping adjacent to lower levee patrol road obstructs visibility and access.	
cathom_f_20100928_100.jpg

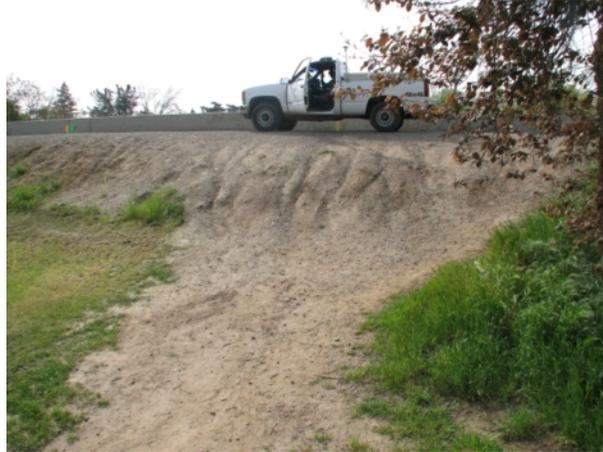
Levee Mile Report Line	16
Start Levee Mile	1.58
End Levee Mile	1.58
Location	Land Side
Category	Earthen Levee
Item	Slope Stability
Erosion of levee slope due in part to pedestrian traffic.	
cathom_f_20100928_102.jpg

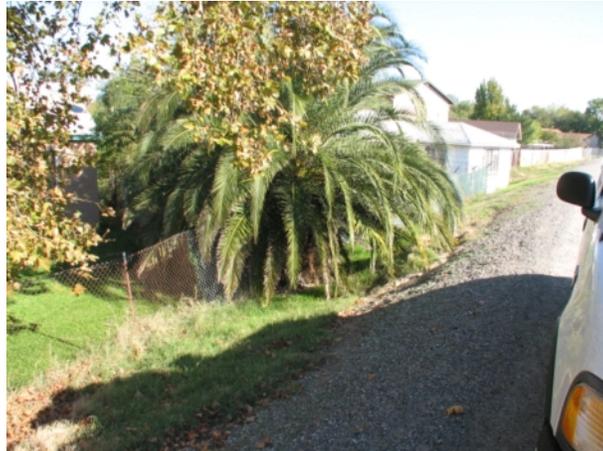
Levee Mile Report Line	28
Start Levee Mile	1.70
End Levee Mile	1.70
Location	Land Side
Category	Earthen Levee
Item	Encroachments
Fall 2009 photo of palm tree within 10-ft of the levee toe obstructs visibility and access.	
cathom_f_20100928_099.jpg

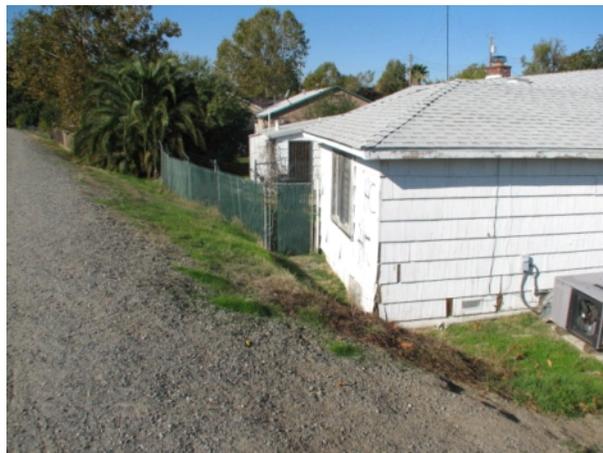
Levee Mile Report Line	29
Start Levee Mile	1.72
End Levee Mile	1.72
Location	Land Side
Category	Earthen Levee
Item	Encroachments
Fall 2009 photo of privacy fence and structure within 10-ft of the levee toe obstructs visibility and access.	
cathom_f_20100928_094.jpg

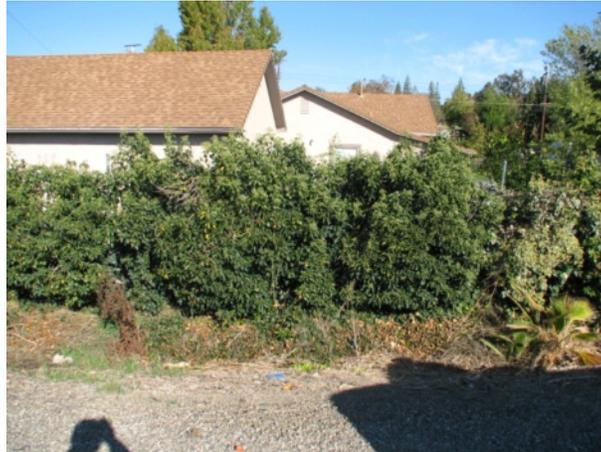
Levee Mile Report Line	34
Start Levee Mile	1.77
End Levee Mile	1.77
Location	Land Side
Category	Earthen Levee
Item	Encroachments
<p>Fall 2009 photo of landscaping within 10-ft of the levee toe obstructs visibility and access.</p>	
<p>cathom_f_20100928_095.jpg</p>

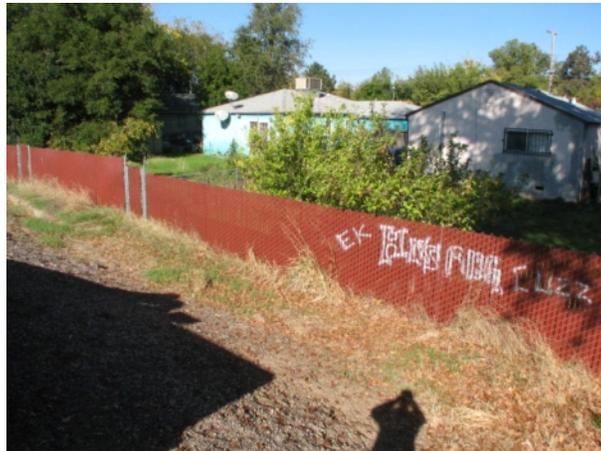
Levee Mile Report Line	38
Start Levee Mile	1.81
End Levee Mile	1.81
Location	Land Side
Category	Earthen Levee
Item	Encroachments
<p>Fall 2009 photo of privacy fence within 10-ft of the levee toe obstructs visibility and access.</p>	
<p>cathom_f_20100928_096.jpg</p>

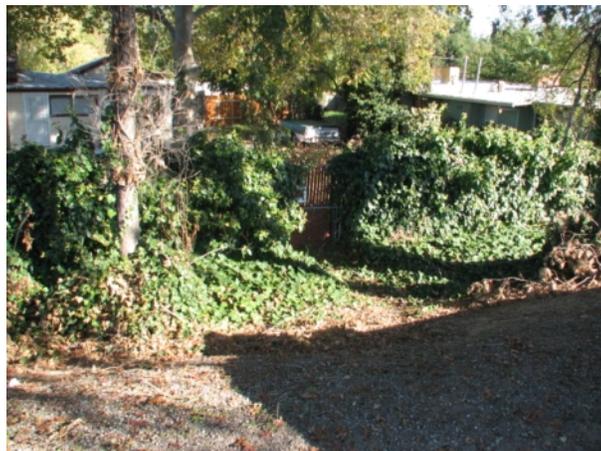
Levee Mile Report Line	40
Start Levee Mile	1.83
End Levee Mile	1.83
Location	Land Side
Category	Earthen Levee
Item	Encroachments
<p>Fall 2009 photo of dense ivy and fence obstruct visibility and access.</p>	
<p>cathom_f_20100928_097.jpg</p>

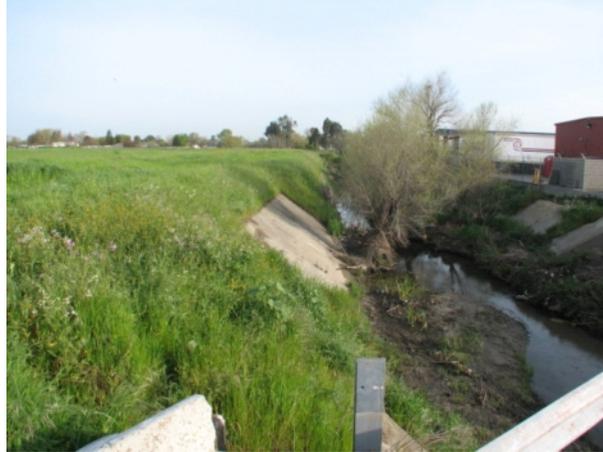
Levee Mile Report Line	4
Start Levee Mile	0.52
End Levee Mile	1.05
Location	Water Side
Category	Channels
Item	Vegetation & Obstructions
Incised channel at LM 1.05 downstream of Vinci Ave.	
cathom_f_20100928_106.jpg

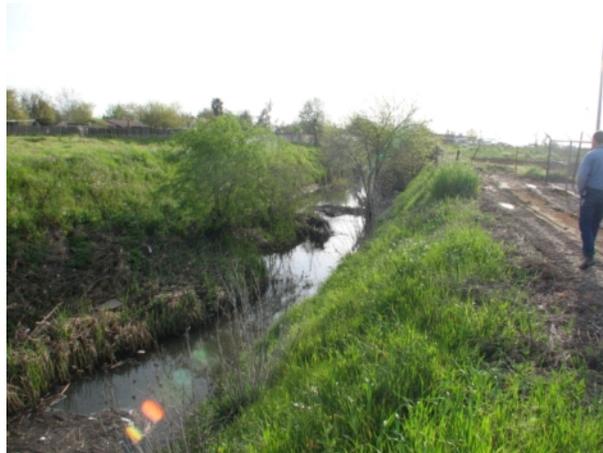
Levee Mile Report Line	4
Start Levee Mile	0.52
End Levee Mile	1.05
Location	Water Side
Category	Channels
Item	Vegetation & Obstructions
Incised channel at LM 0.48 upstream of Dry Creek Rd.	
cathom_f_20100928_107.jpg

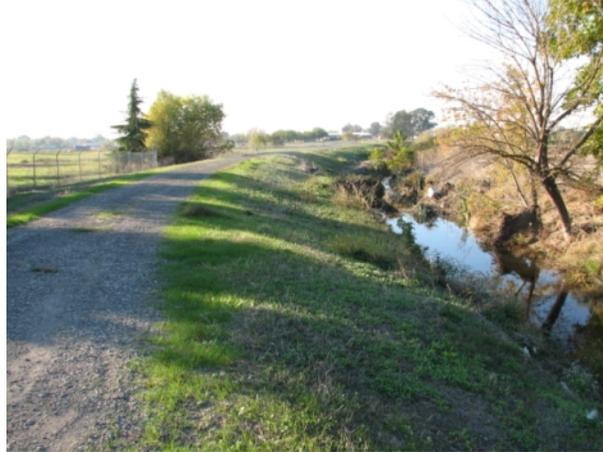
Levee Mile Report Line	7
Start Levee Mile	1.43
End Levee Mile	1.43
Location	Water Side
Category	Earthen Levee
Item	Vegetation
Levee mile 1.43, water side vegetation.	
cathom_f_20101122_205.jpg

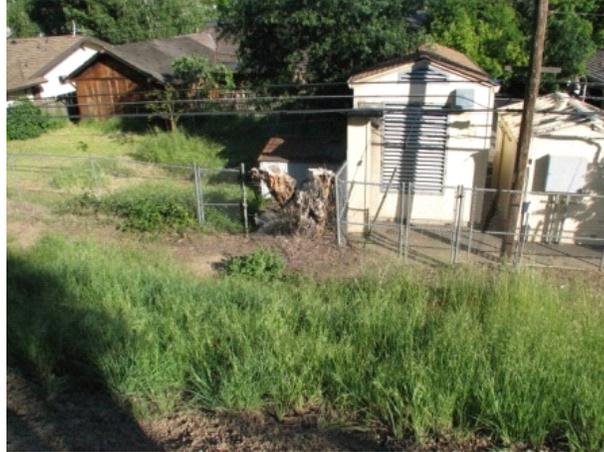
Levee Mile Report Line	2
Start Levee Mile	0.45
End Levee Mile	0.45
Location	Land Side
Category	Earthen Levee
Item	Trim / Thin Trees
Tree trunk at fence line.	
cathom_f_20100928_109.jpg

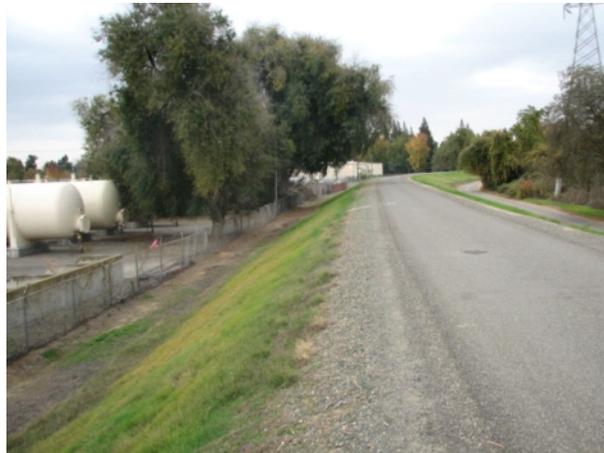
Levee Mile Report Line	10
Start Levee Mile	3.70
End Levee Mile	3.70
Location	Land Side
Category	Earthen Levee
Item	Vegetation
Levee mile 3.70, vegetation land side.	
cathom_f_20101122_220.jpg

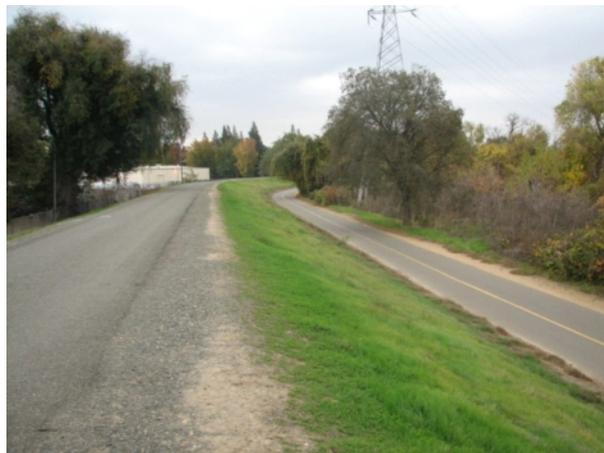
Levee Mile Report Line	11
Start Levee Mile	3.70
End Levee Mile	3.70
Location	Water Side
Category	Earthen Levee
Item	Vegetation
Levee mile 3.70, vegetation water side.	
cathom_f_20101122_221.jpg

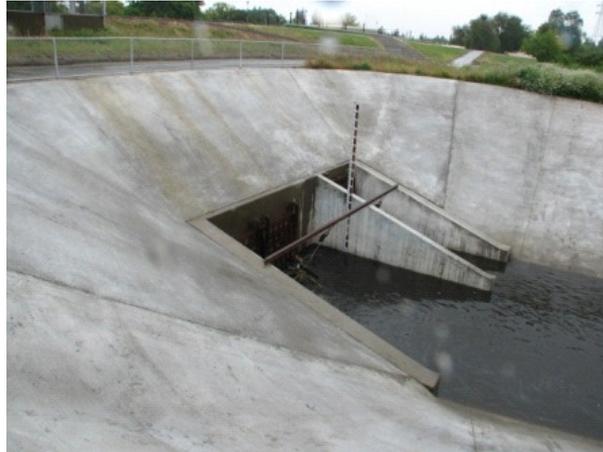
Levee Mile Report Line	13
Start Levee Mile	4.28
End Levee Mile	4.28
Location	Water Side
Category	Interior Drainage & Piping Systems
Item	Culverts: Inlets / Outlets
Gravity drainage to American River upstream of pumping plant.	
cathom_f_20100928_108.jpg

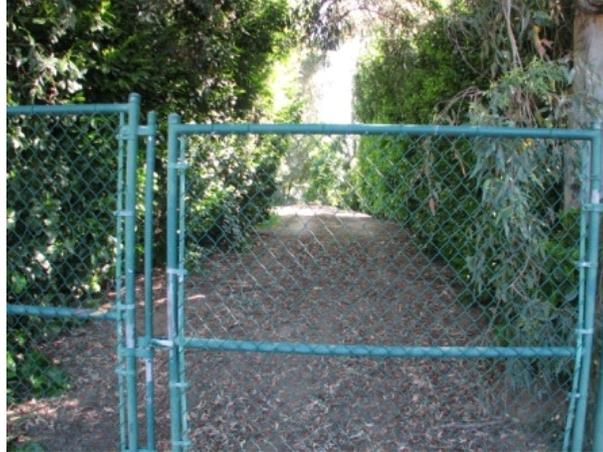
Levee Mile Report Line	1
Start Levee Mile	0.00
End Levee Mile	0.70
Location	Crown
Category	Earthen Levee
Item	Encroachments
Levee encroached on by property owners north of Arden.	
cathom_f_20100928_115.jpg

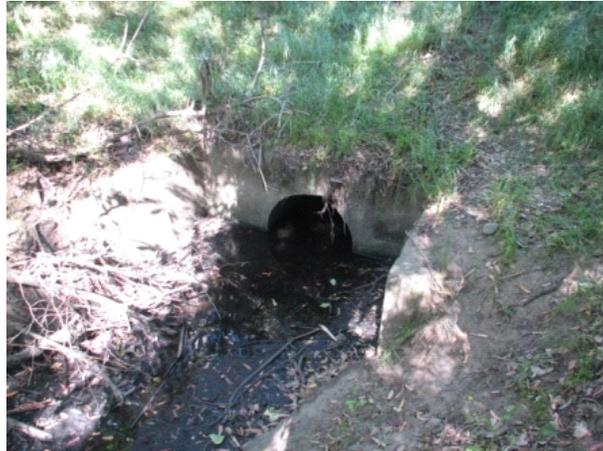
Levee Mile Report Line	2
Start Levee Mile	1.01
End Levee Mile	1.01
Location	Water Side
Category	Interior Drainage & Piping Systems
Item	Culverts: Inlets / Outlets
Drainage outfall in floodplain. Flap and slide gate in concrete box on waterside shoulder.	
cathom_f_20100928_114.jpg

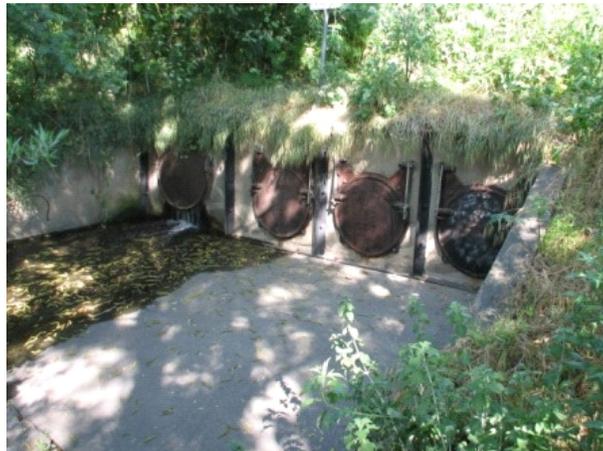
Levee Mile Report Line	4
Start Levee Mile	1.71
End Levee Mile	1.71
Location	Crown
Category	Interior Drainage & Piping Systems
Item	Culverts: Inlets / Outlets
Flap gates at outfall in floodway.	
cathom_f_20100928_112.jpg

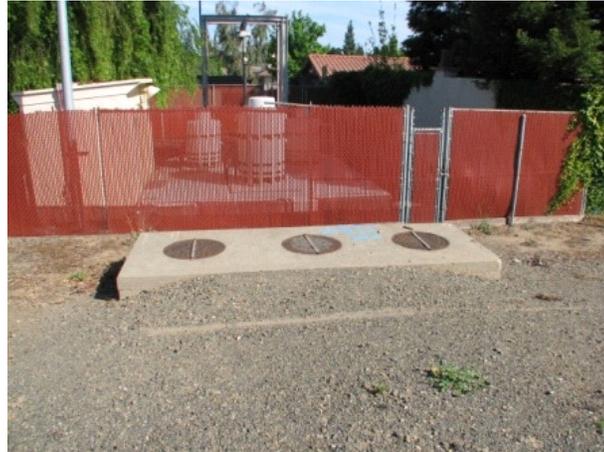
Levee Mile Report Line	4
Start Levee Mile	1.71
End Levee Mile	1.71
Location	Crown
Category	Interior Drainage & Piping Systems
Item	Culverts: Inlets / Outlets
Pump plant at outfall.	
cathom_f_20100928_113.jpg

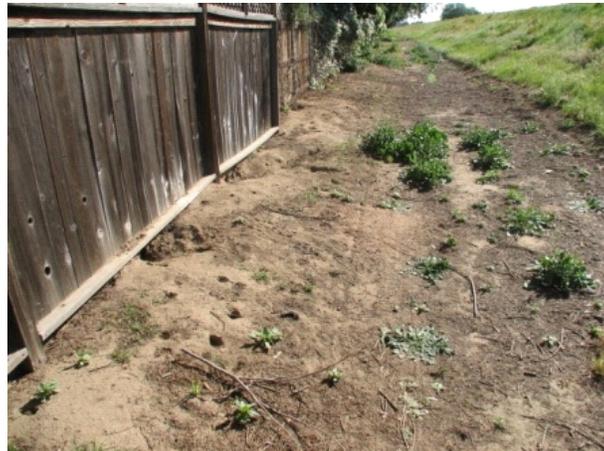
Levee Mile Report Line	6
Start Levee Mile	2.75
End Levee Mile	2.75
Location	Land Side
Category	Earthen Levee
Item	Animal Control
Active rodents persist along fence line.	
cathom_f_20100928_110.jpg

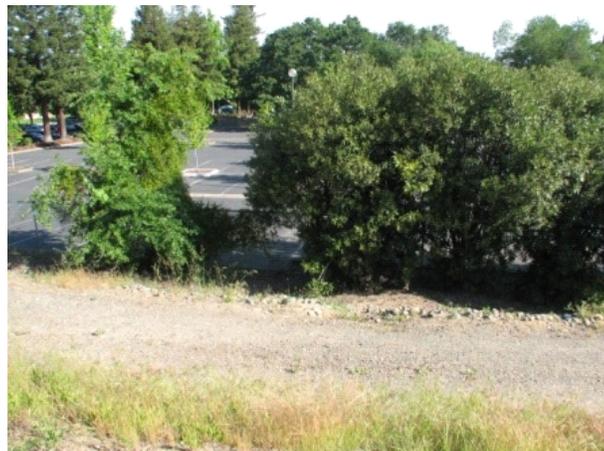
Levee Mile Report Line	9
Start Levee Mile	3.58
End Levee Mile	3.58
Location	Land Side
Category	Earthen Levee
Item	Encroachments
Trees at fence line obstruct access and visibility.	
cathom_f_20100928_111.jpg

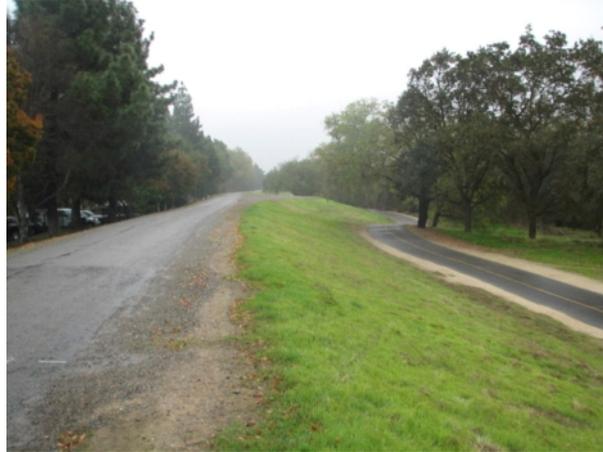
Levee Mile Report Line	12
Start Levee Mile	3.97
End Levee Mile	3.97
Location	Water Side
Category	Earthen Levee
Item	Vegetation
Levee mile 3.97, vegetation water side.	
cathom_f_20101122_222.jpg

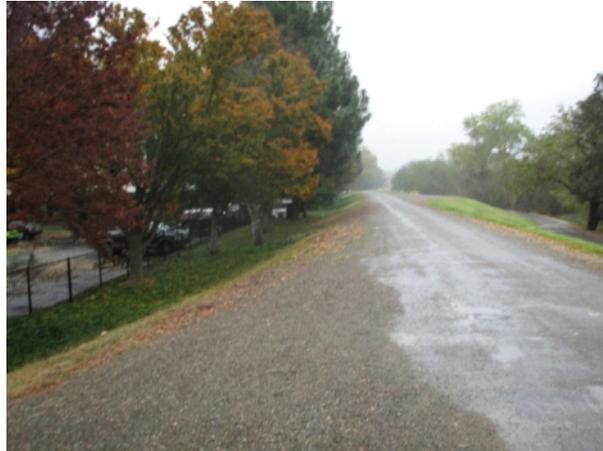
Levee Mile Report Line	13
Start Levee Mile	3.97
End Levee Mile	3.97
Location	Land Side
Category	Earthen Levee
Item	Vegetation
Levee mile 3.97, vegetation land side.	
cathom_f_20101122_223.jpg

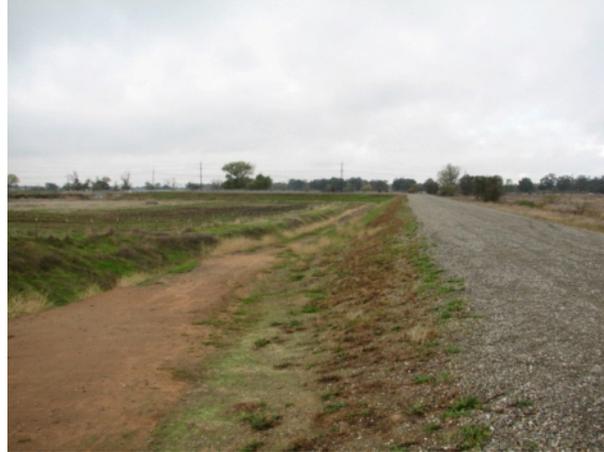
Levee Mile Report Line	1
Start Levee Mile	0.71
End Levee Mile	0.71
Location	Land Side
Category	Earthen Levee
Item	Vegetation
Levee mile 0.70, land side vegetation.	
cathom_f_20101129_224.jpg

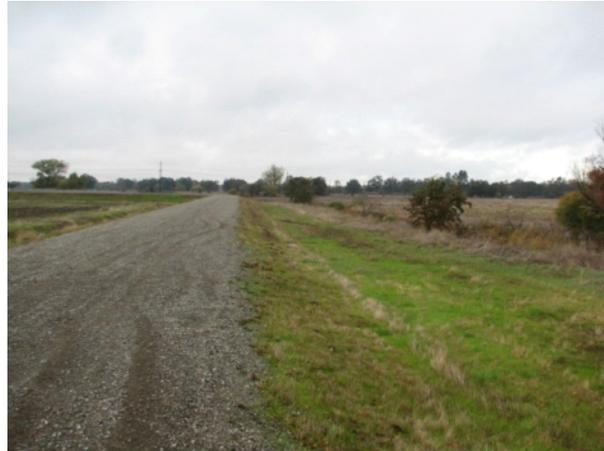
Levee Mile Report Line	2
Start Levee Mile	0.71
End Levee Mile	0.71
Location	Water Side
Category	Earthen Levee
Item	Vegetation
Levee mile 0.70, water side vegetation.	
cathom_f_20101129_225.jpg
