**Flood Control Project Maintenance  
Levee Inspections**

**Fall 2014 Levee Maintenance Deficiency Summary Report**

**Sacramento River Basin**

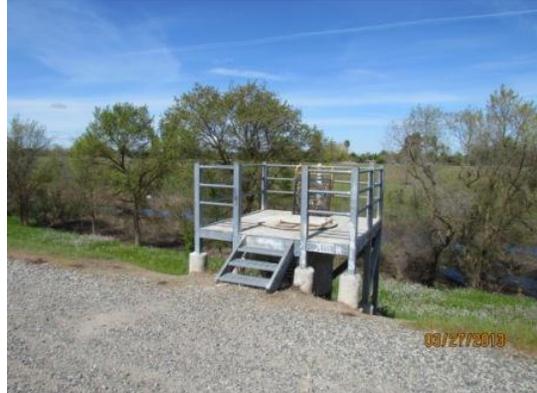
Photo 1 of 1 : FA\_2014\_NA0001\_51\_60\_20141001\_00034.jpg

LM Start	<b>0.40</b>	Rating **	A/W	Issue No.	<b>60</b>
LM End	<b>0.40</b>	Issue Type +	Ma	Location *	WS
Category	Earthen Levee		GPS Latitude/Longitude		
			Start	End	
Item	Encroachments		38.622579 °	38.622579 °	
			-121.461567 °	-121.461567 °	
DWR ID	DWR_NA0001_01_s_2012_60				
Action/Comments					
Pipe

View of the pipe at the waterside levee hinge.

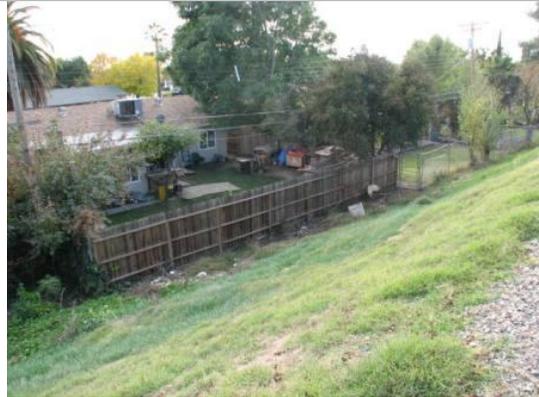
Photo 1 of 1 : FA\_2014\_NA0001\_51\_183\_20141001\_00046.jpg

LM Start	<b>0.77</b>	Rating **	U	Issue No.	<b>183</b>
LM End	<b>0.77</b>	Issue Type +	En	Location *	LS
Category	Earthen Levee		GPS Latitude/Longitude		
			Start	End	
Item	Encroachments		38.624016 °	38.624016 °	
			-121.455193 °	-121.455193 °	
DWR ID	DWR_NA0001_01_s_2012_183				
Action/Comments					
Fence Inspector Comments: Dog-eared fence built within 10' of the toe

11/17/2011 Wooden privacy fence.

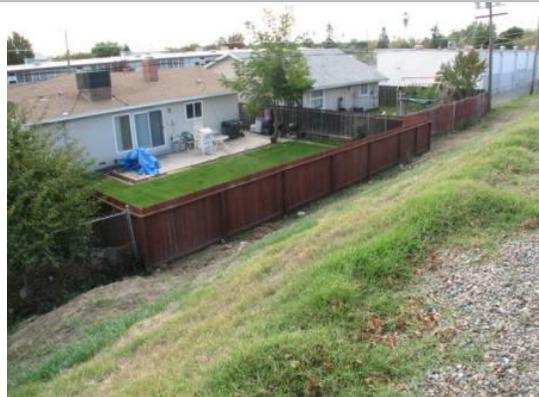
Photo 1 of 1 : FA\_2014\_NA0001\_51\_182\_20141001\_00045.jpg

LM Start	<b>0.95</b>	Rating **	U	Issue No.	<b>182</b>
LM End	<b>0.95</b>	Issue Type +	En	Location *	LS
Category	Earthen Levee		GPS Latitude/Longitude		
			Start	End	
Item	Encroachments		38.625072 °	38.625072 °	
			-121.452225 °	-121.452225 °	
DWR ID	DWR_NA0001_01_s_2012_182				
Action/Comments					
Fence Inspector Comments: Dog-eared wooden fence built within 10' of the toe.

11/17/2011 Wooden privacy fence built at the levee toe.

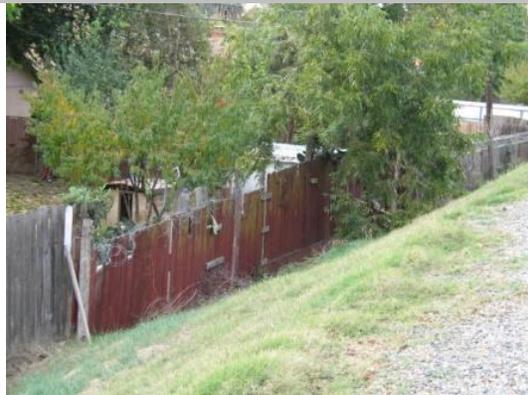
Photo 1 of 1 : FA\_2014\_NA0001\_51\_22\_20141001\_00019.jpg

LM Start	<b>1.17</b>	Rating **	<b>U</b>	Issue No.	<b>22</b>
LM End	<b>1.17</b>	Issue Type +	<b>En</b>	Location *	<b>LS</b>
Category	Earthen Levee		GPS Latitude/Longitude		
			Start	End	
Item	Encroachments		38.624850 °	38.624850 °	
			-121.448428 °	-121.448428 °	
DWR ID	DWR_NA0001_01_s_2012_22				
Action/Comments					
Fence Inspector Comments: Dog-eared wooden fence is built against the levee slope.

11/17/2011 Wooden privacy fence built at the levee toe.

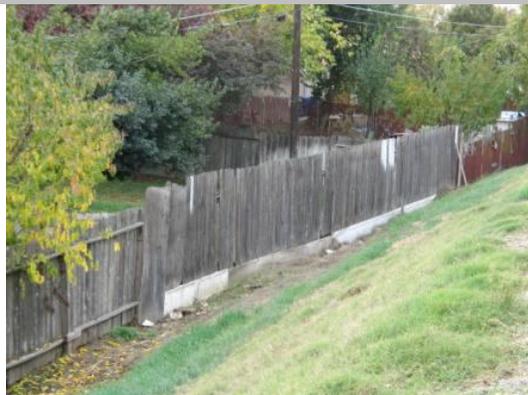
Photo 1 of 1 : FA\_2014\_NA0001\_51\_21\_20141001\_00018.jpg

LM Start	<b>1.18</b>	Rating **	<b>U</b>	Issue No.	<b>21</b>
LM End	<b>1.18</b>	Issue Type +	<b>En</b>	Location *	<b>LS</b>
Category	Earthen Levee		GPS Latitude/Longitude		
			Start	End	
Item	Encroachments		38.624877 °	38.624877 °	
			-121.448248 °	-121.448248 °	
DWR ID	DWR_NA0001_01_s_2012_21				
Action/Comments					
Fence Inspector Comments: Dog-eared wooden fence is built against the levee slope.

11/17/2011 Wooden privacy fence built at the levee toe.

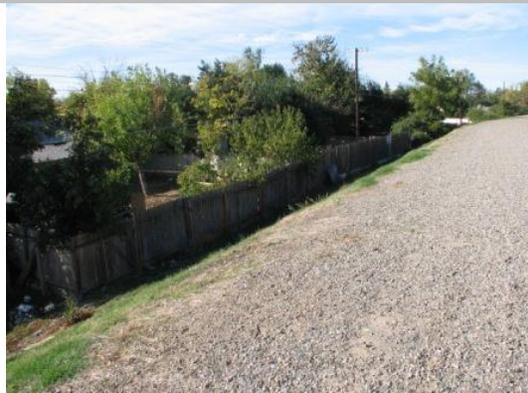
Photo 1 of 1 : FA\_2014\_NA0001\_51\_20\_20141001\_00017.jpg

LM Start	<b>1.19</b>	Rating **	<b>U</b>	Issue No.	<b>20</b>
LM End	<b>1.19</b>	Issue Type +	<b>En</b>	Location *	<b>LS</b>
Category	Earthen Levee		GPS Latitude/Longitude		
			Start	End	
Item	Encroachments		38.624900 °	38.624900 °	
			-121.448037 °	-121.448037 °	
DWR ID	DWR_NA0001_01_s_2012_20				
Action/Comments					
Fence Inspector Comments: Dog-eared wooden fence is built against the levee slope.

Photo of solid fences built against the levee slope.

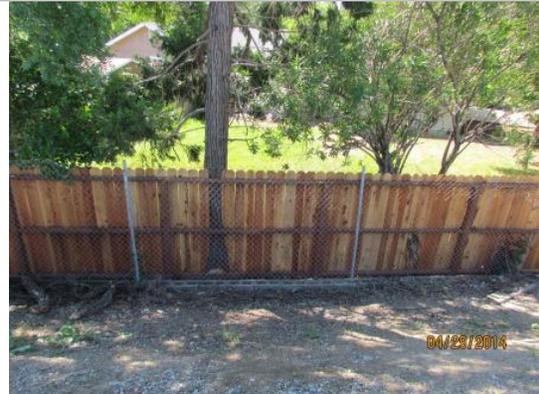
Photo 1 of 1 : FA\_2014\_NA0001\_51\_50\_20141001\_00031.jpg

LM Start	<b>1.35</b>	Rating **	U	Issue No.	<b>50</b>
LM End	<b>1.35</b>	Issue Type +	En	Location *	LS
Category	Earthen Levee		GPS Latitude/Longitude		
			Start	End	
Item	Encroachments		38.625982 °	38.625982 °	
			-121.445231 °	-121.445231 °	
DWR ID	DWR_NA0001_01_s_2014_50				
Action/Comments					
Fence

View of the fence at the landside levee toe obstructing visibility and access.

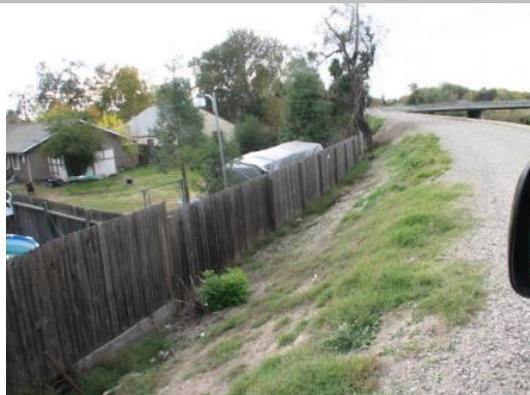
Photo 1 of 1 : FA\_2014\_NA0001\_51\_16\_20141001\_00014.jpg

LM Start	<b>1.37</b>	Rating **	U	Issue No.	<b>16</b>
LM End	<b>1.37</b>	Issue Type +	En	Location *	LS
Category	Earthen Levee		GPS Latitude/Longitude		
			Start	End	
Item	Encroachments		38.626000 °	38.626000 °	
			-121.444978 °	-121.444978 °	
DWR ID	DWR_NA0001_01_s_2012_16				
Action/Comments					
Fence Inspector Comments: Wooden privacy fence

11/17/2011 Wooden privacy fence built at the levee toe.

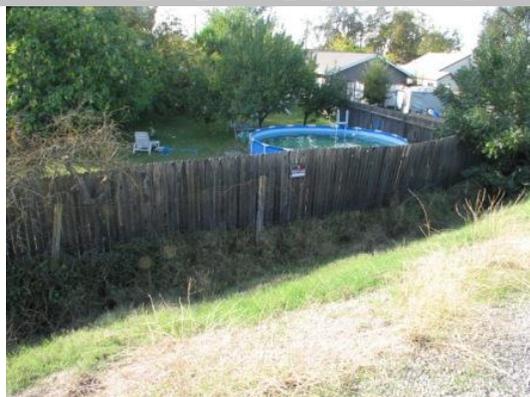
Photo 1 of 1 : FA\_2014\_NA0001\_51\_15\_20141001\_00013.jpg

LM Start	<b>1.38</b>	Rating **	U	Issue No.	<b>15</b>
LM End	<b>1.38</b>	Issue Type +	En	Location *	LS
Category	Earthen Levee		GPS Latitude/Longitude		
			Start	End	
Item	Encroachments		38.626048 °	38.626048 °	
			-121.444785 °	-121.444785 °	
DWR ID	DWR_NA0001_01_s_2012_15				
Action/Comments					
Fence Inspector Comments: Wooden privacy fence with vine on levee slope.

Fall 2009 photo: Wooden and wire fence are within 10-ft of levee toe.

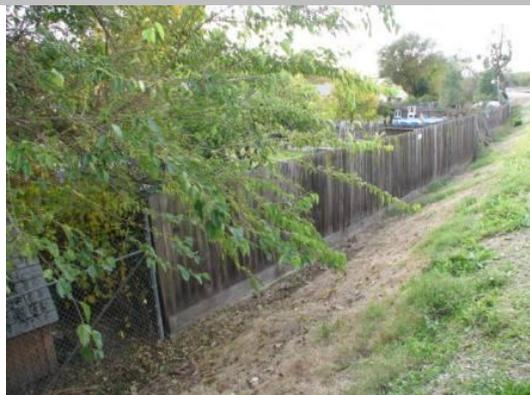
Photo 1 of 1 : FA\_2014\_NA0001\_51\_14\_20141001\_00012.jpg

LM Start	<b>1.39</b>	Rating **	U	Issue No.	<b>14</b>
LM End	<b>1.39</b>	Issue Type +	En	Location *	LS
Category	Earthen Levee		GPS Latitude/Longitude		
			Start	End	
Item	Encroachments		38.626085 °	38.626085 °	
			-121.444580 °	-121.444580 °	
DWR ID	DWR_NA0001_01_s_2012_14				
Action/Comments					
Fence Inspector Comments: Wooden privacy fence

11/17/2011 Wooden privacy fence built at the levee toe.

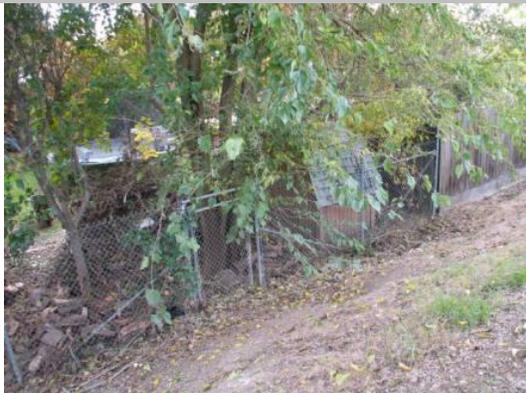
Photo 1 of 1 : FA\_2014\_NA0001\_51\_38\_20141001\_00029.jpg

LM Start	<b>1.40</b>	Rating **	M	Issue No.	<b>38</b>
LM End	<b>1.40</b>	Issue Type +	En	Location *	LS
Category	Earthen Levee		GPS Latitude/Longitude		
			Start	End	
Item	Encroachments		38.626210 °	38.626210 °	
			-121.444320 °	-121.444320 °	
DWR ID	DWR_NA0001_01_s_2012_38				
Action/Comments					
Building Inspector Comments: Small wooden storage shed and firewood are placed along chain link fence within 10-ft of levee toe.

11/17/2011 Shed and firewood can be seen through the chainlink fence.

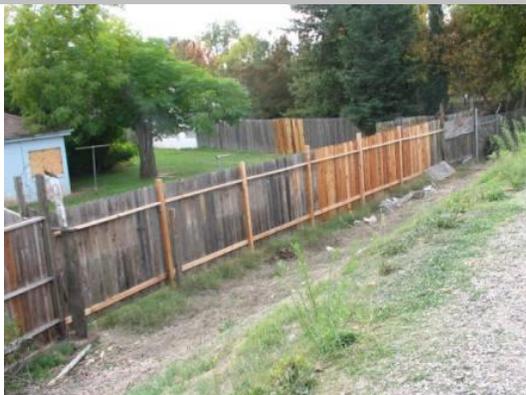
Photo 1 of 1 : FA\_2014\_NA0001\_51\_13\_20141001\_00011.jpg

LM Start	<b>1.41</b>	Rating **	U	Issue No.	<b>13</b>
LM End	<b>1.41</b>	Issue Type +	En	Location *	LS
Category	Earthen Levee		GPS Latitude/Longitude		
			Start	End	
Item	Encroachments		38.626155 °	38.626155 °	
			-121.444250 °	-121.444250 °	
DWR ID	DWR_NA0001_01_s_2012_13				
Action/Comments					
Fence Inspector Comments: Wooden fence with barbed wire is built within 10-ft of levee toe. 04/13/2011 Fence has blown over and now partially rests on the levee. Fall insp 2011 fence has been rebuilt in same location, within 10' of levee toe.

11/17/2011 New wooden privacy fence built within 15' of the levee toe.

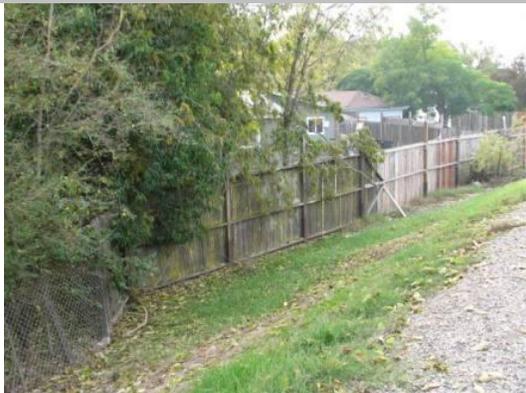
Photo 1 of 1 : FA\_2014\_NA0001\_51\_12\_20141001\_00010.jpg

LM Start	<b>1.42</b>	Rating **	U	Issue No.	<b>12</b>
LM End	<b>1.42</b>	Issue Type +	En	Location *	LS
Category	Earthen Levee		GPS Latitude/Longitude		
			Start	End	
Item	Encroachments		38.626212 °	38.626212 °	
			-121.444082 °	-121.444082 °	
DWR ID	DWR_NA0001_01_s_2012_12				
Action/Comments					
Fence Inspector Comments: Dog-eared wooden fence is built near the levee slope.

11/17/2011 Wooden privacy fence built within 15' of the levee toe.

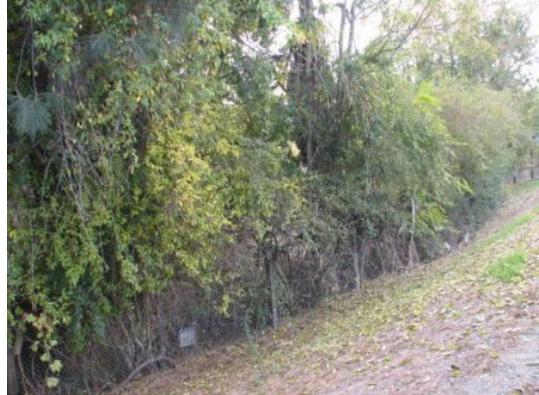
Photo 1 of 1 : FA\_2014\_NA0001\_51\_177\_20141001\_00043.jpg

LM Start	<b>1.43</b>	Rating **	U	Issue No.	<b>177</b>
LM End	<b>1.43</b>	Issue Type +	En	Location *	LS
Category	Earthen Levee		GPS Latitude/Longitude		
			Start	End	
Item	Vegetation		38.626429 °	38.626429 °	
			-121.443835 °	-121.443835 °	
DWR ID	DWR_NA0001_01_s_2012_177				
Action/Comments					
Landscaping Inspector Comments: Thick vegetation at the toe.

11/17/2011 Thick vegetation at the levee toe.

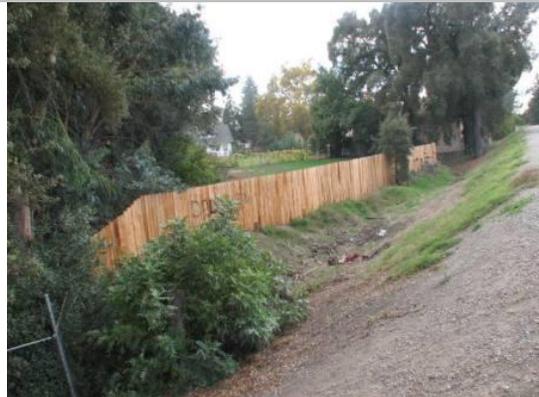
Photo 1 of 1 : FA\_2014\_NA0001\_51\_176\_20141001\_00042.jpg

LM Start	<b>1.48</b>	Rating **	U	Issue No.	<b>176</b>
LM End	<b>1.48</b>	Issue Type +	En	Location *	LS
Category	Earthen Levee		GPS Latitude/Longitude		
			Start	End	
Item	Encroachments		38.626881 °	38.626881 °	
			-121.443253 °	-121.443253 °	
DWR ID	DWR_NA0001_01_s_2012_176				
Action/Comments					
Fence Inspector Comments: Wooden privacy fence within 10' of the levee toe.

11/17/2011 Wooden privacy fence built within 15' of the levee toe.

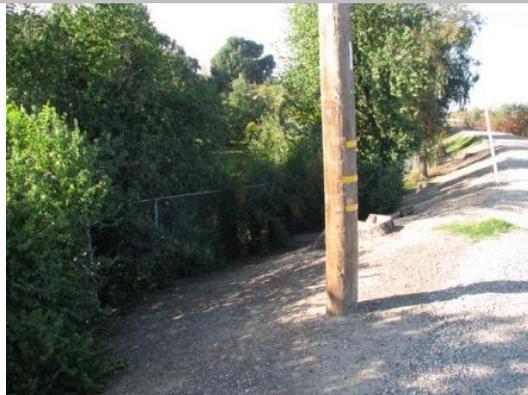
Photo 1 of 1 : FA\_2014\_NA0001\_51\_35\_20141001\_00027.jpg

LM Start	<b>1.54</b>	Rating **	M	Issue No.	<b>35</b>
LM End	<b>1.54</b>	Issue Type +	En	Location *	LS
Category	Earthen Levee		GPS Latitude/Longitude		
			Start	End	
Item	Vegetation		38.627281 °	38.627281 °	
			-121.442203 °	-121.442203 °	
DWR ID	DWR_NA0001_01_s_2012_35				
Action/Comments					
Landscaping Inspector Comments: Bushes and trees along chain link fence block access and visibility.

Fall 2009 photo:Vegetation obstructing visibility near levee slope.

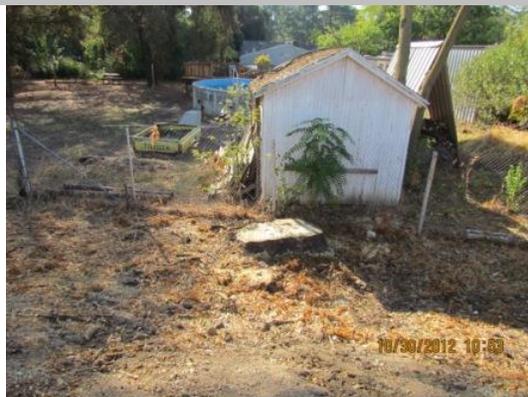
Photo 1 of 1 : FA\_2014\_NA0001\_51\_31\_20141001\_00025.jpg

LM Start	<b>1.59</b>	Rating **	N	Issue No.	<b>31</b>
LM End	<b>1.59</b>	Issue Type +	Ma	Location *	LS
Category	Earthen Levee		GPS Latitude/Longitude		
			Start	End	
Item	Trim / Thin Trees		38.627335 °	38.627335 °	
			-121.441172 °	-121.441172 °	
DWR ID	DWR_NA0001_01_f_2012_31				
Action/Comments					
Tree stumps.

View of large tree stump at levee toe.

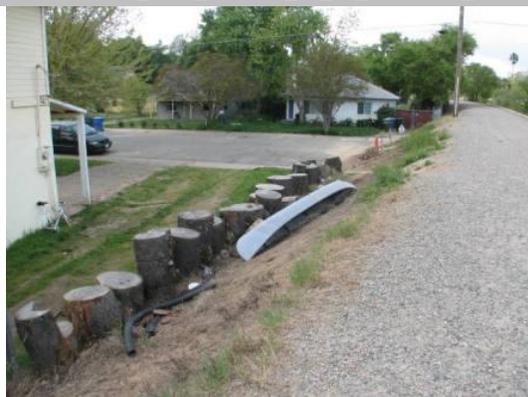
Photo 1 of 1 : FA\_2014\_NA0001\_51\_37\_20141001\_00028.jpg

LM Start	<b>1.59</b>	Rating **	M	Issue No.	<b>37</b>
LM End	<b>1.59</b>	Issue Type +	En	Location *	LS
Category	Earthen Levee		GPS Latitude/Longitude		
			Start	End	
Item	Encroachments		38.627215 °	38.627215 °	
			-121.441218 °	-121.441218 °	
DWR ID	DWR_NA0001_01_s_2012_37				
Action/Comments					
Debris Inspector Comments: Wood rounds and some pieces of pipe may be being stored on levee, need to be removed.

04/13/2011 Items appear to be stored on levee, need to be removed.

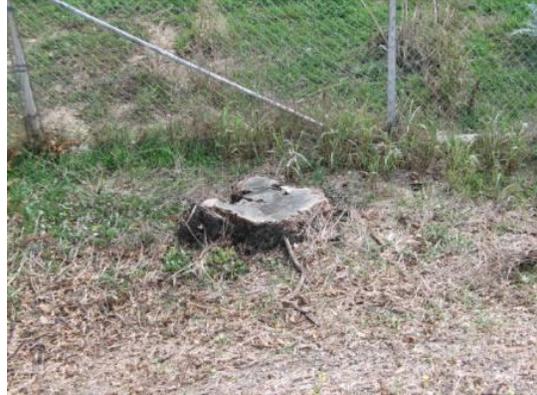
Photo 1 of 1 : FA\_2014\_NA0001\_51\_173\_20141001\_00040.jpg

LM Start	<b>1.65</b>	Rating **	N	Issue No.	<b>173</b>
LM End	<b>1.65</b>	Issue Type +	Ma	Location *	LS
Category	Earthen Levee		GPS Latitude/Longitude		
			Start	End	
Item	Trim / Thin Trees		38.627297 °	38.627297 °	
			-121.440188 °	-121.440188 °	
DWR ID	DWR_NA0001_01_s_2012_173				
Action/Comments					
Tree stumps. Inspector Comments: Large stump at levee toe.

11/17/2011 Stump at levee toe.

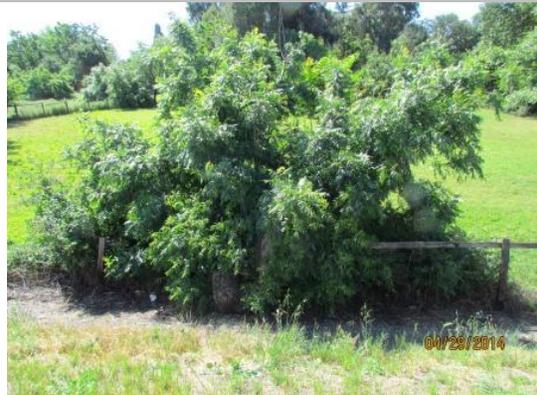
Photo 1 of 1 : FA\_2014\_NA0001\_51\_48\_20141001\_00030.jpg

LM Start	<b>1.69</b>	Rating **	A/W	Issue No.	<b>48</b>
LM End	<b>1.69</b>	Issue Type +	Ma	Location *	LS
Category	Earthen Levee		GPS Latitude/Longitude		
			Start	End	
Item	Vegetation		38.627594 °	38.627594 °	
			-121.439540 °	-121.439540 °	
DWR ID	DWR_NA0001_01_s_2014_48				
Action/Comments					
Trees / Woody Vegetation Inspector Comments: Tree obstructing visibility and access.

View of the overgrown tree at the landside levee toe.

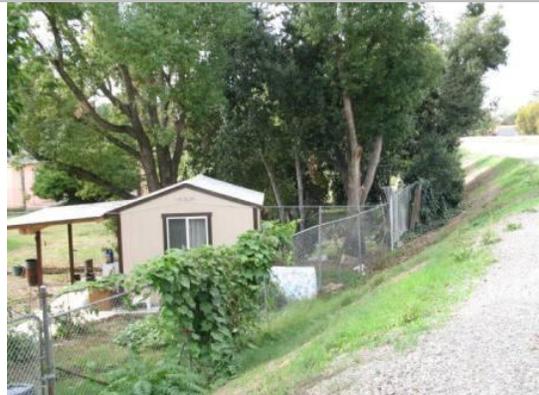
Photo 1 of 1 : FA\_2014\_NA0001\_51\_169\_20141001\_00038.jpg

LM Start	<b>1.82</b>	Rating **	U	Issue No.	<b>169</b>
LM End	<b>1.82</b>	Issue Type +	En	Location *	LS
Category	Earthen Levee		GPS Latitude/Longitude		
			Start	End	
Item	Encroachments		38.627914 °	38.627914 °	
			-121.437263 °	-121.437263 °	
DWR ID	DWR_NA0001_01_s_2012_169				
Action/Comments					
Building Inspector Comments: Shed on concrete pad within 10' of the levee toe.

11/17/2011 Wooden shed on concrete pad built within 15' of levee toe.

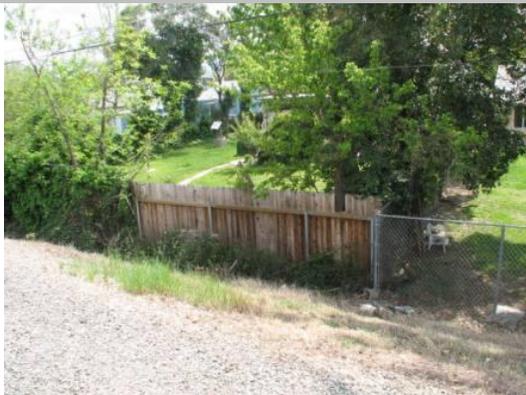
Photo 1 of 1 : FA\_2014\_NA0001\_51\_9\_20141001\_00008.jpg

LM Start	<b>1.83</b>	Rating **	M	Issue No.	<b>9</b>
LM End	<b>1.83</b>	Issue Type +	En	Location *	LS
Category	Earthen Levee		GPS Latitude/Longitude		
			Start	End	
Item	Encroachments		38.627880 °	38.627880 °	
			-121.437368 °	-121.437368 °	
DWR ID	DWR_NA0001_01_s_2012_9				
Action/Comments					
Fence Inspector Comments: Dog-eared wooden fence is built near the levee slope and has partially fallen. Bushes are overgrown. Fence has fallen over. Portion of the fence has been replaced.

04/13/2011 Portion of fence has been replaced, assume that this is the portion that fell down and was referenced in the fall '10 inspection.

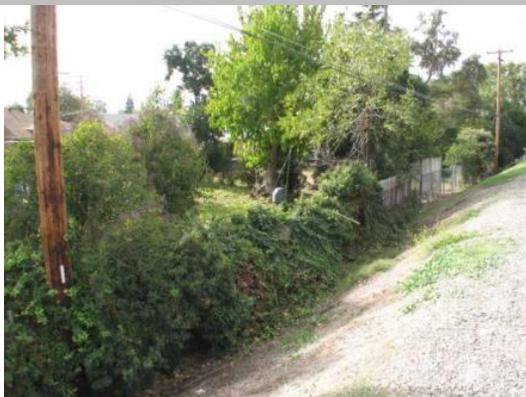
Photo 1 of 1 : FA\_2014\_NA0001\_51\_8\_20141001\_00007.jpg

LM Start	<b>1.85</b>	Rating **	M	Issue No.	<b>8</b>
LM End	<b>1.85</b>	Issue Type +	En	Location *	LS
Category	Earthen Levee		GPS Latitude/Longitude		
			Start	End	
Item	Vegetation		38.627889 °	38.627889 °	
			-121.436638 °	-121.436638 °	
DWR ID	DWR_NA0001_01_s_2012_8				
Action/Comments					
Landscaping Inspector Comments: Ivy, trees and other landscaping growing on a wooden privacy fence are obstructing visibility.

11/17/2011 Landscaping vegetation growth on the fence is obstructive.

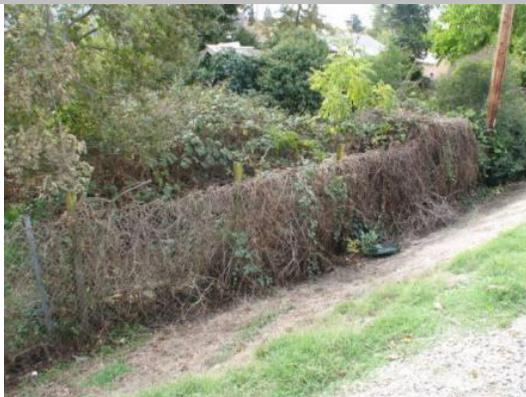
Photo 1 of 1 : FA\_2014\_NA0001\_51\_7\_20141001\_00006.jpg

LM Start	<b>1.86</b>	Rating **	U	Issue No.	<b>7</b>
LM End	<b>1.86</b>	Issue Type +	En	Location *	LS
Category	Earthen Levee		GPS Latitude/Longitude		
			Start	End	
Item	Vegetation		38.627889 °	38.627889 °	
			-121.436454 °	-121.436454 °	
DWR ID	DWR_NA0001_01_s_2012_7				
Action/Comments					
Landscaping Inspector Comments: Metal sided shelter, blackberries and cherry trees are obstructive.

11/17/2011 Blackberries growing on fence are obstructive.

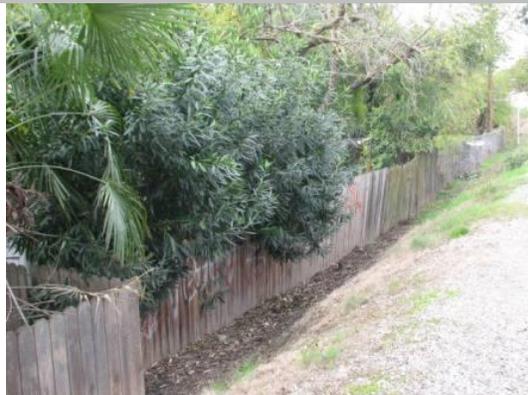
Photo 1 of 1 : FA\_2014\_NA0001\_51\_6\_20141001\_00005.jpg

LM Start	<b>1.92</b>	Rating **	U	Issue No.	<b>6</b>
LM End	<b>1.92</b>	Issue Type +	En	Location *	LS
Category	Earthen Levee		GPS Latitude/Longitude		
			Start	End	
Item	Encroachments		38.627725 °	38.627725 °	
			-121.435715 °	-121.435715 °	
DWR ID	DWR_NA0001_01_s_2012_6				
Action/Comments					
Fence Inspector Comments: Dog-eared wooden fence is built within 10-ft of the levee slope.

11/17/2011 Wooden privacy fence built at the levee toe.

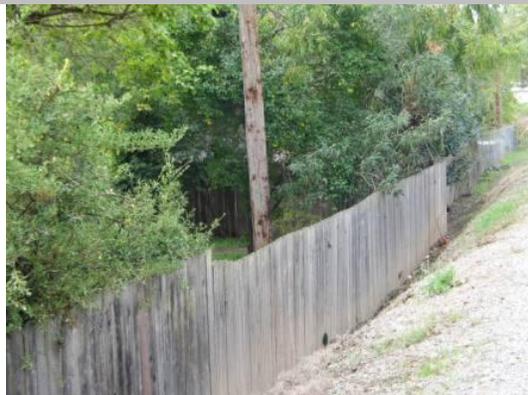
Photo 1 of 1 : FA\_2014\_NA0001\_51\_5\_20141001\_00004.jpg

LM Start	<b>1.93</b>	Rating **	U	Issue No.	<b>5</b>
LM End	<b>1.93</b>	Issue Type +	En	Location *	LS
Category	Earthen Levee		GPS Latitude/Longitude		
			Start	End	
Item	Encroachments		38.627680 °	38.627680 °	
			-121.435555 °	-121.435555 °	
DWR ID	DWR_NA0001_01_s_2012_5				
Action/Comments					
Fence Inspector Comments: Dog-eared wooden fence is built against the levee slope.

11/17/2011 Wooden privacy fence built at the levee toe.

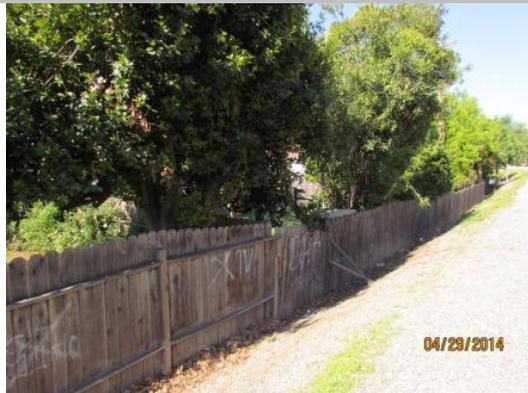
Photo 1 of 1 : FA\_2014\_NA0001\_51\_4\_20141001\_00003.jpg

LM Start	<b>1.93</b>	Rating **	U	Issue No.	<b>4</b>
LM End	<b>1.93</b>	Issue Type +	En	Location *	LS
Category	Earthen Levee		GPS Latitude/Longitude		
			Start	End	
Item	Encroachments		38.627683 °	38.627683 °	
			-121.435298 °	-121.435298 °	
DWR ID	DWR_NA0001_01_s_2012_4				
Action/Comments					
Fence Inspector Comments: Wooden fence and landscaping completely block visibility.

View of the wooden fence at the landside levee toe.

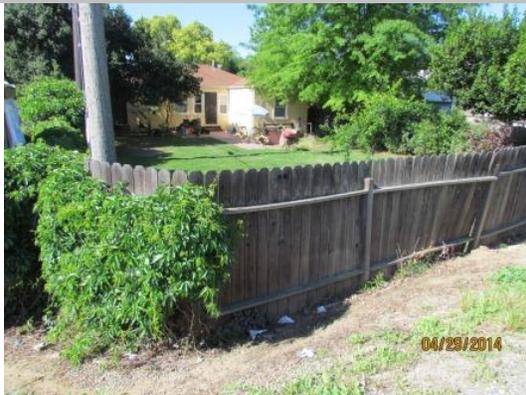
Photo 1 of 1 : FA\_2014\_NA0001\_51\_3\_20141001\_00002.jpg

LM Start	<b>1.93</b>	Rating **	<b>U</b>	Issue No.	<b>3</b>
LM End	<b>1.93</b>	Issue Type +	<b>En</b>	Location *	<b>LS</b>
Category	Earthen Levee		GPS Latitude/Longitude		
			Start	End	
Item	Encroachments		38.627658 °	38.627658 °	
			-121.435192 °	-121.435192 °	
DWR ID	DWR_NA0001_01_s_2012_3				
Action/Comments					
Fence Inspector Comments: Dog-eared wooden fence is built against the levee slope.

View of the fence at the landside levee toe.

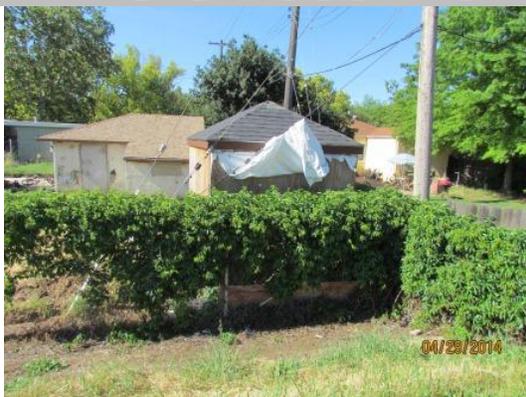
Photo 1 of 1 : FA\_2014\_NA0001\_51\_30\_20141001\_00024.jpg

LM Start	<b>1.94</b>	Rating **	<b>U</b>	Issue No.	<b>30</b>
LM End	<b>1.94</b>	Issue Type +	<b>En</b>	Location *	<b>LS</b>
Category	Earthen Levee		GPS Latitude/Longitude		
			Start	End	
Item	Encroachments		38.627646 °	38.627646 °	
			-121.435151 °	-121.435151 °	
DWR ID	DWR_NA0001_01_s_2012_30				
Action/Comments					
Building Inspector Comments: Concrete pad and wooden frame structure is being built within 15-ft of levee toe.

Building on concrete pad within 15 feet of the landside levee toe.

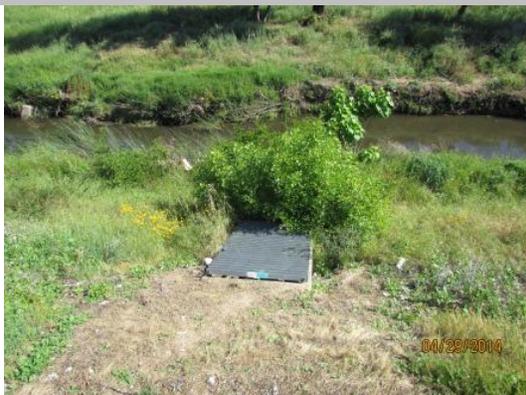
Photo 1 of 1 : FA\_2014\_NA0001\_51\_168\_20141001\_00037.jpg

LM Start	<b>1.95</b>	Rating **	<b>A/W</b>	Issue No.	<b>168</b>
LM End	<b>1.95</b>	Issue Type +	<b>En</b>	Location *	<b>WS</b>
Category	Earthen Levee		GPS Latitude/Longitude		
			Start	End	
Item	Encroachments		38.627565 °	38.627565 °	
			-121.434818 °	-121.434818 °	
DWR ID	DWR_NA0001_01_s_2012_168				
Action/Comments					
Pipe Inspector Comments: Flap gate is blocked by tulies growing in the outfall structure. Gate is blocked in the closed position.

View of the vegetation obstructing the outfall.

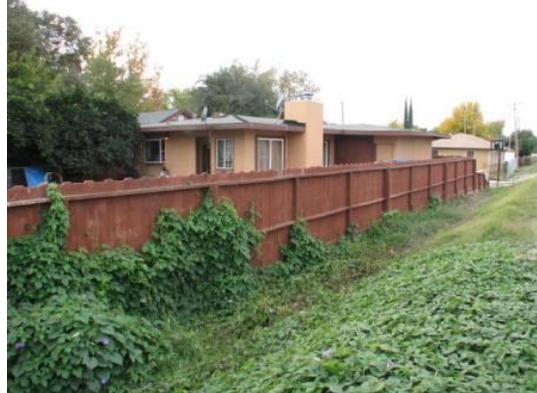
Photo 1 of 1 : FA\_2014\_NA0001\_51\_167\_20141001\_00036.jpg

LM Start	<b>1.98</b>	Rating **	U	Issue No.	<b>167</b>
LM End	<b>1.98</b>	Issue Type +	En	Location *	LS
Category	Earthen Levee		GPS Latitude/Longitude		
			Start	End	
Item	Encroachments		38.627433 °	38.627433 °	
			-121.434341 °	-121.434341 °	
DWR ID	DWR_NA0001_01_s_2012_167				
Action/Comments					
Fence Inspector Comments: Wooden privacy fence within 10' of the levee toe.

11/17/2011 Wooden privacy fence built at the levee toe.

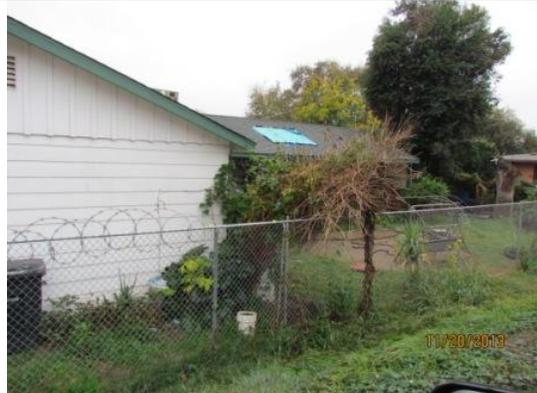
Photo 1 of 1 : FA\_2014\_NA0001\_51\_1\_20141001\_00001.jpg

LM Start	<b>2.00</b>	Rating **	M	Issue No.	<b>1</b>
LM End	<b>2.00</b>	Issue Type +	En	Location *	LS
Category	Earthen Levee		GPS Latitude/Longitude		
			Start	End	
Item	Vegetation		38.627318 °	38.627318 °	
			-121.434208 °	-121.434208 °	
DWR ID	DWR_NA0001_01_s_2012_1				
Action/Comments					
Landscaping Inspector Comments: Vine growing on fence and slope blocks visibility.

View of the fence and landscaping at the landside levee toe.

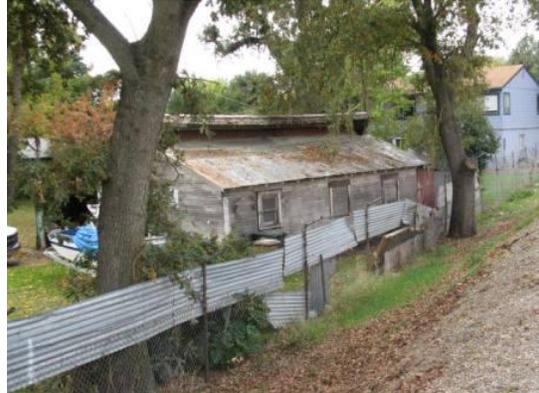
Photo 1 of 1 : FA\_2014\_NA0001\_51\_28\_20141001\_00022.jpg

LM Start	<b>2.04</b>	Rating **	<b>U</b>	Issue No.	<b>28</b>
LM End	<b>2.04</b>	Issue Type +	<b>En</b>	Location *	<b>LS</b>
Category	Earthen Levee		GPS Latitude/Longitude		
			Start	End	
Item	Encroachments		38.627257 °	38.627257 °	
			-121.433327 °	-121.433327 °	
DWR ID	DWR_NA0001_01_s_2012_28				
Action/Comments					
Building Inspector Comments: Large wooden building behind corrugated metal covered fence is within 10-ft of levee toe.

11/17/2011 Wooden structure is within 15' of the levee toe.

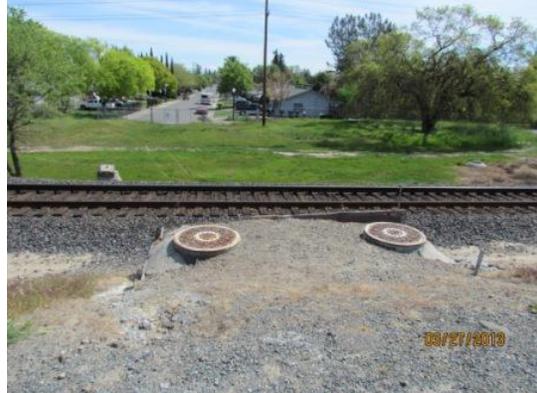
Photo 1 of 1 : FA\_2014\_NA0001\_52\_7\_20141001\_00003.jpg

LM Start	<b>0.77</b>	Rating **	A/W	Issue No.	<b>7</b>
LM End	<b>0.77</b>	Issue Type +	Ob	Location *	CR
Category	Earthen Levee			GPS Latitude/Longitude	
				Start	End
Item	Encroachments			38.612234 °	38.612234 °
				-121.466633 °	-121.466633 °
DWR ID	DWR_NA0001_02_s_2012_7				
Action/Comments					
Pipe Inspector Comments: Manhole access to pipes on hinge point.

View of the pipe access at the landside levee hinge.

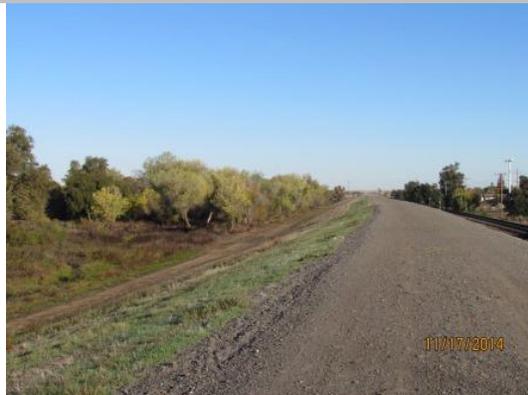
Photo 1 of 1 : FA\_2014\_NA0001\_52\_24\_20141119\_00013.jpg

LM Start	<b>0.82</b>	Rating **	A	Issue No.	<b>24</b>
LM End	<b>0.82</b>	Issue Type +	Ma	Location *	WS
Category	Earthen Levee		GPS Latitude/Longitude		
			Start	End	
Item	Vegetation		38.613285 °	38.613285 °	
			-121.466542 °	-121.466542 °	
DWR ID	DWR_NA0001_02_f_2014_24				
Action/Comments					
Control annual grass and weeds on the levee slopes and easements.

View of acceptable vegetation control.

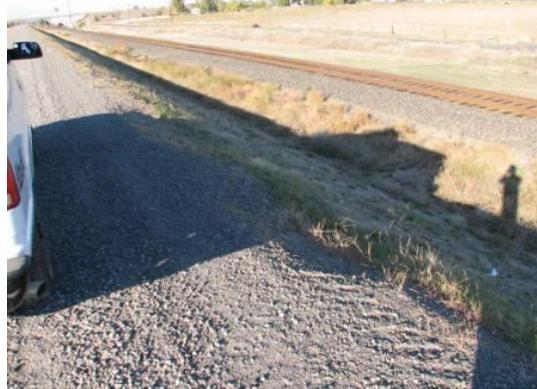
Photo 2 of 2 : FA\_2014\_NA0001\_52\_150\_20141001\_00007.jpg

LM Start	<b>2.33</b>	Rating **	A/W	Issue No.	<b>150 (cont)</b>
LM End	<b>2.33</b>	Issue Type +	Ob	Location *	LS
Category	Earthen Levee		GPS Latitude/Longitude		
			Start	End	
Item	Erosion / Bank Caving		38.634446 °	38.634446 °	
			-121.470573 °	-121.470573 °	
DWR ID	DWR_NA0001_02_s_2012_150				
Action/Comments					
Note and monitor erosion site. Inspector Comments: Monitor erosion at this location. Also noted in USACE PI.

11/16/2011 Depressions present on levee slope.

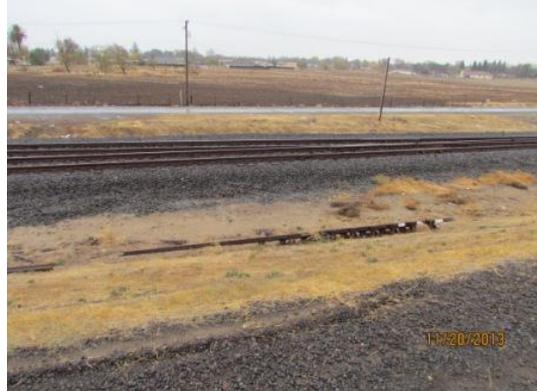
Photo 1 of 1 : FA\_2014\_NA0001\_52\_11\_20141001\_00005.jpg

LM Start	<b>2.52</b>	Rating **	M	Issue No.	<b>11</b>
LM End	<b>2.52</b>	Issue Type +	En	Location *	LS
Category	Earthen Levee		GPS Latitude/Longitude		
			Start	End	
Item	Encroachments		38.637177 °	38.637177 °	
			-121.471076 °	-121.471076 °	
DWR ID	DWR_NA0001_02_f_2013_11				
Action/Comments					
Material Inspector Comments: Railroad rails on landside levee slope.

View of the rails at the landside levee toe.

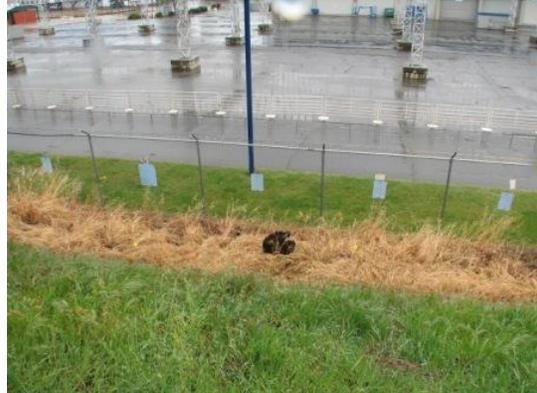
Photo 1 of 1 : FA\_2014\_NA0001\_490\_11\_20141001\_00003.jpg

LM Start	<b>0.74</b>	Rating **	N	Issue No.	<b>11</b>
LM End	<b>0.74</b>	Issue Type +	Ma	Location *	LS
Category	Earthen Levee		GPS Latitude/Longitude		
			Start	End	
Item	Trim / Thin Trees		38.589359 °	38.589359 °	
			-121.430990 °	-121.430990 °	
DWR ID	DWR_NA0001_03_s_2012_11				
Action/Comments					
Tree stumps. Inspector Comments: Tree stump >2" Dia.

Tree stump on levee slope greater than 2" Dia.

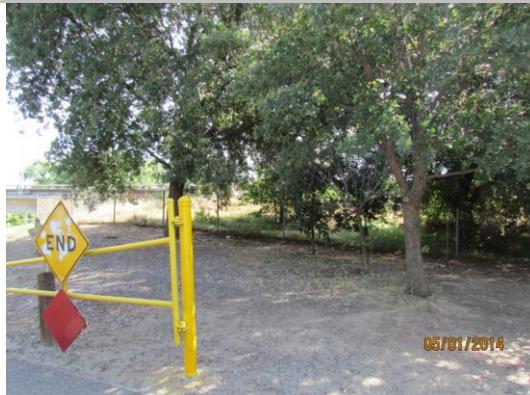
Photo 1 of 1 : FA\_2014\_NA0001\_55\_177\_20141001\_00155.jpg

LM Start	<b>0.23</b>	Rating **	M	Issue No.	<b>177</b>
LM End	<b>0.23</b>	Issue Type +	En	Location *	CR
Category	Earthen Levee			GPS Latitude/Longitude	
				Start	End
Item	Vegetation			38.598980 °	38.598980 °
				-121.504773 °	-121.504773 °
DWR ID	DWR_NA0001_04_s_2012_177				
Action/Comments					
Landscaping Inspector Comments: Landscaping on levee crown at overpass.

View of the landscaping on the levee crown.

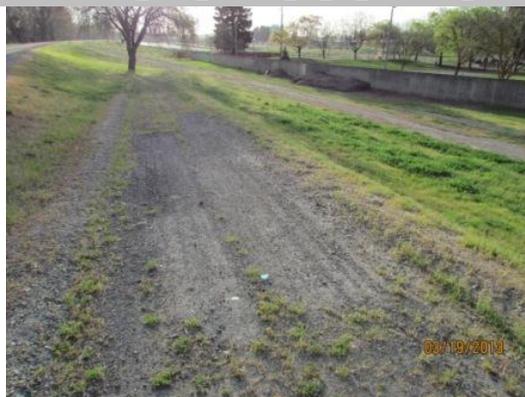
Photo 1 of 1 : FA\_2014\_NA0001\_55\_67\_20141001\_00052.jpg

LM Start	<b>0.85</b>	Rating **	M	Issue No.	<b>67</b>
LM End	<b>0.85</b>	Issue Type +	En	Location *	LS
Category	Earthen Levee		GPS Latitude/Longitude		
			Start	End	
Item	Encroachments		38.601688 °	38.601688 °	
			-121.494286 °	-121.494286 °	
DWR ID	DWR_NA0001_04_s_2013_67				
Action/Comments					
Ramp Inspector Comments: Old bicycle ramp has not been properly graded.

View of improperly graded bicycle ramp.

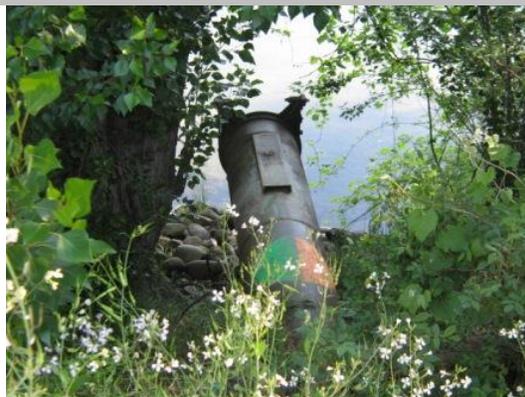
Photo 1 of 1 : FA\_2014\_NA0001\_55\_244\_20141001\_00189.jpg

LM Start	<b>0.94</b>	Rating **	A/W	Issue No.	<b>244</b>
LM End	<b>0.94</b>	Issue Type +	En	Location *	CR
Category	Earthen Levee		GPS Latitude/Longitude		
			Start	End	
Item	Encroachments		38.601642 °	38.601642 °	
			-121.492620 °	-121.492620 °	
DWR ID	DWR_NA0001_04_s_2012_244				
Action/Comments					
Pipe Inspector Comments: Printing shop discharge.

Discharge pipe from printing shop into American River.

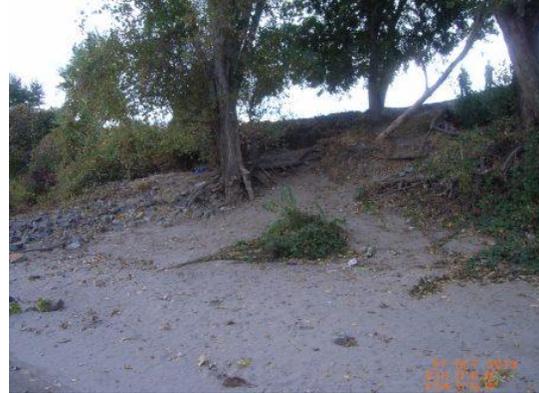
Photo 1 of 1 : FA\_2014\_NA0001\_55\_7\_20141001\_00007.jpg

LM Start	<b>1.62</b>	Rating **	M	Issue No.	<b>7</b>
LM End	<b>1.62</b>	Issue Type +	Ma	Location *	WS
Category	Supplemental			GPS Latitude/Longitude	
				Start	End
Item	USACE Erosion Survey			38.599095 °	38.598791 °
				-121.480337 °	-121.479799 °
DWR ID	DWR_NA0001_04_f_2014_7				
Action/Comments					
Inspector Comments: 2012 - Located just downstream of older repair. Failing rock at the upstream end. Erosion of the bank has exposed large tree roots. 2013: No observed changes. [2013 Site ID: LAR_1-8_L]

USACE 2013 Photo #1

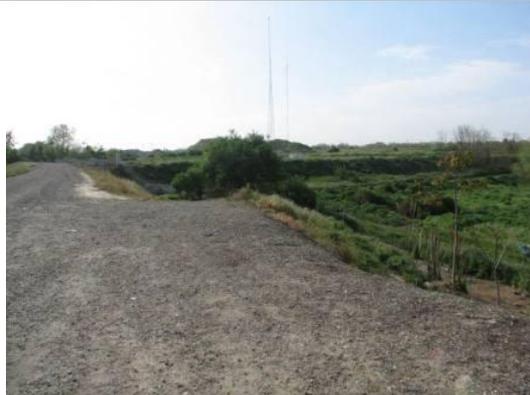
Photo 1 of 1 : FA\_2014\_NA0001\_55\_184\_20141001\_00160.jpg

LM Start	<b>2.50</b>	Rating **	M	Issue No.	<b>184</b>
LM End	<b>2.50</b>	Issue Type +	Ma	Location *	LS
Category	Earthen Levee		GPS Latitude/Longitude		
			Start	End	
Item	Vegetation		38.589590 °	38.589590 °	
			-121.470524 °	-121.470524 °	
DWR ID	DWR_NA0001_04_s_2012_184				
Action/Comments					
Elderberries are blocking visibility and flood fight capability.

04/14/2011 Elderberry bush prevents visibility of levee toe.

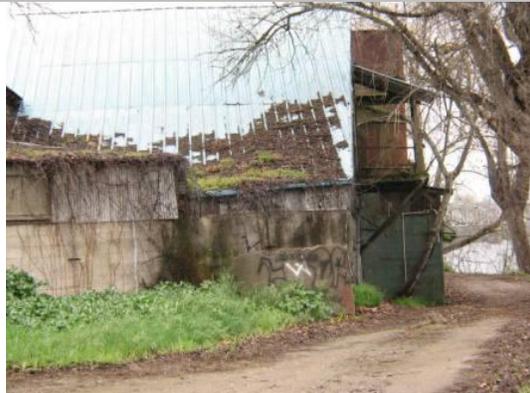
Photo 1 of 1 : FA\_2014\_NA0001\_55\_2\_20141001\_00002.jpg

LM Start	<b>2.68</b>	Rating **	U	Issue No.	<b>2</b>
LM End	<b>2.68</b>	Issue Type +	En	Location *	LS
Category	Earthen Levee		GPS Latitude/Longitude		
			Start	End	
Item	Encroachments		38.588913 °	38.588913 °	
			-121.467210 °	-121.467210 °	
DWR ID	DWR_NA0001_04_s_2012_2				
Action/Comments					
Building Inspector Comments: Bell Marine

03/16/2012 Structure on Bell Marine property.

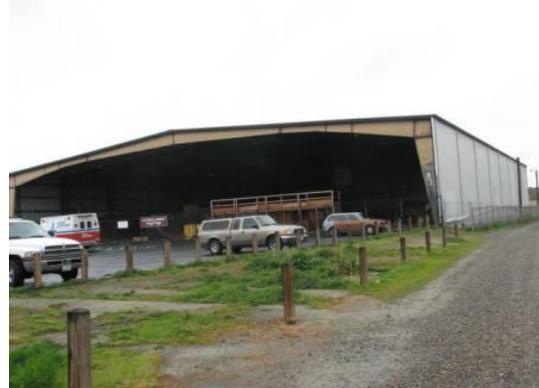
Photo 1 of 1 : FA\_2014\_NA0001\_55\_5\_20141001\_00005.jpg

LM Start	<b>2.92</b>	Rating **	U	Issue No.	<b>5</b>
LM End	<b>2.96</b>	Issue Type +	En	Location *	LS
Category	Earthen Levee		GPS Latitude/Longitude		
			Start	End	
Item	Encroachments		38.587251 °	38.587318 °	
			-121.463237 °	-121.462513 °	
DWR ID	DWR_NA0001_04_s_2012_5				
Action/Comments					
Building Inspector Comments: City of Sacramento building. Building is now Sutter's Landing Skate Park.

03/16/2012 Sutter's Landing Skate Park.

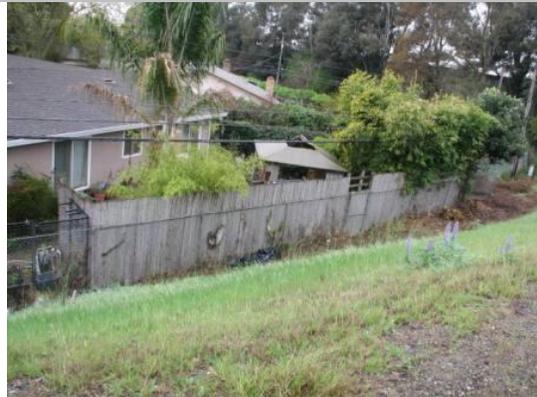
Photo 1 of 2 : FA\_2014\_NA0001\_55\_8\_20141001\_00008.jpg

LM Start	<b>3.88</b>	Rating **	U	Issue No.	<b>8</b>
LM End	<b>3.88</b>	Issue Type +	En	Location *	LS
Category	Earthen Levee			GPS Latitude/Longitude	
				Start	End
Item	Encroachments			38.586327 °	38.586327 °
				-121.447373 °	-121.447373 °
DWR ID	DWR_NA0001_04_s_2012_8				
Action/Comments					
Fence Inspector Comments: Bamboo privacy fence within 10-ft of the landside toe obstructs visibility.

03/16/2012 Wood privacy fence completely obstructs access and visibility.

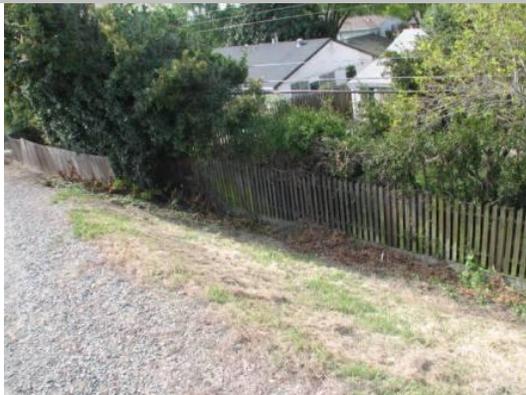
Photo 1 of 1 : FA\_2014\_NA0001\_55\_6\_20141001\_00006.jpg

LM Start	<b>3.90</b>	Rating **	U	Issue No.	<b>6</b>
LM End	<b>3.90</b>	Issue Type +	En	Location *	LS
Category	Earthen Levee		GPS Latitude/Longitude		
			Start	End	
Item	Encroachments		38.586154 °	38.586154 °	
			-121.447115 °	-121.447115 °	
DWR ID	DWR_NA0001_04_s_2012_6				
Action/Comments					
Fence Inspector Comments: Privacy fence within 10-ft of the landside toe obstructs visibility. 04/14/2011 Landscaping has been removed.

04/14/2011 Landscaping, which was a Fall inspection issue has been removed, however wooden fence is still obstructing access and visibility.

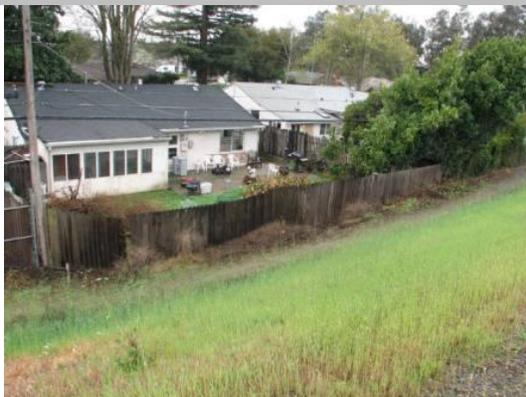
Photo 1 of 1 : FA\_2014\_NA0001\_55\_9\_20141001\_00010.jpg

LM Start	<b>3.91</b>	Rating **	U	Issue No.	<b>9</b>
LM End	<b>3.91</b>	Issue Type +	En	Location *	LS
Category	Earthen Levee		GPS Latitude/Longitude		
			Start	End	
Item	Encroachments		38.586047 °	38.586047 °	
			-121.446975 °	-121.446975 °	
DWR ID	DWR_NA0001_04_s_2012_9				
Action/Comments					
Fence Inspector Comments: Wooden privacy fence on the levee slope obstructs access and visibility.

03/16/2012 Wood privacy fence completely obstructs access and visibility.

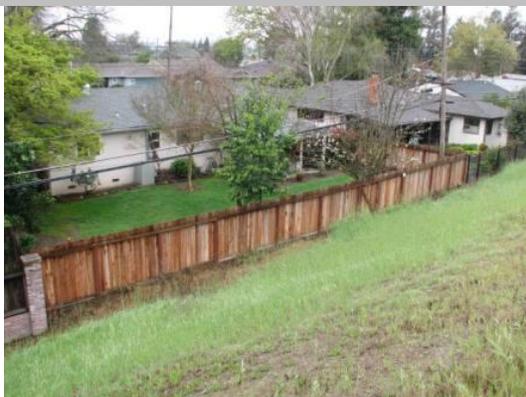
Photo 1 of 1 : FA\_2014\_NA0001\_55\_11\_20141001\_00011.jpg

LM Start	<b>3.95</b>	Rating **	U	Issue No.	<b>11</b>
LM End	<b>3.95</b>	Issue Type +	En	Location *	LS
Category	Earthen Levee		GPS Latitude/Longitude		
			Start	End	
Item	Encroachments		38.585639 °	38.585639 °	
			-121.446451 °	-121.446451 °	
DWR ID	DWR_NA0001_04_s_2012_11				
Action/Comments					
Fence Inspector Comments: Privacy fence and landscaping within 10-ft of the levee toe obstruct access and visibility.

03/16/2012 Wood privacy fence completely obstructs access and visibility.

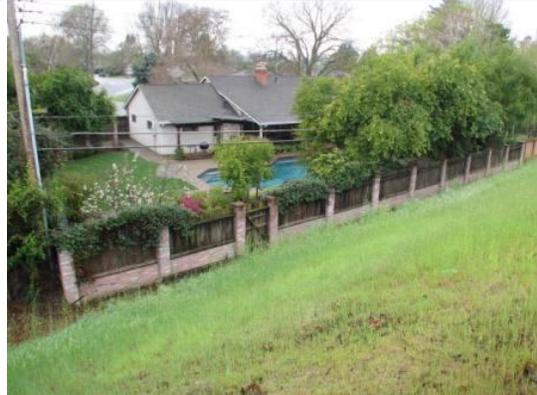
Photo 1 of 1 : FA\_2014\_NA0001\_55\_12\_20141001\_00012.jpg

LM Start	<b>3.96</b>	Rating **	U	Issue No.	<b>12</b>
LM End	<b>3.96</b>	Issue Type +	En	Location *	LS
Category	Earthen Levee		GPS Latitude/Longitude		
			Start	End	
Item	Encroachments		38.585496 °	38.585496 °	
			-121.446309 °	-121.446309 °	
DWR ID	DWR_NA0001_04_s_2012_12				
Action/Comments					
Fence Inspector Comments: Privacy fence and landscaping within 10-ft of the levee toe obstruct access and visibility.

03/16/2012 Wood privacy fence completely obstructs access and visibility.

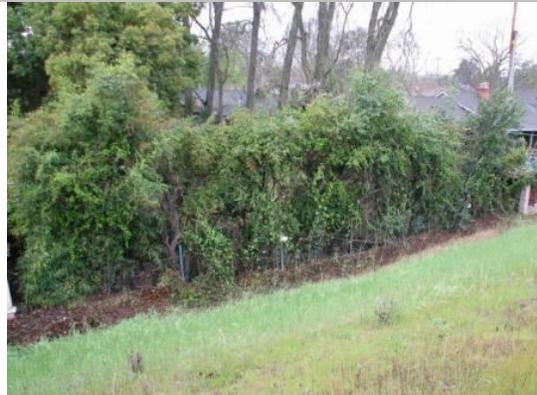
Photo 1 of 1 : FA\_2014\_NA0001\_55\_112\_20141001\_00095.jpg

LM Start	<b>3.97</b>	Rating **	U	Issue No.	<b>112</b>
LM End	<b>3.97</b>	Issue Type +	En	Location *	LS
Category	Earthen Levee		GPS Latitude/Longitude		
			Start	End	
Item	Vegetation		38.585385 °	38.585385 °	
			-121.446168 °	-121.446168 °	
DWR ID	DWR_NA0001_04_s_2012_112				
Action/Comments					
Landscaping Inspector Comments: Landscaping completely blocks visibility.

03/16/2012 Landscape obstructs visibility and access.

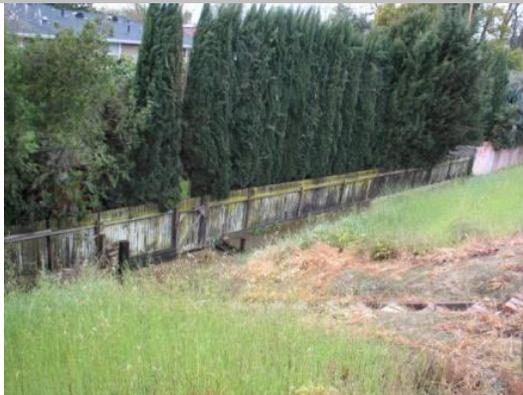
Photo 1 of 1 : FA\_2014\_NA0001\_55\_14\_20141001\_00014.jpg

LM Start	<b>4.00</b>	Rating **	U	Issue No.	<b>14</b>
LM End	<b>4.00</b>	Issue Type +	En	Location *	LS
Category	Earthen Levee		GPS Latitude/Longitude		
			Start	End	
Item	Encroachments		38.585175 °	38.585175 °	
			-121.445883 °	-121.445883 °	
DWR ID	DWR_NA0001_04_s_2012_14				
Action/Comments					
Fence Inspector Comments: Privacy fence and helix pencil shrubs planted within 10-ft of the levee toe obstruct access and visibility.

03/16/2012 Wood privacy fence completely obstructs access and visibility.

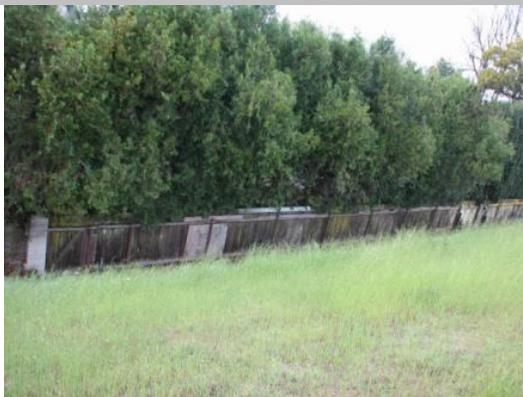
Photo 1 of 1 : FA\_2014\_NA0001\_55\_15\_20141001\_00015.jpg

LM Start	<b>4.01</b>	Rating **	U	Issue No.	<b>15</b>
LM End	<b>4.01</b>	Issue Type +	En	Location *	LS
Category	Earthen Levee		GPS Latitude/Longitude		
			Start	End	
Item	Encroachments		38.585021 °	38.585021 °	
			-121.445678 °	-121.445678 °	
DWR ID	DWR_NA0001_04_s_2012_15				
Action/Comments					
Fence Inspector Comments: Privacy fence and evergreen shrub landscaping within 10-ft of the levee toe obstruct access and visibility.

03/16/2012 Wood privacy fence completely obstructs access and visibility.

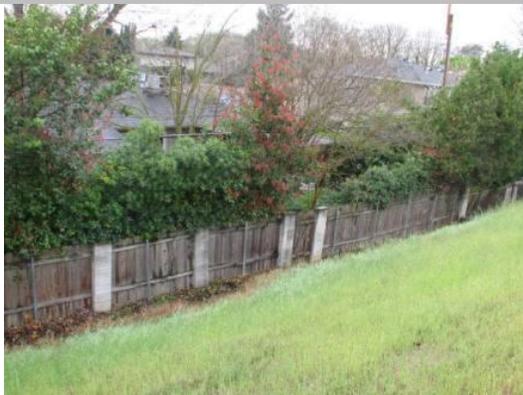
Photo 1 of 1 : FA\_2014\_NA0001\_55\_16\_20141001\_00016.jpg

LM Start	<b>4.02</b>	Rating **	U	Issue No.	<b>16</b>
LM End	<b>4.02</b>	Issue Type +	En	Location *	LS
Category	Earthen Levee		GPS Latitude/Longitude		
			Start	End	
Item	Encroachments		38.584885 °	38.584885 °	
			-121.445520 °	-121.445520 °	
DWR ID	DWR_NA0001_04_s_2012_16				
Action/Comments					
Fence Inspector Comments: Privacy fence and landscaping within 10-ft of the levee toe obstruct access and visibility.

03/16/2012 Wood privacy fence completely obstructs access and visibility.

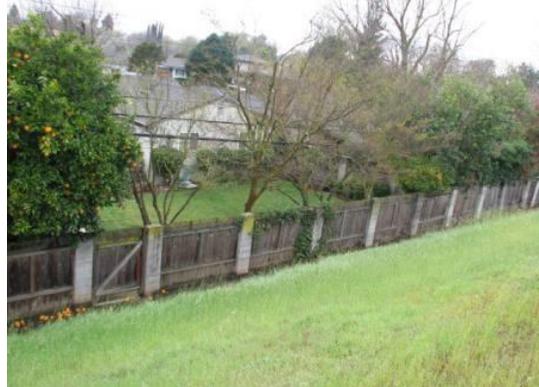
Photo 1 of 1 : FA\_2014\_NA0001\_55\_17\_20141001\_00017.jpg

LM Start	<b>4.03</b>	Rating **	U	Issue No.	<b>17</b>
LM End	<b>4.03</b>	Issue Type +	En	Location *	LS
Category	Earthen Levee		GPS Latitude/Longitude		
			Start	End	
Item	Encroachments		38.584810 °	38.584810 °	
			-121.445403 °	-121.445403 °	
DWR ID	DWR_NA0001_04_s_2012_17				
Action/Comments					
Fence Inspector Comments: Privacy fence and maple tree landscaping within 10-ft of the levee toe obstruct access and visibility.

03/16/2012 Wood privacy fence completely obstructs access and visibility.

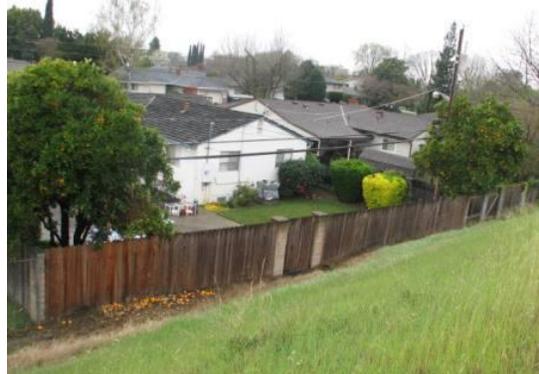
Photo 1 of 1 : FA\_2014\_NA0001\_55\_18\_20141001\_00018.jpg

LM Start	<b>4.04</b>	Rating **	U	Issue No.	<b>18</b>
LM End	<b>4.04</b>	Issue Type +	En	Location *	LS
Category	Earthen Levee		GPS Latitude/Longitude		
			Start	End	
Item	Encroachments		38.584694 °	38.584694 °	
			-121.445255 °	-121.445255 °	
DWR ID	DWR_NA0001_04_s_2012_18				
Action/Comments					
Fence Inspector Comments: Wooden fence between orange trees is within 10-ft of the levee toe.

03/16/2012 Wood privacy fence completely obstructs access and visibility.

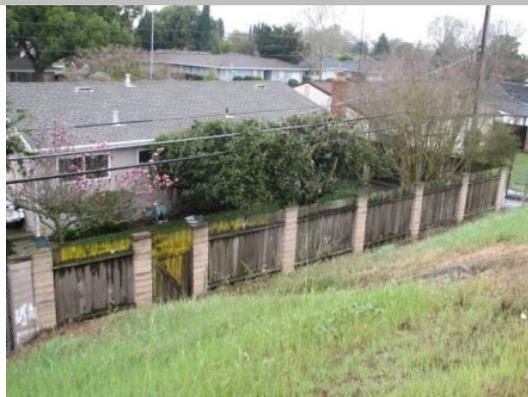
Photo 1 of 1 : FA\_2014\_NA0001\_55\_19\_20141001\_00019.jpg

LM Start	<b>4.07</b>	Rating **	U	Issue No.	<b>19</b>
LM End	<b>4.07</b>	Issue Type +	En	Location *	LS
Category	Earthen Levee		GPS Latitude/Longitude		
			Start	End	
Item	Encroachments		38.584459 °	38.584459 °	
			-121.444951 °	-121.444951 °	
DWR ID	DWR_NA0001_04_s_2012_19				
Action/Comments					
Fence Inspector Comments: Privacy fence within 10-ft of the levee toe obstruct access and visibility.

03/16/2012 Wood privacy fence completely obstructs access and visibility.

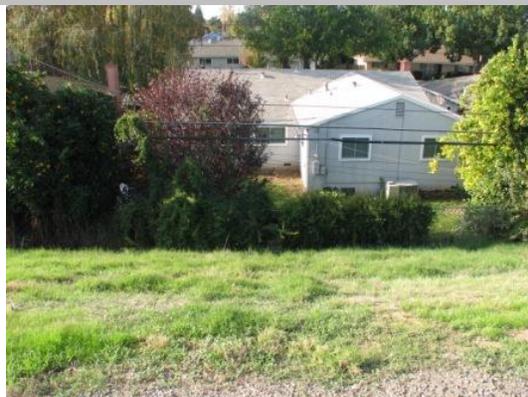
Photo 1 of 1 : FA\_2014\_NA0001\_55\_186\_20141001\_00162.jpg

LM Start	<b>4.08</b>	Rating **	M	Issue No.	<b>186</b>
LM End	<b>4.08</b>	Issue Type +	En	Location *	LS
Category	Earthen Levee		GPS Latitude/Longitude		
			Start	End	
Item	Vegetation		38.584354 °	38.584354 °	
			-121.444792 °	-121.444792 °	
DWR ID	DWR_NA0001_04_s_2012_186				
Action/Comments					
Landscaping Inspector Comments: Landscaping on cyclone fence within 10-ft of levee toe obstructs access and visibility.

Fall 2009 photo: Landscaping within 10-ft of levee toe obstructs access and visibility.

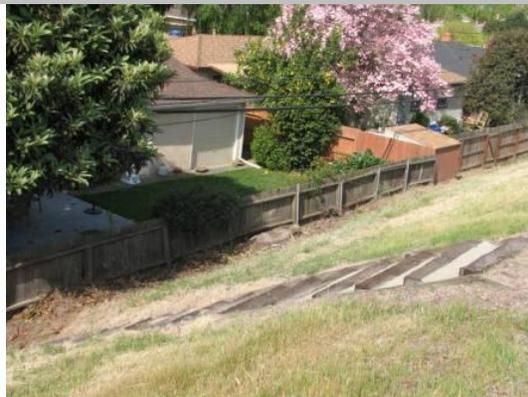
Photo 1 of 1 : FA\_2014\_NA0001\_55\_21\_20141001\_00021.jpg

LM Start	<b>4.10</b>	Rating **	U	Issue No.	<b>21</b>
LM End	<b>4.10</b>	Issue Type +	En	Location *	LS
Category	Earthen Levee		GPS Latitude/Longitude		
			Start	End	
Item	Vegetation		38.584129 °	38.584129 °	
			-121.444485 °	-121.444485 °	
DWR ID	DWR_NA0001_04_s_2012_21				
Action/Comments					
Landscaping Inspector Comments: Palms and other landscaping on levee slope, as well as the wooden privacy fence within 10-ft of the levee toe obstruct access and visibility. 04/14/2011 Palms have been removed.

04/14/2011 Palms have been removed.

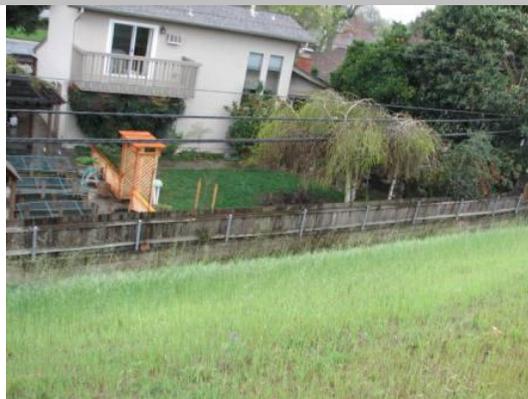
Photo 1 of 1 : FA\_2014\_NA0001\_55\_22\_20141001\_00022.jpg

LM Start	<b>4.11</b>	Rating **	U	Issue No.	<b>22</b>
LM End	<b>4.11</b>	Issue Type +	En	Location *	LS
Category	Earthen Levee		GPS Latitude/Longitude		
			Start	End	
Item	Encroachments		38.584034 °	38.584034 °	
			-121.444322 °	-121.444322 °	
DWR ID	DWR_NA0001_04_s_2012_22				
Action/Comments					
Fence Inspector Comments: Cement block and wooden fence as well as the landscape planting are within 10-ft of the levee slope and obstruct access and visibility.

03/16/2012 Wood privacy fence completely obstructs access and visibility.

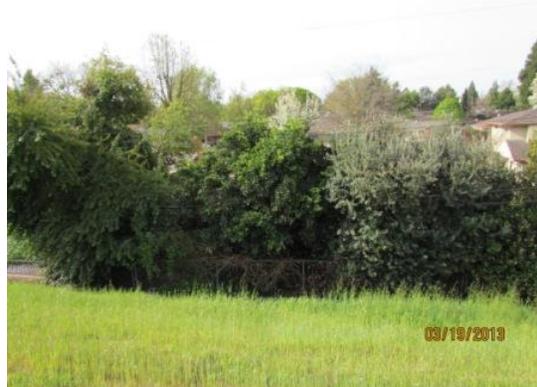
Photo 1 of 1 : FA\_2014\_NA0001\_55\_187\_20141001\_00163.jpg

LM Start	<b>4.13</b>	Rating **	M	Issue No.	<b>187</b>
LM End	<b>4.13</b>	Issue Type +	En	Location *	LS
Category	Earthen Levee		GPS Latitude/Longitude		
			Start	End	
Item	Vegetation		38.583858 °	38.583858 °	
			-121.443981 °	-121.443981 °	
DWR ID	DWR_NA0001_04_s_2012_187				
Action/Comments					
Landscaping Inspector Comments: Orange, guava and other trees and landscaping obstruct access and visibility.

View of the obstructing vegetation at levee toe.

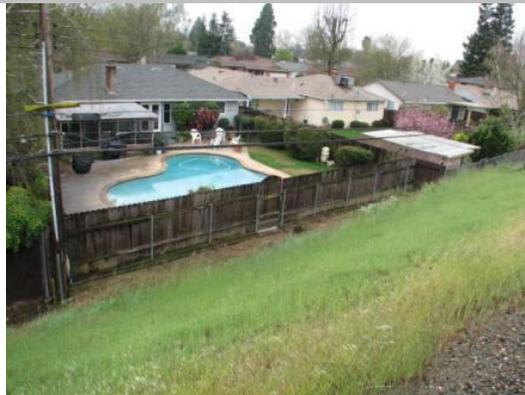
Photo 1 of 1 : FA\_2014\_NA0001\_55\_190\_20141001\_00164.jpg

LM Start	<b>4.17</b>	Rating **	U	Issue No.	<b>190</b>
LM End	<b>4.17</b>	Issue Type +	En	Location *	LS
Category	Earthen Levee		GPS Latitude/Longitude		
			Start	End	
Item	Vegetation		38.583559 °	38.583559 °	
			-121.443485 °	-121.443485 °	
DWR ID	DWR_NA0001_04_s_2012_190				
Action/Comments					
Landscaping Inspector Comments: Planter boxes built into levee slope. Wooden fence obstructs visibility. Pool is just outside 10-ft from levee toe.

03/16/2012 Wood privacy fence completely obstructs access and visibility.

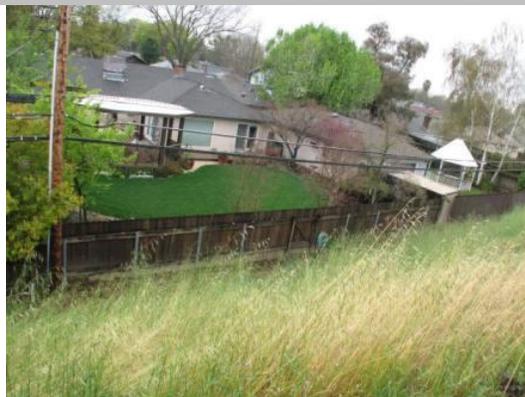
Photo 1 of 1 : FA\_2014\_NA0001\_55\_191\_20141001\_00165.jpg

LM Start	<b>4.19</b>	Rating **	U	Issue No.	<b>191</b>
LM End	<b>4.19</b>	Issue Type +	En	Location *	LS
Category	Earthen Levee		GPS Latitude/Longitude		
			Start	End	
Item	Encroachments		38.583355 °	38.583355 °	
			-121.443123 °	-121.443123 °	
DWR ID	DWR_NA0001_04_s_2012_191				
Action/Comments					
Fence Inspector Comments: Wooden privacy fence within 10-ft of the levee toe obstruct access and visibility.

03/16/2012 Wood privacy fence completely obstructs access and visibility.
