**Flood Control Project Maintenance  
Levee Inspections**

**Fall 2014 Levee Maintenance Deficiency Summary Report**

**Sacramento River Basin**

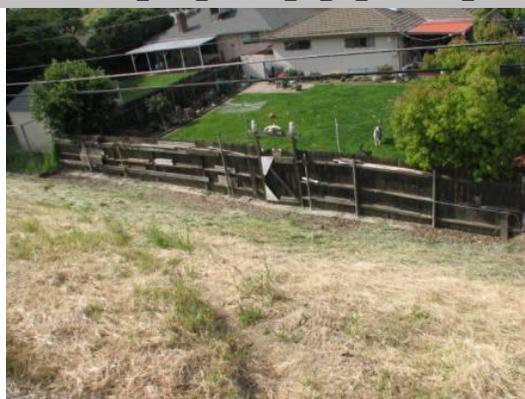
Photo 1 of 1 : FA\_2014\_NA0001\_55\_24\_20141001\_00024.jpg

LM Start	<b>4.21</b>	Rating **	U	Issue No.	<b>24</b>
LM End	<b>4.21</b>	Issue Type +	En	Location *	LS
Category	Earthen Levee		GPS Latitude/Longitude		
			Start	End	
Item	Encroachments		38.583265 °	38.583265 °	
			-121.442965 °	-121.442965 °	
DWR ID	DWR_NA0001_04_s_2012_24				
Action/Comments					
Fence Inspector Comments: Wooden privacy fence obstructs visibility. Retaining wall built into levee toe. 04/14/2011 retaining wall removed.

04/14/2011 Retaining wall has been removed. Wooden fence remains and is obstructing access and visibility.

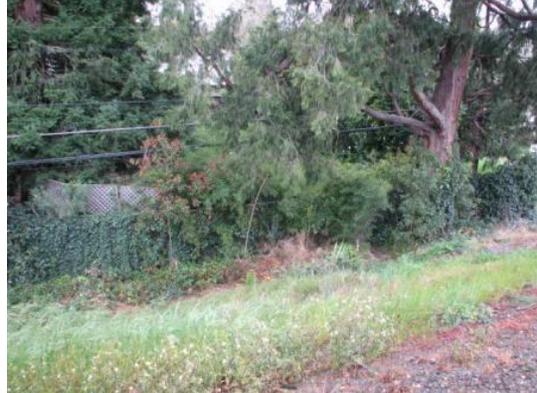
Photo 1 of 1 : FA\_2014\_NA0001\_55\_192\_20141001\_00166.jpg

LM Start	<b>4.23</b>	Rating **	U	Issue No.	<b>192</b>
LM End	<b>4.23</b>	Issue Type +	En	Location *	LS
Category	Earthen Levee		GPS Latitude/Longitude		
			Start	End	
Item	Vegetation		38.583031 °	38.583031 °	
			-121.442620 °	-121.442620 °	
DWR ID	DWR_NA0001_04_s_2012_192				
Action/Comments					
Landscaping Inspector Comments: Ivy and vine growth on cyclone fence obstruct visibility. Steps and landscaping built up levee slope.

03/16/2012 Landscaping on fence obstructs visibility and access.

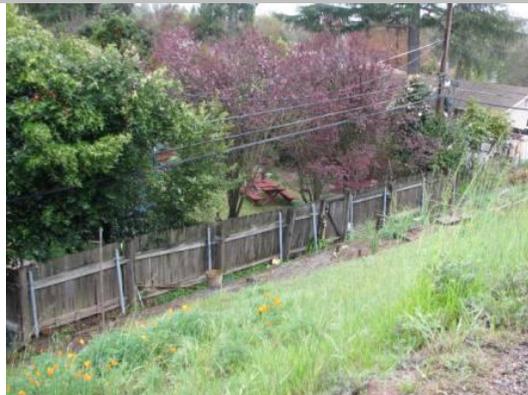
Photo 1 of 1 : FA\_2014\_NA0001\_55\_26\_20141001\_00025.jpg

LM Start	<b>4.29</b>	Rating **	U	Issue No.	<b>26</b>
LM End	<b>4.29</b>	Issue Type +	En	Location *	LS
Category	Earthen Levee		GPS Latitude/Longitude		
			Start	End	
Item	Encroachments		38.582479 °	38.582479 °	
			-121.441768 °	-121.441768 °	
DWR ID	DWR_NA0001_04_s_2012_26				
Action/Comments					
Fence Inspector Comments: Wooden fence within 10-ft of the levee toe. Garden and ramp built on levee slope.

03/16/2012 Wood privacy fence completely obstructs access and visibility.

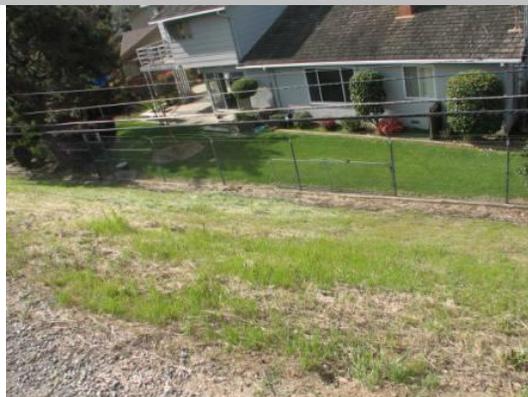
Photo 1 of 1 : FA\_2014\_NA0001\_55\_195\_20141001\_00168.jpg

LM Start	<b>4.31</b>	Rating **	M	Issue No.	<b>195</b>
LM End	<b>4.31</b>	Issue Type +	En	Location *	LS
Category	Earthen Levee		GPS Latitude/Longitude		
			Start	End	
Item	Encroachments		38.582333 °	38.582333 °	
			-121.441506 °	-121.441506 °	
DWR ID	DWR_NA0001_04_s_2012_195				
Action/Comments					
Fence Inspector Comments: Landscaping planted on levee slope. 04/14/2011 Landscaping removed, chainlink fence remains.

04/14/2011 Landscape removed, chainlink fence remains.

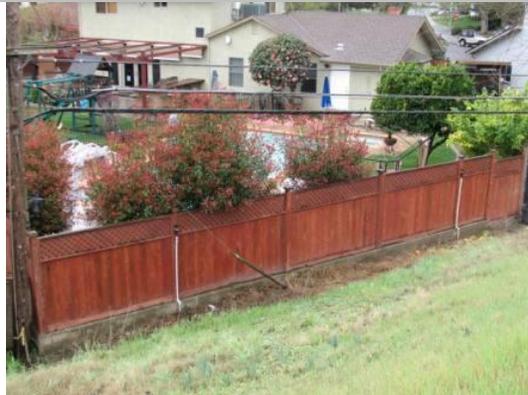
Photo 1 of 1 : FA\_2014\_NA0001\_55\_27\_20141001\_00026.jpg

LM Start	<b>4.33</b>	Rating **	U	Issue No.	<b>27</b>
LM End	<b>4.33</b>	Issue Type +	En	Location *	LS
Category	Earthen Levee		GPS Latitude/Longitude		
			Start	End	
Item	Encroachments		38.582223 °	38.582223 °	
			-121.441264 °	-121.441264 °	
DWR ID	DWR_NA0001_04_s_2012_27				
Action/Comments					
Fence Inspector Comments: Wooden privacy fence obstructs visibility.

03/16/2012 Wood privacy fence completely obstructs access and visibility.

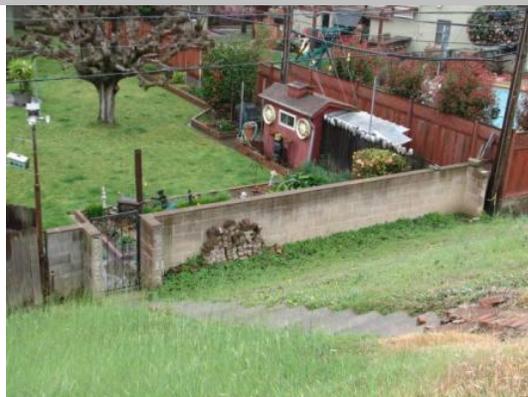
Photo 1 of 1 : FA\_2014\_NA0001\_55\_28\_20141001\_00027.jpg

LM Start	<b>4.33</b>	Rating **	U	Issue No.	<b>28</b>
LM End	<b>4.33</b>	Issue Type +	En	Location *	LS
Category	Earthen Levee		GPS Latitude/Longitude		
			Start	End	
Item	Encroachments		38.582186 °	38.582186 °	
			-121.441160 °	-121.441160 °	
DWR ID	DWR_NA0001_04_s_2012_28				
Action/Comments					
Fence Inspector Comments: Cement block fence obstructs access and visibility.

03/16/2012 Cinder block wall obstructs visibility and access.

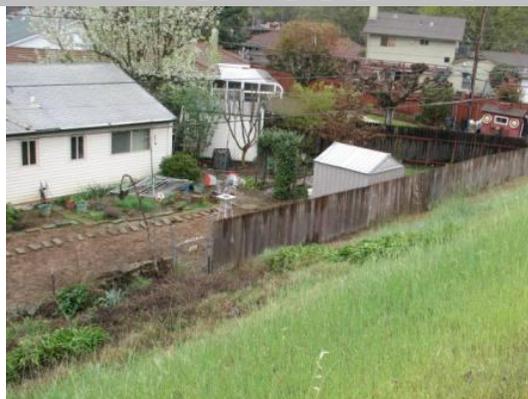
Photo 1 of 1 : FA\_2014\_NA0001\_55\_29\_20141001\_00028.jpg

LM Start	<b>4.35</b>	Rating **	M	Issue No.	<b>29</b>
LM End	<b>4.35</b>	Issue Type +	En	Location *	LS
Category	Earthen Levee		GPS Latitude/Longitude		
			Start	End	
Item	Encroachments		38.582083 °	38.582083 °	
			-121.440875 °	-121.440875 °	
DWR ID	DWR_NA0001_04_s_2012_29				
Action/Comments					
Fence Inspector Comments: Large flowering bush on levee slope - removed by ARFCD 2012. Retaining wall removed by ARFCD 2012. Wooden fence located at the levee toe obstructs access and visibility. 04/14/2011

03/16/2012 Flowering bush is dormant, landscaping on levee slope and wooden privacy fence.

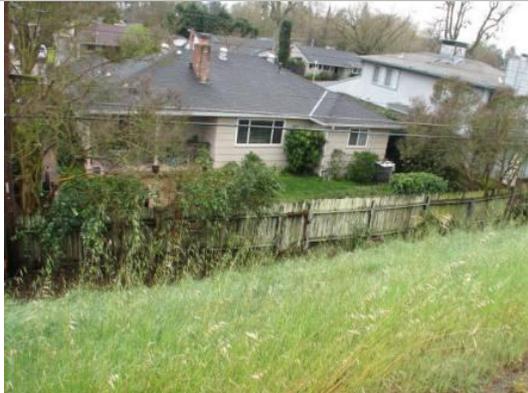
Photo 1 of 1 : FA\_2014\_NA0001\_55\_198\_20141001\_00170.jpg

LM Start	<b>4.40</b>	Rating **	U	Issue No.	<b>198</b>
LM End	<b>4.40</b>	Issue Type +	En	Location *	LS
Category	Earthen Levee		GPS Latitude/Longitude		
			Start	End	
Item	Encroachments		38.581788 °	38.581788 °	
			-121.440086 °	-121.440086 °	
DWR ID	DWR_NA0001_04_s_2012_198				
Action/Comments					
Fence Inspector Comments: Privacy fence and landscaping within 10-ft of the levee toe obstruct access and visibility.

03/16/2012 Wood privacy fence completely obstructs access and visibility.

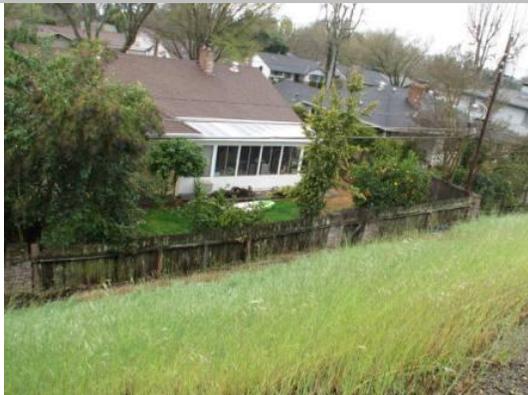
Photo 1 of 1 : FA\_2014\_NA0001\_55\_30\_20141001\_00029.jpg

LM Start	<b>4.41</b>	Rating **	U	Issue No.	<b>30</b>
LM End	<b>4.41</b>	Issue Type +	En	Location *	LS
Category	Earthen Levee		GPS Latitude/Longitude		
			Start	End	
Item	Encroachments		38.581724 °	38.581724 °	
			-121.439891 °	-121.439891 °	
DWR ID	DWR_NA0001_04_s_2012_30				
Action/Comments					
Fence Inspector Comments: Privacy fence and landscaping within 10-ft of the levee toe obstruct access and visibility.

03/16/2012 Wood privacy fence completely obstructs access and visibility.

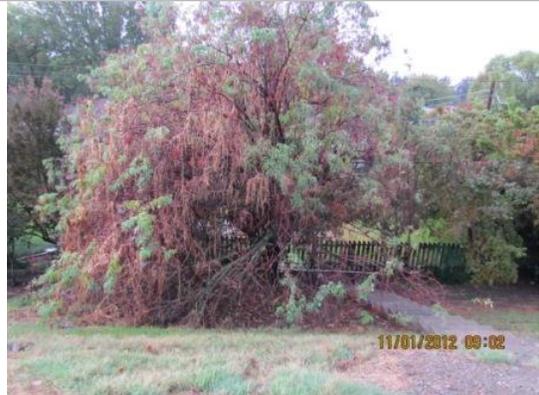
Photo 1 of 1 : FA\_2014\_NA0001\_55\_253\_20141001\_00192.jpg

LM Start	<b>4.50</b>	Rating **	M	Issue No.	<b>253</b>
LM End	<b>4.50</b>	Issue Type +	Ma	Location *	WS
Category	Earthen Levee		GPS Latitude/Longitude		
			Start	End	
Item	Vegetation		38.581320 °	38.581320 °	
			-121.438263 °	-121.438263 °	
DWR ID	DWR_NA0001_04_s_2012_253				
Action/Comments					
Elderberries are blocking visibility and flood fight capability.

View of large elderberry bush obstructing visibility and access.

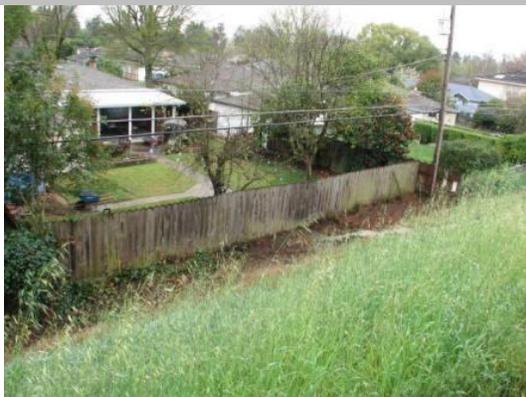
Photo 1 of 1 : FA\_2014\_NA0001\_55\_35\_20141001\_00031.jpg

LM Start	<b>4.52</b>	Rating **	U	Issue No.	<b>35</b>
LM End	<b>4.52</b>	Issue Type +	En	Location *	LS
Category	Earthen Levee		GPS Latitude/Longitude		
			Start	End	
Item	Encroachments		38.581246 °	38.581246 °	
			-121.438033 °	-121.438033 °	
DWR ID	DWR_NA0001_04_s_2012_35				
Action/Comments					
Fence Inspector Comments: Wooden fence within 10-ft of the levee toe obstructs access and visibility.

03/16/2012 Wood privacy fence completely obstructs access and visibility.

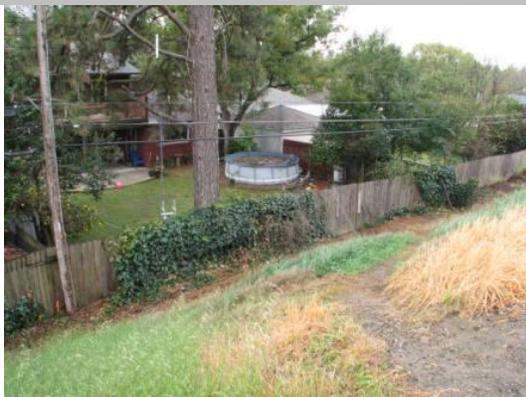
Photo 1 of 1 : FA\_2014\_NA0001\_55\_199\_20141001\_00171.jpg

LM Start	<b>4.53</b>	Rating **	U	Issue No.	<b>199</b>
LM End	<b>4.53</b>	Issue Type +	En	Location *	LS
Category	Earthen Levee		GPS Latitude/Longitude		
			Start	End	
Item	Encroachments		38.581205 °	38.581205 °	
			-121.437830 °	-121.437830 °	
DWR ID	DWR_NA0001_04_s_2012_199				
Action/Comments					
Fence Inspector Comments: Wooden fence is within 10-ft of the levee toe.

03/16/2012 Wood privacy fence completely obstructs access and visibility.

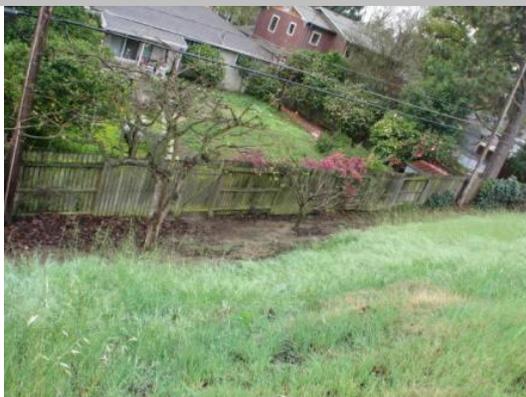
Photo 1 of 1 : FA\_2014\_NA0001\_55\_200\_20141001\_00172.jpg

LM Start	<b>4.54</b>	Rating **	U	Issue No.	<b>200</b>
LM End	<b>4.54</b>	Issue Type +	En	Location *	LS
Category	Earthen Levee		GPS Latitude/Longitude		
			Start	End	
Item	Encroachments		38.581178 °	38.581178 °	
			-121.437584 °	-121.437584 °	
DWR ID	DWR_NA0001_04_s_2012_200				
Action/Comments					
Fence Inspector Comments: Privacy fence, persimmon tree and landscaping within 10-ft of the levee toe obstruct access and visibility.

03/16/2012 Wood privacy fence completely obstructs access and visibility.

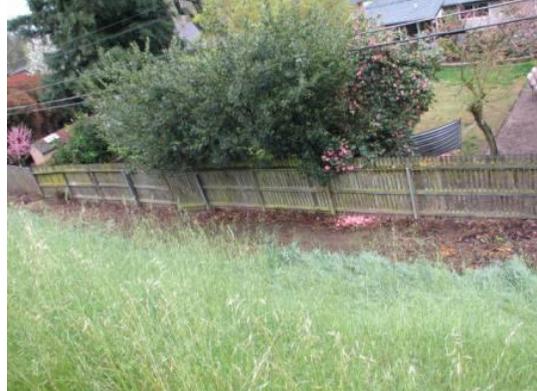
Photo 1 of 1 : FA\_2014\_NA0001\_55\_201\_20141001\_00173.jpg

LM Start	<b>4.55</b>	Rating **	U	Issue No.	<b>201</b>
LM End	<b>4.55</b>	Issue Type +	En	Location *	LS
Category	Earthen Levee			GPS Latitude/Longitude	
				Start	End
Item	Encroachments			38.581155 °	38.581155 °
				-121.437320 °	-121.437320 °
DWR ID	DWR_NA0001_04_s_2012_201				
Action/Comments					
Fence Inspector Comments: Privacy fence within 10-ft of the levee toe obstruct access and visibility.

03/16/2012 Wood privacy fence completely obstructs access and visibility.

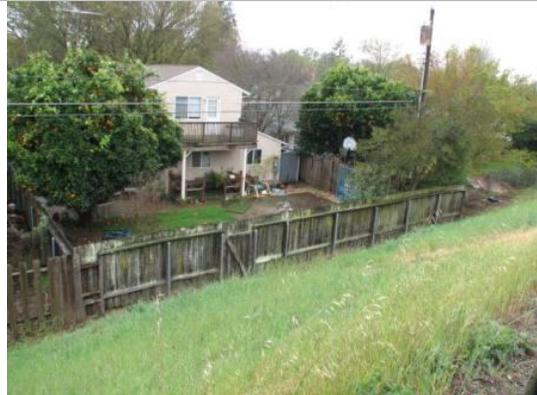
Photo 1 of 1 : FA\_2014\_NA0001\_55\_40\_20141001\_00032.jpg

LM Start	<b>4.73</b>	Rating **	U	Issue No.	<b>40</b>
LM End	<b>4.73</b>	Issue Type +	En	Location *	LS
Category	Earthen Levee		GPS Latitude/Longitude		
			Start	End	
Item	Encroachments		38.580759 °	38.580759 °	
			-121.434294 °	-121.434294 °	
DWR ID	DWR_NA0001_04_s_2012_40				
Action/Comments					
Fence Inspector Comments: Privacy fence within 10-ft of the levee toe obstruct access and visibility.

03/16/2012 Wood privacy fence completely obstructs access and visibility.

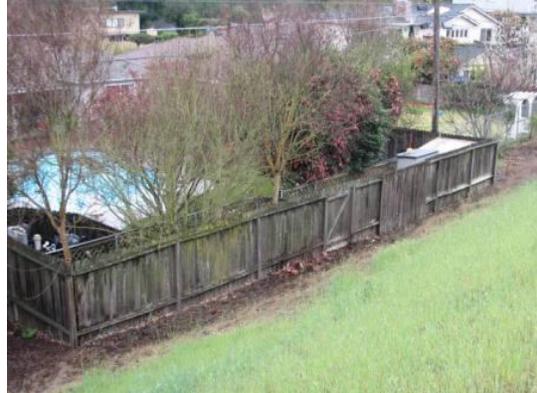
Photo 1 of 1 : FA\_2014\_NA0001\_55\_43\_20141001\_00034.jpg

LM Start	<b>4.77</b>	Rating **	U	Issue No.	<b>43</b>
LM End	<b>4.77</b>	Issue Type +	En	Location *	LS
Category	Earthen Levee		GPS Latitude/Longitude		
			Start	End	
Item	Encroachments		38.580731 °	38.580731 °	
			-121.433490 °	-121.433490 °	
DWR ID	DWR_NA0001_04_s_2012_43				
Action/Comments					
Fence Inspector Comments: Privacy fence and storage sheds within 10-ft of the levee toe obstruct access and visibility.

03/16/2012 Wood privacy fence completely obstructs access and visibility.

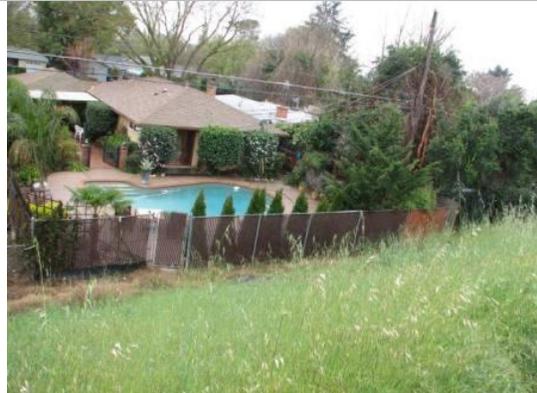
Photo 1 of 1 : FA\_2014\_NA0001\_55\_205\_20141001\_00177.jpg

LM Start	<b>4.82</b>	Rating **	U	Issue No.	<b>205</b>
LM End	<b>4.82</b>	Issue Type +	En	Location *	LS
Category	Earthen Levee		GPS Latitude/Longitude		
			Start	End	
Item	Encroachments		38.580723 °	38.580723 °	
			-121.432577 °	-121.432577 °	
DWR ID	DWR_NA0001_04_s_2012_205				
Action/Comments					
Fence Inspector Comments: Privacy fence and landscape prunings on levee slope and toe. prunings removed. Fence obstructs access and visibility.

03/16/2012 Chainlink fence with privacy slats obstructs visibility and access.

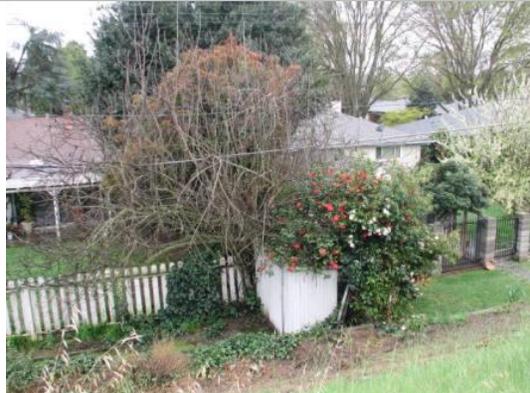
Photo 1 of 1 : FA\_2014\_NA0001\_55\_206\_20141001\_00178.jpg

LM Start	<b>4.87</b>	Rating **	U	Issue No.	<b>206</b>
LM End	<b>4.87</b>	Issue Type +	En	Location *	LS
Category	Earthen Levee		GPS Latitude/Longitude		
			Start	End	
Item	Vegetation		38.580778 °	38.580778 °	
			-121.431704 °	-121.431704 °	
DWR ID	DWR_NA0001_04_s_2012_206				
Action/Comments					
Landscaping Inspector Comments: Fig tree obstructs visibility and access.

03/16/2012 Landscaping obstructs visibility and access.

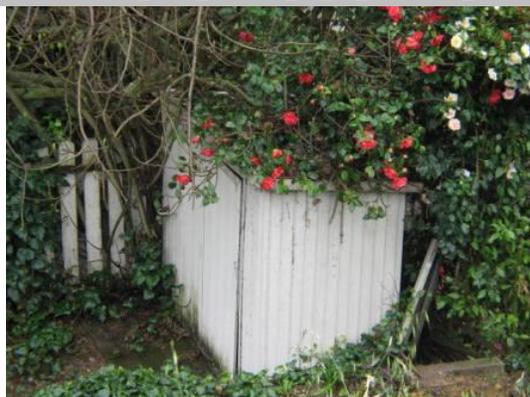
Photo 1 of 1 : FA\_2014\_NA0001\_55\_96\_20141001\_00079.jpg

LM Start	<b>4.87</b>	Rating **	U	Issue No.	<b>96</b>
LM End	<b>4.87</b>	Issue Type +	En	Location *	LS
Category	Earthen Levee		GPS Latitude/Longitude		
			Start	End	
Item	Encroachments		38.580767 °	38.580767 °	
			-121.431684 °	-121.431684 °	
DWR ID	DWR_NA0001_04_s_2012_96				
Action/Comments					
Building Inspector Comments: Wooden shed is located beneath the fig tree.

3/16/2012 Structure is within 15' of levee toe.

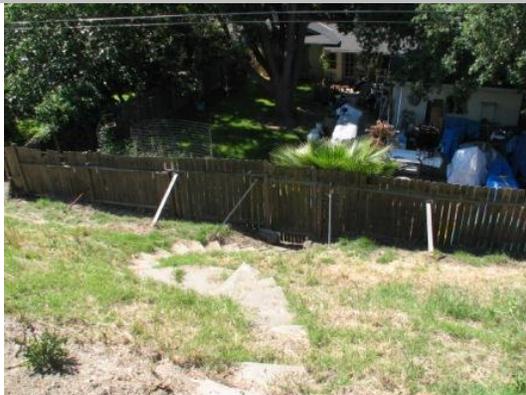
Photo 1 of 1 : FA\_2014\_NA0001\_55\_45\_20141001\_00035.jpg

LM Start	<b>4.93</b>	Rating **	U	Issue No.	<b>45</b>
LM End	<b>4.93</b>	Issue Type +	En	Location *	LS
Category	Earthen Levee		GPS Latitude/Longitude		
			Start	End	
Item	Encroachments		38.580846 °	38.580846 °	
			-121.430699 °	-121.430699 °	
DWR ID	DWR_NA0001_04_s_2012_45				
Action/Comments					
Fence Inspector Comments: Wooden fence with bracing obstructs access and visibility.

Wooden fence and braces obstruct access and visibility.

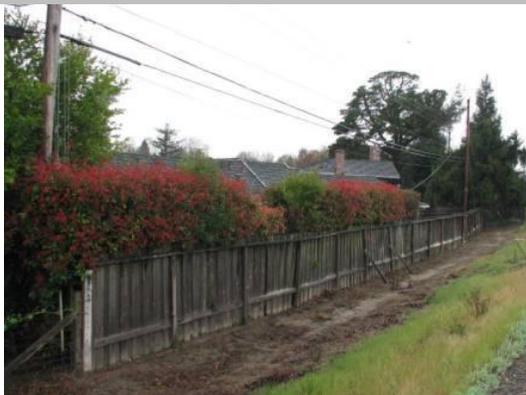
Photo 1 of 1 : FA\_2014\_NA0001\_55\_46\_20141001\_00036.jpg

LM Start	<b>5.08</b>	Rating **	U	Issue No.	<b>46</b>
LM End	<b>5.08</b>	Issue Type +	En	Location *	LS
Category	Earthen Levee		GPS Latitude/Longitude		
			Start	End	
Item	Encroachments		38.581001 °	38.581001 °	
			-121.427854 °	-121.427854 °	
DWR ID	DWR_NA0001_04_s_2012_46				
Action/Comments					
Fence Inspector Comments: Privacy fence and landscaping within 10-ft of the levee toe obstruct access and visibility.

03/16/2012 Wood privacy fence completely obstructs access and visibility.

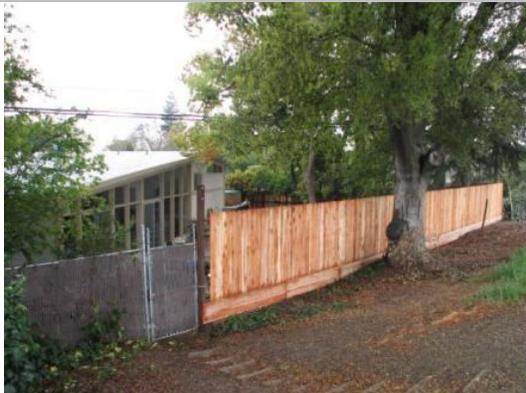
Photo 1 of 1 : FA\_2014\_NA0001\_55\_208\_20141001\_00179.jpg

LM Start	<b>5.13</b>	Rating **	U	Issue No.	<b>208</b>
LM End	<b>5.13</b>	Issue Type +	En	Location *	LS
Category	Earthen Levee		GPS Latitude/Longitude		
			Start	End	
Item	Encroachments		38.580913 °	38.580913 °	
			-121.427119 °	-121.427119 °	
DWR ID	DWR_NA0001_04_s_2012_208				
Action/Comments					
Fence Inspector Comments: Privacy fence and landscaping within 10-ft of the levee toe obstruct access and visibility.

03/16/2012 Wood privacy fence completely obstructs access and visibility.

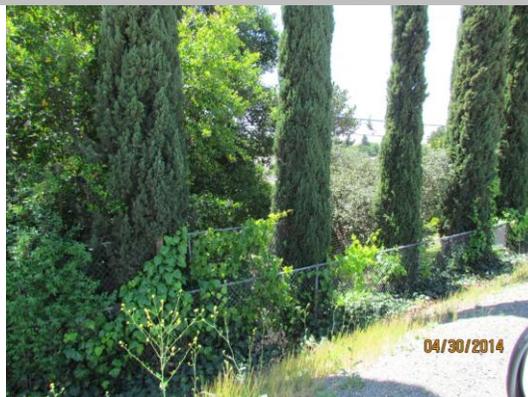
Photo 1 of 1 : FA\_2014\_NA0001\_55\_47\_20141001\_00037.jpg

LM Start	<b>5.15</b>	Rating **	M	Issue No.	<b>47</b>
LM End	<b>5.15</b>	Issue Type +	En	Location *	LS
Category	Earthen Levee		GPS Latitude/Longitude		
			Start	End	
Item	Encroachments		38.580773 °	38.580773 °	
			-121.426691 °	-121.426691 °	
DWR ID	DWR_NA0001_04_s_2012_47				
Action/Comments					
Fence Inspector Comments: Chain link fence, helix sky pencil, and landscaping within 10-ft of the levee toe obstruct access and visibility.

View of the fence and vegetation at the landside levee toe.

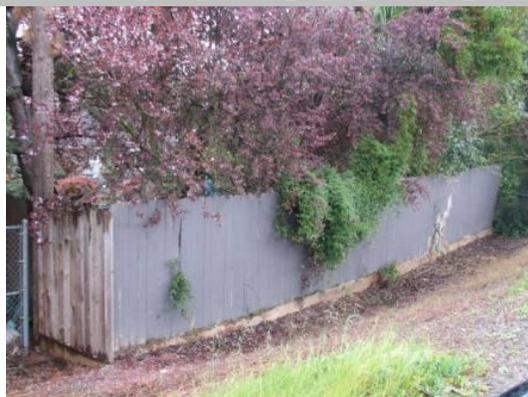
Photo 1 of 1 : FA\_2014\_NA0001\_55\_48\_20141001\_00038.jpg

LM Start	<b>5.17</b>	Rating **	U	Issue No.	<b>48</b>
LM End	<b>5.17</b>	Issue Type +	En	Location *	LS
Category	Earthen Levee		GPS Latitude/Longitude		
			Start	End	
Item	Encroachments		38.580622 °	38.580622 °	
			-121.426372 °	-121.426372 °	
DWR ID	DWR_NA0001_04_s_2012_48				
Action/Comments					
Fence Inspector Comments: Wood privacy fence and landscaping within 10-ft of the levee toe obstruct access and visibility.

03/16/2012 Wood privacy fence completely obstructs access and visibility.

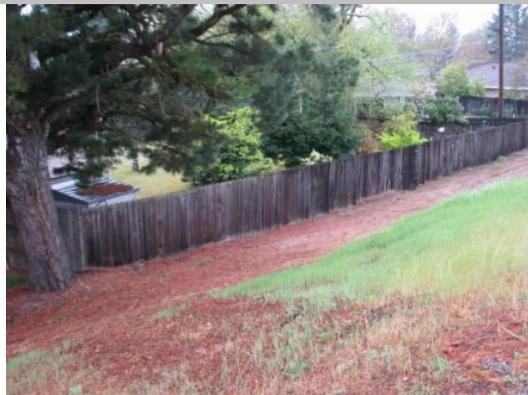
Photo 1 of 1 : FA\_2014\_NA0001\_55\_49\_20141001\_00039.jpg

LM Start	<b>5.45</b>	Rating **	U	Issue No.	<b>49</b>
LM End	<b>5.45</b>	Issue Type +	En	Location *	LS
Category	Earthen Levee		GPS Latitude/Longitude		
			Start	End	
Item	Encroachments		38.577589 °	38.577589 °	
			-121.423350 °	-121.423350 °	
DWR ID	DWR_NA0001_04_s_2012_49				
Action/Comments					
Fence Inspector Comments: Wood privacy fence within 10-ft of the levee toe obstruct access and visibility.

03/16/2012 Wood privacy fence completely obstructs access and visibility.

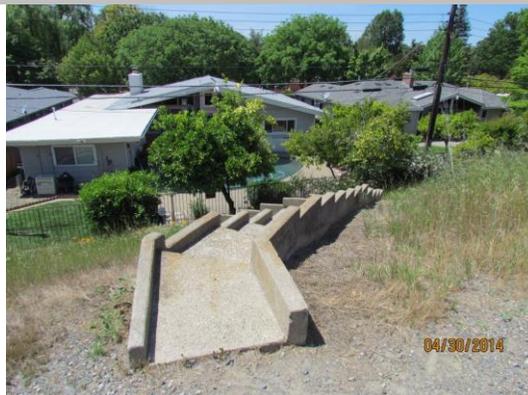
Photo 1 of 1 : FA\_2014\_NA0001\_55\_197\_20141001\_00169.jpg

LM Start	<b>5.57</b>	Rating **	U	Issue No.	<b>197</b>
LM End	<b>5.57</b>	Issue Type +	En	Location *	LS
Category	Earthen Levee		GPS Latitude/Longitude		
			Start	End	
Item	Encroachments		38.575887 °	38.575887 °	
			-121.423113 °	-121.423113 °	
DWR ID	DWR_NA0001_04_s_2013_197				
Action/Comments					
Stairway Inspector Comments: Unpermitted stairs to be removed by ARFCD.

View of the stairs on the landside levee slope.

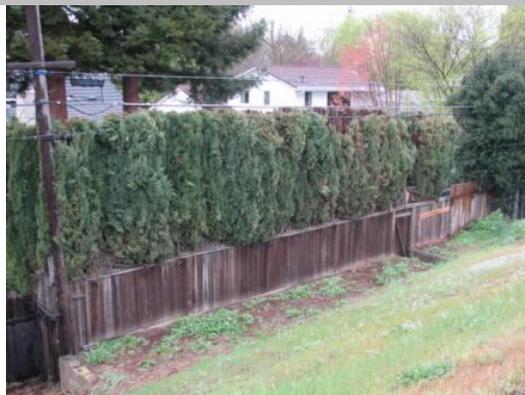
Photo 1 of 1 : FA\_2014\_NA0001\_55\_53\_20141001\_00042.jpg

LM Start	<b>5.63</b>	Rating **	<b>U</b>	Issue No.	<b>53</b>
LM End	<b>5.63</b>	Issue Type +	<b>En</b>	Location *	<b>LS</b>
Category	Earthen Levee		GPS Latitude/Longitude		
			Start	End	
Item	Vegetation		38.575250 °	38.575250 °	
			-121.423240 °	-121.423240 °	
DWR ID	DWR_NA0001_04_s_2012_53				
Action/Comments					
Landscaping Inspector Comments: Wood privacy fence, helix sky pencil, vines and landscaping within 10-ft of the levee toe obstruct access and visibility. Cement stairs up levee slope.

03/16/2012 Landscaping and fence obstruct visibility and access.

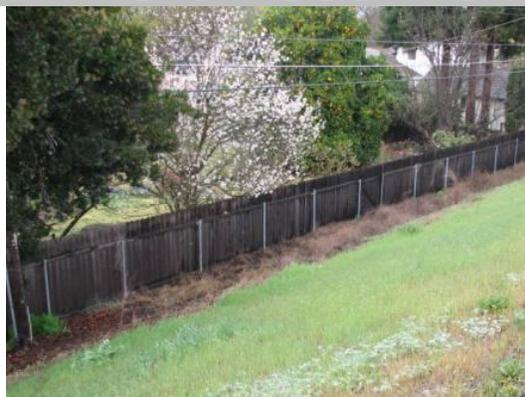
Photo 1 of 1 : FA\_2014\_NA0001\_55\_54\_20141001\_00043.jpg

LM Start	<b>5.64</b>	Rating **	<b>U</b>	Issue No.	<b>54</b>
LM End	<b>5.64</b>	Issue Type +	<b>En</b>	Location *	<b>LS</b>
Category	Earthen Levee		GPS Latitude/Longitude		
			Start	End	
Item	Encroachments		38.575093 °	38.575093 °	
			-121.423263 °	-121.423263 °	
DWR ID	DWR_NA0001_04_s_2012_54				
Action/Comments					
Fence Inspector Comments: Wood privacy fence and landscaping within 10-ft of the levee toe obstruct access and visibility.

03/16/2012 Wood privacy fence completely obstructs access and visibility.

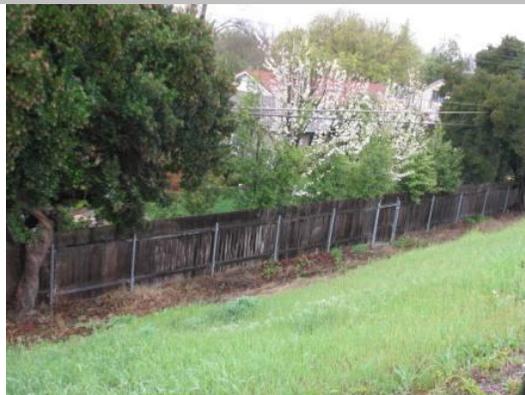
Photo 1 of 1 : FA\_2014\_NA0001\_55\_55\_20141001\_00044.jpg

LM Start	<b>5.66</b>	Rating **	<b>U</b>	Issue No.	<b>55</b>
LM End	<b>5.66</b>	Issue Type +	<b>En</b>	Location *	<b>LS</b>
Category	Earthen Levee		GPS Latitude/Longitude		
			Start	End	
Item	Encroachments		38.574837 °	38.574837 °	
			-121.423297 °	-121.423297 °	
DWR ID	DWR_NA0001_04_s_2012_55				
Action/Comments					
Fence Inspector Comments: Wood privacy fence within 10-ft of the levee toe obstructs visibility.

03/16/2012 Wood privacy fence completely obstructs access and visibility.

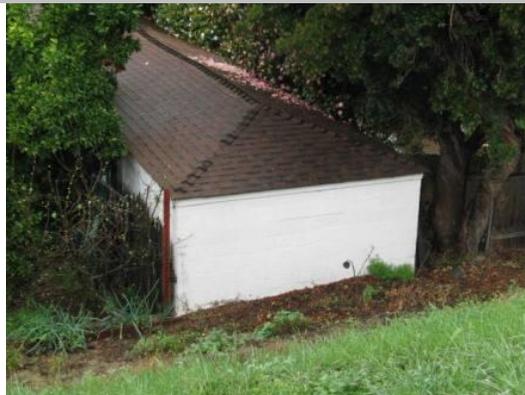
Photo 1 of 1 : FA\_2014\_NA0001\_55\_56\_20141001\_00045.jpg

LM Start	<b>5.67</b>	Rating **	<b>U</b>	Issue No.	<b>56</b>
LM End	<b>5.67</b>	Issue Type +	<b>En</b>	Location *	<b>LS</b>
Category	Earthen Levee		GPS Latitude/Longitude		
			Start	End	
Item	Encroachments		38.574648 °	38.574648 °	
			-121.423348 °	-121.423348 °	
DWR ID	DWR_NA0001_04_s_2012_56				
Action/Comments					
Building Inspector Comments: Cement block building on levee slope obstructs access.

03/16/2012 Structure within 15' of levee toe.

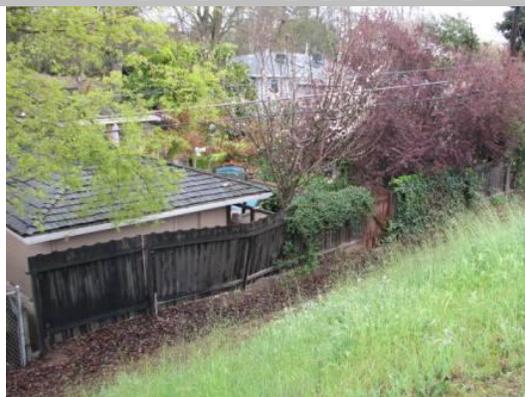
Photo 1 of 1 : FA\_2014\_NA0001\_55\_57\_20141001\_00046.jpg

LM Start	<b>5.72</b>	Rating **	<b>U</b>	Issue No.	<b>57</b>
LM End	<b>5.72</b>	Issue Type +	<b>En</b>	Location *	<b>LS</b>
Category	Earthen Levee		GPS Latitude/Longitude		
			Start	End	
Item	Encroachments		38.573927 °	38.573927 °	
			-121.423480 °	-121.423480 °	
DWR ID	DWR_NA0001_04_s_2012_57				
Action/Comments					
Fence Inspector Comments: Wood privacy fence with ivy obstructs visibility.

03/16/2012 Wood privacy fence completely obstructs access and visibility.

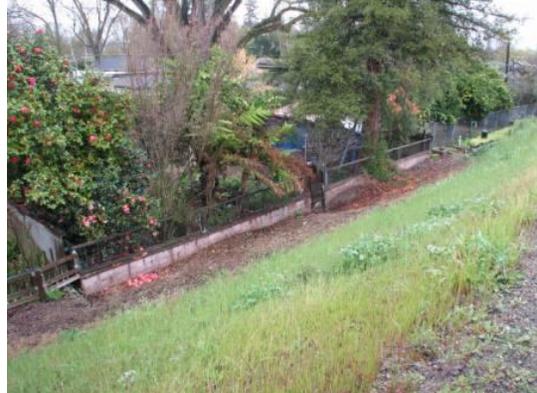
Photo 1 of 1 : FA\_2014\_NA0001\_55\_59\_20141001\_00047.jpg

LM Start	<b>5.76</b>	Rating **	U	Issue No.	<b>59</b>
LM End	<b>5.76</b>	Issue Type +	En	Location *	LS
Category	Earthen Levee		GPS Latitude/Longitude		
			Start	End	
Item	Encroachments		38.573403 °	38.573403 °	
			-121.423642 °	-121.423642 °	
DWR ID	DWR_NA0001_04_s_2012_59				
Action/Comments					
Fence Inspector Comments: Brick fence and landscaping within 10-ft of the levee toe obstructs access and visibility.

03/16/2012 Fence and landscaping obstruct visibility and access.

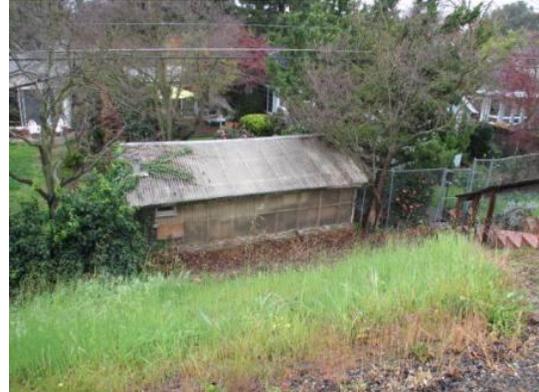
Photo 1 of 1 : FA\_2014\_NA0001\_55\_63\_20141001\_00049.jpg

LM Start	<b>5.83</b>	Rating **	U	Issue No.	<b>63</b>
LM End	<b>5.83</b>	Issue Type +	En	Location *	LS
Category	Earthen Levee		GPS Latitude/Longitude		
			Start	End	
Item	Encroachments		38.572325 °	38.572325 °	
			-121.423913 °	-121.423913 °	
DWR ID	DWR_NA0001_04_s_2012_63				
Action/Comments					
Building Inspector Comments: Wood and fiberglass structure within 10-ft of the levee toe.

03/16/2012 Wood and fiberglass structure is within 15' of levee toe.

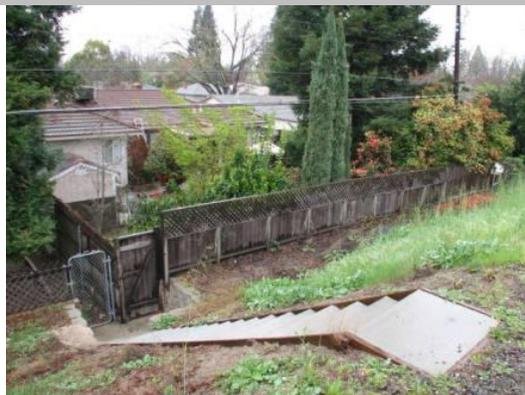
Photo 1 of 1 : FA\_2014\_NA0001\_55\_65\_20141001\_00050.jpg

LM Start	<b>5.85</b>	Rating **	<b>U</b>	Issue No.	<b>65</b>
LM End	<b>5.85</b>	Issue Type +	<b>En</b>	Location *	<b>LS</b>
Category	Earthen Levee		GPS Latitude/Longitude		
			Start	End	
Item	Encroachments		38.572067 °	38.572067 °	
			-121.423970 °	-121.423970 °	
DWR ID	DWR_NA0001_04_s_2012_65				
Action/Comments					
Fence Inspector Comments: Extended privacy fence and retaining wall within 10-ft of levee toe.

03/16/2012 Wood privacy fence completely obstructs access and visibility.

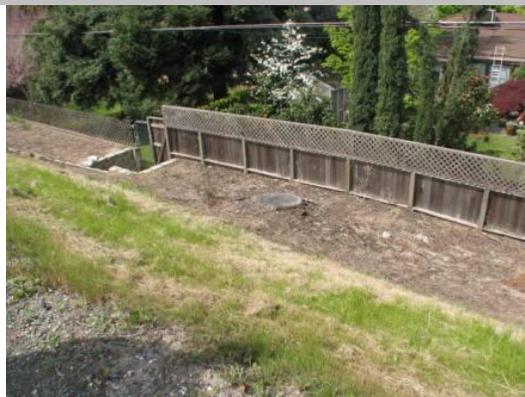
Photo 1 of 1 : FA\_2014\_NA0001\_55\_181\_20141001\_00159.jpg

LM Start	<b>5.85</b>	Rating **	<b>N</b>	Issue No.	<b>181</b>
LM End	<b>5.85</b>	Issue Type +	<b>Ma</b>	Location *	<b>LS</b>
Category	Earthen Levee		GPS Latitude/Longitude		
			Start	End	
Item	Trim / Thin Trees		38.572032 °	38.572032 °	
			-121.423981 °	-121.423981 °	
DWR ID	DWR_NA0001_04_s_2012_181				
Action/Comments					
Tree stumps. Inspector Comments: 04/14/2011 Large stump at toe of levee.

04/14/2011 Large stump at toe of levee.

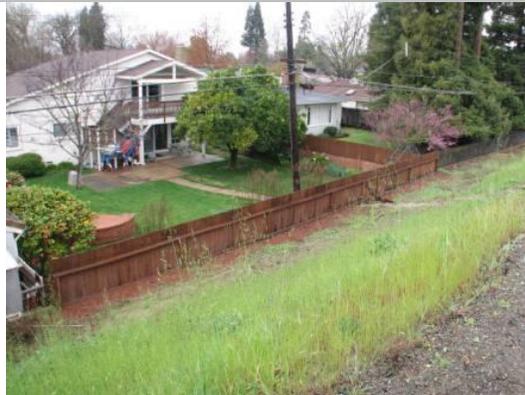
Photo 1 of 1 : FA\_2014\_NA0001\_55\_210\_20141001\_00180.jpg

LM Start	<b>5.87</b>	Rating **	<b>U</b>	Issue No.	<b>210</b>
LM End	<b>5.87</b>	Issue Type +	<b>En</b>	Location *	<b>LS</b>
Category	Earthen Levee		GPS Latitude/Longitude		
			Start	End	
Item	Encroachments		38.571733 °	38.571733 °	
			-121.424055 °	-121.424055 °	
DWR ID	DWR_NA0001_04_s_2012_210				
Action/Comments					
Fence Inspector Comments: Privacy fence and retaining wall are within 10-ft of levee toe.

03/16/2012 Wood privacy fence completely obstructs access and visibility.

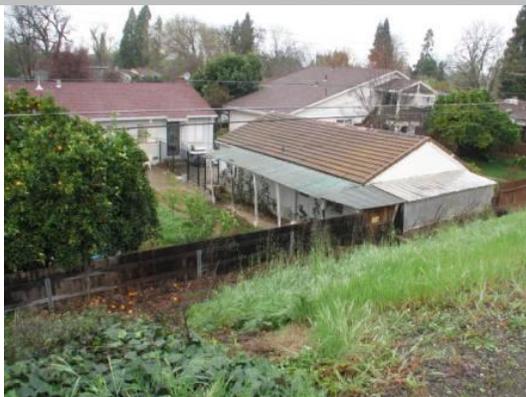
Photo 1 of 1 : FA\_2014\_NA0001\_55\_66\_20141001\_00051.jpg

LM Start	<b>5.88</b>	Rating **	<b>U</b>	Issue No.	<b>66</b>
LM End	<b>5.88</b>	Issue Type +	<b>En</b>	Location *	<b>LS</b>
Category	Earthen Levee		GPS Latitude/Longitude		
			Start	End	
Item	Encroachments		38.571586 °	38.571586 °	
			-121.424097 °	-121.424097 °	
DWR ID	DWR_NA0001_04_s_2012_66				
Action/Comments					
Building

03/16/2012 Structure is within 15' of levee toe.

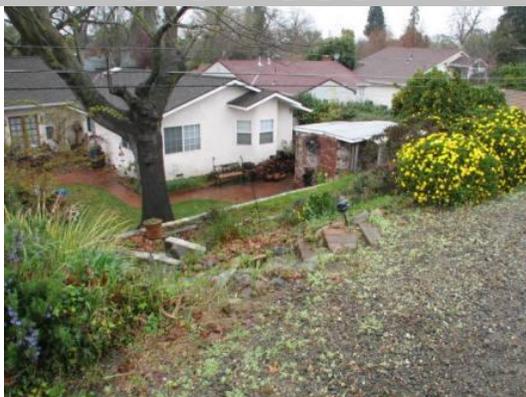
Photo 1 of 1 : FA\_2014\_NA0001\_55\_68\_20141001\_00053.jpg

LM Start	<b>5.89</b>	Rating **	<b>U</b>	Issue No.	<b>68</b>
LM End	<b>5.89</b>	Issue Type +	<b>En</b>	Location *	<b>LS</b>
Category	Earthen Levee		GPS Latitude/Longitude		
			Start	End	
Item	Vegetation		38.571525 °	38.571525 °	
			-121.424152 °	-121.424152 °	
DWR ID	DWR_NA0001_04_f_2013_68				
Action/Comments					
Landscaping Inspector Comments: Levee slope has been landscaped. This obstructs visibility.

03/16/2012 Levee slope is heavily landscaped, retaining wall has been constructed at the levee toe.

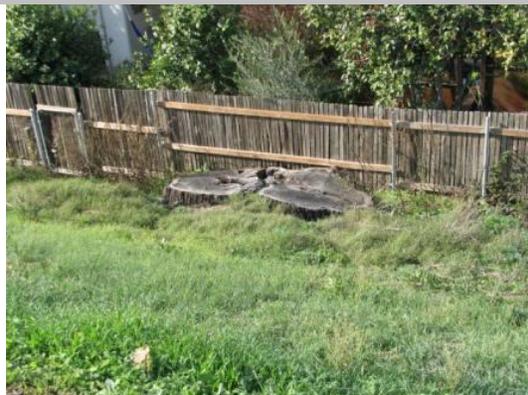
Photo 1 of 1 : FA\_2014\_NA0001\_55\_740\_20141001\_00195.jpg

LM Start	<b>5.93</b>	Rating **	N	Issue No.	<b>740</b>
LM End	<b>5.93</b>	Issue Type +	Ma	Location *	LS
Category	Earthen Levee		GPS Latitude/Longitude		
			Start	End	
Item	Trim / Thin Trees		38.570940 °	38.570940 °	
			-121.424173 °	-121.424173 °	
DWR ID	DWR_NA0001_04_s_2012_740				
Action/Comments					
Tree stumps. Inspector Comments: Large stump

11/15/2011 Large stump at levee toe.

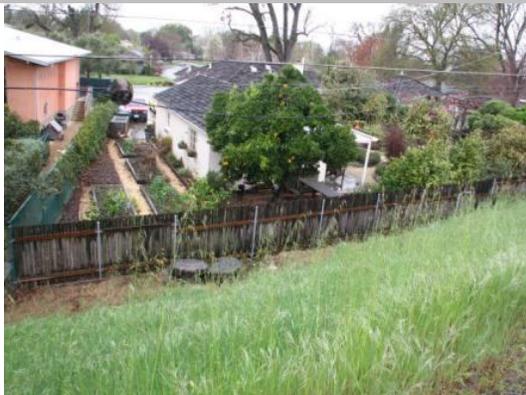
Photo 1 of 1 : FA\_2014\_NA0001\_55\_88\_20141001\_00071.jpg

LM Start	<b>5.94</b>	Rating **	<b>U</b>	Issue No.	<b>88</b>
LM End	<b>5.94</b>	Issue Type +	<b>En</b>	Location *	<b>LS</b>
Category	Earthen Levee		GPS Latitude/Longitude		
			Start	End	
Item	Encroachments		38.570752 °	38.570752 °	
			-121.424219 °	-121.424219 °	
DWR ID	DWR_NA0001_04_f_2012_88				
Action/Comments					
Fence Inspector Comments: Wooden privacy fence.

03/16/2012 Wood privacy fence completely obstructs access and visibility.

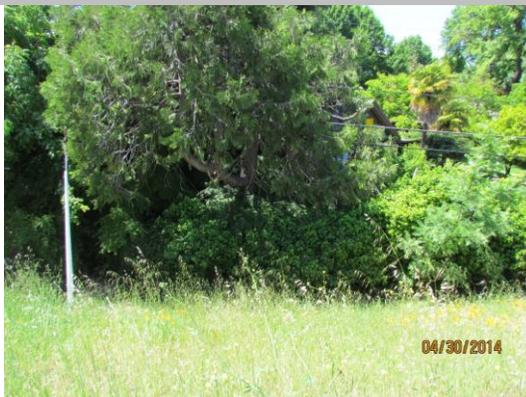
Photo 1 of 1 : FA\_2014\_NA0001\_55\_71\_20141001\_00054.jpg

LM Start	<b>5.97</b>	Rating **	<b>M</b>	Issue No.	<b>71</b>
LM End	<b>5.97</b>	Issue Type +	<b>En</b>	Location *	<b>LS</b>
Category	Earthen Levee		GPS Latitude/Longitude		
			Start	End	
Item	Vegetation		38.570450 °	38.570450 °	
			-121.424237 °	-121.424237 °	
DWR ID	DWR_NA0001_04_s_2012_71				
Action/Comments					
Landscaping Inspector Comments: Landscaping and garden within 10-ft of the levee toe.

View of the landscaping at the landside levee toe.

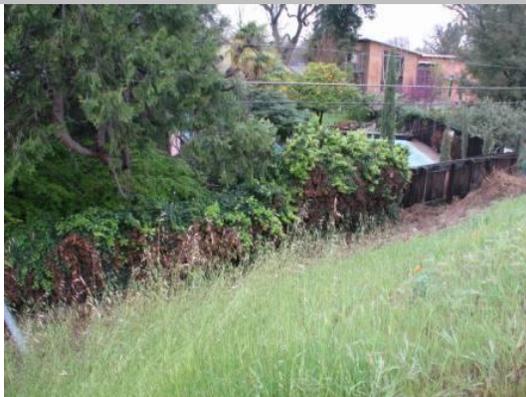
Photo 1 of 1 : FA\_2014\_NA0001\_55\_72\_20141001\_00055.jpg

LM Start	<b>5.97</b>	Rating **	<b>U</b>	Issue No.	<b>72</b>
LM End	<b>5.97</b>	Issue Type +	<b>En</b>	Location *	<b>LS</b>
Category	Earthen Levee		GPS Latitude/Longitude		
			Start	End	
Item	Encroachments		38.570391 °	38.570391 °	
			-121.424227 °	-121.424227 °	
DWR ID	DWR_NA0001_04_s_2012_72				
Action/Comments					
Fence Inspector Comments: Wood fence and landscaping within 10-ft of the levee toe obstructs visibility.

03/16/2012 Wood privacy fence completely obstructs access and visibility.

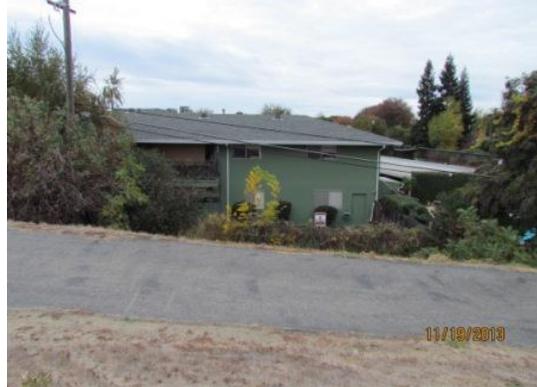
Photo 1 of 1 : FA\_2014\_NA0001\_55\_211\_20141001\_00181.jpg

LM Start	<b>6.00</b>	Rating **	M	Issue No.	<b>211</b>
LM End	<b>6.00</b>	Issue Type +	En	Location *	LS
Category	Earthen Levee		GPS Latitude/Longitude		
			Start	End	
Item	Encroachments		38.569893 °	38.569893 °	
			-121.424310 °	-121.424310 °	
DWR ID	DWR_NA0001_04_s_2012_211				
Action/Comments					
Fence Inspector Comments: Apartment complex privacy fence and shrubs within 10-ft of the slope obstruct visibility.

View of the fence at the landside levee toe.

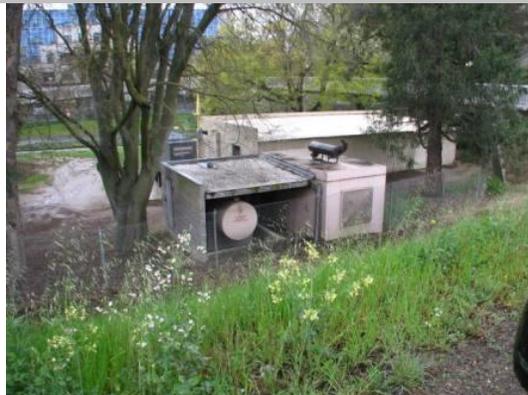
Photo 1 of 1 : FA\_2014\_NA0001\_55\_73\_20141001\_00056.jpg

LM Start	<b>6.61</b>	Rating **	U	Issue No.	<b>73</b>
LM End	<b>6.61</b>	Issue Type +	En	Location *	LS
Category	Earthen Levee		GPS Latitude/Longitude		
			Start	End	
Item	Encroachments		38.561643 °	38.561643 °	
			-121.421262 °	-121.421262 °	
DWR ID	DWR_NA0001_04_s_2012_73				
Action/Comments					
Building Inspector Comments: Generator and sheds within 10-ft of levee slope.

03/16/2012 Structure for generator is within 5' of levee toe.

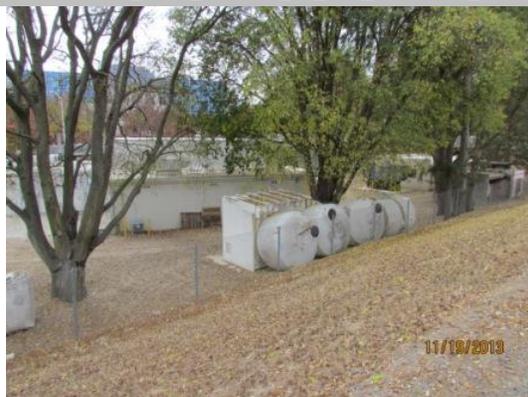
Photo 1 of 1 : FA\_2014\_NA0001\_55\_185\_20141001\_00161.jpg

LM Start	<b>6.63</b>	Rating **	M	Issue No.	<b>185</b>
LM End	<b>6.63</b>	Issue Type +	En	Location *	LS
Category	Earthen Levee		GPS Latitude/Longitude		
			Start	End	
Item	Encroachments		38.561448 °	38.561448 °	
			-121.421071 °	-121.421071 °	
DWR ID	DWR_NA0001_04_f_2013_185				
Action/Comments					
Tank Inspector Comments: 5 water tanks and storage shed within 10 feet of landside levee toe.

View of the water tanks stored at the landside levee toe.

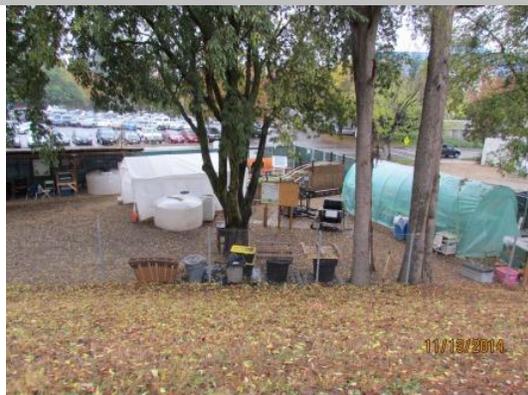
Photo 1 of 1 : FA\_2014\_NA0001\_55\_51\_20141119\_00216.jpg

LM Start	<b>6.66</b>	Rating **	M	Issue No.	<b>51</b>
LM End	<b>6.66</b>	Issue Type +	En	Location *	LS
Category	Earthen Levee		GPS Latitude/Longitude		
			Start	End	
Item	Encroachments		38.561117 °	38.561117 °	
			-121.420749 °	-121.420749 °	
DWR ID	DWR_NA0001_04_f_2013_51				
Action/Comments					
Material Inspector Comments: Pipe and other material stored within 10 feet of landside levee toe.

View of the material stored at the landside levee toe.

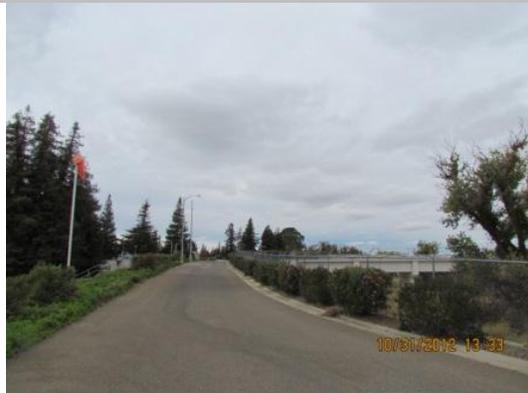
Photo 1 of 1 : FA\_2014\_NA0001\_55\_140\_20141001\_00120.jpg

LM Start	<b>6.85</b>	Rating **	M	Issue No.	<b>140</b>
LM End	<b>6.98</b>	Issue Type +	En	Location *	WS
Category	Earthen Levee			GPS Latitude/Longitude	
				Start	End
Item	Vegetation			38.559152 °	38.558115 °
				-121.418108 °	-121.416328 °
DWR ID	DWR_NA0001_04_f_2012_140				
Action/Comments					
Landscaping Inspector Comments: Bushes at waterside hinge obstruct visibility of waterside slope from levee crown.

View of landscaping at waterside hinge obstructing visibility.

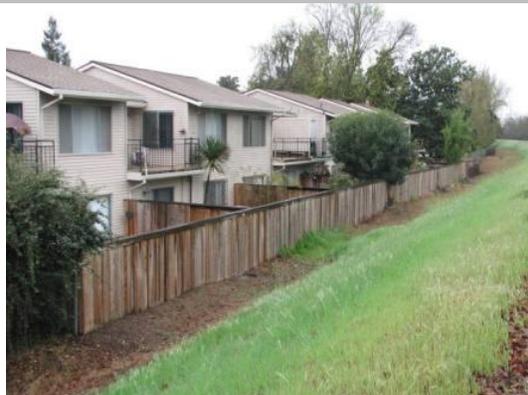
Photo 1 of 1 : FA\_2014\_NA0001\_55\_74\_20141001\_00057.jpg

LM Start	<b>7.70</b>	Rating **	U	Issue No.	<b>74</b>
LM End	<b>7.73</b>	Issue Type +	En	Location *	LS
Category	Earthen Levee		GPS Latitude/Longitude		
			Start	End	
Item	Encroachments		38.559177 °	38.559218 °	
			-121.403541 °	-121.402967 °	
DWR ID	DWR_NA0001_04_s_2012_74				
Action/Comments					
Fence Inspector Comments: Wooden privacy fence for seven apartment units is within 10-ft of levee toe and obstructs access and visibility.

03/16/2012 Wood privacy fence completely obstructs access and visibility.

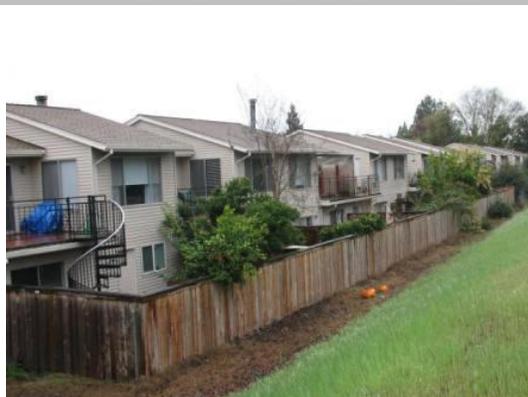
Photo 1 of 1 : FA\_2014\_NA0001\_55\_75\_20141001\_00058.jpg

LM Start	<b>7.75</b>	Rating **	U	Issue No.	<b>75</b>
LM End	<b>7.77</b>	Issue Type +	En	Location *	LS
Category	Earthen Levee		GPS Latitude/Longitude		
			Start	End	
Item	Encroachments		38.559230 °	38.559261 °	
			-121.402708 °	-121.402219 °	
DWR ID	DWR_NA0001_04_s_2012_75				
Action/Comments					
Fence Inspector Comments: Wooden privacy fence for seven apartment units is within 10-ft of levee toe and obstructs access and visibility.

03/16/2012 Wood privacy fence completely obstructs access and visibility.

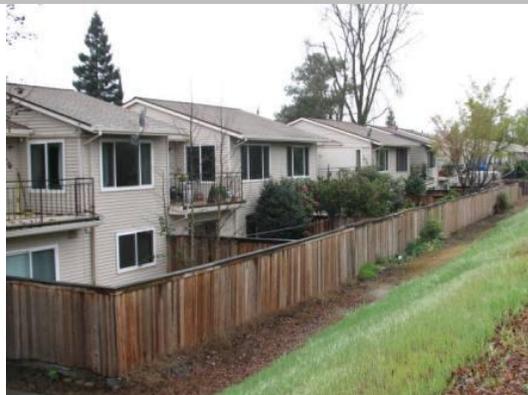
Photo 1 of 1 : FA\_2014\_NA0001\_55\_76\_20141001\_00059.jpg

LM Start	<b>7.80</b>	Rating **	U	Issue No.	<b>76</b>
LM End	<b>7.82</b>	Issue Type +	En	Location *	LS
Category	Earthen Levee		GPS Latitude/Longitude		
			Start	End	
Item	Encroachments		38.559308 °	38.559309 °	
			-121.401717 °	-121.401388 °	
DWR ID	DWR_NA0001_04_s_2012_76				
Action/Comments					
Fence Inspector Comments: Wooden privacy fence for seven apartment units is within 10-ft of levee toe and obstructs access and visibility.

03/16/2012 Wood privacy fence completely obstructs access and visibility.

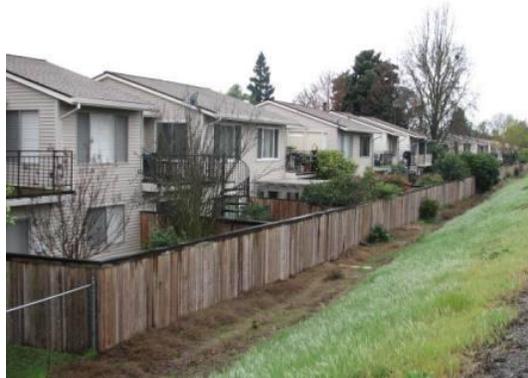
Photo 1 of 1 : FA\_2014\_NA0001\_55\_77\_20141001\_00060.jpg

LM Start	<b>7.83</b>	Rating **	U	Issue No.	<b>77</b>
LM End	<b>7.86</b>	Issue Type +	En	Location *	LS
Category	Earthen Levee			GPS Latitude/Longitude	
				Start	End
Item	Encroachments			38.559330 °	38.559366 °
				-121.401162 °	-121.400683 °
DWR ID	DWR_NA0001_04_s_2012_77				
Action/Comments					
Fence Inspector Comments: Wooden privacy fence for seven apartment units is within 10-ft of levee toe and obstructs access and visibility.

03/16/2012 Wood privacy fence completely obstructs access and visibility.

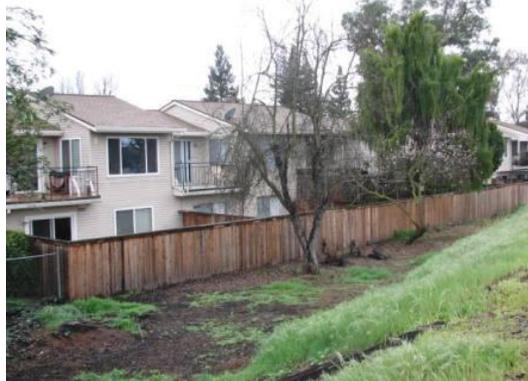
Photo 1 of 1 : FA\_2014\_NA0001\_55\_78\_20141001\_00061.jpg

LM Start	<b>7.88</b>	Rating **	U	Issue No.	<b>78</b>
LM End	<b>7.90</b>	Issue Type +	En	Location *	LS
Category	Earthen Levee			GPS Latitude/Longitude	
				Start	End
Item	Encroachments			38.559379 °	38.559435 °
				-121.400354 °	-121.399944 °
DWR ID	DWR_NA0001_04_s_2012_78				
Action/Comments					
Fence Inspector Comments: Wooden privacy fence for seven apartment units is within 10-ft of levee toe and obstructs access and visibility.

03/16/2012 Wood privacy fence completely obstructs access and visibility.

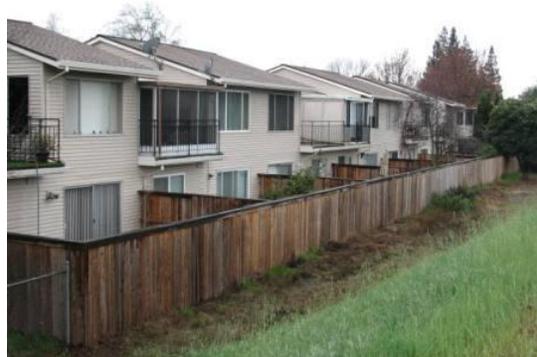
Photo 1 of 1 : FA\_2014\_NA0001\_55\_79\_20141001\_00062.jpg

LM Start	<b>7.91</b>	Rating **	U	Issue No.	<b>79</b>
LM End	<b>7.94</b>	Issue Type +	En	Location *	LS
Category	Earthen Levee		GPS Latitude/Longitude		
			Start	End	
Item	Encroachments		38.559514 °	38.559643 °	
			-121.399700 °	-121.399248 °	
DWR ID	DWR_NA0001_04_s_2012_79				
Action/Comments					
Fence Inspector Comments: Wooden privacy fence for seven apartment units is within 10-ft of levee toe and obstructs access and visibility.

03/16/2012 Wood privacy fence completely obstructs access and visibility.

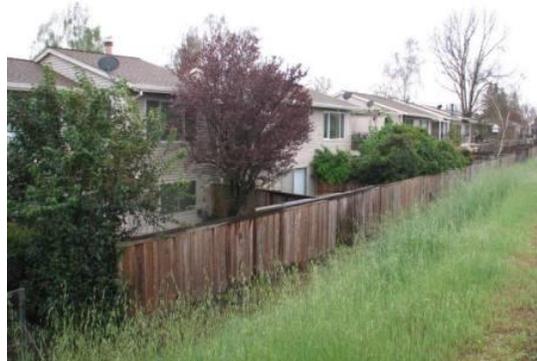
Photo 1 of 1 : FA\_2014\_NA0001\_55\_80\_20141001\_00063.jpg

LM Start	<b>7.96</b>	Rating **	U	Issue No.	<b>80</b>
LM End	<b>7.98</b>	Issue Type +	En	Location *	LS
Category	Earthen Levee		GPS Latitude/Longitude		
			Start	End	
Item	Encroachments		38.559753 °	38.559911 °	
			-121.398982 °	-121.398506 °	
DWR ID	DWR_NA0001_04_s_2012_80				
Action/Comments					
Fence Inspector Comments: Wooden privacy fence for seven apartment units is within 10-ft of levee toe and obstructs access and visibility.

03/16/2012 Wood privacy fence completely obstructs access and visibility.

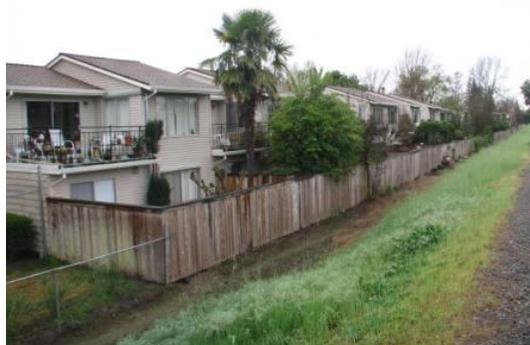
Photo 1 of 1 : FA\_2014\_NA0001\_55\_224\_20141001\_00182.jpg

LM Start	<b>8.00</b>	Rating **	U	Issue No.	<b>224</b>
LM End	<b>8.03</b>	Issue Type +	En	Location *	LS
Category	Earthen Levee		GPS Latitude/Longitude		
			Start	End	
Item	Encroachments		38.559994 °	38.560185 °	
			-121.398318 °	-121.397845 °	
DWR ID	DWR_NA0001_04_s_2012_224				
Action/Comments					
Fence Inspector Comments: Wooden privacy fence for seven apartment units is within 10-ft of levee toe and obstructs access and visibility.

03/16/2012 Wood privacy fence completely obstructs access and visibility.

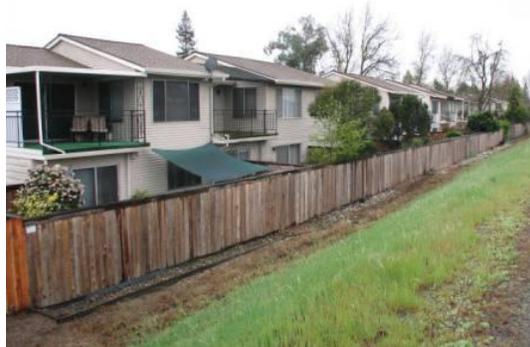
Photo 1 of 1 : FA\_2014\_NA0001\_55\_81\_20141001\_00064.jpg

LM Start	<b>8.04</b>	Rating **	U	Issue No.	<b>81</b>
LM End	<b>8.07</b>	Issue Type +	En	Location *	LS
Category	Earthen Levee		GPS Latitude/Longitude		
			Start	End	
Item	Encroachments		38.560281 °	38.560435 °	
			-121.397604 °	-121.397239 °	
DWR ID	DWR_NA0001_04_s_2012_81				
Action/Comments					
Fence Inspector Comments: Wooden privacy fence for seven apartment units is within 10-ft of levee toe and obstructs access and visibility.

03/16/2012 Wood privacy fence completely obstructs access and visibility.

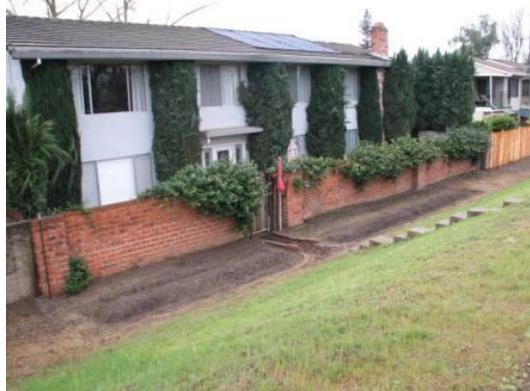
Photo 1 of 1 : FA\_2014\_NA0001\_55\_82\_20141001\_00065.jpg

LM Start	<b>8.09</b>	Rating **	U	Issue No.	<b>82</b>
LM End	<b>8.09</b>	Issue Type +	En	Location *	LS
Category	Earthen Levee		GPS Latitude/Longitude		
			Start	End	
Item	Encroachments		38.560537 °	38.560537 °	
			-121.396912 °	-121.396912 °	
DWR ID	DWR_NA0001_04_s_2012_82				
Action/Comments					
Fence Inspector Comments: Brick fence is within 10-ft of levee toe, obstructing access and visibility.

03/16/2012 Brick wall completely obstructs access and visibility.

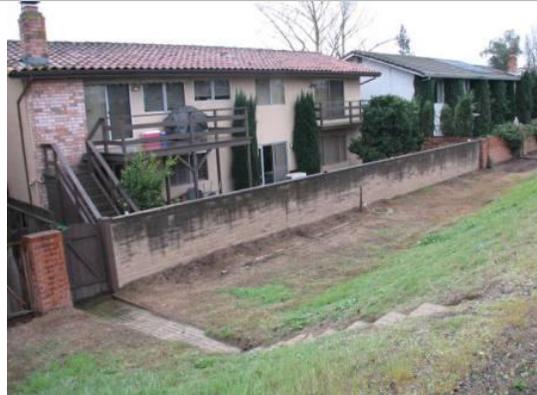
Photo 1 of 1 : FA\_2014\_NA0001\_55\_83\_20141001\_00066.jpg

LM Start	<b>8.10</b>	Rating **	U	Issue No.	<b>83</b>
LM End	<b>8.10</b>	Issue Type +	En	Location *	LS
Category	Earthen Levee		GPS Latitude/Longitude		
			Start	End	
Item	Encroachments		38.560647 °	38.560647 °	
			-121.396660 °	-121.396660 °	
DWR ID	DWR_NA0001_04_s_2012_83				
Action/Comments					
Fence Inspector Comments: Brick fence is within 10-ft of levee toe and obstructs access and visibility.

03/16/2012 Brick wall completely obstructs access and visibility.

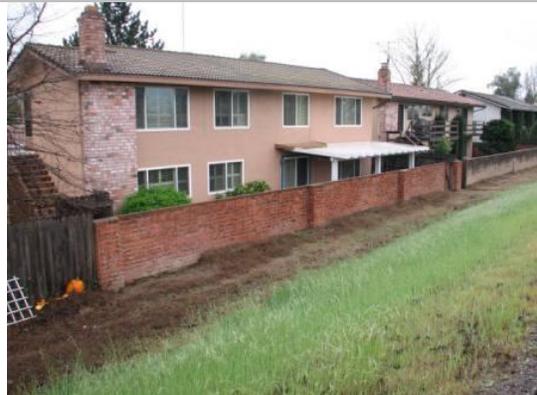
Photo 1 of 1 : FA\_2014\_NA0001\_55\_84\_20141001\_00067.jpg

LM Start	<b>8.11</b>	Rating **	U	Issue No.	<b>84</b>
LM End	<b>8.11</b>	Issue Type +	En	Location *	LS
Category	Earthen Levee		GPS Latitude/Longitude		
			Start	End	
Item	Encroachments		38.560728 °	38.560728 °	
			-121.396471 °	-121.396471 °	
DWR ID	DWR_NA0001_04_s_2012_84				
Action/Comments					
Fence Inspector Comments: Brick fence is within 10-ft of levee toe and obstructs access and visibility.

03/16/2012 Brick wall completely obstructs access and visibility.

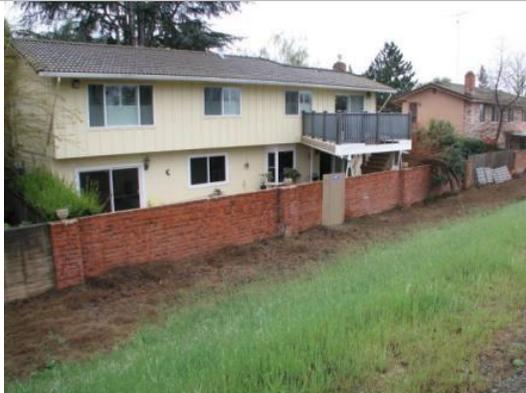
Photo 1 of 1 : FA\_2014\_NA0001\_55\_85\_20141001\_00068.jpg

LM Start	<b>8.13</b>	Rating **	U	Issue No.	<b>85</b>
LM End	<b>8.13</b>	Issue Type +	En	Location *	LS
Category	Earthen Levee		GPS Latitude/Longitude		
			Start	End	
Item	Encroachments		38.560845 °	38.560845 °	
			-121.396189 °	-121.396189 °	
DWR ID	DWR_NA0001_04_s_2012_85				
Action/Comments					
Fence Inspector Comments: Brick fence is within 10-ft of levee toe and obstructs access and visibility.

03/16/2012 Brick wall completely obstructs access and visibility.

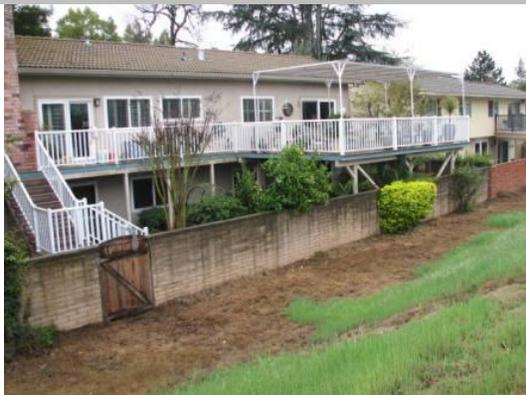
Photo 1 of 1 : FA\_2014\_NA0001\_55\_86\_20141001\_00069.jpg

LM Start	<b>8.14</b>	Rating **	U	Issue No.	<b>86</b>
LM End	<b>8.14</b>	Issue Type +	En	Location *	LS
Category	Earthen Levee		GPS Latitude/Longitude		
			Start	End	
Item	Encroachments		38.560907 °	38.560907 °	
			-121.396043 °	-121.396043 °	
DWR ID	DWR_NA0001_04_s_2012_86				
Action/Comments					
Fence Inspector Comments: Brick fence is within 10-ft of levee toe and obstructs access and visibility.

03/16/2012 Brick wall completely obstructs access and visibility.

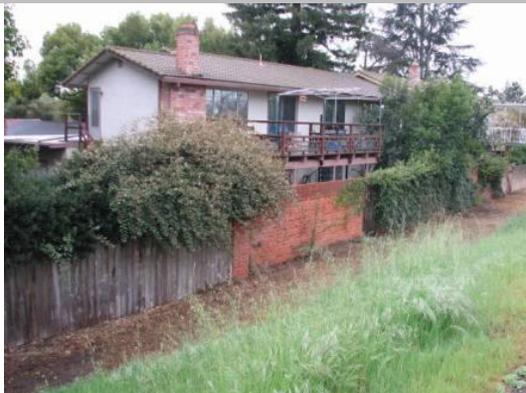
Photo 1 of 1 : FA\_2014\_NA0001\_55\_87\_20141001\_00070.jpg

LM Start	<b>8.15</b>	Rating **	U	Issue No.	<b>87</b>
LM End	<b>8.15</b>	Issue Type +	En	Location *	LS
Category	Earthen Levee		GPS Latitude/Longitude		
			Start	End	
Item	Encroachments		38.561008 °	38.561008 °	
			-121.395817 °	-121.395817 °	
DWR ID	DWR_NA0001_04_s_2012_87				
Action/Comments					
Fence Inspector Comments: Brick fence is within 10-ft of levee toe and obstructs access and visibility.

03/16/2012 Brick wall completely obstructs access and visibility.
