**Flood Control Project Maintenance  
Levee Inspections**

**Fall 2014 Levee Maintenance Deficiency Summary Report**

**Sacramento River Basin**

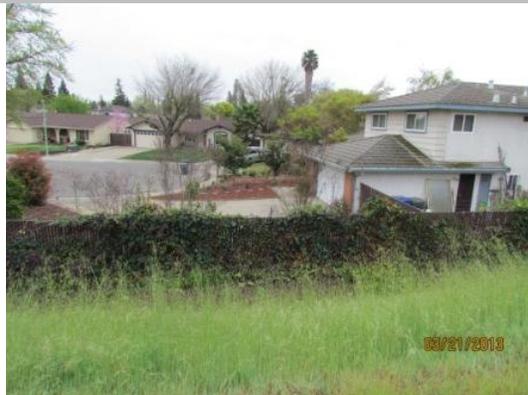
Photo 1 of 1 : FA\_2014\_NA0001\_55\_225\_20141001\_00183.jpg

LM Start	<b>8.19</b>	Rating **	M	Issue No.	<b>225</b>
LM End	<b>8.19</b>	Issue Type +	En	Location *	LS
Category	Earthen Levee		GPS Latitude/Longitude		
			Start	End	
Item	Vegetation		38.561248 °	38.561248 °	
			-121.395169 °	-121.395169 °	
DWR ID	DWR_NA0001_04_s_2012_225				
Action/Comments					
Landscaping Inspector Comments: Landscaping along chain link fence within 10-ft of levee toe obstructs access and visibility.

View of the landscaping at the levee toe.

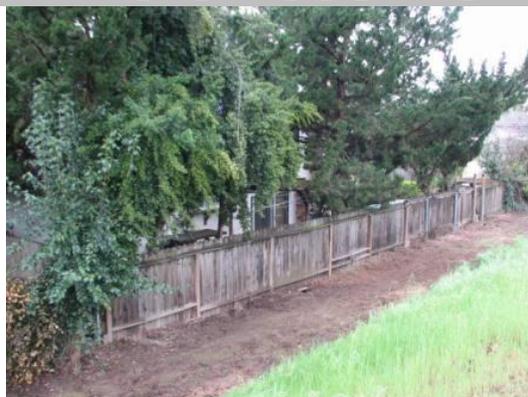
Photo 1 of 1 : FA\_2014\_NA0001\_55\_89\_20141001\_00072.jpg

LM Start	<b>8.22</b>	Rating **	U	Issue No.	<b>89</b>
LM End	<b>8.22</b>	Issue Type +	En	Location *	LS
Category	Earthen Levee		GPS Latitude/Longitude		
			Start	End	
Item	Encroachments		38.561467 °	38.561467 °	
			-121.394728 °	-121.394728 °	
DWR ID	DWR_NA0001_04_s_2012_89				
Action/Comments					
Fence Inspector Comments: Fence and landscaping arbor within 10-ft of levee toe obstructs access and visibility.

03/16/2012 Wood privacy fence completely obstructs access and visibility.

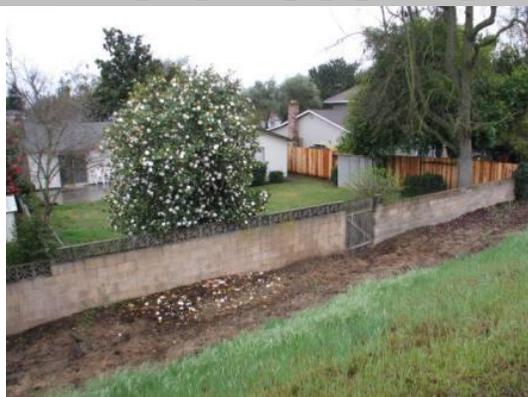
Photo 1 of 1 : FA\_2014\_NA0001\_55\_90\_20141001\_00073.jpg

LM Start	<b>8.23</b>	Rating **	U	Issue No.	<b>90</b>
LM End	<b>8.23</b>	Issue Type +	En	Location *	LS
Category	Earthen Levee		GPS Latitude/Longitude		
			Start	End	
Item	Encroachments		38.561544 °	38.561544 °	
			-121.394494 °	-121.394494 °	
DWR ID	DWR_NA0001_04_s_2012_90				
Action/Comments					
Fence Inspector Comments: Cement block fence within 10-ft of the levee toe.

03/16/2012 Cinder block wall completely obstructs access and visibility.

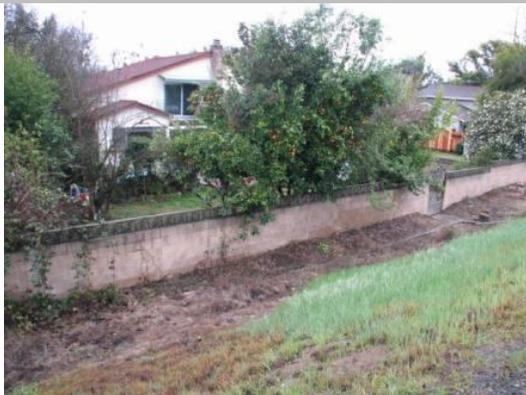
Photo 1 of 1 : FA\_2014\_NA0001\_55\_91\_20141001\_00074.jpg

LM Start	<b>8.25</b>	Rating **	U	Issue No.	<b>91</b>
LM End	<b>8.25</b>	Issue Type +	En	Location *	LS
Category	Earthen Levee		GPS Latitude/Longitude		
			Start	End	
Item	Encroachments		38.561593 °	38.561593 °	
			-121.394315 °	-121.394315 °	
DWR ID	DWR_NA0001_04_s_2012_91				
Action/Comments					
Fence Inspector Comments: Concrete block fence and landscaping within 10-ft of levee toe obstructs access and visibility.

03/16/2012 Cinder block wall completely obstructs access and visibility.

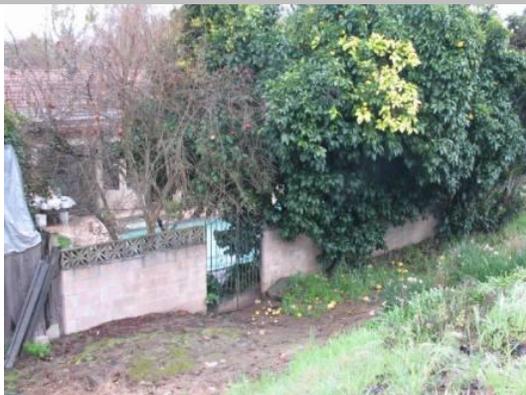
Photo 1 of 1 : FA\_2014\_NA0001\_55\_92\_20141001\_00075.jpg

LM Start	<b>8.25</b>	Rating **	U	Issue No.	<b>92</b>
LM End	<b>8.25</b>	Issue Type +	En	Location *	LS
Category	Earthen Levee		GPS Latitude/Longitude		
			Start	End	
Item	Encroachments		38.561658 °	38.561658 °	
			-121.394157 °	-121.394157 °	
DWR ID	DWR_NA0001_04_s_2012_92				
Action/Comments					
Fence Inspector Comments: Cement block fence and landscaping within 10-ft of levee toe obstructs access and visibility.

03/16/2012 Cinder block fence completely obstructs access and visibility.

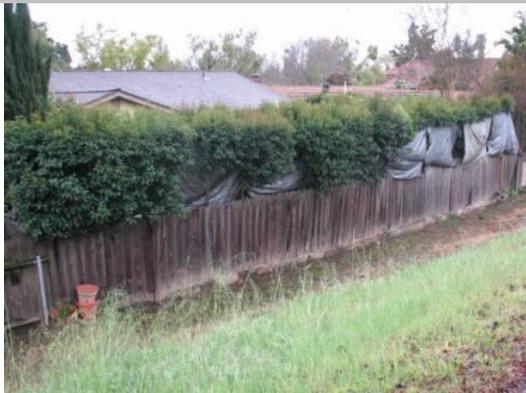
Photo 1 of 1 : FA\_2014\_NA0001\_55\_93\_20141001\_00076.jpg

LM Start	<b>8.27</b>	Rating **	U	Issue No.	<b>93</b>
LM End	<b>8.27</b>	Issue Type +	En	Location *	LS
Category	Earthen Levee		GPS Latitude/Longitude		
			Start	End	
Item	Encroachments		38.561750 °	38.561750 °	
			-121.393917 °	-121.393917 °	
DWR ID	DWR_NA0001_04_s_2012_93				
Action/Comments					
Fence Inspector Comments: Wooden fence, strung tarps, and landscaping within 10-ft of levee toe obstructs access and visibility.

03/16/2012 Wood privacy fence completely obstructs access and visibility.

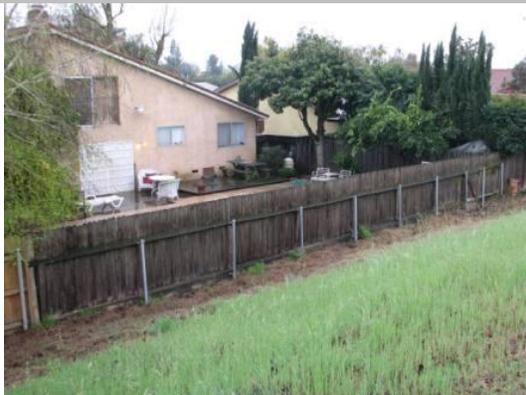
Photo 1 of 1 : FA\_2014\_NA0001\_55\_94\_20141001\_00077.jpg

LM Start	<b>8.28</b>	Rating **	U	Issue No.	<b>94</b>
LM End	<b>8.28</b>	Issue Type +	En	Location *	LS
Category	Earthen Levee		GPS Latitude/Longitude		
			Start	End	
Item	Encroachments		38.561799 °	38.561799 °	
			-121.393758 °	-121.393758 °	
DWR ID	DWR_NA0001_04_s_2012_94				
Action/Comments					
Fence Inspector Comments: Wood privacy fence and pool within 10-ft of levee toe obstructs access and visibility.

03/16/2012 Wood privacy fence completely obstructs access and visibility.

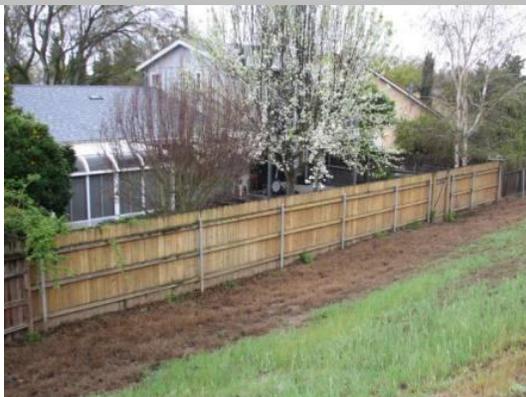
Photo 1 of 1 : FA\_2014\_NA0001\_55\_95\_20141001\_00078.jpg

LM Start	<b>8.29</b>	Rating **	U	Issue No.	<b>95</b>
LM End	<b>8.29</b>	Issue Type +	En	Location *	LS
Category	Earthen Levee		GPS Latitude/Longitude		
			Start	End	
Item	Encroachments		38.561900 °	38.561900 °	
			-121.393547 °	-121.393547 °	
DWR ID	DWR_NA0001_04_s_2012_95				
Action/Comments					
Fence Inspector Comments: Wood privacy fence within 10-ft of levee toe obstructs access and visibility.

03/16/2012 Wood privacy fence completely obstructs access and visibility.

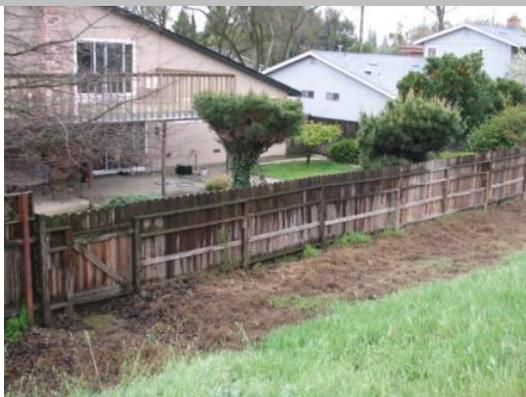
Photo 1 of 1 : FA\_2014\_NA0001\_55\_97\_20141001\_00080.jpg

LM Start	<b>8.31</b>	Rating **	U	Issue No.	<b>97</b>
LM End	<b>8.31</b>	Issue Type +	En	Location *	LS
Category	Earthen Levee		GPS Latitude/Longitude		
			Start	End	
Item	Encroachments		38.561986 °	38.561986 °	
			-121.393343 °	-121.393343 °	
DWR ID	DWR_NA0001_04_s_2012_97				
Action/Comments					
Fence Inspector Comments: Wood privacy fence within 10-ft of levee toe obstructs access and visibility.

03/16/2012 Wood privacy fence completely obstructs access and visibility.

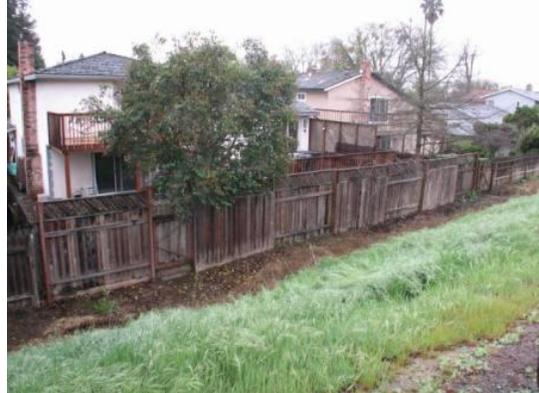
Photo 1 of 1 : FA\_2014\_NA0001\_55\_98\_20141001\_00081.jpg

LM Start	<b>8.32</b>	Rating **	U	Issue No.	<b>98</b>
LM End	<b>8.32</b>	Issue Type +	En	Location *	LS
Category	Earthen Levee		GPS Latitude/Longitude		
			Start	End	
Item	Encroachments		38.562054 °	38.562054 °	
			-121.393190 °	-121.393190 °	
DWR ID	DWR_NA0001_04_s_2012_98				
Action/Comments					
Fence Inspector Comments: Wood privacy fence within 10-ft of levee toe obstructs access and visibility.

03/16/2012 Wood privacy fence completely obstructs access and visibility.

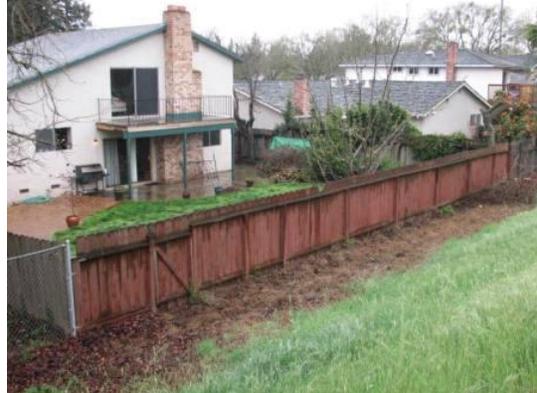
Photo 1 of 1 : FA\_2014\_NA0001\_55\_100\_20141001\_00083.jpg

LM Start	<b>8.34</b>	Rating **	U	Issue No.	<b>100</b>
LM End	<b>8.34</b>	Issue Type +	En	Location *	LS
Category	Earthen Levee		GPS Latitude/Longitude		
			Start	End	
Item	Encroachments		38.562182 °	38.562182 °	
			-121.392778 °	-121.392778 °	
DWR ID	DWR_NA0001_04_s_2012_100				
Action/Comments					
Fence Inspector Comments: Wood privacy fence within 10-ft of levee toe obstructs access and visibility.

03/16/2012 Wood privacy fence completely obstructs access and visibility.

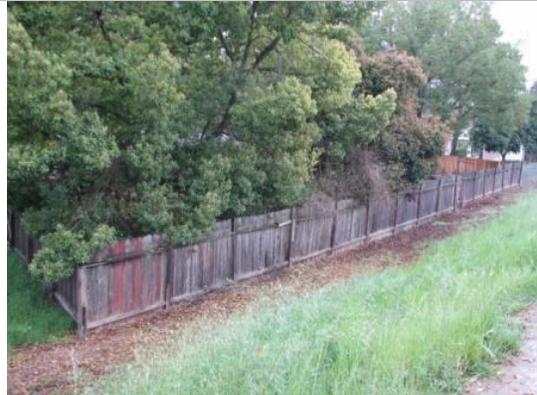
Photo 1 of 1 : FA\_2014\_NA0001\_55\_101\_20141001\_00084.jpg

LM Start	<b>8.39</b>	Rating **	U	Issue No.	<b>101</b>
LM End	<b>8.39</b>	Issue Type +	En	Location *	LS
Category	Earthen Levee		GPS Latitude/Longitude		
			Start	End	
Item	Encroachments		38.562508 °	38.562508 °	
			-121.392037 °	-121.392037 °	
DWR ID	DWR_NA0001_04_s_2012_101				
Action/Comments					
Fence Inspector Comments: Wood privacy fence within 10-ft of levee toe obstructs access and visibility.

03/16/2012 Wood privacy fence completely obstructs access and visibility.

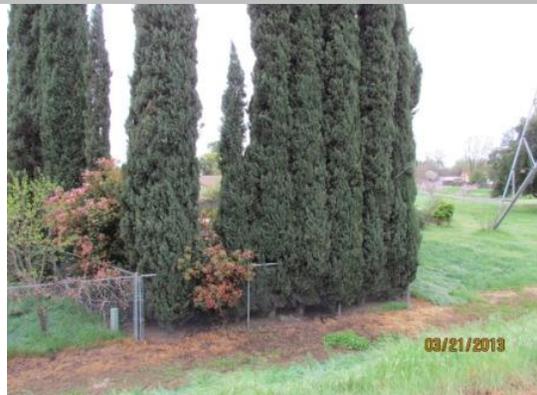
Photo 1 of 1 : FA\_2014\_NA0001\_55\_102\_20141001\_00085.jpg

LM Start	<b>8.45</b>	Rating **	M	Issue No.	<b>102</b>
LM End	<b>8.45</b>	Issue Type +	En	Location *	LS
Category	Earthen Levee		GPS Latitude/Longitude		
			Start	End	
Item	Vegetation		38.562889 °	38.562889 °	
			-121.391042 °	-121.391042 °	
DWR ID	DWR_NA0001_04_s_2012_102				
Action/Comments					
Landscaping Inspector Comments: Helix sky pencil along chain link fence is within 10-ft of the levee toe.

View of the landscaping at the levee toe.

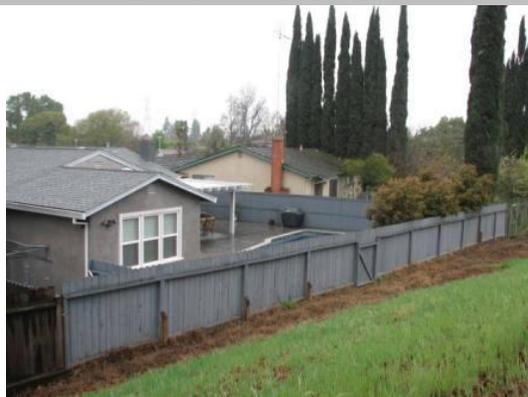
Photo 1 of 1 : FA\_2014\_NA0001\_55\_103\_20141001\_00086.jpg

LM Start	<b>8.47</b>	Rating **	U	Issue No.	<b>103</b>
LM End	<b>8.47</b>	Issue Type +	En	Location *	LS
Category	Earthen Levee		GPS Latitude/Longitude		
			Start	End	
Item	Encroachments		38.563042 °	38.563042 °	
			-121.390692 °	-121.390692 °	
DWR ID	DWR_NA0001_04_s_2012_103				
Action/Comments					
Fence Inspector Comments: Wood privacy fence within 10-ft of levee toe obstructs access and visibility.

03/16/2012 Wood privacy fence completely obstructs access and visibility.

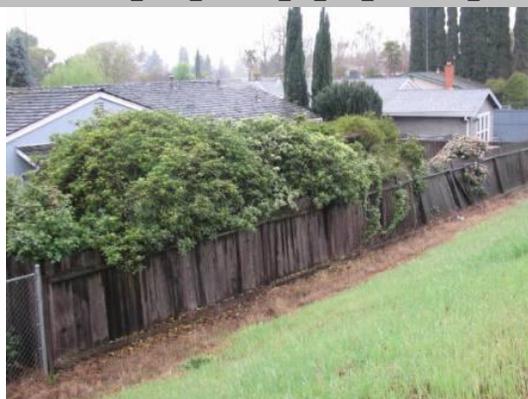
Photo 1 of 1 : FA\_2014\_NA0001\_55\_104\_20141001\_00087.jpg

LM Start	<b>8.48</b>	Rating **	U	Issue No.	<b>104</b>
LM End	<b>8.48</b>	Issue Type +	En	Location *	LS
Category	Earthen Levee		GPS Latitude/Longitude		
			Start	End	
Item	Encroachments		38.563108 °	38.563108 °	
			-121.390452 °	-121.390452 °	
DWR ID	DWR_NA0001_04_s_2012_104				
Action/Comments					
Fence Inspector Comments: Wood privacy fence within 10-ft of levee toe obstructs access and visibility.

03/16/2012 Wood privacy fence completely obstructs access and visibility.

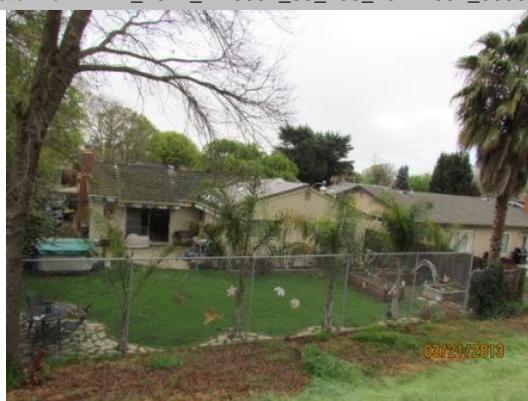
Photo 1 of 1 : FA\_2014\_NA0001\_55\_105\_20141001\_00088.jpg

LM Start	<b>8.51</b>	Rating **	M	Issue No.	<b>105</b>
LM End	<b>8.51</b>	Issue Type +	En	Location *	LS
Category	Earthen Levee		GPS Latitude/Longitude		
			Start	End	
Item	Vegetation		38.563238 °	38.563238 °	
			-121.390073 °	-121.390073 °	
DWR ID	DWR_NA0001_04_s_2012_105				
Action/Comments					
Landscaping Inspector Comments: Palms planted within 10-ft of the levee toe.

View of the palm trees at the levee toe.

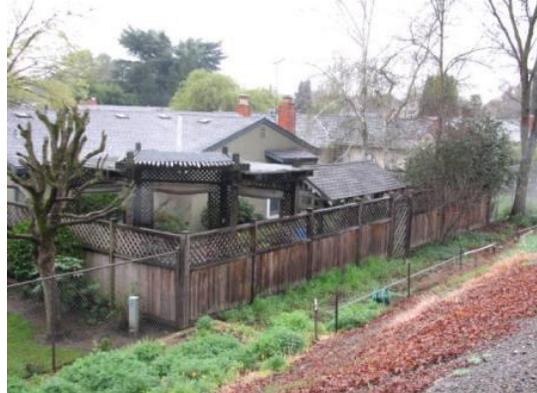
Photo 1 of 1 : FA\_2014\_NA0001\_55\_106\_20141001\_00089.jpg

LM Start	<b>8.52</b>	Rating **	U	Issue No.	<b>106</b>
LM End	<b>8.52</b>	Issue Type +	En	Location *	LS
Category	Earthen Levee		GPS Latitude/Longitude		
			Start	End	
Item	Encroachments		38.563308 °	38.563308 °	
			-121.389885 °	-121.389885 °	
DWR ID	DWR_NA0001_04_s_2012_106				
Action/Comments					
Fence Inspector Comments: Wood privacy fence within 10-ft of levee toe obstructs access and visibility. Block wall built into the levee.

03/16/2012 Wood privacy fence completely obstructs access and visibility.

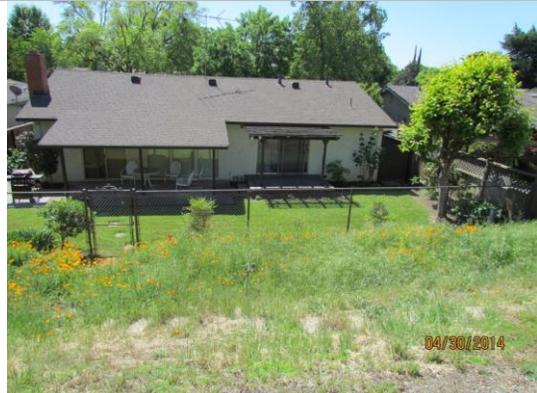
Photo 1 of 1 : FA\_2014\_NA0001\_55\_246\_20141001\_00191.jpg

LM Start	<b>8.53</b>	Rating **	M	Issue No.	<b>246</b>
LM End	<b>8.53</b>	Issue Type +	En	Location *	LS
Category	Earthen Levee		GPS Latitude/Longitude		
			Start	End	
Item	Encroachments		38.563434 °	38.563434 °	
			-121.389675 °	-121.389675 °	
DWR ID	DWR_NA0001_04_s_2014_246				
Action/Comments					
Retaining Wall Inspector Comments: Retaining wall and irrigation at landside levee toe.

View of the irrigation and retaining wall at the landside levee toe.

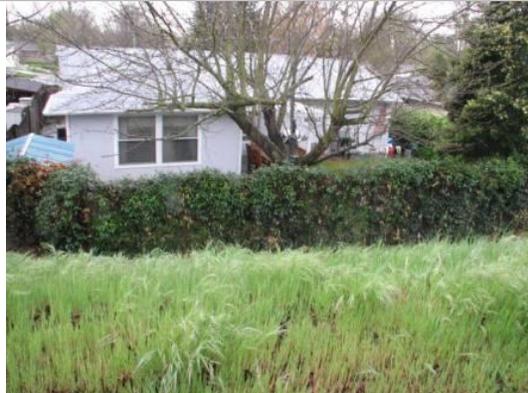
Photo 1 of 1 : FA\_2014\_NA0001\_55\_108\_20141001\_00091.jpg

LM Start	<b>8.55</b>	Rating **	<b>U</b>	Issue No.	<b>108</b>
LM End	<b>8.55</b>	Issue Type +	<b>En</b>	Location *	<b>LS</b>
Category	Earthen Levee		GPS Latitude/Longitude		
			Start	End	
Item	Vegetation		38.563587 °	38.563587 °	
			-121.389313 °	-121.389313 °	
DWR ID	DWR_NA0001_04_s_2012_108				
Action/Comments					
Landscaping

03/16/2012 Landscaping obstructs visibility and access.

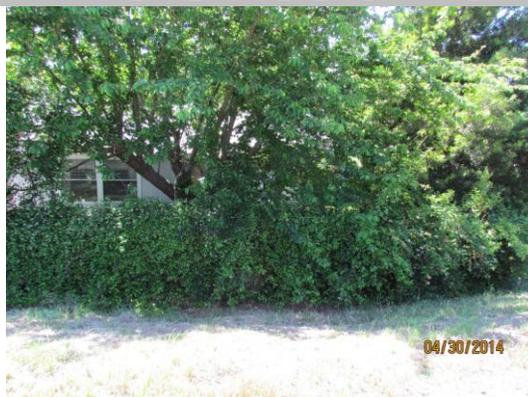
Photo 1 of 1 : FA\_2014\_NA0001\_55\_236\_20141001\_00186.jpg

LM Start	<b>8.56</b>	Rating **	<b>M</b>	Issue No.	<b>236</b>
LM End	<b>8.56</b>	Issue Type +	<b>En</b>	Location *	<b>LS</b>
Category	Earthen Levee		GPS Latitude/Longitude		
			Start	End	
Item	Vegetation		38.566948 °	38.566948 °	
			-121.371562 °	-121.371562 °	
DWR ID	DWR_NA0001_04_s_2012_236				
Action/Comments					
Landscaping Inspector Comments: Landscaping within 10-ft of levee toe.

View of the landscaping at the landside levee to obstructing visibility and access.

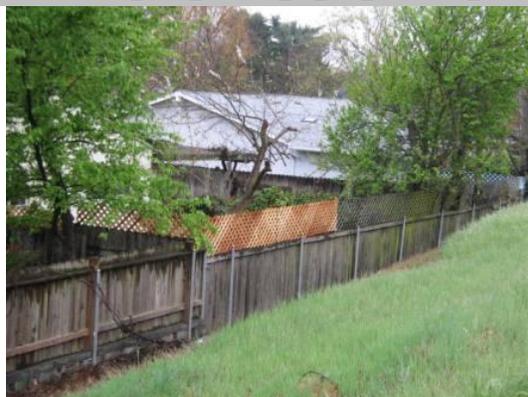
Photo 1 of 1 : FA\_2014\_NA0001\_55\_109\_20141001\_00092.jpg

LM Start	<b>8.57</b>	Rating **	<b>U</b>	Issue No.	<b>109</b>
LM End	<b>8.57</b>	Issue Type +	<b>En</b>	Location *	<b>LS</b>
Category	Earthen Levee		GPS Latitude/Longitude		
			Start	End	
Item	Encroachments		38.563580 °	38.563580 °	
			-121.389140 °	-121.389140 °	
DWR ID	DWR_NA0001_04_s_2012_109				
Action/Comments					
Fence Inspector Comments: Wood privacy fence within 10-ft of levee toe obstructs access and visibility.

03/16/2012 Wood privacy fence completely obstructs access and visibility.

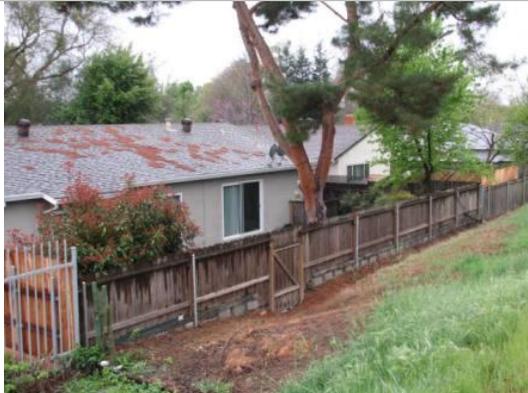
Photo 1 of 1 : FA\_2014\_NA0001\_55\_110\_20141001\_00093.jpg

LM Start	<b>8.58</b>	Rating **	U	Issue No.	<b>110</b>
LM End	<b>8.58</b>	Issue Type +	En	Location *	LS
Category	Earthen Levee		GPS Latitude/Longitude		
			Start	End	
Item	Encroachments		38.563732 °	38.563732 °	
			-121.388930 °	-121.388930 °	
DWR ID	DWR_NA0001_04_s_2012_110				
Action/Comments					
Fence Inspector Comments: Wood privacy fence within 10-ft of levee toe obstructs access and visibility.

03/16/2012 Wood privacy fence completely obstructs access and visibility.

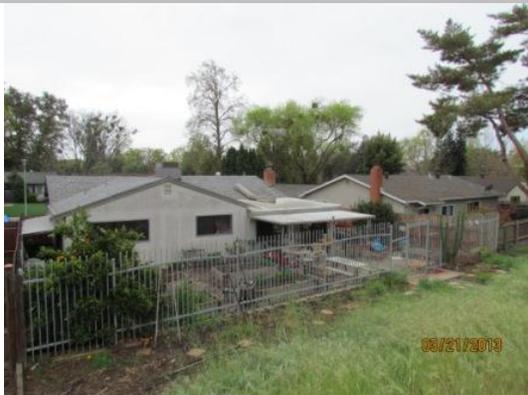
Photo 1 of 1 : FA\_2014\_NA0001\_55\_226\_20141001\_00184.jpg

LM Start	<b>8.59</b>	Rating **	M	Issue No.	<b>226</b>
LM End	<b>8.59</b>	Issue Type +	En	Location *	LS
Category	Earthen Levee		GPS Latitude/Longitude		
			Start	End	
Item	Vegetation		38.563793 °	38.563793 °	
			-121.388758 °	-121.388758 °	
DWR ID	DWR_NA0001_04_s_2012_226				
Action/Comments					
Landscaping Inspector Comments: Garden, trees and cactus planted against the levee toe.

View of landscaping at the levee toe.

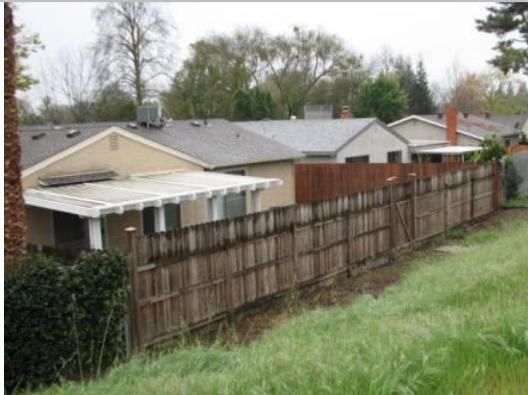
Photo 1 of 1 : FA\_2014\_NA0001\_55\_111\_20141001\_00094.jpg

LM Start	<b>8.60</b>	Rating **	U	Issue No.	<b>111</b>
LM End	<b>8.60</b>	Issue Type +	En	Location *	LS
Category	Earthen Levee		GPS Latitude/Longitude		
			Start	End	
Item	Encroachments		38.563820 °	38.563820 °	
			-121.388518 °	-121.388518 °	
DWR ID	DWR_NA0001_04_s_2012_111				
Action/Comments					
Fence Inspector Comments: Wood privacy fence within 10-ft of levee toe obstructs access and visibility.

03/16/2012 Wood privacy fence completely obstructs access and visibility.

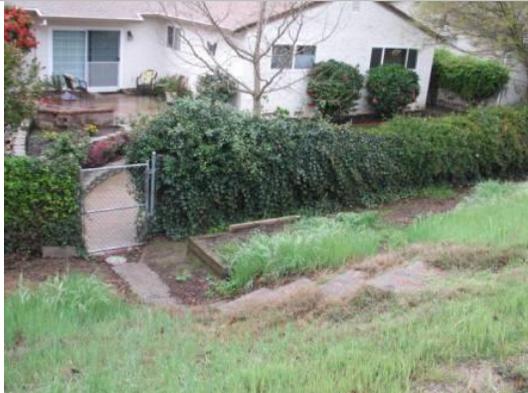
Photo 1 of 1 : FA\_2014\_NA0001\_55\_113\_20141001\_00096.jpg

LM Start	<b>8.61</b>	Rating **	<b>U</b>	Issue No.	<b>113</b>
LM End	<b>8.61</b>	Issue Type +	<b>En</b>	Location *	<b>LS</b>
Category	Earthen Levee		GPS Latitude/Longitude		
			Start	End	
Item	Vegetation		38.563877 °	38.563877 °	
			-121.388343 °	-121.388343 °	
DWR ID	DWR_NA0001_04_s_2012_113				
Action/Comments					
Landscaping

03/16/2012 Landscaping on chainlink fence blocks visibility and access.

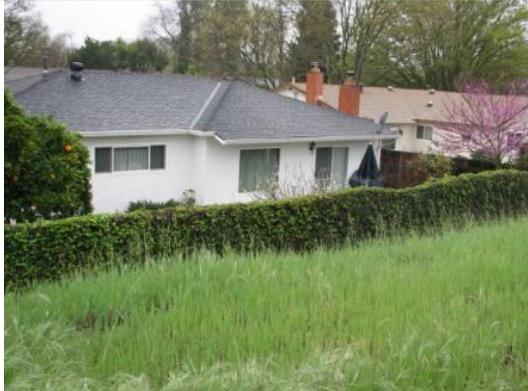
Photo 1 of 1 : FA\_2014\_NA0001\_55\_114\_20141001\_00097.jpg

LM Start	<b>8.63</b>	Rating **	<b>U</b>	Issue No.	<b>114</b>
LM End	<b>8.63</b>	Issue Type +	<b>En</b>	Location *	<b>LS</b>
Category	Earthen Levee		GPS Latitude/Longitude		
			Start	End	
Item	Vegetation		38.563945 °	38.563945 °	
			-121.388137 °	-121.388137 °	
DWR ID	DWR_NA0001_04_s_2012_114				
Action/Comments					
Landscaping Inspector Comments: Ivy and orange tree obstruct visibility.

03/16/2012 Ivy on chainlink fence completely obstructs visibility and access.

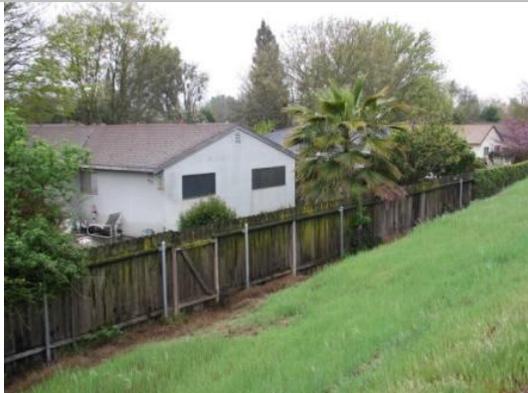
Photo 1 of 1 : FA\_2014\_NA0001\_55\_115\_20141001\_00098.jpg

LM Start	<b>8.65</b>	Rating **	<b>U</b>	Issue No.	<b>115</b>
LM End	<b>8.65</b>	Issue Type +	<b>En</b>	Location *	<b>LS</b>
Category	Earthen Levee		GPS Latitude/Longitude		
			Start	End	
Item	Encroachments		38.564047 °	38.564047 °	
			-121.387743 °	-121.387743 °	
DWR ID	DWR_NA0001_04_s_2012_115				
Action/Comments					
Fence Inspector Comments: Wood privacy fence and 2-story play house within 10-ft of levee toe obstructs access and visibility.

03/16/2012 Wood privacy fence completely obstructs access and visibility.

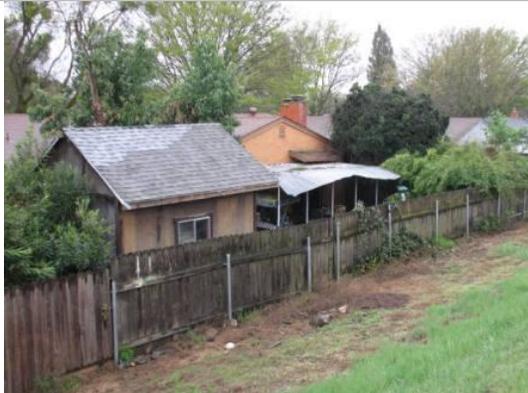
Photo 1 of 1 : FA\_2014\_NA0001\_55\_117\_20141001\_00100.jpg

LM Start	<b>8.66</b>	Rating **	U	Issue No.	<b>117</b>
LM End	<b>8.66</b>	Issue Type +	En	Location *	LS
Category	Earthen Levee		GPS Latitude/Longitude		
			Start	End	
Item	Encroachments		38.564033 °	38.564033 °	
			-121.387572 °	-121.387572 °	
DWR ID	DWR_NA0001_04_s_2012_117				
Action/Comments					
Fence Inspector Comments: Wood privacy fence and wood out building within 10-ft of levee toe obstructs access and visibility.

03/16/2012 Wood privacy fence completely obstructs access and visibility.

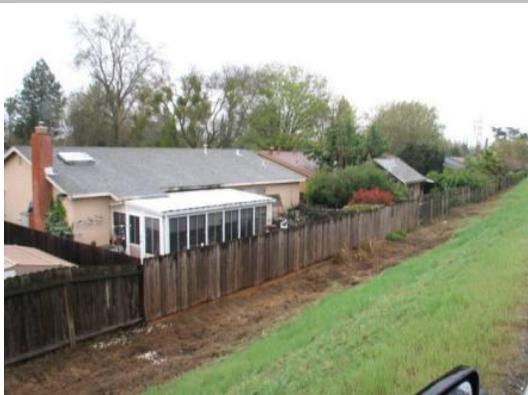
Photo 1 of 1 : FA\_2014\_NA0001\_55\_116\_20141001\_00099.jpg

LM Start	<b>8.67</b>	Rating **	U	Issue No.	<b>116</b>
LM End	<b>8.67</b>	Issue Type +	En	Location *	LS
Category	Earthen Levee		GPS Latitude/Longitude		
			Start	End	
Item	Encroachments		38.564133 °	38.564133 °	
			-121.387318 °	-121.387318 °	
DWR ID	DWR_NA0001_04_s_2012_116				
Action/Comments					
Fence Inspector Comments: Wood privacy fence within 10-ft of levee toe obstructs access and visibility.

03/16/2012 Wood privacy fence completely obstructs access and visibility.

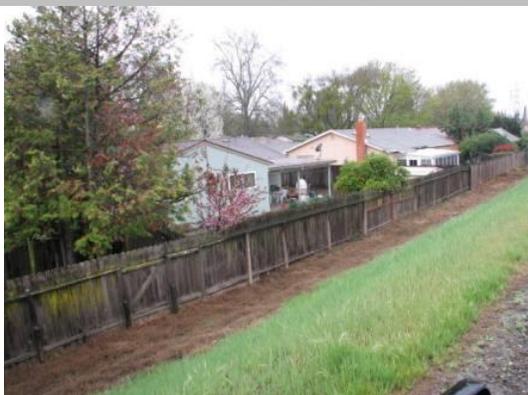
Photo 1 of 1 : FA\_2014\_NA0001\_55\_118\_20141001\_00101.jpg

LM Start	<b>8.68</b>	Rating **	U	Issue No.	<b>118</b>
LM End	<b>8.68</b>	Issue Type +	En	Location *	LS
Category	Earthen Levee		GPS Latitude/Longitude		
			Start	End	
Item	Encroachments		38.564133 °	38.564133 °	
			-121.387092 °	-121.387092 °	
DWR ID	DWR_NA0001_04_s_2012_118				
Action/Comments					
Fence Inspector Comments: Wood privacy fence within 10-ft of levee toe obstructs access and visibility.

03/16/2012 Wood privacy fence completely obstructs access and visibility.

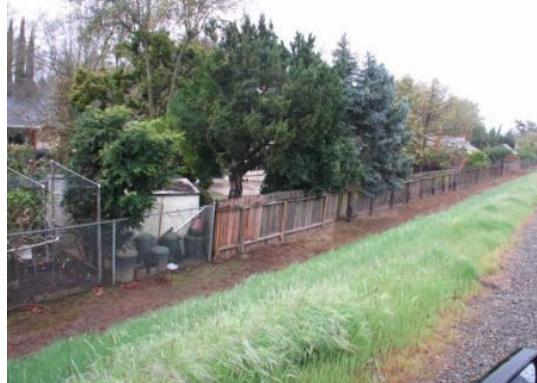
Photo 1 of 1 : FA\_2014\_NA0001\_55\_119\_20141001\_00102.jpg

LM Start	<b>8.70</b>	Rating **	U	Issue No.	<b>119</b>
LM End	<b>8.70</b>	Issue Type +	En	Location *	LS
Category	Earthen Levee			GPS Latitude/Longitude	
				Start	End
Item	Encroachments			38.564217 °	38.564217 °
				-121.386846 °	-121.386846 °
DWR ID	DWR_NA0001_04_s_2012_119				
Action/Comments					
Fence Inspector Comments: Wood privacy fence within 10-ft of levee toe obstructs access and visibility.

03/16/2012 Wood privacy fence completely obstructs access and visibility.

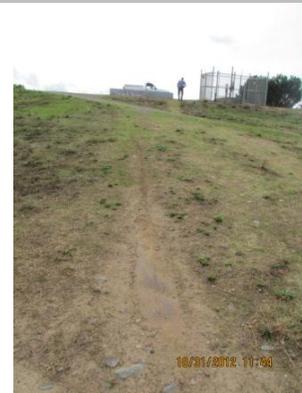
Photo 1 of 2 : FA\_2014\_NA0001\_55\_175\_20141001\_00152.jpg

LM Start	<b>9.49</b>	Rating **	A/W	Issue No.	<b>175</b>
LM End	<b>9.49</b>	Issue Type +	En	Location *	WS
Category	Earthen Levee			GPS Latitude/Longitude	
				Start	End
Item	Encroachments			38.566700 °	38.566700 °
				-121.372961 °	-121.372961 °
DWR ID	DWR_NA0001_04_s_2012_175				
Action/Comments					
Pipe Inspector Comments: Flap gates in good condition. Pipe is exposed at waterside toe.

View of exposed pipe at waterside toe.

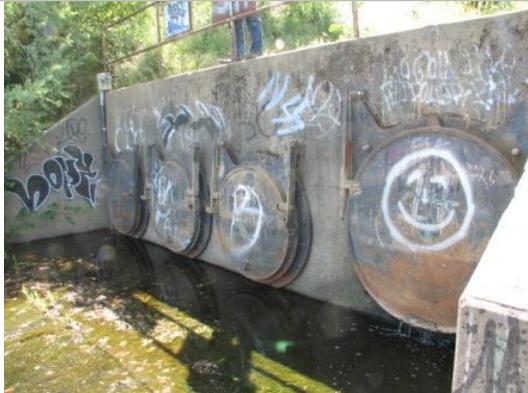
Photo 2 of 2 : FA\_2014\_NA0001\_55\_175\_20141001\_00153.jpg

LM Start	<b>9.49</b>	Rating **	A/W	Issue No.	<b>175 (cont)</b>
LM End	<b>9.49</b>	Issue Type +	En	Location *	WS
Category	Earthen Levee		GPS Latitude/Longitude		
			Start	End	
Item	Encroachments		38.566700 °	38.566700 °	
			-121.372961 °	-121.372961 °	
DWR ID	DWR_NA0001_04_s_2012_175				
Action/Comments					
Pipe Inspector Comments: Flap gates in good condition. Pipe is exposed at waterside toe.

Drainage outfall to American River.

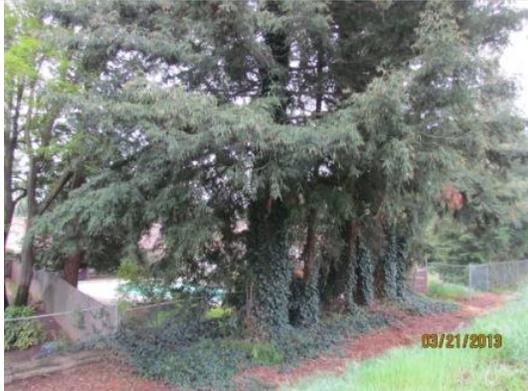
Photo 1 of 1 : FA\_2014\_NA0001\_55\_237\_20141001\_00187.jpg

LM Start	<b>9.57</b>	Rating **	M	Issue No.	<b>237</b>
LM End	<b>9.57</b>	Issue Type +	En	Location *	LS
Category	Earthen Levee		GPS Latitude/Longitude		
			Start	End	
Item	Vegetation		38.566938 °	38.566938 °	
			-121.371550 °	-121.371550 °	
DWR ID	DWR_NA0001_04_s_2012_237				
Action/Comments					
Landscaping Inspector Comments: Redwoods and ivy along fence within 10-ft of levee toe.

View of landscaping at levee toe.

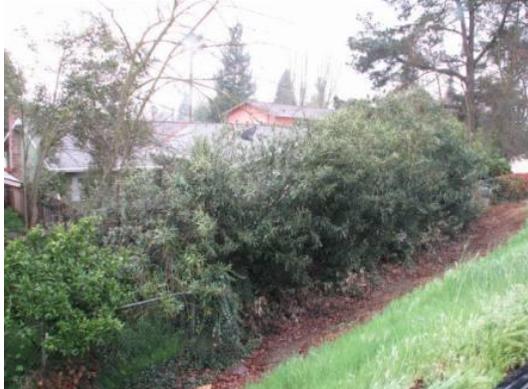
Photo 1 of 1 : FA\_2014\_NA0001\_55\_121\_20141001\_00103.jpg

LM Start	<b>9.61</b>	Rating **	U	Issue No.	<b>121</b>
LM End	<b>9.61</b>	Issue Type +	En	Location *	LS
Category	Earthen Levee		GPS Latitude/Longitude		
			Start	End	
Item	Vegetation		38.567058 °	38.567058 °	
			-121.370954 °	-121.370954 °	
DWR ID	DWR_NA0001_04_s_2012_121				
Action/Comments					
Landscaping Inspector Comments: Oleander bushes and shrubs within 10-ft of landside toe.

03/16/2012 Landscaping obstructs visibility and access.

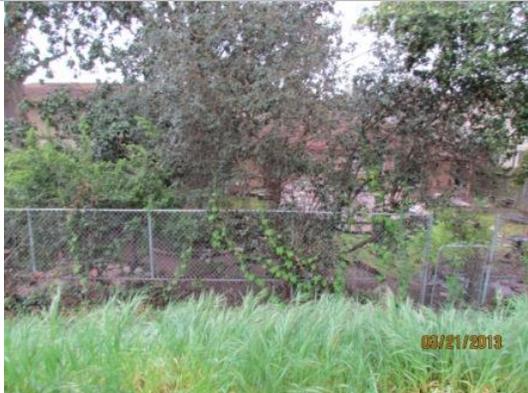
Photo 1 of 1 : FA\_2014\_NA0001\_55\_122\_20141001\_00104.jpg

LM Start	<b>9.64</b>	Rating **	M	Issue No.	<b>122</b>
LM End	<b>9.64</b>	Issue Type +	En	Location *	LS
Category	Earthen Levee		GPS Latitude/Longitude		
			Start	End	
Item	Vegetation		38.567181 °	38.567181 °	
			-121.370366 °	-121.370366 °	
DWR ID	DWR_NA0001_04_s_2012_122				
Action/Comments					
Landscaping Inspector Comments: Trees and ground cover within 10-ft of levee toe.

View of landscaping at levee toe.

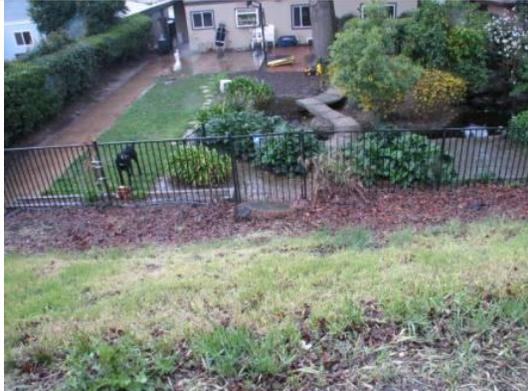
Photo 1 of 1 : FA\_2014\_NA0001\_55\_123\_20141001\_00105.jpg

LM Start	<b>9.66</b>	Rating **	N	Issue No.	<b>123</b>
LM End	<b>9.66</b>	Issue Type +	Ma	Location *	LS
Category	Earthen Levee		GPS Latitude/Longitude		
			Start	End	
Item	Trim / Thin Trees		38.567285 °	38.567285 °	
			-121.369964 °	-121.369964 °	
DWR ID	DWR_NA0001_04_s_2012_123				
Action/Comments					
Tree stumps. Inspector Comments: Trees, bushes and ground cover within 10-ft of levee toe.

03/16/2012 Large tree stump at levee toe.

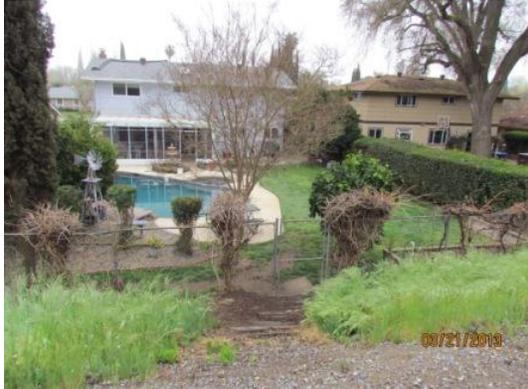
Photo 1 of 1 : FA\_2014\_NA0001\_55\_124\_20141001\_00106.jpg

LM Start	<b>9.67</b>	Rating **	M	Issue No.	<b>124</b>
LM End	<b>9.67</b>	Issue Type +	En	Location *	LS
Category	Earthen Levee		GPS Latitude/Longitude		
			Start	End	
Item	Vegetation		38.567242 °	38.567242 °	
			-121.369858 °	-121.369858 °	
DWR ID	DWR_NA0001_04_s_2012_124				
Action/Comments					
Landscaping Inspector Comments: Ivy and vines on chain link fence within 10-ft of levee toe.

View of landscaping at levee toe.

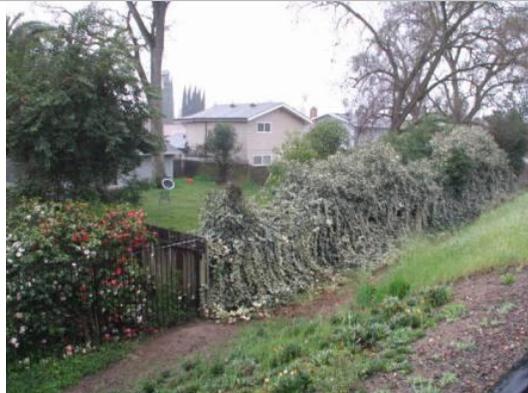
Photo 1 of 1 : FA\_2014\_NA0001\_55\_125\_20141001\_00107.jpg

LM Start	<b>9.69</b>	Rating **	U	Issue No.	<b>125</b>
LM End	<b>9.69</b>	Issue Type +	En	Location *	LS
Category	Earthen Levee		GPS Latitude/Longitude		
			Start	End	
Item	Vegetation		38.567360 °	38.567360 °	
			-121.369555 °	-121.369555 °	
DWR ID	DWR_NA0001_04_s_2012_125				
Action/Comments					
Landscaping Inspector Comments: Dense golden ivy on C/L fence obstructs access and visibility.

03/16/2012 Landscaping obstructs visibility and access.

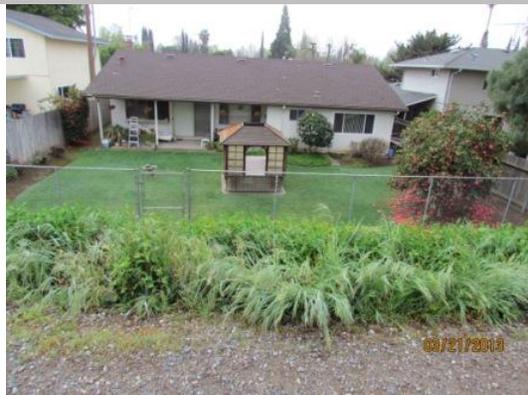
Photo 1 of 1 : FA\_2014\_NA0001\_55\_127\_20141001\_00108.jpg

LM Start	<b>9.72</b>	Rating **	M	Issue No.	<b>127</b>
LM End	<b>9.72</b>	Issue Type +	En	Location *	LS
Category	Earthen Levee		GPS Latitude/Longitude		
			Start	End	
Item	Vegetation		38.567451 °	38.567451 °	
			-121.368962 °	-121.368962 °	
DWR ID	DWR_NA0001_04_s_2012_127				
Action/Comments					
Landscaping Inspector Comments: Ground cover on levee slope.

View of landscaping on levee slope.

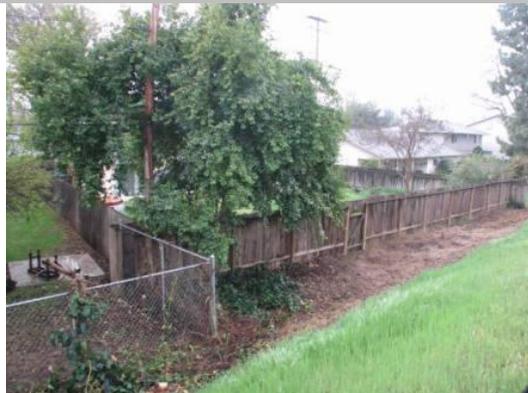
Photo 1 of 1 : FA\_2014\_NA0001\_55\_128\_20141001\_00109.jpg

LM Start	<b>9.74</b>	Rating **	U	Issue No.	<b>128</b>
LM End	<b>9.74</b>	Issue Type +	En	Location *	LS
Category	Earthen Levee		GPS Latitude/Longitude		
			Start	End	
Item	Encroachments		38.567493 °	38.567493 °	
			-121.368633 °	-121.368633 °	
DWR ID	DWR_NA0001_04_s_2012_128				
Action/Comments					
Fence Inspector Comments: Wooden privacy fence within 10-ft of levee toe.

03/16/2012 Wood privacy fence completely obstructs access and visibility.

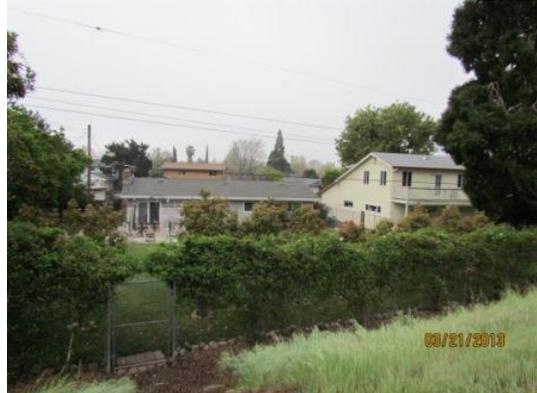
Photo 1 of 1 : FA\_2014\_NA0001\_55\_129\_20141001\_00110.jpg

LM Start	<b>9.76</b>	Rating **	M	Issue No.	<b>129</b>
LM End	<b>9.76</b>	Issue Type +	En	Location *	LS
Category	Earthen Levee		GPS Latitude/Longitude		
			Start	End	
Item	Vegetation		38.567594 °	38.567594 °	
			-121.368195 °	-121.368195 °	
DWR ID	DWR_NA0001_04_s_2012_129				
Action/Comments					
Landscaping Inspector Comments: Trees and vines along C/L fence within 10-ft of levee toe.

View of landscaping at levee toe.

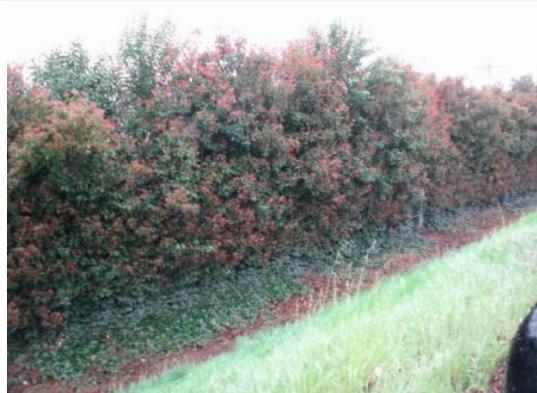
Photo 1 of 1 : FA\_2014\_NA0001\_55\_130\_20141001\_00111.jpg

LM Start	<b>9.78</b>	Rating **	U	Issue No.	<b>130</b>
LM End	<b>9.78</b>	Issue Type +	En	Location *	LS
Category	Earthen Levee		GPS Latitude/Longitude		
			Start	End	
Item	Vegetation		38.567626 °	38.567626 °	
			-121.367921 °	-121.367921 °	
DWR ID	DWR_NA0001_04_s_2012_130				
Action/Comments					
Landscaping Inspector Comments: Tall hedge obstructs access and visibility.

03/16/2012 Tall hedge obstructs visibility and access.

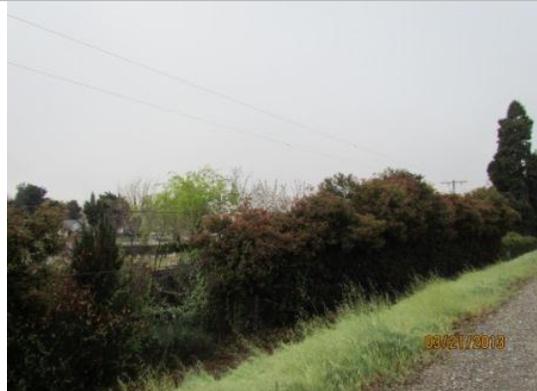
Photo 1 of 1 : FA\_2014\_NA0001\_55\_131\_20141001\_00112.jpg

LM Start	<b>9.79</b>	Rating **	M	Issue No.	<b>131</b>
LM End	<b>9.79</b>	Issue Type +	En	Location *	LS
Category	Earthen Levee		GPS Latitude/Longitude		
			Start	End	
Item	Vegetation		38.567680 °	38.567680 °	
			-121.367674 °	-121.367674 °	
DWR ID	DWR_NA0001_04_s_2012_131				
Action/Comments					
Landscaping Inspector Comments: Tall hedge obstructs access and visibility.

View of landscaping at levee toe.

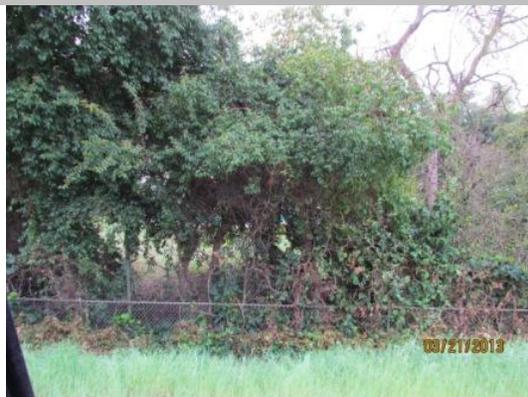
Photo 1 of 1 : FA\_2014\_NA0001\_55\_132\_20141001\_00113.jpg

LM Start	<b>9.82</b>	Rating **	M	Issue No.	<b>132</b>
LM End	<b>9.82</b>	Issue Type +	En	Location *	LS
Category	Earthen Levee		GPS Latitude/Longitude		
			Start	End	
Item	Vegetation		38.567772 °	38.567772 °	
			-121.367227 °	-121.367227 °	
DWR ID	DWR_NA0001_04_s_2012_132				
Action/Comments					
Landscaping Inspector Comments: Trees and ivy on levee slope obstruct access and visibility.

View of obstructive landscaping.

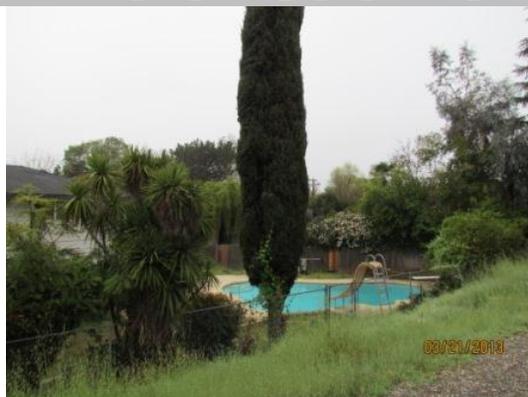
Photo 1 of 1 : FA\_2014\_NA0001\_55\_133\_20141001\_00114.jpg

LM Start	<b>9.84</b>	Rating **	M	Issue No.	<b>133</b>
LM End	<b>9.84</b>	Issue Type +	En	Location *	LS
Category	Earthen Levee		GPS Latitude/Longitude		
			Start	End	
Item	Vegetation		38.567856 °	38.567856 °	
			-121.366892 °	-121.366892 °	
DWR ID	DWR_NA0001_04_s_2012_133				
Action/Comments					
Landscaping Inspector Comments: Lemon tree, palm, sky pencil and ivy planted within 10-ft of levee toe obstructs access and visibility.

View of landscaping at levee toe.

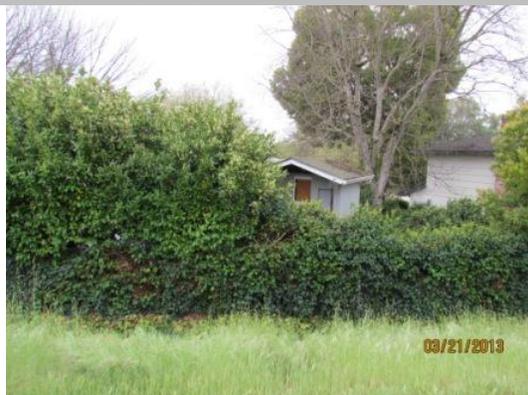
Photo 1 of 1 : FA\_2014\_NA0001\_55\_134\_20141001\_00115.jpg

LM Start	<b>9.86</b>	Rating **	M	Issue No.	<b>134</b>
LM End	<b>9.86</b>	Issue Type +	En	Location *	LS
Category	Earthen Levee		GPS Latitude/Longitude		
			Start	End	
Item	Vegetation		38.567873 °	38.567873 °	
			-121.366410 °	-121.366410 °	
DWR ID	DWR_NA0001_04_s_2012_134				
Action/Comments					
Landscaping Inspector Comments: Ivy, hedge and play house is within 10-ft of levee toe.

View of landscaping and playhouse.

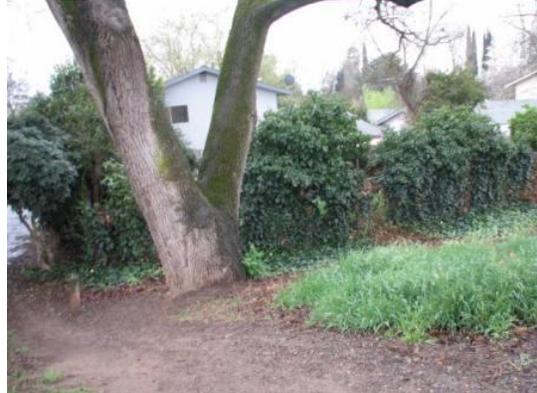
Photo 1 of 1 : FA\_2014\_NA0001\_55\_135\_20141001\_00116.jpg

LM Start	<b>9.98</b>	Rating **	M	Issue No.	<b>135</b>
LM End	<b>9.98</b>	Issue Type +	En	Location *	LS
Category	Earthen Levee		GPS Latitude/Longitude		
			Start	End	
Item	Vegetation		38.568446 °	38.568446 °	
			-121.364385 °	-121.364385 °	
DWR ID	DWR_NA0001_04_s_2012_135				
Action/Comments					
Landscaping Inspector Comments: Tall hedge and ivy within 10-ft of landside levee toe.

03/16/2012 Landscaping is obstructing visibility.

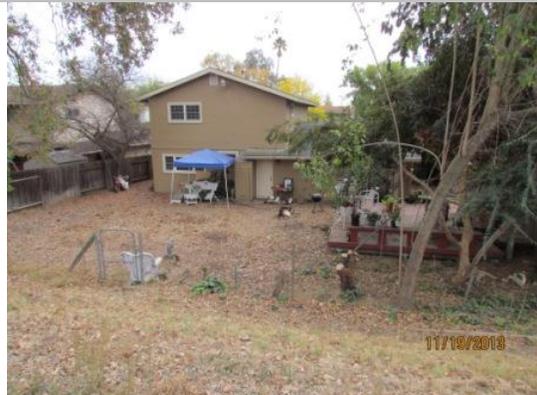
Photo 1 of 1 : FA\_2014\_NA0001\_55\_136\_20141001\_00117.jpg

LM Start	<b>10.04</b>	Rating **	M	Issue No.	<b>136</b>
LM End	<b>10.04</b>	Issue Type +	En	Location *	LS
Category	Earthen Levee		GPS Latitude/Longitude		
			Start	End	
Item	Encroachments		38.568714 °	38.568714 °	
			-121.363257 °	-121.363257 °	
DWR ID	DWR_NA0001_04_s_2012_136				
Action/Comments					
Fence Inspector Comments: Wire fence within 10-ft of landside levee toe.

View of the fence and tree stump at the landside levee toe.

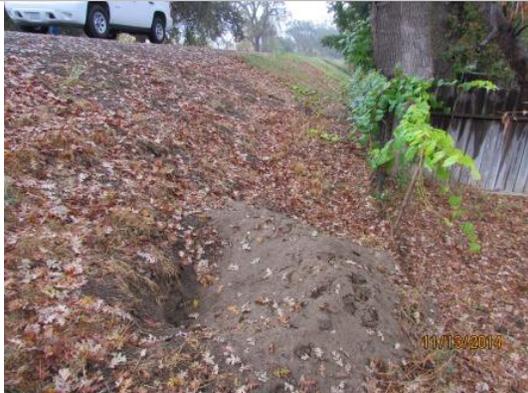
Photo 1 of 1 : FA\_2014\_NA0001\_55\_239\_20141119\_00214.jpg

LM Start	<b>10.06</b>	Rating **	M	Issue No.	<b>239</b>
LM End	<b>10.06</b>	Issue Type +	Ma	Location *	LS
Category	Earthen Levee		GPS Latitude/Longitude		
			Start	End	
Item	Animal Control		38.568773 °	38.568773 °	
			-121.363057 °	-121.363057 °	
DWR ID	DWR_NA0001_04_f_2014_239				
Action/Comments					
Exterminate rodents and backfill and compact or grout burrows.

View of several large rodent burrows.

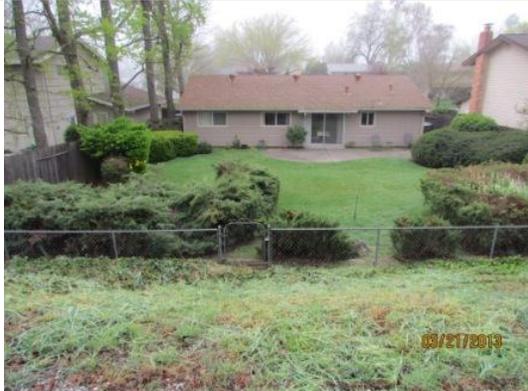
Photo 1 of 1 : FA\_2014\_NA0001\_55\_137\_20141001\_00118.jpg

LM Start	<b>10.07</b>	Rating **	M	Issue No.	<b>137</b>
LM End	<b>10.07</b>	Issue Type +	En	Location *	LS
Category	Earthen Levee		GPS Latitude/Longitude		
			Start	End	
Item	Vegetation		38.568833 °	38.568833 °	
			-121.362783 °	-121.362783 °	
DWR ID	DWR_NA0001_04_s_2012_137				
Action/Comments					
Landscaping Inspector Comments: Ivy on levee slope and Juniper at levee toe.

View of encroaching landscaping.

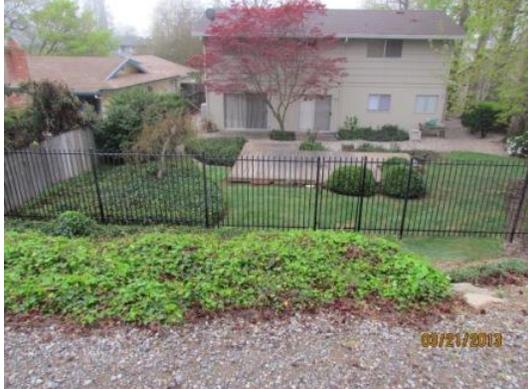
Photo 1 of 1 : FA\_2014\_NA0001\_55\_238\_20141001\_00188.jpg

LM Start	<b>10.09</b>	Rating **	M	Issue No.	<b>238</b>
LM End	<b>10.09</b>	Issue Type +	En	Location *	LS
Category	Earthen Levee		GPS Latitude/Longitude		
			Start	End	
Item	Vegetation		38.568918 °	38.568918 °	
			-121.362533 °	-121.362533 °	
DWR ID	DWR_NA0001_04_s_2012_238				
Action/Comments					
Landscaping Inspector Comments: Landscaping on levee slope.

View of the landscaping on levee slope.

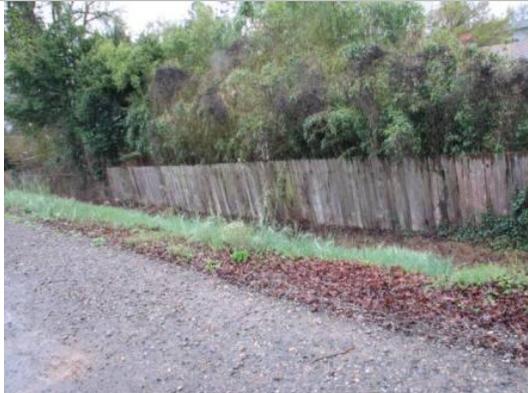
Photo 1 of 1 : FA\_2014\_NA0001\_55\_138\_20141001\_00119.jpg

LM Start	<b>10.10</b>	Rating **	<b>U</b>	Issue No.	<b>138</b>
LM End	<b>10.10</b>	Issue Type +	<b>En</b>	Location *	<b>LS</b>
Category	Earthen Levee		GPS Latitude/Longitude		
			Start	End	
Item	Encroachments		38.568953 °	38.568953 °	
			-121.362396 °	-121.362396 °	
DWR ID	DWR_NA0001_04_s_2012_138				
Action/Comments					
Fence Inspector Comments: 03/16/2012 Wood privacy fence completely obstructs visibility and access.

03/16/2012 Wood privacy fence completely obstructs access and visibility.

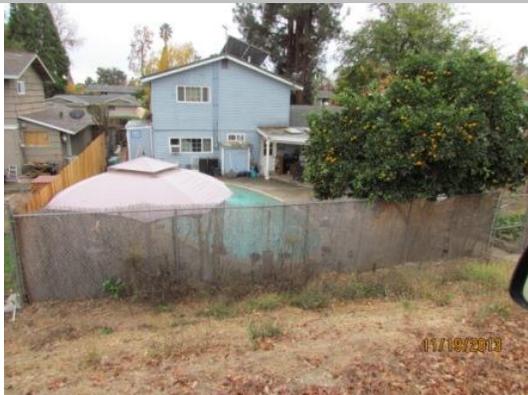
Photo 1 of 1 : FA\_2014\_NA0001\_55\_202\_20141001\_00174.jpg

LM Start	<b>10.12</b>	Rating **	<b>A/W</b>	Issue No.	<b>202</b>
LM End	<b>10.12</b>	Issue Type +	<b>En</b>	Location *	<b>LS</b>
Category	Earthen Levee		GPS Latitude/Longitude		
			Start	End	
Item	Encroachments		38.569111 °	38.569111 °	
			-121.361921 °	-121.361921 °	
DWR ID	DWR_NA0001_04_s_2013_202				
Action/Comments					
Pool Inspector Comments: Pool filled with water.

View of the pool filled with water.

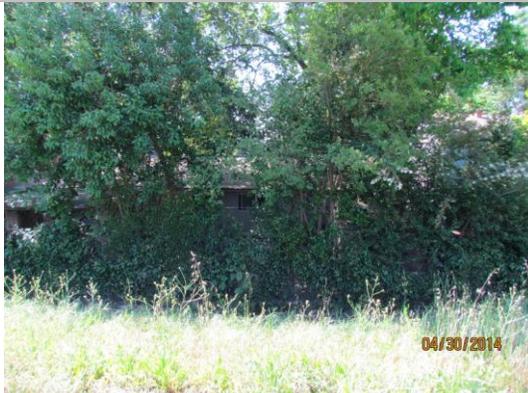
Photo 1 of 1 : FA\_2014\_NA0001\_55\_245\_20141001\_00190.jpg

LM Start	<b>10.16</b>	Rating **	<b>U</b>	Issue No.	<b>245</b>
LM End	<b>10.16</b>	Issue Type +	<b>En</b>	Location *	<b>LS</b>
Category	Earthen Levee		GPS Latitude/Longitude		
			Start	End	
Item	Encroachments		38.569247 °	38.569247 °	
			-121.361315 °	-121.361315 °	
DWR ID	DWR_NA0001_04_s_2014_245				
Action/Comments					
Fence Inspector Comments: Rod fence covered with vegetation within 10ft of levee toe.

View of the fence at the landside levee toe.

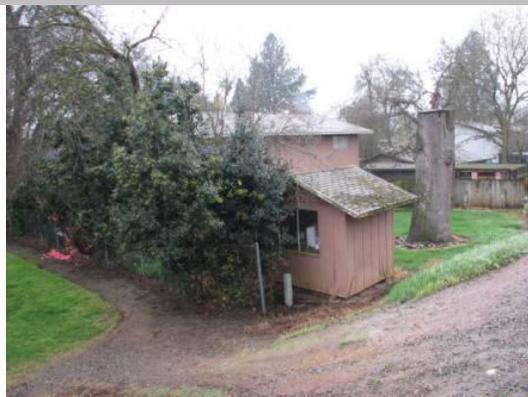
Photo 1 of 1 : FA\_2014\_NA0001\_55\_176\_20141001\_00154.jpg

LM Start	<b>10.18</b>	Rating **	U	Issue No.	<b>176</b>
LM End	<b>10.18</b>	Issue Type +	En	Location *	LS
Category	Earthen Levee		GPS Latitude/Longitude		
			Start	End	
Item	Encroachments		38.569293 °	38.569293 °	
			-121.361002 °	-121.361002 °	
DWR ID	DWR_NA0001_04_s_2012_176				
Action/Comments					
Building

03/16/2012 Wood structure within 15' of levee toe.

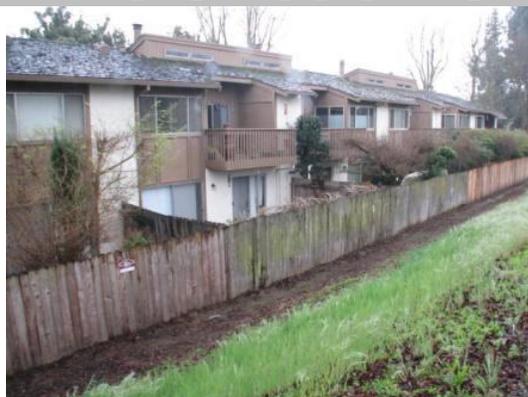
Photo 1 of 1 : FA\_2014\_NA0001\_55\_141\_20141001\_00121.jpg

LM Start	<b>10.34</b>	Rating **	U	Issue No.	<b>141</b>
LM End	<b>10.37</b>	Issue Type +	En	Location *	LS
Category	Earthen Levee		GPS Latitude/Longitude		
			Start	End	
Item	Encroachments		38.569982 °	38.570118 °	
			-121.358134 °	-121.357604 °	
DWR ID	DWR_NA0001_04_s_2012_141				
Action/Comments					
Fence Inspector Comments: Wooden fence behind six apartment units is within 10-ft of levee slope.

03/16/2012 Wood privacy fence completely obstructs access and visibility.

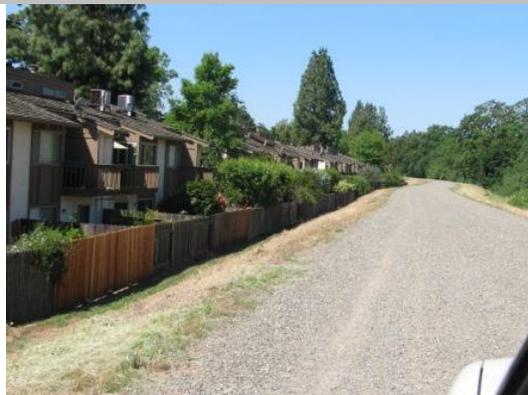
Photo 1 of 1 : FA\_2014\_NA0001\_55\_142\_20141001\_00122.jpg

LM Start	<b>10.38</b>	Rating **	U	Issue No.	<b>142</b>
LM End	<b>10.40</b>	Issue Type +	En	Location *	LS
Category	Earthen Levee		GPS Latitude/Longitude		
			Start	End	
Item	Encroachments		38.570175 °	38.570229 °	
			-121.357390 °	-121.357041 °	
DWR ID	DWR_NA0001_04_s_2012_142				
Action/Comments					
Fence Inspector Comments: Wooden fence behind six apartment units is within 10-ft of levee slope.

Wooden fence behind apartments within 10' of levee toe.

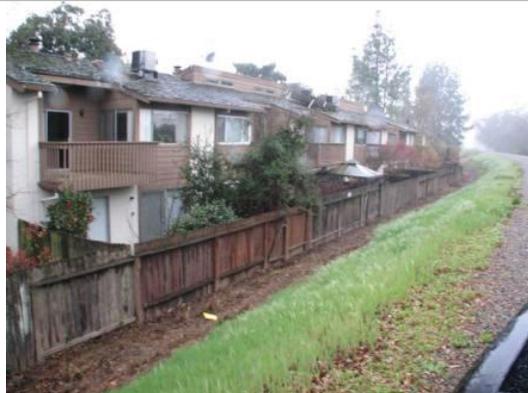
Photo 1 of 1 : FA\_2014\_NA0001\_55\_146\_20141001\_00126.jpg

LM Start	<b>10.41</b>	Rating **	U	Issue No.	<b>146</b>
LM End	<b>10.42</b>	Issue Type +	En	Location *	LS
Category	Earthen Levee		GPS Latitude/Longitude		
			Start	End	
Item	Encroachments		38.570225 °	38.570245 °	
			-121.357014 °	-121.356791 °	
DWR ID	DWR_NA0001_04_s_2012_146				
Action/Comments					
Fence Inspector Comments: Wooden fence behind 6 apartments.

03/16/2012 Wood privacy fence completely obstructs access and visibility.

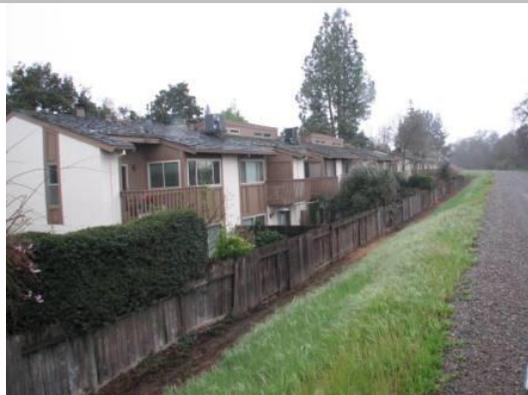
Photo 1 of 1 : FA\_2014\_NA0001\_55\_143\_20141001\_00123.jpg

LM Start	<b>10.42</b>	Rating **	U	Issue No.	<b>143</b>
LM End	<b>10.44</b>	Issue Type +	En	Location *	LS
Category	Earthen Levee		GPS Latitude/Longitude		
			Start	End	
Item	Encroachments		38.570257 °	38.570297 °	
			-121.356783 °	-121.356403 °	
DWR ID	DWR_NA0001_04_s_2012_143				
Action/Comments					
Fence Inspector Comments: Wooden fence behind six apartment units is within 10-ft of levee slope.

03/16/2012 Wood privacy fence completely obstructs access and visibility.

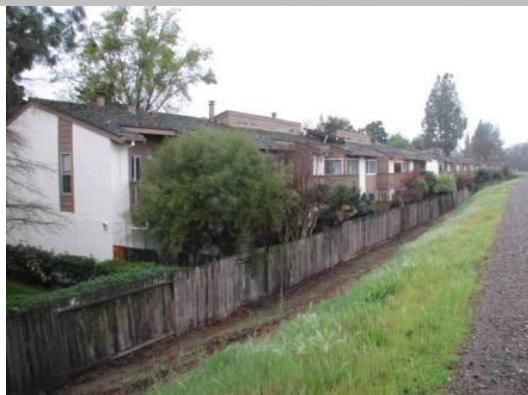
Photo 1 of 1 : FA\_2014\_NA0001\_55\_144\_20141001\_00124.jpg

LM Start	<b>10.45</b>	Rating **	U	Issue No.	<b>144</b>
LM End	<b>10.48</b>	Issue Type +	En	Location *	LS
Category	Earthen Levee		GPS Latitude/Longitude		
			Start	End	
Item	Encroachments		38.570325 °	38.570397 °	
			-121.356185 °	-121.355757 °	
DWR ID	DWR_NA0001_04_s_2012_144				
Action/Comments					
Fence Inspector Comments: Wooden fence behind six apartment units is within 10-ft of levee slope.

03/16/2012 Wood privacy fence completely obstructs access and visibility.

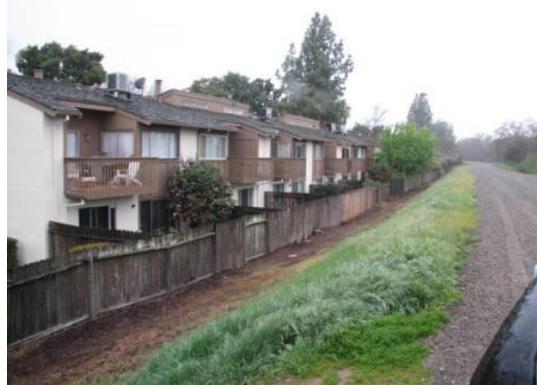
Photo 1 of 1 : FA\_2014\_NA0001\_55\_145\_20141001\_00125.jpg

LM Start	<b>10.48</b>	Rating **	U	Issue No.	<b>145</b>
LM End	<b>10.51</b>	Issue Type +	En	Location *	LS
Category	Earthen Levee			GPS Latitude/Longitude	
				Start	End
Item	Encroachments			38.570417 °	38.570500 °
				-121.355625 °	-121.355151 °
DWR ID	DWR_NA0001_04_s_2012_145				
Action/Comments					
Fence Inspector Comments: Wooden fence behind six apartment units is within 10-ft of levee slope.

03/16/2012 Wood privacy fence completely obstructs access and visibility.

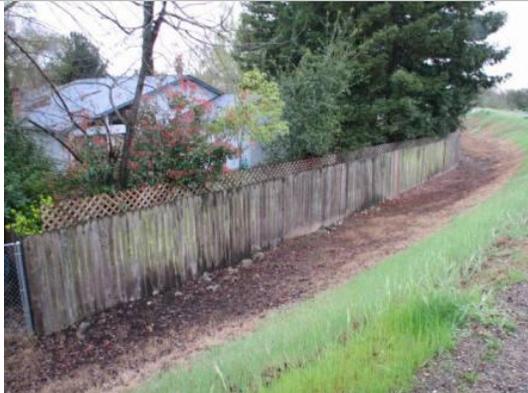
Photo 1 of 1 : FA\_2014\_NA0001\_55\_148\_20141001\_00128.jpg

LM Start	<b>10.56</b>	Rating **	U	Issue No.	<b>148</b>
LM End	<b>10.56</b>	Issue Type +	En	Location *	LS
Category	Earthen Levee		GPS Latitude/Longitude		
			Start	End	
Item	Encroachments		38.570524 °	38.570524 °	
			-121.354359 °	-121.354359 °	
DWR ID	DWR_NA0001_04_s_2012_148				
Action/Comments					
Fence Inspector Comments: Wooden privacy fence obstructs visibility and access.

03/16/2012 Wood privacy fence completely obstructs access and visibility.
