**Flood Control Project Maintenance  
Levee Inspections**

**Fall 2014 Levee Maintenance Deficiency Summary Report**

**Sacramento River Basin**

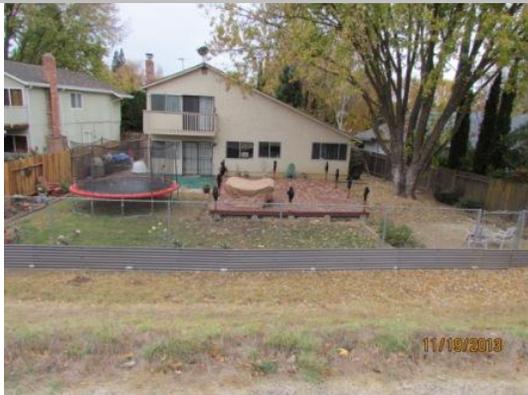
Photo 1 of 1 : FA\_2014\_NA0001\_55\_180\_20141001\_00158.jpg

LM Start	<b>10.57</b>	Rating **	M	Issue No.	<b>180</b>
LM End	<b>10.57</b>	Issue Type +	En	Location *	LS
Category	Earthen Levee		GPS Latitude/Longitude		
			Start	End	
Item	Encroachments		38.570397 °	38.570397 °	
			-121.354084 °	-121.354084 °	
DWR ID	DWR_NA0001_04_s_2012_180				
Action/Comments					
Fence Inspector Comments: Chainlink fence partially obstructs, currently visibility is unobstructed.

Chainlink fence is partially obstructing visibility and access.

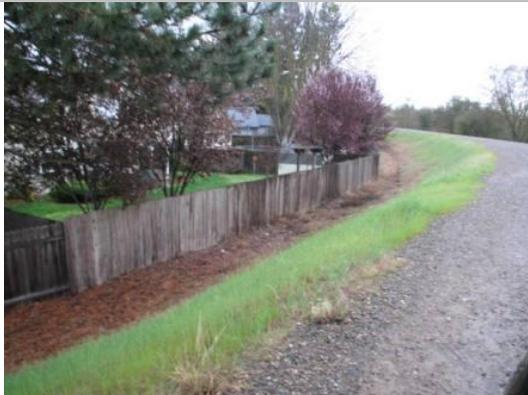
Photo 1 of 1 : FA\_2014\_NA0001\_55\_149\_20141001\_00129.jpg

LM Start	<b>10.58</b>	Rating **	U	Issue No.	<b>149</b>
LM End	<b>10.58</b>	Issue Type +	En	Location *	LS
Category	Earthen Levee		GPS Latitude/Longitude		
			Start	End	
Item	Encroachments		38.570234 °	38.570234 °	
			-121.353862 °	-121.353862 °	
DWR ID	DWR_NA0001_04_s_2012_149				
Action/Comments					
Fence Inspector Comments: Wooden privacy fence is within 10-ft of levee toe.

03/16/2012 Wood privacy fence completely obstructs access and visibility.

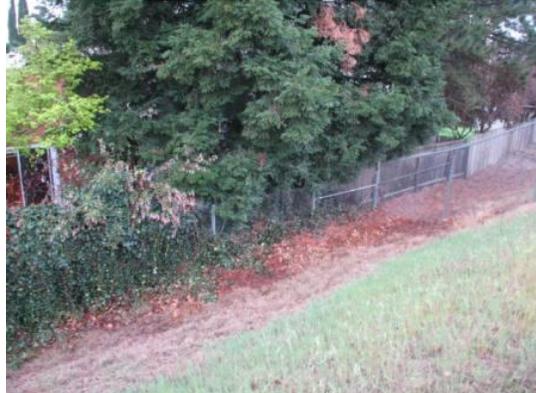
Photo 1 of 1 : FA\_2014\_NA0001\_55\_150\_20141001\_00130.jpg

LM Start	<b>10.60</b>	Rating **	U	Issue No.	<b>150</b>
LM End	<b>10.60</b>	Issue Type +	En	Location *	LS
Category	Earthen Levee		GPS Latitude/Longitude		
			Start	End	
Item	Encroachments		38.570095 °	38.570095 °	
			-121.353807 °	-121.353807 °	
DWR ID	DWR_NA0001_04_s_2012_150				
Action/Comments					
Fence Inspector Comments: Wooden privacy fence within 10-ft of levee toe.

03/16/2012 Wood privacy fence completely obstructs access and visibility.

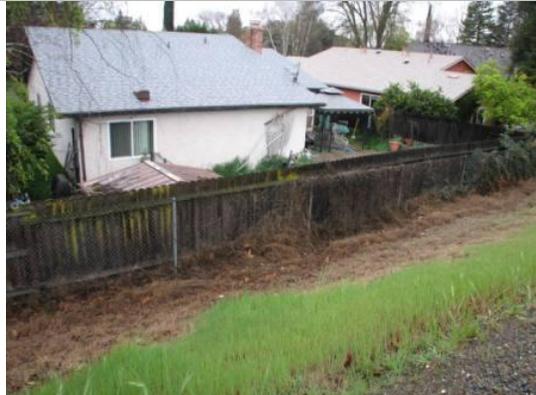
Photo 1 of 1 : FA\_2014\_NA0001\_55\_151\_20141001\_00131.jpg

LM Start	<b>10.62</b>	Rating **	U	Issue No.	<b>151</b>
LM End	<b>10.62</b>	Issue Type +	En	Location *	LS
Category	Earthen Levee		GPS Latitude/Longitude		
			Start	End	
Item	Encroachments		38.569921 °	38.569921 °	
			-121.353643 °	-121.353643 °	
DWR ID	DWR_NA0001_04_s_2012_151				
Action/Comments					
Fence Inspector Comments: Wooden privacy fence within 10-ft of levee toe.

03/16/2012 Wood privacy fence completely obstructs access and visibility.

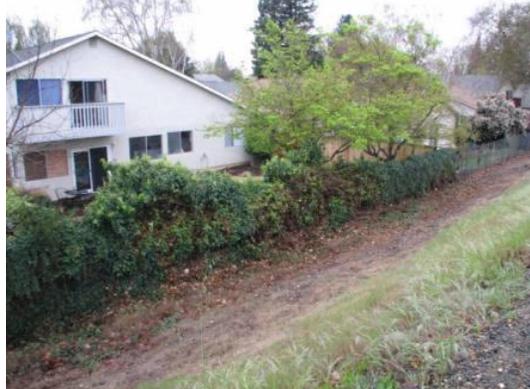
Photo 1 of 1 : FA\_2014\_NA0001\_55\_153\_20141001\_00133.jpg

LM Start	<b>10.67</b>	Rating **	U	Issue No.	<b>153</b>
LM End	<b>10.67</b>	Issue Type +	En	Location *	LS
Category	Earthen Levee			GPS Latitude/Longitude	
				Start	End
Item	Encroachments			38.569166 °	38.569166 °
				-121.353272 °	-121.353272 °
DWR ID	DWR_NA0001_04_s_2012_153				
Action/Comments					
Fence Inspector Comments: Wooden privacy fence and ivy within 10-ft of levee toe.

03/16/2012 Wood privacy fence completely obstructs access and visibility.

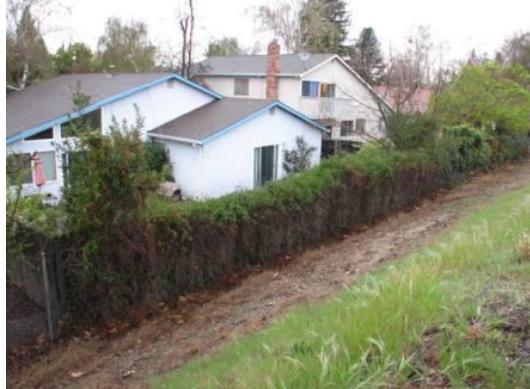
Photo 1 of 1 : FA\_2014\_NA0001\_55\_154\_20141001\_00134.jpg

LM Start	<b>10.68</b>	Rating **	U	Issue No.	<b>154</b>
LM End	<b>10.68</b>	Issue Type +	En	Location *	LS
Category	Earthen Levee			GPS Latitude/Longitude	
				Start	End
Item	Encroachments			38.569020 °	38.569020 °
				-121.353313 °	-121.353313 °
DWR ID	DWR_NA0001_04_s_2012_154				
Action/Comments					
Fence Inspector Comments: Wooden privacy fence within 10-ft of levee toe.

03/16/2012 Wood privacy fence completely obstructs access and visibility.

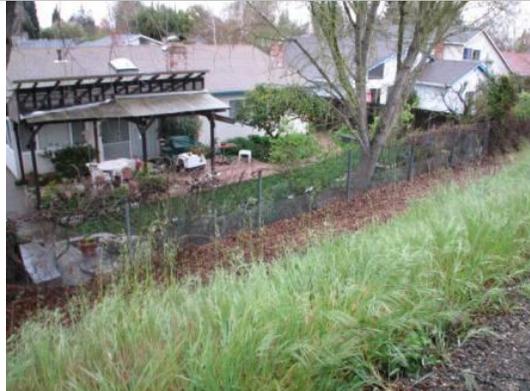
Photo 1 of 1 : FA\_2014\_NA0001\_55\_155\_20141001\_00135.jpg

LM Start	<b>10.69</b>	Rating **	M	Issue No.	<b>155</b>
LM End	<b>10.69</b>	Issue Type +	En	Location *	LS
Category	Earthen Levee			GPS Latitude/Longitude	
				Start	End
Item	Vegetation			38.568892 °	38.568892 °
				-121.353162 °	-121.353162 °
DWR ID	DWR_NA0001_04_s_2012_155				
Action/Comments					
Landscaping Inspector Comments: Trees and bushes are within 10-ft of the levee toe.

03/16/2012 Trees and bushes within 10' of levee toe.

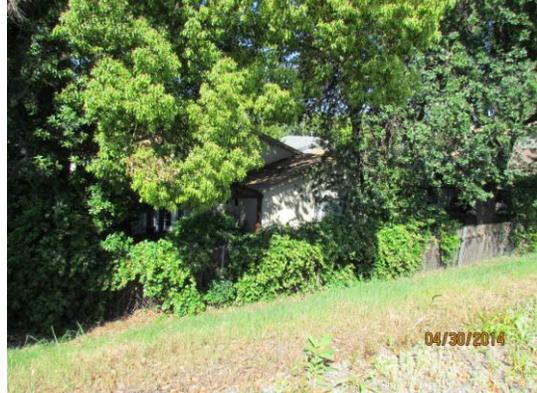
Photo 1 of 1 : FA\_2014\_NA0001\_55\_156\_20141001\_00136.jpg

LM Start	<b>10.71</b>	Rating **	U	Issue No.	<b>156</b>
LM End	<b>10.71</b>	Issue Type +	En	Location *	LS
Category	Earthen Levee			GPS Latitude/Longitude	
				Start	End
Item	Encroachments			38.568713 °	38.568713 °
				-121.353150 °	-121.353150 °
DWR ID	DWR_NA0001_04_s_2012_156				
Action/Comments					
Fence Inspector Comments: Wooden privacy fence and landscaping within 10-ft of levee toe.

View of the fence at the landside levee toe obstructing visibility and access.

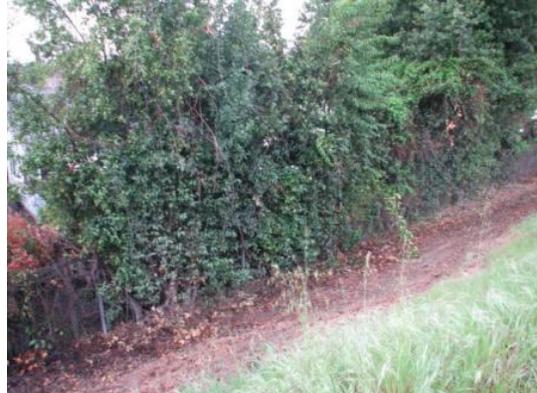
Photo 1 of 1 : FA\_2014\_NA0001\_55\_157\_20141001\_00137.jpg

LM Start	<b>10.71</b>	Rating **	M	Issue No.	<b>157</b>
LM End	<b>10.71</b>	Issue Type +	En	Location *	LS
Category	Earthen Levee			GPS Latitude/Longitude	
				Start	End
Item	Vegetation			38.568608 °	38.568608 °
				-121.353054 °	-121.353054 °
DWR ID	DWR_NA0001_04_s_2012_157				
Action/Comments					
Landscaping Inspector Comments: Tall hedge and vine on levee toe.

03/16/2012 Landscaping obstructs visibility

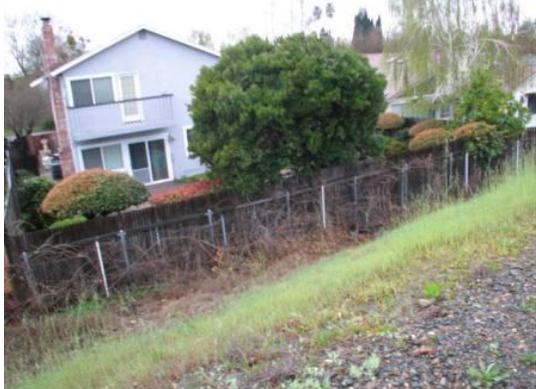
Photo 1 of 1 : FA\_2014\_NA0001\_55\_159\_20141001\_00139.jpg

LM Start	<b>10.73</b>	Rating **	U	Issue No.	<b>159</b>
LM End	<b>10.73</b>	Issue Type +	En	Location *	LS
Category	Earthen Levee		GPS Latitude/Longitude		
			Start	End	
Item	Encroachments		38.568313 °	38.568313 °	
			-121.352941 °	-121.352941 °	
DWR ID	DWR_NA0001_04_s_2012_159				
Action/Comments					
Fence Inspector Comments: Wooden privacy fence within 10-ft of levee toe.

03/16/2012 Wood privacy fence completely obstructs access and visibility.

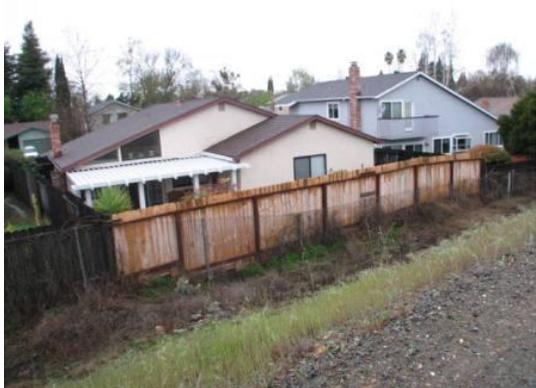
Photo 1 of 1 : FA\_2014\_NA0001\_55\_160\_20141001\_00140.jpg

LM Start	<b>10.74</b>	Rating **	U	Issue No.	<b>160</b>
LM End	<b>10.74</b>	Issue Type +	En	Location *	LS
Category	Earthen Levee		GPS Latitude/Longitude		
			Start	End	
Item	Encroachments		38.568188 °	38.568188 °	
			-121.352864 °	-121.352864 °	
DWR ID	DWR_NA0001_04_f_2012_160				
Action/Comments					
Fence Inspector Comments: Tall wooden privacy fence within 10-ft of levee toe.

03/16/2012 Wood privacy fence completely obstructs access and visibility.

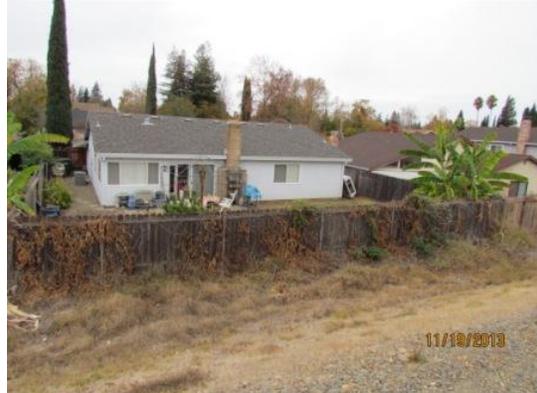
Photo 1 of 1 : FA\_2014\_NA0001\_55\_161\_20141001\_00141.jpg

LM Start	<b>10.75</b>	Rating **	U	Issue No.	<b>161</b>
LM End	<b>10.75</b>	Issue Type +	En	Location *	LS
Category	Earthen Levee		GPS Latitude/Longitude		
			Start	End	
Item	Encroachments		38.568058 °	38.568058 °	
			-121.352785 °	-121.352785 °	
DWR ID	DWR_NA0001_04_s_2012_161				
Action/Comments					
Fence Inspector Comments: Wooden privacy fence and vine within 10-ft of levee toe.

View of wood privacy fence completely obstructing access and visibility.

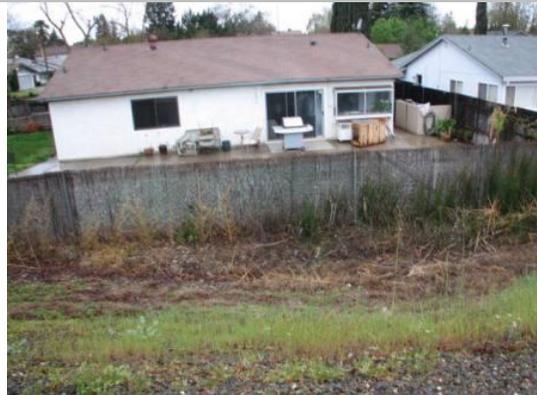
Photo 1 of 1 : FA\_2014\_NA0001\_55\_179\_20141001\_00157.jpg

LM Start	<b>10.77</b>	Rating **	U	Issue No.	<b>179</b>
LM End	<b>10.77</b>	Issue Type +	En	Location *	LS
Category	Earthen Levee		GPS Latitude/Longitude		
			Start	End	
Item	Encroachments		38.567917 °	38.567917 °	
			-121.352698 °	-121.352698 °	
DWR ID	DWR_NA0001_04_s_2012_179				
Action/Comments					
Fence Inspector Comments: Chainlink fence with bamboo mats prevent visibility.

03/16/2012 Bamboo panels on chainlink fence completely obstruct visibility.

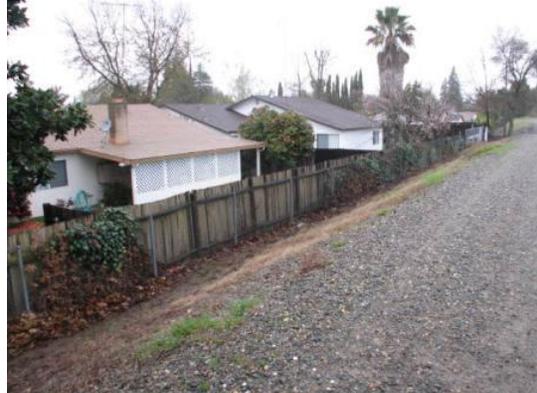
Photo 1 of 1 : FA\_2014\_NA0001\_55\_162\_20141001\_00142.jpg

LM Start	<b>10.80</b>	Rating **	U	Issue No.	<b>162</b>
LM End	<b>10.80</b>	Issue Type +	En	Location *	LS
Category	Earthen Levee		GPS Latitude/Longitude		
			Start	End	
Item	Encroachments		38.567402 °	38.567402 °	
			-121.352415 °	-121.352415 °	
DWR ID	DWR_NA0001_04_s_2012_162				
Action/Comments					
Fence Inspector Comments: Wooden privacy fence within 10-ft of levee toe.

03/16/2012 Wood privacy fence completely obstructs access and visibility.

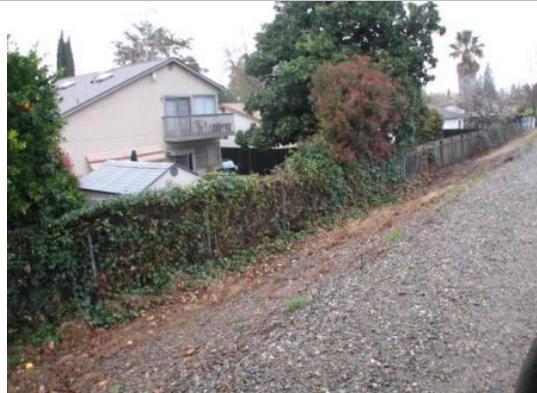
Photo 1 of 1 : FA\_2014\_NA0001\_55\_163\_20141001\_00143.jpg

LM Start	<b>10.82</b>	Rating **	U	Issue No.	<b>163</b>
LM End	<b>10.82</b>	Issue Type +	En	Location *	LS
Category	Earthen Levee		GPS Latitude/Longitude		
			Start	End	
Item	Encroachments		38.567250 °	38.567250 °	
			-121.352341 °	-121.352341 °	
DWR ID	DWR_NA0001_04_s_2012_163				
Action/Comments					
Fence Inspector Comments: Wooden privacy fence and landscaping within 10-ft of levee toe.

03/16/2012 Wood privacy fence completely obstructs access and visibility.

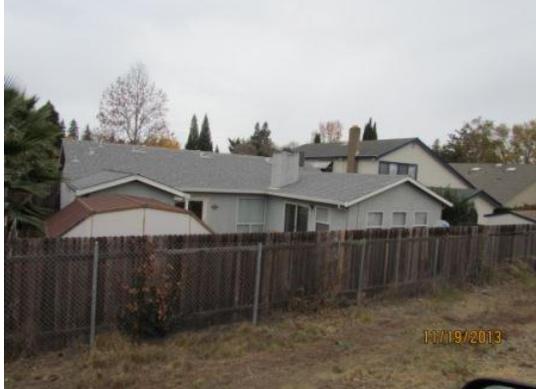
Photo 1 of 1 : FA\_2014\_NA0001\_55\_170\_20141001\_00149.jpg

LM Start	<b>10.84</b>	Rating **	U	Issue No.	<b>170</b>
LM End	<b>10.84</b>	Issue Type +	En	Location *	LS
Category	Earthen Levee		GPS Latitude/Longitude		
			Start	End	
Item	Encroachments		38.566981 °	38.566981 °	
			-121.352213 °	-121.352213 °	
DWR ID	DWR_NA0001_04_f_2012_170				
Action/Comments					
Fence Inspector Comments: Wooden privacy fence within 10-ft of levee toe.

View of the fence obstructing visibility and access.

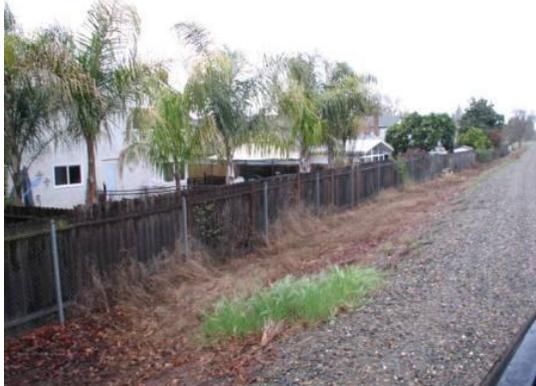
Photo 1 of 1 : FA\_2014\_NA0001\_55\_166\_20141001\_00145.jpg

LM Start	<b>10.86</b>	Rating **	U	Issue No.	<b>166</b>
LM End	<b>10.86</b>	Issue Type +	En	Location *	LS
Category	Earthen Levee		GPS Latitude/Longitude		
			Start	End	
Item	Encroachments		38.566705 °	38.566705 °	
			-121.352063 °	-121.352063 °	
DWR ID	DWR_NA0001_04_s_2012_166				
Action/Comments					
Fence Inspector Comments: Wooden privacy fence within 10-ft of levee toe.

03/16/2012 Wood privacy fence completely obstructs access and visibility.

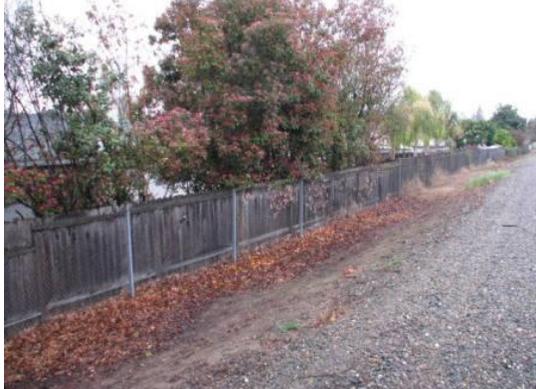
Photo 1 of 1 : FA\_2014\_NA0001\_55\_171\_20141001\_00150.jpg

LM Start	<b>10.87</b>	Rating **	U	Issue No.	<b>171</b>
LM End	<b>10.87</b>	Issue Type +	En	Location *	LS
Category	Earthen Levee		GPS Latitude/Longitude		
			Start	End	
Item	Encroachments		38.566545 °	38.566545 °	
			-121.352004 °	-121.352004 °	
DWR ID	DWR_NA0001_04_s_2012_171				
Action/Comments					
Fence Inspector Comments: Wooden privacy fence and tall hedge within 10-ft of levee toe.

03/16/2012 Wood privacy fence completely obstructs access and visibility.

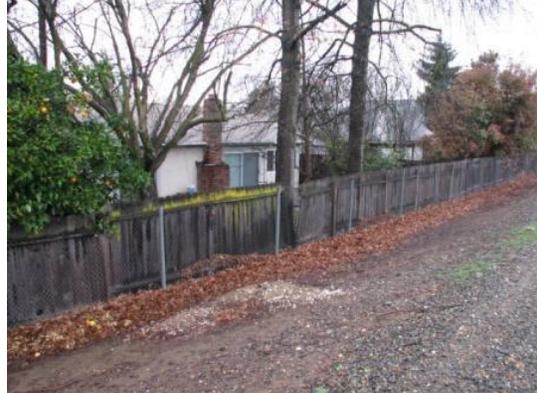
Photo 1 of 1 : FA\_2014\_NA0001\_55\_169\_20141001\_00148.jpg

LM Start	<b>10.88</b>	Rating **	U	Issue No.	<b>169</b>
LM End	<b>10.88</b>	Issue Type +	En	Location *	LS
Category	Earthen Levee		GPS Latitude/Longitude		
			Start	End	
Item	Encroachments		38.566399 °	38.566399 °	
			-121.351931 °	-121.351931 °	
DWR ID	DWR_NA0001_04_s_2012_169				
Action/Comments					
Fence Inspector Comments: Wooden privacy fence within 10-ft of levee toe.

03/16/2012 Wood privacy fence completely obstructs access and visibility.

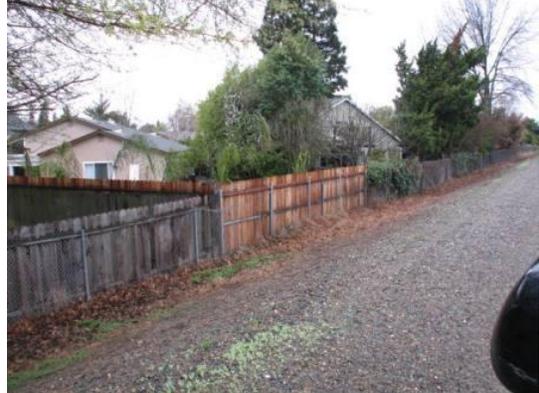
Photo 1 of 1 : FA\_2014\_NA0001\_55\_165\_20141001\_00144.jpg

LM Start	<b>10.91</b>	Rating **	U	Issue No.	<b>165</b>
LM End	<b>10.91</b>	Issue Type +	En	Location *	LS
Category	Earthen Levee		GPS Latitude/Longitude		
			Start	End	
Item	Encroachments		38.566044 °	38.566044 °	
			-121.351747 °	-121.351747 °	
DWR ID	DWR_NA0001_04_s_2012_165				
Action/Comments					
Fence Inspector Comments: Wooden privacy fence within 10-ft of levee toe.

03/16/2012 Wood privacy fence completely obstructs access and visibility.

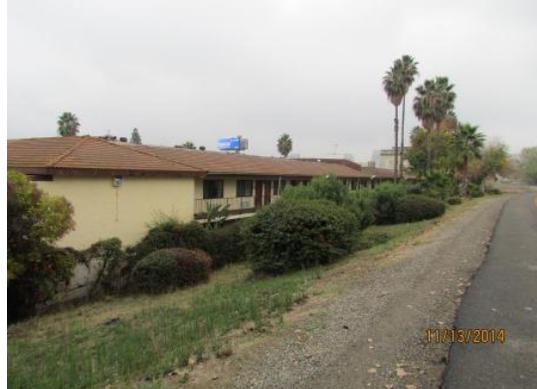
Photo 1 of 1 : FA\_2014\_NA0001\_56\_2\_20141119\_00003.jpg

LM Start	<b>0.10</b>	Rating **	M	Issue No.	<b>2</b>
LM End	<b>0.16</b>	Issue Type +	En	Location *	LS
Category	Earthen Levee		GPS Latitude/Longitude		
			Start	End	
Item	Vegetation		38.595044 °	38.594117 °	
			-121.506497 °	-121.506377 °	
DWR ID	DWR_NA0001_05_s_2012_2				
Action/Comments					
Landscaping Inspector Comments: Landcaping behind Best Western.

View of the landscaping on the landside levee slope obstructing visibility and access.

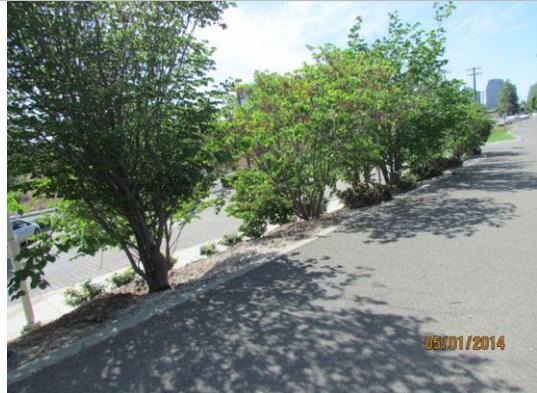
Photo 1 of 1 : FA\_2014\_NA0001\_56\_5\_20141001\_00002.jpg

LM Start	<b>0.27</b>	Rating **	M	Issue No.	<b>5</b>
LM End	<b>0.35</b>	Issue Type +	En	Location *	LS
Category	Earthen Levee		GPS Latitude/Longitude		
			Start	End	
Item	Vegetation		38.592630 °	38.591517 °	
			-121.505850 °	-121.505447 °	
DWR ID	DWR_NA0001_05_s_2012_5				
Action/Comments					
Landscaping Inspector Comments: Landscaping at City intake facility.

View of the landscaping on the landside levee slope at the City intake facility.

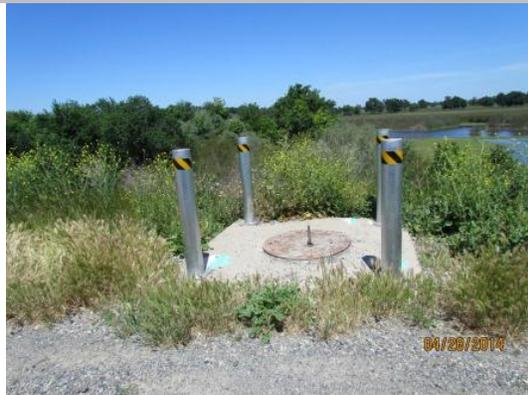
Photo 1 of 1 : FA\_2014\_NA0001\_57\_10\_20141001\_00002.jpg

LM Start	<b>0.01</b>	Rating **	A/W	Issue No.	<b>10</b>
LM End	<b>0.01</b>	Issue Type +	En	Location *	CR
Category	Earthen Levee		GPS Latitude/Longitude		
			Start	End	
Item	Encroachments		38.657424 °	38.657424 °	
			-121.474434 °	-121.474434 °	
DWR ID	DWR_NA0001_06_s_2014_10				
Action/Comments					
Pipe

View of the pipe from the levee crown.

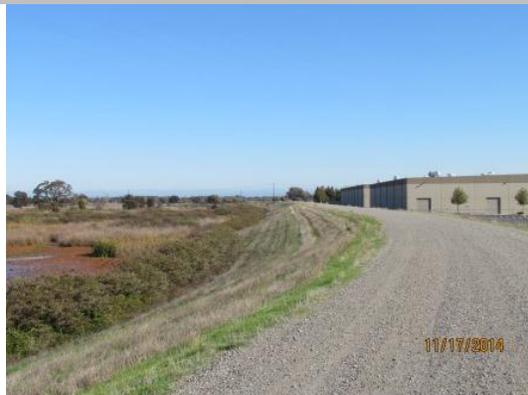
Photo 1 of 1 : FA\_2014\_NA0001\_57\_9\_20141119\_00005.jpg

LM Start	<b>0.18</b>	Rating **	A	Issue No.	<b>9</b>
LM End	<b>0.18</b>	Issue Type +	Ma	Location *	WS
Category	Earthen Levee		GPS Latitude/Longitude		
			Start	End	
Item	Vegetation		38.657256 °	38.657256 °	
			-121.471372 °	-121.471372 °	
DWR ID	DWR_NA0001_06_f_2014_9				
Action/Comments					
Control annual grass and weeds on the levee slopes and easements.

View of acceptable vegetation control.

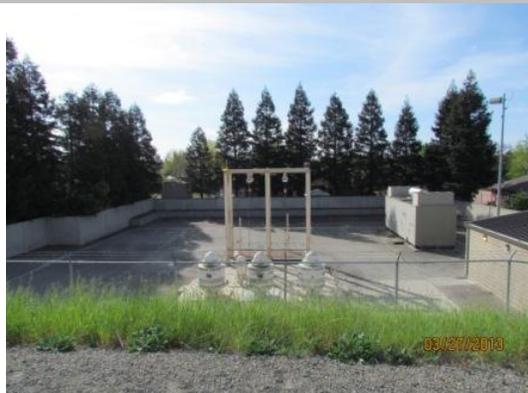
Photo 1 of 1 : FA\_2014\_NA0001\_57\_8\_20141001\_00001.jpg

LM Start	<b>0.60</b>	Rating **	A/W	Issue No.	<b>8</b>
LM End	<b>0.60</b>	Issue Type +	En	Location *	LS
Category	Earthen Levee		GPS Latitude/Longitude		
			Start	End	
Item	Encroachments		38.659649 °	38.659649 °	
			-121.464167 °	-121.464167 °	
DWR ID	DWR_NA0001_06_s_2013_8				
Action/Comments					
Pipe

View of the pumping plant at the landside levee toe.

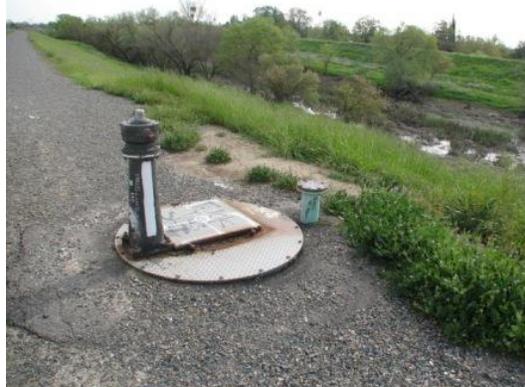
Photo 1 of 1 : FA\_2014\_NA0001\_58\_17\_20141001\_00016.jpg

LM Start	<b>0.36</b>	Rating **	A/W	Issue No.	<b>17</b>
LM End	<b>0.36</b>	Issue Type +	En	Location *	CR
Category	Earthen Levee		GPS Latitude/Longitude		
			Start	End	
Item	Encroachments		38.623325 °	38.623325 °	
			-121.462217 °	-121.462217 °	
DWR ID	DWR_NA0001_07_s_2012_17				
Action/Comments					
Pipe Inspector Comments: Closure device for sewer line located on levee crown.

Closure device for SS beneath channel.

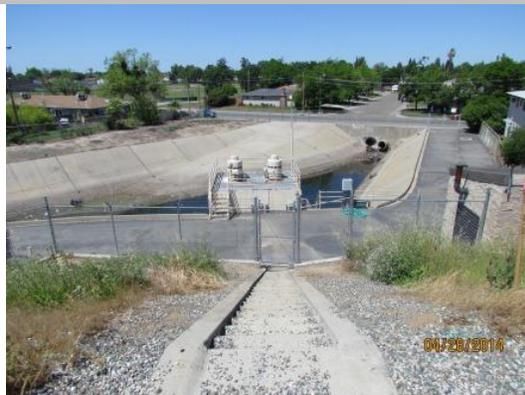
Photo 1 of 1 : FA\_2014\_NA0001\_58\_42\_20141001\_00030.jpg

LM Start	<b>0.58</b>	Rating **	A/W	Issue No.	<b>42</b>
LM End	<b>0.58</b>	Issue Type +	En	Location *	CR
Category	Earthen Levee		GPS Latitude/Longitude		
			Start	End	
Item	Encroachments		38.625311 °	38.625311 °	
			-121.458994 °	-121.458994 °	
DWR ID	DWR_NA0001_07_s_2014_42				
Action/Comments					
Pipe Inspector Comments: Two pipes crossing the levee.

View of the pump station on the landside levee toe.

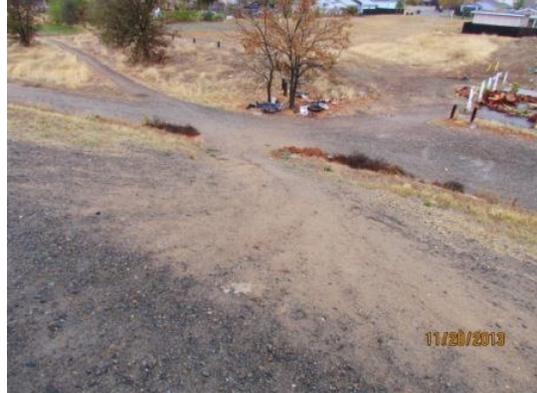
Photo 1 of 1 : FA\_2014\_NA0001\_58\_19\_20141001\_00017.jpg

LM Start	<b>0.92</b>	Rating **	M	Issue No.	<b>19</b>
LM End	<b>0.92</b>	Issue Type +	Ma	Location *	LS
Category	Earthen Levee		GPS Latitude/Longitude		
			Start	End	
Item	Slope Stability		38.625733 °	38.625733 °	
			-121.453153 °	-121.453153 °	
DWR ID	DWR_NA0001_07_f_2013_19				
Action/Comments					
Repair the levee slope damaged by foot traffic and prevent access where possible.

View of the foot traffic on the landside levee slope.

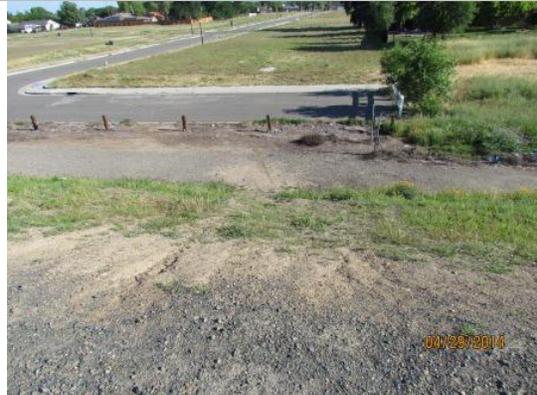
Photo 1 of 1 : FA\_2014\_NA0001\_58\_32\_20141001\_00028.jpg

LM Start	<b>1.04</b>	Rating **	M	Issue No.	<b>32</b>
LM End	<b>1.04</b>	Issue Type +	Ma	Location *	LS
Category	Earthen Levee		GPS Latitude/Longitude		
			Start	End	
Item	Slope Stability		38.625851 °	38.625851 °	
			-121.450993 °	-121.450993 °	
DWR ID	DWR_NA0001_07_f_2013_32				
Action/Comments					
Repair the levee slope damaged by foot traffic and prevent access where possible.

View of the foot traffic on the landside levee toe.

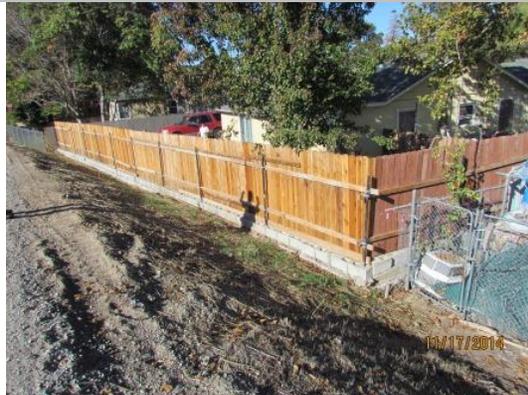
Photo 1 of 1 : FA\_2014\_NA0001\_58\_43\_20141119\_00037.jpg

LM Start	<b>1.51</b>	Rating **	<b>U</b>	Issue No.	<b>43</b>
LM End	<b>1.52</b>	Issue Type +	<b>En</b>	Location *	<b>LS</b>
Category	Earthen Levee			GPS Latitude/Longitude	
				Start	End
Item	Encroachments			38.627675 °	38.627718 °
				-121.442874 °	-121.442631 °
DWR ID	DWR_NA0001_07_s_2014_43				
Action/Comments					
Fence Inspector Comments: New fence constructed on the property line with 18 inch CMU block base.

View of a fence at the landside levee toe obstructing visibility and access.

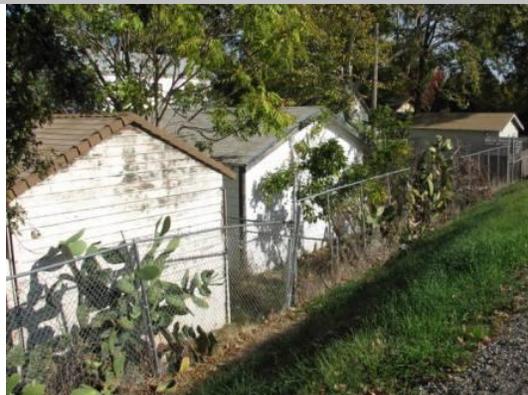
Photo 1 of 1 : FA\_2014\_NA0001\_58\_30\_20141001\_00027.jpg

LM Start	<b>1.54</b>	Rating **	<b>U</b>	Issue No.	<b>30</b>
LM End	<b>1.54</b>	Issue Type +	<b>En</b>	Location *	<b>LS</b>
Category	Earthen Levee			GPS Latitude/Longitude	
				Start	End
Item	Encroachments			38.627744 °	38.627744 °
				-121.442367 °	-121.442367 °
DWR ID	DWR_NA0001_07_s_2012_30				
Action/Comments					
Building Inspector Comments: Large side building is within 10-ft of the levee toe.

11/17/2011 Building obstructs visibility and access.

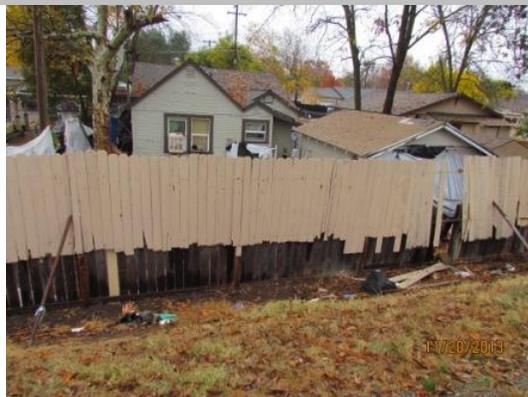
Photo 1 of 1 : FA\_2014\_NA0001\_58\_3\_20141001\_00002.jpg

LM Start	<b>1.56</b>	Rating **	<b>U</b>	Issue No.	<b>3</b>
LM End	<b>1.56</b>	Issue Type +	<b>En</b>	Location *	<b>LS</b>
Category	Earthen Levee			GPS Latitude/Longitude	
				Start	End
Item	Encroachments			38.627682 °	38.627682 °
				-121.442113 °	-121.442113 °
DWR ID	DWR_NA0001_07_s_2012_3				
Action/Comments					
Fence Inspector Comments: Wooden privacy fence is within 10-ft of the levee toe.

Wooden privacy fence is constructed at the landside levee toe.

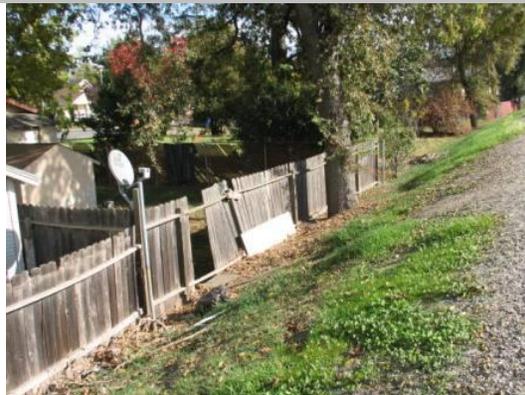
Photo 1 of 1 : FA\_2014\_NA0001\_58\_4\_20141001\_00003.jpg

LM Start	<b>1.56</b>	Rating **	U	Issue No.	<b>4</b>
LM End	<b>1.56</b>	Issue Type +	En	Location *	LS
Category	Earthen Levee		GPS Latitude/Longitude		
			Start	End	
Item	Encroachments		38.627707 °	38.627707 °	
			-121.441965 °	-121.441965 °	
DWR ID	DWR_NA0001_07_s_2012_4				
Action/Comments					
Fence Inspector Comments: Wooden privacy fence is within 10-ft of the levee toe.

11/17/2011 Wooden privacy fence is constructed at the toe.

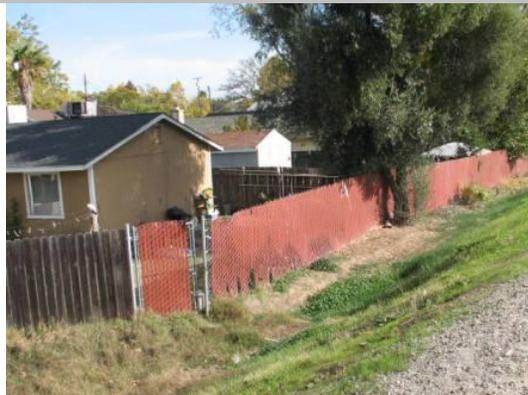
Photo 1 of 1 : FA\_2014\_NA0001\_58\_29\_20141001\_00026.jpg

LM Start	<b>1.59</b>	Rating **	M	Issue No.	<b>29</b>
LM End	<b>1.59</b>	Issue Type +	En	Location *	LS
Category	Earthen Levee		GPS Latitude/Longitude		
			Start	End	
Item	Encroachments		38.627733 °	38.627733 °	
			-121.441415 °	-121.441415 °	
DWR ID	DWR_NA0001_07_s_2012_29				
Action/Comments					
Fence Inspector Comments: Privacy fence is within 10-ft of the levee toe.

11/17/2011 Privacy fence is constructed at the toe.

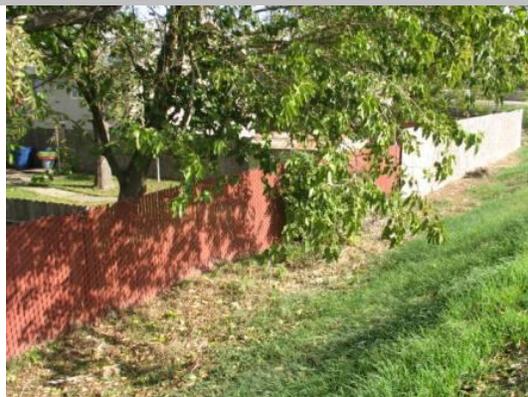
Photo 1 of 1 : FA\_2014\_NA0001\_58\_27\_20141001\_00024.jpg

LM Start	<b>1.62</b>	Rating **	U	Issue No.	<b>27</b>
LM End	<b>1.62</b>	Issue Type +	En	Location *	LS
Category	Earthen Levee		GPS Latitude/Longitude		
			Start	End	
Item	Encroachments		38.627681 °	38.627681 °	
			-121.441021 °	-121.441021 °	
DWR ID	DWR_NA0001_07_s_2012_27				
Action/Comments					
Fence Inspector Comments: Privacy fence and overgrown trees are within 10-ft of the levee toe.

11/17/2011 Privacy fence is constructed at the toe.

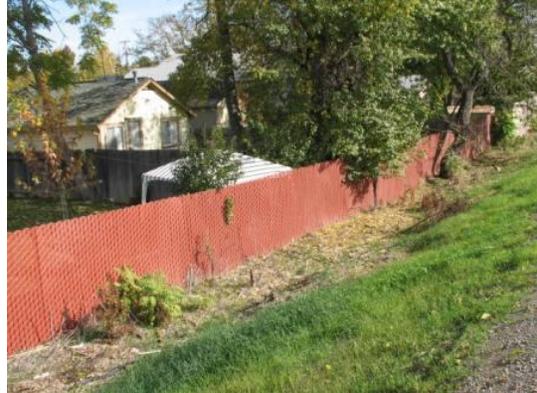
Photo 1 of 1 : FA\_2014\_NA0001\_58\_28\_20141001\_00025.jpg

LM Start	<b>1.62</b>	Rating **	M	Issue No.	<b>28</b>
LM End	<b>1.62</b>	Issue Type +	En	Location *	LS
Category	Earthen Levee		GPS Latitude/Longitude		
			Start	End	
Item	Encroachments		38.627668 °	38.627668 °	
			-121.441018 °	-121.441018 °	
DWR ID	DWR_NA0001_07_s_2012_28				
Action/Comments					
Fence Inspector Comments: Privacy fence is within 10-ft of the levee toe.

11/17/2011 Privacy fence is constructed at the toe.

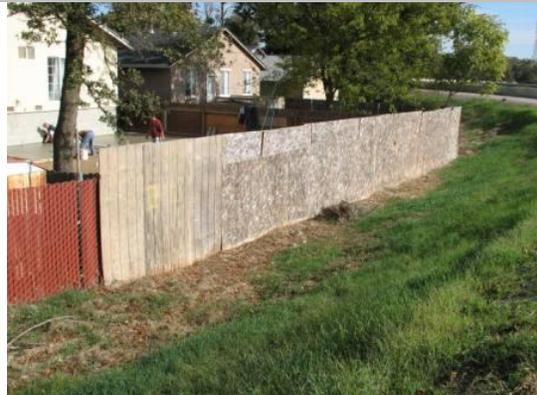
Photo 1 of 1 : FA\_2014\_NA0001\_58\_26\_20141001\_00023.jpg

LM Start	<b>1.62</b>	Rating **	U	Issue No.	<b>26</b>
LM End	<b>1.62</b>	Issue Type +	En	Location *	LS
Category	Earthen Levee		GPS Latitude/Longitude		
			Start	End	
Item	Encroachments		38.627663 °	38.627663 °	
			-121.440784 °	-121.440784 °	
DWR ID	DWR_NA0001_07_s_2012_26				
Action/Comments					
Fence Inspector Comments: Wooden privacy fence is within 10-ft of the levee toe.

11/17/2011 Wooden privacy fence is constructed at the toe.

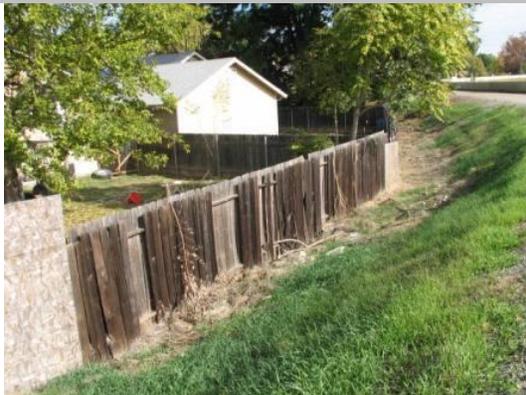
Photo 1 of 1 : FA\_2014\_NA0001\_58\_25\_20141001\_00022.jpg

LM Start	<b>1.64</b>	Rating **	U	Issue No.	<b>25</b>
LM End	<b>1.64</b>	Issue Type +	En	Location *	LS
Category	Earthen Levee		GPS Latitude/Longitude		
			Start	End	
Item	Encroachments		38.627679 °	38.627679 °	
			-121.440582 °	-121.440582 °	
DWR ID	DWR_NA0001_07_s_2012_25				
Action/Comments					
Fence Inspector Comments: Wooden privacy fence is within 10-ft of the levee toe.

11/17/2011 Wooden privacy fence is constructed at the toe.

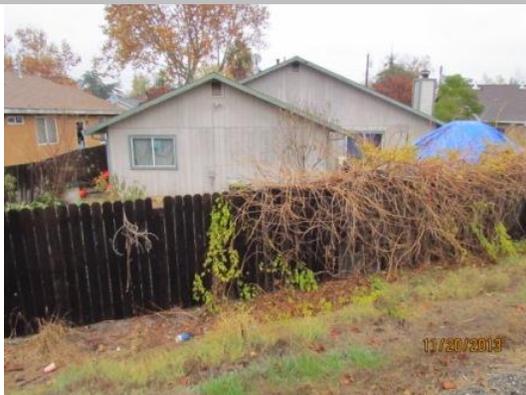
Photo 1 of 1 : FA\_2014\_NA0001\_58\_6\_20141001\_00004.jpg

LM Start	<b>1.67</b>	Rating **	U	Issue No.	<b>6</b>
LM End	<b>1.67</b>	Issue Type +	En	Location *	LS
Category	Earthen Levee		GPS Latitude/Longitude		
			Start	End	
Item	Encroachments		38.627948 °	38.627948 °	
			-121.439958 °	-121.439958 °	
DWR ID	DWR_NA0001_07_s_2012_6				
Action/Comments					
Fence Inspector Comments: Wooden privacy fence with vines are within 10-ft of the levee toe.

View of the wooden fence at the landside levee toe.

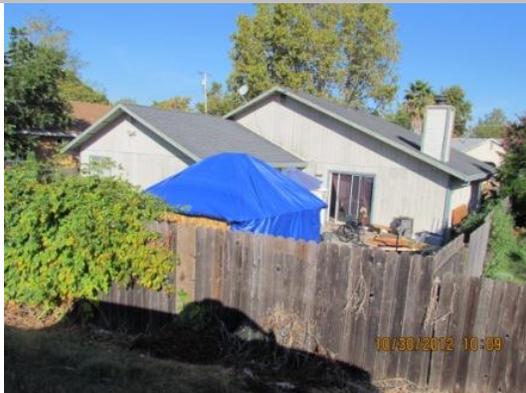
Photo 1 of 1 : FA\_2014\_NA0001\_58\_1\_20141001\_00001.jpg

LM Start	<b>1.68</b>	Rating **	U	Issue No.	<b>1</b>
LM End	<b>1.68</b>	Issue Type +	En	Location *	LS
Category	Earthen Levee		GPS Latitude/Longitude		
			Start	End	
Item	Encroachments		38.628004 °	38.628004 °	
			-121.439927 °	-121.439927 °	
DWR ID	DWR_NA0001_07_s_2012_1				
Action/Comments					
Building Inspector Comments: Construction of new structure is within 15' of levee.

View of wood structure covered in tarp.

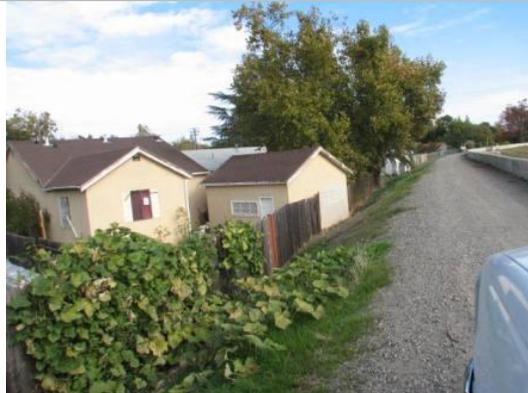
Photo 1 of 1 : FA\_2014\_NA0001\_58\_7\_20141001\_00005.jpg

LM Start	<b>1.69</b>	Rating **	<b>U</b>	Issue No.	<b>7</b>
LM End	<b>1.69</b>	Issue Type +	<b>En</b>	Location *	<b>LS</b>
Category	Earthen Levee		GPS Latitude/Longitude		
			Start	End	
Item	Encroachments		38.627935 °	38.627935 °	
			-121.439758 °	-121.439758 °	
DWR ID	DWR_NA0001_07_s_2012_7				
Action/Comments					
Building Inspector Comments: Corner of building protrudes into levee slope. Wooden fence is built on the levee slope.

11/17/2011 Building is constructed at the toe.

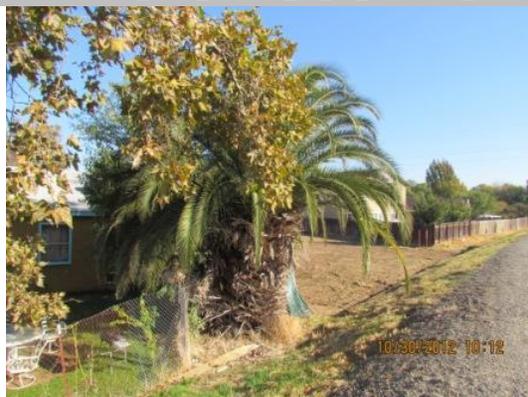
Photo 1 of 1 : FA\_2014\_NA0001\_58\_24\_20141001\_00021.jpg

LM Start	<b>1.70</b>	Rating **	<b>M</b>	Issue No.	<b>24</b>
LM End	<b>1.70</b>	Issue Type +	<b>En</b>	Location *	<b>LS</b>
Category	Earthen Levee		GPS Latitude/Longitude		
			Start	End	
Item	Vegetation		38.628086 °	38.628086 °	
			-121.439544 °	-121.439544 °	
DWR ID	DWR_NA0001_07_s_2012_24				
Action/Comments					
Landscaping Inspector Comments: Palm tree was trimmed up.

View of palm tree within 10-ft of the levee toe trimmed up from previous inspection.

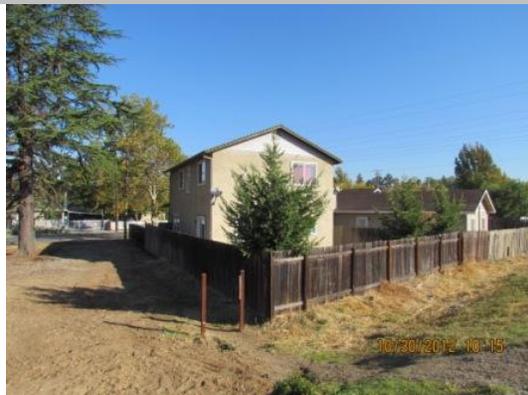
Photo 1 of 1 : FA\_2014\_NA0001\_58\_23\_20141001\_00020.jpg

LM Start	<b>1.73</b>	Rating **	<b>U</b>	Issue No.	<b>23</b>
LM End	<b>1.73</b>	Issue Type +	<b>En</b>	Location *	<b>LS</b>
Category	Earthen Levee		GPS Latitude/Longitude		
			Start	End	
Item	Encroachments		38.628208 °	38.628208 °	
			-121.439142 °	-121.439142 °	
DWR ID	DWR_NA0001_07_s_2012_23				
Action/Comments					
Fence Inspector Comments: Wooden fence and cedar trees are within 10-ft of levee toe.

View of wooden privacy fence constructed at the toe.

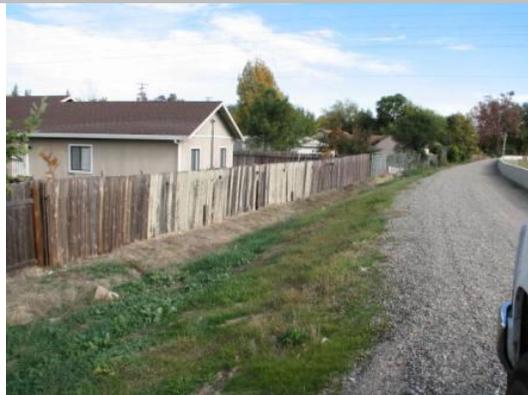
Photo 1 of 1 : FA\_2014\_NA0001\_58\_9\_20141001\_00007.jpg

LM Start	<b>1.74</b>	Rating **	<b>U</b>	Issue No.	<b>9</b>
LM End	<b>1.74</b>	Issue Type +	<b>En</b>	Location *	<b>LS</b>
Category	Earthen Levee		GPS Latitude/Longitude		
			Start	End	
Item	Encroachments		38.628197 °	38.628197 °	
			-121.438863 °	-121.438863 °	
DWR ID	DWR_NA0001_07_s_2012_9				
Action/Comments					
Fence Inspector Comments: Wooden privacy fence is within 10-ft of the levee toe.

11/17/2011 Wooden privacy fence is constructed at the toe.

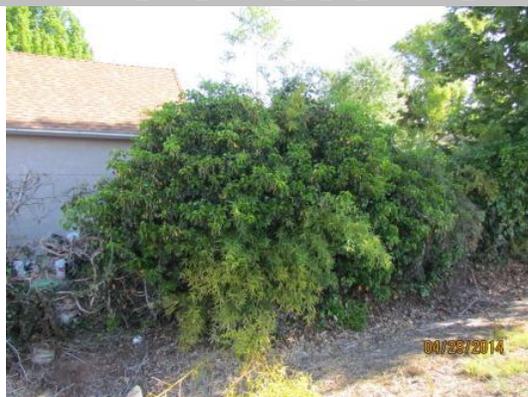
Photo 1 of 1 : FA\_2014\_NA0001\_58\_10\_20141001\_00008.jpg

LM Start	<b>1.77</b>	Rating **	<b>U</b>	Issue No.	<b>10</b>
LM End	<b>1.77</b>	Issue Type +	<b>En</b>	Location *	<b>LS</b>
Category	Earthen Levee		GPS Latitude/Longitude		
			Start	End	
Item	Vegetation		38.628273 °	38.628273 °	
			-121.438255 °	-121.438255 °	
DWR ID	DWR_NA0001_07_s_2012_10				
Action/Comments					
Landscaping Inspector Comments: Ivy and other landscape plantings have grown up chain link fence on the levee toe. Building is within 10-ft of the levee toe. Prunings are on the levee slope.

Landscaping has grown over the fence and obstructs visibility and access.

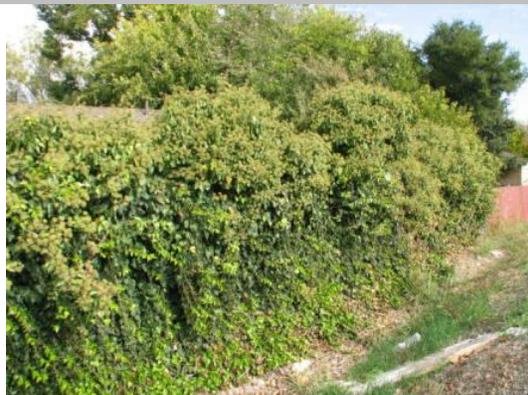
Photo 1 of 1 : FA\_2014\_NA0001\_58\_11\_20141001\_00009.jpg

LM Start	<b>1.79</b>	Rating **	<b>U</b>	Issue No.	<b>11</b>
LM End	<b>1.79</b>	Issue Type +	<b>En</b>	Location *	<b>LS</b>
Category	Earthen Levee		GPS Latitude/Longitude		
			Start	End	
Item	Vegetation		38.628297 °	38.628297 °	
			-121.437995 °	-121.437995 °	
DWR ID	DWR_NA0001_07_f_2012_11				
Action/Comments					
Landscaping Inspector Comments: Dense ivy and landscaping planted on chain link fence on levee toe. Porch and awning are within 10-ft of the levee toe.

11/17/2011 Overgrown vegetation obstructs visibility and access.

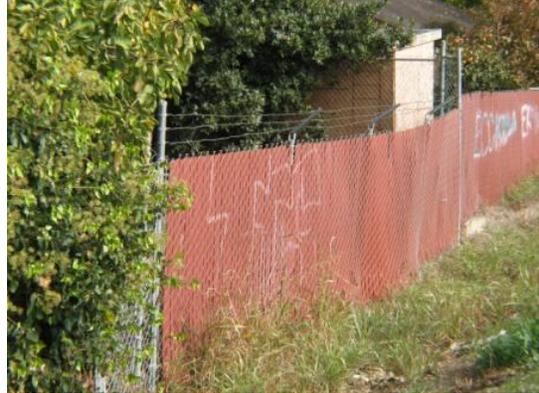
Photo 1 of 1 : FA\_2014\_NA0001\_58\_12\_20141001\_00010.jpg

LM Start	<b>1.80</b>	Rating **	M	Issue No.	<b>12</b>
LM End	<b>1.80</b>	Issue Type +	En	Location *	LS
Category	Earthen Levee		GPS Latitude/Longitude		
			Start	End	
Item	Encroachments		38.628307 °	38.628307 °	
			-121.437842 °	-121.437842 °	
DWR ID	DWR_NA0001_07_s_2012_12				
Action/Comments					
Fence Inspector Comments: Chain link privacy fence with barbed wire is within 10-ft of levee toe.

11/17/2011 Barbed wire topped privacy fence is located at the toe.

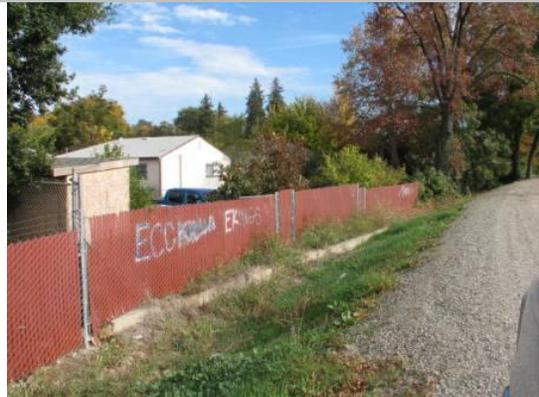
Photo 1 of 1 : FA\_2014\_NA0001\_58\_13\_20141001\_00011.jpg

LM Start	<b>1.81</b>	Rating **	M	Issue No.	<b>13</b>
LM End	<b>1.81</b>	Issue Type +	En	Location *	LS
Category	Earthen Levee		GPS Latitude/Longitude		
			Start	End	
Item	Encroachments		38.628303 °	38.628303 °	
			-121.437693 °	-121.437693 °	
DWR ID	DWR_NA0001_07_s_2012_13				
Action/Comments					
Fence Inspector Comments: Chain link privacy fence is within 10-ft of levee toe.

11/17/2011 Privacy fence is located at the toe.

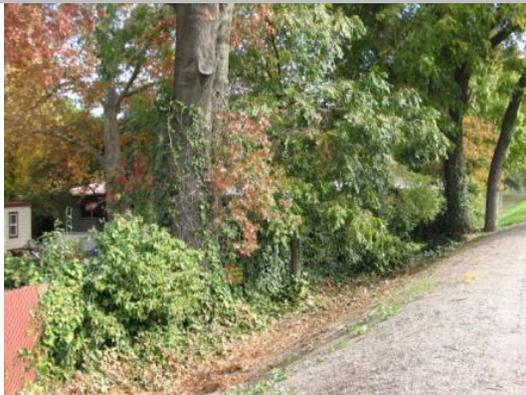
Photo 1 of 2 : FA\_2014\_NA0001\_58\_15\_20141001\_00013.jpg

LM Start	<b>1.83</b>	Rating **	U	Issue No.	<b>15</b>
LM End	<b>1.83</b>	Issue Type +	En	Location *	LS
Category	Earthen Levee		GPS Latitude/Longitude		
			Start	End	
Item	Vegetation		38.628295 °	38.628295 °	
			-121.437282 °	-121.437282 °	
DWR ID	DWR_NA0001_07_s_2012_15				
Action/Comments					
Landscaping Inspector Comments: Dense ivy growing on chain link fence within 10-ft of levee toe.

11/17/2011 Dense vegetation at the toe.

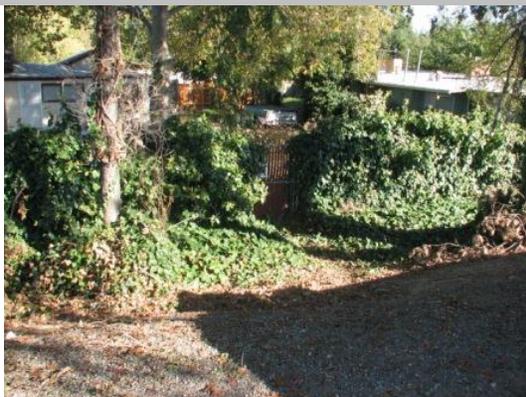
Photo 2 of 2 : FA\_2014\_NA0001\_58\_15\_20141001\_00014.jpg

Fall 2009 photo of dense ivy and fence obstruct visibility and access.

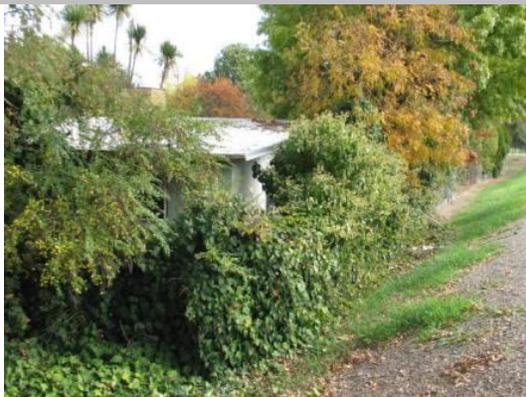
Photo 1 of 1 : FA\_2014\_NA0001\_58\_16\_20141001\_00015.jpg

LM Start	<b>1.84</b>	Rating **	U	Issue No.	<b>16</b>
LM End	<b>1.84</b>	Issue Type +	En	Location *	LS
Category	Earthen Levee		GPS Latitude/Longitude		
			Start	End	
Item	Vegetation		38.628262 °	38.628262 °	
			-121.436985 °	-121.436985 °	
DWR ID	DWR_NA0001_07_s_2012_16				
Action/Comments					
Landscaping Inspector Comments: Dense ivy and trees along chain link fence on levee toe. Large building is within 10-ft of levee toe.

11/17/2011 Vegetation and building obstruct visibility and access to the levee toe.

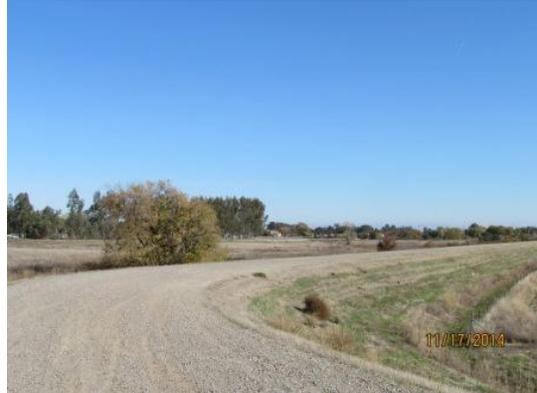
Photo 1 of 1 : FA\_2014\_NA0001\_59\_18\_20141119\_00016.jpg

LM Start	<b>0.01</b>	Rating **	A	Issue No.	<b>18</b>
LM End	<b>0.01</b>	Issue Type +	Ma	Location *	LS
Category	Earthen Levee		GPS Latitude/Longitude		
			Start	End	
Item	Vegetation		38.668096 °	38.668096 °	
			-121.447119 °	-121.447119 °	
DWR ID	DWR_NA0001_08_f_2014_18				
Action/Comments					
Control annual grass and weeds on the levee slopes and easements.

View of acceptable vegetation control.

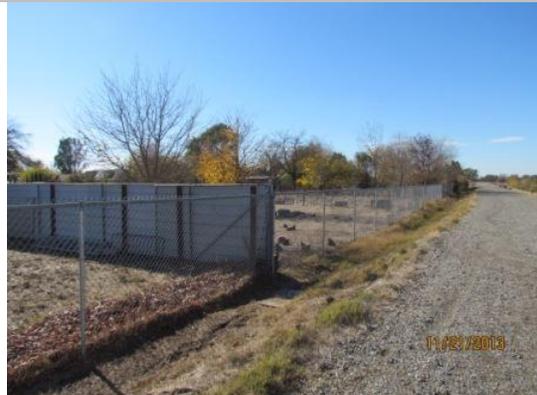
Photo 1 of 1 : FA\_2014\_NA0001\_59\_4\_20141001\_00004.jpg

LM Start	<b>0.31</b>	Rating **	M	Issue No.	<b>4</b>
LM End	<b>0.48</b>	Issue Type +	En	Location *	LS
Category	Earthen Levee		GPS Latitude/Longitude		
			Start	End	
Item	Encroachments		38.668191 °	38.668118 °	
			-121.442059 °	-121.438659 °	
DWR ID	DWR_NA0001_08_s_2012_4				
Action/Comments					
Fence Inspector Comments: Chain link fence near levee toe limits access.

View of the chainlink fence at landside levee toe facing downstream.

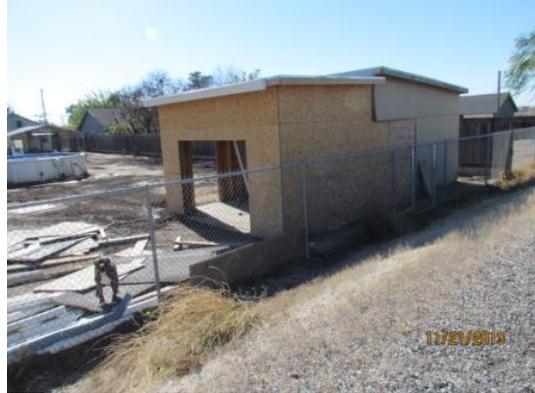
Photo 1 of 1 : FA\_2014\_NA0001\_59\_15\_20141001\_00010.jpg

LM Start	<b>0.33</b>	Rating **	U	Issue No.	<b>15</b>
LM End	<b>0.33</b>	Issue Type +	En	Location *	LS
Category	Earthen Levee		GPS Latitude/Longitude		
			Start	End	
Item	Encroachments		38.668135 °	38.668135 °	
			-121.441563 °	-121.441563 °	
DWR ID	DWR_NA0001_08_f_2013_15				
Action/Comments					
Building Inspector Comments: Building under construction within 10 feet of landside levee toe.

View of the building under long term construction or remodel within 10 feet of landside levee toe, facing downstream.

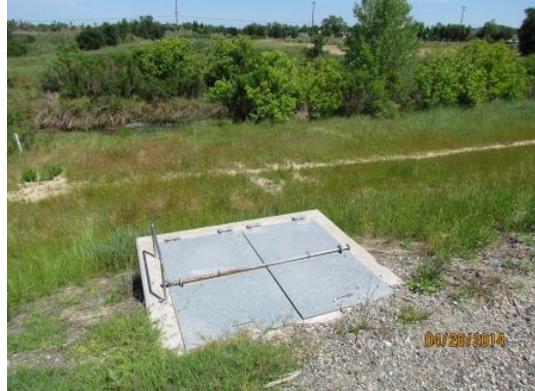
Photo 1 of 1 : FA\_2014\_NA0001\_59\_21\_20141001\_00012.jpg

LM Start	<b>0.41</b>	Rating **	A/W	Issue No.	<b>21</b>
LM End	<b>0.41</b>	Issue Type +	En	Location *	CR
Category	Earthen Levee		GPS Latitude/Longitude		
			Start	End	
Item	Encroachments		38.668159 °	38.668159 °	
			-121.440008 °	-121.440008 °	
DWR ID	DWR_NA0001_08_s_2014_21				
Action/Comments					
Pipe Inspector Comments: Drainage pipe crossing the levee.

View of the pipe from levee crown.

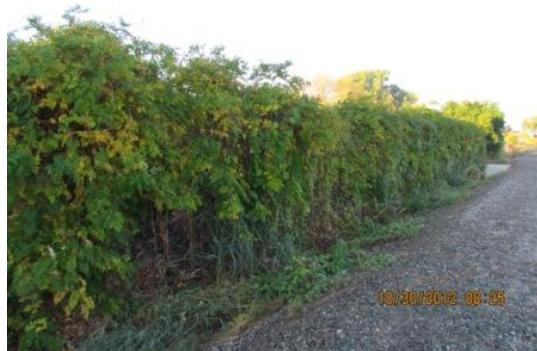
Photo 1 of 1 : FA\_2014\_NA0001\_59\_6\_20141001\_00005.jpg

LM Start	<b>0.43</b>	Rating **	M	Issue No.	<b>6</b>
LM End	<b>0.43</b>	Issue Type +	En	Location *	LS
Category	Earthen Levee		GPS Latitude/Longitude		
			Start	End	
Item	Vegetation		38.668141 °	38.668147 °	
			-121.439755 °	-121.440248 °	
DWR ID	DWR_NA0001_08_s_2012_6				
Action/Comments					
Landscaping Inspector Comments: Vines on fence limit visibility.

View of the vines on fence obstructing visibility of landside toe.

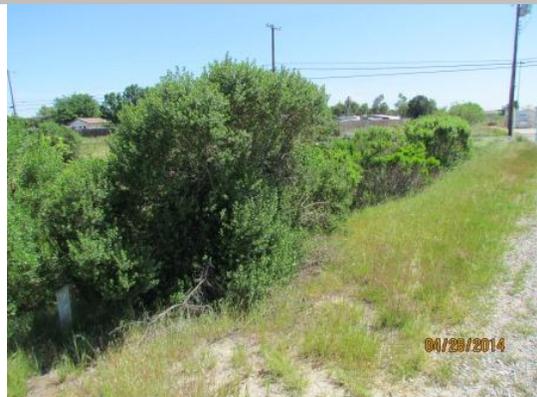
Photo 1 of 1 : FA\_2014\_NA0001\_59\_14\_20141001\_00009.jpg

LM Start	<b>0.48</b>	Rating **	U	Issue No.	<b>14</b>
LM End	<b>0.48</b>	Issue Type +	Ma	Location *	LS
Category	Earthen Levee		GPS Latitude/Longitude		
			Start	End	
Item	Vegetation		38.668110 °	38.668110 °	
			-121.438727 °	-121.438727 °	
DWR ID	DWR_NA0001_08_s_2013_14				
Action/Comments					
Remove the wild growth other than native grasses from the levee slopes. Inspector Comments: Shrubs continue to encroach up the waterside levee slope, obstructing visibility and access.

View of the woody vegetation on the waterside levee slope.

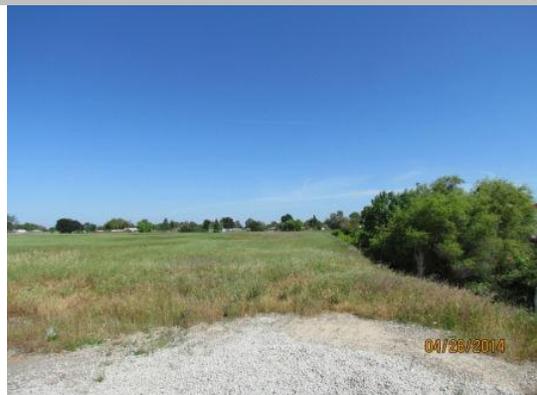
Photo 1 of 1 : FA\_2014\_NA0001\_59\_1\_20141001\_00001.jpg

LM Start	<b>0.51</b>	Rating **	U	Issue No.	<b>1</b>
LM End	<b>1.02</b>	Issue Type +	En	Location *	WS
Category	Earthen Levee		GPS Latitude/Longitude		
			Start	End	
Item	Encroachments		38.668132 °	38.665528 °	
			-121.438229 °	-121.431688 °	
DWR ID	DWR_NA0001_08_s_2012_1				
Action/Comments					
Material Inspector Comments: This portion of the levee is inaccessible for maintenance.

View from downstream end of inaccessible portion of Magpie Creek due to landowner restrictions. There is no levee for ARFCD to maintain at this location. However, the channel maintenance is the responsibility of Sacramento Yard.

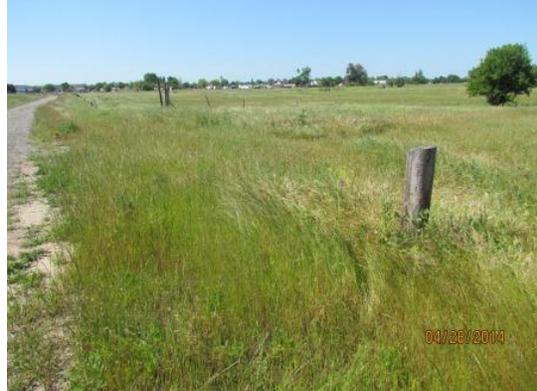
Photo 1 of 1 : FA\_2014\_NA0001\_59\_20\_20141001\_00011.jpg

LM Start	<b>1.21</b>	Rating **	M	Issue No.	<b>20</b>
LM End	<b>1.21</b>	Issue Type +	En	Location *	LS
Category	Earthen Levee			GPS Latitude/Longitude	
				Start	End
Item	Encroachments			38.662860 °	38.662860 °
				-121.431671 °	-121.431671 °
DWR ID	DWR_NA0001_08_s_2014_20				
Action/Comments					
Pole

View of the pole on landside levee toe.

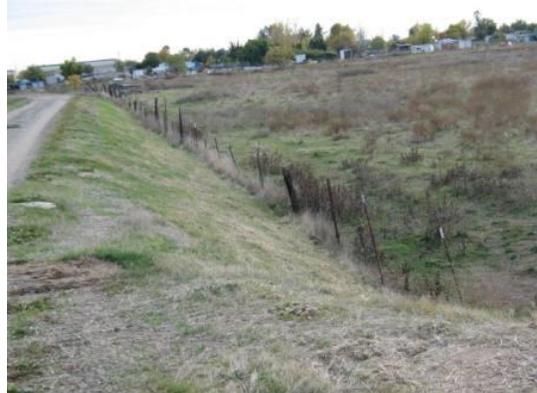
Photo 1 of 1 : FA\_2014\_NA0001\_59\_2\_20141001\_00002.jpg

LM Start	<b>1.22</b>	Rating **	M	Issue No.	<b>2</b>
LM End	<b>1.28</b>	Issue Type +	En	Location *	LS
Category	Earthen Levee			GPS Latitude/Longitude	
				Start	End
Item	Encroachments			38.662715 °	38.661584 °
				-121.431666 °	-121.431402 °
DWR ID	DWR_NA0001_08_s_2012_2				
Action/Comments					
Fence Inspector Comments: Barbed wire fence runs along the levee toe.

11/17/2011 Barbed wire fence at levee toe.

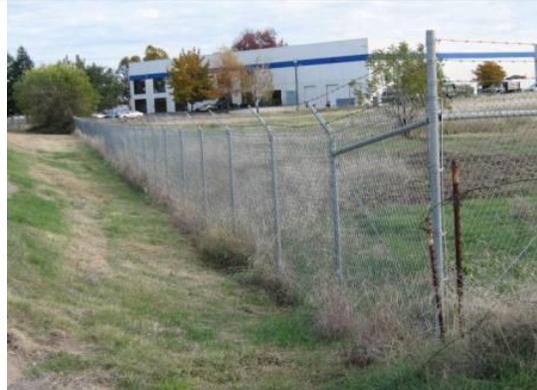
Photo 1 of 1 : FA\_2014\_NA0001\_59\_7\_20141001\_00006.jpg

LM Start	<b>1.29</b>	Rating **	M	Issue No.	<b>7</b>
LM End	<b>1.32</b>	Issue Type +	En	Location *	LS
Category	Earthen Levee			GPS Latitude/Longitude	
				Start	End
Item	Encroachments			38.661593 °	38.661370 °
				-121.431420 °	-121.430943 °
DWR ID	DWR_NA0001_08_s_2012_7				
Action/Comments					
Fence Inspector Comments: Cyclone fence with barbed wire within 10' of toe for part of its alignment.

11/17/2011 Chainlink fence at levee toe.

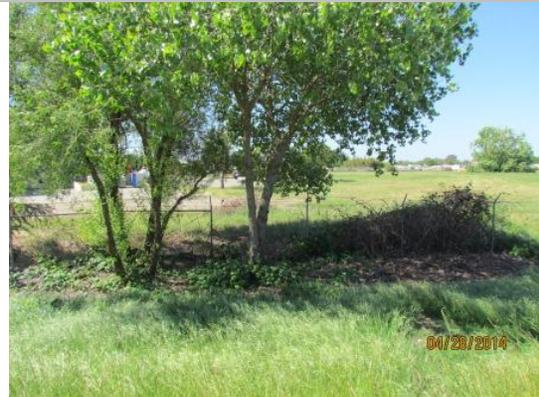
Photo 1 of 1 : FA\_2014\_NA0001\_59\_13\_20141001\_00008.jpg

LM Start	<b>1.38</b>	Rating **	M	Issue No.	<b>13</b>
LM End	<b>1.38</b>	Issue Type +	Ma	Location *	LS
Category	Earthen Levee		GPS Latitude/Longitude		
			Start	End	
Item	Vegetation		38.660987 °	38.660987 °	
			-121.430120 °	-121.430120 °	
DWR ID	DWR_NA0001_08_s_2013_13				
Action/Comments					
Remove the wild growth other than native grasses from the levee slopes. Inspector Comments: The LMA has significantly improved this location and is in the final stages of exterminating invasive vegetation.

View of the woody vegetation to be removed from the landside levee toe.

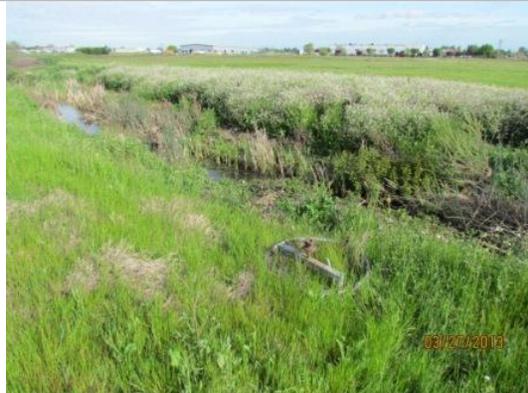
Photo 1 of 1 : FA\_2014\_NA0001\_59\_3\_20141001\_00003.jpg

LM Start	<b>1.39</b>	Rating **	A/W	Issue No.	<b>3</b>
LM End	<b>1.39</b>	Issue Type +	En	Location *	WS
Category	Earthen Levee		GPS Latitude/Longitude		
			Start	End	
Item	Encroachments		38.660896 °	38.660896 °	
			-121.429888 °	-121.429888 °	
DWR ID	DWR_NA0001_08_s_2013_3				
Action/Comments					
Pipe

View of the gate valve at the waterside levee hinge.
