**Flood Control Project Maintenance  
Levee Inspections**

**Fall 2014 Levee Maintenance Deficiency Summary Report**

**Sacramento River Basin**

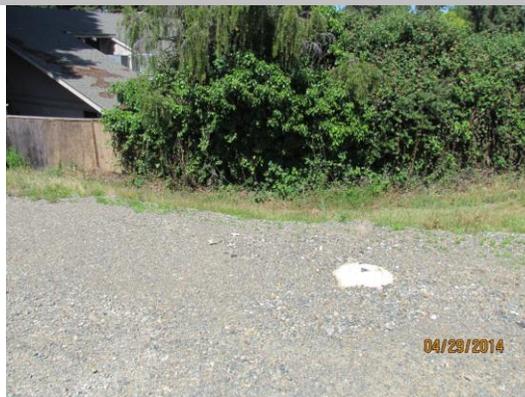
Photo 1 of 1 : FA\_2014\_NA0001\_60\_13\_20141001\_00006.jpg

LM Start	<b>0.02</b>	Rating **	A/W	Issue No.	<b>13</b>
LM End	<b>0.02</b>	Issue Type +	En	Location *	LS
Category	Earthen Levee		GPS Latitude/Longitude		
			Start	End	
Item	Encroachments		38.567955 °	38.567955 °	
			-121.383623 °	-121.383623 °	
DWR ID	DWR_NA0001_09_f_2013_13				
Action/Comments					
Monitoring Well Inspector Comments: Monitoring well at landside levee hinge.

View of the monitoring well cap at the landside levee hinge.

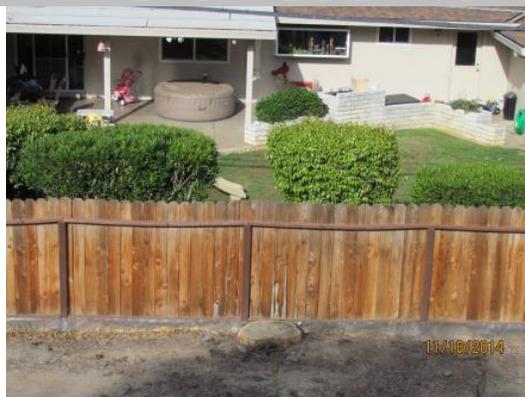
Photo 1 of 1 : FA\_2014\_NA0001\_60\_12\_20141119\_00015.jpg

LM Start	<b>0.40</b>	Rating **	N	Issue No.	<b>12</b>
LM End	<b>0.40</b>	Issue Type +	Ma	Location *	LS
Category	Earthen Levee		GPS Latitude/Longitude		
			Start	End	
Item	Trim / Thin Trees		38.566725 °	38.566725 °	
			-121.389935 °	-121.389935 °	
DWR ID	DWR_NA0001_09_f_2013_12				
Action/Comments					
Tree stumps.

View of the tree stump at the landside levee toe.

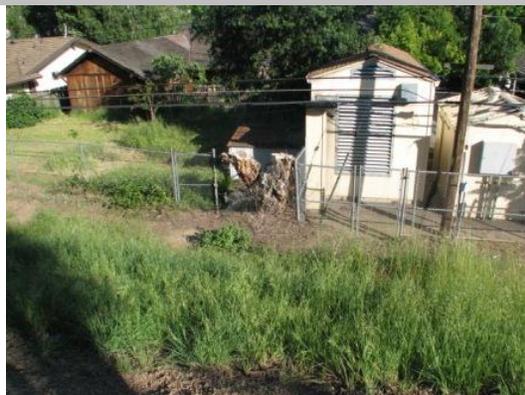
Photo 1 of 1 : FA\_2014\_NA0001\_60\_14\_20141001\_00007.jpg

LM Start	<b>0.45</b>	Rating **	N	Issue No.	<b>14</b>
LM End	<b>0.45</b>	Issue Type +	Ma	Location *	LS
Category	Earthen Levee		GPS Latitude/Longitude		
			Start	End	
Item	Trim / Thin Trees		38.566298 °	38.566298 °	
			-121.390680 °	-121.390680 °	
DWR ID	DWR_NA0001_09_s_2012_14				
Action/Comments					
Tree stumps. Inspector Comments: Tree trunk at fence line.

Tree trunk at fence line.

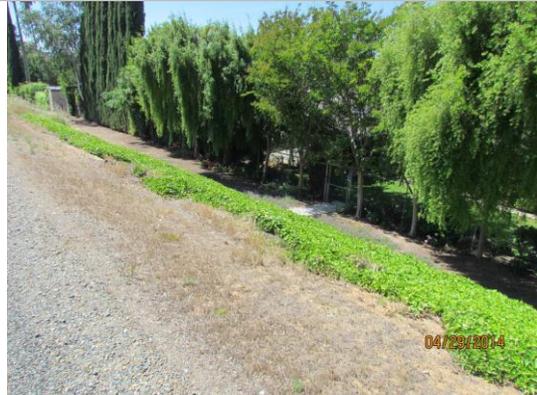
Photo 1 of 1 : FA\_2014\_NA0001\_60\_3\_20141001\_00003.jpg

LM Start	<b>1.13</b>	Rating **	M	Issue No.	<b>3</b>
LM End	<b>1.13</b>	Issue Type +	En	Location *	LS
Category	Earthen Levee		GPS Latitude/Longitude		
			Start	End	
Item	Vegetation		38.563040 °	38.563040 °	
			-121.402168 °	-121.402168 °	
DWR ID	DWR_NA0001_09_s_2012_3				
Action/Comments					
Landscaping Inspector Comments: Ivy on slope

View of the landscaping at the levee toe.

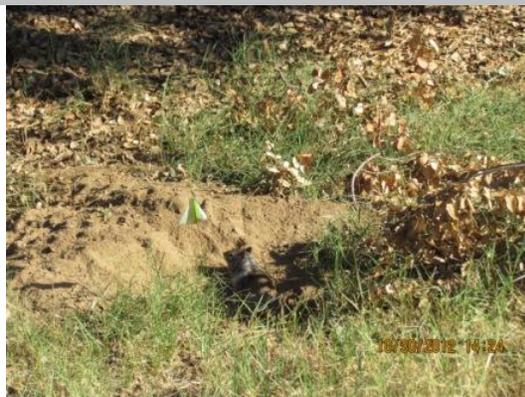
Photo 1 of 1 : FA\_2014\_NA0001\_60\_6\_20141001\_00004.jpg

LM Start	<b>3.01</b>	Rating **	<b>M</b>	Issue No.	<b>6</b>
LM End	<b>3.01</b>	Issue Type +	<b>Ma</b>	Location *	<b>LS</b>
Category	Earthen Levee		GPS Latitude/Longitude		
			Start	End	
Item	Animal Control		38.575035 °	38.575035 °	
			-121.419802 °	-121.419802 °	
DWR ID	DWR_NA0001_09_f_2012_6				
Action/Comments					
Exterminate rodents and backfill and compact or grout burrows.

View of active rodent burrow at landside levee toe.

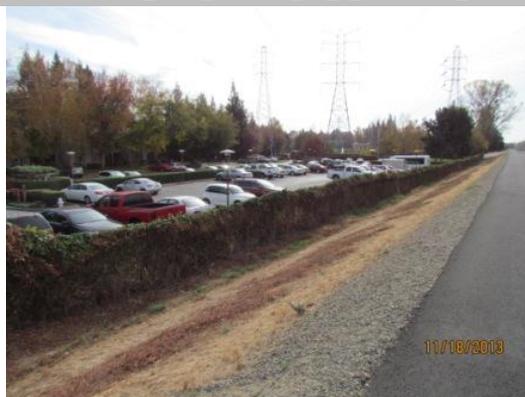
Photo 1 of 1 : FA\_2014\_NA0001\_60\_2\_20141001\_00002.jpg

LM Start	<b>3.11</b>	Rating **	<b>U</b>	Issue No.	<b>2</b>
LM End	<b>3.24</b>	Issue Type +	<b>En</b>	Location *	<b>LS</b>
Category	Earthen Levee		GPS Latitude/Longitude		
			Start	End	
Item	Encroachments		38.576423 °	38.578248 °	
			-121.419117 °	-121.418475 °	
DWR ID	DWR_NA0001_09_s_2012_2				
Action/Comments					
Fence

View of the trimmed vegetation on the chain linked fence still obstructing visibility.

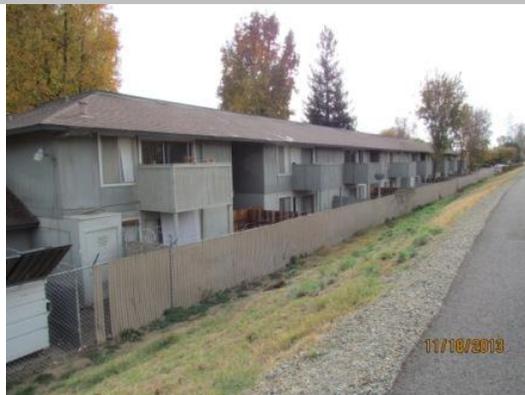
Photo 1 of 1 : FA\_2014\_NA0001\_60\_1\_20141001\_00001.jpg

LM Start	<b>3.24</b>	Rating **	<b>M</b>	Issue No.	<b>1</b>
LM End	<b>3.32</b>	Issue Type +	<b>En</b>	Location *	<b>LS</b>
Category	Earthen Levee		GPS Latitude/Longitude		
			Start	End	
Item	Encroachments		38.578258 °	38.579363 °	
			-121.418475 °	-121.418100 °	
DWR ID	DWR_NA0001_09_s_2012_1				
Action/Comments					
Fence

View of the fence at the landside levee toe.

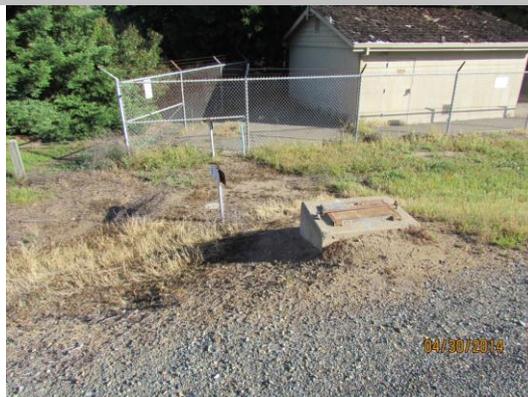
Photo 1 of 1 : FA\_2014\_NA0001\_61\_11\_20141001\_00005.jpg

LM Start	<b>1.62</b>	Rating **	A/W	Issue No.	<b>11</b>
LM End	<b>1.62</b>	Issue Type +	En	Location *	CR
Category	Earthen Levee		GPS Latitude/Longitude		
			Start	End	
Item	Encroachments		38.581572 °	38.581572 °	
			-121.343706 °	-121.343706 °	
DWR ID	DWR_NA0001_10_s_2012_11				
Action/Comments					
Pipe Inspector Comments: Water Line

View of the pipe at the landside levee hinge.

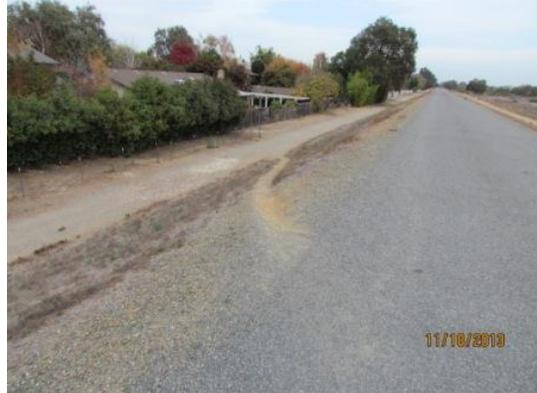
Photo 1 of 1 : FA\_2014\_NA0001\_61\_7\_20141001\_00004.jpg

LM Start	<b>2.51</b>	Rating **	A/W	Issue No.	<b>7</b>
LM End	<b>2.51</b>	Issue Type +	Ma	Location *	LS
Category	Earthen Levee		GPS Latitude/Longitude		
			Start	End	
Item	Slope Stability		38.575126 °	38.575126 °	
			-121.357575 °	-121.357575 °	
DWR ID	DWR_NA0001_10_f_2013_7				
Action/Comments					
Repair the levee slope damaged by foot traffic and prevent access where possible.

View of the pathway on the landside levee slope.

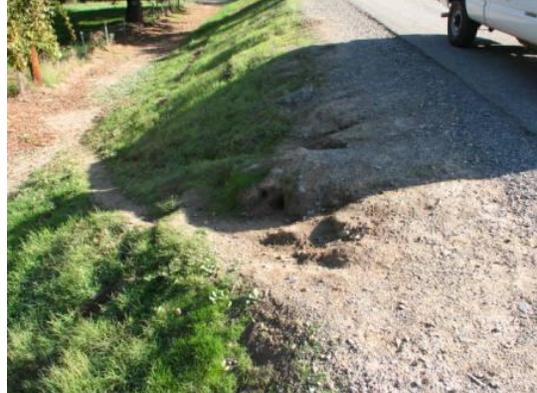
Photo 2 of 2 : FA\_2014\_NA0001\_61\_114\_20141001\_00009.jpg

LM Start	<b>3.37</b>	Rating **	M	Issue No.	<b>114 (cont)</b>
LM End	<b>3.37</b>	Issue Type +	Ma	Location *	LS
Category	Earthen Levee		GPS Latitude/Longitude		
			Start	End	
Item	Erosion / Bank Caving		38.569866 °	38.569866 °	
			-121.371403 °	-121.371403 °	
DWR ID	DWR_NA0001_10_s_2012_114				
Action/Comments					
Note and monitor erosion site. Inspector Comments: Erosion occurring at junction of footpath and burrow at the hinge point.

11/16/2011 Erosion from pedestrian traffic, burrow can be seen in the photo in the lower portion of the shadow.

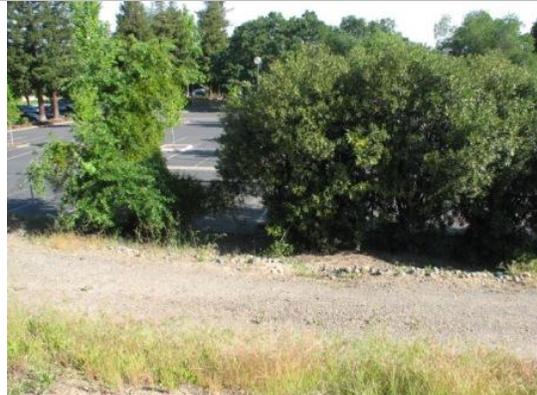
Photo 1 of 1 : FA\_2014\_NA0001\_61\_6\_20141001\_00003.jpg

LM Start	<b>3.58</b>	Rating **	M	Issue No.	<b>6</b>
LM End	<b>3.58</b>	Issue Type +	En	Location *	LS
Category	Earthen Levee		GPS Latitude/Longitude		
			Start	End	
Item	Vegetation		38.569556 °	38.569556 °	
			-121.375302 °	-121.375302 °	
DWR ID	DWR_NA0001_10_s_2012_6				
Action/Comments					
Landscaping

Trees at fence line obstruct access and visibility.

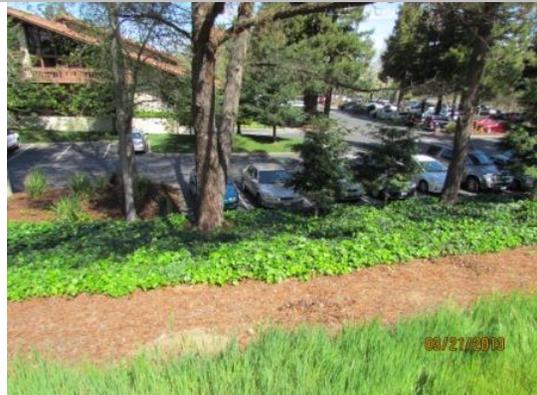
Photo 1 of 1 : FA\_2014\_NA0001\_61\_1\_20141001\_00001.jpg

LM Start	<b>3.64</b>	Rating **	M	Issue No.	<b>1</b>
LM End	<b>3.64</b>	Issue Type +	En	Location *	LS
Category	Earthen Levee		GPS Latitude/Longitude		
			Start	End	
Item	Vegetation		38.569360 °	38.569360 °	
			-121.376388 °	-121.376388 °	
DWR ID	DWR_NA0001_10_s_2013_1				
Action/Comments					
Landscaping

View of the landscaping at the levee toe.

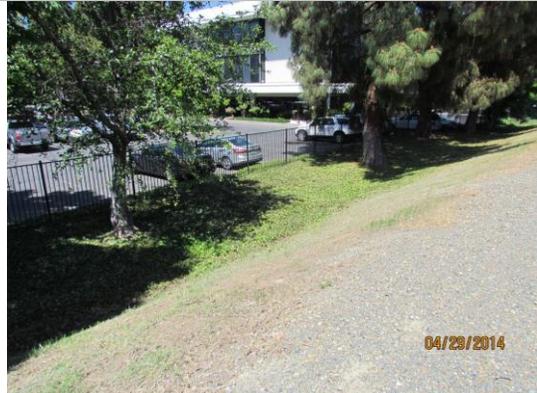
Photo 1 of 1 : FA\_2014\_NA0001\_61\_4\_20141001\_00002.jpg

LM Start	<b>3.88</b>	Rating **	M	Issue No.	<b>4</b>
LM End	<b>3.97</b>	Issue Type +	En	Location *	LS
Category	Earthen Levee		GPS Latitude/Longitude		
			Start	End	
Item	Vegetation		38.568492 °	38.568076 °	
			-121.380477 °	-121.382001 °	
DWR ID	DWR_NA0001_10_s_2012_4				
Action/Comments					
Landscaping Inspector Comments: Ivy and trees.

View of the landscaping at the landside levee toe and slope.

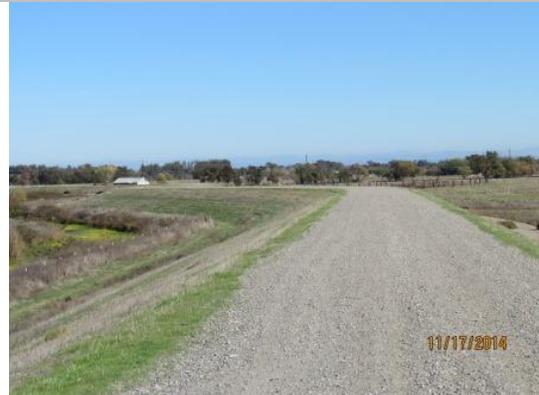
Photo 1 of 1 : FA\_2014\_NA0001\_436\_5\_20141119\_00005.jpg

LM Start	<b>0.09</b>	Rating **	A	Issue No.	<b>5</b>
LM End	<b>0.09</b>	Issue Type +	Ma	Location *	WS
Category	Earthen Levee		GPS Latitude/Longitude		
			Start	End	
Item	Vegetation		38.663024 °	38.663024 °	
			-121.456367 °	-121.456367 °	
DWR ID	DWR_NA0001_11_f_2014_5				
Action/Comments					
Control annual grass and weeds on the levee slopes and easements.

View of acceptable vegetation control.

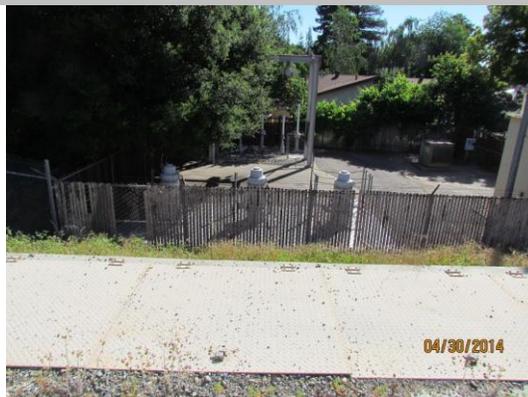
Photo 1 of 1 : FA\_2014\_NA0001\_438\_4\_20141001\_00004.jpg

LM Start	<b>0.05</b>	Rating **	A/W	Issue No.	<b>4</b>
LM End	<b>0.05</b>	Issue Type +	En	Location *	LS
Category	Earthen Levee		GPS Latitude/Longitude		
			Start	End	
Item	Encroachments		38.570691 °	38.570691 °	
			-121.353550 °	-121.353550 °	
DWR ID	DWR_NA0001_12_s_2014_4				
Action/Comments					
Pipe Inspector Comments: 3 pipes across levee.

View of the pumping facility at the landside levee toe.

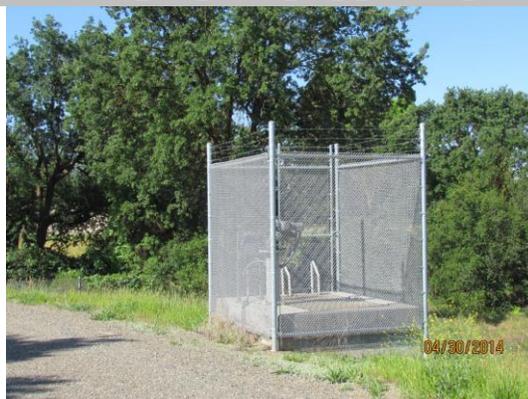
Photo 1 of 1 : FA\_2014\_NA0001\_438\_3\_20141001\_00003.jpg

LM Start	<b>0.06</b>	Rating **	A/W	Issue No.	<b>3</b>
LM End	<b>0.06</b>	Issue Type +	En	Location *	CR
Category	Earthen Levee		GPS Latitude/Longitude		
			Start	End	
Item	Encroachments		38.570879 °	38.570879 °	
			-121.353566 °	-121.353566 °	
DWR ID	DWR_NA0001_12_s_2014_3				
Action/Comments					
Pipe

View of the access hole at the waterside levee hinge.

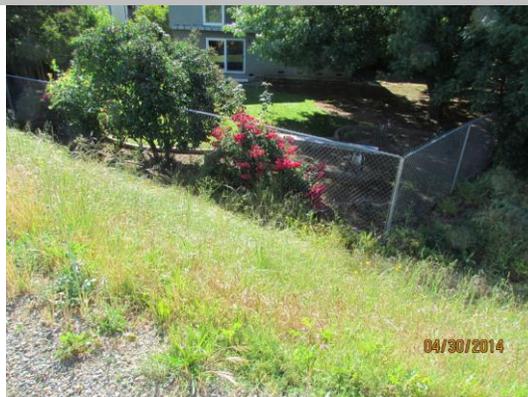
Photo 1 of 1 : FA\_2014\_NA0001\_438\_2\_20141001\_00002.jpg

LM Start	<b>0.07</b>	Rating **	M	Issue No.	<b>2</b>
LM End	<b>0.07</b>	Issue Type +	En	Location *	LS
Category	Earthen Levee		GPS Latitude/Longitude		
			Start	End	
Item	Vegetation		38.571036 °	38.571036 °	
			-121.353441 °	-121.353441 °	
DWR ID	DWR_NA0001_12_s_2014_2				
Action/Comments					
Landscaping

View of the landscaping at the landside levee toe.

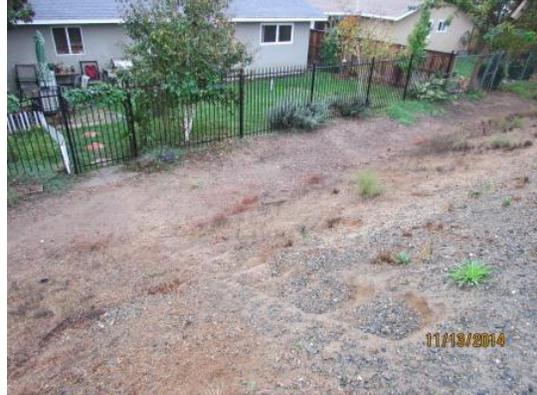
Photo 1 of 1 : FA\_2014\_NA0001\_438\_1\_20141119\_00006.jpg

LM Start	<b>0.20</b>	Rating **	M	Issue No.	<b>1</b>
LM End	<b>0.20</b>	Issue Type +	En	Location *	LS
Category	Earthen Levee		GPS Latitude/Longitude		
			Start	End	
Item	Encroachments		38.572016 °	38.572016 °	
			-121.351633 °	-121.351633 °	
DWR ID	DWR_NA0001_12_f_2014_1				
Action/Comments					
Stairway

View of the stairs on the landside levee slope.
