**Flood Control Project Maintenance
Levee Inspections**

Maintenance Issue Types Only, Levee Inspection Report By Mile - Fall 2017

American River Flood Control District

Waterway	Bank	Unit Miles	Inspection Start/End	Inspector
Unit No. 01 Arcade Creek	Left	2.08	09/20/2017 10/30/2017	Maksim Khashchuk

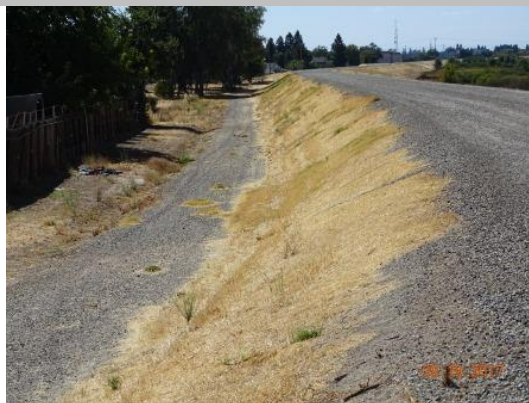
Photo 1 of 1 : FA_2017_NA0001_57_1_20171106_00007.jpg

LM Start	0.04	Rating **	A	Issue No.	1	
LM End	0.96	Issue Type +	Ma	Location *	LS	
Category	Earthen Levee			GPS Latitude/Longitude		
				Start		End
Item	Vegetation			38.657328 °		38.662112 °
				-121.474047 °		-121.458430 °
DWR ID	DWR_NA0001_06_f_2017_1					
Comment Code						
V1 : Control annual grass and weeds on the levee slopes and easements.						
Inspector Comment						
Acceptable vegetation control.

View of the acceptable vegetation on the levee slope.

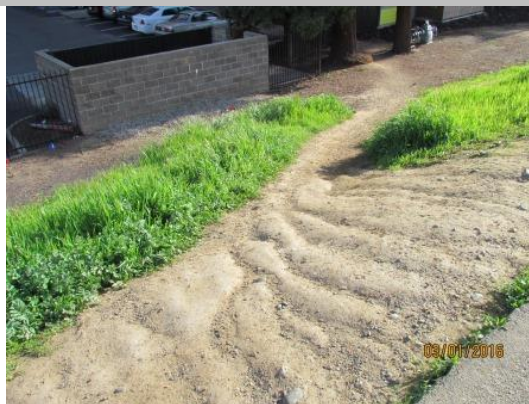
Photo 1 of 1 : FA_2017_NA0001_60_28_20170919_00010.jpg

LM Start	1.88	Rating **	M	Issue No.	28
LM End	1.88	Issue Type +	Ma	Location *	LS
Category	Earthen Levee			GPS Latitude/Longitude	
				Start	End
Item	Slope Stability			38.561171 °	38.561171 °
				-121.415808 °	-121.415808 °
DWR ID	DWR_NA0001_09_s_2016_28				
Comment Code					
S2 : Repair the levee slope damaged by foot traffic and prevent access where possible.					
Inspector Comment

View of the landside levee slope.

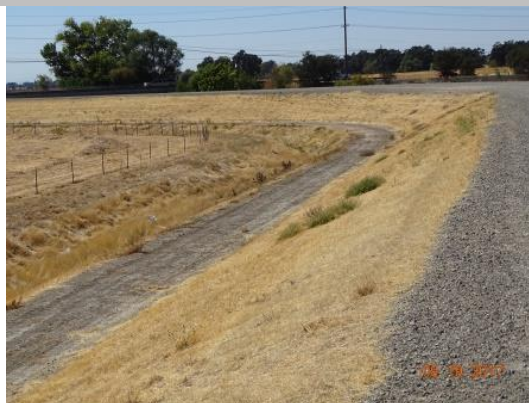
Photo 1 of 1 : FA_2017_NA0001_436_5_20171106_00009.jpg

LM Start	0.03	Rating **	A	Issue No.	5
LM End	0.69	Issue Type +	Ma	Location *	LS
Category	Earthen Levee			GPS Latitude/Longitude	
				Start	End
Item	Vegetation			38.662621 °	38.667898 °
				-121.457388 °	-121.448186 °
DWR ID	DWR_NA0001_11_f_2017_5				
Comment Code					
V1 : Control annual grass and weeds on the levee slopes and easements.					
Inspector Comment					
Acceptable vegetation control.

View of the acceptable vegetation on the levee slope.
