**Flood Control Project Maintenance
Levee Inspections**

Maintenance Issue Types Only, Levee Inspection Report By Mile - Fall 2019

American River Flood Control District

Waterway	Bank	Unit Miles	Inspection Start/End	Inspector
Unit No. 01 Arcade Creek	Left	2.08	11/05/2019 11/05/2019	Luz Dial

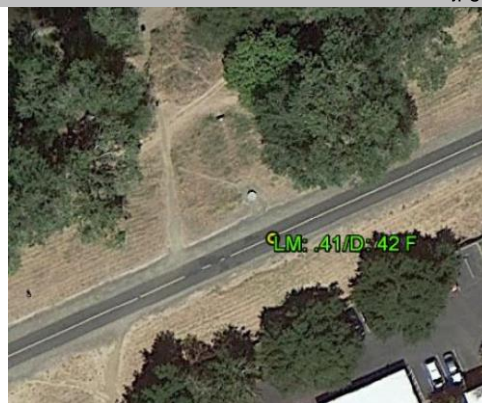
Photo 1 of 3 : UCIP_FA_2019_31249_57212.jpg

Comment Code						
Inspector Comment						
DS_ID:24303 FS_ID:31249 EP_NO: N/A Repair Type: Non-Urgent Crossing Status: Found UCIP Comments: 08/16/2017 DWR Deferred Maintenance Project (DMP), Vince Rodriguez, forwarded email received from Tim Kerr, General Manager of American River Flood Control District (ARFCD) with file "DWR Eligible Pipes Found in ARFCD" from ARFCD that shows the ownership and location of the pipes Tim Kerr investigated. No owner was identified, ARFCD Staff Notes indicate Abandoned (ARFCD/Bill) - No As-builts. (DWR UCIP - O. Magana) 12/19/2013 Non-functional crossing--need additional information about how crossing was abandoned. (DWR UCIP - O. Magana) FIELD_STRUCT_DESC: *ABANDONED* 42-inch corrugated metal drainage pipe through the levee, 16.5 feet below the crown. Gravel filled with both ends welded shut. Flap gate on the waterside (WS) end. Slide gate in corrugated metal riser and splash board drain structure on the landside (LS). (no permit has been identified authorizing this structure, no owner has been identified) [Additional Reference(s): DWR Levee Log, 2002. USACE Sacramento O&M Manual Unit 118 Part 1, August 1955, (Station 10+00)]. FS Date: 12/19/2013

Overview of crossing location.

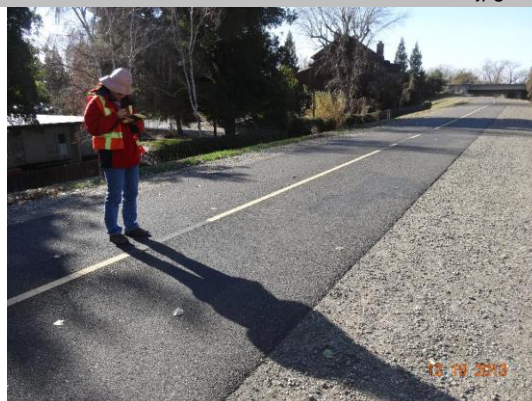
Photo 2 of 3 : UCIP_FA_2019_31249_57209.jpg

LM Start	0.40	Rating **	M	Issue No.	748 (cont)
LM End	0.40	Issue Type +	Ma	Location *

View of levee crown at this location.

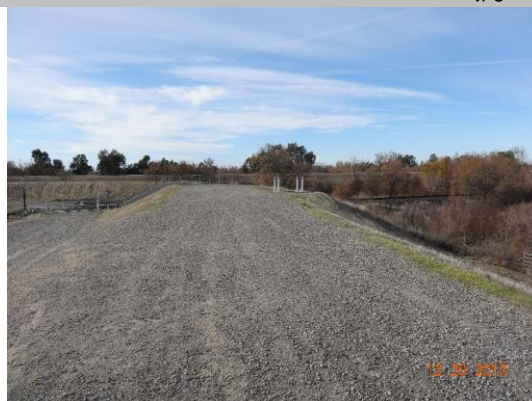
Photo 1 of 3 : UCIP_FA_2019_26884_49630.jpg

Comment Code						
Inspector Comment						
DS_ID:24092						
FS_ID:26884						
EP_NO: N/A						
Repair Type: No Action Needed						
Crossing Status: Found						
UCIP Comments:						
FIELD_STRUCT_DESC: 24-inch corrugated metal (CM) drainage pipe through the levee, 22.7 feet below the crown. Two CM cutoff walls around pipe. Slide gate in 30-inch CM riser and flap gate at located on the waterside (WS) end. Concrete headwalls on both ends, WS and landside (LS). [Additional Reference(s): DWR Levee Log, 2002. USACE Sacramento O&M Manual Unit 118 Part 2, August 1959, Drawing No. 1-4-392 of Exhibit B, (Station 396+65)].						
FS Date: 12/20/2013

View of levee crown at crossing.

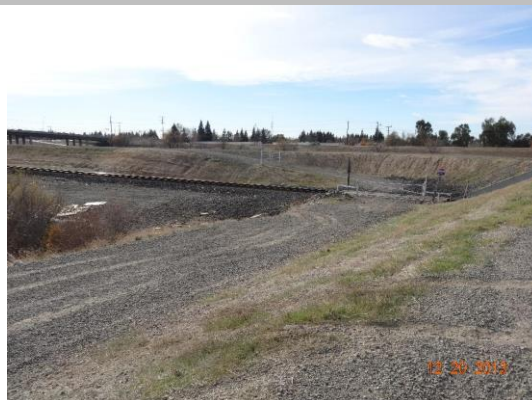
Photo 2 of 3 : UCIP_FA_2019_26884_49629.jpg

View of landward side.

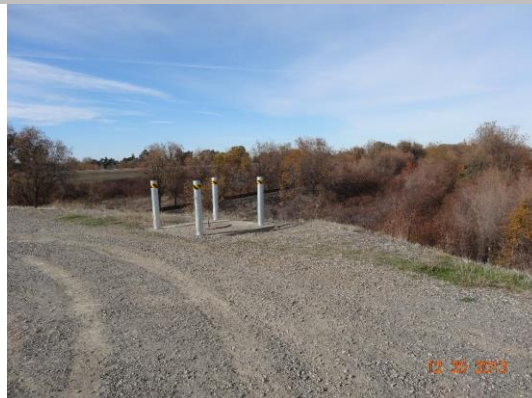
Photo 3 of 3 : UCIP_FA_2019_26884_49628.jpg

Comment Code						
Inspector Comment						
DS_ID:24092						
FS_ID:26884						
EP_NO: N/A						
Repair Type: No Action Needed						
Crossing Status: Found						
UCIP Comments:						
FIELD_STRUCT_DESC: 24-inch corrugated metal (CM) drainage pipe through the levee, 22.7 feet below the crown. Two CM cutoff walls around pipe. Slide gate in 30-inch CM riser and flap gate at located on the waterside (WS) end. Concrete headwalls on both ends, WS and landside (LS). [Additional Reference(s): DWR Levee Log, 2002. USACE Sacramento O&M Manual Unit 118 Part 2, August 1959, Drawing No. 1-4-392 of Exhibit B, (Station 396+65)].						
FS Date: 12/20/2013

Concrete vault protected by posts located on waterward shoulder.

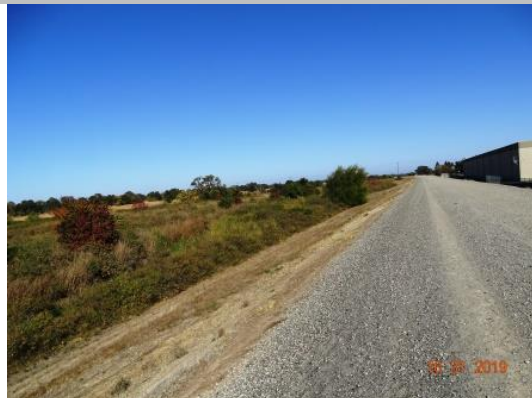
Photo 1 of 1 : FA_2019_NA0001_57_4_20191119_00010.jpg

LM Start	0.32	Rating **	A	Issue No.	4
LM End	1.30	Issue Type +	Ma	Location *	WS
Category	Earthen Levee			GPS Latitude/Longitude	
				Start	End
Item	Vegetation			38.657893 °	38.662273 °
				-121.469085 °	-121.452393 °
DWR ID	DWR_NA0001_06_f_2019_4				
Comment Code					
V1 : Control annual grass and weeds on the levee slopes and easements.					
Inspector Comment

View of well-maintained waterside vegetation. Fall 2019

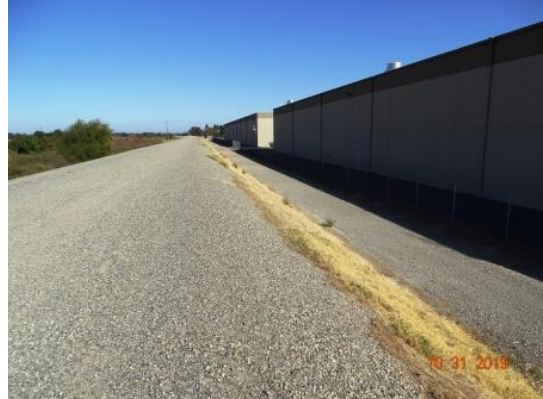
Photo 1 of 1 : FA_2019_NA0001_57_5_20191119_00011.jpg

LM Start	0.32	Rating **	A	Issue No.	5
LM End	1.30	Issue Type +	Ma	Location *	LS
Category	Earthen Levee			GPS Latitude/Longitude	
				Start	End
Item	Vegetation			38.657893 °	38.662272 °
				-121.469085 °	-121.452390 °
DWR ID	DWR_NA0001_06_f_2019_5				
Comment Code					
V1 : Control annual grass and weeds on the levee slopes and easements.					
Inspector Comment

View of well-maintained landside vegetation. Fall 2019

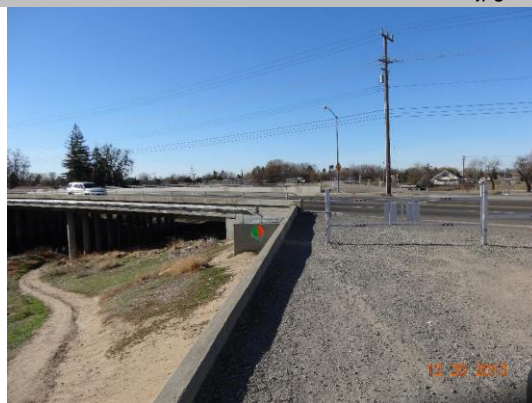
Photo 1 of 3 : UCIP_FA_2019_29301_54278.jpg

Item	DRAFT DWR UCIP LMA Responsibility		38.626321 °	38.626321 °								
			-121.445964 °	-121.445964 °								
DWR ID	24370											
Comment Code												
Inspector Comment												
DS_ID:24370 FS_ID:29301 EP_NO: N/A Repair Type: No Action Needed Crossing Status: Found UCIP Comments: 08/16/2017 DWR Deferred Maintenance Project (DMP), Vince Rodriguez, forwarded email received from Tim Kerr, General Manager of American River Flood Control District (ARFCD) with file "DWR Eligible Pipes Found in ARFCD" from ARFCD that shows the ownership and location of the pipes Tim Kerr investigated. Owner of this crossing is identified as the City of Sacramento, ARFCD Staff Notes indicate Arcade CK just upstream of Rio Linda. (DWR UCIP - O. Magana) FIELD_STRUCT_DESC: 24-inch corrugated metal (CM) drainage pipe through the levee, 11 feet below the crown. Slide gate in CM riser on the waterside (WS) slope. Flap gate on the WS end. Concrete headwalls on both ends, WS and landside (LS). (no permit has been identified authorizing this structure, structure is owned by the City of Sacramento) [Additional Reference(s): DWR Levee Log, 2002. USACE Sacramento O&M Manual Unit 118, Part No. 2, October 1959, Drawing No. 1-4-392 Exhibit B, (Station 65+73)] FS Date: 12/20/2013

View of flood wall along waterward side.

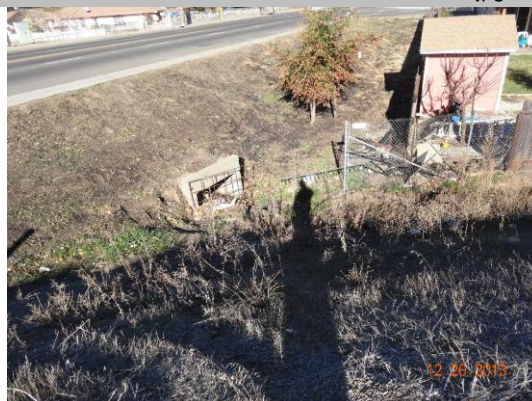
Photo 2 of 3 : UCIP_FA_2019_29301_54277.jpg

Comment Code						
Inspector Comment						
DS_ID:24370 FS_ID:29301 EP_NO: N/A Repair Type: No Action Needed Crossing Status: Found UCIP Comments: 08/16/2017 DWR Deferred Maintenance Project (DMP), Vince Rodriguez, forwarded email received from Tim Kerr, General Manager of American River Flood Control District (ARFCD) with file "DWR Eligible Pipes Found in ARFCD" from ARFCD that shows the ownership and location of the pipes Tim Kerr investigated. Owner of this crossing is identified as the City of Sacramento, ARFCD Staff Notes indicate Arcade CK just upstream of Rio Linda. (DWR UCIP - O. Magana) FIELD_STRUCT_DESC: 24-inch corrugated metal (CM) drainage pipe through the levee, 11 feet below the crown. Slide gate in CM riser on the waterside (WS) slope. Flap gate on the WS end. Concrete headwalls on both ends, WS and landside (LS). (no permit has been identified authorizing this structure, structure is owned by the City of Sacramento) [Additional Reference(s): DWR Levee Log, 2002. USACE Sacramento O&M Manual Unit 118, Part No. 2, October 1959, Drawing No. 1-4-392 Exhibit B, (Station 65+73)] FS Date: 12/20/2013

View of landward side.

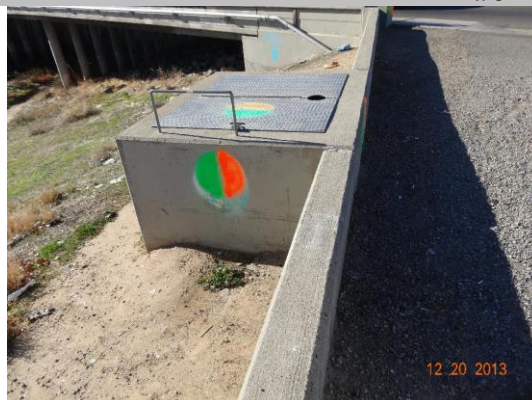
Photo 3 of 3 : UCIP_FA_2019_29301_54276.jpg

LM Start	1.33	Rating **	A/W	Issue No.	54 (cont)
LM End	1.33	Issue Type +	Ma	Location *

Concrete vault located on waterward shoulder.

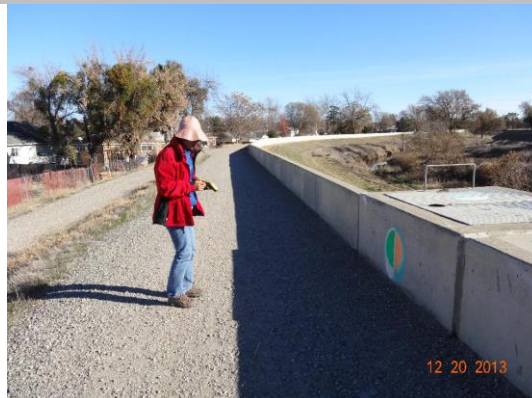
Photo 1 of 3 : UCIP_FA_2019_29302_54282.jpg

FIELD_STRUCT_DESC: 24-inch reinforced concrete drainage pipe through the levee, 9.3 feet below the crown. Concrete headwalls on both waterside (WS) and landside (LS) ends. Slide gate inside CM riser located on the WS slope. Flap gate is located on the WS end. (24-inch referenced in USACE O&M manual -- no permit found, the City of Sacramento is the owner; according to permit records for 12886 "old pipe removed. Concrete pipe in placed and backfilled part of it". Conflicting information makes it difficult to determine fate of 24-inch pipe (extent of work completed under permit); 30-inch pipe and removal of old pipe was authorized under Permit No. 12886, 1980 - City of Sacramento. To remove and replace an existing 24-inch reinforced concrete pipe authorized by Permit No. 19129, 2017 - City of Sacramento, Department of Utilities). [Additional Reference(s): DWR Levee Log, 2002. USACE Sacramento O&M Manual Unit 118, Part No. 2, October 1959, Drawing No. 1-4-392 Exhibit B, (Station 70+09)]. FS Date: 12/20/2013

View of levee crown--flood wall located along waterward shoulder.

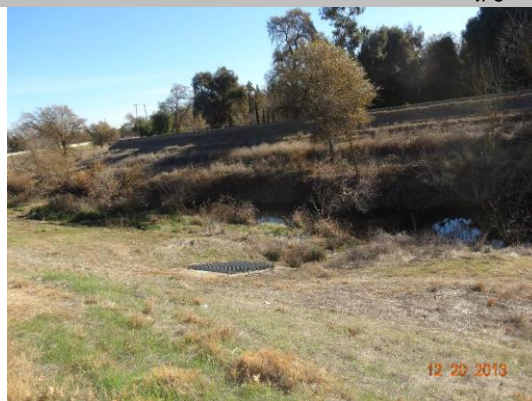
Photo 2 of 3 : UCIP_FA_2019_29302_54283.jpg

FIELD_STRUCT_DESC: 24-inch reinforced concrete drainage pipe through the levee, 9.3 feet below the crown. Concrete headwalls on both waterside (WS) and landside (LS) ends. Slide gate inside CM riser located on the WS slope. Flap gate is located on the WS end. (24-inch referenced in USACE O&M manual -- no permit found, the City of Sacramento is the owner; according to permit records for 12886 "old pipe removed. Concrete pipe in placed and backfilled part of it". Conflicting information makes it difficult to determine fate of 24-inch pipe (extent of work completed under permit); 30-inch pipe and removal of old pipe was authorized under Permit No. 12886, 1980 - City of Sacramento. To remove and replace an existing 24-inch reinforced concrete pipe authorized by Permit No. 19129, 2017 - City of Sacramento, Department of Utilities). [Additional Reference(s): DWR Levee Log, 2002. USACE Sacramento O&M Manual Unit 118, Part No. 2, October 1959, Drawing No. 1-4-392 Exhibit B, (Station 70+09)]. FS Date: 12/20/2013

Headwall with debris screen located at waterward toe.

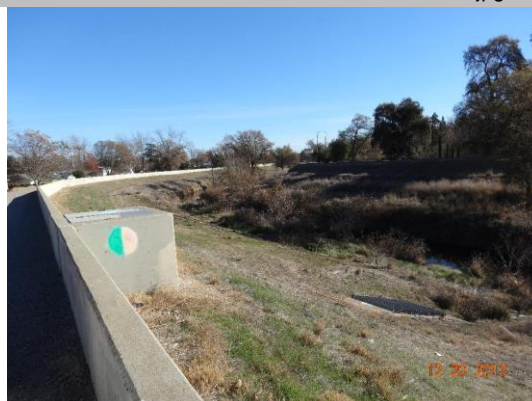
Photo 3 of 3 : UCIP_FA_2019_29302_54284.jpg

View of waterward side--concrete vault and headwall.

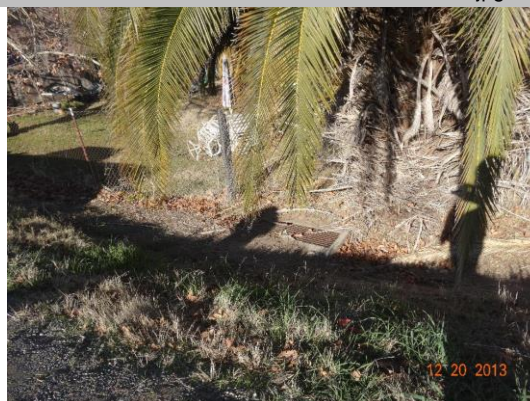
Photo 1 of 3 : UCIP_FA_2019_29324_54305.jpg

Comment Code						
Inspector Comment						
DS_ID:24373 FS_ID:29324 EP_NO: N/A Repair Type: No Action Needed Crossing Status: Found UCIP Comments: 08/16/2017 DWR Deferred Maintenance Project (DMP), Vince Rodriguez, forwarded email received from Tim Kerr, General Manager of American River Flood Control District (ARFCD) with file "DWR Eligible Pipes Found in ARFCD" from ARFCD that shows the ownership and location of the pipes Tim Kerr investigated. Owner of this crossing is identified as the City of Sacramento, ARFCD Staff Notes indicate Arcade Ck. (DWR UCIP - O. Magana) 06/14/2017 This crossing is scheduled to be cut and replaced as part of Sacramento Area Flood Control (SAFCA) North Area Streams (NAS) Levee Improvement Project: City of Sacramento Utility Permit Modifications Along Arcade Creek Levees. Unable to confirm when pipe will be replaced. Need to coordinate with owner and DWR FPIIB Inspector to determine when project is expected to start. (DWR UCIP - O. Magana). FIELD_STRUCT_DESC: 24-inch reinforced concrete drainage pipe through the levee, 7.8 feet below the crown. Concrete headwall on each end. Slide gate inside a corrugated metal (CM) riser on the waterside (WS) slope. Flap gate at the outlet. (No permit has been identified authorizing this structure. Structure is owned by the City of Sacramento. To remove and replace an existing 24-inch reinforced concrete pipe authorized by Permit No. 19126, 2017 - City of Sacramento, Department of Utilities). [Additional Reference(s): DWR Levee Log, 2002. USACE Sacramento O&M Manual Unit 118, Part No. 2, October 1959, Drawing No. 1-4-392 Exhibit B, (Station 77+12)]. FS Date: 12/20/2013

View of landward side.

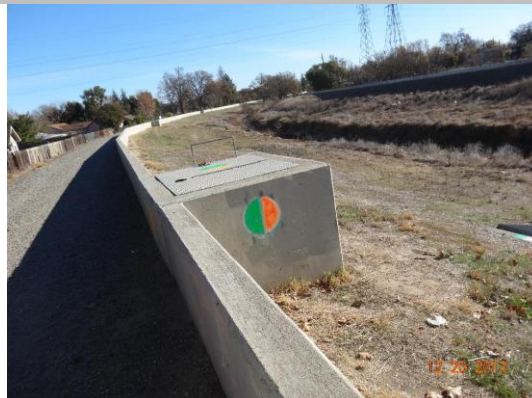
Photo 2 of 3 : UCIP_FA_2019_29324_54307.jpg

Comment Code						
Inspector Comment						
DS_ID:24373 FS_ID:29324 EP_NO: N/A Repair Type: No Action Needed Crossing Status: Found UCIP Comments: 08/16/2017 DWR Deferred Maintenance Project (DMP), Vince Rodriguez, forwarded email received from Tim Kerr, General Manager of American River Flood Control District (ARFCD) with file "DWR Eligible Pipes Found in ARFCD" from ARFCD that shows the ownership and location of the pipes Tim Kerr investigated. Owner of this crossing is identified as the City of Sacramento, ARFCD Staff Notes indicate Arcade Ck. (DWR UCIP - O. Magana) 06/14/2017 This crossing is scheduled to be cut and replaced as part of Sacramento Area Flood Control (SAFCA) North Area Streams (NAS) Levee Improvement Project: City of Sacramento Utility Permit Modifications Along Arcade Creek Levees. Unable to confirm when pipe will be replaced. Need to coordinate with owner and DWR FPIIB Inspector to determine when project is expected to start. (DWR UCIP - O. Magana). FIELD_STRUCT_DESC: 24-inch reinforced concrete drainage pipe through the levee, 7.8 feet below the crown. Concrete headwall on each end. Slide gate inside a corrugated metal (CM) riser on the waterside (WS) slope. Flap gate at the outlet. (No permit has been identified authorizing this structure. Structure is owned by the City of Sacramento. To remove and replace an existing 24-inch reinforced concrete pipe authorized by Permit No. 19126, 2017 - City of Sacramento, Department of Utilities). [Additional Reference(s): DWR Levee Log, 2002. USACE Sacramento O&M Manual Unit 118, Part No. 2, October 1959, Drawing No. 1-4-392 Exhibit B, (Station 77+12)]. FS Date: 12/20/2013

Floodwall along waterward shoulder.

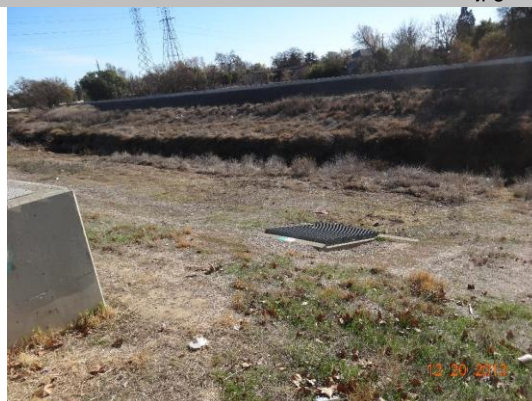
Photo 3 of 3 : UCIP_FA_2019_29324_54306.jpg

Comment Code						
Inspector Comment						
DS_ID:24373 FS_ID:29324 EP_NO: N/A Repair Type: No Action Needed Crossing Status: Found UCIP Comments: 08/16/2017 DWR Deferred Maintenance Project (DMP), Vince Rodriguez, forwarded email received from Tim Kerr, General Manager of American River Flood Control District (ARFCD) with file "DWR Eligible Pipes Found in ARFCD" from ARFCD that shows the ownership and location of the pipes Tim Kerr investigated. Owner of this crossing is identified as the City of Sacramento, ARFCD Staff Notes indicate Arcade Ck. (DWR UCIP - O. Magana) 06/14/2017 This crossing is scheduled to be cut and replaced as part of Sacramento Area Flood Control (SAFCA) North Area Streams (NAS) Levee Improvement Project: City of Sacramento Utility Permit Modifications Along Arcade Creek Levees. Unable to confirm when pipe will be replaced. Need to coordinate with owner and DWR FPIIB Inspector to determine when project is expected to start. (DWR UCIP - O. Magana). FIELD_STRUCT_DESC: 24-inch reinforced concrete drainage pipe through the levee, 7.8 feet below the crown. Concrete headwall on each end. Slide gate inside a corrugated metal (CM) riser on the waterside (WS) slope. Flap gate at the outlet. (No permit has been identified authorizing this structure. Structure is owned by the City of Sacramento. To remove and replace an existing 24-inch reinforced concrete pipe authorized by Permit No. 19126, 2017 - City of Sacramento, Department of Utilities). [Additional Reference(s): DWR Levee Log, 2002. USACE Sacramento O&M Manual Unit 118, Part No. 2, October 1959, Drawing No. 1-4-392 Exhibit B, (Station 77+12)]. FS Date: 12/20/2013

Concrete headwall with debris screen located on waterward toe.

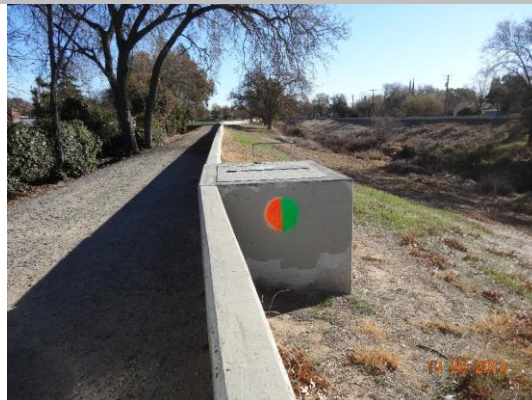
Photo 1 of 3 : UCIP_FA_2019_29326_54319.jpg

FIELD_STRUCT_DESC: 24-inch reinforced concrete drainage pipe through the levee, 8.6 feet below the crown. Slide gate inside a corrugated metal (CM) riser unit on the waterside (WS) slope. Flap gate at the outlet. Concrete headwall on each end. (No permit has been identified authorizing the original structure. Structure is owned by the City of Sacramento. To remove and replace an existing 24-inch reinforced concrete pipe authorized by Permit No. 19127, 2017 - City of Sacramento, Department of Utilities). [Additional Reference(s): DWR Levee Log, 2002. USACE Sacramento O&M Manual Unit No. 118, Part No. 2, October 1959, Drawing No. 1-4-392, Exhibit B, (Station 84+62)]. FS Date: 12/20/2013

Floodwall along waterward shoulder for almost entire Unit.

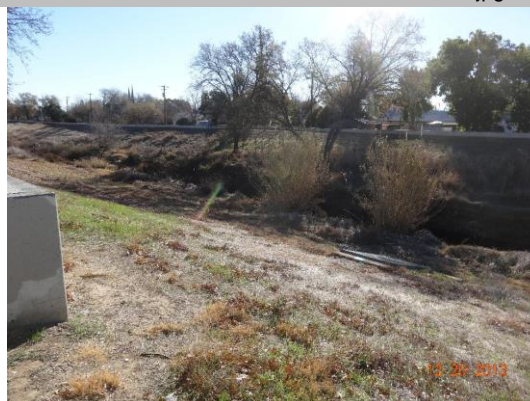
Photo 2 of 3 : UCIP_FA_2019_29326_54318.jpg

Comment Code					
Inspector Comment					
DS_ID:24375 FS_ID:29326 EP_NO: N/A Repair Type: No Action Needed Crossing Status: Found UCIP Comments: 08/16/2017 DWR Deferred Maintenance Project (DMP), Vince Rodriguez, forwarded email received from Tim Kerr, General Manager of American River Flood Control District (ARFCD) with file "DWR Eligible Pipes Found in ARFCD" from ARFCD that shows the ownership and location of the pipes Tim Kerr investigated. Owner of this crossing is identified as the City of Sacramento, ARFCD Staff Notes indicate Arcade Ck. (DWR UCIP - O. Magana) 06/14/2017 This crossing is scheduled to be cut and replaced as part of Sacramento Area Flood Control (SAFCA) North Area Streams (NAS) Levee Improvement Project: City of Sacramento Utility Permit Modifications Along Arcade Creek Levees. Unable to confirm when pipe will be replaced. Need to coordinate with owner and DWR FPIIB Inspector to determine when project is expected to start. (DWR UCIP - O. Magana). FIELD_STRUCT_DESC: 24-inch reinforced concrete drainage pipe through the levee, 8.6 feet below the crown. Slide gate inside a corrugated metal (CM) riser unit on the waterside (WS) slope. Flap gate at the outlet. Concrete headwall on each end. (No permit has been identified authorizing the original structure. Structure is owned by the City of Sacramento. To remove and replace an existing 24-inch reinforced concrete pipe authorized by Permit No. 19127, 2017 - City of Sacramento, Department of Utilities). [Additional Reference(s): DWR Levee Log, 2002. USACE Sacramento O&M Manual Unit No. 118, Part No. 2, October 1959, Drawing No. 1-4-392, Exhibit B, (Station 84+62)]. FS Date: 12/20/2013

View of waterward slope.

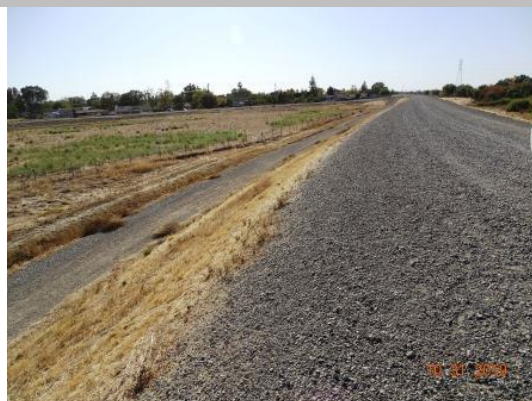
Photo 1 of 1 : FA_2019_NA0001_436_6_20191119_00014.jpg

LM Start	0.00	Rating **	A	Issue No.	6
LM End	0.73	Issue Type +	Ma	Location *	LS
Category	Earthen Levee			GPS Latitude/Longitude	
				Start	End
Item	Vegetation			38.662465 °	38.667975 °
				-121.457807 °	-121.447383 °
DWR ID	DWR_NA0001_11_f_2019_6				
Comment Code					
V1 : Control annual grass and weeds on the levee slopes and easements.					
Inspector Comment

View of well-maintained landside vegetation. Fall 2019

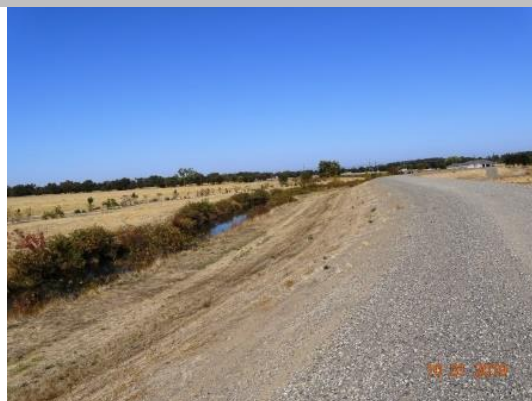
Photo 1 of 1 : FA_2019_NA0001_436_7_20191119_00013.jpg

LM Start	0.00	Rating **	A	Issue No.	7
LM End	0.73	Issue Type +	Ma	Location *	WS
Category	Earthen Levee			GPS Latitude/Longitude	
				Start	End
Item	Vegetation			38.662465 °	38.667975 °
				-121.457807 °	-121.447383 °
DWR ID	DWR_NA0001_11_f_2019_7				
Comment Code					
V1 : Control annual grass and weeds on the levee slopes and easements.					
Inspector Comment

View of well-maintained waterside vegetation. Fall 2019
