**Flood Control Project Maintenance  
Levee Inspections**

**Maintenance Issue Types Only, Levee Inspection Report By Mile - Fall 2020**

**American River Flood Control District**

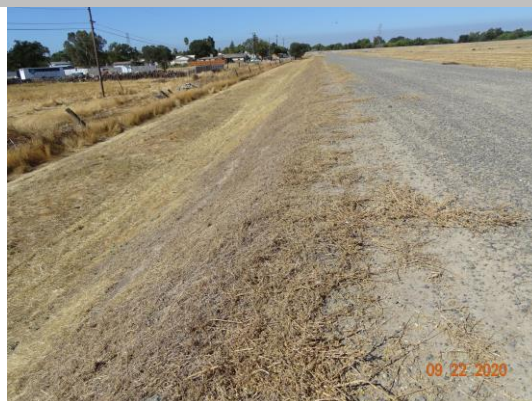
Photo 1 of 1 : FA\_2020\_NA0001\_57\_15\_20200924\_00043.jpg

LM Start	0.01	Rating **	A	Issue No.	15
LM End	1.30	Issue Type +	Ma	Location *	LS
Category	Earthen Levee			GPS Latitude/Longitude	
				Start	End
Item	Vegetation			38.657403 °	38.662313 °
				-121.474560 °	-121.452470 °
DWR ID	DWR_NA0001_06_f_2020_15				
Comment Code					
V1 : Control annual grass and weeds on the levee slopes and easements.					
Inspector Comment

View of well-maintained landside vegetation. Fall 2020

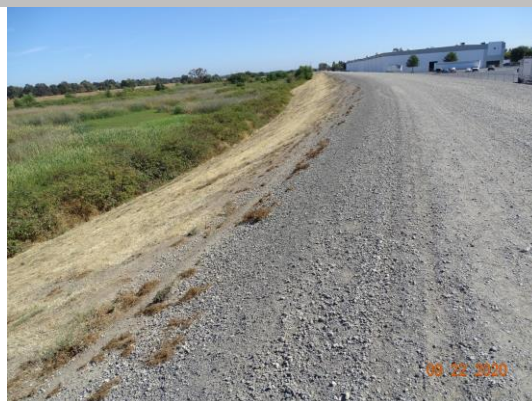
Photo 1 of 1 : FA\_2020\_NA0001\_57\_16\_20200924\_00044.jpg

LM Start	0.01	Rating **	A	Issue No.	16	
LM End	1.30	Issue Type +	Ma	Location *	WS	
Category	Earthen Levee			GPS Latitude/Longitude		
				Start		End
Item	Vegetation			38.657403 °		38.662313 °
				-121.474560 °		-121.452470 °
DWR ID	DWR_NA0001_06_f_2020_16					
Comment Code						
V1 : Control annual grass and weeds on the levee slopes and easements.						
Inspector Comment

View of well-maintained waterside vegetation. Fall 2020

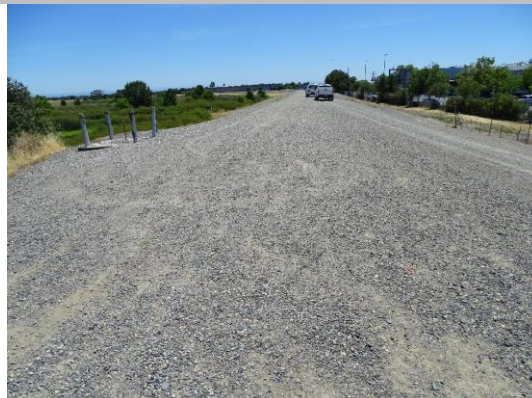
Photo 1 of 3 : UCIP\_FA\_2020\_60393\_85769.jpg

Comment Code						
Inspector Comment						
DS_ID:24092 FS_ID:60393 EP_NO: N/A Repair Type: Non-Urgent EVAL Issue: Geophysical Evaluation (Confirmed) Crossing Status: Found UCIP Comments: 06/18/2020 Crossing evaluated as "Non-Urgent" because there was no permit found authorizing this pipe. Geophysical evaluation found evidence of a pipe at this location. (A. McDonald - DWR UCIP) FIELD_STRUCT_DESC: 24-inch corrugated metal (CM) drainage pipe through the levee, 22.7 feet below the crown. Two CM cutoff walls around the pipe. Slide gate inside a 30-inch CM riser and flap gate are located on the waterside (WS) end. Concrete headwall on each end, WS and landside (LS). [Additional Reference(s): DWR Levee Log, 2002 (HLM 0.02). USACE Sacramento O&M Manual Unit 118, Part No. 2, August 1959, Drawing No. 1-4-392, Exhibit B, (Station 396+65)]. FS Date: 6/18/2020

Overview of levee crown looking u/s.

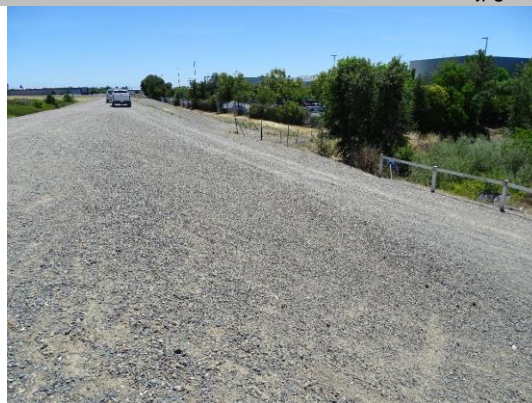
Photo 2 of 3 : UCIP\_FA\_2020\_60393\_85770.jpg

Overview of LS levee slope looking u/s.

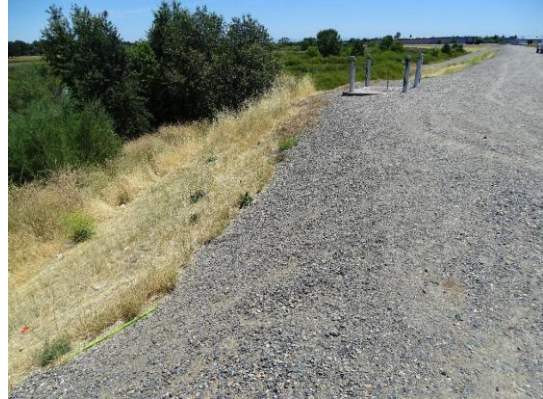
Photo 3 of 3 : UCIP\_FA\_2020\_60393\_85771.jpg

Overview of WS levee slope looking u/s.

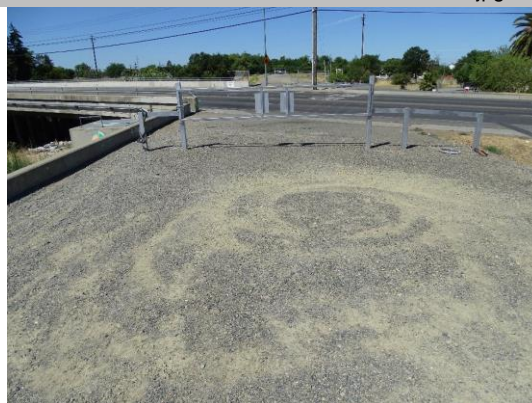
Photo 1 of 3 : UCIP\_FA\_2020\_60151\_85701.jpg

Comment Code					
Inspector Comment					
DS_ID:24370 FS_ID:60151 EP_NO: N/A Repair Type: No Action Needed EVAL Issue: Compliant Crossing Status: Found UCIP Comments: 06/18/2020 Crossing evaluated as "No Action Needed." Permit and inspection requirements have been met. (A. McDonald - DWR UCIP)08/16/2017 DWR Deferred Maintenance Project (DMP), Vince Rodriguez, forwarded email received from Tim Kerr, General Manager of American River Flood Control District (ARFCD) with file "DWR Eligible Pipes Found in ARFCD" from ARFCD that shows the ownership and location of the pipes Tim Kerr investigated. Owner of this crossing is identified as the City of Sacramento, ARFCD Staff Notes indicate Arcade CK just upstream of Rio Linda. (DWR UCIP - O. Magana) FIELD_STRUCT_DESC: 24-inch corrugated metal (CM) drainage pipe through the levee, 11.0 feet below the crown. Slide gate inside a CM riser on the waterside (WS) slope. Flap gate on the WS end. Concrete headwalls on both ends, WS and landside (LS). (No permit has been identified authorizing this structure. Structure is owned by the City of Sacramento). [Additional Reference(s): DWR Levee Log, 2002 (HLM 1.31). USACE Sacramento O&M Manual Unit 118, Part No. 2, October 1959, (Station 65+73). USACE As-Built File No. 1-4-392, Exhibit B, (Station 65+73)]. FS Date: 6/18/2020

Overview of levee crown looking d/s.

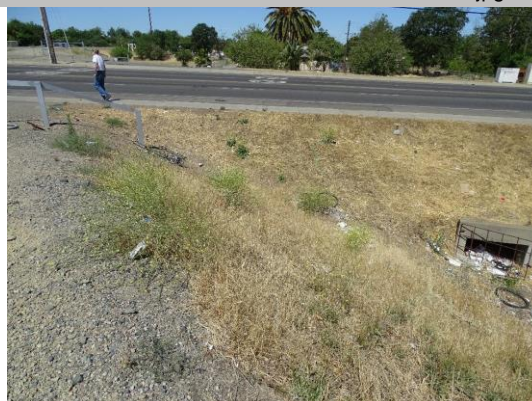
Photo 2 of 3 : UCIP\_FA\_2020\_60151\_85702.jpg

Overview of LS levee slope looking d/s.

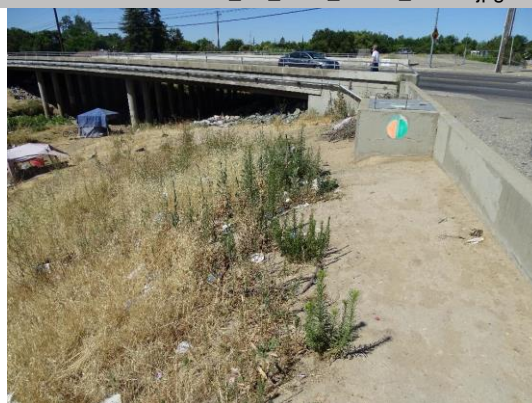
Photo 3 of 3 : UCIP\_FA\_2020\_60151\_85703.jpg

Overview of WS levee slope looking d/s.

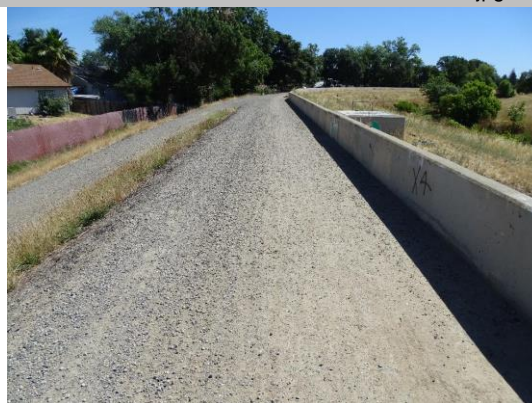
Photo 1 of 3 : UCIP\_FA\_2020\_60152\_85706.jpg

Overview of levee crown looking u/s.

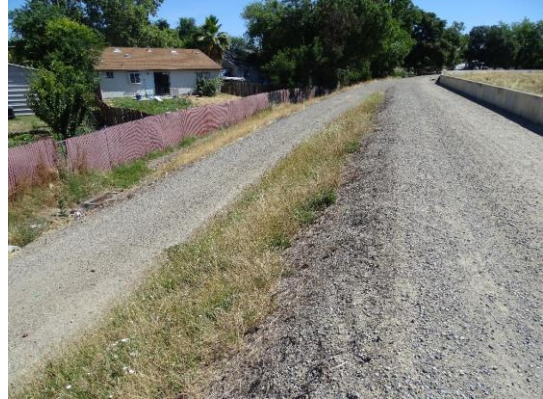
Photo 2 of 3 : UCIP\_FA\_2020\_60152\_85707.jpg

Overview of LS levee slope looking u/s.

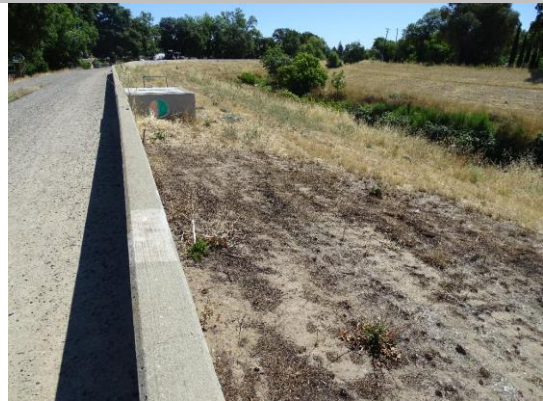
Photo 3 of 3 : UCIP\_FA\_2020\_60152\_85708.jpg

Overview of WS levee slope looking u/s.

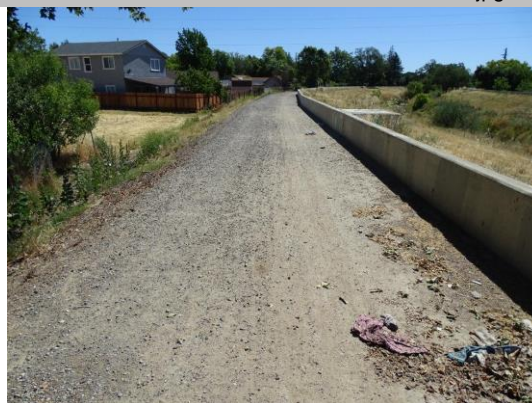
Photo 1 of 3 : UCIP\_FA\_2020\_60157\_85728.jpg

Comment Code					
Inspector Comment					
DS_ID:24373 FS_ID:60157 EP_NO: 19126 Repair Type: No Action Needed EVAL Issue: Compliant Crossing Status: Found UCIP Comments: 06/18/2020 Crossing evaluated as "No Action Needed." Permit and inspection requirements have been met. (A. McDonald - DWR UCIP)08/16/2017 DWR Deferred Maintenance Project (DMP), Vince Rodriguez, forwarded email received from Tim Kerr, General Manager of American River Flood Control District (ARFCD) with file "DWR Eligible Pipes Found in ARFCD" from ARFCD that shows the ownership and location of the pipes Tim Kerr investigated. Owner of this crossing is identified as the City of Sacramento, ARFCD Staff Notes indicate Arcade Ck. (DWR UCIP - O. Magana) 06/14/2017 This crossing is scheduled to be cut and replaced as part of Sacramento Area Flood Control (SAFCA) North Area Streams (NAS) Levee Improvement Project: City of Sacramento Utility Permit Modifications Along Arcade Creek Levees. Unable to confirm when pipe will be replaced. Need to coordinate with owner and DWR FPIIB Inspector to determine when project is expected to start. (DWR UCIP - O. Magana). FIELD_STRUCT_DESC: 24-inch reinforced concrete drainage pipe through the levee, 7.8 feet below the crown. Concrete headwall on each end. Slide gate inside a corrugated metal (CM) riser on the waterside (WS) slope. Flap gate at the outlet. (No permit has been identified authorizing this structure. Structure is owned by the City of Sacramento. To remove and replace an existing 24-inch reinforced concrete pipe authorized under Permit No. 19126, 2017 - City of Sacramento, Department of Utilities). [Additional Reference(s): DWR Levee Log, 2002 (HLM 1.70). USACE Sacramento O&M Manual Unit 118, Part No. 2, October 1959, (Station 77+12). USACE As-Built File No. 1-4-392, Exhibit B, (Station 77+12)]. FS Date: 6/18/2020

Overview of levee crown looking u/s.

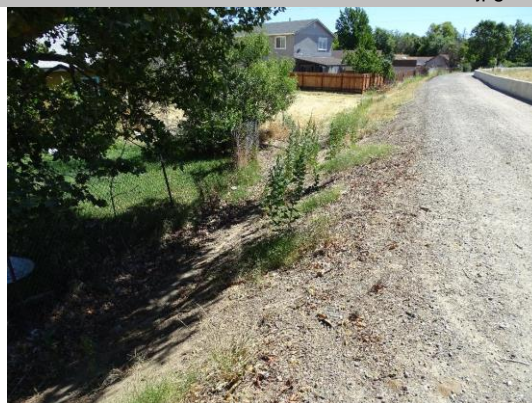
Photo 2 of 3 : UCIP\_FA\_2020\_60157\_85729.jpg

Overview of LS levee slope looking u/s.

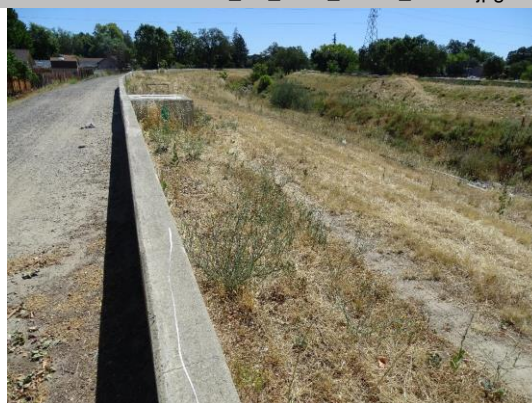
Photo 3 of 3 : UCIP\_FA\_2020\_60157\_85730.jpg

Overview of WS levee slope looking u/s.

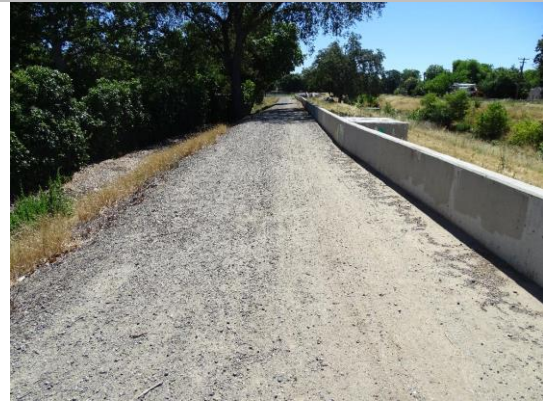
Photo 1 of 3 : UCIP\_FA\_2020\_60160\_85741.jpg

FIELD\_STRUCT\_DESC: 24-inch reinforced concrete drainage pipe through the levee, 8.6 feet below the crown. Slide gate inside a corrugated metal (CM) riser unit on the waterside (WS) slope. Flap gate at the outlet. Concrete headwall on each end. (No permit has been identified authorizing the original structure. Structure is owned by the City of Sacramento. To remove and replace an existing 24-inch reinforced concrete pipe authorized by Permit No. 19127, 2017 - City of Sacramento, Department of Utilities). [Additional Reference(s): DWR Levee Log, 2002 (HLM 1.82). USACE Sacramento O&M Manual Unit 118, Part No. 2, October 1959, (Station 84+62). USACE As-Built File No. 1-4-392, Exhibit B, (Station 84+62)].  
 FS Date: 6/18/2020

Overview of levee crown looking u/s.

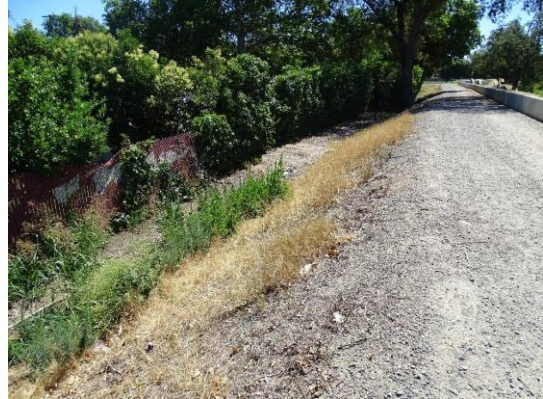
Photo 2 of 3 : UCIP\_FA\_2020\_60160\_85742.jpg

Overview of LS levee slope looking u/s.

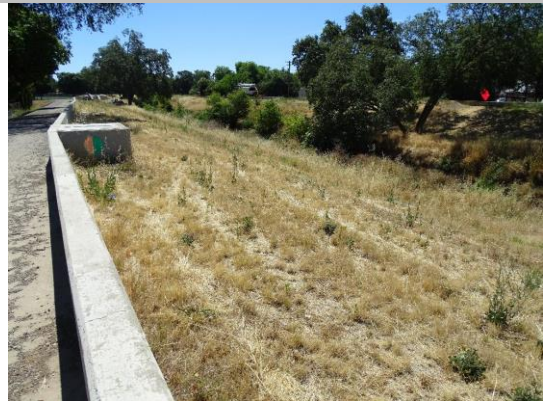
Photo 3 of 3 : UCIP\_FA\_2020\_60160\_85743.jpg

Overview of WS levee slope looking u/s.

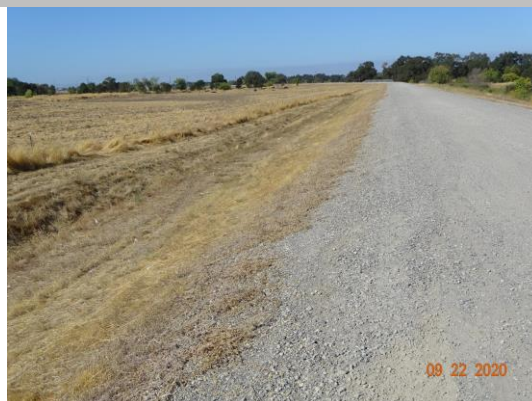
Photo 1 of 1 : FA\_2020\_NA0001\_59\_30\_20200924\_00045.jpg

LM Start	0.24	Rating **	A	Issue No.	30
LM End	1.10	Issue Type +	Ma	Location *	LS
Category	Earthen Levee			GPS Latitude/Longitude	
				Start	End
Item	Vegetation			38.668287 °	38.664552 °
				-121.443070 °	-121.431688 °
DWR ID	DWR_NA0001_08_f_2020_30				
Comment Code					
V1 : Control annual grass and weeds on the levee slopes and easements.					
Inspector Comment					
Landside vegetation is maintained well.

View of well-maintained landside vegetation. Fall 2020

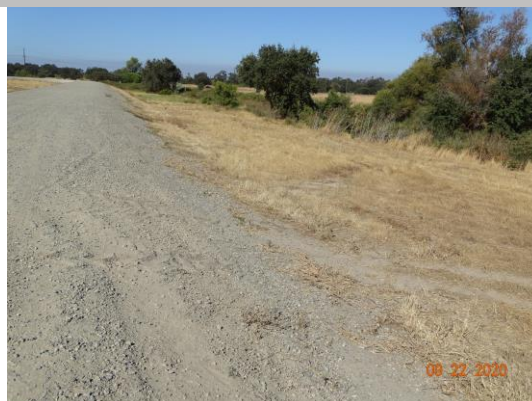
Photo 1 of 1 : FA\_2020\_NA0001\_59\_29\_20200924\_00044.jpg

LM Start	0.24	Rating **	A	Issue No.	29	
LM End	1.10	Issue Type +	Ma	Location *	WS	
Category	Earthen Levee			GPS Latitude/Longitude		
				Start		End
Item	Vegetation			38.668287 °		38.664552 °
				-121.443070 °		-121.431688 °
DWR ID	DWR_NA0001_08_f_2020_29					
Comment Code						
V1 : Control annual grass and weeds on the levee slopes and easements.						
Inspector Comment						
Waterside vegetation is maintained well.

View of well-maintained waterside vegetation. Fall 2020

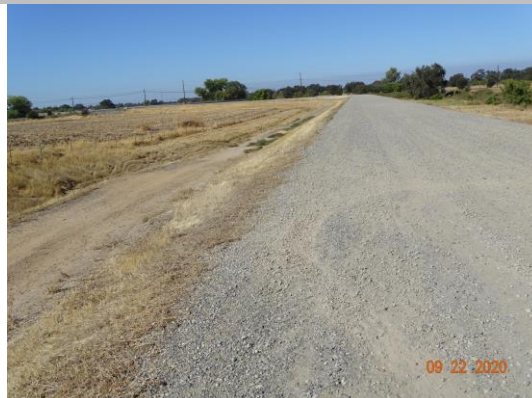
Photo 1 of 1 : FA\_2020\_NA0001\_436\_6\_20200924\_00018.jpg

LM Start	0.73	Rating **	A	Issue No.	6
LM End	0.73	Issue Type +	Ma	Location *	LS
Category	Earthen Levee			GPS Latitude/Longitude	
				Start	End
Item	Vegetation			38.667958 °	38.667958 °
				-121.447520 °	-121.447520 °
DWR ID	DWR_NA0001_11_f_2020_6				
Comment Code					
V1 : Control annual grass and weeds on the levee slopes and easements.					
Inspector Comment

View of well-maintained landside vegetation. Fall 2020

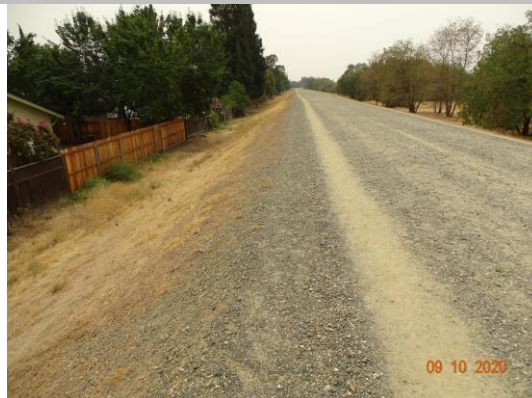
Photo 1 of 1 : FA\_2020\_NA0001\_438\_5\_20200915\_00011.jpg

LM Start	0.57	Rating **	A	Issue No.	5
LM End	0.57	Issue Type +	Ma	Location *	LS
Category	Earthen Levee			GPS Latitude/Longitude	
				Start	End
Item	Vegetation			38.575500 °	38.575500 °
				-121.346370 °	-121.346370 °
DWR ID	DWR_NA0001_12_f_2020_5				
Comment Code					
V1 : Control annual grass and weeds on the levee slopes and easements.					
Inspector Comment

View of well-maintained landside vegetation. Fall 2020

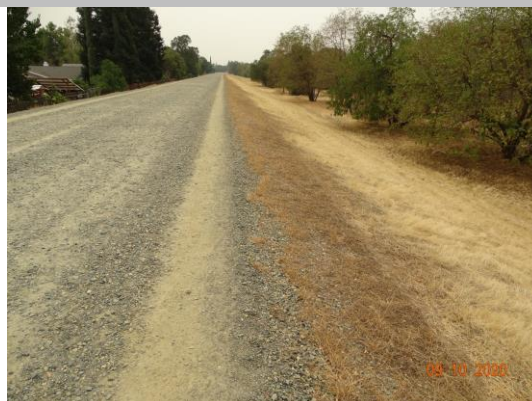
Photo 1 of 1 : FA\_2020\_NA0001\_438\_9\_20200915\_00010.jpg

LM Start	0.57	Rating **	A	Issue No.	9
LM End	0.57	Issue Type +	Ma	Location *	WS
Category	Earthen Levee			GPS Latitude/Longitude	
				Start	End
Item	Vegetation			38.575500 °	38.575500 °
				-121.346370 °	-121.346370 °
DWR ID	DWR_NA0001_12_f_2020_9				
Comment Code					
V1 : Control annual grass and weeds on the levee slopes and easements.					
Inspector Comment

View of well-maintained waterside vegetation. Fall 2020
