**Flood Control Project Maintenance  
Levee Inspections****Maintenance Issue Types Only, Levee Inspection Report By Mile - Fall 2024****American River Flood Control District**

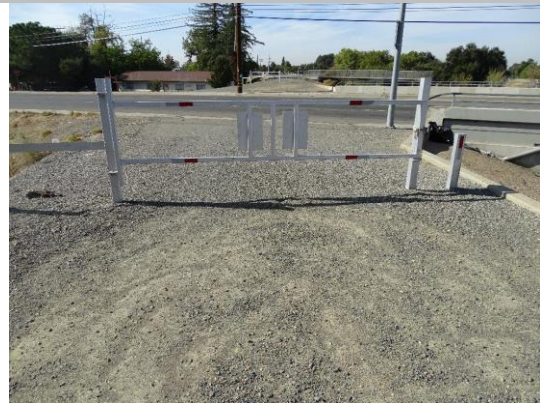
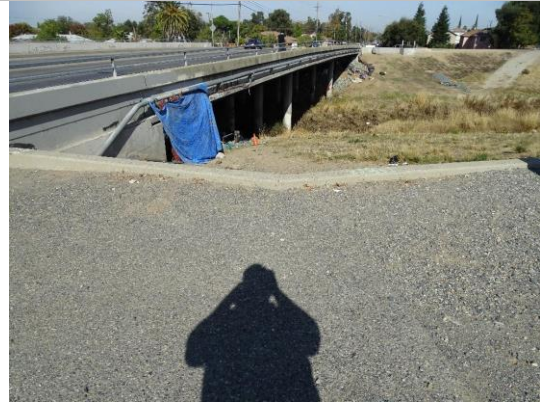
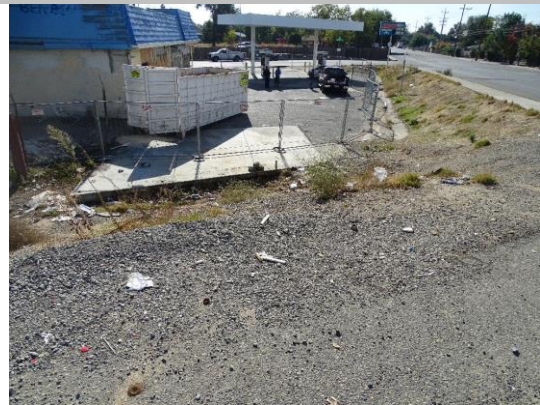
DS\_ID:24575  
FS\_ID:82720  
EP\_NO: N/A  
Repair Type: Non-Urgent  
EVAL Issue:  
Crossing Status: Not Found  
UCIP Comments: 11/02/2023 Crossing evaluated as "Non-Urgent."  
Code 9a - pipe not found; during inspection there was no evidence of a pipe. Code 12b - unauthorized encroachment. (A. McDonald - DWR UCIP)  
06/16/2020 Crossing evaluated as "Non-Urgent" because pipe was not found during inspection and there is no permit for this pipe. (A. McDonald - DWR UCIP)  
FIELD\_STRUCT\_DESC: 2 of 2: 12-inch corrugated metal (CM) drainage pipe through the levee, 14.0 feet below the crown. Flap gate on the waterside (WS) end. [Additional Reference(s): DWR Levee Log, 2002 (HLM 1.30). USACE Sacramento O&M Manual Unit 118, Part No. 2, October 1959, (Station A 68+40)].  
FS Date: 11/2/2023

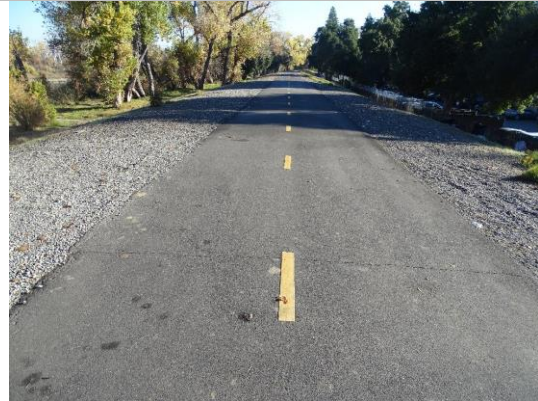
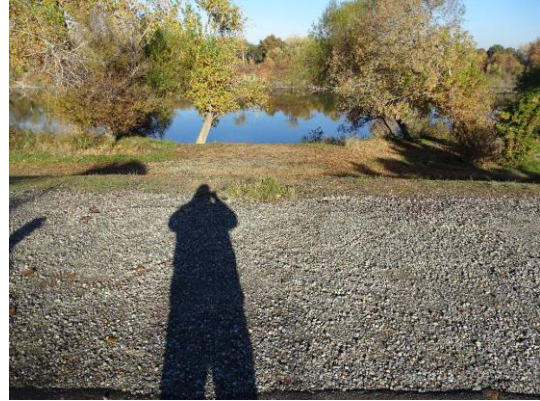
| DS_ID:24303<br>FS_ID:84752<br>EP_NO: N/A<br>Repair Type: Non-Urgent<br>EVAL Issue:<br>Crossing Status: Indicator Found<br>UCIP Comments: 12/13/2023 Crossing evaluated as "Non-Urgent."<br>Code 9c - pipe not found; during inspection there was no evidence of a pipe; however, previous inspections indicate that a pipe exists at this location. Code 12b - unauthorized encroachment; USACE O&M legacy system pipe. Code 16 - pipe abandoned, filled with gravel, and both ends welded shut. Removed Code 4c - results missing from geophysical survey. (A. McDonald - DWR UCIP 06/25/2020 Crossing evaluated as "Non-Urgent" because pipe looks abandoned and there was no permit found authorizing this pipe. Geophysical evaluation found evidence of a pipe at this location. (A. McDonald - DWR UCIP 08/16/2017 DWR Deferred Maintenance Project (DMP), Vince Rodriguez, forwarded email received from Tim Kerr, General Manager of American River Flood Control District (ARFCD) with file "DWR Eligible Pipes Found in ARFCD" from ARFCD that shows the ownership and location of the pipes Tim Kerr investigated. No owner was identified, ARFCD Staff Notes indicate Abandoned (ARFCD/Bill) - No As-builts. (DWR UCIP - O. Magana 02/19/2013 Non-functional crossing--need additional information about how crossing was abandoned. (DWR UCIP - O. Magana)<br>FIELD_STRUCT_DESC: 42-inch corrugated metal (CM) drainage pipe through the levee, 16.5 feet below the crown. Gravel filled with both ends welded shut. Flap gate on the waterside (WS) end. Slide gate inside a CM riser and splash board drain structure on the landside (LS). (No permit found authorizing this structure. Owner unknown). [Additional Reference(s): DWR Levee Log, 2002 (HLM 0.44). USACE Sacramento O&M Manual Unit 118, Part No. 1, August 1955, (Station 10+00). USACE As-Built Drawing No. 50-10-2792, Sheet 2792/1, (Station 10+00), March 1951].<br>FS Date: 12/13/2023 | | | | | |

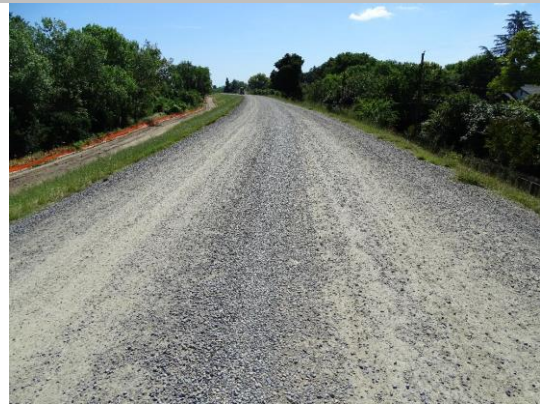
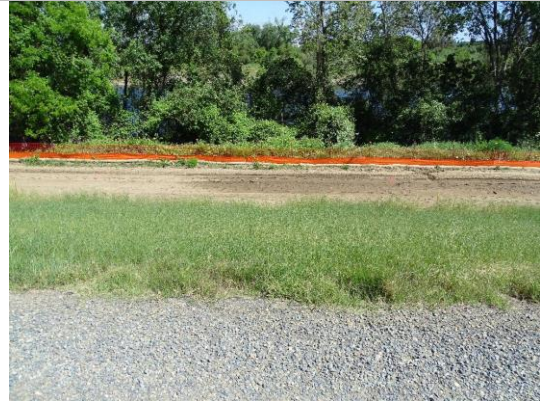
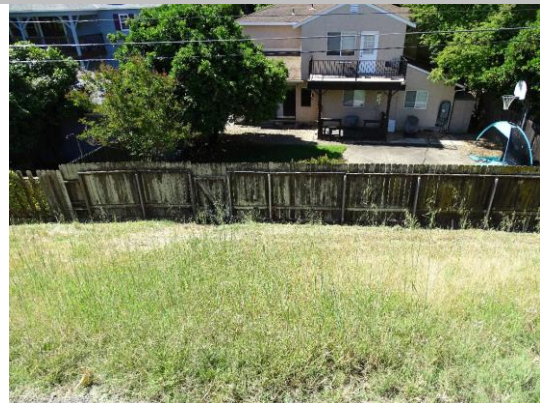
| DS_ID:24496<br>FS_ID:83834<br>EP_NO: N/A<br>Repair Type: Non-Urgent<br>EVAL Issue:<br>Crossing Status: Not Found<br>UCIP Comments: 05/07/2024 Crossing evaluated as "Non-Urgent."<br>Code 9a - pipe not found; during inspection there was no evidence of a pipe. (A. McDonald - DWR UCIP)<br>06/25/2020 Crossing evaluated as "Non-Urgent" because pipe was not found during inspection and there was no permit found authorizing this pipe. (A. McDonald - DWR UCIP)<br>FIELD_STRUCT_DESC: 18-inch steel drainage pipe through the levee, at an unknown depth. Flap gate on the waterside (WS) end. (No permit found authorizing this pipe. Owner unknown). [Additional Reference(s): USACE Sacramento O&M Manual Unit 118, Part No. 1, August 1955, (Station 265+07). USACE As-Built Drawing No. 1-4-362, Sheet 362/2, (Station 265+07), December 1947].<br>FS Date: 5/7/2024 | | | | | |

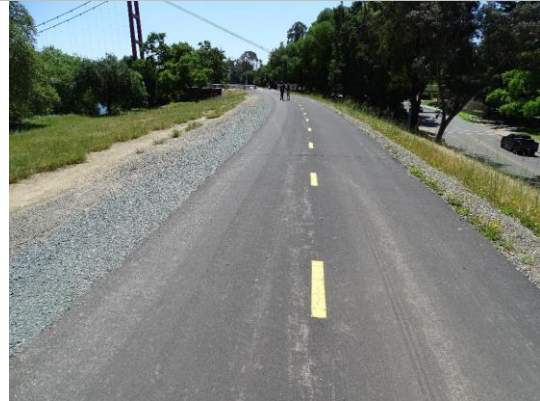
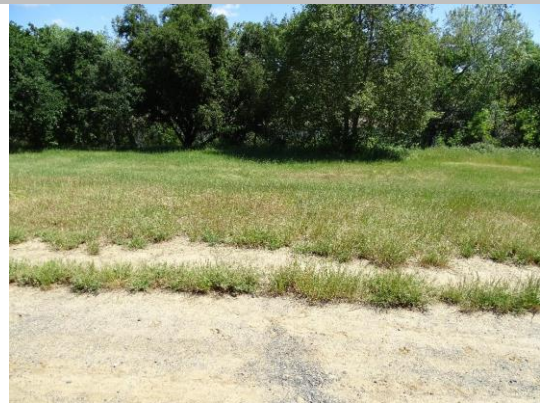
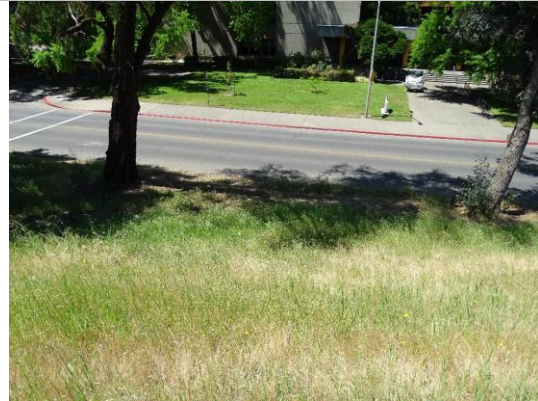
| DS_ID:24497<br>FS_ID:84647<br>EP_NO: N/A<br>Repair Type: Non-Urgent<br>EVAL Issue:<br>Crossing Status: Not Found<br>UCIP Comments: 05/07/2024 Crossing evaluated as "Non-Urgent."<br>Code 9a - pipe not found; during inspection there was no evidence of a pipe, and there was no permit found indicating a pipe. (A. McDonald - DWR UCIP)<br>06/30/2020 Crossing evaluated as "Non-Urgent" because pipe was not found during inspection and there was no permit found authorizing this pipe. (A. McDonald - DWR UCIP)<br>FIELD_STRUCT_DESC: 1 of 3: 18-inch corrugated metal (CM) drainage pipe through the levee, at an unknown depth. Flap gate on the waterside (WS) end. (No permit found authorizing this pipe. Owner unknown). [Additional Reference(s): USACE Sacramento O&M Manual Unit 118, Part No. 1, August 1955, (Station 367+40). USACE As-Built Drawing No. 1-4-362, Sheet 362/3, (Station 367+40), December 1947].<br>FS Date: 5/7/2024 | | | | | |

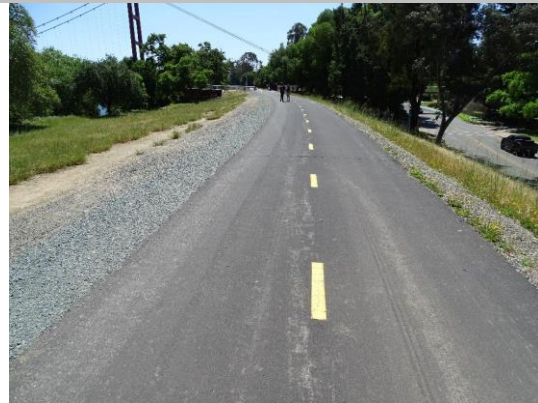
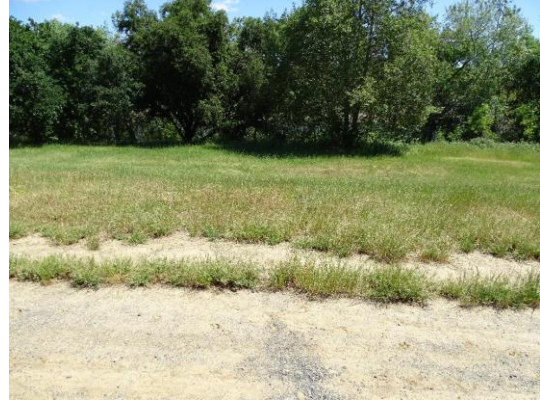
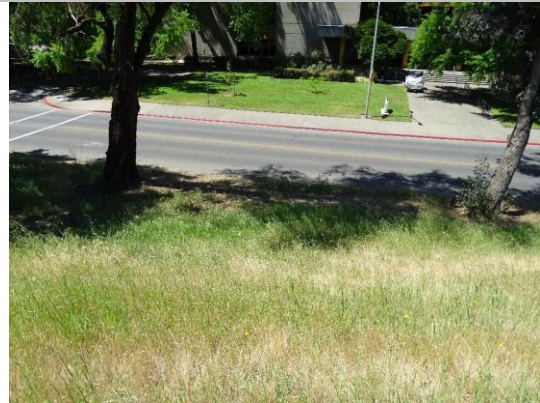
DS\_ID:24585  
 FS\_ID:84648  
 EP\_NO: N/A  
 Repair Type: Non-Urgent  
 EVAL Issue:  
 Crossing Status: Not Found  
 UCIP Comments: 05/07/2024 Crossing evaluated as "Non-Urgent."  
 Code 9a - pipe not found; during inspection there was no evidence of a pipe, and there was no permit found indicating a pipe. (A. McDonald - DWR UCIP)  
 06/30/2020 Crossing evaluated as "Non-Urgent" because pipe was not found during inspection and there was no permit found authorizing this pipe. (A. McDonald - DWR UCIP)  
 FIELD\_STRUCT\_DESC: 2 of 3: 18-inch corrugated metal (CM) drainage pipe through the levee, at an unknown depth. Flap gate on the waterside (WS) end. (No permit found authorizing this pipe. Owner unknown). [Additional Reference(s): USACE Sacramento O&M Manual Unit 118, Part No. 1, August 1955, (Station 367+40). USACE As-Built Drawing No. 1-4-362, Sheet 362/3, (Station 367+40), December 1947].  
 FS Date: 5/7/2024

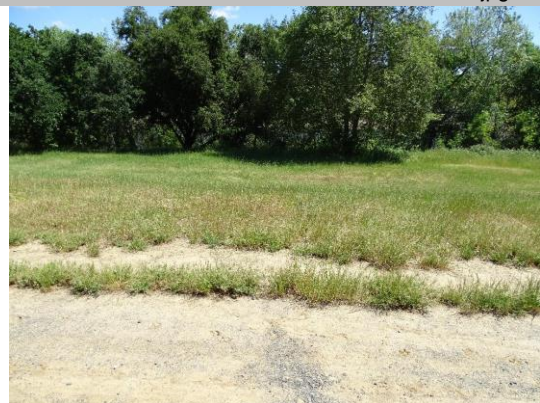
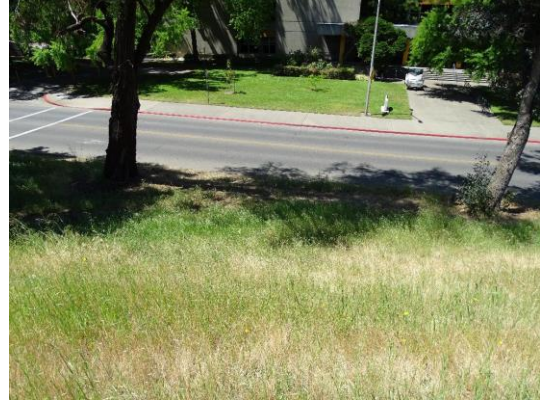
| DS_ID:24586<br>FS_ID:84649<br>EP_NO: N/A<br>Repair Type: Non-Urgent<br>EVAL Issue:<br>Crossing Status: Not Found<br>UCIP Comments: 05/07/2024 Crossing evaluated as "Non-Urgent."<br>Code 9a - pipe not found; during inspection there was no evidence of a pipe, and there was no permit found indicating a pipe. (A. McDonald - DWR UCIP)<br>06/30/2020 Crossing evaluated as "Non-Urgent" because pipe was not found during inspection and there was no permit found authorizing this pipe. (A. McDonald - DWR UCIP)<br>FIELD_STRUCT_DESC: 3 of 3: 18-inch corrugated metal (CM) drainage pipe through the levee, at an unknown depth. Flap gate on the waterside (WS) end. (No permit found authorizing this pipe. Owner unknown). [Additional Reference(s): USACE Sacramento O&M Manual Unit 118, Part No. 1, August 1955, (Station 367+40). USACE As-Built Drawing No. 1-4-362, Sheet 362/3, (Station 367+40), December 1947].<br>FS Date: 5/7/2024 | | | | | |

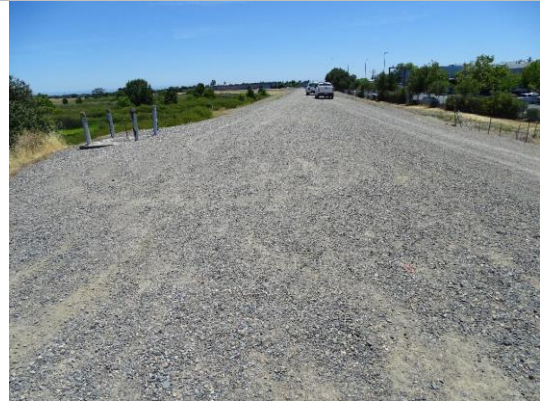
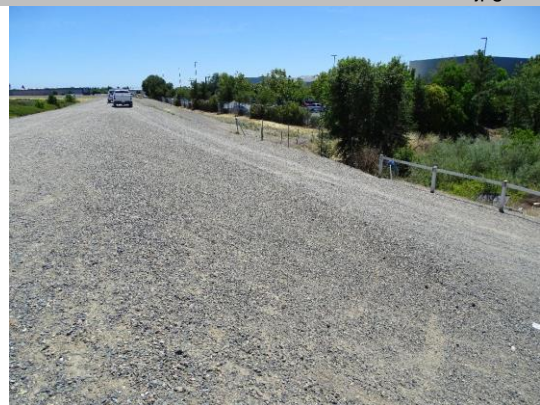
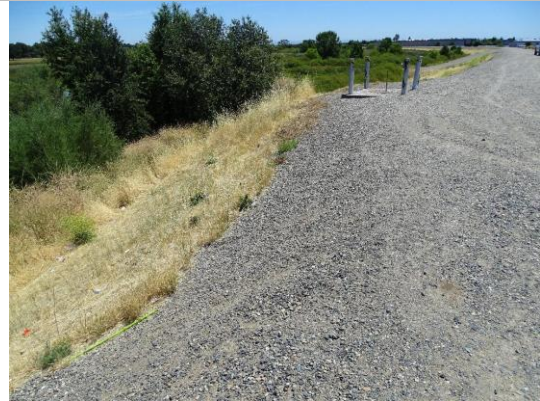
| DS_ID:24092<br>FS_ID:68568<br>EP_NO: N/A<br>Repair Type: Non-Urgent<br>EVAL Issue:<br>Crossing Status: Found<br>UCIP Comments: 06/18/2020 Crossing evaluated as "Non-Urgent" because there was no permit found authorizing this pipe. Geophysical evaluation found evidence of a pipe at this location. (A. McDonald - DWR UCIP)<br>FIELD_STRUCT_DESC: 24-inch corrugated metal (CM) drainage pipe through the levee, 22.7 feet below the crown. Two CM cutoff walls around the pipe. Slide gate inside a 30-inch CM riser and flap gate are located on the waterside (WS) end. Concrete headwall on each end, WS and landside (LS). [Additional Reference(s): DWR Levee Log, 2002 (HLM 0.02). USACE Sacramento O&M Manual, Unit 118, Part No. 2, October 1959, (Station 396+65). USACE As-Built Drawing No. 1-4-392, Sheet 392/8, (Station 396+65), December 1954].<br>FS Date: 6/18/2020 | | | | | |

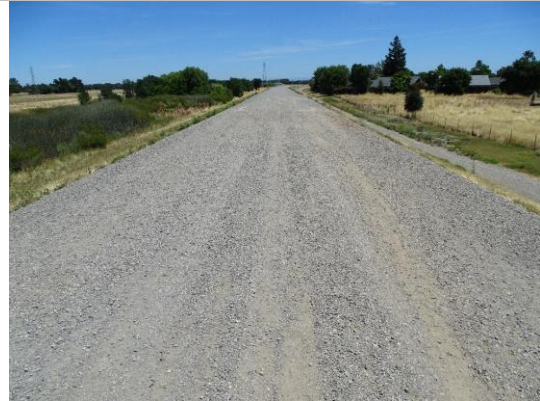
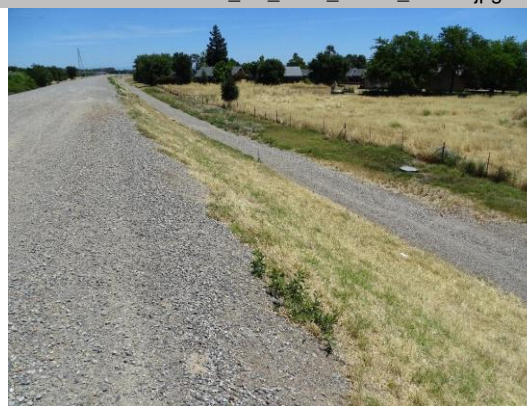
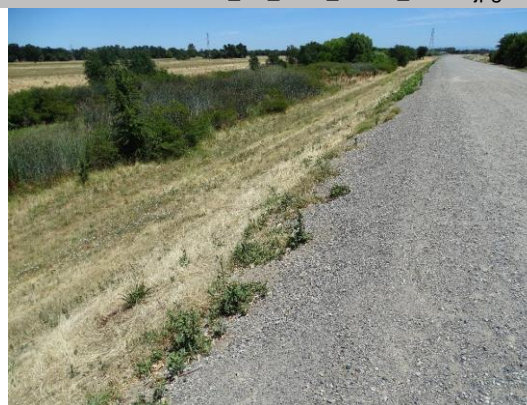
| DS_ID:24354<br>FS_ID:68578<br>EP_NO: N/A<br>Repair Type: Non-Urgent<br>EVAL Issue:<br>Crossing Status: Indicator Found<br>UCIP Comments: 06/18/2020 Crossing evaluated as "Non-Urgent" because there was no permit found for this pipe. (A. McDonald - DWR UCIP 08/16/2017 DWR Deferred Maintenance Project (DMP), Vince Rodriguez, forwarded email received from Tim Kerr, General Manager of American River Flood Control District (ARFCD) with file "DWR Eligible Pipes Found in ARFCD" from ARFCD that shows the ownership and location of the pipes Tim Kerr investigated. Owner of this crossing was not identified, ARFCD Staff Notes indicate old pipe between Kelton and Sully (not found). (DWR UCIP - O. Magana)<br>12/20/2013 Unable to find CM riser and flap gate on waterward end--need to contact owner to determine status of crossing. Manhole found on landward side however unable to determine if manhole is part of this crossing. (DWR UCIP - O. Magana)<br>FIELD_STRUCT_DESC: 24-inch corrugated metal (CM) drainage pipe through the levee, 12.5 feet below the crown. Two CM cutoff walls around the pipe. Slide gate inside a CM riser and flap gate on the waterside (WS) end. Concrete headwall on each end, WS and landside (LS). (No permit found authorizing this structure. Owner unknown).<br>[Additional Reference(s): USACE Sacramento O&M Manual, Unit 118, Part No. 2, October 1959, (Station 440+50). USACE As-Built Drawing No. 1-4-392, Sheet 392/9, (Station 440+50), December 1954].<br>FS Date: 6/18/2020 | | | | | | |

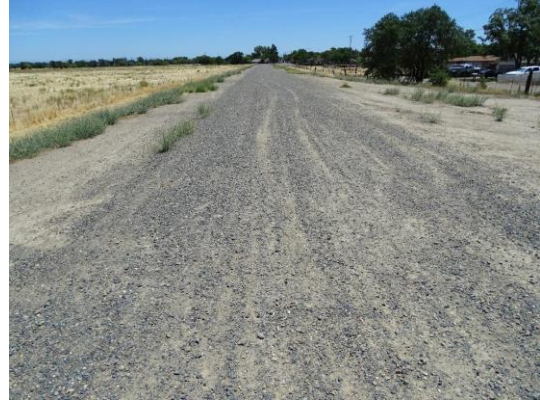
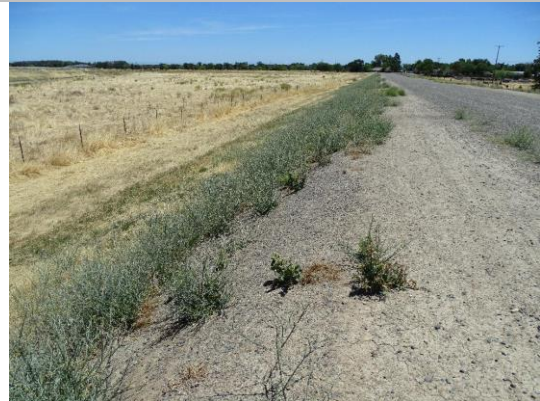
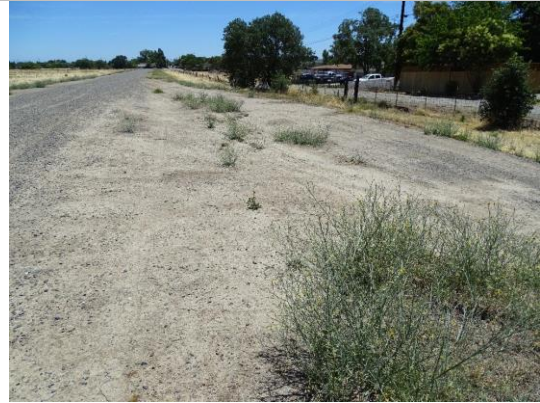
| DS_ID:24350<br>FS_ID:71915<br>EP_NO: N/A<br>Repair Type: Non-Urgent<br>EVAL Issue:<br>Crossing Status: Not Found<br>UCIP Comments: 06/18/2020 Crossing evaluated as "Non-Urgent" because pipe was not found during inspection and there was no permit found for this crossing. Geophysical evaluation found a potential pipe at this location. (A. McDonald - DWR UCIP)<br>FIELD_STRUCT_DESC: 24-inch corrugated metal drainage pipe (CMP) through the levee, at an unknown depth. Flap gate and riser on the waterside (WS). Slide gate Vault No. 2 on the WS shoulder. (No permit found authorizing this structure. Owner unknown). [Additional Reference(s): USACE Sacramento O&M Manual, Unit 118, Part No. 2, October 1959, (Station 14+00). USACE As-Built Drawing No. 1-4-392, Sheet 392/9, (Station 14+00), December 1954].<br>FS Date: 6/18/2020 | | | | | |

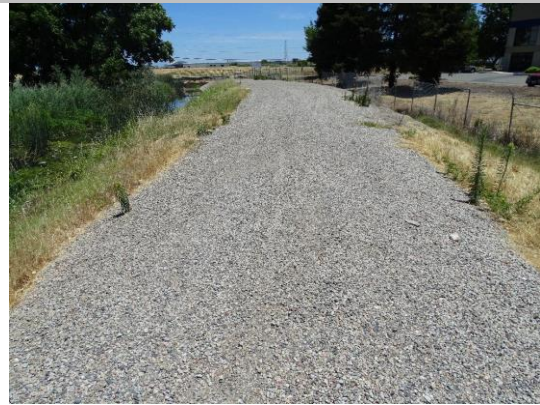
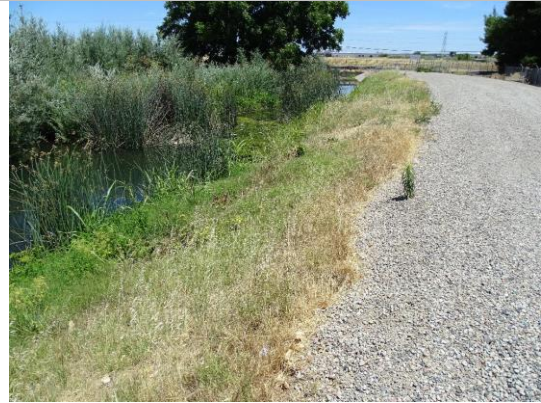
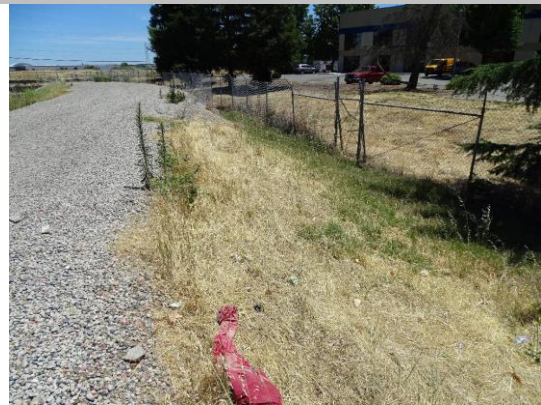
| DS_ID:24384<br>FS_ID:69467<br>EP_NO: N/A<br>Repair Type: Non-Urgent<br>EVAL Issue:<br>Crossing Status: Indicator Found<br>UCIP Comments: 06/18/2020 Crossing evaluated as "Non-Urgent" because this is an abandoned encroachment and there is no permit found for this crossing. Geophysical evaluation found evidence of a pipe at this location. (A. McDonald - DWR UCIP) Non-functional crossing-- need to coordinate with owner, DWR-Inspector, and CVFPB to determine how to properly abandon crossing.<br>FIELD_STRUCT_DESC: 24-inch corrugated metal (CM) drainage pipe through the levee, 8.0 feet below the crown. Two CM cutoff walls around the pipe. Slide gate inside a 30-inch CM riser. Flap gate on the waterside (WS) end. Concrete U-shaped headwall and splash apron on the WS end. Landside (LS) end cut off and plugged. Riser filled with dirt. [Additional Reference(s): DWR Levee Log, 2002 (HLM 1.44). USACE Sacramento O&M Manual, Unit 118, Part No. 2, October 1959, (Station A 72+10). USACE As-Built Drawing No. 1-4-392, Sheet 392/10, (Station A 72+10), December 1954].<br>FS Date: 6/18/2020 | | | | | |

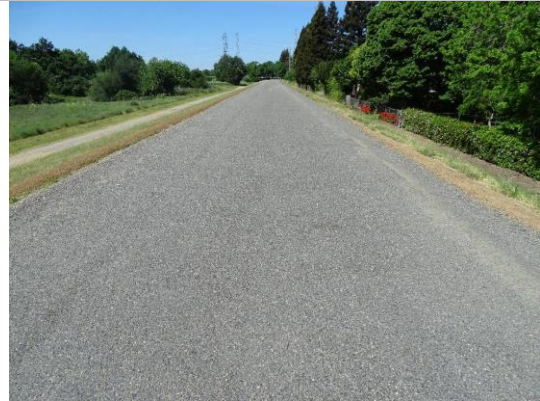
Photo 1 of 3 : UCIP\_FA\_2024\_69473\_84108.jpg

| DS_ID:24394<br>FS_ID:69473<br>EP_NO: N/A<br>Repair Type: Non-Urgent<br>EVAL Issue:<br>Crossing Status: Indicator Found<br>UCIP Comments: 04/30/2020 This crossing is rated "Non-Urgent." It has been abandoned without a permit. Geophysical evaluation found no evidence of a pipe at this location. (A. McDonald - DWR UCIP 08/16/2017 DWR Deferred Maintenance Project (DMP), Vince Rodriguez, forwarded email received from Tim Kerr, General Manager of American River Flood Control District (ARFCD) with file "DWR Eligible Pipes Found in ARFCD" from ARFCD that shows the ownership and location of the pipes Tim Kerr investigated. No owner mentioned in email, ARFCD Staff Notes indicate riser in floodway near Beckenwood Way. (DWR UCIP - O. Magana)<br>12/05/2013 Need to contact owner to determine status of crossing. (DWR UCIP - O. Magana)<br>FIELD_STRUCT_DESC: *ASSUMED ABANDONED* 12-inch steel pipe of an unknown purpose through the levee, 14.0 feet below the crown. Riser on the waterside (WS). (Reference to 12-inch pipe scheduled to be abandoned [no clear direction of action taken available in permit recordation, see page 14 of 27 electronic permit copy] under Permit No. 4622, 1964 - County of Sacramento). [Additional Reference(s): DWR Levee Log, 2002 (HLM 1.31). USACE Sacramento O&M Manual, Unit 517, Part No. 1, November 1959, (Station 296+85). USACE As-Built Drawing No. 1-4-415, Sheet 415/6, (Station 296+85), February 1957]. FS Date: 4/30/2020 | | | | | | |

Overview of levee crown looking d/s.

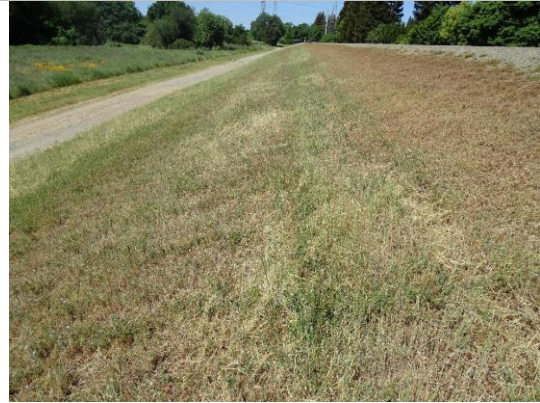
Photo 2 of 3 : UCIP\_FA\_2024\_69473\_84109.jpg

Overview of WS levee slope looking d/s.

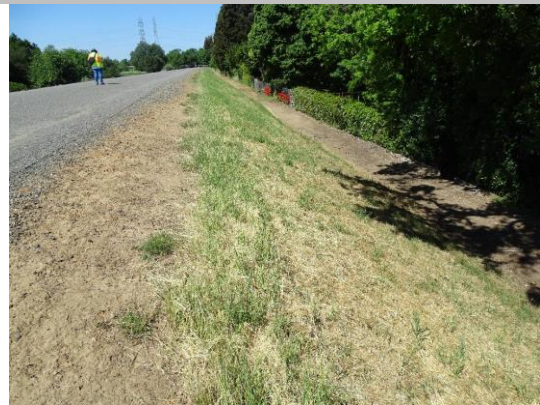
Photo 3 of 3 : UCIP\_FA\_2024\_69473\_84111.jpg

Overview of LS levee slope looking d/s.

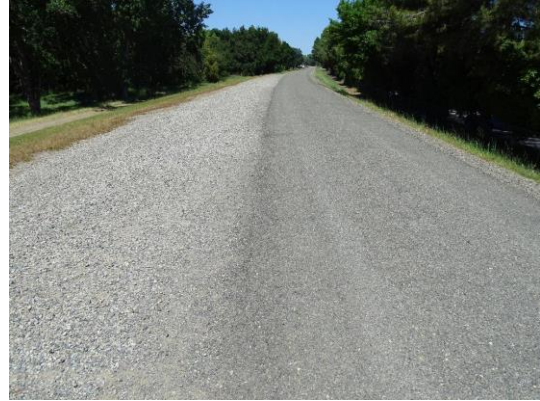
Photo 1 of 3 : UCIP\_FA\_2024\_69476\_84145.jpg

| DS_ID:24397<br>FS_ID:69476<br>EP_NO: N/A<br>Repair Type: Non-Urgent<br>EVAL Issue:<br>Crossing Status: Not Found<br>UCIP Comments: 04/30/2020 This crossing is rated "Non-Urgent."<br>Crossing was not found during inspection. Geophysical evaluation found no evidence of a pipe at this location. Unable to locate a permit and confirm proper pipe abandonment. (A. McDonald - DWR UCIP)<br>FIELD_STRUCT_DESC: 12-inch pipe of an unknown material or purpose through the levee, 11.2 feet below the crown. Riser unit on the waterside (WS). (Reference to 12-inch pipe scheduled to be abandoned [no clear direction of action taken available in permit recordation, see page 14 of 27 electronic permit copy] under Permit No. 4622, 1964 - County of Sacramento). [Additional Reference(s): DWR Levee Log, 2002 (HLM 2.26). USACE Sacramento O&M Manual, Unit 517, Part No. 1, November 1959, (Station 346+09). USACE As-Built Drawing No. 1-4-415, Sheet 415/6, (Station 346+09), February 1957].<br>FS Date: 4/30/2020 | | | | | |

Overview of levee crown looking d/s.

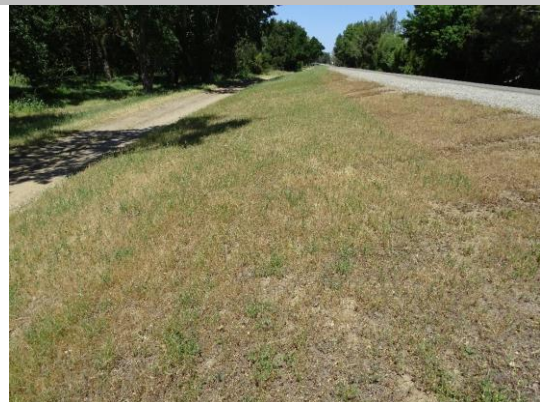
Photo 2 of 3 : UCIP\_FA\_2024\_69476\_84147.jpg

Overview of WS levee slope looking d/s.

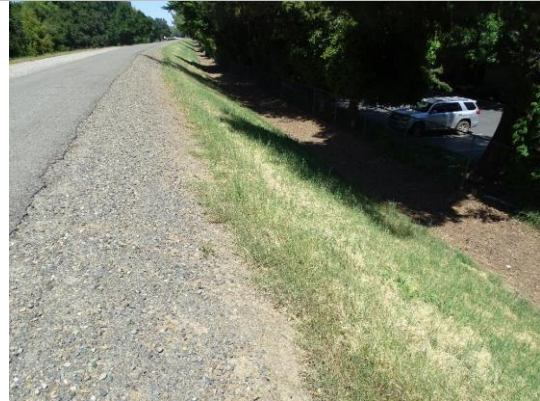
Photo 3 of 3 : UCIP\_FA\_2024\_69476\_84146.jpg

Overview of LS levee slope looking d/s.

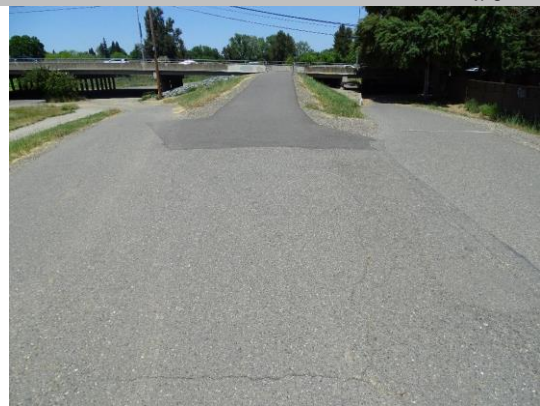
Photo 1 of 3 : UCIP\_FA\_2024\_69477\_84148.jpg

DS\_ID:24515  
FS\_ID:69477  
EP\_NO: N/A  
Repair Type: Non-Urgent  
EVAL Issue:  
Crossing Status: Indicator Found  
UCIP Comments: 04/30/2020 This crossing is rated "Non-Urgent."  
Crossing was not found during inspection. (A. McDonald - DWR UCIP) 2/05/2013 Unable to confirm crossing. will need to contact owner to determine specifics and status of crossing.  
FIELD\_STRUCT\_DESC: 36-inch corrugated metal (CM) drainage pipe through the levee, at an unknown depth. Riser on the waterside (WS).  
[Additional Reference(s): USACE Sacramento O&M Manual, Unit 517, Part No. 1, November 1959, (Station 365+14). USACE As-Built Drawing No. 1-4-415, Sheet 415/9, (Station 365+14), February 1957].  
FS Date: 4/30/2020

Overview of levee crown looking d/s. "H" Street Bridge in the background.

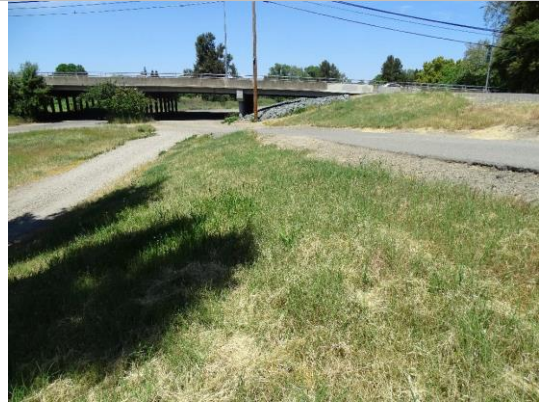
Photo 2 of 3 : UCIP\_FA\_2024\_69477\_84150.jpg

Overview of WS levee slope looking d/s. "H" Street Bridge in the background.

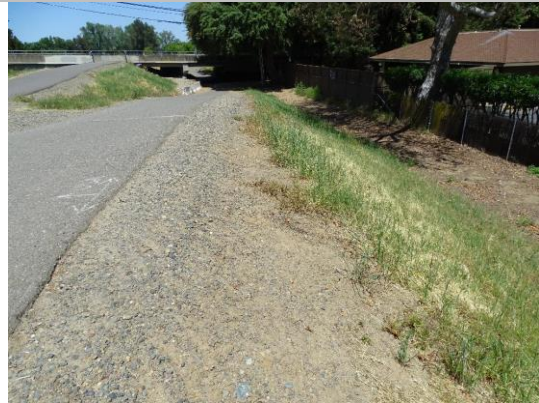
Photo 3 of 3 : UCIP\_FA\_2024\_69477\_84149.jpg

Overview of LS levee slope looking d/s. "H" Street Bridge in the background.

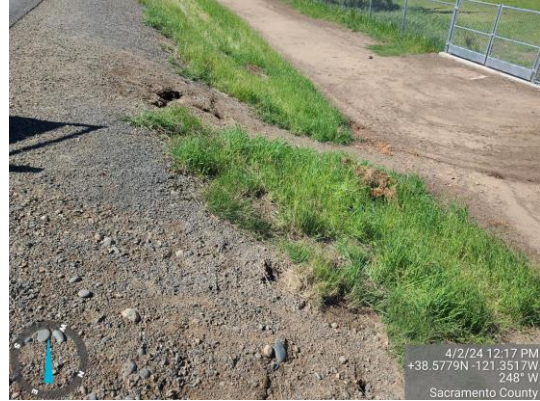
Photo 1 of 1 : FA\_2024\_NA0001\_61\_3\_20240911\_00001.jpg

| No active rodent activity. Continue to monitor for reinfestation. | | | | | |

Rodent holes on the LS slope. Spring 2024

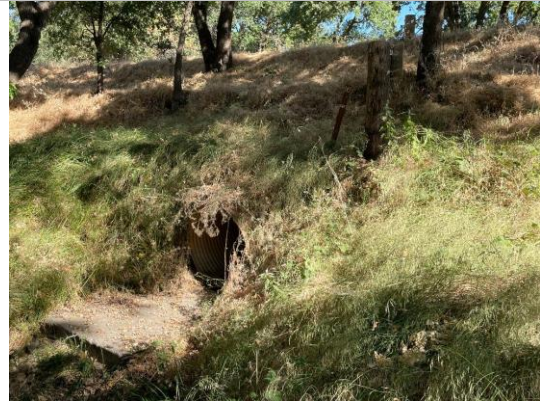
Photo 1 of 3 : UCIP\_FA\_2024\_84440\_124778.jpg

| DS_ID:24571<br>FS_ID:84440<br>EP_NO: N/A<br>Repair Type: No Action Needed<br>EVAL Issue:<br>Crossing Status: Found<br>UCIP Comments: 06/24/2024 Drainage pipes appear to be in good condition, no issues to report. Code 12b removed since this is a system feature. (J. Singh - DWR UCIP 05/29/2019 Drainage structure appears to be in good condition. Crossing evaluated as No Action Needed: Visual and permit documentation requirements have been met. Need to contact owner for maintenance records and internal inspection reports. (A. McDonald - DWR UCIP 10/27/2017 This structure is inspected annually under the Structure and Channel Summer Inspection (part of the Levee Inspection Program) conducted by the DWR Flood Project Integrity and Inspection Branch (FPIIB). (O. Magana - DWR UCIP)<br>FIELD_STRUCT_DESC: [Pumping Plant No. 2: Wilhaggin Storm Drain D-43] 2 of 4: 24-inch concrete drainage pipe through the levee, 17.9 feet below the crown. Pump house on the landside (LS). Flap gate and discharge channel on the waterside (WS). Electric screw gate on the WS shoulder. Large sump basin on the LS. (No permit found with details of 24-inch pipe through the levee. Drainage pipe and sump of Pumping Plant No. 2 authorized under Permit No. 3102, 1959 - County of Sacramento. Electric screw gate authorized under Permit No. 14508, 1987 - County of Sacramento, Water Resources Division). [Additional Reference(s): DWR Levee Log, 2002 (HLM 3.57). USACE Sacramento O&M Manual, Unit 517, Part No. 1, November 1959, (Station 203+45). USACE As-Built Drawing No. 1-4-415, Sheet 415/5, (Station 203+45), February 1957].<br>FS Date: 6/24/2024 4:05:57 PM | | | | | | |

Closer view of culvert on waterside

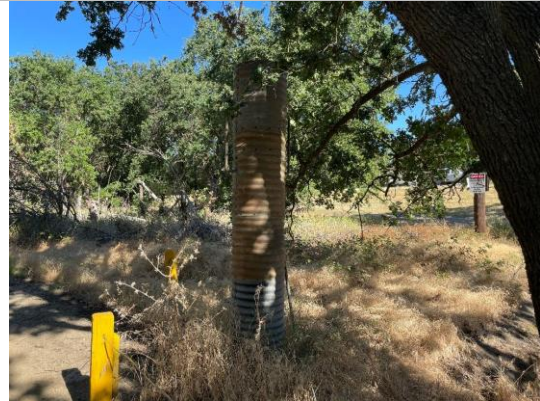
Photo 2 of 3 : UCIP\_FA\_2024\_84440\_124777.jpg

View of CMP riser next to WS drainage ditch

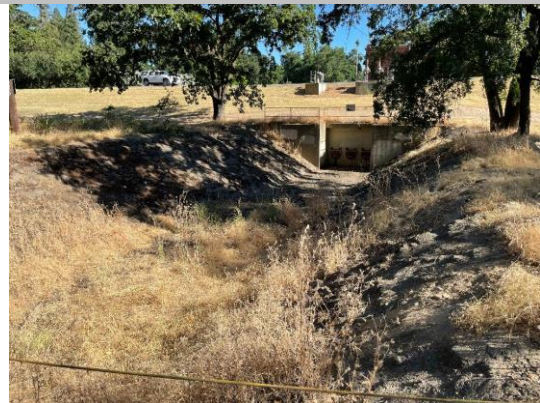
Photo 3 of 3 : UCIP\_FA\_2024\_84440\_124776.jpg

View of waterside drainage ditch and flap gates looking towards the crown

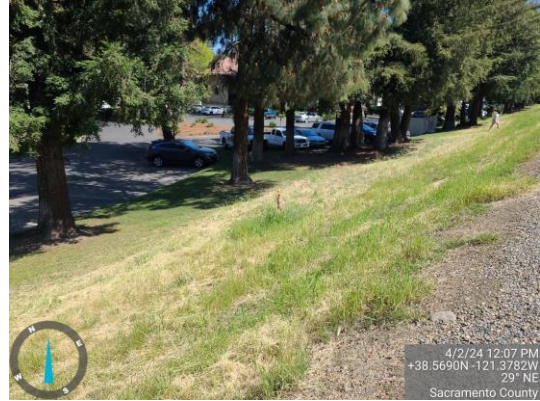
Photo 1 of 1 : FA\_2024\_NA0001\_61\_32\_20240911\_00006.jpg

| Abandoned well not documented. | | | | | |

Abandoned well on the LS slope. Spring 2024
