**Flood Control Project Maintenance
Levee Inspections****LMA District Cover Sheet****Spring 2013 Levee Inspection Results****Brannan Andrus Levee Maintenance District**

Spring 2013 Levee Inspection Results

Brannan Andrus Levee Maintenance District

Levee Inspection Report By Mile - Spring 2013

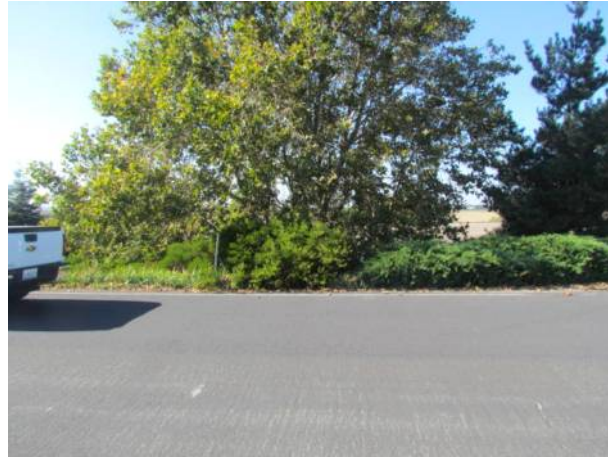
Levee Mile Report Line	20
Start Levee Mile	3.93
End Levee Mile	3.97
Location	Land Side
Category	
Item	Vegetation
Looking west at dense landscape on landside slope.	
richard_s_20130304_009.jpg

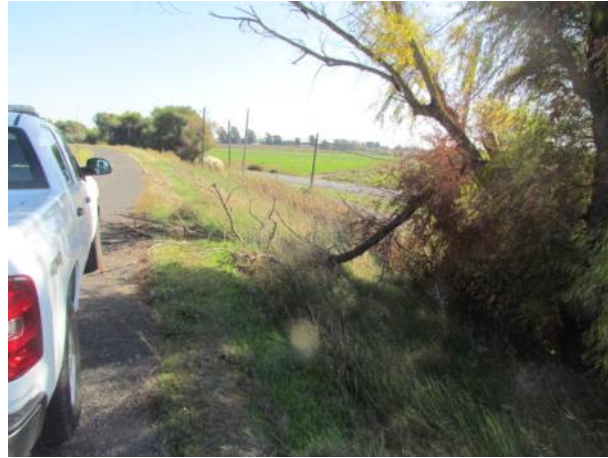
Levee Mile Report Line	30
Start Levee Mile	5.42
End Levee Mile	5.42
Location	Land Side
Category	
Item	Encroachments

Looking southwest downed tree limb on landside slope.

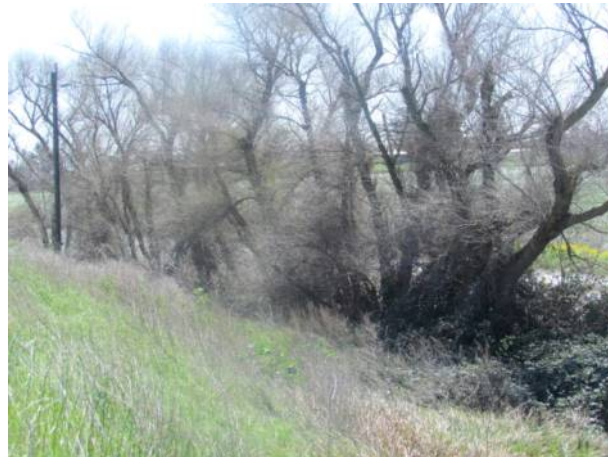
Levee Mile Report Line	31
Start Levee Mile	5.46
End Levee Mile	5.57
Location	Land Side
Category	
Item	Vegetation

Looking south at trees and berry vines and wild rose on landside toe.

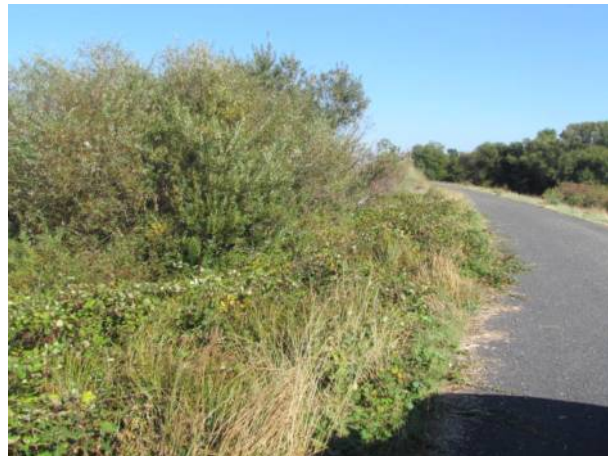
Levee Mile Report Line	32
Start Levee Mile	5.63
End Levee Mile	5.67
Location	Water Side
Category	
Item	Vegetation

Looking south at dense vegetation on waterside slope.

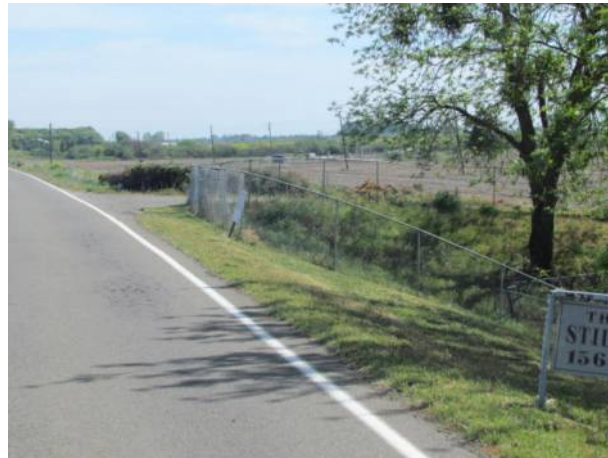
Looking northeast at fence on landward shoulder and slope.

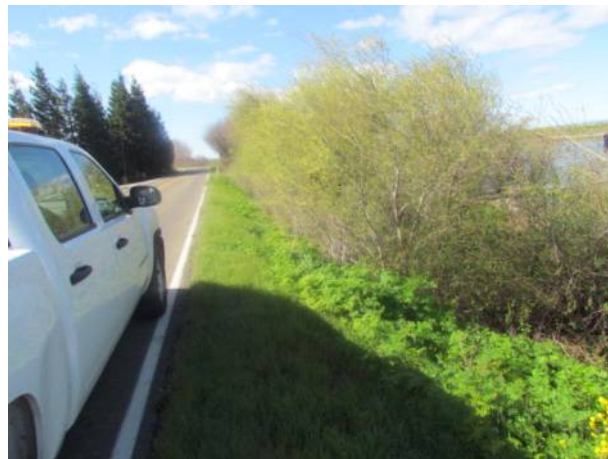
Levee Mile Report Line	5
Start Levee Mile	0.78
End Levee Mile	0.83
Location	Water Side
Category	
Item	Trim / Thin Trees

Looking south at dense vegetation on waterside slope.

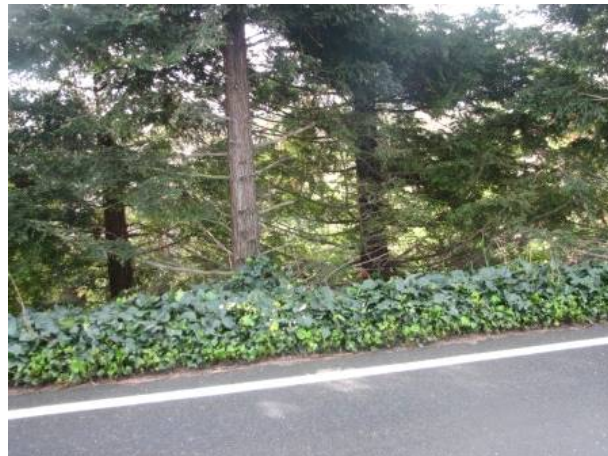
Levee Mile Report Line	6
Start Levee Mile	0.81
End Levee Mile	0.83
Location	Land Side
Category	
Item	Vegetation

Landscaping on landside slope blocking view of slope from LM .81 to 0.83.

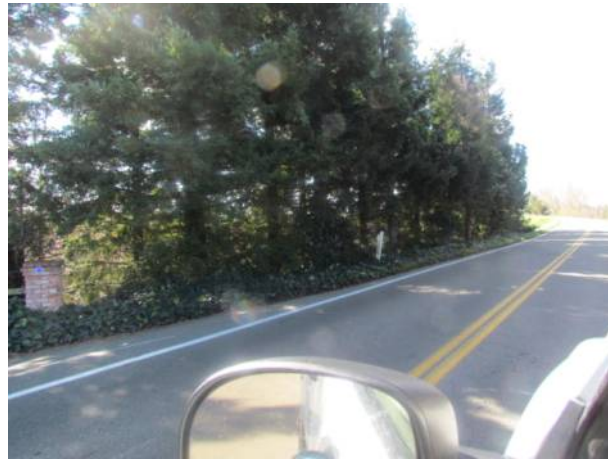
Looking southeast at dense landscaping on landside slope.

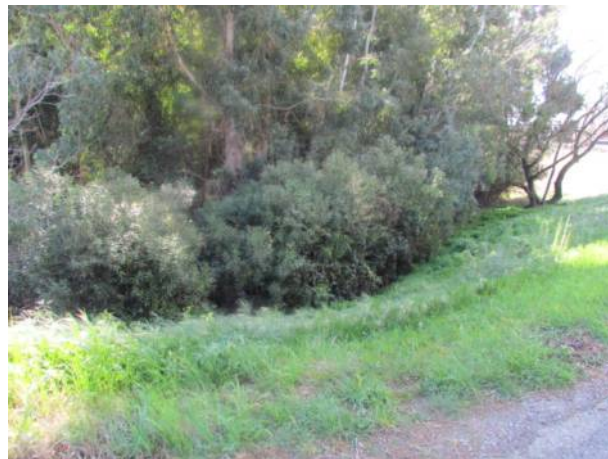
Levee Mile Report Line	7
Start Levee Mile	1.44
End Levee Mile	1.44
Location	Land Side
Category	
Item	Trim / Thin Trees

Looking southeast at dense trees on landside toe.

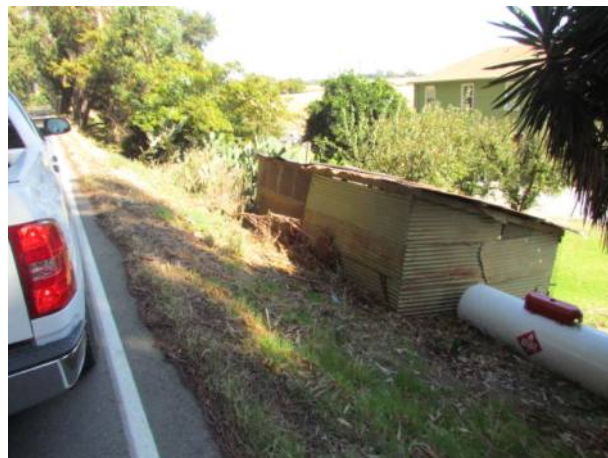
Levee Mile Report Line	12
Start Levee Mile	1.83
End Levee Mile	1.83
Location	Land Side
Category	
Item	Encroachments

Looking northeast pump shed on landside toe.

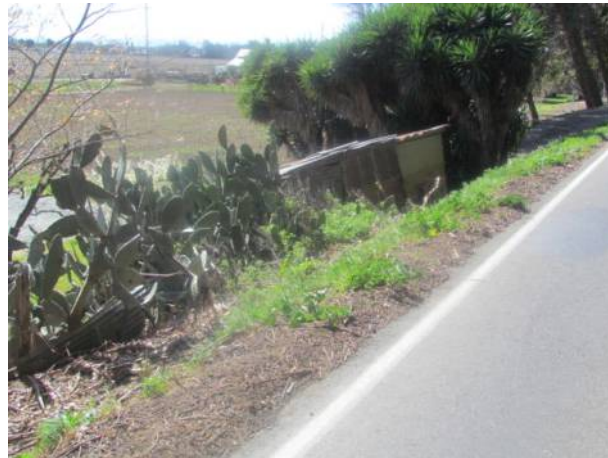
Looking southeast at pump shed and landscaping on landside slope and toe.

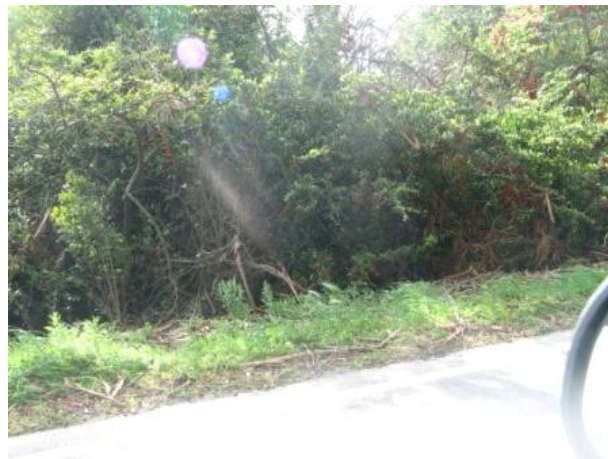
Levee Mile Report Line	14
Start Levee Mile	1.91
End Levee Mile	1.95
Location	Land Side
Category	
Item	Vegetation

Landscaping on landside slope blocking view of slope from LM 1.91 to 1.95.

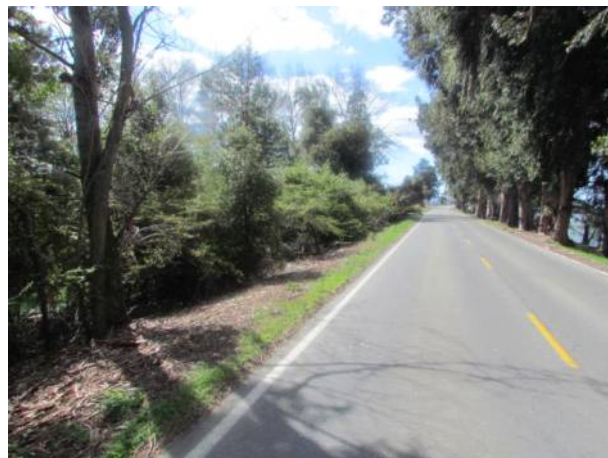
Levee Mile Report Line	14
Start Levee Mile	1.91
End Levee Mile	1.95
Location	Land Side
Category	
Item	Vegetation

Looking south at dense landscaping on landside slope and toe.

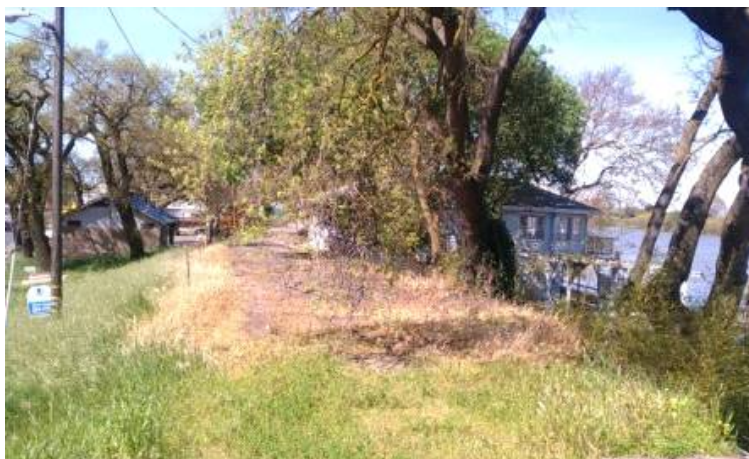
Levee Mile Report Line	20
Start Levee Mile	3.17
End Levee Mile	3.17
Location	Water Side
Category	
Item	Trim / Thin Trees

Looking south at overhanging tree on waterside shoulder.

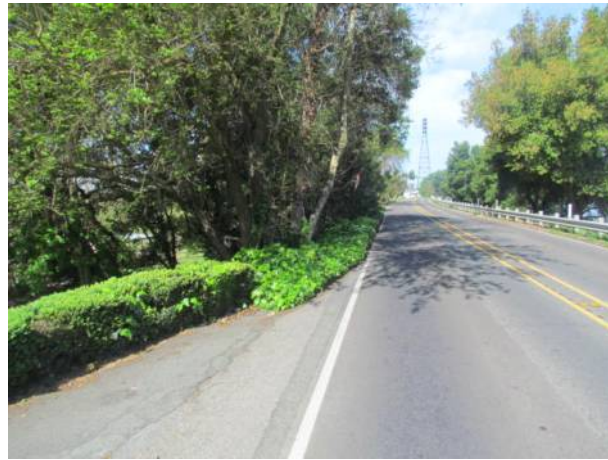
Looking south at dense landscaping on landward slope.

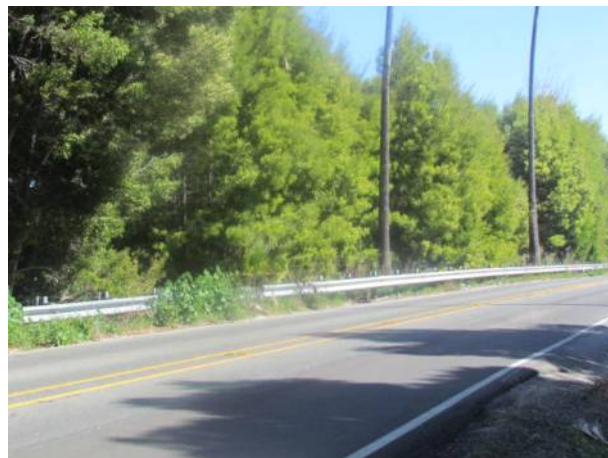
Looking southeast at dense trees on landside slope and toe.

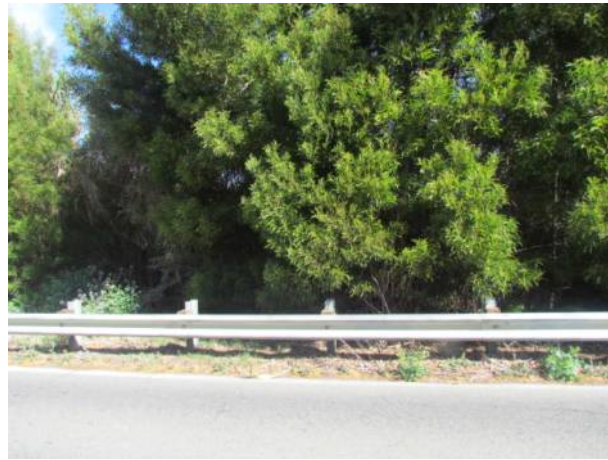
Looking west at dense trees on waterward should and slope.

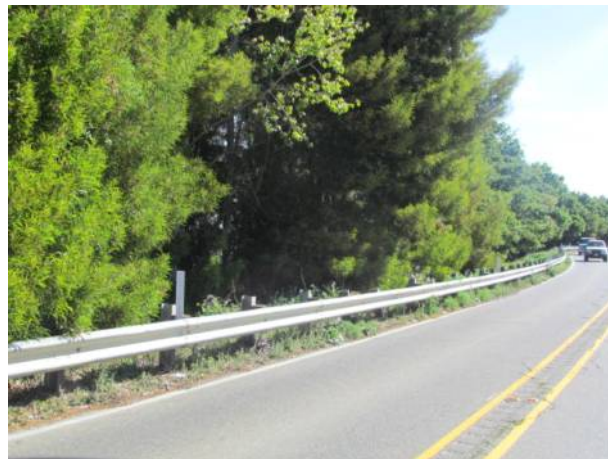
Levee Mile Report Line	30
Start Levee Mile	5.19
End Levee Mile	5.43
Location	Water Side
Category	
Item	Trim / Thin Trees

Looking northwest at dense trees on waterward shoulder and slope.

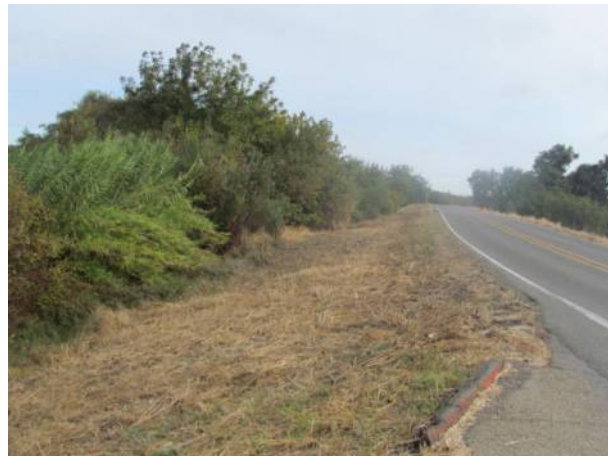
Levee Mile Report Line	32
Start Levee Mile	5.66
End Levee Mile	5.70
Location	Water Side
Category	
Item	Vegetation

Ma								DWR ID: DWR_NA0002_02_s_2012_10		
32	5.66	5.70		Vegetation	WSA/W	U	V2 : Remove the wild growth other than native grasses from the levee slopes.	38.172308 ° -121.651552 °	38.172497 ° -121.652243 °	11 Y
Ma								DWR ID: DWR_NA0002_02_s_2012_11		
33	5.68	5.73	Supplemental	USACE Erosion Survey	WS	M	Inspector Comments: 2009 - Tension cracks on road on top of levee. Erosion into the levee slope with large mass failure scallop. 2010 - Site extended further upstream to account for additional erosion. Very steep slope with slumping. 2012: No observed change. [2012 Site ID: SAC_15-0_L]	38.172580 ° -121.651821 °	38.172733 ° -121.652499 °	21 Y
Ma								DWR ID: DWR_NA0002_02_s_2013_21		
34	5.68	5.71		Trim / Thin Trees	LS	M	T1 : Trim trees to at least five feet above ground level.	38.172388 ° -121.651892 °	38.172512 ° -121.652322 °	36 Y
Ma								DWR ID: DWR_NA0002_02_s_2012_36		
35	5.70	5.70		Encroachments	LS	M	BU : Building	38.172442 ° -121.652182 °	38.172442 ° -121.652182 °	51 Y

Looking northwest at compliant vegetation on waterside slope.

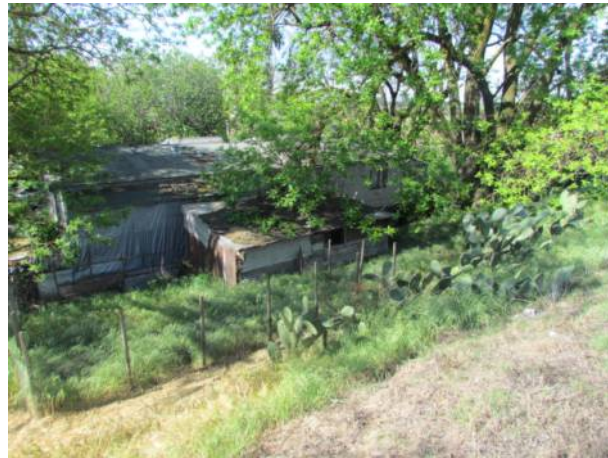
Levee Mile Report Line	35
Start Levee Mile	5.70
End Levee Mile	5.70
Location	Land Side
Category	
Item	Encroachments
Looking east tool shed and animal corral on landward slope and toe.	
richard_s_20130404_050.JPG

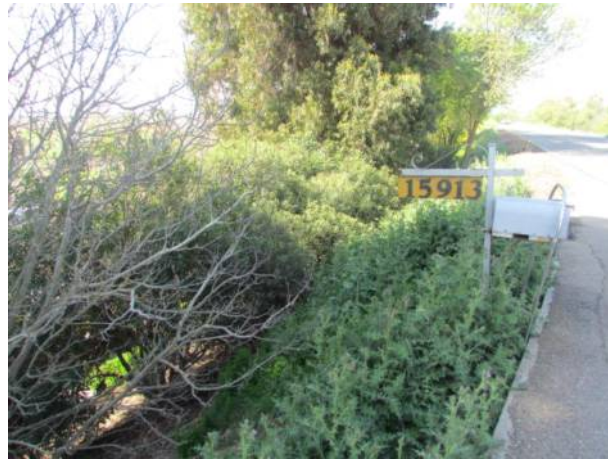
Looking south at dense landscaping on landward slope.

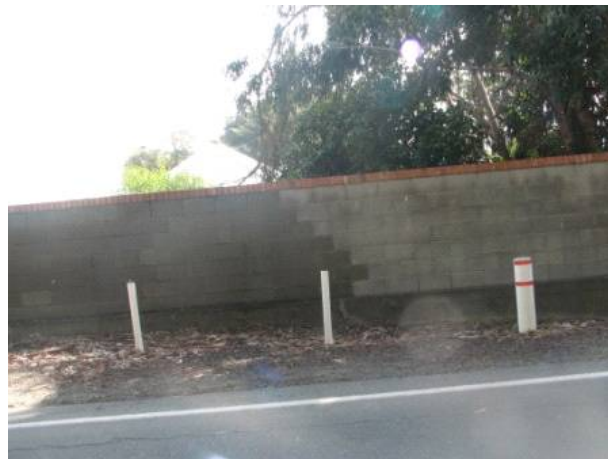
Levee Mile Report Line	40
Start Levee Mile	6.82
End Levee Mile	6.82
Location	Land Side
Category	
Item	Encroachments

Brick wall on landside shoulder at LM 6.82.

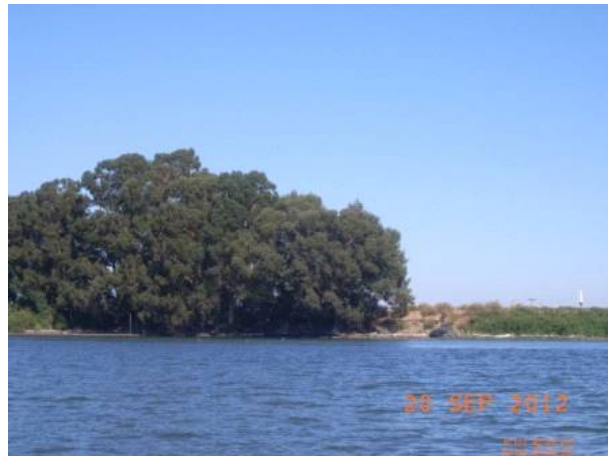
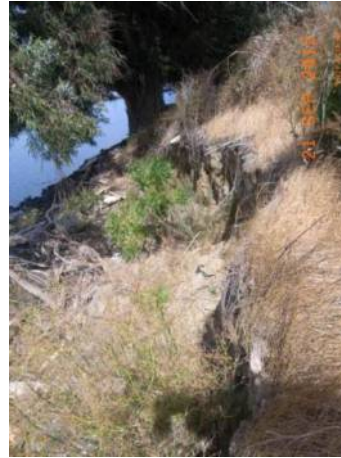
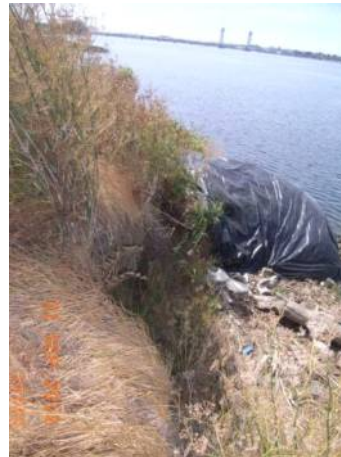
Levee Mile Report Line	41
Start Levee Mile	6.97
End Levee Mile	7.03
Location	Water Side
Category	Supplemental
Item	USACE Erosion Survey

LMR No.	Levee Mile		Category	Item	Location	Rating	Action/Comment	GPS Latitude/Longitude		Issue No.
	Start	End						Start	End	Photo
41	6.97	7.03	Supplemental	USACE Erosion Survey	WS	M Ma	Inspector Comments: 2011 - Large section of bank slumped off. 2012: No observed change. [2012 Site ID: SAC_13-6_L]	38.166583 ° -121.670684 °	38.165794 ° -121.671014 °	23 Y
								DWR ID: DWR_NA0002_02_s_2013_23		
42	7.63	7.63		Trim / Thin Trees	LS	M Ma	T1 : Trim trees to at least five feet above ground level.	38.157930 ° -121.675528 °	38.157930 ° -121.675528 °	49 Y
								DWR ID: DWR_NA0002_02_s_2013_49		
43	7.66	7.66		Encroachments	LS	A/W Ma	PR : Prunings	38.157055 ° -121.675445 °	38.157055 ° -121.675445 °	24 Y
								DWR ID: DWR_NA0002_02_s_2012_24		
44	8.26	8.50	Supplemental	USACE Erosion Survey	WS	M Ma	Inspector Comments: 2010 - Small inlet area behind a man-built spit. Bank is slumping and could possibly be fixed with maintenance. 2011 - Site continues to worsen. 2012: No observed change. [2012 Site ID: SAC_12-1_L]	38.151867 ° -121.682201 °	38.148711 ° -121.682790 °	37 Y

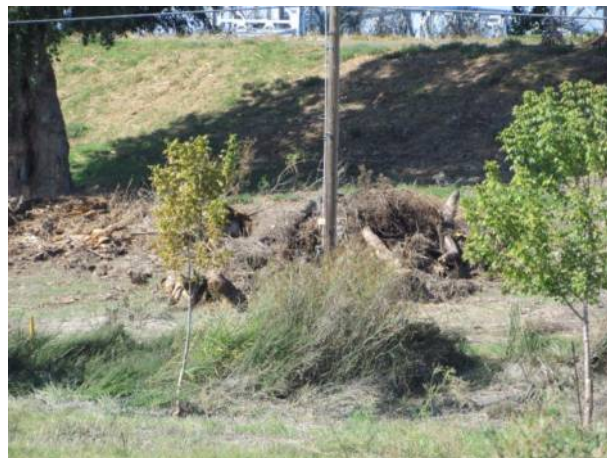
Levee Mile Report Line	43
Start Levee Mile	7.66
End Levee Mile	7.66
Location	Land Side
Category	
Item	Encroachments

Looking west at prunings on landside toe.

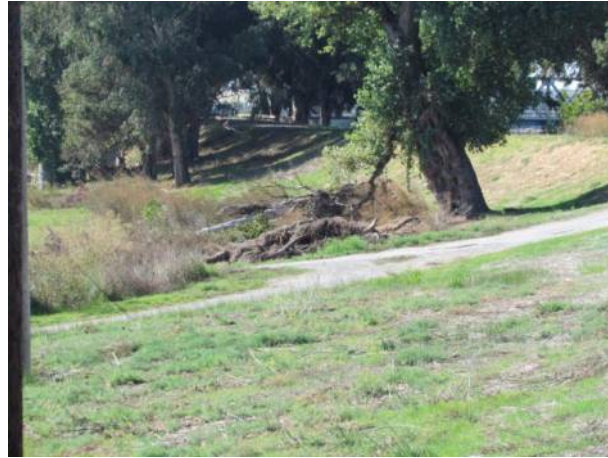
richard_s_20130304_045.jpg

Looking south at prunings on landside toe.

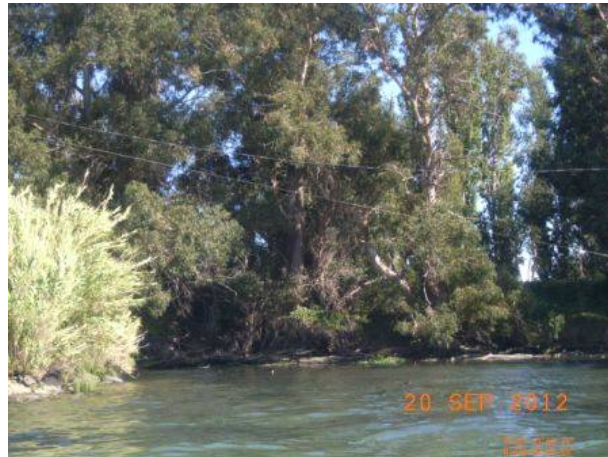
USACE 2012 Photo #1

Levee Mile Report Line	44
Start Levee Mile	8.26
End Levee Mile	8.50
Location	Water Side
Category	Supplemental
Item	USACE Erosion Survey

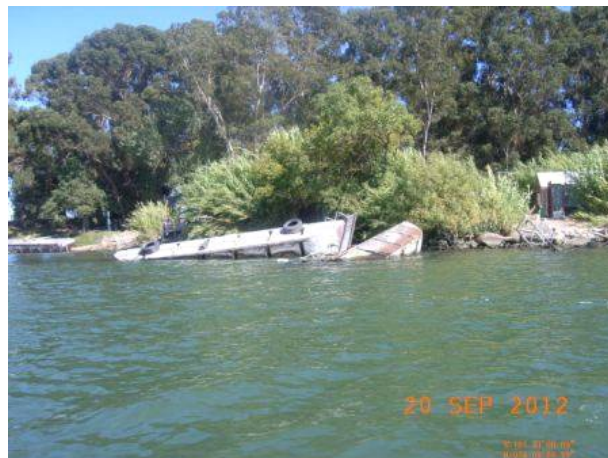
USACE 2012 Photo #2

Levee Mile Report Line	44
Start Levee Mile	8.26
End Levee Mile	8.50
Location	Water Side
Category	Supplemental
Item	USACE Erosion Survey

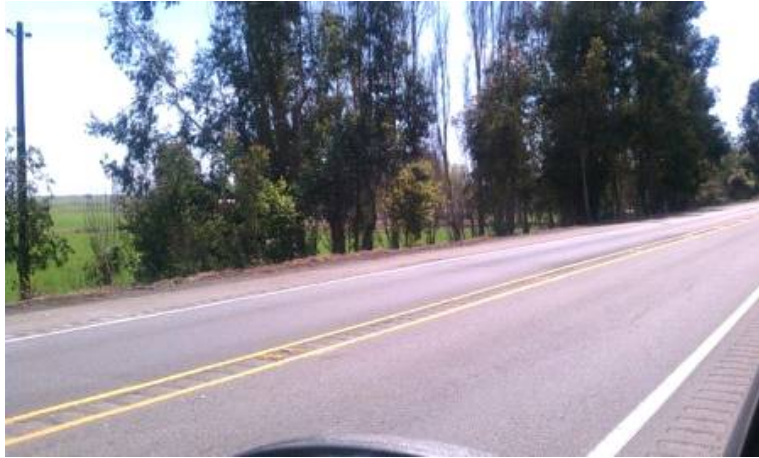
Levee Mile Report Line	45
Start Levee Mile	8.35
End Levee Mile	8.71
Location	Land Side
Category	
Item	Trim / Thin Trees
Looking southeast at trees on landside shoulder and slope.	
richard_s_20130304_058.jpg

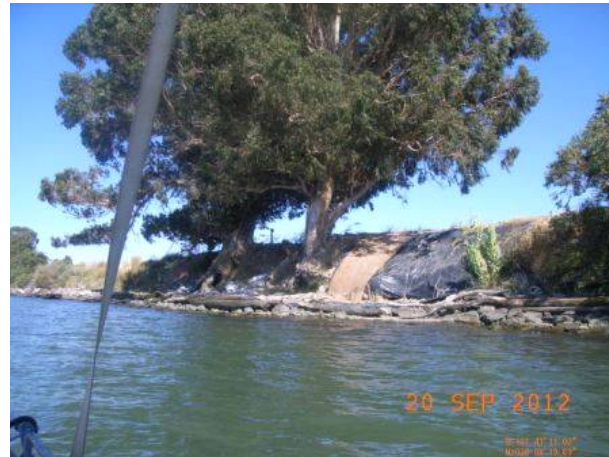
USACE 2012 Photo #2

Levee Mile Report Line	49
Start Levee Mile	8.95
End Levee Mile	9.17
Location	Water Side
Category	Supplemental
Item	USACE Erosion Survey

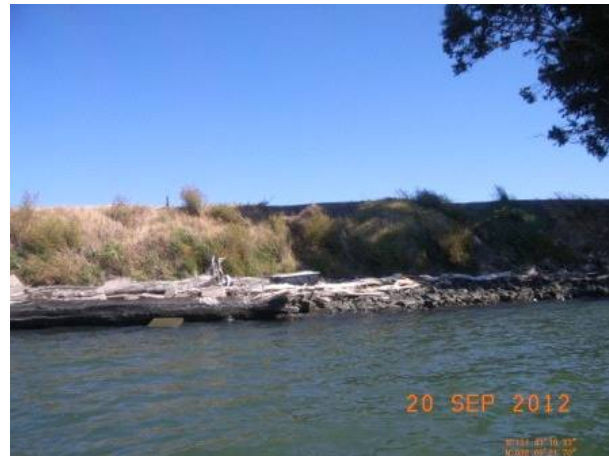
USACE 2012 Photo #3

Levee Mile Report Line	49
Start Levee Mile	8.95
End Levee Mile	9.17
Location	Water Side
Category	Supplemental
Item	USACE Erosion Survey

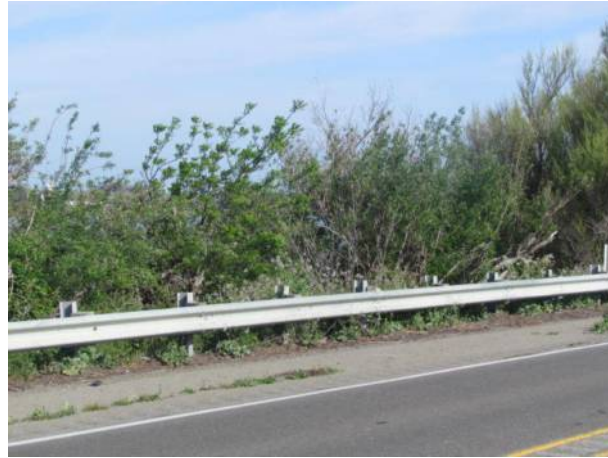
richard_s_20130404_045.JPG

Looking west at dense vegetation on waterward shoulder and slope.
