**Flood Control Project Maintenance
Levee Inspections**
LMA District Cover Sheet
Spring 2014 Levee Inspection Results

Brannan Andrus Levee Maintenance District

Spring 2014 Levee Inspection Results

Waterway		Bank	Unit Miles
Unit No. 01 Georgiana Slough		Right	6.02

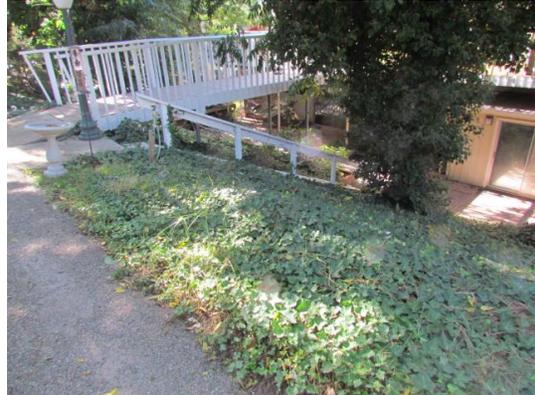
Photo 2 of 4 : richard_s_20140318_491.jpg

LM Start	2.29	Rating **	U	Issue No.	36 (cont)
LM End	2.34	Issue Type +	En	Location *	LS
Category	Earthen Levee			GPS Latitude/Longitude	
				Start	End
Item	Vegetation			38.162918 °	38.162322 °
				-121.584721 °	-121.585081 °
DWR ID	DWR_NA0002_01_s_2012_36				
Action/Comments					
Landscaping

Looking west at ground cover on landside slope.

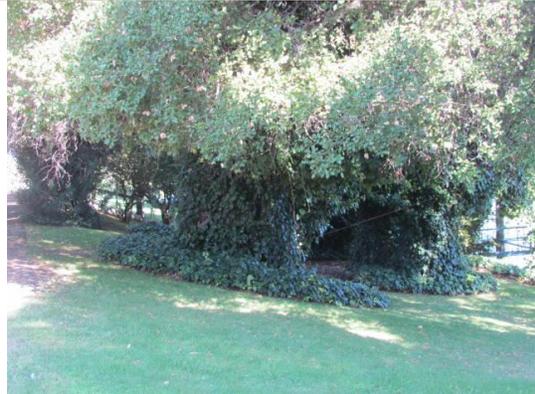
Photo 3 of 4 : richard_s_20140318_492.jpg

Looking north at dense vegetation on waterside slope.

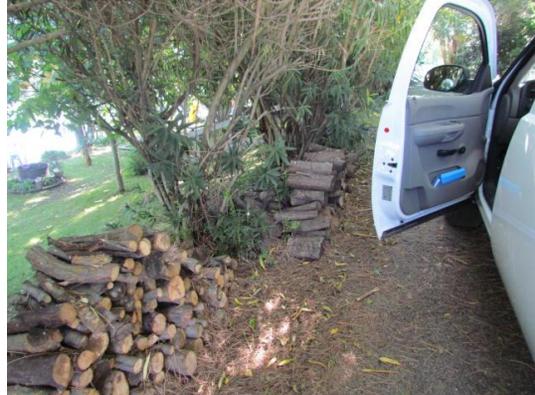
Photo 1 of 3 : richard_s_20140318_470.jpg

LM Start	2.30	Rating **	M	Issue No.	3
LM End	2.30	Issue Type +	Ma	Location *	WS
Category	Earthen Levee		GPS Latitude/Longitude		
			Start	End	
Item	Encroachments		38.162773 °	38.162773 °	
			-121.584767 °	-121.584767 °	
DWR ID	DWR_NA0002_01_s_2012_3				
Action/Comments					
Firewood

Looking east at firewood on waterside shoulder.

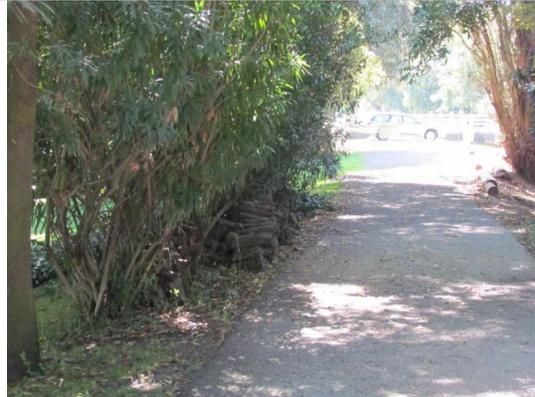
Photo 2 of 3 : richard_s_20140318_471.jpg

Looking south at firewood on waterside shoulder.

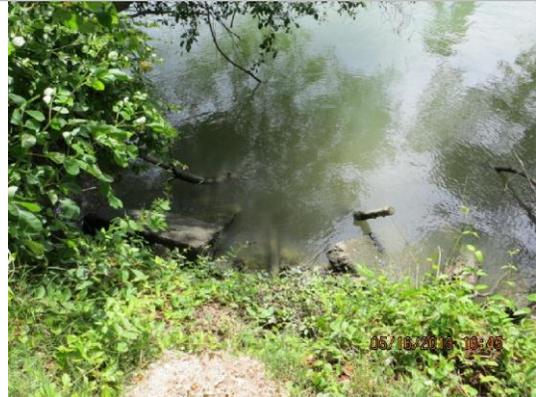
Photo 1 of 1 : UCIP_1411.jpg

LM Start	2.34	Rating **	M	Issue No.	41
LM End	2.34	Issue Type +	En	Location *	WS
Category	Supplemental			GPS Latitude/Longitude	
				Start	End
Item	DWR UCIP Field Study			38.162332 °	38.162332 °
				-121.585032 °	-121.585032 °
DWR ID	DWR_NA0002_01_s_2014_41				
Action/Comments					
Inspector Comments: FS_ID:16123

Pipe visible in water at WS toe.

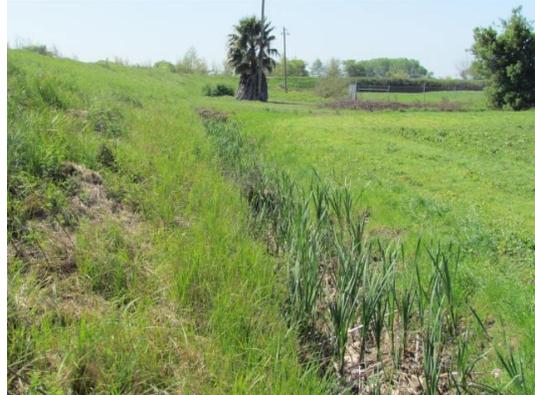
Photo 1 of 3 : richard_s_20140328_487.jpg

LM Start	2.43	Rating **	M	Issue No.	56
LM End	2.58	Issue Type +	En	Location *	LS
Category	Earthen Levee		GPS Latitude/Longitude		
			Start	End	
Item	Encroachments			o	o
				o	o
DWR ID	DWR_NA0002_01_s_2014_56				
Action/Comments					
Ditch Inspector Comments: Ditch has been in place for several year. Ditch should be removed from within fifteen feet of landward toe.

Looking south at ditch within fifteen feet of landward toe.

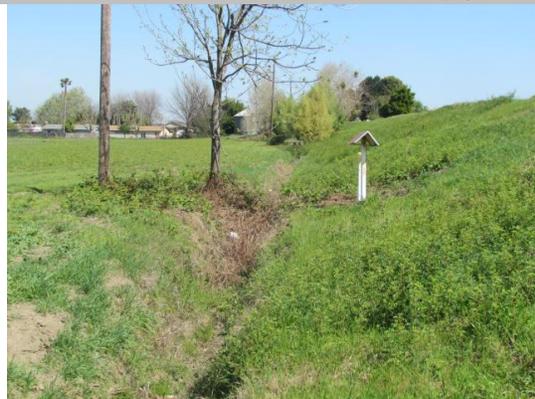
Photo 2 of 3 : richard_s_20140328_488.jpg

Looking north at ditch within fifteen feet of landward toe.

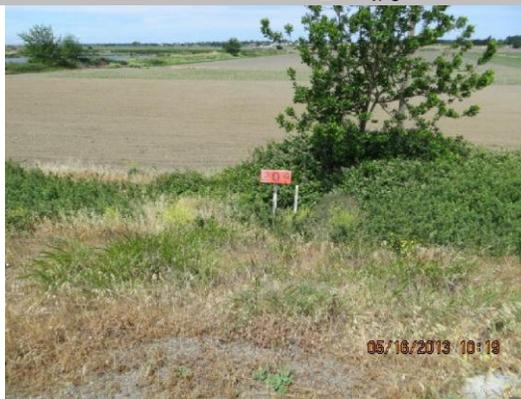
Photo 1 of 1 : UCIP_875.jpg

LM Start	2.54	Rating **	M	Issue No.	43
LM End	2.54	Issue Type +	En	Location *	LS
Category	Supplemental			GPS Latitude/Longitude	
				Start	End
Item	DWR UCIP Field Study			38.159569 °	38.159569 °
				-121.586339 °	-121.586339 °
DWR ID	DWR_NA0002_01_s_2014_43				
Action/Comments					
Inspector Comments: FS_ID:13525 EP_NO: 17250 Repair Type: Crossing Status: UCIP Comments: Needs better location markers. FIELD_STRUCT_DESC: 24-inch steel natural-gas pipeline through the levee 117-feet below the crown (Permit No. 17250, 2001). Possible sign on LS toe. FS Date: 5/16/2013

Gasline marker on LS toe.

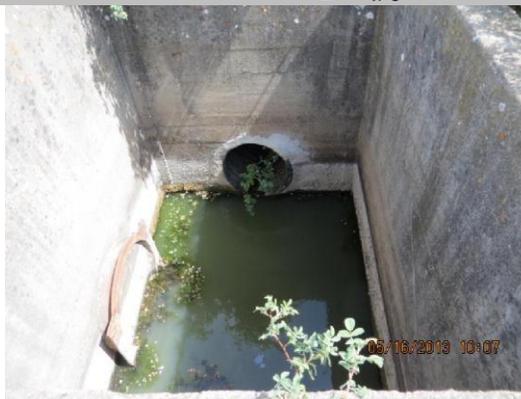
Photo 1 of 1 : UCIP_870.jpg

LM Start	2.60	Rating **	M	Issue No.	44
LM End	2.60	Issue Type +	En	Location *	LS
Category	Supplemental			GPS Latitude/Longitude	
				Start	End
Item	DWR UCIP Field Study			38.158683 °	38.158683 °
				-121.586784 °	-121.586784 °
DWR ID	DWR_NA0002_01_s_2014_44				
Action/Comments					
Inspector Comments: FS_ID:13524 EP_NO: 11238 Repair Type: Crossing Status: UCIP Comments: Erosion along pipe at WS toe goes into levee prism. Animal activity appears to be the cause of some pretty heavy erosion damage. Some settlement along the pipe alignment on crown may indicate other problems with this pipe. FIELD_STRUCT_DESC: 1 of 5: 12-inch steel pipe through levee 4.0 feet below crown. Siphon breaker on landward shoulder. 7X9-foot concrete distribution box on LS toe (ABO No. 11238, 1975). Originally included in the 1954 O&M manual. (pipe replaced under Permit No. 18549 7/11/2009). FS Date: 5/16/2013

Concrete distribution box on LS toe.

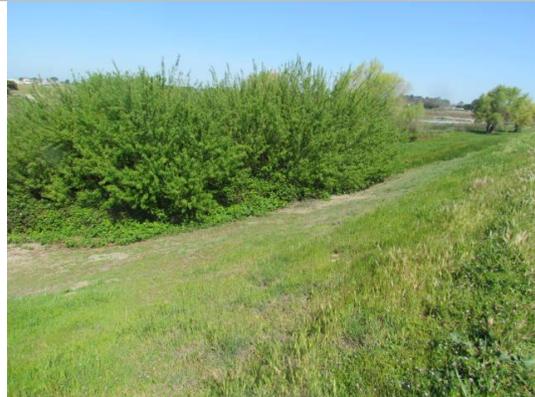
Photo 1 of 1 : richard_s_20140328_490.jpg

LM Start	3.00	Rating **	U	Issue No.	55
LM End	3.00	Issue Type +	Ma	Location *	LS
Category	Earthen Levee		GPS Latitude/Longitude		
			Start	End	
Item	Vegetation			°	°
				°	°
DWR ID	DWR_NA0002_01_s_2014_55				
Action/Comments					
Remove the wild growth other than native grasses from the levee slopes. Inspector Comments: Dense vegetation on landward toe.

Looking north at dense vegetation within fifteen feet of landward toe.

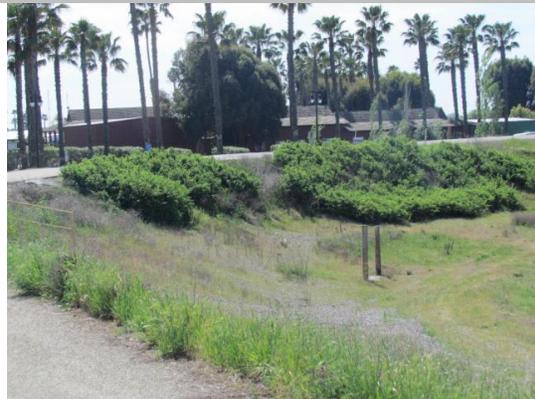
Photo 1 of 1 : richard_s_20140318_489.jpg

LM Start	3.32	Rating **	A/W	Issue No.	29
LM End	3.35	Issue Type +	Ma	Location *	LS
Category	Earthen Levee		GPS Latitude/Longitude		
			Start	End	
Item	Vegetation		38.152052 °	38.151683 °	
			-121.591500 °	-121.591662 °	
DWR ID	DWR_NA0002_01_s_2013_29				
Action/Comments					
Remove the wild growth other than native grasses from the levee slopes. Inspector Comments: Wild roses on landside slope.

Looking south at wild roses on landward slope and toe.

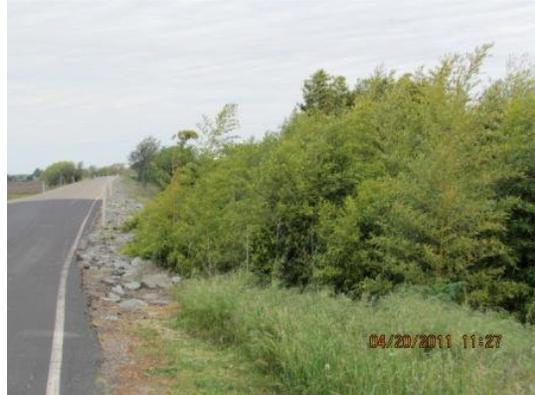
Photo 1 of 3 : richard_s_20140318_476.jpg

LM Start	3.93	Rating **	A/W	Issue No.	10
LM End	3.93	Issue Type +	Ma	Location *	WS
Category	Earthen Levee			GPS Latitude/Longitude	
				Start	End
Item	Vegetation			38.148379 °	38.148379 °
				-121.599970 °	-121.599970 °
DWR ID	DWR_NA0002_01_s_2012_10				
Action/Comments					
Remove the wild growth other than native grasses from the levee slopes.

Looking west at dense vegetation on waterside slope.

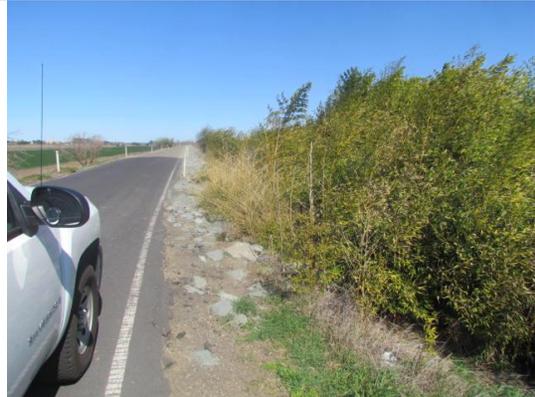
Photo 2 of 3 : richard_s_20140318_477.jpg

Looking west at dense vegetation on waterside slope spring 2012.

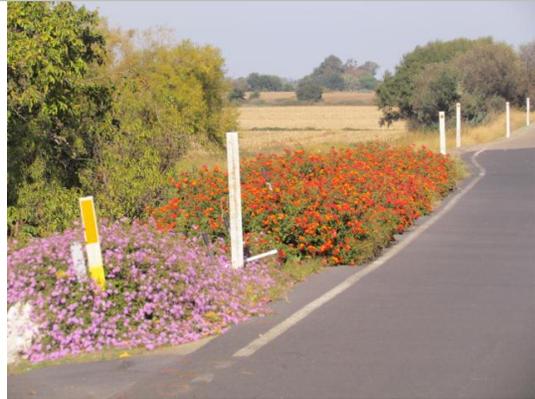
Photo 1 of 3 : richard_s_20140318_479.jpg

LM Start	3.93	Rating **	U	Issue No.	11
LM End	3.97	Issue Type +	En	Location *	LS
Category	Earthen Levee		GPS Latitude/Longitude		
			Start	End	
Item	Vegetation		38.148318 °	38.147898 °	
			-121.599947 °	-121.600347 °	
DWR ID	DWR_NA0002_01_s_2012_11				
Action/Comments					
Landscaping

Looking northeast at landscaping on landside slope.

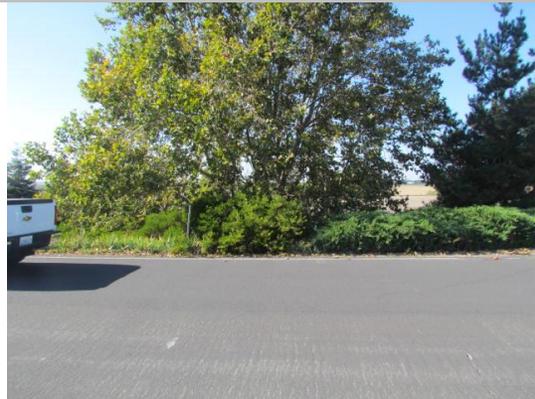
Photo 2 of 3 : richard_s_20140318_480.jpg

Looking west at dense landscaping on landside slope.

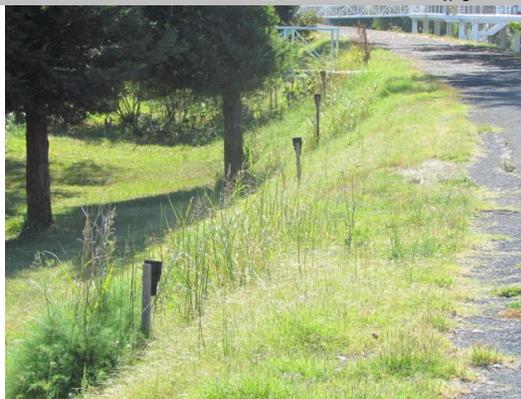
Photo 1 of 1 : richard_s_20140318_483.jpg

LM Start	4.22	Rating **	M	Issue No.	20
LM End	4.28	Issue Type +	En	Location *	WS
Category	Earthen Levee		GPS Latitude/Longitude		
			Start	End	
Item	Encroachments		38.144471 °	38.143652 °	
			-121.601381 °	-121.600877 °	
DWR ID	DWR_NA0002_01_f_2013_20				
Action/Comments					
Landscape Irrigation Inspector Comments: Sprinkler system on waterside of levee.

Looking south at a sprinkler system on waterward slope.

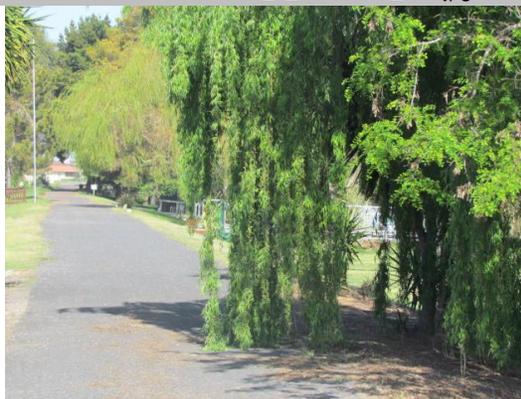
Photo 1 of 1 : richard_s_20140328_491.jpg

LM Start	5.17	Rating **	M	Issue No.	31
LM End	5.17	Issue Type +	Ma	Location *	WS
Category	Earthen Levee		GPS Latitude/Longitude		
			Start	End	
Item	Trim / Thin Trees		38.133145 °	38.133145 °	
			-121.591895 °	-121.591895 °	
DWR ID	DWR_NA0002_01_s_2013_31				
Action/Comments					
Trim trees over roadway to at least 12 feet above ground level.

Looking north at overhanging tree limbs on landward shoulder.

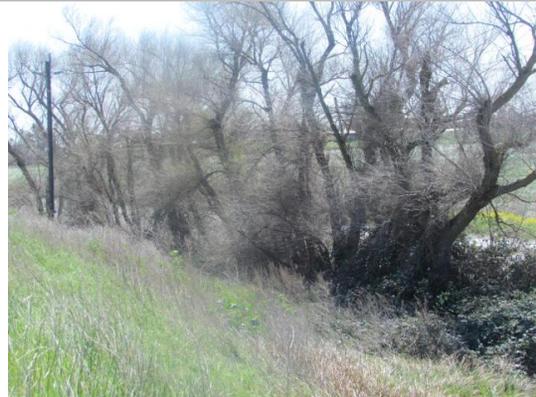
Photo 1 of 3 : richard_s_20140318_484.jpg

LM Start	5.46	Rating **	M	Issue No.	23
LM End	5.57	Issue Type +	Ma	Location *	LS
Category	Earthen Levee		GPS Latitude/Longitude		
			Start	End	
Item	Vegetation		38.129810 °	38.129325 °	
			-121.588218 °	-121.586448 °	
DWR ID	DWR_NA0002_01_s_2012_23				
Action/Comments					
Remove the wild growth other than native grasses from the levee slopes. Inspector Comments: Remove vegetation at landside toe.

Looking south at trees, berry vines, and wild rose on landside toe.

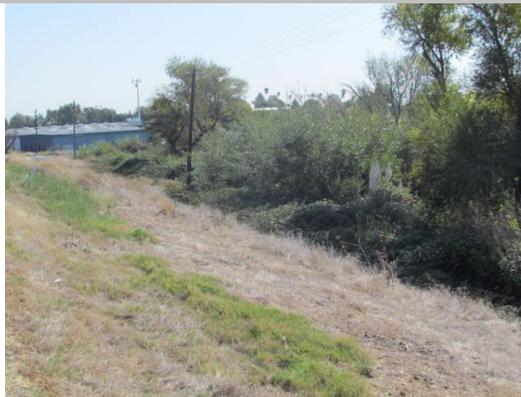
Photo 3 of 3 : richard_s_20140318_486.jpg

LM Start	5.46	Rating **	M	Issue No.	23 (cont)
LM End	5.57	Issue Type +	Ma	Location *	LS
Category	Earthen Levee		GPS Latitude/Longitude		
			Start	End	
Item	Vegetation		38.129810 °	38.129325 °	
			-121.588218 °	-121.586448 °	
DWR ID	DWR_NA0002_01_s_2012_23				
Action/Comments					
Remove the wild growth other than native grasses from the levee

Looking east at dense vegetation on landward toe.

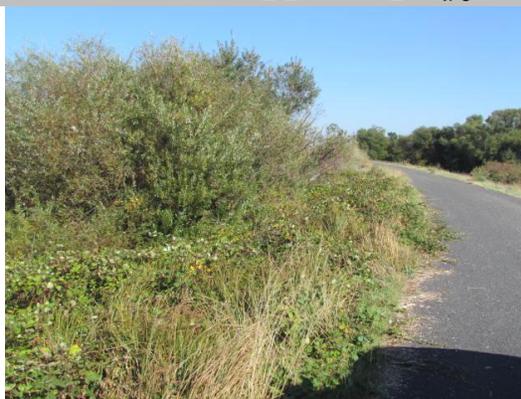
Photo 1 of 1 : richard_s_20140318_482.jpg

LM Start	5.64	Rating **	M	Issue No.	18
LM End	5.67	Issue Type +	Ma	Location *	WS
Category	Earthen Levee		GPS Latitude/Longitude		
			Start	End	
Item	Vegetation		38.129240 °	38.129252 °	
			-121.585328 °	-121.584723 °	
DWR ID	DWR_NA0002_01_s_2012_18				
Action/Comments					
Remove the wild growth other than native grasses from the levee slopes. Inspector Comments: Wild roses or berry vines on waterside slope.

Looking south at dense vegetation on waterside slope.

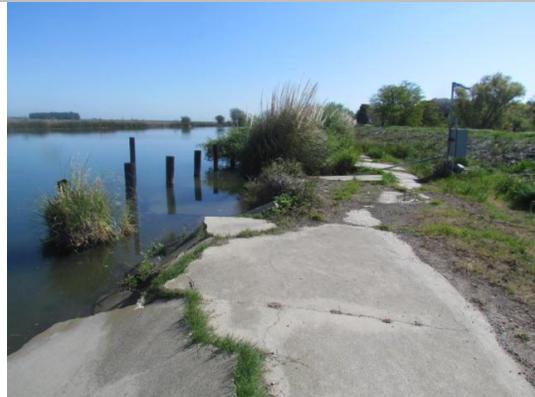
Photo 2 of 4 : richard_s_20140328_493.jpg

LM Start	5.72	Rating **	M	Issue No.	53
LM End	5.72	Issue Type +	Ma	Location *	WS
Category	Earthen Levee		GPS Latitude/Longitude		
			Start	End	
Item	Encroachments			o	o
				o	o
DWR ID	DWR_NA0002_01_s_2014_53				
Action/Comments					
Material					
Inspector Comments: Concrete slabs on water ward berm area. Possible undermining slab should be removed or broken up in place to meet Title 23 standard for Rip Rap.

Looking south at collapse concrete slab on waterward berm.

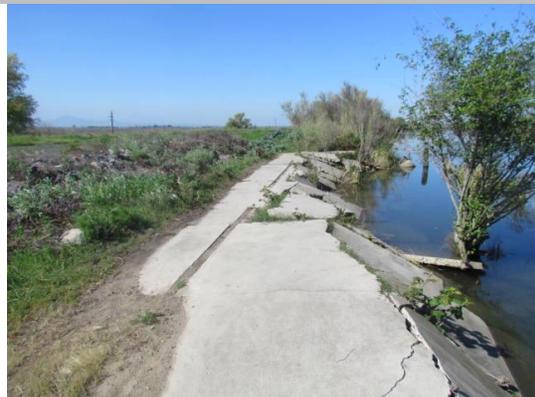
Photo 3 of 4 : richard_s_20140328_494.jpg

Looking north at collapse concrete slab on waterward berm.

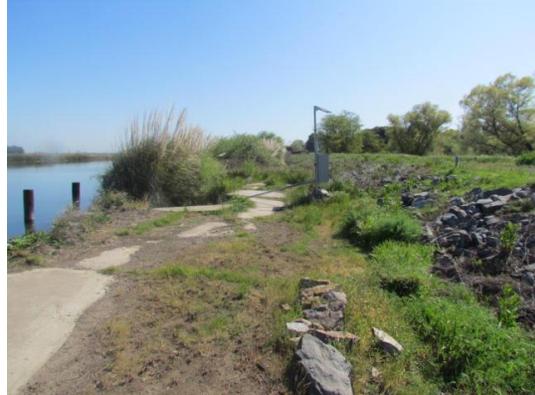
Photo 4 of 4 : richard_s_20140328_495.jpg

LM Start	5.72	Rating **	M	Issue No.	53 (cont)
LM End	5.72	Issue Type +	Ma	Location *	WS
Category	Earthen Levee		GPS Latitude/Longitude		
			Start	End	
Item	Encroachments			°	°
				°	°
DWR ID	DWR_NA0002_01_s_2014_53				
Action/Comments					
Material

Looking south at south end of concrete slab on waterward berm.

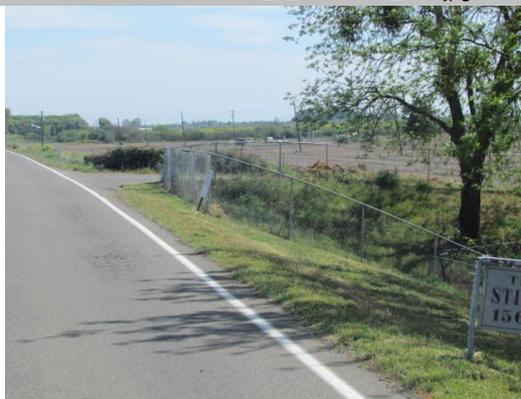
Photo 1 of 1 : richard_s_20140318_539.jpg

LM Start	0.42	Rating **	M	Issue No.	26
LM End	0.42	Issue Type +	En	Location *	LS
Category	Earthen Levee		GPS Latitude/Longitude		
			Start	End	
Item	Encroachments		38.189212 °	38.189212 °	
			-121.574757 °	-121.574757 °	
DWR ID	DWR_NA0002_02_s_2012_26				
Action/Comments					
Fence

Looking northeast at fence on landward shoulder and slope.

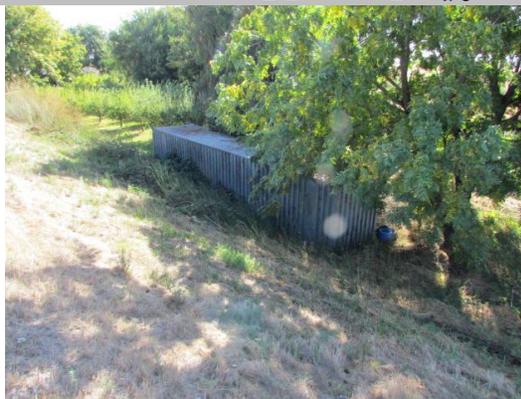
Photo 1 of 1 : richard_s_20140318_549.jpg

LM Start	0.48	Rating **	M	Issue No.	39
LM End	0.48	Issue Type +	En	Location *	LS
Category	Earthen Levee		GPS Latitude/Longitude		
			Start	End	
Item	Encroachments		38.188872 °	38.188872 °	
			-121.575775 °	-121.575775 °	
DWR ID	DWR_NA0002_02_f_2013_39				
Action/Comments					
Building Inspector Comments: Storage container at landward toe.

Looking east at storage container at landward toe.

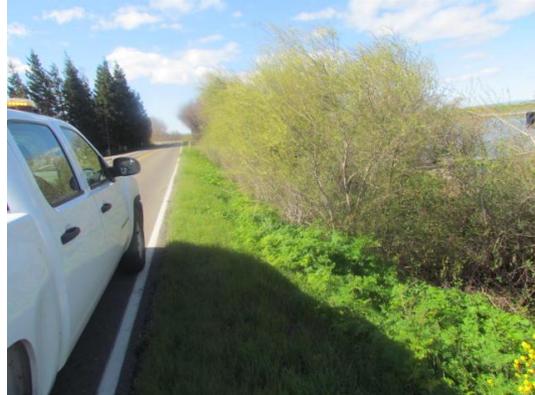
Photo 1 of 2 : richard_s_20140318_508.jpg

LM Start	0.78	Rating **	U	Issue No.	2
LM End	0.83	Issue Type +	Ma	Location *	WS
Category	Earthen Levee		GPS Latitude/Longitude		
			Start	End	
Item	Trim / Thin Trees		38.186535 °	38.186103 °	
			-121.580395 °	-121.581127 °	
DWR ID	DWR_NA0002_02_s_2012_2				
Action/Comments					
Trim trees to at least five feet above ground level.

Looking south at dense vegetation on waterside slope.

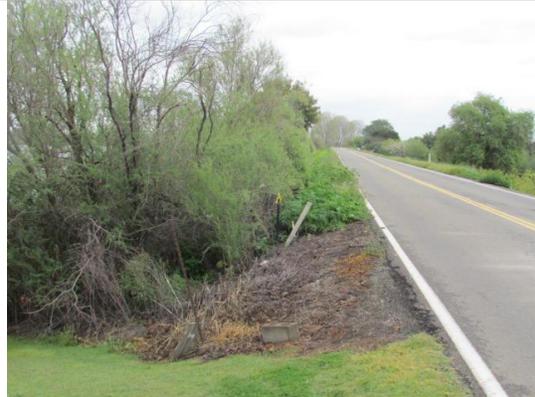
Photo 2 of 2 : richard_s_20140328_497.jpg

LM Start	0.78	Rating **	U	Issue No.	2 (cont)
LM End	0.83	Issue Type +	Ma	Location *	WS

Looking north at dense vegetation on waterward slope.

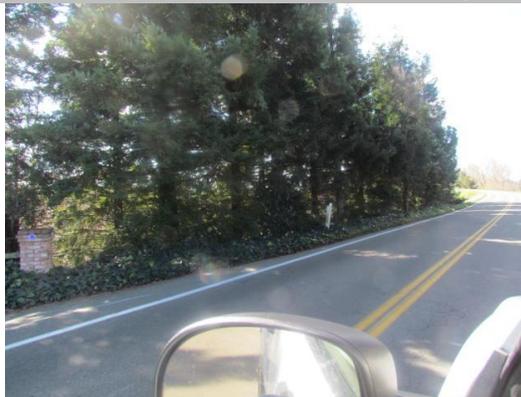
Photo 2 of 2 : richard_s_20140318_511.jpg

LM Start	0.81	Rating **	M	Issue No.	8 (cont)
LM End	0.83	Issue Type +	En	Location *	LS
Category	Earthen Levee			GPS Latitude/Longitude	
				Start	End
Item	Vegetation			38.186455 °	38.186215 °
				-121.580712 °	-121.581060 °
DWR ID	DWR_NA0002_02_s_2012_8				
Action/Comments					
Landscaping

Looking southeast at dense landscaping on landside slope.

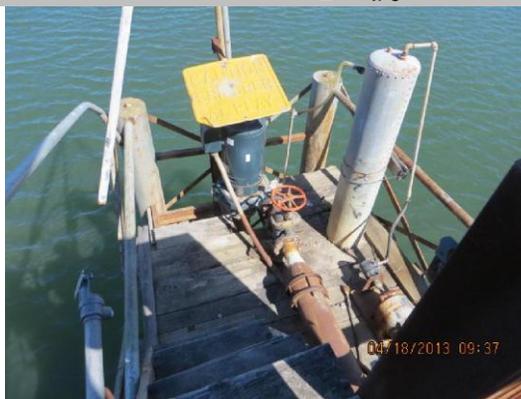
Photo 1 of 1 : UCIP_541.jpg

LM Start	0.82	Rating **	M	Issue No.	34
LM End	0.82	Issue Type +	En	Location *	LS
Category	Supplemental			GPS Latitude/Longitude	
				Start	End
Item	DWR UCIP Field Study			38.186199 °	38.186199 °
				-121.580968 °	-121.580968 °
DWR ID	DWR_NA0002_02_s_2014_34				
Action/Comments					
Inspector Comments: FS_ID:12164 EP_NO: 1173 Repair Type: Crossing Status: UCIP Comments: Several patches on pipe, walkway in disrepair and 24-inch standpipe for siphon breaker on LS slope has been dislodged from the LS slope and rests at LS toe. Pipe appears to be failing at multiple places due to corrosion. FIELD_STRUCT_DESC: 2 of 4: 12-inch pipe through levee 7.0 feet below the crown. Pump on pile structure with a walkway in the river. Siphon breaker in 24-inch CMP riser on LS slope with a 7X9-foot concrete distribution box on LS toe. Service pole on the landward slope with a 1.5-inch galvanized iron electrical conduit at the same location. (Permit No. 1173, 1947). Included in the 1954 O&M manual. FS Date: 4/18/2013

Pump and slide gate on WS pier.

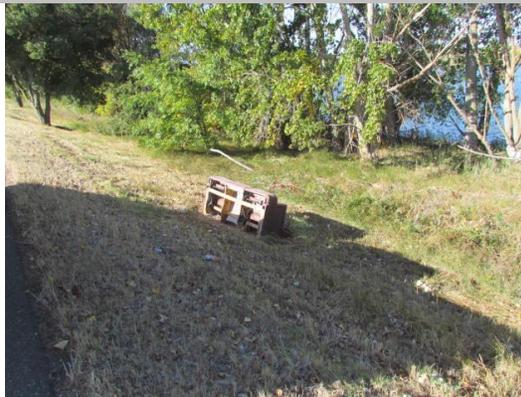
Photo 1 of 1 : richard_s_20140318_550.jpg

LM Start	1.16	Rating **	M	Issue No.	41
LM End	1.16	Issue Type +	Ma	Location *	WS
Category	Earthen Levee			GPS Latitude/Longitude	
				Start	End
Item	Encroachments			38.182465 °	38.182465 °
				-121.584957 °	-121.584957 °
DWR ID	DWR_NA0002_02_f_2013_41				
Action/Comments					
Garbage Inspector Comments: Trash (sofa) on waterward slope.

Looking southwest at garbage on waterward slope and toe.

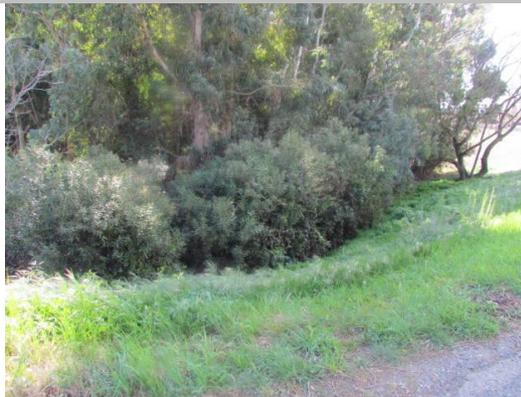
Photo 1 of 2 : richard_s_20140318_540.jpg

LM Start	1.44	Rating **	M	Issue No.	27
LM End	1.44	Issue Type +	En	Location *	LS
Category	Earthen Levee		GPS Latitude/Longitude		
			Start	End	
Item	Trim / Thin Trees		38.178950 °	38.178950 °	
			-121.587717 °	-121.587717 °	
DWR ID	DWR_NA0002_02_s_2012_27				
Action/Comments					
Trim trees to at least five feet above ground level. Inspector Comments: Dense vegetation should be trimmed back fifteen feet from landward toe.

Looking southeast at dense trees on landside toe.

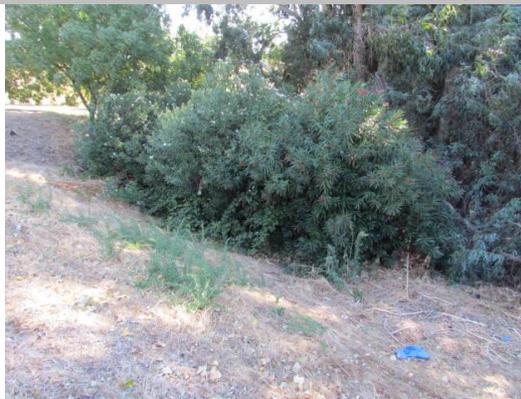
Photo 2 of 2 : richard_s_20140318_541.jpg

LM Start	1.44	Rating **	M	Issue No.	27 (cont)
LM End	1.44	Issue Type +	En	Location *	LS

Looking northeast at dense vegetation on landward toe.

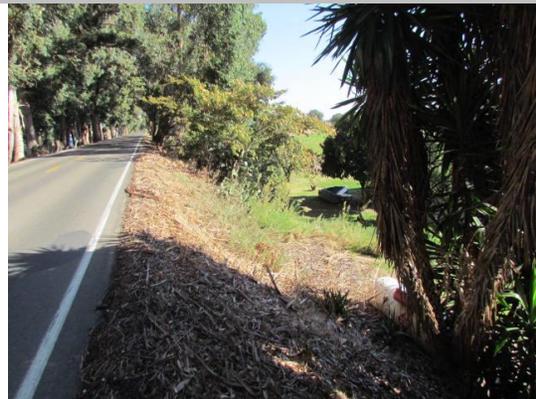
Photo 1 of 2 : richard_s_20140318_553.jpg

LM Start	1.80	Rating **	U	Issue No.	45
LM End	1.82	Issue Type +	Ma	Location *	LS
Category	Earthen Levee		GPS Latitude/Longitude		
			Start	End	
Item	Vegetation		38.174437 °	38.174153 °	
			-121.590786 °	-121.590980 °	
DWR ID	DWR_NA0002_02_f_2013_45				
Action/Comments					
Remove the wild growth other than native grasses from the levee slopes. Inspector Comments: Dense vegetation on landward slope and toe

Looking north at dense vegetation on landward slope and toe.

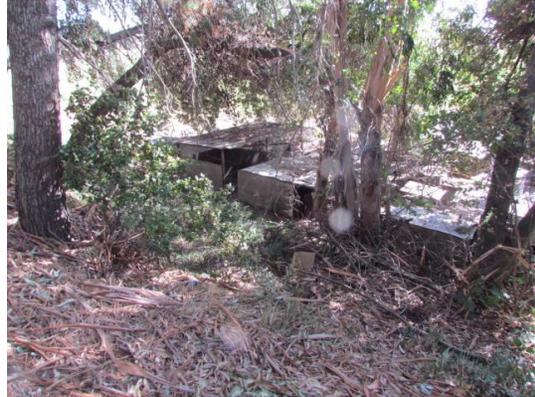
Photo 1 of 1 : richard_s_20140318_555.jpg

LM Start	1.80	Rating **	M	Issue No.	46
LM End	1.80	Issue Type +	En	Location *	LS
Category	Earthen Levee		GPS Latitude/Longitude		
			Start	End	
Item	Encroachments		38.174433 °	38.174433 °	
			-121.590792 °	-121.590792 °	
DWR ID	DWR_NA0002_02_f_2013_46				
Action/Comments					
Building

Looking east at animal pens at landward toe.

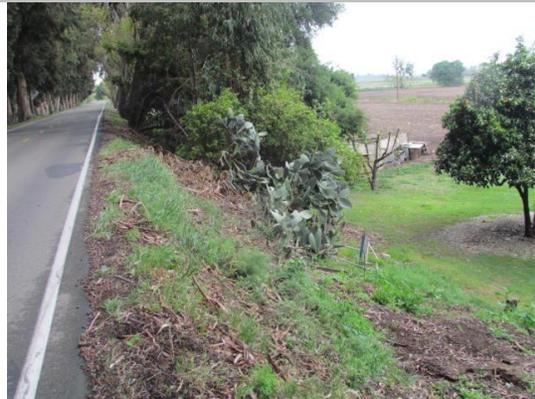
Photo 1 of 1 : richard_s_20140328_498.jpg

LM Start	1.81	Rating **	M	Issue No.	28
LM End	1.81	Issue Type +	En	Location *	LS
Category	Earthen Levee		GPS Latitude/Longitude		
			Start	End	
Item	Vegetation		38.174302 °	38.174302 °	
			-121.590863 °	-121.590863 °	
DWR ID	DWR_NA0002_02_s_2012_28				
Action/Comments					
Landscaping Inspector Comments: Cactus on landward slope.

Looking northeast at cactus on landward slope and toe.

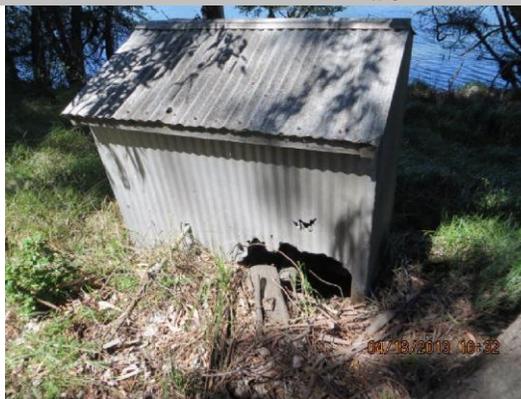
Photo 1 of 1 : UCIP_552.jpg

LM Start	1.90	Rating **	M	Issue No.	62
LM End	1.90	Issue Type +	En	Location *	LS
Category	Supplemental		GPS Latitude/Longitude		
			Start	End	
Item	DWR UCIP Field Study		38.173197 °	38.173197 °	
			-121.591552 °	-121.591552 °	
DWR ID	DWR_NA0002_02_s_2014_62				
Action/Comments					
Inspector Comments: FS_ID:12185 EP_NO: 11294 Repair Type: Crossing Status: UCIP Comments: Pipe abandoned on both sides. Pipe should be abandoned properly. FIELD_STRUCT_DESC: 6-inch pipe through the levee 6.5 feet below the crown. Pump in pumphouse on the water ward slope. 1-inch galvanized iron steel electrical conduit at same location (ABO No. 11294, 1975). Originally included in the 1954 O&M manual. FS Date: 4/18/2013

Pumphouse on WS slope.

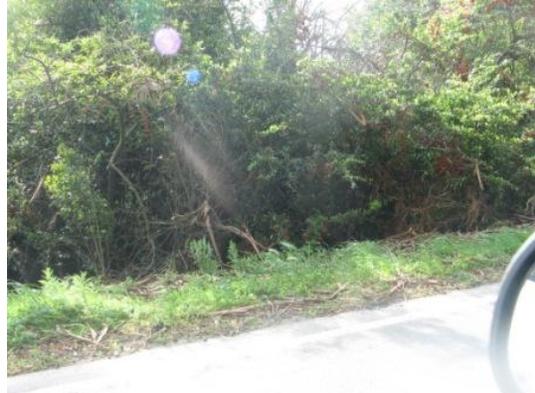
Photo 1 of 2 : richard_s_20140318_516.jpg

LM Start	1.91	Rating **	U	Issue No.	12
LM End	1.95	Issue Type +	En	Location *	LS
Category	Earthen Levee		GPS Latitude/Longitude		
			Start	End	
Item	Vegetation		38.173120 °	38.172598 °	
			-121.591505 °	-121.591853 °	
DWR ID	DWR_NA0002_02_s_2012_12				
Action/Comments					
Landscaping

Landscaping on landside slope blocking view of slope from LM 1.91 to 1.95.

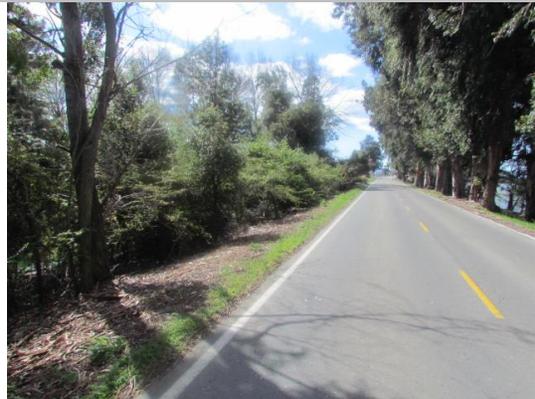
Photo 2 of 2 : richard_s_20140318_517.jpg

LM Start	1.91	Rating **	U	Issue No.	12 (cont)
LM End	1.95	Issue Type +	En	Location *	LS

Looking south at dense landscaping on landside slope and toe.

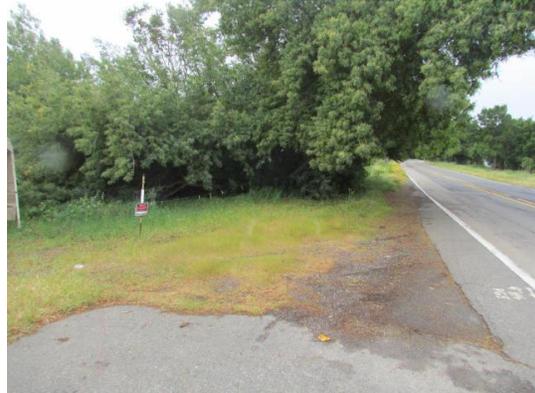
Photo 1 of 2 : richard_s_20140328_499.jpg

LM Start	2.48	Rating **	U	Issue No.	29
LM End	2.48	Issue Type +	En	Location *	LS
Category	Earthen Levee		GPS Latitude/Longitude		
			Start	End	
Item	Trim / Thin Trees		38.166378 °	38.166378 °	
			-121.597570 °	-121.597570 °	
DWR ID	DWR_NA0002_02_s_2012_29				
Action/Comments					
Trim trees to at least five feet above ground level.

Looking south at dense vegetation on landward slope.

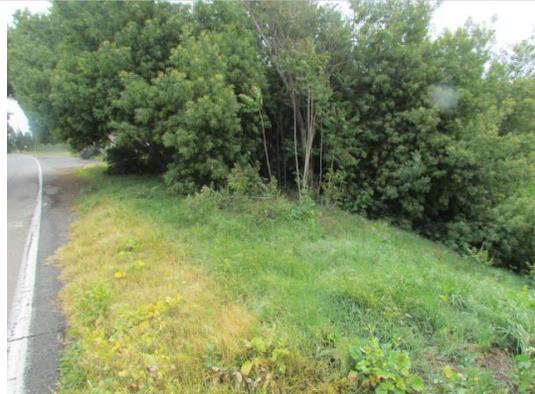
Photo 2 of 2 : richard_s_20140328_500.jpg

LM Start	2.48	Rating **	U	Issue No.	29 (cont)
LM End	2.48	Issue Type +	En	Location *	LS

Looking north at dense vegetation on landward slope.

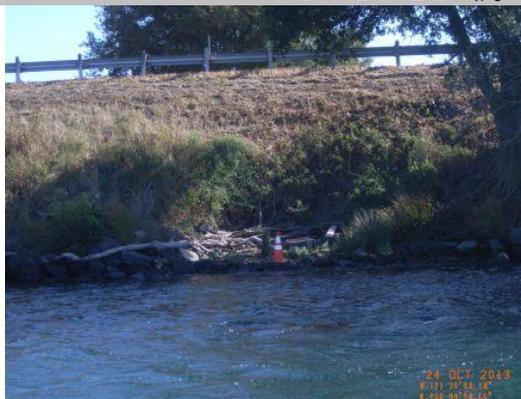
Photo 1 of 2 : USACE2013A_SAC_18-0_L_11.jpg

LM Start	2.66	Rating **	M	Issue No.	38
LM End	2.74	Issue Type +	Ma	Location *	WS
Category	Supplemental			GPS Latitude/Longitude	
				Start	End
Item	USACE Erosion Survey			38.165303 °	38.164682 °
				-121.600477 °	-121.601804 °
DWR ID					
Action/Comments					
Inspector Comments: 2009 - Large scallop from rotational failure. One fallen tree and one large tree with half of its root structure exposed. 2013: No observed changes. [2013 Site ID: SAC_18-0_L]

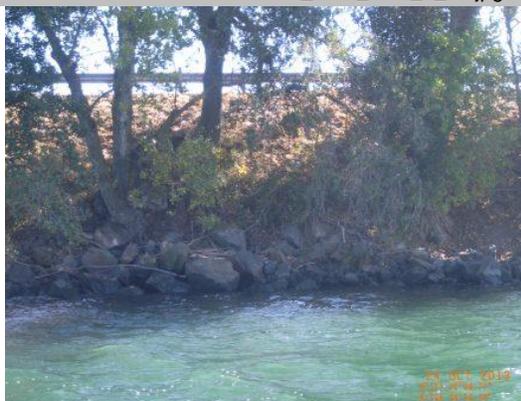
Photo 2 of 2 : USACE2013A_SAC_18-0_L_12.jpg

LM Start	2.66	Rating **	M	Issue No.	38 (cont)
LM End	2.74	Issue Type +	Ma	Location *	WS

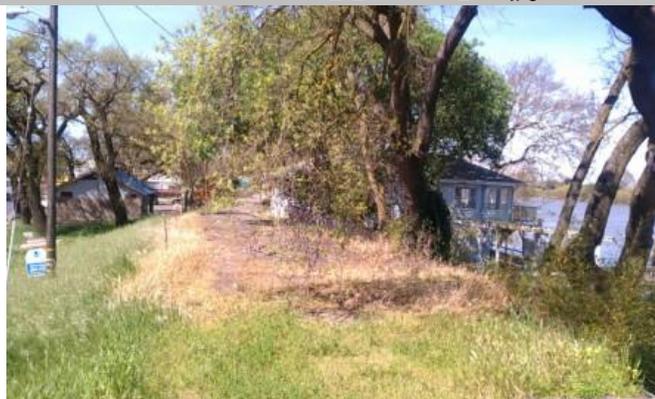
Photo 1 of 1 : richard_s_20140318_509.jpg

LM Start	3.17	Rating **	M	Issue No.	5
LM End	3.17	Issue Type +	Ma	Location *	WS
Category	Earthen Levee			GPS Latitude/Longitude	
				Start	End
Item	Trim / Thin Trees			38.162638 °	38.162638 °
				-121.609068 °	-121.609068 °
DWR ID	DWR_NA0002_02_s_2012_5				
Action/Comments					
Trim trees over roadway to at least 12 feet above ground level.

Looking south at overhanging tree on waterside shoulder.

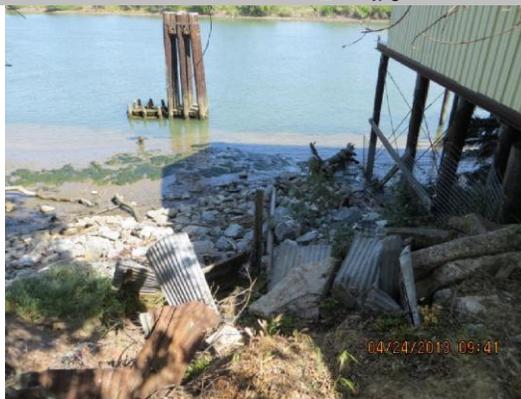
Photo 1 of 1 : UCIP_709.jpg

LM Start	3.38	Rating **	M	Issue No.	73
LM End	3.38	Issue Type +	En	Location *	LS
Category	Supplemental			GPS Latitude/Longitude	
				Start	End
Item	DWR UCIP Field Study			38.162387 °	38.162387 °
				-121.612847 °	-121.612847 °
DWR ID	DWR_NA0002_02_s_2014_73				
Action/Comments					
Inspector Comments: FS_ID:12745 EP_NO: 11266 Repair Type: Crossing Status: UCIP Comments: This pipe has been abandoned and should be abandoned properly. Pumphouse has collapsed. FIELD_STRUCT_DESC: 6-inch pipe through levee 4.5 feet below crown. Pump in pump house on the water ward side (ABO No. 11266, 1975). FS Date: 4/24/2013

Pipe and wrecked pumphouse on WS toe.

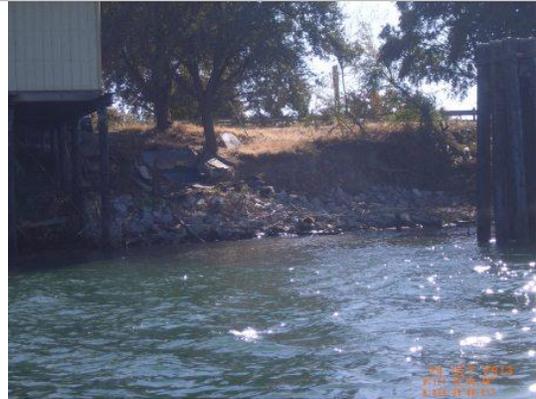
Photo 1 of 2 : USACE2013A_SAC_17-2_L_1.jpg

LM Start	3.40	Rating **	U	Issue No.	37
LM End	3.57	Issue Type +	Ma	Location *	WS
Category	Supplemental			GPS Latitude/Longitude	
				Start	End
Item	USACE Erosion Survey			38.162641 °	38.162828 °
				-121.612800 °	-121.616263 °
DWR ID					
Action/Comments					
Inspector Comments: 2009 - Fluvial erosion, into the levee slope, close to vertical bank with roadway on top. Pilings that were once at the bankline are now 30 ft out. 2010 - Very steep slope with slumps and overturned trees. 2011 - Upgraded to CRITICAL. Sections of vertical slope with highway on top. Heavy vegetation in front of most of the erosion pockets. Structures built into the levee on the upstream end. 2012 - Site continues to worsen. 2013: Some rock added on the upstream end, but site remains critical. [2013 Site ID: SAC_17-2_L]

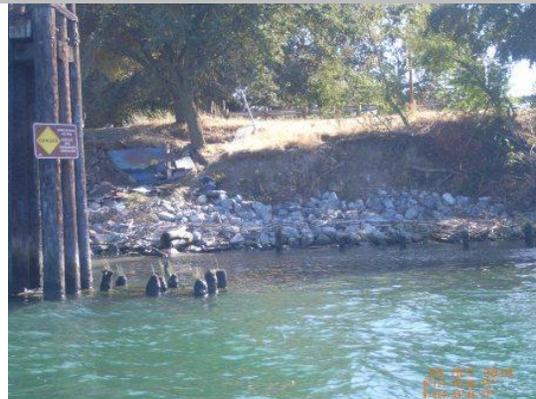
Photo 2 of 2 : USACE2013A_SAC_17-2_L_3.jpg

LM Start	3.40	Rating **	U	Issue No.	37 (cont)
LM End	3.57	Issue Type +	Ma	Location *	WS

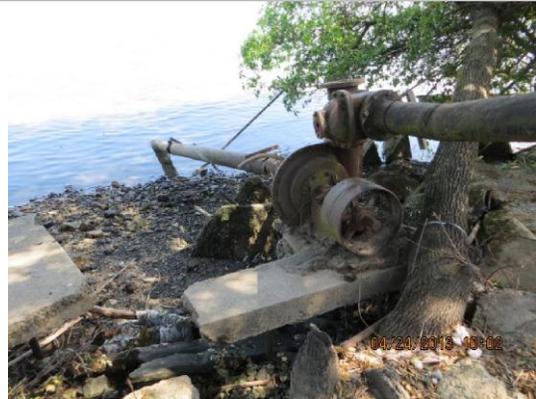
Photo 1 of 1 : UCIP_710.jpg

LM Start	3.44	Rating **	M	Issue No.	74
LM End	3.44	Issue Type +	En	Location *	WS
Category	Supplemental			GPS Latitude/Longitude	
				Start	End
Item	DWR UCIP Field Study			38.162473 °	38.162473 °
				-121.613963 °	-121.613963 °
DWR ID	DWR_NA0002_02_s_2014_74				
Action/Comments					
Inspector Comments: FS_ID:12746

Pipe and pump on WS toe.

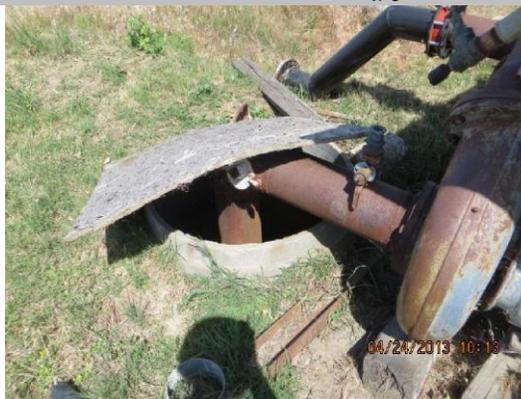
Photo 1 of 1 : UCIP_716.jpg

LM Start	3.67	Rating **	M	Issue No.	75
LM End	3.67	Issue Type +	En	Location *	LS
Category	Supplemental			GPS Latitude/Longitude	
				Start	End
Item	DWR UCIP Field Study			38.162908 °	38.162908 °
				-121.618075 °	-121.618075 °
DWR ID	DWR_NA0002_02_s_2014_75				
Action/Comments					
Inspector Comments: FS_ID:12747 EP_NO: 13462 Repair Type: Crossing Status: UCIP Comments: Possible sinkhole over pipe on WS shoulder. Good candidate for video inspection. FIELD_STRUCT_DESC: 16-inch pipe through levee 2.5 feet below crown (Permit No. 13462, 1982). Connected to an existing 42" concrete pipe sump. Replaces a pipe that was grouted in place. FS Date: 4/24/2013

Pump and sump on LS toe.

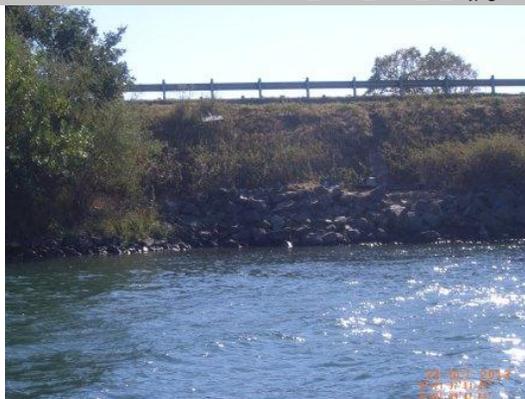
Photo 1 of 1 : USACE2013A_SAC_16-8_L_5.jpg

LM Start	3.67	Rating **	U	Issue No.	23
LM End	3.74	Issue Type +	Ma	Location *	WS
Category	Supplemental			GPS Latitude/Longitude	
				Start	End
Item	USACE Erosion Survey			38.162959 °	38.163334 °
				-121.617323 °	-121.619312 °
DWR ID					
Action/Comments					
Inspector Comments: 2008 - Overstepped levee section with pocket

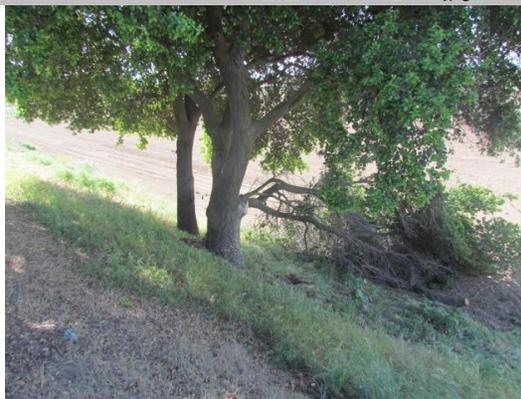
Photo 1 of 1 : richard_s_20140318_561.jpg

LM Start	4.59	Rating **	A/W	Issue No.	53
LM End	4.59	Issue Type +	En	Location *	LS
Category	Earthen Levee			GPS Latitude/Longitude	
				Start	End
Item	Encroachments			38.167650 °	38.167650 °
				-121.633770 °	-121.633770 °
DWR ID	DWR_NA0002_02_s_2013_53				
Action/Comments					
Tree or limb Inspector Comments: Broken tree limb on landside slope and toe.

Looking northeast at broken tree limb on landward slope and toe.

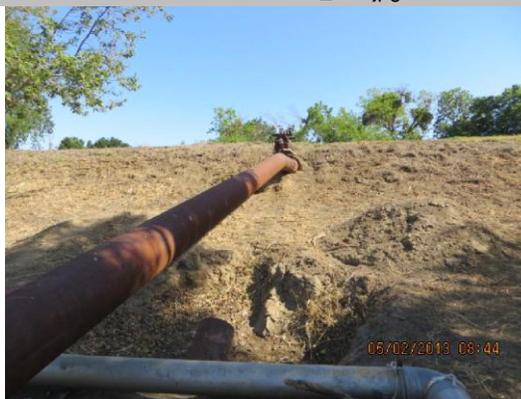
Photo 1 of 1 : UCIP_726.jpg

LM Start	4.80	Rating **	M	Issue No.	81
LM End	4.80	Issue Type +	En	Location *	LS
Category	Supplemental			GPS Latitude/Longitude	
				Start	End
Item	DWR UCIP Field Study			38.168744 °	38.168744 °
				-121.637154 °	-121.637154 °
DWR ID	DWR_NA0002_02_s_2014_81				
Action/Comments					
Inspector Comments: FS_ID:12773 EP_NO: 11285 Repair Type: Crossing Status: UCIP Comments: Pit under pipe on WS shoulder - possible leak. Excavation of pipe on LS slope into levee prism. FIELD_STRUCT_DESC: 20-inch pipe sleeved through a 22-inch sleeved through a 24-inch pipe through levee 3-feet below the crown. Pump on landward side (ABO No. 11285, 1975). Small pump on LS shoulder and a 7'X9' concrete sump on the LS toe. Originally included in the 1959 O&M manual. FS Date: 5/2/2013

Pipe on LS slope with excavation in levee prism.

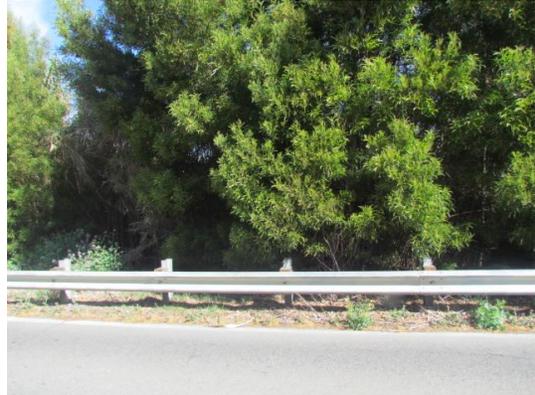
Photo 2 of 3 : richard_s_20140318_513.jpg

Looking west at dense trees on waterward should and slope.

LM Start	5.19	Rating **	U	Issue No.	9 (cont)
LM End	5.43	Issue Type +	Ma	Location *	WS
Category	Earthen Levee			GPS Latitude/Longitude	
				Start	End
Item	Trim / Thin Trees			38.171878 °	38.171800 °
				-121.645552 °	-121.647447 °
DWR ID	DWR_NA0002_02_s_2012_9				
Action/Comments					
Trim trees to at least five feet above ground level.

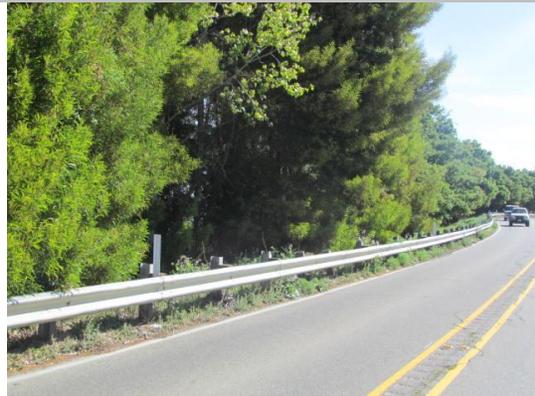
Photo 3 of 3 : richard_s_20140318_514.jpg

LM Start	5.19	Rating **	U	Issue No.	9 (cont)
LM End	5.43	Issue Type +	Ma	Location *	WS

Looking northwest at dense trees on waterward shoulder and slope.

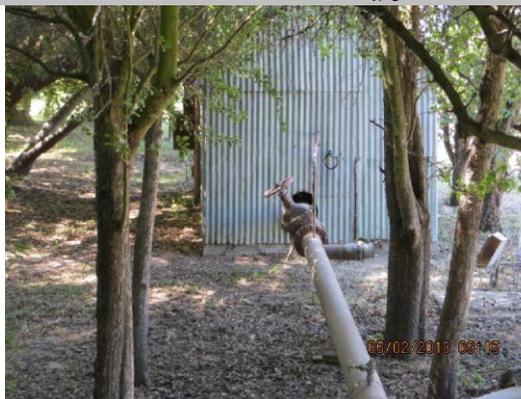
Photo 1 of 1 : UCIP_737.jpg

LM Start	5.42	Rating **	M	Issue No.	83
LM End	5.42	Issue Type +	En	Location *	LS
Category	Supplemental			GPS Latitude/Longitude	
				Start	End
Item	DWR UCIP Field Study			38.171824 °	38.171824 °
				-121.647265 °	-121.647265 °
DWR ID	DWR_NA0002_02_s_2014_83				
Action/Comments					
Inspector Comments: FS_ID:12776 EP_NO: 7089A Repair Type: Crossing Status: UCIP Comments: Hole at LS toe over pipe possible sign of leakage. FIELD_STRUCT_DESC: 7-inch pipe through levee 13.0 feet below crown. Pump in pump house on the landward side. 1.5-inch galvanized steel electrical conduit at same location. 4'X6' concrete distribution box off LS toe next to pumphouse. Originally included in the 1959 O&M manual. FS Date: 5/2/2013

Pumphouse with gate valve off LS toe.

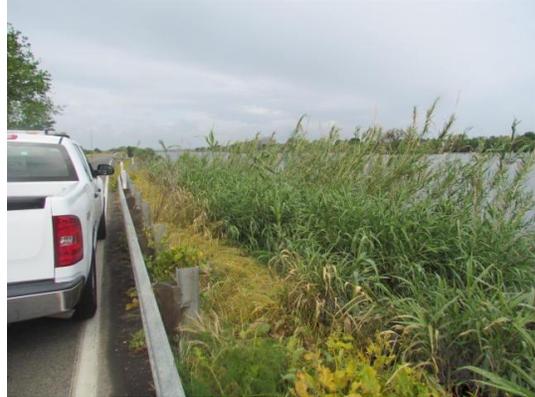
Photo 1 of 1 : richard_s_20140328_502.jpg

LM Start	5.66	Rating **	M	Issue No.	11
LM End	5.70	Issue Type +	Ma	Location *	WS
Category	Earthen Levee		GPS Latitude/Longitude		
			Start	End	
Item	Vegetation		38.172308 °	38.172497 °	
			-121.651552 °	-121.652243 °	
DWR ID	DWR_NA0002_02_s_2012_11				
Action/Comments					
Remove the wild growth other than native grasses from the levee slopes. Inspector Comments: Bamboo on waterward slope.

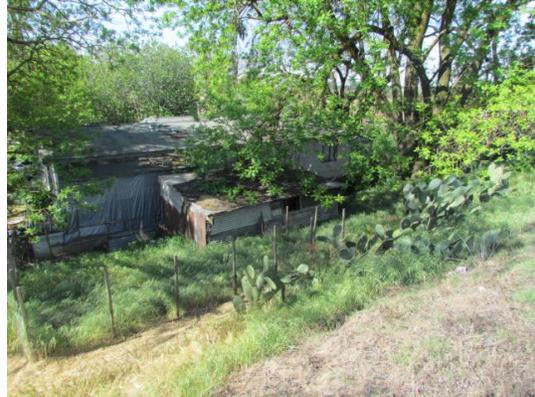
Photo 1 of 1 : richard_s_20140318_560.jpg

LM Start	5.70	Rating **	M	Issue No.	51
LM End	5.70	Issue Type +	En	Location *	LS
Category	Earthen Levee		GPS Latitude/Longitude		
			Start	End	
Item	Encroachments		38.172442 °	38.172442 °	
			-121.652182 °	-121.652182 °	
DWR ID	DWR_NA0002_02_s_2013_51				
Action/Comments					
Building Inspector Comments: Tool shed and animal pen at landside toe.

Looking east tool shed and animal corral on landward slope and toe.

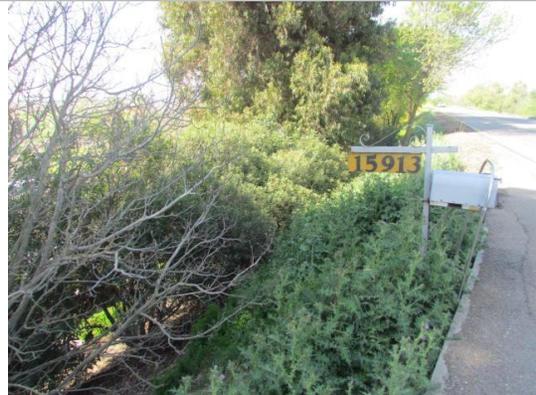
Photo 2 of 2 : richard_s_20140318_559.jpg

LM Start	6.29	Rating **	U	Issue No.	50 (cont)
LM End	6.29	Issue Type +	En	Location *	LS
Category	Earthen Levee			GPS Latitude/Longitude	
				Start	End
Item	Vegetation			38.173922 °	38.173922 °
				-121.662272 °	-121.662272 °
DWR ID	DWR_NA0002_02_s_2013_50				
Action/Comments					
Landscaping

Looking south at dense landscaping on landward slope.

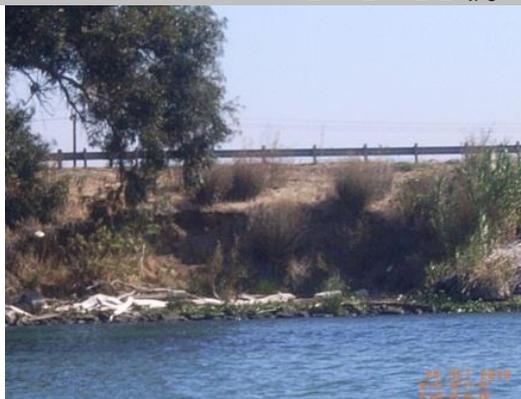
Photo 1 of 1 : USACE2013A_SAC_13-6_L_2.jpg

LM Start	7.00	Rating **	M	Issue No.	20
LM End	7.09	Issue Type +	Ma	Location *	WS
Category	Supplemental			GPS Latitude/Longitude	
				Start	End
Item	USACE Erosion Survey			38.166583 °	38.165794 °
				-121.670684 °	-121.671014 °
DWR ID					
Action/Comments					
Inspector Comments: 2011 - Large section of bank slumped off. 2013: No observed changes. [2013 Site ID: SAC_13-6_L]

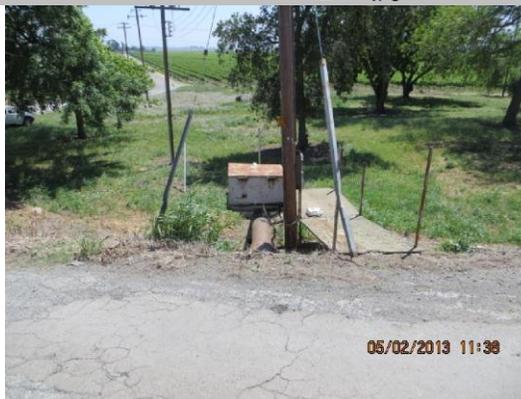
Photo 1 of 1 : UCIP_776.jpg

LM Start	7.47	Rating **	M	Issue No.	87
LM End	7.47	Issue Type +	En	Location *	WS
Category	Supplemental			GPS Latitude/Longitude	
				Start	End
Item	DWR UCIP Field Study			38.160387 °	38.160387 °
				-121.673972 °	-121.673972 °
DWR ID	DWR_NA0002_02_s_2014_87				
Action/Comments					
Inspector Comments: FS_ID:12814 EP_NO: 11293 Repair Type: Crossing Status: UCIP Comments: Erosion or sinkhole on WS shoulder. Does not appear to be an immediate threat. FIELD_STRUCT_DESC: 2 of 2: 16-inch pipe through levee 7.1 feet below crown. Pump on the landward slope. Service pole on the landward slope. 72-inch Concrete standpipe at toe of landward slope (ABO No. 11293, 1975). Originally included in the 1959 O&M manual. FS Date: 5/2/2013

Pipe and pump on LS shoulder.

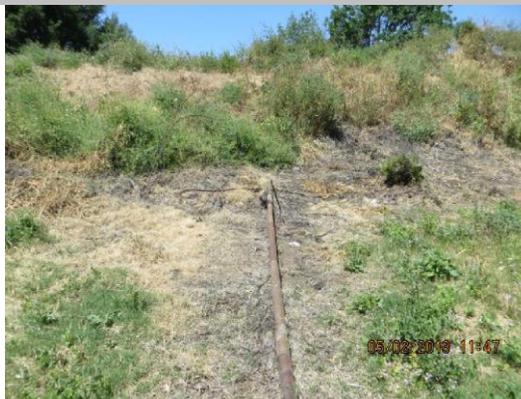
Photo 1 of 1 : UCIP_780.jpg

LM Start	7.51	Rating **	M	Issue No.	88
LM End	7.51	Issue Type +	En	Location *	WS
Category	Supplemental			GPS Latitude/Longitude	
				Start	End
Item	DWR UCIP Field Study			38.159940 °	38.159940 °
				-121.674429 °	-121.674429 °
DWR ID	DWR_NA0002_02_s_2014_88				
Action/Comments					
Inspector Comments: FS_ID:12817 EP_NO: N/A Repair Type: Crossing Status: UCIP Comments: Pipe should be abandoned properly. FIELD_STRUCT_DESC: 3-inch pipe through levee 7.7 feet below crown. Inactive service pole on the landward slope. FS Date: 5/2/2013

3.5-inch galvanized iron pipe on LS slope.

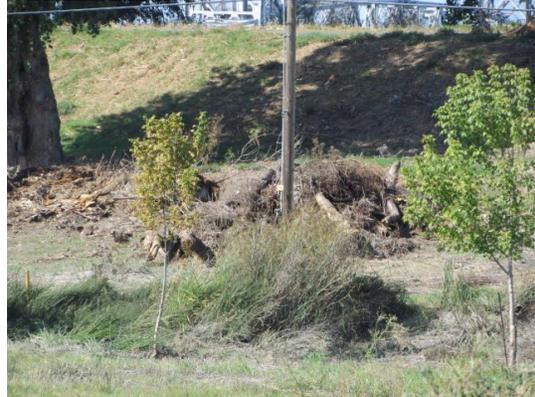
Photo 1 of 2 : richard_s_20140318_537.jpg

LM Start	7.66	Rating **	A/W	Issue No.	24
LM End	7.66	Issue Type +	Ma	Location *	LS
Category	Earthen Levee		GPS Latitude/Longitude		
			Start	End	
Item	Encroachments		38.157055 °	38.157055 °	
			-121.675445 °	-121.675445 °	
DWR ID	DWR_NA0002_02_s_2012_24				
Action/Comments					
Prunings

Looking west at prunings on landside toe.

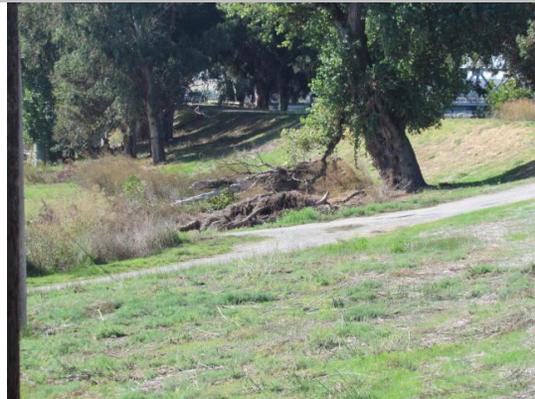
Photo 2 of 2 : richard_s_20140318_538.jpg

LM Start	7.66	Rating **	A/W	Issue No.	24 (cont)
LM End	7.66	Issue Type +	Ma	Location *	LS

Looking south at prunings on landside toe.

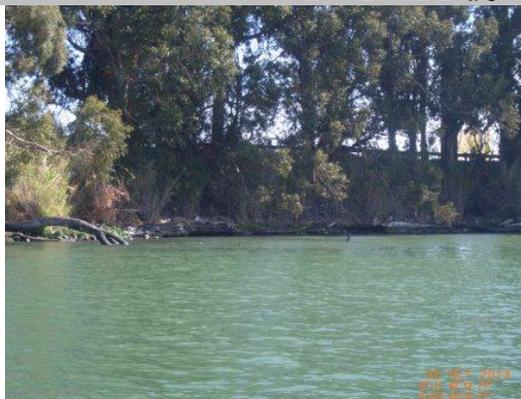
Photo 1 of 1 : USACE2013A_SAC_12-1_L_1.jpg

LM Start	8.26	Rating **	M	Issue No.	19
LM End	8.50	Issue Type +	Ma	Location *	WS
Category	Supplemental			GPS Latitude/Longitude	
				Start	End
Item	USACE Erosion Survey			38.151867 °	38.148711 °
				-121.682201 °	-121.682790 °
DWR ID					
Action/Comments					
Inspector Comments: 2010 - Small inlet area behind a man-built spit. Bank is slumping and could possibly be fixed with maintenance. 2011 - Site continues to worsen. 2013: No observed changes. [2013 Site ID: SAC_12-1_L]

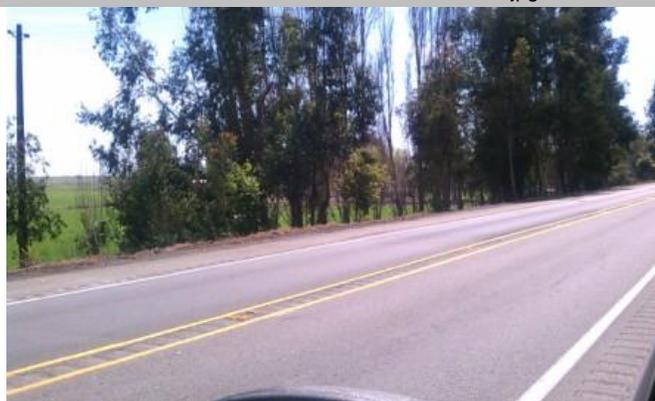
Photo 1 of 1 : richard_s_20140318_552.jpg

Looking southeast at trees on landside shoulder and slope.

LM Start	8.35	Rating **	M	Issue No.	44
LM End	8.71	Issue Type +	Ma	Location *	LS
Category	Earthen Levee			GPS Latitude/Longitude	
				Start	End
Item	Trim / Thin Trees			38.150112 °	38.144977 °
				-121.682305 °	-121.683345 °
DWR ID	DWR_NA0002_02_s_2012_44				
Action/Comments					
Trim trees to at least five feet above ground level.

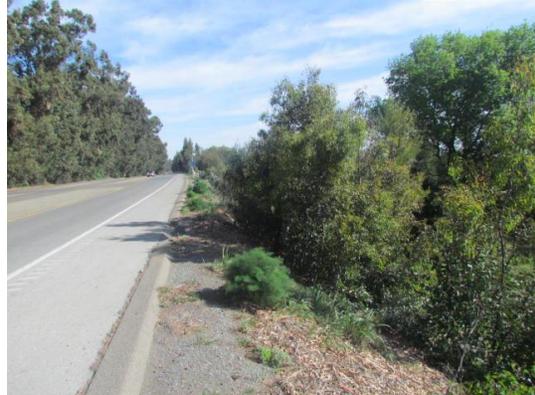
Photo 1 of 2 : richard_s_20140318_556.jpg

Looking north at dense trees on landward slope and toe.

LM Start	8.68	Rating **	U	Issue No.	48
LM End	8.89	Issue Type +	Ma	Location *	LS
Category	Earthen Levee			GPS Latitude/Longitude	
				Start	End
Item	Trim / Thin Trees			38.145368 °	38.142430 °
				-121.683072 °	-121.683978 °
DWR ID	DWR_NA0002_02_s_2013_48				
Action/Comments					
Trim trees to at least five feet above ground level.

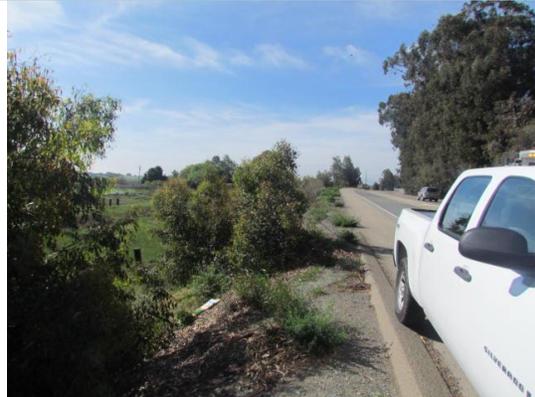
Photo 2 of 2 : richard_s_20140318_557.jpg

LM Start	8.68	Rating **	U	Issue No.	48 (cont)
LM End	8.89	Issue Type +	Ma	Location *	LS

Looking south at trees on landward slope.

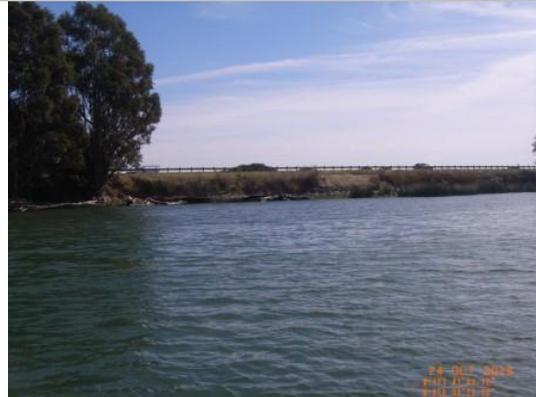
Photo 1 of 1 : USACE2013A_SAC_11-2_L_1.jpg

LM Start	8.94	Rating **	U	Issue No.	18
LM End	9.17	Issue Type +	Ma	Location *	WS
Category	Supplemental		GPS Latitude/Longitude		
			Start	End	
Item	USACE Erosion Survey		38.141399 °	38.138158 °	
			-121.685346 °	-121.686531 °	
DWR ID					
Action/Comments					
Inspector Comments: 2008 - Erosion causing vertical bank at the highway on top of levee. The whole bank along the highway should be repaired. 2009 - Minimal new erosion. 2011 - Bank continues to slowly erode. 2012 - Upgrade to critical, new erosion since lat year and steeper slopes in sections. 2013: No observed changes. [2013 Site ID: SAC_11-2_L]
