**Flood Control Project Maintenance
Levee Inspections**
LMA District Cover Sheet
Spring 2014 Levee Inspection Results

Brannan Andrus Levee Maintenance District

Spring 2014 Levee Inspection Results

Waterway		Bank	Unit Miles
Unit No. 01 Georgiana Slough		Right	6.02

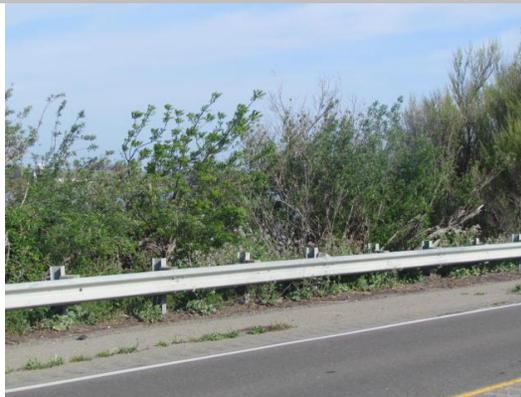
Photo 1 of 2 : richard_s_20140318_519.jpg

Looking west at dense vegetation on waterward shoulder and slope.

LM Start	9.68	Rating **	U	Issue No.	16
LM End	9.74	Issue Type +	Ma	Location *	WS
Category	Earthen Levee		GPS Latitude/Longitude		
			Start	End	
Item	Vegetation		38.132499 °	38.130537 °	
			-121.686135 °	-121.686737 °	
DWR ID	DWR_NA0002_02_s_2012_16				
Action/Comments					
Remove the wild growth other than native grasses from the levee slopes.

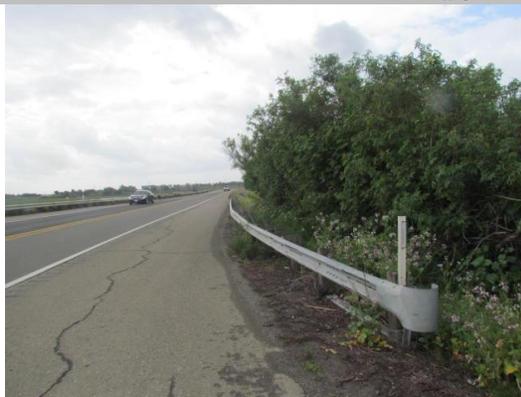
Photo 2 of 2 : richard_s_20140328_504.jpg

LM Start	9.68	Rating **	U	Issue No.	16 (cont)
LM End	9.74	Issue Type +	Ma	Location *	WS

Looking south at dense vegetation on waterward shoulder and slope.

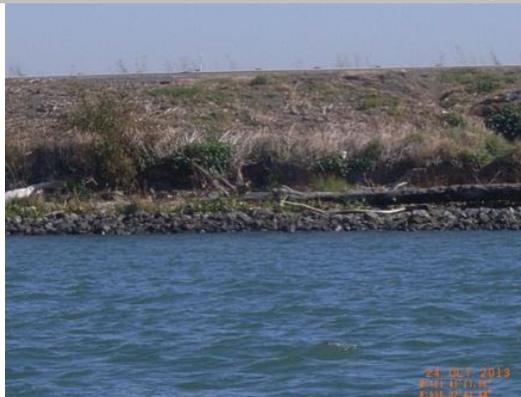
Photo 1 of 1 : USACE2013A_SAC_10-8_L_2.jpg

LM Start	9.85	Rating **	M	Issue No.	17
LM End	9.98	Issue Type +	Ma	Location *	WS
Category	Supplemental		GPS Latitude/Longitude		
			Start	End	
Item	USACE Erosion Survey		38.129722 °	38.127672 °	
			-121.687468 °	-121.688646 °	
DWR ID					
Action/Comments					
Inspector Comments: 2004 - Wave wash pockets approximately 100 ft
