**Flood Control Project Maintenance
Levee Inspections****LMA District Cover Sheet****Spring 2015 Levee Inspection Results****Brannan Andrus Levee Maintenance District**

Spring 2015 Levee Inspection Results

Brannan Andrus Levee Maintenance District

Waterway			Bank	Unit Miles
Unit No. 01 Georgiana Slough			Right	6.01
	Spring (March - May)	Summer (June - August)	(September - November) Fall	Winter (December - February)
Unit Maintenance Rating (Fall Only)				
Date of Inspection	03/11/2015 - 03/11/2015			
DWR Inspector	Richard Willoughby			
Accompanied By	Gilbert Labrie DCC Engineering Co, Inc

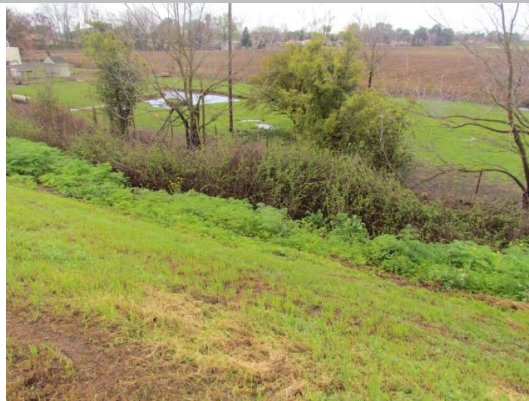
Photo 1 of 1 : SP_2015_NA0002_62_26_20150313_00056.jpg

LM Start	2.20	Rating **	M	Issue No.	26
LM End	2.22	Issue Type +	Ma	Location *	LS
Category	Earthen Levee			GPS Latitude/Longitude	
				Start	End
Item	Vegetation			38.164138 °	38.163797 °
				-121.584078 °	-121.584225 °
DWR ID	DWR_NA0002_01_s _ 2013_26				
Action/Comments					
Remove the wild growth other than native grasses from the levee slopes.					
Inspector Comments: Control wild growth at landside slope and toe.

Looking southwest at dense vegetation at landward toe.

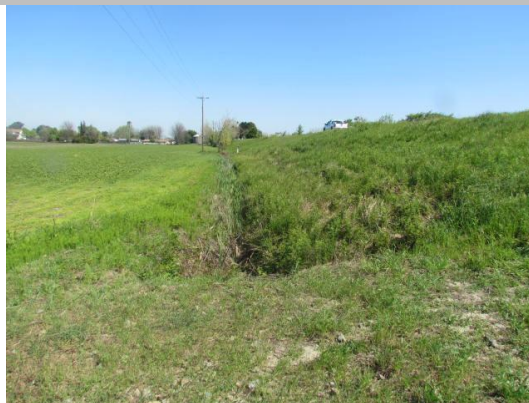
Photo 2 of 3 : SP_2015_NA0002_62_56_20150309_00037.jpg

LM Start	2.43	Rating **	M	Issue No.	56 (cont)		
LM End	2.58	Issue Type +	En	Location *	LS		
Category	Earthen Levee			GPS Latitude/Longitude			
				Start	End		
Item	Encroachments				°		°
					°		°
DWR ID	DWR_NA0002_01_s _ 2014_56						
Action/Comments							
Ditch							
Inspector Comments: Ditch has been in place for several years. Ditch should be removed from within fifteen feet of landward toe.

Looking north at south end of ditch within fifteen feet of landward toe.

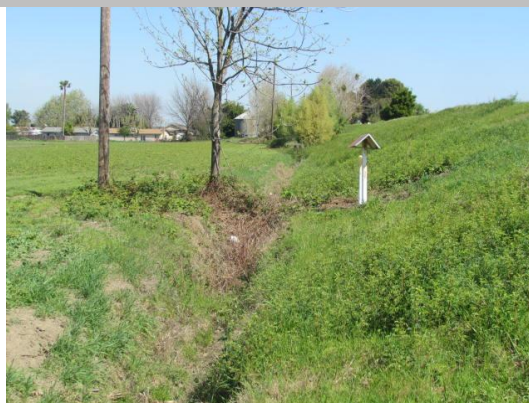
Photo 3 of 3 : SP_2015_NA0002_62_56_20150309_00038.jpg

Looking north at ditch within fifteen feet of landward toe.

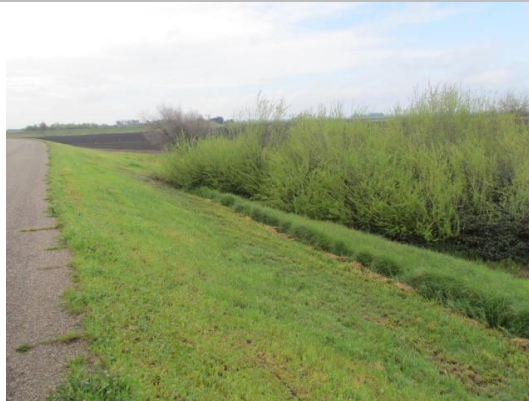
Photo 1 of 3 : SP_2015_NA0002_62_55_20150313_00058.jpg

LM Start	3.00	Rating **	U	Issue No.	55 (cont)
LM End	3.00	Issue Type +	Ma	Location *	LS

Looking southwest at dense vegetation at landward toe. (Spring 2015)

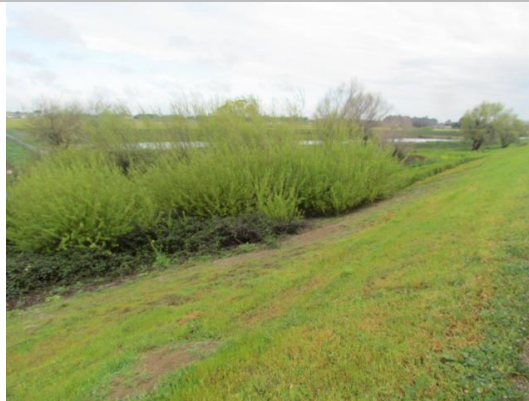
Photo 2 of 3 : SP_2015_NA0002_62_55_20150313_00059.jpg

Looking north at dense vegetation withing fifteen feet of landward toe.

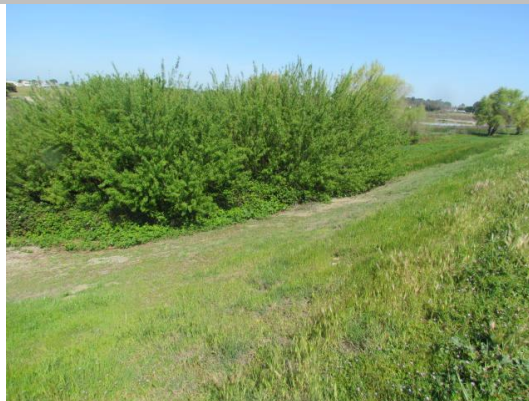
Photo 3 of 3 : SP_2015_NA0002_62_55_20150309_00035.jpg

Looking north at dense vegetation within fifteen feet of landward toe.

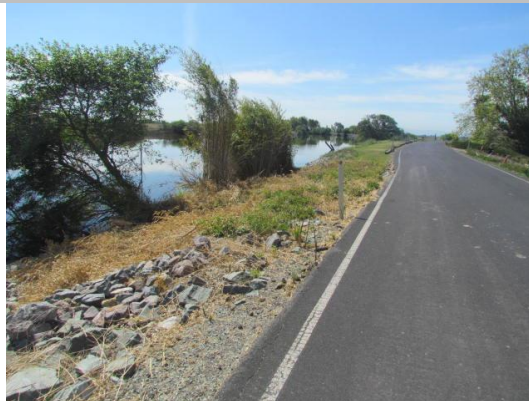
Photo 2 of 3 : SP_2015_NA0002_62_10_20150309_00009.jpg

LM Start	3.93	Rating **	A/W	Issue No.	10 (cont)
LM End	3.93	Issue Type +	Ma	Location *	WS

Looking south at dead willows on waterward slope. (Spring 2013)

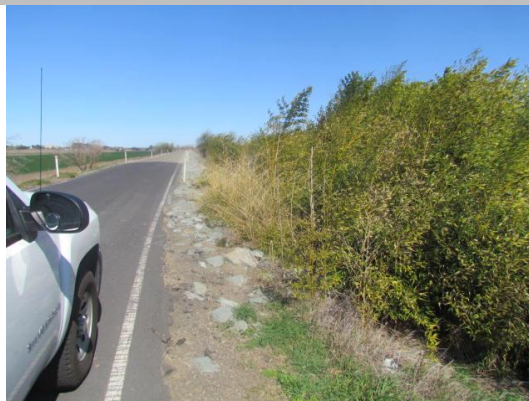
Photo 3 of 3 : SP_2015_NA0002_62_10_20150309_00010.jpg

Looking west at dense vegetation on waterside slope spring 2012.

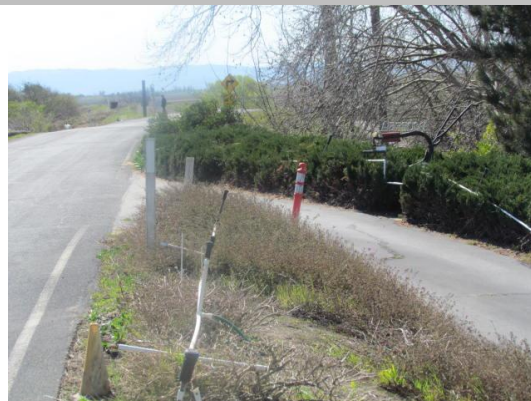
Photo 2 of 3 : SP_2015_NA0002_62_11_20150309_00012.jpg

LM Start	3.93	Rating **	U	Issue No.	11 (cont)	
LM End	3.97	Issue Type +	En	Location *	LS	
Category	Earthen Levee			GPS Latitude/Longitude		
				Start		End
Item	Vegetation			38.148318 °		38.147898 °
				-121.599947 °		-121.600347 °
DWR ID	DWR_NA0002_01_s_2012_11					
Action/Comments						
Landscaping

Looking south at bushes on landside shoulder and slope.

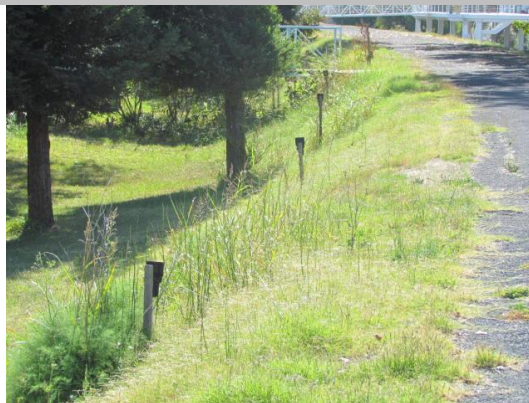
Photo 1 of 1 : SP_2015_NA0002_62_20_20150309_00015.jpg

LM Start	4.23	Rating **	M	Issue No.	20
LM End	4.29	Issue Type +	En	Location *	WS
Category	Earthen Levee			GPS Latitude/Longitude	
				Start	End
Item	Encroachments			38.144471 °	38.143652 °
				-121.601381 °	-121.600877 °
DWR ID	DWR_NA0002_01_f_2013_20				
Action/Comments					
Landscape Irrigation					
Inspector Comments: Sprinkler system on waterside of levee.

Looking south at a sprinkler system on waterward slope.

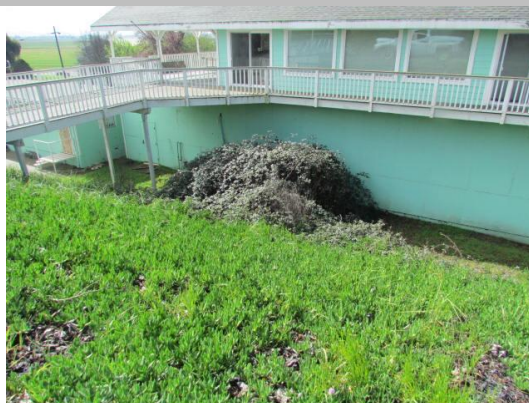
Photo 1 of 1 : SP_2015_NA0002_62_1_20150313_00060.jpg

LM Start	4.97	Rating **	M	Issue No.	1
LM End	4.97	Issue Type +	Ma	Location *	LS
Category	Earthen Levee			GPS Latitude/Longitude	
				Start	End
Item	Vegetation			38.135235 °	38.135235 °
				-121.594275 °	-121.594275 °
DWR ID	DWR_NA0002_01_s_2015_1				
Action/Comments					
Remove the wild growth other than native grasses from the levee slopes.					
Inspector Comments: Wild rose on landward slope and toe.

Looking west at dense vegetation at landward toe. (Spring 2015)

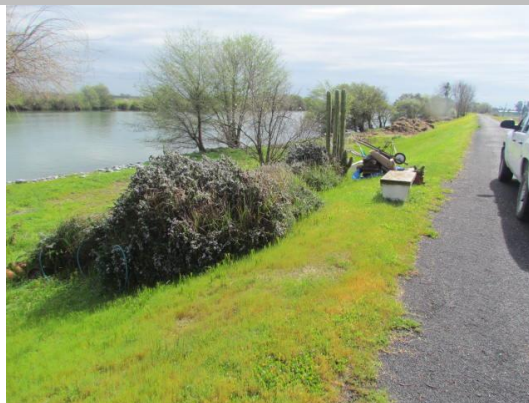
Photo 2 of 2 : SP_2015_NA0002_62_61_20150313_00062.jpg

LM Start	5.25	Rating **	M	Issue No.	61 (cont)
LM End	5.25	Issue Type +	En	Location *	WS
Category	Earthen Levee			GPS Latitude/Longitude	
				Start	End
Item	Vegetation			38.132261 °	38.132261 °
				-121.590914 °	-121.590914 °
DWR ID	DWR_NA0002_01_s_2015_61				
Action/Comments					
Landscaping					
Inspector Comments: Overgrowth landscaping on waterward slope.

Looking southeast at overgrowth landscaping on waterward slope.
(Spring 2015)

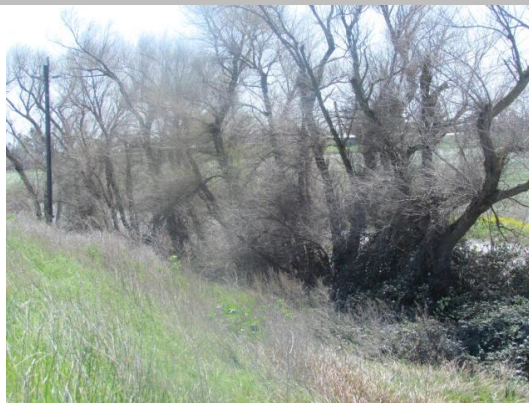
Photo 1 of 3 : SP_2015_NA0002_62_23_20150309_00016.jpg

LM Start	5.47	Rating **	M	Issue No.	23
LM End	5.56	Issue Type +	Ma	Location *	LS
Category	Earthen Levee			GPS Latitude/Longitude	
				Start	End
Item	Vegetation			38.129810 °	38.129415 °
				-121.588218 °	-121.586807 °
DWR ID	DWR_NA0002_01_s_2012_23				
Action/Comments					
Remove the wild growth other than native grasses from the levee slopes.					
Inspector Comments: Remove vegetation at landside toe.

Looking south at trees, berry vines, and wild rose on landside toe.

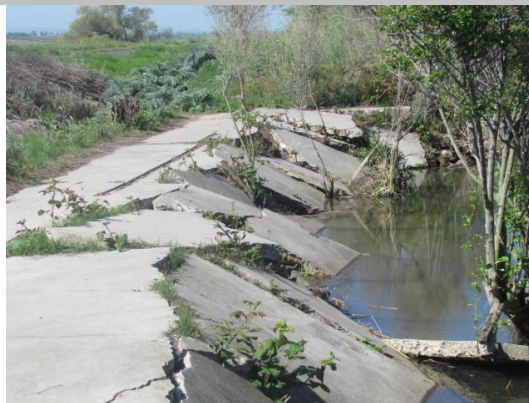
Photo 1 of 4 : SP_2015_NA0002_62_53_20150309_00031.jpg

LM Start	5.72	Rating **	M	Issue No.	53 (cont)
LM End	5.72	Issue Type +	Ma	Location *	WS

Looking north at a collapsed concrete slab on waterward berm.

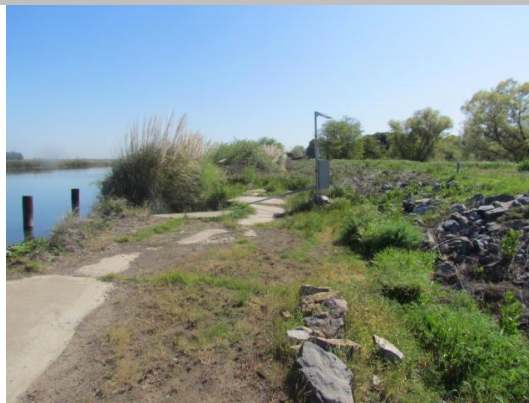
Photo 2 of 4 : SP_2015_NA0002_62_53_20150309_00032.jpg

Looking south at south end of a concrete slab on waterward berm.

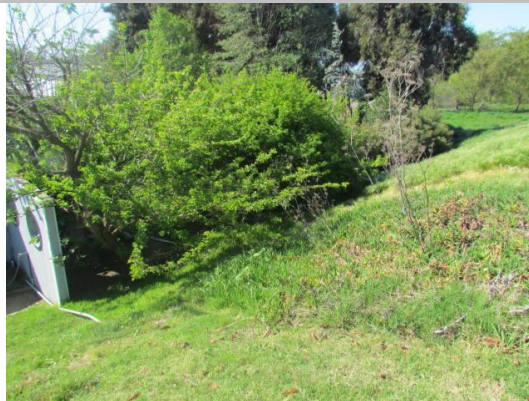
Photo 1 of 1 : SP_2015_NA0002_62_52_20150309_00030.jpg

LM Start	5.85	Rating **	A/W	Issue No.	52
LM End	5.85	Issue Type +	En	Location *	LS
Category	Earthen Levee			GPS Latitude/Longitude	
				Start	End
Item	Vegetation				°
					°
DWR ID	DWR_NA0002_01_s_2014_52				
Action/Comments					
Landscaping					
Inspector Comments: Fruit trees on landward toe blocking view.

Looking north at dense vegetation at landward toe.

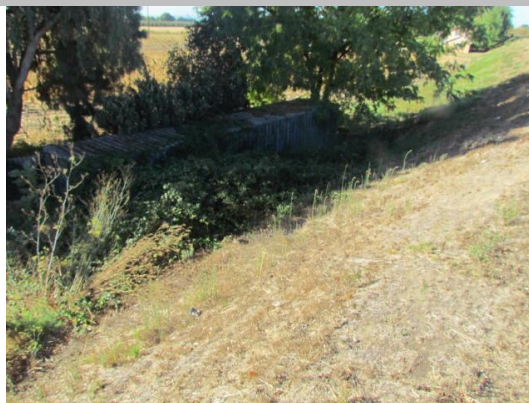
Photo 1 of 3 : SP_2015_NA0002_63_40_20150309_00037.jpg

LM Start	0.49	Rating **	M	Issue No.	40
LM End	0.49	Issue Type +	Ma	Location *	LS
Category	Earthen Levee			GPS Latitude/Longitude	
				Start	End
Item	Vegetation			38.188871 °	38.188871 °
				-121.575775 °	-121.575775 °
DWR ID	DWR_NA0002_02_f_2013_40				
Action/Comments					
Remove the wild growth other than native grasses from the levee slopes.					
Inspector Comments: Berryvines at landward toe.

Looking southeast at berryvines at landward toe.

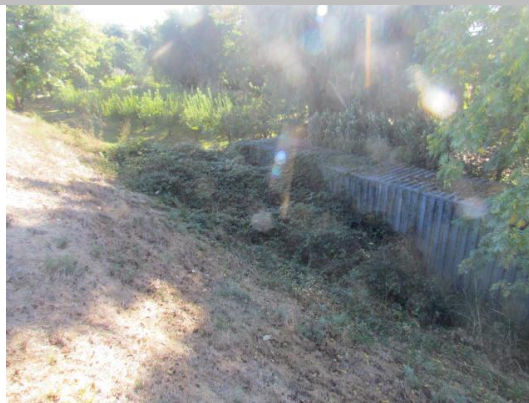
Photo 3 of 3 : SP_2015_NA0002_63_40_20150309_00039.jpg

LM Start	0.49	Rating **	M	Issue No.	40 (cont)
LM End	0.49	Issue Type +	Ma	Location *	LS
Category	Earthen Levee			GPS Latitude/Longitude	
				Start	End
Item	Vegetation			38.188871 °	38.188871 °
				-121.575775 °	-121.575775 °
DWR ID	DWR_NA0002_02_f_2013_40				
Action/Comments					
Remove the wild growth other than native grasses from the levee slopes.					
Inspector Comments: Berryvines at landward toe.

Looking northeast at berryvines at landward toe.

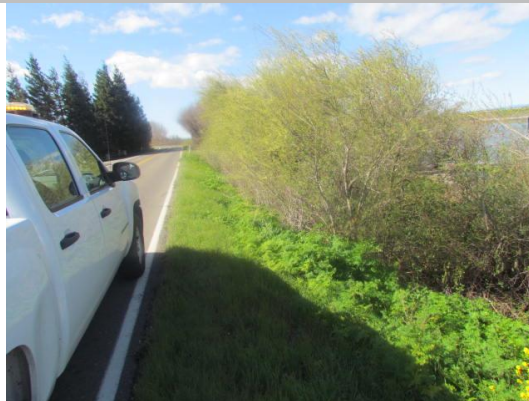
Photo 2 of 2 : SP_2015_NA0002_63_2_20150309_00002.jpg

LM Start	0.79	Rating **	U	Issue No.	2 (cont)	
LM End	0.84	Issue Type +	Ma	Location *	WS	
Category	Earthen Levee			GPS Latitude/Longitude		
				Start		End
Item	Trim / Thin Trees			38.186535 °	38.186103 °	
				-121.580395 °	-121.581127 °	
DWR ID	DWR_NA0002_02_s _ 2012_2					
Action/Comments						
Trim trees to at least five feet above ground level.

Looking south at dense vegetation on waterside slope.

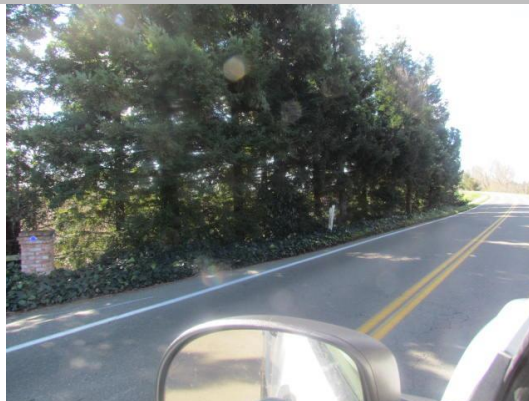
Photo 1 of 2 : SP_2015_NA0002_63_8_20150309_00006.jpg

LM Start	0.80	Rating **	M	Issue No.	8
LM End	0.83	Issue Type +	En	Location *	LS
Category	Earthen Levee			GPS Latitude/Longitude	
				Start	End
Item	Vegetation			38.186455 °	38.186215 °
				-121.580712 °	-121.581060 °
DWR ID	DWR_NA0002_02_s _ 2012_8				
Action/Comments					
Landscaping

Looking southeast at dense landscaping on landside slope.

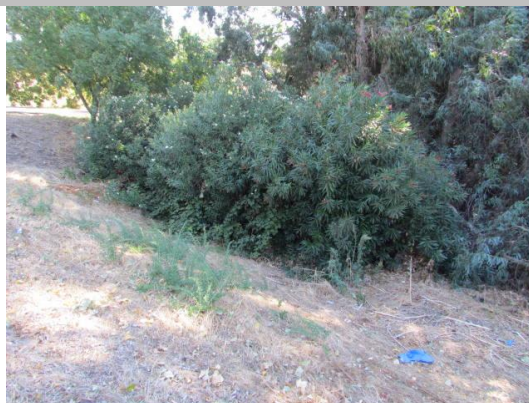
Photo 1 of 2 : SP_2015_NA0002_63_27_20150309_00025.jpg

LM Start	1.45	Rating **	M	Issue No.	27
LM End	1.45	Issue Type +	En	Location *	LS
Category	Earthen Levee			GPS Latitude/Longitude	
				Start	End
Item	Trim / Thin Trees			38.178950 °	38.178950 °
				-121.587717 °	-121.587717 °
DWR ID	DWR_NA0002_02_s _ 2012_27				
Action/Comments					
Trim trees to at least five feet above ground level. Inspector Comments: Dense vegetation should be trimmed back fifteen feet from landward toe.

Looking northeast at dense vegetation on landward toe.

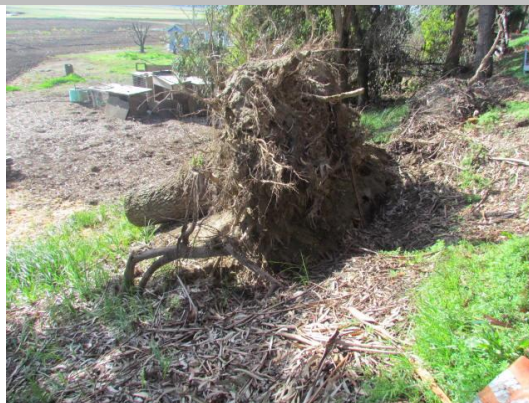
Photo 4 of 4 : SP_2015_NA0002_63_109_20150313_00101.jpg

Looking southeast at tree stump on landward slope. (Spring 2015).

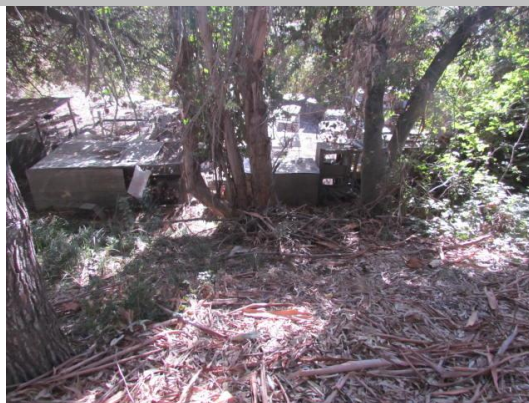
Photo 1 of 2 : SP_2015_NA0002_63_98_20150309_00058.jpg

LM Start	1.80	Rating **	M	Issue No.	98
LM End	1.80	Issue Type +	En	Location *	LS
Category	Earthen Levee			GPS Latitude/Longitude	
				Start	End
Item	Encroachments			38.174466 °	38.174466 °
				-121.590791 °	-121.590791 °
DWR ID	DWR_NA0002_02_f _ 2014_98				
Action/Comments					
Building					
Inspector Comments: Animal pens within 15 feet of landward toe.

Looking southeast at animal pens at landward toe.

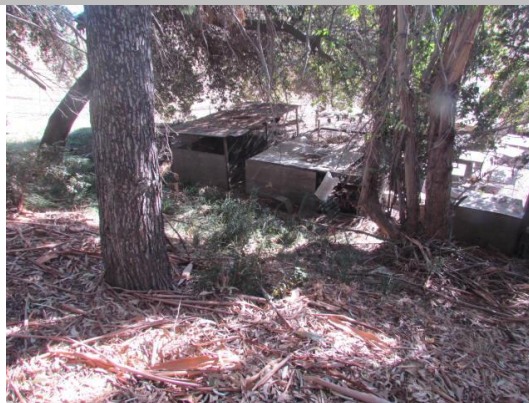
Photo 2 of 2 : SP_2015_NA0002_63_98_20150309_00059.jpg

LM Start	1.80	Rating **	M	Issue No.	98 (cont)
LM End	1.80	Issue Type +	En	Location *	LS
Category	Earthen Levee			GPS Latitude/Longitude	
				Start	End
Item	Encroachments			38.174466 °	38.174466 °
				-121.590791 °	-121.590791 °
DWR ID	DWR_NA0002_02_f_2014_98				
Action/Comments					
Building					
Inspector Comments: Animal pens within 15 feet of landward toe.

Looking east at animal pens at landward toe.

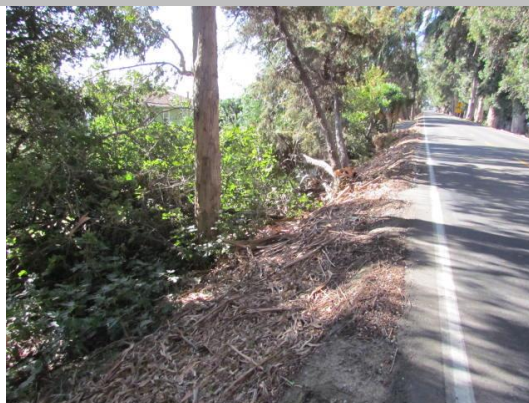
Photo 1 of 2 : SP_2015_NA0002_63_45_20150309_00043.jpg

LM Start	1.80	Rating **	U	Issue No.	45
LM End	1.82	Issue Type +	Ma	Location *	LS
Category	Earthen Levee			GPS Latitude/Longitude	
				Start	End
Item	Vegetation			38.174437 °	38.174153 °
				-121.590786 °	-121.590980 °
DWR ID	DWR_NA0002_02_f_2013_45				
Action/Comments					
Remove the wild growth other than native grasses from the levee slopes.					
Inspector Comments: Dense vegetation on landward slope and toe

Looking southeast at dense vegetation on landward slope.

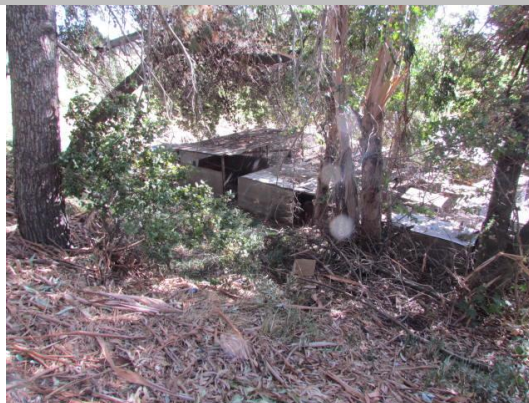
Photo 1 of 1 : SP_2015_NA0002_63_46_20150309_00045.jpg

LM Start	1.80	Rating **	M	Issue No.	46
LM End	1.80	Issue Type +	En	Location *	LS
Category	Earthen Levee			GPS Latitude/Longitude	
				Start	End
Item	Encroachments			38.174433 °	38.174433 °
				-121.590792 °	-121.590792 °
DWR ID	DWR_NA0002_02_f_2013_46				
Action/Comments					
Building					
Inspector Comments: Animal pens at landward toe.

Looking east at animal pens at landward toe.

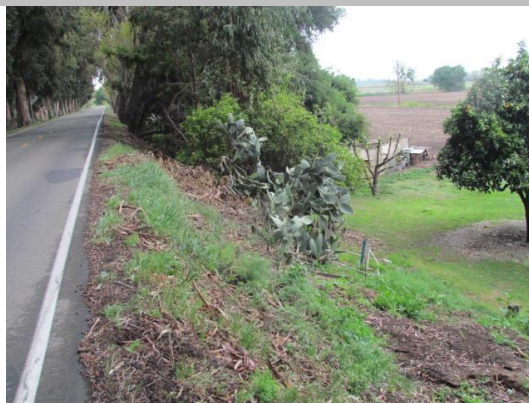
Photo 1 of 1 : SP_2015_NA0002_63_28_20150309_00027.jpg

LM Start	1.81	Rating **	M	Issue No.	28
LM End	1.81	Issue Type +	En	Location *	LS
Category	Earthen Levee			GPS Latitude/Longitude	
				Start	End
Item	Vegetation			38.174302 °	38.174302 °
				-121.590863 °	-121.590863 °
DWR ID	DWR_NA0002_02_s_2012_28				
Action/Comments					
Landscaping Inspector Comments: Cactus on landward slope.

Looking northeast at cactus on landward slope and toe.

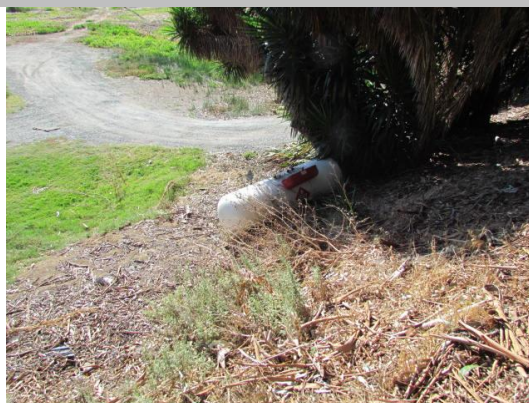
Photo 1 of 1 : SP_2015_NA0002_63_54_20150309_00051.jpg

LM Start	1.83	Rating **	M	Issue No.	54
LM End	1.83	Issue Type +	En	Location *	LS
Category	Earthen Levee			GPS Latitude/Longitude	
				Start	End
Item	Encroachments			38.174097 °	38.174097 °
				-121.591002 °	-121.591002 °
DWR ID	DWR_NA0002_02_f_2013_54				
Action/Comments					
Tank					
Inspector Comments: Propane tank on landward slope.

Looking southeast at propane tank on landward slope and toe.

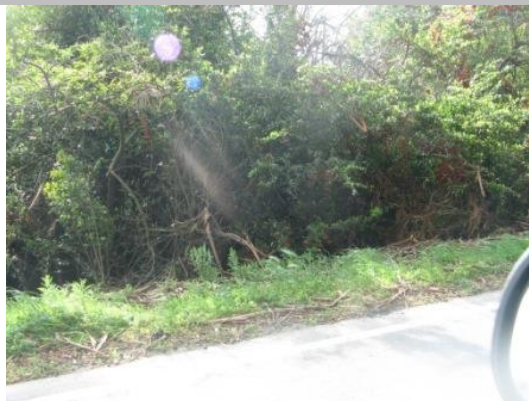
Photo 2 of 2 : SP_2015_NA0002_63_12_20150309_00013.jpg

LM Start	1.90	Rating **	U	Issue No.	12 (cont)	
LM End	1.94	Issue Type +	En	Location *	LS	
Category	Earthen Levee			GPS Latitude/Longitude		
				Start		End
Item	Vegetation			38.173120 °		38.172598 °
				-121.591505 °		-121.591853 °
DWR ID	DWR_NA0002_02_s _ 2012_12					
Action/Comments						
Landscaping

Landscaping on landside slope blocking view of slope from LM 1.91 to 1.95.

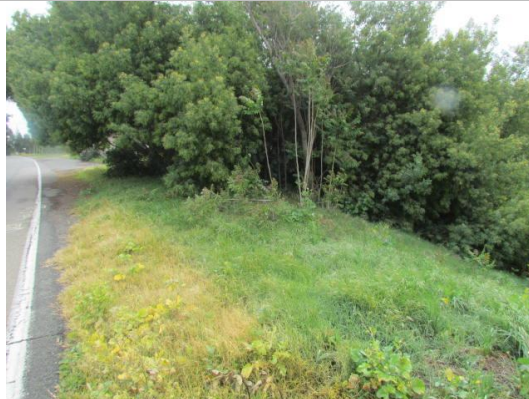
Photo 1 of 2 : SP_2015_NA0002_63_29_20150309_00028.jpg

LM Start	2.48	Rating **	U	Issue No.	29
LM End	2.48	Issue Type +	En	Location *	LS
Category	Earthen Levee			GPS Latitude/Longitude	
				Start	End
Item	Trim / Thin Trees			38.166378 °	38.166378 °
				-121.597570 °	-121.597570 °
DWR ID	DWR_NA0002_02_s _ 2012_29				
Action/Comments					
Trim trees to at least five feet above ground level.

Looking north at dense vegetation on landward slope.

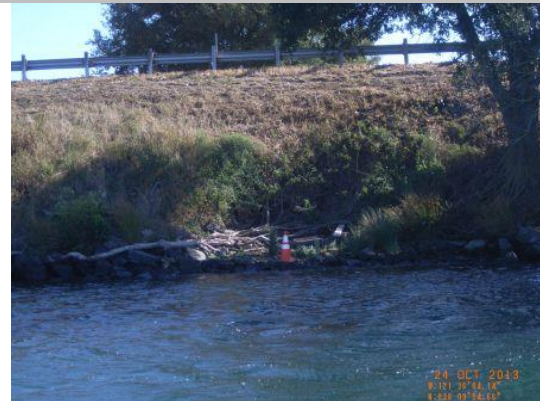
Photo 1 of 2 : SP_2015_NA0002_63_38_20150309_00034.jpg

LM Start	2.65	Rating **	M	Issue No.	38
LM End	2.74	Issue Type +	Ma	Location *	WS
Category	Supplemental			GPS Latitude/Longitude	
				Start	End
Item	USACE Erosion Survey			38.165303 °	38.164682 °
				-121.600477 °	-121.601804 °
DWR ID	DWR_NA0002_02_f_2014_38				
Action/Comments					
Inspector Comments: 2009 - Large scallop from rotational failure. One fallen tree and one large tree with half of its root structure exposed. 2013: No observed changes. [2013 Site ID: SAC_18-0_L]

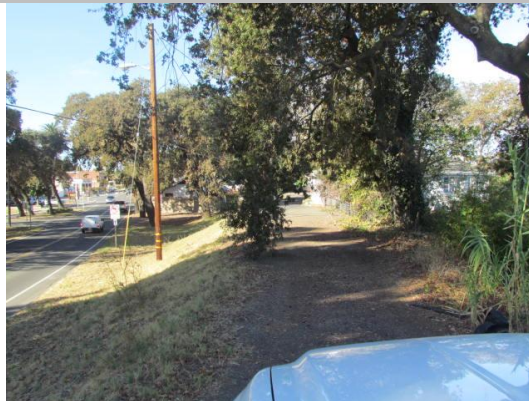
Photo 1 of 2 : SP_2015_NA0002_63_5_20150309_00003.jpg

LM Start	3.17	Rating **	M	Issue No.	5
LM End	3.17	Issue Type +	Ma	Location *	WS
Category	Earthen Levee			GPS Latitude/Longitude	
				Start	End
Item	Trim / Thin Trees			38.162638 °	38.162638 °
				-121.609068 °	-121.609068 °
DWR ID	DWR_NA0002_02_s _ 2012_5				
Action/Comments					
Trim trees over roadway to at least 12 feet above ground level.

Looking south at overhanging tree on waterward shoulder. (Fall 2014)

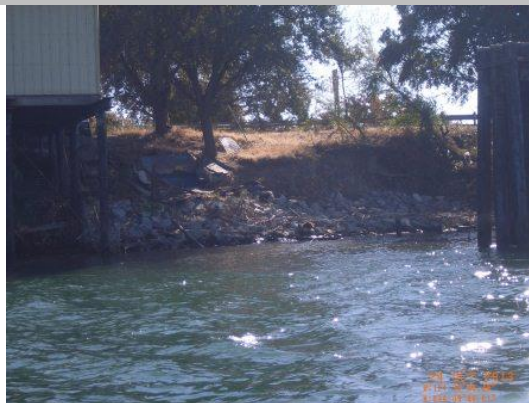
Photo 1 of 2 : SP_2015_NA0002_63_37_20150309_00032.jpg

LM Start	3.37	Rating **	U	Issue No.	37
LM End	3.56	Issue Type +	Ma	Location *	WS
Category	Supplemental			GPS Latitude/Longitude	
				Start	End
Item	USACE Erosion Survey			38.162641 °	38.162828 °
				-121.612800 °	-121.616263 °
DWR ID	DWR_NA0002_02_f_2014_37				
Action/Comments					
Inspector Comments: 2009 - Fluvial erosion, into the levee slope, close to vertical bank with roadway on top. Pilings that were once at the bankline are now 30 ft out. 2010 - Very steep slope with slumps and overturned trees. 2011 - Upgraded to CRITICAL. Sections of vertical slope with highway on top. Heavy vegetation in front of most of the erosion pockets. Structures built into the levee on the upstream end. 2012 - Site continues to worsen. 2013: Some rock added on the upstream end, but site remains critical. [2013 Site ID: SAC_17-2_L]

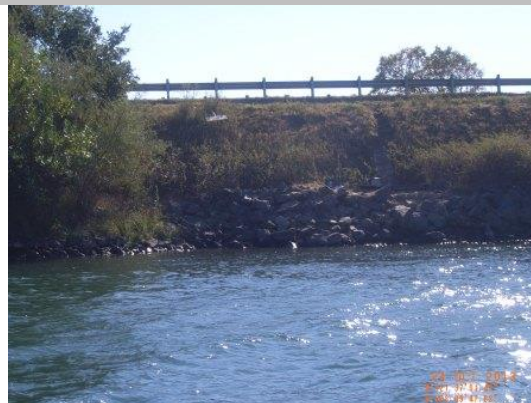
Photo 1 of 1 : SP_2015_NA0002_63_23_20150309_00021.jpg

LM Start	3.62	Rating **	U	Issue No.	23
LM End	3.73	Issue Type +	Ma	Location *	WS
Category	Supplemental			GPS Latitude/Longitude	
				Start	End
Item	USACE Erosion Survey			38.162959 °	38.163334 °
				-121.617323 °	-121.619312 °
DWR ID	DWR_NA0002_02_f_2014_23				
Action/Comments					
Inspector Comments: 2008 - Overstepped levee section with pocket erosion. Plans for repair currently in the design phase. 2010 - Very steep slope with slumps, longitudinal cracking, and overturned trees. 2011 - Upgraded to CRITICAL. Sections of vertical slope with highway on top. Heavy vegetation in front of most of the erosion pockets. 2013: No observed changes. [2013 Site ID: SAC_16-8_L]

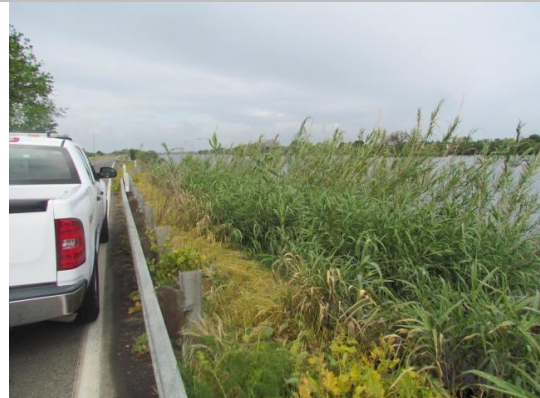
Photo 1 of 1 : SP_2015_NA0002_63_11_20150309_00011.jpg

LM Start	5.65	Rating **	A/W	Issue No.	11
LM End	5.69	Issue Type +	Ma	Location *	WS
Category	Earthen Levee			GPS Latitude/Longitude	
				Start	End
Item	Vegetation			38.172308 °	38.172497 °
				-121.651552 °	-121.652243 °
DWR ID	DWR_NA0002_02_s_2012_11				
Action/Comments					
Remove the wild growth other than native grasses from the levee slopes.					
Inspector Comments: Bamboo on waterward slope.

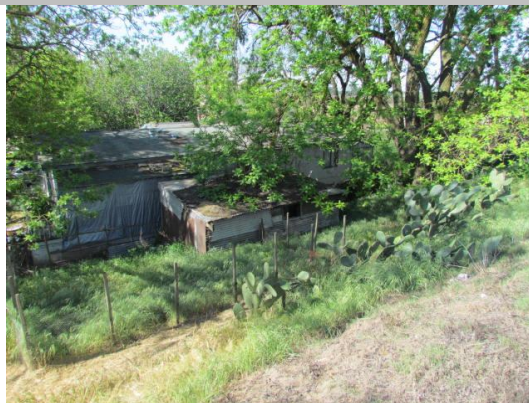
Photo 1 of 1 : SP_2015_NA0002_63_51_20150309_00050.jpg

LM Start	5.68	Rating **	M	Issue No.	51
LM End	5.68	Issue Type +	En	Location *	LS
Category	Earthen Levee			GPS Latitude/Longitude	
				Start	End
Item	Encroachments			38.172442 °	38.172442 °
				-121.652182 °	-121.652182 °
DWR ID	DWR_NA0002_02_s _ 2013_51				
Action/Comments					
Building					
Inspector Comments: Tool shed and animal pen at landside toe.

Looking east tool shed and animal corral on landward slope and toe.

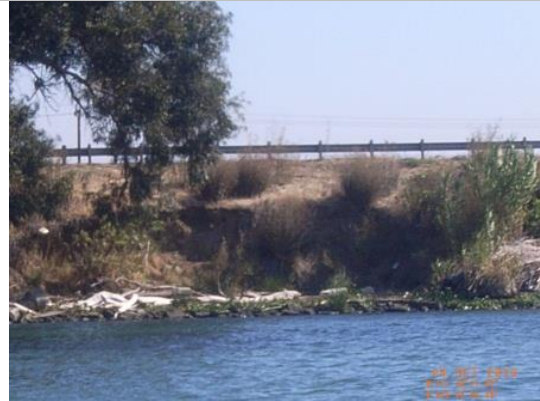
Photo 1 of 1 : SP_2015_NA0002_63_20_20150309_00020.jpg

LM Start	6.98	Rating **	M	Issue No.	20
LM End	7.04	Issue Type +	Ma	Location *	WS
Category	Supplemental			GPS Latitude/Longitude	
				Start	End
Item	USACE Erosion Survey			38.166583 °	38.165794 °
				-121.670684 °	-121.671014 °
DWR ID	DWR_NA0002_02_f_2014_20				
Action/Comments					
Inspector Comments: 2011 - Large section of bank slumped off. 2013: No observed changes. [2013 Site ID: SAC_13-6_L]

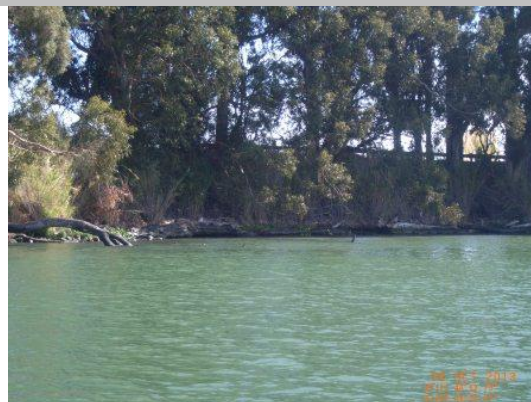
Photo 1 of 1 : SP_2015_NA0002_63_19_20150309_00019.jpg

LM Start	8.20	Rating **	M	Issue No.	19
LM End	8.42	Issue Type +	Ma	Location *	WS
Category	Supplemental			GPS Latitude/Longitude	
				Start	End
Item	USACE Erosion Survey			38.151867 °	38.148711 °
				-121.682201 °	-121.682790 °
DWR ID	DWR_NA0002_02_f_2014_19				
Action/Comments					
Inspector Comments: 2010 - Small inlet area behind a man-built spit. Bank is slumping and could possibly be fixed with maintenance. 2011 - Site continues to worsen. 2013: No observed changes. [2013 Site ID: SAC_12-1_L]

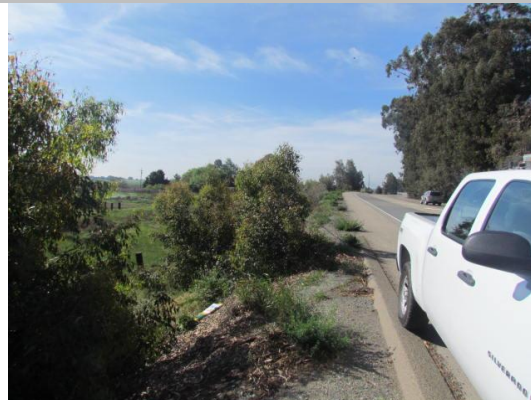
Photo 1 of 2 : SP_2015_NA0002_63_48_20150309_00046.jpg

LM Start	8.65	Rating **	U	Issue No.	48
LM End	8.86	Issue Type +	Ma	Location *	LS
Category	Earthen Levee			GPS Latitude/Longitude	
				Start	End
Item	Trim / Thin Trees			38.145368 °	38.142430 °
				-121.683072 °	-121.683978 °
DWR ID	DWR_NA0002_02_s_ 2013_48				
Action/Comments					
Trim trees to at least five feet above ground level.

Looking south at trees on landward slope.

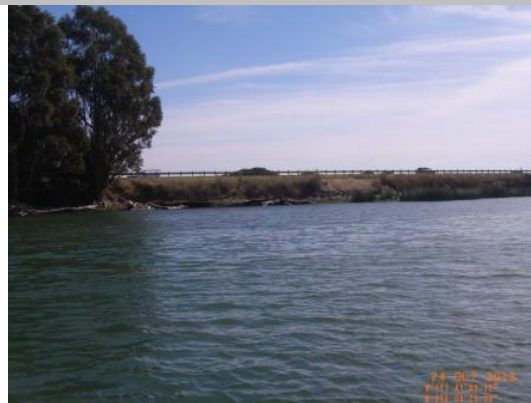
Photo 1 of 1 : SP_2015_NA0002_63_18_20150309_00018.jpg

LM Start	8.94	Rating **	U	Issue No.	18
LM End	9.18	Issue Type +	Ma	Location *	WS
Category	Supplemental			GPS Latitude/Longitude	
				Start	End
Item	USACE Erosion Survey			38.141399 °	38.138158 °
				-121.685346 °	-121.686531 °
DWR ID	DWR_NA0002_02_f_2014_18				
Action/Comments					
Inspector Comments: 2008 - Erosion causing vertical bank at the highway on top of levee. The whole bank along the highway should be repaired. 2009 - Minimal new erosion. 2011 - Bank continues to slowly erode. 2012 - Upgrade to critical, new erosion since lat year and steeper slopes in sections. 2013: No observed changes. [2013 Site ID: SAC_11-2_L]

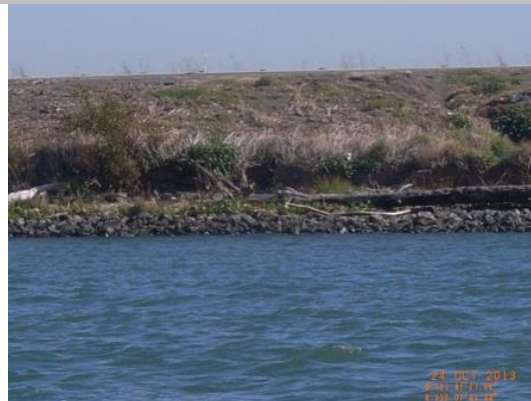
Photo 1 of 1 : SP_2015_NA0002_63_17_20150309_00017.jpg

LM Start	9.78	Rating **	M	Issue No.	17
LM End	9.93	Issue Type +	Ma	Location *	WS
Category	Supplemental			GPS Latitude/Longitude	
				Start	End
Item	USACE Erosion Survey			38.129722 °	38.127672 °
				-121.687468 °	-121.688646 °
DWR ID	DWR_NA0002_02_f_2014_17				
Action/Comments					
Inspector Comments: 2004 - Wave wash pockets approximately 100 ft long with new full bank rock between the pockets. 2005 - Spot repairs, but toe is still eroding in several places. 2006 - Low vertical bank along roadway. 2007 - A PL 84-99 repair was constructed, it cover the majority of the site with the exception of the upstream 150 to 200 ft and the downstream 250 ft, therefore it is being kept in the inventory. 2009 - Minimal new erosion. 2010 - Outboard berm looks good, but the banks are still very steep. 2011 - While the outboard berm is protecting against wave wash, bank still has slumping issues. 2013: No observed changes. [2013 Site ID: SAC_10-8_L]
