**Flood Control Project Maintenance
Levee Inspections****LMA District Cover Sheet****Spring 2016 Levee Inspection Results****Brannan Andrus Levee Maintenance District**

Spring 2016 Levee Inspection Results

Brannan Andrus Levee Maintenance District

Waterway			Bank	Unit Miles
Unit No. 01 Georgiana Slough			Right	6.01
	Spring (March - May)	Summer (June - August)	(September - November) Fall	Winter (December - February)
Unit Maintenance Rating (Fall Only)				
Date of Inspection	3/22/2016 - 3/22/2016			
DWR Inspector	Richard Willoughby			
Accompanied By	Gilbert Labrie DCC Engineering Co, Inc

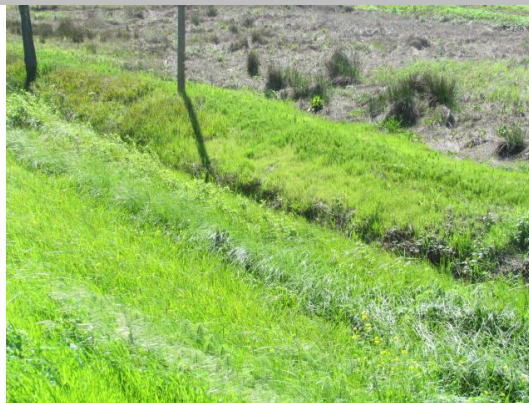
Photo 2 of 4 : SP_2016_NA0002_62_67_20160323_00098.jpg

LM Start	0.50	Rating **	A	Issue No.	67 (cont)
LM End	2.17	Issue Type +	Ob	Location *	LS

Looking north at drainage ditch along landward toe.

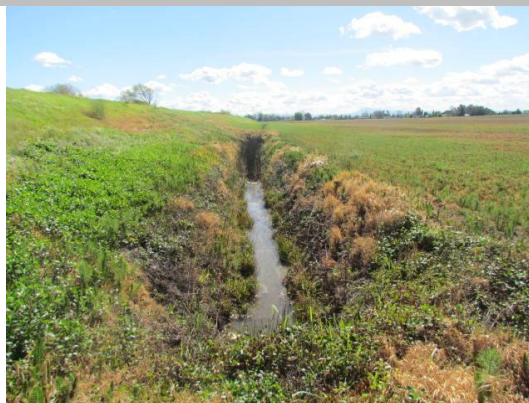
Photo 3 of 4 : SP_2016_NA0002_62_67_20160323_00100.jpg

Looking south at drainage ditch along landward toe.

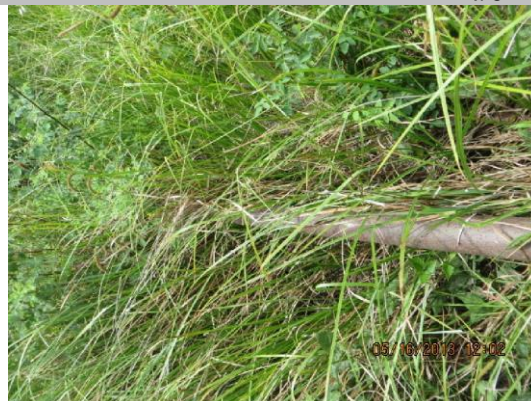
Photo 1 of 2 : UCIP_SP_2016_13560_22173.jpg

LM Start	0.61	Rating **	M	Issue No.	72
LM End	0.61	Issue Type +	En	Location *	LS
Category	Supplemental			GPS Latitude/Longitude	
				Start	End
Item	DWR UCIP Field Study			38.182213 °	38.182213 °
				-121.572357 °	-121.572357 °
DWR ID					
Comment Code					
Inspector Comment					
FS_ID:13560 DS_ID:21752 EP_NO: 2015 Repair Type: Non-Urgent Crossing Status: Found UCIP Comments: This pipe appears abandoned and should be removed. FIELD_STRUCT_DESC: 2-inch galvanized pipe through levee 2.0 feet below crown. Gas well drain (Permit No. 2015, 1959). FS Date: 5/16/2013

Pipe in grass on WS slope.

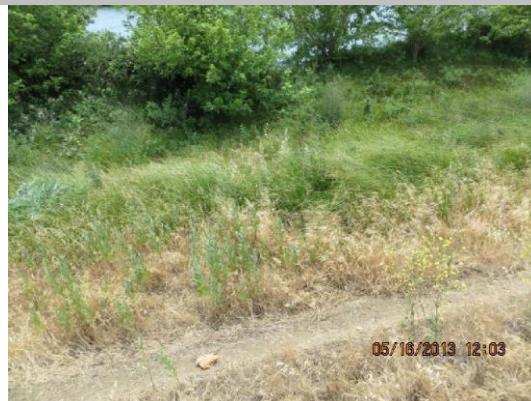
Photo 2 of 2 : UCIP_SP_2016_13560_22172.jpg

Pipe in grass on WS slope.

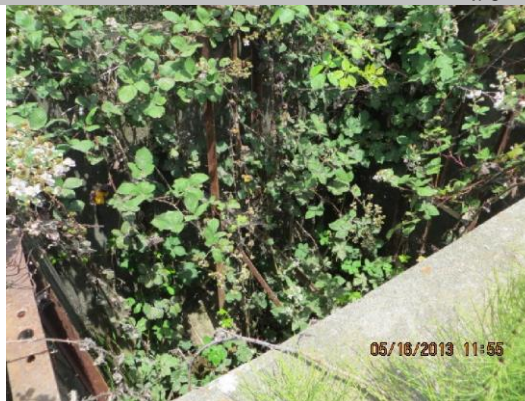
Photo 1 of 1 : UCIP_SP_2016_15984_26969.jpg

LM Start	0.75	Rating **	M	Issue No.	78
LM End	0.75	Issue Type +	En	Location *	LS
Category	Supplemental			GPS Latitude/Longitude	
				Start	End
Item	DWR UCIP Field Study			38.182212 °	38.182212 °
				-121.574987 °	-121.574987 °
DWR ID					
Comment Code					
Inspector Comment					
FS_ID:15984					
DS_ID:21753					
EP_NO: 11232					
Repair Type: Non-Urgent					
Crossing Status: Found					
UCIP Comments: Unable to locate any appurtances other than distro box. Need to verify proper abandonment.					
FIELD_STRUCT_DESC: 12-inch pipe through levee 3.2 feet below crown. Siphon breaker on landward slope. Concrete distribution box located landward of the toe (ABO No. 11232, 1975). 2" primer valve. Originally included in the 1954 O&M manual.					
FS Date: 5/16/2013

Concrete distribution box on LS toe.

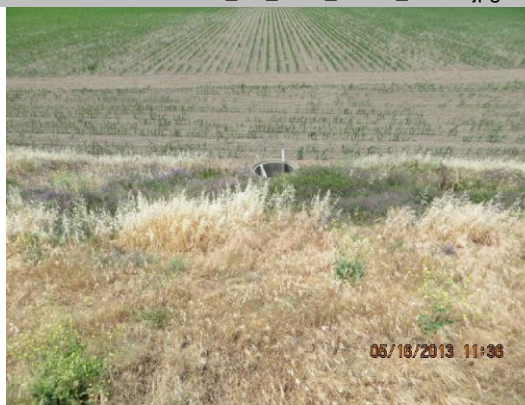
Photo 1 of 2 : UCIP_SP_2016_13558_22169.jpg

LM Start	1.22	Rating **	M	Issue No.	71
LM End	1.22	Issue Type +	En	Location *	LS
Category	Supplemental			GPS Latitude/Longitude	
				Start	End
Item	DWR UCIP Field Study			38.177669 °	38.177669 °
				-121.580222 °	-121.580222 °
DWR ID					
Comment Code					
Inspector Comment					
FS_ID:13558 DS_ID:21754 EP_NO: 11234 Repair Type: Non-Urgent Crossing Status: Found UCIP Comments: Appears abandoned and should be done so properly. FIELD_STRUCT_DESC: 1 of 2: 8-inch steel pipe through levee 4.3 feet below crown. Pump in pump house on waterward berm. 60-inch diameter concrete standpipe on LS toe (ABO No. 11234, 1975). Originally included in the 1954 O&M manual. FS Date: 5/16/2013

Concrete standpipe on LS toe.

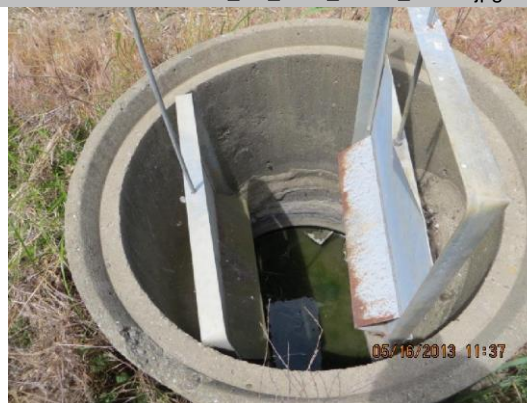
Photo 2 of 2 : UCIP_SP_2016_13558_22168.jpg

Concrete standpipe on LS toe.

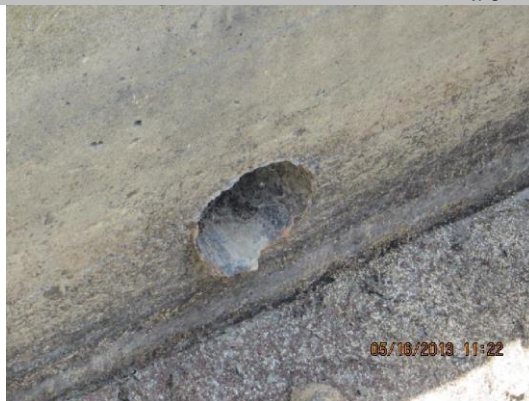
Photo 2 of 2 : UCIP_SP_2016_13554_22163.jpg

LM Start	1.54	Rating **	M	Issue No.	70 (cont)	
LM End	1.54	Issue Type +	En	Location *	LS	
Category	Supplemental			GPS Latitude/Longitude		
				Start		End
Item	DWR UCIP Field Study			38.173254 °		38.173254 °
				-121.580718 °		-121.580718 °
DWR ID						
Comment Code						
Inspector Comment						
FS_ID:13554 DS_ID:21755 EP_NO: 11252 Repair Type: Non-Urgent Crossing Status: Found UCIP Comments: Pipe heavily rusted at distribution box. Good candidate for video inspection. FIELD_STRUCT_DESC: 1 of 3: 8-inch steel pipe through levee 4.6 feet below crown. Pump and valve on waterward slope. Siphon breaker in 24-inch CMP riser on LS shoulder. 7'X10'-concrete distribution box at LS toe (ABO No. 11252, 1976). Originally included in the 1954 O&M manual. FS Date: 5/16/2013

Pipe shows excessive rust at inlet to distribution box on LS toe.

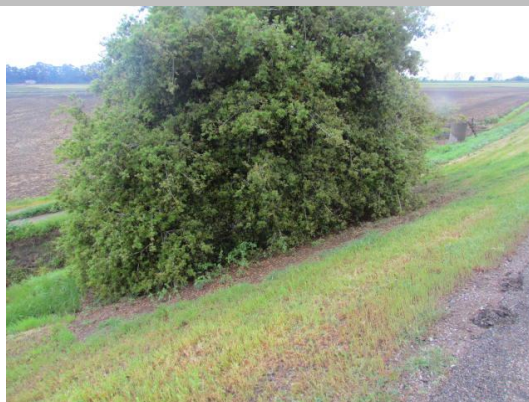
Photo 1 of 3 : SP_2016_NA0002_62_25_20160308_00024.jpg

LM Start	1.56	Rating **	U	Issue No.	25
LM End	1.56	Issue Type +	Ma	Location *	LS
Category	Earthen Levee			GPS Latitude/Longitude	
				Start	End
Item	Trim / Thin Trees			38.172869 °	38.172869 °
				-121.580681 °	-121.580681 °
DWR ID	DWR_NA0002_01_s_2012_25				
Comment Code					
T1 : Trim trees to at least five feet above ground level.					
Inspector Comment					
Tree blocking landward toe.

Looking northwest at untrimmed tree at landward toe. (Spring 2015)

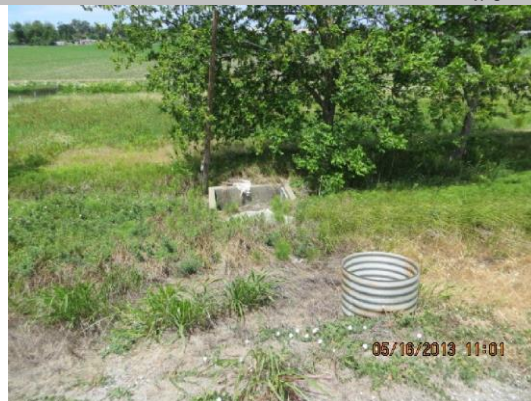
Photo 1 of 2 : UCIP_SP_2016_13549_22155.jpg

LM Start	2.17	Rating **	M	Issue No.	68
LM End	2.17	Issue Type +	En	Location *	LS
Category	Supplemental			GPS Latitude/Longitude	
				Start	End
Item	DWR UCIP Field Study			38.164491 °	38.164491 °
				-121.583943 °	-121.583943 °
DWR ID					
Comment Code					
Inspector Comment					
FS_ID:13549 DS_ID:21758 EP_NO: 11252 Repair Type: Non-Urgent Crossing Status: Found UCIP Comments: Pipe rusted through at inlet to box. Good candidate for video inspection. FIELD_STRUCT_DESC: 3 of 3: 12-inch steel pipe through the levee 4.0 feet below the crown. Slant pump on bank. Switch box on berm, conduit through levee. Siphon breaker in 24-inch CMP riser on landward slope. Power pole and electrical panel at landward toe (ABO No. 11252, 1975). 7'X10' concrete distribution box on LS toe. Originally included in the 1954 O&M manual. FS Date: 5/16/2013

Concrete distribution box and siphon breaker in CMP riser on LS.

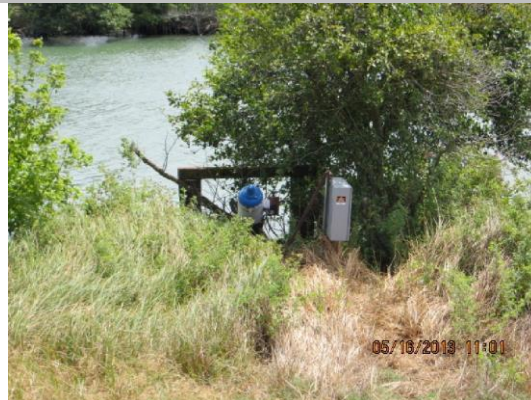
Photo 2 of 2 : UCIP_SP_2016_13549_22154.jpg

Slant pump on WS toe.

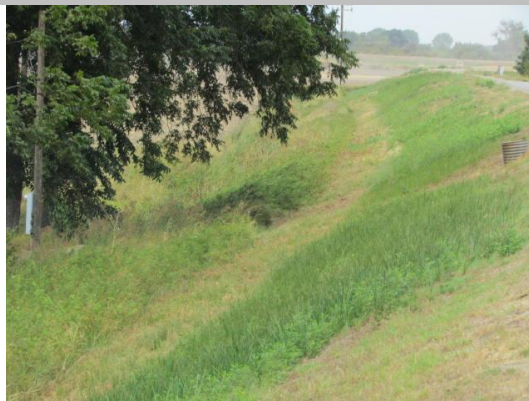
Photo 1 of 2 : SP_2016_NA0002_62_26_20160308_00027.jpg

Looking west at dense vegetation at landward toe.

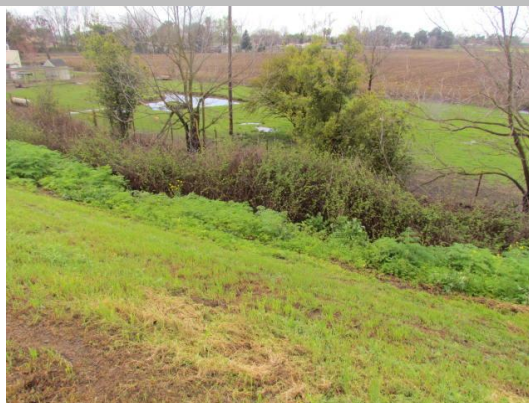
Photo 2 of 2 : SP_2016_NA0002_62_26_20160308_00028.jpg

Looking southwest at dense vegetation at landward toe.

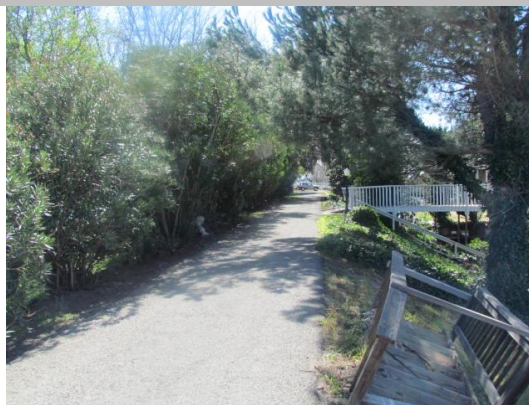
Photo 2 of 4 : SP_2016_NA0002_62_36_20160308_00034.jpg

Looking south at dense oleander on waterside shoulder, spring 2012.

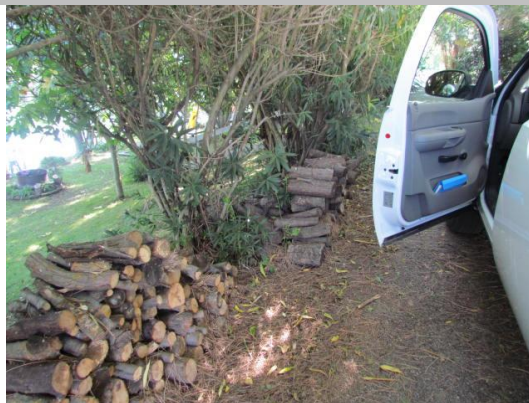
Photo 1 of 3 : SP_2016_NA0002_62_3_20160308_00003.jpg

LM Start	2.30	Rating **	M	Issue No.	3
LM End	2.30	Issue Type +	Ma	Location *	WS
Category	Earthen Levee			GPS Latitude/Longitude	
				Start	End
Item	Encroachments			38.162773 °	38.162773 °
				-121.584767 °	-121.584767 °
DWR ID	DWR_NA0002_01_s _ 2012_3				
Comment Code					
FW : Firewood					
Inspector Comment

Looking east at firewood on waterside shoulder.

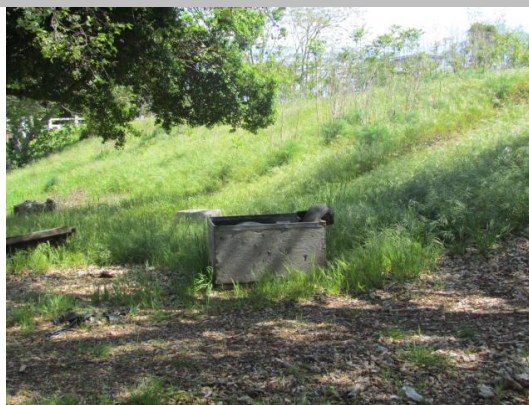
Photo 1 of 1 : SP_2016_NA0002_62_8_20160308_00007.jpg

LM Start	2.40	Rating **	M	Issue No.	8
LM End	2.40	Issue Type +	Ma	Location *	LS
Category	Earthen Levee			GPS Latitude/Longitude	
				Start	End
Item	Encroachments			38.161573 °	38.161573 °
				-121.585720 °	-121.585720 °
DWR ID	DWR_NA0002_01_s _ 2013_8				
Comment Code					
GA : Garbage					
Inspector Comment

Looking northeast at garbage at landward toe.

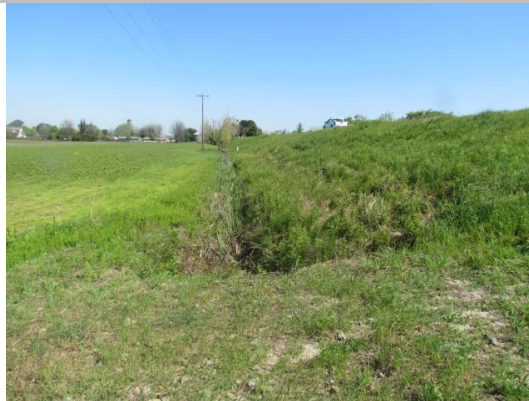
Photo 2 of 3 : SP_2016_NA0002_62_56_20160308_00053.jpg

Looking north at south end of ditch within fifteen feet of landward toe.

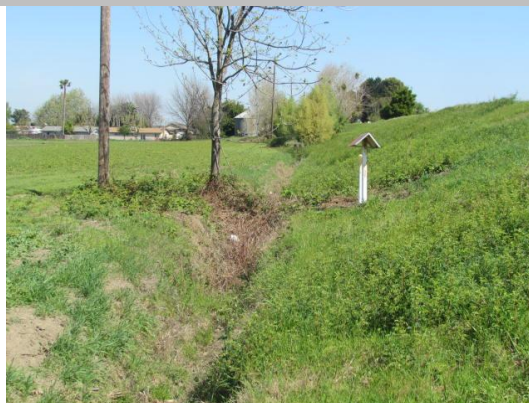
Photo 3 of 3 : SP_2016_NA0002_62_56_20160308_00054.jpg

Looking north at ditch within fifteen feet of landward toe.

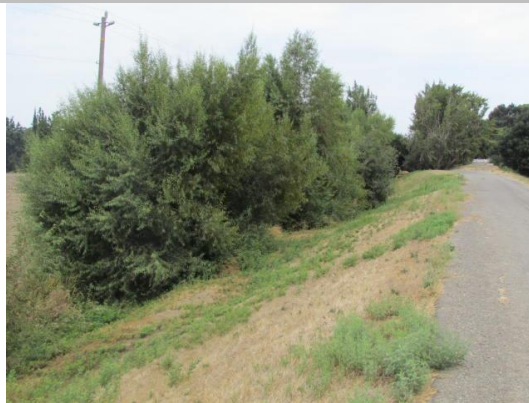
Photo 1 of 1 : SP_2016_NA0002_62_28_20160308_00029.jpg

LM Start	2.45	Rating **	U	Issue No.	28
LM End	2.49	Issue Type +	Ma	Location *	LS
Category	Earthen Levee			GPS Latitude/Longitude	
				Start	End
Item	Vegetation			38.160805 °	38.160281 °
				-121.585782 °	-121.586007 °
DWR ID	DWR_NA0002_01_s _ 2013_28				
Comment Code					
V2 : Remove the wild growth other than native grasses from the levee slopes.					
Inspector Comment					
Dense vegetation and wild roses on landside slope and toe.

Look west at dense vegetation at landward toe.

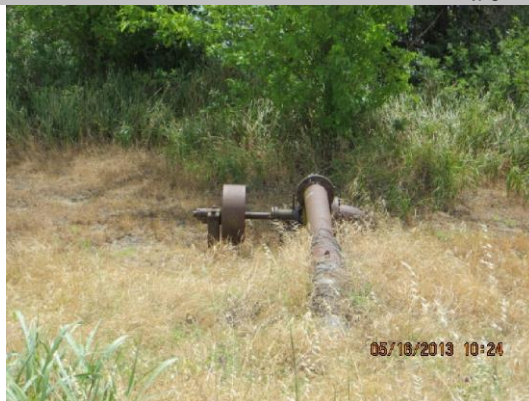
Photo 1 of 2 : UCIP_SP_2016_13545_22145.jpg

FS_ID:13545
DS_ID:21762
EP_NO: N/A
Repair Type: Non-Urgent
Crossing Status: Found
UCIP Comments: Pipe appears abandoned and should be done so properly. standpipe on LS is covered in brush.
FIELD_STRUCT_DESC: 8-inch steel pipe through the levee 3.4 feet below the crown. 6" pump on waterward side. 36-inch concrete standpipe on LS toe. Originally included in the 1954 O&M manual.
FS Date: 5/16/2013

Pipe and pump on WS slope.

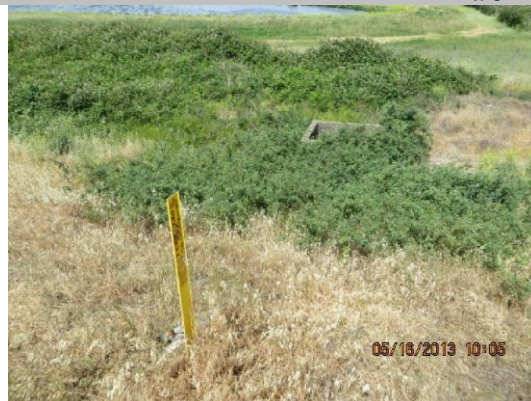
Photo 1 of 2 : UCIP_SP_2016_42846_22124.jpg

Comment Code					
Inspector Comment					
FS_ID:42846 DS_ID:21765 EP_NO: 11238 Repair Type: Urgent Crossing Status: Found UCIP Comments: Erosion along pipe at WS toe goes into levee prism. Animal activity appears to be the cause of some pretty heavy erosion damage. Some settlement along the pipe alignment on crown may indicate other problems with this pipe. FIELD_STRUCT_DESC: 1 of 5: 12-inch steel pipe through levee 4.0 feet below crown. Siphon breaker on landward shoulder. 7X9-foot concrete distribution box on LS toe (ABO No. 11238, 1975). Originally included in the 1954 O&M manual. (pipe replaced under Permit No. 18549 7/11/2009). FS Date: 5/16/2013

Pipe visible on LS shoulder with concrete distribution box on LS toe.
Gasline marker placed at pipe.

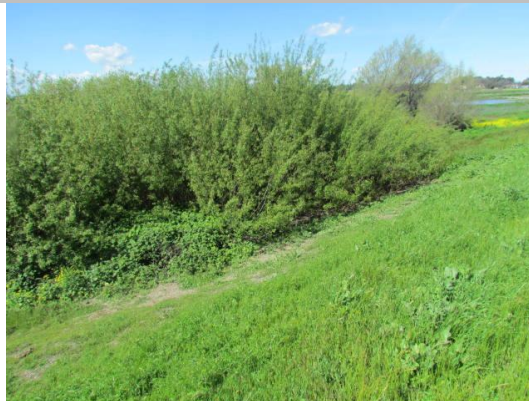
Photo 1 of 4 : SP_2016_NA0002_62_55_20160323_00102.jpg

Looking northwest at dense vegetation at landward toe. (Spring 2016)

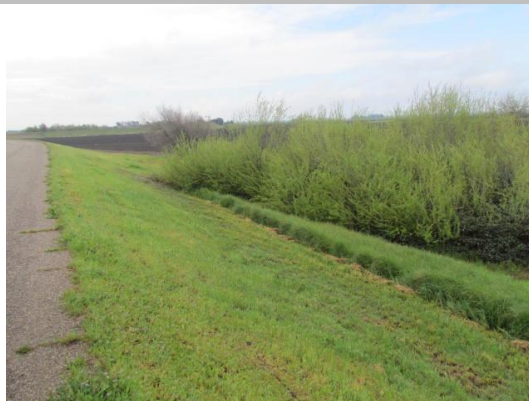
Photo 2 of 4 : SP_2016_NA0002_62_55_20160308_00049.jpg

Looking southwest at dense vegetation at landward toe. (Spring 2015)

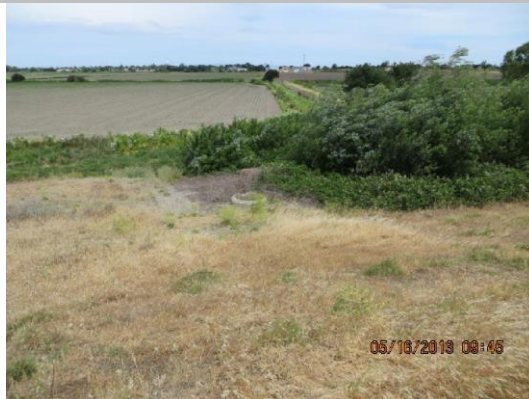
Photo 2 of 2 : UCIP_SP_2016_41561_27228.jpg

LM Start	3.01	Rating **	M	Issue No.	80 (cont)	
LM End	3.01	Issue Type +	En	Location *	LS	
Category	Supplemental			GPS Latitude/Longitude		
				Start		End
Item	DWR UCIP Field Study			38.156379 °		38.156379 °
				-121.592527 °		-121.592527 °
DWR ID						
Comment Code						
Inspector Comment						
FS_ID:41561						
DS_ID:21766						
EP_NO: N/A						
Repair Type: Non-Urgent						
Crossing Status: Indicator Found						
UCIP Comments: Appears abandoned						
FIELD_STRUCT_DESC: 12-inch pipeline through levee, 5-foot diameter concrete riser on LS toe.						
FS Date: 5/16/2013

5-foot diameter concrete riser on LS toe, but no pipe visible.

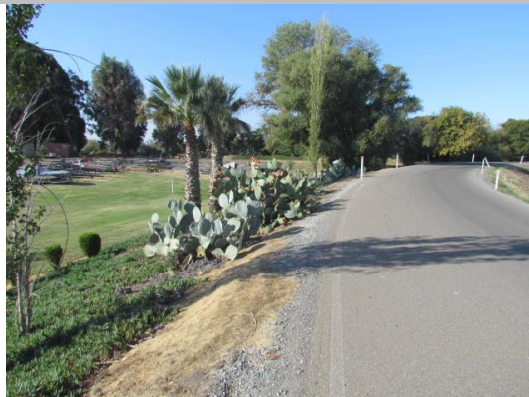
Photo 1 of 1 : SP_2016_NA0002_62_5_20160308_00006.jpg

LM Start	3.37	Rating **	M	Issue No.	5
LM End	3.37	Issue Type +	Ma	Location *	WS
Category	Earthen Levee			GPS Latitude/Longitude	
				Start	End
Item	Vegetation			38.151492 °	38.151492 °
				-121.591942 °	-121.591942 °
DWR ID	DWR_NA0002_01_f_2013_5				
Comment Code					
V2 : Remove the wild growth other than native grasses from the levee slopes.					
Inspector Comment					
Remove cactus from waterward slope.

Looking south at cacti on waterward slope near Oxbow Harbor.

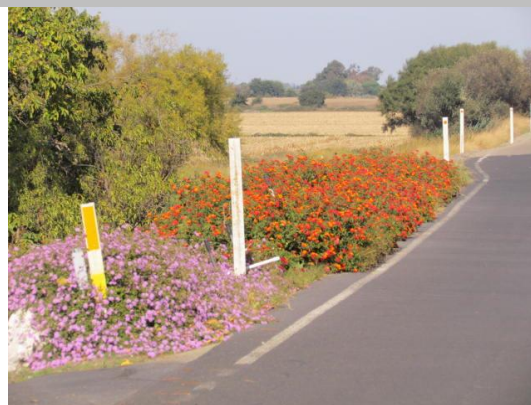
Photo 1 of 3 : SP_2016_NA0002_62_11_20160308_00011.jpg

LM Start	3.93	Rating **	U	Issue No.	11
LM End	3.97	Issue Type +	En	Location *	LS
Category	Earthen Levee			GPS Latitude/Longitude	
				Start	End
Item	Vegetation			38.148318 °	38.147898 °
				-121.599947 °	-121.600347 °
DWR ID	DWR_NA0002_01_s _ 2012_11				
Comment Code					
V6 : Landscaping					
Inspector Comment

Looking northeast at landscaping on landside slope.

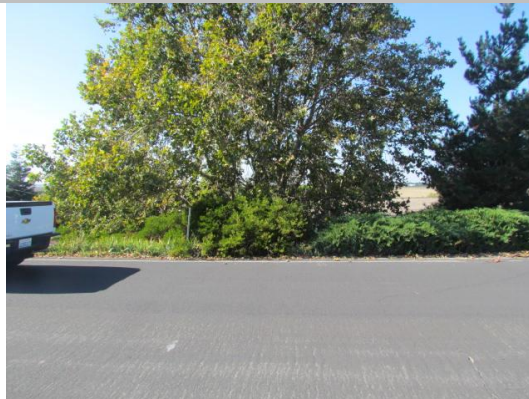
Photo 3 of 3 : SP_2016_NA0002_62_11_20160308_00013.jpg

Looking west at dense landscaping on landside slope.

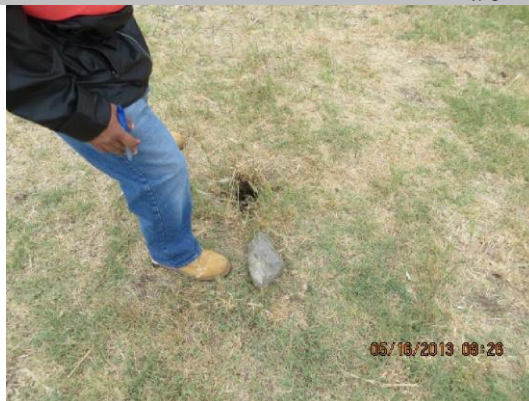
Photo 2 of 2 : UCIP_SP_2016_13487_22052.jpg

LM Start	3.99	Rating **	M	Issue No.	75 (cont)	
LM End	3.99	Issue Type +	En	Location *	LS	
Category	Supplemental			GPS Latitude/Longitude		
				Start	End	
Item	DWR UCIP Field Study			38.147653 °	38.147653 °	
				-121.600491 °	-121.600491 °	
DWR ID						
Comment Code						
Inspector Comment						
FS_ID:13487						
DS_ID:21825						
EP_NO: 11248						
Repair Type: Non-Urgent						
Crossing Status: Found						
UCIP Comments: Leakage of pipe at WS toe creating erosion.						
Possible cavity collapse along pipe alignment on WS berm.						
FIELD_STRUCT_DESC: 2 of 2: 4-inch pipe through levee 4.0 feet below crown. Siphon breaker on waterward slope. Pump on landward side (ABO No. 11248, 1975).						
FS Date: 5/16/2013

Possible indicator of internal pipe failure along pipe alignment as there appears to be a cavity collapse over the pipe on the WS berm.

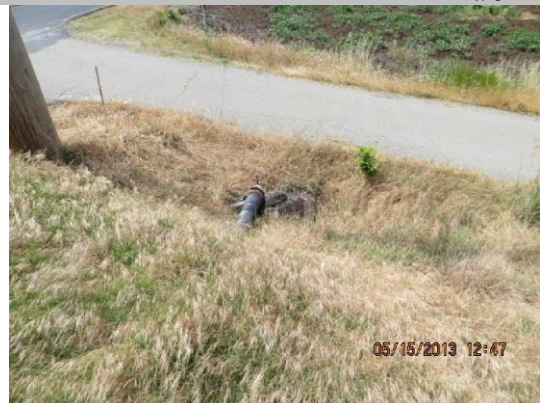
Photo 1 of 2 : UCIP_SP_2016_13483_22042.jpg

LM Start	4.04	Rating **	U	Issue No.	74
LM End	4.04	Issue Type +	En	Location *	LS
Category	Supplemental			GPS Latitude/Longitude	
				Start	End
Item	DWR UCIP Field Study			38.146985 °	38.146985 °
				-121.601019 °	-121.601019 °
DWR ID					
Comment Code					
Inspector Comment					
FS_ID:13483 DS_ID:21775 EP_NO: 11238 Repair Type: Urgent Crossing Status: Found UCIP Comments: Missing cover on concrete sump is an immediate hazard and should be repaired. FIELD_STRUCT_DESC: 5 of 5: 8-inch steel pipe through levee 3.7 feet below crown. 5X5-foot concrete spillbox on LS slope (ABO No. 11238, 1975). Originally included in the 1954 O&M manual. FS Date: 5/8/2013

Pipe and concrete sump on LS.

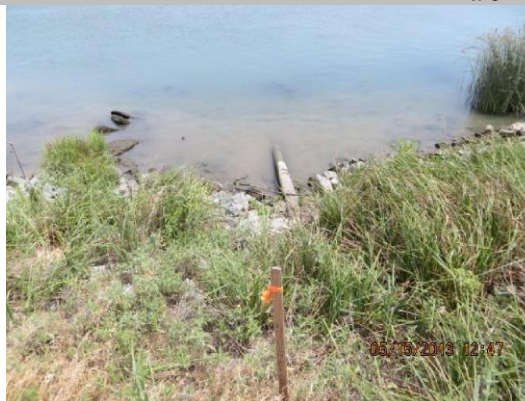
Photo 2 of 2 : UCIP_SP_2016_13483_22041.jpg

LM Start	4.04	Rating **	U	Issue No.	74 (cont)	
LM End	4.04	Issue Type +	En	Location *	LS	
Category	Supplemental			GPS Latitude/Longitude		
				Start	End	
Item	DWR UCIP Field Study			38.146985 °	38.146985 °	
				-121.601019 °	-121.601019 °	
DWR ID						
Comment Code						
Inspector Comment						
FS_ID:13483						
DS_ID:21775						
EP_NO: 11238						
Repair Type: Urgent						
Crossing Status: Found						
UCIP Comments: Missing cover on concrete sump is an immediate hazard and should be repaired.						
FIELD_STRUCT_DESC: 5 of 5: 8-inch steel pipe through levee 3.7 feet below crown. 5X5-foot concrete spillbox on LS slope (ABO No. 11238, 1975). Originally included in the 1954 O&M manual.						
FS Date: 5/8/2013

Pipe visible at waters edge on WS toe.

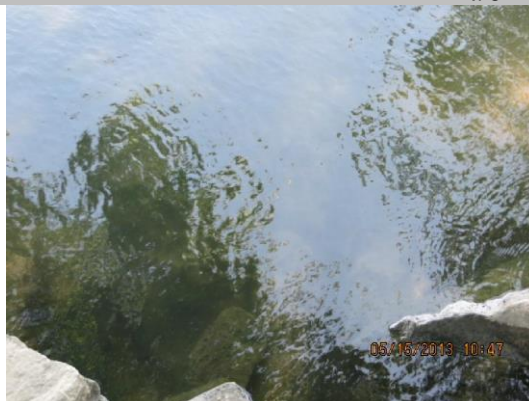
Photo 1 of 2 : UCIP_SP_2016_13442_21942.jpg

FS_ID:13442
DS_ID:21781
EP_NO: 11237
Repair Type: Non-Urgent
Crossing Status: Found
UCIP Comments: Appears abandoned. Good candidate for video inspection.
FIELD_STRUCT_DESC: 3 of 3: 6-inch steel pipe through levee 3.6 feet below crown. 42-inch concrete standpipe on LS toe.. (ABO No. 11237, 1975). Originally included in the 1954 O&M manual.
FS Date: 5/15/2013

Pipe visible just under the water surface

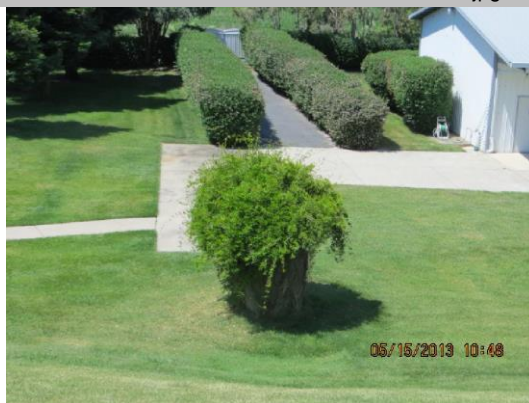
Photo 2 of 2 : UCIP_SP_2016_13442_21941.jpg

42-inch concrete riser on LS toe.

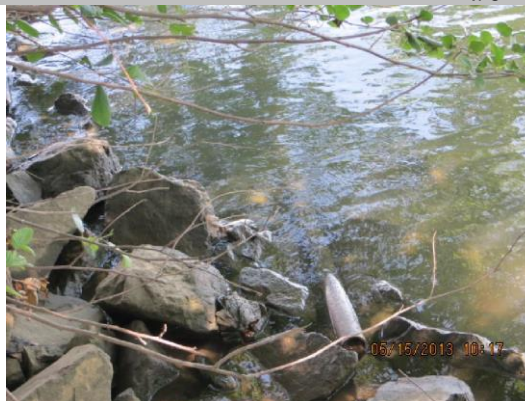
Photo 1 of 1 : UCIP_SP_2016_41562_21935.jpg

LM Start	4.79	Rating **	M	Issue No.	81
LM End	4.79	Issue Type +	En	Location *	LS
Category	Supplemental			GPS Latitude/Longitude	
				Start	End
Item	DWR UCIP Field Study			38.137306 °	38.137306 °
				-121.596371 °	-121.596371 °
DWR ID					
Comment Code					
Inspector Comment					
FS_ID:41562 DS_ID:21782 EP_NO: 11233 Repair Type: Non-Urgent Crossing Status: Indicator Found UCIP Comments: Need to verify type of abandonment. FIELD_STRUCT_DESC: 2.5-inch pipe through levee 3.2 feet below crown. Found pipe in water on WS toe. (ABO No. 11233, 1975). FS Date: 5/15/2013

Pipe found at WS shoreline.

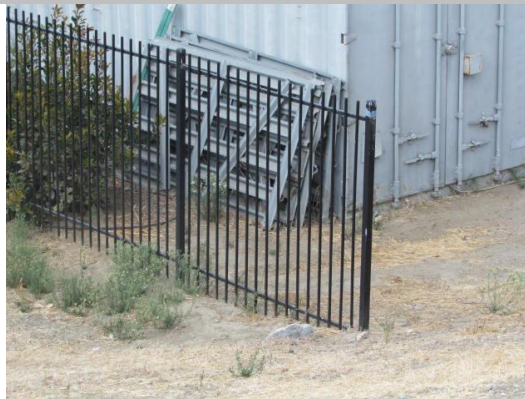
Photo 1 of 2 : SP_2016_NA0002_62_48_20160308_00038.jpg

LM Start	4.83	Rating **	M	Issue No.	48
LM End	4.83	Issue Type +	En	Location *	LS
Category	Earthen Levee			GPS Latitude/Longitude	
				Start	End
Item	Encroachments			38.136839 °	38.136839 °
				-121.595994 °	-121.595994 °
DWR ID	DWR_NA0002_01_f_2015_48				
Comment Code					
FE : Fence					
Inspector Comment					
Unauthorized fence at landward toe.

Looking at close-up view of fence at landward toe.

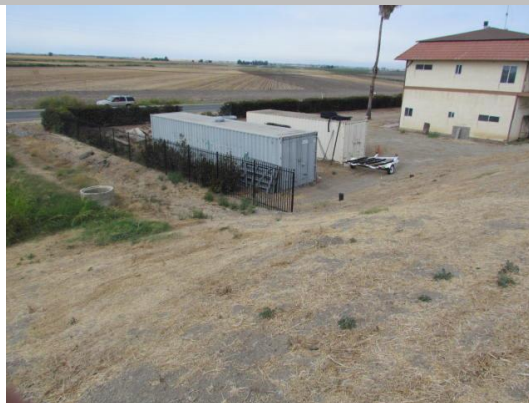
Photo 2 of 2 : SP_2016_NA0002_62_48_20160308_00039.jpg

LM Start	4.83	Rating **	M	Issue No.	48 (cont)	
LM End	4.83	Issue Type +	En	Location *	LS	
Category	Earthen Levee			GPS Latitude/Longitude		
				Start		End
Item	Encroachments			38.136839 °		38.136839 °
				-121.595994 °		-121.595994 °
DWR ID	DWR_NA0002_01_f_2015_48					
Comment Code						
FE : Fence						
Inspector Comment						
Unauthorized fence at landward toe.

Looking southwest at unfinished fence at landward toe.

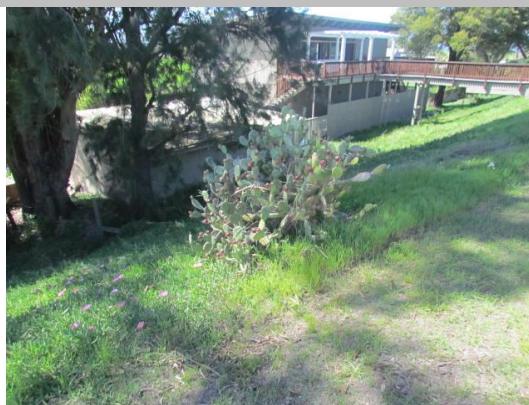
Photo 1 of 1 : SP_2016_NA0002_62_65_20160323_00103.jpg

LM Start	5.12	Rating **	M	Issue No.	65
LM End	5.12	Issue Type +	Ma	Location *	LS
Category	Earthen Levee			GPS Latitude/Longitude	
				Start	End
Item	Vegetation			38.133695 °	38.133695 °
				-121.592516 °	-121.592516 °
DWR ID	DWR_NA0002_01_s _ 2016_65				
Comment Code					
V2 : Remove the wild growth other than native grasses from the levee slopes.					
Inspector Comment					
Remove cactus from landward slope.

Looking south at cactus on landward slope.

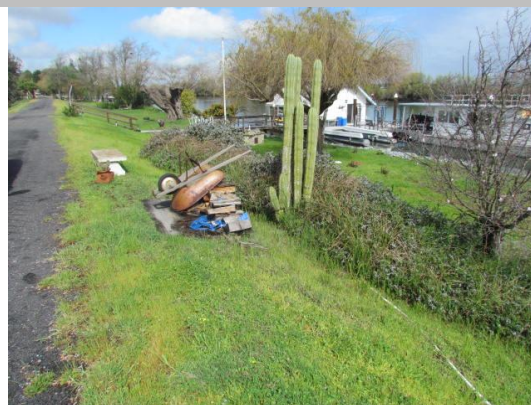
Photo 1 of 2 : SP_2016_NA0002_62_61_20160308_00056.jpg

Looking northeast at overgrowth landscaping on waterward slope.
(Spring 2015)

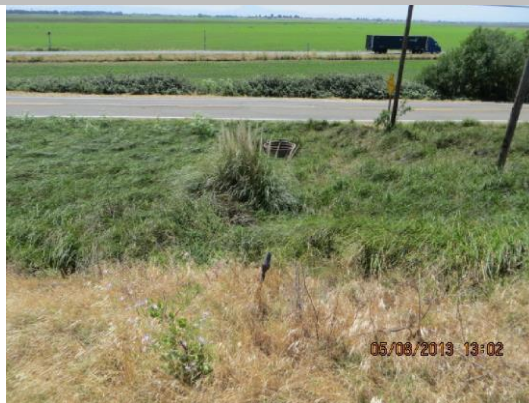
Photo 1 of 2 : UCIP_SP_2016_13090_21282.jpg

LM Start	5.36	Rating **	M	Issue No.	69
LM End	5.36	Issue Type +	En	Location *	WS
Category	Supplemental			GPS Latitude/Longitude	
				Start	End
Item	DWR UCIP Field Study			38.131048 °	38.131048 °
				-121.589655 °	-121.589655 °
DWR ID					
Comment Code					
Inspector Comment					
FS_ID:13090 DS_ID:21816 EP_NO: 11245 Repair Type: Non-Urgent Crossing Status: Found UCIP Comments: Appears abandoned. Pipe at slide gate in riser on LS toe is rusted through. FIELD_STRUCT_DESC: 1 of 2: 14-inch steel pipe through levee 3.8 feet below crown (ABO 11245, 1975). 2" primer valve and 48-inch concrete standpipe on LS. Originally included in the 1954 O&M manual. FS Date: 5/8/2013

Filler pipe and standpipe on LS.

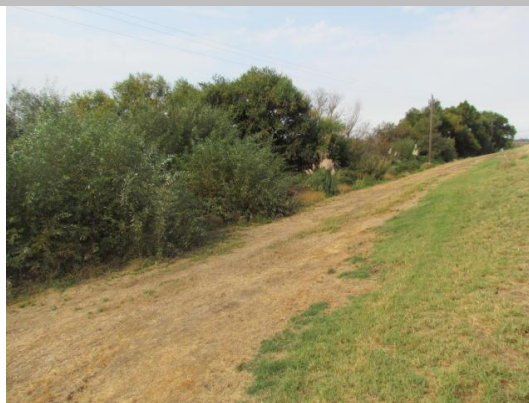
Photo 2 of 6 : SP_2016_NA0002_62_23_20160308_00018.jpg

Looking west at dense vegetation at landward toe.

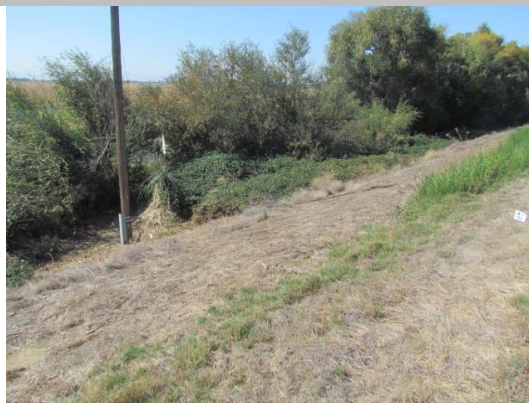
Photo 5 of 6 : SP_2016_NA0002_62_23_20160308_00021.jpg

Looking south at dense berry vines and trees on the landward slope and toe.

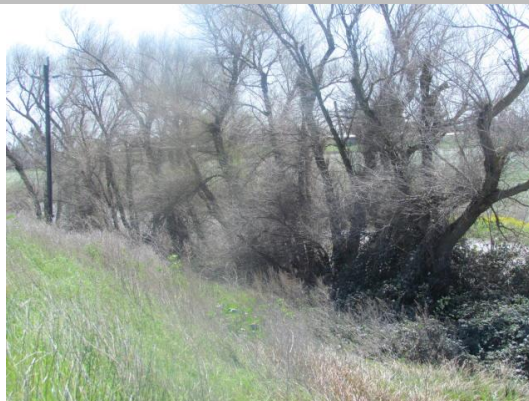
Photo 6 of 6 : SP_2016_NA0002_62_23_20160308_00022.jpg

Looking south at trees, berry vines, and wild rose on landside toe.

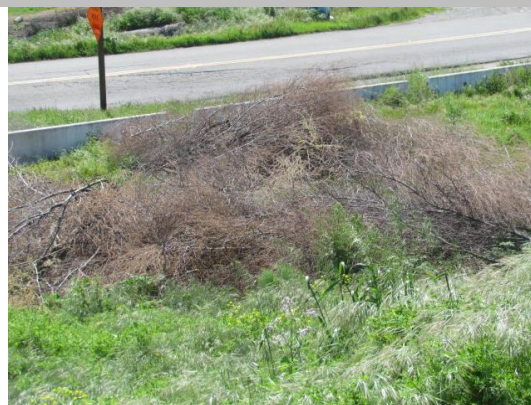
Photo 1 of 1 : SP_2016_NA0002_62_64_20160323_00106.jpg

LM Start	5.65	Rating **	M	Issue No.	64
LM End	5.65	Issue Type +	Ma	Location *	LS
Category	Earthen Levee			GPS Latitude/Longitude	
				Start	End
Item	Encroachments			38.129243 °	38.129243 °
				-121.585098 °	-121.585098 °
DWR ID	DWR_NA0002_01_s _ 2016_64				
Comment Code					
PR : Prunings					
Inspector Comment					
Prunings on landward slope.

Looking southwest at prunings at landward toe and berm.

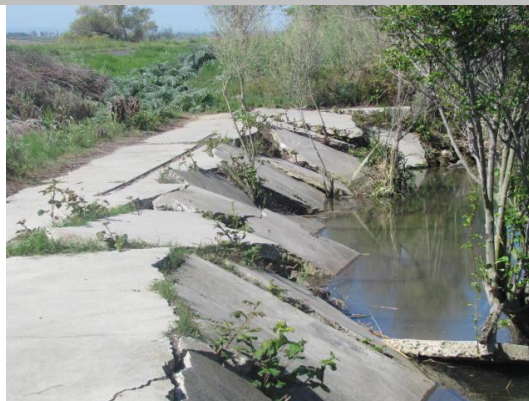
Photo 1 of 4 : SP_2016_NA0002_62_53_20160308_00044.jpg

LM Start	5.72	Rating **	U	Issue No.	53
LM End	5.72	Issue Type +	En	Location *	WS
Category	Earthen Levee			GPS Latitude/Longitude	
				Start	End
Item	Encroachments			38.129392 °	38.129392 °
				-121.583782 °	-121.583782 °
DWR ID	DWR_NA0002_01_s _ 2014_53				
Comment Code					
MA : Material					
Inspector Comment					
Concrete slabs on water ward berm area. Possible undermining. The Slab should be removed or broken up in place to meet Title 23 standard for Rip Rap.

Looking north at a collapsed concrete slab on waterward berm.

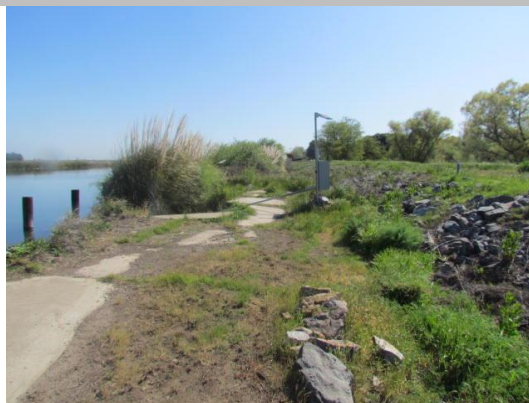
Photo 2 of 4 : SP_2016_NA0002_62_53_20160308_00045.jpg

Looking south at south end of a concrete slab on waterward berm.

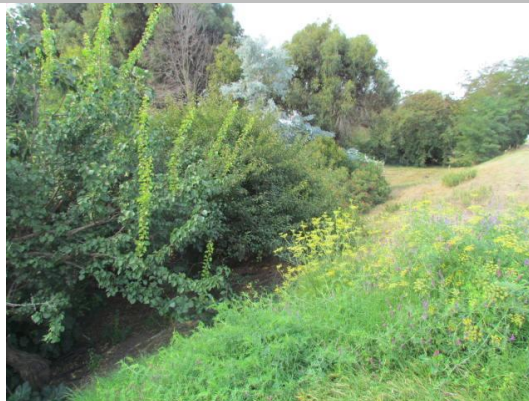
Photo 1 of 2 : SP_2016_NA0002_62_52_20160308_00042.jpg

Looking west at dense trees on landward slope & toe.

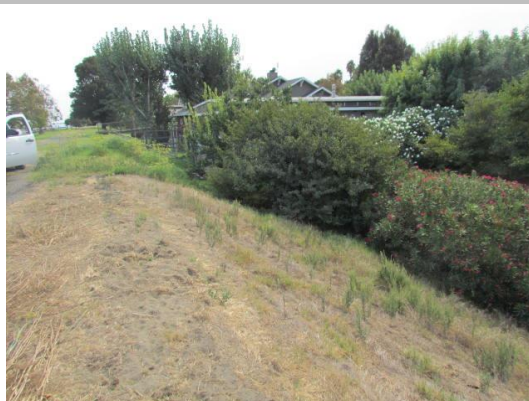
Photo 2 of 2 : SP_2016_NA0002_62_52_20160308_00043.jpg

Looking east at dense trees on landward slope and toe.

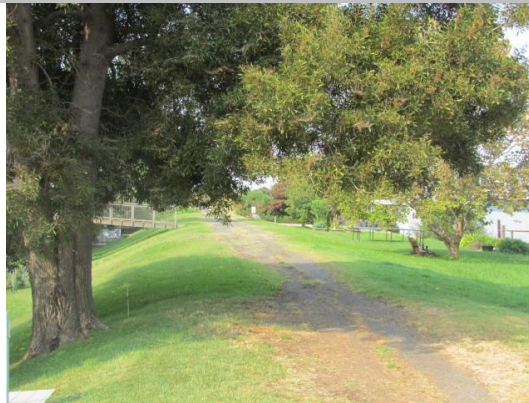
Photo 1 of 1 : SP_2016_NA0002_62_51_20160308_00041.jpg

LM Start	5.88	Rating **	M	Issue No.	51
LM End	5.88	Issue Type +	Ma	Location *	LS
Category	Earthen Levee			GPS Latitude/Longitude	
				Start	End
Item	Trim / Thin Trees			38.129722 °	38.129722 °
				-121.580823 °	-121.580823 °
DWR ID	DWR_NA0002_01_f _ 2014_51				
Comment Code					
T4 : Trim trees over roadway to at least 12 feet above ground level.					
Inspector Comment					
Tree should be trimmed back from hanging over levee crown.

Looking at tree overhanging levee crown.

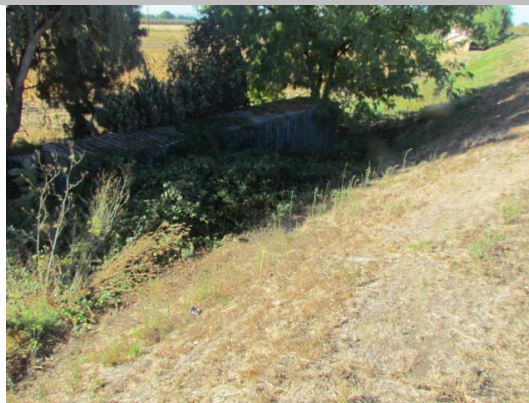
Photo 1 of 3 : SP_2016_NA0002_63_40_20160308_00037.jpg

LM Start	0.49	Rating **	M	Issue No.	40
LM End	0.49	Issue Type +	Ma	Location *	LS
Category	Earthen Levee			GPS Latitude/Longitude	
				Start	End
Item	Vegetation			38.188871 °	38.188871 °
				-121.575775 °	-121.575775 °
DWR ID	DWR_NA0002_02_f_2013_40				
Comment Code					
V2 : Remove the wild growth other than native grasses from the levee slopes.					
Inspector Comment					
Berryvines at landward toe.

Looking southeast at berryvines at landward toe.

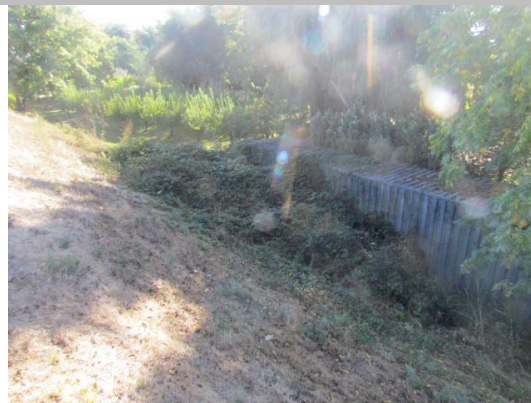
Photo 3 of 3 : SP_2016_NA0002_63_40_20160308_00039.jpg

LM Start	0.49	Rating **	M	Issue No.	40 (cont)	
LM End	0.49	Issue Type +	Ma	Location *	LS	
Category	Earthen Levee			GPS Latitude/Longitude		
				Start		End
Item	Vegetation			38.188871 °		38.188871 °
				-121.575775 °		-121.575775 °
DWR ID	DWR_NA0002_02_f_2013_40					
Comment Code						
V2 : Remove the wild growth other than native grasses from the levee slopes.						
Inspector Comment						
Berryvines at landward toe.

Looking northeast at berryvines at landward toe.

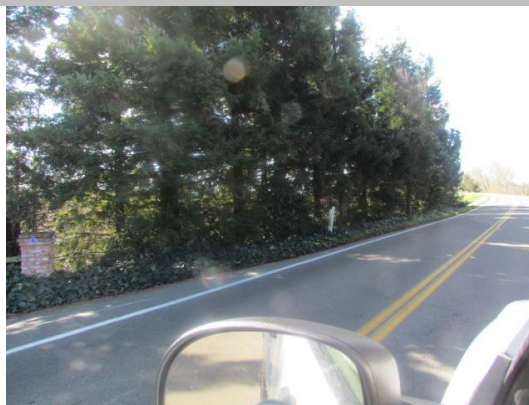
Photo 2 of 3 : SP_2016_NA0002_63_8_20160308_00006.jpg

Looking southeast at dense landscaping on landside slope.

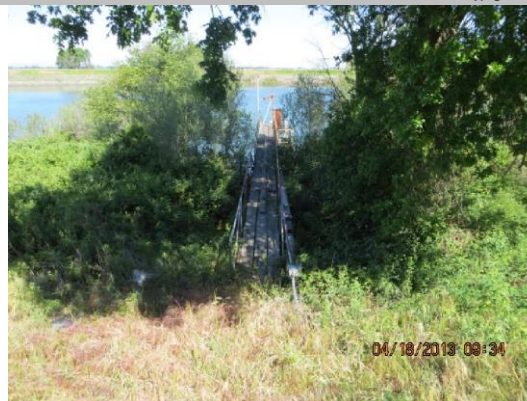
Photo 1 of 2 : UCIP_SP_2016_12164_19726.jpg

Comment Code					
Inspector Comment					
FS_ID:12164 DS_ID:21868 EP_NO: 1173 Repair Type: Non-Urgent Crossing Status: Found UCIP Comments: Several patches on pipe, walkway in disrepair and 24-inch standpipe for siphon breaker on LS slope has been dislodged from the LS slope and rests at LS toe. Pipe appears to be failing at multiple places due to corrosion. FIELD_STRUCT_DESC: 2 of 4: 12-inch pipe through levee 7.0 feet below the crown. Pump on pile structure with a walkway in the river. Siphon breaker in 24-inch CMP riser on LS slope with a 7X9-foot concrete distribution box on LS toe. Service pole on the landward slope with a 1.5-inch galvanized iron electrical conduit at the same location. (Permit No. 1173, 1947). Included in the 1954 O&M manual. FS Date: 4/18/2013

Pump on pile structure with walkway on WS berm.

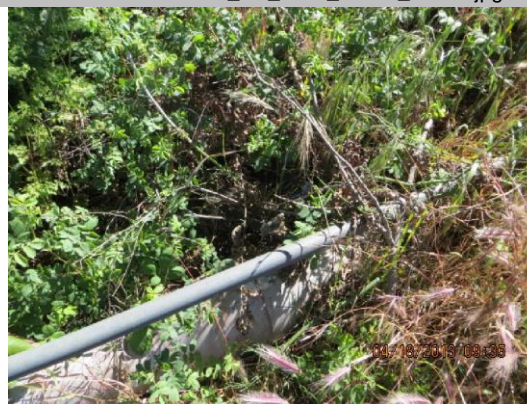
Photo 2 of 2 : UCIP_SP_2016_12164_19725.jpg

1.5-inch galvanized iron electrical conduit at same location as 12-inch pipe on WS slope.

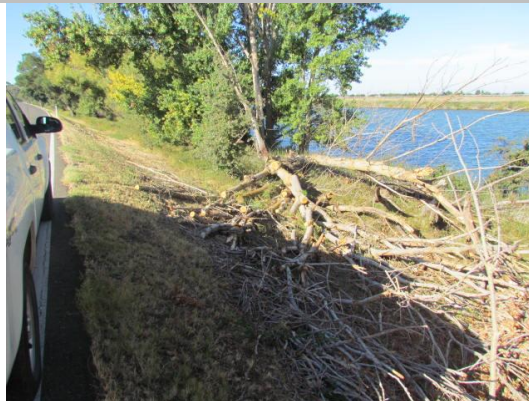
Photo 1 of 2 : SP_2016_NA0002_63_91_20160308_00057.jpg

Looking south west at fallen tree on waterward slope and berm.

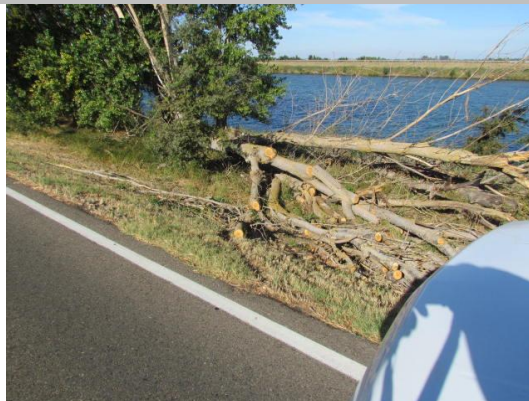
Photo 2 of 2 : SP_2016_NA0002_63_91_20160308_00058.jpg

Looking west at fallen tree on waterward slope and berm.

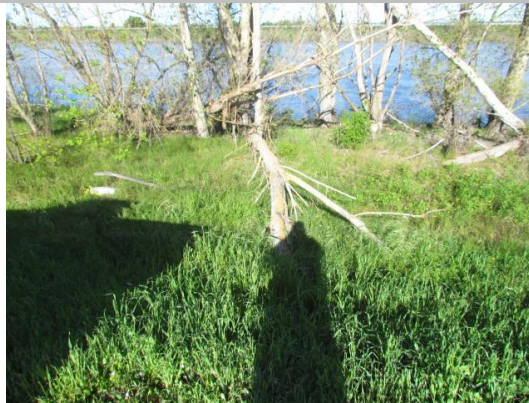
Photo 1 of 2 : SP_2016_NA0002_63_92_20160323_00165.jpg

LM Start	1.16	Rating **	M	Issue No.	92
LM End	1.16	Issue Type +	En	Location *	WS
Category	Earthen Levee			GPS Latitude/Longitude	
				Start	End
Item	Encroachments			38.182527 °	38.182527 °
				-121.584901 °	-121.584901 °
DWR ID	DWR_NA0002_02_f_2015_92				
Comment Code					
TR : Tree or limb					
Inspector Comment					
Downed tree branch on waterward slope and berm.

Looking west at fallen tree branch on waterward berm. (Spring 2016)

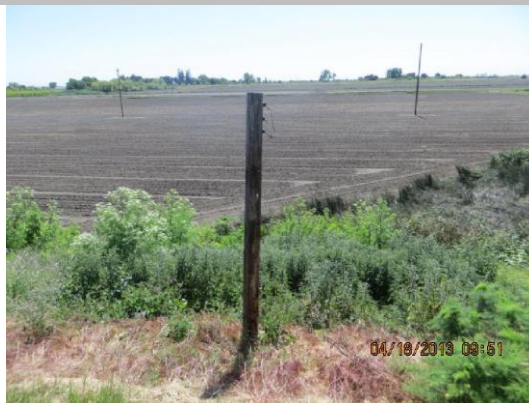
Photo 1 of 2 : UCIP_SP_2016_12165_19731.jpg

LM Start	1.39	Rating **	M	Issue No.	119
LM End	1.39	Issue Type +	En	Location *	WS
Category	Supplemental			GPS Latitude/Longitude	
				Start	End
Item	DWR UCIP Field Study			38.179666 °	38.179666 °
				-121.587109 °	-121.587109 °
DWR ID					
Comment Code					
Inspector Comment					
FS_ID:12165 DS_ID:21869 EP_NO: 11261 Repair Type: Non-Urgent Crossing Status: Found UCIP Comments: Pipe abandoned and should be done so properly. Pipe open on WS. FIELD_STRUCT_DESC: 8-inch pipe through levee 6.5 feet below crown. Pump in pump house on berm. 7'X9' concrete distribution box on LS toe. Service poles on the landward slope with a 1.5-inch galvanized steel electrical conduit at same location (ABO No. 11261, 1975). Originally included in the 1954 O&M manual. FS Date: 4/18/2013

JP on LS slope.

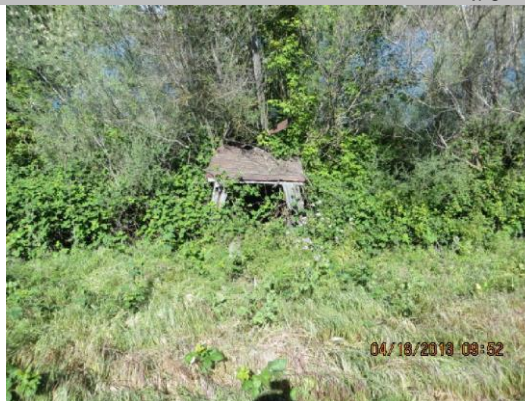
Photo 2 of 2 : UCIP_SP_2016_12165_19730.jpg

LM Start	1.39	Rating **	M	Issue No.	119 (cont)
LM End	1.39	Issue Type +	En	Location *	WS
Category	Supplemental			GPS Latitude/Longitude	
				Start	End
Item	DWR UCIP Field Study			38.179666 °	38.179666 °
				-121.587109 °	-121.587109 °
DWR ID					
Comment Code					
Inspector Comment					
FS_ID:12165 DS_ID:21869 EP_NO: 11261 Repair Type: Non-Urgent Crossing Status: Found UCIP Comments: Pipe abandoned and should be done so properly. Pipe open on WS. FIELD_STRUCT_DESC: 8-inch pipe through levee 6.5 feet below crown. Pump in pump house on berm. 7'X9' concrete distribution box on LS toe. Service poles on the landward slope with a 1.5-inch galvanized steel electrical conduit at same location (ABO No. 11261, 1975). Originally included in the 1954 O&M manual. FS Date: 4/18/2013

Pipe and pumphouse on WS berm.

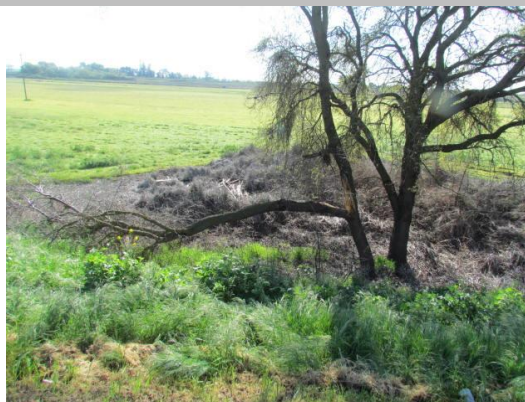
Photo 1 of 1 : SP_2016_NA0002_63_96_20160308_00063.jpg

LM Start	1.40	Rating **	M	Issue No.	96
LM End	1.40	Issue Type +	Ma	Location *	LS
Category	Earthen Levee			GPS Latitude/Longitude	
				Start	End
Item	Encroachments			38.179543 °	38.179543 °
				-121.587226 °	-121.587226 °
DWR ID	DWR_NA0002_02_s_ 2015_96				
Comment Code					
TR : Tree or limb					
Inspector Comment					
Broken tree branch on landward toe.

Looking east at broken tree limb at landward toe.

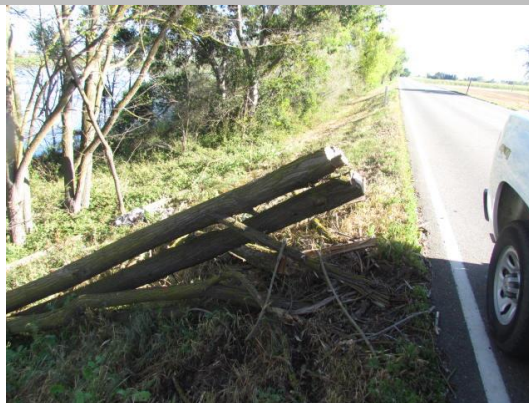
Photo 1 of 3 : SP_2016_NA0002_63_109_20160323_00167.jpg

LM Start	1.43	Rating **	U	Issue No.	109
LM End	1.43	Issue Type +	En	Location *	WS
Category	Earthen Levee			GPS Latitude/Longitude	
				Start	End
Item	Encroachments			38.179171 °	38.179171 °
				-121.587529 °	-121.587529 °
DWR ID	DWR_NA0002_02_s_2016_109				
Comment Code					
TR : Tree or limb					
Inspector Comment					
Downed tree branches and limbs on waterward.

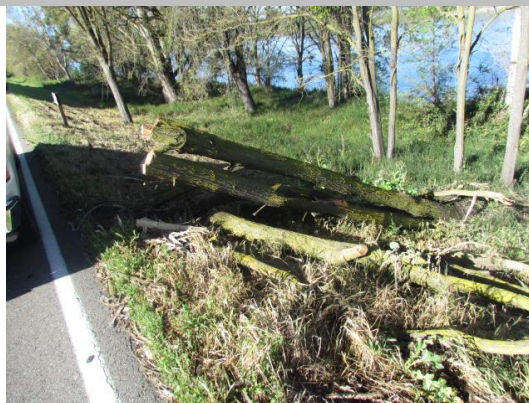
Photo 2 of 3 : SP_2016_NA0002_63_109_20160323_00166.jpg

Looking west at tree limbs on waterward slope.

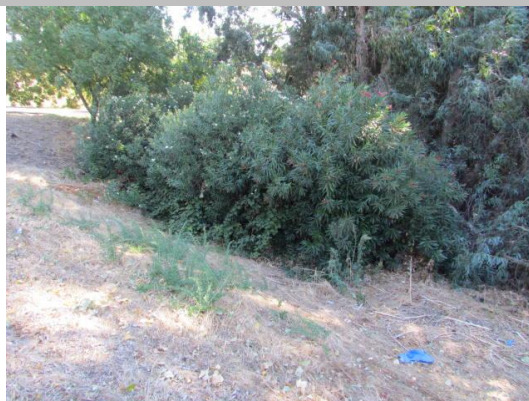
Photo 3 of 4 : SP_2016_NA0002_63_27_20160308_00025.jpg

Looking north at dense vegetation on landward toe.

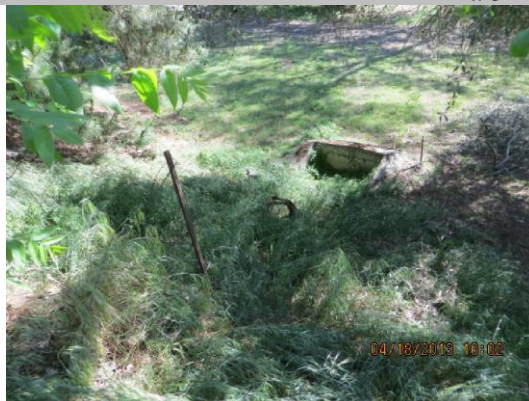
Photo 1 of 2 : UCIP_SP_2016_12183_19742.jpg

LM Start	1.61	Rating **	M	Issue No.	120
LM End	1.61	Issue Type +	En	Location *	LS
Category	Supplemental			GPS Latitude/Longitude	
				Start	End
Item	DWR UCIP Field Study			38.176874 °	38.176874 °
				-121.589200 °	-121.589200 °
DWR ID					
Comment Code					
Inspector Comment					
FS_ID:12183					
DS_ID:21870					
EP_NO: N/A					
Repair Type: Non-Urgent					
Crossing Status: Found					
UCIP Comments: Pipe appears abandoned and should be done so properly.					
FIELD_STRUCT_DESC: 6-inch steel irrigation pipe through the levee					
5.8 feet below the crown. 3'X3' concrete distribution box at LS toe.					
PVC standpipe at WS toe. Hose bib attachment on pipe at LS toe.					
FS Date: 4/18/2013

Concrete distribution box on LS toe.

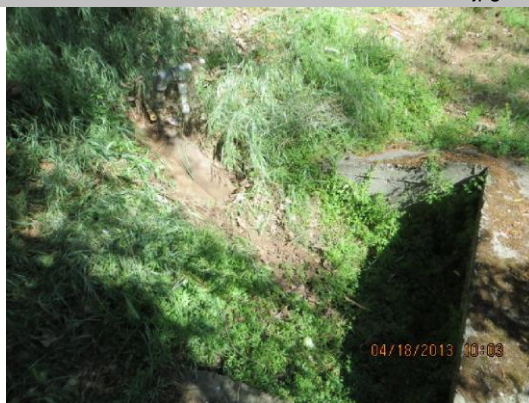
Photo 2 of 2 : UCIP_SP_2016_12183_19741.jpg

Distribution box and hose bib on LS toe.

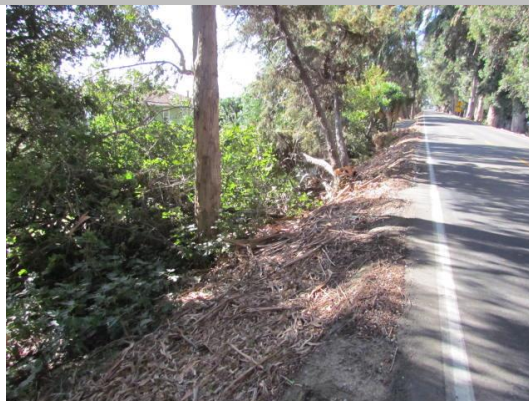
Photo 1 of 2 : SP_2016_NA0002_63_45_20160308_00041.jpg

Looking southeast at dense vegetation on landward slope.

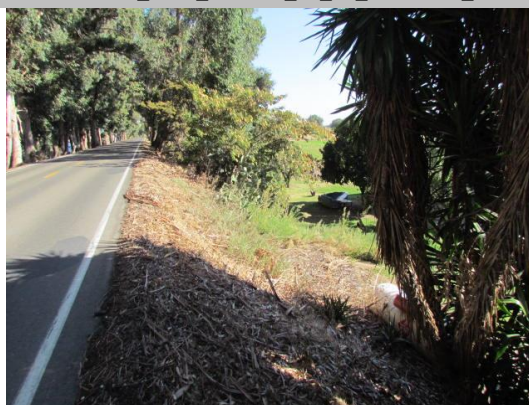
Photo 2 of 2 : SP_2016_NA0002_63_45_20160308_00042.jpg

Looking north at dense vegetation on landward slope and toe.

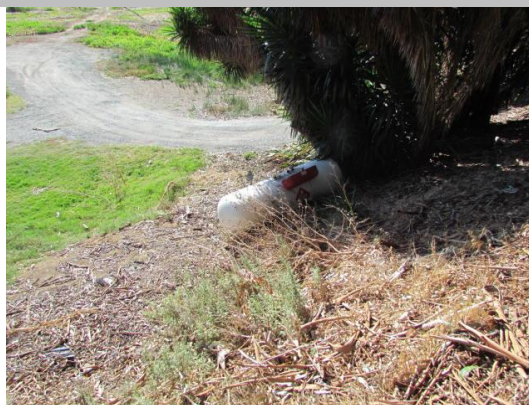
Photo 1 of 1 : SP_2016_NA0002_63_54_20160308_00049.jpg

LM Start	1.83	Rating **	M	Issue No.	54
LM End	1.83	Issue Type +	En	Location *	LS
Category	Earthen Levee			GPS Latitude/Longitude	
				Start	End
Item	Encroachments			38.174097 °	38.174097 °
				-121.591002 °	-121.591002 °
DWR ID	DWR_NA0002_02_f_2013_54				
Comment Code					
TA : Tank					
Inspector Comment					
Propane tank on landward slope.

Looking southeast at propane tank on landward slope and toe.

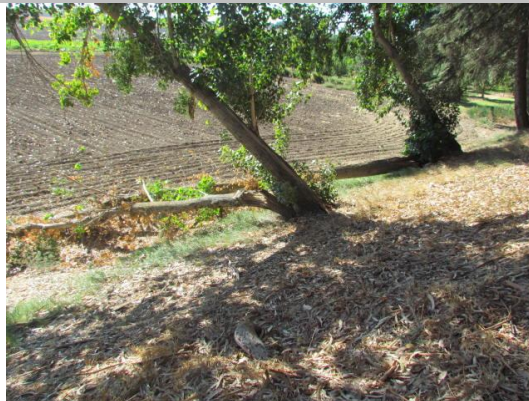
Photo 1 of 2 : SP_2016_NA0002_63_93_20160308_00060.jpg

LM Start	1.87	Rating **	A/W	Issue No.	93
LM End	1.89	Issue Type +	En	Location *	LS
Category	Earthen Levee			GPS Latitude/Longitude	
				Start	End
Item	Encroachments			38.173571 °	38.173288 °
				-121.591343 °	-121.591531 °
DWR ID	DWR_NA0002_02_f_2015_93				
Comment Code					
TR : Tree or limb					
Inspector Comment					
Broken tree limbs on landward slope and toe.

Looking southeast at broken tree limb on landward slope.

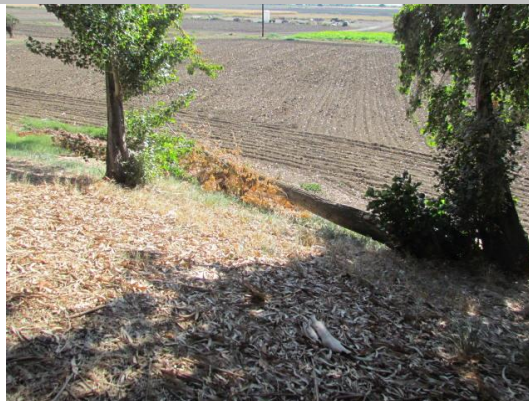
Photo 2 of 2 : SP_2016_NA0002_63_93_20160308_00061.jpg

Looking northeast at broken tree limb at landward toe.

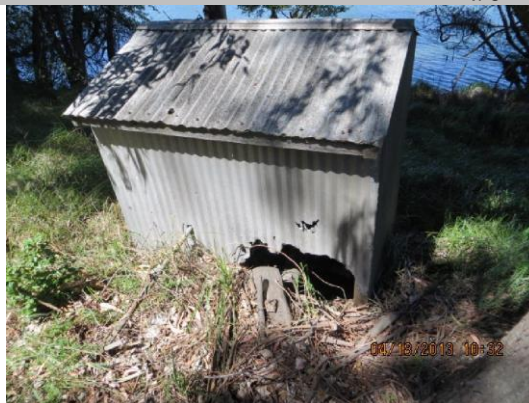
Photo 1 of 2 : UCIP_SP_2016_12185_19751.jpg

LM Start	1.90	Rating **	M	Issue No.	121
LM End	1.90	Issue Type +	En	Location *	LS
Category	Supplemental			GPS Latitude/Longitude	
				Start	End
Item	DWR UCIP Field Study			38.173197°	38.173197°
				-121.591552°	-121.591552°
DWR ID					
Comment Code					
Inspector Comment					
FS_ID:12185 DS_ID:21872 EP_NO: 11294 Repair Type: Non-Urgent Crossing Status: Found UCIP Comments: Pipe abandoned on both sides. Pipe should be abandoned properly. FIELD_STRUCT_DESC: 6-inch pipe through the levee 6.5 feet below the crown. Pump in pumphouse on the water ward slope. 1-inch galvanized iron steel electrical conduit at same location (ABO No. 11294, 1975). Originally included in the 1954 O&M manual. FS Date: 4/18/2013

Pumphouse on WS slope.
