**Flood Control Project Maintenance
Levee Inspections****LMA District Cover Sheet****Spring 2016 Levee Inspection Results****Brannan Andrus Levee Maintenance District**

Spring 2016 Levee Inspection Results

Brannan Andrus Levee Maintenance District

Waterway			Bank	Unit Miles
Unit No. 01 Georgiana Slough			Right	6.01
	Spring (March - May)	Summer (June - August)	(September - November) Fall	Winter (December - February)
Unit Maintenance Rating (Fall Only)				
Date of Inspection	3/22/2016 - 3/22/2016			
DWR Inspector	Richard Willoughby			
Accompanied By	Gilbert Labrie DCC Engineering Co, Inc

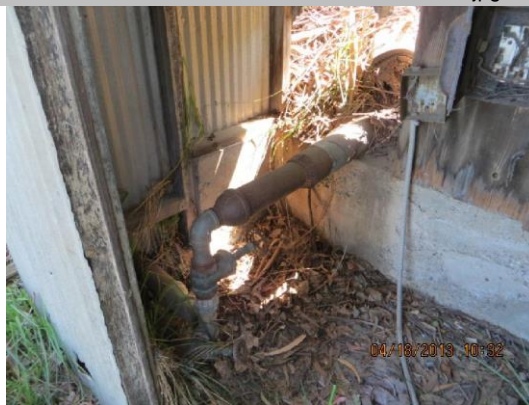
Photo 2 of 2 : UCIP_SP_2016_12185_19750.jpg

Pipe and shutoff valve at pumphouse on WS slope.

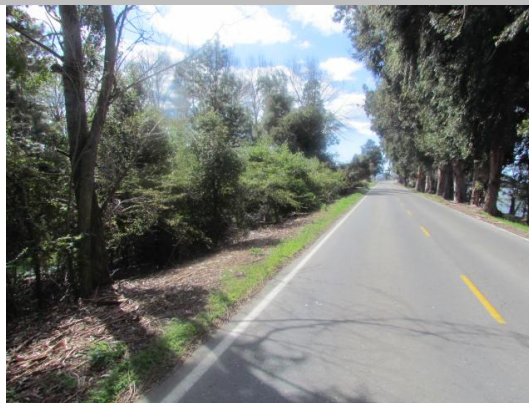
Photo 1 of 2 : SP_2016_NA0002_63_12_20160308_00012.jpg

Looking south at dense landscaping on landside slope and toe.

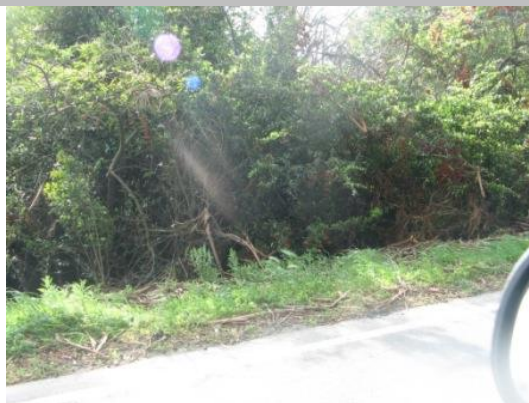
Photo 2 of 2 : SP_2016_NA0002_63_12_20160308_00013.jpg

Landscaping on landside slope blocking view of slope from LM 1.91 to 1.95.

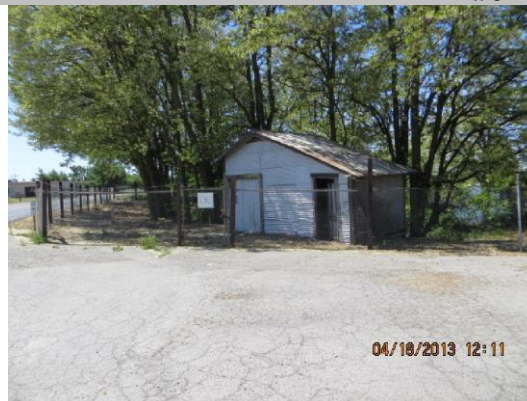
Photo 1 of 2 : UCIP_SP_2016_12211_19770.jpg

LM Start	2.42	Rating **	M	Issue No.	122
LM End	2.42	Issue Type +	En	Location *	LS
Category	Supplemental			GPS Latitude/Longitude	
				Start	End
Item	DWR UCIP Field Study			38.166819 °	38.166819 °
				-121.596590 °	-121.596590 °
DWR ID					
Comment Code					
Inspector Comment					
FS_ID:12211 DS_ID:21878 EP_NO: 11263 Repair Type: Non-Urgent Crossing Status: Indicator Found UCIP Comments: Further investigation to determine location of pipe should be done. Pumphouse needs to be unlocked to gather additional information. FIELD_STRUCT_DESC: 8-inch pipe through levee 3.7 feet below crown. Pump in pump house on the waterward berm (ABO No. 11263, 1975). 30" concrete standpipe landward side. Originally included in the 1954 O&M manual. FS Date: 4/18/2013

Possible pumphouse on WS shoulder.

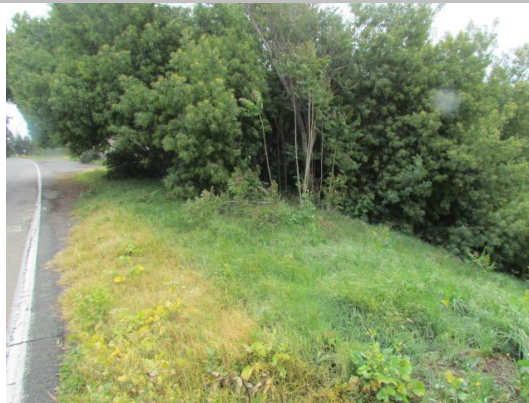
Photo 1 of 2 : SP_2016_NA0002_63_29_20160308_00028.jpg

LM Start	2.48	Rating **	U	Issue No.	29
LM End	2.48	Issue Type +	En	Location *	LS
Category	Earthen Levee			GPS Latitude/Longitude	
				Start	End
Item	Trim / Thin Trees			38.166378 °	38.166378 °
				-121.597570 °	-121.597570 °
DWR ID	DWR_NA0002_02_s _ 2012_29				
Comment Code					
T1 : Trim trees to at least five feet above ground level.					
Inspector Comment

Looking north at dense vegetation on landward slope.

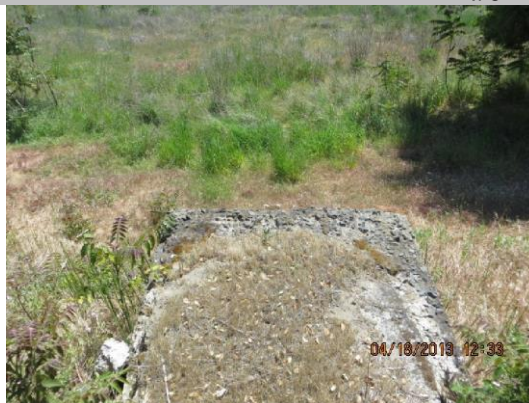
Photo 2 of 2 : UCIP_SP_2016_12212_19772.jpg

LM Start	2.54	Rating **	U	Issue No.	123 (cont)
LM End	2.54	Issue Type +	En	Location *	LS
Category	Supplemental			GPS Latitude/Longitude	
				Start	End
Item	DWR UCIP Field Study			38.165980 °	38.165980 °
				-121.598520 °	-121.598520 °
DWR ID					
Comment Code					
Inspector Comment					
FS_ID:12212 DS_ID:21879 EP_NO: N/A Repair Type: Urgent Crossing Status: Found UCIP Comments: Culvert open on both ends. Needs to be abandoned properly. FIELD_STRUCT_DESC: *Abandoned* 3 x 3.5-foot open concrete culvert through levee 6.0-inches below the crown. Originally included in the 1954 O&M manual. FS Date: 4/18/2013

Top of concrete tunnel on LS shoulder.

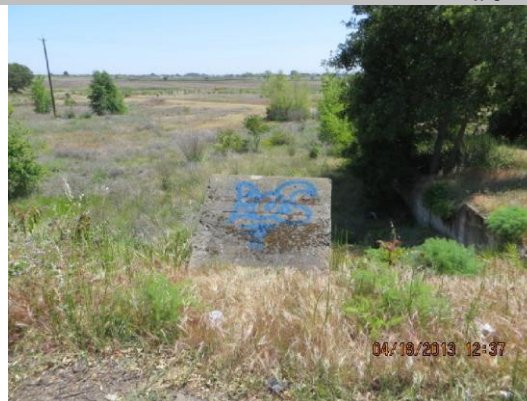
Photo 2 of 2 : UCIP_SP_2016_12213_19775.jpg

LM Start	2.57	Rating **	U	Issue No.	124 (cont)
LM End	2.57	Issue Type +	En	Location *	LS
Category	Supplemental			GPS Latitude/Longitude	
				Start	End
Item	DWR UCIP Field Study			38.165775 °	38.165775 °
				-121.599048 °	-121.599048 °
DWR ID					
Comment Code					
Inspector Comment					
FS_ID:12213 DS_ID:21880 EP_NO: N/A Repair Type: Urgent Crossing Status: Found UCIP Comments: tunnel should be abandoned properly. FIELD_STRUCT_DESC: *Abandoned* 4.0 x 4.0-foot open concrete culvert through levee 6.5-inches below the crown. Originally included in the 1954 O&M manual. FS Date: 4/18/2013

Concrete tunnel on LS shoulder.

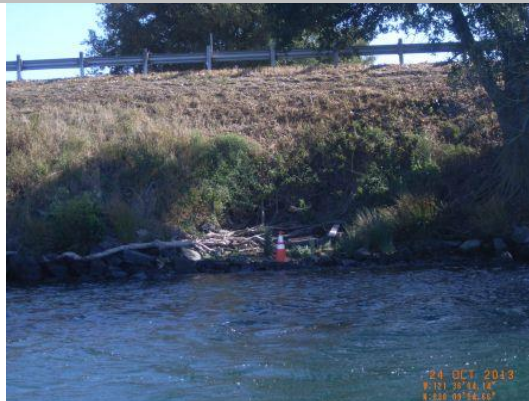
Photo 1 of 2 : SP_2016_NA0002_63_37_20160308_00034.jpg

LM Start	2.66	Rating **	M	Issue No.	37
LM End	2.74	Issue Type +	Ma	Location *	WS
Category	Supplemental			GPS Latitude/Longitude	
				Start	End
Item	2015 USACE Erosion Survey, DRAFT			38.165303 °	38.164682 °
				-121.600477 °	-121.601804 °
DWR ID	DWR_NA0002_02_s _ 2016_37				
Comment Code					
Inspector Comment					
2009 - Large scallop from rotational failure. One fallen tree and one large tree with half of its root structure exposed. 2015: Large tree expected to pop out within next couple of years, will take very large chunk of levee out. [2015 Site ID: SAC_18-0_L]

USACE 2013 Photo #1

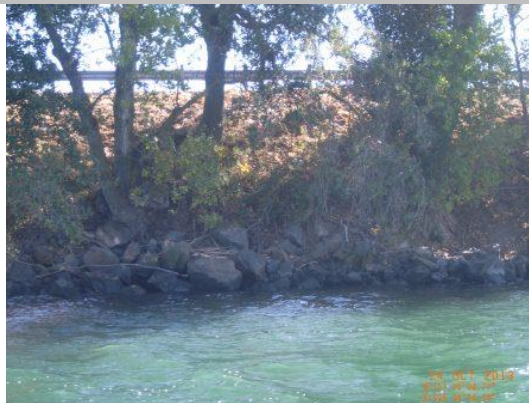
Photo 2 of 2 : SP_2016_NA0002_63_37_20160308_00035.jpg

USACE 2013 Photo #2

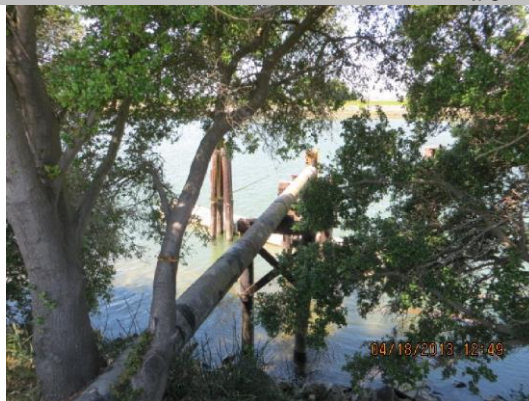
Photo 1 of 2 : UCIP_SP_2016_12214_19778.jpg

LM Start	2.75	Rating **	M	Issue No.	125
LM End	2.75	Issue Type +	En	Location *	WS
Category	Supplemental			GPS Latitude/Longitude	
				Start	End
Item	DWR UCIP Field Study			38.164432 °	38.164432 °
				-121.601918 °	-121.601918 °
DWR ID					
Comment Code					
Inspector Comment					
FS_ID:12214					
DS_ID:21881					
EP_NO: 2005					
Repair Type: Non-Urgent					
Crossing Status: Found					
UCIP Comments: Pipe appears abandoned and rusty. It should be abandoned properly if it is no longer in use.					
FIELD_STRUCT_DESC: 18-inch sewer discharge line through levee 4.0 feet below crown. Two pile dolphins in stream, fire hydrant on landward shoulder (Permit No. 2005, 1959).					
FS Date: 4/18/2013

Pipe, pile structure, and dolphins on WS.

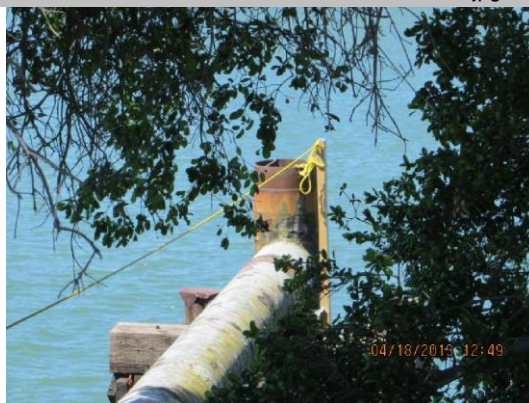
Photo 2 of 2 : UCIP_SP_2016_12214_19777.jpg

Pipe on pier at WS.

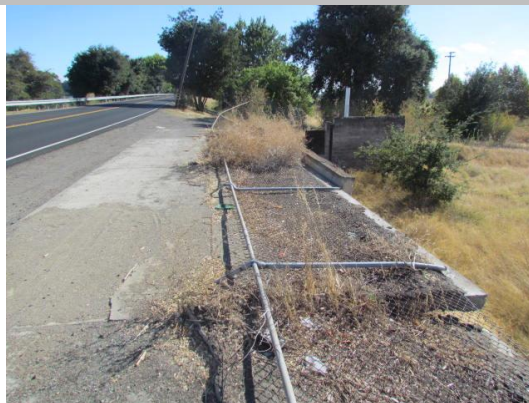
Photo 1 of 1 : SP_2016_NA0002_63_94_20160308_00062.jpg

LM Start	2.81	Rating **	M	Issue No.	94
LM End	2.81	Issue Type +	En	Location *	LS
Category	Earthen Levee			GPS Latitude/Longitude	
				Start	End
Item	Encroachments			38.164077 °	38.164077 °
				-121.602853 °	-121.602853 °
DWR ID	DWR_NA0002_02_f_2015_94				
Comment Code					
FE : Fence					
Inspector Comment					
Discard downed fence on landward shoulder.

Looking northeast at downed fence on landward shoulder.

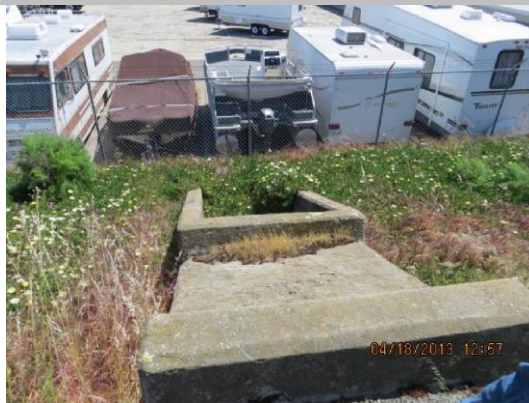
Photo 1 of 2 : UCIP_SP_2016_12216_19782.jpg

LM Start	2.84	Rating **	U	Issue No.	126
LM End	2.84	Issue Type +	En	Location *	LS
Category	Supplemental			GPS Latitude/Longitude	
				Start	End
Item	DWR UCIP Field Study			38.163850 °	38.163850 °
				-121.603317 °	-121.603317 °
DWR ID					
Comment Code					
Inspector Comment					
FS_ID:12216 DS_ID:21882 EP_NO: N/A Repair Type: Urgent Crossing Status: Found UCIP Comments: Tunnel open on both ends and should be abandoned properly. FIELD_STRUCT_DESC: *Abandoned* 4'X6' open concrete culvert through levee 1.0 foot below the crown. Originally included in the 1954 O&M manual. FS Date: 4/18/2013

Entrance to tunnel on LS slope.

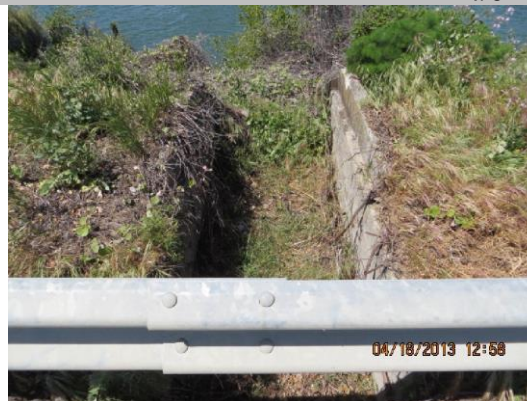
Photo 2 of 2 : UCIP_SP_2016_12216_19781.jpg

LM Start	2.84	Rating **	U	Issue No.	126 (cont)	
LM End	2.84	Issue Type +	En	Location *	LS	
Category	Supplemental			GPS Latitude/Longitude		
				Start	End	
Item	DWR UCIP Field Study			38.163850 °	38.163850 °	
				-121.603317 °	-121.603317 °	
DWR ID						
Comment Code						
Inspector Comment						
FS_ID:12216 DS_ID:21882 EP_NO: N/A Repair Type: Urgent Crossing Status: Found UCIP Comments: Tunnel open on both ends and should be abandoned properly. FIELD_STRUCT_DESC: *Abandoned* 4'X6' open concrete culvert through levee 1.0 foot below the crown. Originally included in the 1954 O&M manual. FS Date: 4/18/2013

Tunnel opening on WS slope.

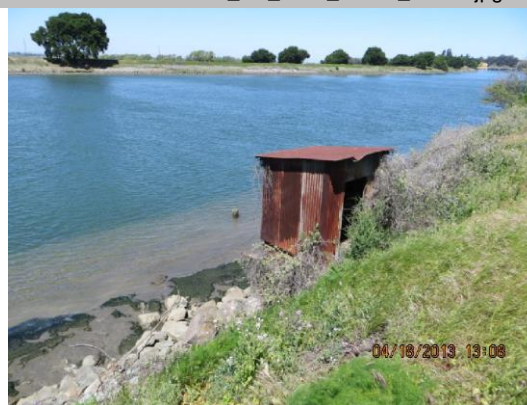
Photo 1 of 2 : UCIP_SP_2016_12217_19785.jpg

LM Start	2.90	Rating **	M	Issue No.	127
LM End	2.90	Issue Type +	En	Location *	LS
Category	Supplemental			GPS Latitude/Longitude	
				Start	End
Item	DWR UCIP Field Study			38.163475 °	38.163475 °
				-121.604221 °	-121.604221 °
DWR ID					
Comment Code					
Inspector Comment					
FS_ID:12217					
DS_ID:21883					
EP_NO: 11269					
Repair Type: Non-Urgent					
Crossing Status: Found					
UCIP Comments: Pipe needs to be abandoned properly if it is truly abandoned.					
FIELD_STRUCT_DESC: 8-inch pipe through levee 8.7 feet below crown. Pump in pump house on the waterward slope. Slide gate in pumphouse. Pipe not visible on LS. (ABO No. 11269,1975). Originally included in the 1959 O&M manual.					
FS Date: 4/18/2013

Pumphouse on WS slope.

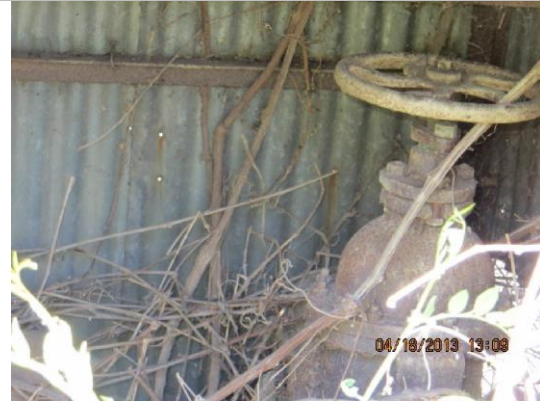
Photo 2 of 2 : UCIP_SP_2016_12217_19784.jpg

LM Start	2.90	Rating **	M	Issue No.	127 (cont)	
LM End	2.90	Issue Type +	En	Location *	LS	
Category	Supplemental			GPS Latitude/Longitude		
				Start		End
Item	DWR UCIP Field Study			38.163475 °		38.163475 °
				-121.604221 °		-121.604221 °
DWR ID						
Comment Code						
Inspector Comment						
FS_ID:12217						
DS_ID:21883						
EP_NO: 11269						
Repair Type: Non-Urgent						
Crossing Status: Found						
UCIP Comments: Pipe needs to be abandoned properly if it is truly abandoned.						
FIELD_STRUCT_DESC: 8-inch pipe through levee 8.7 feet below crown. Pump in pump house on the waterward slope. Slide gate in pumphouse. Pipe not visible on LS. (ABO No. 11269,1975). Originally included in the 1959 O&M manual.						
FS Date: 4/18/2013

Slide gate in pumphouse on WS slope.

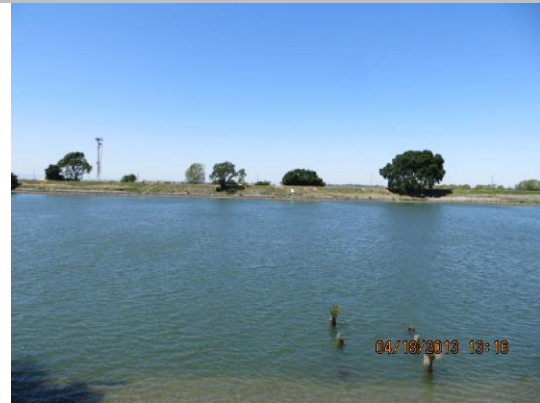
Photo 1 of 2 : UCIP_SP_2016_16005_27067.jpg

LM Start	2.91	Rating **	M	Issue No.	150
LM End	2.91	Issue Type +	En	Location *	LS
Category	Supplemental			GPS Latitude/Longitude	
				Start	End
Item	DWR UCIP Field Study			38.163413 °	38.163413 °
				-121.604399 °	-121.604399 °
DWR ID					
Comment Code					
Inspector Comment					
FS_ID:16005 DS_ID:21884 EP_NO: 14173 Repair Type: Non-Urgent Crossing Status: Indicator Found UCIP Comments: If pipe is still in use it should be marked properly on levee. FIELD_STRUCT_DESC: 12-inch telephone conduit through levee 2.0 feet below crown and under channel (Permit No. 14173, 1985). Four 4-inch galvanized iron conductor pipe sleeved through it. Sign on WS slope of levee across river provides location for this crossing. FS Date: 4/18/2013

Sign on opposite side of river provides indication of pipe location.

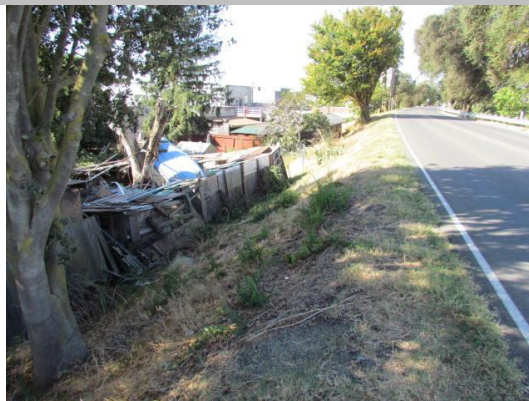
Photo 2 of 2 : SP_2016_NA0002_63_30_20160308_00031.jpg

LM Start	2.93	Rating **	M	Issue No.	30 (cont)	
LM End	3.12	Issue Type +	En	Location *	LS	
Category	Earthen Levee			GPS Latitude/Longitude		
				Start		End
Item	Encroachments			38.163317 °	38.162707 °	
				-121.604813 °	-121.608262 °	
DWR ID	DWR_NA0002_02_s_2012_30					
Comment Code						
UR : Urban						
Inspector Comment

Looking south at urban encroachments on landward slope.

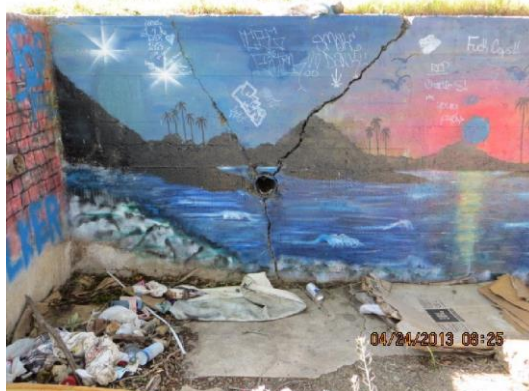
Photo 1 of 2 : UCIP_SP_2016_12724_20643.jpg

LM Start	2.99	Rating **	M	Issue No.	128
LM End	2.99	Issue Type +	En	Location *	LS
Category	Supplemental			GPS Latitude/Longitude	
				Start	End
Item	DWR UCIP Field Study			38.163063 °	38.163063 °
				-121.605799 °	-121.605799 °
DWR ID					
Comment Code					
Inspector Comment					
FS_ID:12724 DS_ID:21886 EP_NO: N/A Repair Type: Non-Urgent Crossing Status: Found UCIP Comments: Pipe should be abandoned properly. FIELD_STRUCT_DESC: *Abandoned* 6-inch pipe through levee 4.5 feet below crown. Originally included in the 1959 O&M manual. Pipe visible at foundation on WS shoulder. FS Date: 4/24/2013 10:00:00 AM

Pipe visible at concrete foundation on WS shoulder.

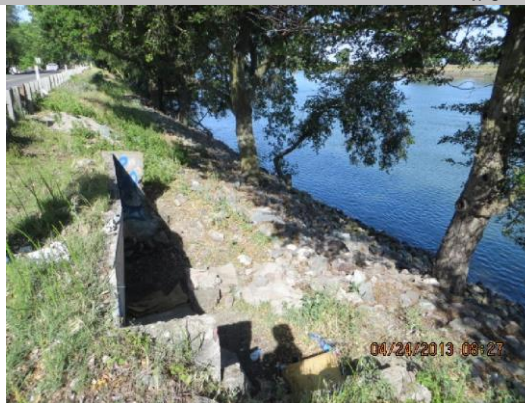
Photo 2 of 2 : UCIP_SP_2016_12724_20642.jpg

LM Start	2.99	Rating **	M	Issue No.	128 (cont)
LM End	2.99	Issue Type +	En	Location *	LS
Category	Supplemental			GPS Latitude/Longitude	
				Start	End
Item	DWR UCIP Field Study			38.163063 °	38.163063 °
				-121.605799 °	-121.605799 °
DWR ID					
Comment Code					
Inspector Comment					
FS_ID:12724 DS_ID:21886 EP_NO: N/A Repair Type: Non-Urgent Crossing Status: Found UCIP Comments: Pipe should be abandoned properly. FIELD_STRUCT_DESC: *Abandoned* 6-inch pipe through levee 4.5 feet below crown. Originally included in the 1959 O&M manual. Pipe visible at foundation on WS shoulder. FS Date: 4/24/2013 10:00:00 AM

Foundation on WS shoulder.

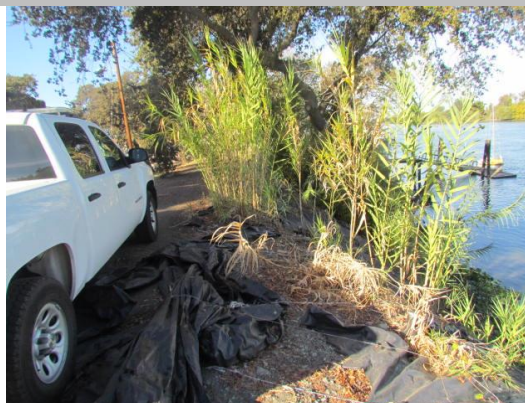
Photo 1 of 1 : SP_2016_NA0002_63_104_20160308_00070.jpg

LM Start	3.13	Rating **	M	Issue No.	104
LM End	3.13	Issue Type +	Ma	Location *	WS
Category	Earthen Levee			GPS Latitude/Longitude	
				Start	End
Item	Vegetation			38.162718 °	38.162718 °
				-121.608452 °	-121.608452 °
DWR ID	DWR_NA0002_02_f_2014_104				
Comment Code					
V2 : Remove the wild growth other than native grasses from the levee slopes.					
Inspector Comment					
Bamboo reestablishing on waterward slope.

Looking southwest at bamboo on waterward slope.

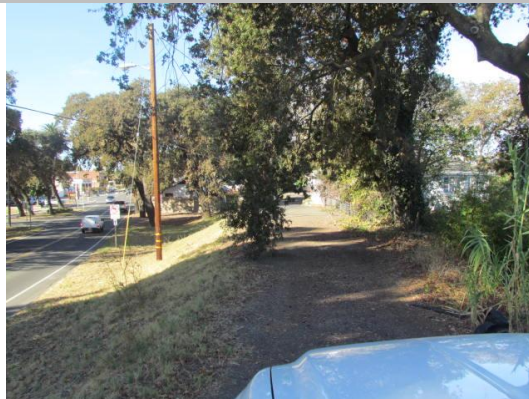
Photo 1 of 2 : SP_2016_NA0002_63_5_20160308_00003.jpg

LM Start	3.17	Rating **	M	Issue No.	5
LM End	3.17	Issue Type +	Ma	Location *	WS
Category	Earthen Levee			GPS Latitude/Longitude	
				Start	End
Item	Trim / Thin Trees			38.162638 °	38.162638 °
				-121.609068 °	-121.609068 °
DWR ID	DWR_NA0002_02_s _ 2012_5				
Comment Code					
T4 : Trim trees over roadway to at least 12 feet above ground level.					
Inspector Comment

Looking south at overhanging tree on waterward shoulder. (Fall 2014)

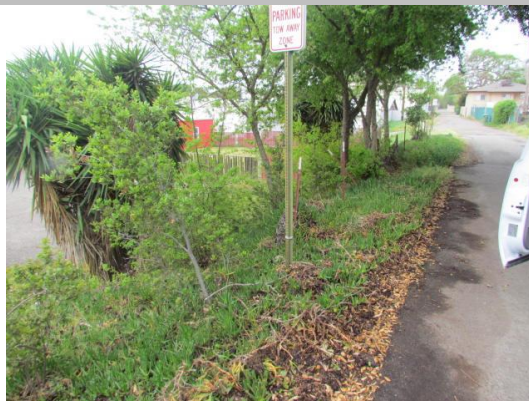
Photo 1 of 1 : SP_2016_NA0002_63_7_20160308_00005.jpg

LM Start	3.22	Rating **	M	Issue No.	7
LM End	3.22	Issue Type +	En	Location *	LS
Category	Earthen Levee			GPS Latitude/Longitude	
				Start	End
Item	Vegetation			38.162609 °	38.162609 °
				-121.609979 °	-121.609979 °
DWR ID	DWR_NA0002_02_s_2012_7				
Comment Code					
V6 : Landscaping					
Inspector Comment

Looking south at overgrown landscaping on landward slope.

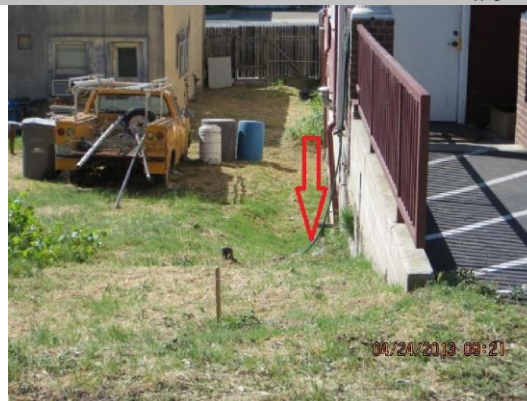
Photo 2 of 2 : UCIP_SP_2016_15966_26948.jpg

LM Start	3.29	Rating **	M	Issue No.	149 (cont)
LM End	3.29	Issue Type +	En	Location *	LS
Category	Supplemental			GPS Latitude/Longitude	
				Start	End
Item	DWR UCIP Field Study			38.162430 °	38.162430 °
				-121.611248 °	-121.611248 °
DWR ID					
Comment Code					
Inspector Comment					
FS_ID:15966 DS_ID:23135 EP_NO: N/A Repair Type: Non-Urgent Crossing Status: Found UCIP Comments: Need to determine disposition and use of pipe. FIELD_STRUCT_DESC: 4-inch cast iron pipe through the levee 8-feet below the crown. Pipe visible next to foundation on LS toe. FS Date: 4/24/2013

Pipe visible next to foundation on LS slope.

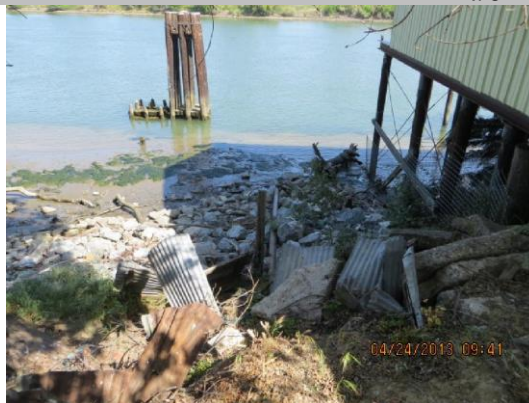
Photo 1 of 2 : UCIP_SP_2016_12745_20683.jpg

FS_ID:12745
DS_ID:21892
EP_NO: 11266
Repair Type: Non-Urgent
Crossing Status: Found
UCIP Comments: This pipe has been abandoned and should be abandoned properly. Pumphouse has collapsed.
FIELD_STRUCT_DESC: 6-inch pipe through levee 4.5 feet below crown. Pump in pump house on the water ward side (ABO No. 11266, 1975).
FS Date: 4/24/2013

Pipe and wrecked pumphouse on WS toe.

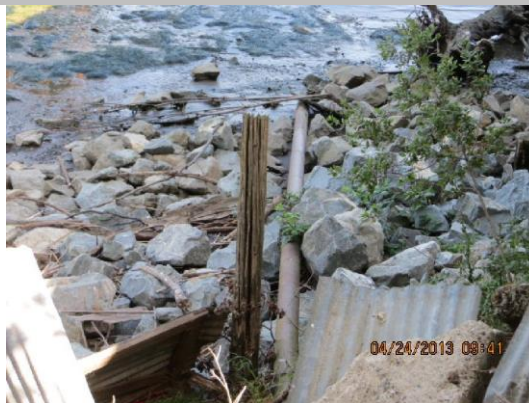
Photo 2 of 2 : UCIP_SP_2016_12745_20682.jpg

Pipe visible on WS toe.

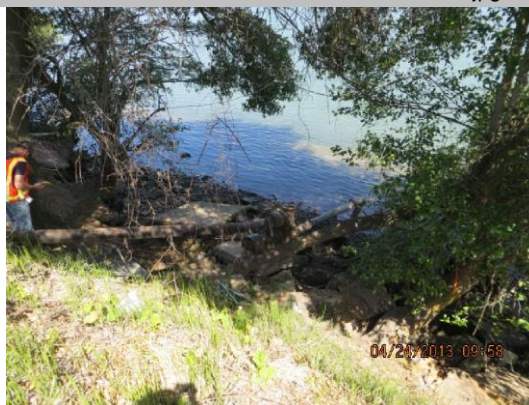
Photo 1 of 2 : UCIP_SP_2016_12746_20686.jpg

LM Start	3.44	Rating **	M	Issue No.	130
LM End	3.44	Issue Type +	En	Location *	WS
Category	Supplemental			GPS Latitude/Longitude	
				Start	End
Item	DWR UCIP Field Study			38.162473 °	38.162473 °
				-121.613963 °	-121.613963 °
DWR ID					
Comment Code					
Inspector Comment					
FS_ID:12746 DS_ID:21893 EP_NO: 11275 Repair Type: Non-Urgent Crossing Status: Found UCIP Comments: Pipe abandoned and should be abandoned properly. Pipe open on both ends. FIELD_STRUCT_DESC: 8-inch pipe through levee 7.7 feet below crown. Pump in pump house on the water ward slope (ABO No. 11275, 1975). Originally included in the 1959 O&M manual. FS Date: 4/24/2013

Pipe and pump visible on WS slope

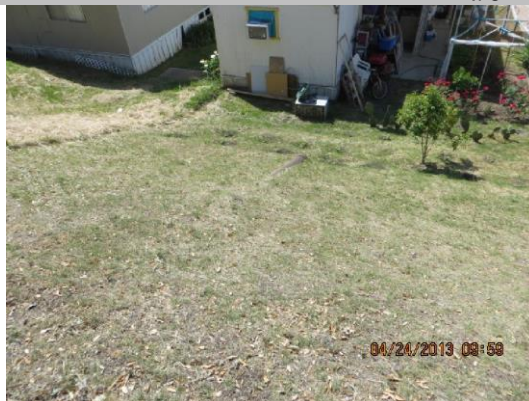
Photo 2 of 2 : UCIP_SP_2016_12746_20685.jpg

Pipe visible on LS slope near toe.

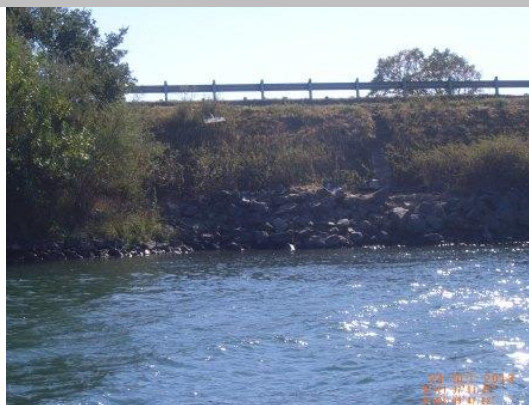
Photo 1 of 1 : SP_2016_NA0002_63_20_20160308_00019.jpg

LM Start	3.62	Rating **	U	Issue No.	20
LM End	3.73	Issue Type +	Ma	Location *	WS
Category	Supplemental			GPS Latitude/Longitude	
				Start	End
Item	2015 USACE Erosion Survey, DRAFT			38.162959 °	38.163334 °
				-121.617323 °	-121.619312 °
DWR ID	DWR_NA0002_02_s _ 2016_20				
Comment Code					
Inspector Comment					
2008 - Overstepped levee section with pocket erosion. Plans for repair currently in the design phase. 2010 - Very steep slope with slumps, longitudinal cracking, and overturned trees. 2011 - Upgraded to CRITICAL. Sections of vertical slope with highway on top. Heavy vegetation in front of most of the erosion pockets. 2015: New rock placed on the levee slope for most of the downstream end, but bad spots still remain. [2015 Site ID: SAC_16-8_L]

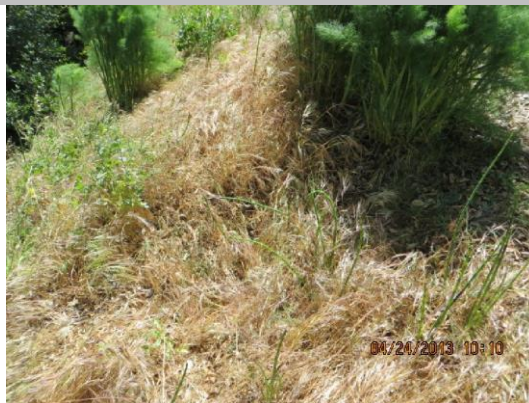
Photo 2 of 2 : UCIP_SP_2016_43103_20688.jpg

Possible sinkhole over pipe on WS shoulder.

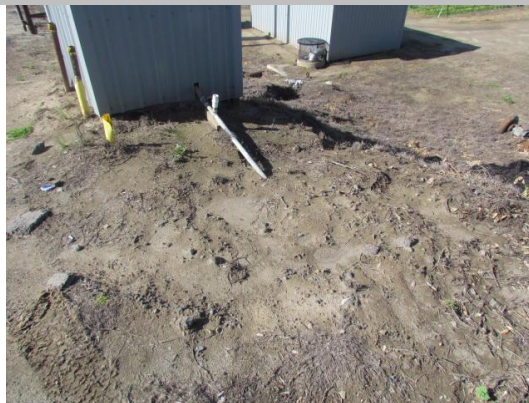
Photo 1 of 5 : SP_2016_NA0002_63_55_20160308_00050.jpg

LM Start	3.66	Rating **	M	Issue No.	55
LM End	3.66	Issue Type +	En	Location *	LS
Category	Earthen Levee			GPS Latitude/Longitude	
				Start	End
Item	Encroachments			38.162855 °	38.162855 °
				-121.618114 °	-121.618114 °
DWR ID	DWR_NA0002_02_f_2013_55				
Comment Code					
PI : Pipe					
Inspector Comment					
Landowner is repairing a pipe (Permit # 1615) without authorization from CVFPB. The excavation next to ramp is four to five feet deep and three to four feet wide. Landowner needs to ensure the hole is backfilled properly. Landowner backfilled trench without compaction results.

Looking southeast at backfilled trench next to ramp on landward slope. (Spring 2015).

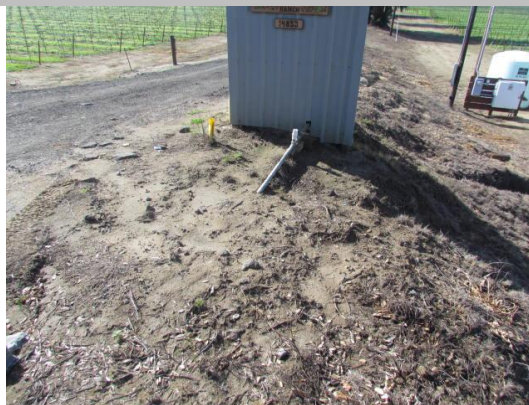
Photo 2 of 5 : SP_2016_NA0002_63_55_20160308_00051.jpg

Looking east at backfilled trench next to ramp on landward slope. (Spring 2015).

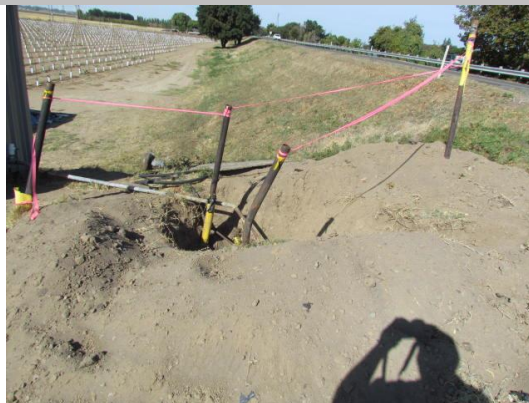
Photo 4 of 5 : SP_2016_NA0002_63_55_20160308_00053.jpg

Looking south at excavation on landward slope. (Spring 2014)

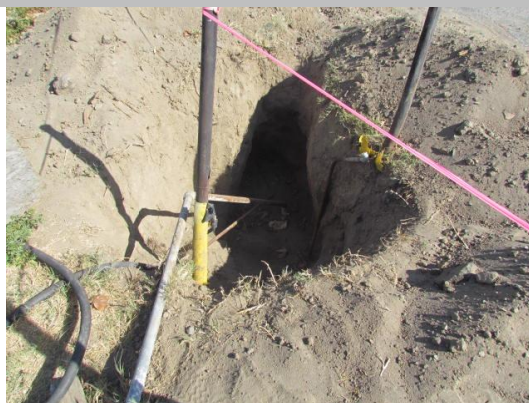
Photo 5 of 5 : SP_2016_NA0002_63_55_20160308_00054.jpg

Looking southeast at excavation on landward slope next to ramp. (Spring 2014)

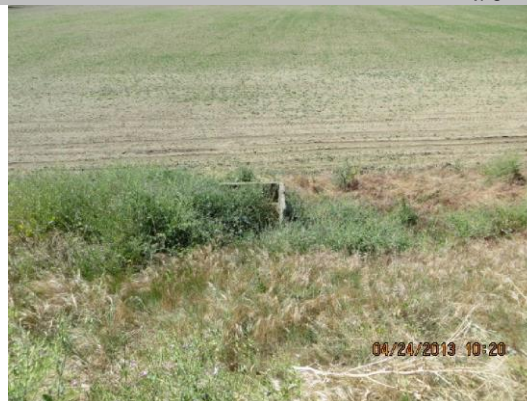
Photo 1 of 2 : UCIP_SP_2016_12748_20692.jpg

LM Start	3.70	Rating **	M	Issue No.	131
LM End	3.70	Issue Type +	En	Location *	LS
Category	Supplemental			GPS Latitude/Longitude	
				Start	End
Item	DWR UCIP Field Study			38.163048 °	38.163048 °
				-121.618839 °	-121.618839 °
DWR ID					
Comment Code					
Inspector Comment					
FS_ID:12748					
DS_ID:21895					
EP_NO: 1615					
Repair Type: Non-Urgent					
Crossing Status: Found					
UCIP Comments: Pipe abandoned and should be abandoned properly.					
FIELD_STRUCT_DESC: 8-inch pipe through levee 7.7 feet below crown. 6'X6' concrete distribution box on LS toe (Permit No. 1615, 1959). Included in the 1959 O&M manual.					
FS Date: 4/24/2013

Concrete distribution box on LS toe.

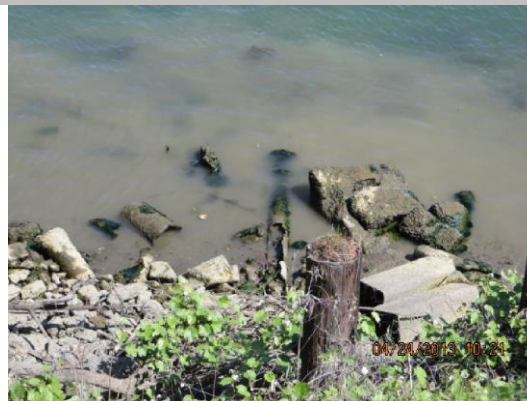
Photo 2 of 2 : UCIP_SP_2016_12748_20691.jpg

Rusted out pipe visible at WS toe.

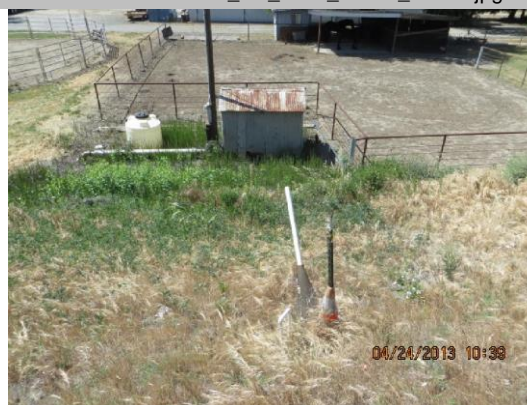
Photo 1 of 2 : UCIP_SP_2016_12752_20699.jpg

LM Start	3.92	Rating **	M	Issue No.	132
LM End	3.92	Issue Type +	En	Location *	LS
Category	Supplemental			GPS Latitude/Longitude	
				Start	End
Item	DWR UCIP Field Study			38.164063 °	38.164063 °
				-121.622650 °	-121.622650 °
DWR ID					
Comment Code					
Inspector Comment					
FS_ID:12752					
DS_ID:21898					
EP_NO: 11287					
Repair Type: Non-Urgent					
Crossing Status: Found					
UCIP Comments: Aging pipe with repair on WS slope. Good candidate for video inspection.					
FIELD_STRUCT_DESC: 5-inch pipe through levee 5.5 feet below crown. Pump in pump house on the landward side (ABO No. 11287, 1959). Shutoff valve in pumphouse on LS toe. Originally included in the 1959 O&M manual.					
FS Date: 4/24/2013

Pipe and pumphouse on LS.

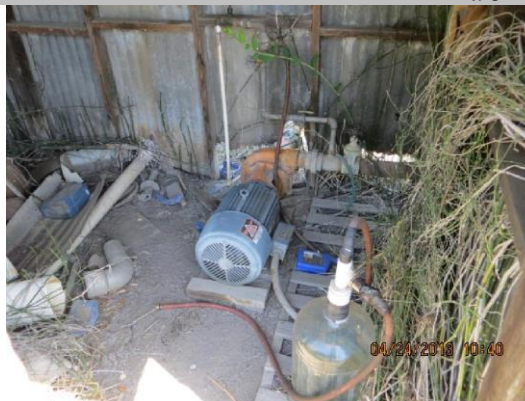
Photo 2 of 2 : UCIP_SP_2016_12752_20698.jpg

Pump and shutoff valve inside pumphouse on LS toe.

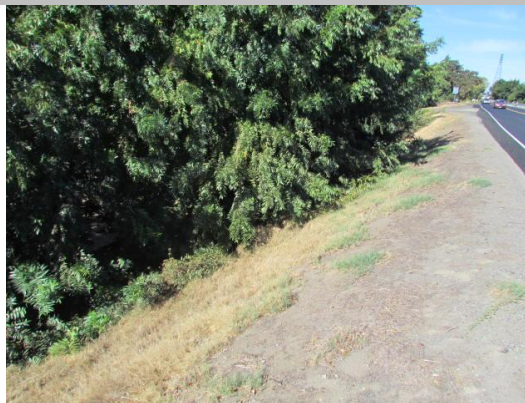
Photo 1 of 1 : SP_2016_NA0002_63_102_20160308_00069.jpg

LM Start	3.96	Rating **	U	Issue No.	102
LM End	3.96	Issue Type +	Ma	Location *	LS
Category	Earthen Levee			GPS Latitude/Longitude	
				Start	End
Item	Trim / Thin Trees			38.164246 °	38.164246 °
				-121.623272 °	-121.623272 °
DWR ID	DWR_NA0002_02_s_2014_102				
Comment Code					
T1 : Trim trees to at least five feet above ground level.					
Inspector Comment					
Untrimmed tree blocking landward slope and toe.

Looking south at dense trees on landward slope and toe.

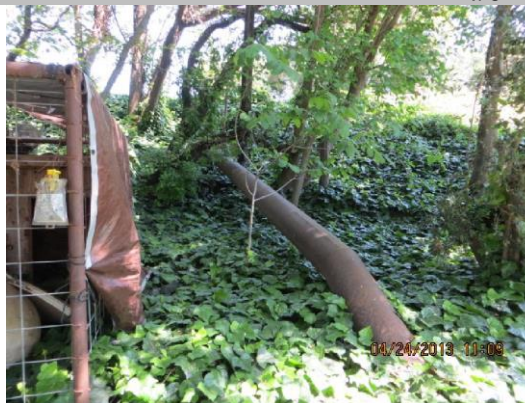
Photo 2 of 2 : UCIP_SP_2016_12768_20730.jpg

Pipe on LS slope.

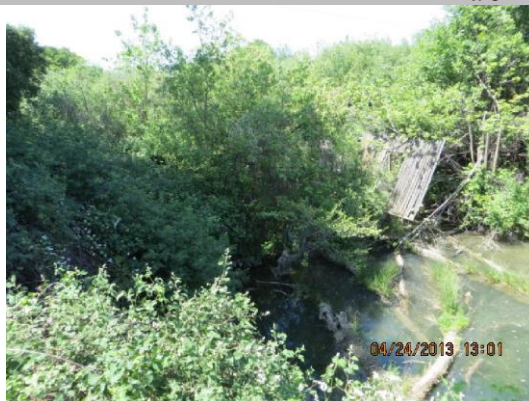
Photo 1 of 2 : UCIP_SP_2016_16010_27085.jpg

LM Start	4.48	Rating **	M	Issue No.	151
LM End	4.48	Issue Type +	En	Location *	LS
Category	Supplemental			GPS Latitude/Longitude	
				Start	End
Item	DWR UCIP Field Study			38.167174 °	38.167174 °
				-121.631927 °	-121.631927 °
DWR ID					
Comment Code					
Inspector Comment					
FS_ID:16010					
DS_ID:21907					
EP_NO: 11274					
Repair Type: Non-Urgent					
Crossing Status: Found					
UCIP Comments: Pipe abandoned and should be abandoned properly if not already done so.					
FIELD_STRUCT_DESC: 2 of 2: 10-inch pipe through levee 6.6 feet below crown. Pump in pump house on the landward slope (ABO No. 11274,1975). Originally included in the 1959 O&M manual.					
Pumphouse not visible 4/24/2013.					
FS Date: 4/24/2013

Possible portion of pumphouse visible off WS toe.

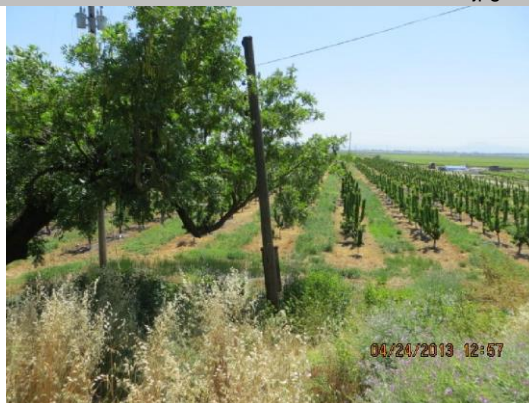
Photo 2 of 2 : UCIP_SP_2016_16010_27087.jpg

JP and meter on LS slope at location of abandoned pipe.

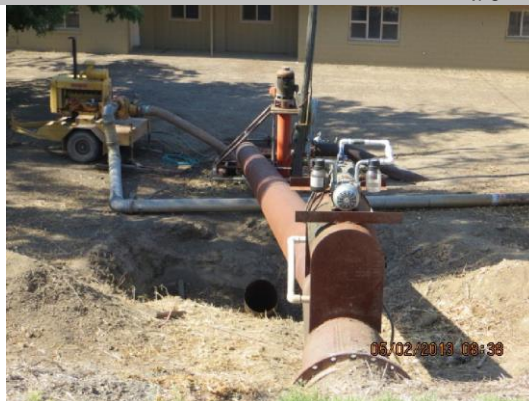
Photo 1 of 2 : UCIP_SP_2016_12773_20740.jpg

LM Start	4.78	Rating **	M	Issue No.	142
LM End	4.78	Issue Type +	En	Location *	LS
Category	Supplemental			GPS Latitude/Longitude	
				Start	End
Item	DWR UCIP Field Study			38.168744 °	38.168744 °
				-121.637155 °	-121.637155 °
DWR ID					
Comment Code					
Inspector Comment					
FS_ID:12773					
DS_ID:21908					
EP_NO: 11285					
Repair Type: Non-Urgent					
Crossing Status: Found					
UCIP Comments: Pit under pipe on WS shoulder - possible leak.					
Excavation of pipe on LS slope into levee prism.					
FIELD_STRUCT_DESC: 20-inch pipe sleeved through a 22-inch					
sleeved through a 24-inch pipe through levee 3-feet below the crown.					
Pump on landward side (ABO No. 11285, 1975). Small pump on LS					
shoulder and a 7'X9' concrete sump on the LS toe. Originally included					
in the 1959 O&M manual.					
FS Date: 5/2/2013

Small pump on LS shoulder with concrete distribution box on LS toe.

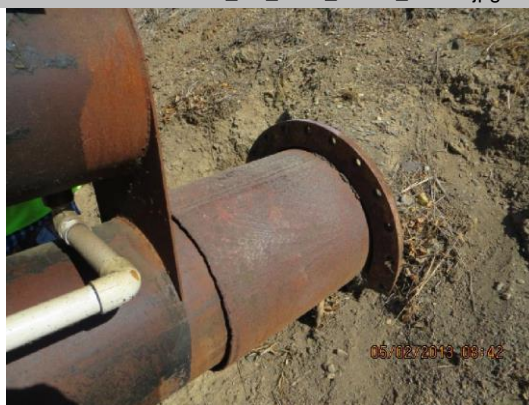
Photo 2 of 2 : UCIP_SP_2016_12773_20739.jpg

20-inch pipe sleeved through 22-inch pipe sleeved through a 24-inch steel pipe.

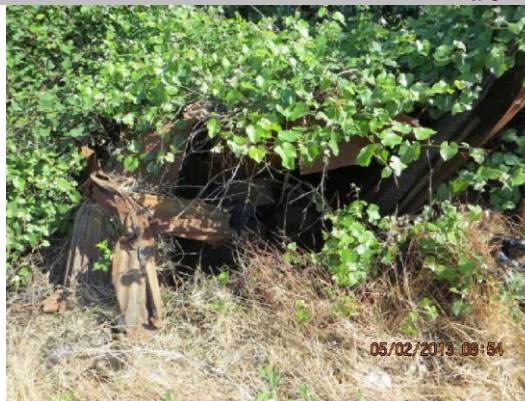
Photo 1 of 2 : UCIP_SP_2016_12774_20745.jpg

Comment Code					
Inspector Comment					
FS_ID:12774					
DS_ID:21909					
EP_NO: 724					
Repair Type: Non-Urgent					
Crossing Status: Found					
UCIP Comments: Pipe open on waterside at fallen down pumphouse.					
Pipe abandoned. Service pole on LS slope down on ground near					
broken standpipe. Pipe needs to be properly abandoned.					
FIELD_STRUCT_DESC: 10-inch pipe through levee 3.8 feet below					
crown. Pump in pumphouse on the water ward slope. Service pole on					
the landward slope (Permit No. 724, 1937). Replaces a 10-inch pipe					
approx. same location. 32-inch concrete standpipe on LS toe. 1.5-inch					
electrical conduit runs parallel to 10-inch pipe. Included in the 1959					
O&M manual.					
FS Date: 5/2/2013

Broken down pumphouse on WS slope.

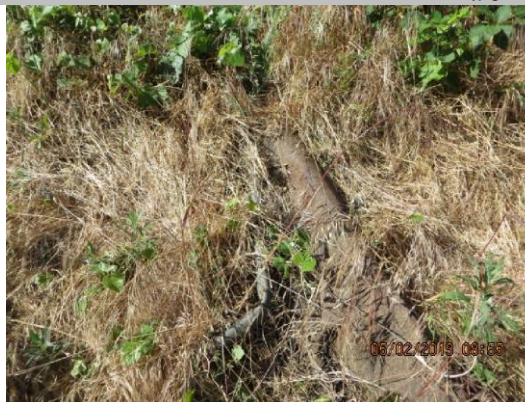
Photo 2 of 2 : UCIP_SP_2016_12774_20744.jpg

deformed and crushed pipe with 1.5-inch electrical conduit on WS slope.

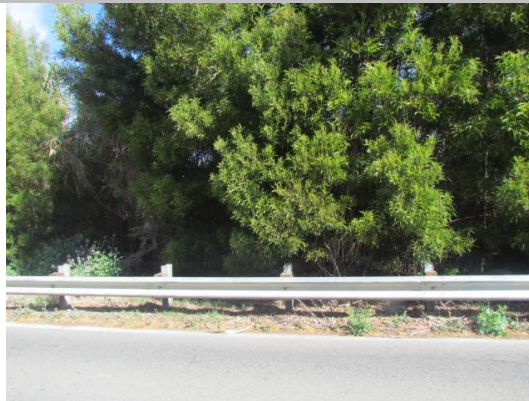
Photo 3 of 3 : SP_2016_NA0002_63_9_20160308_00010.jpg

LM Start	5.31	Rating **	U	Issue No.	9 (cont)	
LM End	5.42	Issue Type +	Ma	Location *	WS	
Category	Earthen Levee			GPS Latitude/Longitude		
				Start		End
Item	Trim / Thin Trees			38.171878 °		38.171800 °
				-121.645552 °		-121.647447 °
DWR ID	DWR_NA0002_02_s_2012_9					
Comment Code						
T2 : Thin trees to allow visibility of the ground and room to flood fight.						
Inspector Comment

Looking west at dense trees on waterward should and slope.

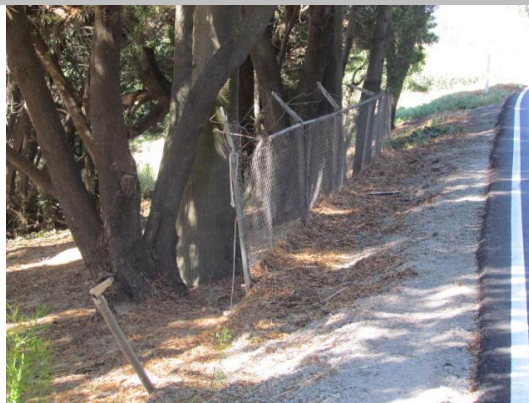
Photo 1 of 1 : SP_2016_NA0002_63_56_20160308_00055.jpg

LM Start	5.39	Rating **	M	Issue No.	56
LM End	5.39	Issue Type +	En	Location *	LS
Category	Earthen Levee			GPS Latitude/Longitude	
				Start	End
Item	Encroachments			38.171850 °	38.171850 °
				-121.647000 °	-121.647000 °
DWR ID	DWR_NA0002_02_f_2013_56				
Comment Code					
FE : Fence					
Inspector Comment					
Fencing should be removed.

Looking at unauthorized fence on landward slope.

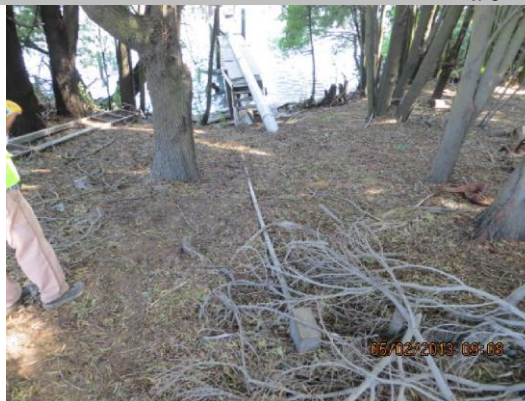
Photo 1 of 2 : UCIP_SP_2016_12776_20754.jpg

LM Start	5.41	Rating **	M	Issue No.	144
LM End	5.41	Issue Type +	En	Location *	LS
Category	Supplemental			GPS Latitude/Longitude	
				Start	End
Item	DWR UCIP Field Study			38.171824 °	38.171824 °
				-121.647265 °	-121.647265 °
DWR ID					
Comment Code					
Inspector Comment					
FS_ID:12776					
DS_ID:21910					
EP_NO: 7089A					
Repair Type: Non-Urgent					
Crossing Status: Found					
UCIP Comments: Hole at LS toe over pipe possible sign of leakage.					
FIELD_STRUCT_DESC: 7-inch pipe through levee 13.0 feet below crown. Pump in pump house on the landward side. 1.5-inch galvanized steel electrical conduit at same location. 4'X6' concrete distribution box off LS toe next to pumphouse. Originally included in the 1959 O&M manual.					
FS Date: 5/2/2013

Pipe and electrical conduit on WS slope.

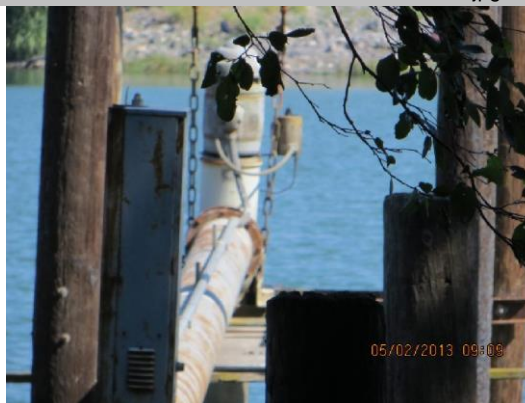
Photo 2 of 2 : UCIP_SP_2016_12776_20753.jpg

Pump on pier at WS toe.

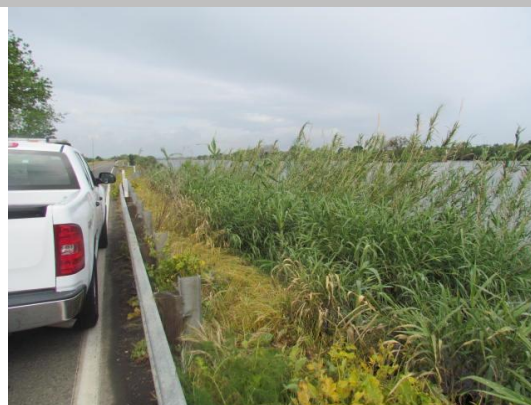
Photo 1 of 1 : SP_2016_NA0002_63_11_20160308_00011.jpg

LM Start	5.65	Rating **	M	Issue No.	11
LM End	5.69	Issue Type +	Ma	Location *	WS
Category	Earthen Levee			GPS Latitude/Longitude	
				Start	End
Item	Vegetation			38.172308 °	38.172497 °
				-121.651552 °	-121.652243 °
DWR ID	DWR_NA0002_02_s _ 2012_11				
Comment Code					
V2 : Remove the wild growth other than native grasses from the levee slopes.					
Inspector Comment					
Bamboo on waterward slope.

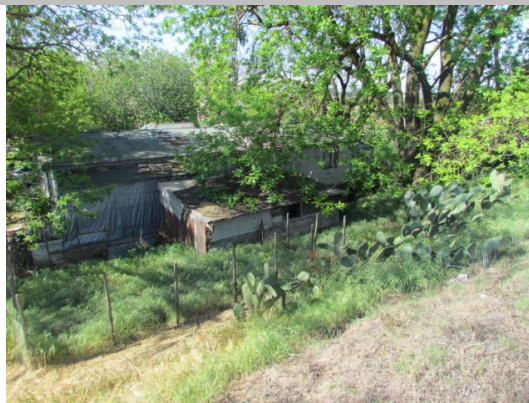
Photo 1 of 1 : SP_2016_NA0002_63_51_20160308_00048.jpg

LM Start	5.68	Rating **	M	Issue No.	51
LM End	5.68	Issue Type +	En	Location *	LS
Category	Earthen Levee			GPS Latitude/Longitude	
				Start	End
Item	Encroachments			38.172442 °	38.172442 °
				-121.652182 °	-121.652182 °
DWR ID	DWR_NA0002_02_s _ 2013_51				
Comment Code					
BU : Building					
Inspector Comment					
Tool shed and animal pen at landside toe.

Looking east tool shed and animal corral on landward slope and toe.

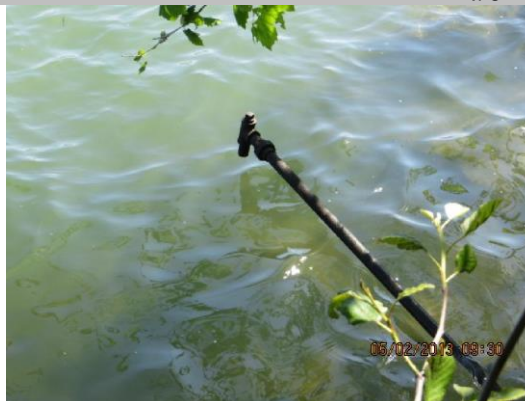
Photo 1 of 2 : UCIP_SP_2016_12778_20762.jpg

LM Start	5.77	Rating **	M	Issue No.	145
LM End	5.77	Issue Type +	En	Location *	LS
Category	Supplemental			GPS Latitude/Longitude	
				Start	End
Item	DWR UCIP Field Study			38.172940 °	38.172940 °
				-121.653700 °	-121.653700 °
DWR ID					
Comment Code					
Inspector Comment					
FS_ID:12778					
DS_ID:21912					
EP_NO: N/A					
Repair Type: Non-Urgent					
Crossing Status: Found					
UCIP Comments: Pipe abandoned. Erosion on WS slope at location where pipe should be.					
FIELD_STRUCT_DESC: 12-inch pipe through levee 13.0 feet below crown. Pump and gate valve in pumphouse at landside toe. 1.5-inch electrical conduit along pipe at same location. 42-inch concrete stand pipe at LS toe. Concrete standpipe at landside toe.					
FS Date: 5/2/2013

Conduit at WS toe.

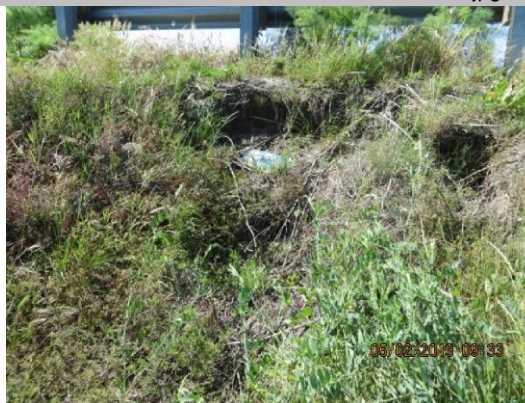
Photo 2 of 2 : UCIP_SP_2016_12778_20761.jpg

Erosion along pipe alignment at WS slope.

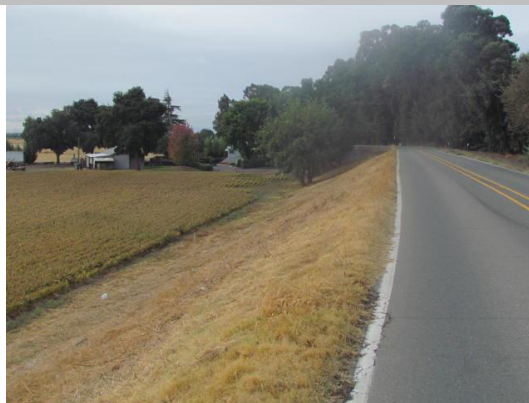
Photo 1 of 1 : SP_2016_NA0002_63_13_20160308_00014.jpg

LM Start	5.80	Rating **	M	Issue No.	13
LM End	6.13	Issue Type +	En	Location *	LS
Category	Earthen Levee			GPS Latitude/Longitude	
				Start	End
Item	Vegetation			38.173130 °	38.174559 °
				-121.654285 °	-121.659867 °
DWR ID	DWR_NA0002_02_s_2012_13				
Comment Code					
V2 : Remove the wild growth other than native grasses from the levee slopes.					
Inspector Comment

Looking southeast at compliant vegetation on landside slope.

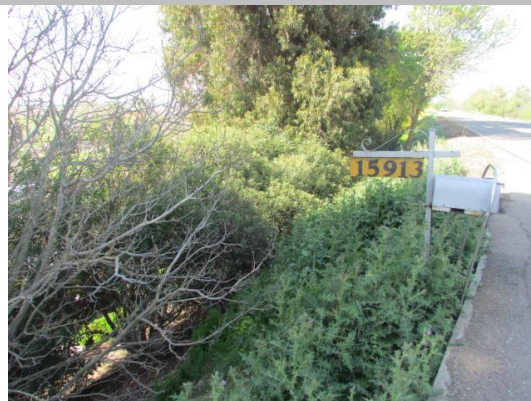
Photo 1 of 2 : SP_2016_NA0002_63_50_20160308_00046.jpg

LM Start	6.27	Rating **	U	Issue No.	50
LM End	6.27	Issue Type +	En	Location *	LS
Category	Earthen Levee			GPS Latitude/Longitude	
				Start	End
Item	Vegetation			38.173922 °	38.173922 °
				-121.662272 °	-121.662272 °
DWR ID	DWR_NA0002_02_s_2013_50				
Comment Code					
V6 : Landscaping					
Inspector Comment

Looking south at dense landscaping on landward slope.

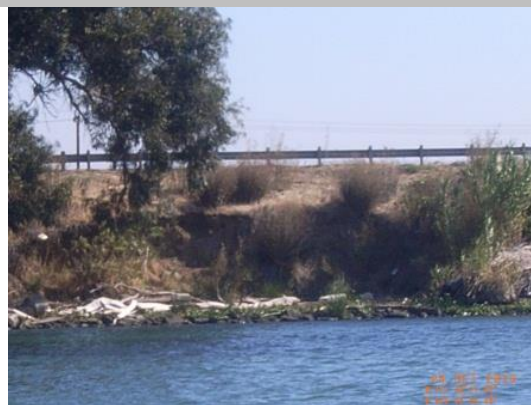
Photo 1 of 1 : SP_2016_NA0002_63_23_20160308_00022.jpg

LM Start	6.98	Rating **	M	Issue No.	23
LM End	7.04	Issue Type +	Ma	Location *	WS
Category	Supplemental			GPS Latitude/Longitude	
				Start	End
Item	2015 USACE Erosion Survey, DRAFT			38.166583 °	38.165794 °
				-121.670684 °	-121.671014 °
DWR ID	DWR_NA0002_02_s _ 2016_23				
Comment Code					
Inspector Comment					
2011 - Large section of bank slumped off. 2015: No observed changes. [2015 Site ID: SAC_13-6_L]

USACE 2013 Photo #1

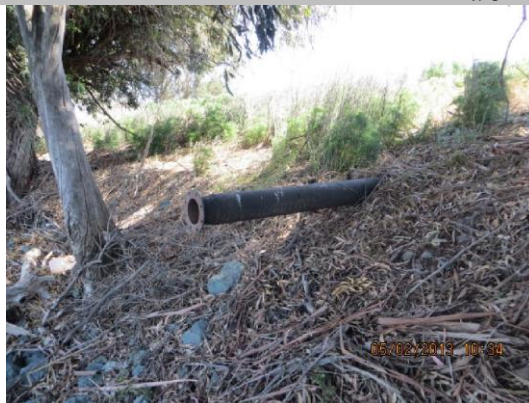
Photo 1 of 2 : UCIP_SP_2016_16011_27090.jpg

FS_ID:16011
DS_ID:21916
EP_NO: N/A
Repair Type: Urgent
Crossing Status: Found
UCIP Comments: Pipe open on WS.
FIELD_STRUCT_DESC: *Abandoned* 8-inch pipe through levee 8.7 feet below crown. Pipe measures 8-inch Inside diameter and 10-inch outside diameter. 5'X5' Concrete distribution box on landside toe. Originally included in the 1959 O&M manual.
FS Date: 5/2/2013

Pipe open on WS slope.

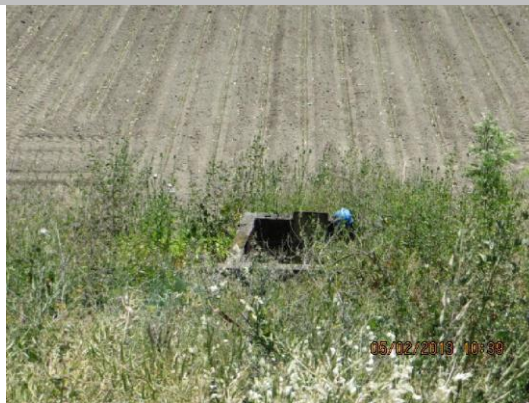
Photo 2 of 2 : UCIP_SP_2016_16011_27091.jpg

5X5 concrete distribution box at LS toe

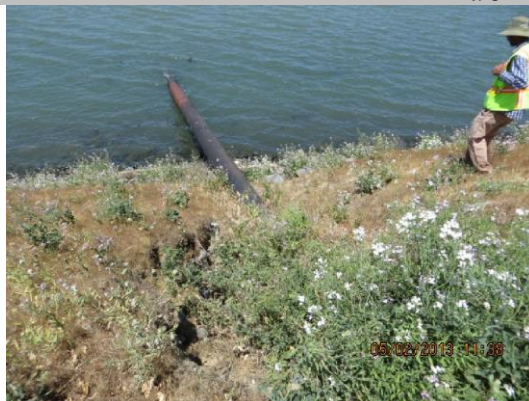
Photo 2 of 2 : UCIP_SP_2016_12814_20820.jpg

LM Start	7.45	Rating **	M	Issue No.	147 (cont)
LM End	7.45	Issue Type +	En	Location *	LS
Category	Supplemental			GPS Latitude/Longitude	
				Start	End
Item	DWR UCIP Field Study			38.160387 °	38.160387 °
				-121.673972 °	-121.673972 °
DWR ID					
Comment Code					
Inspector Comment					
FS_ID:12814 DS_ID:21918 EP_NO: 11293 Repair Type: Non-Urgent Crossing Status: Found UCIP Comments: Erosion or sinkhole on WS shoulder. Does not appear to be an immediate threat. FIELD_STRUCT_DESC: 2 of 2: 16-inch pipe through levee 7.1 feet below crown. Pump on the landward slope. Service pole on the landward slope. 72-inch Concrete standpipe at toe of landward slope (ABO No. 11293, 1975). Originally included in the 1959 O&M manual. FS Date: 5/2/2013

Pipe on WS slope.

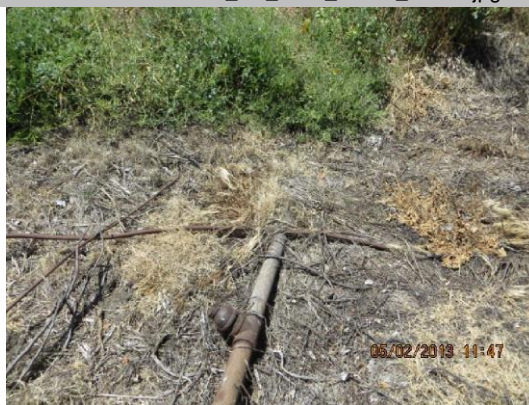
Photo 1 of 2 : UCIP_SP_2016_12817_20825.jpg

LM Start	7.49	Rating **	M	Issue No.	148
LM End	7.49	Issue Type +	En	Location *	LS
Category	Supplemental			GPS Latitude/Longitude	
				Start	End
Item	DWR UCIP Field Study			38.159940 °	38.159940 °
				-121.674430 °	-121.674430 °
DWR ID					
Comment Code					
Inspector Comment					
FS_ID:12817					
DS_ID:21920					
EP_NO: N/A					
Repair Type: Non-Urgent					
Crossing Status: Found					
UCIP Comments: Pipe should be abandoned properly.					
FIELD_STRUCT_DESC: 3-inch pipe through levee 7.7 feet below crown. Inactive service pole on the landward slope.					
FS Date: 5/2/2013

3.5-inch galvanized iron pipe on LS slope.

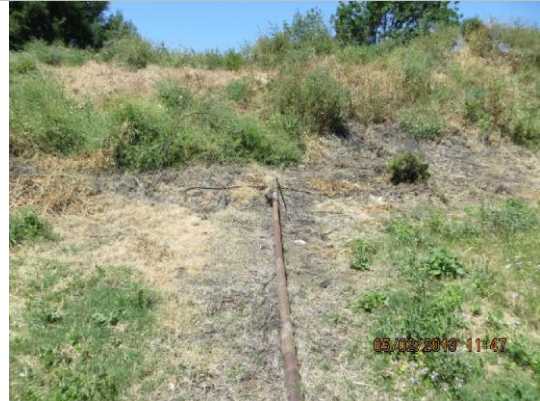
Photo 2 of 2 : UCIP_SP_2016_12817_20824.jpg

3.5-inch galvanized iron pipe on LS slope.

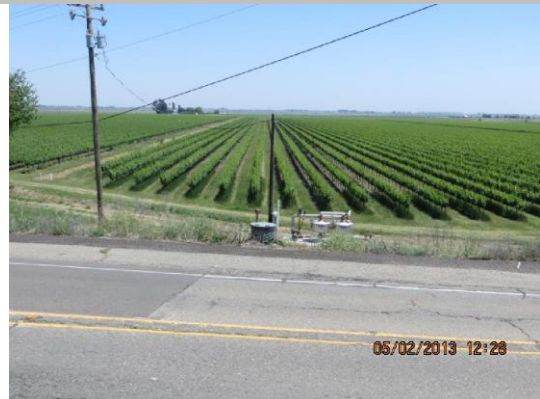
Photo 1 of 2 : UCIP_SP_2016_40795_20835.jpg

LM Start	7.57	Rating **	M	Issue No.	155
LM End	7.57	Issue Type +	En	Location *	LS
Category	Supplemental			GPS Latitude/Longitude	
				Start	End
Item	DWR UCIP Field Study			38.158990 °	38.158990 °
				-121.675374 °	-121.675374 °
DWR ID					
Comment Code					
Inspector Comment					
FS_ID:40795 DS_ID:21922 EP_NO: 1663 Repair Type: Non-Urgent Crossing Status: Found UCIP Comments: Hole over pipe on WS berm that may indicate a leak or other problem. Pipe should be inspected and hole over pipe backfilled. FIELD_STRUCT_DESC: 14-inch pipe through levee 4.4 feet below crown. A 12-inch pipe is sleeved through the 14-inch and then a 6-inch pipe is sleeved through the 12-inch. Siphon breaker in 24-inch CMP standpipe on LS shoulder. 48-inch diameter concrete standpipe on LS toe. (Permit No. 1663,15429 1959). FS Date: 5/2/2013

siphon breaker in 24-inch CMP riser on LS slope and filters at LS toe.

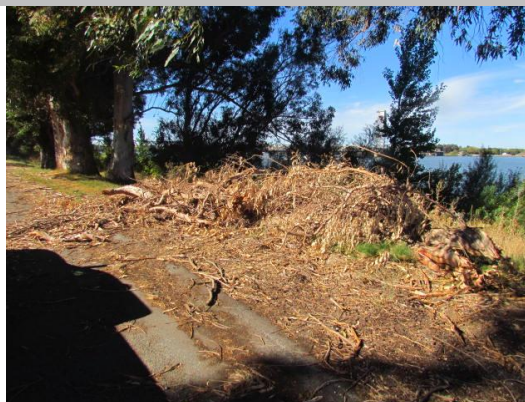
Photo 1 of 1 : SP_2016_NA0002_63_105_20160308_00071.jpg

LM Start	7.71	Rating **	M	Issue No.	105
LM End	7.71	Issue Type +	En	Location *	WS
Category	Earthen Levee			GPS Latitude/Longitude	
				Start	End
Item	Encroachments			38.157841 °	38.157841 °
				-121.677510 °	-121.677510 °
DWR ID	DWR_NA0002_02_f_2014_105				
Comment Code					
TR : Tree or limb					
Inspector Comment					
Tree limbs on waterward shoulder.

Looking southwest at tree limbs on waterward shoulder.
