**Flood Control Project Maintenance
Levee Inspections****LMA District Cover Sheet****Spring 2016 Levee Inspection Results****Brannan Andrus Levee Maintenance District**

Spring 2016 Levee Inspection Results

Brannan Andrus Levee Maintenance District

Waterway			Bank	Unit Miles
Unit No. 01 Georgiana Slough			Right	6.01
	Spring (March - May)	Summer (June - August)	(September - November) Fall	Winter (December - February)
Unit Maintenance Rating (Fall Only)				
Date of Inspection	3/22/2016 - 3/22/2016			
DWR Inspector	Richard Willoughby			
Accompanied By	Gilbert Labrie DCC Engineering Co, Inc

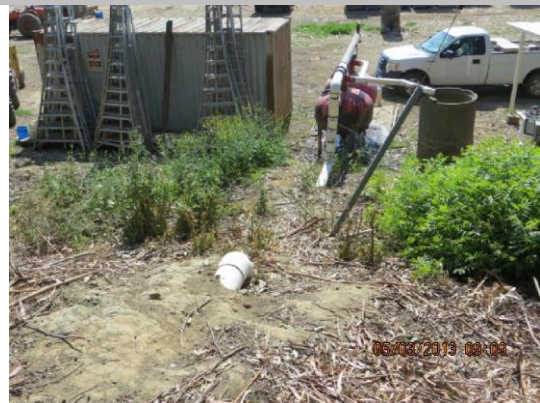
Photo 1 of 2 : UCIP_SP_2016_12869_20933.jpg

LM Start	7.93	Rating **	M	Issue No.	140
LM End	7.93	Issue Type +	En	Location *	LS
Category	Supplemental			GPS Latitude/Longitude	
				Start	End
Item	DWR UCIP Field Study			38.155494 °	38.155494 °
				-121.679988 °	-121.679988 °
DWR ID					
Comment Code					
Inspector Comment					
FS_ID:12869 DS_ID:21925 EP_NO: 2795 Repair Type: Non-Urgent Crossing Status: Found UCIP Comments: Annular space between PVC pipe and 12-inch steel pipe has not been sealed. FIELD_STRUCT_DESC: 20-inch pipe through the levee 3 feet below the crown. 8-inch PVC pipe sleeved through a 12-inch pipe that is sleeved through the 20-inch. Annular space grouted between two metal pipes. Pump and butterfly valve in pumphouse on the water ward slope. 36-inch concrete standpipe and filters on LS toe.(Permit No. 2795,1959). FS Date: 5/3/2013

PVC pipe, filters, and concrete standpipe on LS.

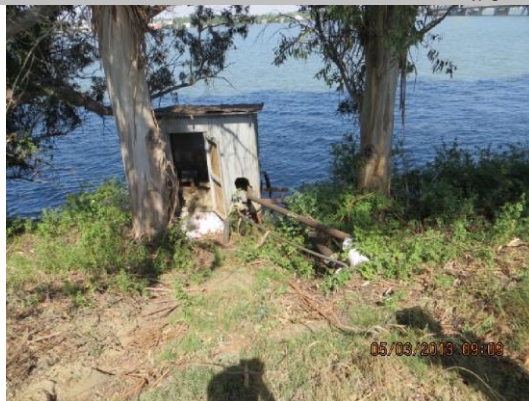
Photo 2 of 2 : UCIP_SP_2016_12869_20932.jpg

LM Start	7.93	Rating **	M	Issue No.	140 (cont)
LM End	7.93	Issue Type +	En	Location *	LS
Category	Supplemental			GPS Latitude/Longitude	
				Start	End
Item	DWR UCIP Field Study			38.155494 °	38.155494 °
				-121.679988 °	-121.679988 °
DWR ID					
Comment Code					
Inspector Comment					
FS_ID:12869 DS_ID:21925 EP_NO: 2795 Repair Type: Non-Urgent Crossing Status: Found UCIP Comments: Annular space between PVC pipe and 12-inch steel pipe has not been sealed. FIELD_STRUCT_DESC: 20-inch pipe through the levee 3 feet below the crown. 8-inch PVC pipe sleeved through a 12-inch pipe that is sleeved through the 20-inch. Annular space grouted between two metal pipes. Pump and butterfly valve in pumphouse on the water ward slope. 36-inch concrete standpipe and filters on LS toe.(Permit No. 2795,1959). FS Date: 5/3/2013

Pumphouse and pipe on WS slope.

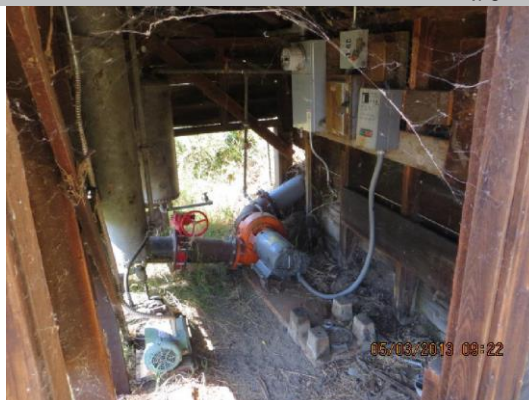
Photo 1 of 2 : UCIP_SP_2016_16143_27242.jpg

LM Start	8.15	Rating **	M	Issue No.	137
LM End	8.15	Issue Type +	En	Location *	LS
Category	Supplemental			GPS Latitude/Longitude	
				Start	End
Item	DWR UCIP Field Study			38.152550 °	38.152550 °
				-121.681560 °	-121.681560 °
DWR ID					
Comment Code					
Inspector Comment					
FS_ID:16143					
DS_ID:21926					
EP_NO: 8661					
Repair Type: Non-Urgent					
Crossing Status: Found					
UCIP Comments: Dip in crown over alignment of pipe. Good candidate for video inspection.					
FIELD_STRUCT_DESC: 8-inch pipe through levee 3.7 feet below crown. Pump in pump house on the landward slope. Service pole and 30-inch concrete standpipe at the landward toe (ABO No. 8661, 1972). Originally included in the 1959 O&M.					
FS Date: 5/3/2013

Pump and butterfly valve in pumphouse on LS toe.

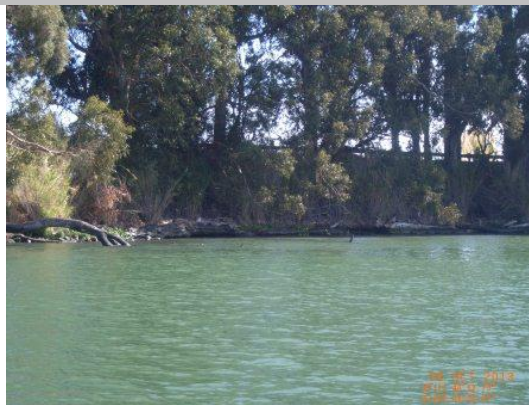
Photo 1 of 1 : SP_2016_NA0002_63_17_20160308_00017.jpg

LM Start	8.20	Rating **	U	Issue No.	17
LM End	8.42	Issue Type +	Ma	Location *	WS
Category	Supplemental			GPS Latitude/Longitude	
				Start	End
Item	2015 USACE Erosion Survey, DRAFT			38.151867 °	38.148711 °
				-121.682201 °	-121.682790 °
DWR ID	DWR_NA0002_02_s_2016_17				
Comment Code					
Inspector Comment					
2010 - Small inlet area behind a man-built spit. Bank is slumping and could possibly be fixed with maintenance. 2011 - Site continues to worsen. 2015: Upgraded to Critical [2015 Site ID: SAC_12-1_L]

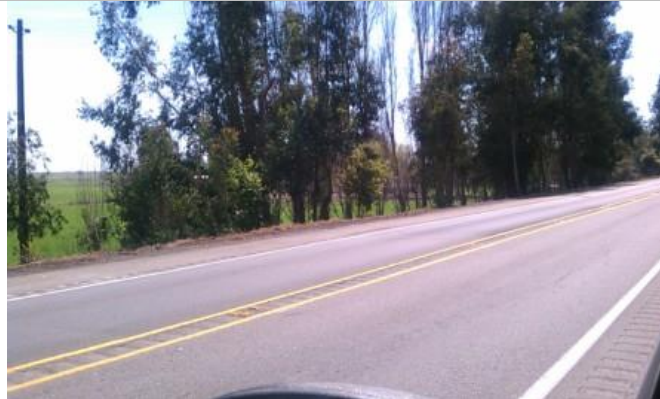
Photo 1 of 1 : SP_2016_NA0002_63_44_20160308_00040.jpg

LM Start	8.32	Rating **	M	Issue No.	44
LM End	8.68	Issue Type +	Ma	Location *	LS
Category	Earthen Levee			GPS Latitude/Longitude	
				Start	End
Item	Trim / Thin Trees			38.150112 °	38.144977 °
				-121.682305 °	-121.683345 °
DWR ID	DWR_NA0002_02_s_2012_44				
Comment Code					
T1 : Trim trees to at least five feet above ground level.					
Inspector Comment

Looking southeast at trees on landside shoulder and slope.

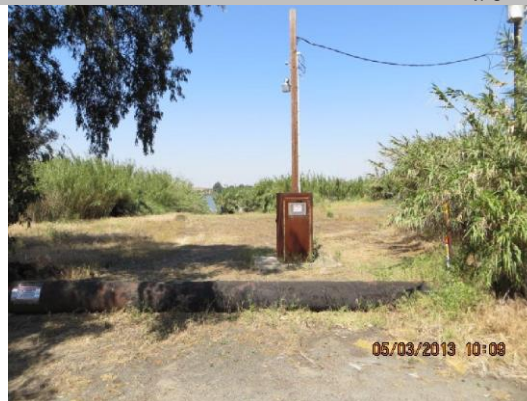
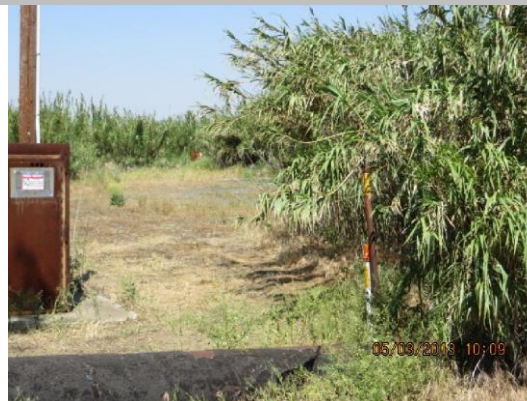
Photo 1 of 2 : UCIP_SP_2016_12886_20946.jpg

LM Start	8.55	Rating **	M	Issue No.	133
LM End	8.55	Issue Type +	En	Location *	WS
Category	Supplemental			GPS Latitude/Longitude	
				Start	End
Item	DWR UCIP Field Study			38.146784 °	38.146784 °
				-121.682780 °	-121.682780 °
DWR ID					
Comment Code					
Inspector Comment					
FS_ID:12886 DS_ID:21929 EP_NO: 842 Repair Type: Non-Urgent Crossing Status: Indicator Found UCIP Comments: Need to determine disposition of pipe. FIELD_STRUCT_DESC: 12-inch gas pipe through levee 3-feet below the crown Gasline marker/vent on WS shoulder. (Permit No. 842, 1940). FS Date: 5/3/2013

Gasline marker and vent to right of JP.

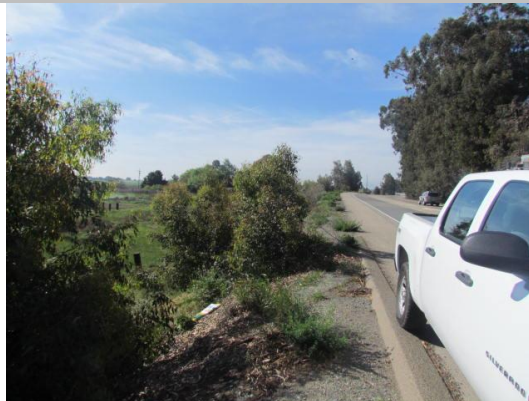
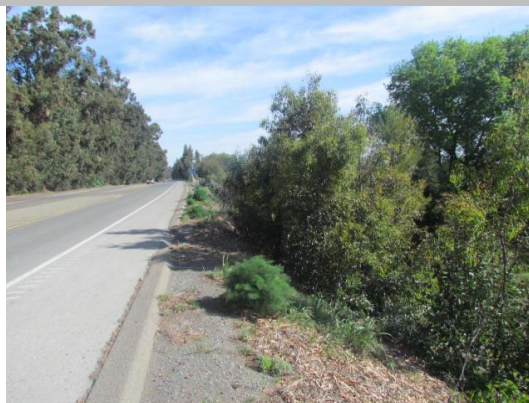
Photo 1 of 2 : SP_2016_NA0002_63_48_20160308_00044.jpg

LM Start	8.65	Rating **	U	Issue No.	48 (cont)
LM End	8.86	Issue Type +	Ma	Location *	LS

Looking south at trees on landward slope.

Looking north at dense trees on landward slope and toe.

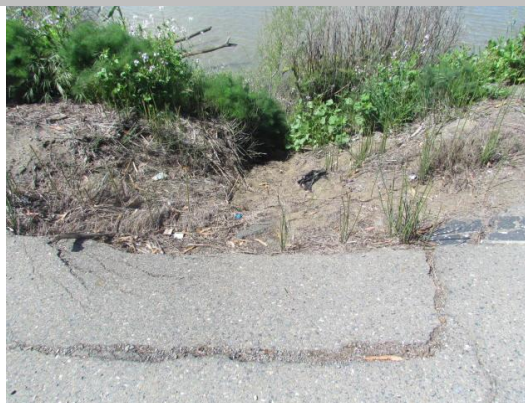
Photo 1 of 3 : SP_2016_NA0002_63_115_20160323_00175.jpg

LM Start	9.15	Rating **	M	Issue No.	115
LM End	9.15	Issue Type +	Ma	Location *	WS
Category	Earthen Levee			GPS Latitude/Longitude	
				Start	End
Item	Erosion / Bank Caving			38.138510 °	38.138510 °
				-121.686124 °	-121.686124 °
DWR ID	DWR_NA0002_02_s_2016_115				
Comment Code					
E1 : Note and monitor erosion site.					
Inspector Comment					
Erosion on waterward shoulder along highway appears to be foot erosion. But should be monitored.

Looking north at erosion on waterward shoulder.

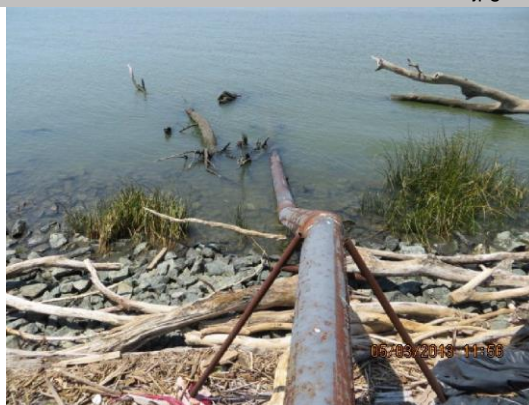
Photo 1 of 2 : UCIP_SP_2016_40528_21002.jpg

LM Start	9.36	Rating **	M	Issue No.	152
LM End	9.36	Issue Type +	En	Location *	LS
Category	Supplemental			GPS Latitude/Longitude	
				Start	End
Item	DWR UCIP Field Study			38.135584 °	38.135584 °
				-121.686108 °	-121.686108 °
DWR ID					
Comment Code					
Inspector Comment					
FS_ID:40528 DS_ID:21931 EP_NO: 16011 Repair Type: Non-Urgent Crossing Status: Found UCIP Comments: Annular space between pipes should be grouted. IF abandoned, these pipes should be abandoned properly. FIELD_STRUCT_DESC: 18-inch corrugated metal conduit pipe through the levee 4.5 feet below the crown. Inactive 12-inch pipe sleeved through 18-inch. Both ends open. Siphon breaker and air valve in 24-inch CMP riser on LS shoulder. 9'X5' concrete box with slide gate off LS toe. Originally included in the 1959 O&M manual. FS Date: 5/3/2013

Pipe on WS slope.

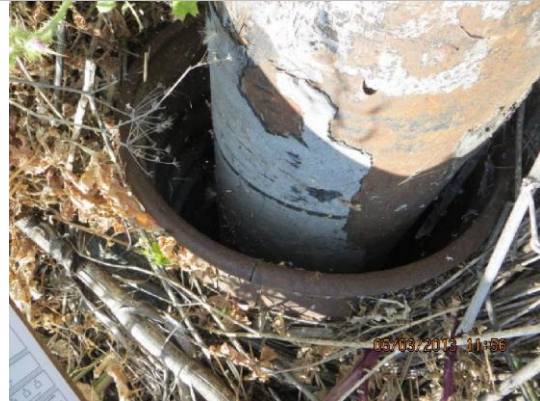
Photo 2 of 2 : UCIP_SP_2016_40528_21001.jpg

LM Start	9.36	Rating **	M	Issue No.	152 (cont)
LM End	9.36	Issue Type +	En	Location *	LS
Category	Supplemental			GPS Latitude/Longitude	
				Start	End
Item	DWR UCIP Field Study			38.135584 °	38.135584 °
				-121.686108 °	-121.686108 °
DWR ID					
Comment Code					
Inspector Comment					
FS_ID:40528					
DS_ID:21931					
EP_NO: 16011					
Repair Type: Non-Urgent					
Crossing Status: Found					
UCIP Comments: Annular space between pipes should be grouted. IF abandoned, these pipes should be abandoned properly.					
FIELD_STRUCT_DESC: 18-inch corrugated metal conduit pipe through the levee 4.5 feet below the crown. Inactive 12-inch pipe sleeved through 18-inch. Both ends open. Siphon breaker and air valve in 24-inch CMP riser on LS shoulder. 9'X5' concrete box with slide gate off LS toe. Originally included in the 1959 O&M manual.					
FS Date: 5/3/2013

18-inch CMP with 12-inch irrigation pipe sleeved through it.

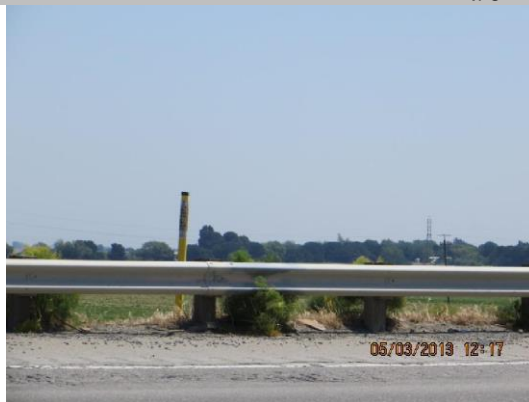
Photo 2 of 2 : UCIP_SP_2016_16146_27250.jpg

Gasline Marker on LS shoulder

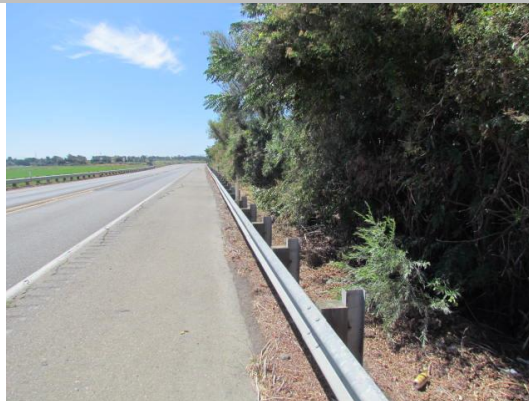
Photo 1 of 2 : SP_2016_NA0002_63_16_20160308_00015.jpg

LM Start	9.60	Rating **	U	Issue No.	16 (cont)
LM End	9.71	Issue Type +	Ma	Location *	WS

Looking south at dense vegetation (trees) on waterward slope.

Looking north at dense vegetation (trees) on waterward slope.

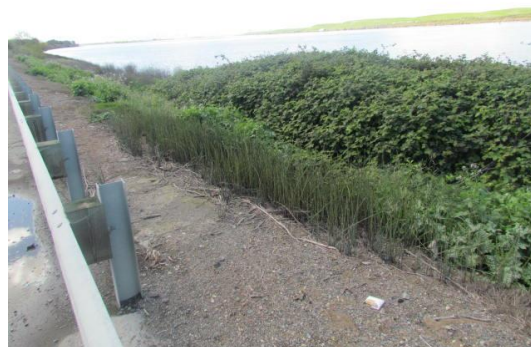
Photo 2 of 2 : SP_2016_NA0002_63_117_20160323_00180.jpg

LM Start	10.17	Rating **	U	Issue No.	117 (cont)	
LM End	10.19	Issue Type +	Ma	Location *	WS	
Category	Earthen Levee			GPS Latitude/Longitude		
				Start		End
Item	Vegetation			38.124372 °		38.124097 °
				-121.690045 °		-121.690186 °
DWR ID	DWR_NA0002_02_s_2016_117					
Comment Code						
V2 : Remove the wild growth other than native grasses from the levee slopes.						
Inspector Comment						
Dense vegetation (vines) on waterward slope.
