**Flood Control Project Maintenance
Levee Inspections**
LMA District Cover Sheet
Spring 2017 Levee Inspection Results

Brannan Andrus Levee Maintenance District

Spring 2017 Levee Inspection Results

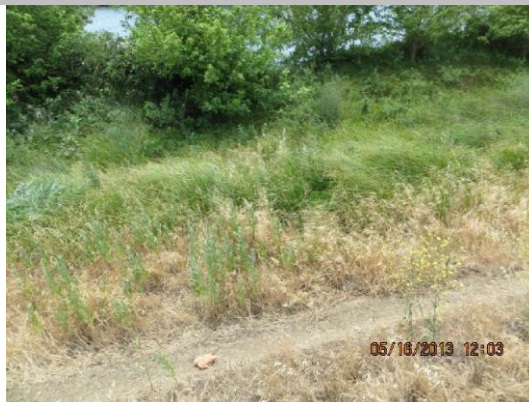
Photo 2 of 3 : UCIP_SP_2017_13560_22172.jpg

LM Start	0.61	Rating **	M	Issue No.	75
LM End	0.61	Issue Type +	En	Location *	WS
Category	Supplemental			GPS Latitude/Longitude	
				Start	End
Item	DWR UCIP Field Study			38.182213 °	38.182213 °
				-121.572357 °	-121.572357 °
DWR ID					
Comment Code					
Inspector Comment					
FS_ID:13560 DS_ID:21752 EP_NO: 2015 Repair Type: Non-Urgent Crossing Status: Found UCIP Comments: This pipe appears abandoned and should be removed. FIELD_STRUCT_DESC: 2-inch galvanized pipe through levee 2.0 feet below crown. Gas well drain (Permit No. 2015, 1959). FS Date: 5/16/2013

Pipe in grass on WS slope.

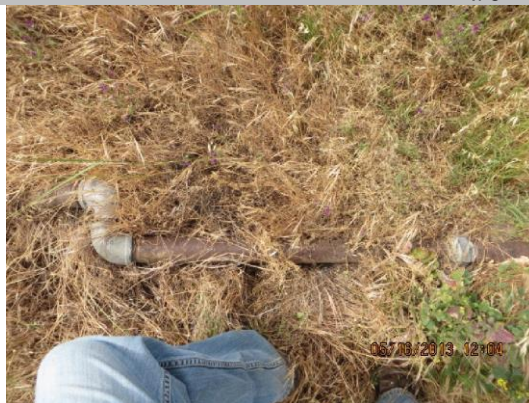
Photo 3 of 3 : UCIP_SP_2017_13560_22171.jpg

LM Start	0.61	Rating **	M	Issue No.	75 (cont)
LM End	0.61	Issue Type +	En	Location *	WS
Category	Supplemental			GPS Latitude/Longitude	
				Start	End
Item	DWR UCIP Field Study			38.182213 °	38.182213 °
				-121.572357 °	-121.572357 °
DWR ID					
Comment Code					
Inspector Comment					
FS_ID:13560 DS_ID:21752 EP_NO: 2015 Repair Type: Non-Urgent Crossing Status: Found UCIP Comments: This pipe appears abandoned and should be removed. FIELD_STRUCT_DESC: 2-inch galvanized pipe through levee 2.0 feet below crown. Gas well drain (Permit No. 2015, 1959). FS Date: 5/16/2013

Pipe on LS slope.

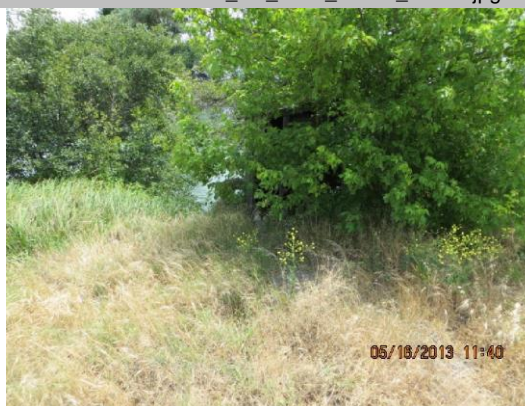
Photo 3 of 3 : UCIP_SP_2017_13558_22167.jpg

LM Start	1.22	Rating **	M	Issue No.	77 (cont)	
LM End	1.22	Issue Type +	En	Location *	WS	
Category	Supplemental			GPS Latitude/Longitude		
				Start	End	
Item	DWR UCIP Field Study			38.177669 °	38.177669 °	
				-121.580222 °	-121.580222 °	
DWR ID						
Comment Code						
Inspector Comment						
FS_ID:13558						
DS_ID:21754						
EP_NO: 11234						
Repair Type: Non-Urgent						
Crossing Status: Found						
UCIP Comments: Appears abandoned and should be done so properly.						
FIELD_STRUCT_DESC: 1 of 2: 8-inch steel pipe through levee 4.3 feet						
below crown. Pump in pump house on waterward berm. 60-inch						
diameter concrete standpipe on LS toe (ABO No. 11234, 1975).						
Originally included in the 1954 O&M manual.						
FS Date: 5/16/2013

Pumphouse on WS slope.

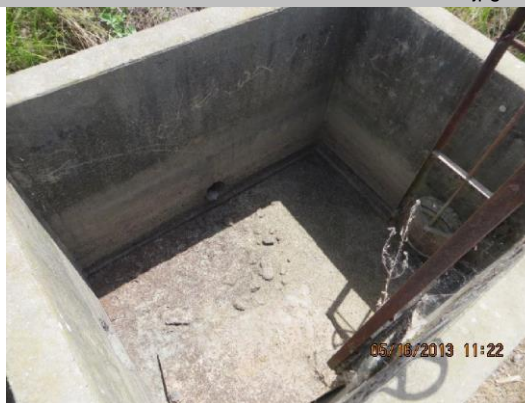
Photo 1 of 3 : UCIP_SP_2017_13554_22164.jpg

LM Start	1.54	Rating **	M	Issue No.	78
LM End	1.54	Issue Type +	En	Location *	WS
Category	Supplemental			GPS Latitude/Longitude	
				Start	End
Item	DWR UCIP Field Study			38.173254 °	38.173254 °
				-121.580718 °	-121.580718 °
DWR ID					
Comment Code					
Inspector Comment					
FS_ID:13554 DS_ID:21755 EP_NO: 11252 Repair Type: Non-Urgent Crossing Status: Found UCIP Comments: Pipe heavily rusted at distribution box. Good candidate for video inspection. FIELD_STRUCT_DESC: 1 of 3: 8-inch steel pipe through levee 4.6 feet below crown. Pump and valve on waterward slope. Siphon breaker in 24-inch CMP riser on LS shoulder. 7'X10'-concrete distribution box at LS toe (ABO No. 11252, 1976). Originally included in the 1954 O&M manual. FS Date: 5/16/2013

7X10-foot concrete distribution box on LS toe.

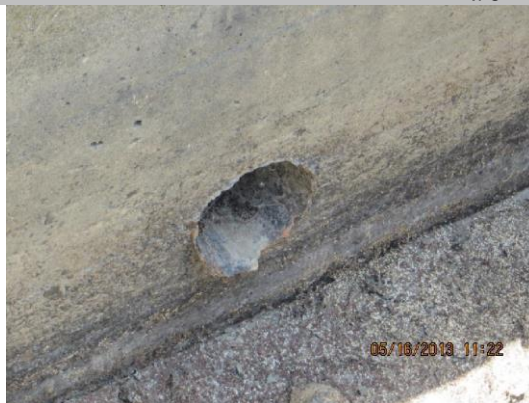
Photo 2 of 3 : UCIP_SP_2017_13554_22163.jpg

LM Start	1.54	Rating **	M	Issue No.	78 (cont)
LM End	1.54	Issue Type +	En	Location *	WS
Category	Supplemental			GPS Latitude/Longitude	
				Start	End
Item	DWR UCIP Field Study			38.173254 °	38.173254 °
				-121.580718 °	-121.580718 °
DWR ID					
Comment Code					
Inspector Comment					
FS_ID:13554 DS_ID:21755 EP_NO: 11252 Repair Type: Non-Urgent Crossing Status: Found UCIP Comments: Pipe heavily rusted at distribution box. Good candidate for video inspection. FIELD_STRUCT_DESC: 1 of 3: 8-inch steel pipe through levee 4.6 feet below crown. Pump and valve on waterward slope. Siphon breaker in 24-inch CMP riser on LS shoulder. 7'X10'-concrete distribution box at LS toe (ABO No. 11252, 1976). Originally included in the 1954 O&M manual. FS Date: 5/16/2013

Pipe shows excessive rust at inlet to distribution box on LS toe.

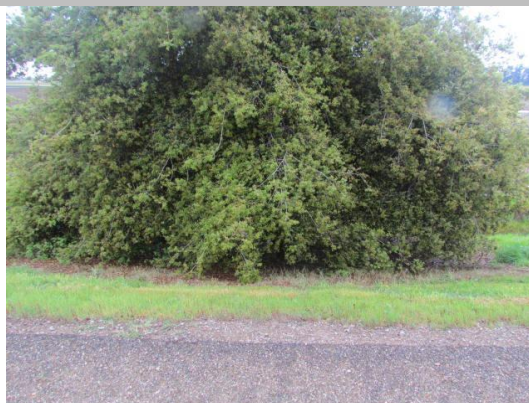
Photo 2 of 3 : SP_2017_NA0002_62_25_20170314_00021.jpg

Looking west at untrimmed tree at landward toe. (Spring 2015)

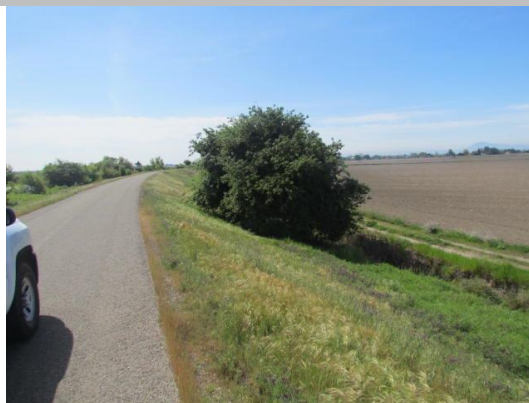
Photo 3 of 3 : SP_2017_NA0002_62_25_20170314_00022.jpg

Looking southwest at an untrimmed tree on landward slope and toe. (Spring 2014)

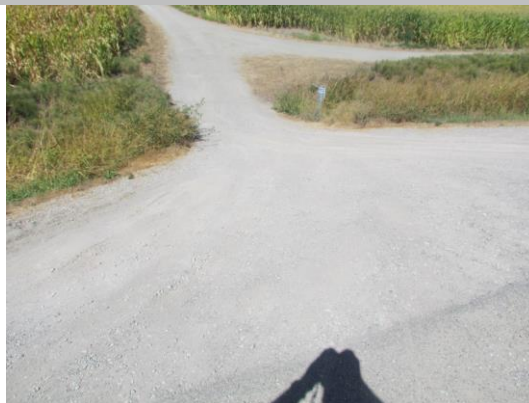
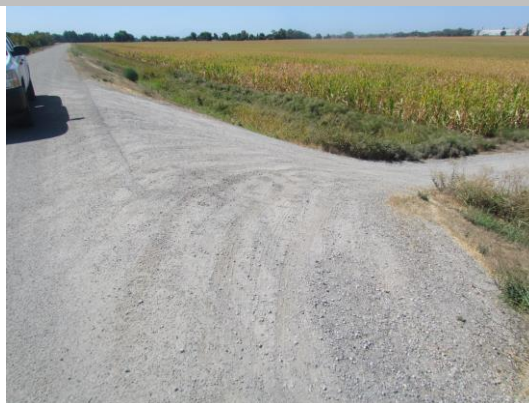
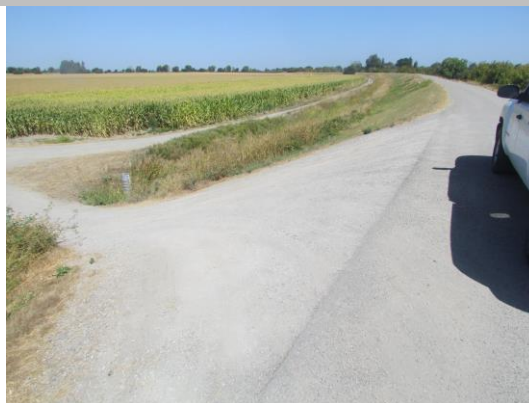
LM Start	1.79	Rating **	U	Issue No.	74
LM End	1.79	Issue Type +	Ma	Location *	LS
Category	Earthen Levee			GPS Latitude/Longitude	
				Start	End
Item	Slope Stability			38.169625 °	38.169625 °
				-121.581542 °	-121.581542 °
DWR ID	DWR_NA0002_01_f_2016_74				
Comment Code					
S3 : Repair the levee slope damaged by vehicle traffic and prevent access where possible.					
Inspector Comment					
Landowner is damaging landward slope by using it as a ramp to access his property.

Looking west at slope damage on waterward slope.

Looking south at slope damage on waterward slope.

Looking north at slope damage on waterward slope.

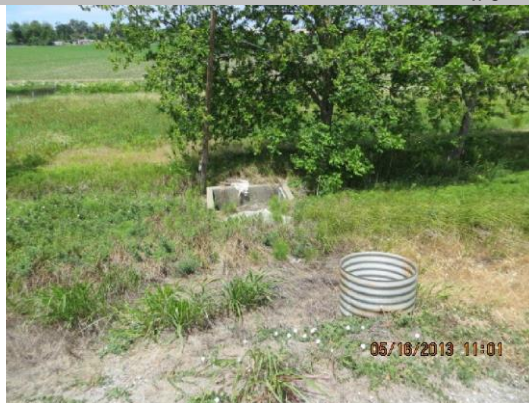
Photo 1 of 3 : UCIP_SP_2017_51471_22155.jpg

FS_ID:51471
DS_ID:21758
EP_NO: 11252
Repair Type: Non-Urgent
Crossing Status: Found
UCIP Comments: 04/06/2017 Landowner has installed a temporary pipe and removed old pipe. Photos and update courtesy of DWR Inspector, Richard Willoughby. 05/16/2013 Pipe rusted through at inlet to box. Good candidate for video inspection. (G. Wylie - DWR)
FIELD_STRUCT_DESC: *REMOVED* 3 of 3: 12-inch steel pipe through the levee 4.0 feet below the crown. Slant pump on bank. Switch box on berm, conduit through levee. Siphon breaker in 24-inch CMP riser on landward slope. Power pole and electrical panel at landward toe (ABO No. 11252, 1975). 7'X10' concrete distribution box on LS toe. As per Richard Willoughby, FPIIB Inspector, landowner has installed a temporary 12-inch PVC pipe on the WS and removed this pipe. New pipe forthcoming. Originally included in the 1954 O&M manual.
FS Date: 4/6/2017

Concrete distribution box and siphon breaker in CMP riser on LS.

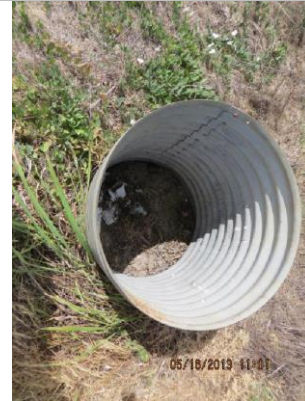
Photo 3 of 3 : UCIP_SP_2017_51471_22153.jpg

Comment Code					
Inspector Comment					
FS_ID:51471 DS_ID:21758 EP_NO: 11252 Repair Type: Non-Urgent Crossing Status: Found UCIP Comments: 04/06/2017 Landowner has installed a temporary pipe and removed old pipe. Photos and update courtesy of DWR Inspector, Richard Willoughby.05/16/2013 Pipe rusted through at inlet to box. Good candidate for video inspection. (G. Wylie - DWR) FIELD_STRUCT_DESC: *REMOVED* 3 of 3: 12-inch steel pipe through the levee 4.0 feet below the crown. Slant pump on bank. Switch box on berm, conduit through levee. Siphon breaker in 24-inch CMP riser on landward slope. Power pole and electrical panel at landward toe (ABO No. 11252, 1975). 7'X10' concrete distribution box on LS toe. As per Richard Willoughby, FPIIB Inspector, landowner has installed a temporary 12-inch PVC pipe on the WS and removed this pipe. New pipe forthcoming. Originally included in the 1954 O&M manual. FS Date: 4/6/2017

siphon breaker in CMP riser on LS.

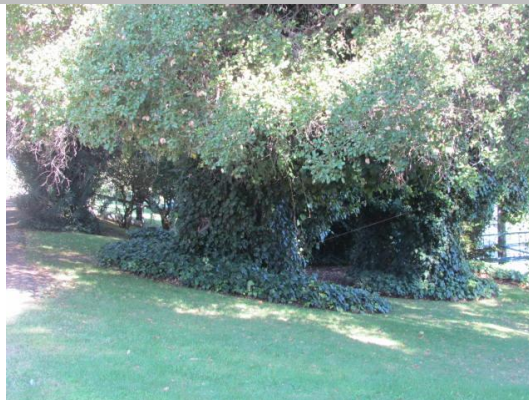
Photo 3 of 4 : SP_2017_NA0002_62_36_20170314_00030.jpg

Looking north at dense vegetation on waterside slope.

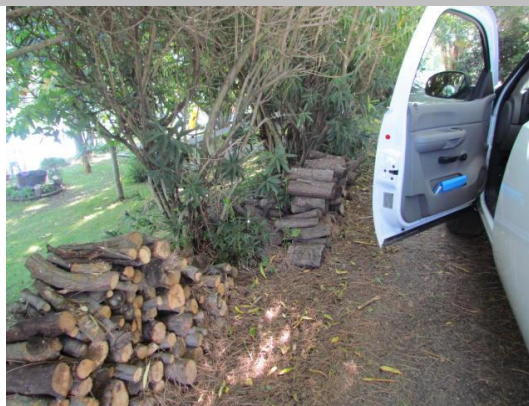
Photo 1 of 3 : SP_2017_NA0002_62_3_20170314_00002.jpg

LM Start	2.30	Rating **	M	Issue No.	3
LM End	2.30	Issue Type +	En	Location *	WS
Category	Earthen Levee			GPS Latitude/Longitude	
				Start	End
Item	Encroachments			38.162773 °	38.162773 °
				-121.584767 °	-121.584767 °
DWR ID	DWR_NA0002_01_s _ 2012_3				
Comment Code					
FW : Firewood					
Inspector Comment

Looking east at firewood on waterside shoulder.

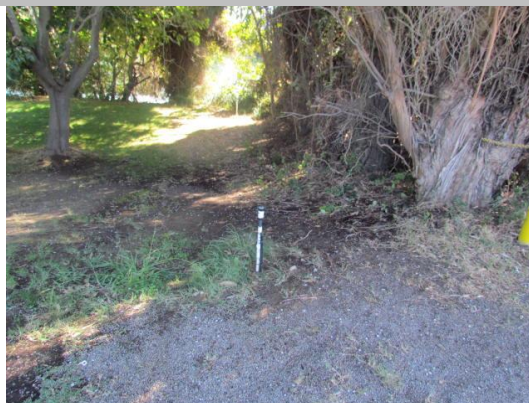
Photo 1 of 1 : SP_2017_NA0002_62_50_20170314_00035.jpg

LM Start	2.33	Rating **	M	Issue No.	50
LM End	2.33	Issue Type +	En	Location *	WS
Category	Earthen Levee			GPS Latitude/Longitude	
				Start	End
Item	Encroachments			38.162343 °	38.162343 °
				-121.585020 °	-121.585020 °
DWR ID	DWR_NA0002_01_f_2014_50				
Comment Code					
LI : Landscape Irrigation					
Inspector Comment					
Landowner installed sprinklers along waterward slope without permit.

Looking east at sprinklers on waterward slope.

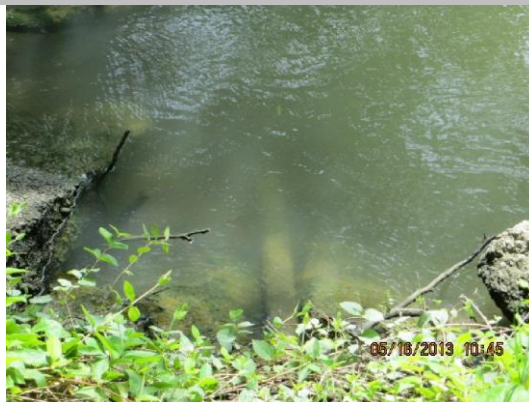
Photo 2 of 2 : UCIP_SP_2017_16123_27220.jpg

LM Start	2.34	Rating **	M	Issue No.	80
LM End	2.34	Issue Type +	En	Location *	WS
Category	Supplemental			GPS Latitude/Longitude	
				Start	End
Item	DWR UCIP Field Study			38.162332 °	38.162332 °
				-121.585032 °	-121.585032 °
DWR ID					
Comment Code					
Inspector Comment					
FS_ID:16123 DS_ID:21819 EP_NO: N/A Repair Type: Non-Urgent Crossing Status: Found UCIP Comments: Pipe appears abandoned and should be done so properly. FIELD_STRUCT_DESC: 2-inch steel pipe through levee 3.0 feet below crown. Originally included in the 1954 O&M manual. FS Date: 5/16/2013

Pipe visible in water at WS toe.

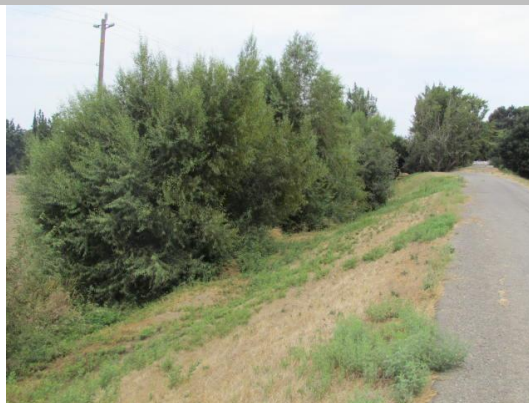
Photo 1 of 2 : SP_2017_NA0002_62_28_20170314_00025.jpg

Look west at dense vegetation at landward toe. (Spring 2016)

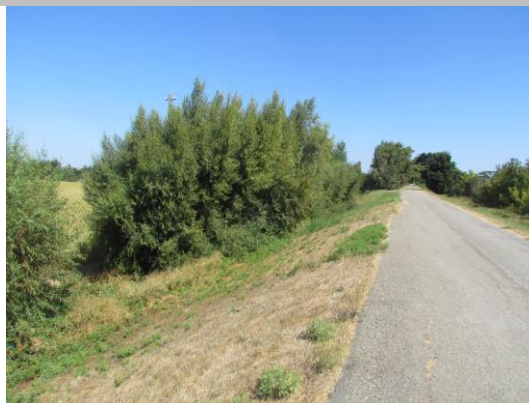
Photo 2 of 2 : SP_2017_NA0002_62_28_20170314_00026.jpg

Look west at dense vegetation at landward toe. (Fall 2016)

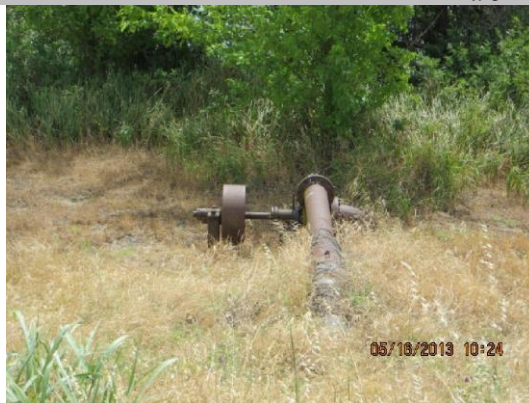
Photo 1 of 3 : UCIP_SP_2017_13545_22145.jpg

FS_ID:13545
DS_ID:21762
EP_NO: N/A
Repair Type: Non-Urgent
Crossing Status: Found
UCIP Comments: Pipe appears abandoned and should be done so properly. standpipe on LS is covered in brush.
FIELD_STRUCT_DESC: 8-inch steel pipe through the levee 3.4 feet below the crown. 6" pump on waterward side. 36-inch concrete standpipe on LS toe. Originally included in the 1954 O&M manual.
FS Date: 5/16/2013

Pipe and pump on WS slope.

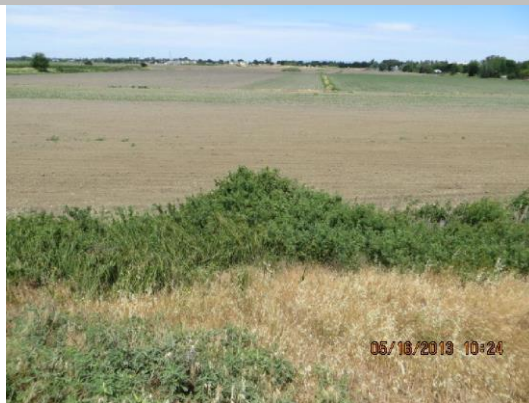
Photo 2 of 3 : UCIP_SP_2017_13545_22144.jpg

Standpipe covered in brush on LS toe.

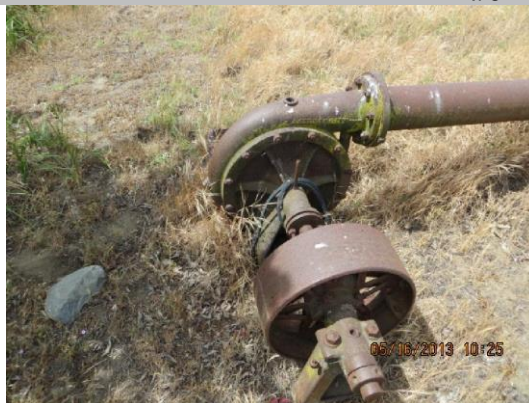
Photo 3 of 3 : UCIP_SP_2017_13545_22143.jpg

LM Start	2.50	Rating **	M	Issue No.	81 (cont)
LM End	2.50	Issue Type +	En	Location *	LS
Category	Supplemental			GPS Latitude/Longitude	
				Start	End
Item	DWR UCIP Field Study			38.160147 °	38.160147 °
				-121.586088 °	-121.586088 °
DWR ID					
Comment Code					
Inspector Comment					
FS_ID:13545					
DS_ID:21762					
EP_NO: N/A					
Repair Type: Non-Urgent					
Crossing Status: Found					
UCIP Comments: Pipe appears abandoned and should be done so properly. standpipe on LS is covered in brush.					
FIELD_STRUCT_DESC: 8-inch steel pipe through the levee 3.4 feet below the crown. 6" pump on waterward side. 36-inch concrete standpipe on LS toe. Originally included in the 1954 O&M manual.					
FS Date: 5/16/2013

Pump and pipe on WS toe.

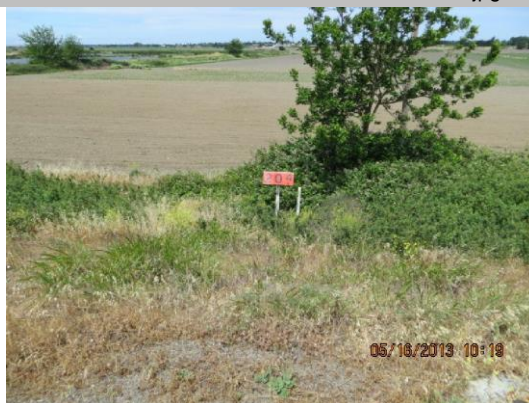
Photo 1 of 2 : UCIP_SP_2017_13525_22128.jpg

LM Start	2.54	Rating **	M	Issue No.	82
LM End	2.54	Issue Type +	En	Location *	LS
Category	Supplemental			GPS Latitude/Longitude	
				Start	End
Item	DWR UCIP Field Study			38.159569 °	38.159569 °
				-121.586340 °	-121.586340 °
DWR ID					
Comment Code					
Inspector Comment					
FS_ID:13525 DS_ID:21764 EP_NO: 17250 Repair Type: Non-Urgent Crossing Status: Indicator Found UCIP Comments: Needs better location markers. FIELD_STRUCT_DESC: 24-inch steel natural-gas pipeline through the levee 117-feet below the crown (Permit No. 17250, 2001). Possible sign on LS toe. FS Date: 5/16/2013

Gasline marker on LS toe.

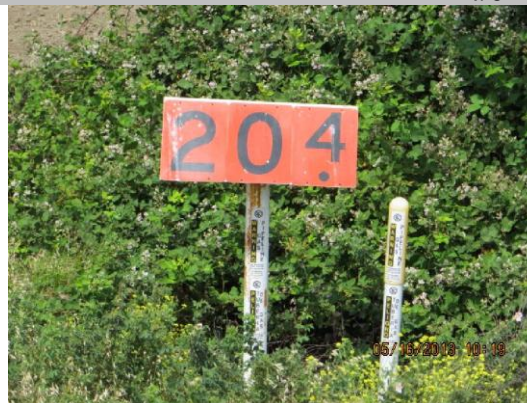
Photo 2 of 2 : UCIP_SP_2017_13525_22127.jpg

LM Start	2.54	Rating **	M	Issue No.	82 (cont)
LM End	2.54	Issue Type +	En	Location *	LS
Category	Supplemental			GPS Latitude/Longitude	
				Start	End
Item	DWR UCIP Field Study			38.159569 °	38.159569 °
				-121.586340 °	-121.586340 °
DWR ID					
Comment Code					
Inspector Comment					
FS_ID:13525 DS_ID:21764 EP_NO: 17250 Repair Type: Non-Urgent Crossing Status: Indicator Found UCIP Comments: Needs better location markers. FIELD_STRUCT_DESC: 24-inch steel natural-gas pipeline through the levee 117-feet below the crown (Permit No. 17250, 2001). Possible sign on LS toe. FS Date: 5/16/2013

Gasline marker on LS toe.

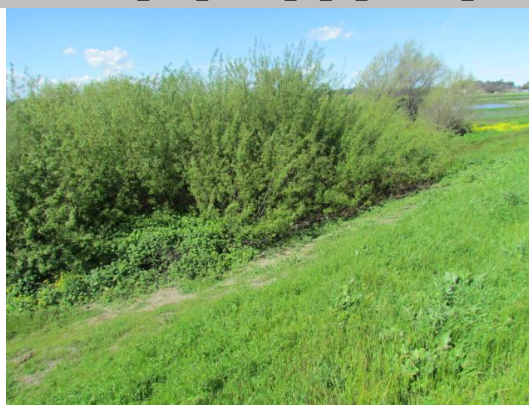
Photo 1 of 4 : SP_2017_NA0002_62_55_20170314_00041.jpg

LM Start	3.00	Rating **	U	Issue No.	55
LM End	3.00	Issue Type +	Ma	Location *	LS
Category	Earthen Levee			GPS Latitude/Longitude	
				Start	End
Item	Vegetation			38.156493 °	38.156493 °
				-121.592481 °	-121.592481 °
DWR ID	DWR_NA0002_01_s_2014_55				
Comment Code					
V2 : Remove the wild growth other than native grasses from the levee slopes.					
Inspector Comment					
Dense vegetation on landward toe.

Looking northwest at dense vegetation at landward toe. (Spring 2016)

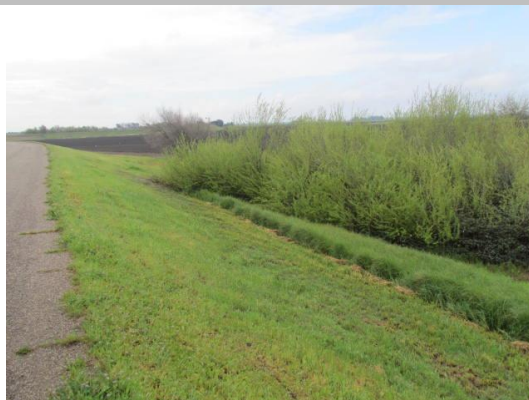
Photo 2 of 4 : SP_2017_NA0002_62_55_20170314_00042.jpg

Looking southwest at dense vegetation at landward toe. (Spring 2015)

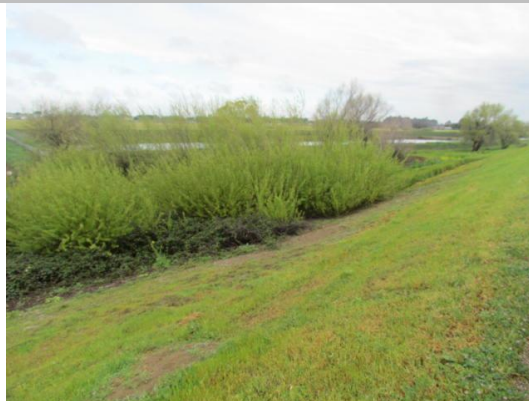
Photo 3 of 4 : SP_2017_NA0002_62_55_20170314_00043.jpg

Looking north at dense vegetation withing fifteen feet of landward toe.

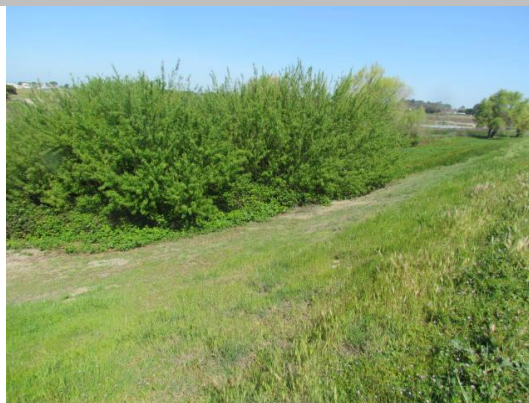
Photo 4 of 4 : SP_2017_NA0002_62_55_20170314_00044.jpg

Looking north at dense vegetation within fifteen feet of landward toe.

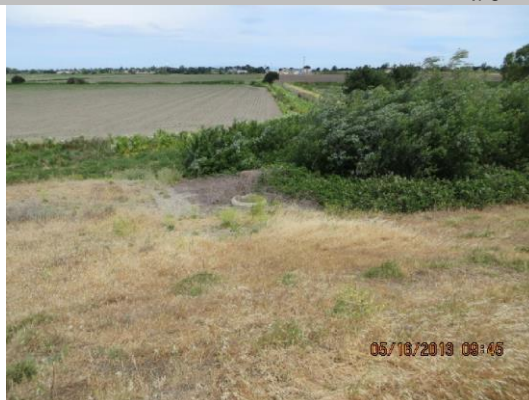
Photo 1 of 2 : UCIP_SP_2017_41561_27229.jpg

LM Start	3.01	Rating **	M	Issue No.	84
LM End	3.01	Issue Type +	En	Location *	LS
Category	Supplemental			GPS Latitude/Longitude	
				Start	End
Item	DWR UCIP Field Study			38.156379 °	38.156379 °
				-121.592527 °	-121.592527 °
DWR ID					
Comment Code					
Inspector Comment					
FS_ID:41561 DS_ID:21766 EP_NO: N/A Repair Type: Non-Urgent Crossing Status: Indicator Found UCIP Comments: Appears abandoned FIELD_STRUCT_DESC: *ABANDONED* 12-inch pipeline through levee, 5-foot diameter concrete riser on LS toe. FS Date: 5/16/2013

5-foot diameter concrete riser on LS toe, but no pipe visible.

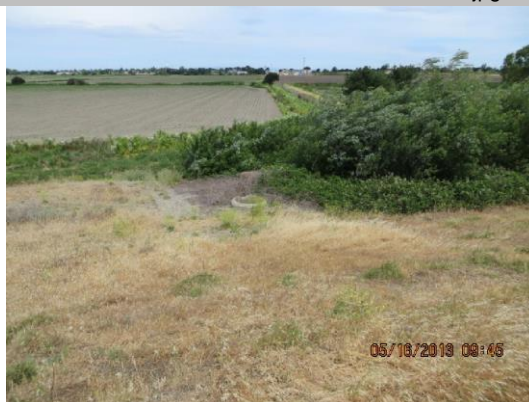
Photo 2 of 2 : UCIP_SP_2017_41561_27228.jpg

LM Start	3.01	Rating **	M	Issue No.	84 (cont)
LM End	3.01	Issue Type +	En	Location *	LS

5-foot diameter concrete riser on LS toe, but no pipe visible.

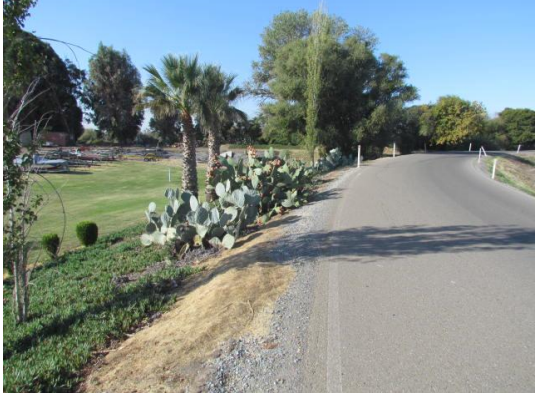
Photo 1 of 2 : SP_2017_NA0002_62_5_20170314_00005.jpg

Looking south at cactus on waterward slope near Oxbow Harbor. (Spring 2016)

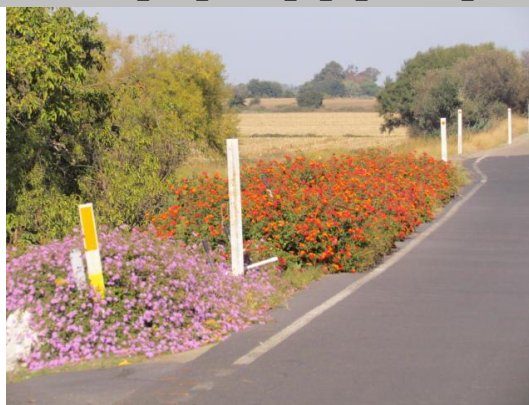
Photo 1 of 3 : SP_2017_NA0002_62_11_20170314_00008.jpg

LM Start	3.93	Rating **	U	Issue No.	11
LM End	3.97	Issue Type +	En	Location *	LS
Category	Earthen Levee			GPS Latitude/Longitude	
				Start	End
Item	Vegetation			38.148318 °	38.147898 °
				-121.599947 °	-121.600347 °
DWR ID	DWR_NA0002_01_s_2012_11				
Comment Code					
V6 : Landscaping					
Inspector Comment

Looking northeast at landscaping on landside slope.

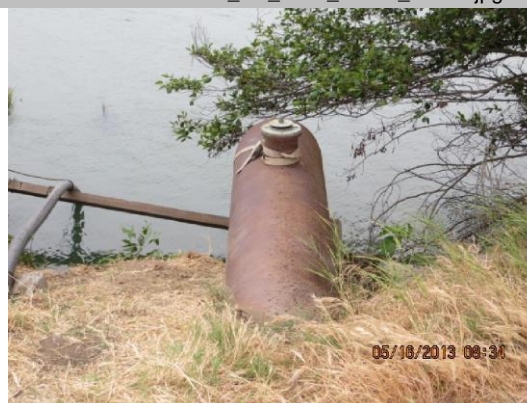
Photo 1 of 3 : UCIP_SP_2017_51303_22078.jpg

Comment Code					
Inspector Comment					
FS_ID:51303 DS_ID:21773 EP_NO: 5534 Repair Type: Urgent Crossing Status: Found UCIP Comments: 10/24/2016 Internal erosion visible on LS where pipe daylights. LS road shoulder appears to be failing. Large sink hole patched and is visible on road/crown. Evidence of burrow activity that appear to be about 6-inches in diameter with depths greater than 3 feet. Burrow holes are located on LS hinge point just upstream of pipe and 3 holes visible on WS. Need to contact owner to address issue and recommend to stop use of crossing to avoid further damage to levee. (O. Magana - DWR UCIP)05/16/2013 Pot holes over pipe may indicate internal failure. Good candidate for video inspection. (W. Wylie - DWR UCIP) FIELD_STRUCT_DESC: 22-inch steel drainage pipe through levee, 3 feet below crown. Siphon breaker is located on the waterside (WS) shoulder. Pump is located on the on the landside (LS). (22-inch pipe authorized under Permit No. 5534, 1966 - Reclamation District No. 407; 22-inch pipe replaced 24-inch discharge pipe) [Additional Reference(s): DWR Levee Log, 2005]. FS Date: 10/24/2016

Pipe and siphon breaker on WS shoulder.

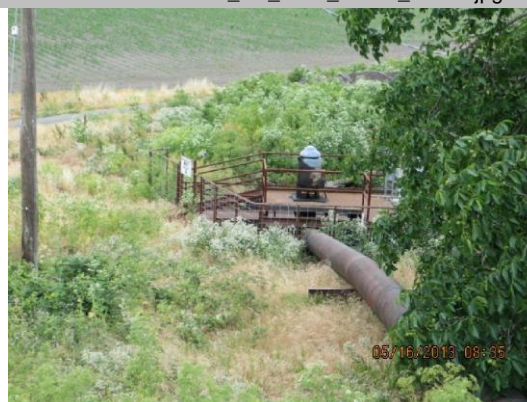
Photo 2 of 3 : UCIP_SP_2017_51303_22077.jpg

Pipe and pumping plant on LS slope.

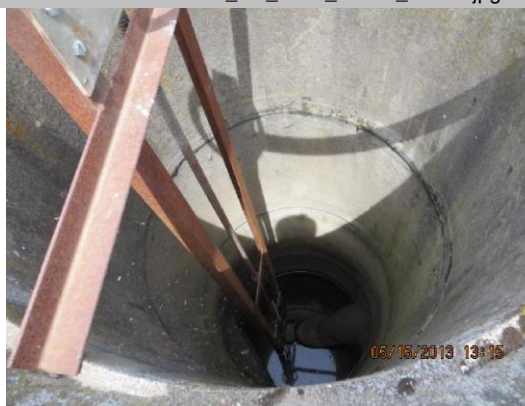
Photo 3 of 3 : UCIP_SP_2017_51308_22048.jpg

FS_ID:51308
DS_ID:21774
EP_NO: 11238
Repair Type: Non-Urgent
Crossing Status: Found
UCIP Comments: 10/24/2016 Unable to determine if WS primer pipe is leaking or if settling is occurring at pipe. Need to contact owner to determine when upgrades to WS were completed. (O. Magana - DWR UCIP)
FIELD_STRUCT_DESC: 10-inch irrigation steel pipe (12-inch referenced in ABO and O&M manual) through levee, 4 feet below crown. Siphon breaker is located on the landside (LS). 1.5-inch primer, 48-inch concrete standpipe on LS toe with slide gate. (12-inch pipe authorized under Automatic Board Order (ABO) issued as Permit No. 11238, 1975 – Gardiner Improvement Company). [Additional Reference(s): DWR Levee Log, 2005. USACE Sacramento O&M Manual Unit 103, June 1954, (Station 106+79), Drawing No. 50-4-2631, page 2631/2].
FS Date: 10/24/2016

Concrete standpipe with slide gate at LS toe.

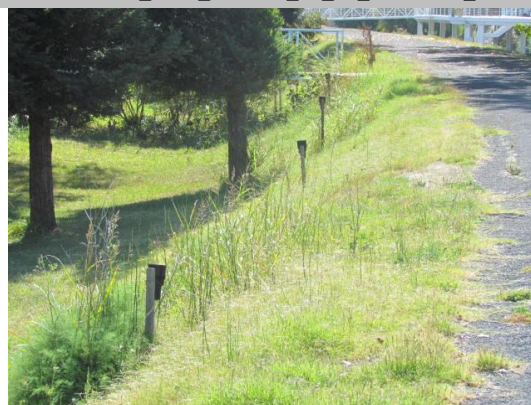
Photo 1 of 1 : SP_2017_NA0002_62_20_20170314_00012.jpg

LM Start	4.23	Rating **	M	Issue No.	20
LM End	4.29	Issue Type +	En	Location *	WS
Category	Earthen Levee			GPS Latitude/Longitude	
				Start	End
Item	Encroachments			38.144471 °	38.143652 °
				-121.601381 °	-121.600877 °
DWR ID	DWR_NA0002_01_f_2013_20				
Comment Code					
LI : Landscape Irrigation					
Inspector Comment					
Sprinkler system on waterside of levee.

Looking south at a sprinkler system on waterward slope.

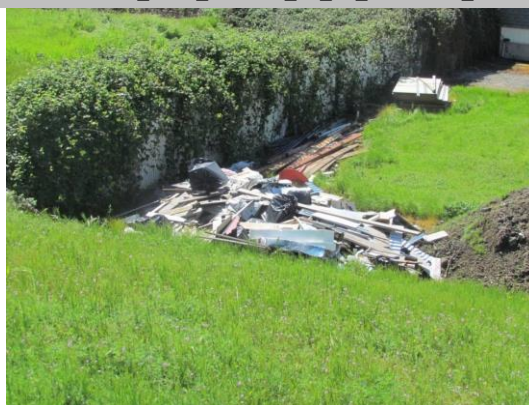
Photo 1 of 2 : SP_2017_NA0002_62_68_20170324_00113.jpg

LM Start	4.54	Rating **	M	Issue No.	68
LM End	4.54	Issue Type +	En	Location *	LS
Category	Earthen Levee			GPS Latitude/Longitude	
				Start	End
Item	Encroachments			38.140556 °	38.140556 °
				-121.598357 °	-121.598357 °
DWR ID	DWR_NA0002_01_f_2016_68				
Comment Code					
GA : Garbage					
Inspector Comment					
Landowner stockpile trash on landward toe.

Looking southwest at trash stockpile at landward toe. (Spring 2017)

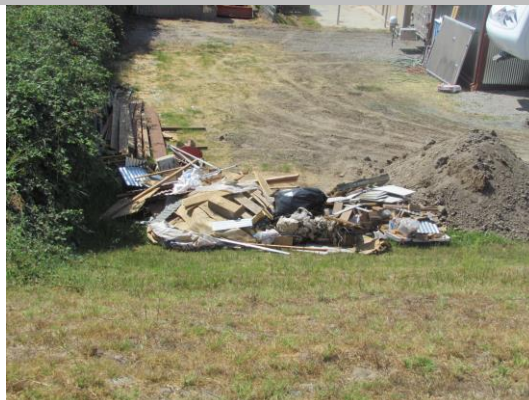
Photo 2 of 2 : SP_2017_NA0002_62_68_20170314_00053.jpg

Looking southwest at trash stockpile at landward toe. (Fall 2016)

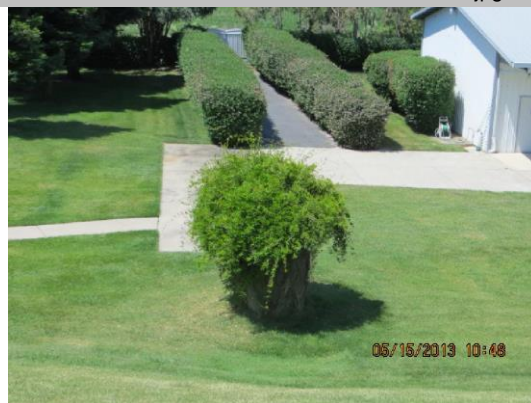
Photo 2 of 2 : UCIP_SP_2017_13442_21941.jpg

LM Start	4.63	Rating **	M	Issue No.	90
LM End	4.63	Issue Type +	En	Location *	LS
Category	Supplemental			GPS Latitude/Longitude	
				Start	End
Item	DWR UCIP Field Study			38.139401 °	38.139401 °
				-121.597678 °	-121.597678 °
DWR ID					
Comment Code					
Inspector Comment					
FS_ID:13442					
DS_ID:21781					
EP_NO: 11237					
Repair Type: Non-Urgent					
Crossing Status: Found					
UCIP Comments: Appears abandoned. Good candidate for video inspection.					
FIELD_STRUCT_DESC: 3 of 3: 6-inch steel pipe through levee 3.6 feet below crown. 42-inch concrete standpipe on LS toe.. (ABO No. 11237, 1975). Originally included in the 1954 O&M manual.					
FS Date: 5/15/2013

42-inch concrete riser on LS toe.

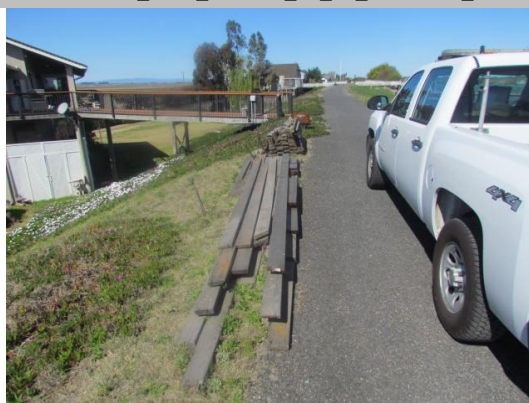
Photo 1 of 1 : SP_2017_NA0002_62_24_20170314_00019.jpg

LM Start	4.78	Rating **	M	Issue No.	24
LM End	4.78	Issue Type +	En	Location *	LS
Category	Earthen Levee			GPS Latitude/Longitude	
				Start	End
Item	Encroachments			38.137478 °	38.137472 °
				-121.596512 °	-121.596512 °
DWR ID	DWR_NA0002_01_s_2012_24				
Comment Code					
GA : Garbage					
Inspector Comment					
Landowner stockpiling wooden boards on landside shoulder.

Looking northwest at wooden boards on landside shoulder.

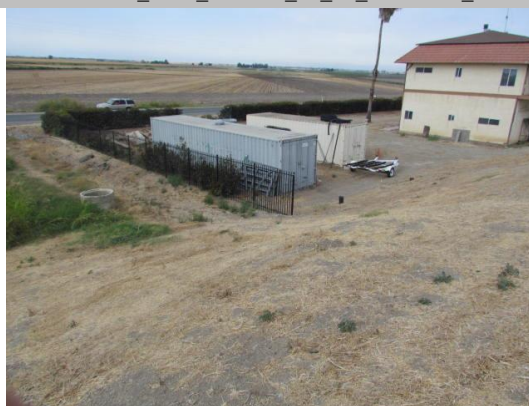
Photo 2 of 2 : SP_2017_NA0002_62_48_20170314_00034.jpg

LM Start	4.83	Rating **	M	Issue No.	48 (cont)	
LM End	4.83	Issue Type +	En	Location *	LS	
Category	Earthen Levee			GPS Latitude/Longitude		
				Start		End
Item	Encroachments			38.136839 °		38.136839 °
				-121.595994 °		-121.595994 °
DWR ID	DWR_NA0002_01_f_2015_48					
Comment Code						
FE : Fence						
Inspector Comment						
Unauthorized fence at landward toe.

Looking southwest at unfinished fence at landward toe.

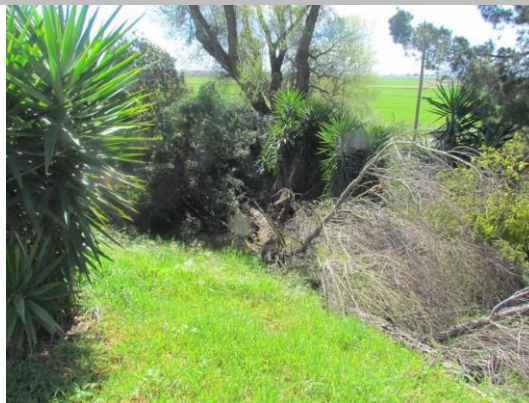
Photo 1 of 1 : SP_2017_NA0002_62_1_20170324_00114.jpg

LM Start	5.06	Rating **	U	Issue No.	1
LM End	5.06	Issue Type +	En	Location *	LS
Category	Earthen Levee			GPS Latitude/Longitude	
				Start	End
Item	Encroachments			38.134293 °	38.134293 °
				-121.593262 °	-121.593262 °
DWR ID	DWR_NA0002_01_s_2017_1				
Comment Code					
TR : Tree or limb					
Inspector Comment					
Fallen tree on landward toe.

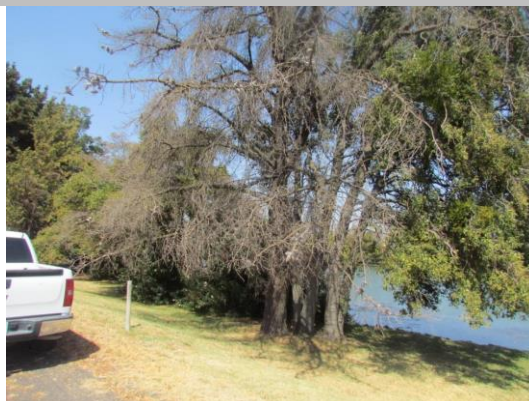
Photo 1 of 2 : SP_2017_NA0002_62_62_20170314_00049.jpg

LM Start	5.06	Rating **	U	Issue No.	62
LM End	5.06	Issue Type +	Ma	Location *	WS
Category	Earthen Levee			GPS Latitude/Longitude	
				Start	End
Item	Encroachments			38.134275 °	38.134275 °
				-121.593213 °	-121.593213 °
DWR ID	DWR_NA0002_01_f_2016_62				
Comment Code					
TR : Tree or limb					
Inspector Comment					
Dead Pine tree on waterward berm.

Looking upstream at dead pine tree on waterward berm.

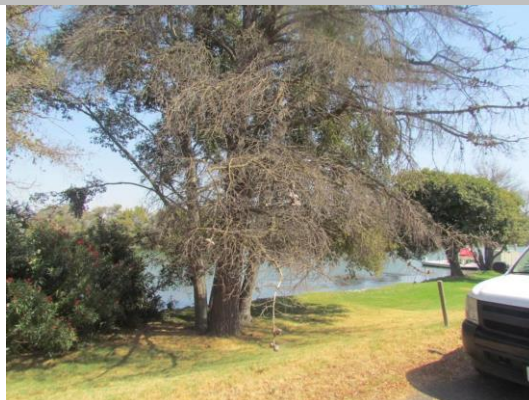
Photo 2 of 2 : SP_2017_NA0002_62_62_20170314_00050.jpg

Looking downstream at dead pine tree on waterward berm.

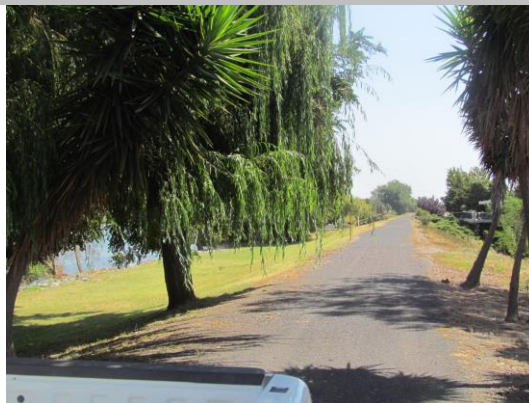
Photo 1 of 1 : SP_2017_NA0002_62_31_20170314_00027.jpg

LM Start	5.17	Rating **	M	Issue No.	31
LM End	5.17	Issue Type +	Ma	Location *	WS
Category	Earthen Levee			GPS Latitude/Longitude	
				Start	End
Item	Trim / Thin Trees			38.133145°	38.133145°
				-121.591895°	-121.591895°
DWR ID	DWR_NA0002_01_s_2013_31				
Comment Code					
T4 : Trim trees over roadway to at least 12 feet above ground level.					
Inspector Comment

Looking southeast at tree over levee crown.

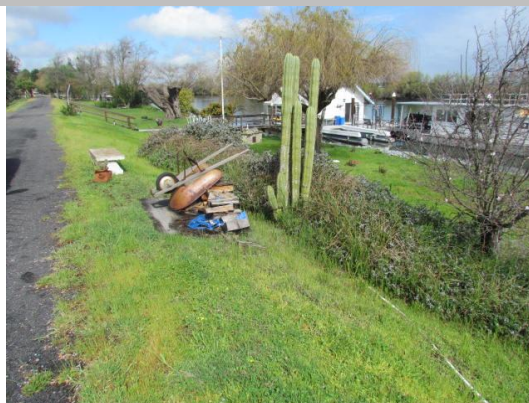
Photo 1 of 2 : SP_2017_NA0002_62_61_20170314_00047.jpg

LM Start	5.25	Rating **	M	Issue No.	61
LM End	5.25	Issue Type +	En	Location *	WS
Category	Earthen Levee			GPS Latitude/Longitude	
				Start	End
Item	Vegetation			38.132261 °	38.132261 °
				-121.590914 °	-121.590914 °
DWR ID	DWR_NA0002_01_s_2015_61				
Comment Code					
V6 : Landscaping					
Inspector Comment					
Overgrowth landscaping on waterward slope.

Looking northeast at overgrowth landscaping on waterward slope.
(Spring 2015)

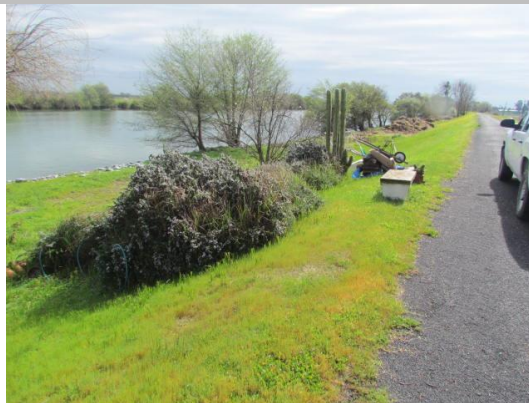
Photo 2 of 2 : SP_2017_NA0002_62_61_20170314_00048.jpg

Looking southeast at overgrowth landscaping on waterward slope.
(Spring 2015)

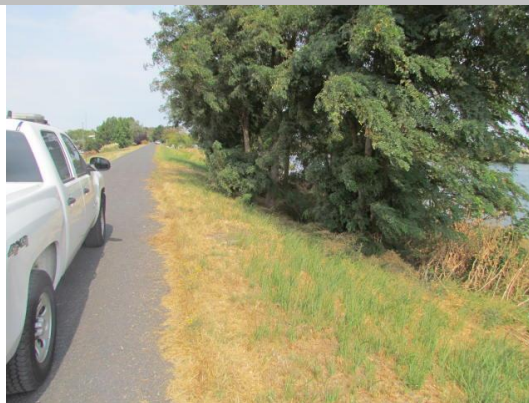
Photo 1 of 1 : SP_2017_NA0002_62_2_20170314_00001.jpg

LM Start	5.33	Rating **	M	Issue No.	2
LM End	5.33	Issue Type +	Ma	Location *	WS
Category	Earthen Levee			GPS Latitude/Longitude	
				Start	End
Item	Trim / Thin Trees			38.131327 °	38.131327 °
				-121.589980 °	-121.589980 °
DWR ID	DWR_NA0002_01_s_2012_2				
Comment Code					
T1 : Trim trees to at least five feet above ground level.					
Inspector Comment

Looking at untrimmed trees on waterward slope.

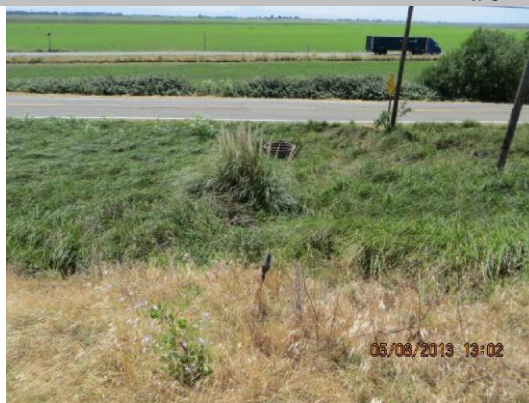
Photo 1 of 3 : UCIP_SP_2017_13090_21282.jpg

LM Start	5.36	Rating **	M	Issue No.	92
LM End	5.36	Issue Type +	En	Location *	WS
Category	Supplemental			GPS Latitude/Longitude	
				Start	End
Item	DWR UCIP Field Study			38.131048 °	38.131048 °
				-121.589655 °	-121.589655 °
DWR ID					
Comment Code					
Inspector Comment					
FS_ID:13090 DS_ID:21816 EP_NO: 11245 Repair Type: Non-Urgent Crossing Status: Found UCIP Comments: Appears abandoned. Pipe at slide gate in riser on LS toe is rusted through. FIELD_STRUCT_DESC: 1 of 2: 14-inch steel pipe through levee 3.8 feet below crown (ABO 11245, 1975). 2" primer valve and 48-inch concrete standpipe on LS. Originally included in the 1954 O&M manual. FS Date: 5/8/2013

Filler pipe and standpipe on LS.

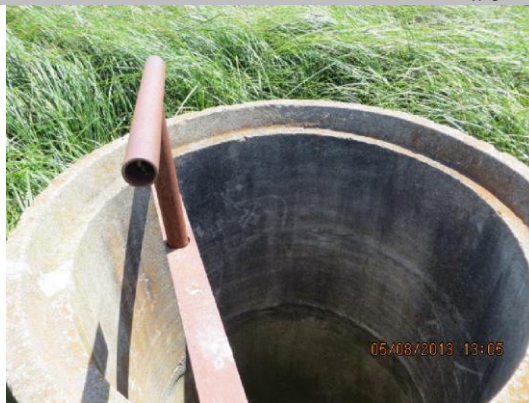
Photo 2 of 3 : UCIP_SP_2017_13090_21281.jpg

Slide gate in 48-inch Concrete riser on LS toe.

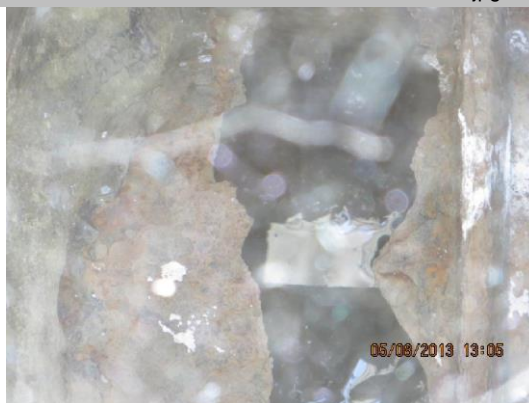
Photo 3 of 3 : UCIP_SP_2017_13090_21280.jpg

Pipe rusted through at slide gate inside concrete riser.

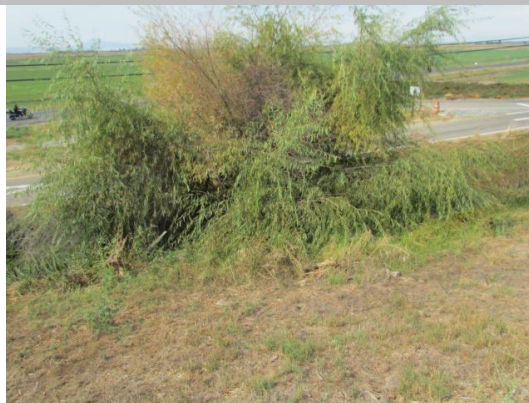
Photo 1 of 1 : SP_2017_NA0002_62_54_20170314_00040.jpg

LM Start	5.42	Rating **	M	Issue No.	54
LM End	5.42	Issue Type +	Ma	Location *	LS
Category	Earthen Levee			GPS Latitude/Longitude	
				Start	End
Item	Trim / Thin Trees			38.130335 °	38.130335 °
				-121.588920 °	-121.588920 °
DWR ID	DWR_NA0002_01_s _ 2014_54				
Comment Code					
T1 : Trim trees to at least five feet above ground level.					
Inspector Comment

Looking at dense trees at landward toe.

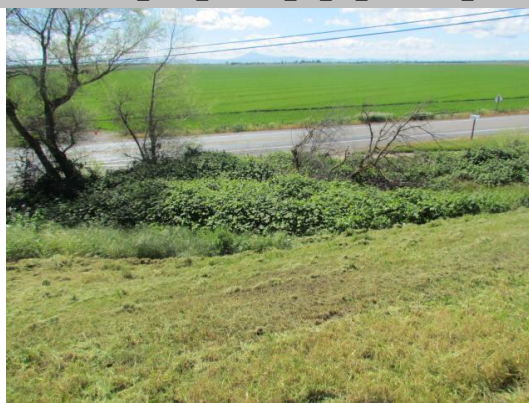
Photo 1 of 6 : SP_2017_NA0002_62_23_20170314_00013.jpg

LM Start	5.43	Rating **	U	Issue No.	23
LM End	5.54	Issue Type +	Ma	Location *	LS
Category	Earthen Levee			GPS Latitude/Longitude	
				Start	End
Item	Vegetation			38.130253 °	38.129451 °
				-121.588822 °	-121.587062 °
DWR ID	DWR_NA0002_01_s _ 2012_23				
Comment Code					
V2 : Remove the wild growth other than native grasses from the levee slopes.					
Inspector Comment					
Control vegetation at landside toe.

Looking south at vegetation at landward toe. (Spring 2016)

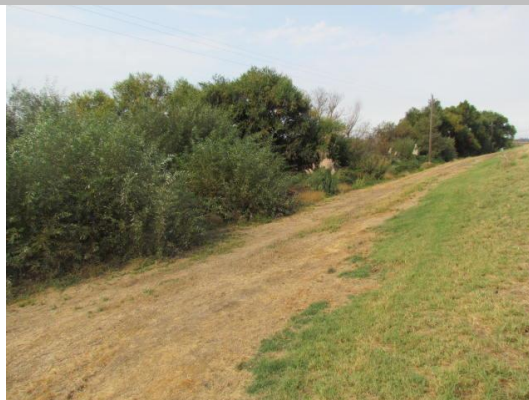
Photo 2 of 6 : SP_2017_NA0002_62_23_20170314_00014.jpg

Looking west at dense vegetation at landward toe.

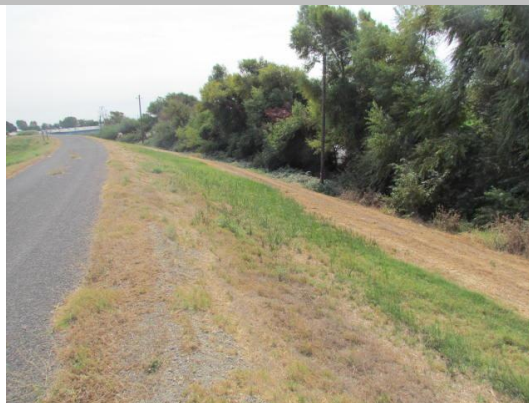
Photo 3 of 6 : SP_2017_NA0002_62_23_20170314_00015.jpg

Looking east at dense vegetation at landward toe.

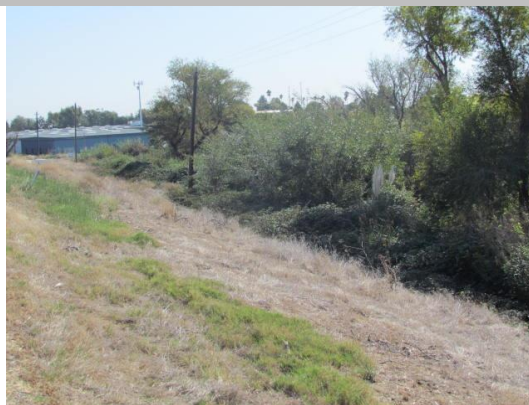
Photo 4 of 6 : SP_2017_NA0002_62_23_20170314_00016.jpg

Looking east at dense vegetation on landward toe.

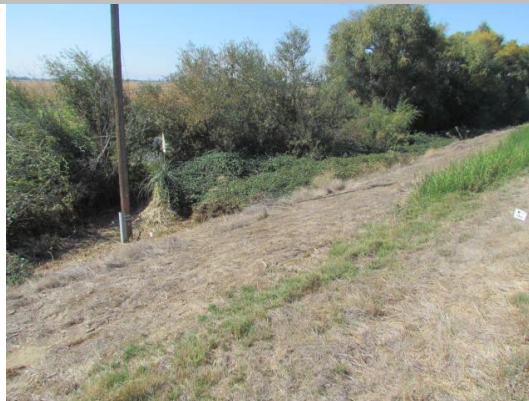
Photo 5 of 6 : SP_2017_NA0002_62_23_20170314_00017.jpg

Looking south at dense berry vines and trees on the landward slope and toe.

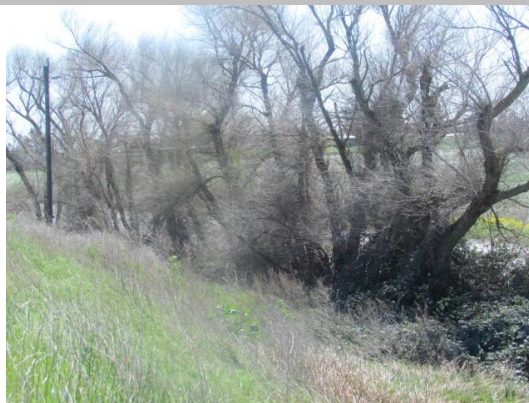
Photo 6 of 6 : SP_2017_NA0002_62_23_20170314_00018.jpg

LM Start	5.43	Rating **	U	Issue No.	23 (cont)	
LM End	5.54	Issue Type +	Ma	Location *	LS	
Category	Earthen Levee			GPS Latitude/Longitude		
				Start		End
Item	Vegetation			38.130253 °		38.129451 °
				-121.588822 °		-121.587062 °
DWR ID	DWR_NA0002_01_s _ 2012_23					
Comment Code						
V2 : Remove the wild growth other than native grasses from the levee slopes.						
Inspector Comment						
Control vegetation at landside toe.

Looking south at trees, berry vines, and wild rose on landside toe.

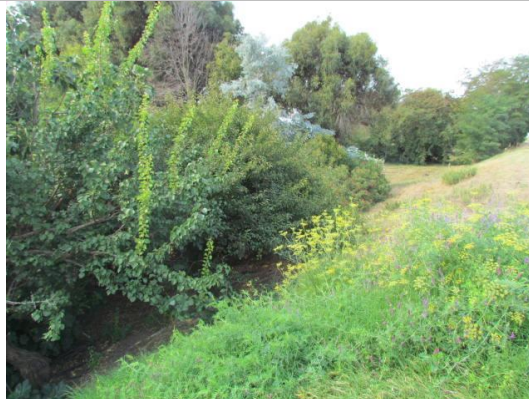
Photo 1 of 2 : SP_2017_NA0002_62_52_20170314_00038.jpg

LM Start	5.84	Rating **	U	Issue No.	52
LM End	5.84	Issue Type +	En	Location *	LS
Category	Earthen Levee			GPS Latitude/Longitude	
				Start	End
Item	Vegetation			38.129649 °	38.129649 °
				-121.581688 °	-121.581688 °
DWR ID	DWR_NA0002_01_s_2014_52				
Comment Code					
V6 : Landscaping					
Inspector Comment					
Fruit trees and other trees on landward toe blocking view.

Looking west at dense trees on landward slope & toe.

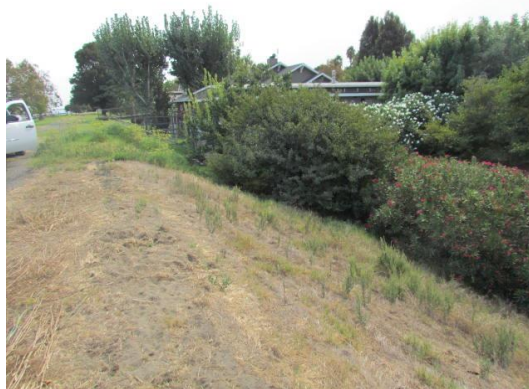
Photo 2 of 2 : SP_2017_NA0002_62_52_20170314_00039.jpg

Looking east at dense trees on landward slope and toe.

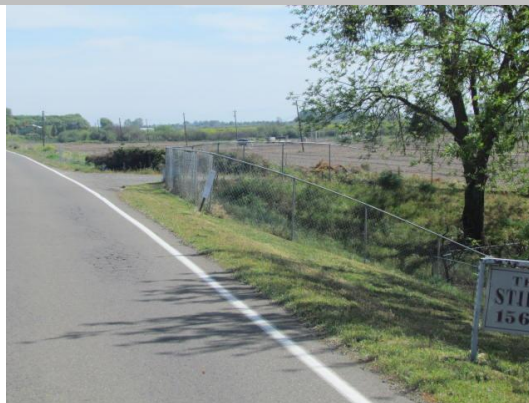
Photo 1 of 1 : SP_2017_NA0002_63_26_20170314_00028.jpg

LM Start	0.43	Rating **	M	Issue No.	26
LM End	0.43	Issue Type +	En	Location *	LS
Category	Earthen Levee			GPS Latitude/Longitude	
				Start	End
Item	Encroachments			38.189212 °	38.189212 °
				-121.574757 °	-121.574757 °
DWR ID	DWR_NA0002_02_s _ 2012_26				
Comment Code					
FE : Fence					
Inspector Comment

Looking northeast at fence on landward shoulder and slope.

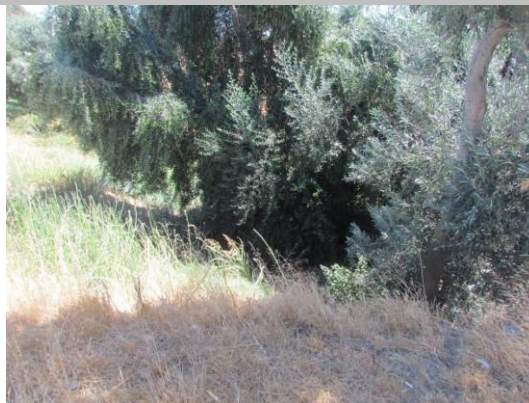
Photo 1 of 1 : SP_2017_NA0002_63_1_20170314_00001.jpg

LM Start	0.66	Rating **	U	Issue No.	1
LM End	0.66	Issue Type +	En	Location *	LS
Category	Earthen Levee			GPS Latitude/Longitude	
				Start	End
Item	Vegetation			38.187672 °	38.187672 °
				-121.578496 °	-121.578496 °
DWR ID	DWR_NA0002_02_s_2012_1				
Comment Code					
V6 : Landscaping					
Inspector Comment

Looking northeast at untrimmed trees at landward toe.

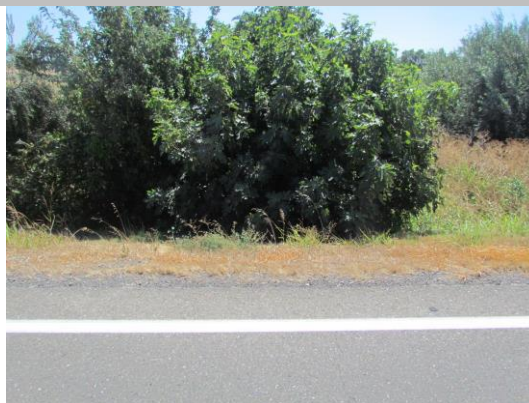
LM Start	0.72	Rating **	U	Issue No.	97
LM End	0.72	Issue Type +	Ma	Location *	LS
Category	Earthen Levee			GPS Latitude/Longitude	
				Start	End
Item	Trim / Thin Trees			38.187102 °	38.187102 °
				-121.579463 °	-121.579463 °
DWR ID	DWR_NA0002_02_f_2016_97				
Comment Code					
T1 : Trim trees to at least five feet above ground level.					
Inspector Comment					
Untrimmed fig tree on landward toe.

Looking east at untrimmed fig tree at landward toe.

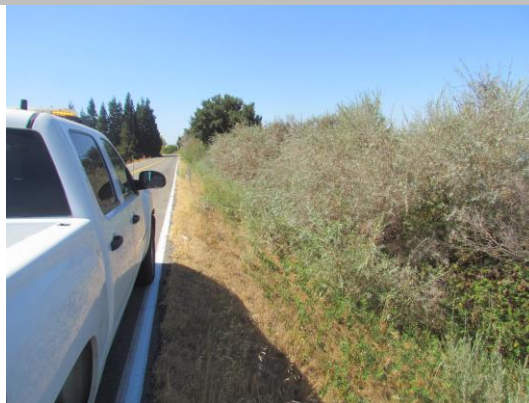
Photo 1 of 1 : SP_2017_NA0002_63_108_20170314_00075.jpg

LM Start	0.73	Rating **	U	Issue No.	108
LM End	0.79	Issue Type +	Ma	Location *	WS
Category	Earthen Levee			GPS Latitude/Longitude	
				Start	End
Item	Vegetation			38.187031 °	38.186511 °
				-121.579588 °	-121.580470 °
DWR ID	DWR_NA0002_02_f_2016_108				
Comment Code					
V2 : Remove the wild growth other than native grasses from the levee slopes.					
Inspector Comment					
Dense willows on waterward slope.

Looking southwest at dense willow trees on waterward slope.

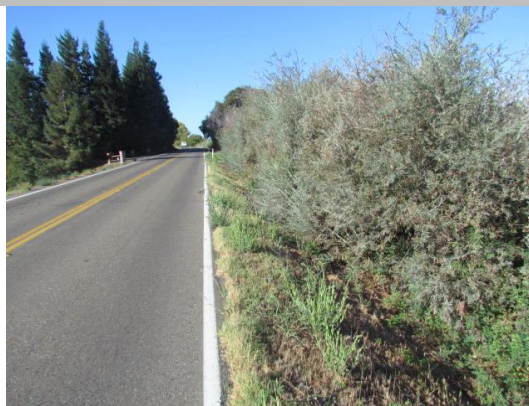
Photo 1 of 1 : SP_2017_NA0002_63_2_20170314_00002.jpg

LM Start	0.79	Rating **	U	Issue No.	2
LM End	0.84	Issue Type +	Ma	Location *	WS
Category	Earthen Levee			GPS Latitude/Longitude	
				Start	End
Item	Trim / Thin Trees			38.186535 °	38.186103 °
				-121.580395 °	-121.581127 °
DWR ID	DWR_NA0002_02_s_2012_2				
Comment Code					
T2 : Thin trees to allow visibility of the ground and room to flood fight.					
Inspector Comment					
Untrimmed trees within twenty foot zone on waterward slope.

Looking southwest at dense willows and trees on waterward slope.

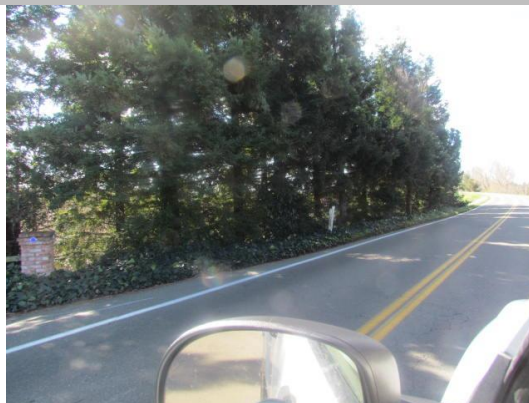
Photo 2 of 3 : SP_2017_NA0002_63_8_20170314_00008.jpg

LM Start	0.80	Rating **	U	Issue No.	8 (cont)	
LM End	0.83	Issue Type +	En	Location *	LS	
Category	Earthen Levee			GPS Latitude/Longitude		
				Start		End
Item	Vegetation			38.186455 °		38.186215 °
				-121.580712 °		-121.581060 °
DWR ID	DWR_NA0002_02_s_2012_8					
Comment Code						
V6 : Landscaping						
Inspector Comment

Looking southwest at dense landscaping on landside slope.

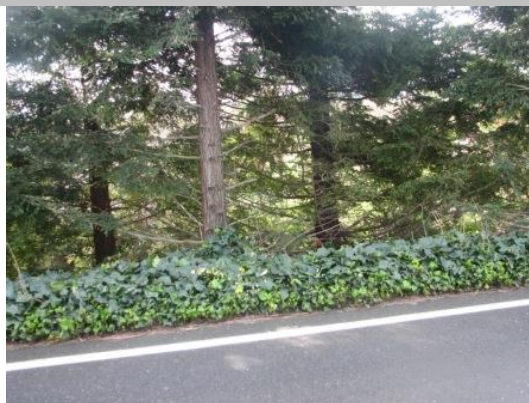
Photo 3 of 3 : SP_2017_NA0002_63_8_20170314_00009.jpg

Landscaping on landside slope blocking view of slope from LM .81 to 0.83.

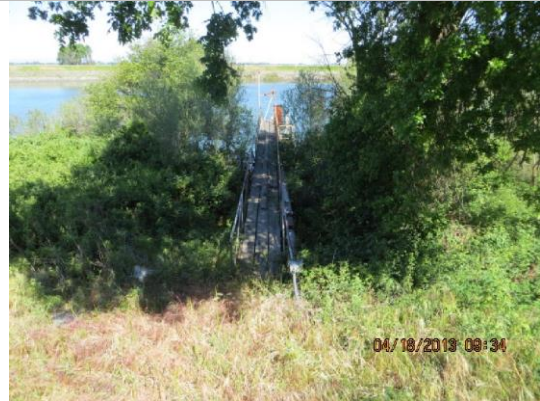
Photo 1 of 3 : UCIP_SP_2017_12164_19726.jpg

Comment Code					
Inspector Comment					
FS_ID:12164 DS_ID:21868 EP_NO: 1173 Repair Type: Non-Urgent Crossing Status: Found UCIP Comments: Several patches on pipe, walkway in disrepair and 24-inch standpipe for siphon breaker on LS slope has been dislodged from the LS slope and rests at LS toe. Pipe appears to be failing at multiple places due to corrosion. FIELD_STRUCT_DESC: 2 of 4: 12-inch pipe through levee 7.0 feet below the crown. Pump on pile structure with a walkway in the river. Siphon breaker in 24-inch CMP riser on LS slope with a 7X9-foot concrete distribution box on LS toe. Service pole on the landward slope with a 1.5-inch galvanized iron electrical conduit at the same location. (Permit No. 1173, 1947). Included in the 1954 O&M manual. FS Date: 4/18/2013

Pump on pile structure with walkway on WS berm.
