**Flood Control Project Maintenance
Levee Inspections**
LMA District Cover Sheet
Spring 2017 Levee Inspection Results

Brannan Andrus Levee Maintenance District

Spring 2017 Levee Inspection Results

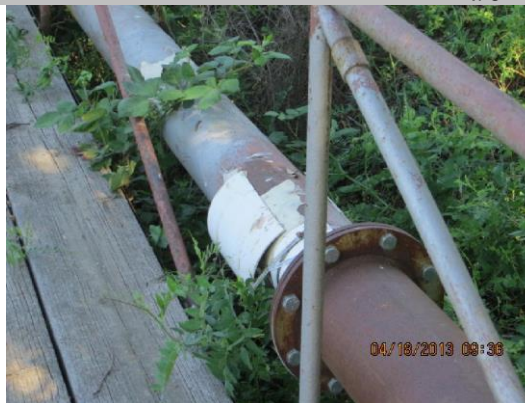
Photo 3 of 3 : UCIP_SP_2017_12164_19724.jpg

Item	DWR UCIP Field Study			38.186199 °	38.186199 °	
				-121.580968 °	-121.580968 °	
DWR ID						
Comment Code						
Inspector Comment						
FS_ID:12164						
DS_ID:21868						
EP_NO: 1173						
Repair Type: Non-Urgent						
Crossing Status: Found						
UCIP Comments: Several patches on pipe, walkway in disrepair and 24-inch standpipe for siphon breaker on LS slope has been dislodged from the LS slope and rests at LS toe. Pipe appears to be failing at multiple places due to corrosion.						
FIELD_STRUCT_DESC: 2 of 4: 12-inch pipe through levee 7.0 feet below the crown. Pump on pile structure with a walkway in the river.						
Siphon breaker in 24-inch CMP riser on LS slope with a 7X9-foot concrete distribution box on LS toe. Service pole on the landward slope with a 1.5-inch galvanized iron electrical conduit at the same location.						
(Permit No. 1173, 1947). Included in the 1954 O&M manual.						
FS Date: 4/18/2013

Multiple patches on Pipe along WS berm.

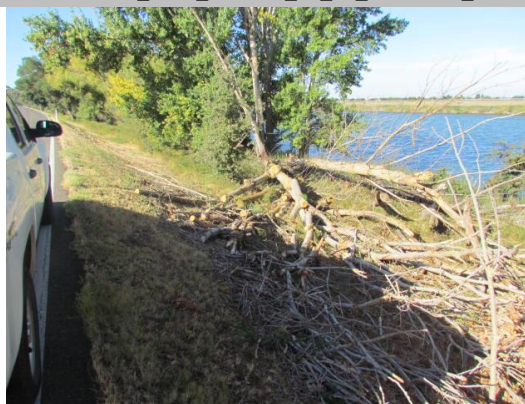
Photo 1 of 2 : SP_2017_NA0002_63_91_20170314_00054.jpg

LM Start	1.07	Rating **	M	Issue No.	91
LM End	1.07	Issue Type +	Ma	Location *	WS
Category	Earthen Levee			GPS Latitude/Longitude	
				Start	End
Item	Encroachments			38.183586 °	38.183586 °
				-121.584010 °	-121.584010 °
DWR ID	DWR_NA0002_02_f_2015_91				
Comment Code					
TR : Tree or limb					
Inspector Comment					
Downed tree branches on waterward slope and berm.

Looking south west at fallen tree on waterward slope and berm.

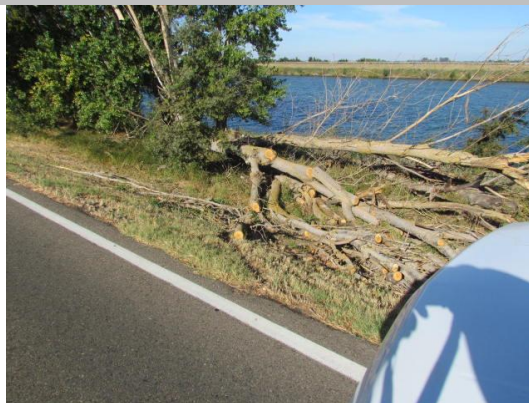
Photo 2 of 2 : SP_2017_NA0002_63_91_20170314_00055.jpg

LM Start	1.07	Rating **	M	Issue No.	91 (cont)	
LM End	1.07	Issue Type +	Ma	Location *	WS	
Category	Earthen Levee			GPS Latitude/Longitude		
				Start		End
Item	Encroachments			38.183586 °	38.183586 °	
				-121.584010 °	-121.584010 °	
DWR ID	DWR_NA0002_02_f_2015_91					
Comment Code						
TR : Tree or limb						
Inspector Comment						
Downed tree branches on waterward slope and berm.

Looking west at fallen tree on waterward slope and berm.

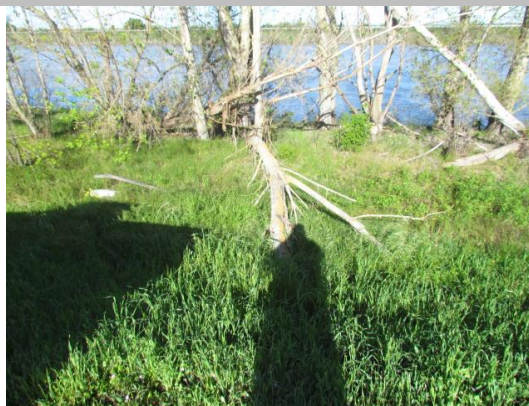
Photo 1 of 2 : SP_2017_NA0002_63_92_20170314_00056.jpg

LM Start	1.16	Rating **	M	Issue No.	92
LM End	1.16	Issue Type +	Ma	Location *	WS
Category	Earthen Levee			GPS Latitude/Longitude	
				Start	End
Item	Encroachments			38.182527 °	38.182527 °
				-121.584901 °	-121.584901 °
DWR ID	DWR_NA0002_02_f_2015_92				
Comment Code					
TR : Tree or limb					
Inspector Comment					
Downed tree branch on waterward slope and berm.

Looking west at fallen tree branch on waterward berm. (Spring 2016)

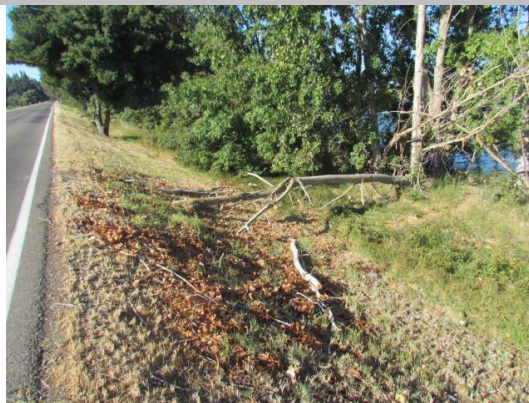
Photo 2 of 2 : SP_2017_NA0002_63_92_20170314_00057.jpg

Looking at fallen tree on waterward slope and berm. (Spring 2015)

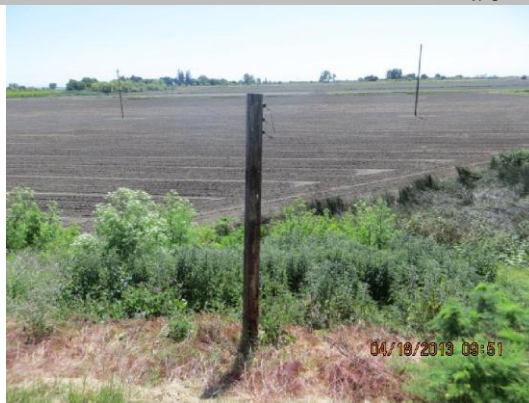
Photo 1 of 3 : UCIP_SP_2017_12165_19731.jpg

LM Start	1.39	Rating **	M	Issue No.	125
LM End	1.39	Issue Type +	En	Location *	WS
Category	Supplemental			GPS Latitude/Longitude	
				Start	End
Item	DWR UCIP Field Study			38.179666 °	38.179666 °
				-121.587109 °	-121.587109 °
DWR ID					
Comment Code					
Inspector Comment					
FS_ID:12165 DS_ID:21869 EP_NO: 11261 Repair Type: Non-Urgent Crossing Status: Found UCIP Comments: Pipe abandoned and should be done so properly. Pipe open on WS. FIELD_STRUCT_DESC: 8-inch pipe through levee 6.5 feet below crown. Pump in pump house on berm. 7'X9' concrete distribution box on LS toe. Service poles on the landward slope with a 1.5-inch galvanized steel electrical conduit at same location (ABO No. 11261, 1975). Originally included in the 1954 O&M manual. FS Date: 4/18/2013

JP on LS slope.

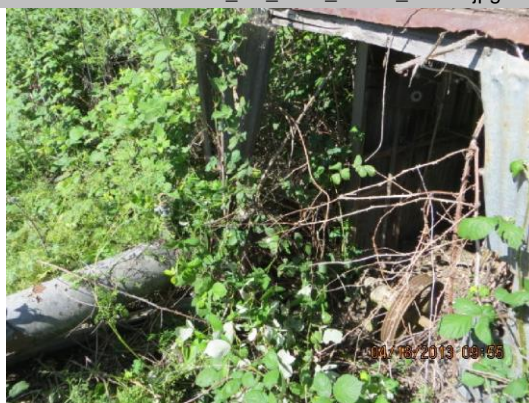
Photo 3 of 3 : UCIP_SP_2017_12165_19729.jpg

LM Start	1.39	Rating **	M	Issue No.	125 (cont)
LM End	1.39	Issue Type +	En	Location *	WS
Category	Supplemental			GPS Latitude/Longitude	
				Start	End
Item	DWR UCIP Field Study			38.179666 °	38.179666 °
				-121.587109 °	-121.587109 °
DWR ID					
Comment Code					
Inspector Comment					
FS_ID:12165 DS_ID:21869 EP_NO: 11261 Repair Type: Non-Urgent Crossing Status: Found UCIP Comments: Pipe abandoned and should be done so properly. Pipe open on WS. FIELD_STRUCT_DESC: 8-inch pipe through levee 6.5 feet below crown. Pump in pump house on berm. 7'X9' concrete distribution box on LS toe. Service poles on the landward slope with a 1.5-inch galvanized steel electrical conduit at same location (ABO No. 11261, 1975). Originally included in the 1954 O&M manual. FS Date: 4/18/2013

Pipe at pumphouse has been disconnected from pump and is open.

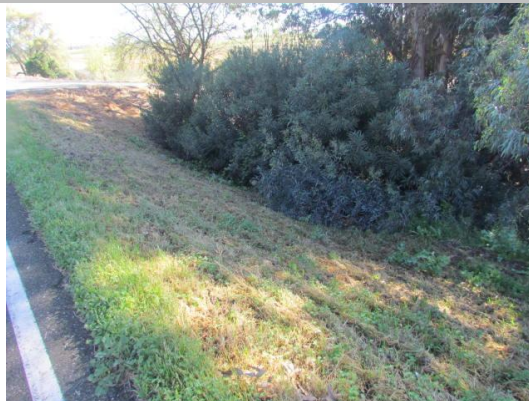
Photo 1 of 4 : SP_2017_NA0002_63_27_20170314_00029.jpg

Looking east at dense vegetation at landward toe.

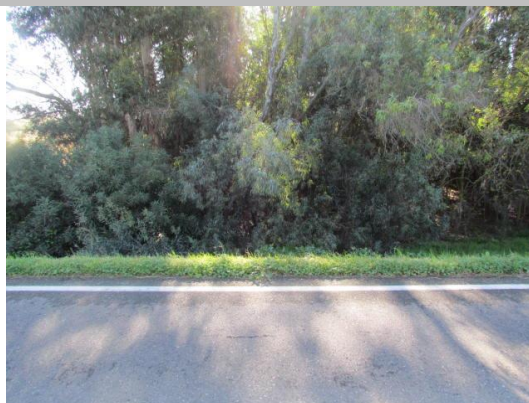
Photo 2 of 4 : SP_2017_NA0002_63_27_20170314_00030.jpg

Looking east at dense vegetation at landward toe.

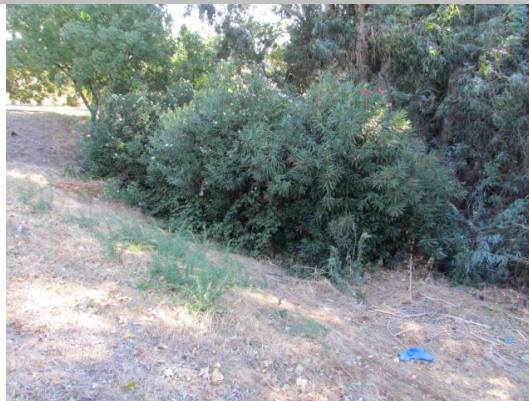
Photo 3 of 4 : SP_2017_NA0002_63_27_20170314_00031.jpg

Looking east at dense vegetation on landward toe.

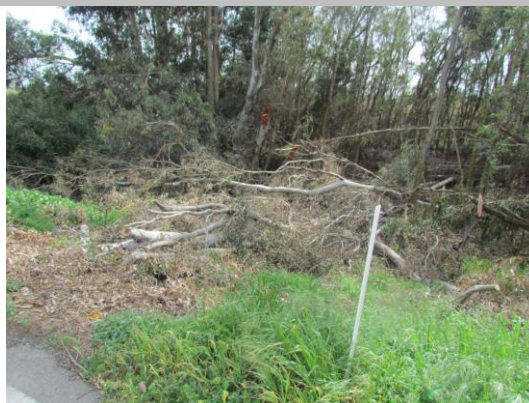
Photo 1 of 2 : SP_2017_NA0002_63_109_20170324_00183.jpg

LM Start	1.46	Rating **	U	Issue No.	109
LM End	1.46	Issue Type +	Ma	Location *	WS
Category	Earthen Levee			GPS Latitude/Longitude	
				Start	End
Item	Encroachments			38.178805 °	38.178805 °
				-121.587850 °	-121.587850 °
DWR ID	DWR_NA0002_02_s_2016_109				
Comment Code					
TR : Tree or limb					
Inspector Comment					
Downed tree branches and limbs on landward slope.

Looking southwest at fallen tree on waterward slope.

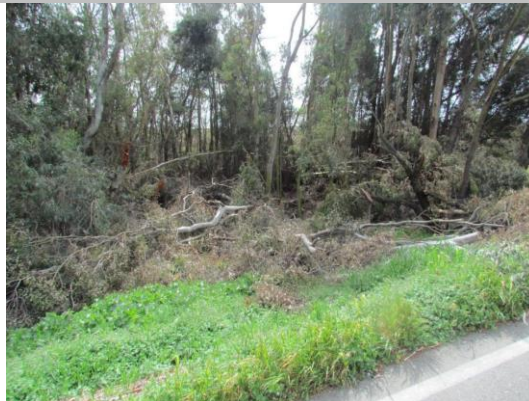
Photo 2 of 2 : SP_2017_NA0002_63_109_20170324_00184.jpg

Looking west at fallen tree on waterward slope.

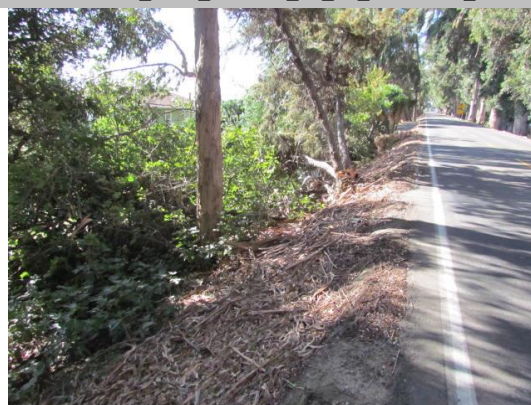
Photo 1 of 2 : SP_2017_NA0002_63_45_20170314_00045.jpg

LM Start	1.80	Rating **	U	Issue No.	45
LM End	1.82	Issue Type +	Ma	Location *	LS
Category	Earthen Levee			GPS Latitude/Longitude	
				Start	End
Item	Vegetation			38.174437 °	38.174153 °
				-121.590786 °	-121.590980 °
DWR ID	DWR_NA0002_02_f_2013_45				
Comment Code					
V2 : Remove the wild growth other than native grasses from the levee slopes.					
Inspector Comment					
Dense vegetation on landward slope and toe

Looking southwest at dense vegetation on landward slope.

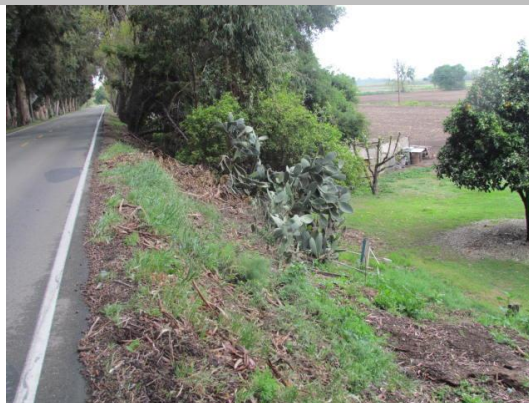
Photo 1 of 1 : SP_2017_NA0002_63_28_20170314_00033.jpg

LM Start	1.81	Rating **	M	Issue No.	28
LM End	1.81	Issue Type +	En	Location *	LS
Category	Earthen Levee			GPS Latitude/Longitude	
				Start	End
Item	Vegetation			38.174302 °	38.174302 °
				-121.590863 °	-121.590863 °
DWR ID	DWR_NA0002_02_s_2012_28				
Comment Code					
V6 : Landscaping					
Inspector Comment					
Cactus on landward slope.

Looking northeast at cactus on landward slope and toe.

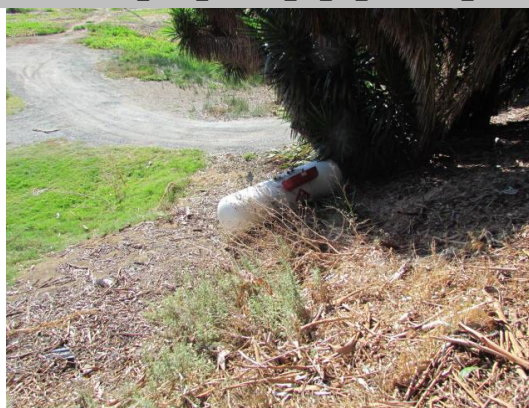
Photo 1 of 1 : SP_2017_NA0002_63_54_20170314_00051.jpg

LM Start	1.83	Rating **	M	Issue No.	54
LM End	1.83	Issue Type +	En	Location *	LS
Category	Earthen Levee			GPS Latitude/Longitude	
				Start	End
Item	Encroachments			38.174097 °	38.174097 °
				-121.591002 °	-121.591002 °
DWR ID	DWR_NA0002_02_f_2013_54				
Comment Code					
TA : Tank					
Inspector Comment					
Propane tank on landward slope.

Looking southeast at propane tank on landward slope and toe.

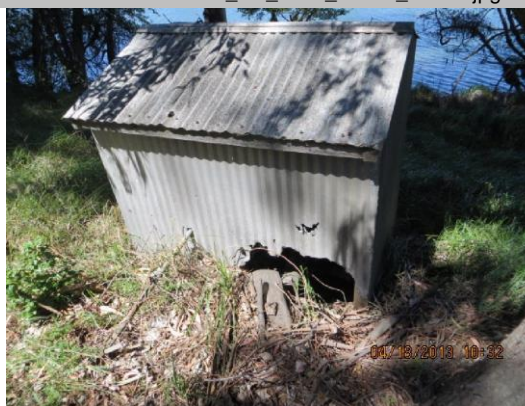
Photo 1 of 3 : UCIP_SP_2017_12185_19751.jpg

LM Start	1.90	Rating **	M	Issue No.	127
LM End	1.90	Issue Type +	En	Location *	LS
Category	Supplemental			GPS Latitude/Longitude	
				Start	End
Item	DWR UCIP Field Study			38.173197°	38.173197°
				-121.591552°	-121.591552°
DWR ID					
Comment Code					
Inspector Comment					
FS_ID:12185					
DS_ID:21872					
EP_NO: 11294					
Repair Type: Non-Urgent					
Crossing Status: Found					
UCIP Comments: Pipe abandoned on both sides. Pipe should be abandoned properly.					
FIELD_STRUCT_DESC: 6-inch pipe through the levee 6.5 feet below the crown. Pump in pumphouse on the water ward slope. 1-inch galvanized iron steel electrical conduit at same location (ABO No. 11294, 1975). Originally included in the 1954 O&M manual.					
FS Date: 4/18/2013

Pumphouse on WS slope.

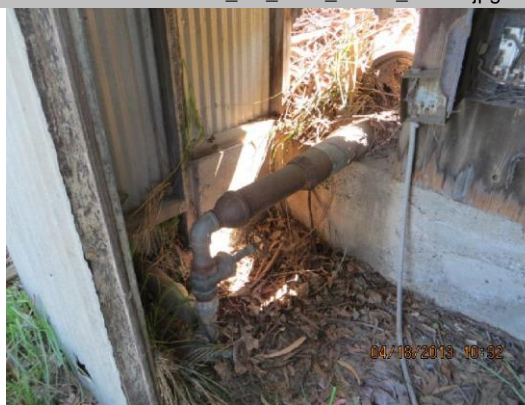
Photo 2 of 3 : UCIP_SP_2017_12185_19750.jpg

Pipe and shutoff valve at pumphouse on WS slope.

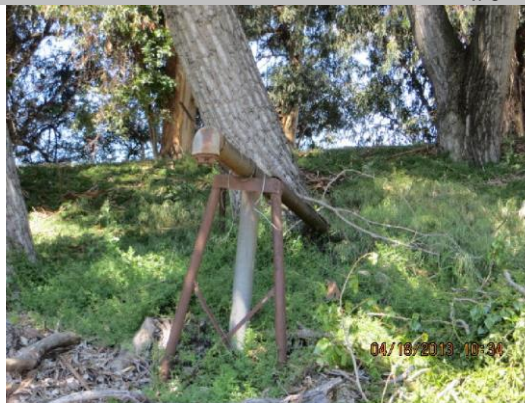
Photo 3 of 3 : UCIP_SP_2017_12185_19749.jpg

LM Start	1.90	Rating **	M	Issue No.	127 (cont)
LM End	1.90	Issue Type +	En	Location *	LS
Category	Supplemental			GPS Latitude/Longitude	
				Start	End
Item	DWR UCIP Field Study			38.173197 °	38.173197 °
				-121.591552 °	-121.591552 °
DWR ID					
Comment Code					
Inspector Comment					
FS_ID:12185					
DS_ID:21872					
EP_NO: 11294					
Repair Type: Non-Urgent					
Crossing Status: Found					
UCIP Comments: Pipe abandoned on both sides. Pipe should be abandoned properly.					
FIELD_STRUCT_DESC: 6-inch pipe through the levee 6.5 feet below the crown. Pump in pumphouse on the water ward slope. 1-inch galvanized iron steel electrical conduit at same location (ABO No. 11294, 1975). Originally included in the 1954 O&M manual.					
FS Date: 4/18/2013

Pipe at LS slope (open).

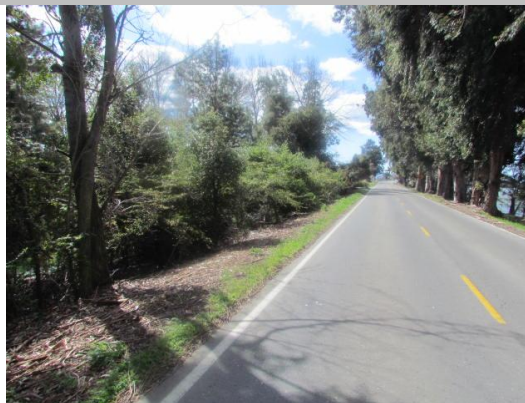
Photo 1 of 2 : SP_2017_NA0002_63_12_20170314_00015.jpg

LM Start	1.90	Rating **	U	Issue No.	12
LM End	1.94	Issue Type +	En	Location *	LS
Category	Earthen Levee			GPS Latitude/Longitude	
				Start	End
Item	Vegetation			38.173120 °	38.172598 °
				-121.591505 °	-121.591853 °
DWR ID	DWR_NA0002_02_s_2012_12				
Comment Code					
V6 : Landscaping					
Inspector Comment

Looking south at dense landscaping on landside slope and toe.

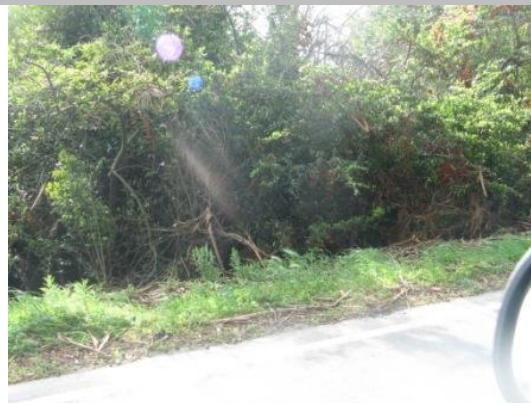
Photo 2 of 2 : SP_2017_NA0002_63_12_20170314_00016.jpg

LM Start	1.90	Rating **	U	Issue No.	12 (cont)	
LM End	1.94	Issue Type +	En	Location *	LS	
Category	Earthen Levee			GPS Latitude/Longitude		
				Start		End
Item	Vegetation			38.173120 °		38.172598 °
				-121.591505 °		-121.591853 °
DWR ID	DWR_NA0002_02_s_2012_12					
Comment Code						
V6 : Landscaping						
Inspector Comment

Landscaping on landside slope blocking view of slope from LM 1.91 to 1.95.

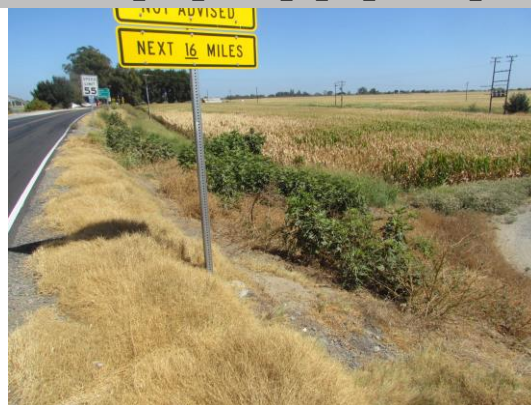
Photo 1 of 1 : SP_2017_NA0002_63_120_20170314_00090.jpg

LM Start	2.16	Rating **	M	Issue No.	120
LM End	2.16	Issue Type +	Ma	Location *	LS
Category	Earthen Levee			GPS Latitude/Longitude	
				Start	End
Item	Vegetation			38.169814 °	38.169814 °
				-121.593951 °	-121.593951 °
DWR ID	DWR_NA0002_02_f_2016_120				
Comment Code					
V2 : Remove the wild growth other than native grasses from the levee slopes.					
Inspector Comment					
Fig tree saplings on landward slope.

Looking northeast at fig tree saplings at landward toe.

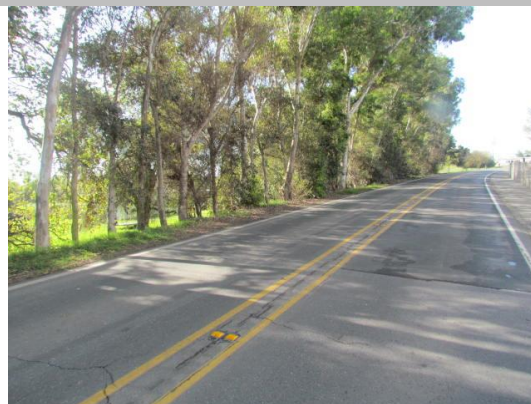
Photo 1 of 1 : SP_2017_NA0002_63_25_20170314_00027.jpg

LM Start	2.34	Rating **	U	Issue No.	25
LM End	2.38	Issue Type +	Ma	Location *	LS
Category	Earthen Levee			GPS Latitude/Longitude	
				Start	End
Item	Trim / Thin Trees			38.167627 °	38.167152 °
				-121.595538 °	-121.595997 °
DWR ID	DWR_NA0002_02_s_2012_25				
Comment Code					
T2 : Thin trees to allow visibility of the ground and room to flood fight.					
Inspector Comment

Looking southeast at trees at landward shoulder. (Spring 2015)

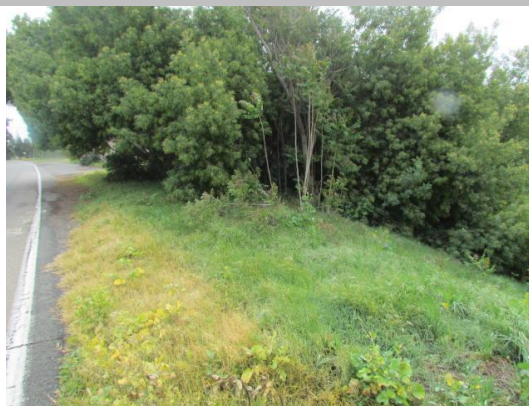
Photo 1 of 2 : SP_2017_NA0002_63_29_20170314_00034.jpg

LM Start	2.48	Rating **	U	Issue No.	29
LM End	2.48	Issue Type +	Ma	Location *	LS
Category	Earthen Levee			GPS Latitude/Longitude	
				Start	End
Item	Trim / Thin Trees			38.166378 °	38.166378 °
				-121.597570 °	-121.597570 °
DWR ID	DWR_NA0002_02_s _ 2012_29				
Comment Code					
T1 : Trim trees to at least five feet above ground level.					
Inspector Comment

Looking northeast at dense vegetation on landward slope.

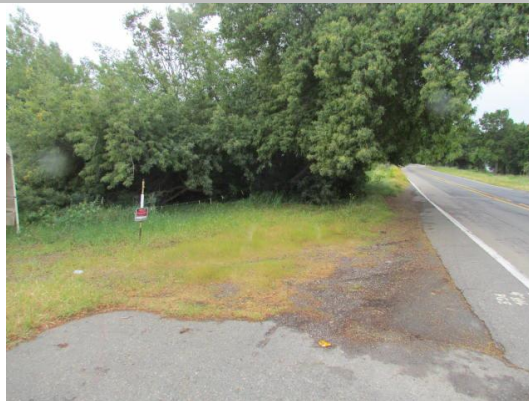
Photo 2 of 2 : SP_2017_NA0002_63_29_20170314_00035.jpg

Looking southwest at dense vegetation on landward slope.

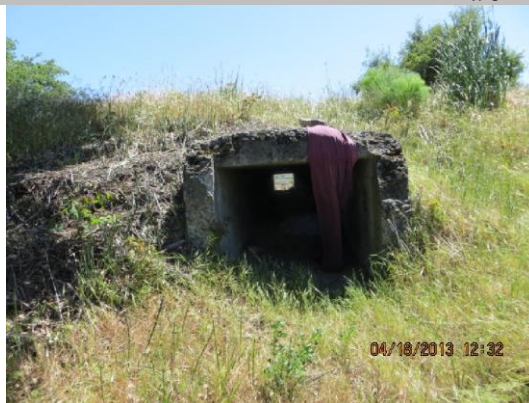
Photo 1 of 3 : UCIP_SP_2017_51314_19773.jpg

LM Start	2.54	Rating **	U	Issue No.	129
LM End	2.54	Issue Type +	Ma	Location *	LS
Category	Supplemental			GPS Latitude/Longitude	
				Start	End
Item	DWR UCIP LMA Responsibility			38.165980 °	38.165980 °
				-121.598520 °	-121.598520 °
DWR ID					
Comment Code					
Inspector Comment					
FS_ID:51314 DS_ID:21879 EP_NO: N/A Repair Type: Urgent Crossing Status: Found UCIP Comments: 10/24/2016 same as previous inspection culvert is open on both ends. WS blocked by blankets -- WS structure is being used as a shelter. (O. Magana - DWR UCIP)04/18/2013 Culvert open on both ends. Needs to be abandoned properly. (W. Wylie - DWR UCIP) FIELD_STRUCT_DESC: *ABANDONED* 3.5-foot by 3.5-foot open concrete culvert through levee, 6 feet below the crown. [Additional Reference(s): DWR Levee Log, 2005. USACE Sacramento O&M Manual Unit 103, June 1954, (RM 18.16), Drawing No. 6-13-1100]. FS Date: 10/24/2016

Concrete tunnel open on both ends.

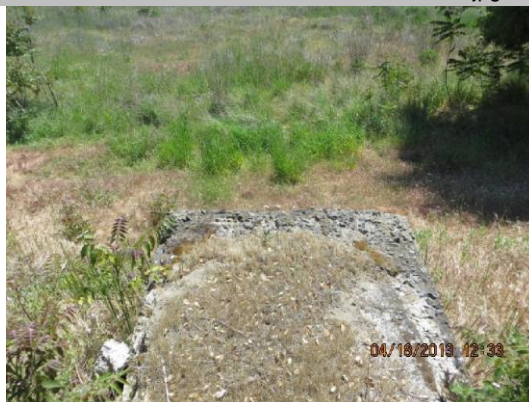
Photo 2 of 3 : UCIP_SP_2017_51314_19772.jpg

Top of concrete tunnel on LS shoulder.

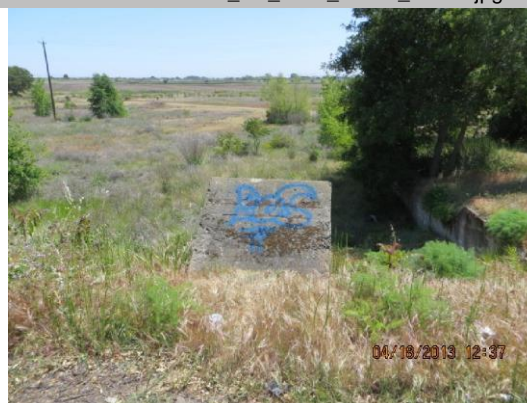
Photo 2 of 3 : UCIP_SP_2017_51315_19775.jpg

Item	DWR UCIP LMA Responsibility			38.165775 °	38.165775 °	
				-121.599048 °	-121.599048 °	
DWR ID						
Comment Code						
Inspector Comment						
FS_ID:51315						
DS_ID:21880						
EP_NO: N/A						
Repair Type: Urgent						
Crossing Status: Found						
UCIP Comments: 10/24/2016 same as previous inspection concrete box culvert will need to be abandoned properly. (O. Magana - DWR UCIP)04/18/2013 tunnel should be abandoned properly. (W. Wylie - DWR UCIP)						
FIELD_STRUCT_DESC: *ABANDONED* 4-feet by 4-feet drainage concrete culvert through levee, 6.5-inches below the crown. [Additional Reference(s): DWR Levee Log, 2005. USACE Sacramento O&M Manual Unit 103, June 1954, (RM 18.16), Drawing No. 6-13-1100].						
FS Date: 10/24/2016

Concrete tunnel on LS shoulder.

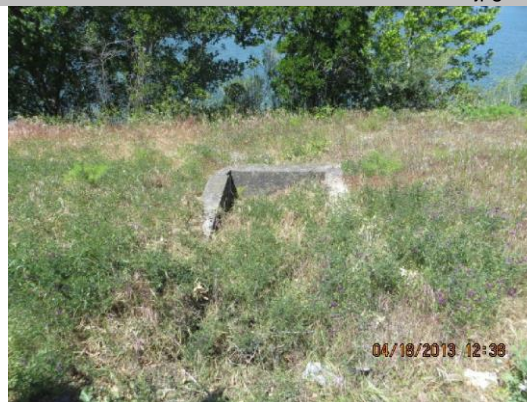
Photo 3 of 3 : UCIP_SP_2017_51315_19774.jpg

LM Start	2.57	Rating **	U	Issue No.	130 (cont)
LM End	2.57	Issue Type +	Ma	Location *	LS

10'X5' concrete box on WS slope, filled with soil.

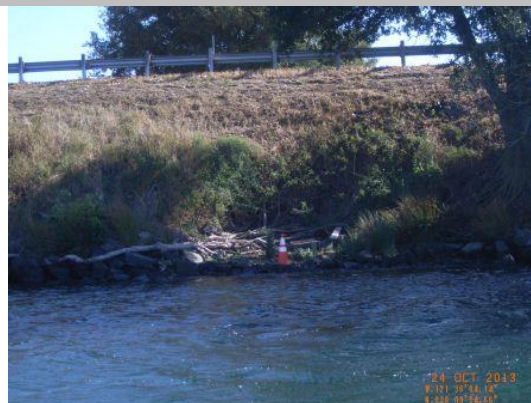
Photo 1 of 2 : SP_2017_NA0002_63_37_20170314_00040.jpg

LM Start	2.66	Rating **	M	Issue No.	37
LM End	2.74	Issue Type +	Ma	Location *	WS
Category	Supplemental			GPS Latitude/Longitude	
				Start	End
Item	2015 USACE Erosion Survey, DRAFT			38.165303 °	38.164682 °
				-121.600477 °	-121.601804 °
DWR ID	DWR_NA0002_02_s _ 2016_37				
Comment Code					
Inspector Comment					
2009 - Large scallop from rotational failure. One fallen tree and one large tree with half of its root structure exposed. 2015: Large tree expected to pop out within next couple of years, will take very large chunk of levee out. [2015 Site ID: SAC_18-0_L]

USACE 2013 Photo #1

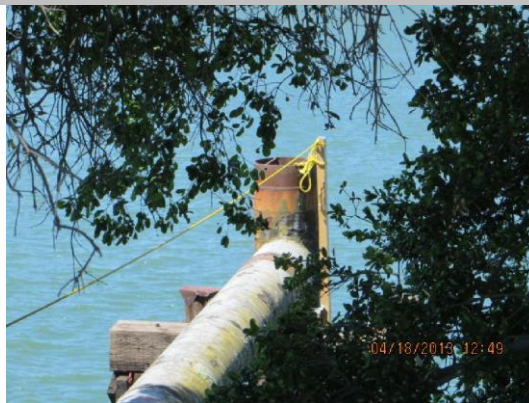
Photo 2 of 3 : UCIP_SP_2017_12214_19777.jpg

Pipe on pier at WS.

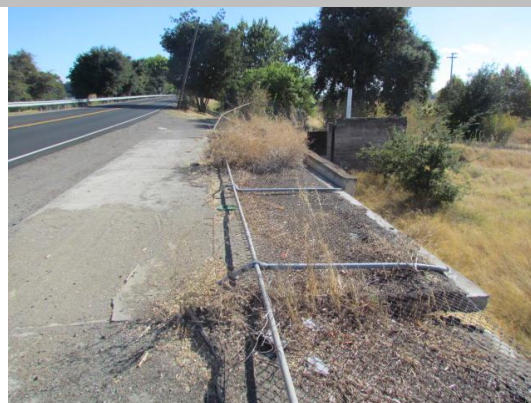
Photo 1 of 1 : SP_2017_NA0002_63_94_20170314_00060.jpg

Looking northeast at downed fence on landward shoulder.

LM Start	2.81	Rating **	M	Issue No.	94
LM End	2.81	Issue Type +	En	Location *	LS
Category	Earthen Levee			GPS Latitude/Longitude	
				Start	End
Item	Encroachments			38.164077 °	38.164077 °
				-121.602853 °	-121.602853 °
DWR ID	DWR_NA0002_02_f_2015_94				
Comment Code					
FE : Fence					
Inspector Comment					
Discard downed fence on landward shoulder.

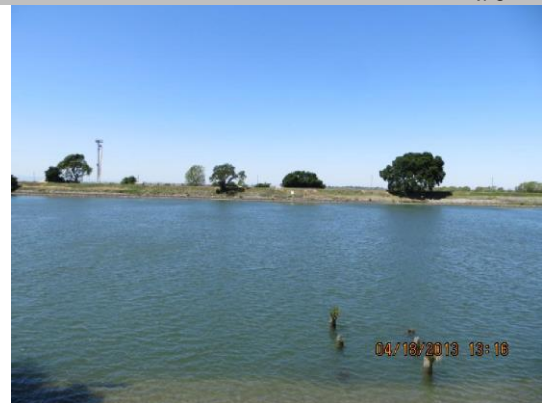
Photo 1 of 2 : UCIP_SP_2017_16005_27067.jpg

LM Start	2.91	Rating **	M	Issue No.	134
LM End	2.91	Issue Type +	En	Location *	LS
Category	Supplemental			GPS Latitude/Longitude	
				Start	End
Item	DWR UCIP Field Study			38.163413 °	38.163413 °
				-121.604399 °	-121.604399 °
DWR ID					
Comment Code					
Inspector Comment					
FS_ID:16005 DS_ID:21884 EP_NO: 14173 Repair Type: Non-Urgent Crossing Status: Indicator Found UCIP Comments: If pipe is still in use it should be marked properly on levee. FIELD_STRUCT_DESC: 12-inch telephone conduit through levee 2.0 feet below crown and under channel (Permit No. 14173, 1985). Four 4-inch galvanized iron conductor pipe sleeved through it. Sign on WS slope of levee across river provides location for this crossing. FS Date: 4/18/2013

Sign on opposite side of river provides indication of pipe location.

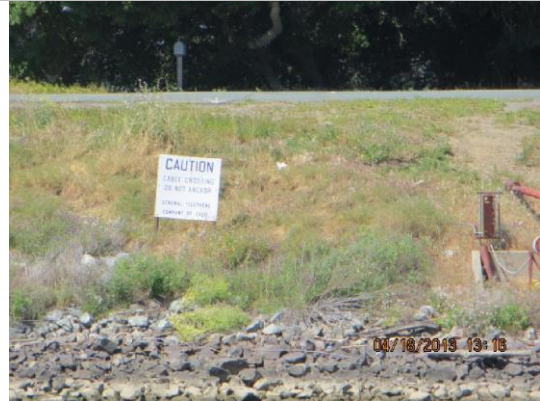
Photo 2 of 2 : UCIP_SP_2017_16005_27066.jpg

Sign on opposite side of river provides indication of pipe location.

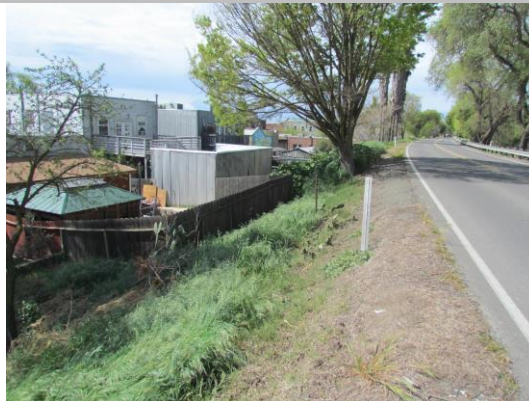
Photo 2 of 2 : SP_2017_NA0002_63_30_20170324_00186.jpg

LM Start	2.93	Rating **	U	Issue No.	30 (cont)	
LM End	3.12	Issue Type +	En	Location *	LS	
Category	Earthen Levee			GPS Latitude/Longitude		
				Start		End
Item	Encroachments			38.163317 °		38.162707 °
				-121.604813 °		-121.608262 °
DWR ID	DWR_NA0002_02_s_2012_30					
Comment Code						
UR : Urban						
Inspector Comment						
Several encroachments within town limits along landward slope.

Looking south at several encroachments along landward slope and toe.

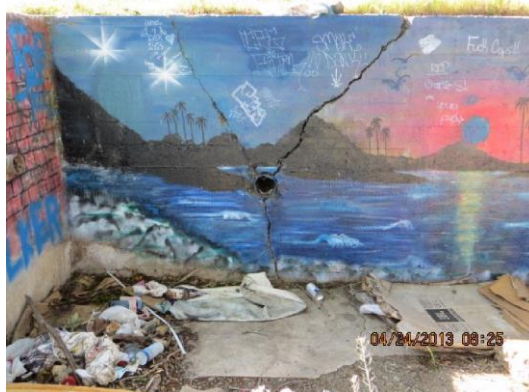
Photo 1 of 2 : UCIP_SP_2017_12724_20643.jpg

LM Start	2.99	Rating **	M	Issue No.	135
LM End	2.99	Issue Type +	En	Location *	LS
Category	Supplemental			GPS Latitude/Longitude	
				Start	End
Item	DWR UCIP Field Study			38.163063 °	38.163063 °
				-121.605799 °	-121.605799 °
DWR ID					
Comment Code					
Inspector Comment					
FS_ID:12724 DS_ID:21886 EP_NO: N/A Repair Type: Non-Urgent Crossing Status: Found UCIP Comments: Pipe should be abandoned properly. FIELD_STRUCT_DESC: *ABANDONED* 6-inch pipe through levee 4.5 feet below crown. Originally included in the 1959 O&M manual. Pipe visible at foundation on WS shoulder. FS Date: 4/24/2013 10:00:00 AM

Pipe visible at concrete foundation on WS shoulder.

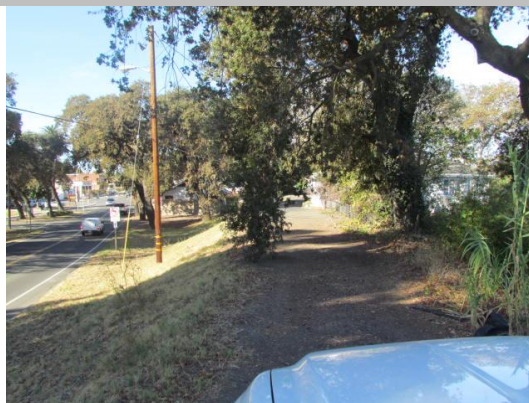
Photo 1 of 2 : SP_2017_NA0002_63_5_20170314_00003.jpg

Looking west at overhanging tree on waterward shoulder. (Fall 2014)

LM Start	3.17	Rating **	M	Issue No.	5
LM End	3.17	Issue Type +	Ma	Location *	WS
Category	Earthen Levee			GPS Latitude/Longitude	
				Start	End
Item	Trim / Thin Trees			38.162638 °	38.162638 °
				-121.609068 °	-121.609068 °
DWR ID	DWR_NA0002_02_s_2012_5				
Comment Code					
T4 : Trim trees over roadway to at least 12 feet above ground level.					
Inspector Comment

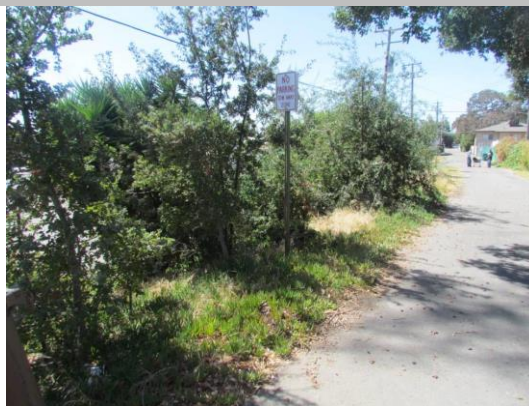
Photo 1 of 2 : SP_2017_NA0002_63_7_20170314_00005.jpg

LM Start	3.22	Rating **	U	Issue No.	7
LM End	3.22	Issue Type +	En	Location *	LS
Category	Earthen Levee			GPS Latitude/Longitude	
				Start	End
Item	Vegetation			38.162609 °	38.162609 °
				-121.609979 °	-121.609979 °
DWR ID	DWR_NA0002_02_s _ 2012_7				
Comment Code					
V6 : Landscaping					
Inspector Comment

Looking south at overgrown landscaping on landward slope. (Fall 2016)

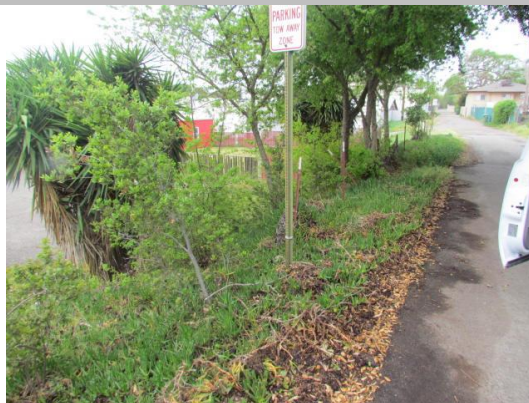
Photo 2 of 2 : SP_2017_NA0002_63_7_20170314_00006.jpg

Looking south at overgrown landscaping on landward slope. (Fall 2015)

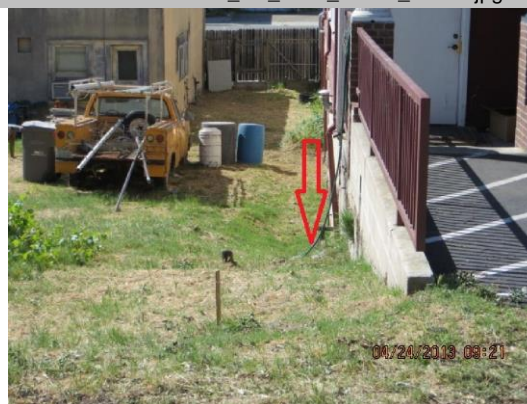
Photo 2 of 2 : UCIP_SP_2017_15966_26948.jpg

LM Start	3.29	Rating **	M	Issue No.	136
LM End	3.29	Issue Type +	En	Location *	LS
Category	Supplemental			GPS Latitude/Longitude	
				Start	End
Item	DWR UCIP Field Study			38.162430 °	38.162430 °
				-121.611248 °	-121.611248 °
DWR ID					
Comment Code					
Inspector Comment					
FS_ID:15966 DS_ID:23135 EP_NO: N/A Repair Type: Non-Urgent Crossing Status: Found UCIP Comments: Need to determine disposition and use of pipe. FIELD_STRUCT_DESC: 4-inch cast iron pipe through the levee 8-feet below the crown. Pipe visible next to foundation on LS toe. FS Date: 4/24/2013

Pipe visible next to foundation on LS slope.

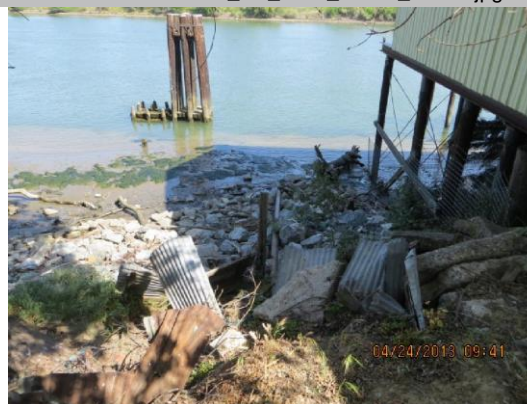
Photo 1 of 2 : UCIP_SP_2017_12745_20683.jpg

LM Start	3.37	Rating **	M	Issue No.	138
LM End	3.37	Issue Type +	En	Location *	LS
Category	Supplemental		GPS Latitude/Longitude		
			Start	End	
Item	DWR UCIP Field Study		38.162388 °	38.162388 °	
			-121.612847 °	-121.612847 °	
DWR ID					
Comment Code					
Inspector Comment					
FS_ID:12745 DS_ID:21892 EP_NO: 11266 Repair Type: Non-Urgent Crossing Status: Found UCIP Comments: This pipe has been abandoned and should be abandoned properly. Pumphouse has colapsed. FIELD_STRUCT_DESC: 6-inch pipe through levee 4.5 feet below crown. Pump in pump house on the water ward side (ABO No. 11266, 1975). FS Date: 4/24/2013

Pipe and wrecked pumphouse on WS toe.

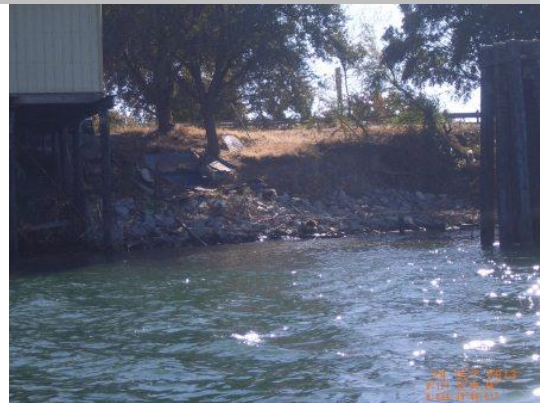
Photo 1 of 2 : SP_2017_NA0002_63_34_20170314_00038.jpg

Comment Code					
Inspector Comment					
2009 - Fluvial erosion, into the levee slope, close to vertical bank with roadway on top. Pilings that were once at the bankline are now 30 ft out. 2010 - Very steep slope with slumps and overturned trees. 2011 - Upgraded to CRITICAL. Sections of vertical slope with highway on top. Heavy vegetation in front of most of the erosion pockets. Structures built into the levee on the upstream end. 2012 - Site continues to worsen. 2013 - Some rock added on the upstream end, but site remains critical. 2015: More rock has been placed in spots along the toe, but it is still insufficient. [2015 Site ID: SAC_17-2_L]

USACE 2013 Photo #1

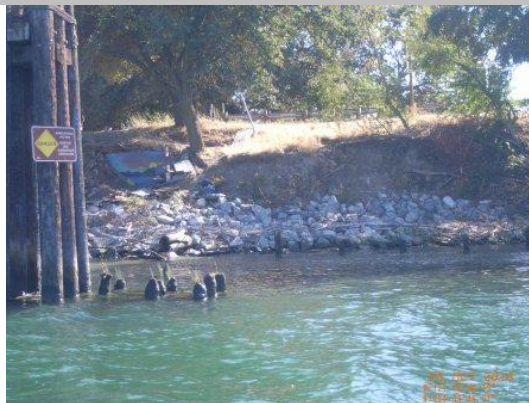
Photo 2 of 2 : SP_2017_NA0002_63_34_20170314_00039.jpg

Comment Code					
Inspector Comment					
2009 - Fluvial erosion, into the levee slope, close to vertical bank with roadway on top. Pilings that were once at the bankline are now 30 ft out. 2010 - Very steep slope with slumps and overturned trees. 2011 - Upgraded to CRITICAL. Sections of vertical slope with highway on top. Heavy vegetation in front of most of the erosion pockets. Structures built into the levee on the upstream end. 2012 - Site continues to worsen. 2013 - Some rock added on the upstream end, but site remains critical. 2015: More rock has been placed in spots along the toe, but it is still insufficient. [2015 Site ID: SAC_17-2_L]

USACE 2013 Photo #2

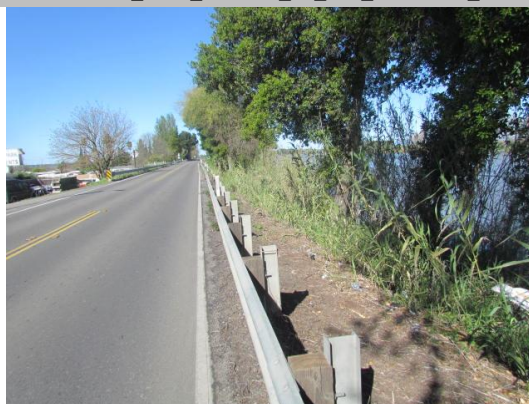
Photo 1 of 1 : SP_2017_NA0002_63_100_20170314_00067.jpg

Looking southwest at vegetation (bamboo) on waterward slope.

LM Start	3.39	Rating **	M	Issue No.	100
LM End	3.42	Issue Type +	Ma	Location *	WS
Category	Earthen Levee			GPS Latitude/Longitude	
				Start	End
Item	Vegetation			38.162394 °	38.162432 °
				-121.613146 °	-121.613637 °
DWR ID	DWR_NA0002_02_s _ 2014_100				
Comment Code					
V2 : Remove the wild growth other than native grasses from the levee slopes.					
Inspector Comment					
Bamboo on waterward slope.

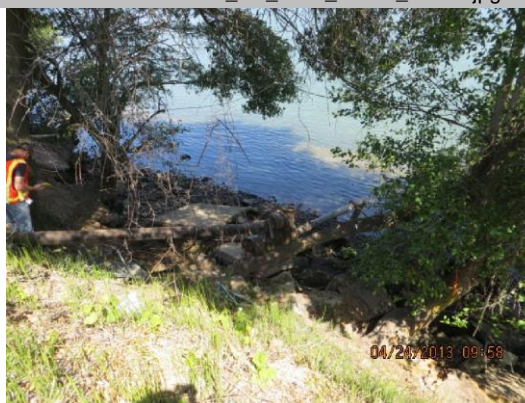
Photo 1 of 3 : UCIP_SP_2017_12746_20686.jpg

LM Start	3.44	Rating **	M	Issue No.	139
LM End	3.44	Issue Type +	En	Location *	WS
Category	Supplemental			GPS Latitude/Longitude	
				Start	End
Item	DWR UCIP Field Study			38.162473 °	38.162473 °
				-121.613963 °	-121.613963 °
DWR ID					
Comment Code					
Inspector Comment					
FS_ID:12746					
DS_ID:21893					
EP_NO: 11275					
Repair Type: Non-Urgent					
Crossing Status: Found					
UCIP Comments: Pipe abandoned and should be abandoned properly.					
Pipe open on both ends.					
FIELD_STRUCT_DESC: 8-inch pipe through levee 7.7 feet below crown. Pump in pump house on the water ward slope (ABO No. 11275, 1975). Originally included in the 1959 O&M manual.					
FS Date: 4/24/2013

Pipe and pump visible on WS slope

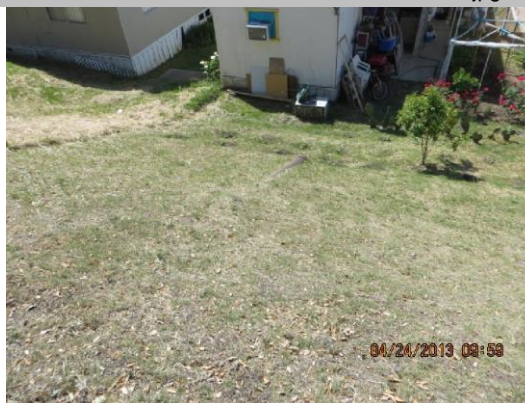
Photo 2 of 3 : UCIP_SP_2017_12746_20685.jpg

Pipe visible on LS slope near toe.

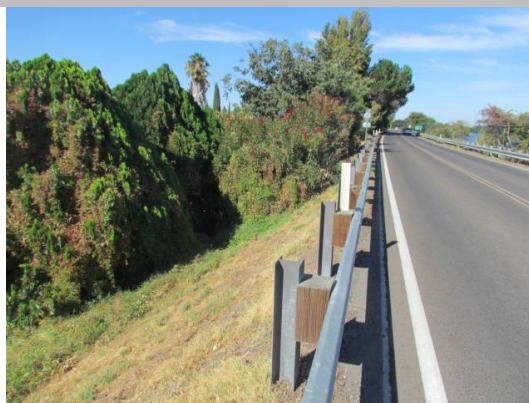
Photo 1 of 1 : SP_2017_NA0002_63_101_20170314_00068.jpg

LM Start	3.47	Rating **	U	Issue No.	101
LM End	3.53	Issue Type +	En	Location *	LS
Category	Earthen Levee			GPS Latitude/Longitude	
				Start	End
Item	Vegetation			38.162492 °	38.162600 °
				-121.614521 °	-121.615667 °
DWR ID	DWR_NA0002_02_s_2014_101				
Comment Code					
V6 : Landscaping					
Inspector Comment

Looking at dense landscaping on landward slope.

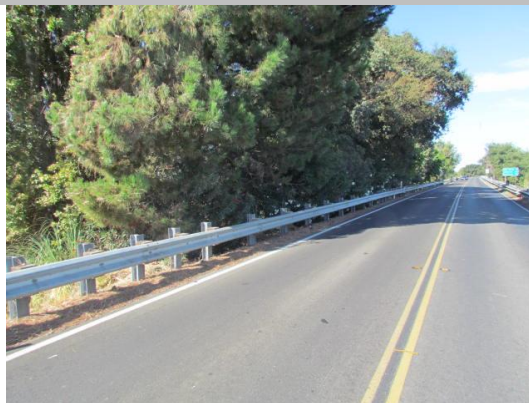
Photo 1 of 1 : SP_2017_NA0002_63_22_20170314_00025.jpg

LM Start	3.51	Rating **	U	Issue No.	22
LM End	3.58	Issue Type +	Ma	Location *	LS
Category	Earthen Levee			GPS Latitude/Longitude	
				Start	End
Item	Trim / Thin Trees			38.162590 °	38.162728 °
				-121.615345 °	-121.616622 °
DWR ID	DWR_NA0002_02_s _ 2012_22				
Comment Code					
T1 : Trim trees to at least five feet above ground level.					
Inspector Comment					
Untrimmed trees on landward slope and toe.

Looking south at dense vegetation (trees) on landward slope and toe.

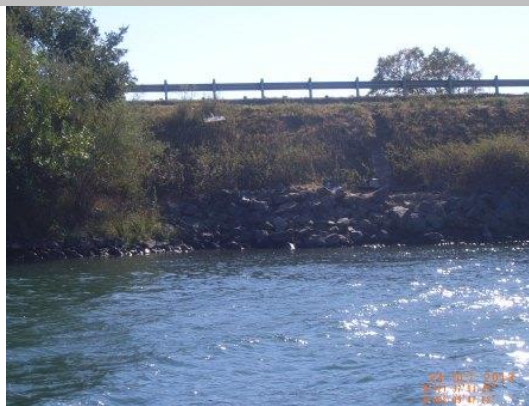
Photo 1 of 1 : SP_2017_NA0002_63_20_20170314_00023.jpg

LM Start	3.62	Rating **	U	Issue No.	20
LM End	3.73	Issue Type +	Ma	Location *	WS
Category	Supplemental			GPS Latitude/Longitude	
				Start	End
Item	2015 USACE Erosion Survey, DRAFT			38.162959 °	38.163334 °
				-121.617323 °	-121.619312 °
DWR ID	DWR_NA0002_02_s _ 2016_20				
Comment Code					
Inspector Comment					
2008 - Overstepped levee section with pocket erosion. Plans for repair currently in the design phase. 2010 - Very steep slope with slumps, longitudinal cracking, and overturned trees. 2011 - Upgraded to CRITICAL. Sections of vertical slope with highway on top. Heavy vegetation in front of most of the erosion pockets. 2015: New rock placed on the levee slope for most of the downstream end, but bad spots still remain. [2015 Site ID: SAC_16-8_L]

USACE 2013 Photo #1

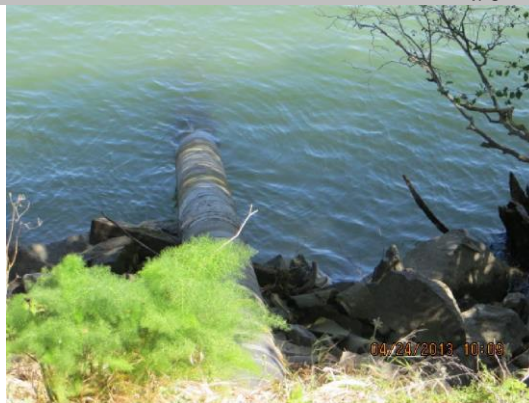
Photo 1 of 3 : UCIP_SP_2017_51317_20689.jpg

Comment Code					
Inspector Comment					
FS_ID:51317 DS_ID:21894 EP_NO: 13462 Repair Type: Urgent Crossing Status: Found UCIP Comments: 10/24/2016 Pipe has been cut and capped for the installation of the rock slope protection (RSP) on the WS bank under the USACE's Sacramento River Bank Protection Project (Contract 7, River Mile 16.8L). The CVFPB issued a letter dated July 20, 2016 for the proposed work and determined that a encroachment permit was unnecessary for the minor alteration (addition of RSP). However, once the work is completed the CVFPB, Minh Chieng, is expecting River Vine Ranch, owner of 16-inch pipe, to submit application for name change. UCIP recommends owner complete internal inspection to determine condition of pipe through levee and LS slope to determine if leak is present on WS shoulder. (O. Magana - DWR UCIP)04/24/2013 Possible sinkhole over pipe on WS shoulder. Good candidate for video inspection. (W. Wylie - DWR UCIP) FIELD_STRUCT_DESC: 16-inch irrigation pipe through levee 2.5 feet below crown. Pipe is connected to 42-inch concrete pipe sump. (16-inch pipe authorized under Permit No. 13462, 1982 - Lee & Correia). [Additional Reference(s): DWR Levee Log, 2005]. FS Date: 10/24/2016

Pipe on WS slope.

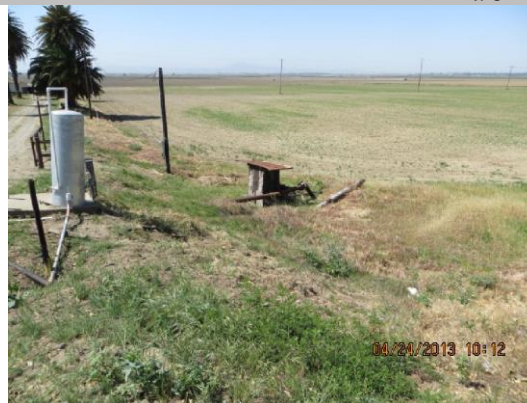
Photo 3 of 3 : UCIP_SP_2017_51317_20687.jpg

Item	DWR UCIP Field Study			38.162908 °		38.162908 °
				-121.618075 °		-121.618075 °
DWR ID						
Comment Code						
Inspector Comment						
FS_ID:51317 DS_ID:21894 EP_NO: 13462 Repair Type: Urgent Crossing Status: Found UCIP Comments: 10/24/2016 Pipe has been cut and capped for the installation of the rock slope protection (RSP) on the WS bank under the USACE's Sacramento River Bank Protection Project (Contract 7, River Mile 16.8L). The CVFPB issued a letter dated July 20, 2016 for the proposed work and determined that a encroachment permit was unnecessary for the minor alteration (addition of RSP). However, once the work is completed the CVFPB, Minh Chieng, is expecting River Vine Ranch, owner of 16-inch pipe, to submit application for name change. UCIP recommends owner complete internal inspection to determine condition of pipe through levee and LS slope to determine if leak is present on WS shoulder. (O. Magana - DWR UCIP)04/24/2013 Possible sinkhole over pipe on WS shoulder. Good candidate for video inspection. (W. Wylie - DWR UCIP) FIELD_STRUCT_DESC: 16-inch irrigation pipe through levee 2.5 feet below crown. Pipe is connected to 42-inch concrete pipe sump. (16-inch pipe authorized under Permit No. 13462, 1982 - Lee & Correia). [Additional Reference(s): DWR Levee Log, 2005]. FS Date: 10/24/2016

Pumphouse on LS toe.

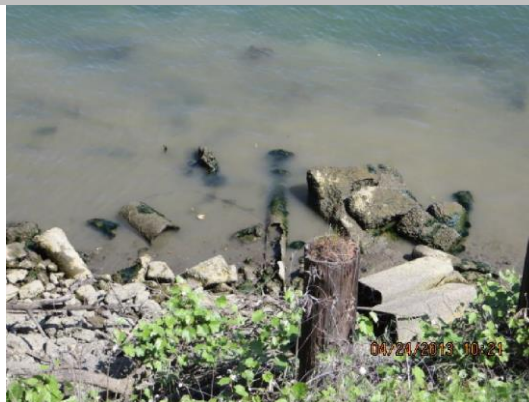
Photo 2 of 2 : UCIP_SP_2017_12748_20691.jpg

LM Start	3.70	Rating **	M	Issue No.	141
LM End	3.70	Issue Type +	En	Location *	WS
Category	Supplemental			GPS Latitude/Longitude	
				Start	End
Item	DWR UCIP Field Study			38.163048 °	38.163048 °
				-121.618839 °	-121.618839 °
DWR ID					
Comment Code					
Inspector Comment					
FS_ID:12748 DS_ID:21895 EP_NO: 1615 Repair Type: Non-Urgent Crossing Status: Found UCIP Comments: Pipe abandoned and should be abandoned properly. FIELD_STRUCT_DESC: 8-inch pipe through levee 7.7 feet below crown. 6'X6' concrete distribution box on LS toe (Permit No. 1615, 1959). Included in the 1959 O&M manual. FS Date: 4/24/2013

Rusted out pipe visible at WS toe.

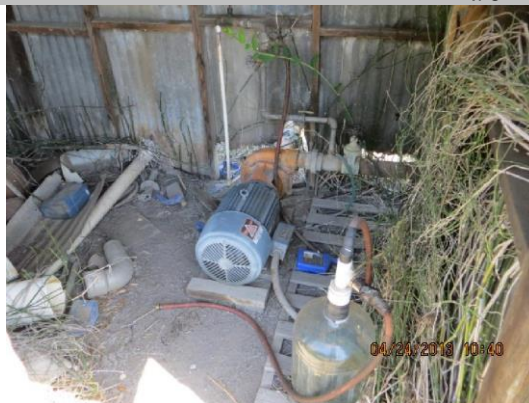
Photo 2 of 3 : UCIP_SP_2017_12752_20698.jpg

LM Start	3.92	Rating **	M	Issue No.	142 (cont)	
LM End	3.92	Issue Type +	En	Location *	LS	
Category	Supplemental			GPS Latitude/Longitude		
				Start	End	
Item	DWR UCIP Field Study			38.164063 °	38.164063 °	
				-121.622650 °	-121.622650 °	
DWR ID						
Comment Code						
Inspector Comment						
FS_ID:12752						
DS_ID:21898						
EP_NO: 11287						
Repair Type: Non-Urgent						
Crossing Status: Found						
UCIP Comments: Aging pipe with repair on WS slope. Good candidate for video inspection.						
FIELD_STRUCT_DESC: 5-inch pipe through levee 5.5 feet below crown. Pump in pump house on the landward side (ABO No. 11287, 1959). Shutoff valve in pumphouse on LS toe. Originally included in the 1959 O&M manual.						
FS Date: 4/24/2013

Pump and shutoff valve inside pumphouse on LS toe.

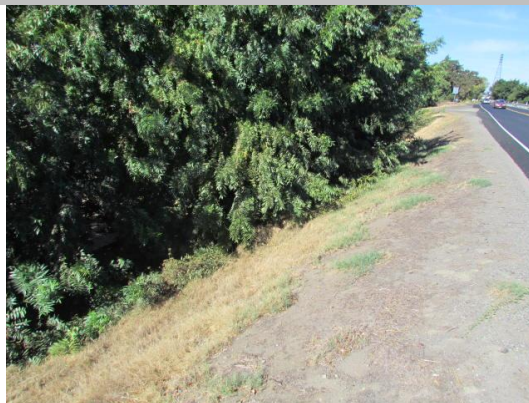
Photo 1 of 1 : SP_2017_NA0002_63_102_20170314_00069.jpg

LM Start	3.96	Rating **	U	Issue No.	102
LM End	3.96	Issue Type +	Ma	Location *	LS
Category	Earthen Levee			GPS Latitude/Longitude	
				Start	End
Item	Trim / Thin Trees			38.164246 °	38.164246 °
				-121.623272 °	-121.623272 °
DWR ID	DWR_NA0002_02_s_2014_102				
Comment Code					
T1 : Trim trees to at least five feet above ground level.					
Inspector Comment					
Untrimmed tree blocking landward slope and toe.

Looking west at dense trees on landward slope and toe.

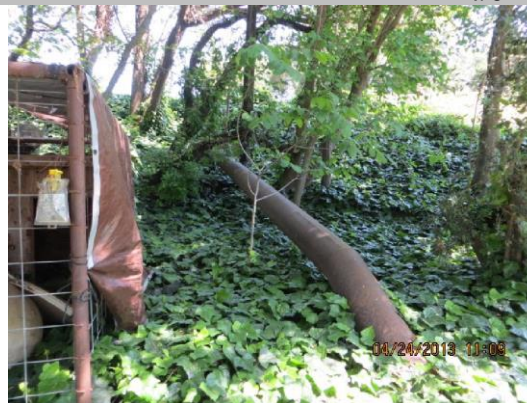
Photo 2 of 3 : UCIP_SP_2017_12768_20730.jpg

LM Start	4.11	Rating **	M	Issue No.	144 (cont)
LM End	4.11	Issue Type +	En	Location *	LS
Category	Supplemental			GPS Latitude/Longitude	
				Start	End
Item	DWR UCIP Field Study			38.165016 °	38.165016 °
				-121.625834 °	-121.625834 °
DWR ID					
Comment Code					
Inspector Comment					
FS_ID:12768					
DS_ID:21904					
EP_NO: 787					
Repair Type: Non-Urgent					
Crossing Status: Found					
UCIP Comments: Pipe may be abandoned and should be done so properly if not being used. Good candidate for video inspection.					
FIELD_STRUCT_DESC: 2 of 2: 14-inch steel irrigation pipe through levee 4.2 feet below crown. Pump on pile structure in stream (Permit No. 787, 1939). Included in the 1959 O&M manual.					
FS Date: 4/24/2013

Pipe on LS slope.

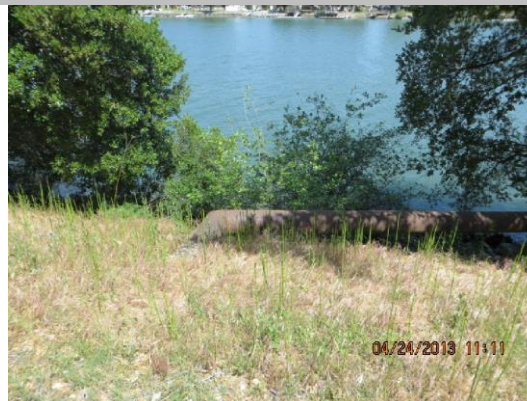
Photo 3 of 3 : UCIP_SP_2017_12768_20729.jpg

Pipe on WS slope.

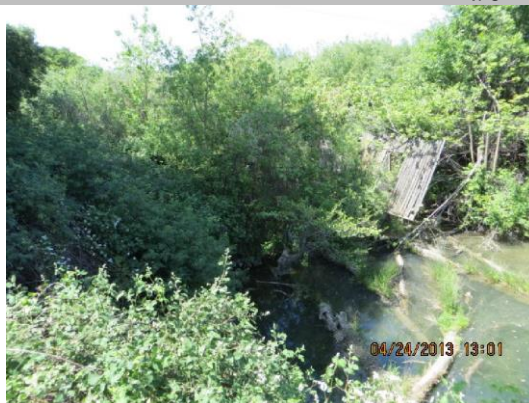
Photo 1 of 3 : UCIP_SP_2017_16010_27085.jpg

LM Start	4.48	Rating **	M	Issue No.	145
LM End	4.48	Issue Type +	En	Location *	LS
Category	Supplemental			GPS Latitude/Longitude	
				Start	End
Item	DWR UCIP Field Study			38.167174 °	38.167174 °
				-121.631927 °	-121.631927 °
DWR ID					
Comment Code					
Inspector Comment					
FS_ID:16010					
DS_ID:21907					
EP_NO: 11274					
Repair Type: Non-Urgent					
Crossing Status: Found					
UCIP Comments: Pipe abandoned and should be abandoned properly if not already done so.					
FIELD_STRUCT_DESC: *ABANDONED* 2 of 2: 10-inch pipe through levee 6.6 feet below crown. Pump in pump house on the landward slope (ABO No. 11274,1975). Originally included in the 1959 O&M manual. Pumphouse not visible 4/24/2013.					
FS Date: 4/24/2013

Possible portion of pumphouse visible off WS toe.

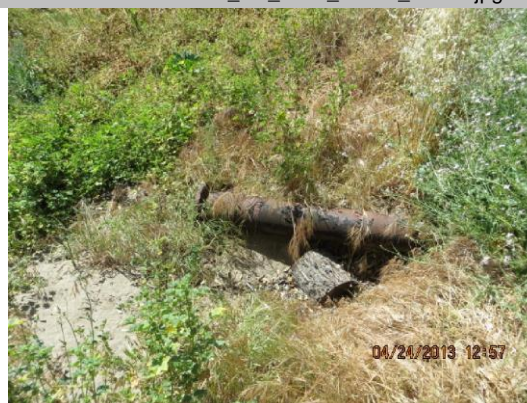
Photo 3 of 3 : UCIP_SP_2017_16010_27086.jpg

LM Start	4.48	Rating **	M	Issue No.	145 (cont)
LM End	4.48	Issue Type +	En	Location *	LS
Category	Supplemental			GPS Latitude/Longitude	
				Start	End
Item	DWR UCIP Field Study			38.167174 °	38.167174 °
				-121.631927 °	-121.631927 °
DWR ID					
Comment Code					
Inspector Comment					
FS_ID:16010					
DS_ID:21907					
EP_NO: 11274					
Repair Type: Non-Urgent					
Crossing Status: Found					
UCIP Comments: Pipe abandoned and should be abandoned properly if not already done so.					
FIELD_STRUCT_DESC: *ABANDONED* 2 of 2: 10-inch pipe through levee 6.6 feet below crown. Pump in pump house on the landward slope (ABO No. 11274,1975). Originally included in the 1959 O&M manual. Pumphouse not visible 4/24/2013.					
FS Date: 4/24/2013

Abandoned pipe on LS slope.

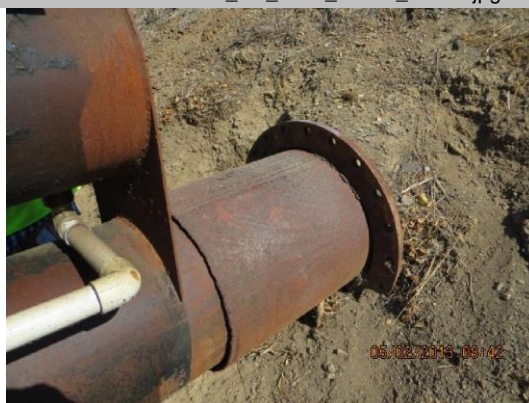
Photo 2 of 3 : UCIP_SP_2017_12773_20739.jpg

LM Start	4.78	Rating **	M	Issue No.	146 (cont)	
LM End	4.78	Issue Type +	En	Location *	WS	
Category	Supplemental			GPS Latitude/Longitude		
				Start		End
Item	DWR UCIP Field Study			38.168744 °	38.168744 °	
				-121.637155 °	-121.637155 °	
DWR ID						
Comment Code						
Inspector Comment						
FS_ID:12773						
DS_ID:21908						
EP_NO: 11285						
Repair Type: Non-Urgent						
Crossing Status: Found						
UCIP Comments: Pit under pipe on WS shoulder - possible leak.						
Excavation of pipe on LS slope into levee prism.						
FIELD_STRUCT_DESC: 20-inch pipe sleeved through a 22-inch						
sleeved through a 24-inch pipe through levee 3-feet below the crown.						
Pump on landward side (ABO No. 11285, 1975). Small pump on LS						
shoulder and a 7'X9' concrete sump on the LS toe. Originally included						
in the 1959 O&M manual.						
FS Date: 5/2/2013

20-inch pipe sleeved through 22-inch pipe sleeved through a 24-inch steel pipe.

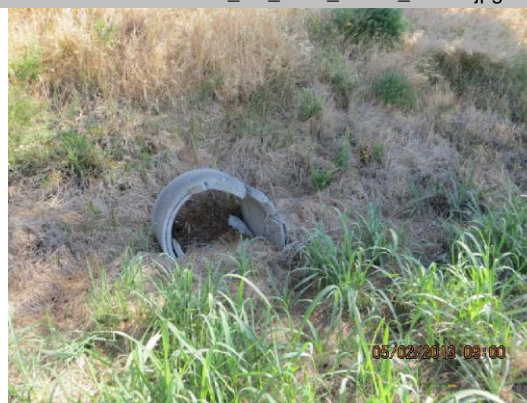
Photo 3 of 3 : UCIP_SP_2017_12774_20743.jpg

Item	DWR UCIP Field Study			38.168887 °		38.168887 °
				-121.637957 °		-121.637957 °
DWR ID						
Comment Code						
Inspector Comment						
FS_ID:12774						
DS_ID:21909						
EP_NO: 724						
Repair Type: Non-Urgent						
Crossing Status: Found						
UCIP Comments: Pipe open on waterside at fallen down pumphouse.						
Pipe abandoned. Service pole on LS slope down on ground near						
broken standpipe. Pipe needs to be properly abandoned.						
FIELD_STRUCT_DESC: 10-inch pipe through levee 3.8 feet below						
crown. Pump in pumphouse on the water ward slope. Service pole on						
the landward slope (Permit No. 724, 1937). Replaces a 10-inch pipe						
approx. same location. 32-inch concrete standpipe on LS toe. 1.5-inch						
electrical conduit runs parallel to 10-inch pipe. Included in the 1959						
O&M manual.						
FS Date: 5/2/2013

Broken Concrete standpipe on LS toe.

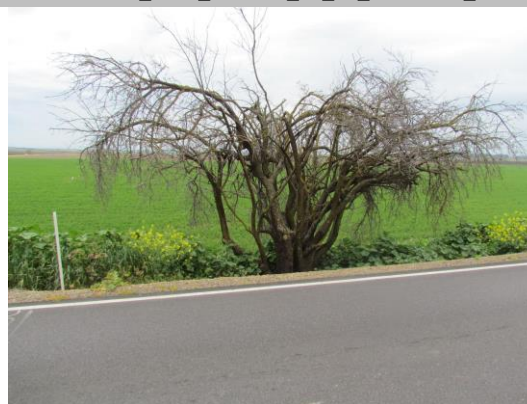
Photo 1 of 1 : SP_2017_NA0002_63_88_20170324_00187.jpg

LM Start	4.92	Rating **	M	Issue No.	88
LM End	4.92	Issue Type +	Ma	Location *	LS
Category	Earthen Levee			GPS Latitude/Longitude	
				Start	End
Item	Encroachments			38.169262 °	38.169262 °
				-121.639497 °	-121.639497 °
DWR ID	DWR_NA0002_02_s_2017_88				
Comment Code					
TR : Tree or limb					
Inspector Comment					
Remove dead tree on landward slope.

Looking east at dead tree on landward slope and toe.
