**Flood Control Project Maintenance
Levee Inspections**
LMA District Cover Sheet
Spring 2017 Levee Inspection Results

Brannan Andrus Levee Maintenance District

Spring 2017 Levee Inspection Results

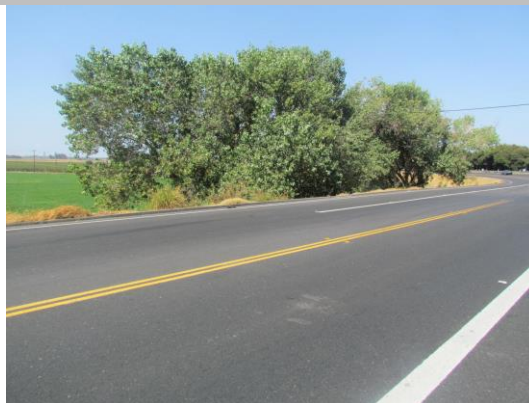
Photo 1 of 1 : SP_2017_NA0002_63_95_20170314_00061.jpg

LM Start	5.16	Rating **	U	Issue No.	95
LM End	5.16	Issue Type +	Ma	Location *	LS
Category	Earthen Levee			GPS Latitude/Longitude	
				Start	End
Item	Trim / Thin Trees			38.171318 °	38.171318 °
				-121.643001 °	-121.643001 °
DWR ID	DWR_NA0002_02_f_2015_95				
Comment Code					
T1 : Trim trees to at least five feet above ground level.					
Inspector Comment

Looking west at untrimmed trees on landward slope.

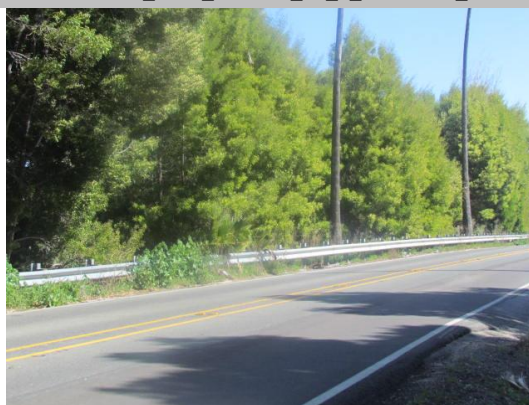
Photo 1 of 3 : SP_2017_NA0002_63_9_20170314_00010.jpg

LM Start	5.23	Rating **	U	Issue No.	9
LM End	5.42	Issue Type +	Ma	Location *	WS
Category	Earthen Levee			GPS Latitude/Longitude	
				Start	End
Item	Trim / Thin Trees			38.171942 °	38.171800 °
				-121.643975 °	-121.647447 °
DWR ID	DWR_NA0002_02_s_2012_9				
Comment Code					
T2 : Thin trees to allow visibility of the ground and room to flood fight.					
Inspector Comment

Looking northeast at dense trees on waterside slope and toe.

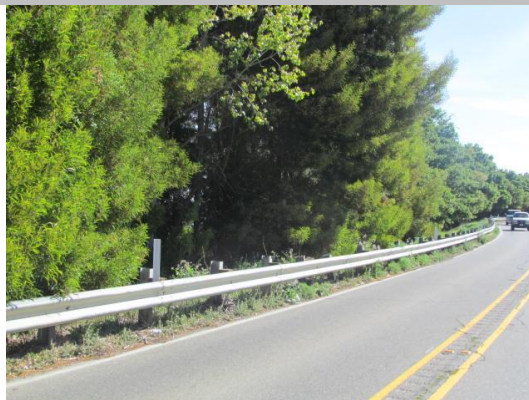
Photo 2 of 3 : SP_2017_NA0002_63_9_20170314_00011.jpg

Looking east at dense trees on waterward shoulder and slope.

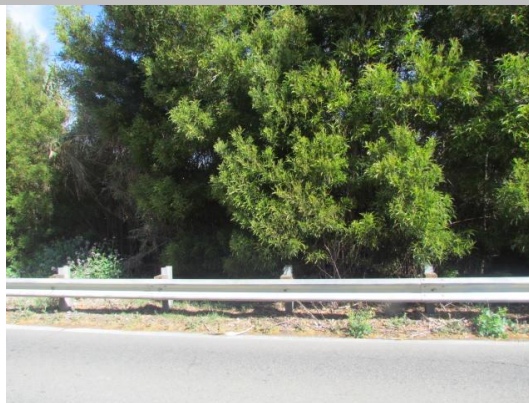
Photo 3 of 3 : SP_2017_NA0002_63_9_20170314_00012.jpg

LM Start	5.23	Rating **	U	Issue No.	9 (cont)	
LM End	5.42	Issue Type +	Ma	Location *	WS	
Category	Earthen Levee			GPS Latitude/Longitude		
				Start		End
Item	Trim / Thin Trees			38.171942 °		38.171800 °
				-121.643975 °		-121.647447 °
DWR ID	DWR_NA0002_02_s_2012_9					
Comment Code						
T2 : Thin trees to allow visibility of the ground and room to flood fight.						
Inspector Comment

Looking north at dense trees on waterward shoulder and slope.

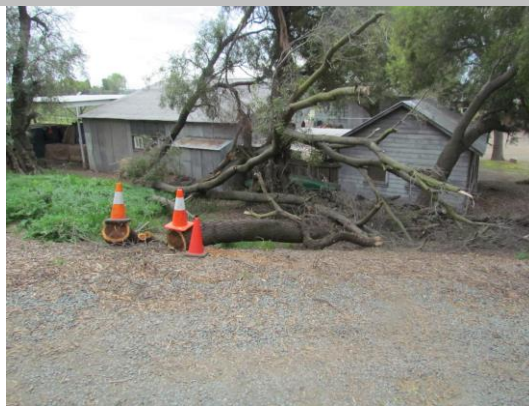
Photo 1 of 1 : SP_2017_NA0002_63_89_20170324_00188.jpg

LM Start	5.37	Rating **	U	Issue No.	89
LM End	5.37	Issue Type +	En	Location *	LS
Category	Earthen Levee			GPS Latitude/Longitude	
				Start	End
Item	Encroachments			38.171783 °	38.171783 °
				-121.646562 °	-121.646562 °
DWR ID	DWR_NA0002_02_s_2017_89				
Comment Code					
TR : Tree or limb					
Inspector Comment					
Discard fallen tree branches and limbs on landward toe.

Looking east at fallen tree on landward slope and toe.

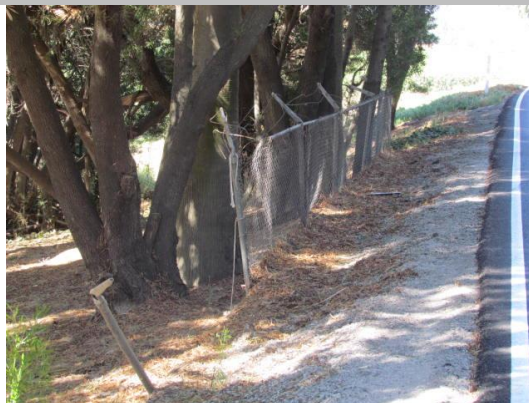
Photo 1 of 1 : SP_2017_NA0002_63_56_20170314_00052.jpg

LM Start	5.39	Rating **	M	Issue No.	56
LM End	5.39	Issue Type +	En	Location *	LS
Category	Earthen Levee			GPS Latitude/Longitude	
				Start	End
Item	Encroachments			38.171850 °	38.171850 °
				-121.647000 °	-121.647000 °
DWR ID	DWR_NA0002_02_f_2013_56				
Comment Code					
FE : Fence					
Inspector Comment					
Fencing should be removed.

Looking at unauthorized fence on landward slope.

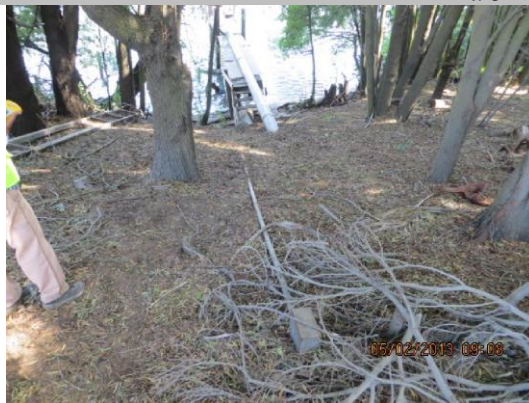
Photo 1 of 3 : UCIP_SP_2017_12776_20754.jpg

LM Start	5.41	Rating **	M	Issue No.	148
LM End	5.41	Issue Type +	Ma	Location *	LS
Category	Supplemental			GPS Latitude/Longitude	
				Start	End
Item	DWR UCIP LMA Responsibility			38.171824 °	38.171824 °
				-121.647265 °	-121.647265 °
DWR ID					
Comment Code					
Inspector Comment					
FS_ID:12776					
DS_ID:21910					
EP_NO: 7089A					
Repair Type: Non-Urgent					
Crossing Status: Found					
UCIP Comments: Hole at LS toe over pipe possible sign of leakage.					
FIELD_STRUCT_DESC: 7-inch pipe through levee 13.0 feet below crown. Pump in pump house on the landward side. 1.5-inch galvanized steel electrical conduit at same location. 4'X6' concrete distribution box off LS toe next to pumphouse. Originally included in the 1959 O&M manual.					
FS Date: 5/2/2013

Pipe and electrical conduit on WS slope.

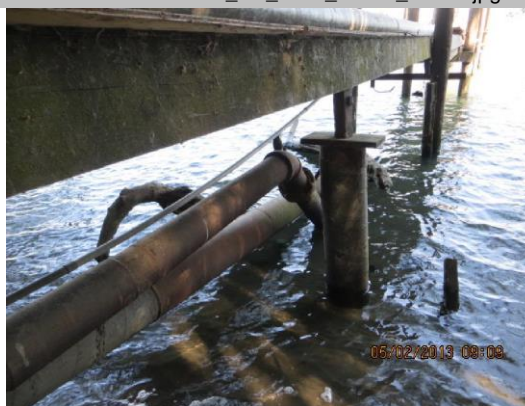
Photo 3 of 3 : UCIP_SP_2017_12776_20752.jpg

LM Start	5.41	Rating **	M	Issue No.	148 (cont)	
LM End	5.41	Issue Type +	Ma	Location *	LS	
Category	Supplemental			GPS Latitude/Longitude		
				Start	End	
Item	DWR UCIP LMA Responsibility			38.171824 °	38.171824 °	
				-121.647265 °	-121.647265 °	
DWR ID						
Comment Code						
Inspector Comment						
FS_ID:12776						
DS_ID:21910						
EP_NO: 7089A						
Repair Type: Non-Urgent						
Crossing Status: Found						
UCIP Comments: Hole at LS toe over pipe possible sign of leakage.						
FIELD_STRUCT_DESC: 7-inch pipe through levee 13.0 feet below crown. Pump in pump house on the landward side. 1.5-inch galvanized steel electrical conduit at same location. 4'X6' concrete distribution box off LS toe next to pumphouse. Originally included in the 1959 O&M manual.						
FS Date: 5/2/2013

Pipe under pier.

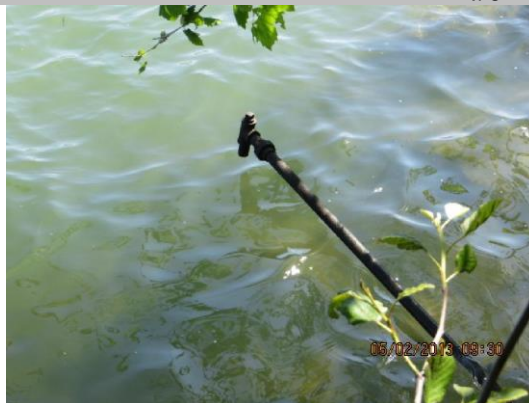
Photo 1 of 3 : UCIP_SP_2017_12778_20762.jpg

FS_ID:12778
DS_ID:21912
EP_NO: N/A
Repair Type: Non-Urgent
Crossing Status: Found
UCIP Comments: Pipe abandoned. Erosion on WS slope at location where pipe should be.
FIELD_STRUCT_DESC: *ABANDONED* 12-inch pipe through levee 13.0 feet below crown. Pump and gate valve in pumphouse at landside toe. 1.5-inch electrical conduit along pipe at same location. 42-inch concrete stand pipe at LS toe. Concrete standpipe at landside toe.
FS Date: 5/2/2013

Conduit at WS toe.

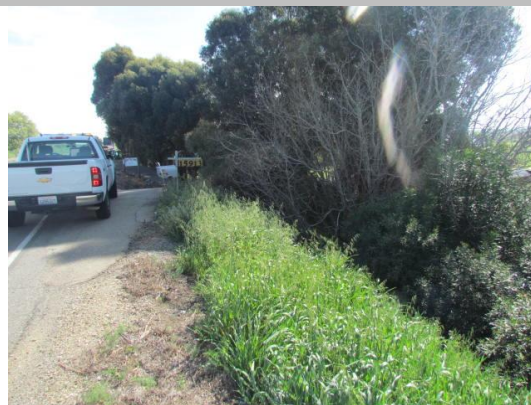
Photo 2 of 2 : SP_2017_NA0002_63_50_20170314_00050.jpg

LM Start	6.27	Rating **	U	Issue No.	50 (cont)
LM End	6.27	Issue Type +	En	Location *	LS

Looking northeast at dense landscaping on landward slope.

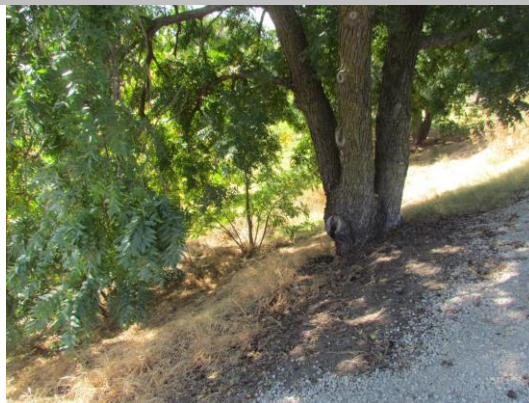
Photo 1 of 2 : SP_2017_NA0002_63_14_20170314_00017.jpg

LM Start	6.36	Rating **	U	Issue No.	14
LM End	6.36	Issue Type +	Ma	Location *	LS
Category	Earthen Levee			GPS Latitude/Longitude	
				Start	End
Item	Trim / Thin Trees			38.173406°	38.173406°
				-121.663815°	-121.663815°
DWR ID	DWR_NA0002_02_s_2012_14				
Comment Code					
T1 : Trim trees to at least five feet above ground level.					
Inspector Comment

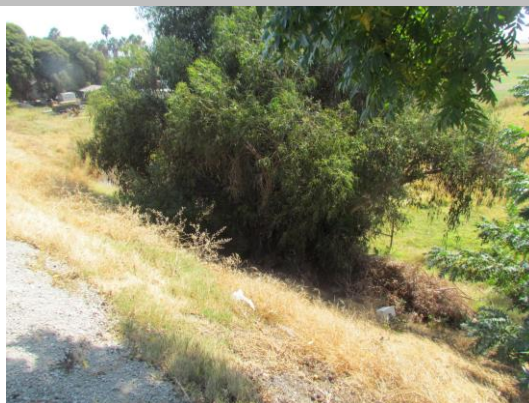
Photo 2 of 2 : SP_2017_NA0002_63_14_20170314_00018.jpg

LM Start	6.36	Rating **	U	Issue No.	14 (cont)
LM End	6.36	Issue Type +	Ma	Location *	LS

Looking east at untrimmed tree on landward slope.

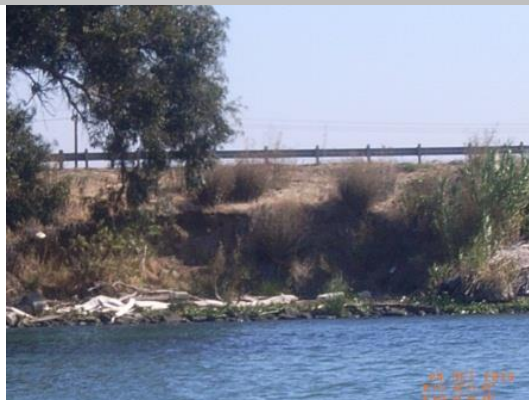
Photo 1 of 1 : SP_2017_NA0002_63_23_20170314_00026.jpg

LM Start	6.98	Rating **	M	Issue No.	23
LM End	7.04	Issue Type +	Ma	Location *	WS
Category	Supplemental			GPS Latitude/Longitude	
				Start	End
Item	2015 USACE Erosion Survey, DRAFT			38.166583°	38.165794°
				-121.670684°	-121.671014°
DWR ID	DWR_NA0002_02_s_2016_23				
Comment Code					
Inspector Comment					
2011 - Large section of bank slumped off. 2015: No observed changes. [2015 Site ID: SAC_13-6_L]

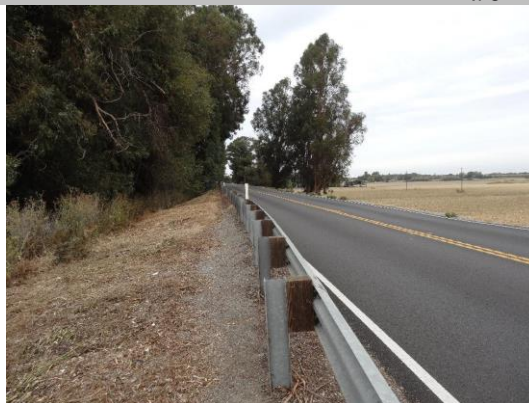
Photo 3 of 3 : UCIP_SP_2017_51434_76478.jpg

Item	DWR UCIP Field Study			38.165949 °	38.165949 °	
				-121.670638 °	-121.670638 °	
DWR ID						
Comment Code						
Inspector Comment						
FS_ID:51434 DS_ID:21916 EP_NO: N/A Repair Type: Urgent Crossing Status: Found UCIP Comments: 10/24/2016 same as previous inspection pipe is opened on the WS. The crossing remains "Urgent" due WS end open. Crossing appears abandoned--need to contact owner to determine status. If crossing is no longer in use owner will need to coordinate with the CVFPB to comply with Title 23. (O. Magana - DWR UCIP)05/02/2013 Pipe open on WS. (W. Wylie - DWR UCIP) FIELD_STRUCT_DESC: *ABANDONED* 8-inch steel irrigation pipe through levee 8.7 feet below crown. Pipe measures 8-inch inner diameter (ID) and 10-inch outer diameter (OD). A 5-foot by 5-foot concrete distribution box is located on the landside (LS) toe. [Additional Reference(s): DWR Levee Log, 2005. USACE Sacramento O&M Manual Unit 103, June 1954, (RM 13.6)]. FS Date: 10/24/2016

View of levee crown and WS slope at pipe crossing.

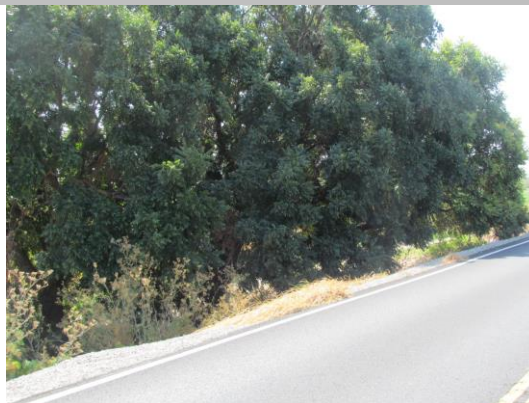
Photo 1 of 1 : SP_2017_NA0002_63_112_20170314_00080.jpg

LM Start	7.13	Rating **	U	Issue No.	112
LM End	7.13	Issue Type +	Ma	Location *	LS
Category	Earthen Levee			GPS Latitude/Longitude	
				Start	End
Item	Trim / Thin Trees			38.164465 °	38.164465 °
				-121.671292 °	-121.671292 °
DWR ID	DWR_NA0002_02_f_2015_112				
Comment Code					
T1 : Trim trees to at least five feet above ground level.					
Inspector Comment

Looking south at untrimmed trees on landward slope.

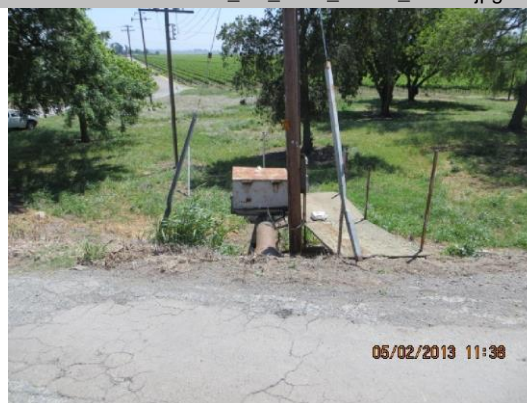
Photo 3 of 3 : UCIP_SP_2017_12814_20819.jpg

LM Start	7.45	Rating **	M	Issue No.	152 (cont)	
LM End	7.45	Issue Type +	En	Location *	LS	
Category	Supplemental			GPS Latitude/Longitude		
				Start	End	
Item	DWR UCIP Field Study			38.160387 °	38.160387 °	
				-121.673972 °	-121.673972 °	
DWR ID						
Comment Code						
Inspector Comment						
FS_ID:12814						
DS_ID:21918						
EP_NO: 11293						
Repair Type: Non-Urgent						
Crossing Status: Found						
UCIP Comments: Erosion or sinkhole on WS shoulder. Does not appear to be an immediate threat.						
FIELD_STRUCT_DESC: 2 of 2: 16-inch pipe through levee 7.1 feet below crown. Pump on the landward slope. Service pole on the landward slope. 72-inch Concrete standpipe at toe of landward slope (ABO No. 11293, 1975). Originally included in the 1959 O&M manual.						
FS Date: 5/2/2013

Pipe and pump on LS shoulder.

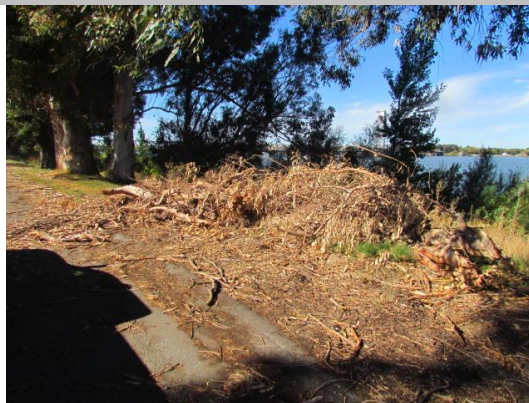
Photo 1 of 1 : SP_2017_NA0002_63_105_20170314_00072.jpg

LM Start	7.71	Rating **	M	Issue No.	105
LM End	7.71	Issue Type +	Ma	Location *	WS
Category	Earthen Levee			GPS Latitude/Longitude	
				Start	End
Item	Encroachments			38.157841 °	38.157841 °
				-121.677510 °	-121.677510 °
DWR ID	DWR_NA0002_02_f_2014_105				
Comment Code					
TR : Tree or limb					
Inspector Comment					
Tree limbs on waterward shoulder.

Looking southwest at tree limbs on waterward shoulder.

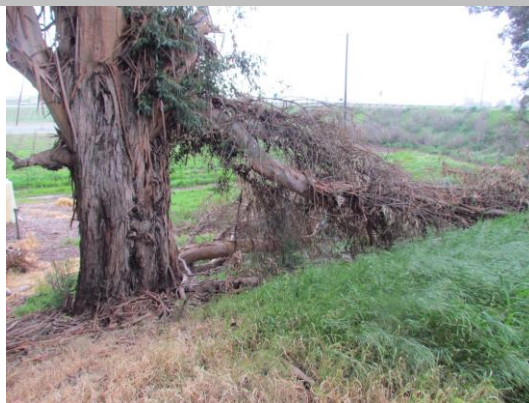
Photo 1 of 1 : SP_2017_NA0002_63_98_20170324_00191.jpg

LM Start	7.79	Rating **	U	Issue No.	98
LM End	7.79	Issue Type +	En	Location *	LS
Category	Earthen Levee			GPS Latitude/Longitude	
				Start	End
Item	Encroachments			38.157050 °	38.157050 °
				-121.678587 °	-121.678587 °
DWR ID	DWR_NA0002_02_s_2017_98				
Comment Code					
TR : Tree or limb					
Inspector Comment					
Discard broken tree branches and limbs on landward slope.

Looking southeast at broken tree branch at landward toe.

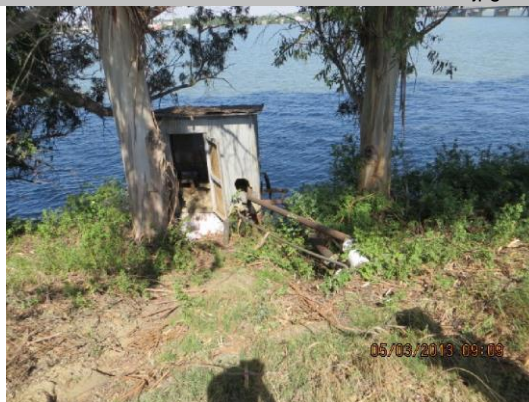
Photo 2 of 3 : UCIP_SP_2017_12869_20932.jpg

Pumphouse and pipe on WS slope.

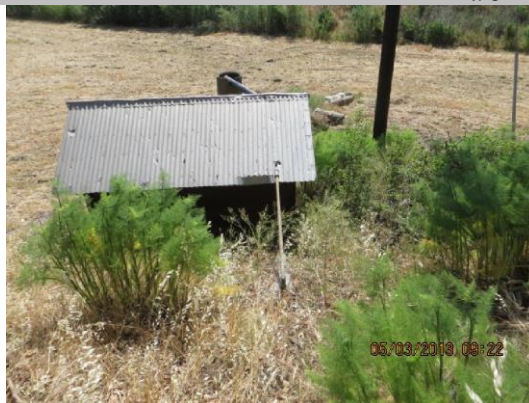
Photo 2 of 3 : UCIP_SP_2017_16143_27241.jpg

LM Start	8.15	Rating **	M	Issue No.	156 (cont)
LM End	8.15	Issue Type +	En	Location *	LS
Category	Supplemental			GPS Latitude/Longitude	
				Start	End
Item	DWR UCIP Field Study			38.152550 °	38.152550 °
				-121.681560 °	-121.681560 °
DWR ID					
Comment Code					
Inspector Comment					
FS_ID:16143					
DS_ID:21926					
EP_NO: 8661					
Repair Type: Non-Urgent					
Crossing Status: Found					
UCIP Comments: Dip in crown over alignment of pipe. Good candidate for video inspection.					
FIELD_STRUCT_DESC: 8-inch pipe through levee 3.7 feet below crown. Pump in pump house on the landward slope. Service pole and 30-inch concrete standpipe at the landward toe (ABO No. 8661, 1972). Originally included in the 1959 O&M.					
FS Date: 5/3/2013

Pumphouse with concrete standpipe in background on LS toe.

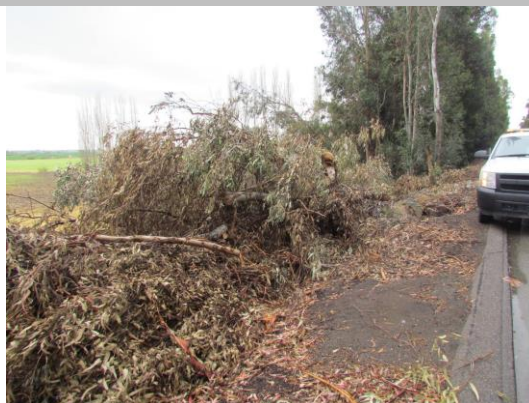
Photo 1 of 4 : SP_2017_NA0002_63_106_20170324_00192.jpg

LM Start	8.31	Rating **	U	Issue No.	106
LM End	8.31	Issue Type +	Ma	Location *	LS
Category	Earthen Levee			GPS Latitude/Longitude	
				Start	End
Item	Encroachments			38.150208 °	38.150208 °
				-121.682130 °	-121.682130 °
DWR ID	DWR_NA0002_02_s _ 2017_106				
Comment Code					
TR : Tree or limb					
Inspector Comment					
Several fallen trees and prunings on landward slope. Tree left hole on landward slope.

Looking southeast at fallen tree prunings on landward shoulder and slope.

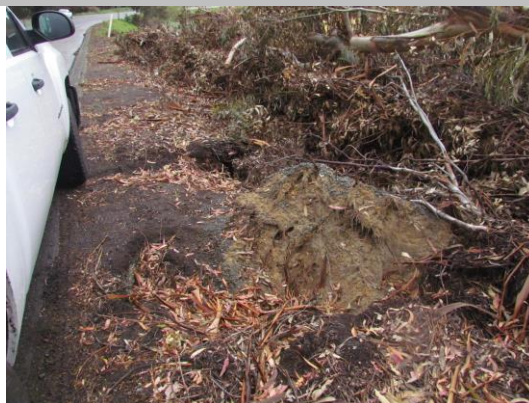
Photo 2 of 4 : SP_2017_NA0002_63_106_20170324_00193.jpg

Looking north at hole on left by fallen tree on landward shoulder and slope.

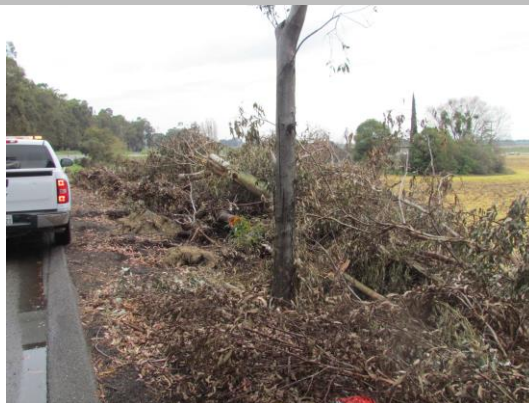
Photo 3 of 4 : SP_2017_NA0002_63_106_20170324_00194.jpg

LM Start	8.31	Rating **	U	Issue No.	106 (cont)	
LM End	8.31	Issue Type +	Ma	Location *	LS	
Category	Earthen Levee			GPS Latitude/Longitude		
				Start		End
Item	Encroachments			38.150208 °		38.150208 °
				-121.682130 °		-121.682130 °
DWR ID	DWR_NA0002_02_s_2017_106					
Comment Code						
TR : Tree or limb						
Inspector Comment						
Several fallen trees and prunings on landward slope. Tree left hole on landward slope.

Looking north at fallen tree prunings on landward slope.

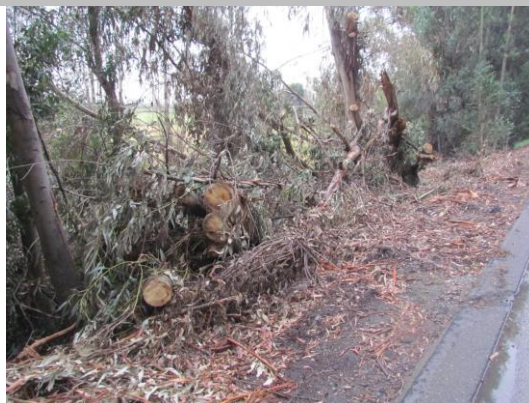
Photo 4 of 4 : SP_2017_NA0002_63_106_20170324_00195.jpg

Looking southeast at second fallen tree prunings on landward shoulder and slope.

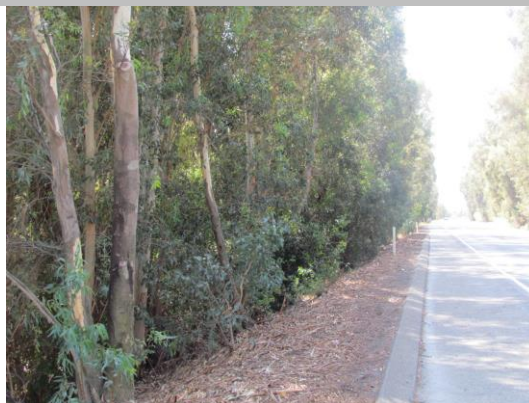
Photo 1 of 1 : SP_2017_NA0002_63_44_20170314_00044.jpg

LM Start	8.32	Rating **	U	Issue No.	44
LM End	8.68	Issue Type +	Ma	Location *	LS
Category	Earthen Levee			GPS Latitude/Longitude	
				Start	End
Item	Trim / Thin Trees			38.150112 °	38.144977 °
				-121.682305 °	-121.683345 °
DWR ID	DWR_NA0002_02_s_2012_44				
Comment Code					
T1 : Trim trees to at least five feet above ground level.					
Inspector Comment					
Dense eucalyptus trees along landside slope.

Looking south at untrimmed trees along landward slope.

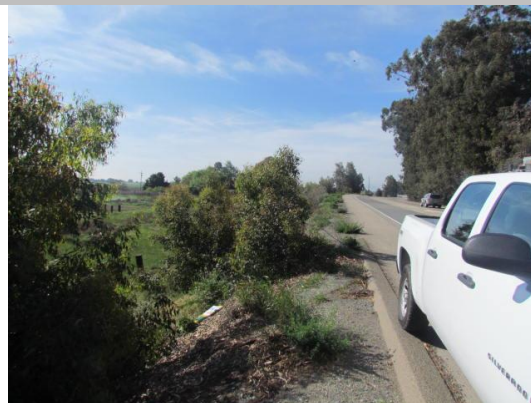
Photo 1 of 2 : SP_2017_NA0002_63_48_20170314_00047.jpg

LM Start	8.65	Rating **	M	Issue No.	48
LM End	8.86	Issue Type +	Ma	Location *	LS
Category	Earthen Levee			GPS Latitude/Longitude	
				Start	End
Item	Trim / Thin Trees			38.145368 °	38.142430 °
				-121.683072 °	-121.683978 °
DWR ID	DWR_NA0002_02_s_2013_48				
Comment Code					
T1 : Trim trees to at least five feet above ground level.					
Inspector Comment

Looking south at trees on landward slope.

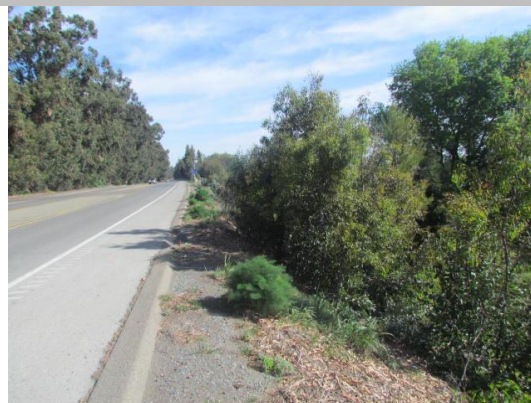
Photo 2 of 2 : SP_2017_NA0002_63_48_20170314_00048.jpg

Looking north at dense trees on landward slope and toe.

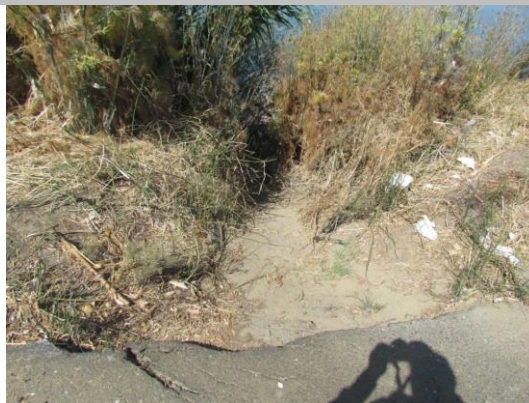
Photo 1 of 4 : SP_2017_NA0002_63_115_20170314_00082.jpg

LM Start	9.15	Rating **	U	Issue No.	115
LM End	9.15	Issue Type +	Ma	Location *	WS
Category	Earthen Levee			GPS Latitude/Longitude	
				Start	End
Item	Erosion / Bank Caving			38.138510 °	38.138510 °
				-121.686124 °	-121.686124 °
DWR ID	DWR_NA0002_02_s_2016_115				
Comment Code					
E1 : Note and monitor erosion site.					
Inspector Comment					
Erosion on waterward shoulder along highway appears to be foot erosion.

Looking west at foot erosion on waterward slope. (Fall 2016)

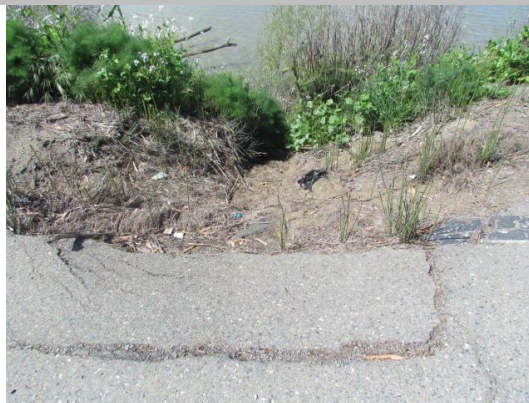
Photo 2 of 4 : SP_2017_NA0002_63_115_20170314_00083.jpg

LM Start	9.15	Rating **	U	Issue No.	115 (cont)	
LM End	9.15	Issue Type +	Ma	Location *	WS	
Category	Earthen Levee			GPS Latitude/Longitude		
				Start		End
Item	Erosion / Bank Caving			38.138510 °		38.138510 °
				-121.686124 °		-121.686124 °
DWR ID	DWR_NA0002_02_s_2016_115					
Comment Code						
E1 : Note and monitor erosion site.						
Inspector Comment						
Erosion on waterward shoulder along highway appears to be foot erosion.

Looking west at foot erosion on waterward slope.

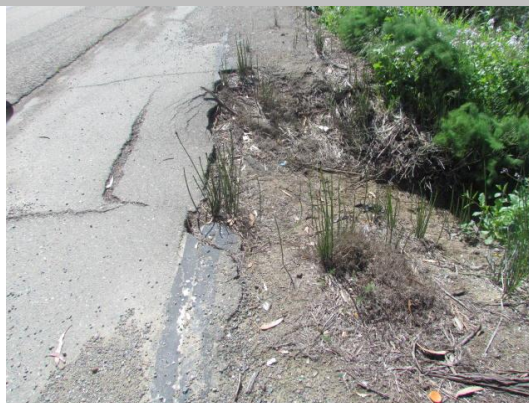
Photo 3 of 4 : SP_2017_NA0002_63_115_20170314_00084.jpg

Looking south at erosion on waterward shoulder.

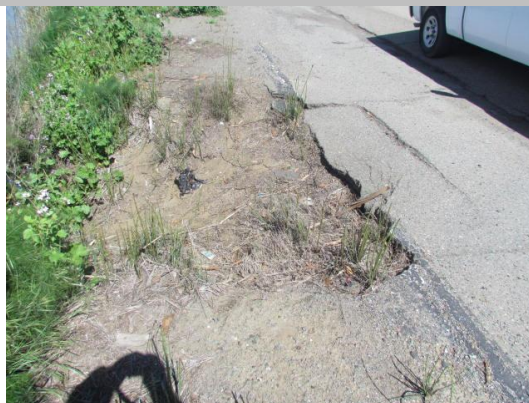
Photo 4 of 4 : SP_2017_NA0002_63_115_20170314_00085.jpg

Looking north at foot erosion at waterward shoulder and slope.

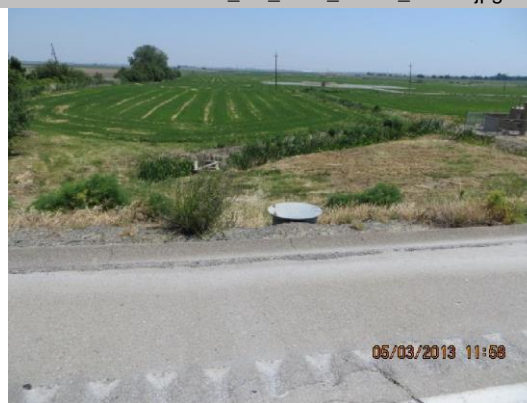
Photo 3 of 3 : UCIP_SP_2017_40528_21000.jpg

LM Start	9.36	Rating **	M	Issue No.	160 (cont)	
LM End	9.36	Issue Type +	Ma	Location *	WS	
Category	Supplemental			GPS Latitude/Longitude		
				Start		End
Item	DWR UCIP LMA Responsibility			38.135584 °		38.135584 °
				-121.686108 °		-121.686108 °
DWR ID						
Comment Code						
Inspector Comment						
FS_ID:40528 DS_ID:21931 EP_NO: 16011 Repair Type: Non-Urgent Crossing Status: Found UCIP Comments: Annular space between pipes should be grouted. IF abandoned, these pipes should be abandoned properly. FIELD_STRUCT_DESC: 18-inch corrugated metal conduit pipe through the levee 4.5 feet below the crown. Inactive 12-inch pipe sleeved through 18-inch. Both ends open. Siphon breaker and air valve in 24-inch CMP riser on LS shoulder. 9'X5' concrete box with slide gate off LS toe. Originally included in the 1959 O&M manual. FS Date: 5/3/2013

Standpipe and concrete box at LS.

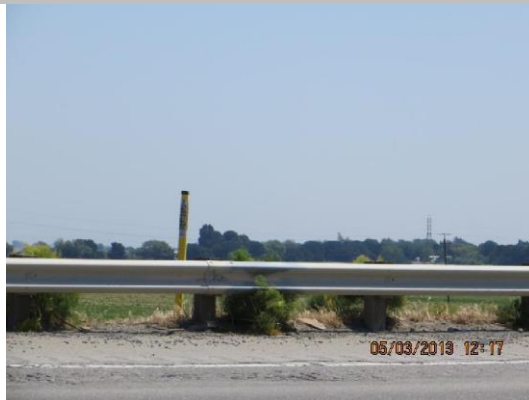
Photo 2 of 2 : UCIP_SP_2017_16146_27250.jpg

Gasline Marker on LS shoulder

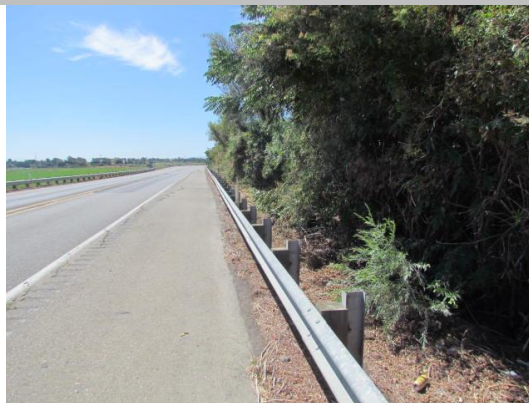
Photo 1 of 2 : SP_2017_NA0002_63_16_20170314_00019.jpg

Looking south at dense vegetation (trees) on waterward slope.

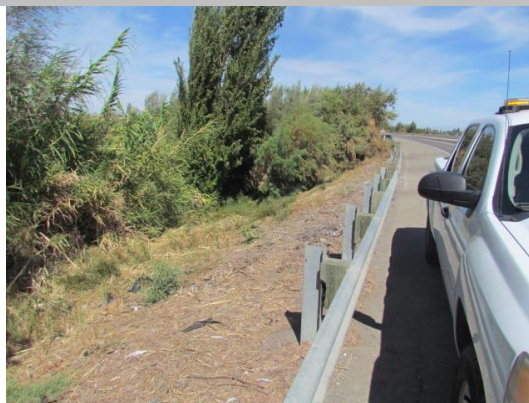
Photo 2 of 2 : SP_2017_NA0002_63_16_20170314_00020.jpg

Looking north at dense vegetation (trees) on waterward slope.

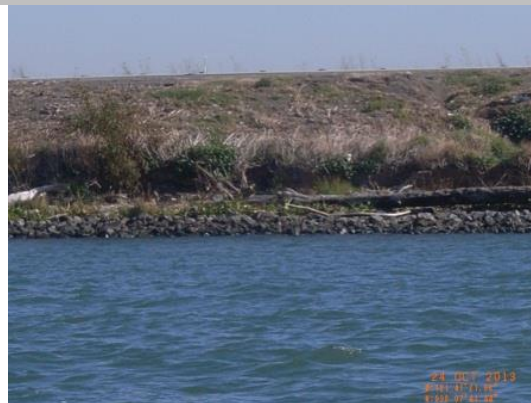
Photo 1 of 1 : SP_2017_NA0002_63_21_20170314_00024.jpg

Comment Code					
Inspector Comment					
2004 - Wave wash pockets approximately 100 ft long with new full bank rock between the pockets. 2005 - Spot repairs, but toe is still eroding in several places. 2006 - Low vertical bank along roadway. 2007 - A PL 84-99 repair was constructed, it cover the majority of the site with the exception of the upstream 150 to 200 ft and the downstream 250 ft, therefore it is being kept in the inventory. 2009 - Minimal new erosion. 2010 - Outboard berm looks good, but the banks are still very steep. 2011 - While the outboard berm is protecting against wave wash, bank still has slumping issues. 2015: No observed changes. [2015 Site ID: SAC_10-8_L]

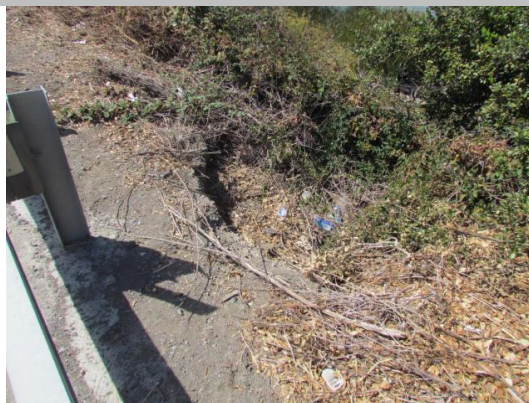
Photo 1 of 1 : SP_2017_NA0002_63_113_20170314_00081.jpg

LM Start	10.28	Rating **	M	Issue No.	113
LM End	10.28	Issue Type +	Ma	Location *	WS
Category	Earthen Levee			GPS Latitude/Longitude	
				Start	End
Item	Erosion / Bank Caving			38.122904 °	38.122904 °
				-121.690819 °	-121.690819 °
DWR ID	DWR_NA0002_02_f_2015_113				
Comment Code					
E2 : Schedule repair of erosion site prior to the next inspection.					
Inspector Comment					
Bank erosion on waterward shoulder greater than 3" depth but less than 3' in length.

Looking at erosion on waterward shoulder.
