**Flood Control Project Maintenance
Levee Inspections**
LMA District Cover Sheet
Spring 2018 Levee Inspection Results

Brannan Andrus Levee Maintenance District

Spring 2018 Levee Inspection Results

Waterway			Bank	Unit Miles
Unit No. 01 Georgiana Slough			Right	6.01
	Spring (March - May)	Summer (June - August)	(September - November) Fall	Winter (December - February)
Unit Maintenance Rating (Fall Only)				
Date of Inspection	4/5/2018 - 4/5/2018			
DWR Inspector	Keith Millard			
Accompanied By

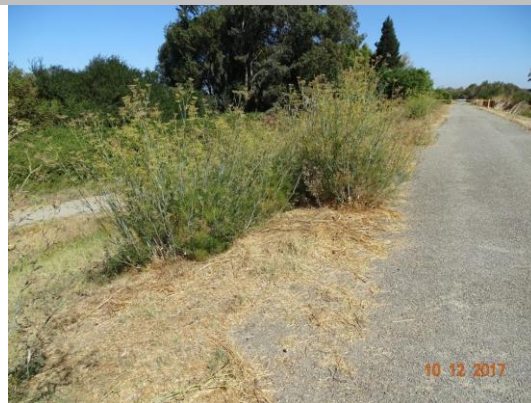
Photo 1 of 1 : SP_2018_NA0002_62_43_20180305_00031.jpg

LM Start	0.02	Rating **	M	Issue No.	43
LM End	2.25	Issue Type +	Ma	Location *	LS
Category	Earthen Levee			GPS Latitude/Longitude	
				Start	End
Item	Vegetation			38.186345 °	38.163432 °
				-121.562957 °	-121.584426 °
DWR ID	DWR_NA0002_01_f_2017_43				
Comment Code					
V1 : Control annual grass and weeds on the levee slopes and easements.					
Inspector Comment

Looking northeast at the landside slope.

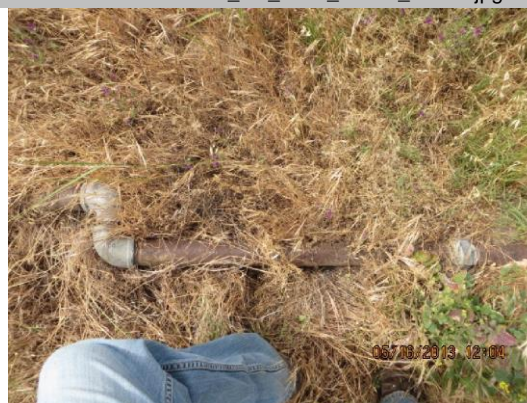
Photo 3 of 3 : UCIP_SP_2018_13560_22171.jpg

LM Start	0.61	Rating **	M	Issue No.	79 (cont)	
LM End	0.61	Issue Type +	En	Location *		
Category	Supplemental			GPS Latitude/Longitude		
				Start	End	
Item	DWR UCIP Field Study			38.182213 °	38.182213 °	
				-121.572357 °	-121.572357 °	
DWR ID						
Comment Code						
Inspector Comment						
FS_ID:13560						
DS_ID:21752						
EP_NO: 2015						
Repair Type: Non-Urgent						
Crossing Status: Found						
UCIP Comments: This pipe appears abandoned and should be removed.						
FIELD_STRUCT_DESC: 2-inch galvanized iron wastewater pipe through the levee, 2 feet below the crown. Gas well drain. (Permit No. 2015, 1954 - Brazos Oil and Gas Company). [Additional Reference(s): DWR Levee Log, 2005].						
FS Date: 5/16/2013

Pipe on LS slope.

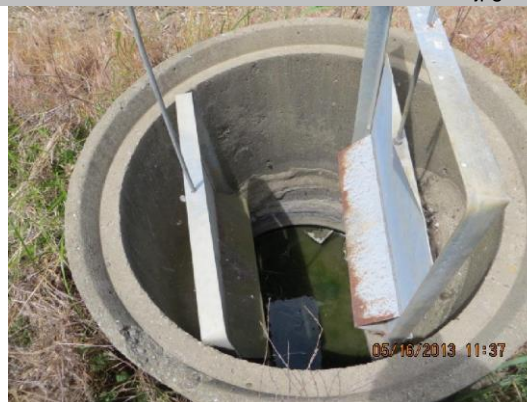
Photo 2 of 3 : UCIP_SP_2018_13558_22168.jpg

Concrete standpipe on LS toe.

Comment Code						
Inspector Comment						
FS_ID:13558						
DS_ID:21754						
EP_NO: 11234						
Repair Type: Non-Urgent						
Crossing Status: Found						
UCIP Comments: Appears abandoned and should be done so properly.						
FIELD_STRUCT_DESC: 1 of 2: 8-inch steel irrigation pipe through the						
levee, 4.3 feet below the crown. Pump in pump house on the waterside						
(WS) berm. 60-inch diameter concrete standpipe on the landside (LS)						
toe. (Automatic Board Order (ABO) issued as Permit No. 11234, 1975 -						
Anthony and John Correia). [Additional Reference(s): USACE						
Sacramento O&M Manual 103, June 1954, (Station ""R"" 255+00)

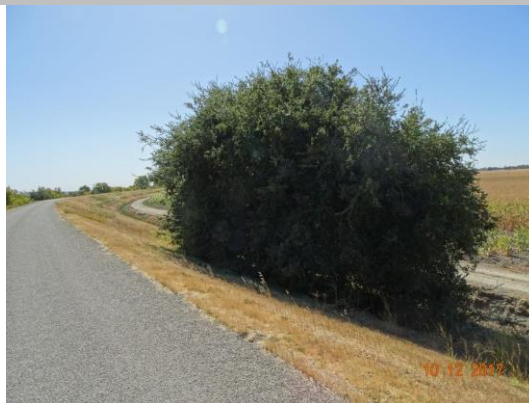
Photo 1 of 3 : SP_2018_NA0002_62_25_20180305_00021.jpg

LM Start	1.56	Rating **	U	Issue No.	25 (cont)
LM End	1.56	Issue Type +	Ma	Location *	LS

Looking southwest at the landside slope.

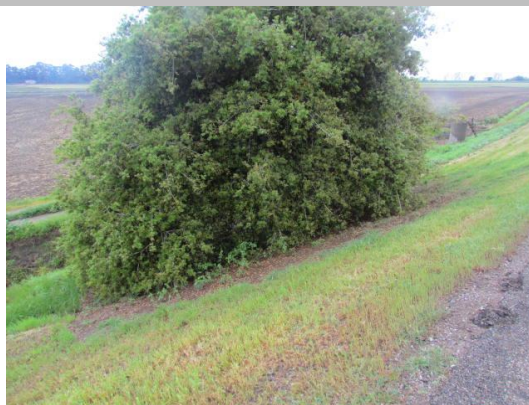
Photo 2 of 3 : SP_2018_NA0002_62_25_20180305_00022.jpg

Looking northwest at untrimmed tree at landward toe. (Spring 2015)

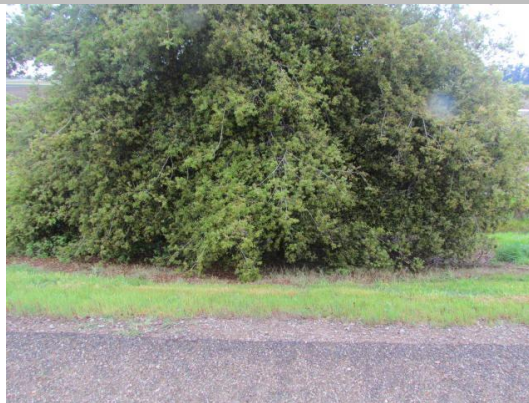
Photo 3 of 3 : SP_2018_NA0002_62_25_20180305_00023.jpg

Looking west at untrimmed tree at landward toe. (Spring 2015)

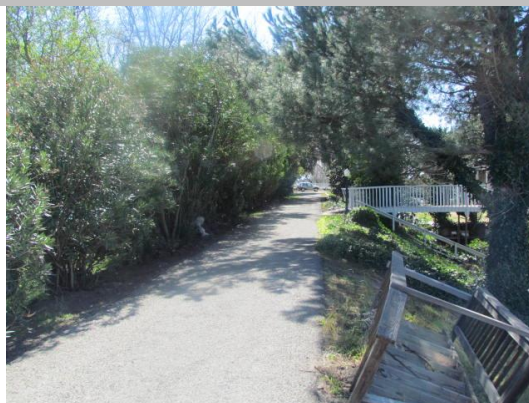
Photo 2 of 4 : SP_2018_NA0002_62_36_20180305_00028.jpg

Looking south at dense oleander on waterside shoulder, spring 2012.

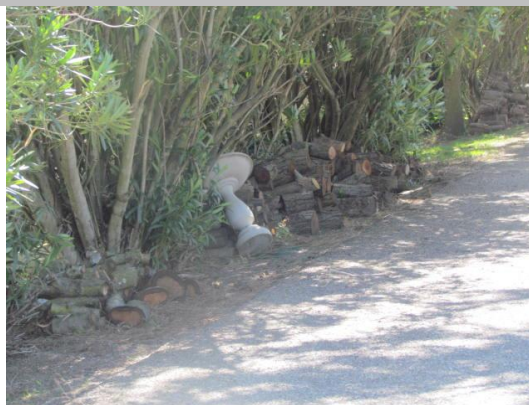
Photo 2 of 3 : SP_2018_NA0002_62_3_20180305_00004.jpg

Looking southeast at firewood on waterside shoulder.

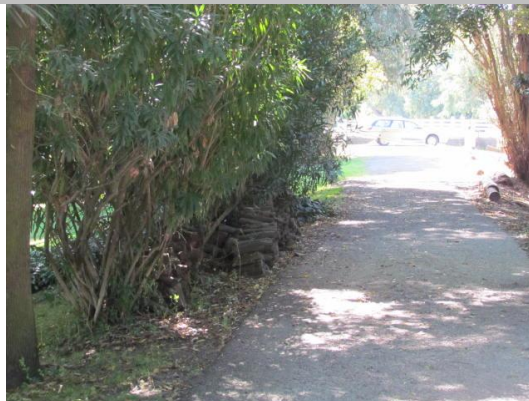
Photo 3 of 3 : SP_2018_NA0002_62_3_20180305_00005.jpg

Looking south at firewood on waterside shoulder.

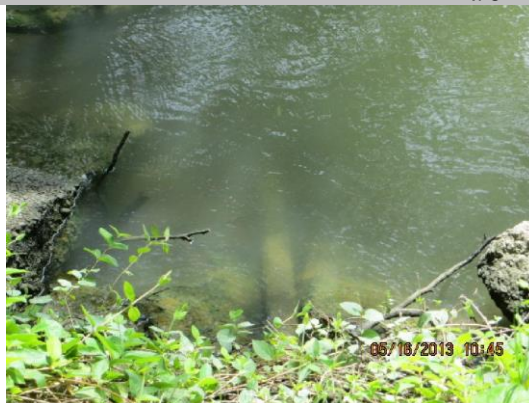
Photo 2 of 2 : UCIP_SP_2018_16123_27220.jpg

LM Start	2.34	Rating **	M	Issue No.	84 (cont)	
LM End	2.34	Issue Type +	En	Location *		
Category	Supplemental			GPS Latitude/Longitude		
				Start		End
Item	DWR UCIP Field Study			38.162332 °	38.162332 °	
				-121.585032 °	-121.585032 °	
DWR ID						
Comment Code						
Inspector Comment						
FS_ID:16123 DS_ID:21819 EP_NO: N/A Repair Type: Non-Urgent Crossing Status: Found UCIP Comments: Pipe appears abandoned and should be done so properly. FIELD_STRUCT_DESC: 2-inch steel irrigation pipe through the levee, 3 feet below the crown. [Additional Reference(s): USACE Sacramento O&M Manual 103, June 1954, (Station ""R"" 196+99) Drawing No. 50-4-2631]. FS Date: 5/16/2013

Pipe visible in water at WS toe.

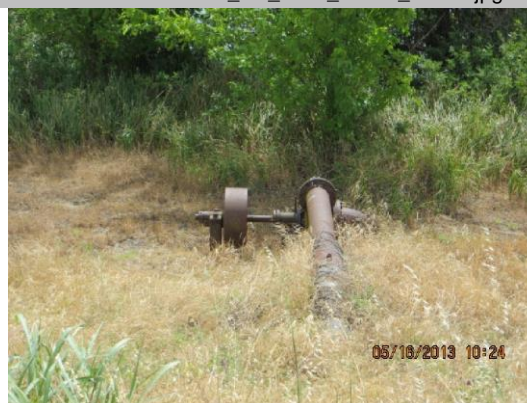
Photo 1 of 3 : UCIP_SP_2018_13545_22145.jpg

LM Start	2.50	Rating **	M	Issue No.	85	
LM End	2.50	Issue Type +	En	Location *		
Category	Supplemental			GPS Latitude/Longitude		
				Start		End
Item	DWR UCIP Field Study			38.160147 °		38.160147 °
				-121.586088 °		-121.586088 °
DWR ID						
Comment Code						
Inspector Comment						
FS_ID:13545						
DS_ID:21762						
EP_NO: N/A						
Repair Type: Non-Urgent						
Crossing Status: Found						
UCIP Comments: Pipe appears abandoned and should be done so properly. standpipe on LS is covered in brush.						
FIELD_STRUCT_DESC: 8-inch steel irrigation pipe through the levee, 3.4 feet below the crown. 6-inch pump on the waterside (WS). 36-inch concrete standpipe on the landside (LS) toe. [Additional Reference(s): DWR Levee Log, 2005. USACE Sacramento O&M Manual 103, June 1954, (Station ""R"" 188+39) Drawing No. 50-4-2631].						
FS Date: 5/16/2013

Pipe and pump on WS slope.

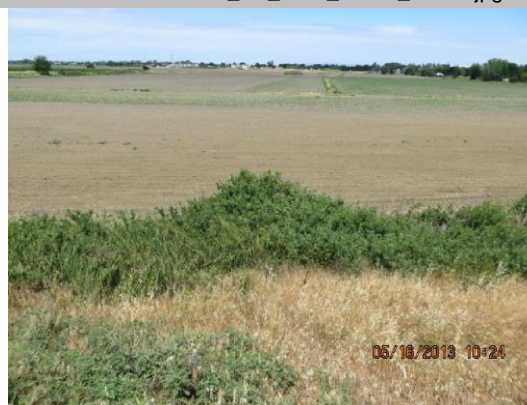
Photo 2 of 3 : UCIP_SP_2018_13545_22144.jpg

Standpipe covered in brush on LS toe.

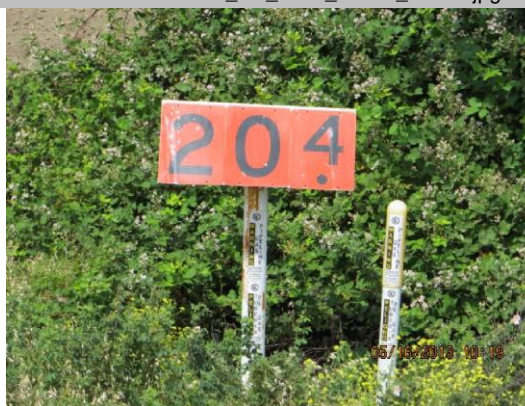
Photo 2 of 2 : UCIP_SP_2018_13525_22127.jpg

LM Start	2.54	Rating **	M	Issue No.	86 (cont)
LM End	2.54	Issue Type +	En	Location *	
Category	Supplemental			GPS Latitude/Longitude	
				Start	End
Item	DWR UCIP Field Study			38.159569 °	38.159569 °
				-121.586340 °	-121.586340 °
DWR ID					
Comment Code					
Inspector Comment					
FS_ID:13525 DS_ID:21764 EP_NO: 17250 Repair Type: Non-Urgent Crossing Status: Indicator Found UCIP Comments: Needs better location markers. FIELD_STRUCT_DESC: 24-inch steel natural gas pipeline through the levee, 117 feet below the crown. Possible sign on the LS toe. (Permit No. 17250, 2001 - Lodi Gas Storage, LLC). FS Date: 5/16/2013

Gasline marker on LS toe.

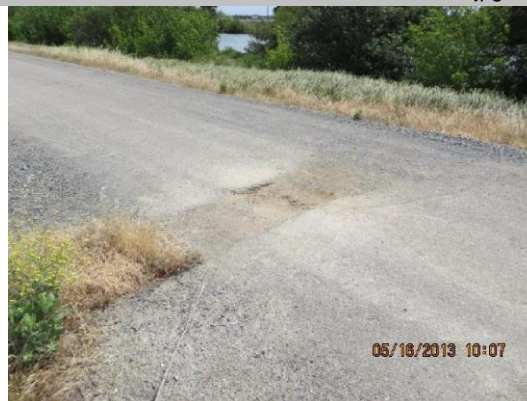
Photo 3 of 3 : UCIP_SP_2018_51299_22122.jpg

Subsidence along pipe alignment at crown.

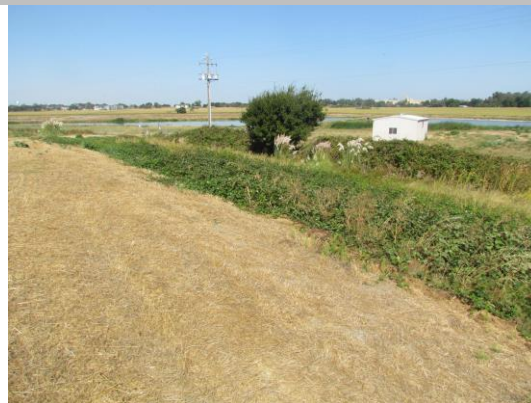
Photo 1 of 1 : SP_2018_NA0002_62_71_20180305_00054.jpg

LM Start	2.76	Rating **	U	Issue No.	71
LM End	2.79	Issue Type +	Ma	Location *	LS
Category	Earthen Levee			GPS Latitude/Longitude	
				Start	End
Item	Vegetation			38.157860 °	38.157925 °
				-121.588920 °	-121.589473 °
DWR ID	DWR_NA0002_01_f_2016_71				
Comment Code					
V2 : Remove the wild growth other than native grasses from the levee slopes.					
Inspector Comment					
Dense wildroses on landside slope.

Looking west at dense vines at landward toe.

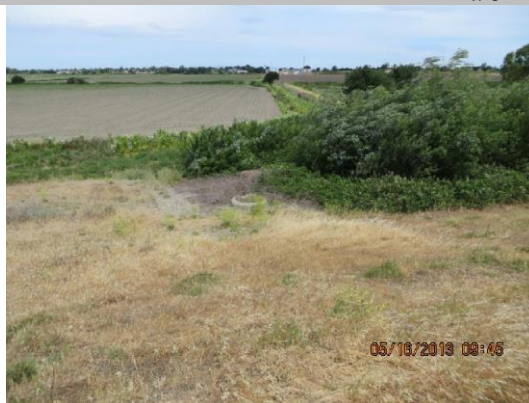
Photo 1 of 2 : UCIP_SP_2018_41561_27229.jpg

LM Start	3.01	Rating **	M	Issue No.	88	
LM End	3.01	Issue Type +	En	Location *		
Category	Supplemental			GPS Latitude/Longitude		
				Start	End	
Item	DWR UCIP Field Study			38.156379 °	38.156379 °	
				-121.592527 °	-121.592527 °	
DWR ID						
Comment Code						
Inspector Comment						
FS_ID:41561 DS_ID:21766 EP_NO: N/A Repair Type: Non-Urgent Crossing Status: Indicator Found UCIP Comments: Appears abandoned FIELD_STRUCT_DESC: *ABANDONED* 12-inch steel irrigation pipe through the levee, at an unknown depth. 5-foot diameter concrete riser unit on the landside (LS) toe. [Additional Reference(s): DWR Levee Log, 2005]. FS Date: 5/16/2013

5-foot diameter concrete riser on LS toe, but no pipe visible.

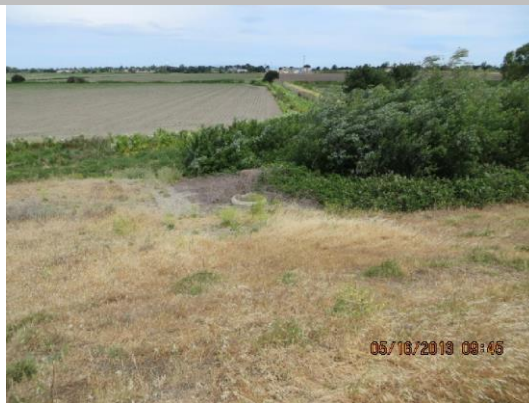
Photo 2 of 2 : UCIP_SP_2018_41561_27228.jpg

5-foot diameter concrete riser on LS toe, but no pipe visible.

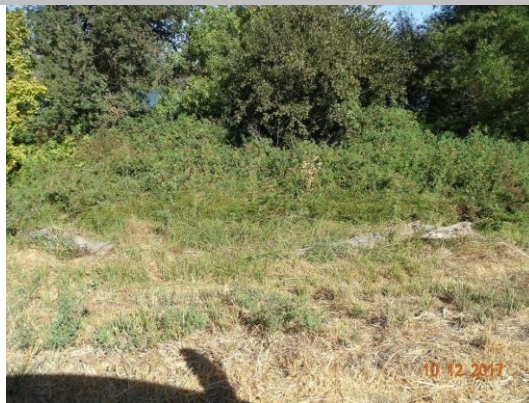
Photo 1 of 1 : SP_2018_NA0002_62_45_20180305_00032.jpg

LM Start	3.29	Rating **	M	Issue No.	45
LM End	3.29	Issue Type +	Ma	Location *	WS
Category	Earthen Levee			GPS Latitude/Longitude	
				Start	End
Item	Encroachments			38.152510 °	38.152510 °
				-121.591748 °	-121.591748 °
DWR ID	DWR_NA0002_01_f_2017_45				
Comment Code					
TR : Tree or limb					
Inspector Comment					
Tree limb on waterside slope.

Looking east at the waterside slope.

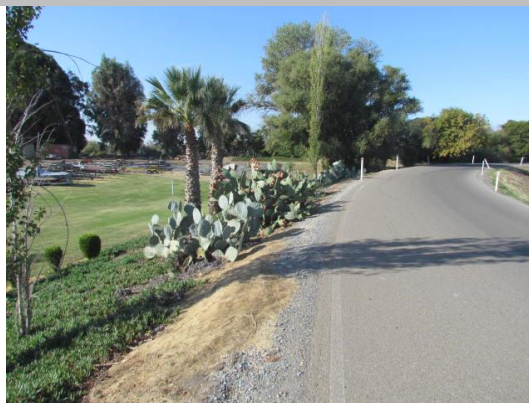
Photo 1 of 2 : SP_2018_NA0002_62_5_20180305_00006.jpg

LM Start	3.37	Rating **	U	Issue No.	5
LM End	3.37	Issue Type +	En	Location *	WS
Category	Earthen Levee			GPS Latitude/Longitude	
				Start	End
Item	Vegetation			38.151492 °	38.151492 °
				-121.591942 °	-121.591942 °
DWR ID	DWR_NA0002_01_f_2013_5				
Comment Code					
V6 : Landscaping					
Inspector Comment					
Remove cactus from waterside slope.

Looking south at cactus on waterward slope near Oxbow Habor. (Spring 2016)

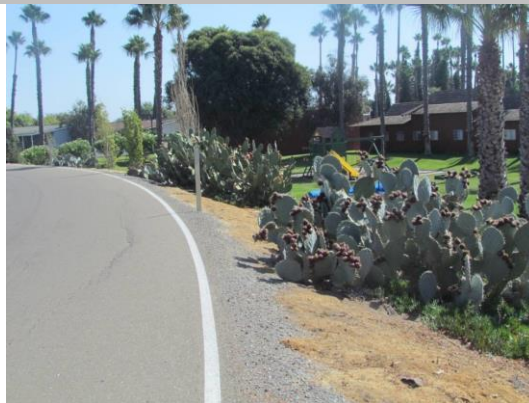
Photo 2 of 2 : SP_2018_NA0002_62_5_20180305_00007.jpg

Looking east at cactus on waterward slope near Oxbow Habor. (Fall 2016)

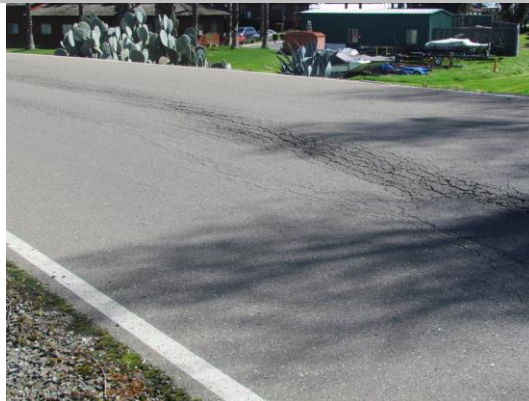
Photo 1 of 3 : SP_2018_NA0002_62_67_20180305_00049.jpg

LM Start	3.38	Rating **	A/W	Issue No.	67
LM End	3.40	Issue Type +	Ma	Location *	CR
Category	Earthen Levee			GPS Latitude/Longitude	
				Start	End
Item	Slope Stability			38.151430 °	38.151390 °
				-121.592085 °	-121.592517 °
DWR ID	DWR_NA0002_01_s_2017_67				
Comment Code					
S1 : Repair slope instability.					
Inspector Comment					
Appears to be beginning of a landside slump. LMA's Engineer (DCC) is monitoring site for movement.

Looking south at sloughing on landward shoulder.

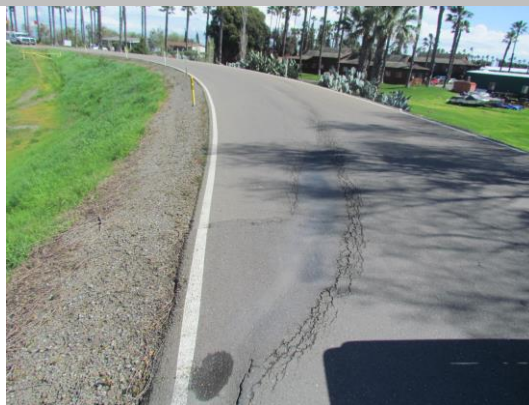
Photo 2 of 3 : SP_2018_NA0002_62_67_20180305_00050.jpg

Looking east at possible sloughing on landward shoulder.

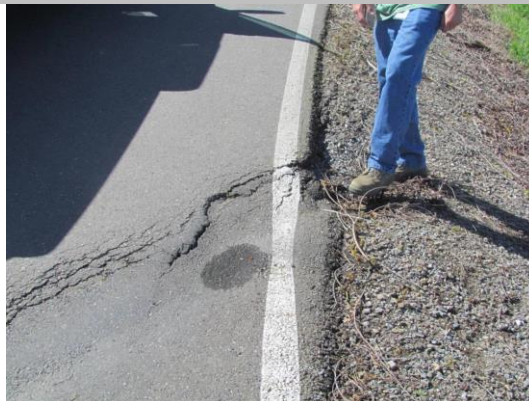
Photo 3 of 3 : SP_2018_NA0002_62_67_20180305_00051.jpg

Looking at downstream corner of slough.

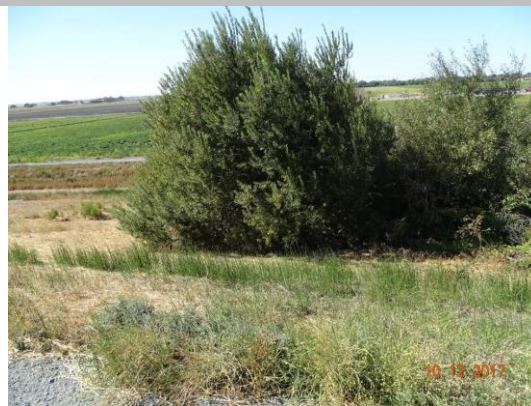
Photo 1 of 1 : SP_2018_NA0002_62_46_20180305_00033.jpg

LM Start	3.74	Rating **	M	Issue No.	46
LM End	3.74	Issue Type +	Ma	Location *	LS
Category	Earthen Levee			GPS Latitude/Longitude	
				Start	End
Item	Trim / Thin Trees			38.150841 °	38.150841 °
				-121.598161 °	-121.598161 °
DWR ID	DWR_NA0002_01_f_2017_46				
Comment Code					
T1 : Trim trees to at least five feet above ground level.					
Inspector Comment

Looking southwest at the landside slope.

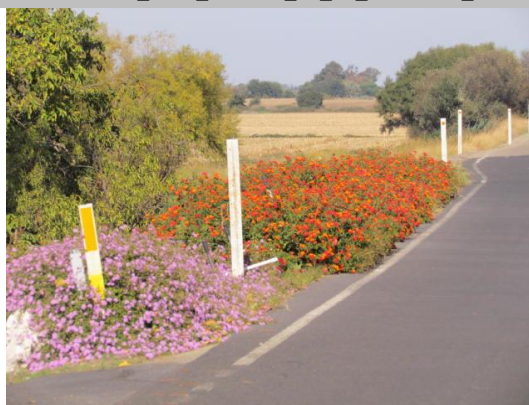
Photo 1 of 3 : SP_2018_NA0002_62_11_20180305_00008.jpg

LM Start	3.93	Rating **	U	Issue No.	11
LM End	3.97	Issue Type +	En	Location *	LS
Category	Earthen Levee			GPS Latitude/Longitude	
				Start	End
Item	Vegetation			38.148318 °	38.147898 °
				-121.599947 °	-121.600347 °
DWR ID	DWR_NA0002_01_s_2012_11				
Comment Code					
V6 : Landscaping					
Inspector Comment

Looking northeast at landscaping on landside slope.

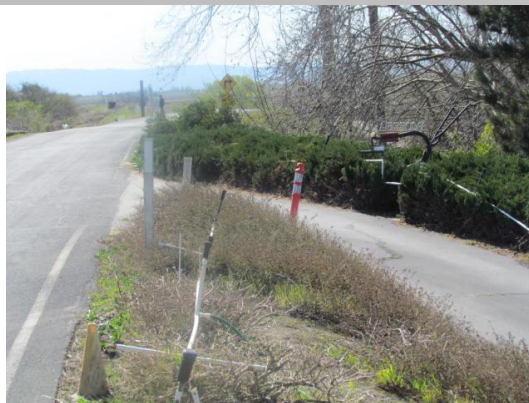
Photo 2 of 3 : SP_2018_NA0002_62_11_20180305_00009.jpg

Looking south at bushes on landside shoulder and slope.

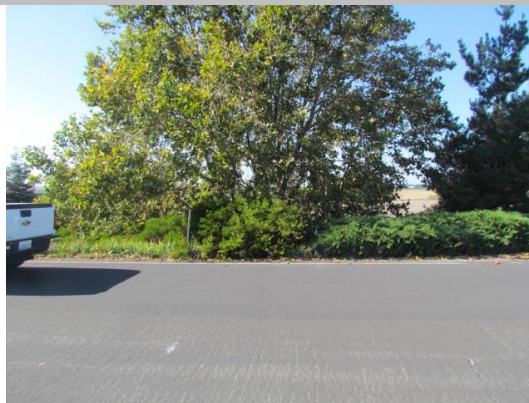
Photo 3 of 3 : SP_2018_NA0002_62_11_20180305_00010.jpg

LM Start	3.93	Rating **	U	Issue No.	11 (cont)	
LM End	3.97	Issue Type +	En	Location *	LS	
Category	Earthen Levee			GPS Latitude/Longitude		
				Start		End
Item	Vegetation			38.148318 °		38.147898 °
				-121.599947 °		-121.600347 °
DWR ID	DWR_NA0002_01_s_2012_11					
Comment Code						
V6 : Landscaping						
Inspector Comment

Looking west at dense landscaping on landside slope.

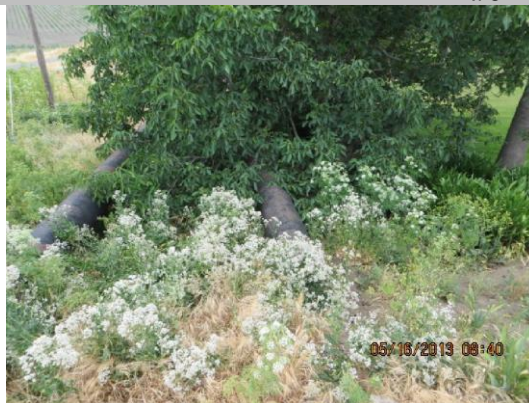
Photo 2 of 3 : UCIP_SP_2018_51302_22081.jpg

Comment Code						
Inspector Comment						
FS_ID:51302 DS_ID:21772 EP_NO: 11248 Repair Type: No Action Needed Crossing Status: Found UCIP Comments: FIELD_STRUCT_DESC: 1 of 2: 24-inch steel drainage pipe through levee, 3 feet below the crown. Siphon breaker is located on the waterside (WS) slope. Pump is located on the landside (LS). (24-inch pipe [HLM 3.99] authorized under Automatic Board Order (ABO) issued as Permit No. 11248, 1975 – Reclamation District No. 407) [Additional Reference(s): DWR Levee Log, 2005. USACE Sacramento O&M Manual Unit 103, June 1954, Drawing No. 50-4-2631, page 2631/2, (Station 107+76), 26-inch listed]. FS Date: 5/16/2013

Pipe visible on LS slope.

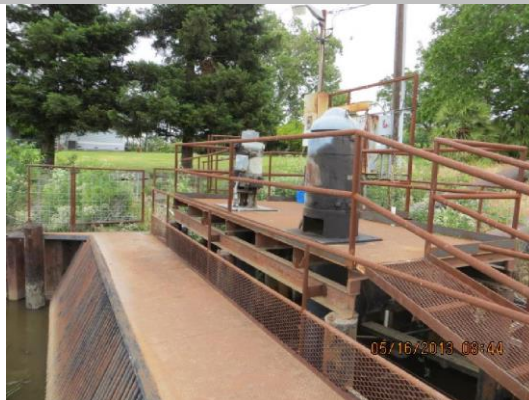
Photo 3 of 3 : UCIP_SP_2018_51302_22080.jpg

Pumping plant on LS toe.

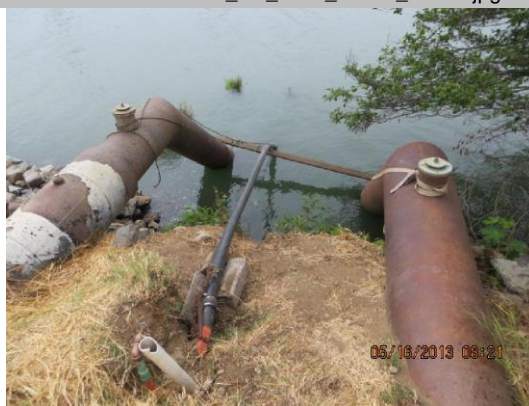
Photo 1 of 3 : UCIP_SP_2018_13487_22053.jpg

LM Start	3.99	Rating **	M	Issue No.	90	
LM End	3.99	Issue Type +	En	Location *		
Category	Supplemental			GPS Latitude/Longitude		
				Start	End	
Item	DWR UCIP Field Study			38.147653 °	38.147653 °	
				-121.600491 °	-121.600491 °	
DWR ID						
Comment Code						
Inspector Comment						
FS_ID:13487						
DS_ID:21825						
EP_NO: 11248						
Repair Type: Non-Urgent						
Crossing Status: Found						
UCIP Comments: Leakage of pipe at WS toe creating erosion.						
Possible cavity collapse along pipe alignment on WS berm.						
FIELD_STRUCT_DESC: 2 of 2: 4-inch pipe through levee 4.0 feet						
below crown. Siphon breaker on waterward slope. Pump on landward						
side (ABO No. 11248, 1975).						
FS Date: 5/16/2013

Pipe visible between two large storm drain pipes on WS.

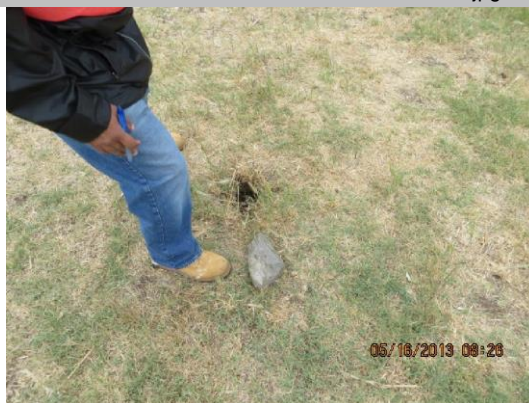
Photo 2 of 3 : UCIP_SP_2018_13487_22052.jpg

Possible indicator of internal pipe failure along pipe alignment as there appears to be a cavity collapse over the pipe on the WS berm.

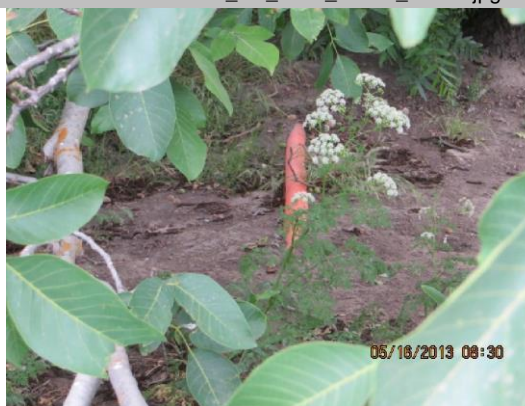
Photo 3 of 3 : UCIP_SP_2018_13487_22051.jpg

LM Start	3.99	Rating **	M	Issue No.	90 (cont)	
LM End	3.99	Issue Type +	En	Location *		
Category	Supplemental			GPS Latitude/Longitude		
				Start	End	
Item	DWR UCIP Field Study			38.147653 °	38.147653 °	
				-121.600491 °	-121.600491 °	
DWR ID						
Comment Code						
Inspector Comment						
FS_ID:13487						
DS_ID:21825						
EP_NO: 11248						
Repair Type: Non-Urgent						
Crossing Status: Found						
UCIP Comments: Leakage of pipe at WS toe creating erosion.						
Possible cavity collapse along pipe alignment on WS berm.						
FIELD_STRUCT_DESC: 2 of 2: 4-inch pipe through levee 4.0 feet						
below crown. Siphon breaker on waterward slope. Pump on landward						
side (ABO No. 11248, 1975).						
FS Date: 5/16/2013

Pipe visible under walnut at LS slope.

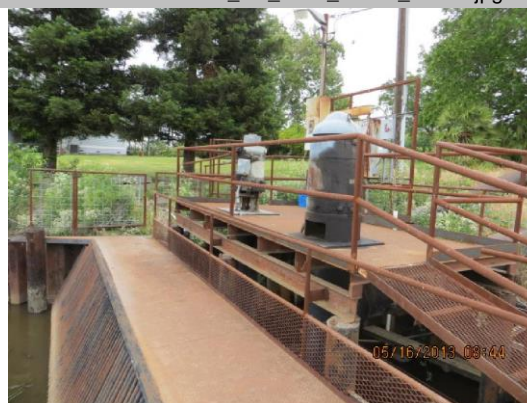
Photo 3 of 3 : UCIP_SP_2018_51303_22079.jpg

Comment Code						
Inspector Comment						
FS_ID:51303 DS_ID:21773 EP_NO: 5534 Repair Type: Urgent Crossing Status: Found UCIP Comments: 10/24/2016 Internal erosion visible on LS where pipe daylights. LS road shoulder appears to be failing. Large sink hole patched and is visible on road/crown. Evidence of burrow activity that appear to be about 6-inches in diameter with depths greater than 3 feet. Burrow holes are located on LS hinge point just upstream of pipe and 3 holes visible on WS. Need to contact owner to address issue and recommend to stop use of crossing to avoid further damage to levee. (O. Magana - DWR UCIP)05/16/2013 Pot holes over pipe may indicate internal failure. Good candidate for video inspection. (W. Wylie - DWR UCIP) FIELD_STRUCT_DESC: 22-inch steel drainage pipe through the levee, 3 feet below the crown. Siphon breaker located on the waterside (WS) shoulder. Pump located on the landside (LS). (22-inch pipe authorized under Permit No. 5534, 1966 - Reclamation District No. 407, 22-inch pipe replaced 24-inch discharge pipe). [Additional Reference(s): DWR Levee Log, 2005, 24-inch pipe listed]. FS Date: 10/24/2016

Pumping plant at channel on LS toe.

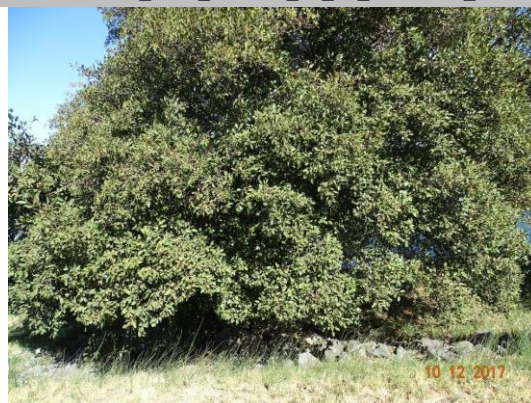
Photo 1 of 1 : SP_2018_NA0002_62_21_20180305_00013.jpg

LM Start	4.36	Rating **	M	Issue No.	21
LM End	4.36	Issue Type +	Ma	Location *	WS
Category	Earthen Levee			GPS Latitude/Longitude	
				Start	End
Item	Trim / Thin Trees			38.142838 °	38.142838 °
				-121.600163 °	-121.600163 °
DWR ID	DWR_NA0002_01_s_2012_21				
Comment Code					
T1 : Trim trees to at least five feet above ground level.					
Inspector Comment

Looking northeast at the waterside slope.

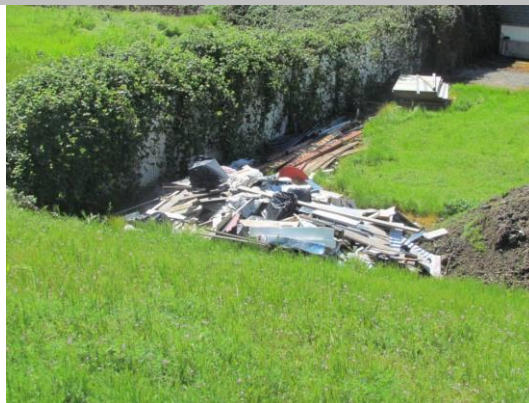
Photo 1 of 2 : SP_2018_NA0002_62_68_20180305_00052.jpg

Looking southwest at trash stockpile at landward toe. (Spring 2017)

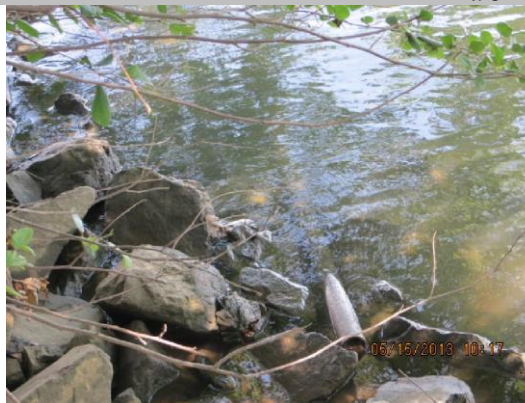
Photo 1 of 1 : UCIP_SP_2018_41562_21935.jpg

LM Start	4.79	Rating **	M	Issue No.	95
LM End	4.79	Issue Type +	En	Location *	
Category	Supplemental			GPS Latitude/Longitude	
				Start	End
Item	DWR UCIP Field Study			38.137306 °	38.137306 °
				-121.596371 °	-121.596371 °
DWR ID					
Comment Code					
Inspector Comment					
FS_ID:41562					
DS_ID:21782					
EP_NO: 11233					
Repair Type: Non-Urgent					
Crossing Status: Indicator Found					
UCIP Comments: Need to verify type of abandonment.					
FIELD_STRUCT_DESC: *ABANDONED* 2.5-inch pipe of an unknown material or purpose through the levee, 3.2 feet below the crown. Found pipe in water on the waterside (WS) toe. (Automatic Board Order (ABO) issued as Permit No. 11233, 1975 - Jose H. and Maria H. Cervantez). [Additional Reference(s): DWR Levee Log, 2005].					
FS Date: 5/15/2013

Pipe found at WS shoreline.

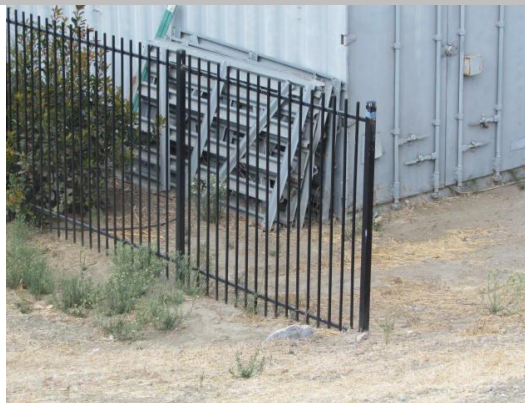
Photo 1 of 2 : SP_2018_NA0002_62_48_20180305_00034.jpg

LM Start	4.83	Rating **	M	Issue No.	48
LM End	4.83	Issue Type +	En	Location *	LS
Category	Earthen Levee			GPS Latitude/Longitude	
				Start	End
Item	Encroachments			38.136839 °	38.136839 °
				-121.595994 °	-121.595994 °
DWR ID	DWR_NA0002_01_f_2015_48				
Comment Code					
FE : Fence					
Inspector Comment					
Unauthorized fence at landside toe.

Looking at close-up view of fence at landward toe.

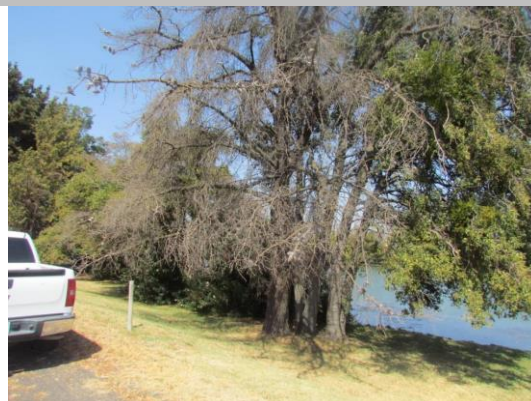
Photo 1 of 2 : SP_2018_NA0002_62_62_20180305_00045.jpg

LM Start	5.06	Rating **	A/W	Issue No.	62
LM End	5.06	Issue Type +	Ma	Location *	WS
Category	Earthen Levee			GPS Latitude/Longitude	
				Start	End
Item	Encroachments			38.134275 °	38.134275 °
				-121.593213 °	-121.593213 °
DWR ID	DWR_NA0002_01_f_2016_62				
Comment Code					
TR : Tree or limb					
Inspector Comment					
Dead Pine tree on waterside berm.

Looking upstream at dead pine tree on waterward berm.

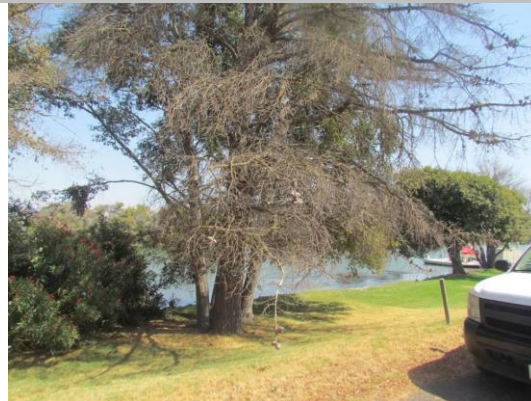
Photo 2 of 2 : SP_2018_NA0002_62_62_20180305_00046.jpg

Looking downstream at dead pine tree on waterward berm.

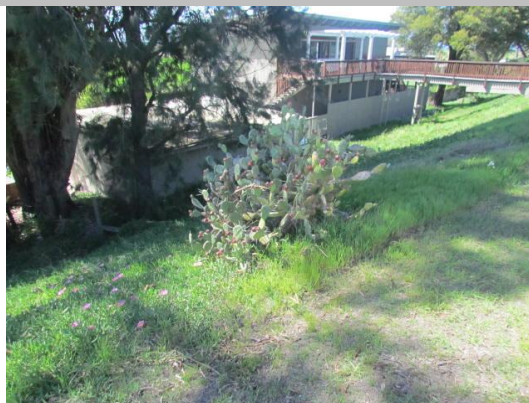
Photo 1 of 1 : SP_2018_NA0002_62_65_20180305_00047.jpg

LM Start	5.12	Rating **	M	Issue No.	65
LM End	5.12	Issue Type +	En	Location *	LS
Category	Earthen Levee			GPS Latitude/Longitude	
				Start	End
Item	Vegetation			38.133695 °	38.133695 °
				-121.592516 °	-121.592516 °
DWR ID	DWR_NA0002_01_s _ 2016_65				
Comment Code					
V6 : Landscaping					
Inspector Comment					
Remove cactus from landside slope.

Looking at cactus on landward slope.

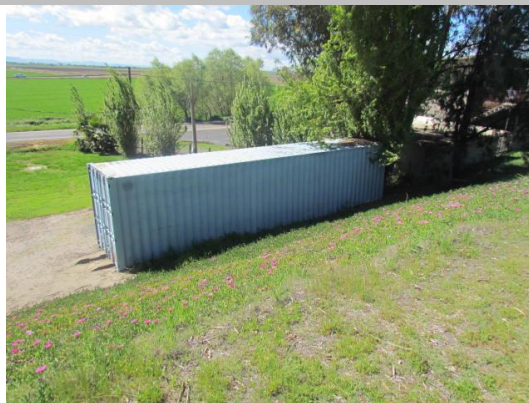
Photo 1 of 1 : SP_2018_NA0002_62_66_20180305_00048.jpg

LM Start	5.13	Rating **	U	Issue No.	66
LM End	5.13	Issue Type +	En	Location *	LS
Category	Earthen Levee			GPS Latitude/Longitude	
				Start	End
Item	Encroachments			38.133600 °	38.133600 °
				-121.592414 °	-121.592414 °
DWR ID	DWR_NA0002_01_s _ 2016_66				
Comment Code					
BU : Building					
Inspector Comment					
Storage container at landside toe.

Looking at storage container at landward toe.

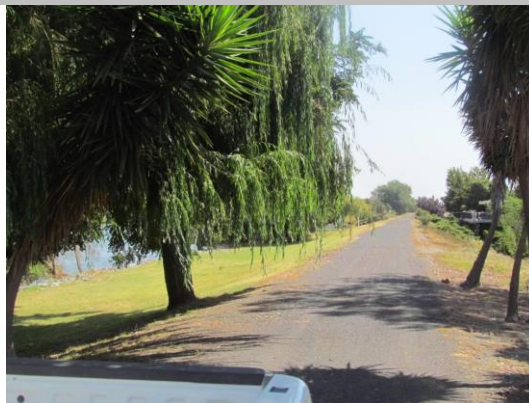
Photo 1 of 1 : SP_2018_NA0002_62_31_20180305_00026.jpg

LM Start	5.17	Rating **	M	Issue No.	31
LM End	5.17	Issue Type +	Ma	Location *	WS
Category	Earthen Levee			GPS Latitude/Longitude	
				Start	End
Item	Trim / Thin Trees			38.133145 °	38.133145 °
				-121.591895 °	-121.591895 °
DWR ID	DWR_NA0002_01_s_2013_31				
Comment Code					
T4 : Trim trees over roadway to at least 12 feet above ground level.					
Inspector Comment

Looking southeast at tree over levee crown.

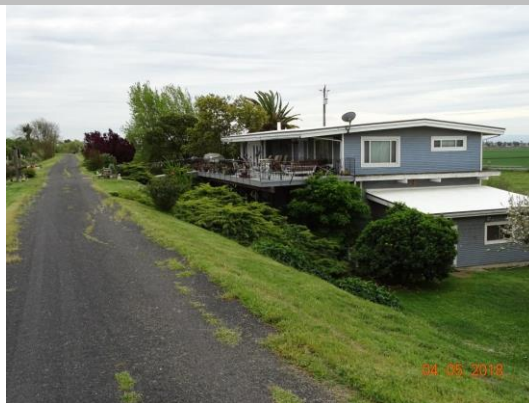
Photo 1 of 1 : SP_2018_NA0002_62_78_20180409_00113.jpg

LM Start	5.22	Rating **	U	Issue No.	78
LM End	5.24	Issue Type +	En	Location *	LS
Category	Earthen Levee			GPS Latitude/Longitude	
				Start	End
Item	Vegetation			38.132606 °	38.132322 °
				-121.591295 °	-121.590989 °
DWR ID	DWR_NA0002_01_s_2018_78				
Comment Code					
V6 : Landscaping					
Inspector Comment					
Heavy landscaping completely blocks visibility and access to landside slope and toe.

Landside landscaping needs to be managed to allow inspection and access.

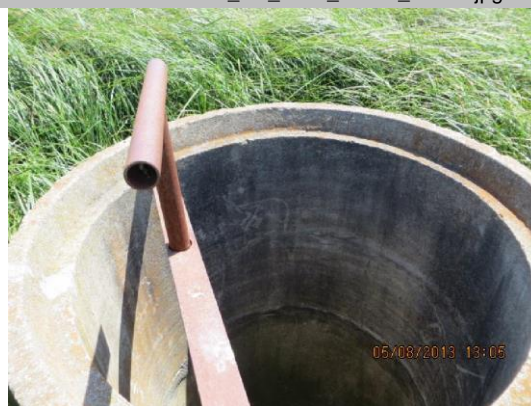
Photo 2 of 3 : UCIP_SP_2018_13090_21281.jpg

Slide gate in 48-inch Concrete riser on LS toe.

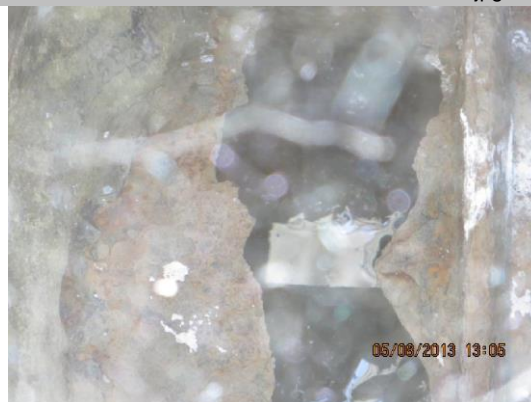
Photo 3 of 3 : UCIP_SP_2018_13090_21280.jpg

Pipe rusted through at slide gate inside concrete riser.

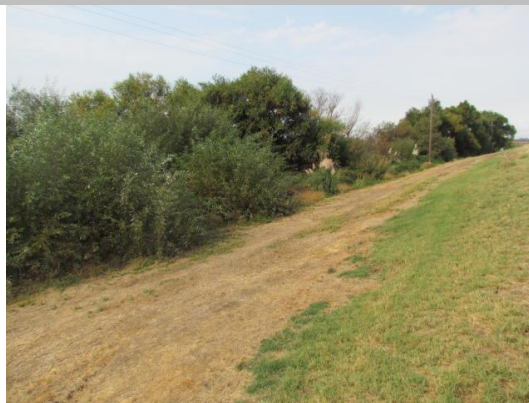
Photo 2 of 6 : SP_2018_NA0002_62_23_20180305_00015.jpg

Looking west at dense vegetation at landward toe.

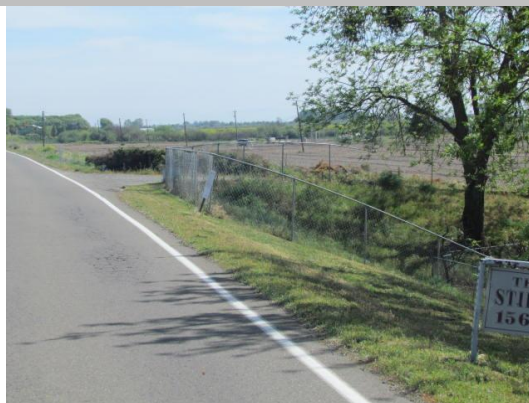
Photo 1 of 1 : SP_2018_NA0002_63_26_20180305_00030.jpg

LM Start	0.43	Rating **	M	Issue No.	26
LM End	0.43	Issue Type +	En	Location *	LS
Category	Earthen Levee			GPS Latitude/Longitude	
				Start	End
Item	Encroachments			38.189212 °	38.189212 °
				-121.574757 °	-121.574757 °
DWR ID	DWR_NA0002_02_s_2012_26				
Comment Code					
FE : Fence					
Inspector Comment

Looking northeast at fence on landward shoulder and slope.

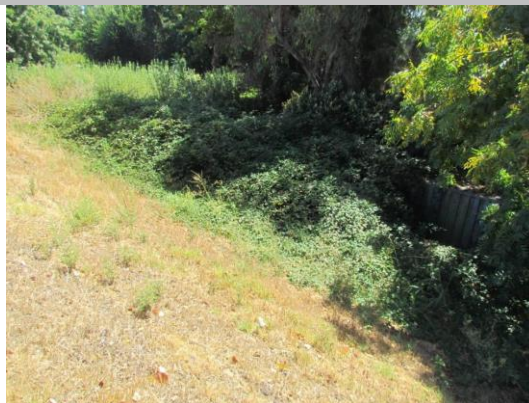
Photo 1 of 1 : SP_2018_NA0002_63_40_20180305_00045.jpg

LM Start	0.49	Rating **	U	Issue No.	40
LM End	0.49	Issue Type +	En	Location *	LS
Category	Earthen Levee			GPS Latitude/Longitude	
				Start	End
Item	Vegetation			38.188871 °	38.188871 °
				-121.575775 °	-121.575775 °
DWR ID	DWR_NA0002_02_f_2013_40				
Comment Code					
V6 : Landscaping					
Inspector Comment					
Dense Berryvines at landside toe.

Looking east at berryvines at landward toe.

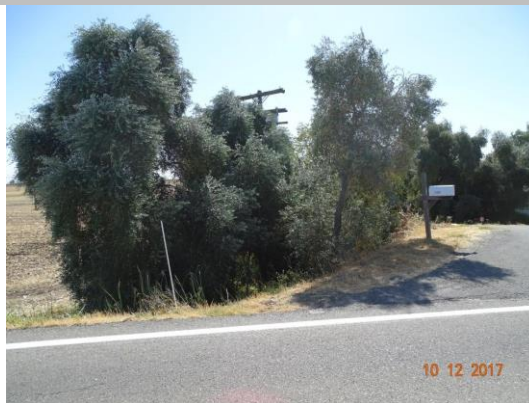
Photo 1 of 2 : SP_2018_NA0002_63_1_20180305_00001.jpg

LM Start	0.66	Rating **	U	Issue No.	1
LM End	0.66	Issue Type +	En	Location *	LS
Category	Earthen Levee			GPS Latitude/Longitude	
				Start	End
Item	Vegetation			38.187672 °	38.187672 °
				-121.578496 °	-121.578496 °
DWR ID	DWR_NA0002_02_s_2012_1				
Comment Code					
V6 : Landscaping					
Inspector Comment

Looking southwest at the landside slope.

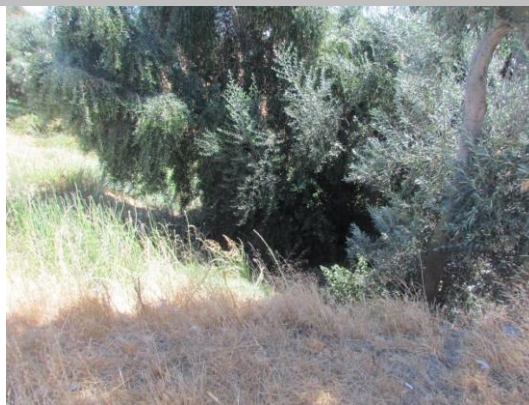
Photo 2 of 2 : SP_2018_NA0002_63_1_20180305_00002.jpg

LM Start	0.66	Rating **	U	Issue No.	1 (cont)
LM End	0.66	Issue Type +	En	Location *	LS

Looking northeast at untrimmed trees at landward toe.

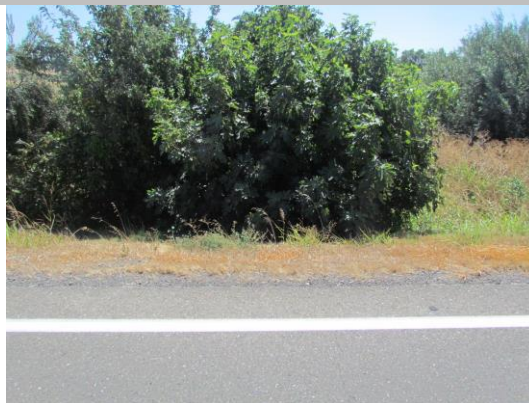
Photo 1 of 2 : SP_2018_NA0002_63_97_20180305_00069.jpg

LM Start	0.72	Rating **	U	Issue No.	97
LM End	0.72	Issue Type +	Ma	Location *	LS
Category	Earthen Levee			GPS Latitude/Longitude	
				Start	End
Item	Trim / Thin Trees			38.187102 °	38.187102 °
				-121.579463 °	-121.579463 °
DWR ID	DWR_NA0002_02_f_2016_97				
Comment Code					
T1 : Trim trees to at least five feet above ground level.					
Inspector Comment					
Untrimmed fig tree on landside toe.

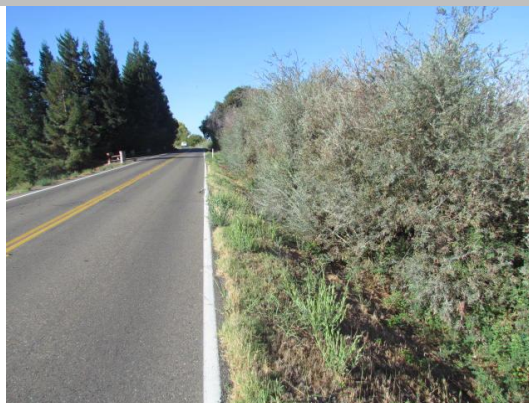
Photo 1 of 1 : SP_2018_NA0002_63_2_20180305_00003.jpg

LM Start	0.73	Rating **	U	Issue No.	2
LM End	0.79	Issue Type +	Ma	Location *	WS
Category	Earthen Levee			GPS Latitude/Longitude	
				Start	End
Item	Trim / Thin Trees			38.187029 °	38.186518 °
				-121.579569 °	-121.580434 °
DWR ID	DWR_NA0002_02_s_2012_2				
Comment Code					
T2 : Thin trees to allow visibility of the ground and room to flood fight.					
Inspector Comment					
Untrimmed trees within twenty foot zone on waterside slope.

Looking southwest at dense willows and trees on waterward slope.

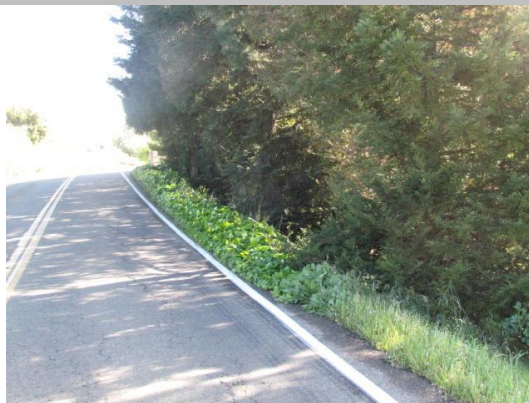
Photo 1 of 3 : SP_2018_NA0002_63_8_20180305_00009.jpg

LM Start	0.80	Rating **	U	Issue No.	8
LM End	0.83	Issue Type +	En	Location *	LS
Category	Earthen Levee			GPS Latitude/Longitude	
				Start	End
Item	Vegetation			38.186410 °	38.186172 °
				-121.580616 °	-121.581023 °
DWR ID	DWR_NA0002_02_s_2012_8				
Comment Code					
V6 : Landscaping					
Inspector Comment

Looking northeast at dense landscaping on landward slope and toe.
(Spring 2016)

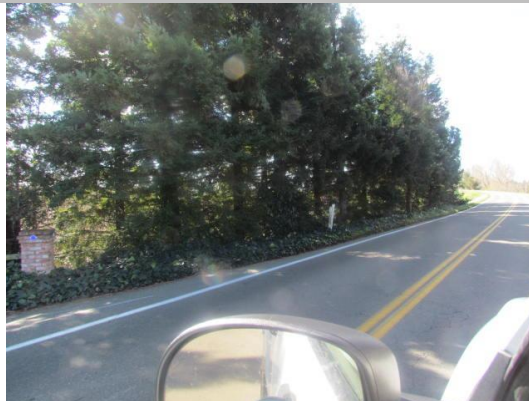
Photo 2 of 3 : SP_2018_NA0002_63_8_20180305_00010.jpg

LM Start	0.80	Rating **	U	Issue No.	8 (cont)	
LM End	0.83	Issue Type +	En	Location *	LS	
Category	Earthen Levee			GPS Latitude/Longitude		
				Start		End
Item	Vegetation			38.186410 °		38.186172 °
				-121.580616 °		-121.581023 °
DWR ID	DWR_NA0002_02_s_2012_8					
Comment Code						
V6 : Landscaping						
Inspector Comment

Looking southwest at dense landscaping on landside slope.

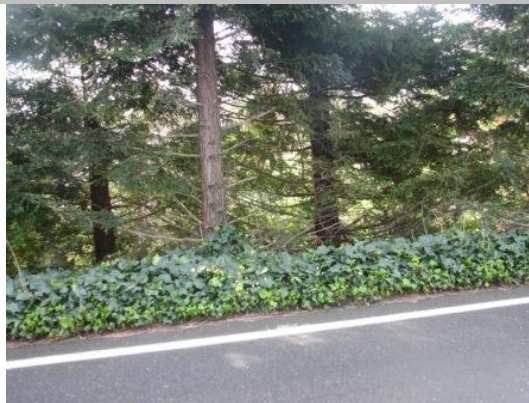
Photo 3 of 3 : SP_2018_NA0002_63_8_20180305_00011.jpg

LM Start	0.80	Rating **	U	Issue No.	8 (cont)
LM End	0.83	Issue Type +	En	Location *	LS

Landscaping on landside slope blocking view of slope from LM .81 to 0.83.

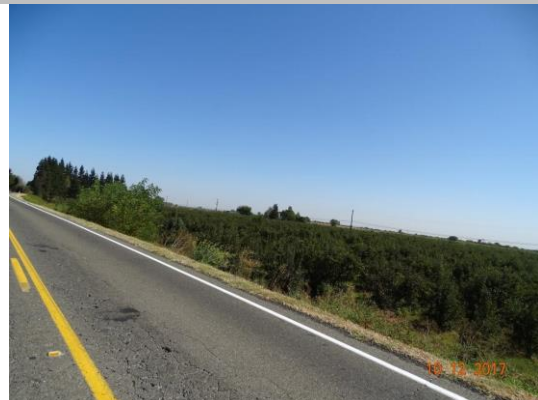
Photo 1 of 1 : SP_2018_NA0002_63_108_20180305_00084.jpg

LM Start	0.85	Rating **	M	Issue No.	108
LM End	1.33	Issue Type +	Ma	Location *	LS
Category	Earthen Levee			GPS Latitude/Longitude	
				Start	End
Item	Vegetation			38.186021 °	38.180473 °
				-121.581267 °	-121.586507 °
DWR ID	DWR_NA0002_02_f_2017_108				
Comment Code					
V2 : Remove the wild growth other than native grasses from the levee slopes.					
Inspector Comment

Looking northeast at the landside slope.

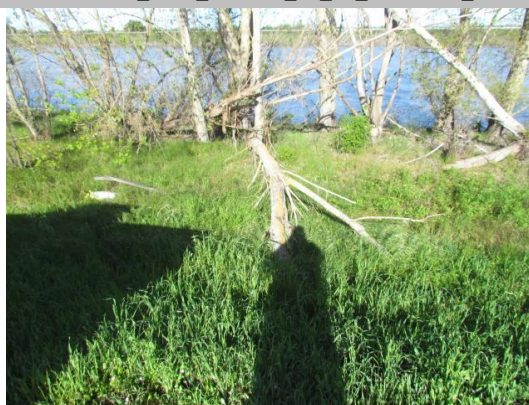
Photo 1 of 2 : SP_2018_NA0002_63_92_20180305_00062.jpg

LM Start	1.16	Rating **	M	Issue No.	92
LM End	1.16	Issue Type +	Ma	Location *	WS
Category	Earthen Levee			GPS Latitude/Longitude	
				Start	End
Item	Encroachments			38.182527 °	38.182527 °
				-121.584901 °	-121.584901 °
DWR ID	DWR_NA0002_02_f_2015_92				
Comment Code					
TR : Tree or limb					
Inspector Comment					
Downed tree branch on waterside slope and berm.

Looking west at fallen tree branch on waterward berm. (Spring 2016)

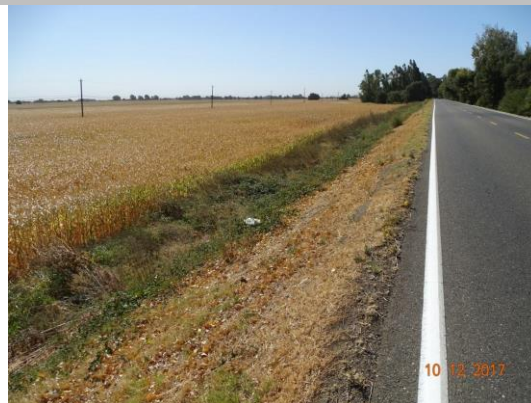
Photo 1 of 1 : SP_2018_NA0002_63_134_20180305_00100.jpg

LM Start	1.23	Rating **	M	Issue No.	134
LM End	1.26	Issue Type +	Ma	Location *	LS
Category	Earthen Levee			GPS Latitude/Longitude	
				Start	End
Item	Vegetation			38.181617 °	38.181265 °
				-121.585589 °	-121.585863 °
DWR ID	DWR_NA0002_02_f_2017_134				
Comment Code					
V2 : Remove the wild growth other than native grasses from the levee slopes.					
Inspector Comment					
Dense wild berry vines at landside toe.

Looking southwest at the landside slope.

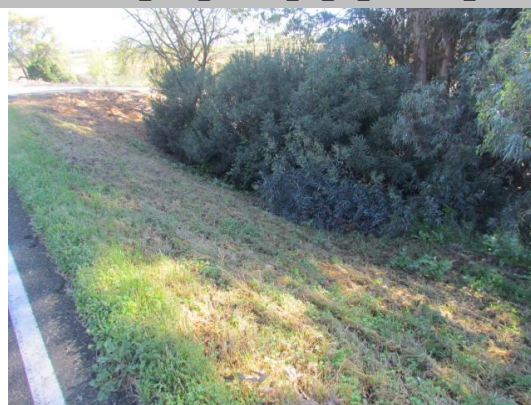
Photo 1 of 4 : SP_2018_NA0002_63_27_20180305_00031.jpg

LM Start	1.45	Rating **	U	Issue No.	27 (cont)
LM End	1.47	Issue Type +	Ma	Location *	LS

Looking east at dense vegetation at landward toe.

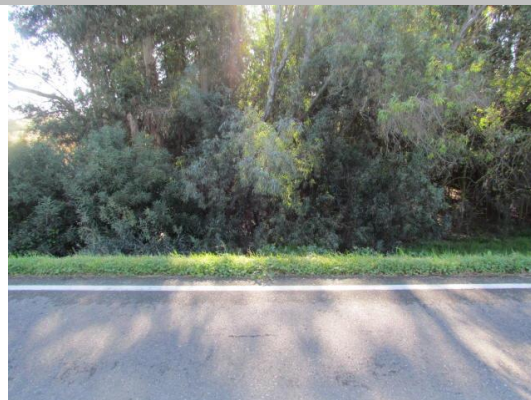
Photo 2 of 4 : SP_2018_NA0002_63_27_20180305_00032.jpg

Looking east at dense vegetation at landward toe.

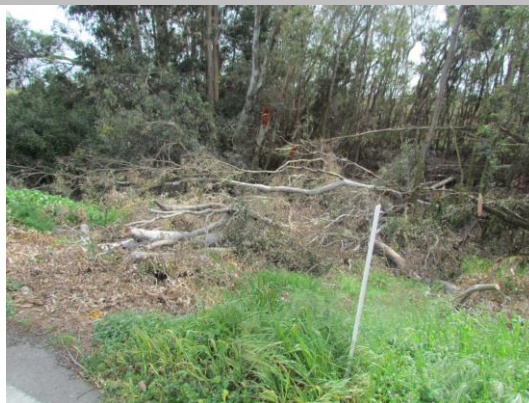
Photo 1 of 2 : SP_2018_NA0002_63_109_20180305_00085.jpg

LM Start	1.46	Rating **	U	Issue No.	109
LM End	1.46	Issue Type +	Ma	Location *	WS
Category	Earthen Levee			GPS Latitude/Longitude	
				Start	End
Item	Encroachments			38.178805 °	38.178805 °
				-121.587850 °	-121.587850 °
DWR ID	DWR_NA0002_02_s_2016_109				
Comment Code					
TR : Tree or limb					
Inspector Comment					
Downed tree branches and limbs on landside slope.

Looking southwest at fallen tree on waterward slope.

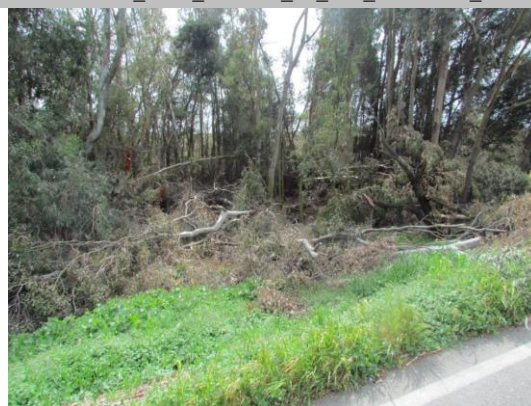
Photo 2 of 2 : SP_2018_NA0002_63_109_20180305_00086.jpg

LM Start	1.46	Rating **	U	Issue No.	109 (cont)	
LM End	1.46	Issue Type +	Ma	Location *	WS	
Category	Earthen Levee			GPS Latitude/Longitude		
				Start		End
Item	Encroachments			38.178805 °		38.178805 °
				-121.587850 °		-121.587850 °
DWR ID	DWR_NA0002_02_s _ 2016_109					
Comment Code						
TR : Tree or limb						
Inspector Comment						
Downed tree branches and limbs on landside slope.

Looking west at fallen tree on waterward slope.

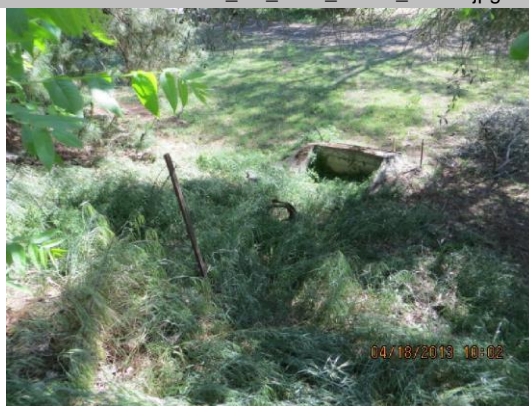
Photo 1 of 3 : UCIP_SP_2018_12183_19742.jpg

LM Start	1.61	Rating **	M	Issue No.	141
LM End	1.61	Issue Type +	En	Location *	
Category	Supplemental			GPS Latitude/Longitude	
				Start	End
Item	DWR UCIP Field Study			38.176874 °	38.176874 °
				-121.589200 °	-121.589200 °
DWR ID					
Comment Code					
Inspector Comment					
FS_ID:12183					
DS_ID:21870					
EP_NO: N/A					
Repair Type: Non-Urgent					
Crossing Status: Found					
UCIP Comments: Pipe appears abandoned and should be done so properly.					
FIELD_STRUCT_DESC: 6-inch steel irrigation pipe through the levee, 5.8 feet below the crown. 3-foot by 3-foot concrete distribution box at the landside (LS) toe. Polyvinyl chloride standpipe at the waterside (WS) toe. Hose bib attachment on pipe at the LS toe.					
FS Date: 4/18/2013

Concrete distribution box on LS toe.

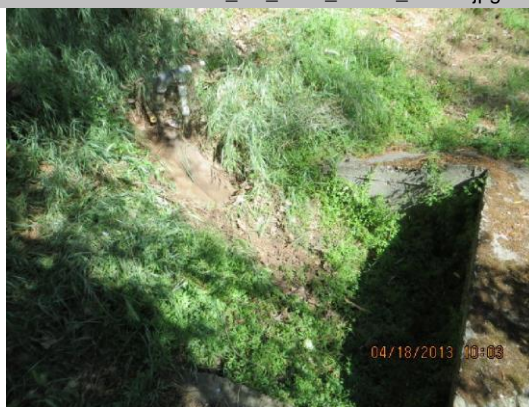
Photo 2 of 3 : UCIP_SP_2018_12183_19741.jpg

LM Start	1.61	Rating **	M	Issue No.	141 (cont)
LM End	1.61	Issue Type +	En	Location *

Distribution box and hose bib on LS toe.

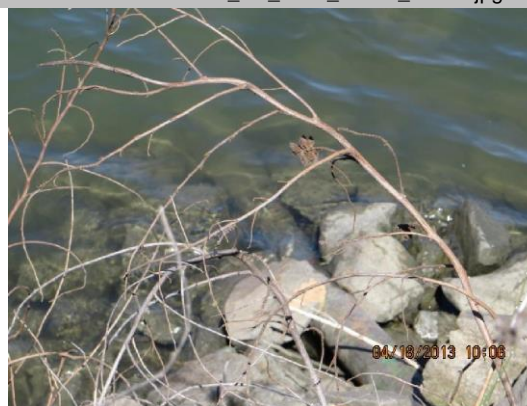
Photo 3 of 3 : UCIP_SP_2018_12183_19740.jpg

LM Start	1.61	Rating **	M	Issue No.	141 (cont)	
LM End	1.61	Issue Type +	En	Location *		
Category	Supplemental			GPS Latitude/Longitude		
				Start	End	
Item	DWR UCIP Field Study			38.176874 °	38.176874 °	
				-121.589200 °	-121.589200 °	
DWR ID						
Comment Code						
Inspector Comment						
FS_ID:12183						
DS_ID:21870						
EP_NO: N/A						
Repair Type: Non-Urgent						
Crossing Status: Found						
UCIP Comments: Pipe appears abandoned and should be done so properly.						
FIELD_STRUCT_DESC: 6-inch steel irrigation pipe through the levee, 5.8 feet below the crown. 3-foot by 3-foot concrete distribution box at the landside (LS) toe. Polyvinyl chloride standpipe at the waterside (WS) toe. Hose bib attachment on pipe at the LS toe.						
FS Date: 4/18/2013

4-inch suction pipe on WS toe.

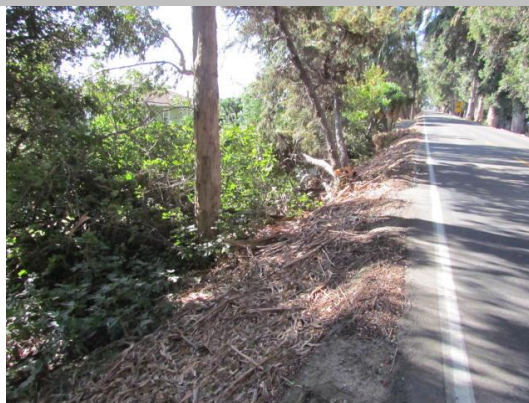
Photo 1 of 2 : SP_2018_NA0002_63_45_20180305_00047.jpg

LM Start	1.80	Rating **	U	Issue No.	45
LM End	1.82	Issue Type +	Ma	Location *	LS
Category	Earthen Levee			GPS Latitude/Longitude	
				Start	End
Item	Vegetation			38.174437 °	38.174153 °
				-121.590786 °	-121.590980 °
DWR ID	DWR_NA0002_02_f_2013_45				
Comment Code					
V2 : Remove the wild growth other than native grasses from the levee slopes.					
Inspector Comment					
Dense vegetation on landside slope and toe

Looking southwest at dense vegetation on landward slope.

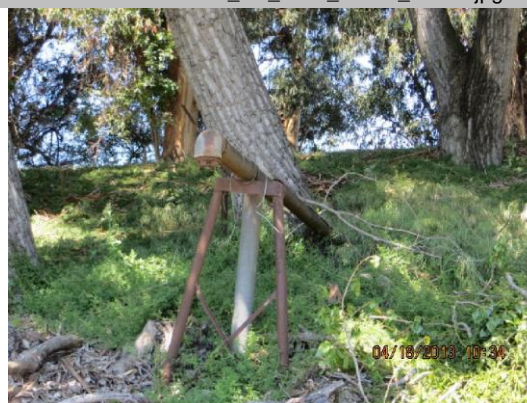
Photo 3 of 3 : UCIP_SP_2018_12185_19749.jpg

Comment Code						
Inspector Comment						
FS_ID:12185 DS_ID:21872 EP_NO: 11294 Repair Type: Non-Urgent Crossing Status: Found UCIP Comments: Pipe abandoned on both sides. Pipe should be abandoned properly. FIELD_STRUCT_DESC: 6-inch irrigation pipe of an unknown material through the levee, 6.5 feet below the crown. Pump in pump house on the waterside (WS) slope. 1-inch galvanized iron steel electrical conduit at same location. (Automatic Board Order (ABO) issued as Permit No. 11294, 1975 - Hubert Vandermaele). [Additional Reference(s): DWR Levee Log, 2005. USACE Sacramento O&M Manual 103, June 1954, (Station ""H"" 8+72) steel pipe listed, Drawing No. 50-4-2277]. FS Date: 4/18/2013

Pipe at LS slope (open).
