**Flood Control Project Maintenance
Levee Inspections**
LMA District Cover Sheet
Spring 2018 Levee Inspection Results

Brannan Andrus Levee Maintenance District

Spring 2018 Levee Inspection Results

Waterway			Bank	Unit Miles
Unit No. 01 Georgiana Slough			Right	6.01
	Spring (March - May)	Summer (June - August)	(September - November) Fall	Winter (December - February)
Unit Maintenance Rating (Fall Only)				
Date of Inspection	4/5/2018 - 4/5/2018			
DWR Inspector	Keith Millard			
Accompanied By

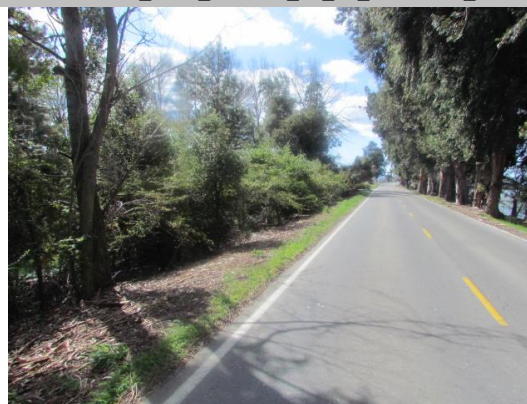
Photo 1 of 2 : SP_2018_NA0002_63_12_20180305_00017.jpg

LM Start	1.91	Rating **	U	Issue No.	12
LM End	1.94	Issue Type +	En	Location *	LS
Category	Earthen Levee			GPS Latitude/Longitude	
				Start	End
Item	Vegetation			38.173030 °	38.172598 °
				-121.591624 °	-121.591853 °
DWR ID	DWR_NA0002_02_s_2012_12				
Comment Code					
V6 : Landscaping					
Inspector Comment					
Dense vegetation on landside slope.

Looking south at dense landscaping on landside slope and toe.

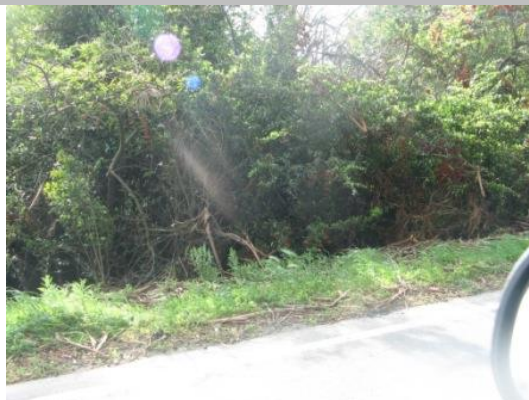
Photo 2 of 2 : SP_2018_NA0002_63_12_20180305_00018.jpg

LM Start	1.91	Rating **	U	Issue No.	12 (cont)	
LM End	1.94	Issue Type +	En	Location *	LS	
Category	Earthen Levee			GPS Latitude/Longitude		
				Start		End
Item	Vegetation			38.173030 °		38.172598 °
				-121.591624 °		-121.591853 °
DWR ID	DWR_NA0002_02_s_2012_12					
Comment Code						
V6 : Landscaping						
Inspector Comment						
Dense vegetation on landside slope.

Landscaping on landside slope blocking view of slope from LM 1.91 to 1.95.

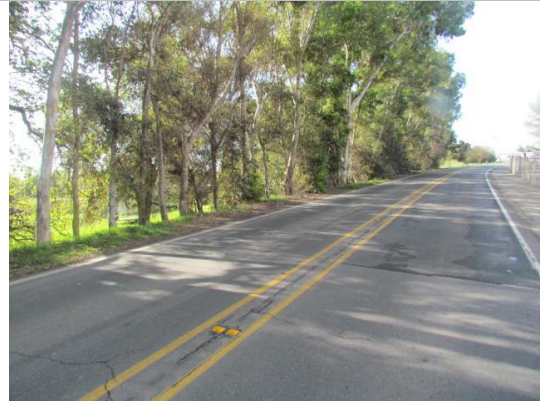
Photo 1 of 1 : SP_2018_NA0002_63_25_20180305_00029.jpg

LM Start	2.34	Rating **	U	Issue No.	25
LM End	2.38	Issue Type +	Ma	Location *	LS
Category	Earthen Levee			GPS Latitude/Longitude	
				Start	End
Item	Trim / Thin Trees			38.167627 °	38.167152 °
				-121.595538 °	-121.595997 °
DWR ID	DWR_NA0002_02_s_2012_25				
Comment Code					
T2 : Thin trees to allow visibility of the ground and room to flood fight.					
Inspector Comment

Looking southeast at trees at landward shoulder. (Spring 2015)

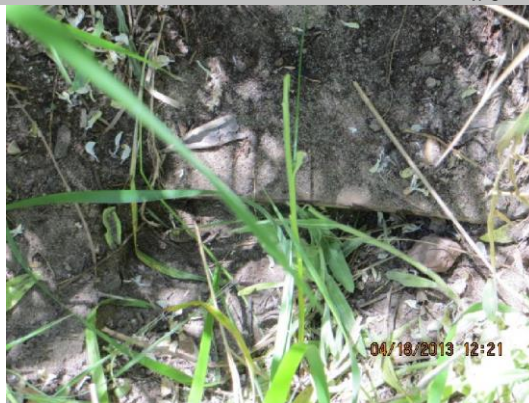
Photo 2 of 3 : UCIP_SP_2018_12211_19769.jpg

Comment Code					
Inspector Comment					
FS_ID:12211 DS_ID:21878 EP_NO: 11263 Repair Type: Non-Urgent Crossing Status: Indicator Found UCIP Comments: Further investigation to determine location of pipe should be done. Pump house needs to be unlocked to gather additional information. FIELD_STRUCT_DESC: 8-inch irrigation pipe of an unknown material through the levee, 3.7 feet below the crown. Pump in pump house on the waterside (WS) berm. 30-inch concrete standpipe on the landside (LS). (Automatic Board Order (ABO) issued as Permit No. 11263, 1975 - Ensher, Alexander, and Barsoon, Inc.). [Additional Reference(s): DWR Levee Log, 2005. USACE Sacramento O&M Manual 103, June 1954, (RM 18.25) welded steel pipe listed, Drawing No. 6-13-1100]. FS Date: 4/18/2013

Evidence of pipe (buried) on LS in ditch.

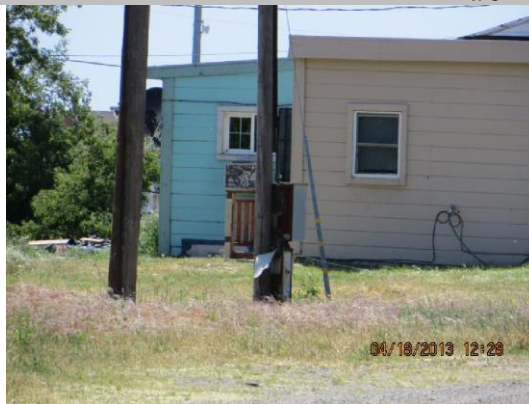
Photo 3 of 3 : UCIP_SP_2018_12211_19768.jpg

JP with a meter on pole that would be appropriate for this crossing.

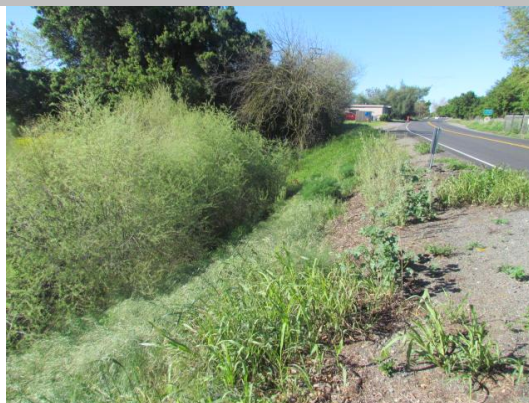
LM Start	2.42	Rating **	U	Issue No.	99 (cont)
LM End	2.42	Issue Type +	Ma	Location *	LS

Looking southwest at vegetation (willows) on landward slope and toe.

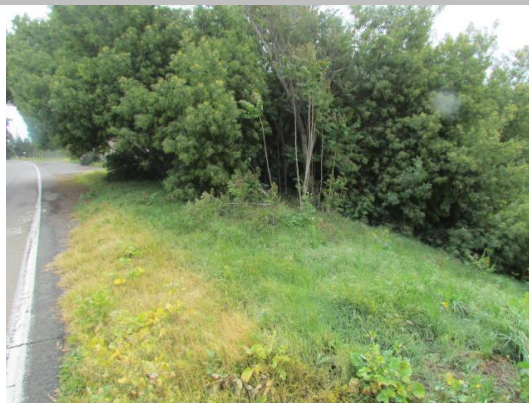
Photo 1 of 2 : SP_2018_NA0002_63_29_20180305_00036.jpg

LM Start	2.48	Rating **	U	Issue No.	29
LM End	2.48	Issue Type +	Ma	Location *	LS
Category	Earthen Levee			GPS Latitude/Longitude	
				Start	End
Item	Trim / Thin Trees			38.166378 °	38.166378 °
				-121.597570 °	-121.597570 °
DWR ID	DWR_NA0002_02_s_2012_29				
Comment Code					
T1 : Trim trees to at least five feet above ground level.					
Inspector Comment

Looking northeast at dense vegetation on landward slope.

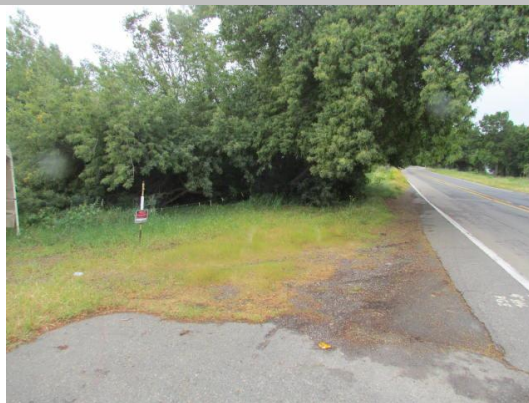
Photo 2 of 2 : SP_2018_NA0002_63_29_20180305_00037.jpg

LM Start	2.48	Rating **	U	Issue No.	29 (cont)	
LM End	2.48	Issue Type +	Ma	Location *	LS	
Category	Earthen Levee			GPS Latitude/Longitude		
				Start		End
Item	Trim / Thin Trees			38.166378 °		38.166378 °
				-121.597570 °		-121.597570 °
DWR ID	DWR_NA0002_02_s_2012_29					
Comment Code						
T1 : Trim trees to at least five feet above ground level.						
Inspector Comment

Looking southwest at dense vegetation on landward slope.

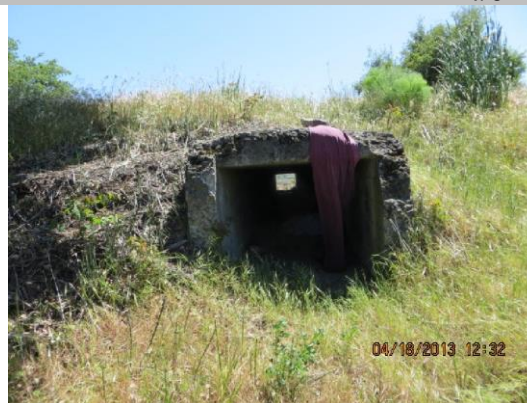
Photo 1 of 3 : UCIP_SP_2018_51314_19773.jpg

Comment Code					
Inspector Comment					
FS_ID:51314 DS_ID:21879 EP_NO: N/A Repair Type: Urgent Crossing Status: Found UCIP Comments: 10/24/2016 same as previous inspection culvert is open on both ends. WS blocked by blankets -- WS structure is being used as a shelter. (O. Magana - DWR UCIP)04/18/2013 Culvert open on both ends. Needs to be abandoned properly. (W. Wylie - DWR UCIP) FIELD_STRUCT_DESC: *ABANDONED* 42-inch by 42-inch open reinforced concrete drainage culvert through the levee, 6 feet below the crown. [Additional Reference(s): DWR Levee Log, 2005, 3-foot by 3.5-foot culvert listed. USACE Sacramento O&M Manual 103, June 1954, (RM 18.16) Drawing No. 6-13-1100]. FS Date: 10/24/2016

Concrete tunnel open on both ends.

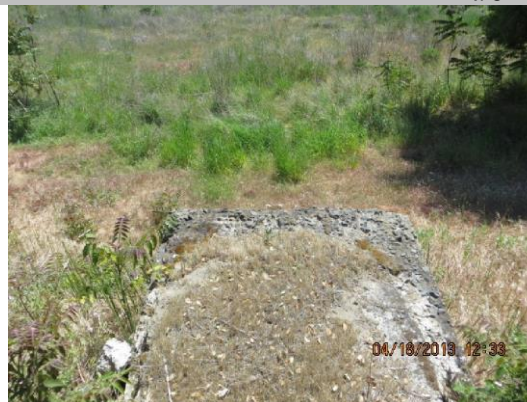
Photo 2 of 3 : UCIP_SP_2018_51314_19772.jpg

Top of concrete tunnel on LS shoulder.

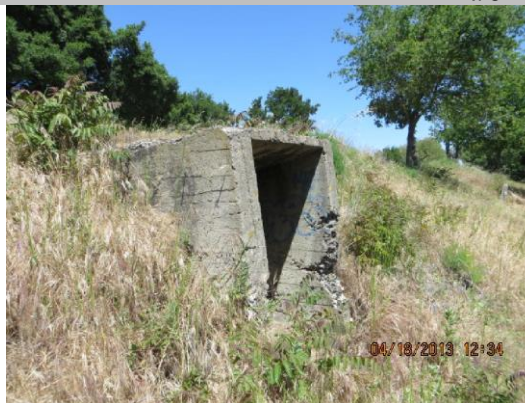
Photo 3 of 3 : UCIP_SP_2018_51314_19771.jpg

Item	DWR UCIP LMA Responsibility			38.165980	°	38.165980	°
				-121.598520	°	-121.598520	°
DWR ID							
Comment Code							
Inspector Comment							
FS_ID:51314 DS_ID:21879 EP_NO: N/A Repair Type: Urgent Crossing Status: Found UCIP Comments: 10/24/2016 same as previous inspection culvert is open on both ends. WS blocked by blankets -- WS structure is being used as a shelter. (O. Magana - DWR UCIP)04/18/2013 Culvert open on both ends. Needs to be abandoned properly. (W. Wylie - DWR UCIP) FIELD_STRUCT_DESC: *ABANDONED* 42-inch by 42-inch open reinforced concrete drainage culvert through the levee, 6 feet below the crown. [Additional Reference(s): DWR Levee Log, 2005, 3-foot by 3.5-foot culvert listed. USACE Sacramento O&M Manual 103, June 1954, (RM 18.16) Drawing No. 6-13-1100]. FS Date: 10/24/2016

Concrete tunnel on LS shoulder.

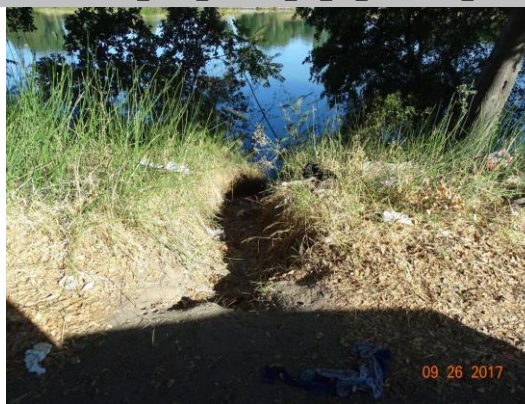
Photo 1 of 1 : SP_2018_NA0002_63_82_20180305_00056.jpg

LM Start	2.56	Rating **	M	Issue No.	82
LM End	2.56	Issue Type +	Ma	Location *	WS
Category	Earthen Levee			GPS Latitude/Longitude	
				Start	End
Item	Slope Stability			38.165898 °	38.165898 °
				-121.598888 °	-121.598888 °
DWR ID	DWR_NA0002_02_f_2017_82				
Comment Code					
S2 : Repair the levee slope damaged by foot traffic and prevent access where possible.					
Inspector Comment

Looking northwest at the waterside slope.

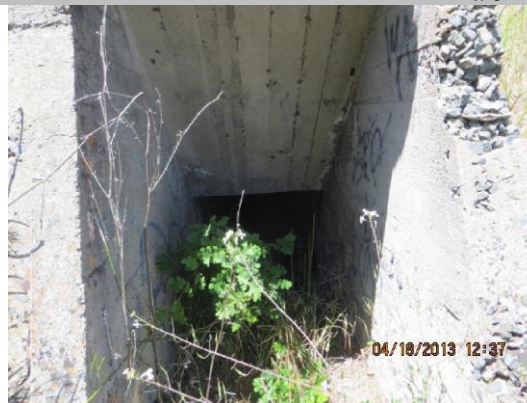
Photo 1 of 3 : UCIP_SP_2018_51315_19776.jpg

LM Start	2.57	Rating **	U	Issue No.	145	
LM End	2.57	Issue Type +	Ma	Location *		
Category	Supplemental			GPS Latitude/Longitude		
				Start		End
Item	DWR UCIP LMA Responsibility			38.165775 °		38.165775 °
				-121.599048 °		-121.599048 °
DWR ID						
Comment Code						
Inspector Comment						
FS_ID:51315 DS_ID:21880 EP_NO: N/A Repair Type: Urgent Crossing Status: Found UCIP Comments: 10/24/2016 same as previous inspection concrete box culvert will need to be abandoned properly. (O. Magana - DWR UCIP)04/18/2013 tunnel should be abandoned properly. (W. Wylie - DWR UCIP) FIELD_STRUCT_DESC: *ABANDONED* 48-inch by 48-inch reinforced concrete drainage culvert through the levee, 6.5-inches below the crown. [Additional Reference(s): DWR Levee Log, 2005. USACE Sacramento O&M Manual 103, June 1954, (RM 18.13) 3-foot by 3-foot concrete box listed, Drawing No. 6-13-1100]. FS Date: 10/24/2016

Tunnel open on LS shoulder.

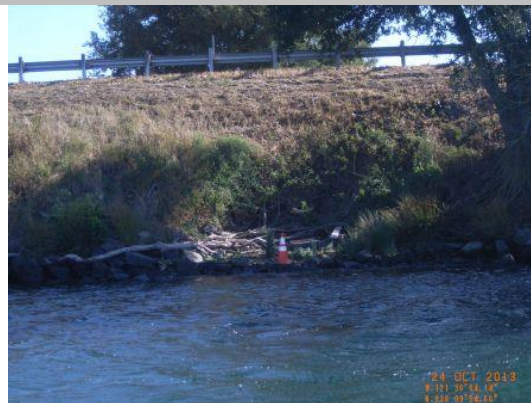
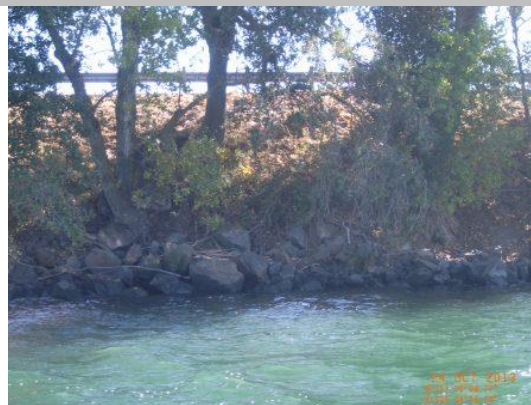
LM Start	2.66	Rating **	M	Issue No.	37
LM End	2.74	Issue Type +	Ma	Location *	WS
Category	Supplemental			GPS Latitude/Longitude	
				Start	End
Item	2015 USACE Erosion Survey, DRAFT			38.165303 °	38.164682 °
				-121.600477 °	-121.601804 °
DWR ID	DWR_NA0002_02_s_2016_37				
Comment Code					
Inspector Comment					
2009 - Large scallop from rotational failure. One fallen tree and one large tree with half of its root structure exposed. 2015: Large tree expected to pop out within next couple of years, will take very large chunk of levee out. [2015 Site ID: SAC_18-0_L]

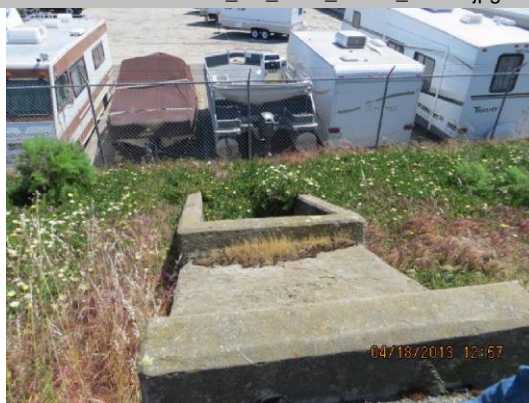
Photo 1 of 3 : UCIP_SP_2018_51316_19782.jpg

Comment Code					
Inspector Comment					
FS_ID:51316 DS_ID:21882 EP_NO: N/A Repair Type: Urgent Crossing Status: Found UCIP Comments: 10/24/2016 same as previous inspection tunnel is opened on both ends. (O. Magana - DWR UCIP)04/18/2013 Tunnel open on both ends and should be abandoned properly. (W. Wylie - DWR UCIP) FIELD_STRUCT_DESC: *ABANDONED* 48-inch by 72-inch reinforced concrete drainage culvert through the levee, 1 foot below the crown. [Additional Reference(s): DWR Levee Log, 2005, 4-foot by 4.5-foot culvert listed. USACE Sacramento O&M Manual 103, June 1954, (RM 17.89) 48-inch by 52-inch concrete box listed, Drawing No. 6-13-1100]. FS Date: 10/24/2016

Entrance to tunnel on LS slope.

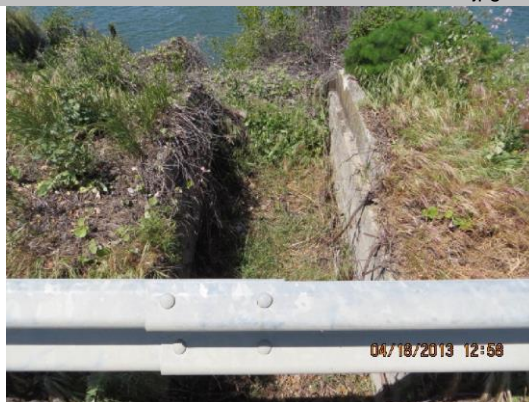
Photo 2 of 3 : UCIP_SP_2018_51316_19781.jpg

Tunnel opening on WS slope.

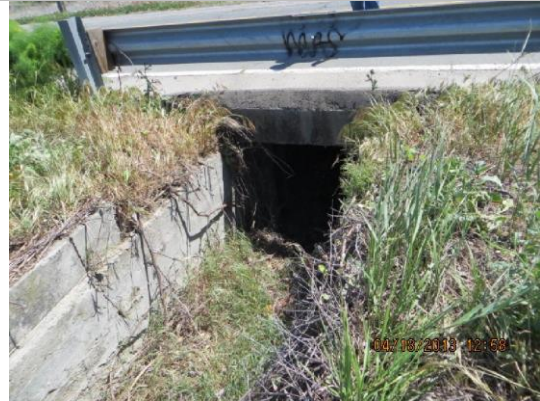
Photo 3 of 3 : UCIP_SP_2018_51316_19780.jpg

Comment Code						
Inspector Comment						
FS_ID:51316 DS_ID:21882 EP_NO: N/A Repair Type: Urgent Crossing Status: Found UCIP Comments: 10/24/2016 same as previous inspection tunnel is opened on both ends. (O. Magana - DWR UCIP)04/18/2013 Tunnel open on both ends and should be abandoned properly. (W. Wylie - DWR UCIP) FIELD_STRUCT_DESC: *ABANDONED* 48-inch by 72-inch reinforced concrete drainage culvert through the levee, 1 foot below the crown. [Additional Reference(s): DWR Levee Log, 2005, 4-foot by 4.5-foot culvert listed. USACE Sacramento O&M Manual 103, June 1954, (RM 17.89) 48-inch by 52-inch concrete box listed, Drawing No. 6-13-1100]. FS Date: 10/24/2016

Tunnel opening on WS slope.

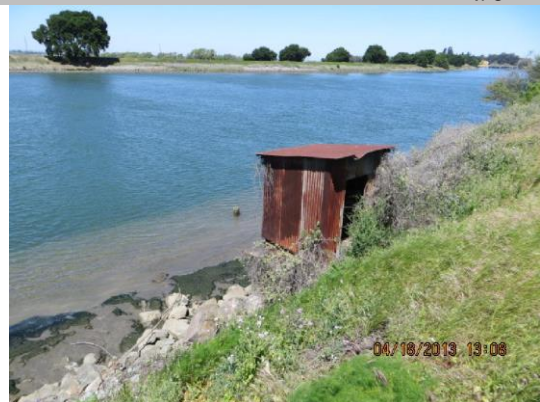
Photo 1 of 2 : UCIP_SP_2018_12217_19785.jpg

LM Start	2.90	Rating **	M	Issue No.	148
LM End	2.90	Issue Type +	En	Location *	
Category	Supplemental			GPS Latitude/Longitude	
				Start	End
Item	DWR UCIP Field Study			38.163475 °	38.163475 °
				-121.604221 °	-121.604221 °
DWR ID					
Comment Code					
Inspector Comment					
FS_ID:12217 DS_ID:21883 EP_NO: 11269 Repair Type: Non-Urgent Crossing Status: Found UCIP Comments: Pipe needs to be abandoned properly if it is truly abandoned. FIELD_STRUCT_DESC: 8-inch irrigation pipe of an unknown material through the levee, 8.7 feet below the crown. Pump in pump house on the waterside (WS) slope. Slide gate in pump house. Pipe not visible on the landside (LS). (Automatic Board Order (ABO) issued as Permit No. 11269, 1975 - Griffin Steel and Supply Company). [Additional Reference(s): DWR Levee Log, 2005]. FS Date: 4/18/2013

Pumphouse on WS slope.

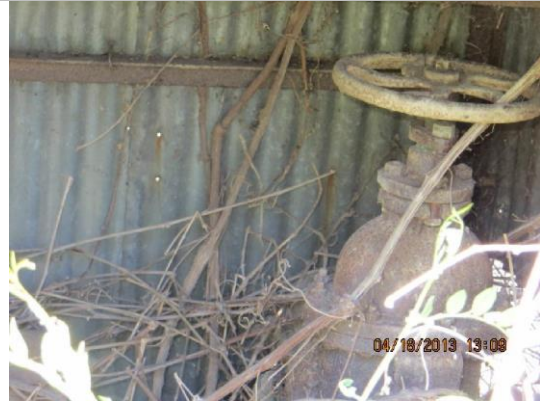
Photo 2 of 2 : UCIP_SP_2018_12217_19784.jpg

LM Start	2.90	Rating **	M	Issue No.	148 (cont)	
LM End	2.90	Issue Type +	En	Location *		
Category	Supplemental			GPS Latitude/Longitude		
				Start	End	
Item	DWR UCIP Field Study			38.163475 °	38.163475 °	
				-121.604221 °	-121.604221 °	
DWR ID						
Comment Code						
Inspector Comment						
FS_ID:12217 DS_ID:21883 EP_NO: 11269 Repair Type: Non-Urgent Crossing Status: Found UCIP Comments: Pipe needs to be abandoned properly if it is truly abandoned. FIELD_STRUCT_DESC: 8-inch irrigation pipe of an unknown material through the levee, 8.7 feet below the crown. Pump in pump house on the waterside (WS) slope. Slide gate in pump house. Pipe not visible on the landside (LS). (Automatic Board Order (ABO) issued as Permit No. 11269, 1975 - Griffin Steel and Supply Company). [Additional Reference(s): DWR Levee Log, 2005]. FS Date: 4/18/2013

Slide gate in pumphouse on WS slope.

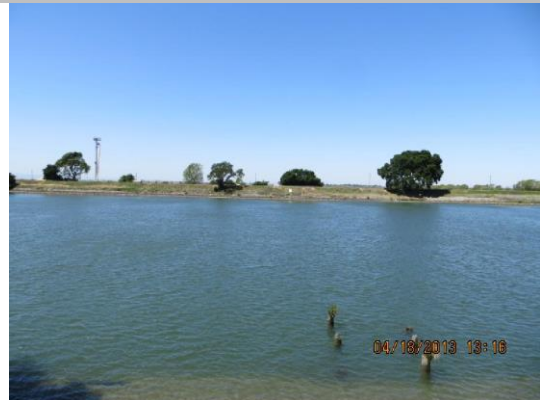
Photo 1 of 2 : UCIP_SP_2018_16005_27067.jpg

LM Start	2.91	Rating **	M	Issue No.	149
LM End	2.91	Issue Type +	En	Location *	
Category	Supplemental			GPS Latitude/Longitude	
				Start	End
Item	DWR UCIP Field Study			38.163413 °	38.163413 °
				-121.604399 °	-121.604399 °
DWR ID					
Comment Code					
Inspector Comment					
FS_ID:16005 DS_ID:21884 EP_NO: 14173 Repair Type: Non-Urgent Crossing Status: Indicator Found UCIP Comments: If pipe is still in use it should be marked properly on levee. FIELD_STRUCT_DESC: 12-inch steel telephone conduit through the levee, 2 feet below the crown, and under the channel. Four 4-inch galvanized iron conductor pipes sleeved through 12-inch steel conduit. Sign on the waterside (WS) slope of levee across river provides location for this crossing. (Permit No. 14173, 1985 - Owner Unknown). [Additional Reference(s): DWR Levee Log, 2005]. FS Date: 4/18/2013

Sign on opposite side of river provides indication of pipe location.

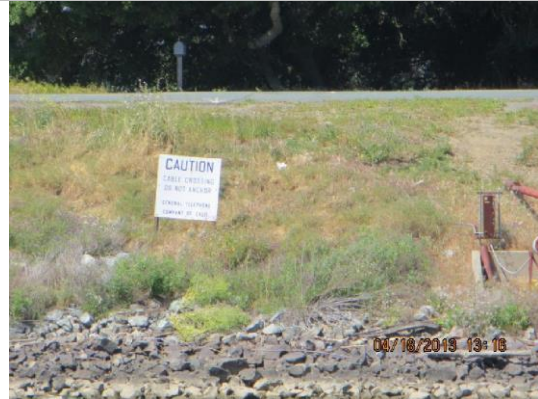
Photo 2 of 2 : UCIP_SP_2018_16005_27066.jpg

LM Start	2.91	Rating **	M	Issue No.	149 (cont)
LM End	2.91	Issue Type +	En	Location *	
Category	Supplemental			GPS Latitude/Longitude	
				Start	End
Item	DWR UCIP Field Study			38.163413 °	38.163413 °
				-121.604399 °	-121.604399 °
DWR ID					
Comment Code					
Inspector Comment					
FS_ID:16005 DS_ID:21884 EP_NO: 14173 Repair Type: Non-Urgent Crossing Status: Indicator Found UCIP Comments: If pipe is still in use it should be marked properly on levee. FIELD_STRUCT_DESC: 12-inch steel telephone conduit through the levee, 2 feet below the crown, and under the channel. Four 4-inch galvanized iron conductor pipes sleeved through 12-inch steel conduit. Sign on the waterside (WS) slope of levee across river provides location for this crossing. (Permit No. 14173, 1985 - Owner Unknown). [Additional Reference(s): DWR Levee Log, 2005]. FS Date: 4/18/2013

Sign on opposite side of river provides indication of pipe location.

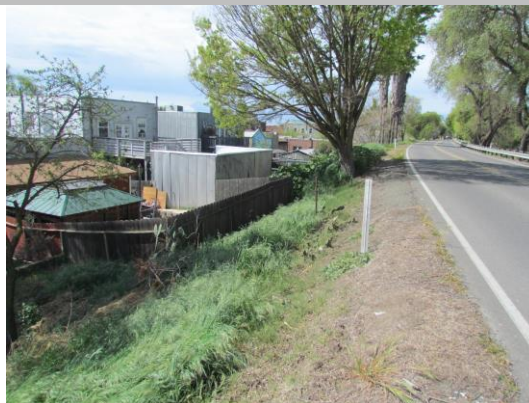
Photo 2 of 2 : SP_2018_NA0002_63_30_20180305_00039.jpg

LM Start	2.93	Rating **	U	Issue No.	30 (cont)	
LM End	3.12	Issue Type +	En	Location *	LS	
Category	Earthen Levee			GPS Latitude/Longitude		
				Start		End
Item	Encroachments			38.163317 °		38.162707 °
				-121.604813 °		-121.608262 °
DWR ID	DWR_NA0002_02_s_2012_30					
Comment Code						
UR : Urban						
Inspector Comment						
Several encroachments within town limits along landside slope.

Looking south at several encroachments along landward slope and toe.

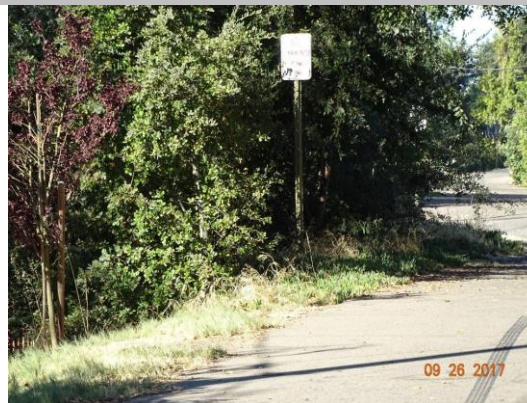
Photo 1 of 3 : SP_2018_NA0002_63_7_20180305_00006.jpg

LM Start	3.22	Rating **	U	Issue No.	7
LM End	3.22	Issue Type +	En	Location *	LS
Category	Earthen Levee			GPS Latitude/Longitude	
				Start	End
Item	Vegetation			38.162609 °	38.162609 °
				-121.609979 °	-121.609979 °
DWR ID	DWR_NA0002_02_s_2012_7				
Comment Code					
V6 : Landscaping					
Inspector Comment

Looking southwest at the landside slope.

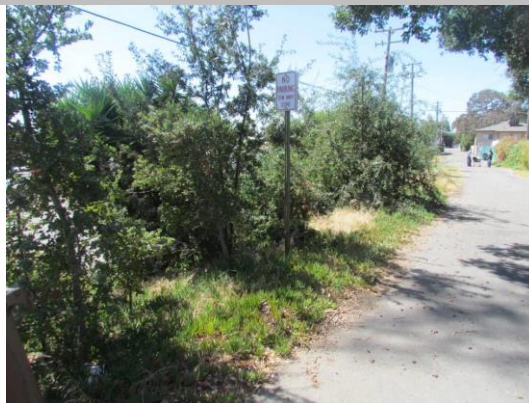
Photo 2 of 3 : SP_2018_NA0002_63_7_20180305_00007.jpg

LM Start	3.22	Rating **	U	Issue No.	7 (cont)
LM End	3.22	Issue Type +	En	Location *	LS

Looking south at overgrown landscaping on landward slope. (Fall 2016)

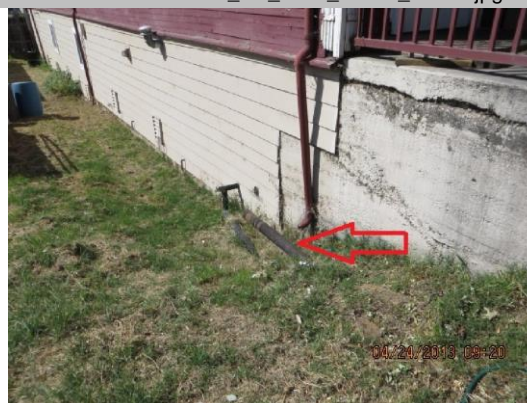
Photo 1 of 2 : UCIP_SP_2018_15966_26949.jpg

LM Start	3.29	Rating **	M	Issue No.	151
LM End	3.29	Issue Type +	En	Location *	
Category	Supplemental			GPS Latitude/Longitude	
				Start	End
Item	DWR UCIP Field Study			38.162430 °	38.162430 °
				-121.611248 °	-121.611248 °
DWR ID					
Comment Code					
Inspector Comment					
FS_ID:15966 DS_ID:23135 EP_NO: N/A Repair Type: Non-Urgent Crossing Status: Found UCIP Comments: Need to determine disposition and use of pipe. FIELD_STRUCT_DESC: 4-inch cast iron drainage pipe through the levee, 8 feet below the crown. Pipe visible next to foundation on the landside (LS) toe. FS Date: 4/24/2013

Pipe visible next to foundation on LS slope.

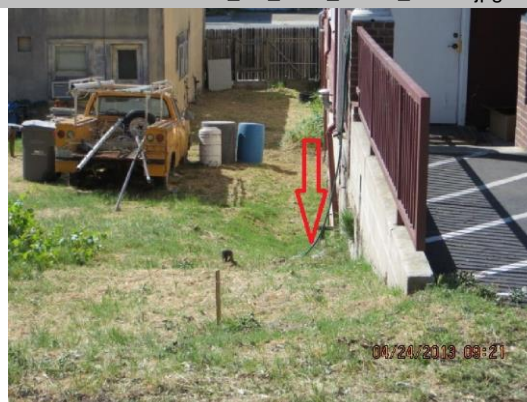
Photo 2 of 2 : UCIP_SP_2018_15966_26948.jpg

LM Start	3.29	Rating **	M	Issue No.	151 (cont)
LM End	3.29	Issue Type +	En	Location *

Pipe visible next to foundation on LS slope.

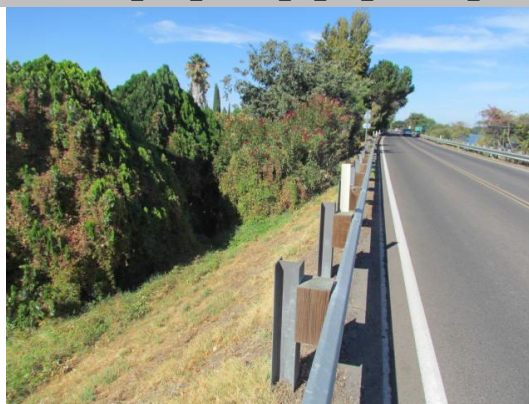
Photo 1 of 1 : SP_2018_NA0002_63_101_20180305_00075.jpg

LM Start	3.47	Rating **	U	Issue No.	101
LM End	3.53	Issue Type +	En	Location *	LS
Category	Earthen Levee			GPS Latitude/Longitude	
				Start	End
Item	Vegetation			38.162492 °	38.162600 °
				-121.614521 °	-121.615667 °
DWR ID	DWR_NA0002_02_s_2014_101				
Comment Code					
V6 : Landscaping					
Inspector Comment

Looking at dense landscaping on landward slope.

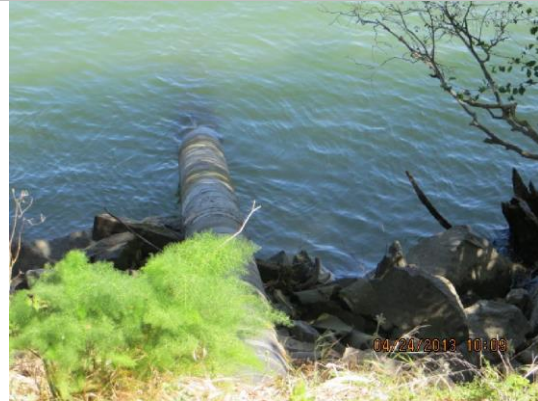
Photo 1 of 3 : UCIP_SP_2018_51317_20689.jpg

Comment Code						
Inspector Comment						
FS_ID:51317 DS_ID:21894 EP_NO: 13462 Repair Type: Urgent Crossing Status: Found UCIP Comments: 10/24/2016 Pipe has been cut and capped for the installation of the rock slope protection (RSP) on the WS bank under the USACE's Sacramento River Bank Protection Project (Contract 7, River Mile 16.8L). The CVFPB issued a letter dated July 20, 2016 for the proposed work and determined that a encroachment permit was unnecessary for the minor alteration (addition of RSP). However, once the work is completed the CVFPB, Minh Chieng, is expecting River Vine Ranch, owner of 16-inch pipe, to submit application for name change. UCIP recommends owner complete internal inspection to determine condition of pipe through levee and LS slope to determine if leak is present on WS shoulder. (O. Magana - DWR UCIP)04/24/2013 Possible sinkhole over pipe on WS shoulder. Good candidate for video inspection. (W. Wylie - DWR UCIP) FIELD_STRUCT_DESC: 16-inch steel irrigation pipe through the levee, 2.5 feet below the crown. Pipe is connected to 42-inch concrete pipe sump. (16-inch pipe authorized under Permit No. 13462, 1982 - Lee and Correia). [Additional Reference(s): DWR Levee Log, 2005]. FS Date: 10/24/2016

Pipe on WS slope.

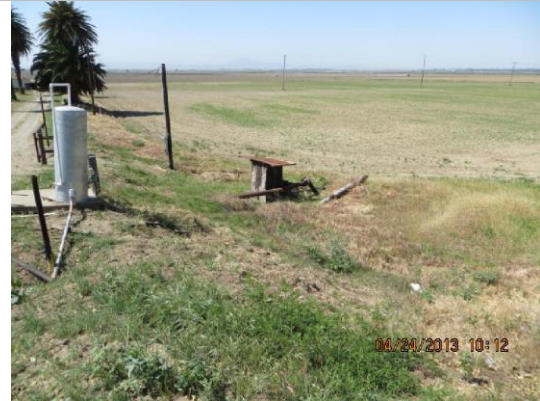
Photo 3 of 3 : UCIP_SP_2018_51317_20687.jpg

Comment Code						
Inspector Comment						
FS_ID:51317 DS_ID:21894 EP_NO: 13462 Repair Type: Urgent Crossing Status: Found UCIP Comments: 10/24/2016 Pipe has been cut and capped for the installation of the rock slope protection (RSP) on the WS bank under the USACE's Sacramento River Bank Protection Project (Contract 7, River Mile 16.8L). The CVFPB issued a letter dated July 20, 2016 for the proposed work and determined that a encroachment permit was unnecessary for the minor alteration (addition of RSP). However, once the work is completed the CVFPB, Minh Chieng, is expecting River Vine Ranch, owner of 16-inch pipe, to submit application for name change. UCIP recommends owner complete internal inspection to determine condition of pipe through levee and LS slope to determine if leak is present on WS shoulder. (O. Magana - DWR UCIP)04/24/2013 Possible sinkhole over pipe on WS shoulder. Good candidate for video inspection. (W. Wylie - DWR UCIP) FIELD_STRUCT_DESC: 16-inch steel irrigation pipe through the levee, 2.5 feet below the crown. Pipe is connected to 42-inch concrete pipe sump. (16-inch pipe authorized under Permit No. 13462, 1982 - Lee and Correia). [Additional Reference(s): DWR Levee Log, 2005]. FS Date: 10/24/2016

Pumphouse on LS toe.

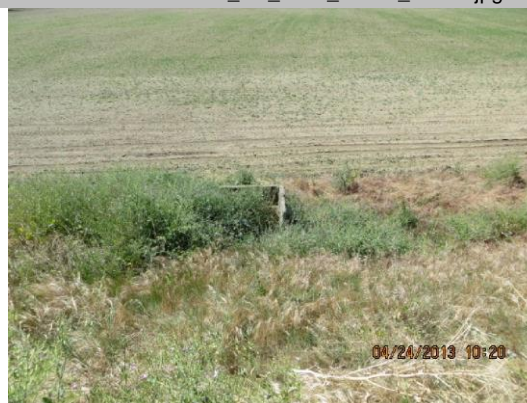
Photo 1 of 2 : UCIP_SP_2018_12748_20692.jpg

LM Start	3.70	Rating **	M	Issue No.	156
LM End	3.70	Issue Type +	En	Location *	
Category	Supplemental			GPS Latitude/Longitude	
				Start	End
Item	DWR UCIP Field Study			38.163048 °	38.163048 °
				-121.618839 °	-121.618839 °
DWR ID					
Comment Code					
Inspector Comment					
FS_ID:12748					
DS_ID:21895					
EP_NO: 1615					
Repair Type: Non-Urgent					
Crossing Status: Found					
UCIP Comments: Pipe abandoned and should be abandoned properly.					
FIELD_STRUCT_DESC: 8-inch irrigation pipe of an unknown material					
through the levee, 7.7 feet below the crown. 6-foot by 6-foot concrete					
distribution box on the LS toe. (Permit No. 1615, 1951 - Jones and					
Miller). [Additional Reference(s): DWR Levee Log, 2005. USACE					
Sacramento O&M Manual 102, April 1959, (RM 17.0) (Reclamation					
District No. 2067) steel pipe listed].					
FS Date: 4/24/2013

Concrete distribution box on LS toe.

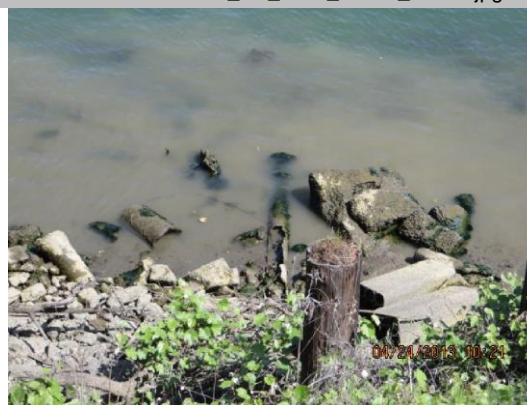
Photo 2 of 2 : UCIP_SP_2018_12748_20691.jpg

LM Start	3.70	Rating **	M	Issue No.	156 (cont)
LM End	3.70	Issue Type +	En	Location *

Rusted out pipe visible at WS toe.

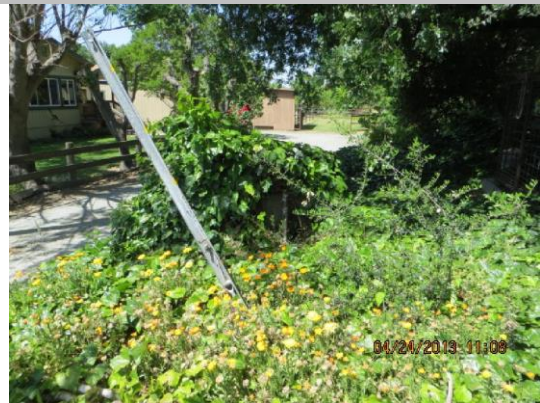
Photo 1 of 3 : UCIP_SP_2018_12768_20731.jpg

LM Start	4.11	Rating **	M	Issue No.	159
LM End	4.11	Issue Type +	En	Location *	
Category	Supplemental		GPS Latitude/Longitude		
			Start	End	
Item	DWR UCIP Field Study		38.165016 °	38.165016 °	
			-121.625834 °	-121.625834 °	
DWR ID					
Comment Code					
Inspector Comment					
FS_ID:12768 DS_ID:21904 EP_NO: 787 Repair Type: Non-Urgent Crossing Status: Found UCIP Comments: Pipe may be abandoned and should be done so properly if not being used. Good candidate for video inspection. FIELD_STRUCT_DESC: 2 of 2: 14-inch steel irrigation pipe through the levee, 4.2 feet below the crown. Pump on pile structure in stream. (Permit No. 787, 1939 - J. E. Silva, et al.). [Additional Reference(s): DWR Levee Log, 2005. USACE Sacramento O&M Manual 102, April 1959, (RM 16.6) (Reclamation District No. 2067)]. FS Date: 4/24/2013

Concrete distribution box at LS toe.

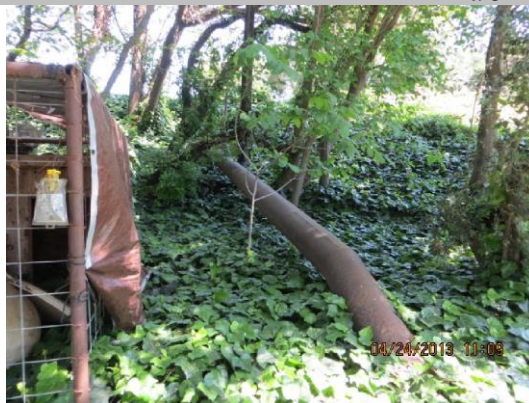
Photo 2 of 3 : UCIP_SP_2018_12768_20730.jpg

LM Start	4.11	Rating **	M	Issue No.	159 (cont)	
LM End	4.11	Issue Type +	En	Location *		
Category	Supplemental			GPS Latitude/Longitude		
				Start	End	
Item	DWR UCIP Field Study			38.165016 °	38.165016 °	
				-121.625834 °	-121.625834 °	
DWR ID						
Comment Code						
Inspector Comment						
FS_ID:12768 DS_ID:21904 EP_NO: 787 Repair Type: Non-Urgent Crossing Status: Found UCIP Comments: Pipe may be abandoned and should be done so properly if not being used. Good candidate for video inspection. FIELD_STRUCT_DESC: 2 of 2: 14-inch steel irrigation pipe through the levee, 4.2 feet below the crown. Pump on pile structure in stream. (Permit No. 787, 1939 - J. E. Silva, et al.). [Additional Reference(s): DWR Levee Log, 2005. USACE Sacramento O&M Manual 102, April 1959, (RM 16.6) (Reclamation District No. 2067)]. FS Date: 4/24/2013

Pipe on LS slope.

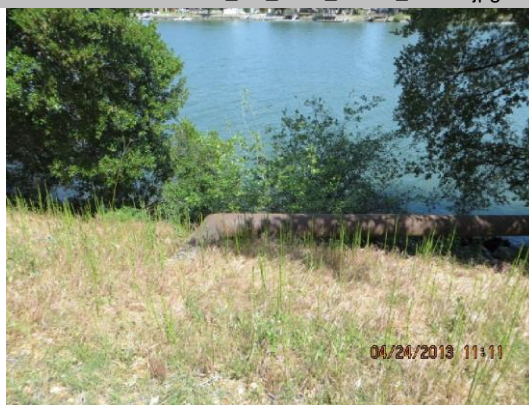
Photo 3 of 3 : UCIP_SP_2018_12768_20729.jpg

LM Start	4.11	Rating **	M	Issue No.	159 (cont)
LM End	4.11	Issue Type +	En	Location *

Pipe on WS slope.

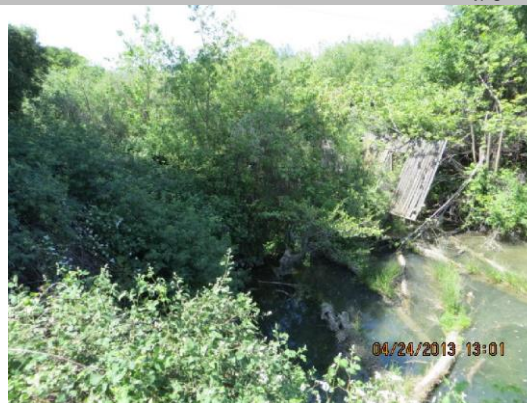
Photo 1 of 3 : UCIP_SP_2018_16010_27085.jpg

Comment Code						
Inspector Comment						
FS_ID:16010 DS_ID:21907 EP_NO: 11274 Repair Type: Non-Urgent Crossing Status: Found UCIP Comments: Pipe abandoned and should be abandoned properly if not already done so. FIELD_STRUCT_DESC: *ABANDONED* 2 of 2: 10-inch irrigation pipe of an unknown material through the levee, 6.6 feet below the crown. Pump in pump house on the landside (LS) slope. Pump house not visible, 4/24/2013. (Automatic Board Order (ABO) issued as Permit No. 11274, 1975 - Henry Martin). [Additional Reference(s): DWR Levee Log, 2005. USACE Sacramento O&M Manual 102, April 1959, (RM 16.2) (Reclamation District No. 2067) steel pipe listed]. FS Date: 4/24/2013

Possible portion of pumphouse visible off WS toe.

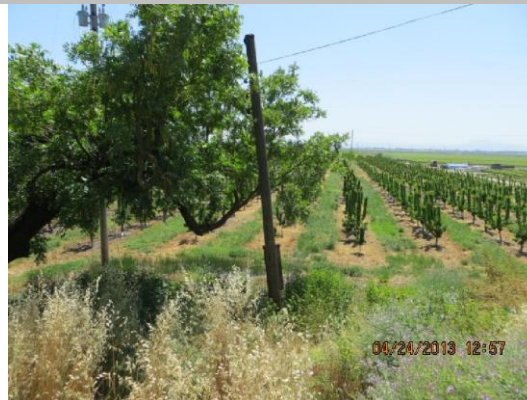
Photo 2 of 3 : UCIP_SP_2018_16010_27087.jpg

JP and meter on LS slope at location of abandoned pipe.

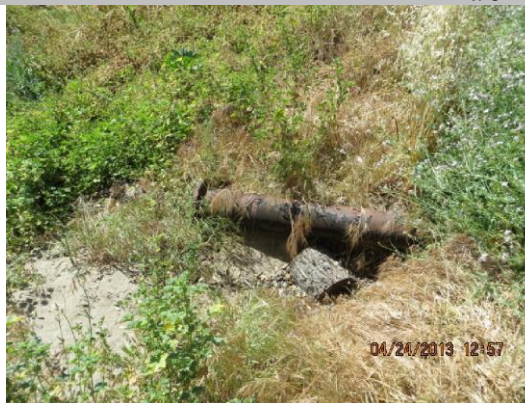
Photo 3 of 3 : UCIP_SP_2018_16010_27086.jpg

Comment Code						
Inspector Comment						
FS_ID:16010 DS_ID:21907 EP_NO: 11274 Repair Type: Non-Urgent Crossing Status: Found UCIP Comments: Pipe abandoned and should be abandoned properly if not already done so. FIELD_STRUCT_DESC: *ABANDONED* 2 of 2: 10-inch irrigation pipe of an unknown material through the levee, 6.6 feet below the crown. Pump in pump house on the landside (LS) slope. Pump house not visible, 4/24/2013. (Automatic Board Order (ABO) issued as Permit No. 11274, 1975 - Henry Martin). [Additional Reference(s): DWR Levee Log, 2005. USACE Sacramento O&M Manual 102, April 1959, (RM 16.2) (Reclamation District No. 2067) steel pipe listed]. FS Date: 4/24/2013

Abandoned pipe on LS slope.

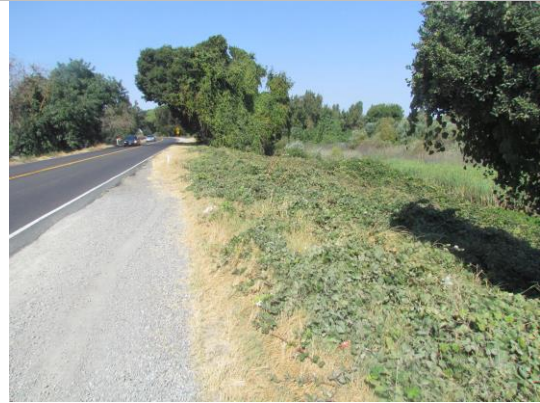
Photo 1 of 1 : SP_2018_NA0002_63_123_20180305_00099.jpg

LM Start	4.70	Rating **	U	Issue No.	123
LM End	4.72	Issue Type +	Ma	Location *	WS
Category	Earthen Levee			GPS Latitude/Longitude	
				Start	End
Item	Vegetation			38.168348 °	38.168456 °
				-121.635726 °	-121.636125 °
DWR ID	DWR_NA0002_02_f_2016_123				
Comment Code					
V2 : Remove the wild growth other than native grasses from the levee slopes.					
Inspector Comment					
Dense grapevines on waterside slope.

Looking west at dense vines on waterward slope and toe.

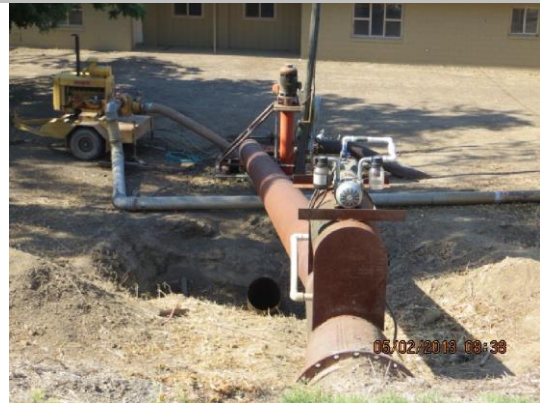
Photo 1 of 3 : UCIP_SP_2018_12773_20740.jpg

Comment Code						
Inspector Comment						
FS_ID:12773 DS_ID:21908 EP_NO: 11285 Repair Type: Non-Urgent Crossing Status: Found UCIP Comments: Pit under pipe on WS shoulder - possible leak. Excavation of pipe on LS slope into levee prism. FIELD_STRUCT_DESC: 20-inch irrigation pipe of an unknown material, sleeved through a 22-inch, sleeved through a 24-inch pipe, through the levee, 3 feet below the crown. Pump on the landside (LS). Small pump on the LS shoulder and a 7-foot by 9-foot concrete sump on the LS toe. (Automatic Board Order (ABO) issued as Permit No. 11285, 1975 - Manuel Silva). [Additional Reference(s): DWR Levee Log, 2005. USACE Sacramento O&M Manual 102, April 1959, (RM 15.9) (Reclamation District No. 2067) steel pipe listed]. FS Date: 5/2/2013

Small pump on LS shoulder with concrete distribution box on LS toe.

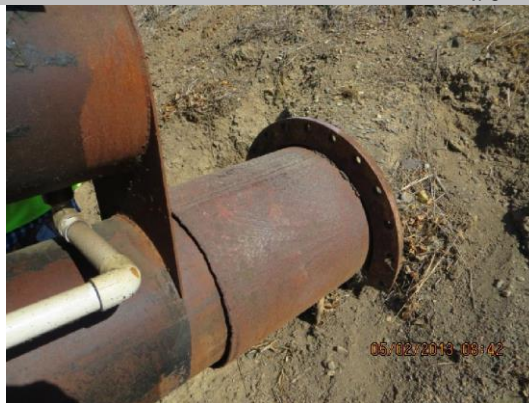
Photo 2 of 3 : UCIP_SP_2018_12773_20739.jpg

20-inch pipe sleeved through 22-inch pipe sleeved through a 24-inch steel pipe.

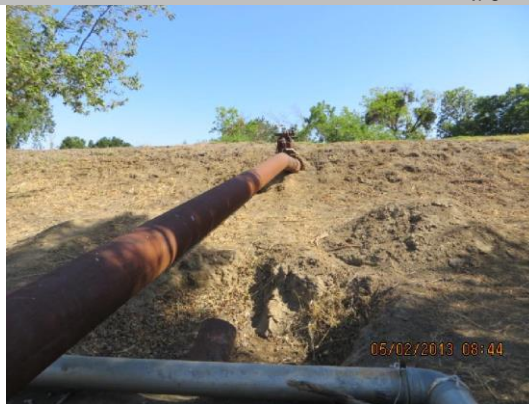
Photo 3 of 3 : UCIP_SP_2018_12773_20738.jpg

Comment Code						
Inspector Comment						
FS_ID:12773						
DS_ID:21908						
EP_NO: 11285						
Repair Type: Non-Urgent						
Crossing Status: Found						
UCIP Comments: Pit under pipe on WS shoulder - possible leak.						
Excavation of pipe on LS slope into levee prism.						
FIELD_STRUCT_DESC: 20-inch irrigation pipe of an unknown material, sleeved through a 22-inch, sleeved through a 24-inch pipe, through the levee, 3 feet below the crown. Pump on the landside (LS). Small pump on the LS shoulder and a 7-foot by 9-foot concrete sump on the LS toe. (Automatic Board Order (ABO) issued as Permit No. 11285, 1975 - Manuel Silva). [Additional Reference(s): DWR Levee Log, 2005. USACE Sacramento O&M Manual 102, April 1959, (RM 15.9) (Reclamation District No. 2067) steel pipe listed].						
FS Date: 5/2/2013

Pipe on LS slope with excavation in levee prism.

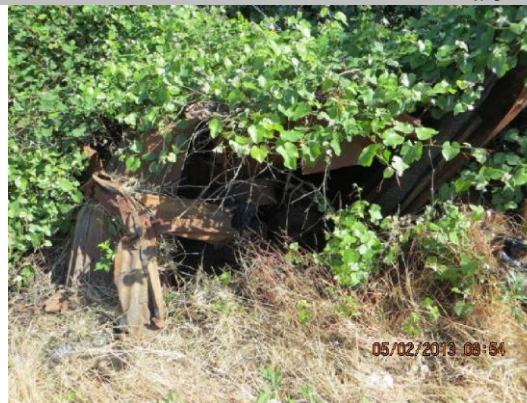
Photo 1 of 3 : UCIP_SP_2018_12774_20745.jpg

Comment Code						
Inspector Comment						
FS_ID:12774 DS_ID:21909 EP_NO: 724 Repair Type: Non-Urgent Crossing Status: Found UCIP Comments: Pipe open on waterside at fallen down pumphouse. Pipe abandoned. Service pole on LS slope down on ground near broken standpipe. Pipe needs to be properly abandoned. FIELD_STRUCT_DESC: 10-inch irrigation pipe of an unknown material through the levee, 3.8 feet below the crown. Pump in pump house on the waterside (WS) slope. Service pole on the landside (LS) slope. Replaces a 10-inch pipe at approximately the same location. 32-inch concrete standpipe on the LS toe. 1.5-inch electrical conduit runs parallel to 10-inch pipe. (Permit No. 724, 1937 - California Lands, Inc., and Frank Hodapp). [Additional Reference(s): DWR Levee Log, 2005. USACE Sacramento O&M Manual 102, April 1959, (RM 15.8) (Reclamation District No. 2067) steel pipe listed]. FS Date: 5/2/2013

Broken down pumphouse on WS slope.

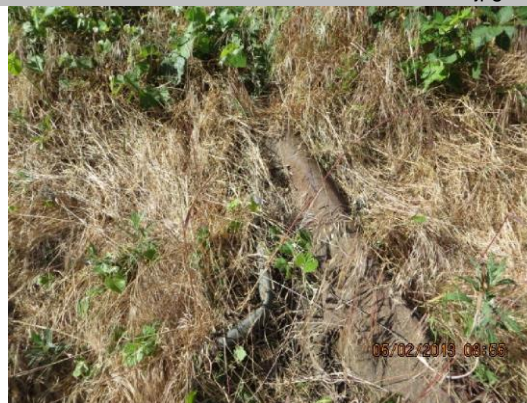
Photo 2 of 3 : UCIP_SP_2018_12774_20744.jpg

deformed and crushed pipe with 1.5-inch electrical conduit on WS slope.

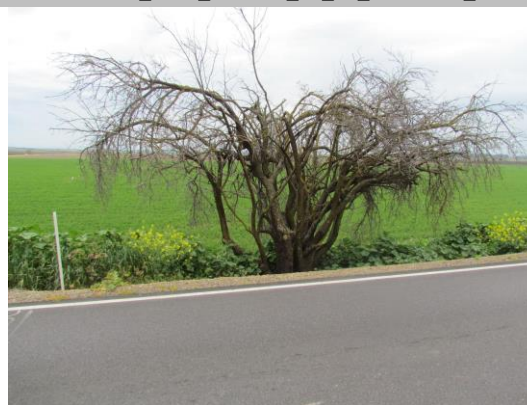
Photo 1 of 1 : SP_2018_NA0002_63_88_20180305_00058.jpg

LM Start	4.92	Rating **	M	Issue No.	88
LM End	4.92	Issue Type +	Ma	Location *	LS
Category	Earthen Levee			GPS Latitude/Longitude	
				Start	End
Item	Encroachments			38.169262 °	38.169262 °
				-121.639497 °	-121.639497 °
DWR ID	DWR_NA0002_02_s_2017_88				
Comment Code					
TR : Tree or limb					
Inspector Comment					
Remove dead tree on landside slope.

Looking east at dead tree on landward slope and toe.

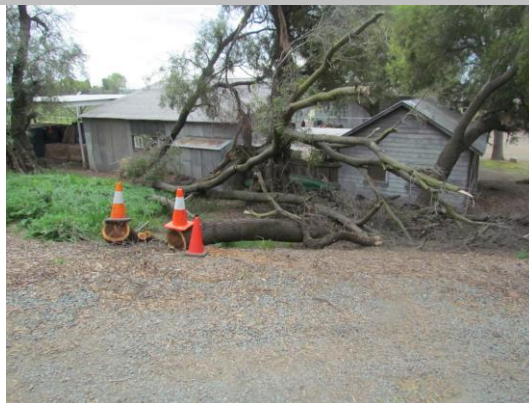
Photo 1 of 1 : SP_2018_NA0002_63_89_20180305_00059.jpg

LM Start	5.37	Rating **	U	Issue No.	89
LM End	5.37	Issue Type +	En	Location *	LS
Category	Earthen Levee			GPS Latitude/Longitude	
				Start	End
Item	Encroachments			38.171783 °	38.171783 °
				-121.646562 °	-121.646562 °
DWR ID	DWR_NA0002_02_s_2017_89				
Comment Code					
TR : Tree or limb					
Inspector Comment					
Discard fallen tree branches and limbs on landside toe.

Looking east at fallen tree on landward slope and toe.

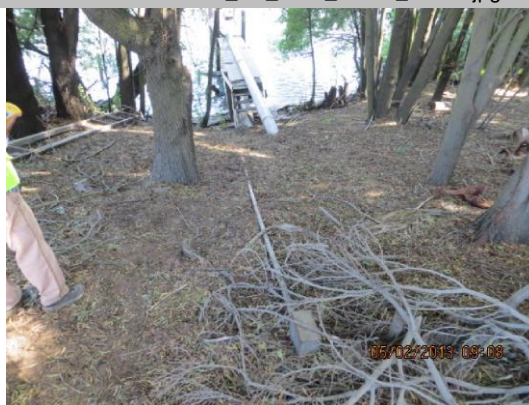
Photo 1 of 3 : UCIP_SP_2018_12776_20754.jpg

Comment Code					
Inspector Comment					
FS_ID:12776 DS_ID:21910 EP_NO: 7089A Repair Type: Non-Urgent Crossing Status: Found UCIP Comments: Hole at LS toe over pipe possible sign of leakage. FIELD_STRUCT_DESC: 7-inch drainage pipe of an unknown material through the levee, 13 feet below the crown. Pump in pump house on the landside (LS). 1.5-inch galvanized steel electrical conduit at same location. 4-foot by 6-foot concrete distribution box off the LS toe next to pump house. [Additional Reference(s): DWR Levee Log, 2005. USACE Sacramento O&M Manual 102, April 1959, (RM 15.3) (Reclamation District No. 2067) steel pipe listed]. FS Date: 5/2/2013

Pipe and electrical conduit on WS slope.

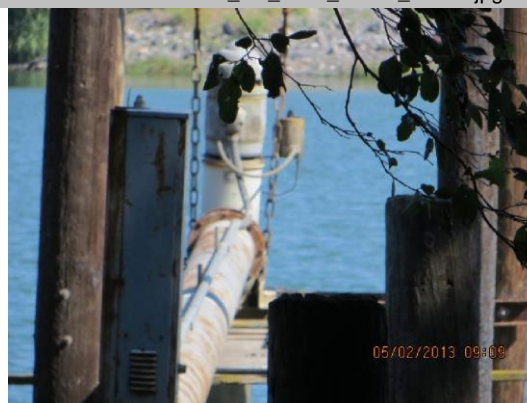
Photo 2 of 3 : UCIP_SP_2018_12776_20753.jpg

Pump on pier at WS toe.

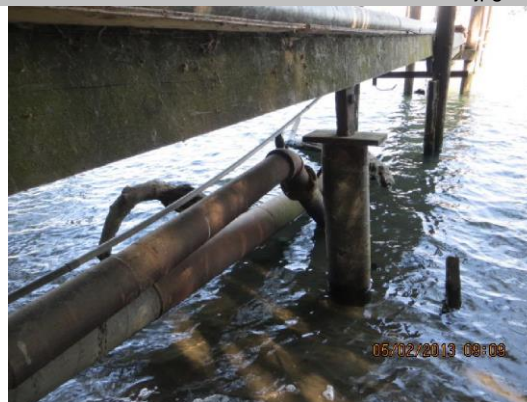
Photo 3 of 3 : UCIP_SP_2018_12776_20752.jpg

Pipe under pier.

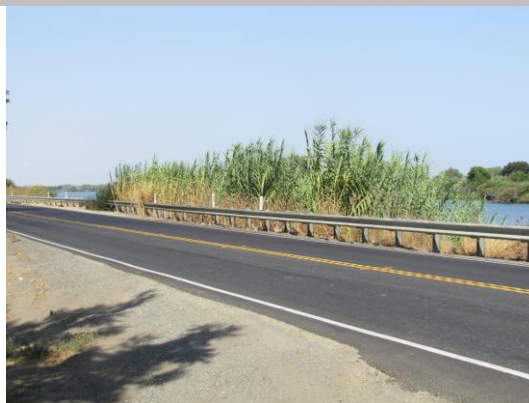
Photo 1 of 2 : SP_2018_NA0002_63_11_20180305_00015.jpg

LM Start	5.65	Rating **	U	Issue No.	11
LM End	5.69	Issue Type +	Ma	Location *	WS
Category	Earthen Levee			GPS Latitude/Longitude	
				Start	End
Item	Vegetation			38.172308 °	38.172497 °
				-121.651552 °	-121.652243 °
DWR ID	DWR_NA0002_02_s_2012_11				
Comment Code					
V2 : Remove the wild growth other than native grasses from the levee slopes.					
Inspector Comment					
Bamboo on waterside slope.

Looking northwest at bamboo on waterward slope. (Fall 2016)

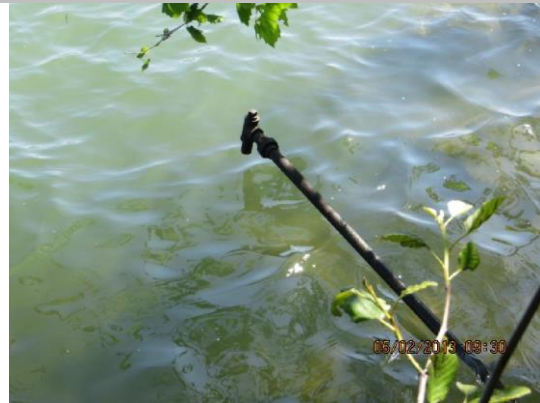
Photo 1 of 3 : UCIP_SP_2018_12778_20762.jpg

LM Start	5.77	Rating **	M	Issue No.	164	
LM End	5.77	Issue Type +	Ma	Location *		
Category	Supplemental			GPS Latitude/Longitude		
				Start	End	
Item	DWR UCIP LMA Responsibility			38.172940 °	38.172940 °	
				-121.653700 °	-121.653700 °	
DWR ID						
Comment Code						
Inspector Comment						
FS_ID:12778 DS_ID:21912 EP_NO: N/A Repair Type: Non-Urgent Crossing Status: Found UCIP Comments: Pipe abandoned. Erosion on WS slope at location where pipe should be. FIELD_STRUCT_DESC: *ABANDONED* 12-inch drainage pipe of an unknown material through the levee, 13 feet below the crown. Pump and gate valve in pump house at the landside (LS) toe. 1.5-inch electrical conduit along pipe at same location. 42-inch concrete standpipe at the LS toe. [Additional Reference(s): USACE Sacramento O&M Manual 102, April 1959, (RM 14.8) (Reclamation District No. 2067) steel pipe listed FS Date: 5/2/2013

Conduit at WS toe.

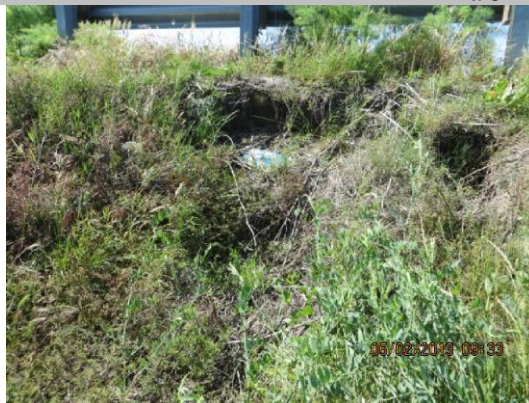
Photo 2 of 3 : UCIP_SP_2018_12778_20761.jpg

Comment Code						
Inspector Comment						
FS_ID:12778 DS_ID:21912 EP_NO: N/A Repair Type: Non-Urgent Crossing Status: Found UCIP Comments: Pipe abandoned. Erosion on WS slope at location where pipe should be. FIELD_STRUCT_DESC: *ABANDONED* 12-inch drainage pipe of an unknown material through the levee, 13 feet below the crown. Pump and gate valve in pump house at the landside (LS) toe. 1.5-inch electrical conduit along pipe at same location. 42-inch concrete standpipe at the LS toe. [Additional Reference(s): USACE Sacramento O&M Manual 102, April 1959, (RM 14.8) (Reclamation District No. 2067) steel pipe listed FS Date: 5/2/2013

Erosion along pipe alignment at WS slope.

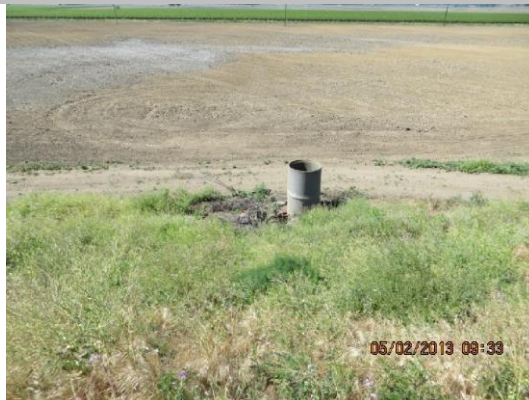
Photo 3 of 3 : UCIP_SP_2018_12778_20760.jpg

Concrete standpipe and pump on LS toe.

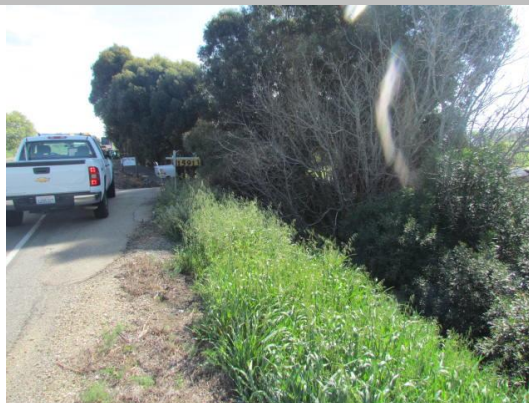
Photo 2 of 2 : SP_2018_NA0002_63_50_20180305_00052.jpg

LM Start	6.27	Rating **	U	Issue No.	50 (cont)	
LM End	6.27	Issue Type +	En	Location *	LS	
Category	Earthen Levee			GPS Latitude/Longitude		
				Start		End
Item	Vegetation			38.173922 °		38.173922 °
				-121.662272 °		-121.662272 °
DWR ID	DWR_NA0002_02_s_2013_50					
Comment Code						
V6 : Landscaping						
Inspector Comment

Looking northeast at dense landscaping on landward slope.

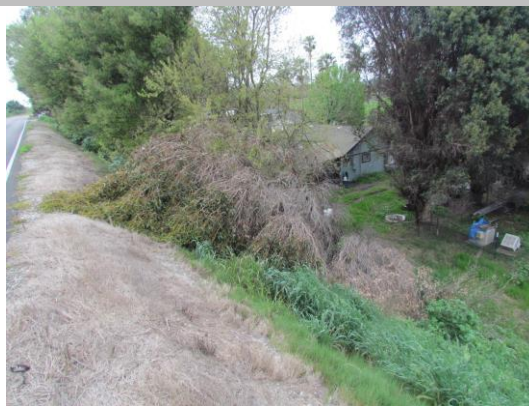
Photo 1 of 1 : SP_2018_NA0002_63_13_20180305_00019.jpg

LM Start	6.32	Rating **	U	Issue No.	13
LM End	6.32	Issue Type +	En	Location *	LS
Category	Earthen Levee			GPS Latitude/Longitude	
				Start	End
Item	Encroachments			38.173697 °	38.173697 °
				-121.663082 °	-121.663082 °
DWR ID	DWR_NA0002_02_s_2017_13				
Comment Code					
TR : Tree or limb					
Inspector Comment					
Fallen tree on landside slope.

Looking northeast at fallen tree on landward slope.

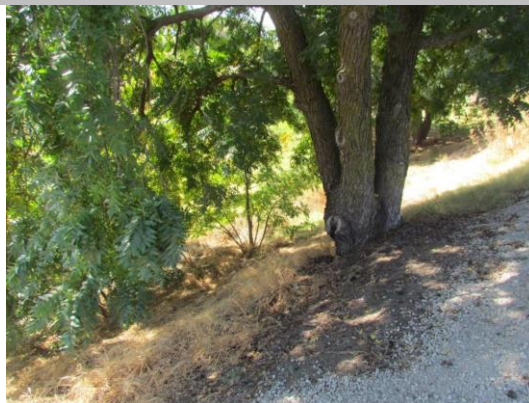
Photo 1 of 2 : SP_2018_NA0002_63_14_20180305_00020.jpg

LM Start	6.36	Rating **	U	Issue No.	14
LM End	6.36	Issue Type +	Ma	Location *	LS
Category	Earthen Levee			GPS Latitude/Longitude	
				Start	End
Item	Trim / Thin Trees			38.173406 °	38.173406 °
				-121.663815 °	-121.663815 °
DWR ID	DWR_NA0002_02_s_2012_14				
Comment Code					
T1 : Trim trees to at least five feet above ground level.					
Inspector Comment

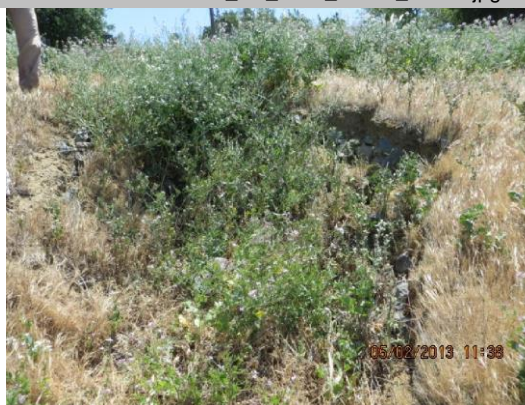
Photo 1 of 3 : UCIP_SP_2018_12814_20821.jpg

Comment Code						
Inspector Comment						
FS_ID:12814 DS_ID:21918 EP_NO: 11293 Repair Type: Non-Urgent Crossing Status: Found UCIP Comments: Erosion or sinkhole on WS shoulder. Does not appear to be an immediate threat. FIELD_STRUCT_DESC: 2 of 2: 16-inch irrigation pipe of an unknown material through the levee, 7.1 feet below the crown. Pump and service pole on the landside (LS) slope. 72-inch concrete standpipe at the landside (LS) toe. (Automatic Board Order (ABO) issued as Permit No. 11293, 1975 - John Wilcox). [Additional Reference(s): DWR Levee Log, 2005. USACE Sacramento O&M Manual 102, April 1959, (RM 13.0) (Reclamation District No. 2067) steel pipe listed]. FS Date: 5/2/2013

Erosion/sinkhole over pipe on WS slope.

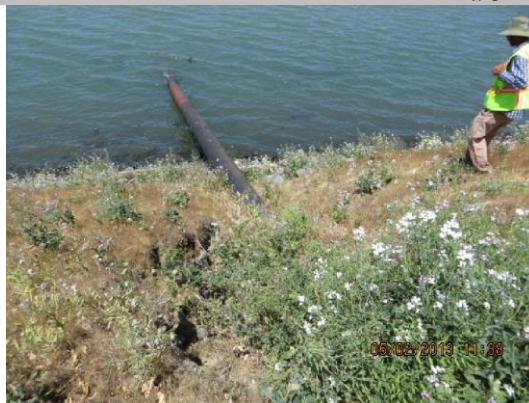
Photo 2 of 3 : UCIP_SP_2018_12814_20820.jpg

Comment Code						
Inspector Comment						
FS_ID:12814 DS_ID:21918 EP_NO: 11293 Repair Type: Non-Urgent Crossing Status: Found UCIP Comments: Erosion or sinkhole on WS shoulder. Does not appear to be an immediate threat. FIELD_STRUCT_DESC: 2 of 2: 16-inch irrigation pipe of an unknown material through the levee, 7.1 feet below the crown. Pump and service pole on the landside (LS) slope. 72-inch concrete standpipe at the landside (LS) toe. (Automatic Board Order (ABO) issued as Permit No. 11293, 1975 - John Wilcox). [Additional Reference(s): DWR Levee Log, 2005. USACE Sacramento O&M Manual 102, April 1959, (RM 13.0) (Reclamation District No. 2067) steel pipe listed]. FS Date: 5/2/2013

Pipe on WS slope.

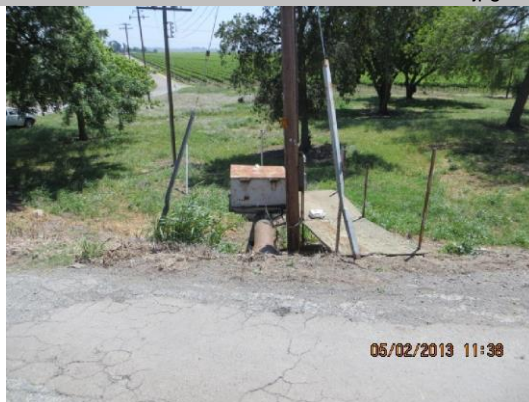
Photo 3 of 3 : UCIP_SP_2018_12814_20819.jpg

Pipe and pump on LS shoulder.
