**Flood Control Project Maintenance
Levee Inspections**
LMA District Cover Sheet
Spring 2018 Levee Inspection Results

Brannan Andrus Levee Maintenance District

Spring 2018 Levee Inspection Results

Waterway			Bank	Unit Miles
Unit No. 01 Georgiana Slough			Right	6.01
	Spring (March - May)	Summer (June - August)	(September - November) Fall	Winter (December - February)
Unit Maintenance Rating (Fall Only)				
Date of Inspection	4/5/2018 - 4/5/2018			
DWR Inspector	Keith Millard			
Accompanied By

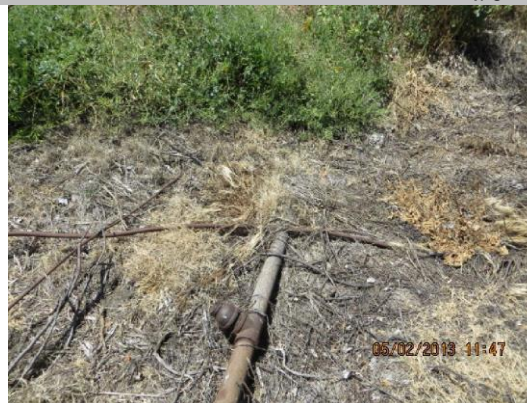
Photo 1 of 2 : UCIP_SP_2018_12817_20825.jpg

LM Start	7.49	Rating **	M	Issue No.	168
LM End	7.49	Issue Type +	En	Location *	
Category	Supplemental			GPS Latitude/Longitude	
				Start	End
Item	DWR UCIP Field Study			38.159940 °	38.159940 °
				-121.674430 °	-121.674430 °
DWR ID					
Comment Code					
Inspector Comment					
FS_ID:12817 DS_ID:21920 EP_NO: N/A Repair Type: Non-Urgent Crossing Status: Found UCIP Comments: Pipe should be abandoned properly. FIELD_STRUCT_DESC: 3-inch pipe of an unknown material or purpose through the levee, 7.7 feet below the crown. Inactive service pole on the landside (LS) slope. [Additional Reference(s): DWR Levee Log, 2005]. FS Date: 5/2/2013

3.5-inch galvanized iron pipe on LS slope.

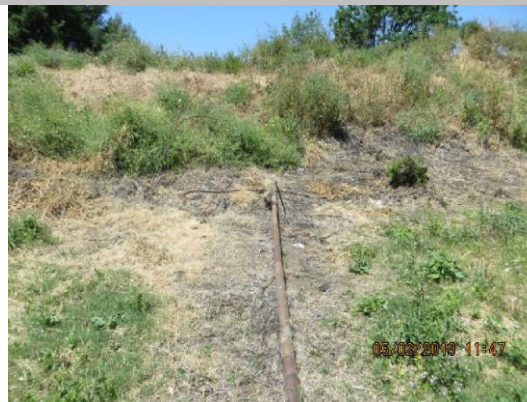
Photo 2 of 2 : UCIP_SP_2018_12817_20824.jpg

3.5-inch galvanized iron pipe on LS slope.

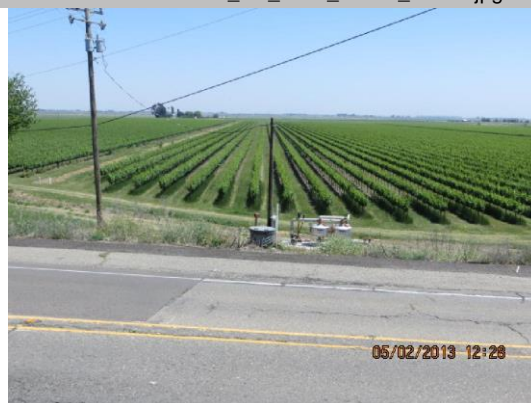
Photo 1 of 3 : UCIP_SP_2018_40795_20835.jpg

Comment Code						
Inspector Comment						
FS_ID:40795						
DS_ID:21922						
EP_NO: 1663						
Repair Type: Non-Urgent						
Crossing Status: Found						
UCIP Comments: Hole over pipe on WS berm that may indicate a leak or other problem. Pipe should be inspected and hole over pipe backfilled.						
FIELD_STRUCT_DESC: 14-inch irrigation pipe of an unknown material through the levee, 4.4 feet below the crown. A 12-inch pipe is sleeved through the 14-inch, and then a 6-inch pipe is sleeved through the 12-inch. Siphon breaker in 24-inch corrugated metal standpipe on the landside (LS) shoulder. 48-inch diameter concrete standpipe on the LS toe. (Permit Nos. 1663, 1952 - David N. Patch and 15429, 1990 - State of California Department of Transportation). [Additional Reference(s): DWR Levee Log, 2005].						
FS Date: 5/2/2013

siphon breaker in 24-inch CMP riser on LS slope and filters at LS toe.

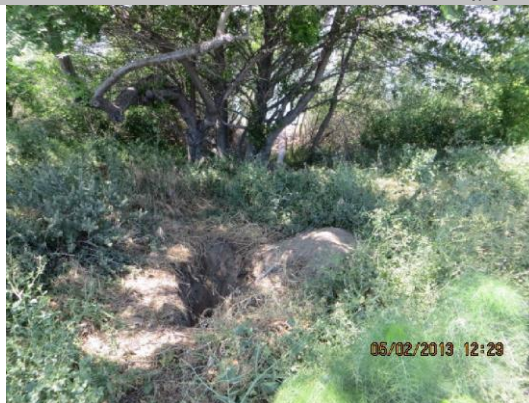
Photo 3 of 3 : UCIP_SP_2018_40795_20833.jpg

Comment Code						
Inspector Comment						
FS_ID:40795 DS_ID:21922 EP_NO: 1663 Repair Type: Non-Urgent Crossing Status: Found UCIP Comments: Hole over pipe on WS berm that may indicate a leak or other problem. Pipe should be inspected and hole over pipe backfilled. FIELD_STRUCT_DESC: 14-inch irrigation pipe of an unknown material through the levee, 4.4 feet below the crown. A 12-inch pipe is sleeved through the 14-inch, and then a 6-inch pipe is sleeved through the 12-inch. Siphon breaker in 24-inch corrugated metal standpipe on the landside (LS) shoulder. 48-inch diameter concrete standpipe on the LS toe. (Permit Nos. 1663, 1952 - David N. Patch and 15429, 1990 - State of California Department of Transportation). [Additional Reference(s): DWR Levee Log, 2005]. FS Date: 5/2/2013

Hole over pipe on WS berm.

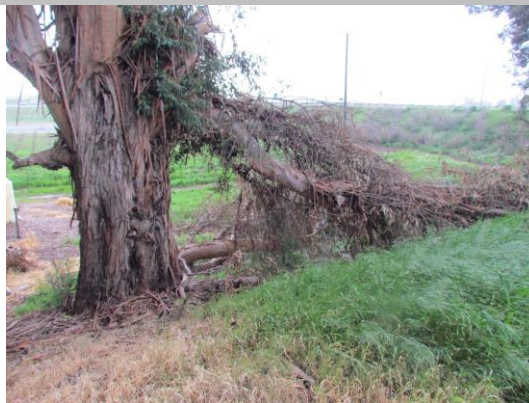
Photo 1 of 1 : SP_2018_NA0002_63_98_20180305_00071.jpg

LM Start	7.79	Rating **	M	Issue No.	98
LM End	7.79	Issue Type +	En	Location *	LS
Category	Earthen Levee			GPS Latitude/Longitude	
				Start	End
Item	Encroachments			38.157050 °	38.157050 °
				-121.678587 °	-121.678587 °
DWR ID	DWR_NA0002_02_s_2017_98				
Comment Code					
TR : Tree or limb					
Inspector Comment					
Discard broken tree branches and limbs on landside slope.

Looking southeast at broken tree branch at landward toe.

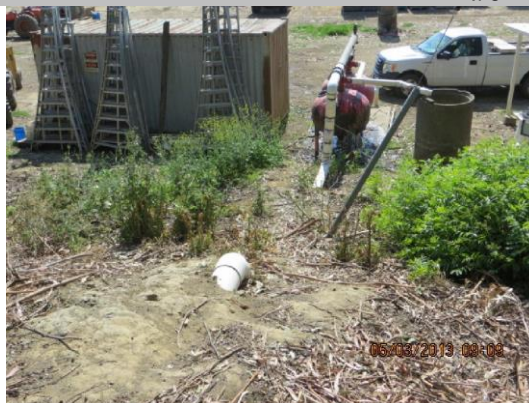
Photo 1 of 3 : UCIP_SP_2018_12869_20933.jpg

Comment Code						
Inspector Comment						
FS_ID:12869 DS_ID:21925 EP_NO: 2795 Repair Type: Non-Urgent Crossing Status: Found UCIP Comments: Annular space between PVC pipe and 12-inch steel pipe has not been sealed. FIELD_STRUCT_DESC: 20-inch irrigation pipe of an unknown material through the levee, 3 feet below the crown. 8-inch polyvinyl chloride pipe sleeved through a 12-inch pipe that is sleeved through the 20-inch. Annular space grouted between two metal pipes. Pump and butterfly valve in pump house on the waterside (WS) slope. 36-inch concrete standpipe and filters on the landside (LS) toe. (Permit No. 2795, 1958 - M. B. McKinnon). [Additional Reference(s): DWR Levee Log, 2005]. FS Date: 5/3/2013

PVC pipe, filters, and concrete standpipe on LS.

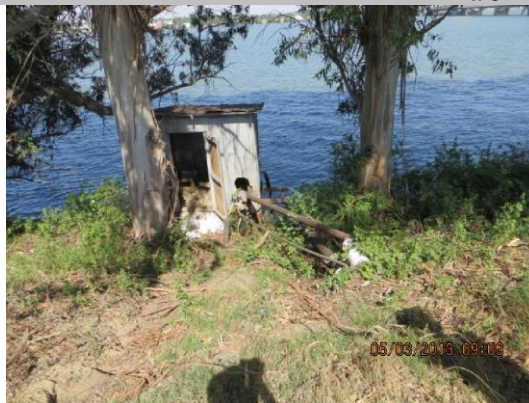
Photo 2 of 3 : UCIP_SP_2018_12869_20932.jpg

Comment Code						
Inspector Comment						
FS_ID:12869 DS_ID:21925 EP_NO: 2795 Repair Type: Non-Urgent Crossing Status: Found UCIP Comments: Annular space between PVC pipe and 12-inch steel pipe has not been sealed. FIELD_STRUCT_DESC: 20-inch irrigation pipe of an unknown material through the levee, 3 feet below the crown. 8-inch polyvinyl chloride pipe sleeved through a 12-inch pipe that is sleeved through the 20-inch. Annular space grouted between two metal pipes. Pump and butterfly valve in pump house on the waterside (WS) slope. 36-inch concrete standpipe and filters on the landside (LS) toe. (Permit No. 2795, 1958 - M. B. McKinnon). [Additional Reference(s): DWR Levee Log, 2005]. FS Date: 5/3/2013

Pumphouse and pipe on WS slope.

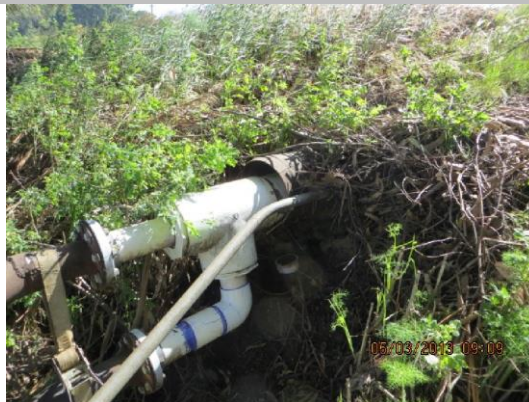
Photo 3 of 3 : UCIP_SP_2018_12869_20931.jpg

PVC pipe sleeved through 12-inch steel pipe on WS slope.

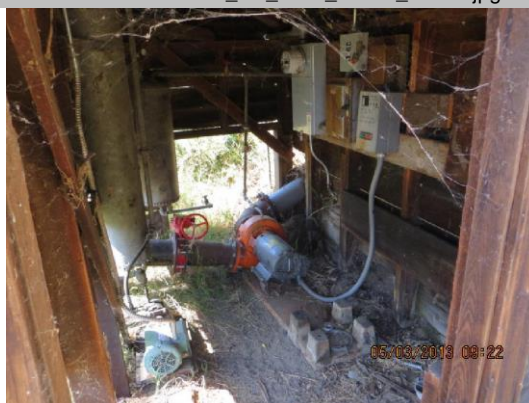
Photo 1 of 3 : UCIP_SP_2018_16143_27242.jpg

Comment Code						
Inspector Comment						
FS_ID:16143 DS_ID:21926 EP_NO: 8661 Repair Type: Non-Urgent Crossing Status: Found UCIP Comments: Dip in crown over alignment of pipe. Good candidate for video inspection. FIELD_STRUCT_DESC: 8-inch irrigation pipe of an unknown material through the levee, 3.7 feet below the crown. Pump in pump house on the landside (LS) slope. Service pole and 30-inch concrete standpipe at the LS toe (Automatic Board Order (ABO) issued as Permit No. 8661, 1972 - Jesse Marks). [Additional Reference(s): DWR Levee Log, 2005. USACE Sacramento O&M Manual 102, April 1959, (RM 12.2) (Reclamation District No. 2067) steel pipe listed]. FS Date: 5/3/2013

Pump and butterfly valve in pumphouse on LS toe.

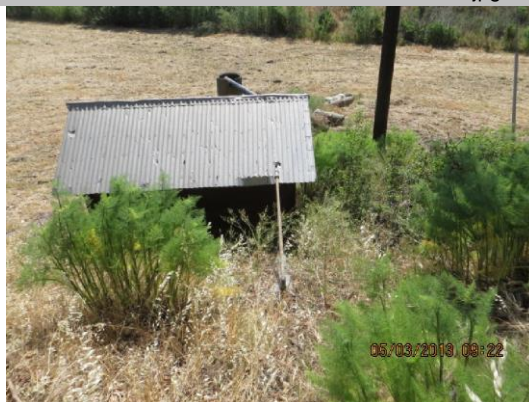
Photo 2 of 3 : UCIP_SP_2018_16143_27241.jpg

Pumphouse with concrete standpipe in background on LS toe.

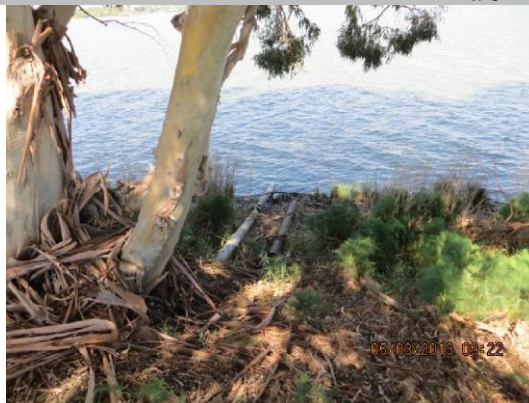
Photo 3 of 3 : UCIP_SP_2018_16143_27240.jpg

Comment Code						
Inspector Comment						
FS_ID:16143 DS_ID:21926 EP_NO: 8661 Repair Type: Non-Urgent Crossing Status: Found UCIP Comments: Dip in crown over alignment of pipe. Good candidate for video inspection. FIELD_STRUCT_DESC: 8-inch irrigation pipe of an unknown material through the levee, 3.7 feet below the crown. Pump in pump house on the landside (LS) slope. Service pole and 30-inch concrete standpipe at the LS toe (Automatic Board Order (ABO) issued as Permit No. 8661, 1972 - Jesse Marks). [Additional Reference(s): DWR Levee Log, 2005. USACE Sacramento O&M Manual 102, April 1959, (RM 12.2) (Reclamation District No. 2067) steel pipe listed]. FS Date: 5/3/2013

Pipe on WS slope.

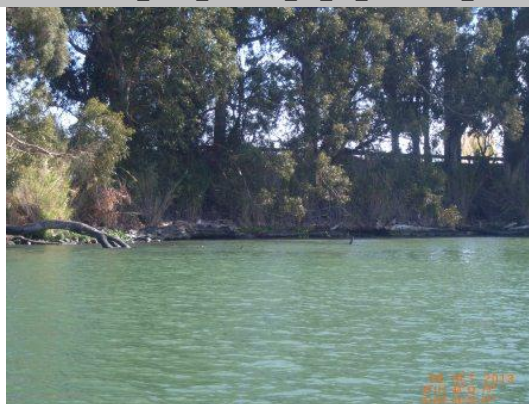
Photo 1 of 1 : SP_2018_NA0002_63_17_20180305_00024.jpg

LM Start	8.20	Rating **	U	Issue No.	17
LM End	8.42	Issue Type +	Ma	Location *	WS
Category	Supplemental			GPS Latitude/Longitude	
				Start	End
Item	2015 USACE Erosion Survey, DRAFT			38.151867 °	38.148711 °
				-121.682201 °	-121.682790 °
DWR ID	DWR_NA0002_02_s_2016_17				
Comment Code					
Inspector Comment					
2010 - Small inlet area behind a man-built spit. Bank is slumping and could possibly be fixed with maintenance. 2011 - Site continues to worsen. 2015: Upgraded to Critical [2015 Site ID: SAC_12-1_L]

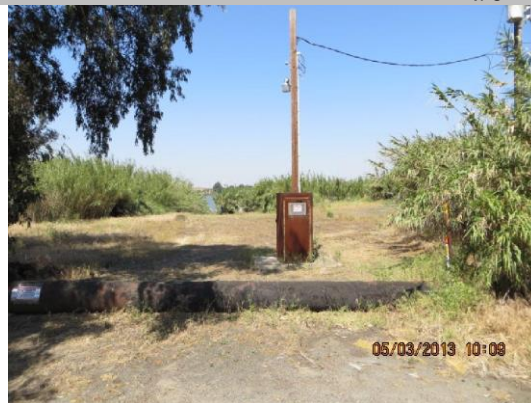
Photo 1 of 2 : UCIP_SP_2018_12886_20946.jpg

LM Start	8.55	Rating **	M	Issue No.	172
LM End	8.55	Issue Type +	En	Location *	
Category	Supplemental			GPS Latitude/Longitude	
				Start	End
Item	DWR UCIP Field Study			38.146784 °	38.146784 °
				-121.682780 °	-121.682780 °
DWR ID					
Comment Code					
Inspector Comment					
FS_ID:12886 DS_ID:21929 EP_NO: 842 Repair Type: Non-Urgent Crossing Status: Indicator Found UCIP Comments: Need to determine disposition of pipe. FIELD_STRUCT_DESC: 12-inch gas pipeline of an unknown material through the levee, 3 feet below the crown. Gas line marker and vent on the waterside (WS) shoulder. (Permit No. 842, 1940 - PG&E). [Additional Reference(s): DWR Levee Log, 2005]. FS Date: 5/3/2013

Gasline marker and vent to right of JP.

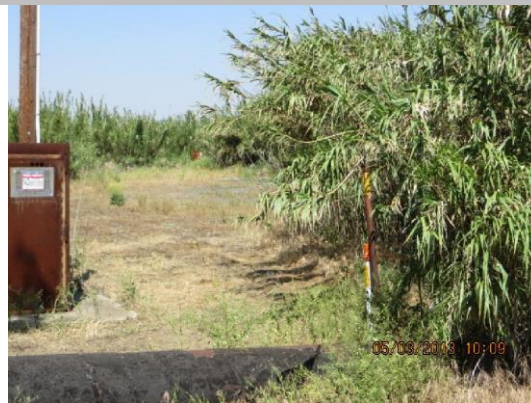
Photo 2 of 2 : UCIP_SP_2018_12886_20945.jpg

Gasline marker and vent to right of JP.

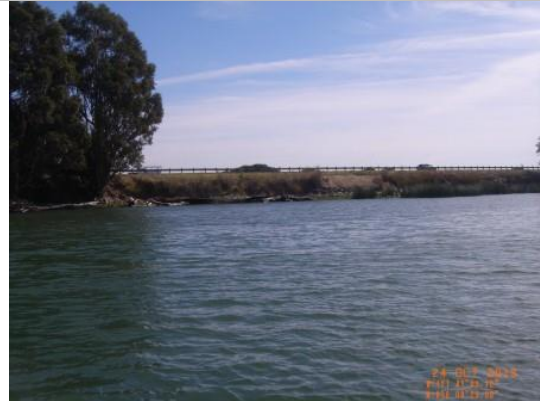
Photo 1 of 1 : SP_2018_NA0002_63_19_20180305_00025.jpg

LM Start	8.96	Rating **	U	Issue No.	19
LM End	9.18	Issue Type +	Ma	Location *	WS
Category	Supplemental			GPS Latitude/Longitude	
				Start	End
Item	2015 USACE Erosion Survey, DRAFT			38.141399 °	38.138158 °
				-121.685346 °	-121.686531 °
DWR ID	DWR_NA0002_02_s_2016_19				
Comment Code					
Inspector Comment					
2008 - Erosion causing vertical bank at the highway on top of levee. The whole bank along the highway should be repaired. 2009 - Minimal new erosion. 2011 - Bank continues to slowly erode. 2012 - Upgrade to critical, new erosion since lat year and steeper slopes in sections. 2015: Road foundation and cables exposed. Extremely large tree with exposed roots looks likely to fail and take out a significant portion of the levee. [2015 Site ID: SAC_11-2_L]

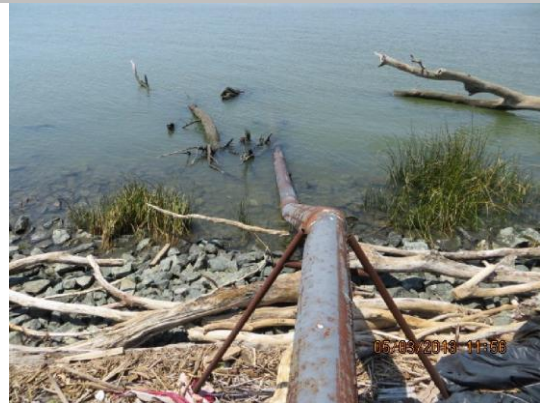
Photo 1 of 3 : UCIP_SP_2018_40528_21002.jpg

Comment Code					
Inspector Comment					
FS_ID:40528 DS_ID:21931 EP_NO: 16011 Repair Type: Non-Urgent Crossing Status: Found UCIP Comments: Annular space between pipes should be grouted. IF abandoned, these pipes should be abandoned properly. FIELD_STRUCT_DESC: 18-inch corrugated metal conduit pipe through the levee, 4.5 feet below the crown. Inactive 12-inch pipe sleeved through 18-inch. Both ends open. Siphon breaker and air valve in 24-inch corrugated metal riser unit on the landside (LS) shoulder. 9-foot by 5-foot concrete box with slide gate off LS toe. [Additional Reference(s): DWR Levee Log, 2005. USACE Sacramento O&M Manual 102, April 1959, (RM 10.9) (Reclamation District No. 2067) steel pipe listed]. FS Date: 5/3/2013

Pipe on WS slope.

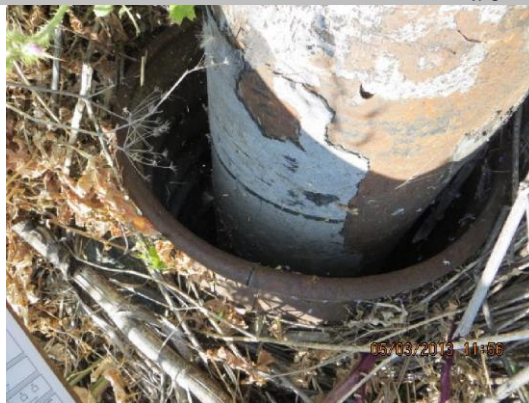
Photo 2 of 3 : UCIP_SP_2018_40528_21001.jpg

LM Start	9.36	Rating **	M	Issue No.	175 (cont)
LM End	9.36	Issue Type +	Ma	Location *

18-inch CMP with 12-inch irrigation pipe sleeved through it.

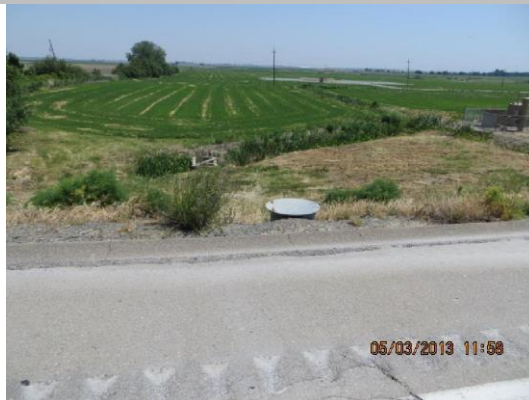
Photo 3 of 3 : UCIP_SP_2018_40528_21000.jpg

Standpipe and concrete box at LS.

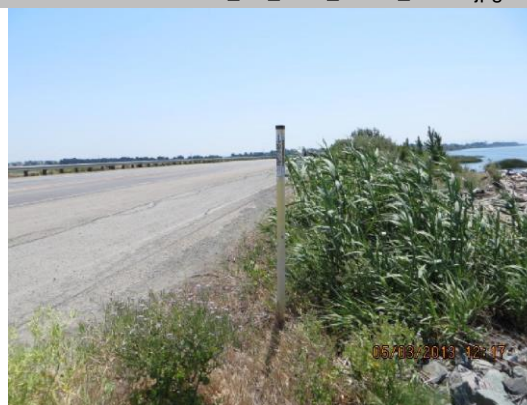
Photo 1 of 2 : UCIP_SP_2018_16146_27251.jpg

LM Start	9.50	Rating **	M	Issue No.	176
LM End	9.50	Issue Type +	En	Location *	
Category	Supplemental			GPS Latitude/Longitude	
				Start	End
Item	DWR UCIP Field Study			38.133512 °	38.133512 °
				-121.685948 °	-121.685948 °
DWR ID					
Comment Code					
Inspector Comment					
FS_ID:16146					
DS_ID:23142					
EP_NO: N/A					
Repair Type: Non-Urgent					
Crossing Status: Indicator Found					
UCIP Comments: Need to determine Permit No. for this crossing.					
FIELD_STRUCT_DESC: Gas line markers on the landside (LS) toe and waterside (WS) shoulder.					
FS Date: 5/3/2013

Gasline Marker on WS shoulder

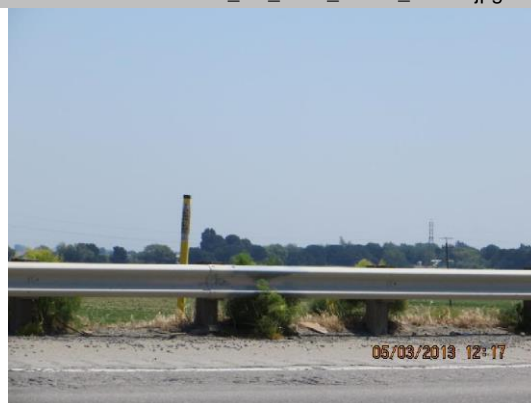
Photo 2 of 2 : UCIP_SP_2018_16146_27250.jpg

Gasline Marker on LS shoulder

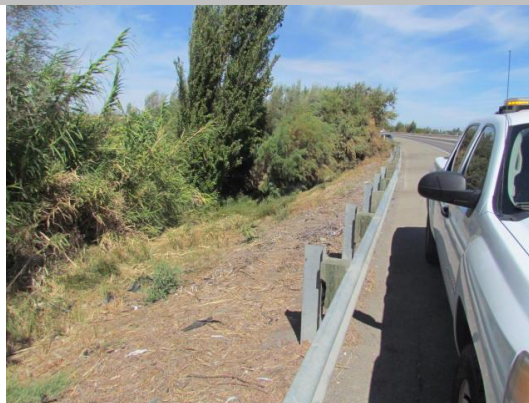
Photo 2 of 2 : SP_2018_NA0002_63_16_20180305_00023.jpg

LM Start	9.58	Rating **	U	Issue No.	16 (cont)	
LM End	9.71	Issue Type +	Ma	Location *	WS	
Category	Earthen Levee			GPS Latitude/Longitude		
				Start		End
Item	Trim / Thin Trees			38.132361 °		38.130537 °
				-121.686173 °		-121.686737 °
DWR ID	DWR_NA0002_02_s_2012_16					
Comment Code						
T3 : Trim and thin trees to allow visibility of the ground and room to flood fight.						
Inspector Comment						
Untrimmed trees within twenty foot zone on waterside slope.

Looking north at dense vegetation (trees) on waterward slope.

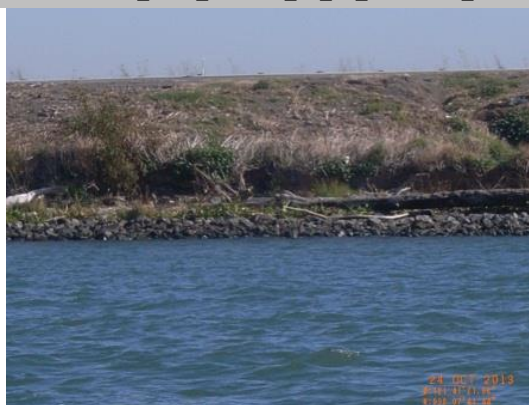
Photo 1 of 1 : SP_2018_NA0002_63_21_20180305_00027.jpg

LM Start	9.78	Rating **	M	Issue No.	21
LM End	9.93	Issue Type +	Ma	Location *	WS
Category	Supplemental			GPS Latitude/Longitude	
				Start	End
Item	2015 USACE Erosion Survey, DRAFT			38.129722 °	38.127672 °
				-121.687468 °	-121.688646 °
DWR ID	DWR_NA0002_02_s_2016_21

Comment Code					
Inspector Comment					
2004 - Wave wash pockets approximately 100 ft long with new full bank rock between the pockets. 2005 - Spot repairs, but toe is still eroding in several places. 2006 - Low vertical bank along roadway. 2007 - A PL 84-99 repair was constructed, it cover the majority of the site with the exception of the upstream 150 to 200 ft and the downstream 250 ft, therefore it is being kept in the inventory. 2009 - Minimal new erosion. 2010 - Outboard berm looks good, but the banks are still very steep. 2011 - While the outboard berm is protecting against wave wash, bank still has slumping issues. 2015: No observed changes. [2015 Site ID: SAC_10-8_L]

USACE 2013 Photo #1

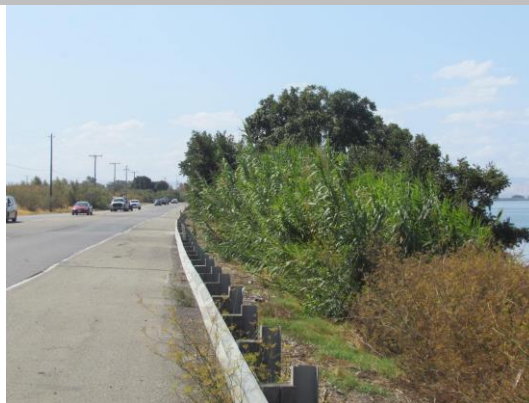
Photo 1 of 2 : SP_2018_NA0002_63_107_20180305_00082.jpg

LM Start	10.26	Rating **	U	Issue No.	107
LM End	11.10	Issue Type +	Ma	Location *	WS
Category	Earthen Levee			GPS Latitude/Longitude	
				Start	End
Item	Vegetation			38.123119 °	38.112414 °
				-121.690488 °	-121.697904 °
DWR ID	DWR_NA0002_02_f_2014_107				
Comment Code					
V2 : Remove the wild growth other than native grasses from the levee slopes.					
Inspector Comment					
Vegetation on waterside slope.

Looking south at bamboo and other vegetation on waterward slope. (Fall 2016)

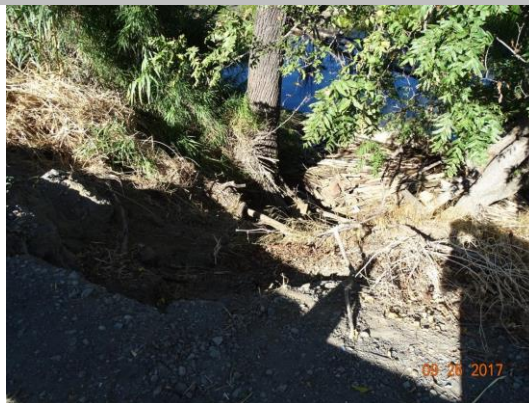
Photo 1 of 1 : SP_2018_NA0002_63_119_20180305_00097.jpg

LM Start	10.74	Rating **	M	Issue No.	119
LM End	10.74	Issue Type +	Ma	Location *	WS
Category	Earthen Levee			GPS Latitude/Longitude	
				Start	End
Item	Erosion / Bank Caving			38.116906 °	38.116906 °
				-121.694595 °	-121.694595 °
DWR ID	DWR_NA0002_02_f_2017_119				
Comment Code					
E2 : Schedule repair of erosion site prior to the next inspection.					
Inspector Comment

Looking northwest at the waterside slope.
