**Flood Control Project Maintenance
Levee Inspections**
LMA District Cover Sheet
Spring 2019 Levee Inspection Results

Brannan Andrus Levee Maintenance District

Spring 2019 Levee Inspection Results

Waterway			Bank	Unit Miles
Unit No. 01 Georgiana Slough			Right	6.01
	Spring (March - May)	Summer (June - August)	(September - November) Fall	Winter (December - February)
Unit Maintenance Rating (Fall Only)				
Date of Inspection	4/23/2019 - 4/23/2019			
DWR Inspector	David Julian			
Accompanied By

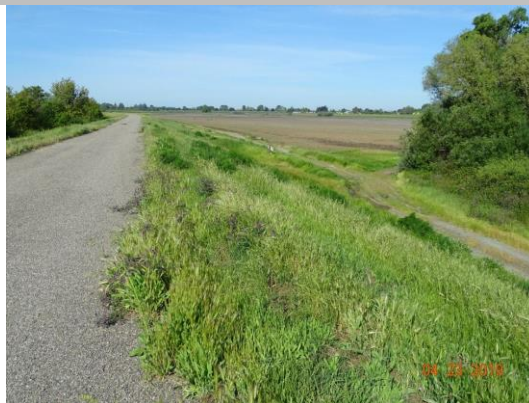
Photo 1 of 1 : SP_2019_NA0002_62_37_20190423_00096.jpg

LM Start	0.02	Rating **	M	Issue No.	37
LM End	2.25	Issue Type +	Ma	Location *	LS
Category	Earthen Levee			GPS Latitude/Longitude	
				Start	End
Item	Vegetation			38.186351 °	38.163473 °
				-121.562967 °	-121.584398 °
DWR ID	DWR_NA0002_01_s_2019_37				
Comment Code					
V1 : Control annual grass and weeds on the levee slopes and easements.					
Inspector Comment					
Maintain annual vegetation

View looking downstream at annual vegetation on the landside slope (Spring 2019).

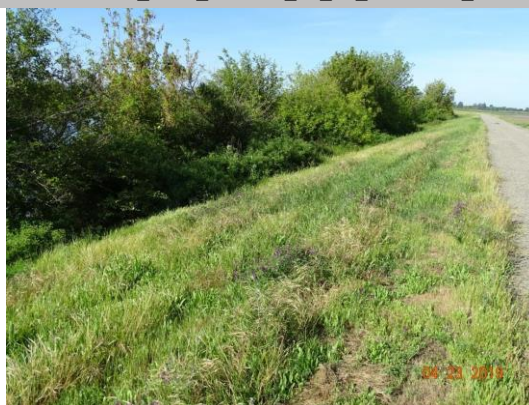
Photo 1 of 1 : SP_2019_NA0002_62_35_20190423_00095.jpg

LM Start	0.02	Rating **	M	Issue No.	35
LM End	2.25	Issue Type +	Ma	Location *	WS
Category	Earthen Levee			GPS Latitude/Longitude	
				Start	End
Item	Vegetation			38.186351 °	38.163473 °
				-121.562968 °	-121.584397 °
DWR ID	DWR_NA0002_01_s_2019_35				
Comment Code					
V1 : Control annual grass and weeds on the levee slopes and easements.					
Inspector Comment					
Maintain annual vegetation

View looking downstream at annual vegetation on the waterside slope (Spring 2019).

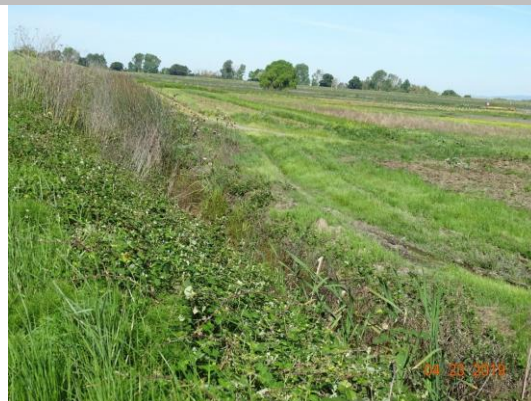
Photo 1 of 1 : SP_2019_NA0002_62_38_20190423_00097.jpg

LM Start	0.49	Rating **	M	Issue No.	38
LM End	0.75	Issue Type +	En	Location *	LS
Category	Earthen Levee			GPS Latitude/Longitude	
				Start	End
Item	Encroachments			38.182760 °	38.182217 °
				-121.570358 °	-121.574883 °
DWR ID	DWR_NA0002_01_s_2019_38				
Comment Code					
DT : Ditch					
Inspector Comment					
Ditch at landside toe

View looking downstream at ditch at the landside toe (Spring 2019).

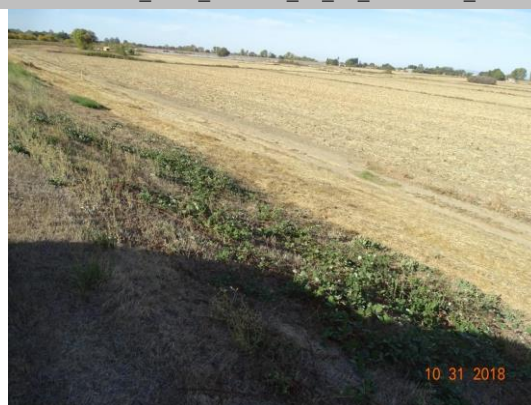
Photo 1 of 1 : SP_2019_NA0002_62_41_20190311_00024.jpg

LM Start	0.50	Rating **	M	Issue No.	41
LM End	0.57	Issue Type +	Ma	Location *	LS
Category	Earthen Levee			GPS Latitude/Longitude	
				Start	End
Item	Vegetation			38.182700 °	38.182258 °
				-121.570470 °	-121.571647 °
DWR ID	DWR_NA0002_01_f_2018_41				
Comment Code					
V2 : Remove the wild growth other than native grasses from the levee slopes.					
Inspector Comment					
Remove blackberries before they get established.

View looking slightly downstream of newly established black berries (October 2018).

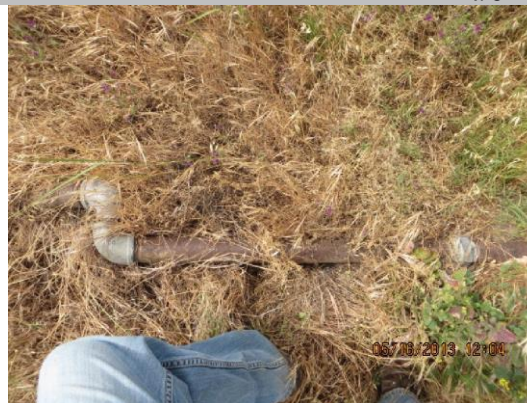
Photo 3 of 3 : UCIP_SP_2019_13560_22171.jpg

LM Start	0.61	Rating **	M	Issue No.	91 (cont)	
LM End	0.61	Issue Type +	En	Location *		
Category	Supplemental			GPS Latitude/Longitude		
				Start	End	
Item	DWR UCIP Field Study			38.182213 °	38.182213 °	
				-121.572357 °	-121.572357 °	
DWR ID	21752					
Comment Code						
Inspector Comment						
FS_ID:13560						
DS_ID:21752						
EP_NO: 2015						
Repair Type: Non-Urgent						
Crossing Status: Found						
UCIP Comments: This pipe appears abandoned and should be removed.						
FIELD_STRUCT_DESC: 2-inch galvanized iron wastewater pipe through the levee, 2 feet below the crown. Gas well drain. (Permit No. 2015, 1954 - Brazos Oil and Gas Company). [Additional Reference(s): DWR Levee Log, 2005].						
FS Date: 5/16/2013

Pipe on LS slope.

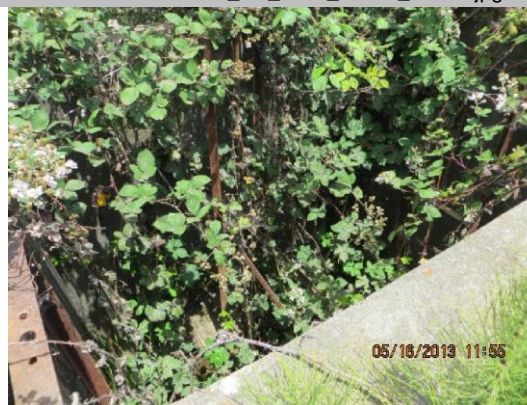
Photo 1 of 1 : UCIP_SP_2019_15984_26969.jpg

LM Start	0.75	Rating **	M	Issue No.	92
LM End	0.75	Issue Type +	En	Location *	
Category	Supplemental			GPS Latitude/Longitude	
				Start	End
Item	DWR UCIP Field Study			38.182212 °	38.182212 °
				-121.574987 °	-121.574987 °
DWR ID	21753

Comment Code					
Inspector Comment					
FS_ID:15984 DS_ID:21753 EP_NO: 11232 Repair Type: Non-Urgent Crossing Status: Found UCIP Comments: Unable to locate any appurtances other than distro box. Need to verify proper abandonment. FIELD_STRUCT_DESC: 12-inch steel irrigation pipe through the levee, 3.2 feet below the crown. Siphon breaker on the landside (LS) slope. Concrete distribution box located LS of the toe. 2-inch primer valve. (Automatic Board Order (ABO) issued as Permit No. 11232, 1975 - Mario Campi). [Additional Reference(s): DWR Levee Log, 2005. USACE Sacramento O&M Manual 103, June 1954, (Station ""R"" 279+70) Drawing No. 50-4-2631]. FS Date: 5/16/2013

Concrete distribution box on LS toe.

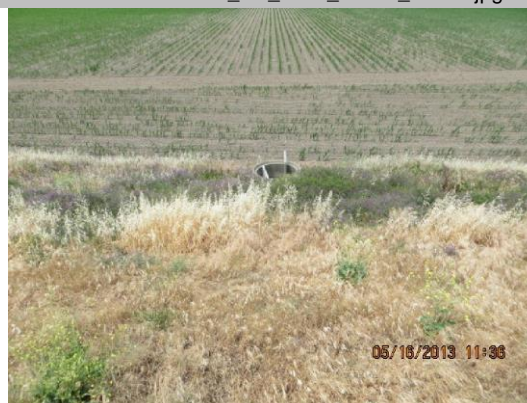
Photo 1 of 3 : UCIP_SP_2019_13558_22169.jpg

LM Start	1.22	Rating **	M	Issue No.	93
LM End	1.22	Issue Type +	En	Location *	
Category	Supplemental			GPS Latitude/Longitude	
				Start	End
Item	DWR UCIP Field Study			38.177669 °	38.177669 °
				-121.580222 °	-121.580222 °
DWR ID	21754				
Comment Code					
Inspector Comment					
FS_ID:13558 DS_ID:21754 EP_NO: 11234 Repair Type: Non-Urgent Crossing Status: Found UCIP Comments: Appears abandoned and should be done so properly. FIELD_STRUCT_DESC: 1 of 2: 8-inch steel irrigation pipe through the levee, 4.3 feet below the crown. Pump in pump house on the waterside (WS) berm. 60-inch diameter concrete standpipe on the landside (LS) toe. (Automatic Board Order (ABO) issued as Permit No. 11234, 1975 - Anthony and John Correia). [Additional Reference(s): USACE Sacramento O&M Manual 103, June 1954, (Station ""R"" 255+00) Drawing No. 50-4-2631]. FS Date: 5/16/2013

Concrete standpipe on LS toe.

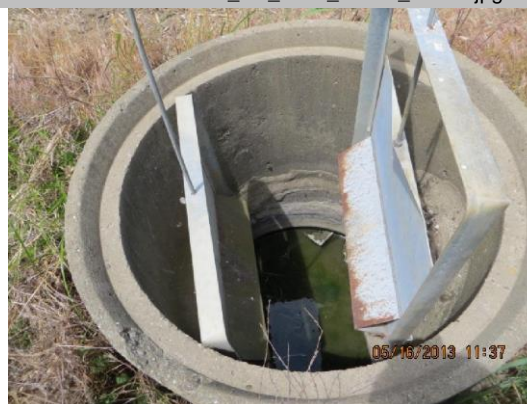
Photo 2 of 3 : UCIP_SP_2019_13558_22168.jpg

LM Start	1.22	Rating **	M	Issue No.	93 (cont)
LM End	1.22	Issue Type +	En	Location *

Concrete standpipe on LS toe.

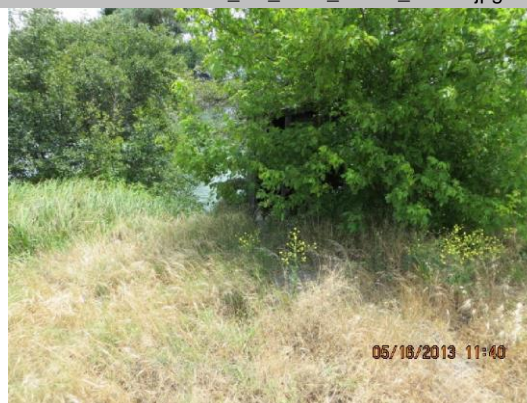
Photo 3 of 3 : UCIP_SP_2019_13558_22167.jpg

LM Start	1.22	Rating **	M	Issue No.	93 (cont)	
LM End	1.22	Issue Type +	En	Location *		
Category	Supplemental			GPS Latitude/Longitude		
				Start		End
Item	DWR UCIP Field Study			38.177669 °		38.177669 °
				-121.580222 °		-121.580222 °
DWR ID	21754					
Comment Code						
Inspector Comment						
FS_ID:13558 DS_ID:21754 EP_NO: 11234 Repair Type: Non-Urgent Crossing Status: Found UCIP Comments: Appears abandoned and should be done so properly. FIELD_STRUCT_DESC: 1 of 2: 8-inch steel irrigation pipe through the levee, 4.3 feet below the crown. Pump in pump house on the waterside (WS) berm. 60-inch diameter concrete standpipe on the landside (LS) toe. (Automatic Board Order (ABO) issued as Permit No. 11234, 1975 - Anthony and John Correia). [Additional Reference(s): USACE Sacramento O&M Manual 103, June 1954, (Station ""R"" 255+00) Drawing No. 50-4-2631]. FS Date: 5/16/2013

Pumphouse on WS slope.

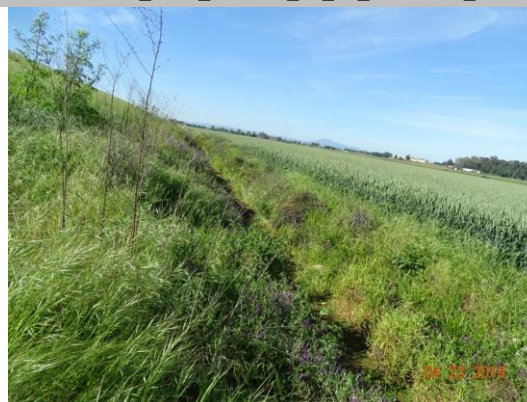
Photo 1 of 1 : SP_2019_NA0002_62_56_20190423_00098.jpg

LM Start	1.22	Rating **	M	Issue No.	56
LM End	2.17	Issue Type +	En	Location *	LS
Category	Earthen Levee			GPS Latitude/Longitude	
				Start	End
Item	Encroachments			38.177635 °	38.164597 °
				-121.580241 °	-121.583921 °
DWR ID	DWR_NA0002_01_s_2019_56				
Comment Code					
DT : Ditch					
Inspector Comment					
Ditch at the landside toe

View looking downstream at ditch at the landside toe (Spring 2019).

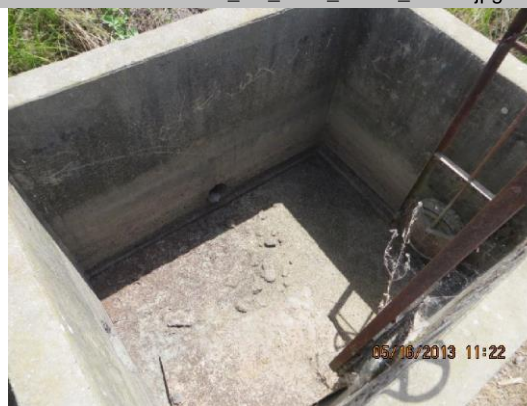
Photo 1 of 3 : UCIP_SP_2019_13554_22164.jpg

Comment Code					
Inspector Comment					
FS_ID:13554 DS_ID:21755 EP_NO: 11252 Repair Type: Non-Urgent Crossing Status: Found UCIP Comments: Pipe heavily rusted at distribution box. Good candidate for video inspection. FIELD_STRUCT_DESC: 1 of 3: 8-inch steel irrigation pipe through the levee, 4.6 feet below the crown. Pump and valve on the waterside (WS) slope. Siphon breaker in 24-inch corrugated metal riser unit on the landside (LS) shoulder. 7-foot by 10-foot concrete distribution box on the LS toe. (Automatic Board Order (ABO) issued as Permit No. 11252, 1975 - Hubert and Palmyra Vandermaele). [Additional Reference(s): DWR Levee Log, 2005. USACE Sacramento O&M Manual 103, June 1954, (Station ""R"" 237+13) Drawing No. 50-4-2631]. FS Date: 5/16/2013

7X10-foot concrete distribution box on LS toe.

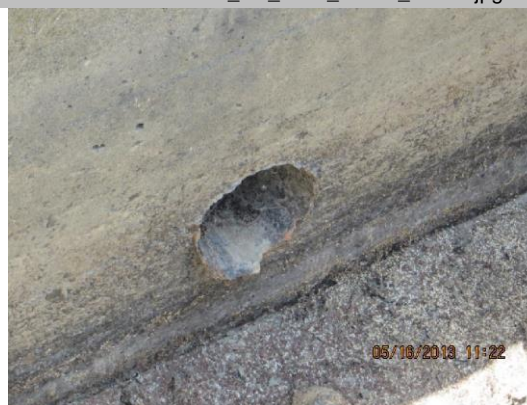
Photo 2 of 3 : UCIP_SP_2019_13554_22163.jpg

LM Start	1.54	Rating **	M	Issue No.	94 (cont)
LM End	1.54	Issue Type +	En	Location *

Pipe shows excessive rust at inlet to distribution box on LS toe.

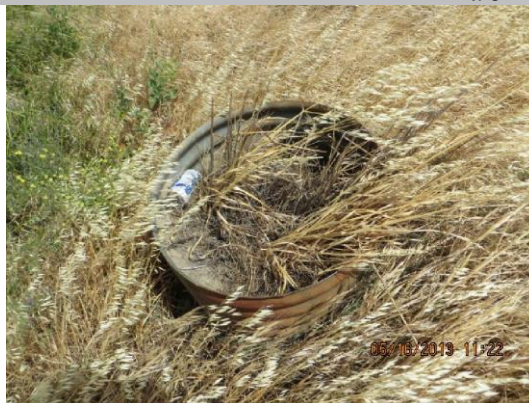
Photo 3 of 3 : UCIP_SP_2019_13554_22162.jpg

Comment Code						
Inspector Comment						
FS_ID:13554 DS_ID:21755 EP_NO: 11252 Repair Type: Non-Urgent Crossing Status: Found UCIP Comments: Pipe heavily rusted at distribution box. Good candidate for video inspection. FIELD_STRUCT_DESC: 1 of 3: 8-inch steel irrigation pipe through the levee, 4.6 feet below the crown. Pump and valve on the waterside (WS) slope. Siphon breaker in 24-inch corrugated metal riser unit on the landside (LS) shoulder. 7-foot by 10-foot concrete distribution box on the LS toe. (Automatic Board Order (ABO) issued as Permit No. 11252, 1975 - Hubert and Palmyra Vandermaele). [Additional Reference(s): DWR Levee Log, 2005. USACE Sacramento O&M Manual 103, June 1954, (Station ""R"" 237+13) Drawing No. 50-4-2631]. FS Date: 5/16/2013

CMP riser on LS slope.

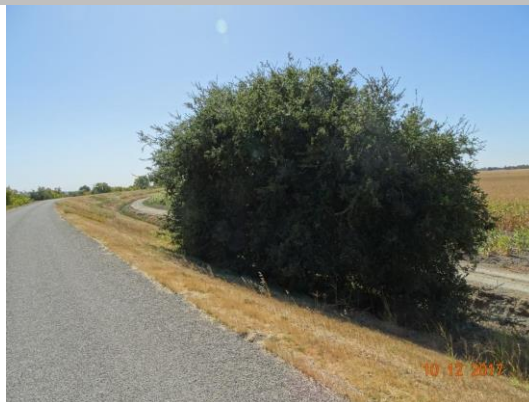
Photo 1 of 1 : SP_2019_NA0002_62_25_20190311_00016.jpg

LM Start	1.56	Rating **	U	Issue No.	25
LM End	1.56	Issue Type +	Ma	Location *	LS
Category	Earthen Levee			GPS Latitude/Longitude	
				Start	End
Item	Trim / Thin Trees			38.172869 °	38.172869 °
				-121.580681 °	-121.580681 °
DWR ID	DWR_NA0002_01_s_2012_25				
Comment Code					
T1 : Trim trees to at least five feet above ground level.					
Inspector Comment					
Tree blocking landside toe.

Looking southwest at the landside slope.

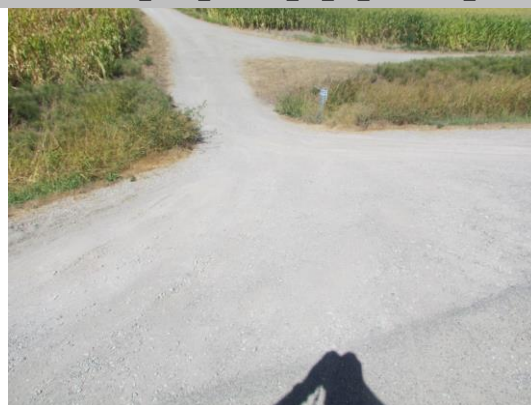
Photo 1 of 1 : SP_2019_NA0002_62_74_20190311_00045.jpg

LM Start	1.79	Rating **	U	Issue No.	74
LM End	1.79	Issue Type +	En	Location *	LS
Category	Earthen Levee			GPS Latitude/Longitude	
				Start	End
Item	Encroachments			38.169625 °	38.169625 °
				-121.581542 °	-121.581542 °
DWR ID	DWR_NA0002_01_f_2016_74				
Comment Code					
RA : Ramp					
Inspector Comment					
The Landowner has created a gravel-covered ramp up the land side of the levee. A permit Application should be submitted and the ramp should be brought up to Title 23 standards after approval.

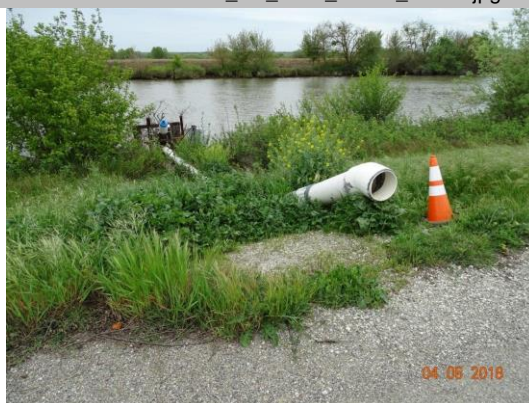
Photo 1 of 2 : UCIP_SP_2019_52615_77544.jpg

FS_ID:52615
DS_ID:21758
EP_NO: 11252
Repair Type: Non-Urgent
Crossing Status: Found
UCIP Comments: 04/06/2017 Landowner has installed a temporary pipe and removed old pipe. Photos and update courtesy of DWR Inspector, Richard Willoughby.05/16/2013 Pipe rusted through at inlet to box. Good candidate for video inspection. (G. Wylie - DWR)
FIELD_STRUCT_DESC: *REMOVED* 3 of 3: 12-inch steel pipe through the levee 4.0 feet below the crown. Slant pump on bank. Switch box on berm, conduit through levee. Siphon breaker in 24-inch CMP riser on landward slope. Power pole and electrical panel at landward toe (ABO No. 11252, 1975). 7'X10' concrete distribution box on LS toe. As per Richard Willoughby, FPIIB Inspector, landowner has installed a temporary 12-inch PVC pipe on the WS and removed this pipe. New pipe forthcoming. Originally included in the 1954 O&M manual.
FS Date: 4/6/2017

A view of disconnected temporary pipe on waterside. Photo courtesy of DWR inspector Keith E Millard.

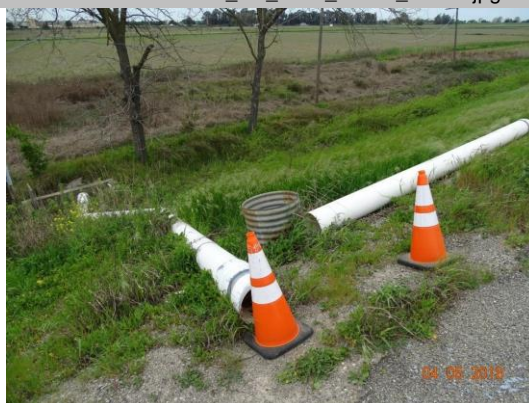
Photo 2 of 2 : UCIP_SP_2019_52615_77545.jpg

A view of disconnected temporary pipe on landside. Photo courtesy of DWR inspector Keith E Millard.

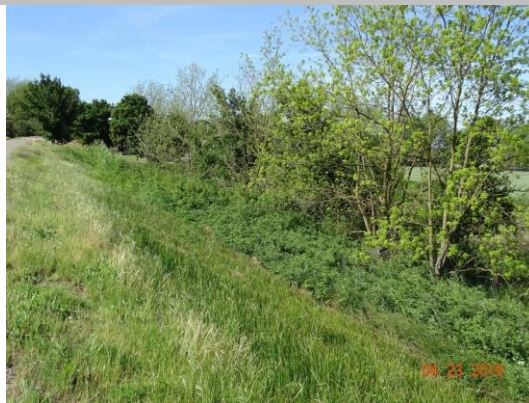
Photo 1 of 1 : SP_2019_NA0002_62_42_20190423_00099.jpg

LM Start	2.19	Rating **	U	Issue No.	42
LM End	2.23	Issue Type +	Ma	Location *	LS
Category	Earthen Levee			GPS Latitude/Longitude	
				Start	End
Item	Vegetation			38.164292 °	38.163777 °
				-121.584028 °	-121.584246 °
DWR ID	DWR_NA0002_01_s_2019_42				
Comment Code					
V2 : Remove the wild growth other than native grasses from the levee slopes.					
Inspector Comment					
Remove wildgrowth all the way down the landside slope

View looking downstream at vegetation on the landside slope (Spring 2019).

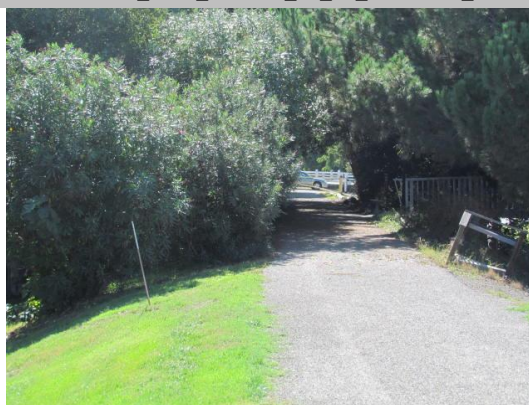
Photo 1 of 4 : SP_2019_NA0002_62_36_20190311_00019.jpg

LM Start	2.29	Rating **	U	Issue No.	36
LM End	2.34	Issue Type +	En	Location *	LS
Category	Earthen Levee			GPS Latitude/Longitude	
				Start	End
Item	Vegetation			38.162918 °	38.162322 °
				-121.584721 °	-121.585081 °
DWR ID	DWR_NA0002_01_s_2012_36				
Comment Code					
V6 : Landscaping					
Inspector Comment					
Vegetation is starting to impede patrol road.

Looking south at dense landscaping on the waterside and landside of levee.

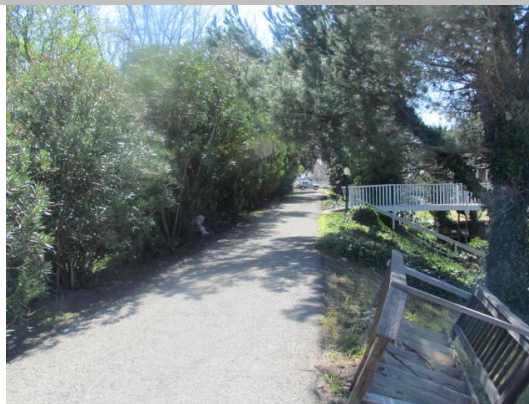
Photo 2 of 4 : SP_2019_NA0002_62_36_20190311_00020.jpg

LM Start	2.29	Rating **	U	Issue No.	36 (cont)
LM End	2.34	Issue Type +	En	Location *	LS

Looking south at dense oleander on waterside shoulder, spring 2012.

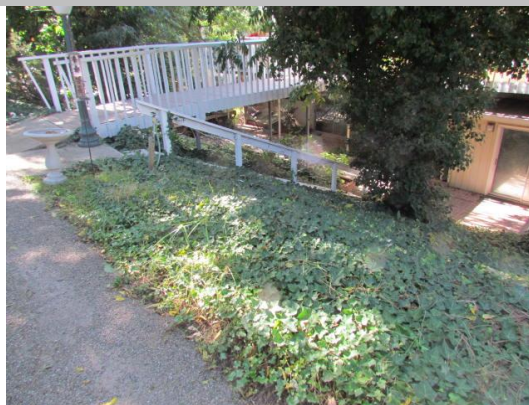
Photo 4 of 4 : SP_2019_NA0002_62_36_20190311_00022.jpg

LM Start	2.29	Rating **	U	Issue No.	36 (cont)
LM End	2.34	Issue Type +	En	Location *	LS

Looking west at ground cover on landside slope.

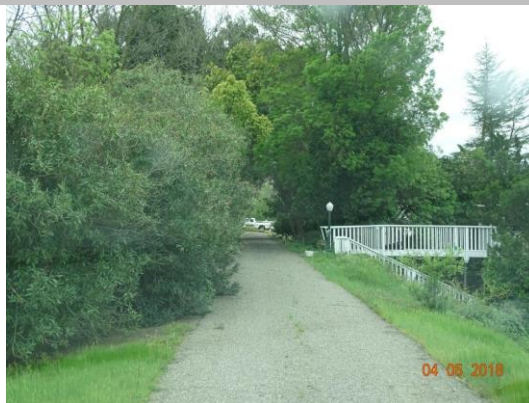
Photo 1 of 1 : SP_2019_NA0002_62_58_20190311_00035.jpg

LM Start	2.30	Rating **	U	Issue No.	58
LM End	2.30	Issue Type +	En	Location *	WS
Category	Earthen Levee			GPS Latitude/Longitude	
				Start	End
Item	Vegetation			38.162806 °	38.162806 °
				-121.584768 °	-121.584768 °
DWR ID	DWR_NA0002_01_s_2018_58				
Comment Code					
V6 : Landscaping					
Inspector Comment					
Remove oleanders.

Remove or thin waterside oleanders.

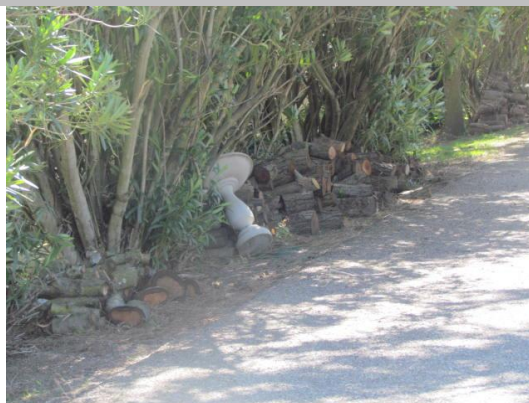
Photo 2 of 3 : SP_2019_NA0002_62_3_20190311_00003.jpg

LM Start	2.30	Rating **	M	Issue No.	3 (cont)
LM End	2.32	Issue Type +	En	Location *	WS

Looking southeast at firewood on waterside shoulder.

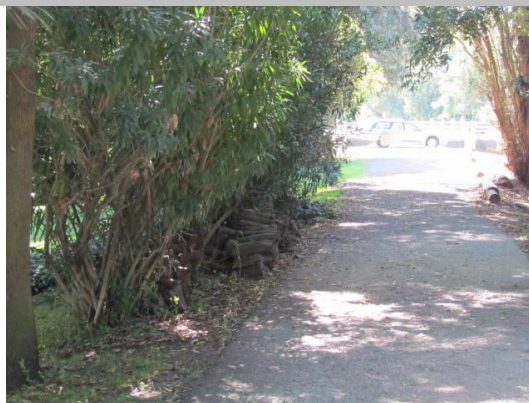
Photo 3 of 3 : SP_2019_NA0002_62_3_20190311_00004.jpg

LM Start	2.30	Rating **	M	Issue No.	3 (cont)
LM End	2.32	Issue Type +	En	Location *	WS

Looking south at firewood on waterside shoulder.

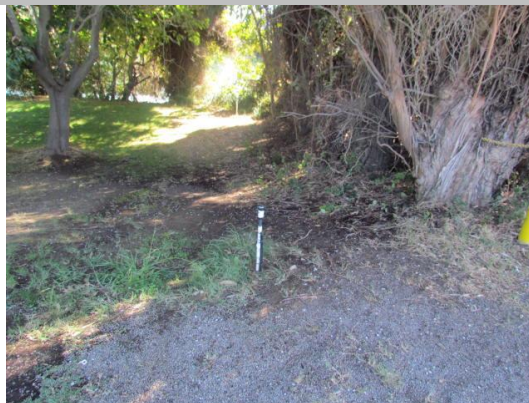
Photo 1 of 1 : SP_2019_NA0002_62_50_20190311_00031.jpg

LM Start	2.33	Rating **	M	Issue No.	50
LM End	2.33	Issue Type +	En	Location *	WS
Category	Earthen Levee			GPS Latitude/Longitude	
				Start	End
Item	Encroachments			38.162343 °	38.162343 °
				-121.585020 °	-121.585020 °
DWR ID	DWR_NA0002_01_f_2014_50				
Comment Code					
LI : Landscape Irrigation					
Inspector Comment					
Landowner installed sprinklers along waterside slope without permit.

Looking east at sprinklers on waterward slope.

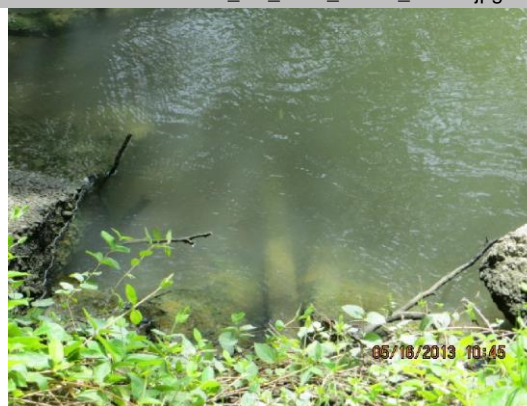
Photo 2 of 2 : UCIP_SP_2019_16123_27220.jpg

Pipe visible in water at WS toe.

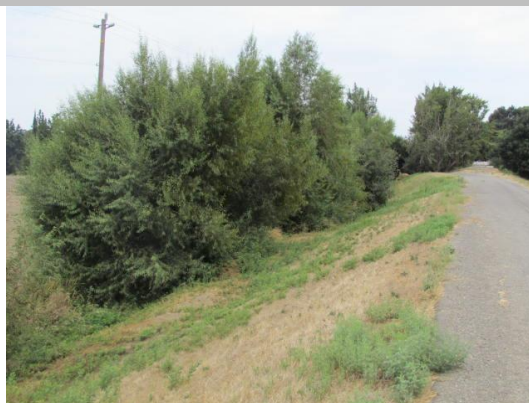
Photo 1 of 2 : SP_2019_NA0002_62_28_20190311_00017.jpg

LM Start	2.41	Rating **	U	Issue No.	28
LM End	2.49	Issue Type +	Ma	Location *	LS
Category	Earthen Levee			GPS Latitude/Longitude	
				Start	End
Item	Vegetation			38.161301 °	38.160281 °
				-121.585560 °	-121.586007 °
DWR ID	DWR_NA0002_01_s _ 2013_28				
Comment Code					
V2 : Remove the wild growth other than native grasses from the levee slopes.					
Inspector Comment					
Dense vegetation and wild roses on landside slope and toe.

Look west at dense vegetation at landward toe. (Spring 2016)

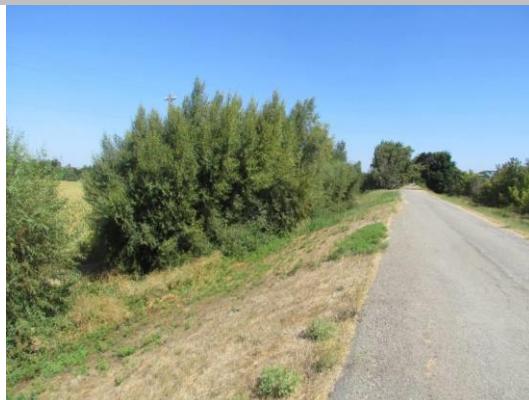
Photo 2 of 2 : SP_2019_NA0002_62_28_20190311_00018.jpg

Look west at dense vegetation at landward toe. (Fall 2016)

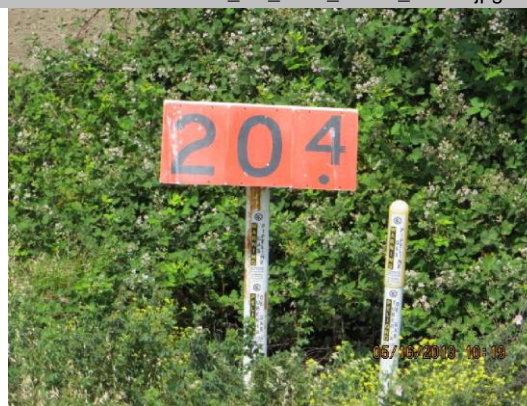
Photo 2 of 2 : UCIP_SP_2019_13525_22127.jpg

LM Start	2.54	Rating **	M	Issue No.	98 (cont)
LM End	2.54	Issue Type +	En	Location *	
Category	Supplemental			GPS Latitude/Longitude	
				Start	End
Item	DWR UCIP Field Study			38.159569 °	38.159569 °
				-121.586340 °	-121.586340 °
DWR ID	21764				
Comment Code					
Inspector Comment					
FS_ID:13525 DS_ID:21764 EP_NO: 17250 Repair Type: Non-Urgent Crossing Status: Indicator Found UCIP Comments: Needs better location markers. FIELD_STRUCT_DESC: 24-inch steel natural gas pipeline through the levee, 117 feet below the crown. Possible sign on the LS toe. (Permit No. 17250, 2001 - Lodi Gas Storage, LLC). FS Date: 5/16/2013

Gasline marker on LS toe.

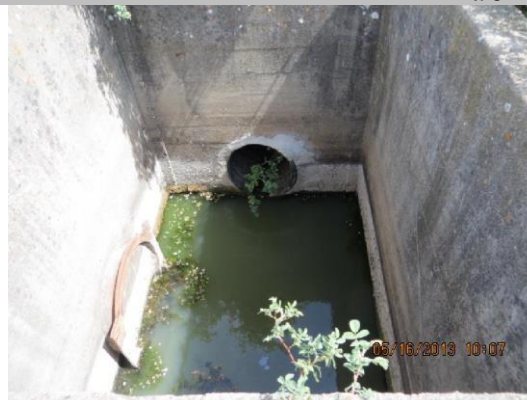
Photo 2 of 3 : UCIP_SP_2019_53386_22123.jpg

Comment Code						
Inspector Comment						
FS_ID:53386 DS_ID:21765 EP_NO: 11238 Repair Type: Urgent Crossing Status: Found UCIP Comments: 07/12/2018 Dense vegetation on both levee slopes. Unable to evaluate erosion on WS. Depression along pipe alignment on levee crown. Recommend internal inspection to determine pipe integrity through levee. (O.Yakimov-DWR UCIP)10/24/2016 Unable to access WS due to heavy vegetation--assume WS remains the same or erosion has progressed but not visible from levee crown. Pipe marker found on LS slope next to 12-inch irrigation pipe indicating high pressure unodorized natural gas pipeline however, unable to confirm if line is present or if it is parallel to levee or if it goes through levee. (O. Magana - DWR UCIP)05/16/2013 Erosion along pipe at WS toe goes into levee prism. Animal activity appears to be the cause of some pretty heavy erosion damage. Some settlement along the pipe alignment on crown may indicate other problems with this pipe. (W. Wylie - DWR UCIP) FIELD_STRUCT_DESC: 1 of 5: 12-inch irrigation steel pipe through levee 4 feet below crown. Siphon breaker is located on landside (LS) shoulder. A 7-foot by 9-foot concrete distribution box is located on LS toe. (12-inch pipe authorized under Permit No. 18549, 2009 - Stockton JACS LLC; previous 12-inch pipe was replaced and authorized under Automatic Board Order (ABO) issued as Permit No. 11238, 1975 - Gardiner Improvement Company). [Additional Reference(s): DWR Levee Log, 2005. USACE Sacramento O&M Manual Unit 103, June 1954, (Station "R" 182+63), Drawing No. 50-4-2631, 50-4-2634]. FS Date: 7/12/2018 2:39:34 PM

Concrete distribution box on LS toe.

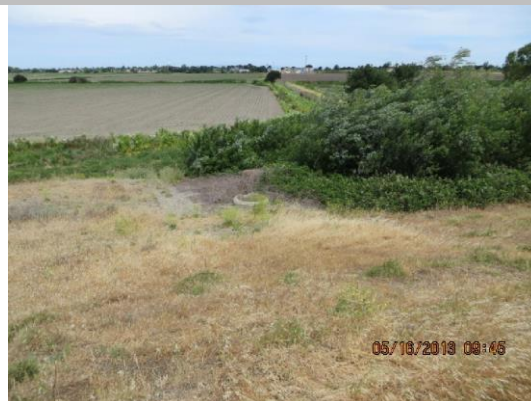
Photo 2 of 2 : UCIP_SP_2019_41561_27228.jpg

5-foot diameter concrete riser on LS toe, but no pipe visible.

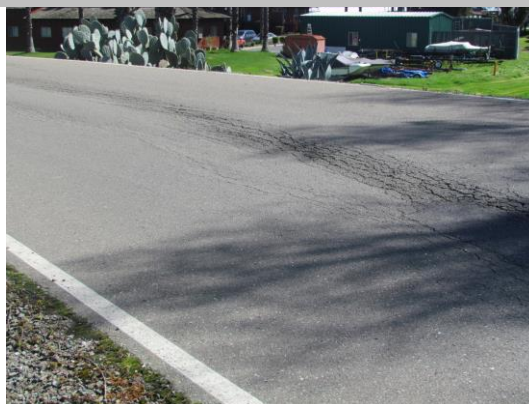
Photo 1 of 3 : SP_2019_NA0002_62_67_20190311_00042.jpg

LM Start	3.38	Rating **	A/W	Issue No.	67
LM End	3.40	Issue Type +	Ma	Location *	CR
Category	Earthen Levee			GPS Latitude/Longitude	
				Start	End
Item	Slope Stability			38.151430 °	38.151390 °
				-121.592085 °	-121.592517 °
DWR ID	DWR_NA0002_01_s_2017_67				
Comment Code					
S1 : Repair slope instability.					
Inspector Comment					
Appears to be beginning of a landside slump. LMA's Engineer (DCC) is monitoring site for movement.

Looking south at sloughing on landward shoulder.

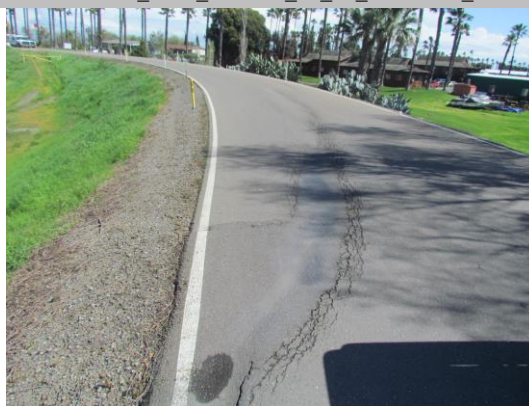
Photo 2 of 3 : SP_2019_NA0002_62_67_20190311_00043.jpg

Looking east at possible sloughing on landward shoulder.

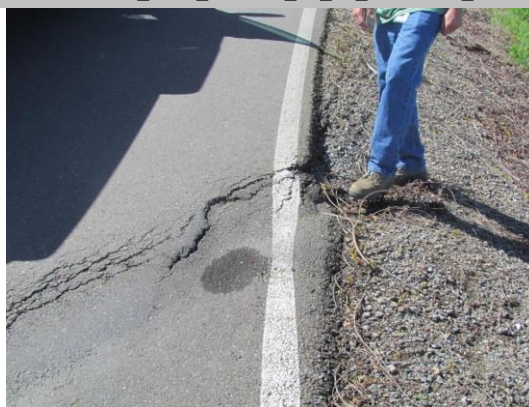
Photo 3 of 3 : SP_2019_NA0002_62_67_20190311_00044.jpg

Looking at downstream corner of slough.

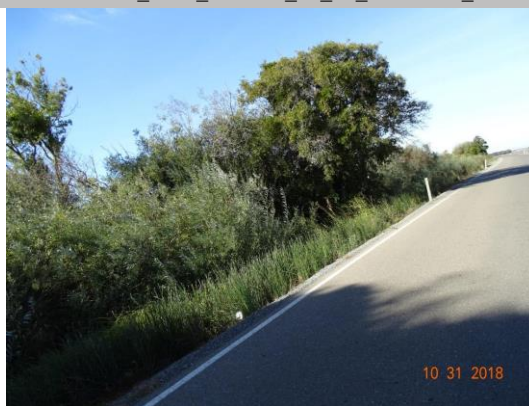
Photo 1 of 1 : SP_2019_NA0002_62_59_20190311_00036.jpg

LM Start	3.43	Rating **	U	Issue No.	59
LM End	3.95	Issue Type +	Ma	Location *	WS
Category	Earthen Levee			GPS Latitude/Longitude	
				Start	End
Item	Vegetation			38.151448 °	38.145753 °
				-121.592898 °	-121.601660 °
DWR ID	DWR_NA0002_01_f_2018_59				
Comment Code					
V2 : Remove the wild growth other than native grasses from the levee slopes.					
Inspector Comment

View looking downstream at vegetation on the water side slope (October 2018).

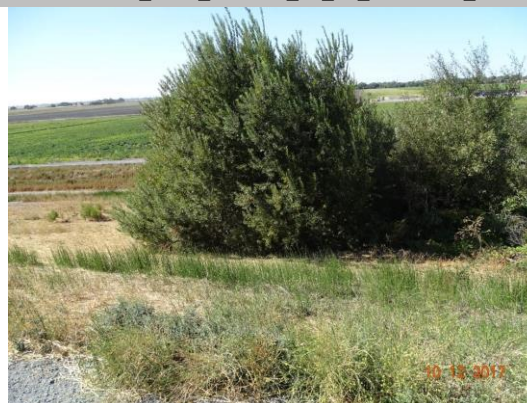
Photo 1 of 1 : SP_2019_NA0002_62_46_20190311_00028.jpg

LM Start	3.74	Rating **	M	Issue No.	46
LM End	3.74	Issue Type +	Ma	Location *	LS
Category	Earthen Levee			GPS Latitude/Longitude	
				Start	End
Item	Trim / Thin Trees			38.150841 °	38.150841 °
				-121.598161 °	-121.598161 °
DWR ID	DWR_NA0002_01_f_2017_46				
Comment Code					
T1 : Trim trees to at least five feet above ground level.					
Inspector Comment

Looking southwest at the landside slope.

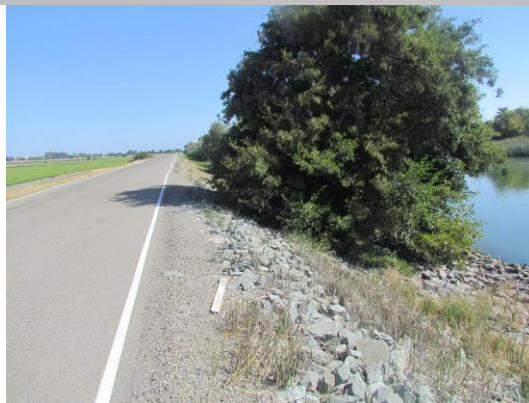
Photo 1 of 1 : SP_2019_NA0002_62_57_20190311_00034.jpg

LM Start	3.87	Rating **	U	Issue No.	57
LM End	3.87	Issue Type +	Ma	Location *	WS
Category	Earthen Levee			GPS Latitude/Longitude	
				Start	End
Item	Trim / Thin Trees			38.149217 °	38.149217 °
				-121.599389 °	-121.599389 °
DWR ID	DWR_NA0002_01_f_2015_57				
Comment Code					
T1 : Trim trees to at least five feet above ground level.					
Inspector Comment

Looking west at untrimmed tree on waterward slope.

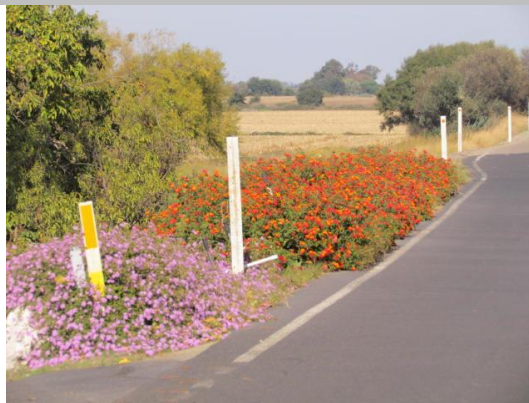
Photo 1 of 3 : SP_2019_NA0002_62_11_20190311_00007.jpg

LM Start	3.93	Rating **	U	Issue No.	11
LM End	4.00	Issue Type +	En	Location *	LS
Category	Earthen Levee			GPS Latitude/Longitude	
				Start	End
Item	Vegetation			38.148318 °	38.147527 °
				-121.599947 °	-121.600635 °
DWR ID	DWR_NA0002_01_s_2012_11				
Comment Code					
V6 : Landscaping					
Inspector Comment

Looking northeast at landscaping on landside slope.

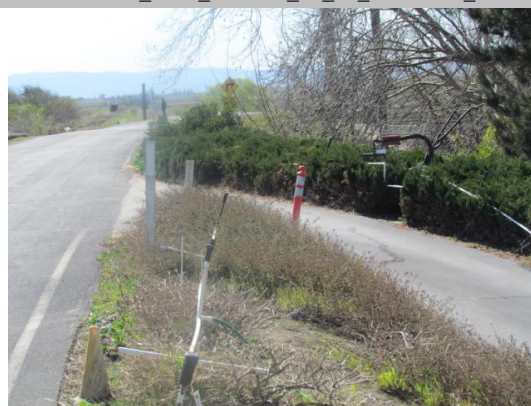
Photo 2 of 3 : SP_2019_NA0002_62_11_20190311_00008.jpg

Looking south at bushes on landside shoulder and slope.

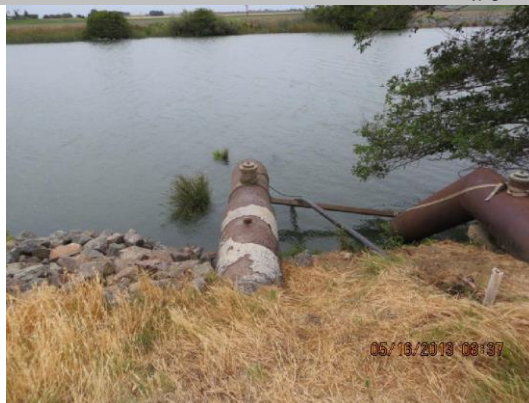
Photo 1 of 3 : UCIP_SP_2019_51302_22082.jpg

Comment Code					
Inspector Comment					
FS_ID:51302 DS_ID:21772 EP_NO: 11248 Repair Type: No Action Needed Crossing Status: Found UCIP Comments: FIELD_STRUCT_DESC: 1 of 2: 24-inch steel drainage pipe through levee, 3 feet below the crown. Siphon breaker is located on the waterside (WS) slope. Pump is located on the landside (LS). (24-inch pipe [HLM 3.99] authorized under Automatic Board Order (ABO) issued as Permit No. 11248, 1975 – Reclamation District No. 407) [Additional Reference(s): DWR Levee Log, 2005. USACE Sacramento O&M Manual Unit 103, June 1954, Drawing No. 50-4-2631, page 2631/2, (Station 107+76), 26-inch listed]. FS Date: 5/16/2013

24-inch pipe and siphon breaker visible on WS slope.

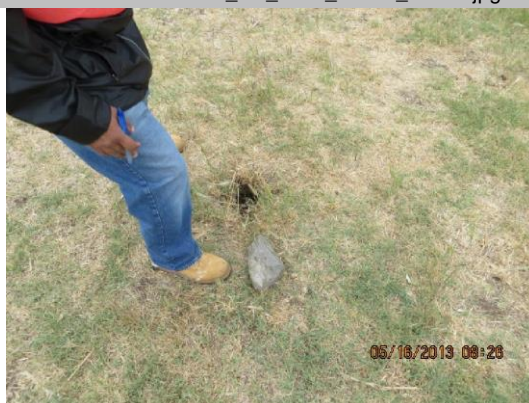
Photo 2 of 3 : UCIP_SP_2019_13487_22052.jpg

LM Start	3.99	Rating **	M	Issue No.	102 (cont)	
LM End	3.99	Issue Type +	En	Location *		
Category	Supplemental			GPS Latitude/Longitude		
				Start	End	
Item	DWR UCIP Field Study			38.147653 °	38.147653 °	
				-121.600491 °	-121.600491 °	
DWR ID	21825					
Comment Code						
Inspector Comment						
FS_ID:13487						
DS_ID:21825						
EP_NO: 11248						
Repair Type: Non-Urgent						
Crossing Status: Found						
UCIP Comments: Leakage of pipe at WS toe creating erosion.						
Possible cavity collapse along pipe alignment on WS berm.						
FIELD_STRUCT_DESC: 2 of 2: 4-inch pipe through levee 4.0 feet						
below crown. Siphon breaker on waterward slope. Pump on landward						
side (ABO No. 11248, 1975).						
FS Date: 5/16/2013

Possible indicator of internal pipe failure along pipe alignment as there appears to be a cavity collapse over the pipe on the WS berm.

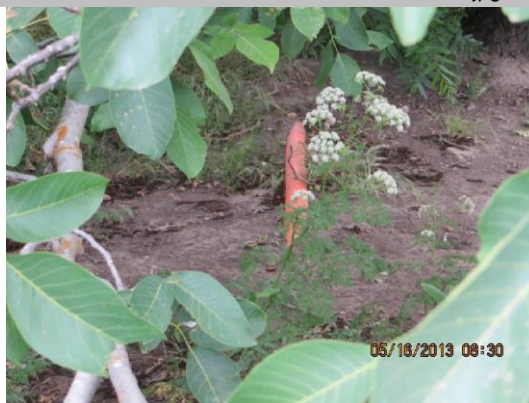
Photo 3 of 3 : UCIP_SP_2019_13487_22051.jpg

Pipe visible under walnut at LS slope.

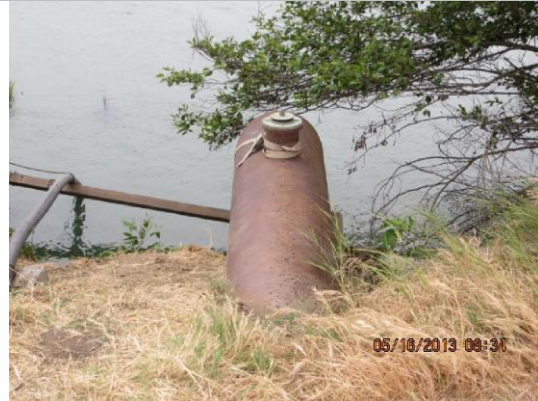
Photo 1 of 3 : UCIP_SP_2019_52693_22078.jpg

Comment Code						
Inspector Comment						
FS_ID:52693 DS_ID:21773 EP_NO: 5534 Repair Type: Urgent Crossing Status: Found UCIP Comments: 07/12/2018 Levee crown on LS shoulder was repaved with asphalt. Dense vegetation limits visibility on LS levee slope and ability to evaluate erosion on LS. Crossing remains "Urgent". (O.Yakimov-DWR)10/24/2016 Internal erosion visible on LS where pipe daylights. LS road shoulder appears to be failing. Large sink hole patched and is visible on road/crown. Evidence of burrow activity that appear to be about 6-inches in diameter with depths greater than 3 feet. Burrow holes are located on LS hinge point just upstream of pipe and 3 holes visible on WS. Need to contact owner to address issue and recommend to stop use of crossing to avoid further damage to levee. (O. Magana - DWR UCIP)05/16/2013 Pot holes over pipe may indicate internal failure. Good candidate for video inspection. (W. Wylie - DWR UCIP) FIELD_STRUCT_DESC: 22-inch steel drainage pipe through the levee, 3 feet below the crown. Siphon breaker located on the waterside (WS) shoulder. Pump located on the landside (LS). (22-inch pipe authorized under Permit No. 5534, 1966 - Reclamation District No. 407, 22-inch pipe replaced 24-inch discharge pipe). [Additional Reference(s): DWR Levee Log, 2005, 24-inch pipe listed]. FS Date: 7/27/2018 2:39:22 PM

Pipe and siphon breaker on WS shoulder.

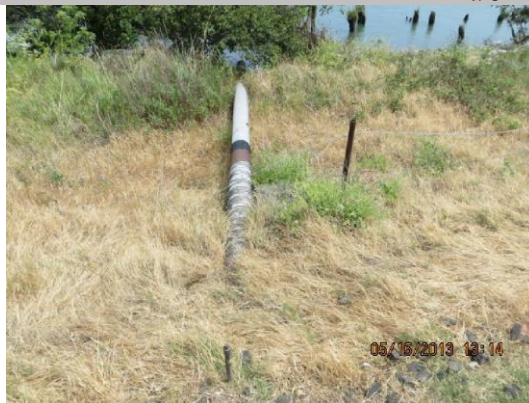
Photo 1 of 3 : UCIP_SP_2019_51308_22050.jpg

Comment Code						
Inspector Comment						
FS_ID:51308 DS_ID:21774 EP_NO: 11238 Repair Type: Non-Urgent Crossing Status: Found UCIP Comments: 10/24/2016 Unable to determine if WS primer pipe is leaking or if settling is occurring at pipe. Need to contact owner to determine when upgrades to WS were completed. (O. Magana - DWR UCIP) FIELD_STRUCT_DESC: 10-inch irrigation steel pipe (12-inch referenced in ABO and O&M manual) through levee, 4 feet below crown. Siphon breaker is located on the landside (LS). 1.5-inch primer, 48-inch concrete standpipe on LS toe with slide gate. (12-inch pipe authorized under Automatic Board Order (ABO) issued as Permit No. 11238, 1975 – Gardiner Improvement Company). [Additional Reference(s): DWR Levee Log, 2005. USACE Sacramento O&M Manual Unit 103, June 1954, (Station 106+79), Drawing No. 50-4-2631, page 2631/2]. FS Date: 10/24/2016

10-inch pipe visible on WS slope.

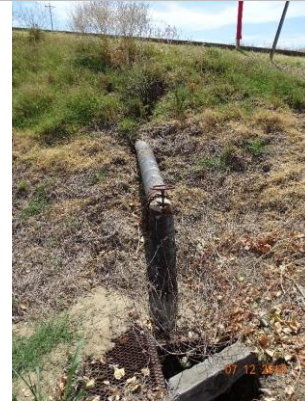
Photo 1 of 3 : UCIP_SP_2019_52692_77567.jpg

FIELD_STRUCT_DESC: 8-inch steel irrigation pipe through the levee, 3.7 feet below the crown. 5-foot by 5-foot concrete spillbox located on the landside (LS) slope. (8-inch pipe authorized under Automatic Board Order (ABO) issued as Permit No. 11238, 1975 - Gardiner Improvement Company). [Additional Reference(s): DWR Levee Log, 2005. USACE Sacramento O&M Manual 103, June 1954, (Station "R" 105+02) Drawing No. 50-4-2631, Page 2631/2].
 FS Date: 7/27/2018 2:17:23 PM

Pipe and concrete sump on LS.

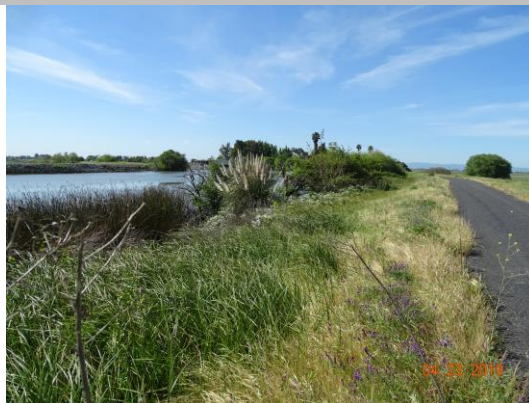
Photo 1 of 1 : SP_2019_NA0002_62_64_20190523_00113.jpg

LM Start	4.05	Rating **	U	Issue No.	64
LM End	4.13	Issue Type +	Ma	Location *	WS
Category	Earthen Levee			GPS Latitude/Longitude	
				Start	End
Item	Vegetation			38.146956 °	38.145776 °
				-121.601033 °	-121.601633 °
DWR ID	DWR_NA0002_01_s_2019_64				
Comment Code					
V1 : Control annual grass and weeds on the levee slopes and easements.					
Inspector Comment

View looking downstream at annual vegetation on the waterside slope (Spring 2019).

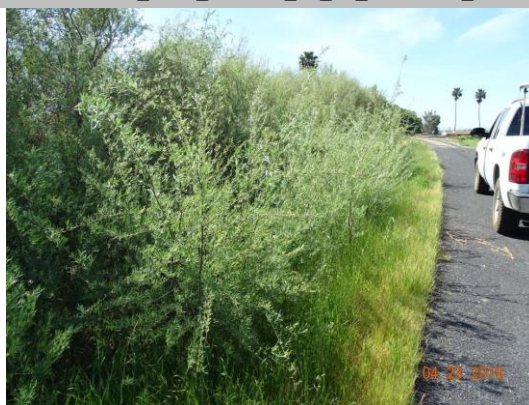
Photo 1 of 1 : SP_2019_NA0002_62_68_20190423_00103.jpg

LM Start	4.12	Rating **	M	Issue No.	68
LM End	4.12	Issue Type +	Ma	Location *	WS
Category	Earthen Levee			GPS Latitude/Longitude	
				Start	End
Item	Vegetation			38.145998 °	38.145998 °
				-121.601588 °	-121.601588 °
DWR ID	DWR_NA0002_01_s_2019_68				
Comment Code					
V2 : Remove the wild growth other than native grasses from the levee slopes.					
Inspector Comment					
Remove new willow growth from waterside slope

View looking downstream at new willows growing on the waterside slope (Spring 2019).

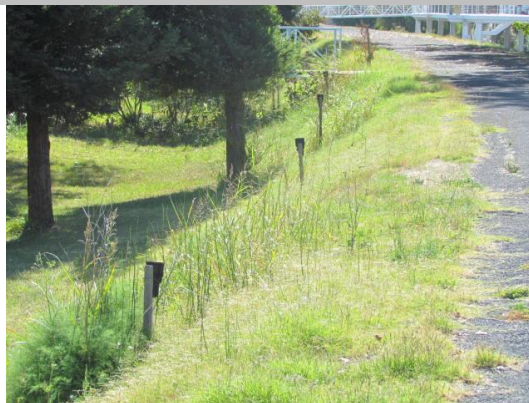
Photo 1 of 1 : SP_2019_NA0002_62_20_20190311_00011.jpg

LM Start	4.23	Rating **	M	Issue No.	20
LM End	4.29	Issue Type +	En	Location *	WS
Category	Earthen Levee			GPS Latitude/Longitude	
				Start	End
Item	Encroachments			38.144471 °	38.143652 °
				-121.601381 °	-121.600877 °
DWR ID	DWR_NA0002_01_f_2013_20				
Comment Code					
LI : Landscape Irrigation					
Inspector Comment					
Sprinkler system on waterside of levee.

Looking south at a sprinkler system on waterward slope.

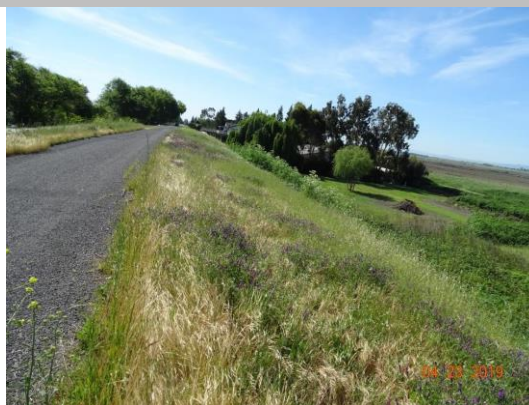
Photo 1 of 1 : SP_2019_NA0002_62_69_20190423_00105.jpg

LM Start	4.55	Rating **	U	Issue No.	69
LM End	4.55	Issue Type +	Ma	Location *	LS
Category	Earthen Levee			GPS Latitude/Longitude	
				Start	End
Item	Vegetation			38.140402 °	38.140402 °
				-121.598276 °	-121.598276 °
DWR ID	DWR_NA0002_01_s_2019_69				
Comment Code					
V1 : Control annual grass and weeds on the levee slopes and easements.					
Inspector Comment

View looking downstream at annual vegetation on the landside slope (Spring 2019).

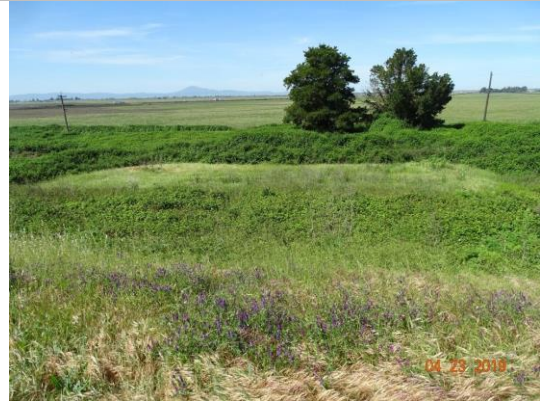
Photo 1 of 1 : SP_2019_NA0002_62_85_20190423_00106.jpg

LM Start	4.55	Rating **	U	Issue No.	85
LM End	4.55	Issue Type +	Ma	Location *	LS
Category	Earthen Levee			GPS Latitude/Longitude	
				Start	End
Item	Vegetation			38.140402 °	38.140402 °
				-121.598275 °	-121.598275 °
DWR ID	DWR_NA0002_01_s_2019_85				
Comment Code					
V2 : Remove the wild growth other than native grasses from the levee slopes.					
Inspector Comment					
Remove blackberries from landside toe

View looking downslope at blackberries at the landside slope (Spring 2019).

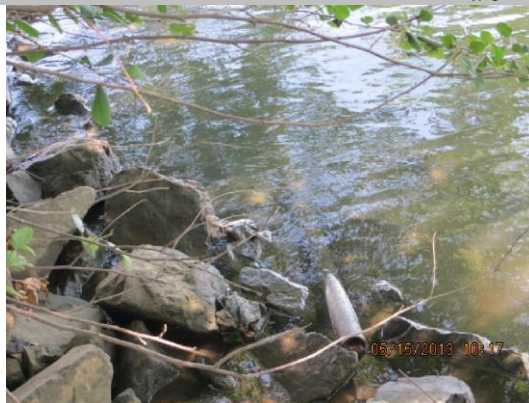
Photo 1 of 1 : UCIP_SP_2019_41562_21935.jpg

LM Start	4.79	Rating **	M	Issue No.	107
LM End	4.79	Issue Type +	En	Location *	
Category	Supplemental			GPS Latitude/Longitude	
				Start	End
Item	DWR UCIP Field Study			38.137306 °	38.137306 °
				-121.596371 °	-121.596371 °
DWR ID	21782				
Comment Code					
Inspector Comment					
FS_ID:41562					
DS_ID:21782					
EP_NO: 11233					
Repair Type: Non-Urgent					
Crossing Status: Indicator Found					
UCIP Comments: Need to verify type of abandonment.					
FIELD_STRUCT_DESC: *ABANDONED* 2.5-inch pipe of an unknown material or purpose through the levee, 3.2 feet below the crown. Found pipe in water on the waterside (WS) toe. (Automatic Board Order (ABO) issued as Permit No. 11233, 1975 - Jose H. and Maria H. Cervantez). [Additional Reference(s): DWR Levee Log, 2005].					
FS Date: 5/15/2013

Pipe found at WS shoreline.

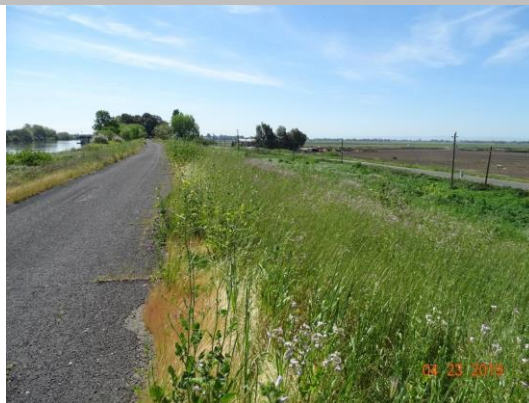
Photo 1 of 1 : SP_2019_NA0002_62_86_20190423_00108.jpg

LM Start	4.83	Rating **	U	Issue No.	86
LM End	4.95	Issue Type +	Ma	Location *	LS
Category	Earthen Levee			GPS Latitude/Longitude	
				Start	End
Item	Vegetation			38.136882 °	38.135516 °
				-121.596015 °	-121.594597 °
DWR ID	DWR_NA0002_01_s_2019_86				
Comment Code					
V1 : Control annual grass and weeds on the levee slopes and easements.					
Inspector Comment					
Maintain annual vegetation

View looking downstream at annual vegetation on the landside slope (Spring 2019).

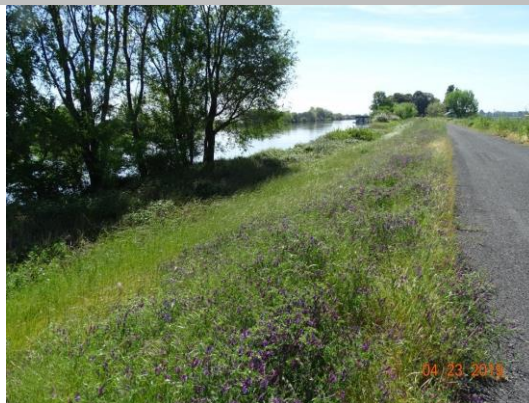
Photo 1 of 1 : SP_2019_NA0002_62_87_20190423_00107.jpg

LM Start	4.83	Rating **	U	Issue No.	87
LM End	4.95	Issue Type +	Ma	Location *	WS
Category	Earthen Levee			GPS Latitude/Longitude	
				Start	End
Item	Vegetation			38.136882 °	38.135516 °
				-121.596015 °	-121.594597 °
DWR ID	DWR_NA0002_01_s_2019_87				
Comment Code					
V1 : Control annual grass and weeds on the levee slopes and easements.					
Inspector Comment					
Maintain annual vegetation

View looking downstream at annual vegetation on the waterside slope (Spring 2019).

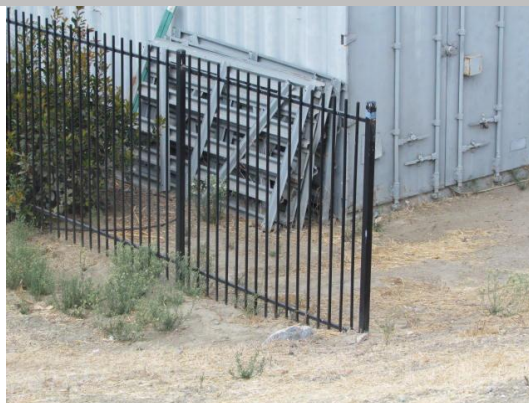
Photo 1 of 2 : SP_2019_NA0002_62_48_20190311_00029.jpg

LM Start	4.83	Rating **	M	Issue No.	48
LM End	4.83	Issue Type +	En	Location *	LS
Category	Earthen Levee			GPS Latitude/Longitude	
				Start	End
Item	Encroachments			38.136839 °	38.136839 °
				-121.595994 °	-121.595994 °
DWR ID	DWR_NA0002_01_f_2015_48				
Comment Code					
FE : Fence					
Inspector Comment					
Unauthorized fence at landside toe.

Looking at close-up view of fence at landward toe.

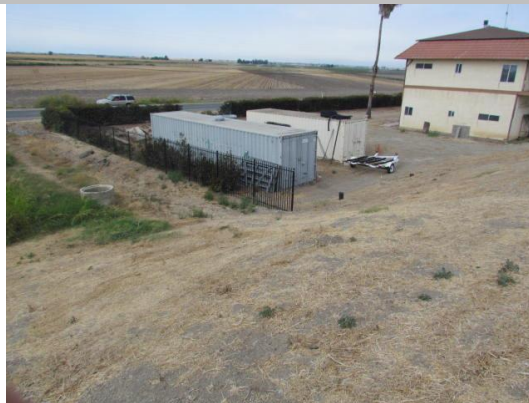
Photo 2 of 2 : SP_2019_NA0002_62_48_20190311_00030.jpg

LM Start	4.83	Rating **	M	Issue No.	48 (cont)
LM End	4.83	Issue Type +	En	Location *	LS

Looking southwest at unfinished fence at landward toe.

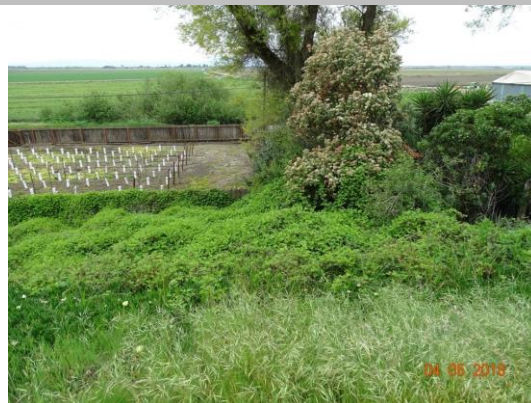
Photo 1 of 1 : SP_2019_NA0002_62_75_20190311_00046.jpg

LM Start	5.06	Rating **	U	Issue No.	75
LM End	5.06	Issue Type +	En	Location *	LS
Category	Earthen Levee			GPS Latitude/Longitude	
				Start	End
Item	Vegetation			38.134286 °	38.134286 °
				-121.593229 °	-121.593229 °
DWR ID	DWR_NA0002_01_s _ 2018_75				
Comment Code					
V6 : Landscaping					
Inspector Comment					
Landscaping has been overgrown with berry vines completely blocking visibility and access. Vegetation here should be thinned or removed.

Landside landscaping is overgrown and needs thinning and removal.

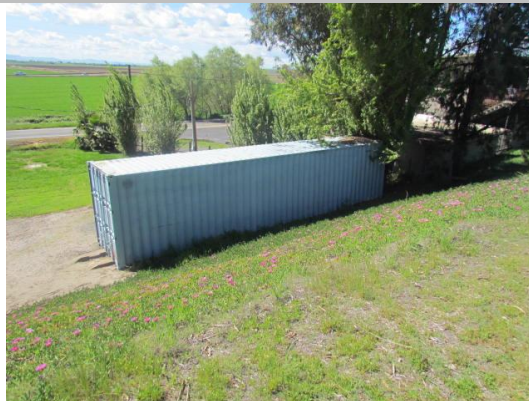
Photo 1 of 1 : SP_2019_NA0002_62_66_20190311_00041.jpg

LM Start	5.13	Rating **	U	Issue No.	66
LM End	5.13	Issue Type +	En	Location *	LS
Category	Earthen Levee			GPS Latitude/Longitude	
				Start	End
Item	Encroachments			38.133600 °	38.133600 °
				-121.592414 °	-121.592414 °
DWR ID	DWR_NA0002_01_s _ 2016_66				
Comment Code					
BU : Building					
Inspector Comment					
Storage container at landside toe.

Looking at storage container at landward toe.

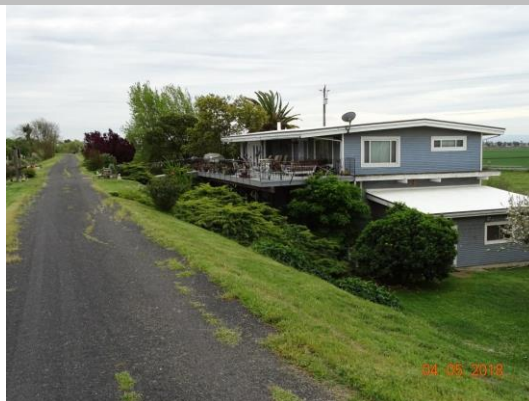
Photo 1 of 1 : SP_2019_NA0002_62_78_20190311_00047.jpg

LM Start	5.22	Rating **	U	Issue No.	78
LM End	5.24	Issue Type +	En	Location *	LS
Category	Earthen Levee			GPS Latitude/Longitude	
				Start	End
Item	Vegetation			38.132606 °	38.132322 °
				-121.591295 °	-121.590989 °
DWR ID	DWR_NA0002_01_s _ 2018_78				
Comment Code					
V6 : Landscaping					
Inspector Comment					
Heavy landscaping completely blocks visibility and access to landside slope and toe.

Landside landscaping needs to be managed to allow inspection and access.

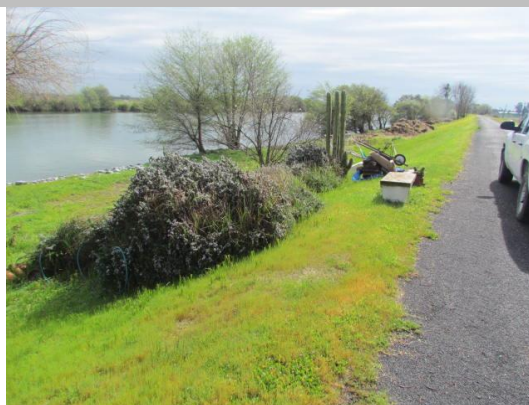
Photo 2 of 2 : SP_2019_NA0002_62_61_20190311_00039.jpg

LM Start	5.25	Rating **	M	Issue No.	61 (cont)
LM End	5.25	Issue Type +	En	Location *	WS

Looking southeast at overgrowth landscaping on waterward slope.
(Spring 2015)

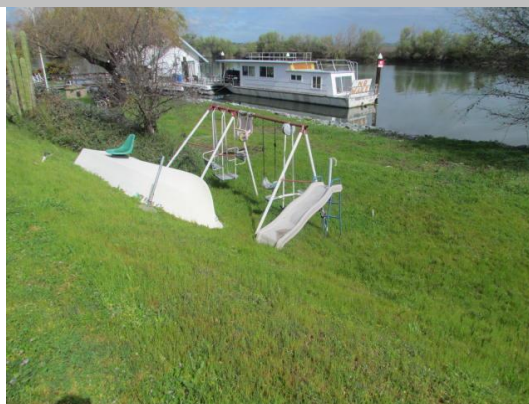
Photo 1 of 1 : SP_2019_NA0002_62_60_20190311_00037.jpg

LM Start	5.26	Rating **	M	Issue No.	60
LM End	5.26	Issue Type +	En	Location *	WS
Category	Earthen Levee			GPS Latitude/Longitude	
				Start	End
Item	Encroachments			38.132199 °	38.132199 °
				-121.590855 °	-121.590855 °
DWR ID	DWR_NA0002_01_s_2015_60				
Comment Code					
GA : Garbage					
Inspector Comment					
An abandoned child's swing set at the waterside toe.

Looking northeast at abandoned child's swing set at waterward toe.

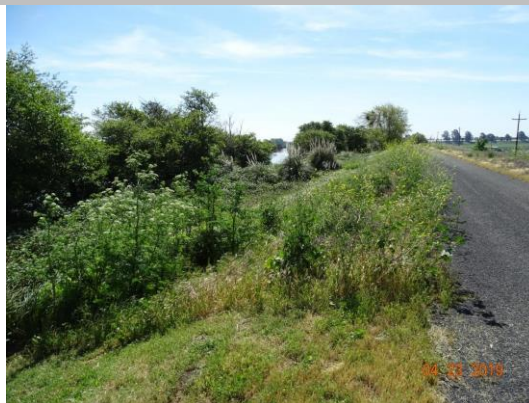
Photo 1 of 1 : SP_2019_NA0002_62_88_20190423_00109.jpg

LM Start	5.26	Rating **	U	Issue No.	88
LM End	5.83	Issue Type +	Ma	Location *	WS
Category	Earthen Levee			GPS Latitude/Longitude	
				Start	End
Item	Vegetation			38.132089 °	38.129641 °
				-121.590747 °	-121.581769 °
DWR ID	DWR_NA0002_01_s_2019_88				
Comment Code					
V1 : Control annual grass and weeds on the levee slopes and easements.					
Inspector Comment

View looking downstream at annual vegetation on the waterside slope (Spring 2019).

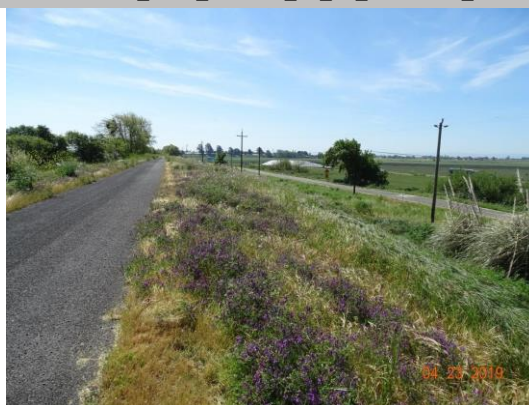
Photo 1 of 1 : SP_2019_NA0002_62_89_20190423_00110.jpg

LM Start	5.26	Rating **	U	Issue No.	89
LM End	5.83	Issue Type +	Ma	Location *	LS
Category	Earthen Levee			GPS Latitude/Longitude	
				Start	End
Item	Vegetation			38.132089 °	38.129643 °
				-121.590746 °	-121.581769 °
DWR ID	DWR_NA0002_01_s_2019_89				
Comment Code					
V1 : Control annual grass and weeds on the levee slopes and easements.					
Inspector Comment

View looking downstream at annual vegetation on the landside slope (Spring 2019).
