**Flood Control Project Maintenance
Levee Inspections**
LMA District Cover Sheet
Spring 2019 Levee Inspection Results

Brannan Andrus Levee Maintenance District

Spring 2019 Levee Inspection Results

Waterway			Bank	Unit Miles
Unit No. 01 Georgiana Slough			Right	6.01
	Spring (March - May)	Summer (June - August)	(September - November) Fall	Winter (December - February)
Unit Maintenance Rating (Fall Only)				
Date of Inspection	4/23/2019 - 4/23/2019			
DWR Inspector	David Julian			
Accompanied By

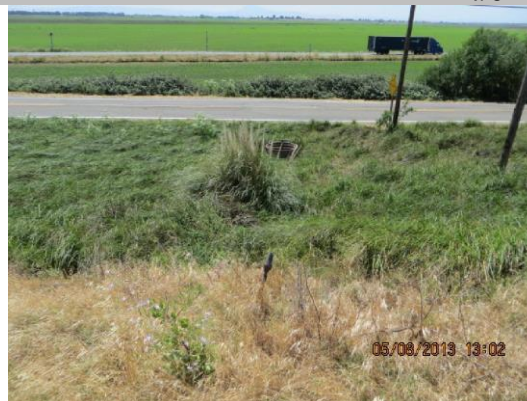
Photo 1 of 3 : UCIP_SP_2019_13090_21282.jpg

Comment Code						
Inspector Comment						
FS_ID:13090 DS_ID:21816 EP_NO: 11245 Repair Type: Non-Urgent Crossing Status: Found UCIP Comments: Appears abandoned. Pipe at slide gate in riser on LS toe is rusted through. FIELD_STRUCT_DESC: 1 of 2: 14-inch steel irrigation pipe through the levee, 3.8 feet below the crown. 2-inch primer valve and 48-inch concrete standpipe on the landside (LS). (Automatic Board Order (ABO) issued as Permit No. 11245, 1975 - Mary Nobrega and Manuel Mendes). [Additional Reference(s): DWR Levee Log, 2005, 12-inch pipe listed. USACE Sacramento O&M Manual 103, June 1954, (Station ""R"" 35+76.7) Drawing No. 50-4-2672]. FS Date: 5/8/2013

Filler pipe and standpipe on LS.

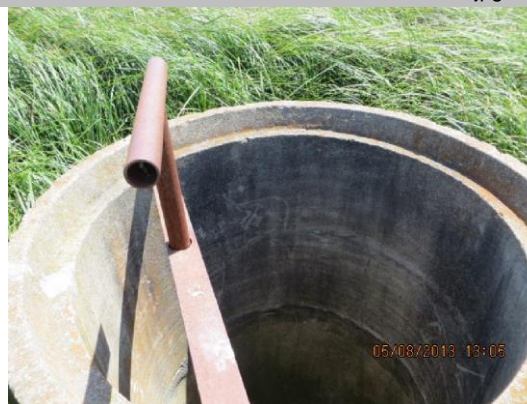
Photo 2 of 3 : UCIP_SP_2019_13090_21281.jpg

LM Start	5.36	Rating **	M	Issue No.	108 (cont)
LM End	5.36	Issue Type +	En	Location *

Slide gate in 48-inch Concrete riser on LS toe.

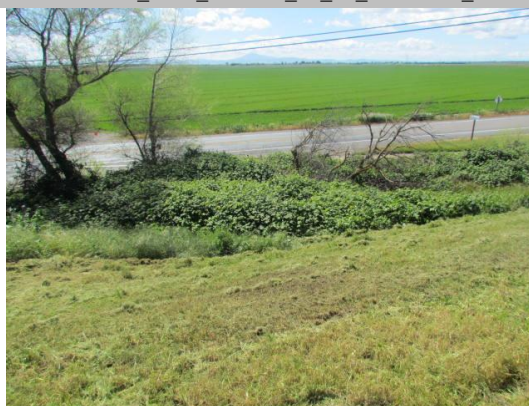
Photo 1 of 3 : SP_2019_NA0002_62_23_20190311_00012.jpg

LM Start	5.43	Rating **	U	Issue No.	23 (cont)
LM End	5.57	Issue Type +	Ma	Location *	LS

Looking south at vegetation at landward toe. (Spring 2016)

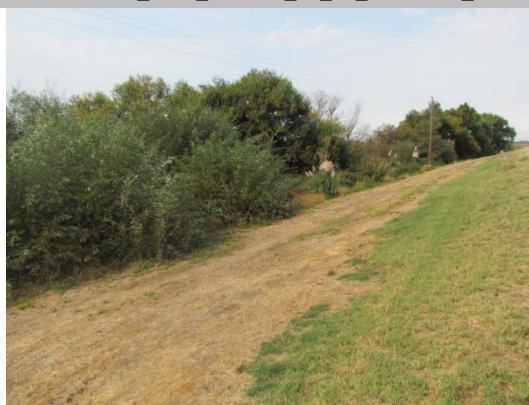
Photo 2 of 3 : SP_2019_NA0002_62_23_20190311_00013.jpg

Looking west at dense vegetation at landward toe.

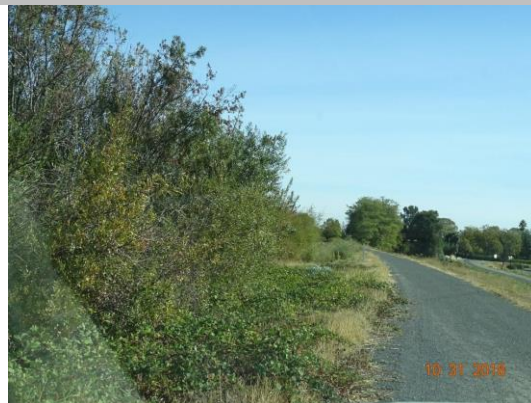
Photo 1 of 1 : SP_2019_NA0002_62_81_20190311_00049.jpg

LM Start	5.64	Rating **	M	Issue No.	81
LM End	5.67	Issue Type +	Ma	Location *	WS
Category	Earthen Levee			GPS Latitude/Longitude	
				Start	End
Item	Vegetation			38.129250 °	38.129281 °
				-121.585193 °	-121.584740 °
DWR ID	DWR_NA0002_01_f_2018_81				
Comment Code					
V2 : Remove the wild growth other than native grasses from the levee slopes.					
Inspector Comment					
Cut blackberries back from waterside shoulder

View of vegetation on the water side slope (October 2018).

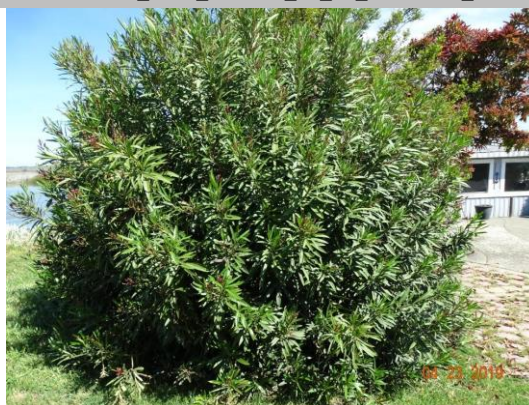
Photo 1 of 1 : SP_2019_NA0002_62_82_20190423_00111.jpg

LM Start	5.84	Rating **	U	Issue No.	82
LM End	5.84	Issue Type +	En	Location *	WS
Category	Earthen Levee			GPS Latitude/Longitude	
				Start	End
Item	Vegetation			38.129663 °	38.129663 °
				-121.581638 °	-121.581638 °
DWR ID	DWR_NA0002_01_f_2018_82				
Comment Code					
V6 : Landscaping					
Inspector Comment

View of thick landscaping vegetation on the waterside slope (Spring 2019).

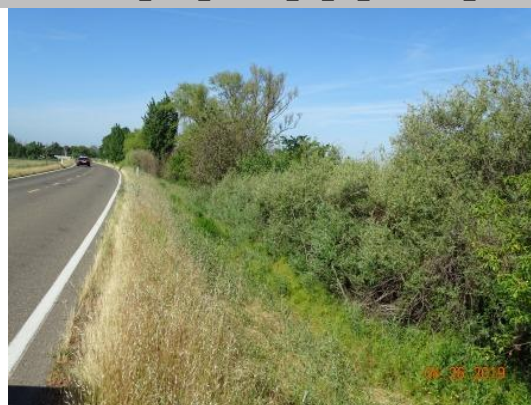
Photo 1 of 1 : SP_2019_NA0002_63_57_20190429_00193.jpg

LM Start	0.04	Rating **	M	Issue No.	57
LM End	2.07	Issue Type +	Ma	Location *	WS
Category	Earthen Levee			GPS Latitude/Longitude	
				Start	End
Item	Vegetation			38.191675 °	38.170978 °
				-121.568377 °	-121.593159 °
DWR ID	DWR_NA0002_02_s _ 2019_57				
Comment Code					
V1 : Control annual grass and weeds on the levee slopes and easements.					
Inspector Comment					
Maintain the annual vegetation.

View looking downstream at annual vegetation on the waterside slope (Spring 2019).

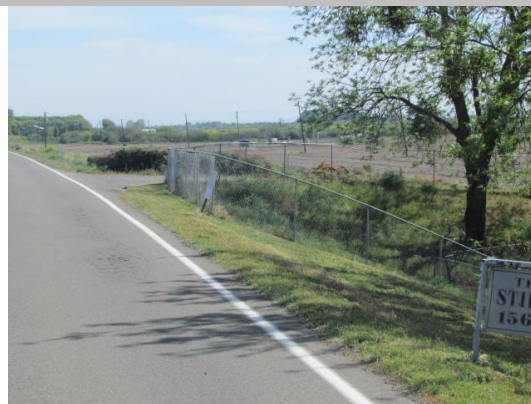
Photo 1 of 1 : SP_2019_NA0002_63_26_20190311_00018.jpg

LM Start	0.43	Rating **	M	Issue No.	26
LM End	0.43	Issue Type +	En	Location *	LS
Category	Earthen Levee			GPS Latitude/Longitude	
				Start	End
Item	Encroachments			38.189212 °	38.189212 °
				-121.574757 °	-121.574757 °
DWR ID	DWR_NA0002_02_s _ 2012_26				
Comment Code					
FE : Fence					
Inspector Comment

Looking northeast at fence on landward shoulder and slope.

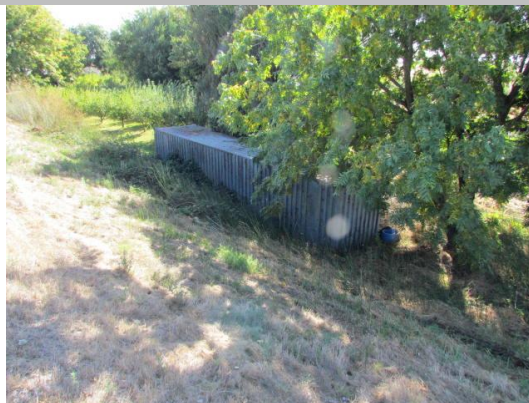
Photo 1 of 1 : SP_2019_NA0002_63_39_20190311_00022.jpg

LM Start	0.49	Rating **	U	Issue No.	39
LM End	0.49	Issue Type +	En	Location *	LS
Category	Earthen Levee			GPS Latitude/Longitude	
				Start	End
Item	Encroachments			38.188872 °	38.188872 °
				-121.575775 °	-121.575775 °
DWR ID	DWR_NA0002_02_f_2013_39				
Comment Code					
BU : Building					
Inspector Comment					
There is a storage container at the landside toe.

Looking south at storage container at landward toe.

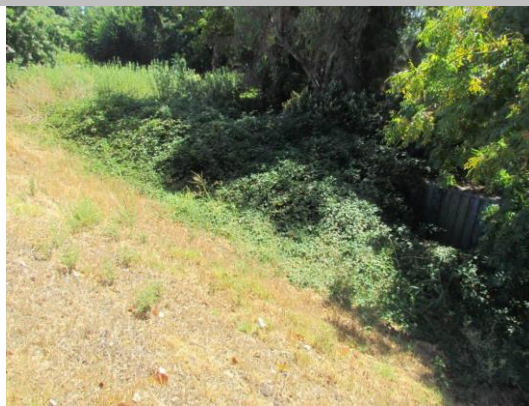
Photo 1 of 1 : SP_2019_NA0002_63_40_20190311_00023.jpg

LM Start	0.49	Rating **	U	Issue No.	40
LM End	0.49	Issue Type +	En	Location *	LS
Category	Earthen Levee			GPS Latitude/Longitude	
				Start	End
Item	Vegetation			38.188871 °	38.188871 °
				-121.575775 °	-121.575775 °
DWR ID	DWR_NA0002_02_f_2013_40				
Comment Code					
V6 : Landscaping					
Inspector Comment					
There are dense berryvines at the landside toe.

Looking east at berryvines at landward toe.

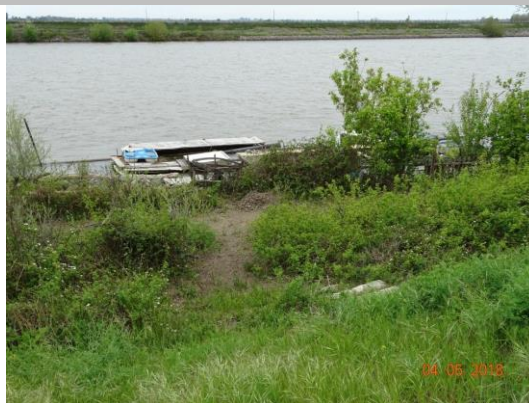
Photo 1 of 1 : SP_2019_NA0002_63_80_20190311_00041.jpg

LM Start	0.59	Rating **	U	Issue No.	80
LM End	0.59	Issue Type +	En	Location *	WS
Category	Earthen Levee			GPS Latitude/Longitude	
				Start	End
Item	Encroachments			38.188260 °	38.188260 °
				-121.577467 °	-121.577467 °
DWR ID	DWR_NA0002_02_s_2018_80				
Comment Code					
BU : Building					
Inspector Comment					
There is a cluster of floating docks on waterside toe.

Floating docks and other debris related to homeless camp on waterside should be removed.

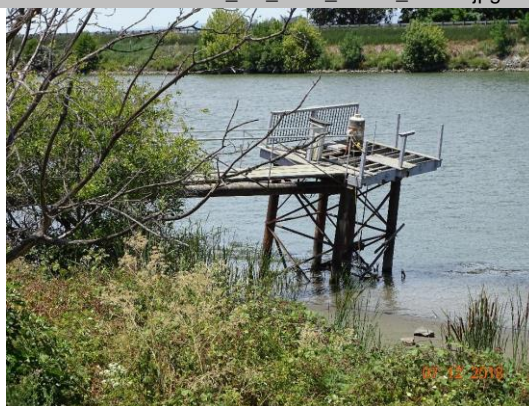
Photo 1 of 3 : UCIP_SP_2019_52689_77595.jpg

Comment Code					
Inspector Comment					
FS_ID:52689 DS_ID:21867 EP_NO: 1173 Repair Type: Non-Urgent Crossing Status: Found UCIP Comments: 07/12/2018 Pump platform is leaning on a side. (O.Yakimov-DWR UCIP) FIELD_STRUCT_DESC: 1 of 4: 12-inch irrigation pipe of an unknown material through the levee, 6 feet below the crown. Pump on pile structure in stream. Siphon breaker in 24-inch corrugated metal riser unit on the landside (LS) slope. 7-foot by 9-foot concrete distribution box at the LS toe. Service pole on the LS slope with a 1-inch steel electrical conduit at same location. (Permit No. 1173, 1947 - Reclamation District No. 556). [Additional Reference(s): DWR Levee Log, 2005. USACE Sacramento O&M Manual 103, June 1954, (Station ""H"" 72+67) steel pipe listed, Drawing No. 50-4-2277]. FS Date: 7/12/2018

Pump platform on WS is distorted.

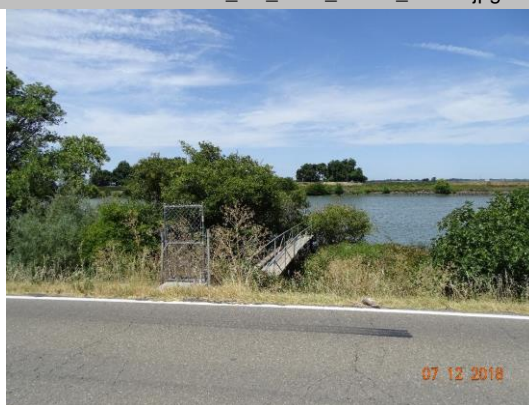
Photo 2 of 3 : UCIP_SP_2019_52689_77596.jpg

View of a bridge to pump platform on WS.

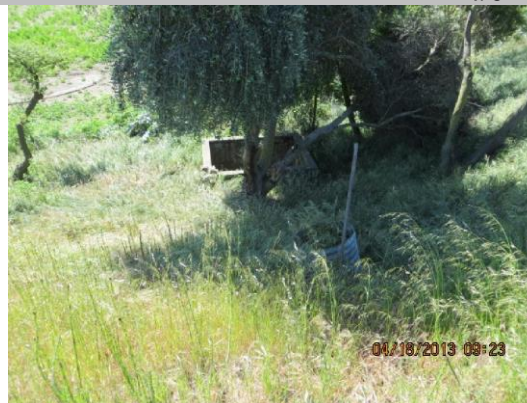
Photo 3 of 3 : UCIP_SP_2019_52689_19722.jpg

Siphon breaker and Concrete distribution box on LS.

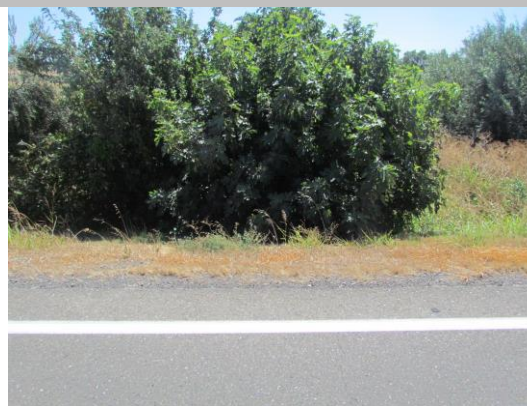
Photo 1 of 2 : SP_2019_NA0002_63_97_20190311_00056.jpg

LM Start	0.72	Rating **	U	Issue No.	97	
LM End	0.72	Issue Type +	Ma	Location *	LS	
Category	Earthen Levee			GPS Latitude/Longitude		
				Start	End	
Item	Trim / Thin Trees			38.187102 °	38.187102 °	
				-121.579463 °	-121.579463 °	
DWR ID	DWR_NA0002_02_f_2018_97					
Comment Code						
T1 : Trim trees to at least five feet above ground level.						
Inspector Comment						
There is an untrimmed fig tree on the landside toe.

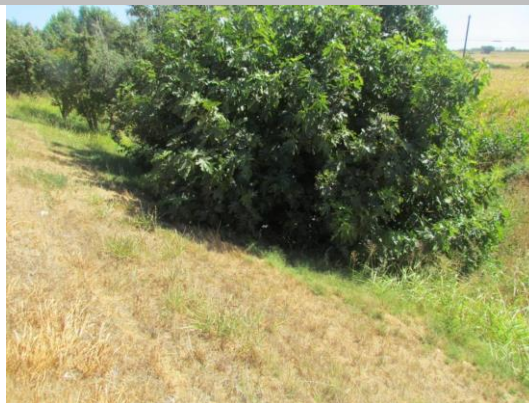
Photo 2 of 2 : SP_2019_NA0002_63_97_20190311_00057.jpg

LM Start	0.72	Rating **	U	Issue No.	97 (cont)	
LM End	0.72	Issue Type +	Ma	Location *	LS	
Category	Earthen Levee			GPS Latitude/Longitude		
				Start		End
Item	Trim / Thin Trees			38.187102 °		38.187102 °
				-121.579463 °		-121.579463 °
DWR ID	DWR_NA0002_02_f_2018_97					
Comment Code						
T1 : Trim trees to at least five feet above ground level.						
Inspector Comment						
There is an untrimmed fig tree on the landside toe.

Looking east at untrimmed fig tree at landward toe.

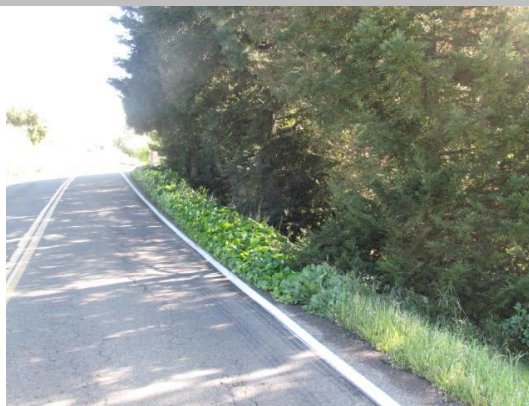
Photo 1 of 3 : SP_2019_NA0002_63_8_20190311_00004.jpg

LM Start	0.80	Rating **	U	Issue No.	8
LM End	0.83	Issue Type +	En	Location *	LS
Category	Earthen Levee			GPS Latitude/Longitude	
				Start	End
Item	Vegetation			38.186410 °	38.186172 °
				-121.580616 °	-121.581023 °
DWR ID	DWR_NA0002_02_s_2012_8				
Comment Code					
V6 : Landscaping					
Inspector Comment

Looking northeast at dense landscaping on landward slope and toe.
(Spring 2016)

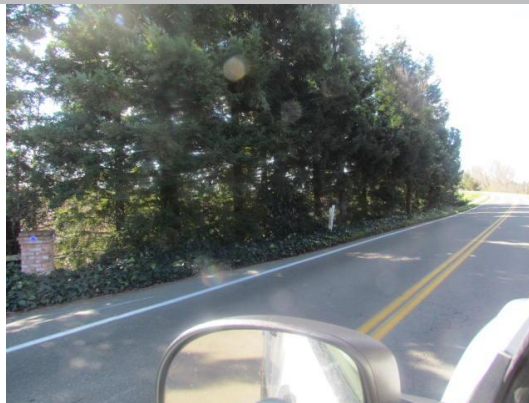
Photo 2 of 3 : SP_2019_NA0002_63_8_20190311_00005.jpg

Looking southwest at dense landscaping on landside slope.

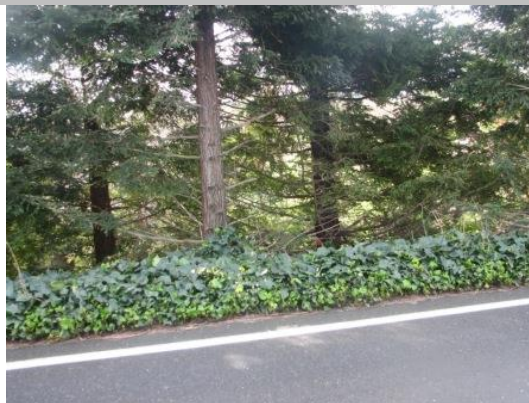
Photo 3 of 3 : SP_2019_NA0002_63_8_20190311_00006.jpg

View of landscaping on landside slope blocking view of slope.

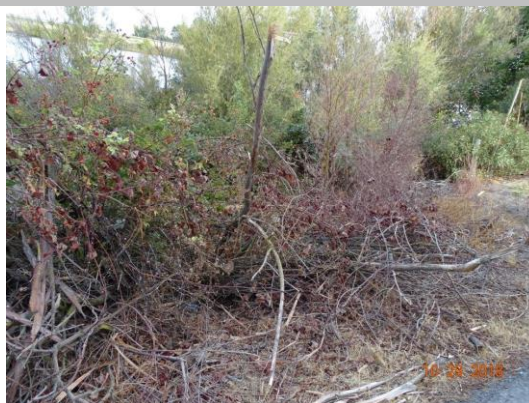
Photo 1 of 1 : SP_2019_NA0002_63_76_20190311_00037.jpg

LM Start	0.82	Rating **	M	Issue No.	76
LM End	0.82	Issue Type +	Ma	Location *	WS
Category	Earthen Levee			GPS Latitude/Longitude	
				Start	End
Item	Encroachments			38.186317 °	38.186317 °
				-121.580837 °	-121.580837 °
DWR ID	DWR_NA0002_02_f_2018_76				
Comment Code					
PR : Prunings					
Inspector Comment					
Remove prunings.

View of prunings on the waterside shoulder (October 2018).

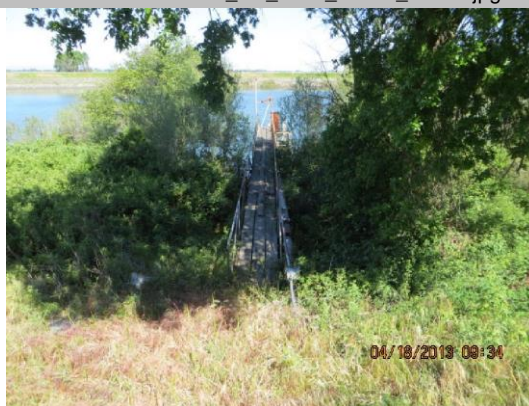
Photo 1 of 3 : UCIP_SP_2019_12164_19726.jpg

Comment Code					
Inspector Comment					
FS_ID:12164 DS_ID:21868 EP_NO: 1173 Repair Type: Non-Urgent Crossing Status: Found UCIP Comments: Several patches on pipe, walkway in disrepair and 24-inch standpipe for siphon breaker on LS slope has been dislodged from the LS slope and rests at LS toe. Pipe appears to be failing at multiple places due to corrosion. FIELD_STRUCT_DESC: 2 of 4: 12-inch irrigation pipe of an unknown material through the levee, 7 feet below the crown. Pump on pile structure with a walkway in the river. Siphon breaker in 24-inch corrugated metal riser unit on the landside (LS) slope with a 7-foot by 9-foot concrete distribution box on the LS toe. Service pole on the LS slope with a 1.5-inch galvanized iron electrical conduit at the same location. (Permit No. 1173, 1947 - Reclamation District No. 556). [Additional Reference(s): DWR Levee Log, 2005. USACE Sacramento O&M Manual 103, June 1954, (Station ""H"" 52+21) steel pipe listed, Drawing No. 50-4-2277]. FS Date: 4/18/2013

Pump on pile structure with walkway on WS berm.

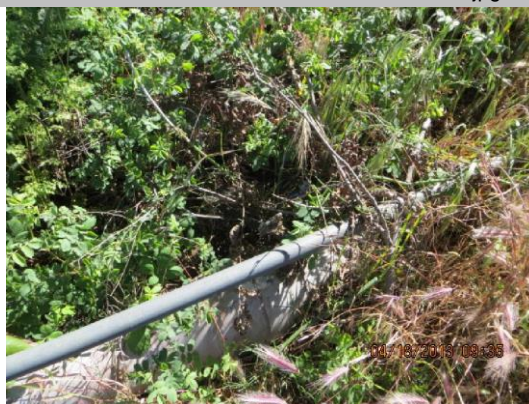
Photo 2 of 3 : UCIP_SP_2019_12164_19725.jpg

1.5-inch galvanized iron electrical conduit at same location as 12-inch pipe on WS slope.

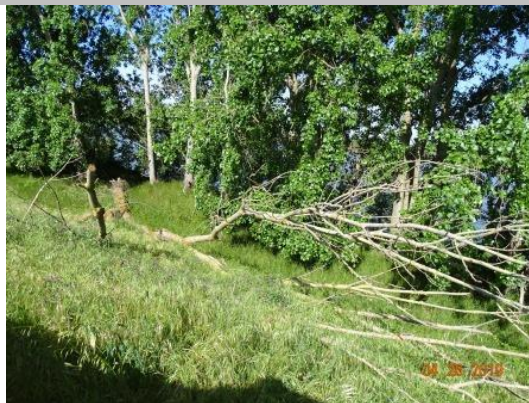
Photo 1 of 1 : SP_2019_NA0002_63_58_20190429_00194.jpg

LM Start	1.24	Rating **	M	Issue No.	58
LM End	1.24	Issue Type +	En	Location *	WS
Category	Earthen Levee			GPS Latitude/Longitude	
				Start	End
Item	Encroachments			38.181519 °	38.181519 °
				-121.585682 °	-121.585682 °
DWR ID	DWR_NA0002_02_s _ 2019_58				
Comment Code					
TR : Tree or limb					
Inspector Comment					
Remove tree limb from waterside slope.

View of downed tree on the waterside slope (Spring 2019).

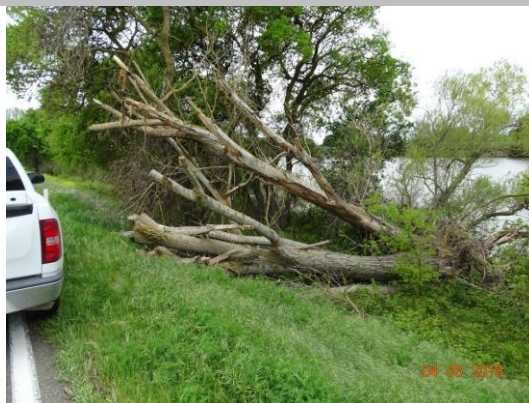
Photo 1 of 1 : SP_2019_NA0002_63_81_20190311_00042.jpg

LM Start	1.33	Rating **	M	Issue No.	81
LM End	1.33	Issue Type +	Ma	Location *	WS
Category	Earthen Levee			GPS Latitude/Longitude	
				Start	End
Item	Encroachments			38.180472 °	38.180472 °
				-121.586510 °	-121.586510 °
DWR ID	DWR_NA0002_02_s _ 2018_81				
Comment Code					
TR : Tree or limb					
Inspector Comment					
Remove large fallen tree on waterside slope.

View of fallen tree on the waterside.

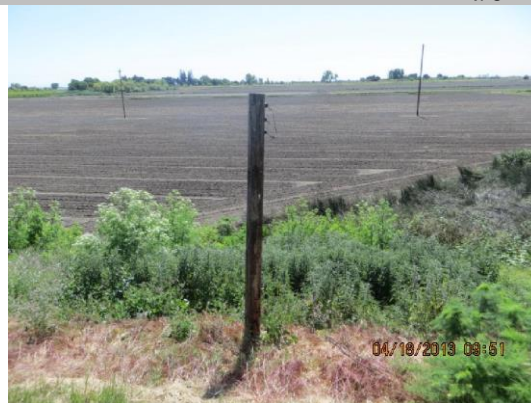
Photo 1 of 3 : UCIP_SP_2019_12165_19731.jpg

Comment Code					
Inspector Comment					
FS_ID:12165 DS_ID:21869 EP_NO: 11261 Repair Type: Non-Urgent Crossing Status: Found UCIP Comments: Pipe abandoned and should be done so properly. Pipe open on WS. FIELD_STRUCT_DESC: 8-inch irrigation pipe of an unknown material through the levee, 6.5 feet below the crown. Pump in pump house on berm. 7-foot by 9-foot concrete distribution box on the landside (LS) toe. Service poles on the LS slope with a 1.5-inch galvanized steel electrical conduit at same location. (Automatic Board Order (ABO) issued as Permit No. 11261, 1975 - Anthony and John Correia). [Additional Reference(s): DWR Levee Log, 2005. USACE Sacramento O&M Manual 103, June 1954, (Station ""H"" 42+33) steel pipe listed, Drawing No. 50-4-2277]. FS Date: 4/18/2013

JP on LS slope.

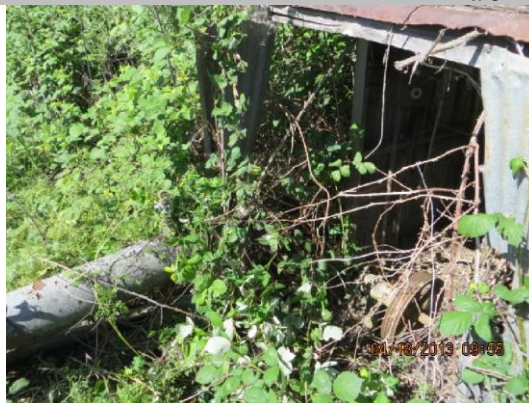
Photo 3 of 3 : UCIP_SP_2019_12165_19729.jpg

Comment Code						
Inspector Comment						
FS_ID:12165 DS_ID:21869 EP_NO: 11261 Repair Type: Non-Urgent Crossing Status: Found UCIP Comments: Pipe abandoned and should be done so properly. Pipe open on WS. FIELD_STRUCT_DESC: 8-inch irrigation pipe of an unknown material through the levee, 6.5 feet below the crown. Pump in pump house on berm. 7-foot by 9-foot concrete distribution box on the landside (LS) toe. Service poles on the LS slope with a 1.5-inch galvanized steel electrical conduit at same location. (Automatic Board Order (ABO) issued as Permit No. 11261, 1975 - Anthony and John Correia). [Additional Reference(s): DWR Levee Log, 2005. USACE Sacramento O&M Manual 103, June 1954, (Station ""H"" 42+33) steel pipe listed, Drawing No. 50-4-2277]. FS Date: 4/18/2013

Pipe at pumphouse has been disconnected from pump and is open.

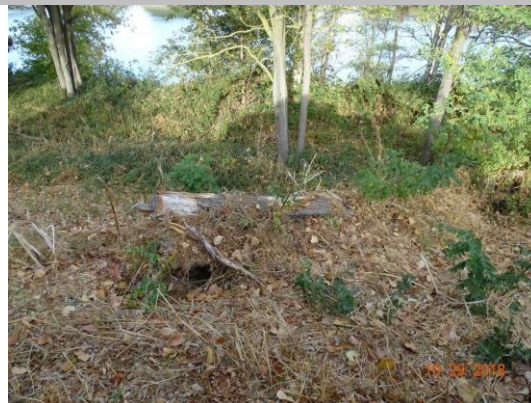
Photo 1 of 1 : SP_2019_NA0002_63_135_20190311_00079.jpg

LM Start	1.43	Rating **	M	Issue No.	135
LM End	1.43	Issue Type +	Ma	Location *	WS
Category	Earthen Levee			GPS Latitude/Longitude	
				Start	End
Item	Encroachments			38.179169 °	38.179169 °
				-121.587511 °	-121.587511 °
DWR ID	DWR_NA0002_02_f_2017_135				
Comment Code					
TR : Tree or limb					
Inspector Comment					
Remove downed tree limbs on waterside slope.

View of tree limbs on the water side slope (October 2018).

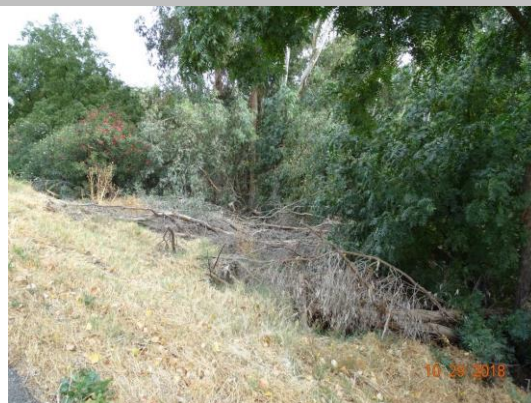
Photo 1 of 1 : SP_2019_NA0002_63_174_20190311_00105.jpg

LM Start	1.46	Rating **	U	Issue No.	174
LM End	1.46	Issue Type +	En	Location *	LS
Category	Earthen Levee			GPS Latitude/Longitude	
				Start	End
Item	Encroachments			38.178722 °	38.178722 °
				-121.587792 °	-121.587792 °
DWR ID	DWR_NA0002_02_f_2018_174				
Comment Code					
TR : Tree or limb					
Inspector Comment					
There are multiple downed trees.

View of down trees on landside slope (October 2018).

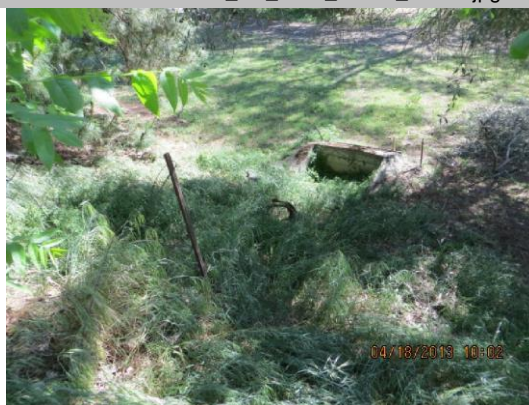
Photo 1 of 3 : UCIP_SP_2019_12183_19742.jpg

LM Start	1.61	Rating **	M	Issue No.	178
LM End	1.61	Issue Type +	En	Location *	
Category	Supplemental			GPS Latitude/Longitude	
				Start	End
Item	DWR UCIP Field Study			38.176874 °	38.176874 °
				-121.589200 °	-121.589200 °
DWR ID	21870				
Comment Code					
Inspector Comment					
FS_ID:12183					
DS_ID:21870					
EP_NO: N/A					
Repair Type: Non-Urgent					
Crossing Status: Found					
UCIP Comments: Pipe appears abandoned and should be done so properly.					
FIELD_STRUCT_DESC: 6-inch steel irrigation pipe through the levee, 5.8 feet below the crown. 3-foot by 3-foot concrete distribution box at the landside (LS) toe. Polyvinyl chloride standpipe at the waterside (WS) toe. Hose bib attachment on pipe at the LS toe.					
FS Date: 4/18/2013

Concrete distribution box on LS toe.

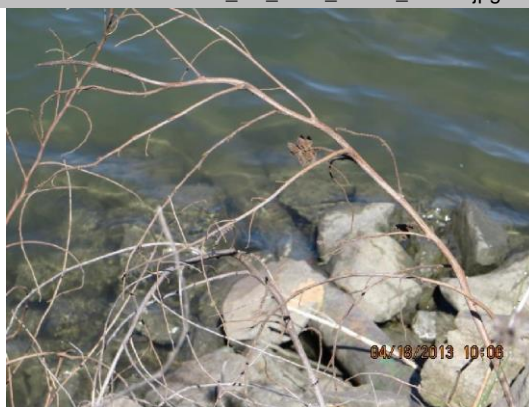
Photo 3 of 3 : UCIP_SP_2019_12183_19740.jpg

4-inch suction pipe on WS toe.

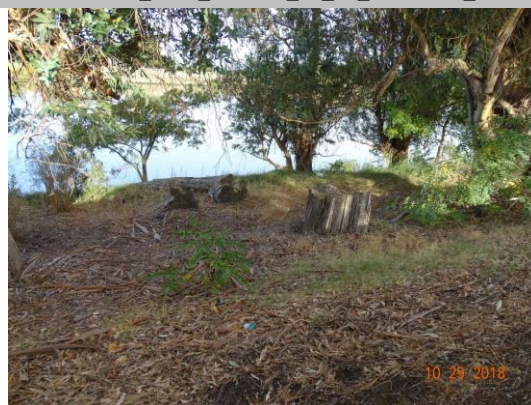
Photo 1 of 1 : SP_2019_NA0002_63_78_20190311_00039.jpg

LM Start	1.65	Rating **	N	Issue No.	78
LM End	1.65	Issue Type +	Ma	Location *	WS
Category	Earthen Levee			GPS Latitude/Longitude	
				Start	End
Item	Trim / Thin Trees			38.176455 °	38.176455 °
				-121.589515 °	-121.589515 °
DWR ID	DWR_NA0002_02_f_2018_78				
Comment Code					
T5 : Tree stumps.					
Inspector Comment

View of tree stump on the waterside slope (October 2018).

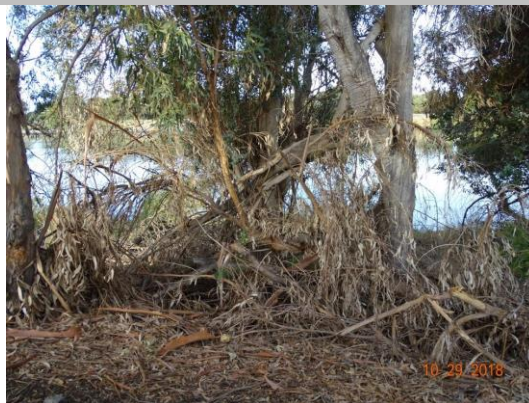
Photo 1 of 1 : SP_2019_NA0002_63_137_20190311_00080.jpg

LM Start	1.71	Rating **	M	Issue No.	137
LM End	1.71	Issue Type +	Ma	Location *	WS
Category	Earthen Levee			GPS Latitude/Longitude	
				Start	End
Item	Encroachments			38.175575 °	38.175575 °
				-121.590055 °	-121.590055 °
DWR ID	DWR_NA0002_02_f_2017_137				
Comment Code					
TR : Tree or limb					
Inspector Comment					
Remove tree limbs from the waterside slope.

View of downed tree limbs on waterside slope (October 2018).

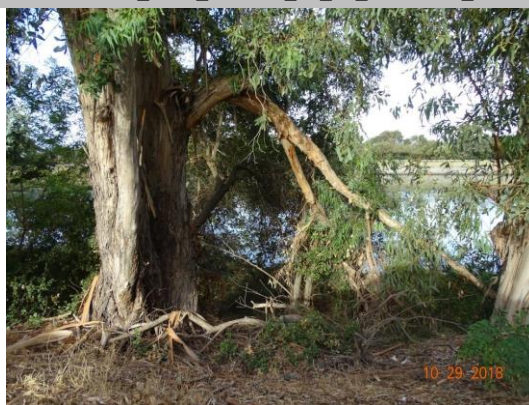
Photo 1 of 1 : SP_2019_NA0002_63_83_20190311_00044.jpg

LM Start	1.80	Rating **	M	Issue No.	83
LM End	1.80	Issue Type +	Ma	Location *	WS
Category	Earthen Levee			GPS Latitude/Longitude	
				Start	End
Item	Encroachments			38.174507 °	38.174507 °
				-121.590758 °	-121.590758 °
DWR ID	DWR_NA0002_02_f_2018_83				
Comment Code					
TR : Tree or limb					
Inspector Comment					
Remove limb from the waterside slope.

View of down tree limb on waterside slope (October 2018).

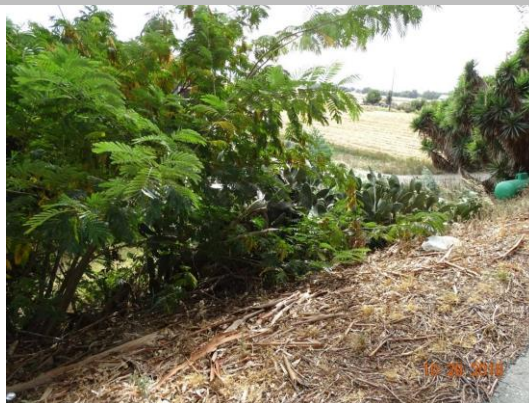
Photo 1 of 3 : SP_2019_NA0002_63_45_20190311_00024.jpg

LM Start	1.80	Rating **	U	Issue No.	45
LM End	1.82	Issue Type +	En	Location *	LS
Category	Earthen Levee			GPS Latitude/Longitude	
				Start	End
Item	Vegetation			38.174437 °	38.174153 °
				-121.590786 °	-121.590980 °
DWR ID	DWR_NA0002_02_f_2013_45				
Comment Code					
V6 : Landscaping					
Inspector Comment					
Dense vegetation and cactus are on the landside slope and toe.

View of cactus on landside slope (October 2018)

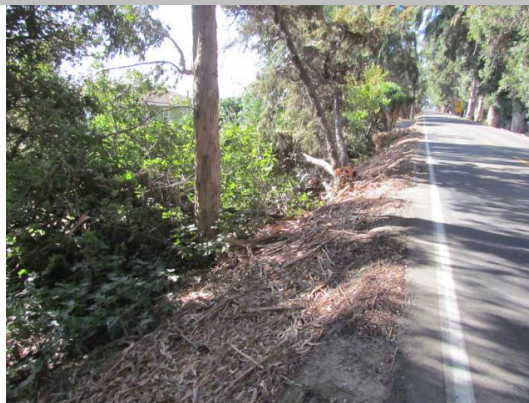
Photo 2 of 3 : SP_2019_NA0002_63_45_20190311_00025.jpg

LM Start	1.80	Rating **	U	Issue No.	45 (cont)	
LM End	1.82	Issue Type +	En	Location *	LS	
Category	Earthen Levee			GPS Latitude/Longitude		
				Start	End	
Item	Vegetation			38.174437 °	38.174153 °	
				-121.590786 °	-121.590980 °	
DWR ID	DWR_NA0002_02_f_2013_45					
Comment Code						
V6 : Landscaping						
Inspector Comment						
Dense vegetation and cactus are on the landside slope and toe.

Looking southwest at dense vegetation on landward slope.

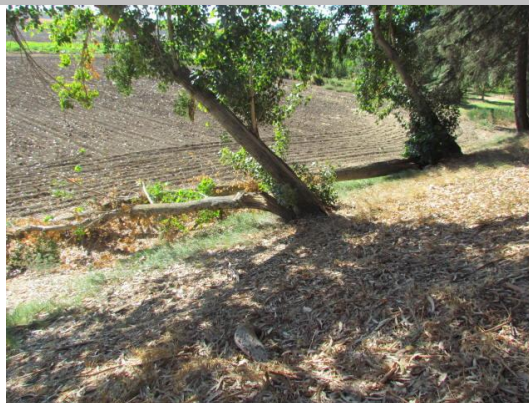
Photo 1 of 2 : SP_2019_NA0002_63_93_20190311_00052.jpg

LM Start	1.88	Rating **	M	Issue No.	93
LM End	1.89	Issue Type +	Ma	Location *	LS
Category	Earthen Levee			GPS Latitude/Longitude	
				Start	End
Item	Encroachments			38.173403 °	38.173221 °
				-121.591389 °	-121.591512 °
DWR ID	DWR_NA0002_02_f_2015_93				
Comment Code					
TR : Tree or limb					
Inspector Comment					
Broken tree limbs are on the landside slope and toe.

Looking southeast at broken tree limb on landward slope.

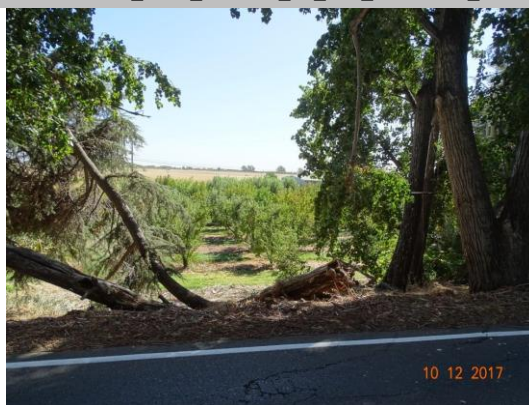
Photo 1 of 1 : SP_2019_NA0002_63_138_20190311_00081.jpg

LM Start	1.89	Rating **	M	Issue No.	138
LM End	1.89	Issue Type +	Ma	Location *	LS
Category	Earthen Levee			GPS Latitude/Longitude	
				Start	End
Item	Encroachments			38.173272 °	38.173272 °
				-121.591509 °	-121.591509 °
DWR ID	DWR_NA0002_02_f_2017_138				
Comment Code					
TR : Tree or limb					
Inspector Comment

Looking southeast at the landside slope.

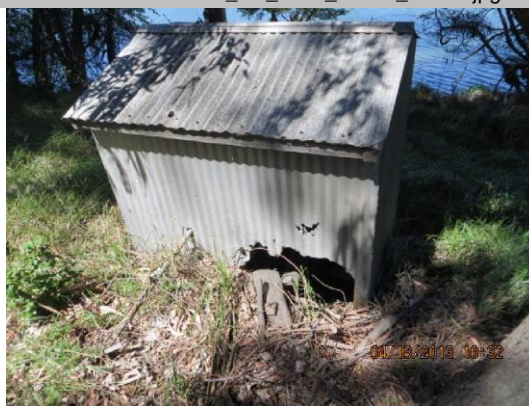
Photo 1 of 3 : UCIP_SP_2019_12185_19751.jpg

Comment Code					
Inspector Comment					
FS_ID:12185 DS_ID:21872 EP_NO: 11294 Repair Type: Non-Urgent Crossing Status: Found UCIP Comments: Pipe abandoned on both sides. Pipe should be abandoned properly. FIELD_STRUCT_DESC: 6-inch irrigation pipe of an unknown material through the levee, 6.5 feet below the crown. Pump in pump house on the waterside (WS) slope. 1-inch galvanized iron steel electrical conduit at same location. (Automatic Board Order (ABO) issued as Permit No. 11294, 1975 - Hubert Vandermaele). [Additional Reference(s): DWR Levee Log, 2005. USACE Sacramento O&M Manual 103, June 1954, (Station ""H"" 8+72) steel pipe listed, Drawing No. 50-4-2277]. FS Date: 4/18/2013

Pumphouse on WS slope.

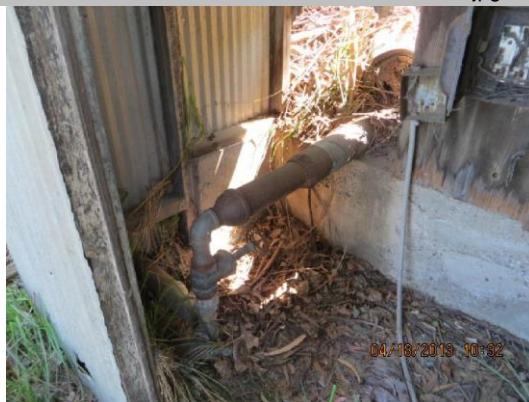
Photo 2 of 3 : UCIP_SP_2019_12185_19750.jpg

Pipe and shutoff valve at pumphouse on WS slope.

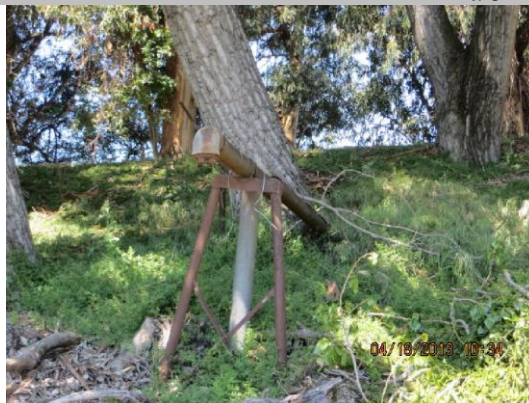
Photo 3 of 3 : UCIP_SP_2019_12185_19749.jpg

Comment Code						
Inspector Comment						
FS_ID:12185 DS_ID:21872 EP_NO: 11294 Repair Type: Non-Urgent Crossing Status: Found UCIP Comments: Pipe abandoned on both sides. Pipe should be abandoned properly. FIELD_STRUCT_DESC: 6-inch irrigation pipe of an unknown material through the levee, 6.5 feet below the crown. Pump in pump house on the waterside (WS) slope. 1-inch galvanized iron steel electrical conduit at same location. (Automatic Board Order (ABO) issued as Permit No. 11294, 1975 - Hubert Vandermaele). [Additional Reference(s): DWR Levee Log, 2005. USACE Sacramento O&M Manual 103, June 1954, (Station ""H"" 8+72) steel pipe listed, Drawing No. 50-4-2277]. FS Date: 4/18/2013

Pipe at LS slope (open).

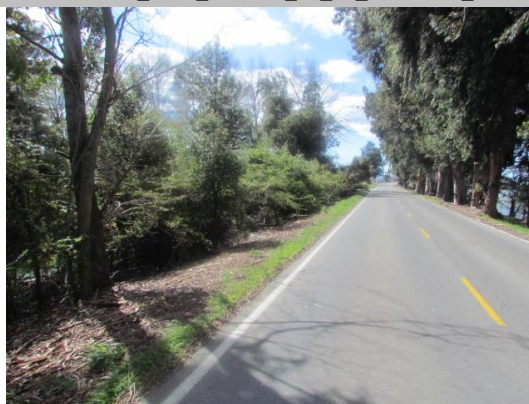
Photo 1 of 2 : SP_2019_NA0002_63_12_20190311_00012.jpg

LM Start	1.91	Rating **	U	Issue No.	12
LM End	1.94	Issue Type +	En	Location *	LS
Category	Earthen Levee			GPS Latitude/Longitude	
				Start	End
Item	Vegetation			38.173030 °	38.172598 °
				-121.591624 °	-121.591853 °
DWR ID	DWR_NA0002_02_s_2012_12				
Comment Code					
V6 : Landscaping					
Inspector Comment					
Dense landscaping vegetation is on the landside slope.

Looking south at dense landscaping on landside slope and toe.

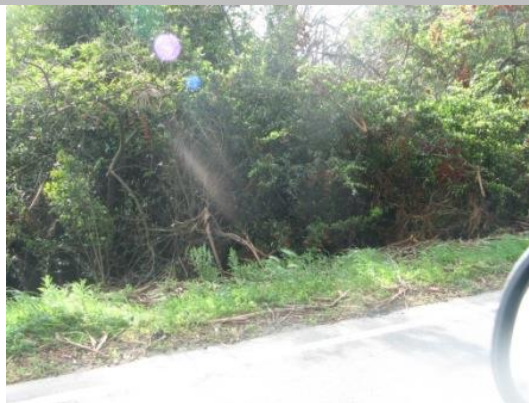
Photo 2 of 2 : SP_2019_NA0002_63_12_20190311_00013.jpg

LM Start	1.91	Rating **	U	Issue No.	12 (cont)	
LM End	1.94	Issue Type +	En	Location *	LS	
Category	Earthen Levee			GPS Latitude/Longitude		
				Start		End
Item	Vegetation			38.173030 °		38.172598 °
				-121.591624 °		-121.591853 °
DWR ID	DWR_NA0002_02_s_2012_12					
Comment Code						
V6 : Landscaping						
Inspector Comment						
Dense landscaping vegetation is on the landside slope.

Landscaping on landside slope blocking view of slope.

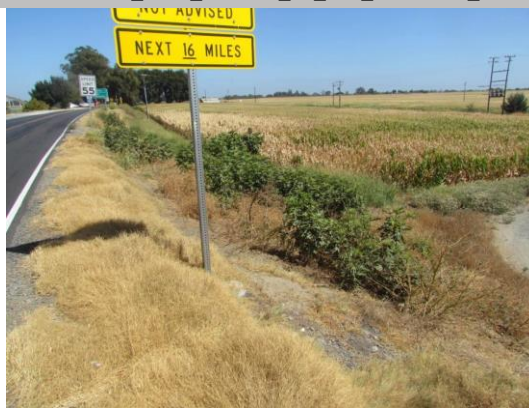
Photo 1 of 1 : SP_2019_NA0002_63_120_20190311_00074.jpg

LM Start	2.16	Rating **	M	Issue No.	120
LM End	2.16	Issue Type +	Ma	Location *	LS
Category	Earthen Levee			GPS Latitude/Longitude	
				Start	End
Item	Vegetation			38.169814 °	38.169814 °
				-121.593951 °	-121.593951 °
DWR ID	DWR_NA0002_02_f_2016_120				
Comment Code					
V2 : Remove the wild growth other than native grasses from the levee slopes.					
Inspector Comment					
Fig tree saplings are on the landside slope.

Looking northeast at fig tree saplings at landward toe.

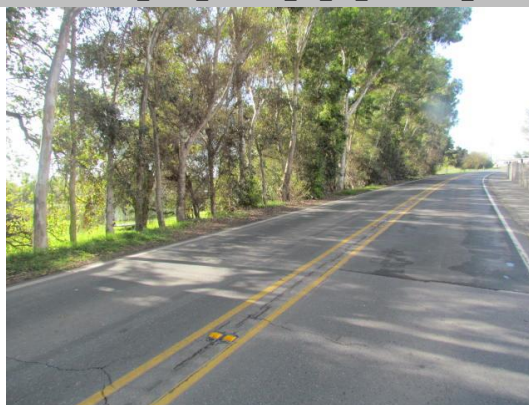
Photo 1 of 1 : SP_2019_NA0002_63_25_20190311_00017.jpg

LM Start	2.34	Rating **	U	Issue No.	25
LM End	2.38	Issue Type +	Ma	Location *	LS
Category	Earthen Levee			GPS Latitude/Longitude	
				Start	End
Item	Trim / Thin Trees			38.167627 °	38.167152 °
				-121.595538 °	-121.595997 °
DWR ID	DWR_NA0002_02_s_2012_25				
Comment Code					
T2 : Thin trees to allow visibility of the ground and room to flood fight.					
Inspector Comment

Looking southeast at trees at landward shoulder. (Spring 2015)

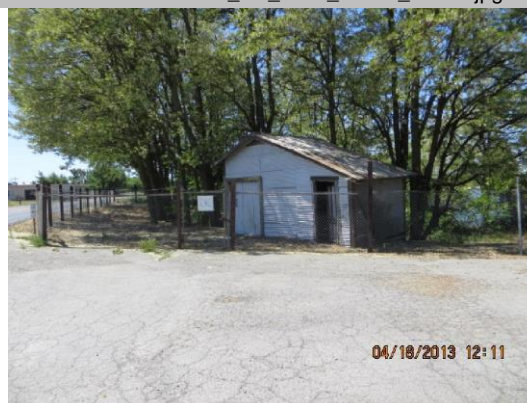
Photo 1 of 3 : UCIP_SP_2019_12211_19770.jpg

Comment Code					
Inspector Comment					
FS_ID:12211 DS_ID:21878 EP_NO: 11263 Repair Type: Non-Urgent Crossing Status: Indicator Found UCIP Comments: Further investigation to determine location of pipe should be done. Pumphouse needs to be unlocked to gather additional information. FIELD_STRUCT_DESC: 8-inch irrigation pipe of an unknown material through the levee, 3.7 feet below the crown. Pump in pump house on the waterside (WS) berm. 30-inch concrete standpipe on the landside (LS). (Automatic Board Order (ABO) issued as Permit No. 11263, 1975 - Ensher, Alexander, and Barsoon, Inc.). [Additional Reference(s): DWR Levee Log, 2005. USACE Sacramento O&M Manual 103, June 1954, (RM 18.25) welded steel pipe listed, Drawing No. 6-13-1100]. FS Date: 4/18/2013

Possible pumphouse on WS shoulder.

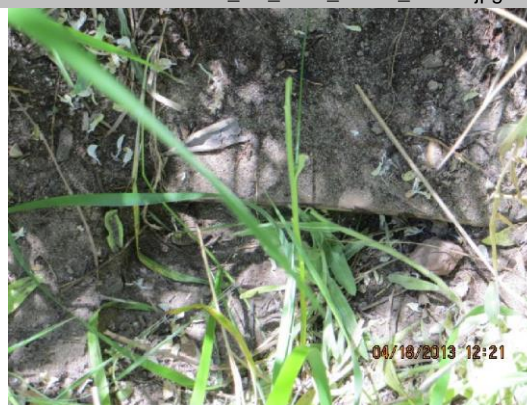
Photo 2 of 3 : UCIP_SP_2019_12211_19769.jpg

Evidence of pipe (buried) on LS in ditch.

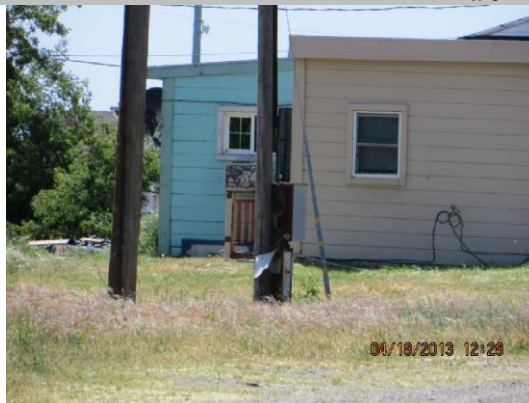
Photo 3 of 3 : UCIP_SP_2019_12211_19768.jpg

Comment Code						
Inspector Comment						
FS_ID:12211 DS_ID:21878 EP_NO: 11263 Repair Type: Non-Urgent Crossing Status: Indicator Found UCIP Comments: Further investigation to determine location of pipe should be done. Pumphouse needs to be unlocked to gather additional information. FIELD_STRUCT_DESC: 8-inch irrigation pipe of an unknown material through the levee, 3.7 feet below the crown. Pump in pump house on the waterside (WS) berm. 30-inch concrete standpipe on the landside (LS). (Automatic Board Order (ABO) issued as Permit No. 11263, 1975 - Ensher, Alexander, and Barsoon, Inc.). [Additional Reference(s): DWR Levee Log, 2005. USACE Sacramento O&M Manual 103, June 1954, (RM 18.25) welded steel pipe listed, Drawing No. 6-13-1100]. FS Date: 4/18/2013

JP with a meter on pole that would be appropriate for this crossing.

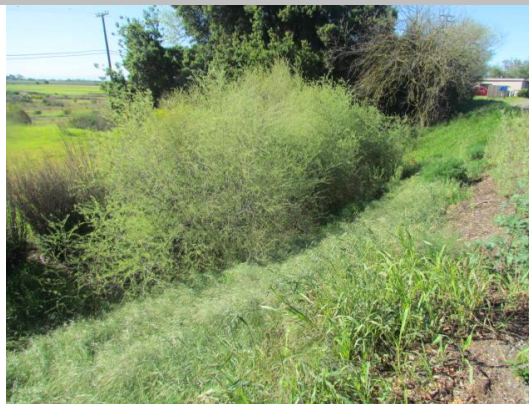
Photo 1 of 2 : SP_2019_NA0002_63_99_20190311_00058.jpg

LM Start	2.42	Rating **	U	Issue No.	99
LM End	2.42	Issue Type +	Ma	Location *	LS
Category	Earthen Levee			GPS Latitude/Longitude	
				Start	End
Item	Vegetation			38.166772 °	38.166772 °
				-121.596667 °	-121.596667 °
DWR ID	DWR_NA0002_02_s_2014_99				
Comment Code					
V2 : Remove the wild growth other than native grasses from the levee slopes.					
Inspector Comment					
Dense willows are on the landside slope.

Looking southwest at vegetation (willows) on landward slope and toe.

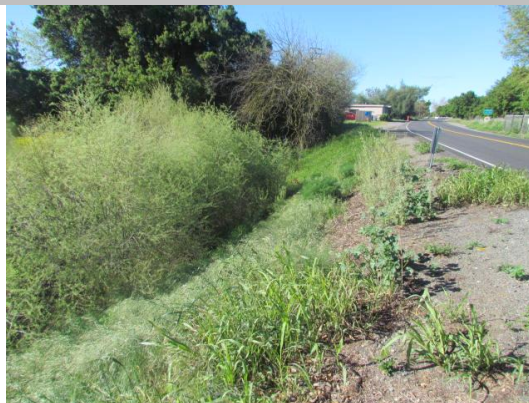
Photo 2 of 2 : SP_2019_NA0002_63_99_20190311_00059.jpg

LM Start	2.42	Rating **	U	Issue No.	99 (cont)	
LM End	2.42	Issue Type +	Ma	Location *	LS	
Category	Earthen Levee			GPS Latitude/Longitude		
				Start		End
Item	Vegetation			38.166772 °		38.166772 °
				-121.596667 °		-121.596667 °
DWR ID	DWR_NA0002_02_s_2014_99					
Comment Code						
V2 : Remove the wild growth other than native grasses from the levee slopes.						
Inspector Comment						
Dense willows are on the landside slope.

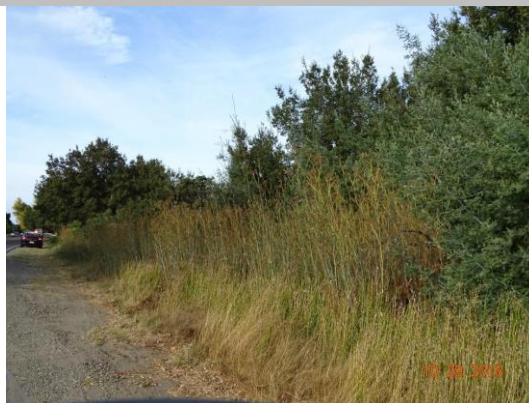
Photo 1 of 1 : SP_2019_NA0002_63_86_20190311_00046.jpg

LM Start	2.47	Rating **	U	Issue No.	86
LM End	2.57	Issue Type +	Ma	Location *	WS
Category	Earthen Levee			GPS Latitude/Longitude	
				Start	End
Item	Vegetation			38.166453 °	38.165842 °
				-121.597387 °	-121.598995 °
DWR ID	DWR_NA0002_02_f_2018_86				
Comment Code					
V2 : Remove the wild growth other than native grasses from the levee slopes.					
Inspector Comment					
Remove wild growth on the waterside slope.

View looking downstream at vegetation on waterside slope (October 2018).

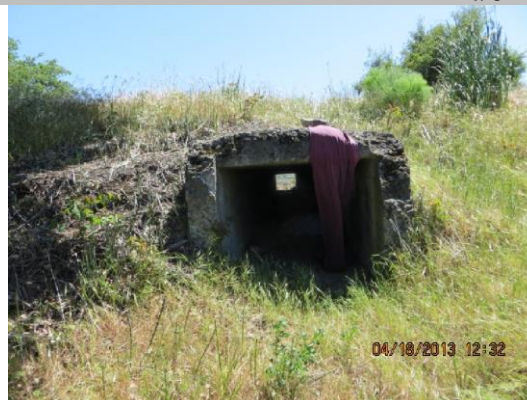
Photo 1 of 3 : UCIP_SP_2019_53389_19773.jpg

Comment Code						
Inspector Comment						
FS_ID:53389 DS_ID:21879 EP_NO: N/A Repair Type: Non-Urgent Crossing Status: Found UCIP Comments: 07/12/2018 Tunnel is open on both sides. No integrity issue observed, therefore crossing downgraded to "Non-Urgent". (O.Yakimov-DWR UCIP)10/24/2016 same as previous inspection culvert is open on both ends. WS blocked by blankets -- WS structure is being used as a shelter. (O. Magana - DWR UCIP)04/18/2013 Culvert open on both ends. Needs to be abandoned properly. (W. Wylie - DWR UCIP) FIELD_STRUCT_DESC: *ABANDONED* 42-inch by 42-inch open reinforced concrete drainage culvert through the levee, 6 feet below the crown. [Additional Reference(s): DWR Levee Log, 2005, 3-foot by 3.5-foot culvert listed. USACE Sacramento O&M Manual 103, June 1954, (RM 18.16) Drawing No. 6-13-1100]. FS Date: 7/12/2018 2:59:33 PM

Concrete tunnel open on both ends.

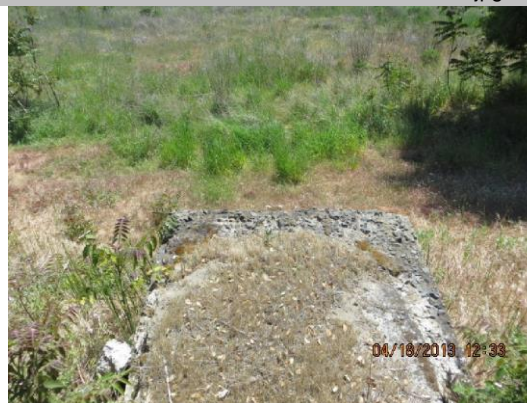
Photo 2 of 3 : UCIP_SP_2019_53389_19772.jpg

Top of concrete tunnel on LS shoulder.

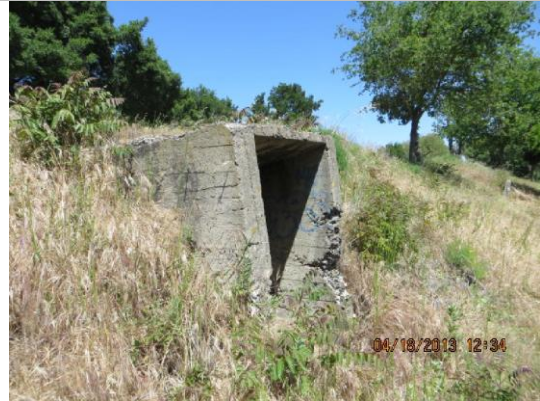
Photo 3 of 3 : UCIP_SP_2019_53389_19771.jpg

Comment Code					
Inspector Comment					
FS_ID:53389 DS_ID:21879 EP_NO: N/A Repair Type: Non-Urgent Crossing Status: Found UCIP Comments: 07/12/2018 Tunnel is open on both sides. No integrity issue observed, therefore crossing downgraded to "Non-Urgent". (O.Yakimov-DWR UCIP)10/24/2016 same as previous inspection culvert is open on both ends. WS blocked by blankets -- WS structure is being used as a shelter. (O. Magana - DWR UCIP)04/18/2013 Culvert open on both ends. Needs to be abandoned properly. (W. Wylie - DWR UCIP) FIELD_STRUCT_DESC: *ABANDONED* 42-inch by 42-inch open reinforced concrete drainage culvert through the levee, 6 feet below the crown. [Additional Reference(s): DWR Levee Log, 2005, 3-foot by 3.5-foot culvert listed. USACE Sacramento O&M Manual 103, June 1954, (RM 18.16) Drawing No. 6-13-1100]. FS Date: 7/12/2018 2:59:33 PM

Concrete tunnel on LS shoulder.

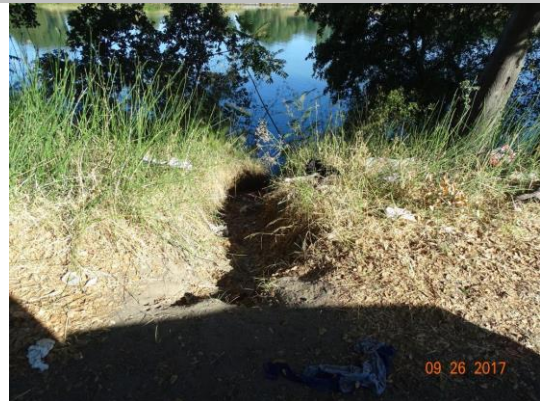
Photo 1 of 1 : SP_2019_NA0002_63_82_20190311_00043.jpg

LM Start	2.56	Rating **	M	Issue No.	82
LM End	2.56	Issue Type +	Ma	Location *	WS
Category	Earthen Levee			GPS Latitude/Longitude	
				Start	End
Item	Slope Stability			38.165898 °	38.165898 °
				-121.598888 °	-121.598888 °
DWR ID	DWR_NA0002_02_f_2017_82				
Comment Code					
S2 : Repair the levee slope damaged by foot traffic and prevent access where possible.					
Inspector Comment					
There is a footpath digging into the levee slope.

Looking northwest at the waterside slope.

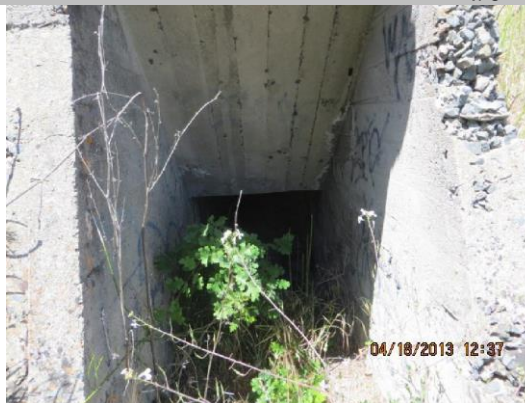
Photo 1 of 3 : UCIP_SP_2019_53513_19776.jpg

Comment Code						
Inspector Comment						
FS_ID:53513 DS_ID:21880 EP_NO: N/A Repair Type: Non-Urgent Crossing Status: Found UCIP Comments: 07/12/2018 Tunnel is open on both sides. No integrity issue observed, therefore crossing downgraded to "Non-Urgent". (O.Yakimov-DWR UCIP)10/24/2016 same as previous inspection concrete box culvert will need to be abandoned properly. (O. Magana - DWR UCIP)04/18/2013 tunnel should be abandoned properly. (W. Wylie - DWR UCIP) FIELD_STRUCT_DESC: *ABANDONED* 48-inch by 48-inch reinforced concrete drainage culvert through the levee, 6.5-inches below the crown. [Additional Reference(s): DWR Levee Log, 2005. USACE Sacramento O&M Manual 103, June 1954, (RM 18.13) 3-foot by 3-foot concrete box listed, Drawing No. 6-13-1100]. FS Date: 7/12/2018 9:05:37 AM

Tunnel open on LS shoulder.

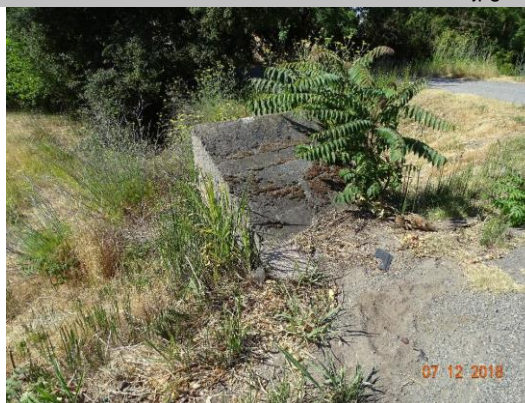
Photo 2 of 3 : UCIP_SP_2019_53513_77578.jpg

Concrete tunnel on LS shoulder.

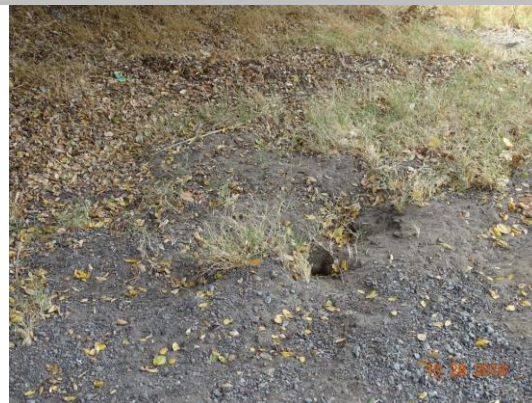
Photo 1 of 2 : SP_2019_NA0002_63_172_20190311_00103.jpg

View of animal hole on the landside slope (October 2018)

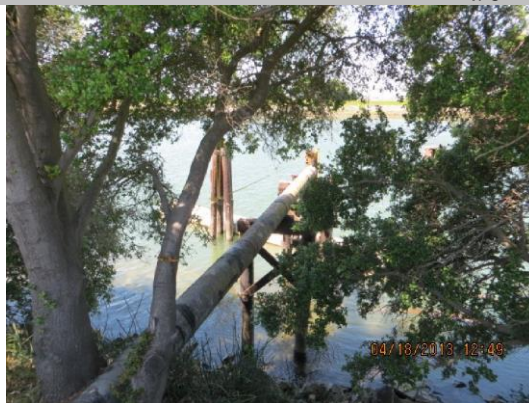
Photo 1 of 3 : UCIP_SP_2019_12214_19778.jpg

LM Start	2.75	Rating **	M	Issue No.	183	
LM End	2.75	Issue Type +	En	Location *		
Category	Supplemental			GPS Latitude/Longitude		
				Start	End	
Item	DWR UCIP Field Study			38.164432 °	38.164432 °	
				-121.601918 °	-121.601918 °	
DWR ID	21881					
Comment Code						
Inspector Comment						
FS_ID:12214						
DS_ID:21881						
EP_NO: 2005						
Repair Type: Non-Urgent						
Crossing Status: Found						
UCIP Comments: Pipe appears abandoned and rusty. It should be abandoned properly if it is no longer in use.						
FIELD_STRUCT_DESC: 18-inch steel sewer discharge line through the levee, 4 feet below the crown. Two pile dolphins in stream. Fire hydrant on the landside (LS) shoulder. (Permit No. 2005, 1954 - City of Isleton).						
[Additional Reference(s): DWR Levee Log, 2005].						
FS Date: 4/18/2013

Pipe, pile structure, and dolphins on WS.

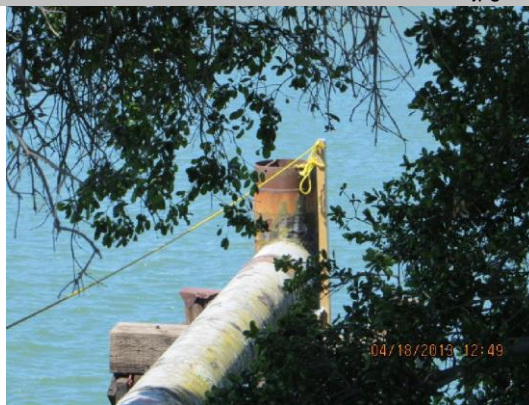
Photo 2 of 3 : UCIP_SP_2019_12214_19777.jpg

LM Start	2.75	Rating **	M	Issue No.	183 (cont)
LM End	2.75	Issue Type +	En	Location *

Pipe on pier at WS.

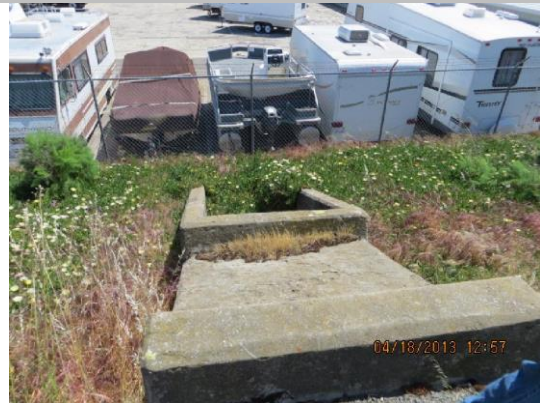
Photo 1 of 3 : UCIP_SP_2019_53514_19782.jpg

Comment Code					
Inspector Comment					
FS_ID:53514 DS_ID:21882 EP_NO: N/A Repair Type: Non-Urgent Crossing Status: Found UCIP Comments: 07/12/2018 Tunnel is open on both ends. No integrity issue observed, therefore crossing downgraded to "Non-Urgent". (O.Yakimov-DWR UCIP)10/24/2016 same as previous inspection tunnel is opened on both ends. (O. Magana - DWR UCIP)04/18/2013 Tunnel open on both ends and should be abandoned properly. (W. Wylie - DWR UCIP) FIELD_STRUCT_DESC: *ABANDONED* 48-inch by 72-inch reinforced concrete drainage culvert through the levee, 1 foot below the crown. [Additional Reference(s): DWR Levee Log, 2005, 4-foot by 4.5-foot culvert listed. USACE Sacramento O&M Manual 103, June 1954, (RM 17.89) 48-inch by 52-inch concrete box listed, Drawing No. 6-13-1100]. FS Date: 7/12/2018 9:07:49 AM

Entrance to tunnel on LS slope.

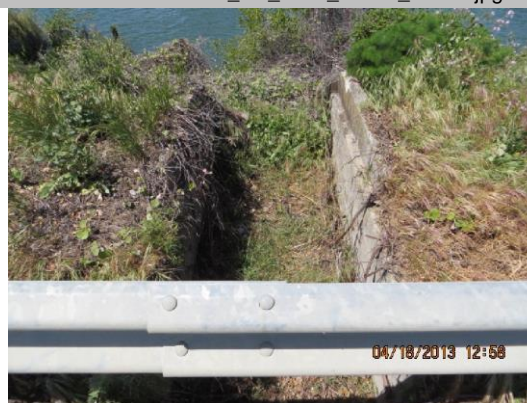
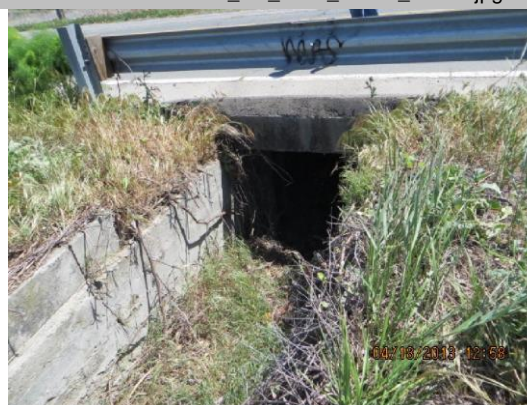
Comment Code						
Inspector Comment						
FS_ID:53514 DS_ID:21882 EP_NO: N/A Repair Type: Non-Urgent Crossing Status: Found UCIP Comments: 07/12/2018 Tunnel is open on both ends. No integrity issue observed, therefore crossing downgraded to "Non-Urgent". (O.Yakimov-DWR UCIP)10/24/2016 same as previous inspection tunnel is opened on both ends. (O. Magana - DWR UCIP)04/18/2013 Tunnel open on both ends and should be abandoned properly. (W. Wylie - DWR UCIP) FIELD_STRUCT_DESC: *ABANDONED* 48-inch by 72-inch reinforced concrete drainage culvert through the levee, 1 foot below the crown. [Additional Reference(s): DWR Levee Log, 2005, 4-foot by 4.5-foot culvert listed. USACE Sacramento O&M Manual 103, June 1954, (RM 17.89) 48-inch by 52-inch concrete box listed, Drawing No. 6-13-1100]. FS Date: 7/12/2018 9:07:49 AM

LM Start	2.84	Rating **	M	Issue No.	184 (cont)
LM End	2.84	Issue Type +	Ma	Location *

Tunnel opening on WS slope.

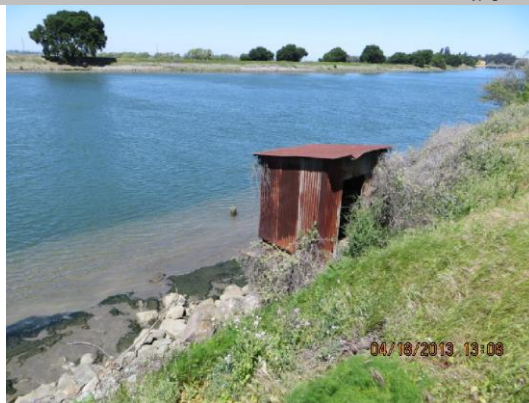
Photo 1 of 2 : UCIP_SP_2019_12217_19785.jpg

LM Start	2.90	Rating **	M	Issue No.	185
LM End	2.90	Issue Type +	En	Location *	
Category	Supplemental			GPS Latitude/Longitude	
				Start	End
Item	DWR UCIP Field Study			38.163475 °	38.163475 °
				-121.604221 °	-121.604221 °
DWR ID	21883				
Comment Code					
Inspector Comment					
FS_ID:12217 DS_ID:21883 EP_NO: 11269 Repair Type: Non-Urgent Crossing Status: Found UCIP Comments: Pipe needs to be abandoned properly if it is truly abandoned. FIELD_STRUCT_DESC: 8-inch irrigation pipe of an unknown material through the levee, 8.7 feet below the crown. Pump in pump house on the waterside (WS) slope. Slide gate in pump house. Pipe not visible on the landside (LS). (Automatic Board Order (ABO) issued as Permit No. 11269, 1975 - Griffin Steel and Supply Company). [Additional Reference(s): DWR Levee Log, 2005]. FS Date: 4/18/2013

Pumphouse on WS slope.
