**Flood Control Project Maintenance
Levee Inspections**
LMA District Cover Sheet
Spring 2019 Levee Inspection Results

Brannan Andrus Levee Maintenance District

Spring 2019 Levee Inspection Results

Waterway			Bank	Unit Miles
Unit No. 01 Georgiana Slough			Right	6.01
	Spring (March - May)	Summer (June - August)	(September - November) Fall	Winter (December - February)
Unit Maintenance Rating (Fall Only)				
Date of Inspection	4/23/2019 - 4/23/2019			
DWR Inspector	David Julian			
Accompanied By

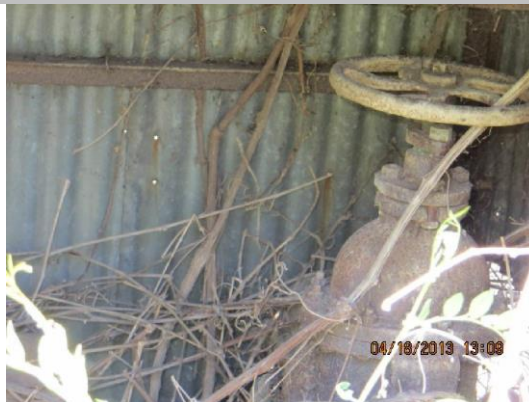
Photo 2 of 2 : UCIP_SP_2019_12217_19784.jpg

LM Start	2.90	Rating **	M	Issue No.	185 (cont)
LM End	2.90	Issue Type +	En	Location *

Slide gate in pumphouse on WS slope.

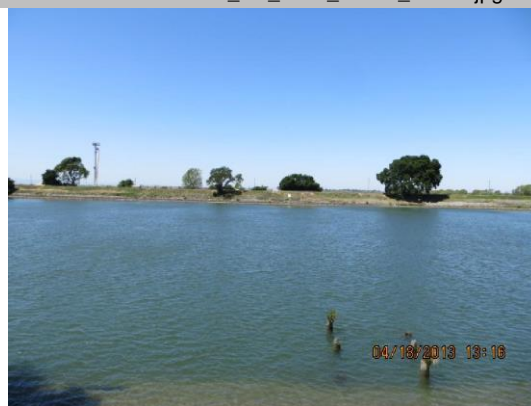
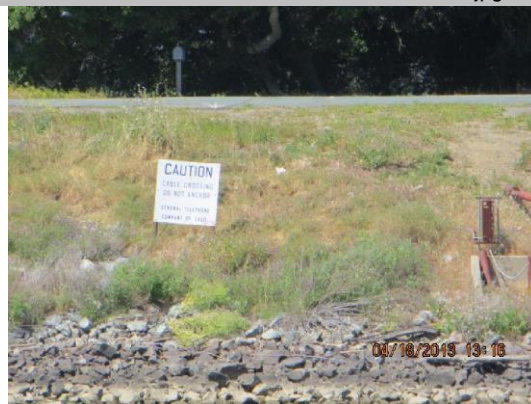
LM Start	2.91	Rating **	M	Issue No.	186
LM End	2.91	Issue Type +	En	Location *	
Category	Supplemental			GPS Latitude/Longitude	
				Start	End
Item	DWR UCIP Field Study			38.163413 °	38.163413 °
				-121.604399 °	-121.604399 °
DWR ID	21884				
Comment Code					
Inspector Comment					
FS_ID:16005 DS_ID:21884 EP_NO: 14173 Repair Type: Non-Urgent Crossing Status: Indicator Found UCIP Comments: If pipe is still in use it should be marked properly on levee. FIELD_STRUCT_DESC: 12-inch steel telephone conduit through the levee, 2 feet below the crown, and under the channel. Four 4-inch galvanized iron conductor pipes sleeved through 12-inch steel conduit. Sign on the waterside (WS) slope of levee across river provides location for this crossing. (Permit No. 14173, 1985 - Owner Unknown). [Additional Reference(s): DWR Levee Log, 2005]. FS Date: 4/18/2013

Sign on opposite side of river provides indication of pipe location.

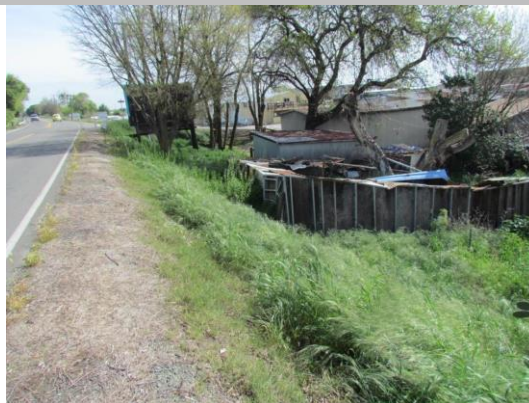
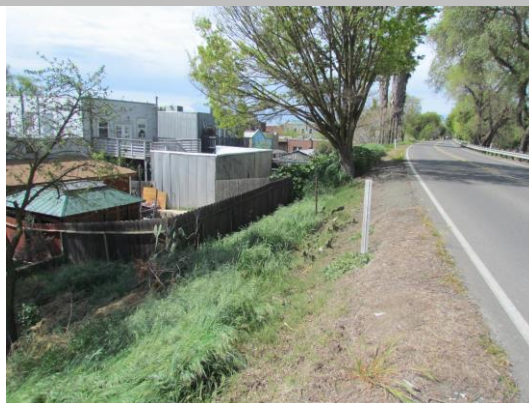
LM Start	2.93	Rating **	U	Issue No.	30 (cont)
LM End	3.12	Issue Type +	En	Location *	LS

Looking north at several encroachments along landward slope and toe.

Looking south at several encroachments along landward slope and toe.

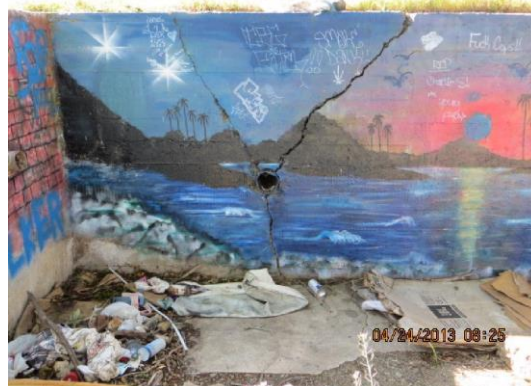
Photo 1 of 2 : UCIP_SP_2019_12724_20643.jpg

LM Start	2.99	Rating **	M	Issue No.	187	
LM End	2.99	Issue Type +	En	Location *		
Category	Supplemental			GPS Latitude/Longitude		
				Start	End	
Item	DWR UCIP Field Study			38.163063 °	38.163063 °	
				-121.605799 °	-121.605799 °	
DWR ID	21886					
Comment Code						
Inspector Comment						
FS_ID:12724 DS_ID:21886 EP_NO: N/A Repair Type: Non-Urgent Crossing Status: Found UCIP Comments: Pipe should be abandoned properly. FIELD_STRUCT_DESC: *ABANDONED* 6-inch pipe of an unknown material or purpose through levee 4.5 feet below crown. Originally included in the 1959 O&M manual. Pipe visible at foundation on WS shoulder. FS Date: 4/24/2013 10:00:00 AM

Pipe visible at concrete foundation on WS shoulder.

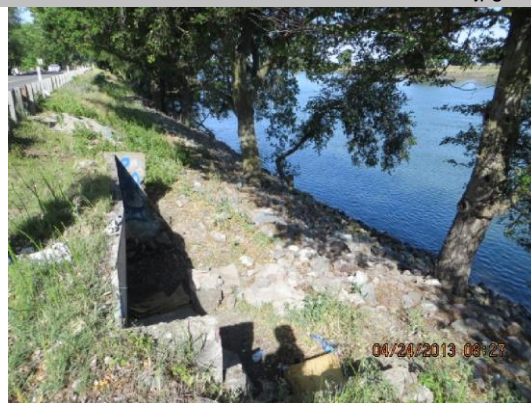
Photo 2 of 2 : UCIP_SP_2019_12724_20642.jpg

LM Start	2.99	Rating **	M	Issue No.	187 (cont)
LM End	2.99	Issue Type +	En	Location *

Foundation on WS shoulder.

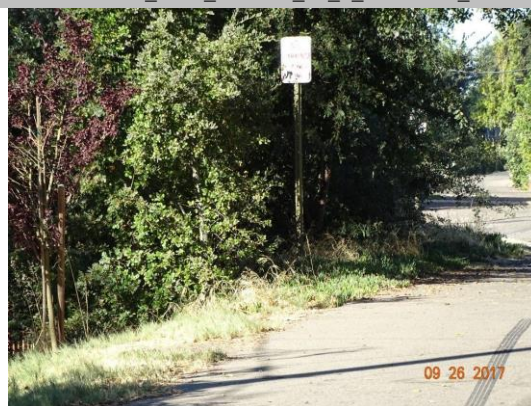
Photo 1 of 3 : SP_2019_NA0002_63_7_20190311_00001.jpg

LM Start	3.22	Rating **	U	Issue No.	7
LM End	3.22	Issue Type +	En	Location *	LS
Category	Earthen Levee			GPS Latitude/Longitude	
				Start	End
Item	Vegetation			38.162609 °	38.162609 °
				-121.609979 °	-121.609979 °
DWR ID	DWR_NA0002_02_s_2012_7				
Comment Code					
V6 : Landscaping					
Inspector Comment

Looking southwest at the landside slope.

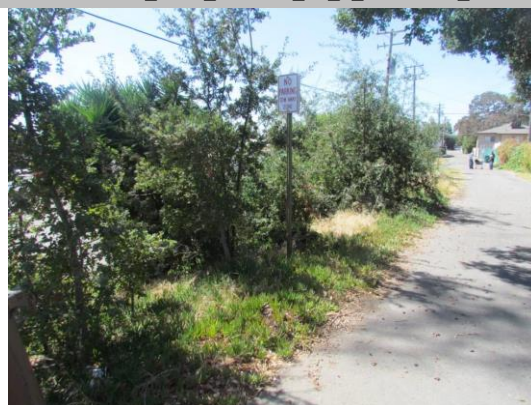
Photo 2 of 3 : SP_2019_NA0002_63_7_20190311_00002.jpg

LM Start	3.22	Rating **	U	Issue No.	7 (cont)
LM End	3.22	Issue Type +	En	Location *	LS

Looking south at overgrown landscaping on landward slope. (Fall 2016)

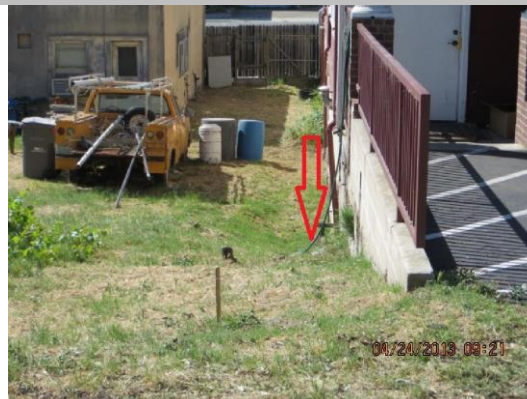
Photo 2 of 2 : UCIP_SP_2019_15966_26948.jpg

LM Start	3.29	Rating **	M	Issue No.	188
LM End	3.29	Issue Type +	En	Location *	
Category	Supplemental			GPS Latitude/Longitude	
				Start	End
Item	DWR UCIP Field Study			38.162430 °	38.162430 °
				-121.611248 °	-121.611248 °
DWR ID	23135				
Comment Code					
Inspector Comment					
FS_ID:15966 DS_ID:23135 EP_NO: N/A Repair Type: Non-Urgent Crossing Status: Found UCIP Comments: Need to determine disposition and use of pipe. FIELD_STRUCT_DESC: 4-inch cast iron drainage pipe through the levee, 8 feet below the crown. Pipe visible next to foundation on the landside (LS) toe. FS Date: 4/24/2013

Pipe visible next to foundation on LS slope.

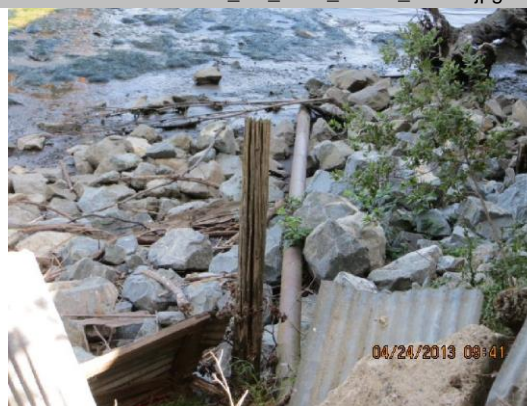
Photo 2 of 2 : UCIP_SP_2019_12745_20682.jpg

LM Start	3.37	Rating **	M	Issue No.	190 (cont)	
LM End	3.37	Issue Type +	En	Location *		
Category	Supplemental			GPS Latitude/Longitude		
				Start	End	
Item	DWR UCIP Field Study			38.162388 °	38.162388 °	
				-121.612847 °	-121.612847 °	
DWR ID	21892					
Comment Code						
Inspector Comment						
FS_ID:12745 DS_ID:21892 EP_NO: 11266 Repair Type: Non-Urgent Crossing Status: Found UCIP Comments: This pipe has been abandoned and should be abandoned properly. Pumphouse has collapsed. FIELD_STRUCT_DESC: 6-inch irrigation pipe of an unknown material through the levee, 4.5 feet below the crown. Pump in pump house on the waterside (WS). (Automatic Board Order (ABO) issued as Permit No. 11266, 1975 - Gardiner Improvement Company). [Additional Reference(s): DWR Levee Log, 2005]. FS Date: 4/24/2013

Pipe visible on WS toe.

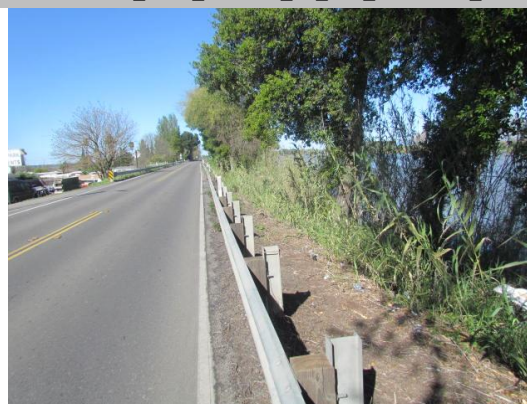
Photo 1 of 1 : SP_2019_NA0002_63_100_20190311_00060.jpg

LM Start	3.39	Rating **	M	Issue No.	100
LM End	3.42	Issue Type +	Ma	Location *	WS
Category	Earthen Levee			GPS Latitude/Longitude	
				Start	End
Item	Vegetation			38.162394 °	38.162432 °
				-121.613146 °	-121.613637 °
DWR ID	DWR_NA0002_02_s_2014_100				
Comment Code					
V2 : Remove the wild growth other than native grasses from the levee slopes.					
Inspector Comment					
There is bamboo on the waterside slope.

Looking southwest at vegetation (bamboo) on waterward slope.

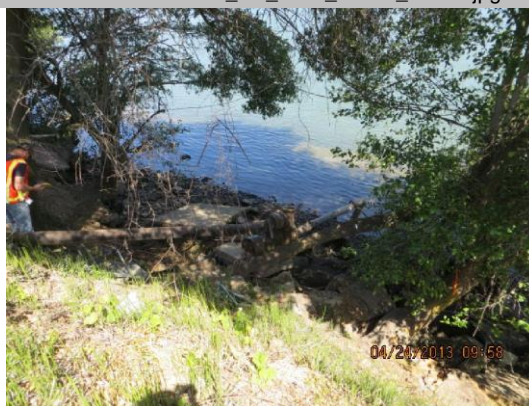
Photo 1 of 3 : UCIP_SP_2019_12746_20686.jpg

LM Start	3.44	Rating **	M	Issue No.	191
LM End	3.44	Issue Type +	En	Location *	
Category	Supplemental			GPS Latitude/Longitude	
				Start	End
Item	DWR UCIP Field Study			38.162473 °	38.162473 °
				-121.613963 °	-121.613963 °
DWR ID	21893				
Comment Code					
Inspector Comment					
FS_ID:12746 DS_ID:21893 EP_NO: 11275 Repair Type: Non-Urgent Crossing Status: Found UCIP Comments: Pipe abandoned and should be abandoned properly. Pipe open on both ends. FIELD_STRUCT_DESC: 8-inch irrigation pipe of an unknown material through the levee, 7.7 feet below the crown. Pump in pump house on the waterside (WS) slope. (Automatic Board Order (ABO) issued as Permit No. 11275, 1975 - M. R. V., Inc., Isleton Motel). [Additional Reference(s): DWR Levee Log, 2005. USACE Sacramento O&M Manual 102, April 1959, (RM 17.3) (Reclamation District No. 2067) steel pipe listed]. FS Date: 4/24/2013

Pipe and pump visible on WS slope

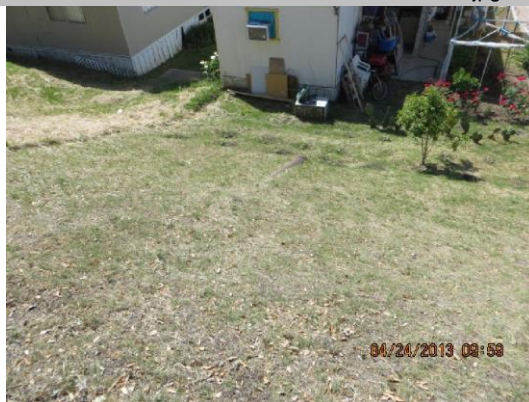
Photo 2 of 3 : UCIP_SP_2019_12746_20685.jpg

Pipe visible on LS slope near toe.

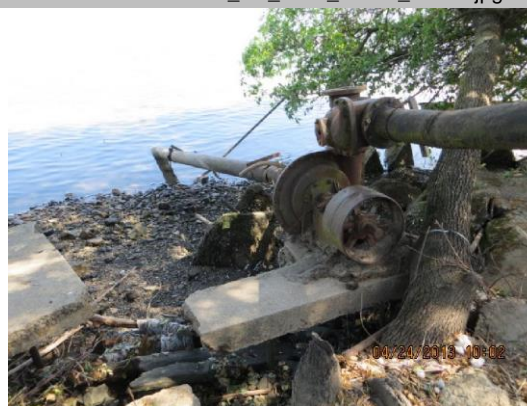
Photo 3 of 3 : UCIP_SP_2019_12746_20684.jpg

Comment Code						
Inspector Comment						
FS_ID:12746 DS_ID:21893 EP_NO: 11275 Repair Type: Non-Urgent Crossing Status: Found UCIP Comments: Pipe abandoned and should be abandoned properly. Pipe open on both ends. FIELD_STRUCT_DESC: 8-inch irrigation pipe of an unknown material through the levee, 7.7 feet below the crown. Pump in pump house on the waterside (WS) slope. (Automatic Board Order (ABO) issued as Permit No. 11275, 1975 - M. R. V., Inc., Isleton Motel). [Additional Reference(s): DWR Levee Log, 2005. USACE Sacramento O&M Manual 102, April 1959, (RM 17.3) (Reclamation District No. 2067) steel pipe listed]. FS Date: 4/24/2013

Pipe and pump on WS toe.

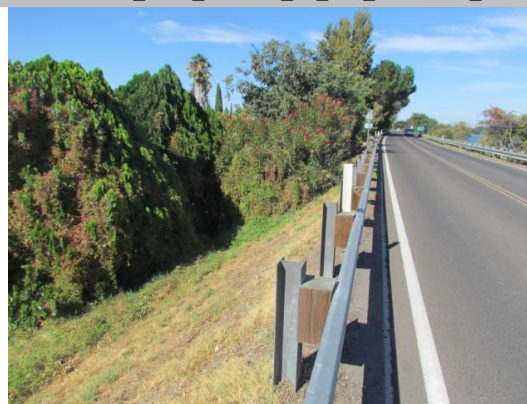
Photo 1 of 1 : SP_2019_NA0002_63_101_20190311_00061.jpg

LM Start	3.47	Rating **	U	Issue No.	101
LM End	3.53	Issue Type +	En	Location *	LS
Category	Earthen Levee			GPS Latitude/Longitude	
				Start	End
Item	Vegetation			38.162492 °	38.162600 °
				-121.614521 °	-121.615667 °
DWR ID	DWR_NA0002_02_s_2014_101				
Comment Code					
V6 : Landscaping					
Inspector Comment

Looking at dense landscaping on landward slope.

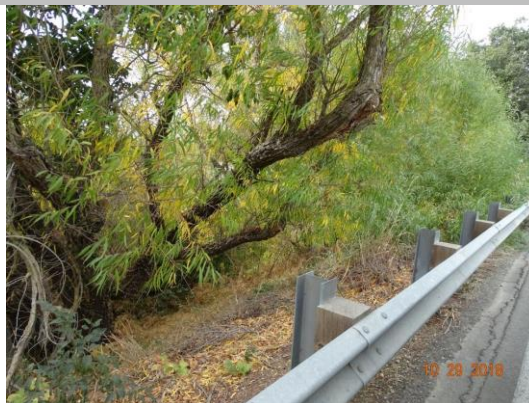
Photo 1 of 1 : SP_2019_NA0002_63_171_20190311_00102.jpg

LM Start	3.53	Rating **	U	Issue No.	171
LM End	3.56	Issue Type +	Ma	Location *	LS
Category	Earthen Levee			GPS Latitude/Longitude	
				Start	End
Item	Vegetation			38.162600 °	38.162658 °
				-121.615664 °	-121.616295 °
DWR ID	DWR_NA0002_02_f_2018_171				
Comment Code					
V2 : Remove the wild growth other than native grasses from the levee slopes.					
Inspector Comment

View looking upstream at thick vegetation on the landside slope (October 2018).

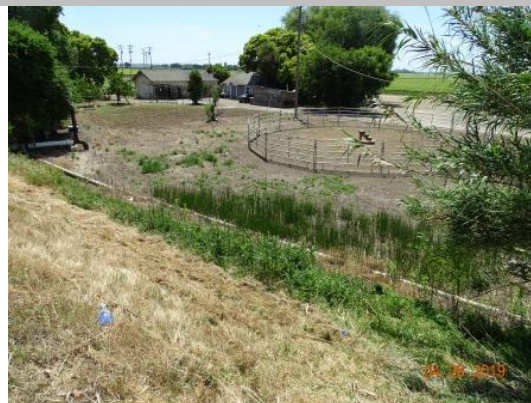
Photo 1 of 1 : SP_2019_NA0002_63_108_20190429_00208.jpg

LM Start	3.92	Rating **	M	Issue No.	108
LM End	3.92	Issue Type +	En	Location *	LS
Category	Earthen Levee			GPS Latitude/Longitude	
				Start	End
Item	Encroachments			38.164020 °	38.164020 °
				-121.622641 °	-121.622641 °
DWR ID	DWR_NA0002_02_s_2019_108				
Comment Code					
LI : Landscape Irrigation					
Inspector Comment					
There is an irrigation pipe along the landside toe.

View of landscape irrigation at the landside toe (Spring 2019).

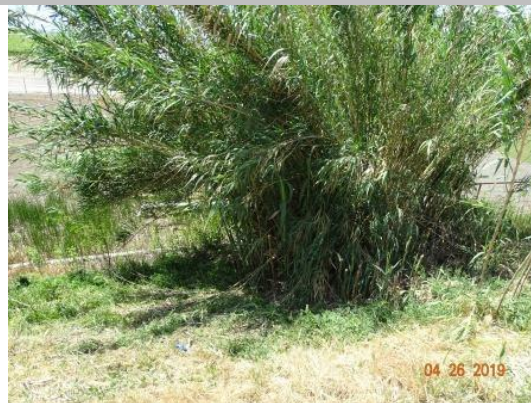
Photo 1 of 1 : SP_2019_NA0002_63_98_20190429_00207.jpg

LM Start	3.92	Rating **	U	Issue No.	98
LM End	3.92	Issue Type +	Ma	Location *	LS
Category	Earthen Levee			GPS Latitude/Longitude	
				Start	End
Item	Vegetation			38.164019 °	38.164019 °
				-121.622642 °	-121.622642 °
DWR ID	DWR_NA0002_02_s_2019_98				
Comment Code					
V2 : Remove the wild growth other than native grasses from the levee slopes.					
Inspector Comment					
Remove arundo from the landside slope.

View of arundo on the landside slope (Spring 2019).

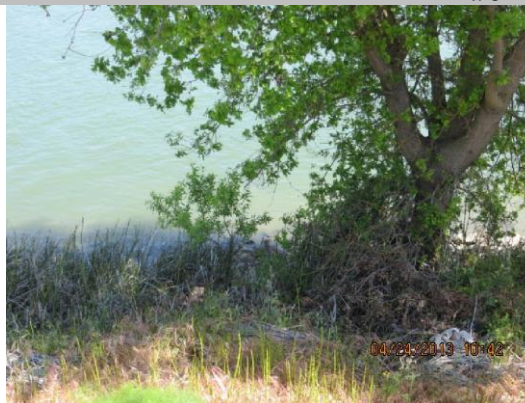
Photo 3 of 3 : UCIP_SP_2019_12752_20697.jpg

Comment Code						
Inspector Comment						
FS_ID:12752						
DS_ID:21898						
EP_NO: 11287						
Repair Type: Non-Urgent						
Crossing Status: Found						
UCIP Comments: Aging pipe with repair on WS slope. Good candidate for vidio inspection.						
FIELD_STRUCT_DESC: 5-inch irrigation pipe of an unknown material through the levee, 5.5 feet below the crown. Pump in pump house on the landside (LS). Shutoff valve in pump house on the LS toe. (Automatic Board Order (ABO) issued as Permit No. 11287, 1975 - Norman Silva). [Additional Reference(s): DWR Levee Log, 2005, 6-inch pipe listed. USACE Sacramento O&M Manual 102, April 1959, (RM 16.8) (Reclamation District No. 2067) 6-inch steel pipe listed].						
FS Date: 4/24/2013

Pipe visible in water at left of tree.

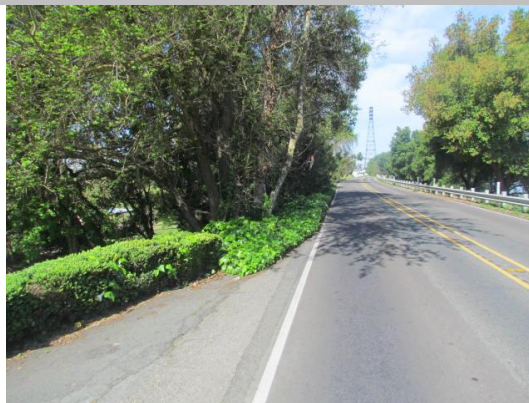
Photo 1 of 1 : SP_2019_NA0002_63_59_20190311_00030.jpg

LM Start	4.02	Rating **	U	Issue No.	59
LM End	4.13	Issue Type +	En	Location *	LS
Category	Earthen Levee			GPS Latitude/Longitude	
				Start	End
Item	Vegetation			38.164498 °	38.165167 °
				-121.624343 °	-121.626273 °
DWR ID	DWR_NA0002_02_s_2012_59				
Comment Code					
V6 : Landscaping					
Inspector Comment

Looking west at dense landscaping on landward slope.

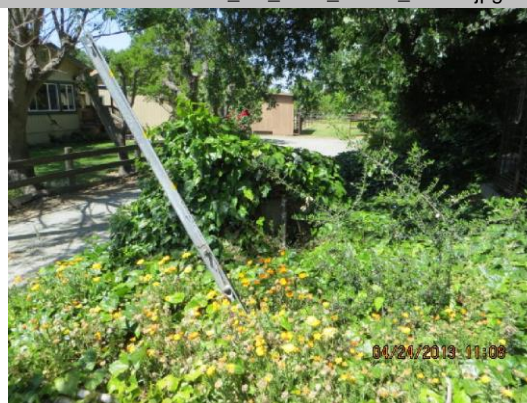
Photo 1 of 3 : UCIP_SP_2019_12768_20731.jpg

LM Start	4.11	Rating **	M	Issue No.	195
LM End	4.11	Issue Type +	En	Location *	
Category	Supplemental			GPS Latitude/Longitude	
				Start	End
Item	DWR UCIP Field Study			38.165016 °	38.165016 °
				-121.625834 °	-121.625834 °
DWR ID	21904				
Comment Code					
Inspector Comment					
FS_ID:12768 DS_ID:21904 EP_NO: 787 Repair Type: Non-Urgent Crossing Status: Found UCIP Comments: Pipe may be abandoned and should be done so properly if not being used. Good candidate for video inspection. FIELD_STRUCT_DESC: 2 of 2: 14-inch steel irrigation pipe through the levee, 4.2 feet below the crown. Pump on pile structure in stream. (Permit No. 787, 1939 - J. E. Silva, et al.). [Additional Reference(s): DWR Levee Log, 2005. USACE Sacramento O&M Manual 102, April 1959, (RM 16.6) (Reclamation District No. 2067)]. FS Date: 4/24/2013

Concrete distribution box at LS toe.

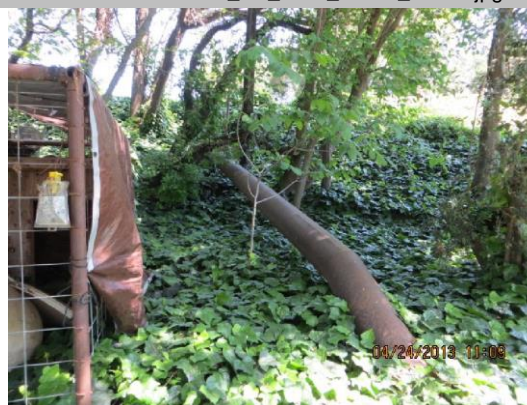
Photo 2 of 3 : UCIP_SP_2019_12768_20730.jpg

Pipe on LS slope.

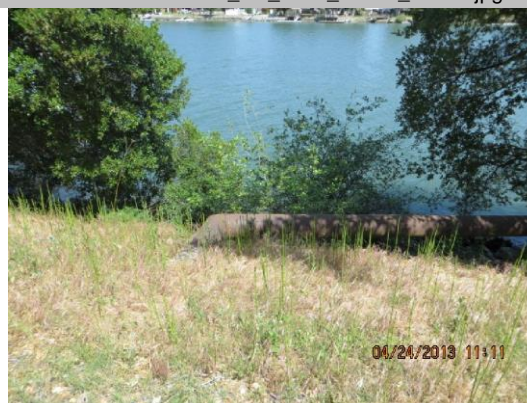
Photo 3 of 3 : UCIP_SP_2019_12768_20729.jpg

Pipe on WS slope.

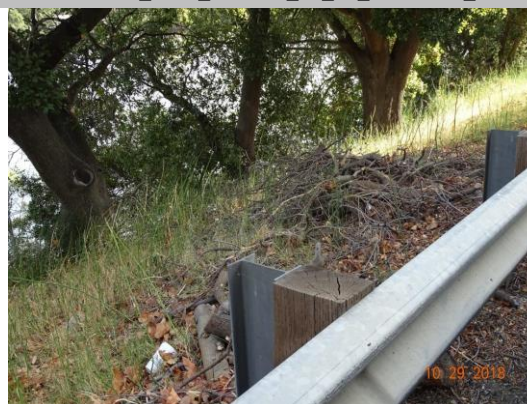
Photo 1 of 1 : SP_2019_NA0002_63_85_20190311_00045.jpg

LM Start	4.13	Rating **	M	Issue No.	85
LM End	4.13	Issue Type +	Ma	Location *	WS
Category	Earthen Levee			GPS Latitude/Longitude	
				Start	End
Item	Encroachments			38.165098 °	38.165098 °
				-121.626133 °	-121.626133 °
DWR ID	DWR_NA0002_02_s_2019_85				
Comment Code					
PR : Prunings					
Inspector Comment

View of prunings on the waterside slope (October 2018).

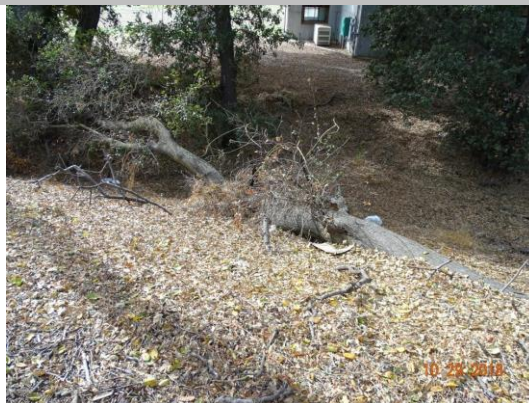
Photo 1 of 1 : SP_2019_NA0002_63_169_20190311_00101.jpg

LM Start	4.29	Rating **	M	Issue No.	169
LM End	4.29	Issue Type +	En	Location *	LS
Category	Earthen Levee			GPS Latitude/Longitude	
				Start	End
Item	Encroachments			38.166258 °	38.166258 °
				-121.628717 °	-121.628717 °
DWR ID	DWR_NA0002_02_f_2018_169				
Comment Code					
TR : Tree or limb					
Inspector Comment					
Remove the downed tree from the landside slope.

View of downed tree on landside slope (October 2018).

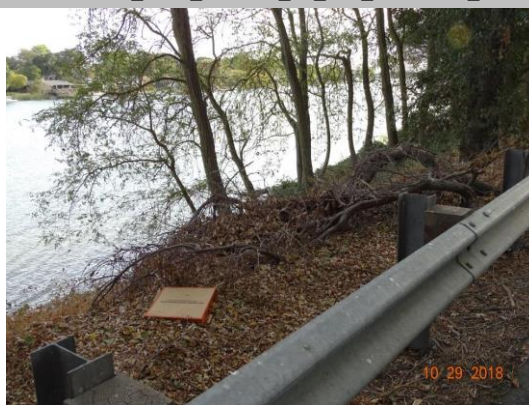
Photo 1 of 1 : SP_2019_NA0002_63_113_20190311_00069.jpg

LM Start	4.29	Rating **	M	Issue No.	113
LM End	4.29	Issue Type +	Ma	Location *	WS
Category	Earthen Levee			GPS Latitude/Longitude	
				Start	End
Item	Encroachments			38.166335 °	38.166335 °
				-121.628785 °	-121.628785 °
DWR ID	DWR_NA0002_02_f_2018_113				
Comment Code					
PR : Prunings					
Inspector Comment					
Remove the prunings from the waterside slope.

View of prunings on the waterside slope (October 2018).

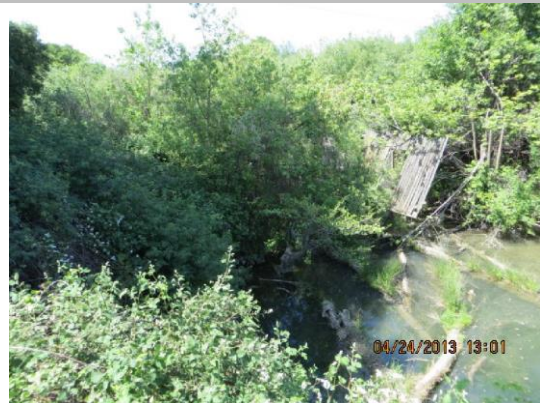
Photo 1 of 3 : UCIP_SP_2019_16010_27085.jpg

Comment Code					
Inspector Comment					
FS_ID:16010 DS_ID:21907 EP_NO: 11274 Repair Type: Non-Urgent Crossing Status: Found UCIP Comments: Pipe abandoned and should be abandoned properly if not already done so. FIELD_STRUCT_DESC: *ABANDONED* 2 of 2: 10-inch irrigation pipe of an unknown material through the levee, 6.6 feet below the crown. Pump in pump house on the landside (LS) slope. Pump house not visible, 4/24/2013. (Automatic Board Order (ABO) issued as Permit No. 11274, 1975 - Henry Martin). [Additional Reference(s): DWR Levee Log, 2005. USACE Sacramento O&M Manual 102, April 1959, (RM 16.2) (Reclamation District No. 2067) steel pipe listed]. FS Date: 4/24/2013

Possible portion of pumphouse visible off WS toe.

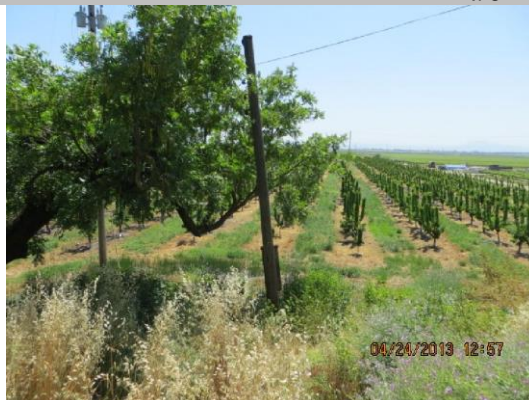
Photo 2 of 3 : UCIP_SP_2019_16010_27087.jpg

JP and meter on LS slope at location of abandoned pipe.

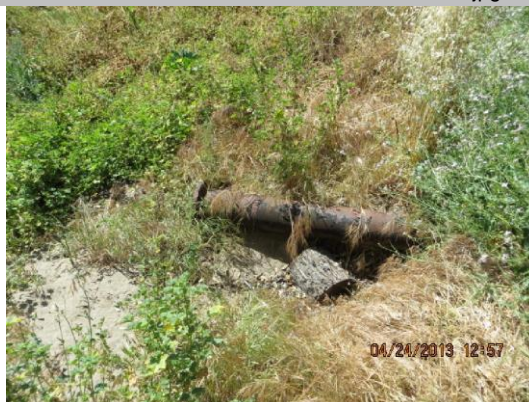
Photo 3 of 3 : UCIP_SP_2019_16010_27086.jpg

Abandoned pipe on LS slope.

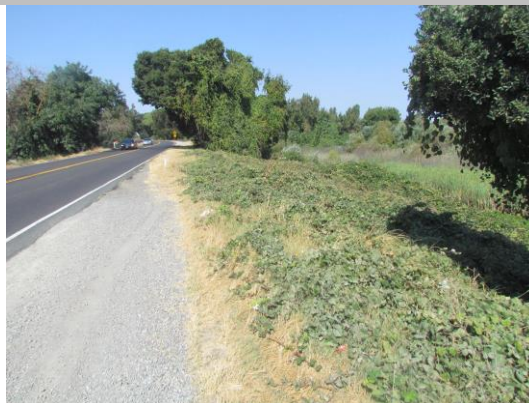
Photo 1 of 1 : SP_2019_NA0002_63_123_20190311_00075.jpg

LM Start	4.70	Rating **	U	Issue No.	123	
LM End	4.72	Issue Type +	Ma	Location *	WS	
Category	Earthen Levee			GPS Latitude/Longitude		
				Start		End
Item	Vegetation			38.168348 °		38.168456 °
				-121.635726 °		-121.636125 °
DWR ID	DWR_NA0002_02_f_2016_123					
Comment Code						
V2 : Remove the wild growth other than native grasses from the levee slopes.						
Inspector Comment						
There are dense grapevines on waterside slope.

Looking west at dense vines on waterward slope and toe.

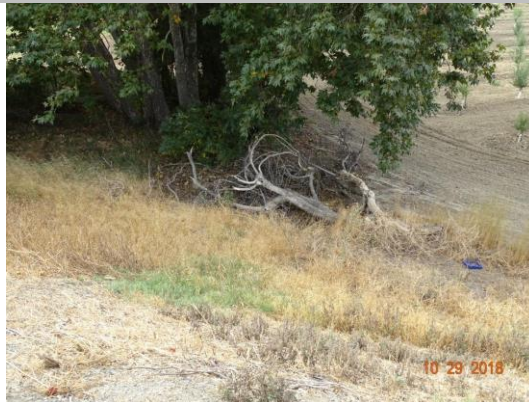
Photo 1 of 1 : SP_2019_NA0002_63_165_20190311_00098.jpg

LM Start	4.73	Rating **	M	Issue No.	165
LM End	4.73	Issue Type +	En	Location *	LS
Category	Earthen Levee			GPS Latitude/Longitude	
				Start	End
Item	Encroachments			38.168435 °	38.168435 °
				-121.636172 °	-121.636172 °
DWR ID	DWR_NA0002_02_f_2018_165				
Comment Code					
TR : Tree or limb					
Inspector Comment					
Remove the downed tree limb from the landside toe.

View of downed tree limbs on the landside toe (October 2018).

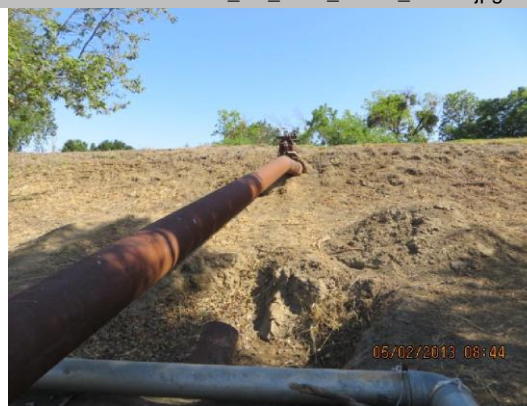
Photo 3 of 3 : UCIP_SP_2019_12773_20738.jpg

Comment Code						
Inspector Comment						
FS_ID:12773						
DS_ID:21908						
EP_NO: 11285						
Repair Type: Non-Urgent						
Crossing Status: Found						
UCIP Comments: Pit under pipe on WS shoulder - possible leak.						
Excavation of pipe on LS slope into levee prism.						
FIELD_STRUCT_DESC: 20-inch irrigation pipe of an unknown material, sleeved through a 22-inch, sleeved through a 24-inch pipe, through the levee, 3 feet below the crown. Pump on the landside (LS). Small pump on the LS shoulder and a 7-foot by 9-foot concrete sump on the LS toe. (Automatic Board Order (ABO) issued as Permit No. 11285, 1975 - Manuel Silva). [Additional Reference(s): DWR Levee Log, 2005. USACE Sacramento O&M Manual 102, April 1959, (RM 15.9) (Reclamation District No. 2067) steel pipe listed].						
FS Date: 5/2/2013

Pipe on LS slope with excavation in levee prism.

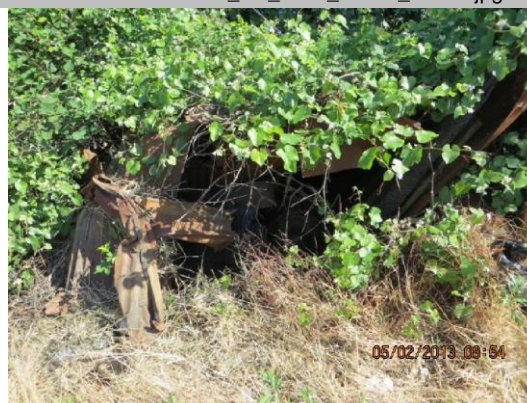
Photo 1 of 3 : UCIP_SP_2019_12774_20745.jpg

Comment Code						
Inspector Comment						
FS_ID:12774 DS_ID:21909 EP_NO: 724 Repair Type: Non-Urgent Crossing Status: Found UCIP Comments: Pipe open on waterside at fallen down pumphouse. Pipe abandoned. Service pole on LS slope down on ground near broken standpipe. Pipe needs to be properly abandoned. FIELD_STRUCT_DESC: 10-inch irrigation pipe of an unknown material through the levee, 3.8 feet below the crown. Pump in pump house on the waterside (WS) slope. Service pole on the landside (LS) slope. Replaces a 10-inch pipe at approximately the same location. 32-inch concrete standpipe on the LS toe. 1.5-inch electrical conduit runs parallel to 10-inch pipe. (Permit No. 724, 1937 - California Lands, Inc., and Frank Hodapp). [Additional Reference(s): DWR Levee Log, 2005. USACE Sacramento O&M Manual 102, April 1959, (RM 15.8) (Reclamation District No. 2067) steel pipe listed]. FS Date: 5/2/2013

Broken down pumphouse on WS slope.

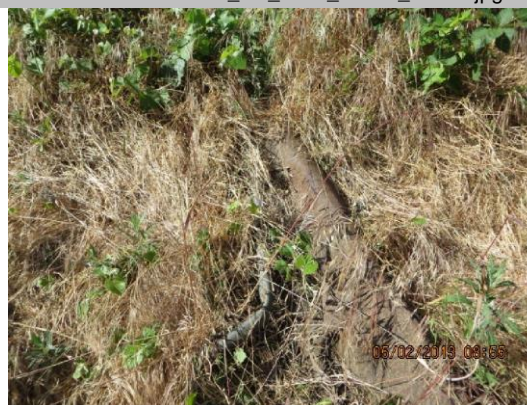
Photo 2 of 3 : UCIP_SP_2019_12774_20744.jpg

deformed and crushed pipe with 1.5-inch electrical conduit on WS slope.

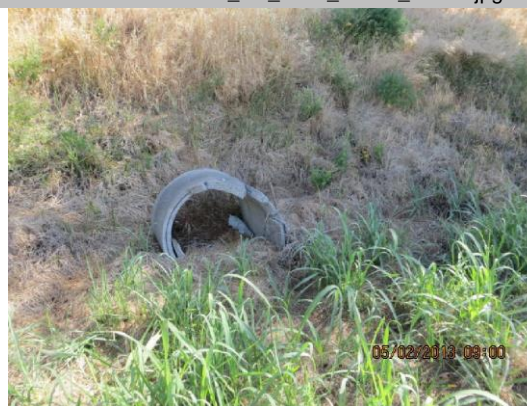
Photo 3 of 3 : UCIP_SP_2019_12774_20743.jpg

Comment Code						
Inspector Comment						
FS_ID:12774 DS_ID:21909 EP_NO: 724 Repair Type: Non-Urgent Crossing Status: Found UCIP Comments: Pipe open on waterside at fallen down pumphouse. Pipe abandoned. Service pole on LS slope down on ground near broken standpipe. Pipe needs to be properly abandoned. FIELD_STRUCT_DESC: 10-inch irrigation pipe of an unknown material through the levee, 3.8 feet below the crown. Pump in pump house on the waterside (WS) slope. Service pole on the landside (LS) slope. Replaces a 10-inch pipe at approximately the same location. 32-inch concrete standpipe on the LS toe. 1.5-inch electrical conduit runs parallel to 10-inch pipe. (Permit No. 724, 1937 - California Lands, Inc., and Frank Hodapp). [Additional Reference(s): DWR Levee Log, 2005. USACE Sacramento O&M Manual 102, April 1959, (RM 15.8) (Reclamation District No. 2067) steel pipe listed]. FS Date: 5/2/2013

Broken Concrete standpipe on LS toe.

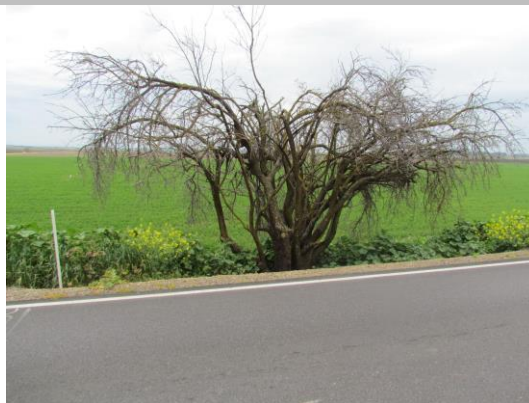
Photo 1 of 1 : SP_2019_NA0002_63_88_20190311_00047.jpg

LM Start	4.92	Rating **	M	Issue No.	88
LM End	4.92	Issue Type +	Ma	Location *	LS
Category	Earthen Levee			GPS Latitude/Longitude	
				Start	End
Item	Encroachments			38.169262 °	38.169262 °
				-121.639497 °	-121.639497 °
DWR ID	DWR_NA0002_02_s_2017_88				
Comment Code					
TR : Tree or limb					
Inspector Comment					
Remove dead tree on landside slope.

Looking east at dead tree on landward slope and toe.

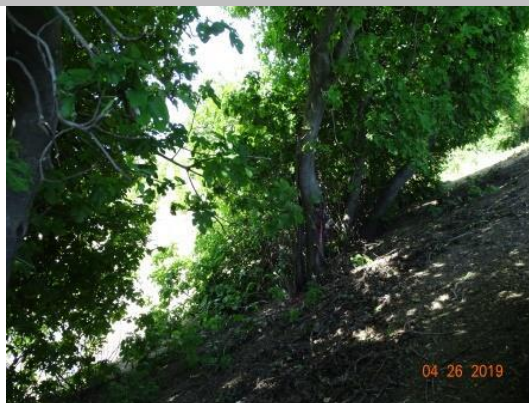
Photo 1 of 1 : SP_2019_NA0002_63_163_20190429_00206.jpg

LM Start	5.01	Rating **	U	Issue No.	163
LM End	5.01	Issue Type +	Ma	Location *	LS
Category	Earthen Levee			GPS Latitude/Longitude	
				Start	End
Item	Trim / Thin Trees			38.169750 °	38.169750 °
				-121.641107 °	-121.641107 °
DWR ID	DWR_NA0002_02_f_2018_163				
Comment Code					
T2 : Thin trees to allow visibility of the ground and room to flood fight.					
Inspector Comment					
Trim the fig tree on the landside slope.

View looking downstream at fig tree on the landside slope (Spring 2019).

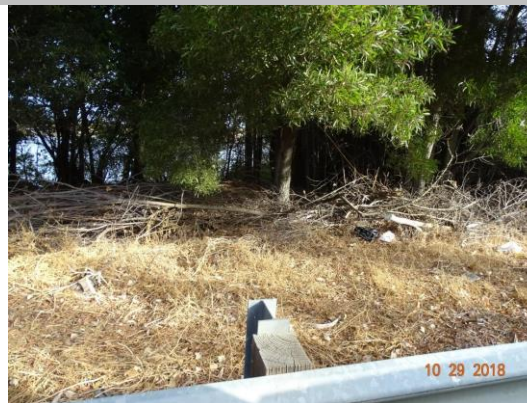
Photo 1 of 1 : SP_2019_NA0002_63_115_20190311_00070.jpg

LM Start	5.36	Rating **	M	Issue No.	115
LM End	5.36	Issue Type +	Ma	Location *	WS
Category	Earthen Levee			GPS Latitude/Longitude	
				Start	End
Item	Encroachments			38.171892 °	38.171892 °
				-121.646387 °	-121.646387 °
DWR ID	DWR_NA0002_02_f_2018_115				
Comment Code					
PR : Prunings					
Inspector Comment					
Remove the prunings from the waterside slope.

View of prunings on the waterside slope (October 2018).

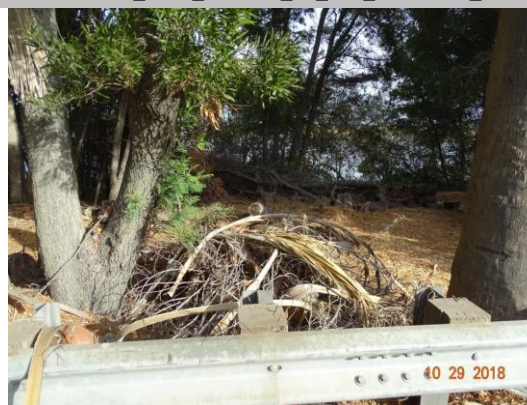
Photo 1 of 1 : SP_2019_NA0002_63_116_20190311_00071.jpg

LM Start	5.38	Rating **	M	Issue No.	116
LM End	5.38	Issue Type +	Ma	Location *	WS
Category	Earthen Levee			GPS Latitude/Longitude	
				Start	End
Item	Encroachments			38.171858 °	38.171858 °
				-121.646832 °	-121.646832 °
DWR ID	DWR_NA0002_02_f_2018_116				
Comment Code					
PR : Prunings					
Inspector Comment					
Remove the prunings from the waterside slope.

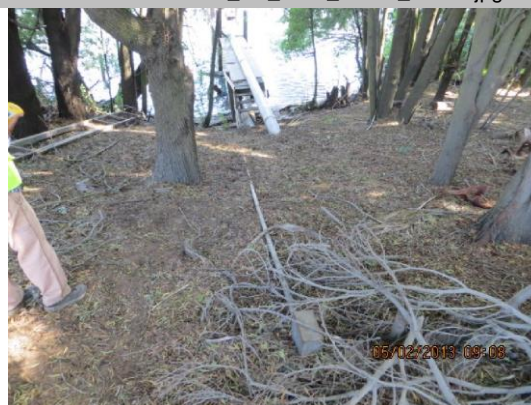
Photo 1 of 3 : UCIP_SP_2019_12776_20754.jpg

LM Start	5.41	Rating **	M	Issue No.	199
LM End	5.41	Issue Type +	En	Location *	
Category	Supplemental			GPS Latitude/Longitude	
				Start	End
Item	DWR UCIP Field Study			38.171824 °	38.171824 °
				-121.647265 °	-121.647265 °
DWR ID	21910				
Comment Code					
Inspector Comment					
FS_ID:12776 DS_ID:21910 EP_NO: 7089A Repair Type: Non-Urgent Crossing Status: Found UCIP Comments: Hole at LS toe over pipe possible sign of leakage. FIELD_STRUCT_DESC: 7-inch drainage pipe of an unknown material through the levee, 13 feet below the crown. Pump in pump house on the landside (LS). 1.5-inch galvanized steel electrical conduit at same location. 4-foot by 6-foot concrete distribution box off the LS toe next to pump house. [Additional Reference(s): DWR Levee Log, 2005. USACE Sacramento O&M Manual 102, April 1959, (RM 15.3) (Reclamation District No. 2067) steel pipe listed]. FS Date: 5/2/2013

Pipe and electrical conduit on WS slope.

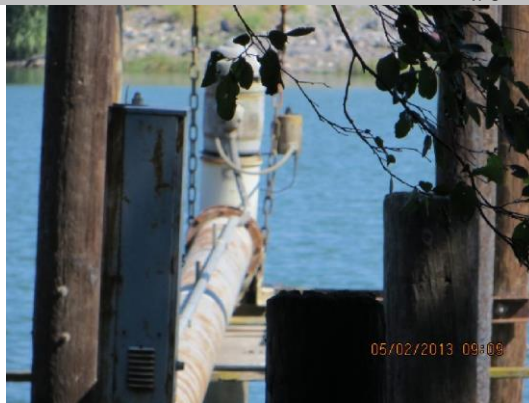
Photo 2 of 3 : UCIP_SP_2019_12776_20753.jpg

Comment Code						
Inspector Comment						
FS_ID:12776 DS_ID:21910 EP_NO: 7089A Repair Type: Non-Urgent Crossing Status: Found UCIP Comments: Hole at LS toe over pipe possible sign of leakage. FIELD_STRUCT_DESC: 7-inch drainage pipe of an unknown material through the levee, 13 feet below the crown. Pump in pump house on the landside (LS). 1.5-inch galvanized steel electrical conduit at same location. 4-foot by 6-foot concrete distribution box off the LS toe next to pump house. [Additional Reference(s): DWR Levee Log, 2005. USACE Sacramento O&M Manual 102, April 1959, (RM 15.3) (Reclamation District No. 2067) steel pipe listed]. FS Date: 5/2/2013

Pump on pier at WS toe.

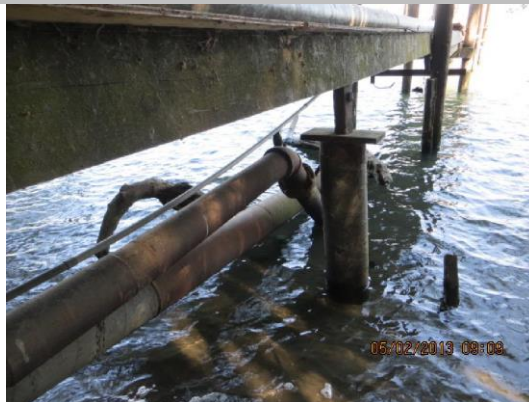
Photo 3 of 3 : UCIP_SP_2019_12776_20752.jpg

Pipe under pier.

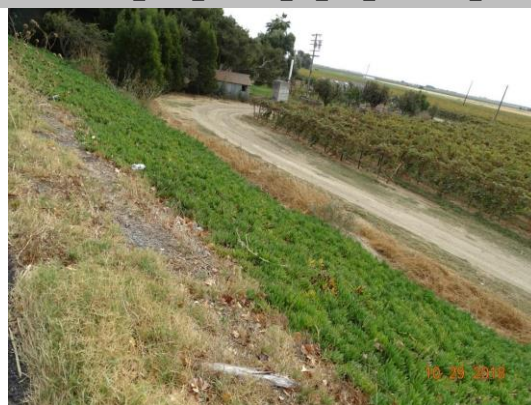
Photo 1 of 1 : SP_2019_NA0002_63_160_20190311_00096.jpg

LM Start	5.44	Rating **	M	Issue No.	160
LM End	5.44	Issue Type +	En	Location *	LS
Category	Earthen Levee			GPS Latitude/Longitude	
				Start	End
Item	Vegetation			38.171782 °	38.171782 °
				-121.647787 °	-121.647787 °
DWR ID	DWR_NA0002_02_f_2018_160				
Comment Code					
V6 : Landscaping					
Inspector Comment					
There is ice plant on the landside slope.

View looking upstream at ice plant on landside slope (October 2018).

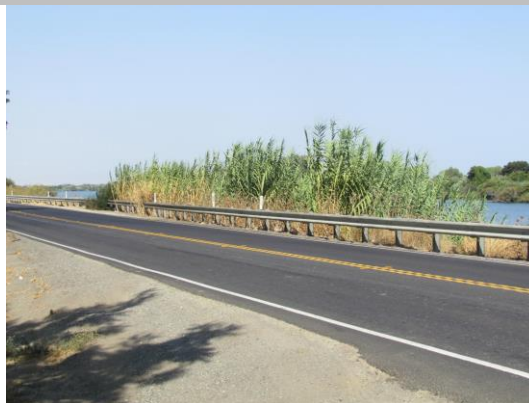
Photo 1 of 2 : SP_2019_NA0002_63_11_20190311_00010.jpg

Looking northwest at arundo on waterward slope. (Fall 2016)

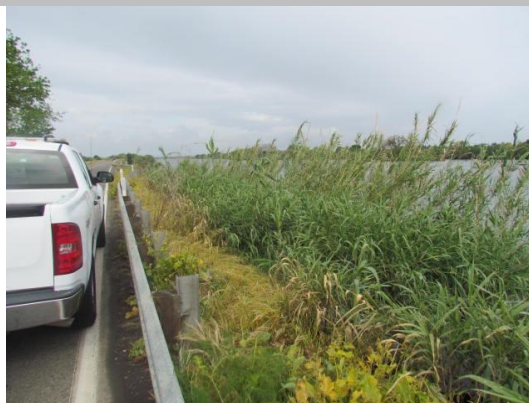
Photo 2 of 2 : SP_2019_NA0002_63_11_20190311_00011.jpg

Looking west at arundo on waterward slope. (Spring 2016)

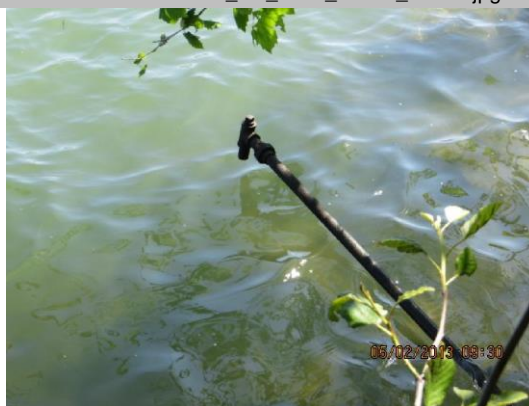
Photo 1 of 3 : UCIP_SP_2019_12778_20762.jpg

LM Start	5.77	Rating **	M	Issue No.	200
LM End	5.77	Issue Type +	Ma	Location *	
Category	Supplemental			GPS Latitude/Longitude	
				Start	End
Item	DWR UCIP LMA Responsibility			38.172940 °	38.172940 °
				-121.653700 °	-121.653700 °
DWR ID	21912				
Comment Code					
Inspector Comment					
FS_ID:12778 DS_ID:21912 EP_NO: N/A Repair Type: Non-Urgent Crossing Status: Found UCIP Comments: Pipe abandoned. Erosion on WS slope at location where pipe should be. FIELD_STRUCT_DESC: *ABANDONED* 12-inch drainage pipe of an unknown material through the levee, 13 feet below the crown. Pump and gate valve in pump house at the landside (LS) toe. 1.5-inch electrical conduit along pipe at same location. 42-inch concrete standpipe at the LS toe. [Additional Reference(s): USACE Sacramento O&M Manual 102, April 1959, (RM 14.8) (Reclamation District No. 2067) steel pipe listed FS Date: 5/2/2013

Conduit at WS toe.

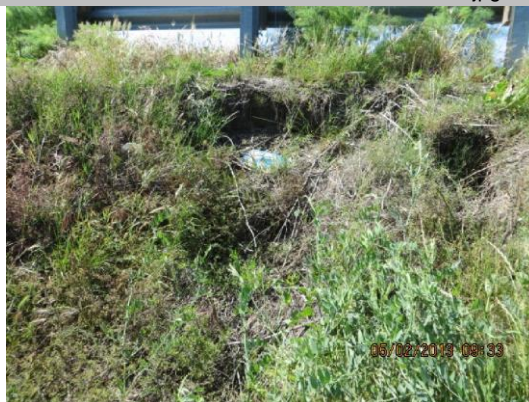
Photo 2 of 3 : UCIP_SP_2019_12778_20761.jpg

Erosion along pipe alignment at WS slope.

Comment Code						
Inspector Comment						
FS_ID:12778 DS_ID:21912 EP_NO: N/A Repair Type: Non-Urgent Crossing Status: Found UCIP Comments: Pipe abandoned. Erosion on WS slope at location where pipe should be. FIELD_STRUCT_DESC: *ABANDONED* 12-inch drainage pipe of an unknown material through the levee, 13 feet below the crown. Pump and gate valve in pump house at the landside (LS) toe. 1.5-inch electrical conduit along pipe at same location. 42-inch concrete standpipe at the LS toe. [Additional Reference(s): USACE Sacramento O&M Manual 102, April 1959, (RM 14.8) (Reclamation District No. 2067) steel pipe listed FS Date: 5/2/2013

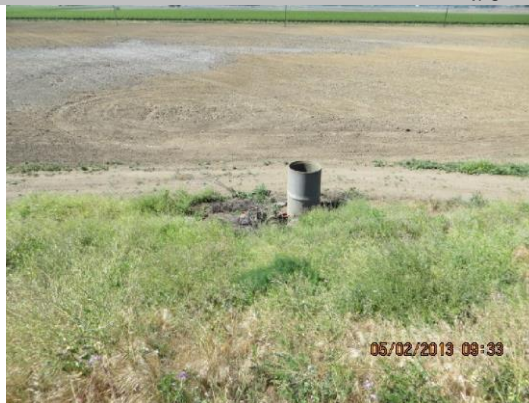
Photo 3 of 3 : UCIP_SP_2019_12778_20760.jpg

Concrete standpipe and pump on LS toe.

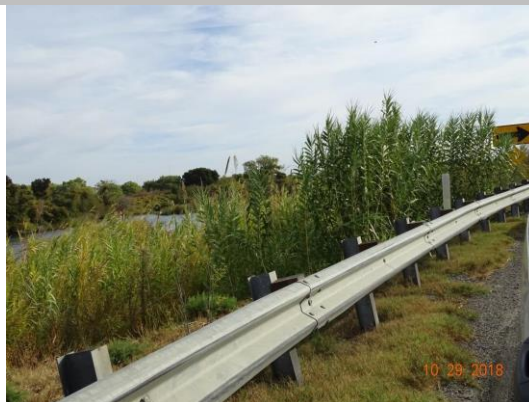
Photo 1 of 1 : SP_2019_NA0002_63_129_20190311_00076.jpg

LM Start	6.04	Rating **	U	Issue No.	129
LM End	6.04	Issue Type +	Ma	Location *	WS
Category	Earthen Levee			GPS Latitude/Longitude	
				Start	End
Item	Vegetation				38.174613 °
				-121.658168 °	-121.658168 °
DWR ID	DWR_NA0002_02_f_2018_129				
Comment Code					
V2 : Remove the wild growth other than native grasses from the levee slopes.					
Inspector Comment					
Remove arundo on the waterside shoulder.

View looking upstream at arundo on waterside shoulder (October 2018).

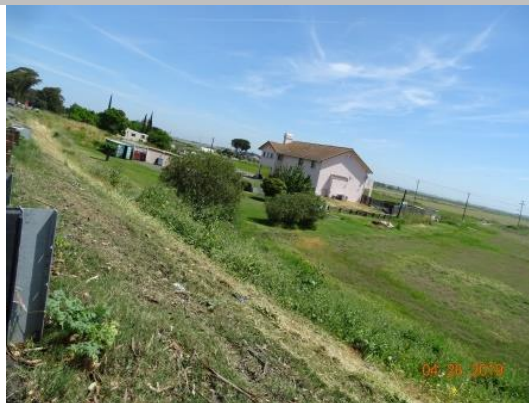
Photo 1 of 1 : SP_2019_NA0002_63_89_20190429_00203.jpg

LM Start	6.05	Rating **	M	Issue No.	89
LM End	7.60	Issue Type +	Ma	Location *	LS
Category	Earthen Levee			GPS Latitude/Longitude	
				Start	End
Item	Vegetation			38.174592 °	38.158514 °
				-121.658292 °	-121.675448 °
DWR ID	DWR_NA0002_02_s_2019_89				
Comment Code					
V1 : Control annual grass and weeds on the levee slopes and easements.					
Inspector Comment					
Maintain annual vegetation all the way down the landside slope.

View looking upstream at annual vegetation at the bottom of the landside slope (Spring 2019).

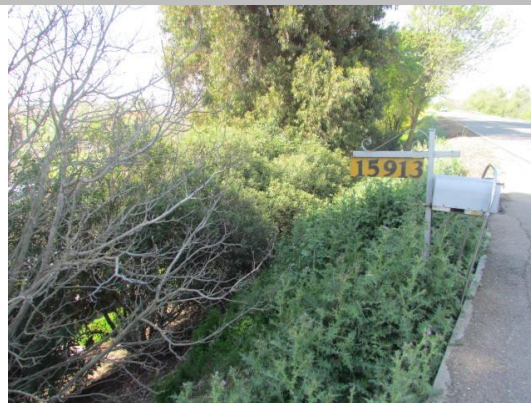
Photo 1 of 2 : SP_2019_NA0002_63_50_20190311_00027.jpg

LM Start	6.27	Rating **	U	Issue No.	50
LM End	6.27	Issue Type +	En	Location *	LS
Category	Earthen Levee			GPS Latitude/Longitude	
				Start	End
Item	Vegetation			38.173922 °	38.173922 °
				-121.662272 °	-121.662272 °
DWR ID	DWR_NA0002_02_s_2013_50				
Comment Code					
V6 : Landscaping					
Inspector Comment

Looking southwest at dense landscaping on landward slope.

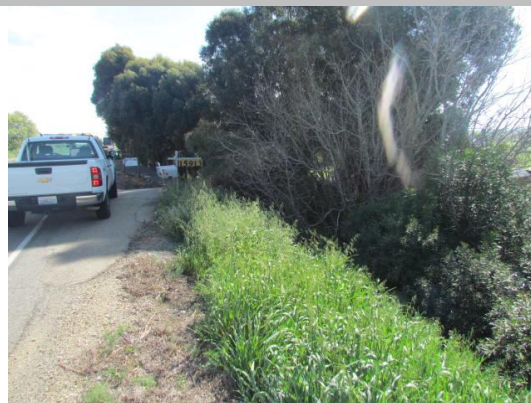
Photo 2 of 2 : SP_2019_NA0002_63_50_20190311_00028.jpg

Looking northeast at dense landscaping on landward slope.

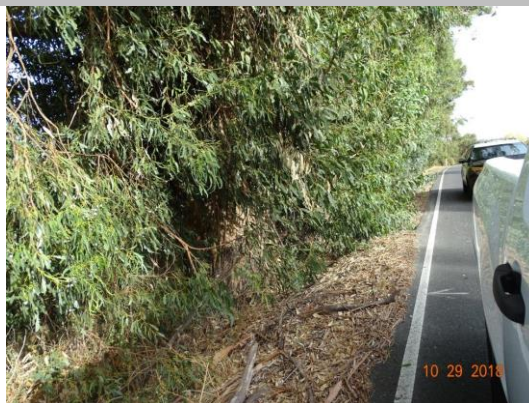
Photo 1 of 1 : SP_2019_NA0002_63_132_20190311_00077.jpg

LM Start	6.78	Rating **	U	Issue No.	132
LM End	6.80	Issue Type +	Ma	Location *	WS
Category	Earthen Levee			GPS Latitude/Longitude	
				Start	End
Item	Trim / Thin Trees			38.169330 °	38.168987 °
				-121.669225 °	-121.669443 °
DWR ID	DWR_NA0002_02_f_2018_132				
Comment Code					
T2 : Thin trees to allow visibility of the ground and room to flood fight.					
Inspector Comment

View looking upstream at thick tree branches on the waterside slope (October 2018).

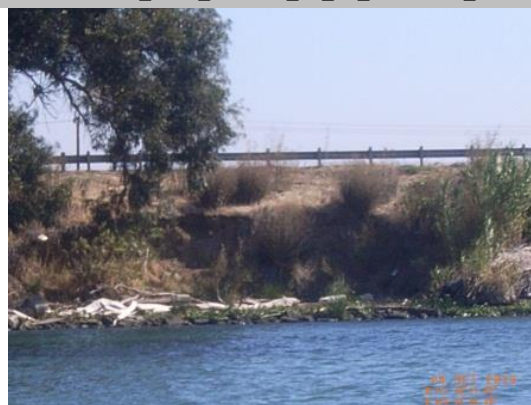
Photo 1 of 1 : SP_2019_NA0002_63_71_20190311_00034.jpg

LM Start	6.98	Rating **	U	Issue No.	71
LM End	7.04	Issue Type +	Ma	Location *	WS
Category	Supplemental			GPS Latitude/Longitude	
				Start	End
Item	2017 USACE Erosion Survey, DRAFT			38.166583 °	38.165794 °
				-121.670684 °	-121.671014 °
DWR ID	DWR_NA0002_02_f_2018_71				
Comment Code					
Inspector Comment					
2017 Site ID: SAC 13.6 L					
Status: Critical					
2017 Field Notes: upgraded to critical. nearly vertical face from levee hinge. trees with large root balls likely to fail.					
Site History: 2011 - Large section of bank slumped off.					
2018: Site should stay critical

USACE 2013 Photo #1

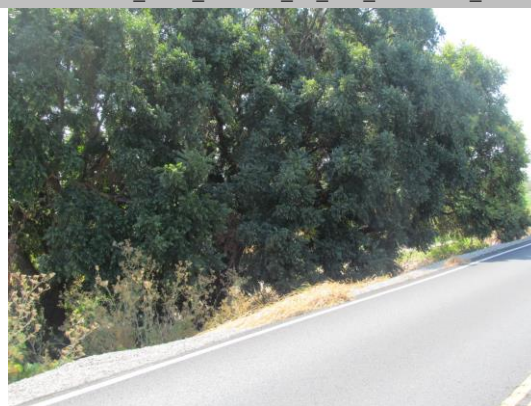
Photo 1 of 1 : SP_2019_NA0002_63_112_20190311_00068.jpg

LM Start	7.13	Rating **	M	Issue No.	112
LM End	7.13	Issue Type +	Ma	Location *	LS
Category	Earthen Levee			GPS Latitude/Longitude	
				Start	End
Item	Trim / Thin Trees			38.164465 °	38.164465 °
				-121.671292 °	-121.671292 °
DWR ID	DWR_NA0002_02_f_2015_112				
Comment Code					
T1 : Trim trees to at least five feet above ground level.					
Inspector Comment

Looking south at untrimmed trees on landward slope.

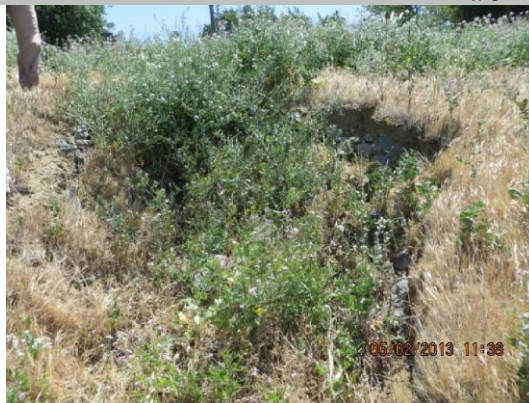
Photo 1 of 3 : UCIP_SP_2019_12814_20821.jpg

Comment Code					
Inspector Comment					
FS_ID:12814 DS_ID:21918 EP_NO: 11293 Repair Type: Non-Urgent Crossing Status: Found UCIP Comments: Erosion or sinkhole on WS shoulder. Does not appear to be an immediate threat. FIELD_STRUCT_DESC: 2 of 2: 16-inch irrigation pipe of an unknown material through the levee, 7.1 feet below the crown. Pump and service pole on the landside (LS) slope. 72-inch concrete standpipe at the landside (LS) toe. (Automatic Board Order (ABO) issued as Permit No. 11293, 1975 - John Wilcox). [Additional Reference(s): DWR Levee Log, 2005. USACE Sacramento O&M Manual 102, April 1959, (RM 13.0) (Reclamation District No. 2067) steel pipe listed]. FS Date: 5/2/2013

Erosion/sinkhole over pipe on WS slope.

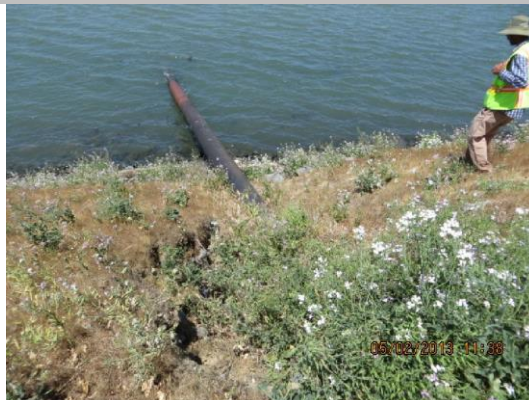
Photo 2 of 3 : UCIP_SP_2019_12814_20820.jpg

Pipe on WS slope.

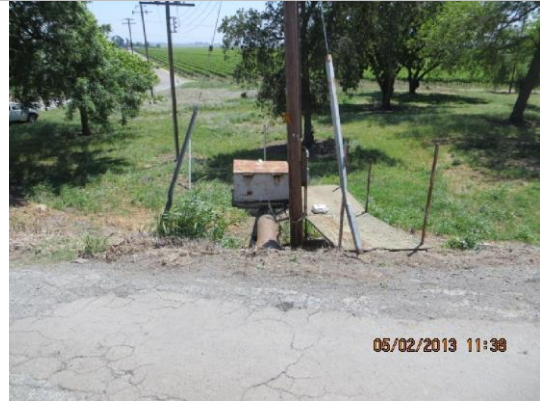
Photo 3 of 3 : UCIP_SP_2019_12814_20819.jpg

Pipe and pump on LS shoulder.

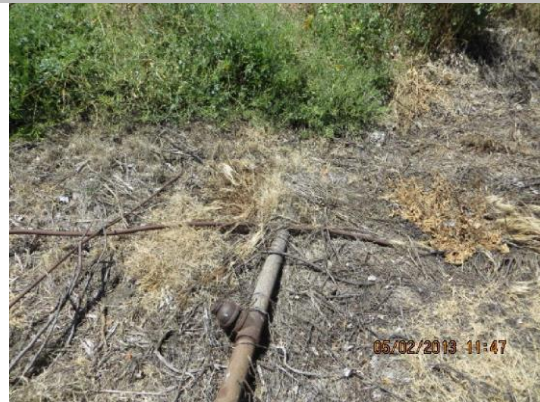
Photo 1 of 2 : UCIP_SP_2019_12817_20825.jpg

LM Start	7.49	Rating **	M	Issue No.	204
LM End	7.49	Issue Type +	En	Location *	
Category	Supplemental			GPS Latitude/Longitude	
				Start	End
Item	DWR UCIP Field Study			38.159940 °	38.159940 °
				-121.674430 °	-121.674430 °
DWR ID	21920				
Comment Code					
Inspector Comment					
FS_ID:12817 DS_ID:21920 EP_NO: N/A Repair Type: Non-Urgent Crossing Status: Found UCIP Comments: Pipe should be abandoned properly. FIELD_STRUCT_DESC: 3-inch pipe of an unknown material or purpose through the levee, 7.7 feet below the crown. Inactive service pole on the landside (LS) slope. [Additional Reference(s): DWR Levee Log, 2005]. FS Date: 5/2/2013

3.5-inch galvanized iron pipe on LS slope.

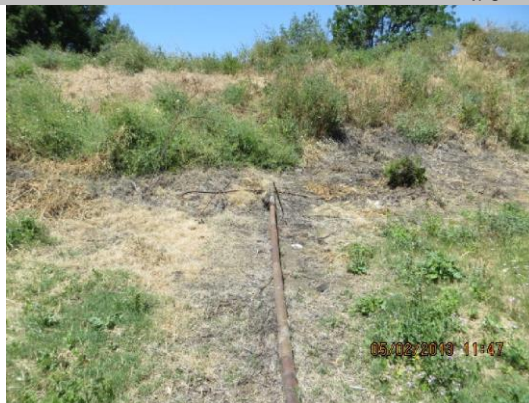
Photo 2 of 2 : UCIP_SP_2019_12817_20824.jpg

3.5-inch galvanized iron pipe on LS slope.

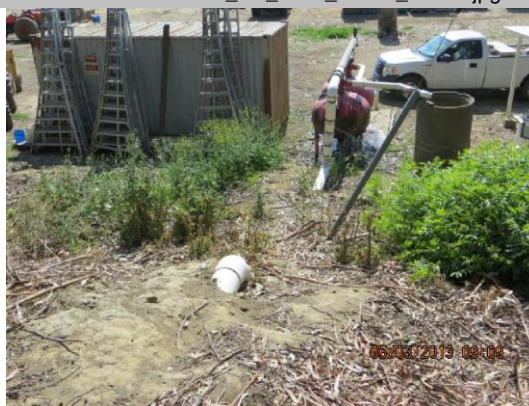
Photo 1 of 3 : UCIP_SP_2019_12869_20933.jpg

Comment Code						
Inspector Comment						
FS_ID:12869 DS_ID:21925 EP_NO: 2795 Repair Type: Non-Urgent Crossing Status: Found UCIP Comments: Annular space between PVC pipe and 12-inch steel pipe has not been sealed. FIELD_STRUCT_DESC: 20-inch irrigation pipe of an unknown material through the levee, 3 feet below the crown. 8-inch polyvinyl chloride pipe sleeved through a 12-inch pipe that is sleeved through the 20-inch. Annular space grouted between two metal pipes. Pump and butterfly valve in pump house on the waterside (WS) slope. 36-inch concrete standpipe and filters on the landside (LS) toe. (Permit No. 2795, 1958 - M. B. McKinnon). [Additional Reference(s): DWR Levee Log, 2005]. FS Date: 5/3/2013

PVC pipe, filters, and concrete standpipe on LS.

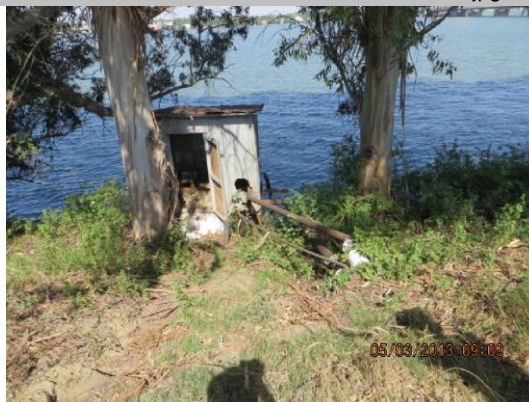
Photo 2 of 3 : UCIP_SP_2019_12869_20932.jpg

Pumphouse and pipe on WS slope.

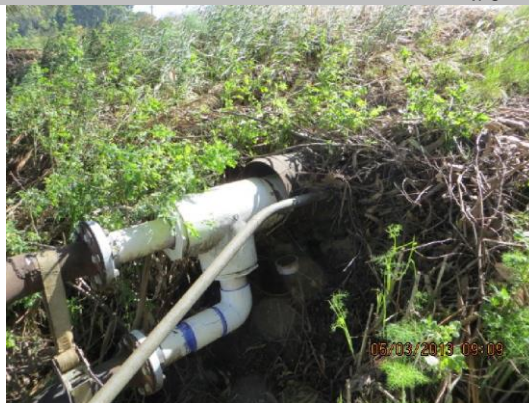
Photo 3 of 3 : UCIP_SP_2019_12869_20931.jpg

Comment Code						
Inspector Comment						
FS_ID:12869 DS_ID:21925 EP_NO: 2795 Repair Type: Non-Urgent Crossing Status: Found UCIP Comments: Annular space between PVC pipe and 12-inch steel pipe has not been sealed. FIELD_STRUCT_DESC: 20-inch irrigation pipe of an unknown material through the levee, 3 feet below the crown. 8-inch polyvinyl chloride pipe sleeved through a 12-inch pipe that is sleeved through the 20-inch. Annular space grouted between two metal pipes. Pump and butterfly valve in pump house on the waterside (WS) slope. 36-inch concrete standpipe and filters on the landside (LS) toe. (Permit No. 2795, 1958 - M. B. McKinnon). [Additional Reference(s): DWR Levee Log, 2005]. FS Date: 5/3/2013

PVC pipe sleeved through 12-inch steel pipe on WS slope.
