**Flood Control Project Maintenance
Levee Inspections**
LMA District Cover Sheet
Spring 2019 Levee Inspection Results

Brannan Andrus Levee Maintenance District

Spring 2019 Levee Inspection Results

Waterway			Bank	Unit Miles
Unit No. 01 Georgiana Slough			Right	6.01
	Spring (March - May)	Summer (June - August)	(September - November) Fall	Winter (December - February)
Unit Maintenance Rating (Fall Only)				
Date of Inspection	4/23/2019 - 4/23/2019			
DWR Inspector	David Julian			
Accompanied By

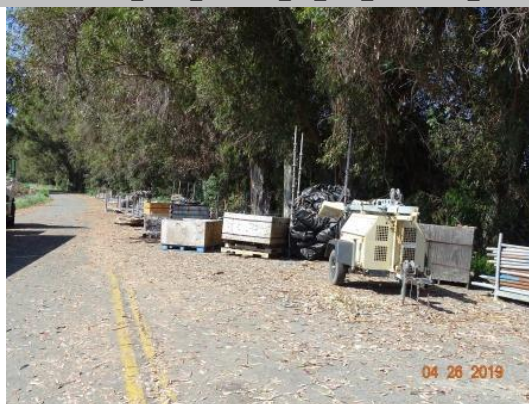
Photo 1 of 1 : SP_2019_NA0002_63_146_20190506_00209.jpg

LM Start	7.93	Rating **	U	Issue No.	146
LM End	7.93	Issue Type +	En	Location *	WS
Category	Earthen Levee			GPS Latitude/Longitude	
				Start	End
Item	Encroachments			38.155483 °	38.155483 °
				-121.679988 °	-121.679988 °
DWR ID	DWR_NA0002_02_f_2018_146				
Comment Code					
EQ : Equipment					
Inspector Comment					
There is equipment from the bridge rehabilitation at this location.

View looking downstream at construction on equipment on the waterside shoulder and crown (Spring 2019).

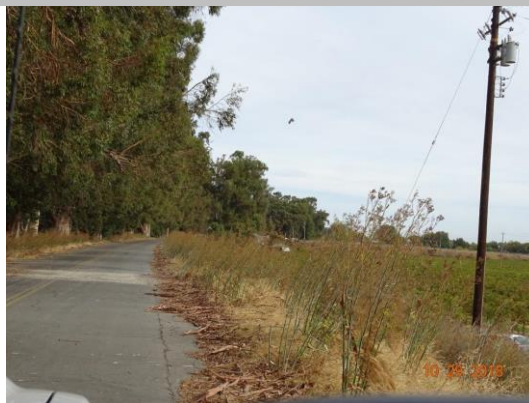
Photo 1 of 1 : SP_2019_NA0002_63_145_20190311_00087.jpg

LM Start	8.06	Rating **	U	Issue No.	145
LM End	8.17	Issue Type +	Ma	Location *	LS
Category	Earthen Levee			GPS Latitude/Longitude	
				Start	End
Item	Vegetation			38.153760 °	38.152197 °
				-121.680967 °	-121.681713 °
DWR ID	DWR_NA0002_02_f_2018_145				
Comment Code					
V1 : Control annual grass and weeds on the levee slopes and easements.					
Inspector Comment					
Maintain vegetation on the landside slope.

View looking upstream at vegetation on the landside shoulder and slope (October 2018).

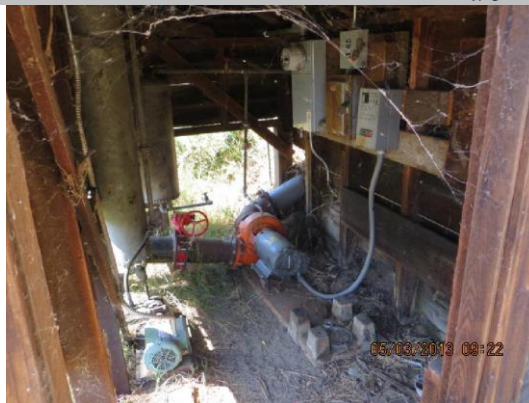
Photo 1 of 3 : UCIP_SP_2019_16143_27242.jpg

Comment Code						
Inspector Comment						
FS_ID:16143 DS_ID:21926 EP_NO: 8661 Repair Type: Non-Urgent Crossing Status: Found UCIP Comments: Dip in crown over alignment of pipe. Good candidate for video inspection. FIELD_STRUCT_DESC: 8-inch irrigation pipe of an unknown material through the levee, 3.7 feet below the crown. Pump in pump house on the landside (LS) slope. Service pole and 30-inch concrete standpipe at the LS toe (Automatic Board Order (ABO) issued as Permit No. 8661, 1972 - Jesse Marks). [Additional Reference(s): DWR Levee Log, 2005. USACE Sacramento O&M Manual 102, April 1959, (RM 12.2) (Reclamation District No. 2067) steel pipe listed]. FS Date: 5/3/2013

Pump and butterfly valve in pumphouse on LS toe.

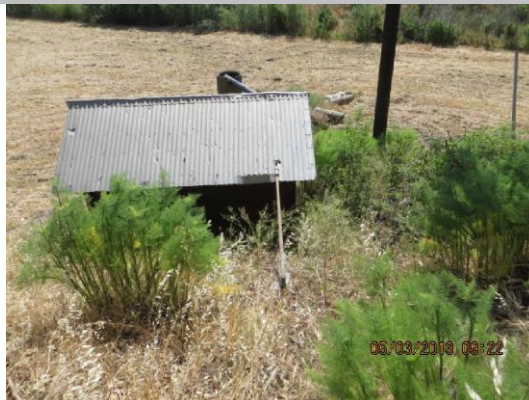
Photo 2 of 3 : UCIP_SP_2019_16143_27241.jpg

Pumphouse with concrete standpipe in background on LS toe.

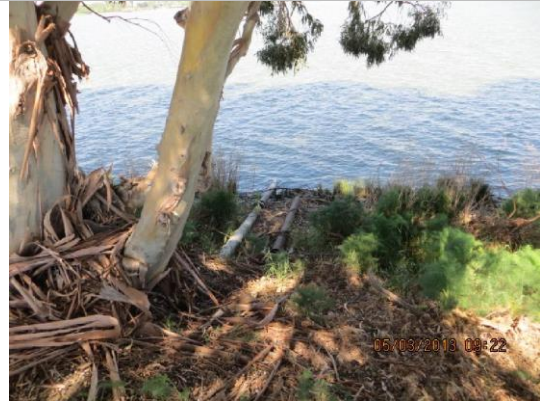
Photo 3 of 3 : UCIP_SP_2019_16143_27240.jpg

Comment Code						
Inspector Comment						
FS_ID:16143						
DS_ID:21926						
EP_NO: 8661						
Repair Type: Non-Urgent						
Crossing Status: Found						
UCIP Comments: Dip in crown over alignment of pipe. Good candidate for video inspection.						
FIELD_STRUCT_DESC: 8-inch irrigation pipe of an unknown material through the levee, 3.7 feet below the crown. Pump in pump house on the landside (LS) slope. Service pole and 30-inch concrete standpipe at the LS toe (Automatic Board Order (ABO) issued as Permit No. 8661, 1972 - Jesse Marks). [Additional Reference(s): DWR Levee Log, 2005. USACE Sacramento O&M Manual 102, April 1959, (RM 12.2) (Reclamation District No. 2067) steel pipe listed].						
FS Date: 5/3/2013

Pipe on WS slope.

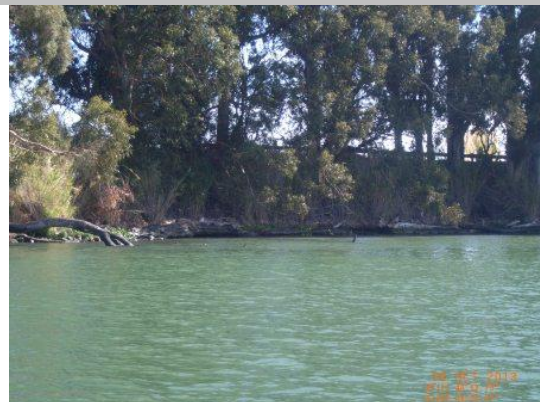
Photo 1 of 1 : SP_2019_NA0002_63_70_20190311_00033.jpg

LM Start	8.20	Rating **	U	Issue No.	70
LM End	8.42	Issue Type +	Ma	Location *	WS
Category	Supplemental			GPS Latitude/Longitude	
				Start	End
Item	2017 USACE Erosion Survey, DRAFT			38.151867 °	38.148711 °
				-121.682201 °	-121.682790 °
DWR ID	DWR_NA0002_02_f_2018_70				
Comment Code					
Inspector Comment					
2017 Site ID: SAC 12.1 L Status: Critical 2017 Field Notes: Continues to worsen and threaten the road. Site History: 2010 - Small inlet area behind a man-built spit. Bank is slumping and could possibly be fixed with maintenance. 2011 - Site continues to worsen. 2015 - Upgraded to CRITICAL. 2016 - Site continues to get worse. 2018: Still threatening roadway. Remain critical

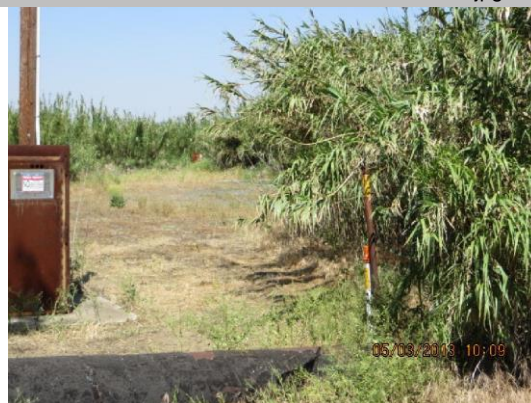
Photo 2 of 2 : UCIP_SP_2019_12886_20945.jpg

Gasline marker and vent to right of JP.

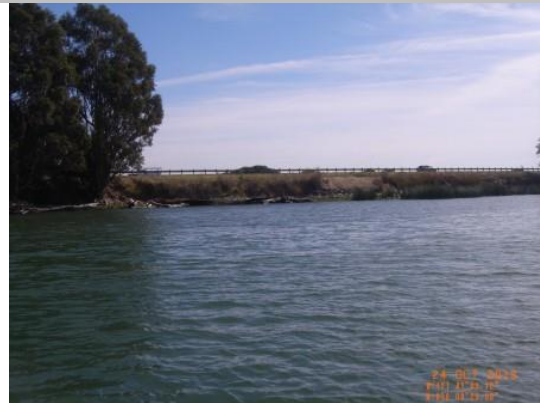
Photo 1 of 1 : SP_2019_NA0002_63_69_20190311_00032.jpg

Comment Code					
Inspector Comment					
2017 Site ID: SAC 11.2 L					
Status: Critical					
2017 Field Notes: New slump section. Erosion under the road has enlarged.					
Site History: 2008 - Erosion causing vertical bank at the highway on top of levee. The whole bank along the highway should be repaired. 2009 - Minimal new erosion. 2011 - Bank continues to slowly erode. 2012 - Upgrade to critical, new erosion since lat year and steeper slopes in sections. 2015 - Road foundation and cables exposed. Extremely large tree with exposed roots looks likely to fail and take out a significant portion of the levee. 2016 - Site continues to erode.

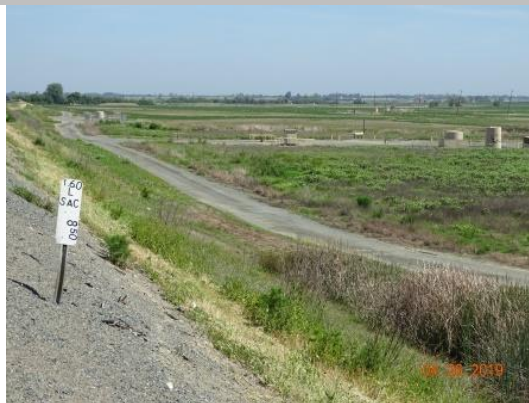
Photo 1 of 1 : SP_2019_NA0002_63_28_20190429_00202.jpg

LM Start	8.97	Rating **	M	Issue No.	28
LM End	10.18	Issue Type +	Ma	Location *	LS
Category	Earthen Levee			GPS Latitude/Longitude	
				Start	End
Item	Vegetation			38.141002 °	38.124229 °
				-121.684934 °	-121.690016 °
DWR ID	DWR_NA0002_02_s_2019_28				
Comment Code					
V1 : Control annual grass and weeds on the levee slopes and easements.					
Inspector Comment					
Maintain annual vegetation all the way down the landside slope.

View looking upstream at annual vegetation on the bottom half of the landside slope (Spring 2019).

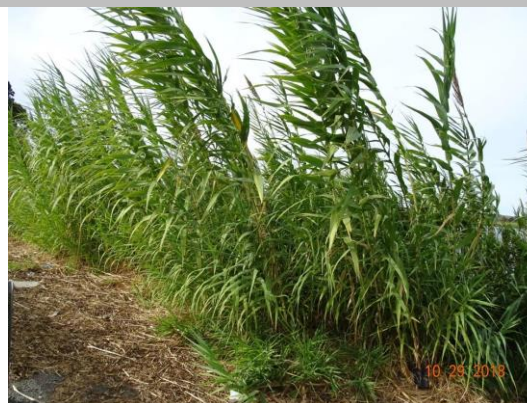
Photo 1 of 1 : SP_2019_NA0002_63_152_20190311_00091.jpg

LM Start	9.06	Rating **	U	Issue No.	152
LM End	9.06	Issue Type +	Ma	Location *	WS
Category	Earthen Levee			GPS Latitude/Longitude	
				Start	End
Item	Vegetation			38.139863 °	38.139862 °
				-121.685617 °	-121.685620 °
DWR ID	DWR_NA0002_02_f_2018_152				
Comment Code					
V2 : Remove the wild growth other than native grasses from the levee slopes.					
Inspector Comment					
Remove arundo from the waterside slope.

View of arundo on waterside slope (October 2018).

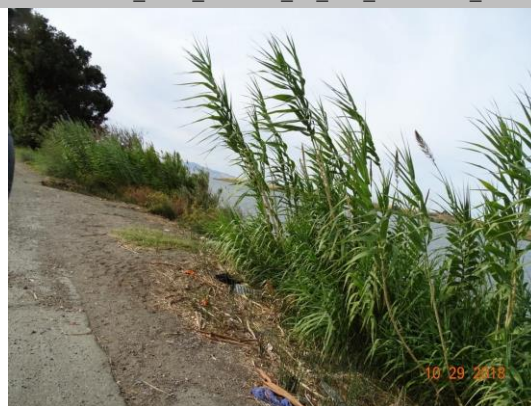
Photo 1 of 1 : SP_2019_NA0002_63_153_20190311_00092.jpg

LM Start	9.15	Rating **	U	Issue No.	153
LM End	9.15	Issue Type +	Ma	Location *	WS
Category	Earthen Levee			GPS Latitude/Longitude	
				Start	End
Item	Vegetation			38.138625 °	38.138625 °
				-121.686138 °	-121.686138 °
DWR ID	DWR_NA0002_02_f_2018_153				
Comment Code					
V2 : Remove the wild growth other than native grasses from the levee slopes.					
Inspector Comment					
Remove arundo.

View of arundo on waterside slope (October 2018).

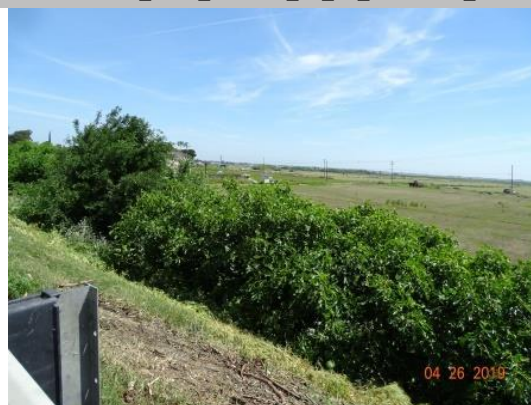
Photo 1 of 1 : SP_2019_NA0002_63_72_20190429_00201.jpg

LM Start	9.19	Rating **	U	Issue No.	72
LM End	9.22	Issue Type +	Ma	Location *	LS
Category	Earthen Levee			GPS Latitude/Longitude	
				Start	End
Item	Trim / Thin Trees			38.138004 °	38.137545 °
				-121.686157 °	-121.686210 °
DWR ID	DWR_NA0002_02_s_2019_72				
Comment Code					
T2 : Thin trees to allow visibility of the ground and room to flood fight.					
Inspector Comment					
Trim fig trees on the landside toe.

View looking downslope at fig tree on the landside slope (Spring 2019).

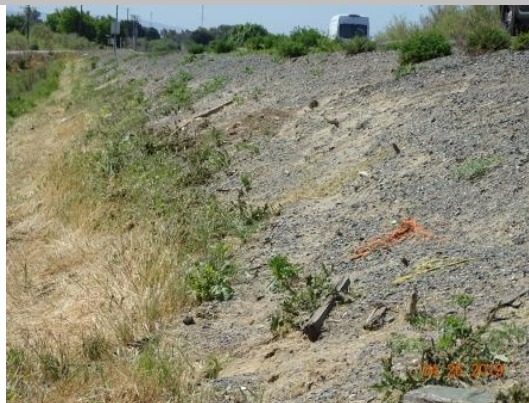
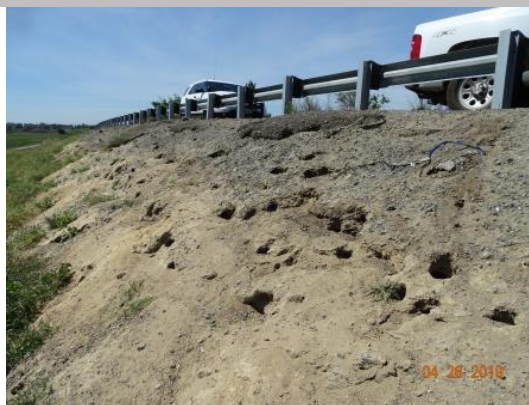
LM Start	9.27	Rating **	U	Issue No.	67
LM End	10.03	Issue Type +	Ma	Location *	LS
Category	Earthen Levee			GPS Latitude/Longitude	
				Start	End
Item	Animal Control			38.136815 °	38.126291 °
				-121.686161 °	-121.688959 °
DWR ID	DWR_NA0002_02_s_2019_67				
Comment Code					
A1 : Exterminate rodents and backfill and compact or grout burrows.					
Inspector Comment					
There is major ground squirrel burrowing activity along this stretch. The LMA is aware of rock piles near the levee toe and says that is the source of the rodents.

View looking downstream at animal holes on the landside slope (Spring 2019).

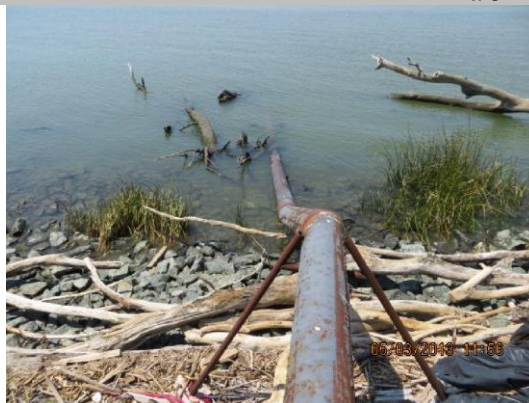
Photo 1 of 3 : UCIP_SP_2019_40528_21002.jpg

Comment Code					
Inspector Comment					
FS_ID:40528 DS_ID:21931 EP_NO: 16011 Repair Type: Non-Urgent Crossing Status: Found UCIP Comments: Annular space between pipes should be grouted. IF abandoned, these pipes should be abandoned properly. FIELD_STRUCT_DESC: 18-inch corrugated metal conduit pipe through the levee, 4.5 feet below the crown. Inactive 12-inch pipe sleeved through 18-inch. Both ends open. Siphon breaker and air valve in 24-inch corrugated metal riser unit on the landside (LS) shoulder. 9-foot by 5-foot concrete box with slide gate off LS toe. [Additional Reference(s): DWR Levee Log, 2005. USACE Sacramento O&M Manual 102, April 1959, (RM 10.9) (Reclamation District No. 2067) steel pipe listed]. FS Date: 5/3/2013

Pipe on WS slope.

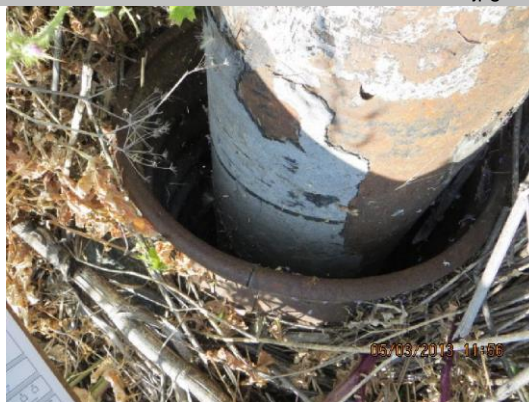
Photo 2 of 3 : UCIP_SP_2019_40528_21001.jpg

18-inch CMP with 12-inch irrigation pipe sleeved through it.

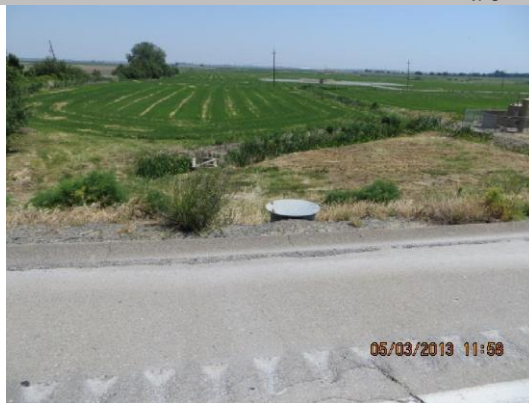
Photo 3 of 3 : UCIP_SP_2019_40528_21000.jpg

Comment Code						
Inspector Comment						
FS_ID:40528 DS_ID:21931 EP_NO: 16011 Repair Type: Non-Urgent Crossing Status: Found UCIP Comments: Annular space between pipes should be grouted. IF abandoned, these pipes should be abandoned properly. FIELD_STRUCT_DESC: 18-inch corrugated metal conduit pipe through the levee, 4.5 feet below the crown. Inactive 12-inch pipe sleeved through 18-inch. Both ends open. Siphon breaker and air valve in 24-inch corrugated metal riser unit on the landside (LS) shoulder. 9-foot by 5-foot concrete box with slide gate off LS toe. [Additional Reference(s): DWR Levee Log, 2005. USACE Sacramento O&M Manual 102, April 1959, (RM 10.9) (Reclamation District No. 2067) steel pipe listed]. FS Date: 5/3/2013

Standpipe and concrete box at LS.

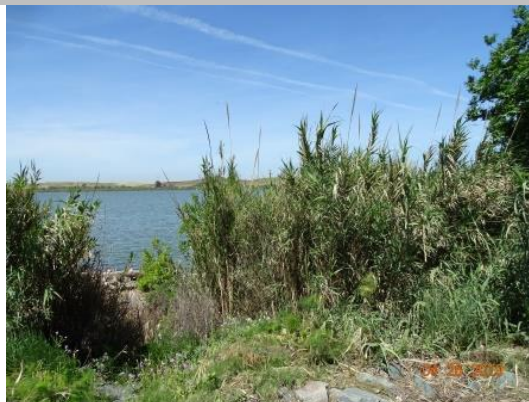
Photo 1 of 1 : SP_2019_NA0002_63_63_20190429_00197.jpg

LM Start	9.38	Rating **	U	Issue No.	63
LM End	9.38	Issue Type +	Ma	Location *	WS
Category	Earthen Levee			GPS Latitude/Longitude	
				Start	End
Item	Vegetation			38.135251 °	38.135251 °
				-121.686131 °	-121.686131 °
DWR ID	DWR_NA0002_02_s_2019_63				
Comment Code					
V2 : Remove the wild growth other than native grasses from the levee slopes.					
Inspector Comment					
Remove arundo.

View of arundo on the waterside slope (Spring 2019).

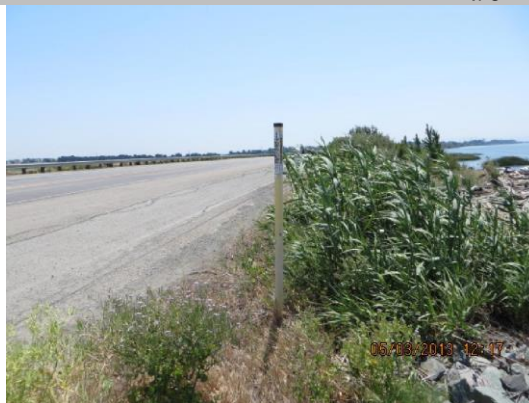
Photo 1 of 2 : UCIP_SP_2019_16146_27251.jpg

LM Start	9.50	Rating **	M	Issue No.	211
LM End	9.50	Issue Type +	En	Location *	
Category	Supplemental			GPS Latitude/Longitude	
				Start	End
Item	DWR UCIP Field Study			38.133512 °	38.133512 °
				-121.685948 °	-121.685948 °
DWR ID	23142				
Comment Code					
Inspector Comment					
FS_ID:16146 DS_ID:23142 EP_NO: N/A Repair Type: Non-Urgent Crossing Status: Indicator Found UCIP Comments: Need to determine Permit No. for this crossing. FIELD_STRUCT_DESC: Gas line markers on the landside (LS) toe and waterside (WS) shoulder. FS Date: 5/3/2013

Gasline Marker on WS shoulder

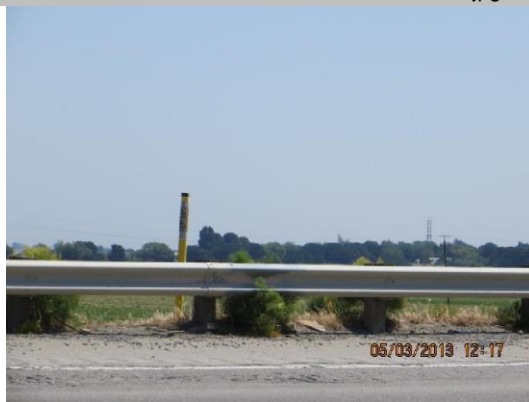
Photo 2 of 2 : UCIP_SP_2019_16146_27250.jpg

Gasline Marker on LS shoulder

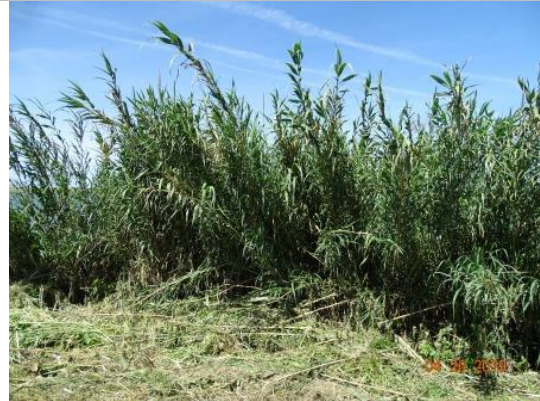
Photo 1 of 1 : SP_2019_NA0002_63_16_20190429_00198.jpg

LM Start	9.71	Rating **	U	Issue No.	16
LM End	9.71	Issue Type +	Ma	Location *	WS
Category	Earthen Levee			GPS Latitude/Longitude	
				Start	End
Item	Vegetation			38.130580 °	38.130580 °
				-121.686730 °	-121.686730 °
DWR ID	DWR_NA0002_02_s_2019_16				
Comment Code					
V2 : Remove the wild growth other than native grasses from the levee slopes.					
Inspector Comment					
Remove arundo on the waterside slope.

View of arundo on the waterside slope (Spring 2019).

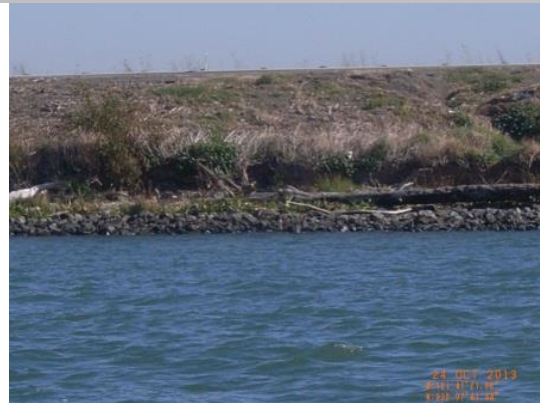
Photo 1 of 1 : SP_2019_NA0002_63_68_20190311_00031.jpg

LM Start	9.78	Rating **	M	Issue No.	68
LM End	9.93	Issue Type +	Ma	Location *	WS
Category	Supplemental			GPS Latitude/Longitude	
				Start	End
Item	2017 USACE Erosion Survey, DRAFT			38.129722 °	38.127672 °
				-121.687468 °	-121.688646 °
DWR ID	DWR_NA0002_02_f_2018_68

Comment Code					
Inspector Comment					
2017 Site ID: SAC 10.8 L					
Status: Eroding					
2017 Field Notes: Lots of new woody debris recruitment.					
Site History: 2004 - Wave wash pockets approximately 100 ft long with new full bank rock between the pockets. 2005 - Spot repairs, but toe is still eroding in several places. 2006 - Low vertical bank along roadway.					
2007 - A PL 84-99 repair was constructed, it cover the majority of the site with the exception of the upstream 150 to 200 ft and the downstream 250 ft, therefore it is being kept in the inventory. 2009 - Minimal new erosion. 2010 - Outboard berm looks good, but the banks are still very steep. 2011 - While the outboard berm is protecting against wave wash, bank still has slumping issues.

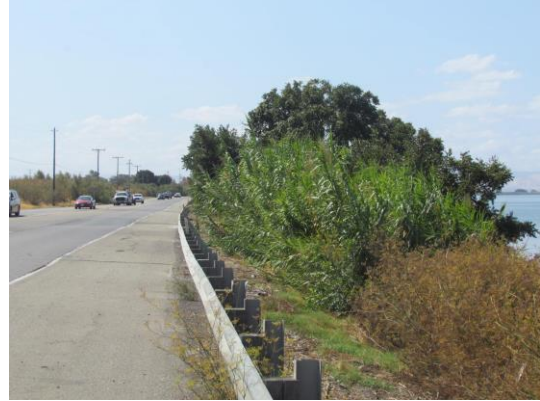
Photo 1 of 2 : SP_2019_NA0002_63_107_20190311_00065.jpg

LM Start	10.26	Rating **	U	Issue No.	107
LM End	11.10	Issue Type +	Ma	Location *	WS
Category	Earthen Levee			GPS Latitude/Longitude	
				Start	End
Item	Vegetation			38.123119 °	38.112414 °
				-121.690488 °	-121.697904 °
DWR ID	DWR_NA0002_02_f _ 2014_107				
Comment Code					
V2 : Remove the wild growth other than native grasses from the levee slopes.					
Inspector Comment					
There is vegetation on the waterside slope.

Looking south at arundo and other vegetation on waterward slope. (Fall 2016)

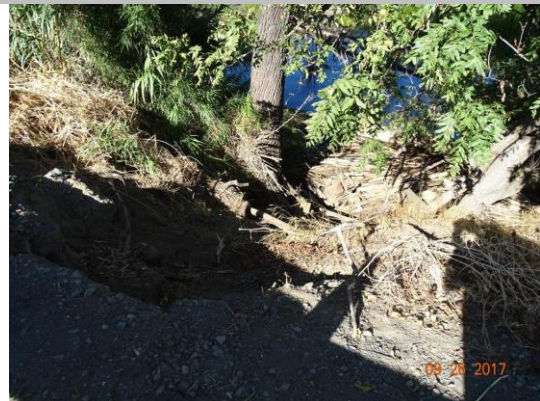
Photo 1 of 1 : SP_2019_NA0002_63_119_20190311_00073.jpg

LM Start	10.74	Rating **	M	Issue No.	119
LM End	10.74	Issue Type +	Ma	Location *	WS
Category	Earthen Levee			GPS Latitude/Longitude	
				Start	End
Item	Erosion / Bank Caving			38.116906 °	38.116906 °
				-121.694595 °	-121.694595 °
DWR ID	DWR_NA0002_02_f_2017_119				
Comment Code					
E2 : Schedule repair of erosion site prior to the next inspection.					
Inspector Comment

Looking northwest at the waterside slope.
