**Flood Control Project Maintenance
Levee Inspections**
LMA District Cover Sheet
Spring 2020 Levee Inspection Results

Brannan Andrus Levee Maintenance District

Spring 2020 Levee Inspection Results

Waterway			Bank	Unit Miles
Unit No. 01 Georgiana Slough			Right	6.01
	Spring (March - May)	Summer (June - August)	(September - November) Fall	Winter (December - February)
Unit Maintenance Rating (Fall Only)				
Date of Inspection	4/2/2020 - 4/2/2020			
DWR Inspector	David Julian			
Accompanied By

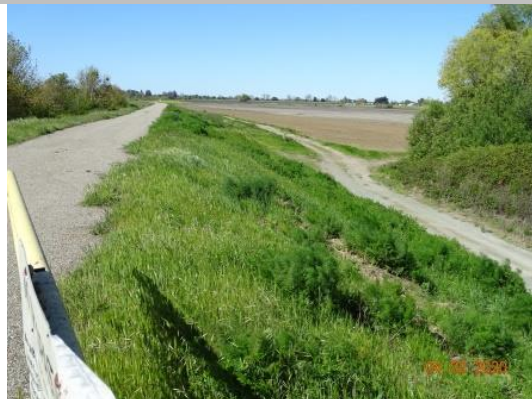
Photo 1 of 1 : SP_2020_NA0002_62_30_20200406_00082.jpg

LM Start	0.01	Rating **	M	Issue No.	30
LM End	2.05	Issue Type +	Ma	Location *	LS
Category	Earthen Levee			GPS Latitude/Longitude	
				Start	End
Item	Vegetation			38.186420 °	38.166243 °
				-121.562802 °	-121.583452 °
DWR ID	DWR_NA0002_01_s_2020_30				
Comment Code					
V1 : Control annual grass and weeds on the levee slopes and easements.					
Inspector Comment

View looking downstream at annual vegetation on the landside slope (Spring 2020).

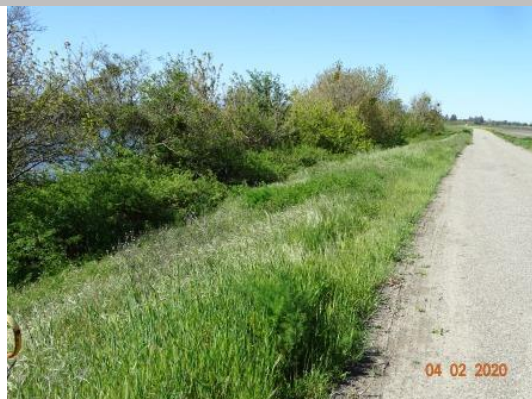
Photo 1 of 1 : SP_2020_NA0002_62_29_20200406_00081.jpg

LM Start	0.01	Rating **	M	Issue No.	29
LM End	2.18	Issue Type +	Ma	Location *	WS
Category	Earthen Levee			GPS Latitude/Longitude	
				Start	End
Item	Vegetation			38.186420 °	38.164448 °
				-121.562802 °	-121.583948 °
DWR ID	DWR_NA0002_01_s_2020_29				
Comment Code					
V1 : Control annual grass and weeds on the levee slopes and easements.					
Inspector Comment

View looking downstream at annual vegetation on the waterside slope (Spring 2020).

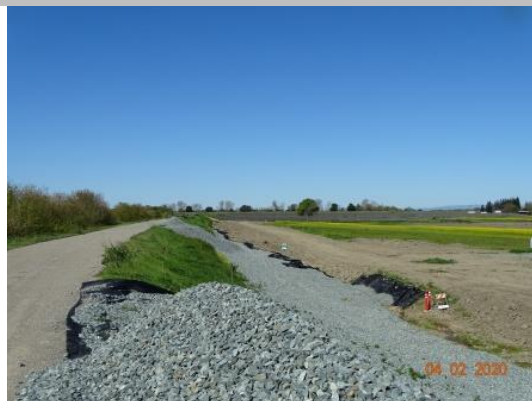
Photo 1 of 1 : SP_2020_NA0002_62_38_20200406_00083.jpg

LM Start	0.49	Rating **	A/W	Issue No.	38
LM End	1.05	Issue Type +	En	Location *	LS
Category	Earthen Levee			GPS Latitude/Longitude	
				Start	End
Item	Encroachments			38.182760 °	38.179933 °
				-121.570358 °	-121.579200 °
DWR ID	DWR_NA0002_01_s_2019_38				
Comment Code					
DT : Ditch					
Inspector Comment					
LMA in process of replacing ditch with pipe and filling in ditch.

view looking downstream on the landside at construction of pipe and removal of ditch (Spring 2020).

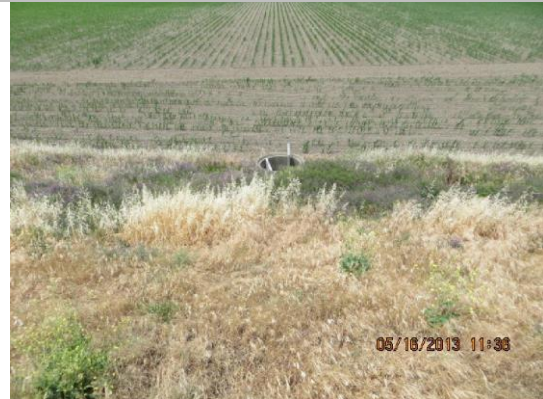
Photo 1 of 3 : UCIP_SP_2020_13558_22169.jpg

LM Start	1.22	Rating **	M	Issue No.	88
LM End	1.22	Issue Type +	En	Location *	
Category	Supplemental			GPS Latitude/Longitude	
				Start	End
Item	DWR UCIP Field Study			38.177669 °	38.177669 °
				-121.580222 °	-121.580222 °
DWR ID	21754				
Comment Code					
Inspector Comment					
DS_ID:21754 FS_ID:13558 EP_NO: 11234 Repair Type: Non-Urgent Crossing Status: Found UCIP Comments: Appears abandoned and should be done so properly. FIELD_STRUCT_DESC: 1 of 2: 8-inch steel irrigation pipe through the levee, 4.3 feet below the crown. Pump in pump house on the waterside (WS) berm. 60-inch diameter concrete standpipe on the landside (LS) toe. (Automatic Board Order (ABO) issued as Permit No. 11234, 1975 - Anthony and John Correia). [Additional Reference(s): USACE Sacramento O&M Manual 103, June 1954, (Station ""R"" 255+00) Drawing No. 50-4-2631]. FS Date: 5/16/2013

Concrete standpipe on LS toe.

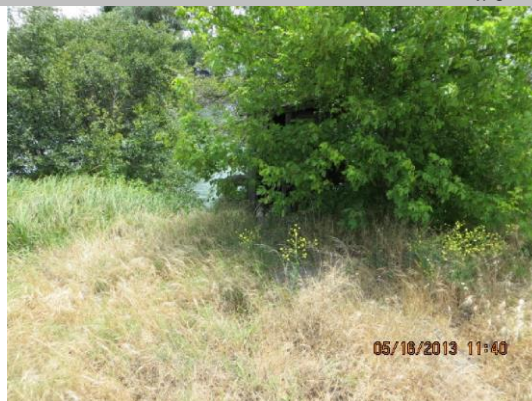
Photo 3 of 3 : UCIP_SP_2020_13558_22167.jpg

LM Start	1.22	Rating **	M	Issue No.	88 (cont)
LM End	1.22	Issue Type +	En	Location *	
Category	Supplemental		GPS Latitude/Longitude		
			Start	End	
Item	DWR UCIP Field Study		38.177669 °	38.177669 °	
			-121.580222 °	-121.580222 °	
DWR ID	21754

Pumphouse on WS slope.

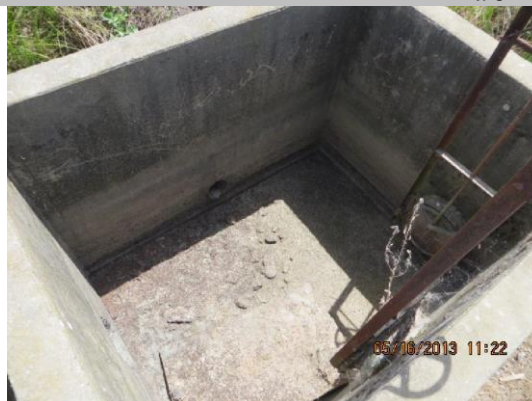
Photo 1 of 3 : UCIP_SP_2020_13554_22164.jpg

Comment Code					
Inspector Comment					
DS_ID:21755 FS_ID:13554 EP_NO: 11252 Repair Type: Non-Urgent Crossing Status: Found UCIP Comments: Pipe heavily rusted at distribution box. Good candidate for video inspection. FIELD_STRUCT_DESC: 1 of 3: 8-inch steel irrigation pipe through the levee, 4.6 feet below the crown. Pump and valve on the waterside (WS) slope. Siphon breaker in 24-inch corrugated metal riser unit on the landside (LS) shoulder. 7-foot by 10-foot concrete distribution box on the LS toe. (Automatic Board Order (ABO) issued as Permit No. 11252, 1975 - Hubert and Palmyra Vandermaele). [Additional Reference(s): DWR Levee Log, 2005. USACE Sacramento O&M Manual 103, June 1954, (Station ""R"" 237+13) Drawing No. 50-4-2631]. FS Date: 5/16/2013

7X10-foot concrete distribution box on LS toe.

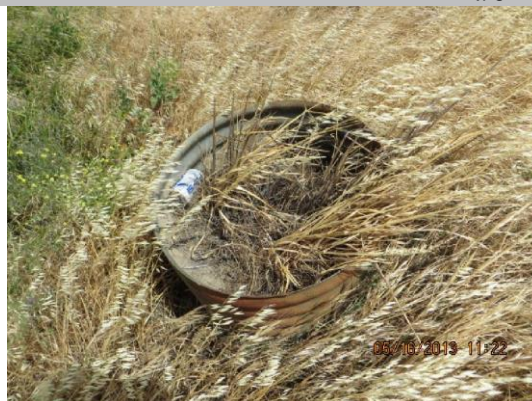
Photo 3 of 3 : UCIP_SP_2020_13554_22162.jpg

LM Start	1.54	Rating **	M	Issue No.	89 (cont)
LM End	1.54	Issue Type +	En	Location *	
Category	Supplemental		GPS Latitude/Longitude		
			Start	End	
Item	DWR UCIP Field Study		38.173254 °	38.173254 °	
			-121.580718 °	-121.580718 °	
DWR ID	21755

CMP riser on LS slope.

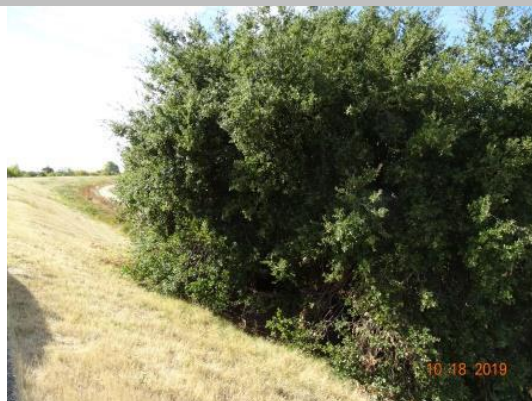
Photo 1 of 1 : SP_2020_NA0002_62_25_20200304_00007.jpg

LM Start	1.56	Rating **	U	Issue No.	25
LM End	1.56	Issue Type +	Ma	Location *	LS
Category	Earthen Levee			GPS Latitude/Longitude	
				Start	End
Item	Trim / Thin Trees			38.172869 °	38.172869 °
				-121.580681 °	-121.580681 °
DWR ID	DWR_NA0002_01_s_2012_25				
Comment Code					
T1 : Trim trees to at least five feet above ground level.					
Inspector Comment					
Tree blocking landside toe.

View looking downstream at thick tree on the landside slope (Fall 2019).

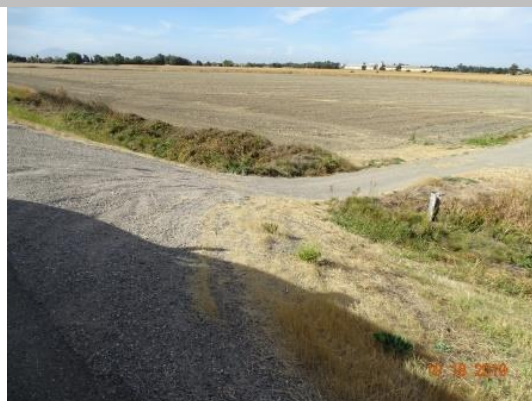
Photo 1 of 1 : SP_2020_NA0002_62_74_20200304_00030.jpg

LM Start	1.79	Rating **	U	Issue No.	74
LM End	1.79	Issue Type +	En	Location *	LS
Category	Earthen Levee			GPS Latitude/Longitude	
				Start	End
Item	Encroachments			38.169625 °	38.169625 °
				-121.581542 °	-121.581542 °
DWR ID	DWR_NA0002_01_f_2016_74				
Comment Code					
RA : Ramp					
Inspector Comment					
The Landowner has created a gravel-covered ramp up the land side of the levee. A permit Application should be submitted and the ramp should be brought up to Title 23 standards after approval.

View looking downslope at unauthorized ramp on the landside (Fall 2019).

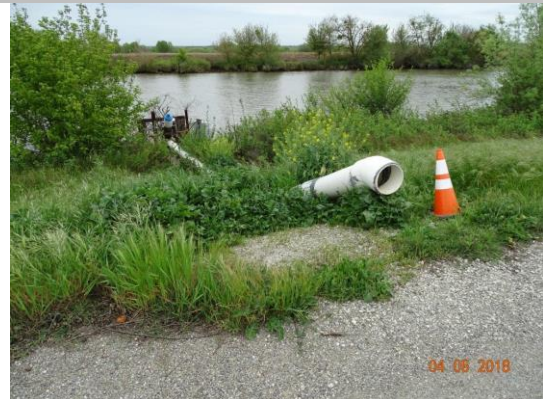
Photo 1 of 2 : UCIP_SP_2020_52615_77544.jpg

Comment Code					
Inspector Comment					
DS_ID:21758 FS_ID:52615 EP_NO: 11252 Repair Type: Non-Urgent Crossing Status: Found UCIP Comments: 04/06/2017 Landowner has installed a temporary pipe and removed old pipe. Photos and update courtesy of DWR Inspector, Richard Willoughby.05/16/2013 Pipe rusted through at inlet to box. Good candidate for video inspection. (G. Wylie - DWR) FIELD_STRUCT_DESC: *REMOVED* 3 of 3: 12-inch steel pipe through the levee 4.0 feet below the crown. Slant pump on bank. Switch box on berm, conduit through levee. Siphon breaker in 24-inch CMP riser on landward slope. Power pole and electrical panel at landward toe (ABO No. 11252, 1975). 7'X10' concrete distribution box on LS toe. As per Richard Willoughby, FPIIB Inspector, landowner has installed a temporary 12-inch PVC pipe on the WS and removed this pipe. New pipe forthcoming. Originally included in the 1954 O&M manual. FS Date: 4/6/2017

A view of disconnected temporary pipe on waterside. Photo courtesy of DWR inspector Keith E Millard.

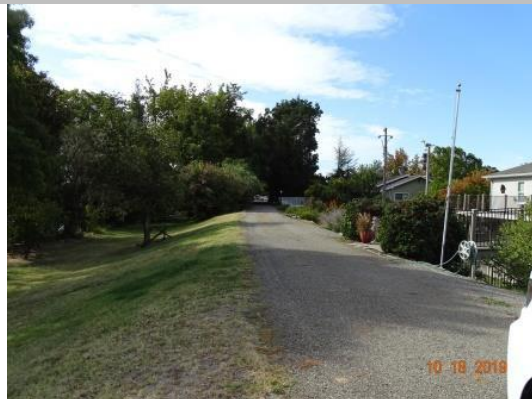
Photo 1 of 1 : SP_2020_NA0002_62_36_20200304_00010.jpg

LM Start	2.29	Rating **	U	Issue No.	36
LM End	2.34	Issue Type +	En	Location *	LS
Category	Earthen Levee			GPS Latitude/Longitude	
				Start	End
Item	Vegetation			38.162918 °	38.162322 °
				-121.584721 °	-121.585081 °
DWR ID	DWR_NA0002_01_s_2012_36				
Comment Code					
V6 : Landscaping					
Inspector Comment					
Vegetation is starting to impede patrol road.

View looking downstream at landscape on the landside slope (Fall 2019).

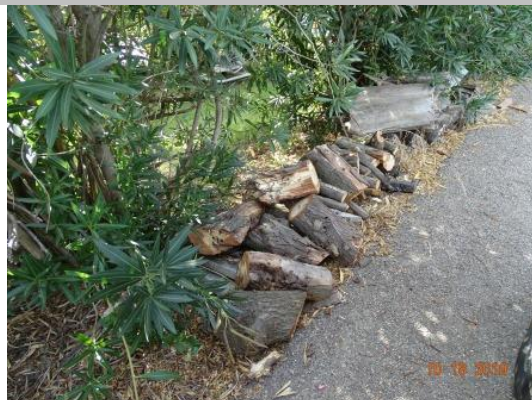
Photo 1 of 1 : SP_2020_NA0002_62_3_20200304_00002.jpg

LM Start	2.30	Rating **	M	Issue No.	3
LM End	2.32	Issue Type +	En	Location *	WS
Category	Earthen Levee			GPS Latitude/Longitude	
				Start	End
Item	Encroachments			38.162773 °	38.162544 °
				-121.584767 °	-121.584909 °
DWR ID	DWR_NA0002_01_s_2012_3				
Comment Code					
FW : Firewood					
Inspector Comment					
Firewood on the waterside shoulder

View of firewood on the waterside shoulder (Fall 2019).

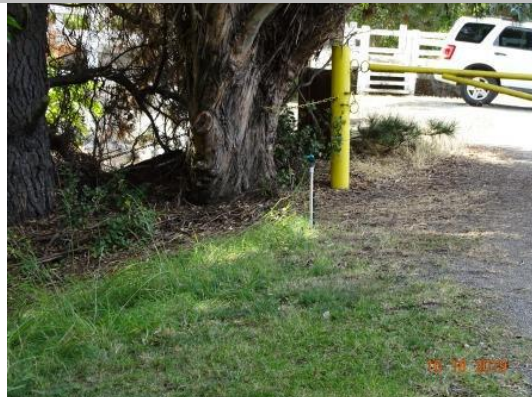
Photo 1 of 1 : SP_2020_NA0002_62_50_20200304_00016.jpg

LM Start	2.33	Rating **	M	Issue No.	50
LM End	2.33	Issue Type +	En	Location *	WS
Category	Earthen Levee			GPS Latitude/Longitude	
				Start	End
Item	Encroachments			38.162343 °	38.162343 °
				-121.585020 °	-121.585020 °
DWR ID	DWR_NA0002_01_f _ 2014_50				
Comment Code					
LI : Landscape Irrigation					
Inspector Comment					
Landowner installed sprinklers along waterside slope without permit.

View looking downstream at sprinkler emitter that is part of a larger sprinkler system on the waterside slope (Fall 2019).

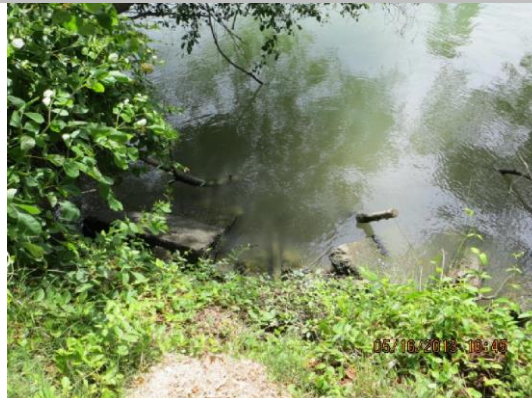
Photo 1 of 2 : UCIP_SP_2020_16123_27221.jpg

LM Start	2.34	Rating **	M	Issue No.	91
LM End	2.34	Issue Type +	En	Location *	
Category	Supplemental			GPS Latitude/Longitude	
				Start	End
Item	DWR UCIP Field Study			38.162332 °	38.162332 °
				-121.585032 °	-121.585032 °
DWR ID	21819				
Comment Code					
Inspector Comment					
DS_ID:21819 FS_ID:16123 EP_NO: N/A Repair Type: Non-Urgent Crossing Status: Found UCIP Comments: Pipe appears abandoned and should be done so properly. FIELD_STRUCT_DESC: 2-inch steel irrigation pipe through the levee, 3 feet below the crown. [Additional Reference(s): USACE Sacramento O&M Manual 103, June 1954, (Station ""R"" 196+99) Drawing No. 50-4-2631]. FS Date: 5/16/2013

Pipe visible in water at WS toe.

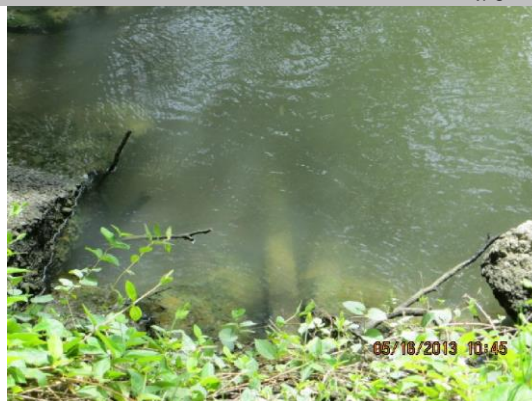
Photo 2 of 2 : UCIP_SP_2020_16123_27220.jpg

LM Start	2.34	Rating **	M	Issue No.	91 (cont)
LM End	2.34	Issue Type +	En	Location *	
Category	Supplemental		GPS Latitude/Longitude		
			Start	End	
Item	DWR UCIP Field Study		38.162332 °	38.162332 °	
			-121.585032 °	-121.585032 °	
DWR ID	21819

Pipe visible in water at WS toe.

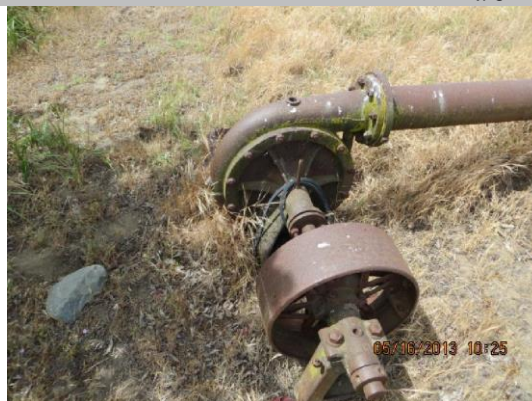
Photo 3 of 3 : UCIP_SP_2020_13545_22143.jpg

LM Start	2.50	Rating **	M	Issue No.	92 (cont)
LM End	2.50	Issue Type +	En	Location *	
Category	Supplemental			GPS Latitude/Longitude	
				Start	End
Item	DWR UCIP Field Study			38.160147 °	38.160147 °
				-121.586088 °	-121.586088 °
DWR ID	21762

Pump and pipe on WS toe.

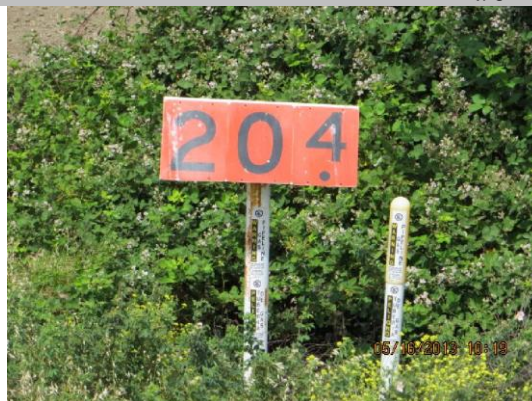
Photo 2 of 2 : UCIP_SP_2020_13525_22127.jpg

DS_ID:21764
 FS_ID:13525
 EP_NO: 17250
 Repair Type: Non-Urgent
 Crossing Status: Indicator Found
 UCIP Comments: Needs better location markers.
 FIELD_STRUCT_DESC: 24-inch steel natural gas pipeline through the levee, 117 feet below the crown. Possible sign on the LS toe. (Permit No. 17250, 2001 - Lodi Gas Storage, LLC).
 FS Date: 5/16/2013

Gasline marker on LS toe.

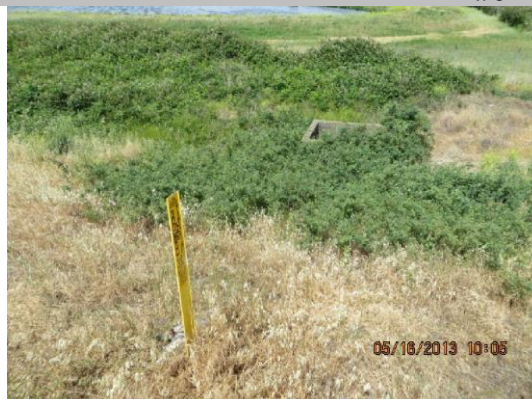
Photo 1 of 3 : UCIP_SP_2020_53386_22124.jpg

DS_ID:21765
FS_ID:53386
EP_NO: 11238
Repair Type: Urgent
Crossing Status: Found
UCIP Comments: 07/12/2018 Dense vegetation on both levee slopes. Unable to evaluate erosion on WS. Depression along pipe alignment on levee crown. Recommend internal inspection to determine pipe integrity through levee. (O.Yakimov-DWR UCIP)10/24/2016 Unable to access WS due to heavy vegetation--assume WS remains the same or erosion has progressed but not visible from levee crown. Pipe marker found on LS slope next to 12-inch irrigation pipe indicating high pressure unodorized natural gas pipeline however, unable to confirm if line is present or if it is parallel to levee or if it goes through levee. (O. Magana - DWR UCIP)05/16/2013 Erosion along pipe at WS toe goes into levee prism. Animal activity appears to be the cause of some pretty heavy erosion damage. Some settlement along the pipe alignment on crown may indicate other problems with this pipe. (W. Wylie - DWR UCIP)

FIELD_STRUCT_DESC: 1 of 5: 12-inch irrigation steel pipe through levee 4 feet below crown. Siphon breaker is located on landside (LS) shoulder. A 7-foot by 9-foot concrete distribution box is located on LS toe. (12-inch pipe authorized under Permit No. 18549, 2009 - Stockton JACS LLC; previous 12-inch pipe was replaced and authorized under Automatic Board Order (ABO) issued as Permit No. 11238, 1975 - Gardiner Improvement Company). [Additional Reference(s): DWR Levee Log, 2005. USACE Sacramento O&M Manual Unit 103, June 1954, (Station "R" 182+63), Drawing No. 50-4-2631, 50-4-2634].
FS Date: 7/12/2018 2:39:34 PM

Pipe visible on LS shoulder with concrete distribution box on LS toe.
Gasline marker placed at pipe.

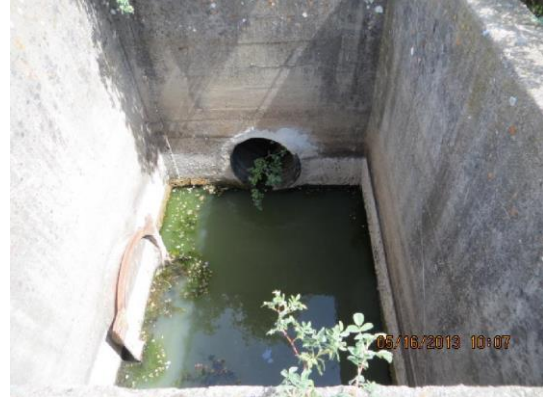
Photo 2 of 3 : UCIP_SP_2020_53386_22123.jpg

Concrete distribution box on LS toe.

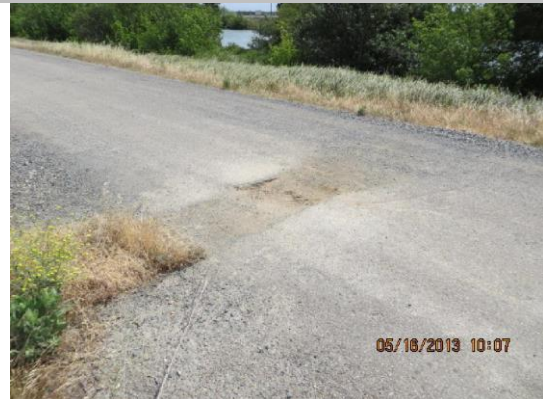
Photo 3 of 3 : UCIP_SP_2020_53386_22122.jpg

Subsidence along pipe alignment at crown.

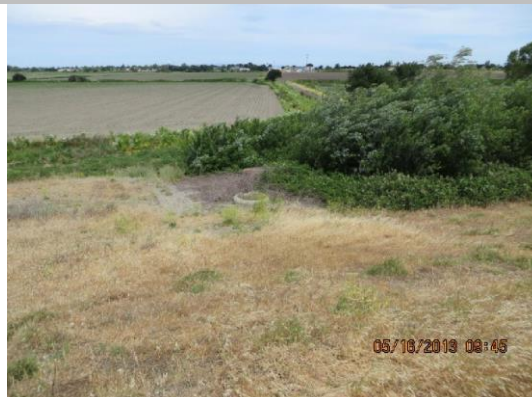
Photo 1 of 2 : UCIP_SP_2020_41561_27229.jpg

LM Start	3.01	Rating **	M	Issue No.	95	
LM End	3.01	Issue Type +	En	Location *		
Category	Supplemental			GPS Latitude/Longitude		
				Start	End	
Item	DWR UCIP Field Study			38.156379 °	38.156379 °	
				-121.592527 °	-121.592527 °	
DWR ID	21766					
Comment Code						
Inspector Comment						
DS_ID:21766 FS_ID:41561 EP_NO: N/A Repair Type: Non-Urgent Crossing Status: Indicator Found UCIP Comments: Appears abandoned FIELD_STRUCT_DESC: *ABANDONED* 12-inch steel irrigation pipe through the levee, at an unknown depth. 5-foot diameter concrete riser unit on the landside (LS) toe. [Additional Reference(s): DWR Levee Log, 2005]. FS Date: 5/16/2013

5-foot diameter concrete riser on LS toe, but no pipe visible.

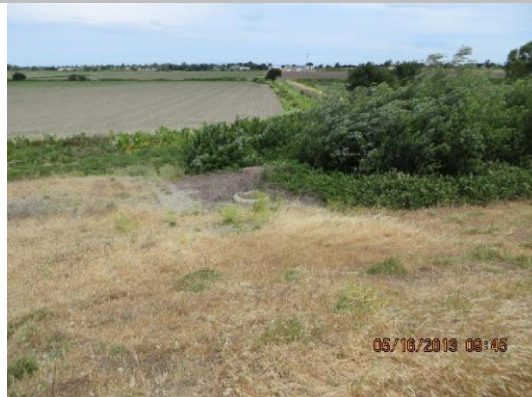
Photo 2 of 2 : UCIP_SP_2020_41561_27228.jpg

5-foot diameter concrete riser on LS toe, but no pipe visible.

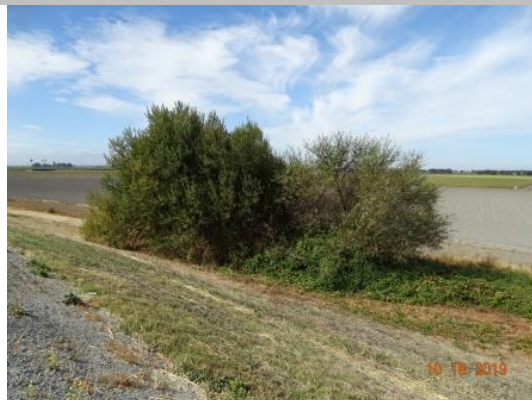
Photo 1 of 1 : SP_2020_NA0002_62_46_20200304_00014.jpg

LM Start	3.74	Rating **	M	Issue No.	46
LM End	3.74	Issue Type +	Ma	Location *	LS
Category	Earthen Levee			GPS Latitude/Longitude	
				Start	End
Item	Trim / Thin Trees			38.150841 °	38.150841 °
				-121.598161 °	-121.598161 °
DWR ID	DWR_NA0002_01_f_2017_46				
Comment Code					
T1 : Trim trees to at least five feet above ground level.					
Inspector Comment

View looking downstream at thick tree on the landside slope (Fall 2019).

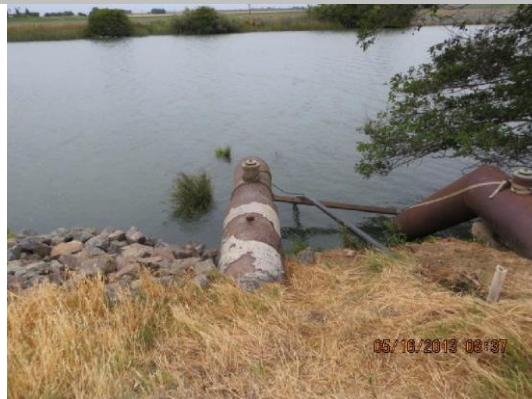
Photo 1 of 3 : UCIP_SP_2020_51302_22082.jpg

Comment Code						
Inspector Comment						
DS_ID:21772						
FS_ID:51302						
EP_NO: 11248						
Repair Type: No Action Needed						
Crossing Status: Found						
UCIP Comments:						
FIELD_STRUCT_DESC: 1 of 2: 24-inch steel drainage pipe through levee, 3 feet below the crown. Siphon breaker is located on the waterside (WS) slope. Pump is located on the landside (LS). (24-inch pipe [HLM 3.99] authorized under Automatic Board Order (ABO) issued as Permit No. 11248, 1975 – Reclamation District No. 407) [Additional Reference(s): DWR Levee Log, 2005. USACE Sacramento O&M Manual Unit 103, June 1954, Drawing No. 50-4-2631, page 2631/2, (Station 107+76), 26-inch listed].						
FS Date: 5/16/2013

24-inch pipe and siphon breaker visible on WS slope.

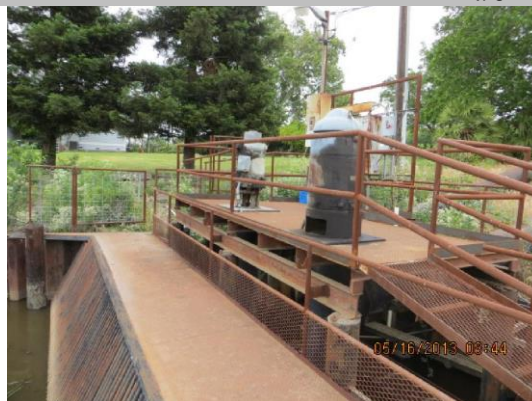
Photo 3 of 3 : UCIP_SP_2020_51302_22080.jpg

Pumping plant on LS toe.

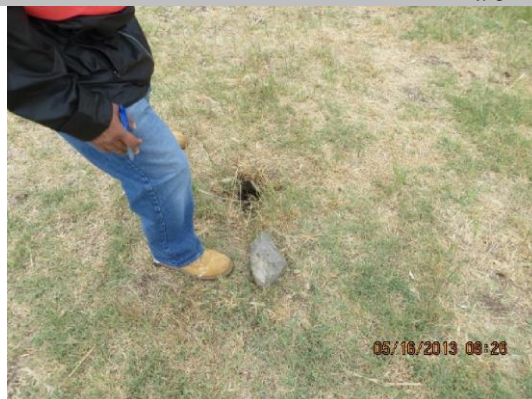
Photo 2 of 3 : UCIP_SP_2020_13487_22052.jpg

DS_ID:21825
 FS_ID:13487
 EP_NO: 11248
 Repair Type: Non-Urgent
 Crossing Status: Found
 UCIP Comments: Leakage of pipe at WS toe creating erosion.
 Possible cavity collapse along pipe alignment on WS berm.
 FIELD_STRUCT_DESC: 2 of 2: 4-inch pipe through levee 4.0 feet below crown. Siphon breaker on waterward slope. Pump on landward side (ABO No. 11248, 1975).
 FS Date: 5/16/2013

Possible indicator of internal pipe failure along pipe alignment as there appears to be a cavity collapse over the pipe on the WS berm.

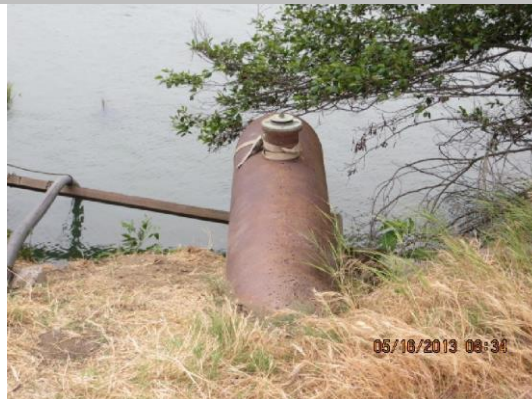
Photo 1 of 3 : UCIP_SP_2020_52693_22078.jpg

DS_ID:21773
FS_ID:52693
EP_NO: 5534
Repair Type: Urgent
Crossing Status: Found
UCIP Comments: 07/12/2018 Levee crown on LS shoulder was repaved with asphalt. Dense vegetation limits visibility on LS levee slope and ability to evaluate erosion on LS. Crossing remains "Urgent". (O.Yakimov-DWR)10/24/2016 Internal erosion visible on LS where pipe daylights. LS road shoulder appears to be failing. Large sink hole patched and is visible on road/crown. Evidence of burrow activity that appear to be about 6-inches in diameter with depths greater than 3 feet. Burrow holes are located on LS hinge point just upstream of pipe and 3 holes visible on WS. Need to contact owner to address issue and recommend to stop use of crossing to avoid further damage to levee. (O. Magana - DWR UCIP)05/16/2013 Pot holes over pipe may indicate internal failure. Good candidate for video inspection. (W. Wylie - DWR UCIP)
FIELD_STRUCT_DESC: 22-inch steel drainage pipe through the levee, 3 feet below the crown. Siphon breaker located on the waterside (WS) shoulder. Pump located on the landside (LS). (22-inch pipe authorized under Permit No. 5534, 1966 - Reclamation District No. 407, 22-inch pipe replaced 24-inch discharge pipe). [Additional Reference(s): DWR Levee Log, 2005, 24-inch pipe listed].

Pipe and siphon breaker on WS shoulder.

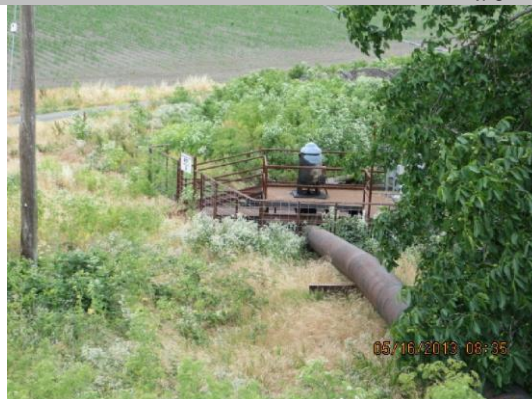
Photo 2 of 3 : UCIP_SP_2020_52693_22077.jpg

Pipe and pumping plant on LS slope.

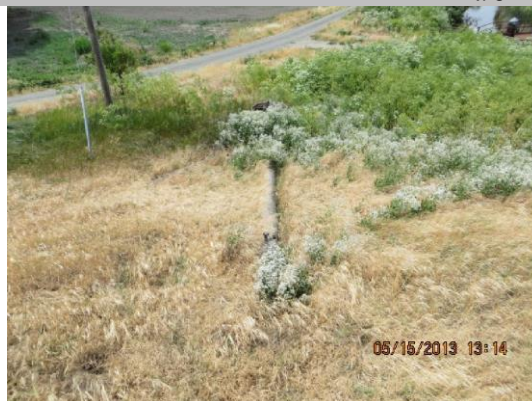
Photo 2 of 3 : UCIP_SP_2020_51308_22049.jpg

10-inch pipe visible on LS slope

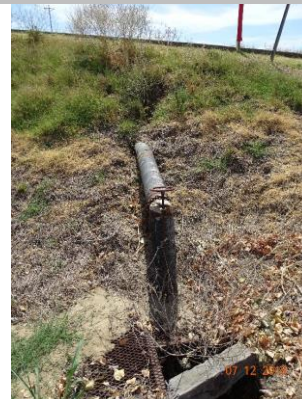
Photo 1 of 3 : UCIP_SP_2020_52692_77567.jpg

DS_ID:21775
FS_ID:52692
EP_NO: 11238
Repair Type: Urgent
Crossing Status: Found
UCIP Comments: 07/12/2018 Hole on LS shoulder under concrete blocks is still present, although haven't increased in size. Part of cover on concrete sump is still missing which is public safety issue. Crossing remain "Urgent" because of potential pipe failure signs. Recommend internal inspection to determine condition of pipe through levee. (DWR-O.Yakimov)
12/30/2016 Left message with Ms. Cabral to inform her that we are working with LMA to find additional information about crossing. Spoke with Andy Giannini, LMA representative, regarding the UCIP report and Mr. Giannini believes the hole is due to ground squirrel activity. According to Mr. Giannini, the issue with ground squirrel has been resolved and the hole filled. Records indicate pipe was installed in the 1950s and authorized under Permit No. 11238 in 1975. This pipe could be about 62 years old. Crossing remains Urgent due to the uncertainty of pipe integrity through levee. Recommend having owner complete an internal inspection of the pipe through the levee to determine integrity of pipe. (O. Magana - DWR UCIP)12/28/2016 Contacted Andy Giannini, LMA representative, and provided him with UCIP report to review. (O. Magana - DWR UCIP)12/27/2016 Contacted Rebecca Cabral, property sales agent from Century 21 Farm & Ranch M&M and Associates, at 1-707-374-3900 to inquire about the property owner for this area. Mrs. Cabral was unaware of pipe through levee and has requested photos to share with client. She was not able to provide me with the current property owner information but mentioned that she will contact me next week (week ending Jan 6, 2017). (O. Magana - DWR UCIP)10/24/2016 Section of cover is still missing. Potential pipe failure through levee. Sink hole is present on LS shoulder. Need to contact owner to stop use of pipe to avoid further damage to levee. Recommend internal inspection of pipe to determine integrity of pipe wall. (O. Magana - DWR UCIP)05/08/2013 Missing cover on concrete sump is an immediate hazard and should be repaired. (W. Wylie - DWR UCIP)

Pipe and concrete sump on LS.

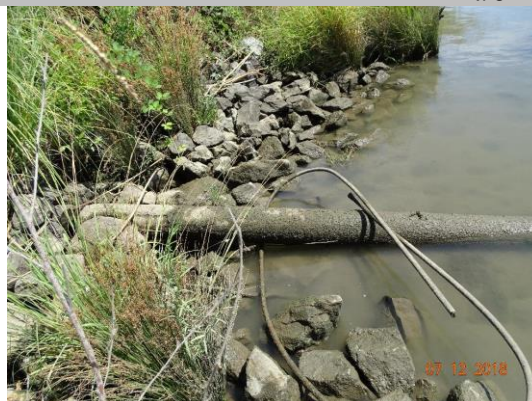
Photo 2 of 3 : UCIP_SP_2020_52692_77569.jpg

Pipe visible at waters edge on WS toe.

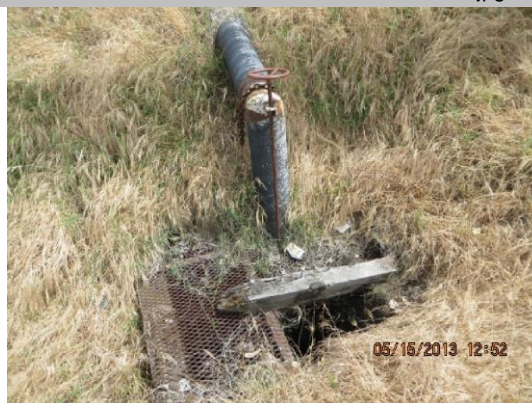
Photo 3 of 3 : UCIP_SP_2020_52692_22043.jpg

Pipe at entrance to concrete sump on LS.

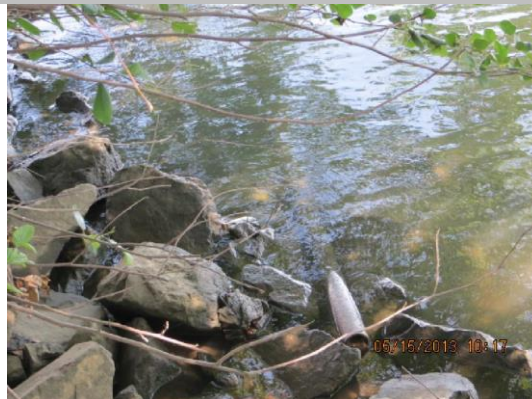
Photo 1 of 1 : UCIP_SP_2020_41562_21935.jpg

LM Start	4.79	Rating **	M	Issue No.	102	
LM End	4.79	Issue Type +	En	Location *		
Category	Supplemental			GPS Latitude/Longitude		
				Start	End	
Item	DWR UCIP Field Study			38.137306 °	38.137306 °	
				-121.596371 °	-121.596371 °	
DWR ID	21782					
Comment Code						
Inspector Comment						
DS_ID:21782						
FS_ID:41562						
EP_NO: 11233						
Repair Type: Non-Urgent						
Crossing Status: Indicator Found						
UCIP Comments: Need to verify type of abandonment.						
FIELD_STRUCT_DESC: *ABANDONED* 2.5-inch pipe of an unknown material or purpose through the levee, 3.2 feet below the crown. Found pipe in water on the waterside (WS) toe. (Automatic Board Order (ABO) issued as Permit No. 11233, 1975 - Jose H. and Maria H. Cervantez). [Additional Reference(s): DWR Levee Log, 2005].						
FS Date: 5/15/2013

Pipe found at WS shoreline.

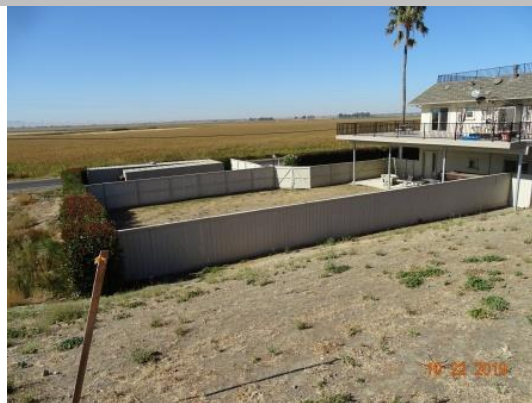
Photo 1 of 1 : SP_2020_NA0002_62_48_20200304_00015.jpg

LM Start	4.83	Rating **	U	Issue No.	48
LM End	4.83	Issue Type +	En	Location *	LS
Category	Earthen Levee			GPS Latitude/Longitude	
				Start	End
Item	Encroachments			38.136839 °	38.136839 °
				-121.595994 °	-121.595994 °
DWR ID	DWR_NA0002_01_f _ 2015_48				
Comment Code					
FE : Fence					
Inspector Comment					
Unauthorized fence at landside toe.

View looking downslope at unauthorized fence on the landside (Fall 2019).

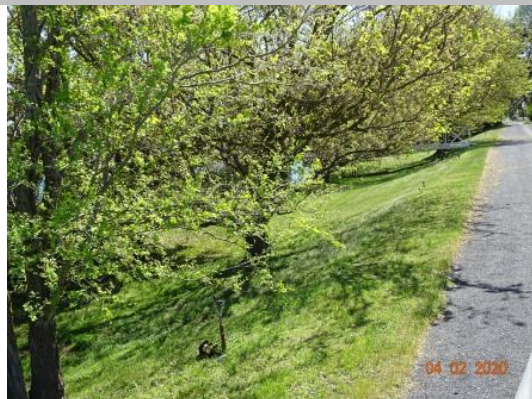
Photo 1 of 1 : SP_2020_NA0002_62_54_20200406_00084.jpg

LM Start	4.96	Rating **	M	Issue No.	54
LM End	5.00	Issue Type +	En	Location *	WS
Category	Earthen Levee			GPS Latitude/Longitude	
				Start	End
Item	Encroachments			38.135407 °	38.135013 °
				-121.594512 °	-121.593970 °
DWR ID	DWR_NA0002_01_s_2020_54				
Comment Code					
LI : Landscape Irrigation					
Inspector Comment					
Sprinklers on the waterside slope.

View looking downstream at sprinklers on the waterside slope (Spring 2020).

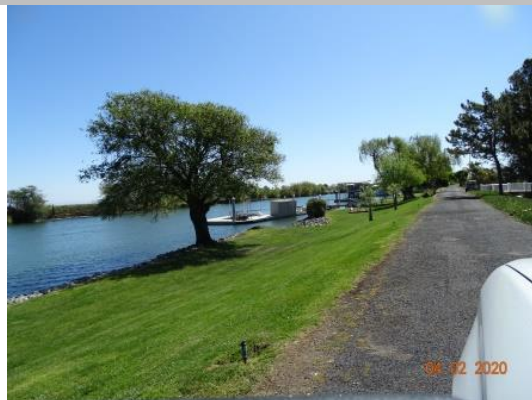
Photo 1 of 1 : SP_2020_NA0002_62_57_20200406_00085.jpg

LM Start	5.07	Rating **	M	Issue No.	57
LM End	5.15	Issue Type +	En	Location *	WS
Category	Earthen Levee			GPS Latitude/Longitude	
				Start	End
Item	Encroachments			38.134238 °	38.133325 °
				-121.593188 °	-121.592032 °
DWR ID	DWR_NA0002_01_s_2020_57				
Comment Code					
LI : Landscape Irrigation					
Inspector Comment					
Sprinklers on the waterside slope.

View looking downstream at sprinklers on the waterside slope (Spring 2020).

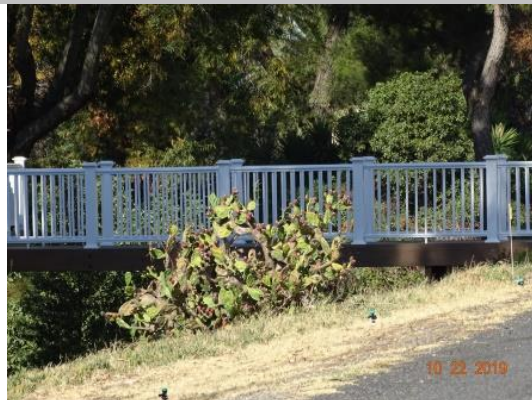
Photo 1 of 1 : SP_2020_NA0002_62_65_20200304_00024.jpg

LM Start	5.12	Rating **	M	Issue No.	65
LM End	5.12	Issue Type +	En	Location *	LS
Category	Earthen Levee			GPS Latitude/Longitude	
				Start	End
Item	Vegetation			38.133695 °	38.133695 °
				-121.592516 °	-121.592516 °
DWR ID	DWR_NA0002_01_s_2016_65				
Comment Code					
V6 : Landscaping					
Inspector Comment					
Remove cactus from landside slope.

View looking upstream at cactus on the landside slope (Fall 2019).

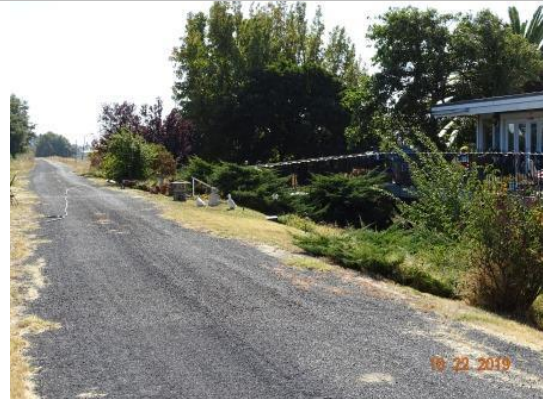
Photo 1 of 1 : SP_2020_NA0002_62_78_20200304_00031.jpg

LM Start	5.22	Rating **	U	Issue No.	78
LM End	5.24	Issue Type +	En	Location *	LS
Category	Earthen Levee			GPS Latitude/Longitude	
				Start	End
Item	Vegetation			38.132606 °	38.132322 °
				-121.591295 °	-121.590989 °
DWR ID	DWR_NA0002_01_s_2018_78				
Comment Code					
V6 : Landscaping					
Inspector Comment					
Heavy landscaping completely blocks visibility and access to landside slope and toe.

View looking downstream at landscaping on the landside slope (Fall 2019).

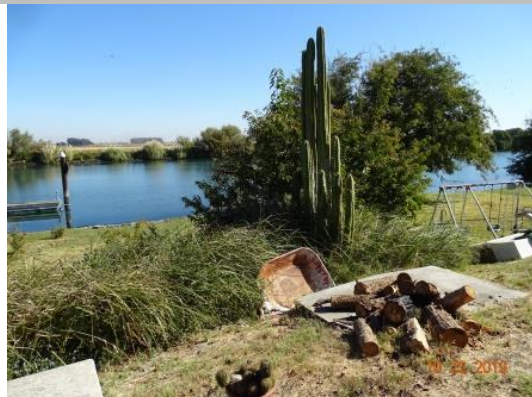
Photo 1 of 1 : SP_2020_NA0002_62_35_20200304_00009.jpg

LM Start	5.25	Rating **	M	Issue No.	35
LM End	5.25	Issue Type +	En	Location *	WS
Category	Earthen Levee			GPS Latitude/Longitude	
				Start	End
Item	Encroachments			38.132185 °	38.132185 °
				-121.590985 °	-121.590985 °
DWR ID	DWR_NA0002_01_f _ 2019_35				
Comment Code					
FW : Firewood					
Inspector Comment

View of small firewood pile on the waterside shoulder (Fall 2019).

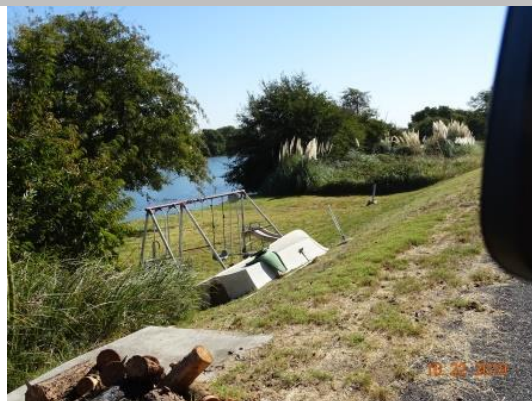
Photo 1 of 1 : SP_2020_NA0002_62_60_20200304_00022.jpg

LM Start	5.26	Rating **	M	Issue No.	60
LM End	5.26	Issue Type +	En	Location *	WS
Category	Earthen Levee			GPS Latitude/Longitude	
				Start	End
Item	Encroachments			38.132199 °	38.132199 °
				-121.590855 °	-121.590855 °
DWR ID	DWR_NA0002_01_s_2015_60				
Comment Code					
GA : Garbage					
Inspector Comment					
An abandoned child's swing set at the waterside toe.

View looking downstream at abandoned child's swing and other garbage on the waterside slope (Fall 2019).

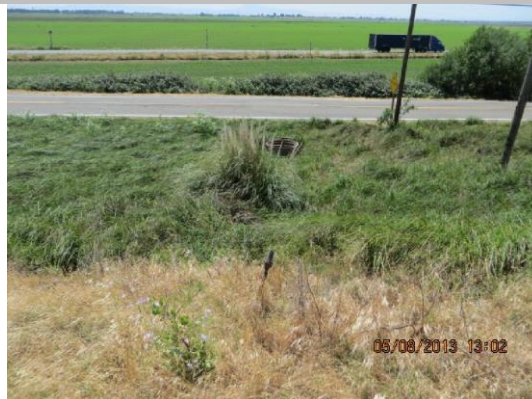
Photo 1 of 3 : UCIP_SP_2020_13090_21282.jpg

Comment Code						
Inspector Comment						
DS_ID:21816 FS_ID:13090 EP_NO: 11245 Repair Type: Non-Urgent Crossing Status: Found UCIP Comments: Appears abandoned. Pipe at slide gate in riser on LS toe is rusted through. FIELD_STRUCT_DESC: 1 of 2: 14-inch steel irrigation pipe through the levee, 3.8 feet below the crown. 2-inch primer valve and 48-inch concrete standpipe on the landside (LS). (Automatic Board Order (ABO) issued as Permit No. 11245, 1975 - Mary Nobrega and Manuel Mendes). [Additional Reference(s): DWR Levee Log, 2005, 12-inch pipe listed. USACE Sacramento O&M Manual 103, June 1954, (Station ""R"" 35+76.7) Drawing No. 50-4-2672]. FS Date: 5/8/2013

Filler pipe and standpipe on LS.

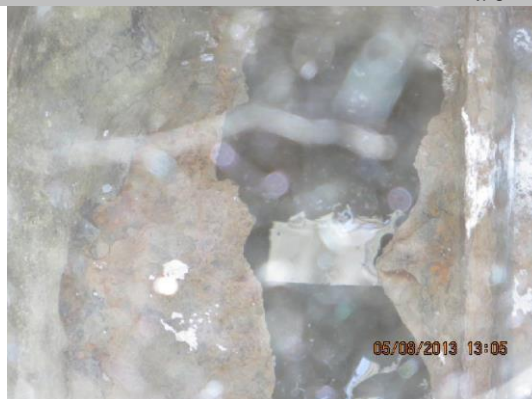
Photo 3 of 3 : UCIP_SP_2020_13090_21280.jpg

Pipe rusted through at slide gate inside concrete riser.

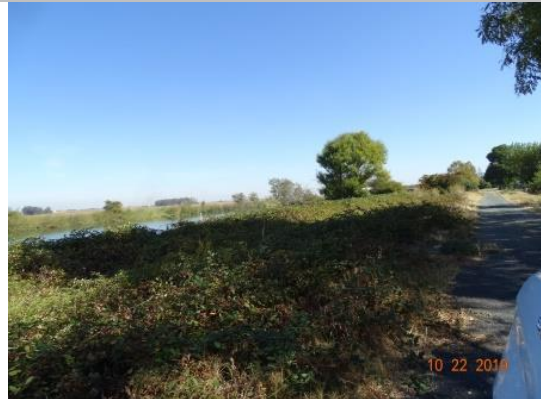
Photo 1 of 2 : SP_2020_NA0002_62_81_20200505_00087.jpg

LM Start	5.64	Rating **	U	Issue No.	81
LM End	5.84	Issue Type +	Ma	Location *	WS
Category	Earthen Levee			GPS Latitude/Longitude	
				Start	End
Item	Vegetation			38.129250 °	38.129637 °
				-121.585193 °	-121.581648 °
DWR ID	DWR_NA0002_01_f _ 2018_81				
Comment Code					
V2 : Remove the wild growth other than native grasses from the levee slopes.					
Inspector Comment

View of blackberries covering the waterside shoulder and slope (Fall 2019).

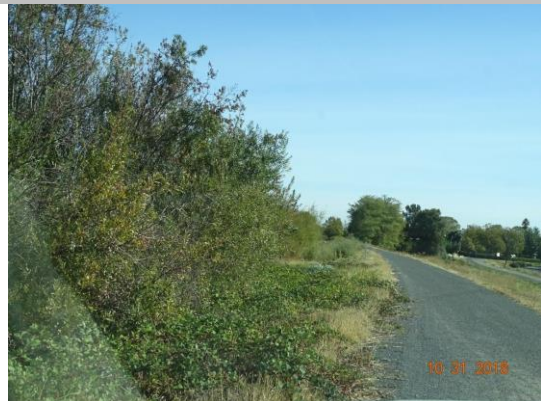
Photo 2 of 2 : SP_2020_NA0002_62_81_20200304_00032.jpg

View of vegetation on the waterside slope (October 2018).

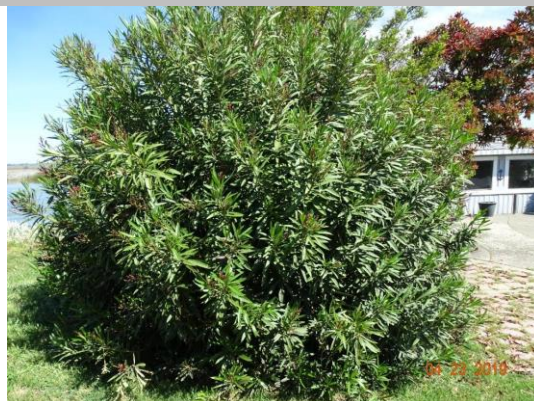
Photo 1 of 1 : SP_2020_NA0002_62_82_20200304_00033.jpg

LM Start	5.84	Rating **	U	Issue No.	82
LM End	5.84	Issue Type +	En	Location *	WS
Category	Earthen Levee			GPS Latitude/Longitude	
				Start	End
Item	Vegetation			38.129663 °	38.129663 °
				-121.581638 °	-121.581638 °
DWR ID	DWR_NA0002_01_f_2018_82				
Comment Code					
V6 : Landscaping					
Inspector Comment

View of thick landscaping vegetation on the waterside slope (Spring 2019).

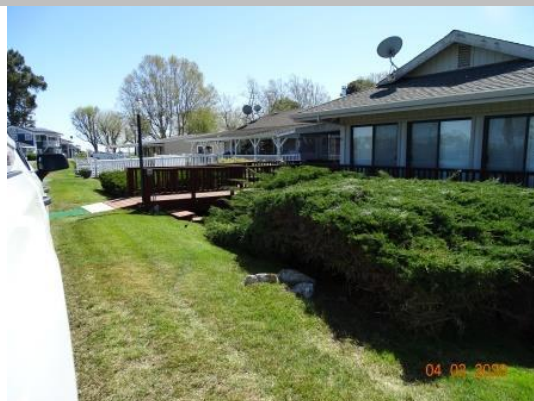
Photo 1 of 1 : SP_2020_NA0002_62_62_20200406_00086.jpg

LM Start	5.96	Rating **	U	Issue No.	62
LM End	5.96	Issue Type +	En	Location *	LS
Category	Earthen Levee			GPS Latitude/Longitude	
				Start	End
Item	Vegetation			38.129677 °	38.129677 °
				-121.579432 °	-121.579432 °
DWR ID	DWR_NA0002_01_s_2020_62				
Comment Code					
V6 : Landscaping					
Inspector Comment

View of thick landscape vegetation on the landside slope (Spring 2020).

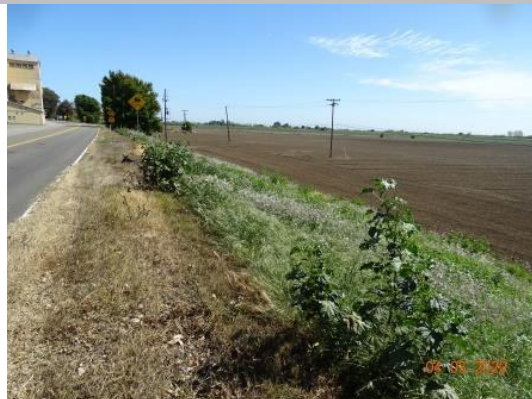
Photo 1 of 1 : SP_2020_NA0002_63_129_20200406_00189.jpg

LM Start	0.01	Rating **	U	Issue No.	129
LM End	2.32	Issue Type +	Ma	Location *	LS
Category	Earthen Levee			GPS Latitude/Longitude	
				Start	End
Item	Vegetation			38.191781 °	38.167791 °
				-121.567890 °	-121.595358 °
DWR ID	DWR_NA0002_02_s_2020_129				
Comment Code					
V1 : Control annual grass and weeds on the levee slopes and easements.					
Inspector Comment

View looking upstream at annual vegetation on the landside slope (Spring 2020).

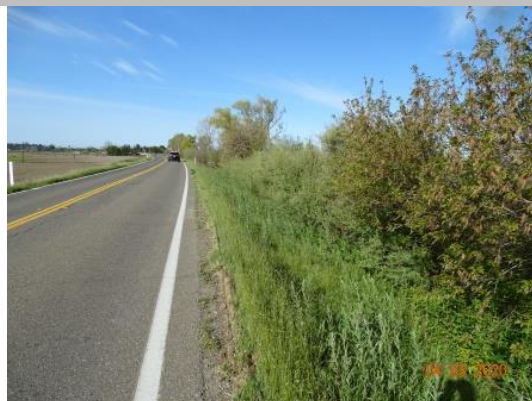
Photo 1 of 1 : SP_2020_NA0002_63_51_20200406_00182.jpg

LM Start	0.04	Rating **	M	Issue No.	51
LM End	1.77	Issue Type +	Ma	Location *	WS
Category	Earthen Levee			GPS Latitude/Longitude	
				Start	End
Item	Vegetation			38.191709 °	38.174817 °
				-121.568305 °	-121.590517 °
DWR ID	DWR_NA0002_02_s_2020_51				
Comment Code					
V1 : Control annual grass and weeds on the levee slopes and easements.					
Inspector Comment

View looking downstream at annual vegetation on the waterside slope (Spring 2020).

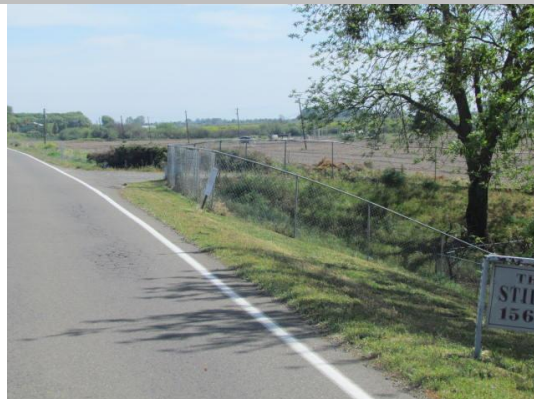
Photo 1 of 1 : SP_2020_NA0002_63_26_20200304_00012.jpg

LM Start	0.43	Rating **	M	Issue No.	26
LM End	0.43	Issue Type +	En	Location *	LS
Category	Earthen Levee			GPS Latitude/Longitude	
				Start	End
Item	Encroachments			38.189212 °	38.189212 °
				-121.574757 °	-121.574757 °
DWR ID	DWR_NA0002_02_s_2012_26				
Comment Code					
FE : Fence					
Inspector Comment

Looking northeast at fence on landward shoulder and slope.

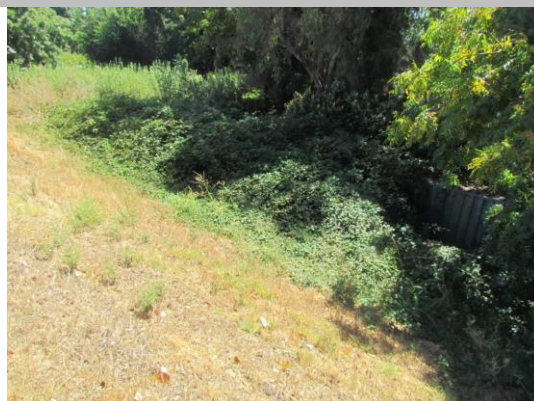
Photo 1 of 1 : SP_2020_NA0002_63_40_20200304_00016.jpg

LM Start	0.49	Rating **	U	Issue No.	40
LM End	0.49	Issue Type +	En	Location *	LS
Category	Earthen Levee			GPS Latitude/Longitude	
				Start	End
Item	Vegetation			38.188871 °	38.188871 °
				-121.575775 °	-121.575775 °
DWR ID	DWR_NA0002_02_f _ 2013_40				
Comment Code					
V6 : Landscaping					
Inspector Comment					
There are dense berryvines at the landside toe.

Looking east at berryvines at landward toe.

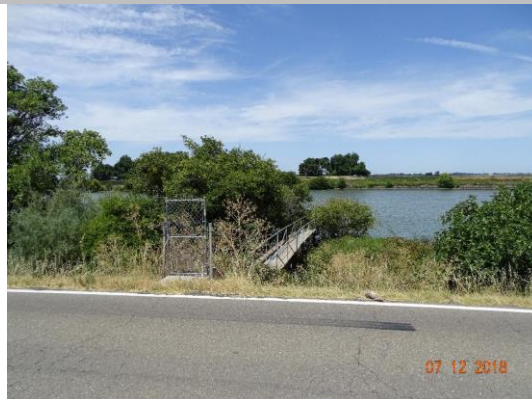
Photo 2 of 3 : UCIP_SP_2020_52689_77596.jpg

Comment Code					
Inspector Comment					
DS_ID:21867 FS_ID:52689 EP_NO: 1173 Repair Type: Non-Urgent Crossing Status: Found UCIP Comments: 07/12/2018 Pump platform is leaning on a side. (O.Yakimov-DWR UCIP) FIELD_STRUCT_DESC: 1 of 4: 12-inch irrigation pipe of an unknown material through the levee, 6 feet below the crown. Pump on pile structure in stream. Siphon breaker in 24-inch corrugated metal riser unit on the landside (LS) slope. 7-foot by 9-foot concrete distribution box at the LS toe. Service pole on the LS slope with a 1-inch steel electrical conduit at same location. (Permit No. 1173, 1947 - Reclamation District No. 556). [Additional Reference(s): DWR Levee Log, 2005. USACE Sacramento O&M Manual 103, June 1954, (Station ""H"" 72+67) steel pipe listed, Drawing No. 50-4-2277]. FS Date: 7/12/2018

View of a bridge to pump platform on WS.

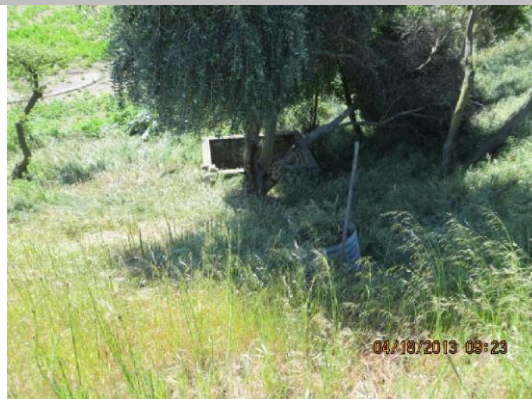
Photo 3 of 3 : UCIP_SP_2020_52689_19722.jpg

Siphon breaker and Concrete distribution box on LS.

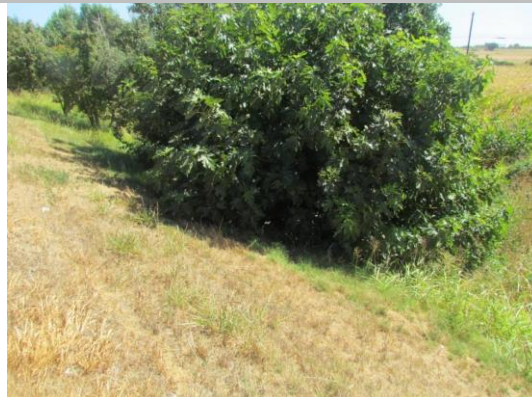
Photo 1 of 1 : SP_2020_NA0002_63_97_20200304_00056.jpg

LM Start	0.72	Rating **	M	Issue No.	97
LM End	0.72	Issue Type +	Ma	Location *	LS
Category	Earthen Levee			GPS Latitude/Longitude	
				Start	End
Item	Trim / Thin Trees			38.187102 °	38.187102 °
				-121.579463 °	-121.579463 °
DWR ID	DWR_NA0002_02_f _ 2018_97				
Comment Code					
T1 : Trim trees to at least five feet above ground level.					
Inspector Comment					
Fig tree on the landside toe.

Looking east at untrimmed fig tree at landward toe.

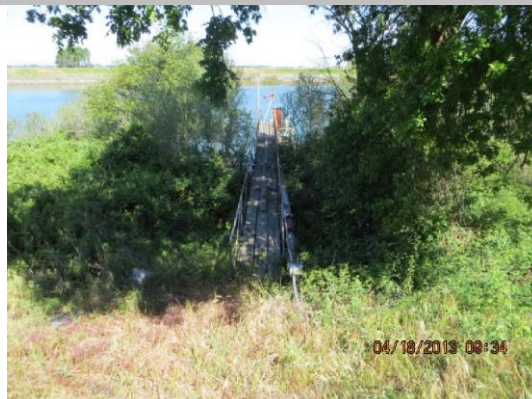
Photo 1 of 3 : UCIP_SP_2020_12164_19726.jpg

DS_ID:21868
FS_ID:12164
EP_NO: 1173
Repair Type: Non-Urgent
Crossing Status: Found
UCIP Comments: Several patches on pipe, walkway in disrepair and 24-inch standpipe for siphon breaker on LS slope has been dislodged from the LS slope and rests at LS toe. Pipe appears to be failing at multiple places due to corrosion.
FIELD_STRUCT_DESC: 2 of 4: 12-inch irrigation pipe of an unknown material through the levee, 7 feet below the crown. Pump on pile structure with a walkway in the river. Siphon breaker in 24-inch corrugated metal riser unit on the landside (LS) slope with a 7-foot by 9-foot concrete distribution box on the LS toe. Service pole on the LS slope with a 1.5-inch galvanized iron electrical conduit at the same location. (Permit No. 1173, 1947 - Reclamation District No. 556).
[Additional Reference(s): DWR Levee Log, 2005. USACE Sacramento O&M Manual 103, June 1954, (Station ""H"" 52+21) steel pipe listed, Drawing No. 50-4-2277].

Pump on pile structure with walkway on WS berm.

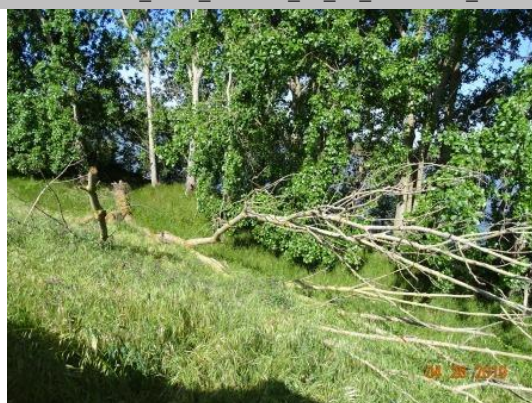
Photo 1 of 1 : SP_2020_NA0002_63_58_20200304_00026.jpg

LM Start	1.24	Rating **	M	Issue No.	58
LM End	1.24	Issue Type +	En	Location *	WS
Category	Earthen Levee			GPS Latitude/Longitude	
				Start	End
Item	Encroachments			38.181519 °	38.181519 °
				-121.585682 °	-121.585682 °
DWR ID	DWR_NA0002_02_s_2019_58				
Comment Code					
TR : Tree or limb					
Inspector Comment					
Remove tree limb from waterside slope.

View of downed tree on the waterside slope (Spring 2019).

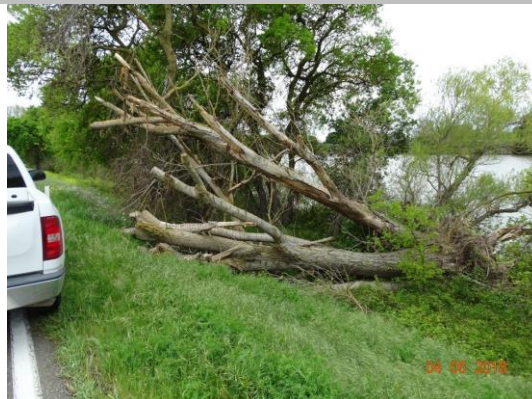
Photo 1 of 1 : SP_2020_NA0002_63_81_20200304_00046.jpg

LM Start	1.33	Rating **	M	Issue No.	81
LM End	1.33	Issue Type +	Ma	Location *	WS
Category	Earthen Levee			GPS Latitude/Longitude	
				Start	End
Item	Encroachments			38.180472 °	38.180472 °
				-121.586510 °	-121.586510 °
DWR ID	DWR_NA0002_02_s_2018_81				
Comment Code					
TR : Tree or limb					
Inspector Comment					
Remove large fallen tree on waterside slope.

View of fallen tree on the waterside.

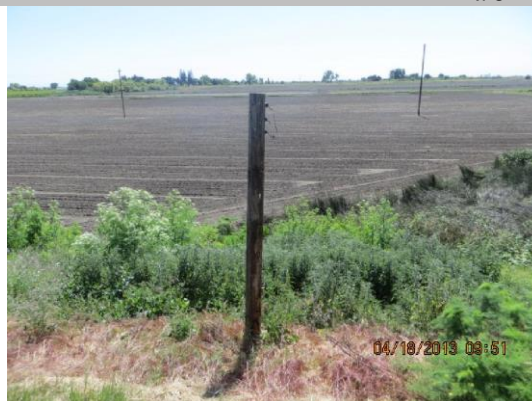
Photo 1 of 3 : UCIP_SP_2020_12165_19731.jpg

Comment Code						
Inspector Comment						
DS_ID:21869 FS_ID:12165 EP_NO: 11261 Repair Type: Non-Urgent Crossing Status: Found UCIP Comments: Pipe abandoned and should be done so properly. Pipe open on WS. FIELD_STRUCT_DESC: 8-inch irrigation pipe of an unknown material through the levee, 6.5 feet below the crown. Pump in pump house on berm. 7-foot by 9-foot concrete distribution box on the landside (LS) toe. Service poles on the LS slope with a 1.5-inch galvanized steel electrical conduit at same location. (Automatic Board Order (ABO) issued as Permit No. 11261, 1975 - Anthony and John Correia). [Additional Reference(s): DWR Levee Log, 2005. USACE Sacramento O&M Manual 103, June 1954, (Station ""H"" 42+33) steel pipe listed, Drawing No. 50-4-2277]. FS Date: 4/18/2013

JP on LS slope.

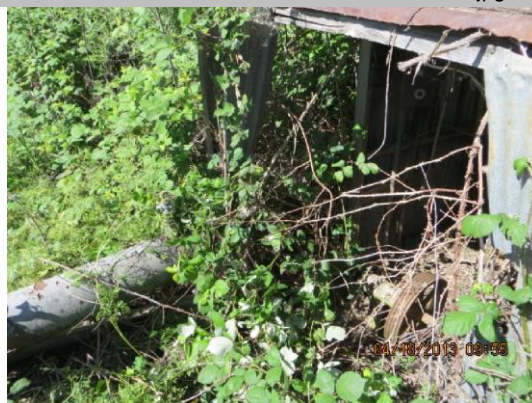
Photo 3 of 3 : UCIP_SP_2020_12165_19729.jpg

Pipe at pumphouse has been disconnected from pump and is open.

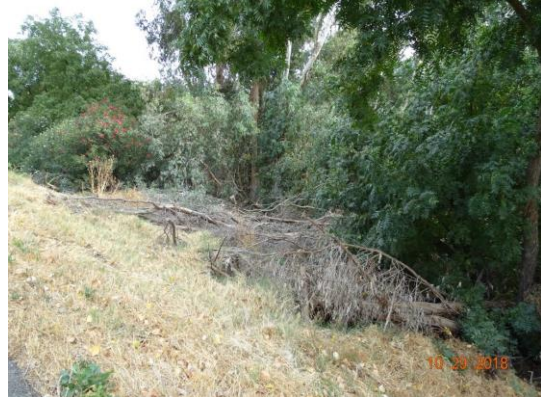
Photo 1 of 1 : SP_2020_NA0002_63_174_20200304_00094.jpg

LM Start	1.46	Rating **	M	Issue No.	174
LM End	1.46	Issue Type +	Ma	Location *	LS
Category	Earthen Levee			GPS Latitude/Longitude	
				Start	End
Item	Encroachments			38.178722 °	38.178722 °
				-121.587792 °	-121.587792 °
DWR ID	DWR_NA0002_02_f _ 2018_174				
Comment Code					
TR : Tree or limb					
Inspector Comment					
Remove down limb on landside slope.

View of downed trees on landside slope (October 2018).

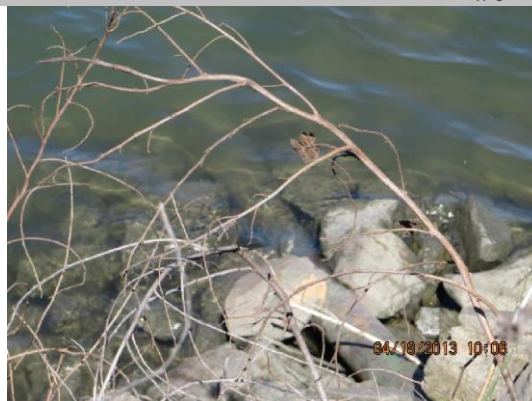
Photo 3 of 3 : UCIP_SP_2020_12183_19740.jpg

4-inch suction pipe on WS toe.

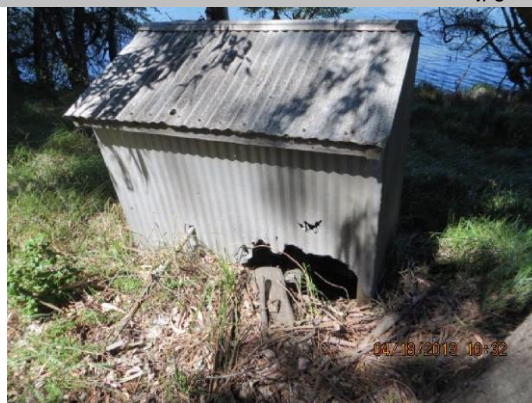
Photo 1 of 3 : UCIP_SP_2020_12185_19751.jpg

Comment Code					
Inspector Comment					
DS_ID:21872 FS_ID:12185 EP_NO: 11294 Repair Type: Non-Urgent Crossing Status: Found UCIP Comments: Pipe abandoned on both sides. Pipe should be abandoned properly. FIELD_STRUCT_DESC: 6-inch irrigation pipe of an unknown material through the levee, 6.5 feet below the crown. Pump in pump house on the waterside (WS) slope. 1-inch galvanized iron steel electrical conduit at same location. (Automatic Board Order (ABO) issued as Permit No. 11294, 1975 - Hubert Vandermaele). [Additional Reference(s): DWR Levee Log, 2005. USACE Sacramento O&M Manual 103, June 1954, (Station ""H"" 8+72) steel pipe listed, Drawing No. 50-4-2277]. FS Date: 4/18/2013

Pumphouse on WS slope.

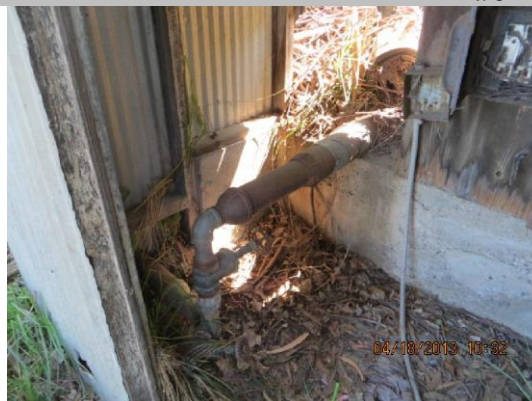
Photo 2 of 3 : UCIP_SP_2020_12185_19750.jpg

Pipe and shutoff valve at pump house on WS slope.
