**Flood Control Project Maintenance
Levee Inspections**
LMA District Cover Sheet
Spring 2020 Levee Inspection Results

Brannan Andrus Levee Maintenance District

Spring 2020 Levee Inspection Results

Waterway			Bank	Unit Miles
Unit No. 01 Georgiana Slough			Right	6.01
	Spring (March - May)	Summer (June - August)	(September - November) Fall	Winter (December - February)
Unit Maintenance Rating (Fall Only)				
Date of Inspection	4/2/2020 - 4/2/2020			
DWR Inspector	David Julian			
Accompanied By

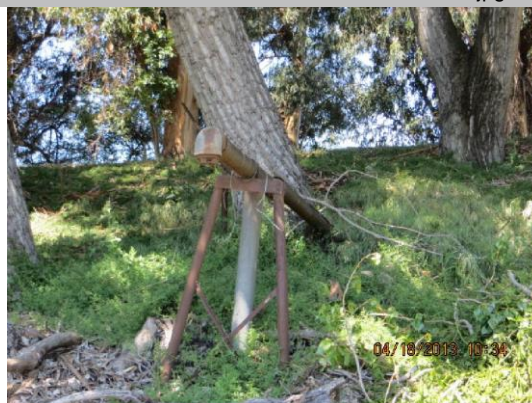
Photo 3 of 3 : UCIP_SP_2020_12185_19749.jpg

Pipe at LS slope (open).

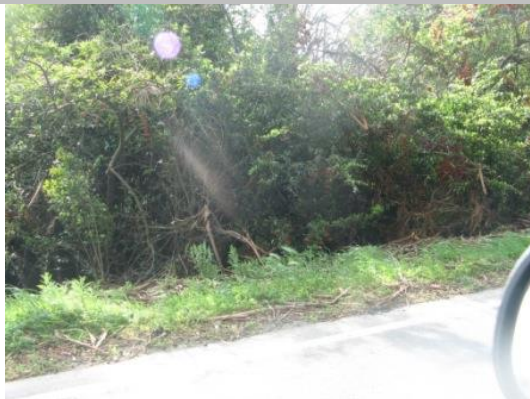
Photo 2 of 2 : SP_2020_NA0002_63_12_20200304_00008.jpg

LM Start	1.91	Rating **	U	Issue No.	12
LM End	1.94	Issue Type +	En	Location *	LS
Category	Earthen Levee			GPS Latitude/Longitude	
				Start	End
Item	Vegetation			38.173030 °	38.172598 °
				-121.591624 °	-121.591853 °
DWR ID	DWR_NA0002_02_s_2012_12				
Comment Code					
V6 : Landscaping					
Inspector Comment					
Dense landscaping vegetation is on the landside slope.

Landscaping on landside slope blocking view of slope.

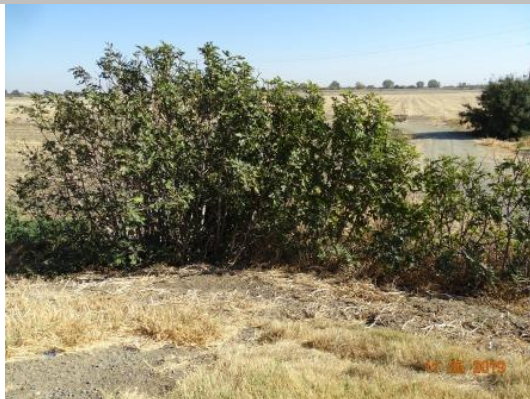
Photo 1 of 1 : SP_2020_NA0002_63_120_20200304_00073.jpg

LM Start	2.16	Rating **	M	Issue No.	120
LM End	2.16	Issue Type +	Ma	Location *	LS
Category	Earthen Levee			GPS Latitude/Longitude	
				Start	End
Item	Trim / Thin Trees			38.169853 °	38.169853 °
				-121.593828 °	-121.593828 °
DWR ID	DWR_NA0002_02_f_2016_120				
Comment Code					
T2 : Thin trees to allow visibility of the ground and room to flood fight.					
Inspector Comment					
Fig tree on the landside slope.

View of young fig tree on the landside slope (Fall 2019).

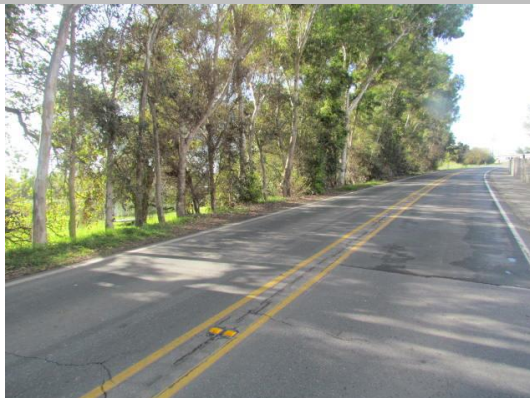
Photo 1 of 1 : SP_2020_NA0002_63_25_20200304_00011.jpg

LM Start	2.34	Rating **	M	Issue No.	25
LM End	2.38	Issue Type +	Ma	Location *	LS
Category	Earthen Levee			GPS Latitude/Longitude	
				Start	End
Item	Trim / Thin Trees			38.167627 °	38.167152 °
				-121.595538 °	-121.595997 °
DWR ID	DWR_NA0002_02_s_2012_25				
Comment Code					
T2 : Thin trees to allow visibility of the ground and room to flood fight.					
Inspector Comment

Looking southeast at trees at landward shoulder. (Spring 2015)

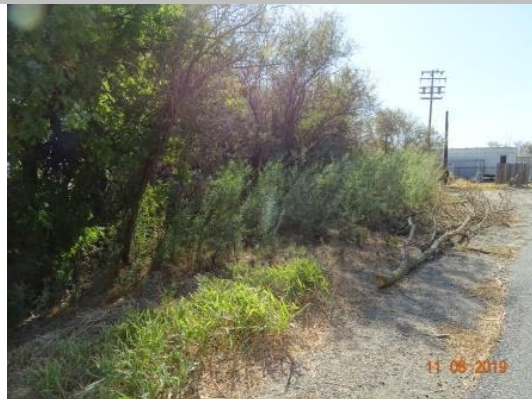
Photo 1 of 1 : SP_2020_NA0002_63_131_20200304_00076.jpg

LM Start	2.42	Rating **	M	Issue No.	131
LM End	2.42	Issue Type +	Ma	Location *	LS
Category	Earthen Levee			GPS Latitude/Longitude	
				Start	End
Item	Encroachments			38.166805 °	38.166805 °
				-121.596508 °	-121.596508 °
DWR ID	DWR_NA0002_02_f _ 2019_131				
Comment Code					
TR : Tree or limb					
Inspector Comment					
Tree limb on the landside shoulder.

View of tree limb on landside shoulder (Fall 2019).

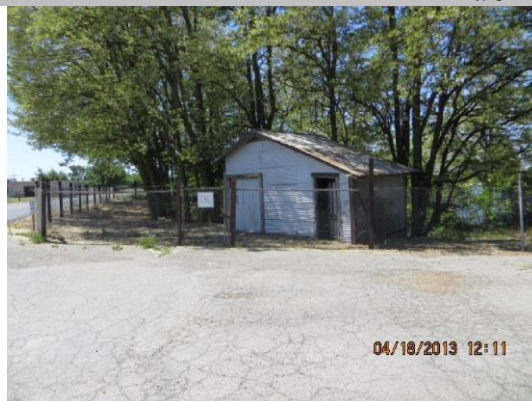
Photo 1 of 3 : UCIP_SP_2020_12211_19770.jpg

Comment Code					
Inspector Comment					
DS_ID:21878 FS_ID:12211 EP_NO: 11263 Repair Type: Non-Urgent Crossing Status: Indicator Found UCIP Comments: Further investigation to determine location of pipe should be done. Pumphouse needs to be unlocked to gather additional information. FIELD_STRUCT_DESC: 8-inch irrigation pipe of an unknown material through the levee, 3.7 feet below the crown. Pump in pump house on the waterside (WS) berm. 30-inch concrete standpipe on the landside (LS). (Automatic Board Order (ABO) issued as Permit No. 11263, 1975 - Ensher, Alexander, and Barsoon, Inc.). [Additional Reference(s): DWR Levee Log, 2005. USACE Sacramento O&M Manual 103, June 1954, (RM 18.25) welded steel pipe listed, Drawing No. 6-13-1100]. FS Date: 4/18/2013

Possible pumphouse on WS shoulder.

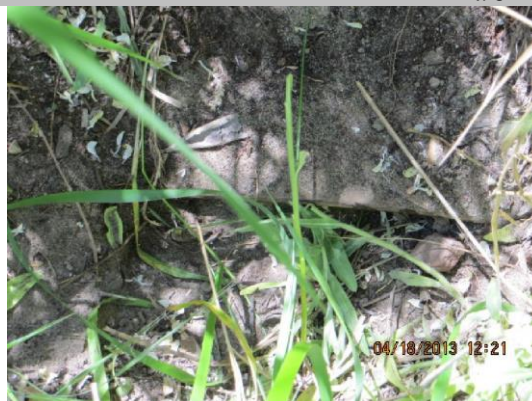
Photo 2 of 3 : UCIP_SP_2020_12211_19769.jpg

Evidence of pipe (buried) on LS in ditch.

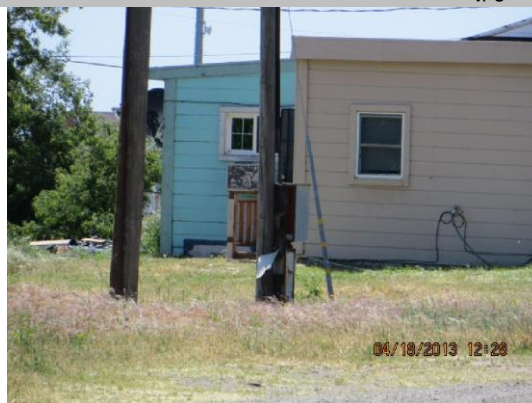
Photo 3 of 3 : UCIP_SP_2020_12211_19768.jpg

JP with a meter on pole that would be appropriate for this crossing.

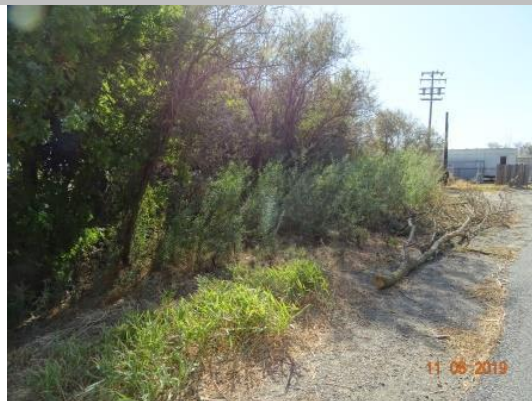
Photo 1 of 1 : SP_2020_NA0002_63_99_20200304_00058.jpg

LM Start	2.42	Rating **	M	Issue No.	99
LM End	2.42	Issue Type +	Ma	Location *	LS
Category	Earthen Levee			GPS Latitude/Longitude	
				Start	End
Item	Vegetation			38.166772 °	38.166772 °
				-121.596667 °	-121.596667 °
DWR ID	DWR_NA0002_02_s_2014_99				
Comment Code					
V2 : Remove the wild growth other than native grasses from the levee slopes.					
Inspector Comment					
Dense willows on the landside slope.

View looking downstream at vegetation on the landside slope (Fall 2019).

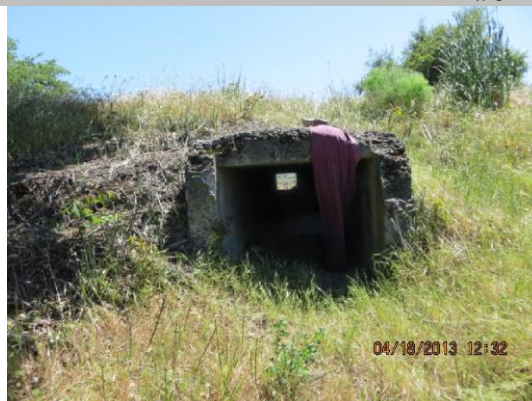
Photo 1 of 3 : UCIP_SP_2020_53389_19773.jpg

Comment Code						
Inspector Comment						
DS_ID:21879						
FS_ID:53389						
EP_NO: N/A						
Repair Type: Non-Urgent						
Crossing Status: Found						
UCIP Comments: 07/12/2018 Tunnel is open on both sides. No integrity issue observed, therefore crossing downgraded to "Non-Urgent". (O.Yakimov-DWR UCIP)10/24/2016 same as previous inspection culvert is open on both ends. WS blocked by blankets -- WS structure is being used as a shelter. (O. Magana - DWR UCIP)04/18/2013 Culvert open on both ends. Needs to be abandoned properly. (W. Wylie - DWR UCIP)						
FIELD_STRUCT_DESC: *ABANDONED* 42-inch by 42-inch open reinforced concrete drainage culvert through the levee, 6 feet below the crown. [Additional Reference(s): DWR Levee Log, 2005, 3-foot by 3.5-foot culvert listed. USACE Sacramento O&M Manual 103, June 1954, (RM 18.16) Drawing No. 6-13-1100].						
FS Date: 7/12/2018 2:59:33 PM

Concrete tunnel open on both ends.

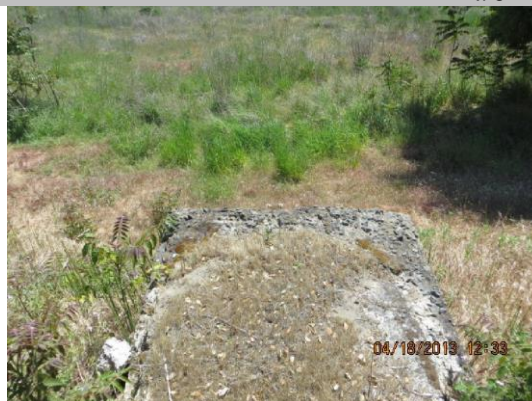
Photo 2 of 3 : UCIP_SP_2020_53389_19772.jpg

Top of concrete tunnel on LS shoulder.

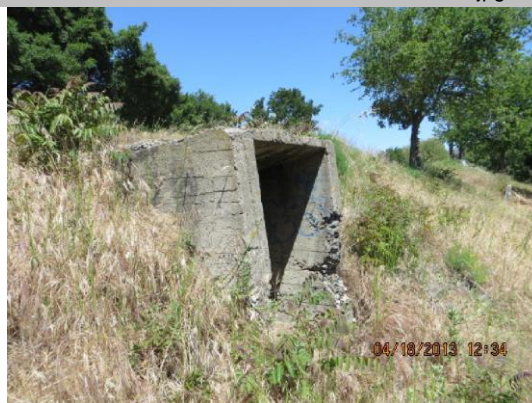
Photo 3 of 3 : UCIP_SP_2020_53389_19771.jpg

Concrete tunnel on LS shoulder.

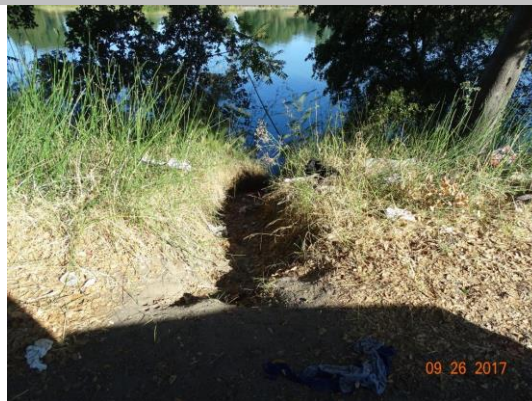
Photo 1 of 1 : SP_2020_NA0002_63_82_20200304_00047.jpg

LM Start	2.56	Rating **	M	Issue No.	82
LM End	2.56	Issue Type +	Ma	Location *	WS
Category	Earthen Levee			GPS Latitude/Longitude	
				Start	End
Item	Slope Stability			38.165898 °	38.165898 °
				-121.598888 °	-121.598888 °
DWR ID	DWR_NA0002_02_f_2017_82				
Comment Code					
S2 : Repair the levee slope damaged by foot traffic and prevent access where possible.					
Inspector Comment					
There is a footpath digging into the levee slope.

Looking northwest at the waterside slope.

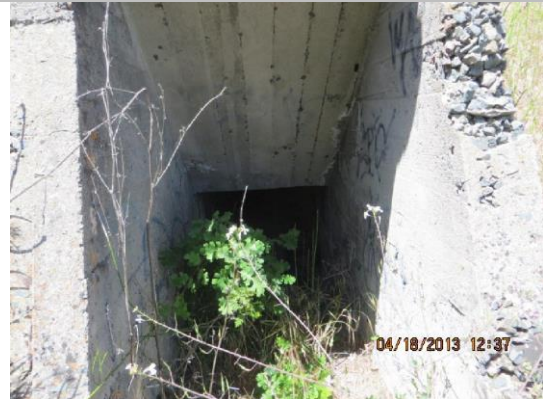
Photo 1 of 3 : UCIP_SP_2020_53513_19776.jpg

Comment Code						
Inspector Comment						
DS_ID:21880 FS_ID:53513 EP_NO: N/A Repair Type: Non-Urgent Crossing Status: Found UCIP Comments: 07/12/2018 Tunnel is open on both sides. No integrity issue observed, therefore crossing downgraded to "Non-Urgent". (O.Yakimov-DWR UCIP)10/24/2016 same as previous inspection concrete box culvert will need to be abandoned properly. (O. Magana - DWR UCIP)04/18/2013 tunnel should be abandoned properly. (W. Wylie - DWR UCIP) FIELD_STRUCT_DESC: *ABANDONED* 48-inch by 48-inch reinforced concrete drainage culvert through the levee, 6.5-inches below the crown. [Additional Reference(s): DWR Levee Log, 2005. USACE Sacramento O&M Manual 103, June 1954, (RM 18.13) 3-foot by 3-foot concrete box listed, Drawing No. 6-13-1100]. FS Date: 7/12/2018 9:05:37 AM

Tunnel open on LS shoulder.

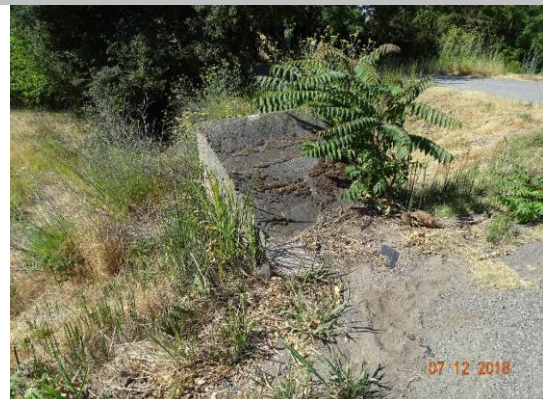
Photo 2 of 3 : UCIP_SP_2020_53513_77578.jpg

Concrete tunnel on LS shoulder.

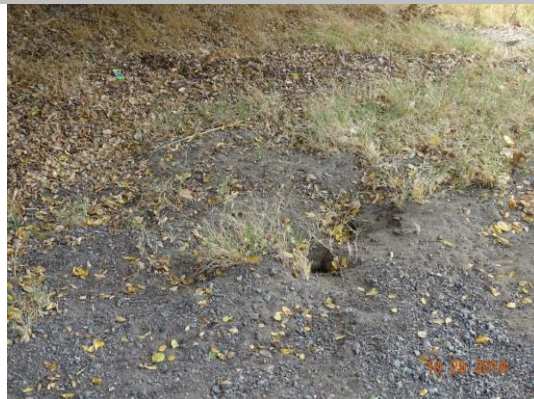
Photo 1 of 2 : SP_2020_NA0002_63_172_20200304_00092.jpg

LM Start	2.62	Rating **	M	Issue No.	172
LM End	2.67	Issue Type +	Ma	Location *	LS
Category	Earthen Levee			GPS Latitude/Longitude	
				Start	End
Item	Animal Control			38.165421 °	38.165028 °
				-121.599809 °	-121.600581 °
DWR ID	DWR_NA0002_02_f_2018_172				
Comment Code					
A1 : Exterminate rodents and backfill and compact or grout burrows.					
Inspector Comment					
There are multiple squirrel holes with material excavated around the holes. Saw two squirrels in the area.

View of animal hole on the landside slope (October 2018)

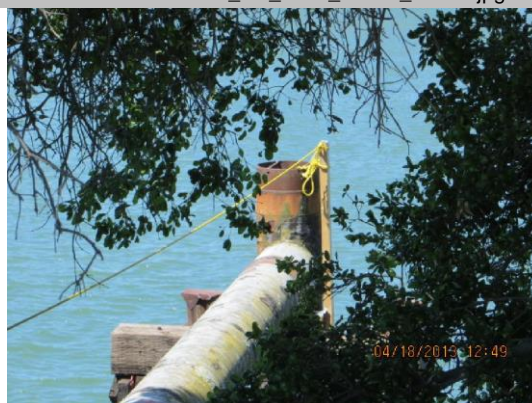
Photo 2 of 3 : UCIP_SP_2020_12214_19777.jpg

Pipe on pier at WS.

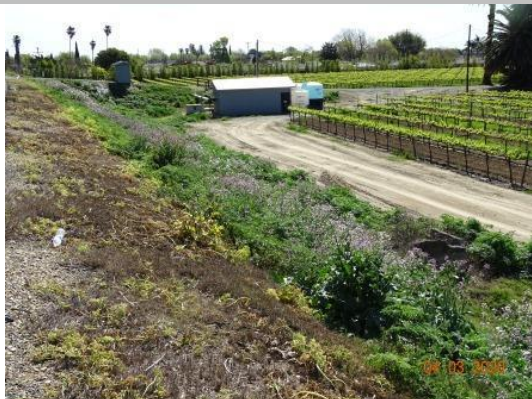
Photo 1 of 1 : SP_2020_NA0002_63_114_20200406_00188.jpg

LM Start	3.11	Rating **	U	Issue No.	114
LM End	6.07	Issue Type +	Ma	Location *	LS
Category	Earthen Levee			GPS Latitude/Longitude	
				Start	End
Item	Vegetation			38.162699 °	38.174663 °
				-121.607956 °	-121.658722 °
DWR ID	DWR_NA0002_02_s_2020_114				
Comment Code					
V1 : Control annual grass and weeds on the levee slopes and easements.					
Inspector Comment

View looking upstream at annual vegetation on the landside slope (Spring 2020).

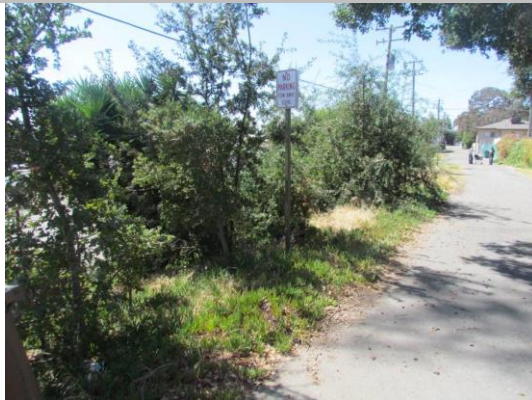
Photo 1 of 1 : SP_2020_NA0002_63_7_20200304_00002.jpg

LM Start	3.22	Rating **	U	Issue No.	7
LM End	3.22	Issue Type +	En	Location *	LS
Category	Earthen Levee			GPS Latitude/Longitude	
				Start	End
Item	Vegetation			38.162609 °	38.162609 °
				-121.609979 °	-121.609979 °
DWR ID	DWR_NA0002_02_f_2019_7				
Comment Code					
V6 : Landscaping					
Inspector Comment

Looking south at overgrown landscaping on landward slope. (Fall 2016)

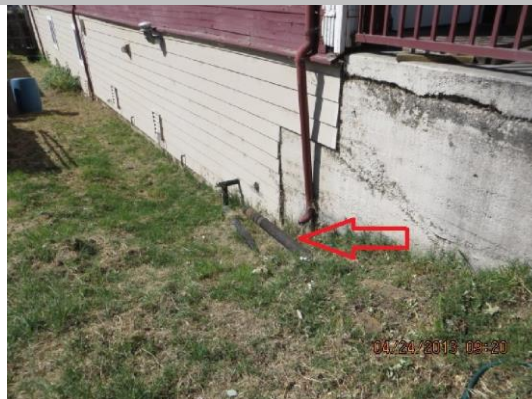
Photo 1 of 2 : UCIP_SP_2020_15966_26949.jpg

LM Start	3.29	Rating **	M	Issue No.	188
LM End	3.29	Issue Type +	En	Location *	
Category	Supplemental			GPS Latitude/Longitude	
				Start	End
Item	DWR UCIP Field Study			38.162430 °	38.162430 °
				-121.611248 °	-121.611248 °
DWR ID	23135				
Comment Code					
Inspector Comment					
DS_ID:23135 FS_ID:15966 EP_NO: N/A Repair Type: Non-Urgent Crossing Status: Found UCIP Comments: Need to determine disposition and use of pipe. FIELD_STRUCT_DESC: 4-inch cast iron drainage pipe through the levee, 8 feet below the crown. Pipe visible next to foundation on the landside (LS) toe. FS Date: 4/24/2013

Pipe visible next to foundation on LS slope.

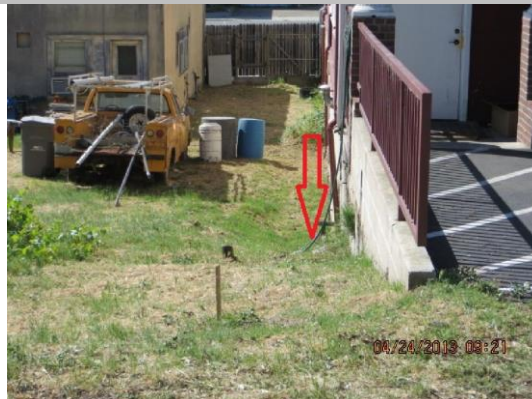
Photo 2 of 2 : UCIP_SP_2020_15966_26948.jpg

Pipe visible next to foundation on LS slope.

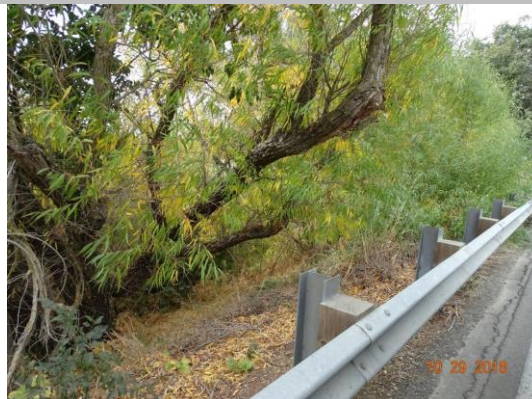
Photo 1 of 1 : SP_2020_NA0002_63_171_20200304_00091.jpg

LM Start	3.53	Rating **	M	Issue No.	171
LM End	3.56	Issue Type +	Ma	Location *	LS
Category	Earthen Levee			GPS Latitude/Longitude	
				Start	End
Item	Vegetation			38.162600 °	38.162658 °
				-121.615664 °	-121.616295 °
DWR ID	DWR_NA0002_02_f_2018_171				
Comment Code					
V2 : Remove the wild growth other than native grasses from the levee slopes.					
Inspector Comment

View looking upstream at thick vegetation on the landside slope (October 2018).

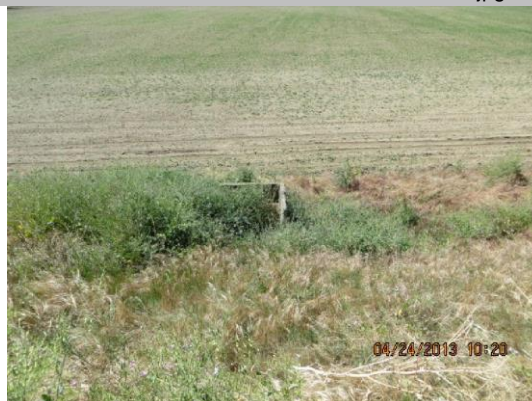
Photo 1 of 2 : UCIP_SP_2020_12748_20692.jpg

LM Start	3.70	Rating **	M	Issue No.	192
LM End	3.70	Issue Type +	En	Location *	
Category	Supplemental			GPS Latitude/Longitude	
				Start	End
Item	DWR UCIP Field Study			38.163048 °	38.163048 °
				-121.618839 °	-121.618839 °
DWR ID	21895				
Comment Code					
Inspector Comment					
DS_ID:21895 FS_ID:12748 EP_NO: 1615 Repair Type: Non-Urgent Crossing Status: Found UCIP Comments: Pipe abandoned and should be abandoned properly. FIELD_STRUCT_DESC: 8-inch irrigation pipe of an unknown material through the levee, 7.7 feet below the crown. 6-foot by 6-foot concrete distribution box on the LS toe. (Permit No. 1615, 1951 - Jones and Miller). [Additional Reference(s): DWR Levee Log, 2005. USACE Sacramento O&M Manual 102, April 1959, (RM 17.0) (Reclamation District No. 2067) steel pipe listed]. FS Date: 4/24/2013

Concrete distribution box on LS toe.

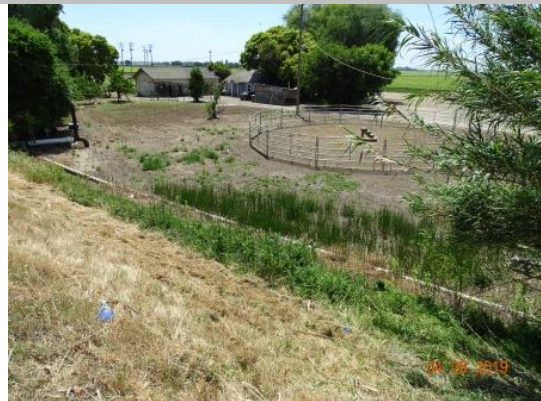
Photo 1 of 1 : SP_2020_NA0002_63_108_20200304_00064.jpg

View of irrigation pipe at landside toe (Spring 2019).

LM Start	3.92	Rating **	M	Issue No.	108
LM End	3.92	Issue Type +	En	Location *	LS
Category	Earthen Levee			GPS Latitude/Longitude	
				Start	End
Item	Encroachments			38.164020 °	38.164020 °
				-121.622641 °	-121.622641 °
DWR ID	DWR_NA0002_02_s_2019_108				
Comment Code					
LI : Landscape Irrigation					
Inspector Comment					
Move irrigation pipe 10 feet away from landside toe.

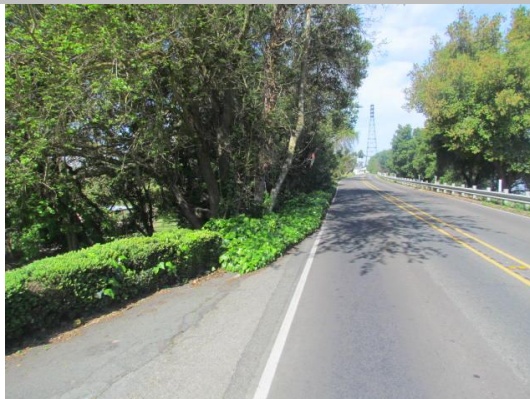
Photo 1 of 1 : SP_2020_NA0002_63_59_20200304_00027.jpg

LM Start	4.06	Rating **	U	Issue No.	59
LM End	4.13	Issue Type +	En	Location *	LS
Category	Earthen Levee			GPS Latitude/Longitude	
				Start	End
Item	Vegetation			38.164728 °	38.165167 °
				-121.624949 °	-121.626273 °
DWR ID	DWR_NA0002_02_s_ 2012_59				
Comment Code					
V6 : Landscaping					
Inspector Comment

Looking west at dense landscaping on landward slope.

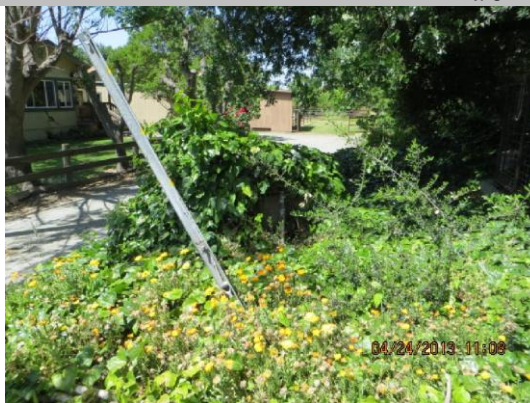
Photo 1 of 3 : UCIP_SP_2020_12768_20731.jpg

LM Start	4.11	Rating **	M	Issue No.	195
LM End	4.11	Issue Type +	En	Location *	
Category	Supplemental			GPS Latitude/Longitude	
				Start	End
Item	DWR UCIP Field Study			38.165016 °	38.165016 °
				-121.625834 °	-121.625834 °
DWR ID	21904				
Comment Code					
Inspector Comment					
DS_ID:21904 FS_ID:12768 EP_NO: 787 Repair Type: Non-Urgent Crossing Status: Found UCIP Comments: Pipe may be abandoned and should be done so properly if not being used. Good candidate for video inspection. FIELD_STRUCT_DESC: 2 of 2: 14-inch steel irrigation pipe through the levee, 4.2 feet below the crown. Pump on pile structure in stream. (Permit No. 787, 1939 - J. E. Silva, et al.). [Additional Reference(s): DWR Levee Log, 2005. USACE Sacramento O&M Manual 102, April 1959, (RM 16.6) (Reclamation District No. 2067)]. FS Date: 4/24/2013

Concrete distribution box at LS toe.

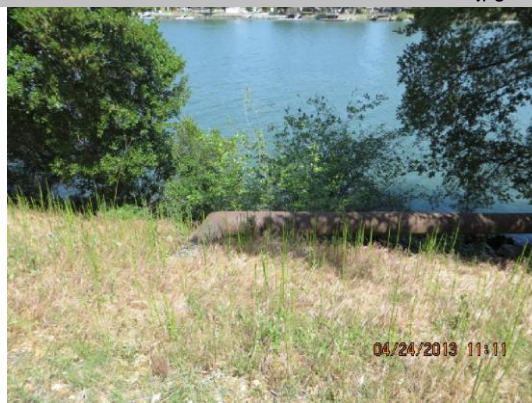
Photo 3 of 3 : UCIP_SP_2020_12768_20729.jpg

Pipe on WS slope.

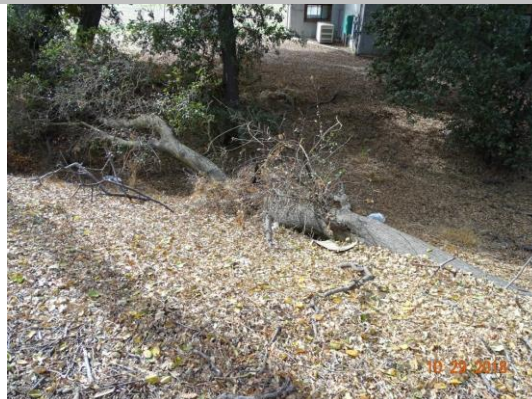
Photo 1 of 1 : SP_2020_NA0002_63_169_20200304_00090.jpg

View of downed tree on landside slope (October 2018).

LM Start	4.29	Rating **	M	Issue No.	169
LM End	4.29	Issue Type +	En	Location *	LS
Category	Earthen Levee			GPS Latitude/Longitude	
				Start	End
Item	Encroachments			38.166258 °	38.166258 °
				-121.628717 °	-121.628717 °
DWR ID	DWR_NA0002_02_f _ 2018_169				
Comment Code					
TR : Tree or limb					
Inspector Comment					
Remove the downed tree from the landside slope.

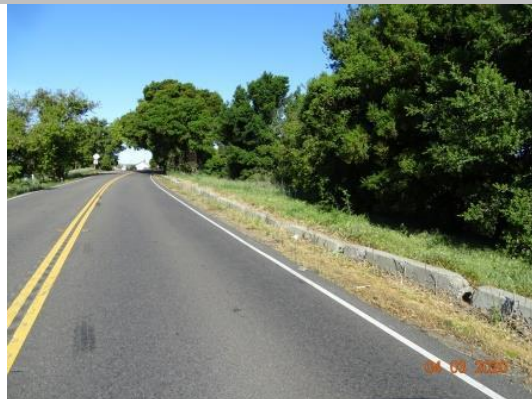
Photo 1 of 1 : SP_2020_NA0002_63_80_20200406_00183.jpg

LM Start	4.43	Rating **	A/W	Issue No.	80
LM End	4.47	Issue Type +	En	Location *	WS
Category	Earthen Levee			GPS Latitude/Longitude	
				Start	End
Item	Encroachments			38.167094 °	38.167171 °
				-121.631101 °	-121.631693 °
DWR ID	DWR_NA0002_02_s_ 2020_80				
Comment Code					
DE : Debris					
Inspector Comment					
Concrete blocks placed to deter parking on waterside of crown.

View looking downstream concrete blocks used to block parking on the waterside slope (Spring 2020).

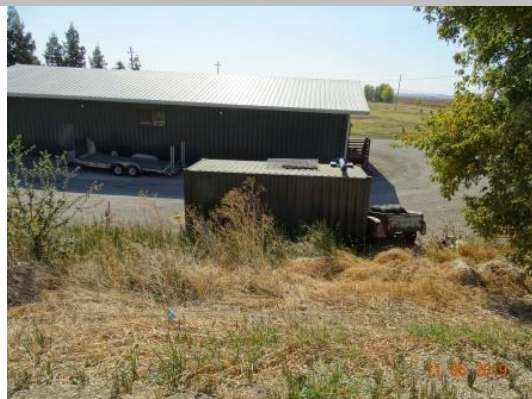
Photo 1 of 1 : SP_2020_NA0002_63_88_20200304_00051.jpg

LM Start	4.46	Rating **	U	Issue No.	88
LM End	4.46	Issue Type +	En	Location *	LS
Category	Earthen Levee			GPS Latitude/Longitude	
				Start	End
Item	Encroachments			38.167132 °	38.167132 °
				-121.631592 °	-121.631592 °
DWR ID	DWR_NA0002_02_f_ 2019_88				
Comment Code					
BU : Building					
Inspector Comment					
Storage container at landside toe

View of storage container at the landside toe (Fall 2019).

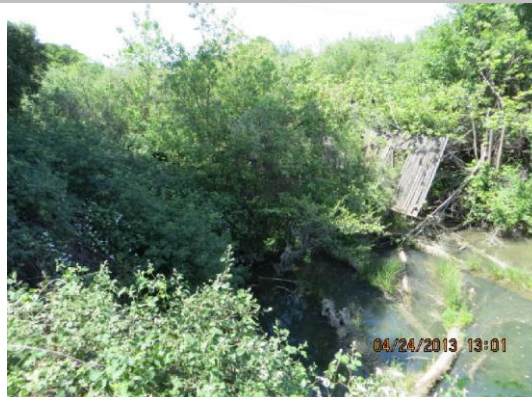
Photo 1 of 3 : UCIP_SP_2020_16010_27085.jpg

Comment Code						
Inspector Comment						
DS_ID:21907 FS_ID:16010 EP_NO: 11274 Repair Type: Non-Urgent Crossing Status: Found UCIP Comments: Pipe abandoned and should be abandoned properly if not already done so. FIELD_STRUCT_DESC: *ABANDONED* 2 of 2: 10-inch irrigation pipe of an unknown material through the levee, 6.6 feet below the crown. Pump in pump house on the landside (LS) slope. Pump house not visible, 4/24/2013. (Automatic Board Order (ABO) issued as Permit No. 11274, 1975 - Henry Martin). [Additional Reference(s): DWR Levee Log, 2005. USACE Sacramento O&M Manual 102, April 1959, (RM 16.2) (Reclamation District No. 2067) steel pipe listed]. FS Date: 4/24/2013

Possible portion of pumphouse visible off WS toe.

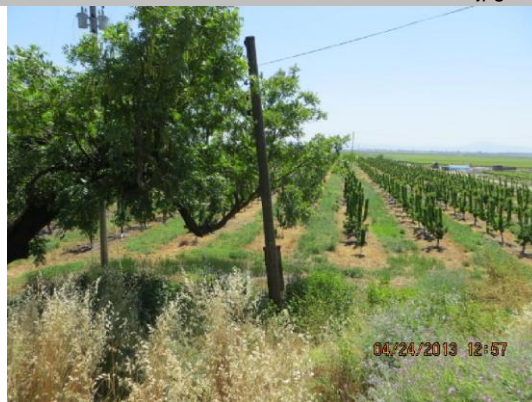
Photo 2 of 3 : UCIP_SP_2020_16010_27087.jpg

JP and meter on LS slope at location of abandoned pipe.

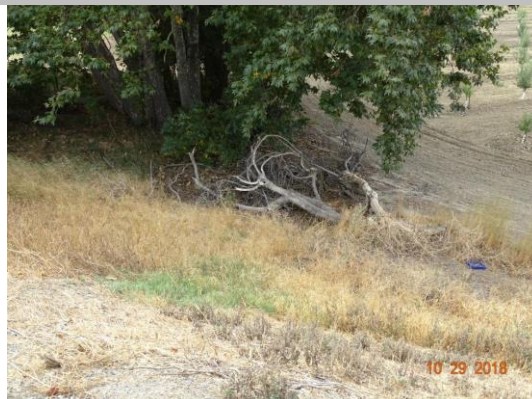
Photo 1 of 1 : SP_2020_NA0002_63_165_20200304_00088.jpg

View of downed tree limbs on the landside toe (October 2018).

LM Start	4.73	Rating **	M	Issue No.	165
LM End	4.73	Issue Type +	Ma	Location *	LS
Category	Earthen Levee			GPS Latitude/Longitude	
				Start	End
Item	Encroachments			38.168435 °	38.168435 °
				-121.636172 °	-121.636172 °
DWR ID	DWR_NA0002_02_f _ 2018_165				
Comment Code					
TR : Tree or limb					
Inspector Comment					
Remove the fallen tree limb from the landside toe.

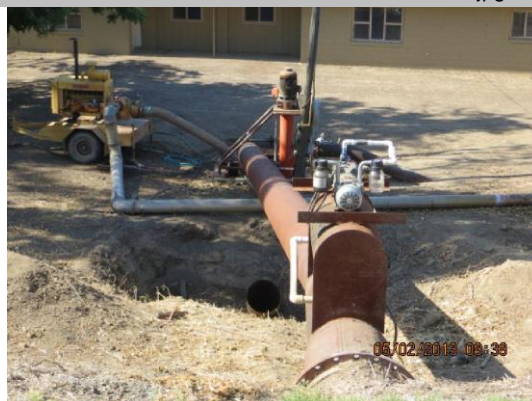
Photo 1 of 3 : UCIP_SP_2020_12773_20740.jpg

Comment Code					
Inspector Comment					
DS_ID:21908 FS_ID:12773 EP_NO: 11285 Repair Type: Non-Urgent Crossing Status: Found UCIP Comments: Pit under pipe on WS shoulder - possible leak. Excavation of pipe on LS slope into levee prism. FIELD_STRUCT_DESC: 20-inch irrigation pipe of an unknown material, sleeved through a 22-inch, sleeved through a 24-inch pipe, through the levee, 3 feet below the crown. Pump on the landside (LS). Small pump on the LS shoulder and a 7-foot by 9-foot concrete sump on the LS toe. (Automatic Board Order (ABO) issued as Permit No. 11285, 1975 - Manuel Silva). [Additional Reference(s): DWR Levee Log, 2005. USACE Sacramento O&M Manual 102, April 1959, (RM 15.9) (Reclamation District No. 2067) steel pipe listed]. FS Date: 5/2/2013

Small pump on LS shoulder with concrete distribution box on LS toe.

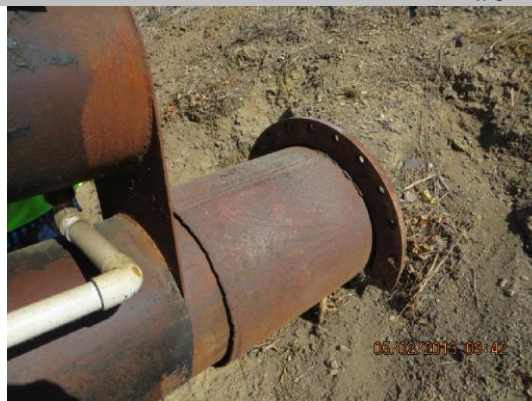
Photo 2 of 3 : UCIP_SP_2020_12773_20739.jpg

20-inch pipe sleeved through 22-inch pipe sleeved through a 24-inch steel pipe.

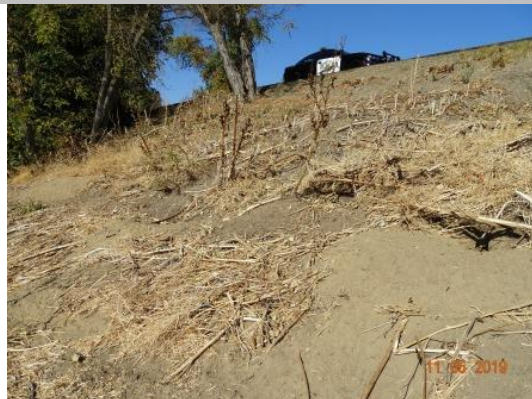
Photo 1 of 1 : SP_2020_NA0002_63_128_20200304_00075.jpg

LM Start	4.81	Rating **	U	Issue No.	128
LM End	4.99	Issue Type +	Ma	Location *	LS
Category	Earthen Levee			GPS Latitude/Longitude	
				Start	End
Item	Animal Control			38.168831 °	38.169583 °
				-121.637619 °	-121.640698 °
DWR ID	DWR_NA0002_02_f_2019_128				
Comment Code					
A1 : Exterminate rodents and backfill and compact or grout burrows.					
Inspector Comment					
Multiple large squirrel holes.

View of multiple large squirrel holes in landside slope (Fall 2019).

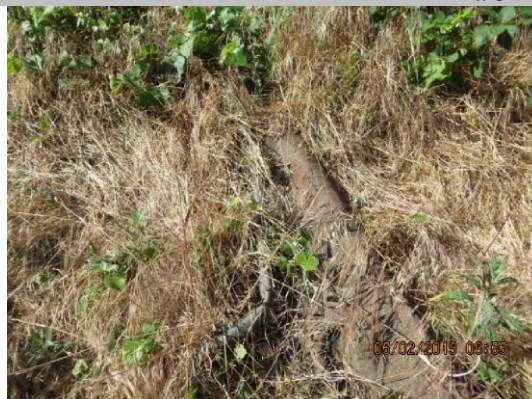
Photo 2 of 3 : UCIP_SP_2020_12774_20744.jpg

deformed and crushed pipe with 1.5-inch electrical conduit on WS slope.

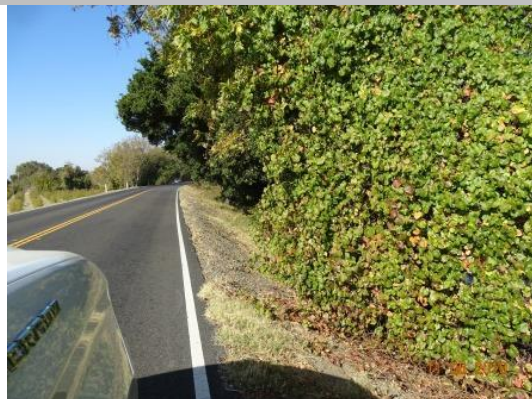
Photo 1 of 1 : SP_2020_NA0002_63_62_20200304_00029.jpg

LM Start	4.95	Rating **	U	Issue No.	62
LM End	4.95	Issue Type +	Ma	Location *	WS
Category	Earthen Levee			GPS Latitude/Longitude	
				Start	End
Item	Vegetation			38.169410 °	38.169410 °
				-121.640013 °	-121.640013 °
DWR ID	DWR_NA0002_02_f _ 2019_62				
Comment Code					
V2 : Remove the wild growth other than native grasses from the levee slopes.					
Inspector Comment					
Wild grapes encroaching close to road.

View looking downstream at wild grapes on the waterside slope encroaching onto slope (Fall 2019).

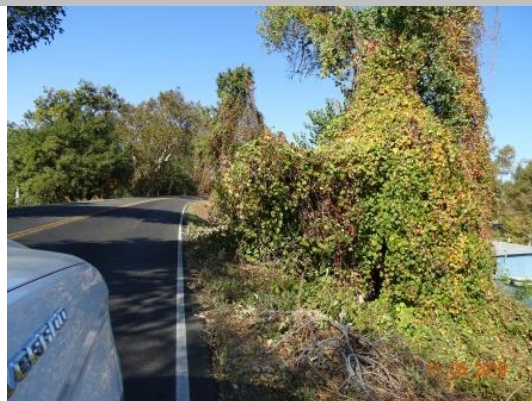
Photo 1 of 1 : SP_2020_NA0002_63_65_20200304_00031.jpg

LM Start	5.01	Rating **	U	Issue No.	65
LM End	5.01	Issue Type +	Ma	Location *	WS
Category	Earthen Levee			GPS Latitude/Longitude	
				Start	End
Item	Vegetation			38.169793 °	38.169793 °
				-121.641003 °	-121.641003 °
DWR ID	DWR_NA0002_02_f_2019_65				
Comment Code					
V2 : Remove the wild growth other than native grasses from the levee slopes.					
Inspector Comment					
Wild grapes encroaching close to roadway.

View looking downstream at wild grapes on the waterside slope encroaching onto slope (Fall 2019).

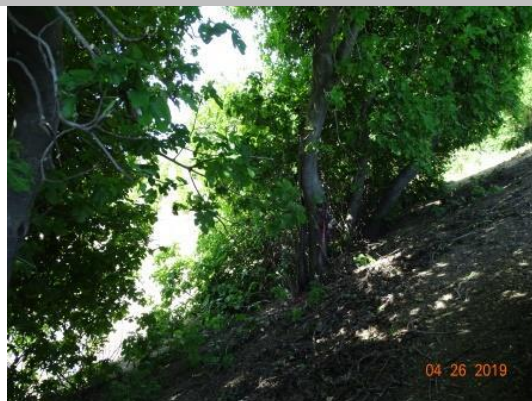
Photo 1 of 1 : SP_2020_NA0002_63_163_20200304_00087.jpg

View looking downstream at fig tree on the landside slope (Spring 2019).

LM Start	5.01	Rating **	U	Issue No.	163
LM End	5.01	Issue Type +	Ma	Location *	LS
Category	Earthen Levee			GPS Latitude/Longitude	
				Start	End
Item	Trim / Thin Trees			38.169750 °	38.169750 °
				-121.641107 °	-121.641107 °
DWR ID	DWR_NA0002_02_f_2019_163				
Comment Code					
T2 : Thin trees to allow visibility of the ground and room to flood fight.					
Inspector Comment					
Trim the fig tree on the landside slope.

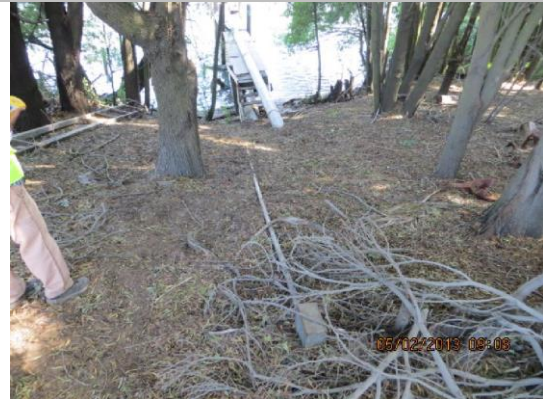
Photo 1 of 3 : UCIP_SP_2020_12776_20754.jpg

Pipe and electrical conduit on WS slope.

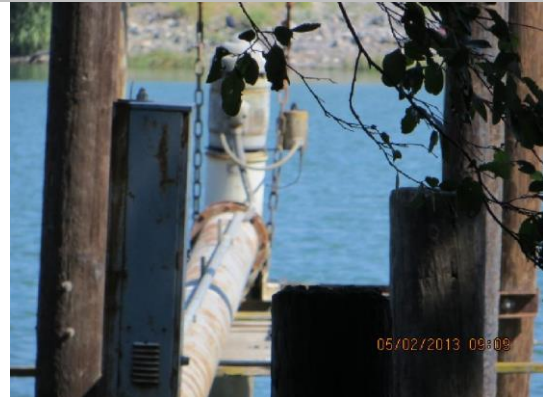
Photo 2 of 3 : UCIP_SP_2020_12776_20753.jpg

Pump on pier at WS toe.

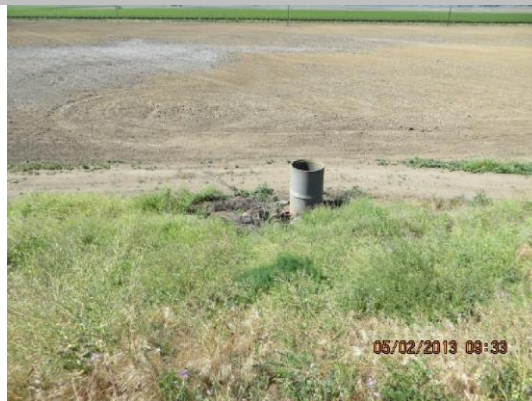
Photo 3 of 3 : UCIP_SP_2020_12778_20760.jpg

Concrete standpipe and pump on LS toe.

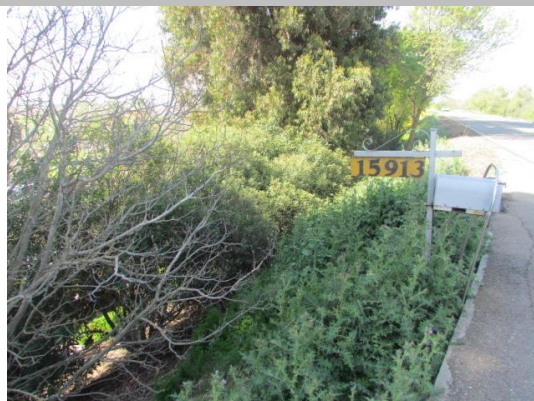
Photo 1 of 2 : SP_2020_NA0002_63_50_20200304_00020.jpg

Looking southwest at dense landscaping on landward slope.

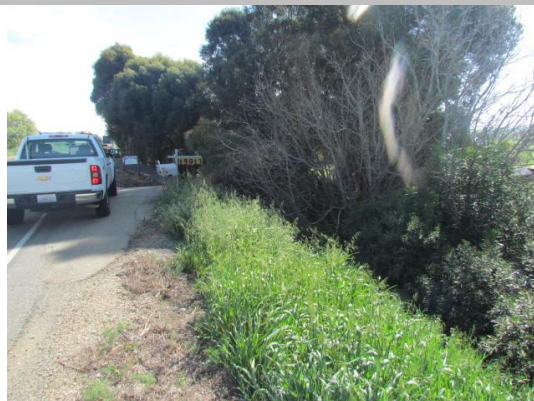
Photo 2 of 2 : SP_2020_NA0002_63_50_20200304_00021.jpg

Looking northeast at dense landscaping on landward slope.

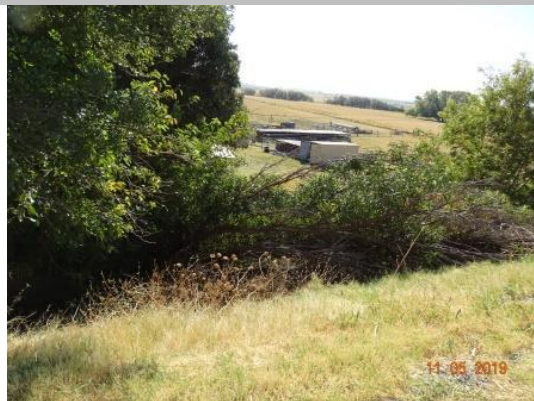
Photo 1 of 1 : SP_2020_NA0002_63_13_20200304_00009.jpg

LM Start	6.32	Rating **	U	Issue No.	13
LM End	6.32	Issue Type +	Ma	Location *	LS
Category	Earthen Levee			GPS Latitude/Longitude	
				Start	End
Item	Encroachments			38.173697 °	38.173697 °
				-121.663082 °	-121.663082 °
DWR ID	DWR_NA0002_02_s_2017_13				
Comment Code					
TR : Tree or limb					
Inspector Comment					
Fallen tree on the landside slope.

View of fallen tree on the landside slope (Fall 2019).

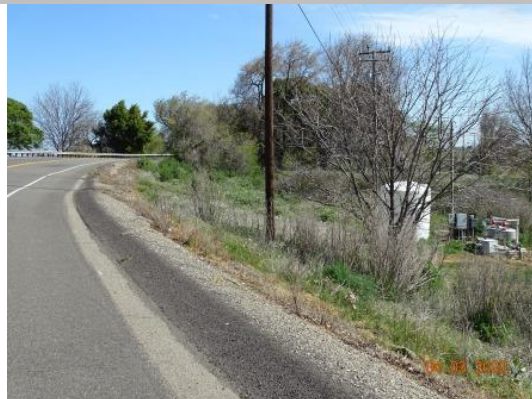
Photo 1 of 1 : SP_2020_NA0002_63_63_20200406_00187.jpg

View looking upstream at annual vegetation on the landside slope (Spring 2020).

LM Start	6.40	Rating **	U	Issue No.	63
LM End	7.60	Issue Type +	Ma	Location *	LS
Category	Earthen Levee			GPS Latitude/Longitude	
				Start	End
Item	Vegetation			38.173130 °	38.158535 °
				-121.664386 °	-121.675441 °
DWR ID	DWR_NA0002_02_s_2020_63				
Comment Code					
V1 : Control annual grass and weeds on the levee slopes and easements.					
Inspector Comment

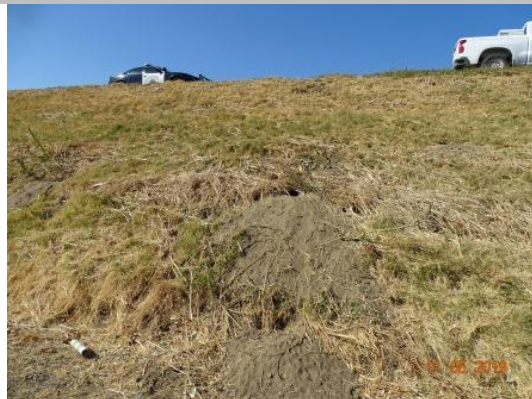
Photo 1 of 1 : SP_2020_NA0002_63_111_20200304_00066.jpg

LM Start	7.37	Rating **	U	Issue No.	111
LM End	7.37	Issue Type +	Ma	Location *	LS
Category	Earthen Levee			GPS Latitude/Longitude	
				Start	End
Item	Animal Control			38.161348 °	38.161348 °
				-121.673138 °	-121.673138 °
DWR ID	DWR_NA0002_02_f_2019_111				
Comment Code					
A1 : Exterminate rodents and backfill and compact or grout burrows.					
Inspector Comment					
Multiple large active squirrel holes.

View of multiple recent squirrel holes on the landside slope (Fall 2019).

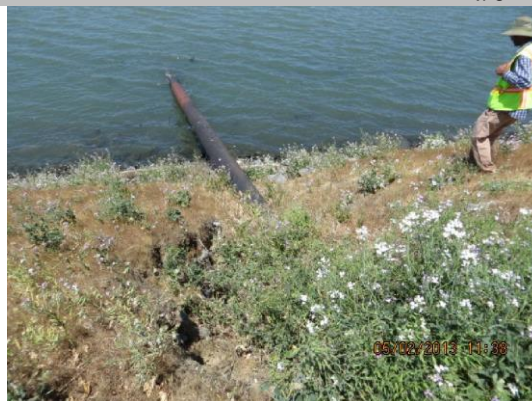
Photo 2 of 3 : UCIP_SP_2020_12814_20820.jpg

Comment Code						
Inspector Comment						
DS_ID:21918 FS_ID:12814 EP_NO: 11293 Repair Type: Non-Urgent Crossing Status: Found UCIP Comments: Erosion or sinkhole on WS shoulder. Does not appear to be an immediate threat. FIELD_STRUCT_DESC: 2 of 2: 16-inch irrigation pipe of an unknown material through the levee, 7.1 feet below the crown. Pump and service pole on the landside (LS) slope. 72-inch concrete standpipe at the landside (LS) toe. (Automatic Board Order (ABO) issued as Permit No. 11293, 1975 - John Wilcox). [Additional Reference(s): DWR Levee Log, 2005. USACE Sacramento O&M Manual 102, April 1959, (RM 13.0) (Reclamation District No. 2067) steel pipe listed]. FS Date: 5/2/2013

Pipe on WS slope.

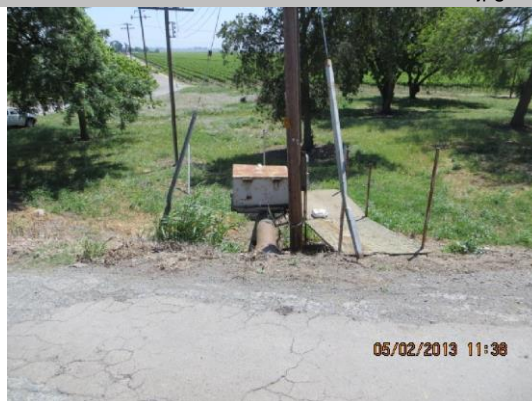
Photo 3 of 3 : UCIP_SP_2020_12814_20819.jpg

Pipe and pump on LS shoulder.

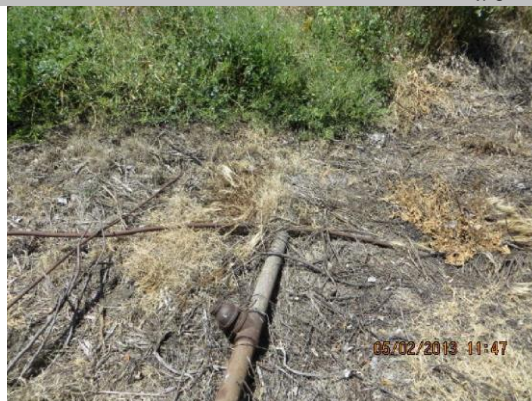
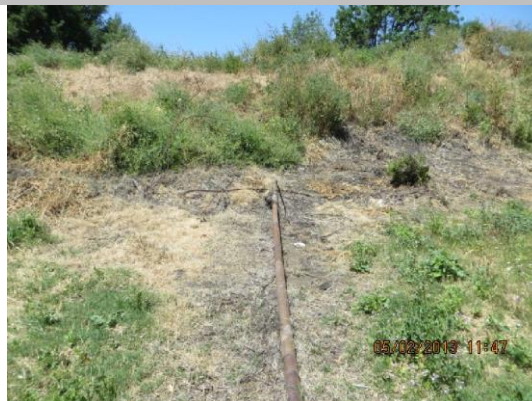
DS_ID:21920
FS_ID:12817
EP_NO: N/A
Repair Type: Non-Urgent
Crossing Status: Found
UCIP Comments: Pipe should be abandoned properly.
FIELD_STRUCT_DESC: 3-inch pipe of an unknown material or purpose through the levee, 7.7 feet below the crown. Inactive service pole on the landside (LS) slope. [Additional Reference(s): DWR Levee Log, 2005].
FS Date: 5/2/2013

3.5-inch galvanized iron pipe on LS slope.

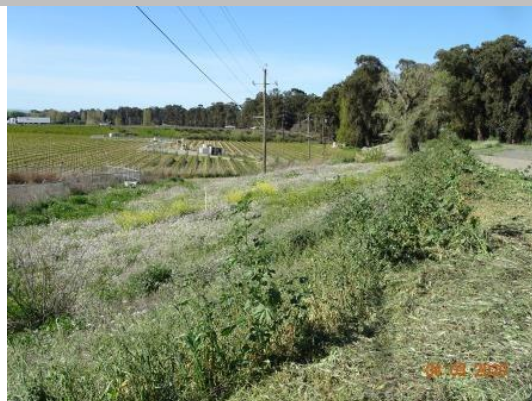
Photo 1 of 1 : SP_2020_NA0002_63_96_20200406_00185.jpg

LM Start	7.60	Rating **	U	Issue No.	96
LM End	7.84	Issue Type +	Ma	Location *	LS
Category	Earthen Levee			GPS Latitude/Longitude	
				Start	End
Item	Vegetation			38.158553 °	38.156605 °
				-121.675652 °	-121.679121 °
DWR ID	DWR_NA0002_02_s_2020_96				
Comment Code					
V1 : Control annual grass and weeds on the levee slopes and easements.					
Inspector Comment

View looking downstream at thick annual vegetation on the landside slope (Spring 2020).

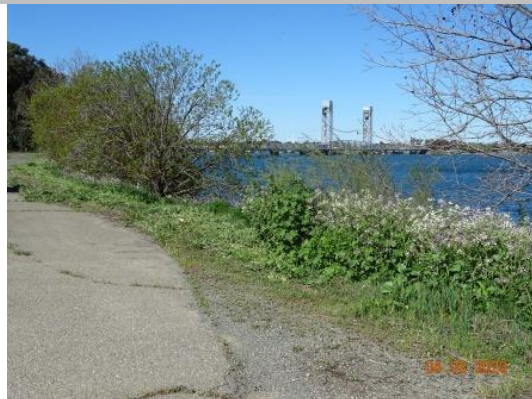
Photo 1 of 1 : SP_2020_NA0002_63_87_20200406_00184.jpg

LM Start	7.60	Rating **	U	Issue No.	87
LM End	7.84	Issue Type +	Ma	Location *	WS
Category	Earthen Levee			GPS Latitude/Longitude	
				Start	End
Item	Vegetation			38.158552 °	38.156605 °
				-121.675653 °	-121.679121 °
DWR ID	DWR_NA0002_02_s_2020_87				
Comment Code					
V1 : Control annual grass and weeds on the levee slopes and easements.					
Inspector Comment

View looking downstream at thick annual vegetation on the waterside slope (Spring 2020).

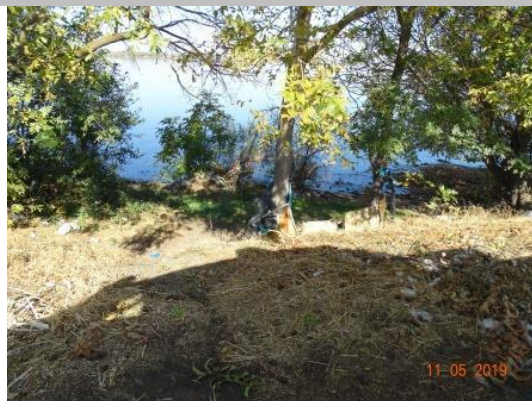
Photo 1 of 1 : SP_2020_NA0002_63_77_20200304_00042.jpg

LM Start	7.66	Rating **	M	Issue No.	77
LM End	7.66	Issue Type +	En	Location *	WS
Category	Earthen Levee			GPS Latitude/Longitude	
				Start	End
Item	Encroachments			38.158228 °	38.158228 °
				-121.676683 °	-121.676683 °
DWR ID	DWR_NA0002_02_f _ 2019_77				
Comment Code					
GA : Garbage					
Inspector Comment

View of camping gear on the waterside slope (Fall 2019).

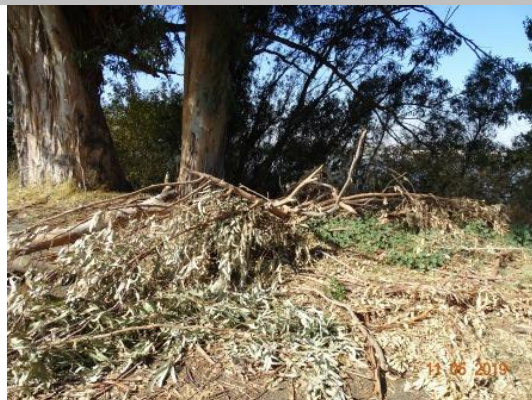
Photo 1 of 1 : SP_2020_NA0002_63_105_20200304_00061.jpg

LM Start	7.71	Rating **	U	Issue No.	105
LM End	7.71	Issue Type +	Ma	Location *	WS
Category	Earthen Levee			GPS Latitude/Longitude	
				Start	End
Item	Encroachments			38.157841 °	38.157841 °
				-121.677510 °	-121.677510 °
DWR ID	DWR_NA0002_02_s_2019_105				
Comment Code					
TR : Tree or limb					
Inspector Comment					
Tree limbs on the waterside shoulder.

View of down tree limbs on waterside shoulder (Fall 2019).

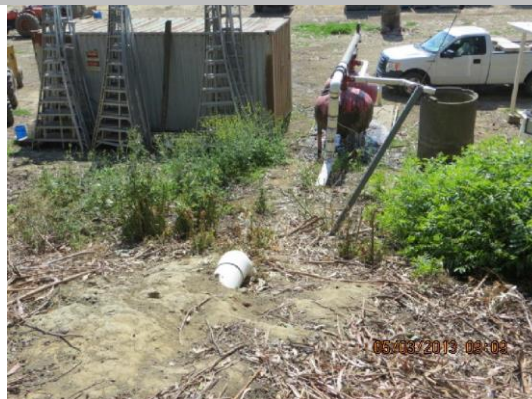
Photo 1 of 3 : UCIP_SP_2020_12869_20933.jpg

Comment Code						
Inspector Comment						
DS_ID:21925 FS_ID:12869 EP_NO: 2795 Repair Type: Non-Urgent Crossing Status: Found UCIP Comments: Annular space between PVC pipe and 12-inch steel pipe has not been sealed. FIELD_STRUCT_DESC: 20-inch irrigation pipe of an unknown material through the levee, 3 feet below the crown. 8-inch polyvinyl chloride pipe sleeved through a 12-inch pipe that is sleeved through the 20-inch. Annular space grouted between two metal pipes. Pump and butterfly valve in pump house on the waterside (WS) slope. 36-inch concrete standpipe and filters on the landside (LS) toe. (Permit No. 2795, 1958 - M. B. McKinnon). [Additional Reference(s): DWR Levee Log, 2005]. FS Date: 5/3/2013

PVC pipe, filters, and concrete standpipe on LS.

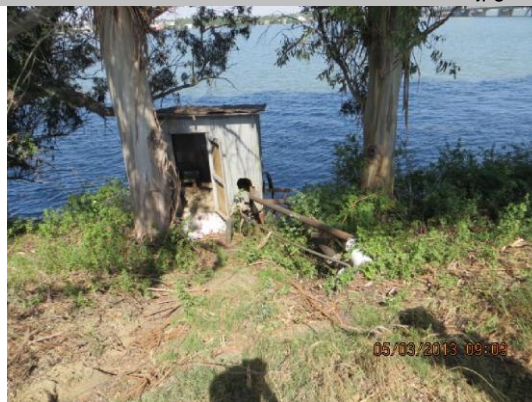
Photo 2 of 3 : UCIP_SP_2020_12869_20932.jpg

Pumphouse and pipe on WS slope.

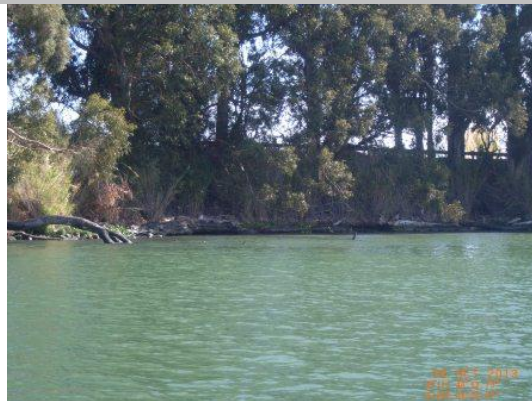
Photo 1 of 1 : SP_2020_NA0002_63_70_20200304_00036.jpg

LM Start	8.20	Rating **	U	Issue No.	70
LM End	8.42	Issue Type +	Ma	Location *	WS
Category	Supplemental			GPS Latitude/Longitude	
				Start	End
Item	2017 USACE Erosion Survey			38.151867 °	38.148711 °
				-121.682201 °	-121.682790 °
DWR ID	DWR_NA0002_02_f_2018_70				
Comment Code					
Inspector Comment					
2017 Site ID: SAC 12.1 L					
Status: Critical					
2017 Field Notes: Continues to worsen and threaten the road.					
Site History: 2010 - Small inlet area behind a man-built spit. Bank is slumping and could possibly be fixed with maintenance. 2011 - Site continues to worsen. 2015 - Upgraded to CRITICAL. 2016 - Site continues to get worse.

USACE 2013 Photo #1

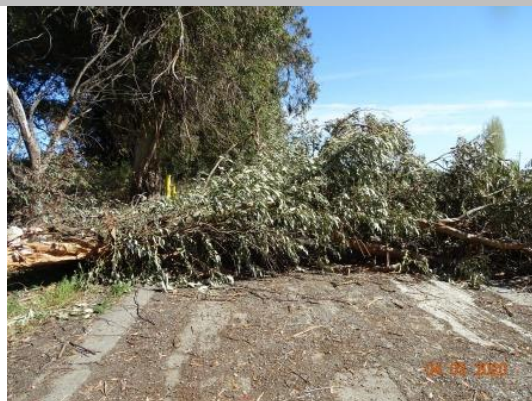
Photo 1 of 1 : SP_2020_NA0002_63_102_20200406_00186.jpg

LM Start	8.22	Rating **	U	Issue No.	102
LM End	8.22	Issue Type +	En	Location *	CR
Category	Earthen Levee			GPS Latitude/Longitude	
				Start	End
Item	Encroachments			38.151610 °	38.151610 °
				-121.681911 °	-121.681911 °
DWR ID	DWR_NA0002_02_s_2020_102				
Comment Code					
TR : Tree or limb					
Inspector Comment					
Large limb blocking the crown

View of large tree on the crown (Spring 2020).

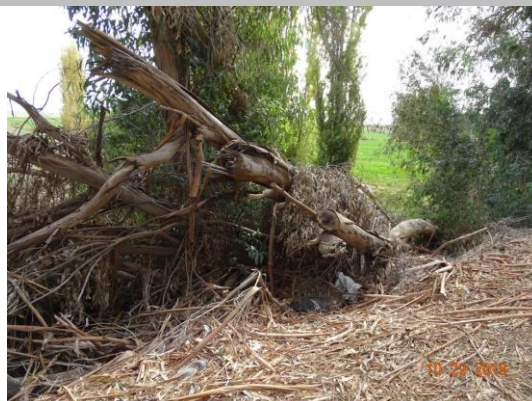
Photo 1 of 1 : SP_2020_NA0002_63_158_20200304_00085.jpg

LM Start	8.35	Rating **	U	Issue No.	158
LM End	8.35	Issue Type +	Ma	Location *	LS
Category	Earthen Levee			GPS Latitude/Longitude	
				Start	End
Item	Encroachments			38.149698 °	38.149698 °
				-121.682255 °	-121.682255 °
DWR ID	DWR_NA0002_02_f _ 2018_158				
Comment Code					
TR : Tree or limb					
Inspector Comment					
Remove the downed tree from landside slope.

View of down tree on landside slope (October 2018).

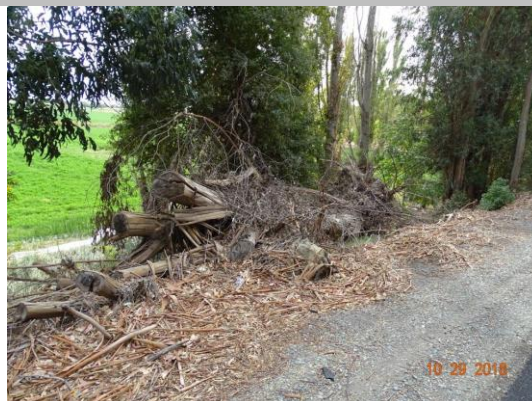
Photo 1 of 1 : SP_2020_NA0002_63_157_20200304_00084.jpg

LM Start	8.40	Rating **	U	Issue No.	157
LM End	8.40	Issue Type +	Ma	Location *	LS
Category	Earthen Levee			GPS Latitude/Longitude	
				Start	End
Item	Encroachments			38.148959 °	38.148959 °
				-121.682385 °	-121.682385 °
DWR ID	DWR_NA0002_02_f _ 2019_157				
Comment Code					
TR : Tree or limb					
Inspector Comment					
Remove the downed tree from the landside slope.

View of downed tree on landside slope (October 2018).

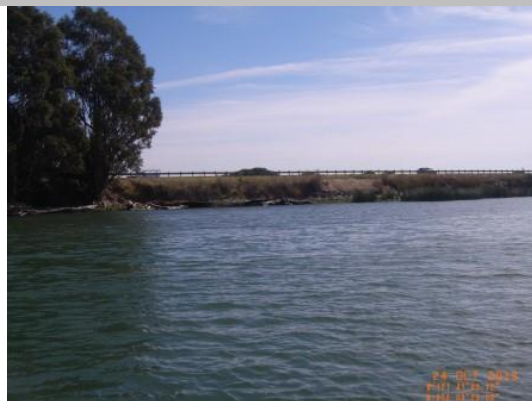
Photo 1 of 1 : SP_2020_NA0002_63_69_20200304_00035.jpg

Comment Code					
Inspector Comment					
2017 Site ID: SAC 11.2 L					
Status: Critical					
2017 Field Notes: New slump section. Erosion under the road has enlarged.					
Site History: 2008 - Erosion causing vertical bank at the highway on top of levee. The whole bank along the highway should be repaired.					
2009 - Minimal new erosion. 2011 - Bank continues to slowly erode.					
2012 - Upgrade to critical, new erosion since lat year and steeper slopes in sections. 2015 - Road foundation and cables exposed.					
Extremely large tree with exposed roots looks likely to fail and take out a significant portion of the levee. 2016 - Site continues to erode.

USACE 2013 Photo #1

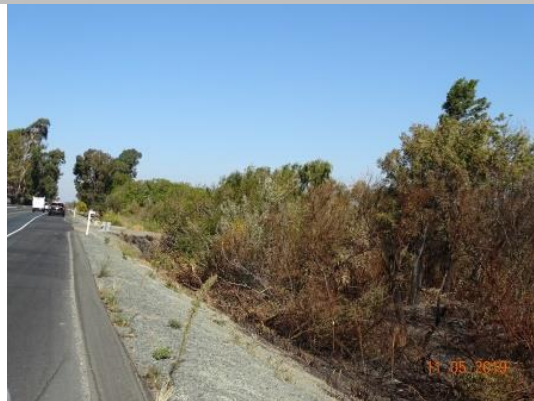
Photo 1 of 1 : SP_2020_NA0002_63_109_20200304_00065.jpg

LM Start	9.20	Rating **	U	Issue No.	109
LM End	9.35	Issue Type +	Ma	Location *	LS
Category	Earthen Levee			GPS Latitude/Longitude	
				Start	End
Item	Vegetation			38.137884 °	38.135612 °
				-121.686183 °	-121.686043 °
DWR ID	DWR_NA0002_02_f _ 2019_109				
Comment Code					
V2 : Remove the wild growth other than native grasses from the levee slopes.					
Inspector Comment

View looking upstream at vegetation on the landside slope (Fall 2019).

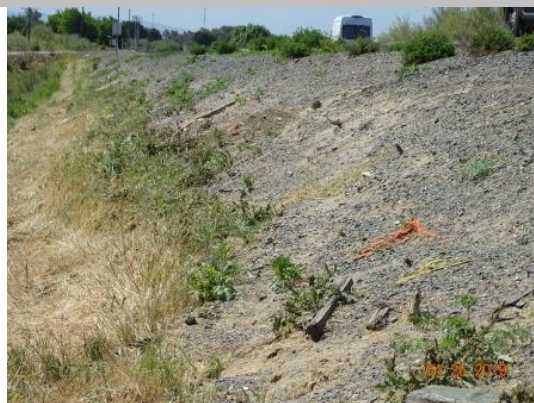
Photo 1 of 2 : SP_2020_NA0002_63_67_20200304_00032.jpg

LM Start	9.36	Rating **	U	Issue No.	67
LM End	10.03	Issue Type +	Ma	Location *	LS
Category	Earthen Levee			GPS Latitude/Longitude	
				Start	End
Item	Animal Control			38.135593 °	38.126291 °
				-121.686057 °	-121.688959 °
DWR ID	DWR_NA0002_02_s_2019_67				
Comment Code					
A1 : Exterminate rodents and backfill and compact or grout burrows.					
Inspector Comment					
There is major ground squirrel burrowing activity along this stretch. The LMA is aware of rock piles near the levee toe and says that is the source of the rodents.

View looking downstream at animal holes on the landside slope (Spring 2019).

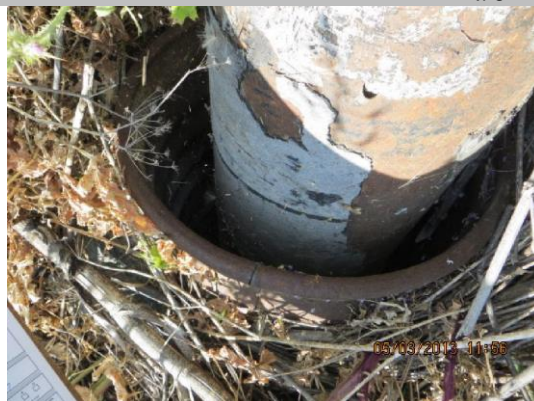
Photo 2 of 3 : UCIP_SP_2020_40528_21001.jpg

18-inch CMP with 12-inch irrigation pipe sleeved through it.

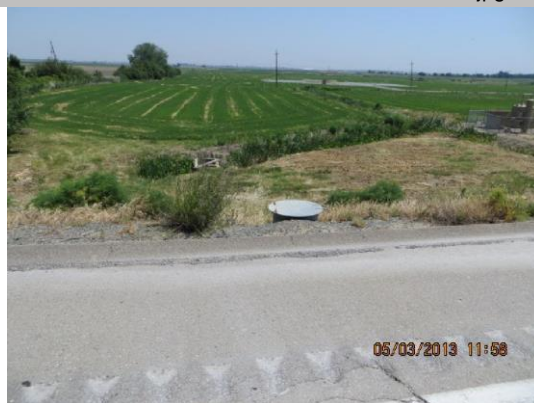
Photo 3 of 3 : UCIP_SP_2020_40528_21000.jpg

Standpipe and concrete box at LS.
