**Flood Control Project Maintenance
Levee Inspections
LMA District Cover Sheet**

Brannan Andrus Levee Maintenance District

Waterway			Bank	Unit Miles
Unit No. 01 Georgiana Slough			Right	6.01
	Spring (March - May)	Summer (June - August)	(September - November) Fall	Winter (December - February)
Unit Maintenance Rating (Fall Only)				
Date of Inspection	3/17/2021 - 3/17/2021			
DWR Inspector	David Julian			
Accompanied By

Levee Inspection Report By Mile - Spring 2021

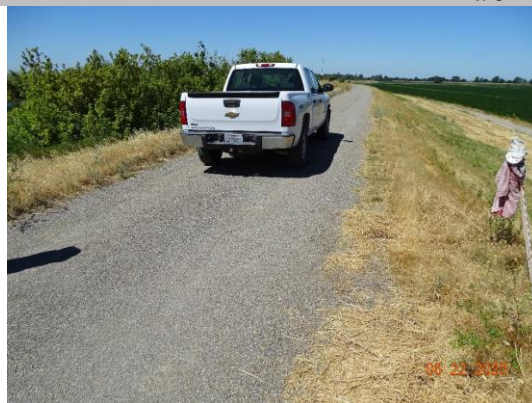
Photo 1 of 3 : UCIP_SP_2021_62290_89869.jpg

Comment Code						
Inspector Comment						
FS_ID:62290 DS_ID:21821 EP_NO: 11229 Repair Type: Non-Urgent Crossing Status: Found UCIP Comments: 06/22/2020 Record updated from No Action Needed to Non-Urgent. No permit has been identified authorizing pipe. Need to have CVFPB review ABO and determine current owner. Recommend owner to restore top cover grate of concrete standpipe and CMP riser to eliminate fall hazard. (O.Yakimov - DWR UCIP) FIELD_STRUCT_DESC: 12-inch steel irrigation siphon pipe through the levee, 4 feet below the crown. Siphon breaker in 10-inch high-density polyethylene riser unit on the landside (LS) shoulder. 1-inch air and vacuum valve. 36-inch diameter concrete distribution standpipe on the LS toe. (12-inch pipe [HLM 0.07] authorized under Automatic Board Order (ABO) issued as Permit No. 11229, 1975 - Paul and Gladys Bettencourt). [Additional Reference(s): DWR Levee Log, 2005 (HLM 0.07). USACE Sacramento O&M Manual, Unit 103, June 1954, Revised 29 December 2016, (Station 'R' 316+00), listed as 12-inch pipe. USACE As-Built Drawing No. 50-04-2631, Sheet 8, Station 316+00, March 1950]. FS Date: 6/22/2020 9:51:25 AM

Top of Levee: View of levee crown looking downstream

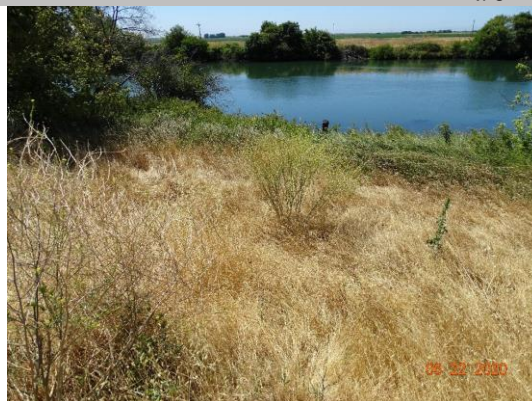
Photo 2 of 3 : UCIP_SP_2021_62290_89875.jpg

Water-Side: View of levee slope looking from crown

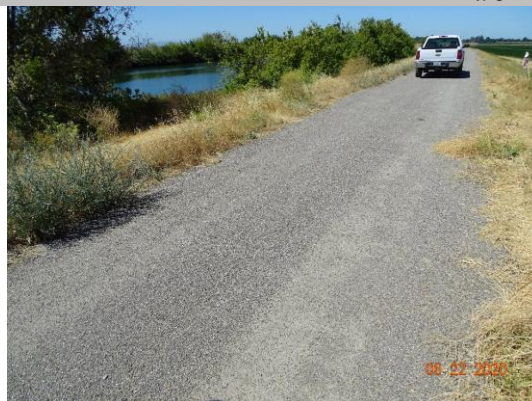
Photo 1 of 3 : UCIP_SP_2021_62289_89863.jpg

FS_ID:62289
DS_ID:21748
EP_NO: 11229
Repair Type: Non-Urgent
Crossing Status: Not Found
UCIP Comments: 06/22/2020 Record updated from No Action Needed to Non-Urgent. Crossing not found. A concrete standpipe on landside with HDPE pipe visible inside may not belong to this O&M crossing. This station "R" 315+56.9 located 43.1 feet downstream (SWW) of found crossing DSID 21821. Coordinates of this point were updated. No permit has been identified authorizing pipe. Need to have CVFPB review ABO and determine current owner. (O.Yakimov - DWR UCIP) 05/16/2013 Unable to locate pump or pipe, but did find a 6-foot diameter concrete standpipe at the LS toe.
FIELD_STRUCT_DESC: 8-inch steel irrigation pipe through the levee, 3.7 feet below the crown. Pipe open on the waterside (WS) end. Siphon breaker on the WS slope. Siphon breaker on the landside (LS) slope. 1-inch air and vacuum valve. 6-foot by 3-foot concrete standpipe. (8-inch pipe [HLM 0.07] authorized under Automatic Board Order (ABO) issued as Permit No. 11229, 1975 - Paul and Gladys Bettencourt). [Additional Reference(s): DWR Levee Log, 2005 (HLM 0.07). USACE Sacramento O&M Manual, Unit 103, June 1954, Revised 29 December 2016, (Station 'R' 315+56.9), listed as 8-inch pipe. USACE As-Built Drawing No. 50-04-2631, Sheet 8, Station 315+56.9, March 1950].

Top of Levee: View of levee crown looking downstream

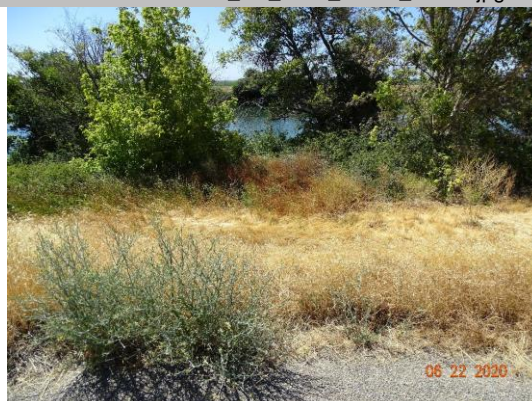
Photo 2 of 3 : UCIP_SP_2021_62289_89865.jpg

Water-Side: View of levee slope looking from crown

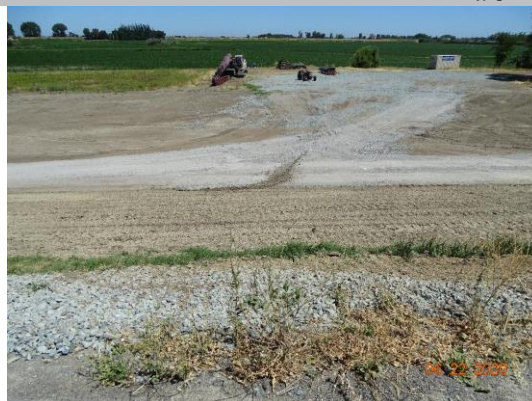
Photo 2 of 3 : UCIP_SP_2021_62295_89896.jpg

Land-Side: View of levee slope looking from crown

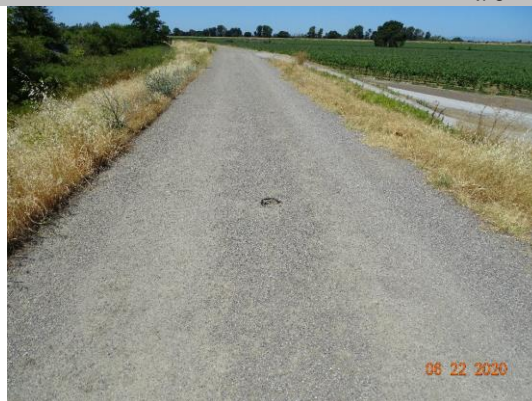
Photo 1 of 3 : UCIP_SP_2021_62296_89897.jpg

FS_ID:62296
DS_ID:21753
EP_NO: 11232
Repair Type: Urgent
Crossing Status: Found
UCIP Comments: 06/22/2020 Record updated from Non-Urgent to Urgent. Sinkhole in the center of crown measures 8-inch in diameter and 2-feet in depth. Damaged siphon breaker pipe on landside shoulder. Vegetation on waterside limits levee inspection at this crossing. Geophysical study indicates possible presence of pipe through levee. Owner needs to coordinate with the CVFPB to remove or abandon crossing according to Title 23 requirements. No permit has been identified authorizing pipe. Need to have CVFPB review ABO and determine current owner. (O.Yakimov - DWR UCIP)
05/16/2013 Unable to locate any appurtenances other than distribution box. Need to verify proper abandonment.
FIELD_STRUCT_DESC: 12-inch steel irrigation pipe through the levee, 3.2 feet below the crown. Siphon breaker on the landside (LS) slope. Concrete distribution box located LS of the toe. 2-inch primer valve. (12-inch pipe [HLM 0.75] authorized under Automatic Board Order (ABO) issued as Permit No. 11232, 1975 - Mario Campi). [Additional Reference(s): DWR Levee Log, 2005 (HLM 0.70). USACE Sacramento O&M Manual, Unit 103, June 1954, Revised 29 December 2016, (Station 'R' 279+70), listed as 12-inch pipe. USACE As-Built Drawing No. 50-04-2631, Sheet 7, Station 279+70, March 1950].

Top of Levee: View of levee crown looking downstream

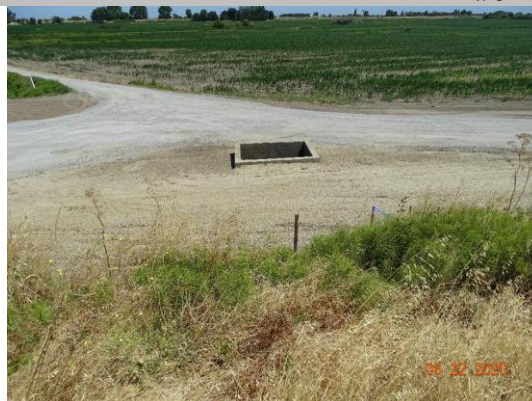
Photo 3 of 3 : UCIP_SP_2021_62296_89898.jpg

Land-Side: View of levee slope looking from crown

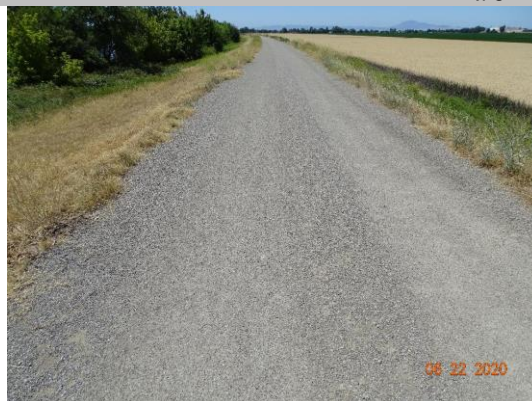
Photo 1 of 3 : UCIP_SP_2021_62297_89905.jpg

FS_ID:62297
DS_ID:21754
EP_NO: 11234
Repair Type: Non-Urgent
Crossing Status: Found
UCIP Comments: 06/22/2020 Record remains Non-Urgent. Crossing appears abandoned. Pumphouse at riverbank in shrubs inaccessible, dense vegetation around concrete standpipe on landside makes slide gate inoperable. Overgrown vegetation limits inspection of levee on both sides at this crossing. No permit has been identified authorizing pipe. Need to have CVFPB review ABO and determine current owner. (O.Yakimov - DWR UCIP)
05/16/2013 Appears abandoned and should be done so properly.
FIELD_STRUCT_DESC: 8-inch steel irrigation pipe through the levee, 4.3 feet below the crown. Pump in pump house on the waterside (WS) berm. 60-inch diameter concrete standpipe on the landside (LS) toe. (8-inch pipe [HLM 1.22] authorized under Automatic Board Order (ABO) issued as Permit No. 11234, 1975 - Anthony and John Correia).
[Additional Reference(s): USACE Sacramento O&M Manual, Unit 103, June 1954, Revised 29 December 2016, (Station 'R' 255+00), listed as 8-inch pipe. USACE As-Built Drawing No. 50-04-2631, Sheet 6, Station 255+00, March 1950].

Top of Levee: View of levee crown looking downstream

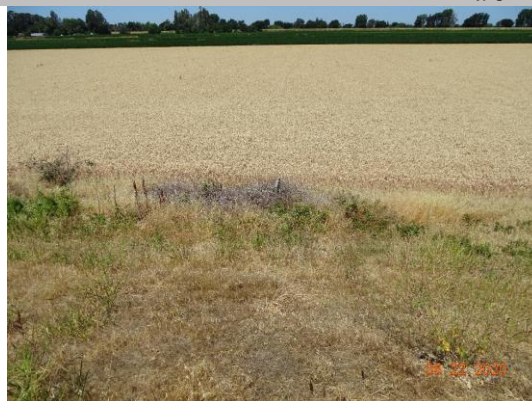
Photo 2 of 3 : UCIP_SP_2021_62297_89906.jpg

Land-Side: View of levee slope looking from crown

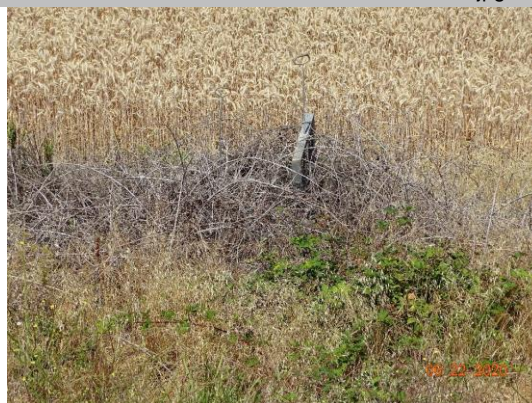
Photo 3 of 3 : UCIP_SP_2021_62297_89907.jpg

Land-Side: Abandoned concrete standpipe with slide gate at levee toe

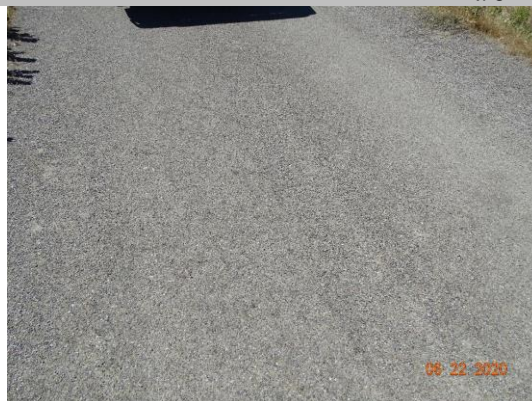
Photo 1 of 3 : UCIP_SP_2021_62299_89908.jpg

Comment Code						
Inspector Comment						
FS_ID:62299						
DS_ID:21820						
EP_NO: N/A						
Repair Type: Non-Urgent						
Crossing Status: Not Found						
UCIP Comments: 06/22/2020 Record updated from No Action Needed to Non-Urgent. Crossing not found. No permit has been identified authorizing pipe. Need to have CVFPB review ABO and determine current owner. (O.Yakimov - DWR UCIP)						
FIELD_STRUCT_DESC: 1.5-inch iron pipe of an unknown purpose, at an unknown depth. [Additional Reference(s): USACE Sacramento O&M Manual, Unit 103, June 1954, Revised 29 December 2016, (Station 'R' 247+80), listed as 1-1/2-inch pipe. USACE As-Built Drawing No. 50-04-2631, Sheet 6, Station 247+80, March 1950, listed as 1-1/2-inch pipe].						
FS Date: 6/22/2020

Top of Levee: View of levee crown looking downstream

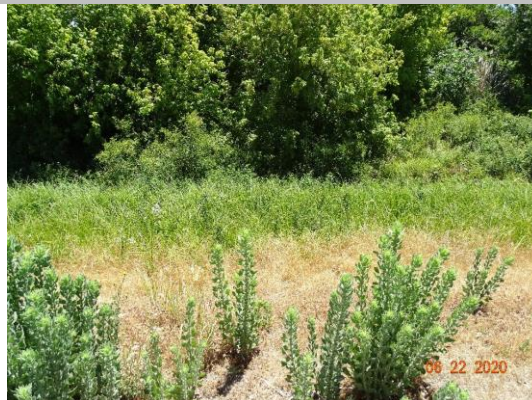
Photo 2 of 3 : UCIP_SP_2021_62299_89909.jpg

Water-Side: View of levee slope looking from crown

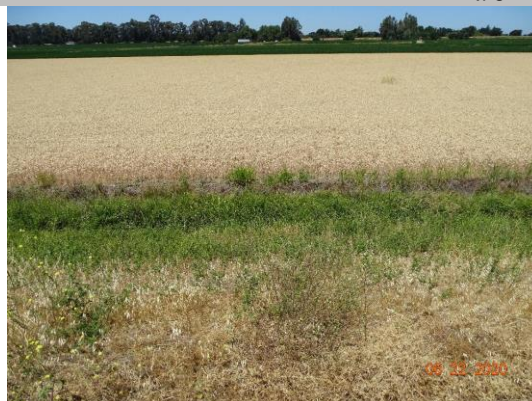
Photo 3 of 3 : UCIP_SP_2021_62299_89910.jpg

Land-Side: View of levee slope looking from crown

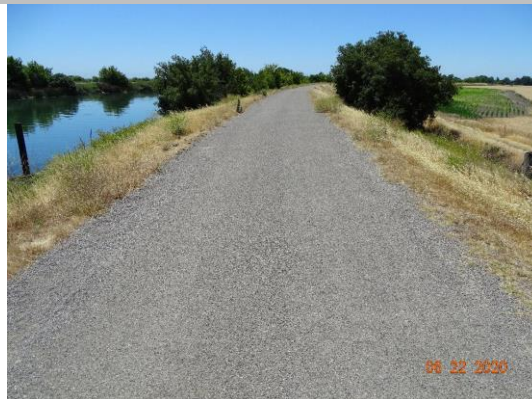
Photo 1 of 3 : UCIP_SP_2021_62300_89912.jpg

FS_ID:62300
DS_ID:21755
EP_NO: 11252
Repair Type: Non-Urgent
Crossing Status: Found
UCIP Comments: 06/22/2020 Record remains Non-Urgent. Crossing appears abandoned. CMP riser on landside slope has been filled with soil. Power supply wires are disconnected from pump on waterside berm. No permit has been identified authorizing pipe. Need to have CVFPB review ABO and determine current owner. (O.Yakimov - DWR UCIP)
05/16/2013 Pipe heavily rusted at distribution box. Good candidate for video inspection.
FIELD_STRUCT_DESC: 8-inch steel irrigation pipe through the levee, 4.6 feet below the crown. Pump and valve on the waterside (WS) slope. Siphon breaker in 24-inch corrugated metal riser unit on the landside (LS) shoulder. 7-foot by 10-foot concrete distribution box on the LS toe. (8-inch pipe [HLM 1.54] authorized under Automatic Board Order (ABO) issued as Permit No. 11252, 1975 - Hubert and Palmyra Vandermaele).

Top of Levee: View of levee crown looking downstream

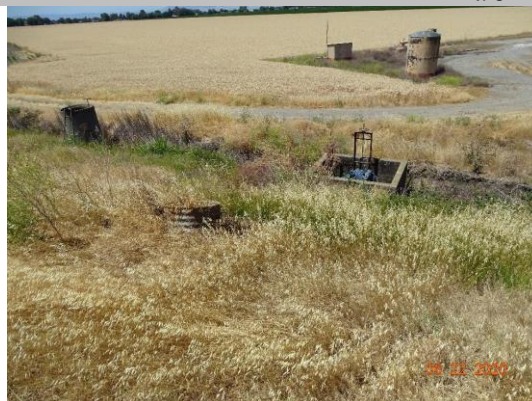
Photo 2 of 3 : UCIP_SP_2021_62300_89913.jpg

Land-Side: View of levee slope looking from crown

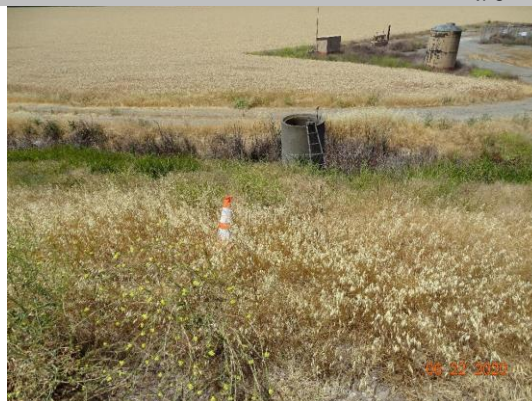
Photo 2 of 3 : UCIP_SP_2021_62301_89918.jpg

Land-Side: View of levee slope looking from crown

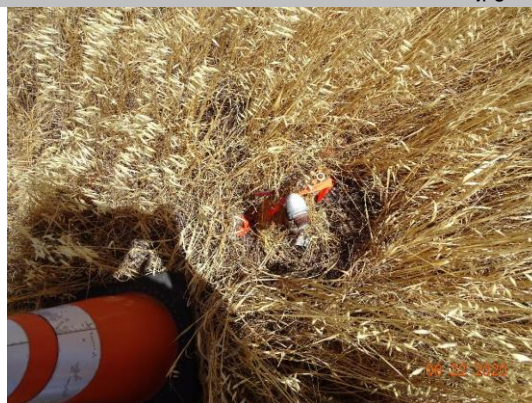
Photo 3 of 3 : UCIP_SP_2021_62301_89921.jpg

Land-Side: Siphon breaker / filler valve under a traffic cone on levee slope

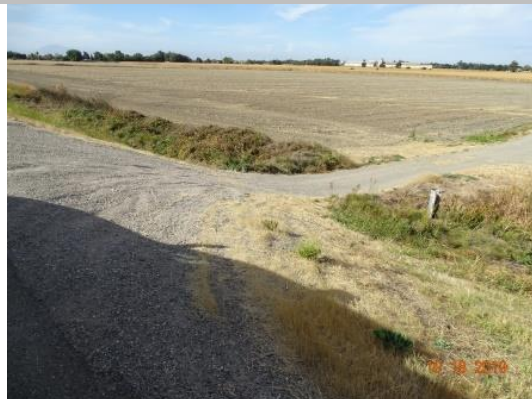
Photo 1 of 1 : SP_2021_NA0002_62_74_20210226_00031.jpg

LM Start	1.79	Rating **	U	Issue No.	74
LM End	1.79	Issue Type +	En	Location *	LS
Category	Earthen Levee			GPS Latitude/Longitude	
				Start	End
Item	Encroachments			38.169625 °	38.169625 °
				-121.581542 °	-121.581542 °
DWR ID	DWR_NA0002_01_f_2016_74				
Comment Code					
RA : Ramp					
Inspector Comment					
The Landowner has created a gravel-covered ramp up the land side of the levee. A permit Application should be submitted and the ramp should be brought up to Title 23 standards after approval.

View looking downslope at unauthorized ramp on the landside (Fall 2019).

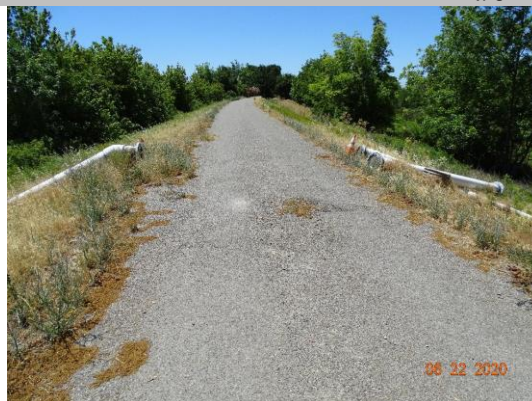
Photo 1 of 3 : UCIP_SP_2021_62304_89930.jpg

FS_ID:62304
DS_ID:21758
EP_NO: 11252
Repair Type: Non-Urgent
Crossing Status: Found
UCIP Comments: 06/22/2020 Record remains Non-Urgent. Old pipe segment is visible inside of concrete box at landside toe. Siphon breaker is still located in CMP riser on landside levee slope. 12-inch PVC pipe is connected to pump at riverbank on one side and discharges to concrete distribution box at landside toe. Pipe is temporarily dismantled on levee crown. Unable to find a permit for modification. Unable to locate a permit to confirm original pipe removal from levee. No permit has been identified authorizing original pipe through the levee. Need to have CVFPB review ABO and determine current owner. (O.Yakimov - DWR UCIP)
04/06/2017 Landowner has installed a temporary pipe and removed old pipe. Photos and update courtesy of DWR Inspector, Richard Willoughby. 05/16/2013 Pipe rusted through at inlet to box. Good candidate for video inspection. (G. Wylie - DWR)

Top of Levee: View of levee crown looking downstream

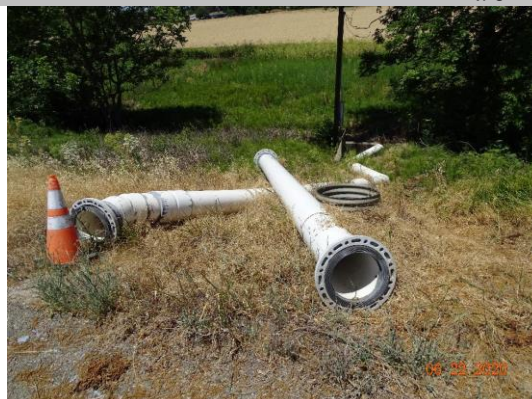
Photo 2 of 3 : UCIP_SP_2021_62304_89931.jpg

Land-Side: View of levee slope looking from crown. Dismantled PVC pipe on slope

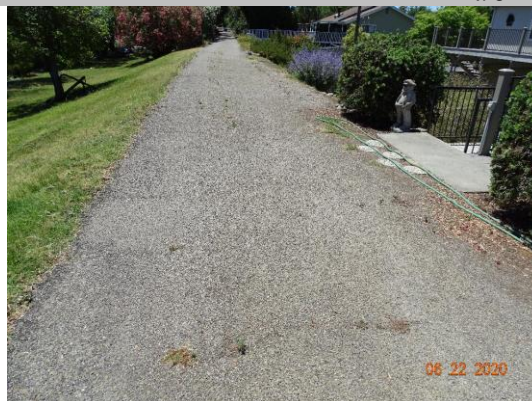
Photo 1 of 3 : UCIP_SP_2021_62305_89937.jpg

LM Start	2.28	Rating **	M	Issue No.	30	
LM End	2.28	Issue Type +	En	Location *		
Category	Supplemental			GPS Latitude/Longitude		
				Start	End	
Item	DWR UCIP Field Study			38.163123 °	38.163123 °	
				-121.584576 °	-121.584576 °	
DWR ID	23128					
Comment Code						
Inspector Comment						
FS_ID:62305 DS_ID:23128 EP_NO: N/A Repair Type: Non-Urgent Crossing Status: Found UCIP Comments: 06/22/2020 Record updated from No Action Needed to Non-Urgent. No permit has been found authorizing this pipe through the levee. (O.Yakimov - DWR UCIP) FIELD_STRUCT_DESC: 0.75-inch electrical conduit of an unknown material through the levee, at an unknown depth. Conduit provides power for irrigation pump at boating dock. FS Date: 6/22/2020 10:58:06 AM

Top of Levee: View of levee crown looking downstream

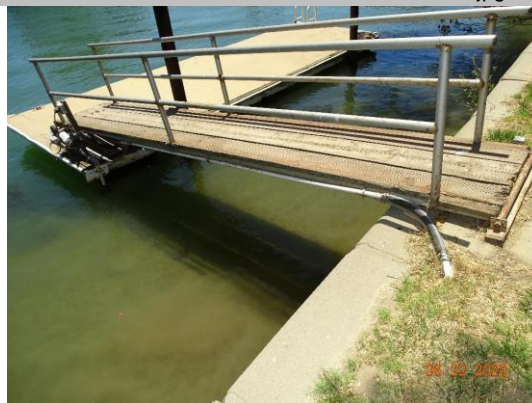
Photo 2 of 3 : UCIP_SP_2021_62305_89939.jpg

Water-Side: Boating dock

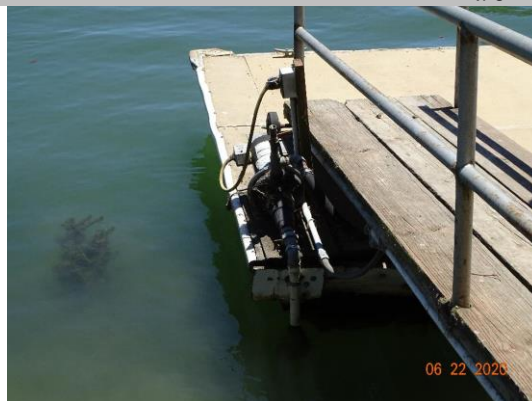
Photo 3 of 3 : UCIP_SP_2021_62305_89940.jpg

Water-Side: Irrigation pump at boating dock

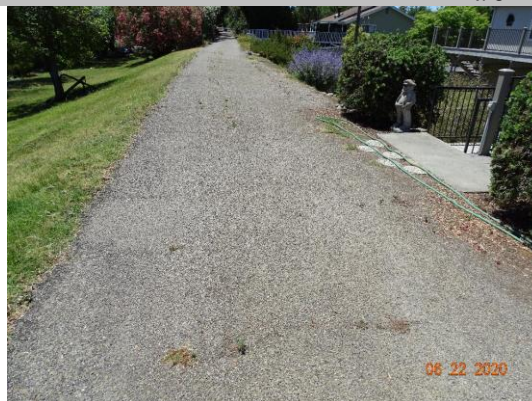
Photo 1 of 3 : UCIP_SP_2021_62306_89941.jpg

FS_ID:62306
DS_ID:23129
EP_NO: N/A
Repair Type: Non-Urgent
Crossing Status: Found
UCIP Comments: 06/22/2020 Record updated from No Action Needed to Non-Urgent. No permit has been found authorizing this pipe through the levee. (O.Yakimov - DWR UCIP)

Top of Levee: View of levee crown looking downstream. Power switch at walkway on landside shoulder

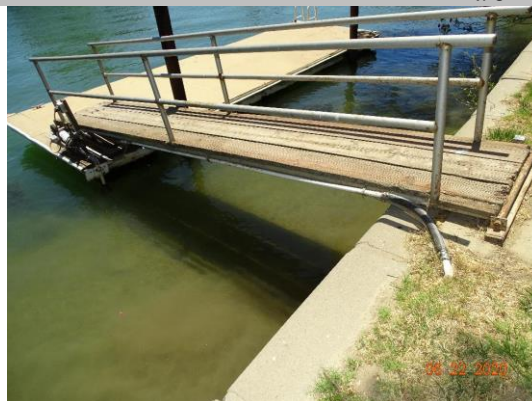
Photo 2 of 3 : UCIP_SP_2021_62306_89942.jpg

Water-Side: Boating dock on waterside

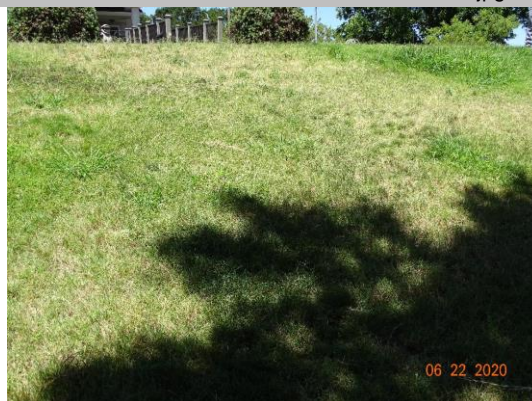
Photo 3 of 3 : UCIP_SP_2021_62306_89943.jpg

Water-Side: View of levee slope looking from toe

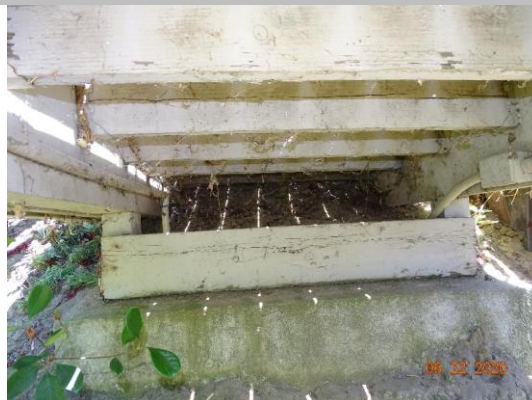
Photo 2 of 3 : UCIP_SP_2021_62307_89945.jpg

LM Start	2.28	Rating **	M	Issue No.	34	
LM End	2.28	Issue Type +	En	Location *		
Category	Supplemental			GPS Latitude/Longitude		
				Start		End
Item	DWR UCIP Field Study			38.163123 °		38.163123 °
				-121.584576 °		-121.584576 °
DWR ID	23130					
Comment Code						
Inspector Comment						
FS_ID:62307 DS_ID:23130 EP_NO: N/A Repair Type: Non-Urgent Crossing Status: Found UCIP Comments: 06/22/2020 Record updated from No Action Needed to Non-Urgent. No permit has been found authorizing this pipe through the levee. (O.Yakimov - DWR UCIP)						
FIELD_STRUCT_DESC: 1-inch water line of an unknown material through the levee, at an unknown depth. Pump on dock at the waterside (WS) toe. Provides irrigation water for sprinklers on waterside berm and landside slope. FS Date: 6/22/2020 12:14:06 PM

Land-Side: Pipe under walkway on landside

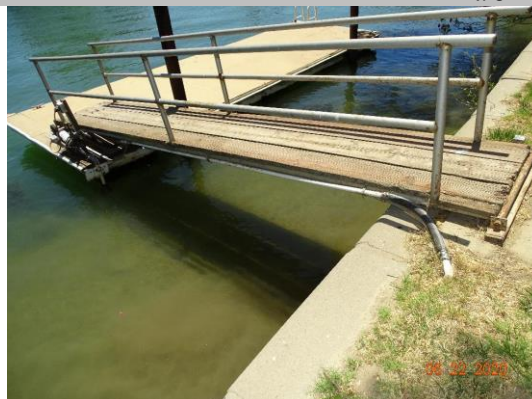
Photo 3 of 3 : UCIP_SP_2021_62307_89946.jpg

Water-Side: Boating dock on waterside. Pipe is entering ground

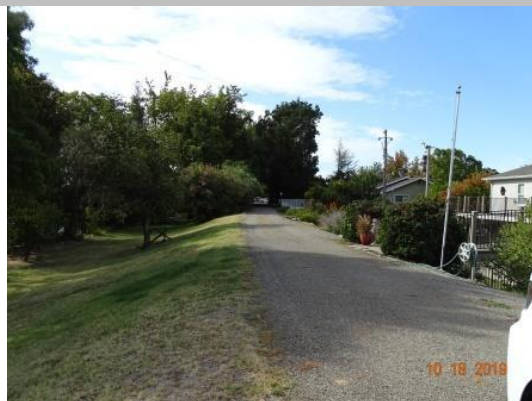
Photo 1 of 1 : SP_2021_NA0002_62_36_20210226_00013.jpg

LM Start	2.29	Rating **	U	Issue No.	36
LM End	2.34	Issue Type +	En	Location *	LS
Category	Earthen Levee			GPS Latitude/Longitude	
				Start	End
Item	Vegetation			38.162918 °	38.162322 °
				-121.584721 °	-121.585081 °
DWR ID	DWR_NA0002_01_s_2012_36				
Comment Code					
V6 : Landscaping					
Inspector Comment					
Vegetation is starting to impede patrol road.

View looking downstream at landscape on the landside slope (Fall 2019).

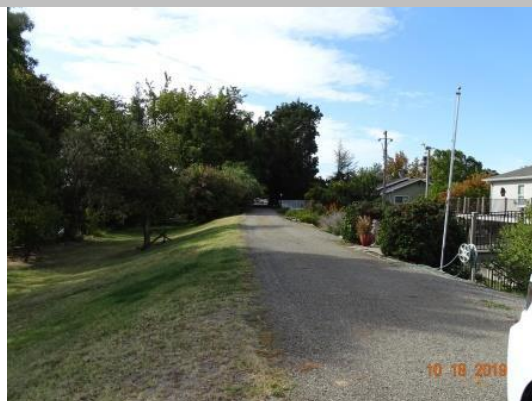
Photo 1 of 1 : SP_2021_NA0002_62_58_20210226_00022.jpg

LM Start	2.30	Rating **	U	Issue No.	58
LM End	2.30	Issue Type +	En	Location *	WS
Category	Earthen Levee			GPS Latitude/Longitude	
				Start	End
Item	Vegetation			38.162806 °	38.162806 °
				-121.584768 °	-121.584768 °
DWR ID	DWR_NA0002_01_s_2018_58				
Comment Code					
V6 : Landscaping					
Inspector Comment					
Remove oleanders.

View looking downstream at thick oleanders on the waterside slope (Fall 2019).

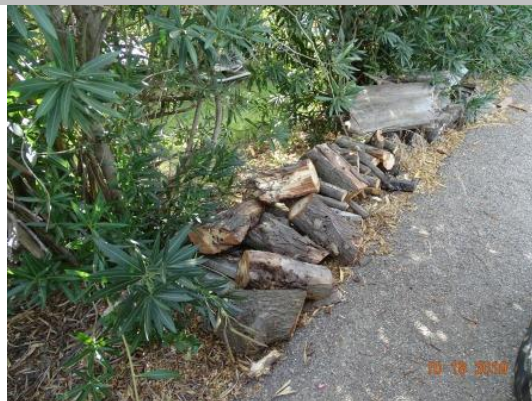
Photo 1 of 1 : SP_2021_NA0002_62_3_20210226_00002.jpg

LM Start	2.30	Rating **	M	Issue No.	3
LM End	2.32	Issue Type +	En	Location *	WS
Category	Earthen Levee			GPS Latitude/Longitude	
				Start	End
Item	Encroachments			38.162773 °	38.162544 °
				-121.584767 °	-121.584909 °
DWR ID	DWR_NA0002_01_s_2012_3				
Comment Code					
FW : Firewood					
Inspector Comment					
Firewood on the waterside shoulder

View of firewood on the waterside shoulder (Fall 2019).

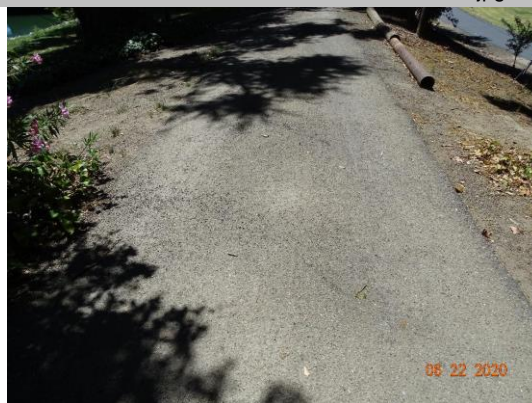
Photo 1 of 3 : UCIP_SP_2021_62308_89949.jpg

LM Start	2.32	Rating **	M	Issue No.	37
LM End	2.32	Issue Type +	En	Location *	
Category	Supplemental			GPS Latitude/Longitude	
				Start	End
Item	DWR UCIP Field Study			38.162487 °	38.162487 °
				-121.584939 °	-121.584939 °
DWR ID	21759

Comment Code					
Inspector Comment					
FS_ID:62308 DS_ID:21759 EP_NO: 11242 Repair Type: Non-Urgent Crossing Status: Found UCIP Comments: 06/22/2020 Record updated from No Action Needed to Non-Urgent. Crossing not found. Pump and pressure tank in pumphouse work for irrigation system on waterside. 4-inch pipe through levee not found on levee slopes. 1.5-inch PVC pipe is sleeved through a segment of 4-inch brass pipe between riverbank and pumphouse. Crossing appears abandoned. CMP riser on landside slope is filled with soil. Unauthorized encroachment recorded in Levee Log prior to 2011. Need to have CVFPB review ABO and determine current owner. (O.Yakimov - DWR UCIP) FIELD_STRUCT_DESC: 4-inch pipe through the levee 3.3 feet below the crown. Pump on berm in pump house. Siphon breaker in 24-inch CMP riser on LS slope. (4-inch pipe [HLM 2.32] authorized under Automatic Board Order (ABO) issued as Permit No. 11242, 1975 - Manuel & Lillian V. Maciel). [Additional Reference(s): DWR Levee Log, 2005 (HLM 2.32)]. FS Date: 6/22/2020 12:34:55 PM

Top of Levee: View of levee crown looking downstream

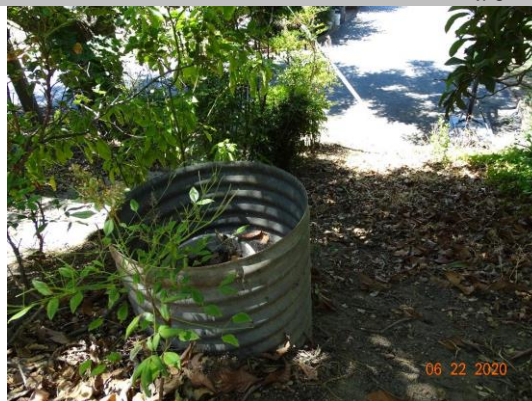
Photo 2 of 3 : UCIP_SP_2021_62308_89950.jpg

Land-Side: View of levee slope looking from crown. CMP riser on levee slope

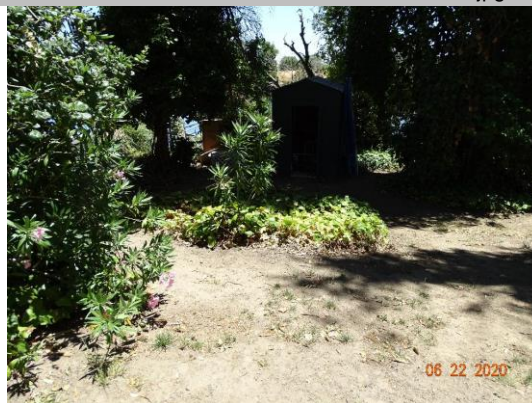
Photo 3 of 3 : UCIP_SP_2021_62308_89951.jpg

Water-Side: View of levee crown looking from crown

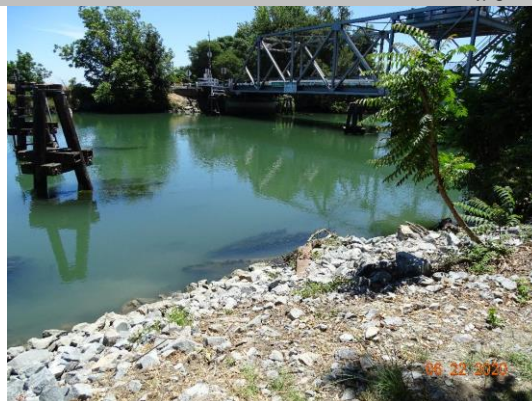
Photo 1 of 3 : UCIP_SP_2021_62309_89956.jpg

Comment Code					
Inspector Comment					
FS_ID:62309 DS_ID:21819 EP_NO: N/A Repair Type: Non-Urgent Crossing Status: Found UCIP Comments: 06/22/2020 Record remains Non-Urgent. Crossing not found. No permit has been identified authorizing pipe. (O.Yakimov - DWR UCIP) 05/16/2013 Pipe appears abandoned and should be done so properly. FIELD_STRUCT_DESC: 2-inch steel irrigation pipe through the levee, 3 feet below the crown. [Additional Reference(s): USACE Sacramento O&M Manual, Unit 103, June 1954, Revised 29 December 2016, (Station 'R' 196+99), listed as 2-inch pipe. USACE As-Built Drawing No. 50-04-2631, Sheet 5, Station 196+99, March 1950]. FS Date: 6/22/2020 1:32:09 PM

Water-Side: View of riverbank at the crossing

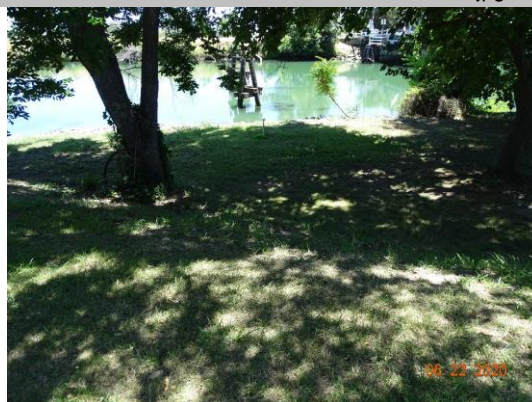
Photo 2 of 3 : UCIP_SP_2021_62309_89957.jpg

Water-Side: View of levee slope looking from crown

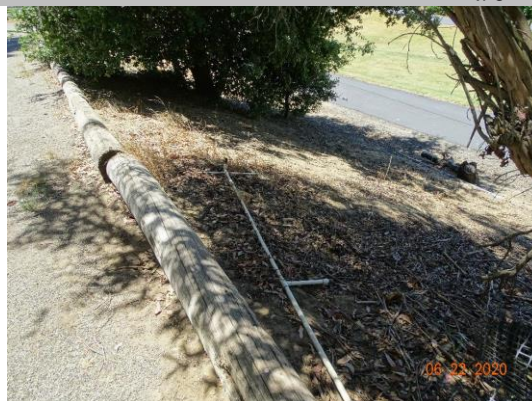
Photo 3 of 3 : UCIP_SP_2021_62309_89958.jpg

Land-Side: View of levee slope looking from crown

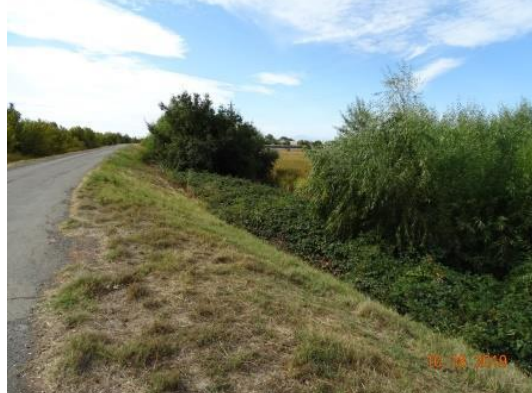
Photo 1 of 1 : SP_2021_NA0002_62_28_20210226_00011.jpg

LM Start	2.41	Rating **	U	Issue No.	28
LM End	2.49	Issue Type +	Ma	Location *	LS
Category	Earthen Levee			GPS Latitude/Longitude	
				Start	End
Item	Vegetation			38.161301 °	38.160281 °
				-121.585560 °	-121.586007 °
DWR ID	DWR_NA0002_01_s_2013_28				
Comment Code					
V2 : Remove the wild growth other than native grasses from the levee slopes.					
Inspector Comment					
Dense vegetation and wild roses on landside slope and toe.

View looking downstream at thick vegetation on the landside slope (Fall 2019).

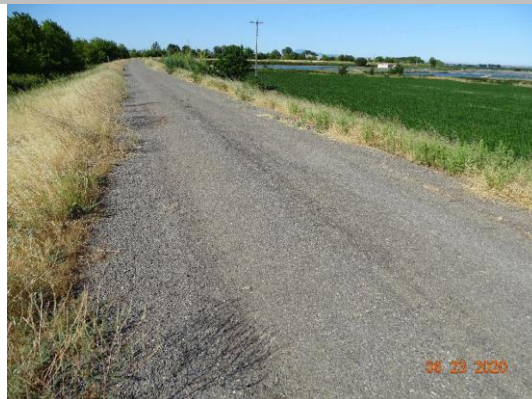
Photo 1 of 3 : UCIP_SP_2021_62311_89963.jpg

FS_ID:62311
DS_ID:21762
EP_NO: N/A
Repair Type: Non-Urgent
Crossing Status: Found
UCIP Comments: 06/23/2020 Record remains Non-Urgent. Crossing appears abandoned. Abandoned pump on waterside berm. Overgrown vegetation on landside limits inspection of levee at this crossing. Unable to see a concrete standpipe on landside. (O.Yakimov - DWR UCIP)
05/16/2013 Pipe appears abandoned and should be done so properly. standpipe on LS is covered in brush.
FIELD_STRUCT_DESC: 8-inch steel irrigation pipe through the levee, 3.4 feet below the crown. 6-inch pump on the waterside (WS). 36-inch concrete standpipe on the landside (LS) toe. [Additional Reference(s): DWR Levee Log, 2005 (HLM 2.44). USACE Sacramento O&M Manual, Unit 103, June 1954, Revised 29 December 2016, (Station 'R' 188+39), listed as 8-inch pipe. USACE As-Built Drawing No. 50-04-2631, Sheet 4, Station 188+39, March 1950].
FS Date: 6/23/2020 2:00:10 PM

Top of Levee: View of levee crown looking downstream

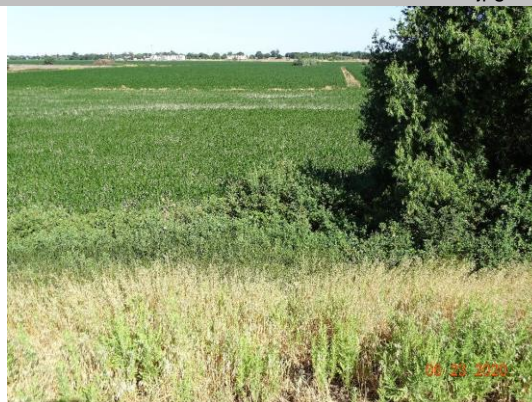
Photo 2 of 3 : UCIP_SP_2021_62311_89965.jpg

Land-Side: View of levee slope looking from crown

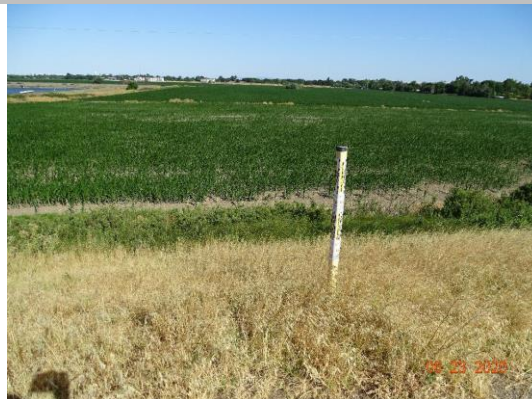
Photo 2 of 3 : UCIP_SP_2021_62313_89975.jpg

Land-Side: View of levee slope looking from crown. Gas line marker on levee slope

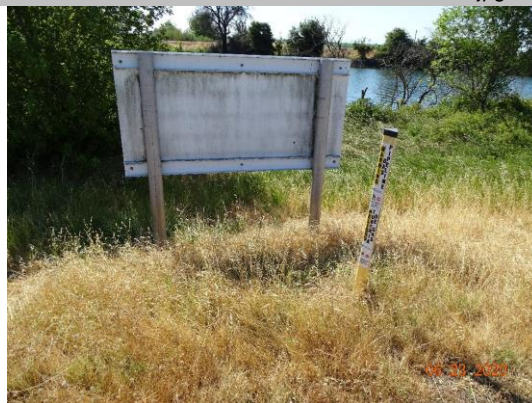
Photo 3 of 3 : UCIP_SP_2021_62313_89974.jpg

Water-Side: View of levee slope looking from crown. Gas line marker and warning sign on shoulder

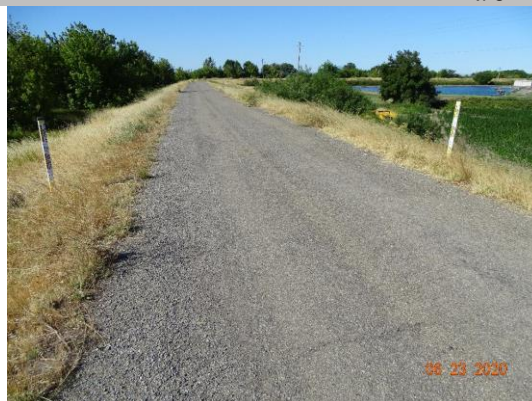
Photo 1 of 3 : UCIP_SP_2021_62314_89979.jpg

Comment Code						
Inspector Comment						
FS_ID:62314						
DS_ID:21824						
EP_NO: 841						
Repair Type: Non-Urgent						
Crossing Status: Indicator Found						
UCIP Comments:						
FIELD_STRUCT_DESC: 8-inch steel gas pipeline through the levee, 3 feet below the crown. Paddle markers located on both the waterside (WS) and the landside (LS) shoulders. Large sign is also present on the WS slope. (8-inch gas line authorized under Permit No. 841, 1940 - Pacific Gas and Electric). [Additional Reference(s): DWR Levee Log, 2005 (HLM 2.51). USACE Sacramento O&M Manual, Unit 103, June 1954, Revised 29 December 2016, (Station 'R' 184+80), listed as 10-inch pipe and two 8-inch pressure gas lines. USACE As-Built Drawing No. 50-04-2631, Sheet 4, Station 184+80, March 1950].						
FS Date: 6/23/2020 4:14:29 PM

Top of Levee: View of levee crown looking downstream

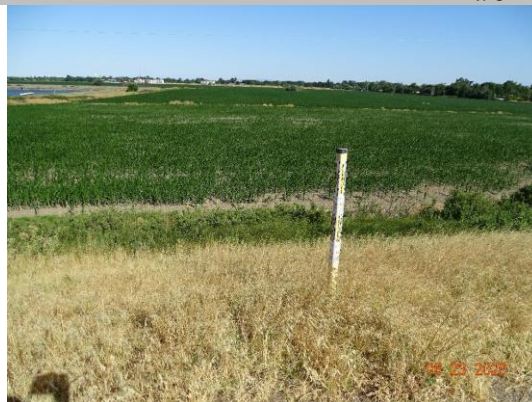
Photo 2 of 3 : UCIP_SP_2021_62314_89981.jpg

Land-Side: View of levee slope looking from crown

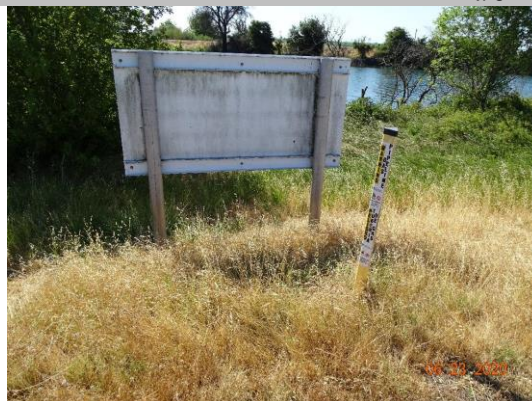
Photo 3 of 3 : UCIP_SP_2021_62314_89980.jpg

Water-Side: View of levee slope looking from crown

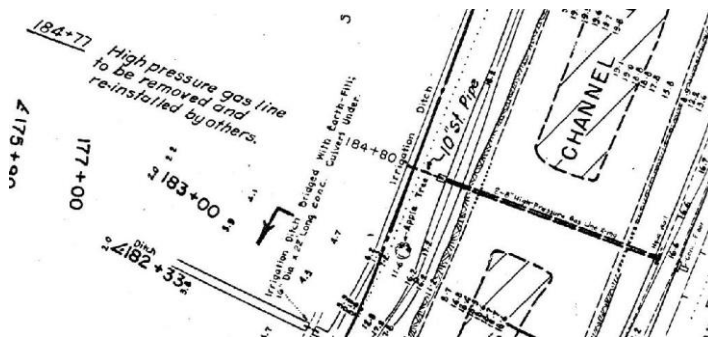
Photo 1 of 3 : UCIP_SP_2021_62315_89983.jpg

FS_ID:62315
DS_ID:21818
EP_NO: N/A
Repair Type: Non-Urgent
Crossing Status: Not Found
UCIP Comments: 06/23/2020 Record updated from No Action Needed to Non-Urgent. Updated coordinates and description of the crossing. Pipeline is semi-through the levee. No inspection records were available to determine status of gas pipeline. (O.Yakimov - DWR UCIP)
FIELD_STRUCT_DESC: 10-inch steel gas pipeline semi-through the levee. Two 8-inch gas lines DSID 21763 and 21824 merge into 10-inch gas line at landside levee shoulder. (Two 8-inch gas lines authorized under Permit No. 841, 1940 - Pacific Gas and Electric). [Additional Reference(s): DWR Levee Log, 2005 (HLM 2.51). USACE Sacramento O&M Manual, Unit 103, June 1954, Revised 29 December 2016, (Station 'R' 184+80), listed as 10-inch pipe and two 8-inch pressure gas lines. USACE As-Built Drawing No. 50-04-2631, Sheet 4, Station 184+80, March 1950].
FS Date: 6/23/2020 4:15:31 PM

Screenshot from As-Built Dwg. 50-04-2631 that shows 10-inch pipe continued from LS slope

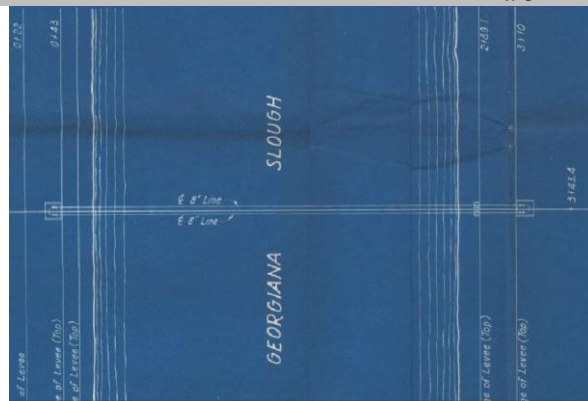
Photo 2 of 3 : UCIP_SP_2021_62315_89984.jpg

Screenshot from Profile Sheet of permit No. 841

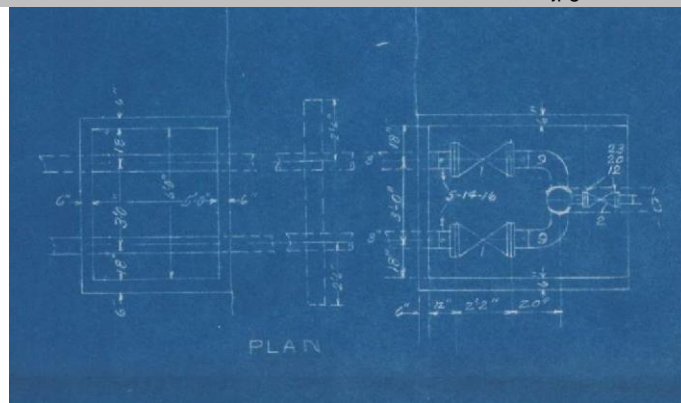
Photo 3 of 3 : UCIP_SP_2021_62315_89985.jpg

Screenshot from Plan Sheet A of permit No. 841

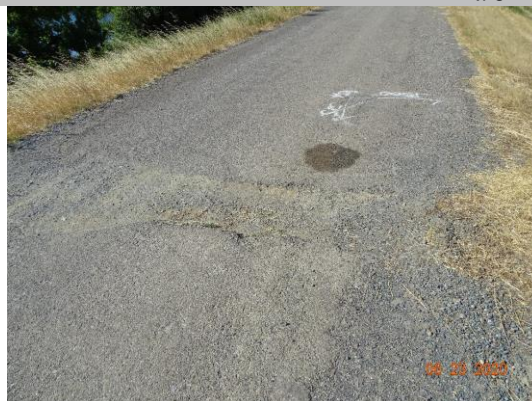
Photo 1 of 3 : UCIP_SP_2021_62316_89986.jpg

FS_ID:62316
DS_ID:21765
EP_NO: 11238
Repair Type: Non-Urgent
Crossing Status: Found
UCIP Comments: 06/23/2020 Record updated from Urgent to Non-Urgent. Visible cut in levee crown is due to emergency replacement of pipe section through levee crown in 2009. Erosion at riverbank within 10 feet from waterside levee toe is still present, but didn't grow in size. Dense vegetation on waterside limits inspection of levee at the crossing. No permit has been identified authorizing original pipe through the levee. Need to have CVFPB review ABO and determine current owner. (O.Yakimov - DWR UCIP)
07/12/2018 Dense vegetation on both levee slopes. Unable to evaluate erosion on WS. Depression along pipe alignment on levee crown. Recommend internal inspection to determine pipe integrity through levee. (O.Yakimov-DWR UCIP)10/24/2016 Unable to access WS due to heavy vegetation--assume WS remains the same or erosion has progressed but not visible from levee crown. Pipe marker found on LS slope next to 12-inch irrigation pipe indicating high pressure non-odorized natural gas pipeline however, unable to confirm if line is present or if it is parallel to levee or if it goes through levee. (O. Magana - DWR UCIP)05/16/2013 Erosion along pipe at WS toe goes into levee prism. Animal activity appears to be the cause of some pretty heavy erosion damage. Some settlement along the pipe alignment on crown may indicate other problems with this pipe. (W. Wylie - DWR UCIP)

FIELD_STRUCT_DESC: 12-inch irrigation steel pipe through levee 4 feet below crown. Siphon breaker is located on landside (LS) shoulder. A 7-foot by 9-foot concrete distribution box is located on LS toe. (12-inch pipe [HLM 2.60] authorized under Automatic Board Order (ABO) issued as Permit No. 11238, 1975 - Gardiner Improvement Company). (Emergency replacement of 12-inch deteriorated section of pipe through levee crown was authorized under Permit 18549, 2010 - Stockton JACS LLC, and completed 07/17/2009). Pipe section was replaced with in-kind sized pipe raised within levee crown while maintaining minimum of 2-feet cover. [Additional Reference(s): DWR Levee Log, 2005 (HLM 2.55). USACE Sacramento O&M Manual, Unit 103, June 1954, Revised 29 December 2016, (Station 'R' 182+63), listed as 12-inch pipe. USACE As-Built Drawing No. 50-04-2631, Sheet 4, Station 182+63, March 1950].
FS Date: 6/23/2020 10:57:12 AM

Top of Levee: View of levee crown looking downstream

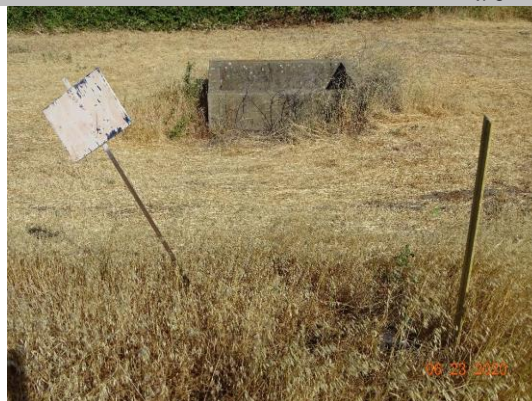
Photo 2 of 3 : UCIP_SP_2021_62316_89987.jpg

Land-Side: View of levee slope looking from crown

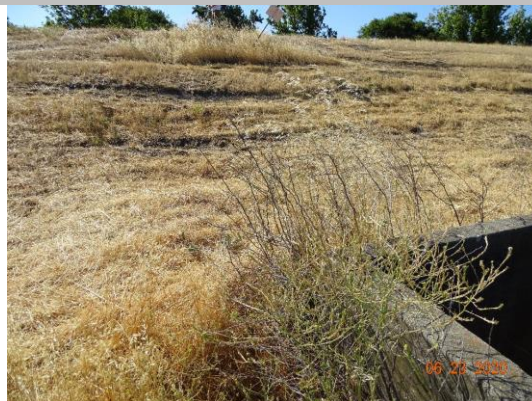
Photo 3 of 3 : UCIP_SP_2021_62316_89990.jpg

Land-Side: View of levee slope looking from toe

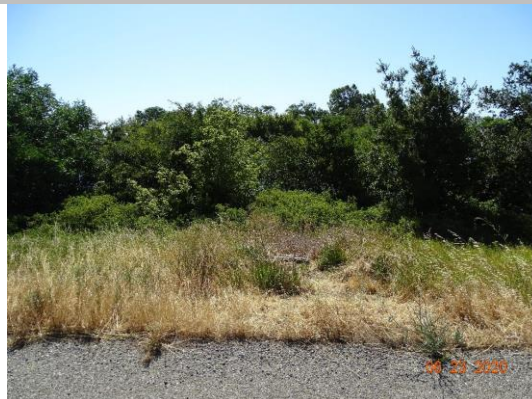
Photo 2 of 3 : UCIP_SP_2021_62317_89997.jpg

Water-Side: View of levee slope looking from crown

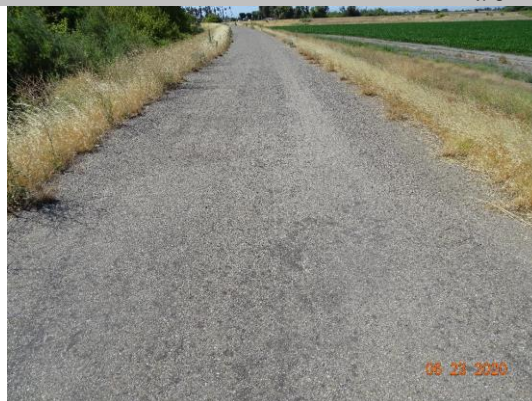
Photo 1 of 3 : UCIP_SP_2021_62318_90001.jpg

FS_ID:62318
DS_ID:21767
EP_NO: 11238
Repair Type: Non-Urgent
Crossing Status: Found
UCIP Comments: 06/23/2020 Record updated from No Action Needed to Non-Urgent. Crossing appears abandoned. Broken air release valve on landside shoulder. Concrete pad was constructed on landside of levee toe. No permit has been identified authorizing pipe. Need to have CVFPB review ABO and determine current owner. (O.Yakimov - DWR UCIP)

Top of Levee: View of levee crown looking downstream

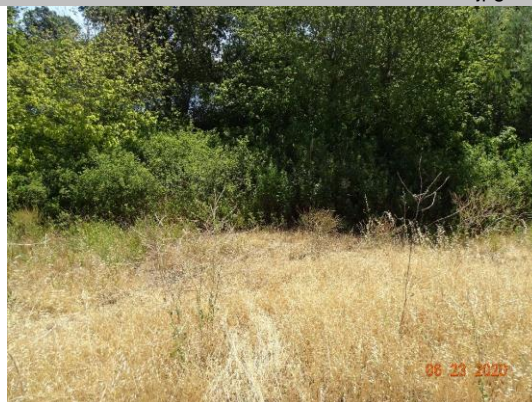
Photo 2 of 3 : UCIP_SP_2021_62318_90002.jpg

Water-Side: View of levee slope looking from crown

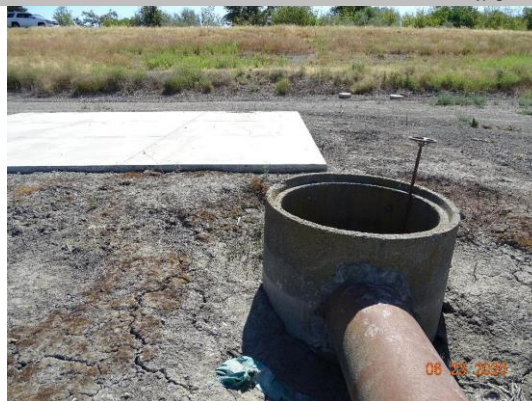
Photo 3 of 3 : UCIP_SP_2021_62318_89999.jpg

Land-Side: View of levee slope looking from crown. Standpipe at levee toe, concrete pad

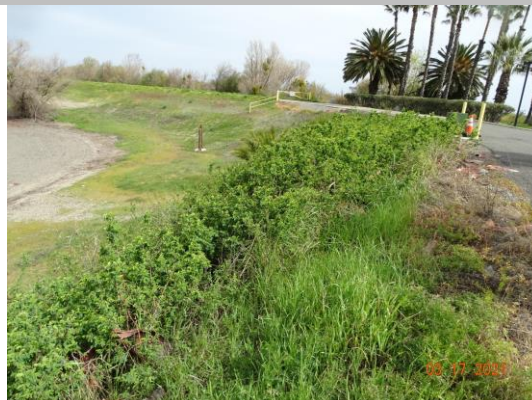
Photo 1 of 1 : SP_2021_NA0002_62_127_20210317_00237.jpg

LM Start	3.33	Rating **	U	Issue No.	127
LM End	3.35	Issue Type +	Ma	Location *	LS
Category	Earthen Levee			GPS Latitude/Longitude	
				Start	End
Item	Vegetation			38.151946 °	38.151759 °
				-121.591551 °	-121.591641 °
DWR ID	DWR_NA0002_01_s_2021_127				
Comment Code					
V2 : Remove the wild growth other than native grasses from the levee slopes.					
Inspector Comment

View of thick wild roses on the landside slope (Spring 2021).

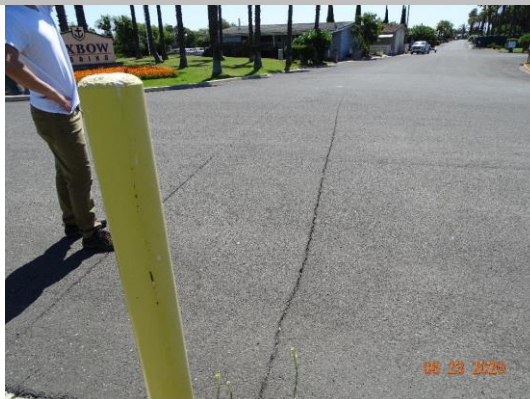
Photo 1 of 3 : UCIP_SP_2021_62322_90012.jpg

LM Start	3.34	Rating **	M	Issue No.	64	
LM End	3.34	Issue Type +	En	Location *		
Category	Supplemental			GPS Latitude/Longitude		
				Start		End
Item	DWR UCIP Field Study			38.151861 °		38.151861 °
				-121.591579 °		-121.591579 °
DWR ID	25484					
Comment Code						
Inspector Comment						
FS_ID:62322 DS_ID:25484 EP_NO: N/A Repair Type: Non-Urgent Crossing Status: Indicator Found UCIP Comments: 06/23/2020 Record is Non-Urgent. No permit has been found authorizing this pipe through the levee. (O.Yakimov - DWR UCIP) FIELD_STRUCT_DESC: 12-inch steel water pipe of an unknown depth below the crown. Shut-off valve on landside (LS) shoulder. Installation of pipe was field discovered by DWR inspector Richard Willoughby. Construction notice sign shows Kimberly Korth of Ox Bow Marina Mutual Water Company 209-969-7452. FS Date: 6/23/2020 3:30:29 PM

Top of Levee: View of levee crown looking towards waterside. Cut in road pavement

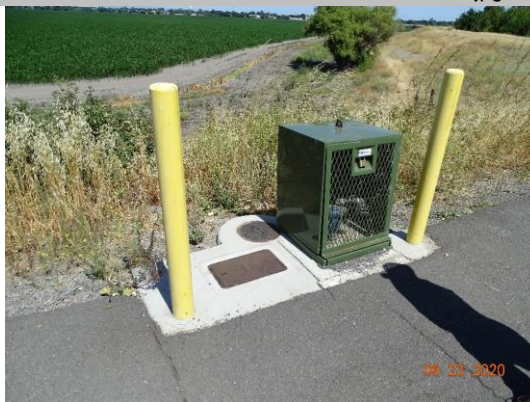
Photo 2 of 3 : UCIP_SP_2021_62322_90013.jpg

Land-Side: Service box on levee shoulder

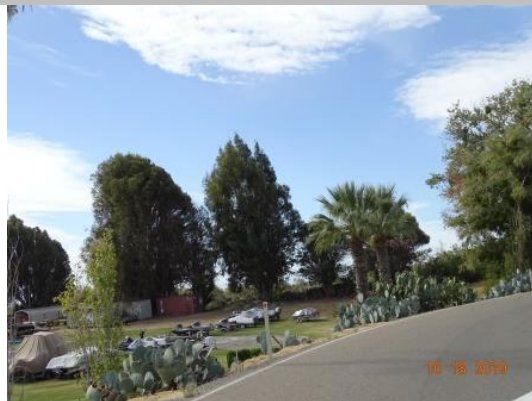
Photo 1 of 1 : SP_2021_NA0002_62_5_20210226_00003.jpg

LM Start	3.37	Rating **	U	Issue No.	5
LM End	3.37	Issue Type +	En	Location *	WS
Category	Earthen Levee			GPS Latitude/Longitude	
				Start	End
Item	Vegetation			38.151492 °	38.151492 °
				-121.591942 °	-121.591942 °
DWR ID	DWR_NA0002_01_f_2013_5				
Comment Code					
V6 : Landscaping					
Inspector Comment					
Remove cactus from waterside slope.

View of cactus on the waterside slope (Fall 2019).

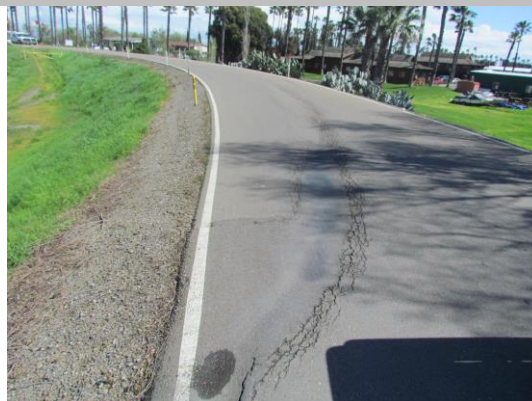
Photo 1 of 1 : SP_2021_NA0002_62_67_20210226_00029.jpg

LM Start	3.38	Rating **	A/W	Issue No.	67
LM End	3.40	Issue Type +	Ma	Location *	CR
Category	Earthen Levee			GPS Latitude/Longitude	
				Start	End
Item	Slope Stability			38.151430 °	38.151390 °
				-121.592085 °	-121.592517 °
DWR ID	DWR_NA0002_01_s_2017_67				
Comment Code					
S1 : Repair slope instability.					
Inspector Comment					
Appears to be beginning of a landslide slump. LMA's Engineer (DCC) is monitoring site for movement.

Looking east at possible sloughing on landward shoulder.

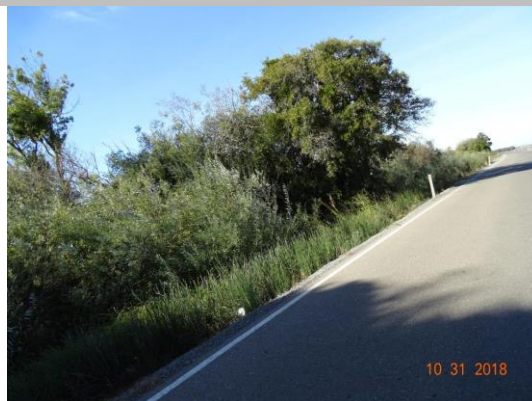
Photo 1 of 1 : SP_2021_NA0002_62_59_20210226_00023.jpg

LM Start	3.43	Rating **	U	Issue No.	59
LM End	3.95	Issue Type +	Ma	Location *	WS
Category	Earthen Levee			GPS Latitude/Longitude	
				Start	End
Item	Vegetation			38.151448 °	38.145753 °
				-121.592898 °	-121.601660 °
DWR ID	DWR_NA0002_01_f _ 2018_59				
Comment Code					
V2 : Remove the wild growth other than native grasses from the levee slopes.					
Inspector Comment

View looking downstream at vegetation on the water side slope (October 2018).

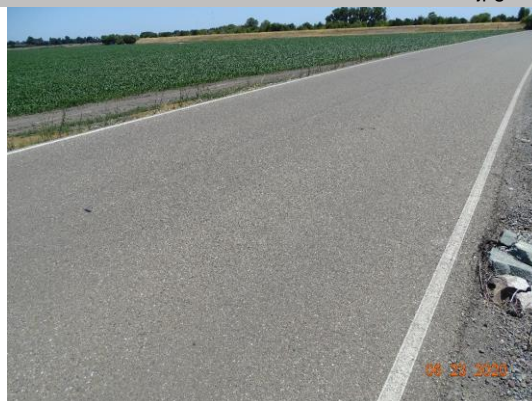
Photo 1 of 3 : UCIP_SP_2021_62325_90029.jpg

Comment Code						
Inspector Comment						
FS_ID:62325 DS_ID:21771 EP_NO: 11238 Repair Type: Non-Urgent Crossing Status: Found UCIP Comments: 06/23/2020 Record updated from No Action Needed to Non-Urgent. HDPE riser on landside shoulder needs a permanent cover for avoid fall hazard. No permit has been identified authorizing pipe. Need to have CVFPB review ABO and determine current owner. (O.Yakimov - DWR UCIP) FIELD_STRUCT_DESC: 8-inch steel irrigation pipe through the levee, 3.7 feet below the crown. Siphon breaker in 16-inch high-density polyethylene riser unit on the landside (LS) shoulder. 36-inch diameter concrete standpipe located LS of toe. (8-inch pipe [HLM 3.60] authorized under Automatic Board Order (ABO) issued as Permit No. 11238, 1975 - Gardiner Improvement Company). [Additional Reference(s): DWR Levee Log, 2005 (HLM 3.58). USACE Sacramento O&M Manual, Unit 103, June 1954, Revised 29 December 2016, (Station 'R' 127+98), listed as 8-inch pipe. USACE As-Built Drawing No. 50-04-2631, Sheet 2, Station 127+98, March 1950]. FS Date: 6/23/2020 4:38:39 PM

Top of Levee: View of levee crown looking upstream

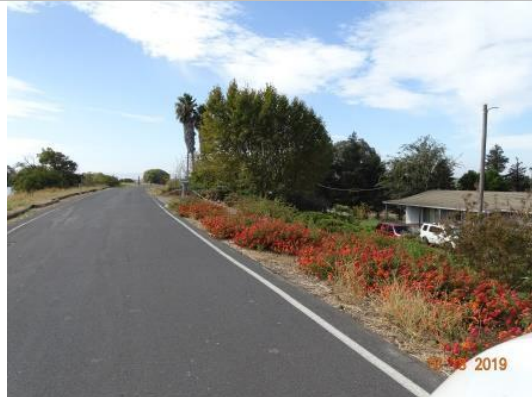
Photo 1 of 1 : SP_2021_NA0002_62_11_20210226_00006.jpg

LM Start	3.93	Rating **	U	Issue No.	11
LM End	3.97	Issue Type +	En	Location *	LS
Category	Earthen Levee			GPS Latitude/Longitude	
				Start	End
Item	Vegetation			38.148318 °	38.147923 °
				-121.599947 °	-121.600245 °
DWR ID	DWR_NA0002_01_s_2012_11				
Comment Code					
V6 : Landscaping					
Inspector Comment

View looking downstream at landscape on the landside slope (Fall 2019).

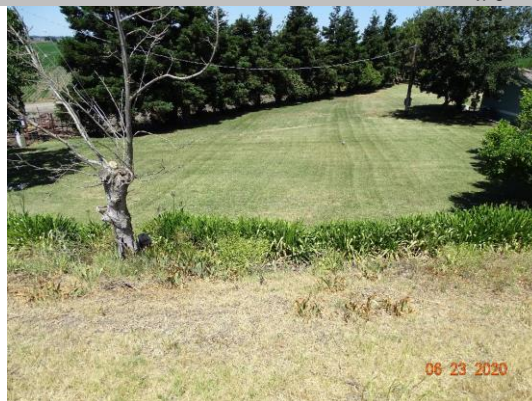
Photo 1 of 3 : UCIP_SP_2021_62326_90603.jpg

Comment Code						
Inspector Comment						
FS_ID:62326 DS_ID:21817 EP_NO: N/A Repair Type: Non-Urgent Crossing Status: Found UCIP Comments: 06/23/2020 Record updated from No Action Needed to Non-Urgent. Steel pipe with hose bib visible on waterside berm. No permit has been identified authorizing pipe. (O.Yakimov - DWR UCIP) FIELD_STRUCT_DESC: 0.75-inch iron water line, 11.6 feet below the crown. [Additional Reference(s): USACE Sacramento O&M Manual, Unit 103, June 1954, Revised 29 December 2016, (Station 'R' 108+35), listed as 3/4-inch water line. USACE As-Built Drawing No. 50-04-2631, Sheet 2, Station 108+35, March 1950, listed as 3/4-inch water line]. FS Date: 6/23/2020 8:23:36 AM

Land-Side: View of levee slope looking from crown
