**Flood Control Project Maintenance
Levee Inspections
LMA District Cover Sheet**

Brannan Andrus Levee Maintenance District

Waterway			Bank	Unit Miles
Unit No. 01 Georgiana Slough			Right	6.01
	Spring (March - May)	Summer (June - August)	(September - November) Fall	Winter (December - February)
Unit Maintenance Rating (Fall Only)				
Date of Inspection	3/17/2021 - 3/17/2021			
DWR Inspector	David Julian			
Accompanied By

Levee Inspection Report By Mile - Spring 2021

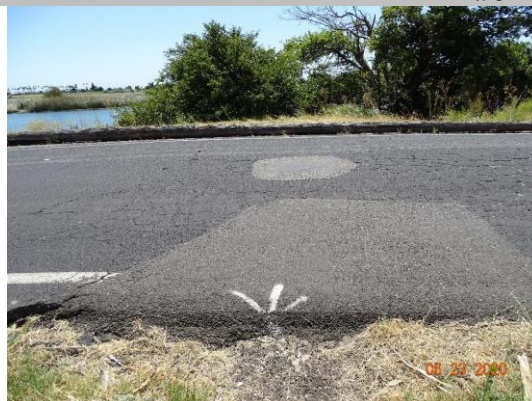
Photo 1 of 3 : UCIP_SP_2021_62328_90609.jpg

FS_ID:62328
 DS_ID:21826
 EP_NO: N/A
 Repair Type: Non-Urgent
 Crossing Status: Not Found
 UCIP Comments: 06/23/2020 Record updated from No Action Needed to Non-Urgent. Crossing not found. No permit has been identified authorizing pipe. (O.Yakimov - DWR UCIP)
 FIELD_STRUCT_DESC: 1.5-inch electrical conduit through the levee, 3 feet below the crown. [Additional Reference(s): USACE Sacramento O&M Manual, Unit 103, June 1954, Revised 29 December 2016, (Station 'R' 107+76), listed as 1-1/2-inch pipe. USACE As-Built Drawing No. 50-04-2631, Sheet 2, Station 107+76, March 1950].
 FS Date: 6/23/2020 9:47:52 AM

Top of Levee: View of levee crown looking towards waterside

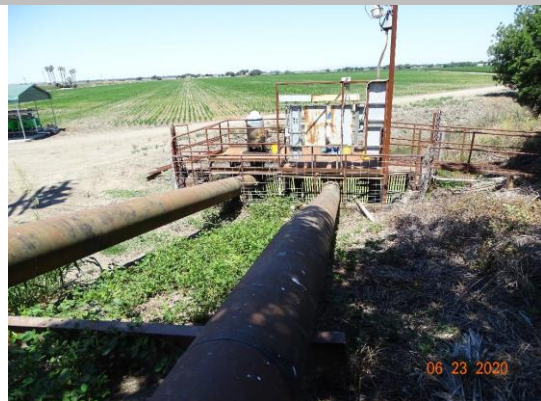
Photo 3 of 3 : UCIP_SP_2021_62328_90607.jpg

Land-Side: Pumping plant at landside toe

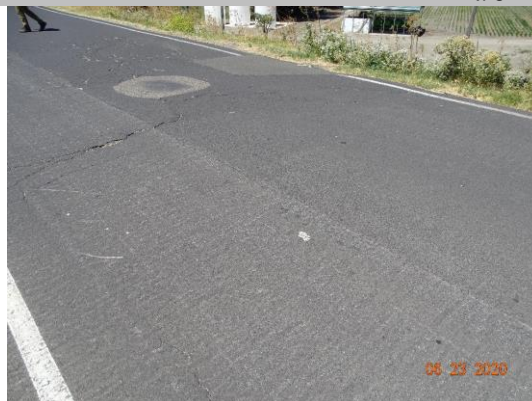
Photo 1 of 3 : UCIP_SP_2021_62327_90037.jpg

FS_ID:62327
DS_ID:21772
EP_NO: 11248
Repair Type: Non-Urgent
Crossing Status: Found
UCIP Comments: 06/23/2020 Record updated from No Action Needed to Non-Urgent. 20-inch steel drainage pipe sleeved through 24-inch steel pipe. Annular space between pipes seems to be grouted. Unable to find a permit for modification. Asphalt repair patches on levee crown. No permit has been identified authorizing pipe. Need to have CVFPB review ABO and determine current owner. (O.Yakimov - DWR UCIP)
FIELD_STRUCT_DESC: 20-inch steel drainage pipe sleeved through 24-inch steel pipe through the levee, 3 feet below the crown. Siphon breaker is located on the waterside (WS) slope. Pump is located on the landside (LS). (24-inch pipe [HLM 3.99] authorized under Automatic Board Order (ABO) issued as Permit No. 11248, 1975 - Reclamation District No.407). [Additional Reference(s): DWR Levee Log, 2005 (HLM 3.99), listed as 24-inch pipe. USACE Sacramento O&M Manual, Unit 103, June 1954, Revised 29 December 2016, (Station 'R' 107+76), listed as 26-inch pipe. USACE As-Built Drawing No. 50-04-2631, Sheet 2, Station 107+76, March 1950, listed as 26-inch pipe].

Top of Levee: View of levee crown looking downstream

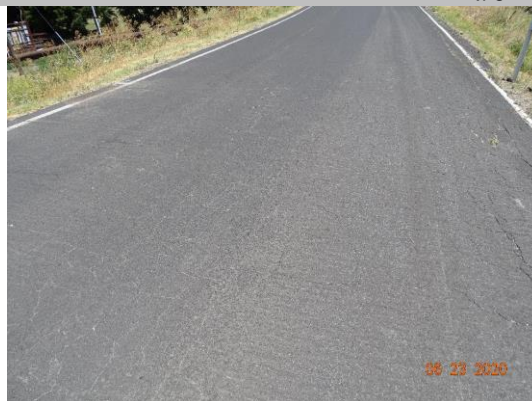
Photo 1 of 3 : UCIP_SP_2021_62331_90056.jpg

Comment Code						
Inspector Comment						
FS_ID:62331 DS_ID:21774 EP_NO: 11238 Repair Type: Non-Urgent Crossing Status: Found UCIP Comments: 06/23/2020 Record remains Non-Urgent. Scour hole around air release pipe on waterside shoulder has been repaired, pipe is capped. Flanged coupler installed on pipe on landside levee shoulder and a new pipe put on landside levee slope to pumping plant bypassing concrete standpipe. Concrete standpipe with slide gate is abandoned. Diesel pump and media filtering facility installed on landside off levee toe. Unable to find a permit for modification. No permit has been identified authorizing pipe. Need to have CVFPB review ABO and determine current owner. (O.Yakimov - DWR UCIP) 10/24/2016 Unable to determine if WS primer pipe is leaking or if settling is occurring at pipe. Need to contact owner to determine when upgrades to WS were completed. (O. Magana - DWR UCIP) FIELD_STRUCT_DESC: 10-inch irrigation steel pipe through levee, 4 feet below crown. Siphon breaker is located on the landside (LS). 1.5-inch primer, 48-inch concrete standpipe on LS toe with slide gate. (12-inch pipe [HLM 4.01] authorized under Automatic Board Order (ABO) issued as Permit No. 11238, 1975 - Gardiner Improvement Company). [Additional Reference(s): DWR Levee Log, 2005 (HLM 4.00), listed as 12-inch pipe. USACE Sacramento O&M Manual, Unit 103, June 1954, Revised 29 December 2016, (Station 'R' 106+79), listed as 12-inch pipe. USACE As-Built Drawing No. 50-04-2631, Sheet 2, Station 106+79, March 1950, listed as 12-inch pipe]. FS Date: 6/23/2020 11:49:07 AM

Top of Levee: View of levee crown looking upstream

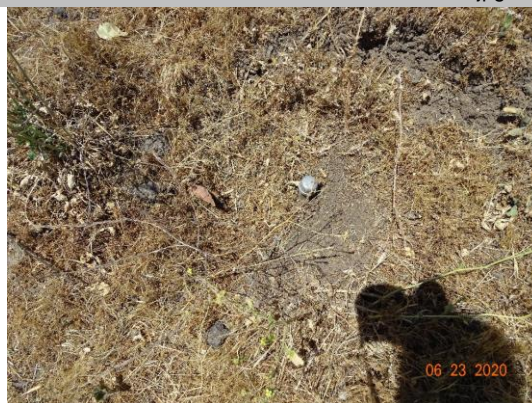
Photo 3 of 3 : UCIP_SP_2021_62331_90057.jpg

Land-Side: Air vent/primer line on levee shoulder

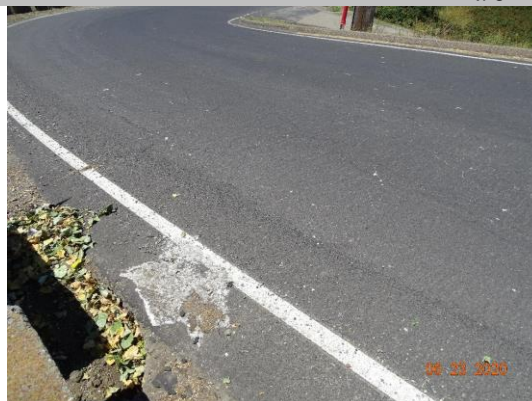
Photo 1 of 3 : UCIP_SP_2021_62333_90065.jpg

FS_ID:62333
DS_ID:21775
EP_NO: 11238
Repair Type: Urgent
Crossing Status: Found
UCIP Comments: 06/23/2020 Record remains Urgent. Levee slope subsidence in pipe alignment on landside is more than 2-feet-deep. Sinkhole on waterside shoulder at public road pavement keeps growing and measures 3' x 2' x 0.75' deep. Missing cover on the top of vault at landside toe creates fall hazard. No permit has been identified authorizing pipe. Need to have CVFPB review ABO and determine current owner. (O.Yakimov - DWR UCIP)
07/12/2018 Hole on LS shoulder under concrete blocks is still present, although haven't increased in size. Part of cover on concrete sump is still missing which is public safety issue. Crossing remain "Urgent" because of potential pipe failure signs. Recommend internal inspection to determine condition of pipe through levee. (DWR-O.Yakimov)
12/30/2016 Left message with Ms. Cabral to inform her that we are working with LMA to find additional information about crossing. Spoke with Andy Giannini, LMA representative, regarding the UCIP report and Mr. Giannini believes the hole is due to ground squirrel activity. According to Mr. Giannini, the issue with ground squirrel has been resolved and the hole filled. Records indicate pipe was installed in the 1950s and authorized under Permit No. 11238 in 1975. This pipe could be about 62 years old. Crossing remains Urgent due to the uncertainty of pipe integrity through levee. Recommend having owner complete an internal inspection of the pipe through the levee to determine integrity of pipe. (O. Magana - DWR UCIP)12/28/2016 Contacted Andy Giannini, LMA representative, and provided him with UCIP report to review. (O. Magana - DWR UCIP)12/27/2016 Contacted Rebecca Cabral, property sales agent from Century 21 Farm & Ranch M&M and Associates, at 1-707-374-3900 to inquire about the property owner for this area. Mrs. Cabral was unaware of pipe through levee and has requested photos to share with client. She was not able to provide me with the current property owner information but mentioned that she will contact me next week (week ending Jan 6, 2017). (O. Magana - DWR UCIP)10/24/2016 Section of cover is still missing. Potential pipe failure through levee. Sink hole is present on LS shoulder. Need to contact owner to stop use of pipe to avoid further damage to levee. Recommend internal inspection of pipe to determine integrity of pipe wall. (O. Magana - DWR UCIP)05/08/2013 Missing cover on concrete sump is an immediate hazard and should be repaired. (W. Wylie - DWR UCIP)

Top of Levee: View of levee crown looking downstream

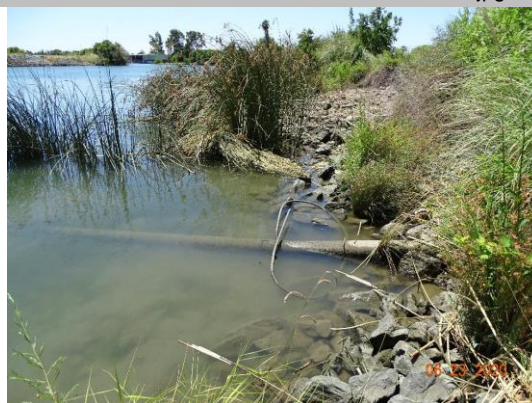
Photo 2 of 3 : UCIP_SP_2021_62333_90066.jpg

Water-Side: View of pipe at riverbank

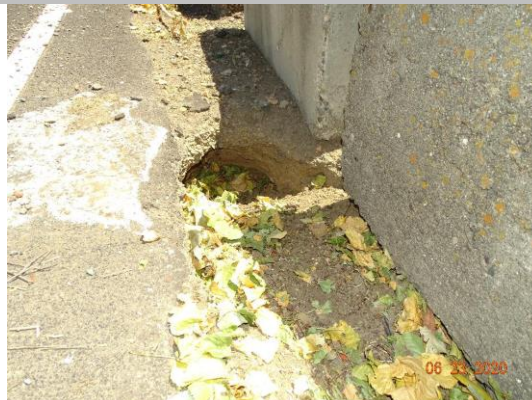
Photo 3 of 3 : UCIP_SP_2021_62333_90064.jpg

Water-Side: Sinkhole on levee shoulder at the edge of road pavement

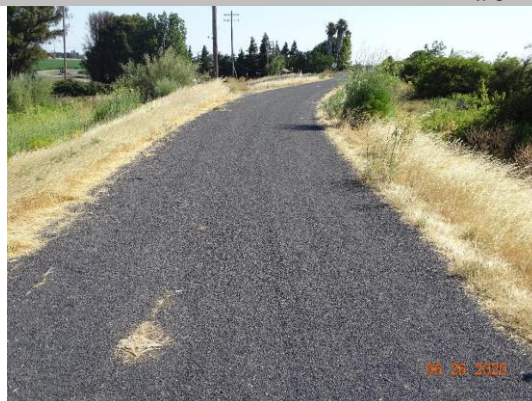
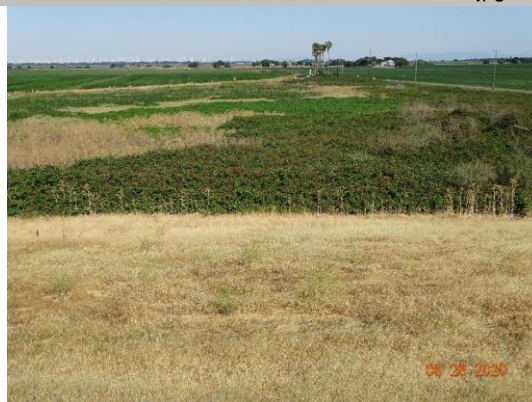
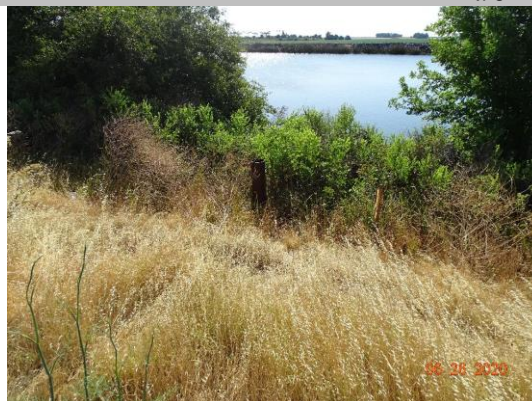
Photo 1 of 3 : UCIP_SP_2021_62334_90069.jpg

FS_ID:62334
DS_ID:21777
EP_NO: 11236
Repair Type: Non-Urgent
Crossing Status: Not Found
UCIP Comments: 06/26/2020 Record updated from No Action Needed to Non-Urgent. Crossing not found. Abandoned piles on waterside may indicate location of former pumping structure at riverbank. No permit has been identified authorizing pipe. Need to have CVFPB review ABO and determine current owner. (O.Yakimov - DWR UCIP)
FIELD_STRUCT_DESC: 8-inch steel irrigation pipe through the levee, 3 feet below the crown. Siphon breaker on the landside (LS). 0.75-inch primer valve, 15-foot by 3-foot concrete standpipe. (8-inch pipe [HLM 4.10] authorized under Automatic Board Order (ABO) issued as Permit No. 11236, 1975 - Edward Robert Freitas). [Additional Reference(s): DWR Levee Log, 2005 (HLM 4.10). USACE Sacramento O&M Manual, Unit 103, June 1954, Revised 29 December 2016, (Station 'R' 101+79.1), listed as 8-inch pipe. USACE As-Built Drawing No. 50-04-2672, Sheet 6, Station 101+79.1, 25 January 1951].

Water-Side: View of levee slope looking from crown. Piles at riverbank

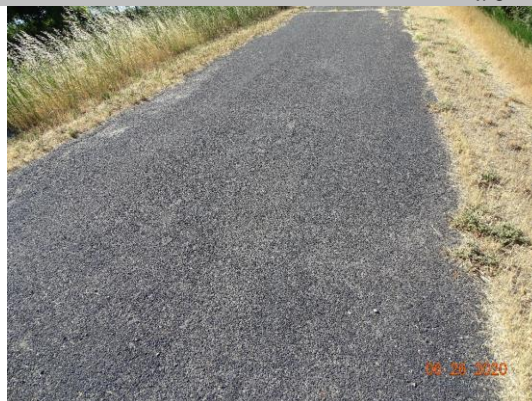
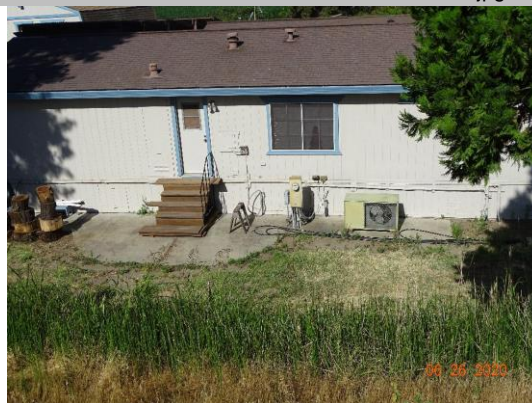
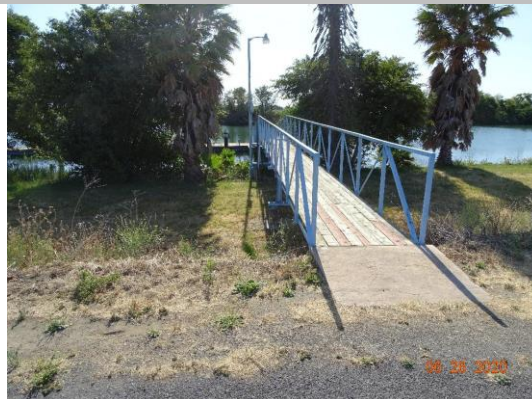
Photo 1 of 3 : UCIP_SP_2021_62335_90074.jpg

LM Start	4.19	Rating **	M	Issue No.	87	
LM End	4.19	Issue Type +	En	Location *		
Category	Supplemental			GPS Latitude/Longitude		
				Start	End	
Item	DWR UCIP Field Study			38.144978 °	38.144978 °	
				-121.601539 °	-121.601539 °	
DWR ID	23127					
Comment Code						
Inspector Comment						
FS_ID:62335 DS_ID:23127 EP_NO: N/A Repair Type: Non-Urgent Crossing Status: Found UCIP Comments: 06/26/2020 Record remains No Action Needed. No issues observed during inspection. (O.Yakimov - DWR UCIP) FIELD_STRUCT_DESC: 1-inch electrical conduit of an unknown material through the levee, at an unknown depth. 18-inch plastic riser unit on the waterside (WS) slope. FS Date: 6/26/2020 11:12:42 AM

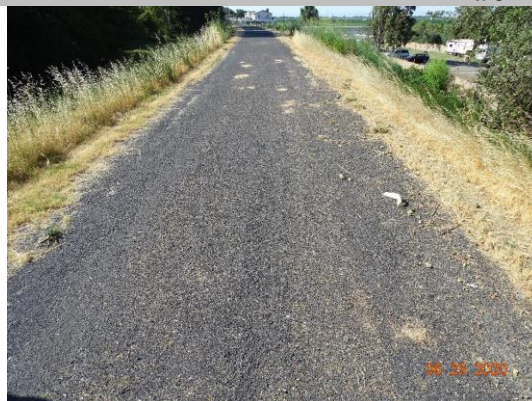
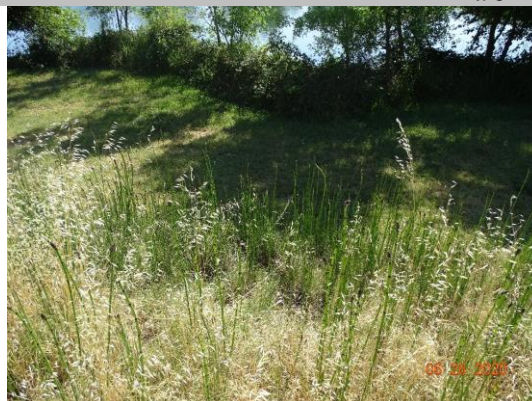
Photo 1 of 3 : UCIP_SP_2021_62337_90082.jpg

Repair Type: Non-Urgent

Crossing Status: Found

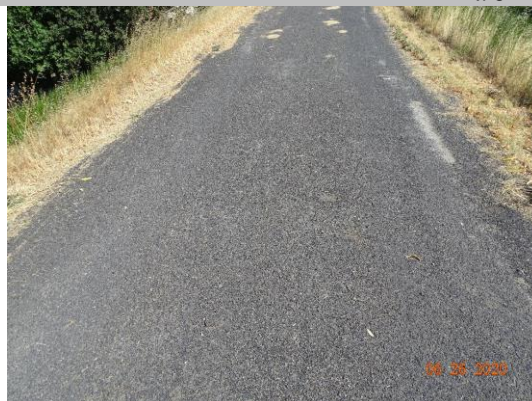
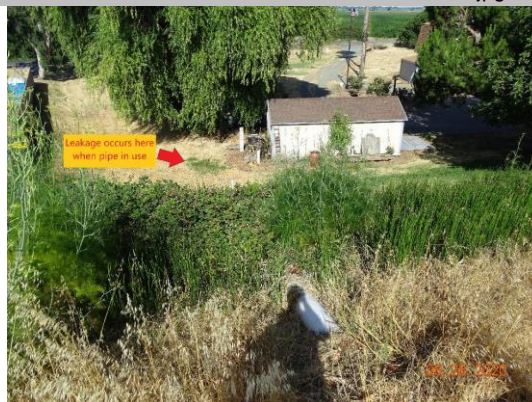
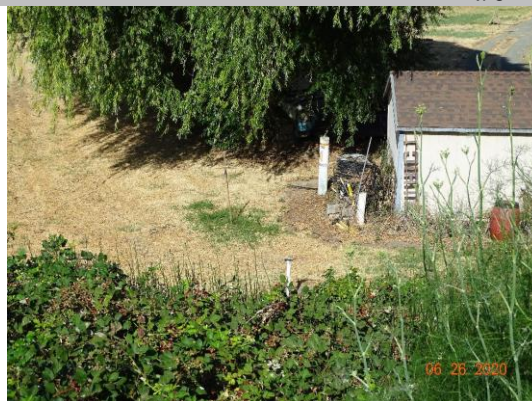
Photo 1 of 3 : UCIP_SP_2021_62338_90092.jpg

FS_ID:62338
DS_ID:21813
EP_NO: 16762
Repair Type: Urgent
Crossing Status: Found
UCIP Comments: 06/26/2020 Record updated from No Action Needed to Urgent. Local landowner informed that leakage on landside occurs when pipe is running. Excess vegetation in pipe alignment is visible at the approximate leakage spot. Recommend pipe owner to perform pipe integrity test. (O.Yakimov - DWR UCIP)
FIELD_STRUCT_DESC: 10-inch steel drainage pipe through the levee, 2 feet below the crown. Siphon breaker on the landside (LS) shoulder. Shutoff valve at the LS toe. This crossing replaces 10-inch pipe (see DSID 21779). (12-inch pipe authorized under Permit No. 16762, 1997 - Brannan Andrus Levee Maintenance District). [Additional Reference(s): DWR Levee Log, 2005 (HLM 4.21). USACE Sacramento O&M Manual, Unit 103, June 1954, Revised 29 December 2016, (Station 'R' 95+61), listed as 8-inch pipe. USACE As-Built Drawing No. 50-04-2672, Sheet 5, Station 95+61, 25 January 1951, listed as 8-inch pipe].

Land-Side: Levee slope. Shut-off valve at levee toe

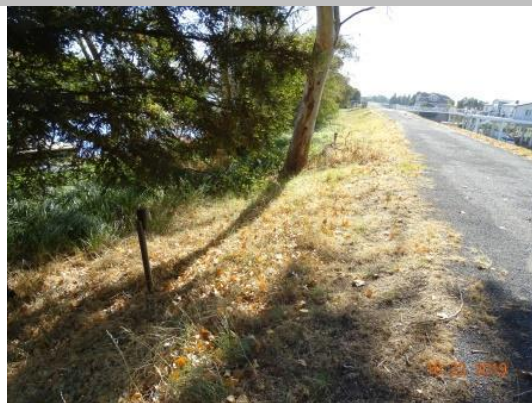
Photo 1 of 1 : SP_2021_NA0002_62_20_20210226_00008.jpg

LM Start	4.23	Rating **	M	Issue No.	20
LM End	4.29	Issue Type +	En	Location *	WS
Category	Earthen Levee			GPS Latitude/Longitude	
				Start	End
Item	Encroachments			38.144471 °	38.143652 °
				-121.601381 °	-121.600877 °
DWR ID	DWR_NA0002_01_f _ 2019_20				
Comment Code					
LI : Landscape Irrigation					
Inspector Comment					
Sprinkler system on waterside of levee.

View looking downstream at sprinkler system on the waterside slope (Fall 2019).

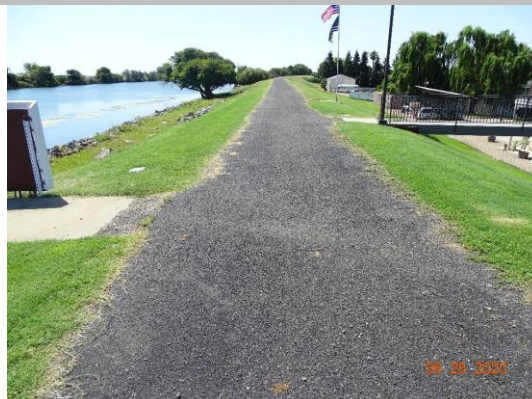
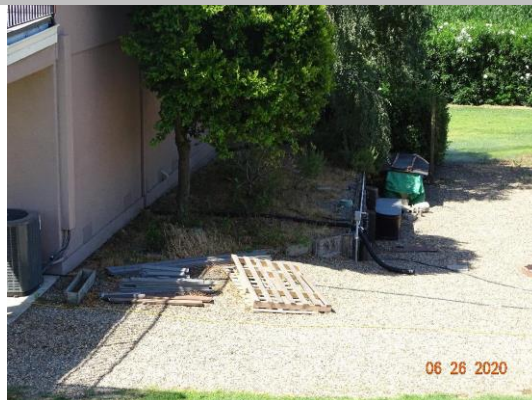
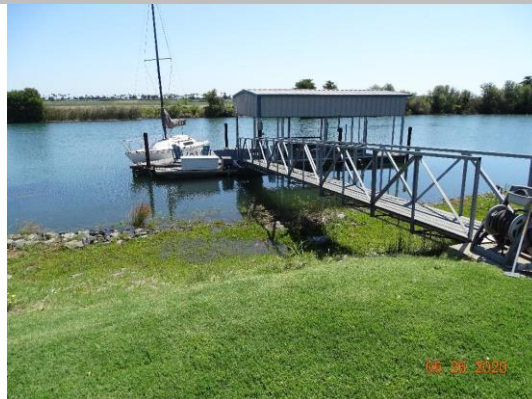
Photo 1 of 3 : UCIP_SP_2021_62347_90133.jpg

LM Start	4.37	Rating **	M	Issue No.	90
LM End	4.37	Issue Type +	En	Location *	
Category	Supplemental			GPS Latitude/Longitude	
				Start	End
Item	DWR UCIP Field Study			38.142643 °	38.142643 °
				-121.599993 °	-121.599993 °
DWR ID	23124				
Comment Code					
Inspector Comment					
FS_ID:62347 DS_ID:23124 EP_NO: N/A Repair Type: Non-Urgent Crossing Status: Found UCIP Comments: 06/26/2020 Record updated from No Action Needed to Non-Urgent. No permit has been found authorizing this pipe through the levee. (O.Yakimov - DWR UCIP) FIELD_STRUCT_DESC: 0.5-inch polyvinyl chloride electrical conduit through the levee, 2 feet below the crown. Pipes visible under walkway. Permit T2017119 to install sprinklers on both sides of levee road is withdrawn. FS Date: 6/26/2020 1:39:35 PM

Land-Side: Electrical conduit next to house

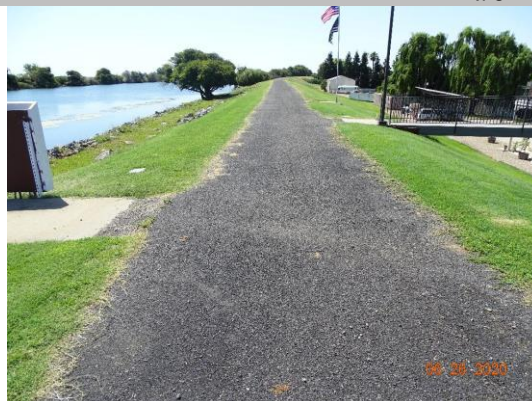
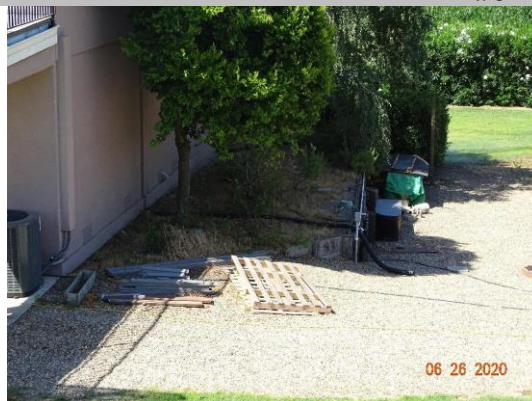
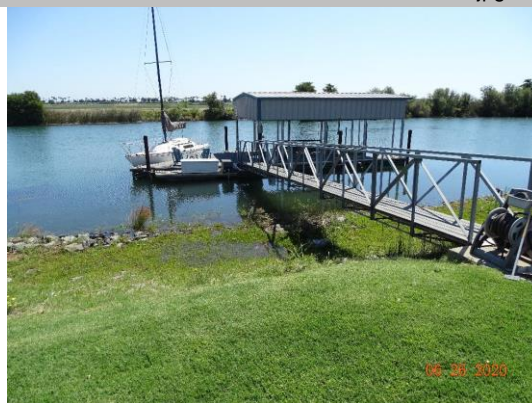
Photo 1 of 3 : UCIP_SP_2021_62348_90138.jpg

FS_ID:62348
DS_ID:23123
EP_NO: N/A
Repair Type: Non-Urgent
Crossing Status: Found
UCIP Comments: 06/26/2020 Record updated from No Action Needed to Non-Urgent. No permit has been found authorizing this pipe through the levee. (O.Yakimov - DWR UCIP)
FIELD_STRUCT_DESC: 0.5-inch polyvinyl chloride electrical conduit through the levee, 2 feet below the crown. Pipes visible under walkway on the waterside (WS) shoulder.
FS Date: 6/26/2020 1:42:40 PM

Land-Side: Electrical conduit next to house

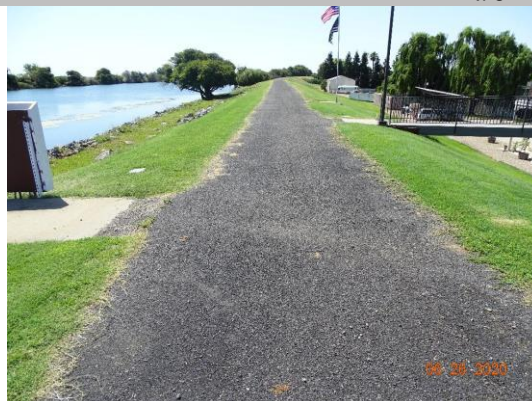
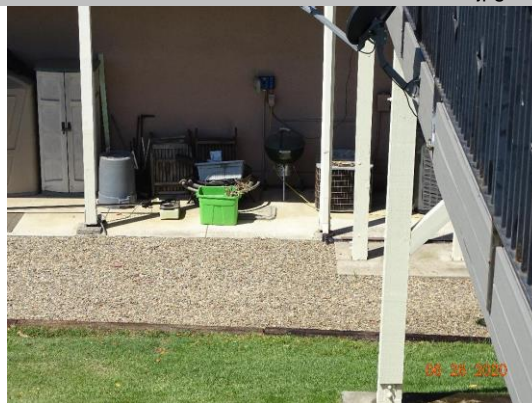
Photo 1 of 3 : UCIP_SP_2021_62349_90144.jpg

LM Start	4.38	Rating **	M	Issue No.	92
LM End	4.38	Issue Type +	En	Location *	
Category	Supplemental			GPS Latitude/Longitude	
				Start	End
Item	DWR UCIP Field Study			38.142643 °	38.142643 °
				-121.599993 °	-121.599993 °
DWR ID	23122				
Comment Code					
Inspector Comment					
FS_ID:62349 DS_ID:23122 EP_NO: N/A Repair Type: Non-Urgent Crossing Status: Found UCIP Comments: 06/26/2020 Record updated from No Action Needed to Non-Urgent. No permit has been found authorizing this pipe through the levee. (O.Yakimov - DWR UCIP) FIELD_STRUCT_DESC: 2-inch polyvinyl chloride irrigation pipe through the levee, 2 feet below the crown. Pump on boat dock on the waterside (WS) with walkway. Pipes visible under walkway. FS Date: 6/26/2020 1:45:03 PM

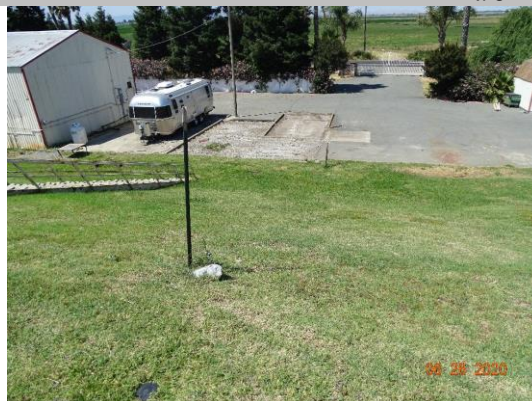
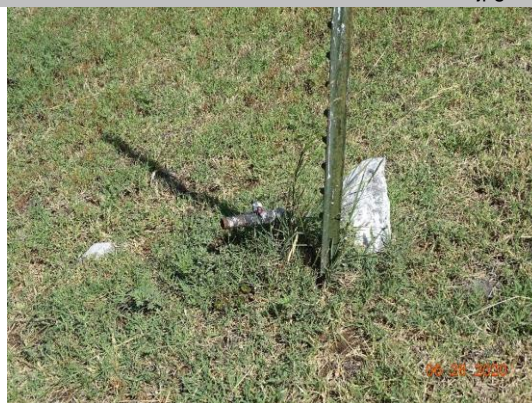
Photo 2 of 3 : UCIP_SP_2021_62350_90151.jpg

Land-Side: Siphon breaker / filler pipe on levee slope

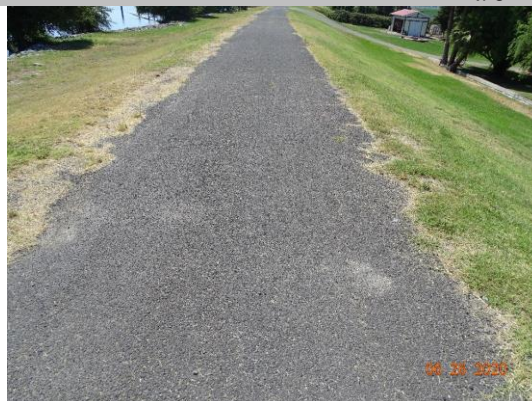
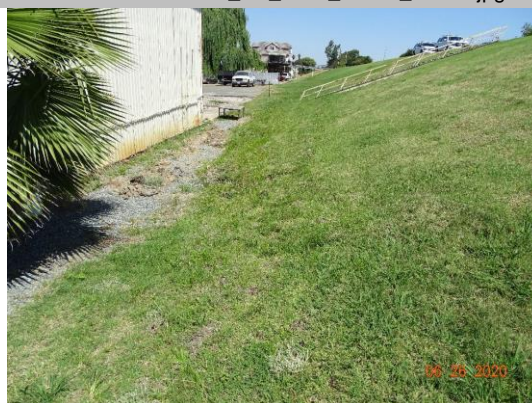
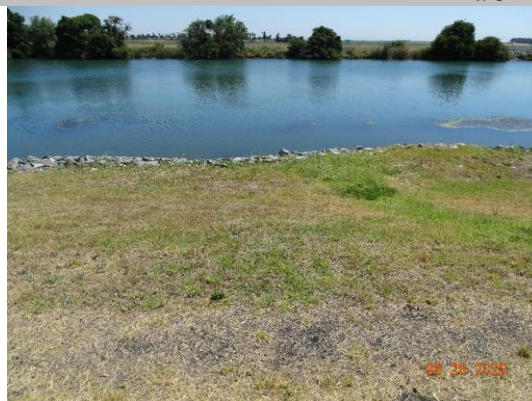
Photo 1 of 3 : UCIP_SP_2021_62351_90157.jpg

FS_ID:62351
DS_ID:21827
EP_NO: 11237
Repair Type: Non-Urgent
Crossing Status: Not Found
UCIP Comments: 06/26/2020 Record updated from No Action Needed to Non-Urgent. Crossing not found. No permit has been identified authorizing pipe. Need to have CVFPB review ABO and determine current owner. (O.Yakimov - DWR UCIP)

Land-Side: View of levee slope at potential crossing

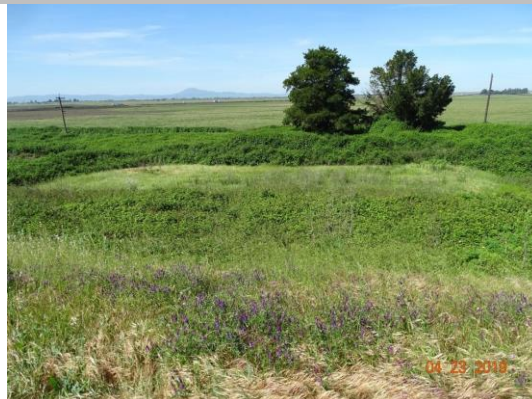
Photo 1 of 1 : SP_2021_NA0002_62_85_20210226_00035.jpg

LM Start	4.55	Rating **	U	Issue No.	85
LM End	4.55	Issue Type +	Ma	Location *	LS
Category	Earthen Levee			GPS Latitude/Longitude	
				Start	End
Item	Vegetation			38.140402 °	38.140402 °
				-121.598275 °	-121.598275 °
DWR ID	DWR_NA0002_01_s_2019_85				
Comment Code					
V2 : Remove the wild growth other than native grasses from the levee slopes.					
Inspector Comment					
Remove blackberries from landside toe

View looking downslope at blackberries at the landside slope (Spring 2019).

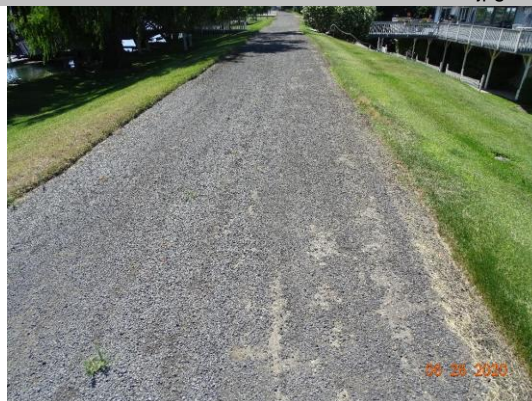
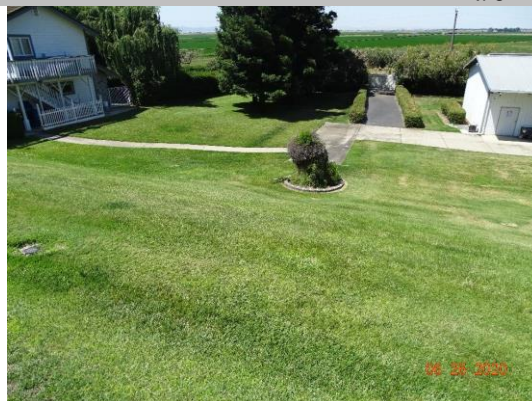
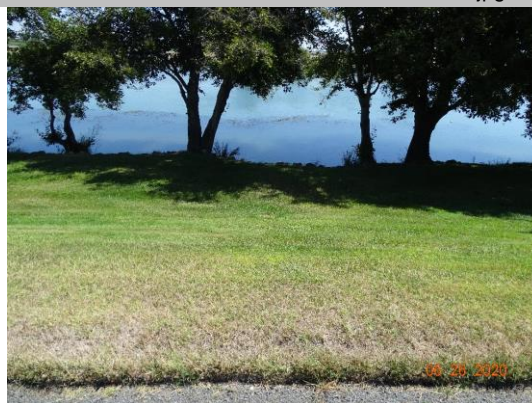
Photo 1 of 3 : UCIP_SP_2021_62355_90176.jpg

Comment Code					
Inspector Comment					
FS_ID:62355 DS_ID:21781 EP_NO: 11237 Repair Type: Non-Urgent Crossing Status: Found UCIP Comments: 06/26/2020 Record remains Non-Urgent. Crossing appears abandoned. Vegetation grows in concrete standpipe on landside. Pipe is under water at riverbank. No permit has been identified authorizing pipe. Need to have CVFPB review ABO and determine current owner. (O.Yakimov - DWR UCIP) 05/15/2013 Appears abandoned. Good candidate for video inspection. FIELD_STRUCT_DESC: 6-inch steel irrigation pipe through the levee, 3.6 feet below the crown. 42-inch concrete standpipe on the landside (LS) toe. (7-inch pipe [HLM 4.63] authorized under Automatic Board Order (ABO) issued as Permit No. 11237, 1975 - Bruna Galli). [Additional Reference(s): DWR Levee Log, 2005 (HLM 4.63). USACE Sacramento O&M Manual, Unit 103, June 1954, Revised 29 December 2016, (Station 'R' 74+06), listed as 6-inch pipe. USACE As-Built Drawing No. 50-04-2672, Sheet 5, Station 74+06, 25 January 1951]. FS Date: 6/26/2020 8:21:40 AM

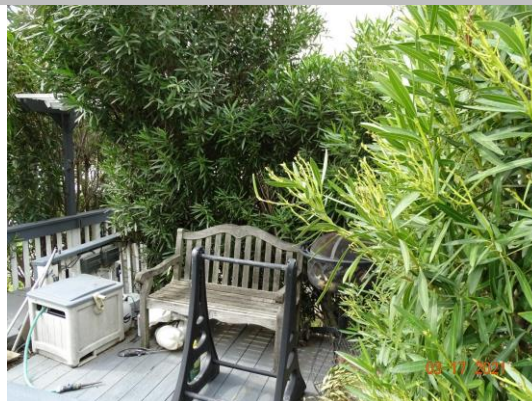
Photo 1 of 1 : SP_2021_NA0002_62_131_20210317_00238.jpg

LM Start	4.65	Rating **	U	Issue No.	131
LM End	4.65	Issue Type +	En	Location *	LS
Category	Earthen Levee			GPS Latitude/Longitude	
				Start	End
Item	Vegetation			38.139167 °	38.139167 °
				-121.597561 °	-121.597561 °
DWR ID	DWR_NA0002_01_s_2021_131				
Comment Code					
V6 : Landscaping					
Inspector Comment					
Oleanders blocking view down landside slope.

View of oleanders on the landside slope (Spring 2021).

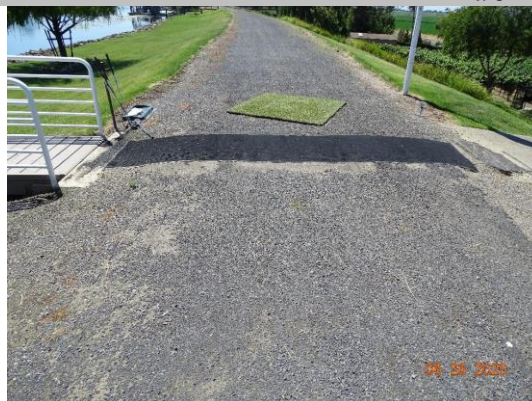
Photo 1 of 3 : UCIP_SP_2021_62360_90196.jpg

LM Start	4.70	Rating **	M	Issue No.	96	
LM End	4.70	Issue Type +	En	Location *		
Category	Supplemental			GPS Latitude/Longitude		
				Start	End	
Item	DWR UCIP Field Study			38.138546 °	38.138546 °	
				-121.597213 °	-121.597213 °	
DWR ID	23117					
Comment Code						
Inspector Comment						
FS_ID:62360						
DS_ID:23117						
EP_NO: N/A						
Repair Type: Non-Urgent						
Crossing Status: Found						
UCIP Comments: 06/26/2020 Record updated from No Action Needed to Non-Urgent. No permit has been found authorizing this pipe through the levee. (O.Yakimov - DWR UCIP)						
FIELD_STRUCT_DESC: 1-inch polyvinyl chloride irrigation pipe through the levee, 1.5 feet below the crown. Pump on dock. Pipes visible under walkway.						
FS Date: 6/26/2020 9:36:38 AM

Top of Levee: View of levee crown looking downstream

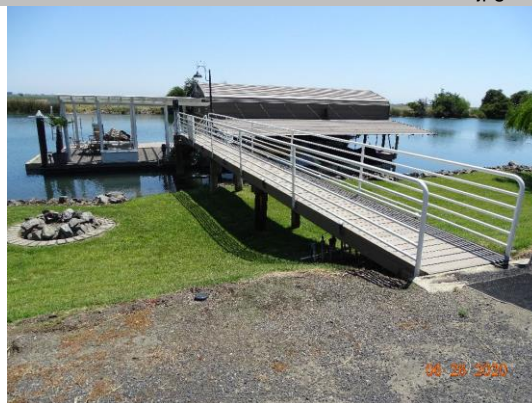
Photo 2 of 3 : UCIP_SP_2021_62360_90197.jpg

Water-Side: View of levee slope looking from crown

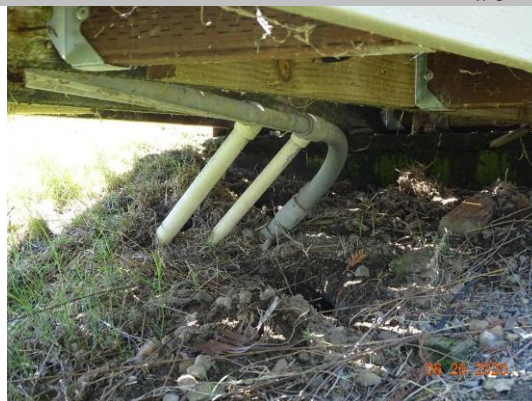
Photo 3 of 3 : UCIP_SP_2021_62360_90198.jpg

Water-Side: Pipe under walkway

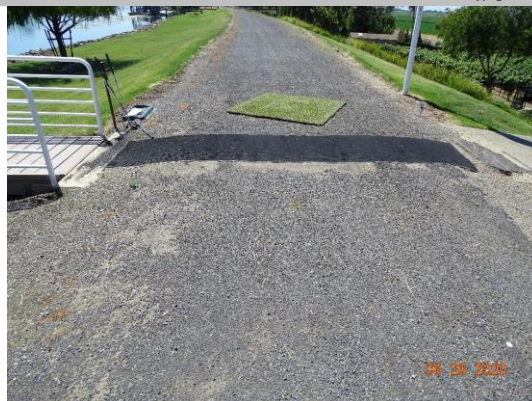
Photo 1 of 3 : UCIP_SP_2021_62361_90203.jpg

FS_ID:62361
DS_ID:23118
EP_NO: N/A
Repair Type: Non-Urgent
Crossing Status: Found
UCIP Comments: 06/26/2020 Record updated from No Action Needed to Non-Urgent. No permit has been found authorizing this pipe through the levee. (O.Yakimov - DWR UCIP)

Top of Levee: View of levee crown looking downstream

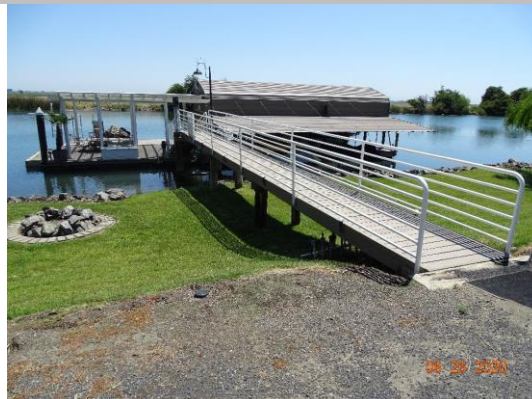
Photo 2 of 3 : UCIP_SP_2021_62361_90204.jpg

Water-Side: View of levee slope looking from crown

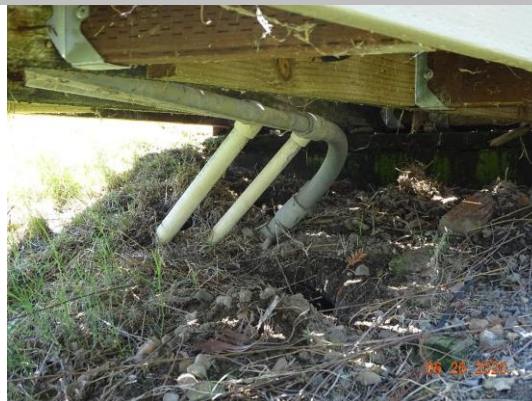
Photo 3 of 3 : UCIP_SP_2021_62361_90205.jpg

Water-Side: Pipe under walkway

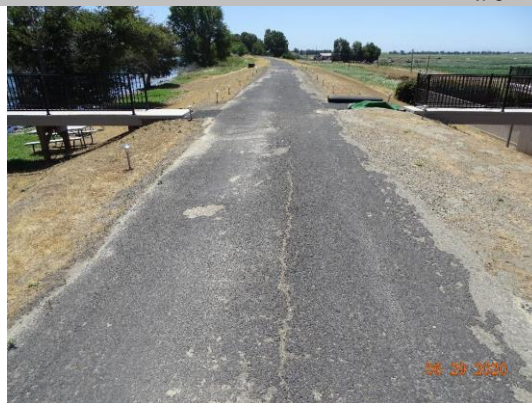
Photo 1 of 3 : UCIP_SP_2021_62371_90241.jpg

FS_ID:62371
DS_ID:21796
EP_NO: 13667
Repair Type: Non-Urgent
Crossing Status: Found
UCIP Comments: 06/29/2020 Record updated from No Action Needed to Non-Urgent. Recommend owner to install utility box and conduit to protect electrical cable on waterside. (O.Yakimov - DWR UCIP)
FIELD_STRUCT_DESC: 1-inch electrical conduit of an unknown material through the levee, 2 feet below the crown. (Utility line (special condition 23) authorized under Permit No. 13667, 1983 - Ted Amlick).
FS Date: 6/29/2020 1:43:47 PM

Top of Levee: View of levee crown looking downstream

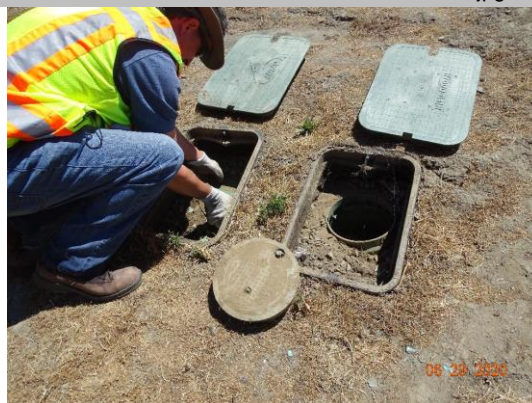
Photo 3 of 3 : UCIP_SP_2021_62371_90243.jpg

Land-Side: Christie box on levee slope

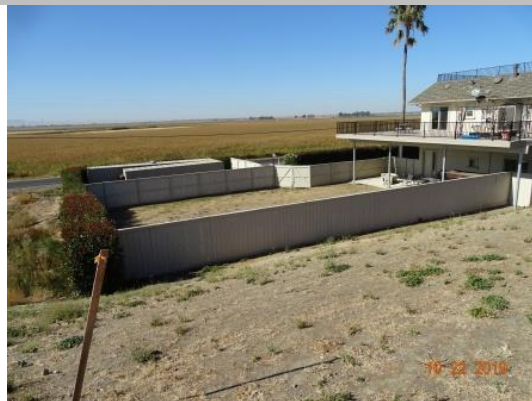
Photo 1 of 1 : SP_2021_NA0002_62_48_20210226_00016.jpg

LM Start	4.83	Rating **	U	Issue No.	48
LM End	4.83	Issue Type +	En	Location *	LS
Category	Earthen Levee			GPS Latitude/Longitude	
				Start	End
Item	Encroachments			38.136839 °	38.136839 °
				-121.595994 °	-121.595994 °
DWR ID	DWR_NA0002_01_f_2015_48				
Comment Code					
FE : Fence					
Inspector Comment					
Unauthorized fence at landside toe.

View looking downslope at unauthorized fence on the landside (Fall 2019).

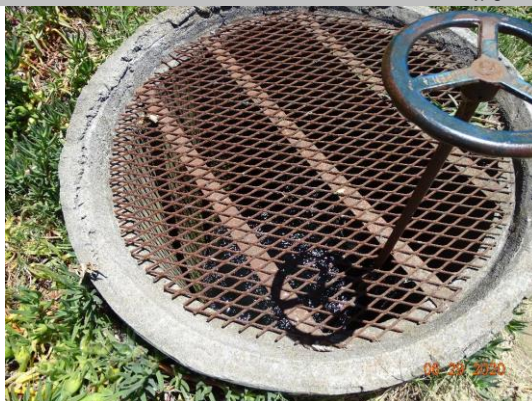
Photo 3 of 3 : UCIP_SP_2021_62377_90275.jpg

FS_ID:62377
DS_ID:21784
EP_NO: 11244
Repair Type: Non-Urgent
Crossing Status: Found
UCIP Comments: 06/29/2020 Record updated from No Action Needed to Non-Urgent. No permit has been identified authorizing pipe. Need to have CVFPB review ABO and determine current owner. Pipe is running - no leaks detected. (O.Yakimov - DWR UCIP)

Land-Side: Concrete standpipe with screw gate at levee toe

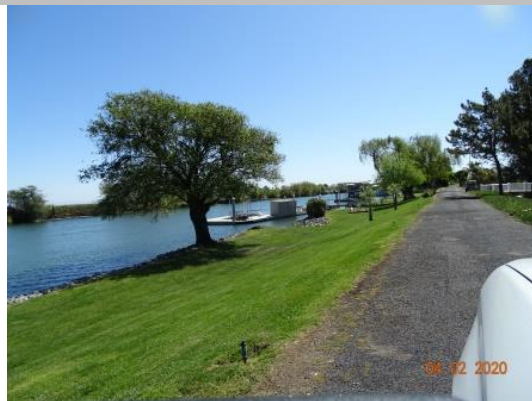
Photo 1 of 1 : SP_2021_NA0002_62_57_20210226_00021.jpg

LM Start	5.07	Rating **	M	Issue No.	57
LM End	5.15	Issue Type +	En	Location *	WS
Category	Earthen Levee			GPS Latitude/Longitude	
				Start	End
Item	Encroachments			38.134238 °	38.133325 °
				-121.593188 °	-121.592032 °
DWR ID	DWR_NA0002_01_s_2020_57				
Comment Code					
LI : Landscape Irrigation					
Inspector Comment					
Sprinklers on the waterside slope.

View looking downstream at sprinklers on the waterside slope (Spring 2020).

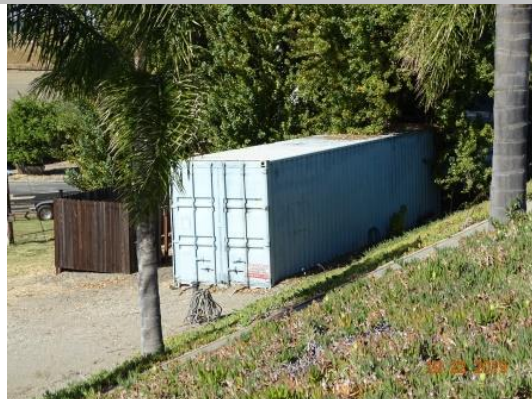
Photo 1 of 1 : SP_2021_NA0002_62_66_20210226_00027.jpg

LM Start	5.13	Rating **	U	Issue No.	66
LM End	5.13	Issue Type +	En	Location *	LS
Category	Earthen Levee			GPS Latitude/Longitude	
				Start	End
Item	Encroachments			38.133600 °	38.133600 °
				-121.592414 °	-121.592414 °
DWR ID	DWR_NA0002_01_s_2016_66				
Comment Code					
BU : Building					
Inspector Comment					
Storage container at landside toe.

View looking upstream at storage container at the landside toe (Fall 2019).

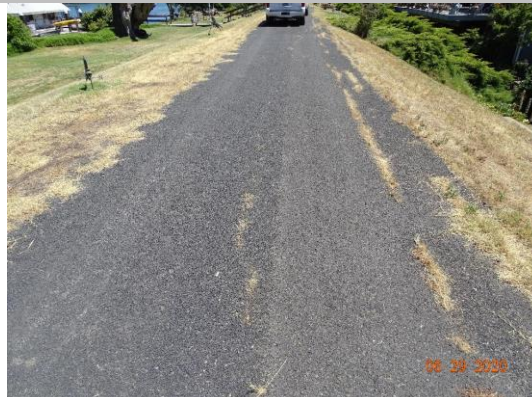
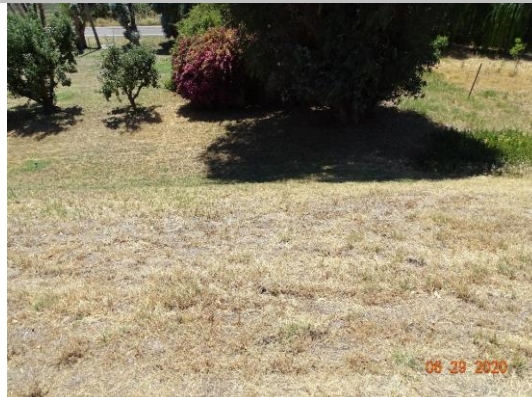
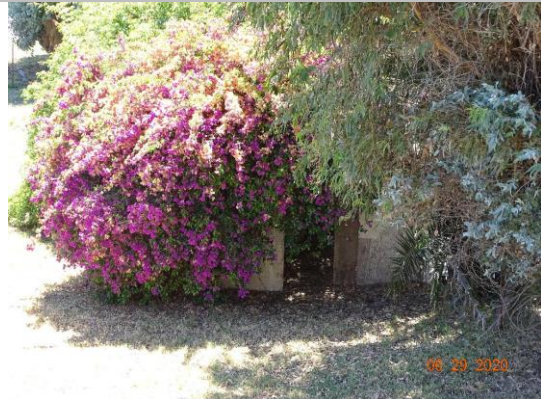
LM Start	5.21	Rating **	M	Issue No.	109	
LM End	5.21	Issue Type +	En	Location *		
Category	Supplemental			GPS Latitude/Longitude		
				Start		End
Item	DWR UCIP Field Study			38.132682 °		38.132682 °
				-121.591369 °		-121.591369 °
DWR ID	21785					
Comment Code						
Inspector Comment						
FS_ID:62389 DS_ID:21785 EP_NO: N/A Repair Type: Non-Urgent Crossing Status: Indicator Found UCIP Comments: 06/29/2020 Record updated from No Action Needed to Non-Urgent. Crossing appears abandoned. Abandoned pumphouse on landside, 3/4-inch air vent pipe on waterside shoulder. No permit has been found authorizing this pipe through the levee. (O.Yakimov - DWR UCIP) FIELD_STRUCT_DESC: 2.5-inch pipe of an unknown material or purpose through the levee, 2.2 feet below the crown. FS Date: 6/29/2020 2:17:41 PM

Top of Levee: View of levee crown looking downstream

Land-Side: View of levee slope looking crown

Land-Side: Abandoned pumphouse off levee toe

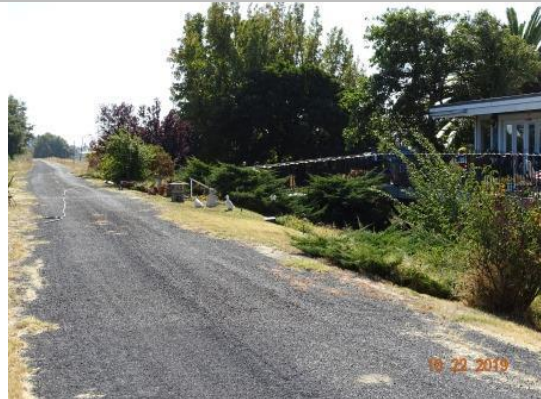
Photo 1 of 1 : SP_2021_NA0002_62_78_20210226_00032.jpg

LM Start	5.22	Rating **	U	Issue No.	78
LM End	5.24	Issue Type +	En	Location *	LS
Category	Earthen Levee			GPS Latitude/Longitude	
				Start	End
Item	Vegetation			38.132606 °	38.132322 °
				-121.591295 °	-121.590989 °
DWR ID	DWR_NA0002_01_s_2018_78				
Comment Code					
V6 : Landscaping					
Inspector Comment					
Heavy landscaping completely blocks visibility and access to landside slope and toe.

View looking downstream at landscaping on the landside slope (Fall 2019).

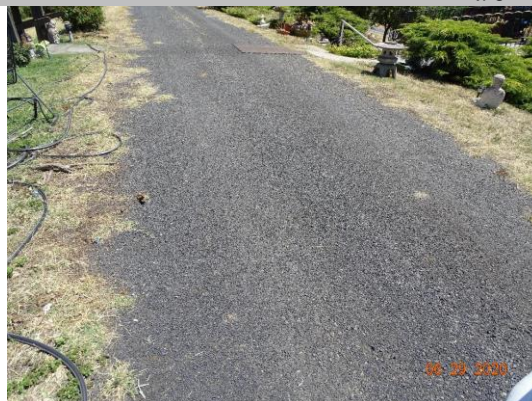
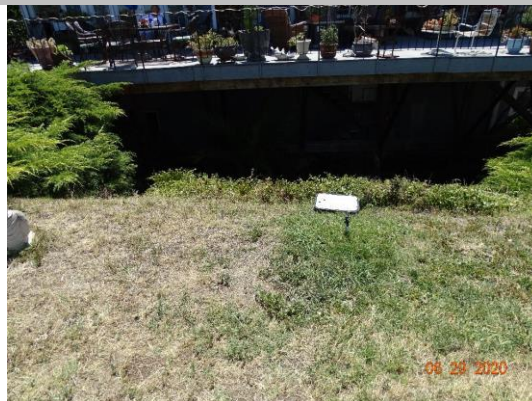
LM Start	5.23	Rating **	M	Issue No.	110
LM End	5.23	Issue Type +	En	Location *	
Category	Supplemental			GPS Latitude/Longitude	
				Start	End
Item	DWR UCIP Field Study			38.132462 °	38.132462 °
				-121.591131 °	-121.591131 °
DWR ID	21786				
Comment Code					
Inspector Comment					
FS_ID:62390 DS_ID:21786 EP_NO: N/A Repair Type: Non-Urgent Crossing Status: Not Found UCIP Comments: 06/29/2020 Record updated from No Action Needed to Non-Urgent. Crossing not found. No permit has been found authorizing this pipe through the levee. (O.Yakimov - DWR UCIP) FIELD_STRUCT_DESC: 2-inch pipe of an unknown material or purpose through the levee, 3.2 feet below the crown. FS Date: 6/29/2020 2:20:01 PM

Top of Levee: View of levee crown looking downstream

Land-Side: View of levee slope looking from crown. Private dwelling on landside

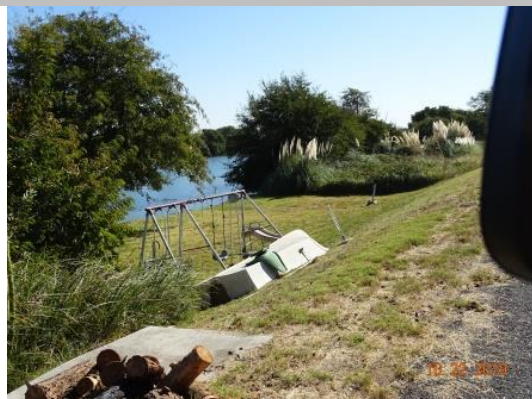
Photo 1 of 1 : SP_2021_NA0002_62_60_20210226_00024.jpg

LM Start	5.26	Rating **	M	Issue No.	60
LM End	5.26	Issue Type +	En	Location *	WS
Category	Earthen Levee			GPS Latitude/Longitude	
				Start	End
Item	Encroachments			38.132199 °	38.132199 °
				-121.590855 °	-121.590855 °
DWR ID	DWR_NA0002_01_s_2015_60				
Comment Code					
GA : Garbage					
Inspector Comment					
An abandoned child's swing set at the waterside toe.

View looking downstream at abandoned child's swing and other garbage on the waterside slope (Fall 2019).

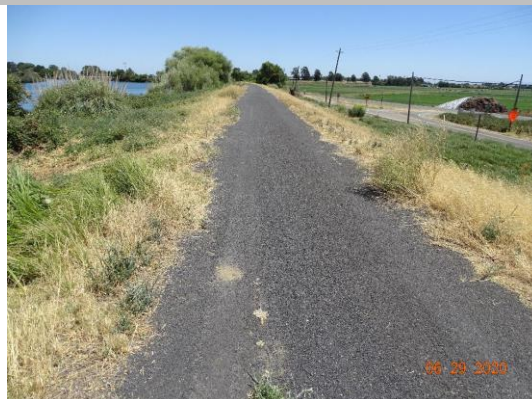
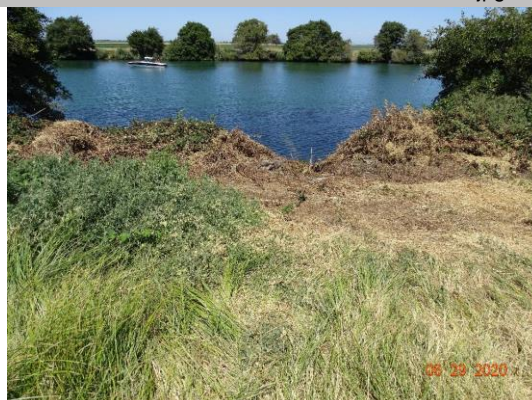
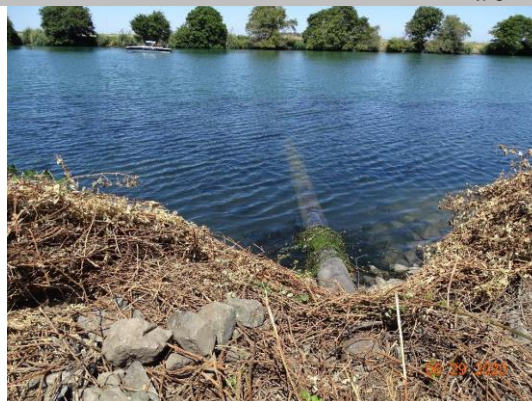
FS_ID:62393
DS_ID:21816
EP_NO: 11245
Repair Type: Non-Urgent
Crossing Status: Found
UCIP Comments: 06/29/2020 Record remains Non-Urgent. Slide gate is closed, pipe is under water inside of concrete riser - unable to evaluate pipe condition and compare with previous inspection comment. No permit has been identified authorizing pipe. Need to have CVFPB review ABO and determine current owner. (O.Yakimov - DWR UCIP)
05/08/2013 Appears abandoned. Pipe at slide gate in riser on LS toe is rusted through.
FIELD_STRUCT_DESC: 14-inch steel irrigation pipe through the levee, 3.8 feet below the crown. 2-inch primer valve and 48-inch concrete standpipe on the landside (LS). (12-inch pipe [HLM 5.37] authorized under Automatic Board Order (ABO) issued as Permit No. 11245, 1975 - Mary Nobrega & Manuel Mendes et.al). [Additional Reference(s): DWR Levee Log, 2005 (HLM 5.36), listed as 14-inch pipe. USACE Sacramento O&M Manual, Unit 103, June 1954, Revised 29 December 2016, (Station 'R' 35+76.7), listed as 14-inch pipe. USACE As-Built Drawing No. 50-04-2672, Sheet 3, Station 35+76.7, 25 January 1951].

Top of Levee: View of levee crown looking downstream

Water-Side: View of levee slope looking from crown

Water-Side: View of pipe at riverbank

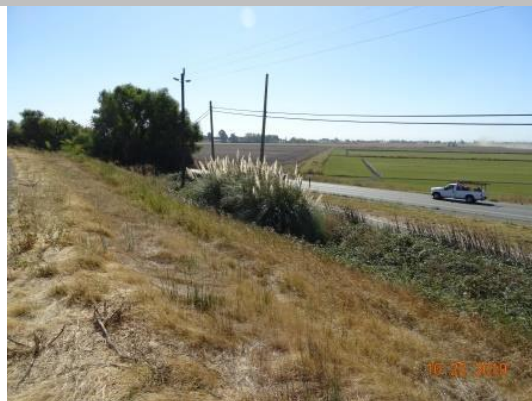
Photo 1 of 1 : SP_2021_NA0002_62_23_20210226_00009.jpg

LM Start	5.44	Rating **	M	Issue No.	23
LM End	5.57	Issue Type +	Ma	Location *	LS
Category	Earthen Levee			GPS Latitude/Longitude	
				Start	End
Item	Vegetation			38.130115 °	38.129359 °
				-121.588662 °	-121.586487 °
DWR ID	DWR_NA0002_01_s_2012_23				
Comment Code					
V2 : Remove the wild growth other than native grasses from the levee slopes.					
Inspector Comment

View looking downstream at vegetation at the landside toe (Fall 2019).

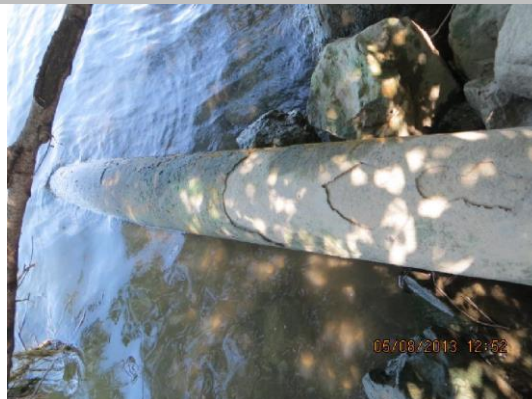
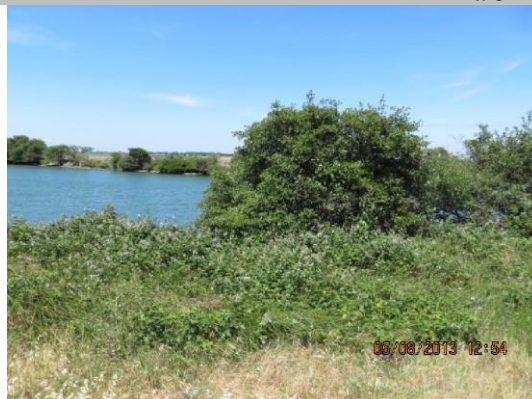
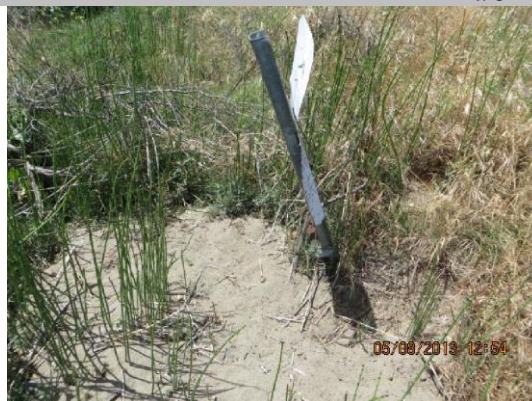
FS_ID:62394
DS_ID:21788
EP_NO: 11245
Repair Type: Urgent
Crossing Status: Found
UCIP Comments: 07/01/2020 Record updated from No Action Needed to Urgent. Soil depression on landside slope from concrete standpipe up the slope measures 13' x 3' x 1'-deep. Overgrown vegetation on waterside limits inspection of levee at this crossing. Crossing appears abandoned. Slide gate inside of concrete standpipe not in operable condition. 1-1/2 hose connected to siphon breaker / filler pipe on landside shoulder. No permit has been identified authorizing pipe. Need to have CVFPB review ABO and determine current owner.
(O.Yakimov - DWR UCIP)

10-inch pipe at WS toe.

Pipe visible at WS toe to left of tree in photo.

Siphon breaker next to paddle marker on LS shoulder.

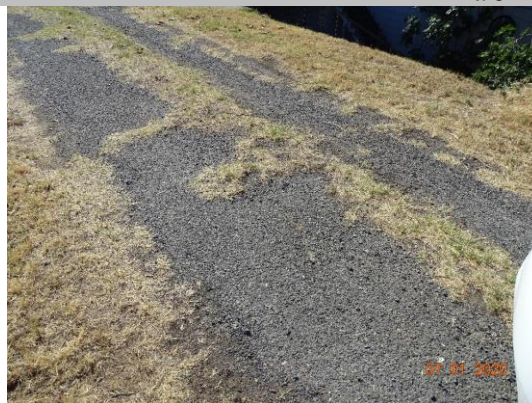
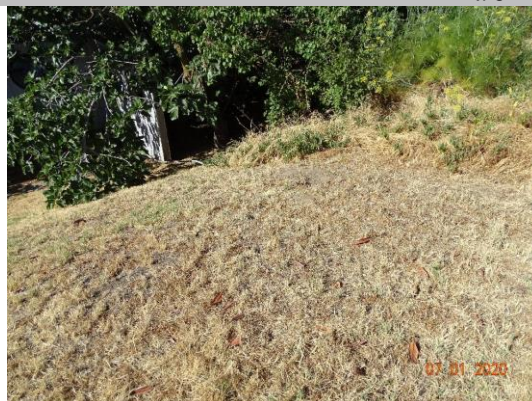
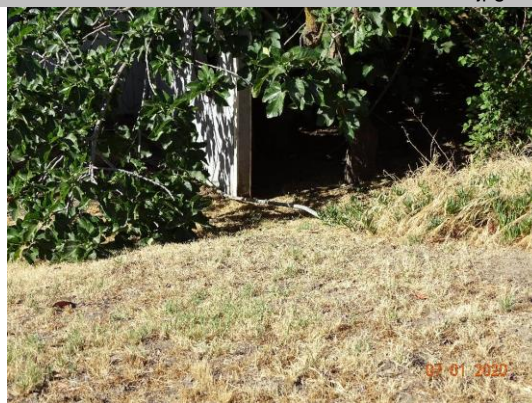
LM Start	5.84	Rating **	M	Issue No.	113	
LM End	5.84	Issue Type +	En	Location *		
Category	Supplemental			GPS Latitude/Longitude		
				Start		End
Item	DWR UCIP Field Study			38.129652 °	38.129652 °	
				-121.581641 °	-121.581641 °	
DWR ID	23131					
Comment Code						
Inspector Comment						
FS_ID:62395 DS_ID:23131 EP_NO: N/A Repair Type: Non-Urgent Crossing Status: Found UCIP Comments: 07/01/2020 Record updated from No Action Needed to Non-Urgent. No permit has been found authorizing this pipe through the levee. Need to have CVFPB review ABO and determine current owner. Pipe visible only on landside. (O.Yakimov - DWR UCIP) FIELD_STRUCT_DESC: 1-inch galvanized iron water line, at an unknown depth, visible at the landside (LS) toe. (Waterline authorized under Automatic Board Order (ABO) issued as Permit No. 4366B, 1974 - Mr. Aramis Fouche). FS Date: 7/1/2020 9:53:54 AM

Top of Levee: View of levee crown looking downstream

Land-Side: View of levee slope looking from crown

Land-Side: Pipe visible on levee toe at a structure covered with tree branches

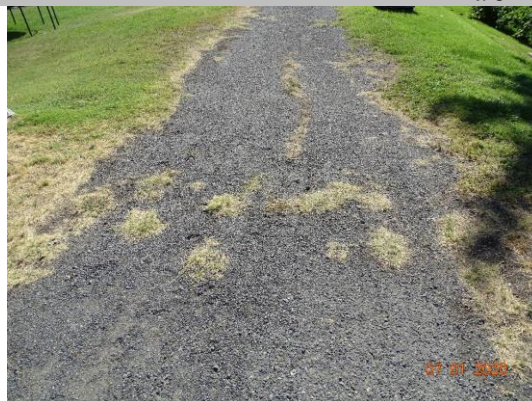
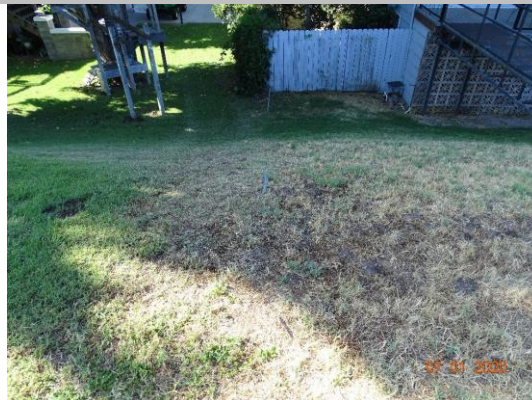
Comment Code						
Inspector Comment						
FS_ID:62396 DS_ID:23132 EP_NO: N/A Repair Type: Non-Urgent Crossing Status: Found UCIP Comments: 07/01/2020 Record updated from No Action Needed to Non-Urgent. No permit has been found authorizing this pipe through the levee. Need to have CVFPB review ABO and determine current owner. (O.Yakimov - DWR UCIP) FIELD_STRUCT_DESC: 1.5-inch galvanized iron water line, at an unknown depth, visible on the landside (LS) toe and at building corner at the waterside (WS) toe. (Waterline authorized under Automatic Board Order (ABO) issued as Permit No. 4366B, 1974 - Mr. Aramis Fouche). FS Date: 7/1/2020 9:56:55 AM

Top of Levee: View of levee crown looking downstream

Land-Side: View of levee slope looking from crown
