**Flood Control Project Maintenance
Levee Inspections
LMA District Cover Sheet**

Brannan Andrus Levee Maintenance District

Waterway			Bank	Unit Miles
Unit No. 01 Georgiana Slough			Right	6.01
	Spring (March - May)	Summer (June - August)	(September - November) Fall	Winter (December - February)
Unit Maintenance Rating (Fall Only)				
Date of Inspection	3/17/2021 - 3/17/2021			
DWR Inspector	David Julian			
Accompanied By

Levee Inspection Report By Mile - Spring 2021

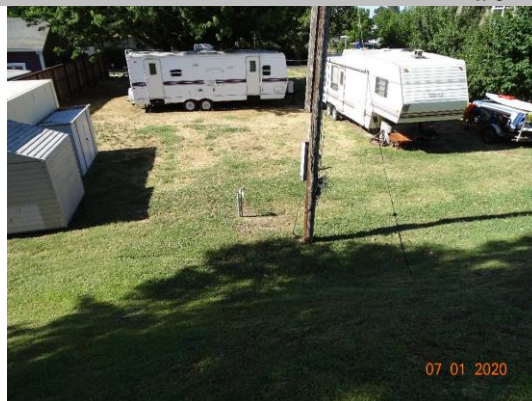
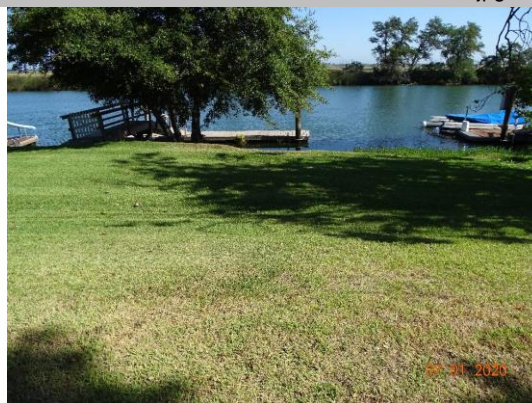
Land-Side: View of levee slope looking from crown

Water-Side: View of levee slope looking from crown

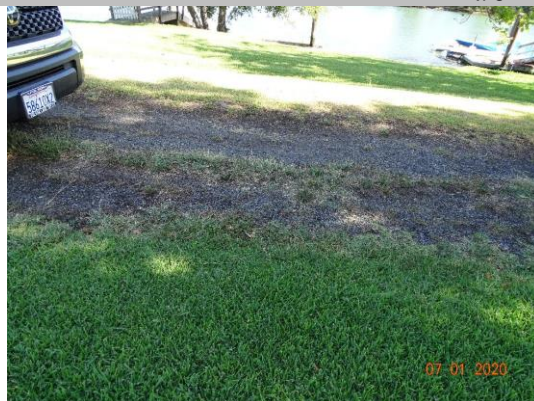
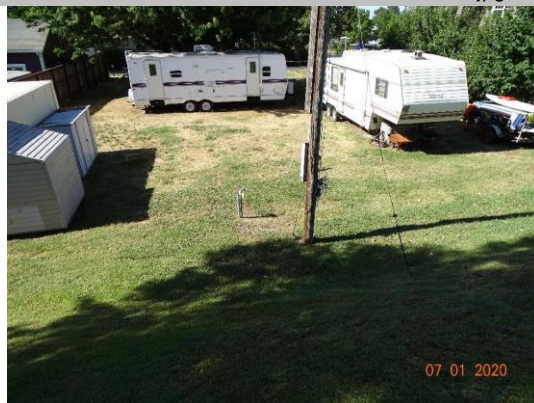
LM Start	5.88	Rating **	M	Issue No.	116	
LM End	5.88	Issue Type +	En	Location *		
Category	Supplemental			GPS Latitude/Longitude		
				Start	End	
Item	DWR UCIP Field Study			38.129712 °	38.129712 °	
				-121.581011 °	-121.581011 °	
DWR ID	21858					
Comment Code						
Inspector Comment						
FS_ID:62400 DS_ID:21858 EP_NO: 14429 Repair Type: Non-Urgent Crossing Status: Not Found UCIP Comments: 07/01/2020 Record updated from No Action Needed to Non-Urgent. Crossing not found. (O.Yakimov - DWR UCIP) FIELD_STRUCT_DESC: Utility conduit of an unknown size or material through the levee, 2 feet below the crown. (Utility line authorized under Permit No. 14429, 1986 - James A. and Joan Deak). FS Date: 7/1/2020 10:13:26 AM

Top of Levee: View of levee crown looking towards waterside

Land-Side: View of levee slope looking from crown

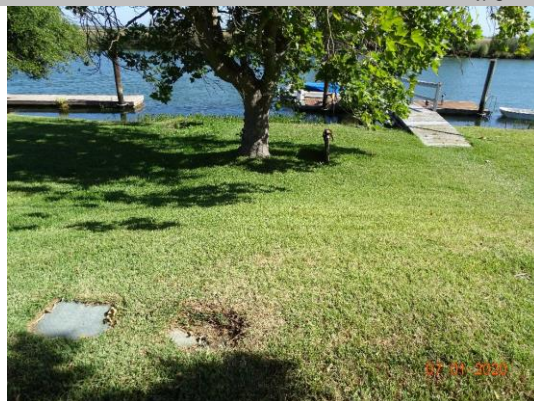
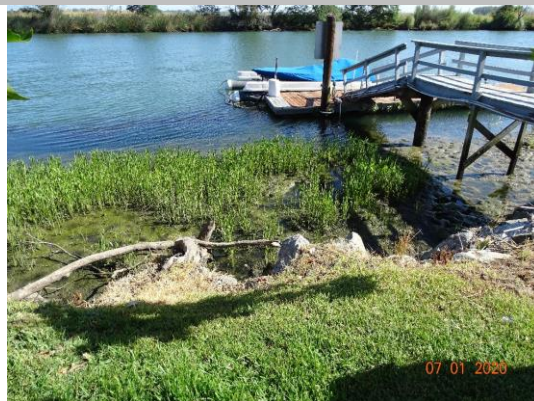
Water-Side: View of levee slope looking from crown

Water-Side: View of pipe at riverbank

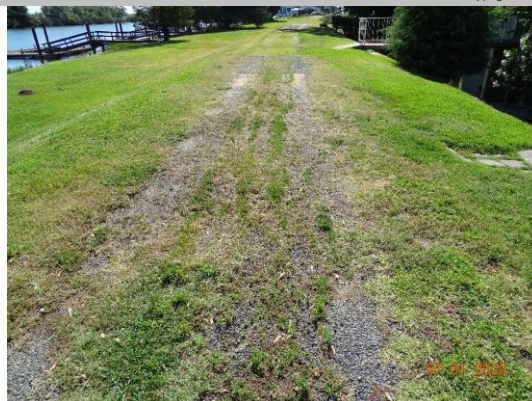
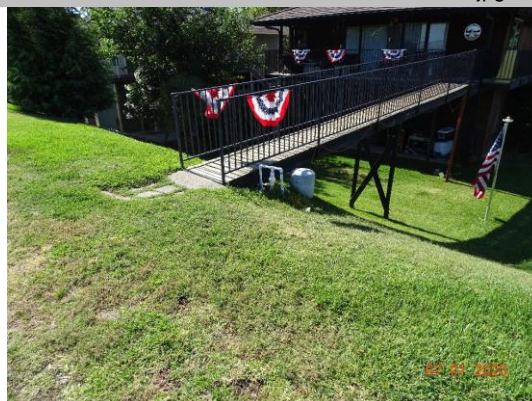
Comment Code						
Inspector Comment						
FS_ID:62404 DS_ID:21815 EP_NO: N/A Repair Type: Non-Urgent Crossing Status: Found UCIP Comments: 07/01/2020 Record updated from No Action Needed to Non-Urgent. No permit has been identified authorizing pipe. (O.Yakimov - DWR UCIP) FIELD_STRUCT_DESC: 1.75-inch galvanized iron irrigation line through the levee, 3.5 feet below the crown. Pump on pad on the landside (LS) shoulder. Pier on the waterside (WS). [Additional Reference(s): USACE Sacramento O&M Manual, Unit 103, June 1954, Revised 29 December 2016, (Station 'R' 6+76.9), listed as 2-inch pipe. USACE As-Built Drawing No. 50-04-2672, Sheet 3, Station 6+76.9, 25 January 1951, listed as 2-inch pipe]. FS Date: 7/1/2020 10:22:11 AM

Top of Levee: View of levee crown looking downstream

Land-Side: View of levee slope looking from crown

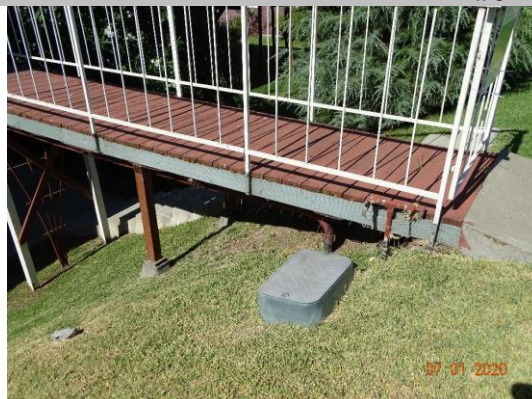
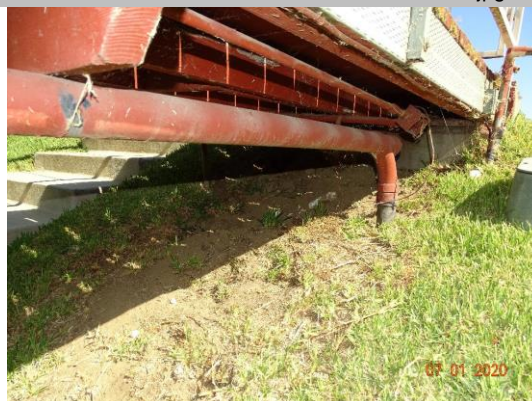
Land-Side: View of levee slope. Drainage pipe just behind irrigation box

Land-Side: Drainage pipe enters ground under walkway

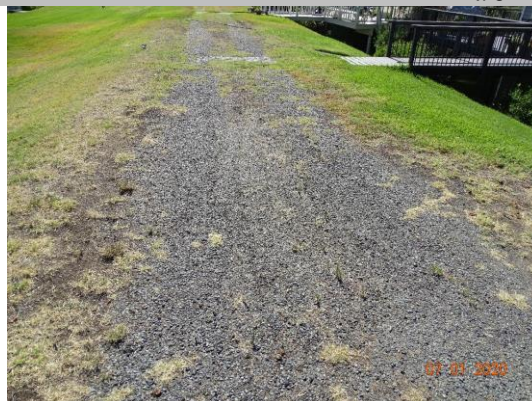
Photo 1 of 3 : UCIP_SP_2021_62410_90440.jpg

Comment Code						
Inspector Comment						
FS_ID:62410 DS_ID:21790 EP_NO: 11231 Repair Type: Non-Urgent Crossing Status: Indicator Found UCIP Comments: 07/01/2020 Record updated from No Action Needed to Non-Urgent. Unauthorized encroachment recorded in Levee Log prior to 2011. Need to have CVFPB review ABO and determine current owner. (O.Yakimov - DWR UCIP)						
FIELD_STRUCT_DESC: 7-inch pipe through levee 3.6 feet below crown. Pump on bank. 1-inch steel pipe visible at WS toe. (7-inch pipe [HLM 5.92] authorized under Automatic Board Order (ABO) issued as Permit No. 11231, 1975 - B&W Resort Marina). [Additional Reference(s): DWR Levee Log, 2005 (HLM 5.94)]. FS Date: 7/1/2020 1:11:08 PM

Top of Levee: View of levee crown looking downstream

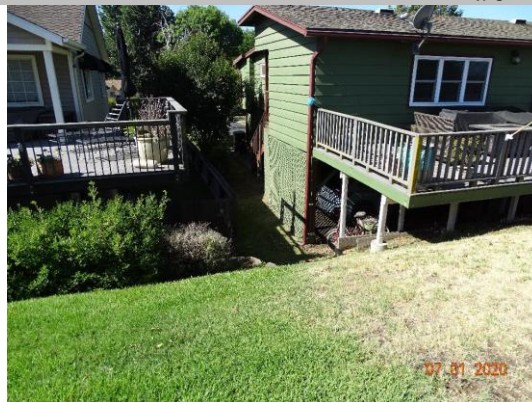
Photo 2 of 3 : UCIP_SP_2021_62410_90441.jpg

Land-Side: View of levee slope looking from crown

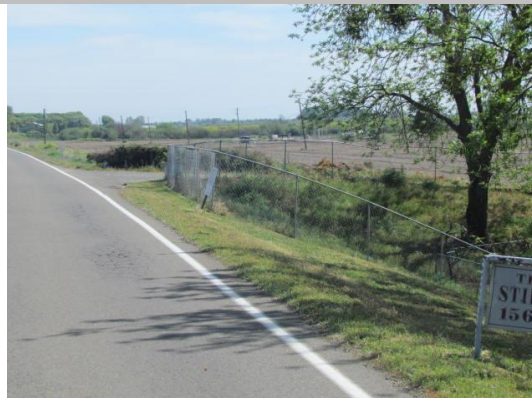
Photo 1 of 1 : SP_2021_NA0002_63_26_20210226_00006.jpg

LM Start	0.43	Rating **	M	Issue No.	26
LM End	0.43	Issue Type +	En	Location *	LS
Category	Earthen Levee			GPS Latitude/Longitude	
				Start	End
Item	Encroachments			38.189212 °	38.189212 °
				-121.574757 °	-121.574757 °
DWR ID	DWR_NA0002_02_s_2012_26				
Comment Code					
FE : Fence					
Inspector Comment

Looking northeast at fence on landward shoulder and slope.

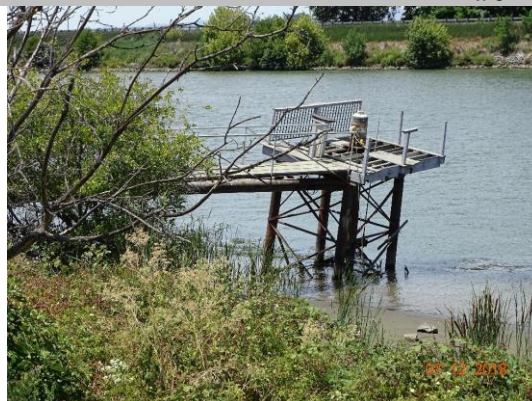
Photo 1 of 3 : UCIP_SP_2021_52689_77595.jpg

Comment Code						
Inspector Comment						
FS_ID:52689 DS_ID:21867 EP_NO: 1173 Repair Type: Non-Urgent Crossing Status: Found UCIP Comments: 07/12/2018 Pump platform is leaning on a side. (O.Yakimov-DWR UCIP) FIELD_STRUCT_DESC: 1 of 4: 12-inch irrigation pipe of an unknown material through the levee, 6 feet below the crown. Pump on pile structure in stream. Siphon breaker in 24-inch corrugated metal riser unit on the landside (LS) slope. 7-foot by 9-foot concrete distribution box at the LS toe. Service pole on the LS slope with a 1-inch steel electrical conduit at same location. (Permit No. 1173, 1947 - Reclamation District No. 556). [Additional Reference(s): DWR Levee Log, 2005. USACE Sacramento O&M Manual 103, June 1954, (Station ""H"" 72+67) steel pipe listed, Drawing No. 50-4-2277]. FS Date: 7/12/2018

Pump platform on WS is distorted.

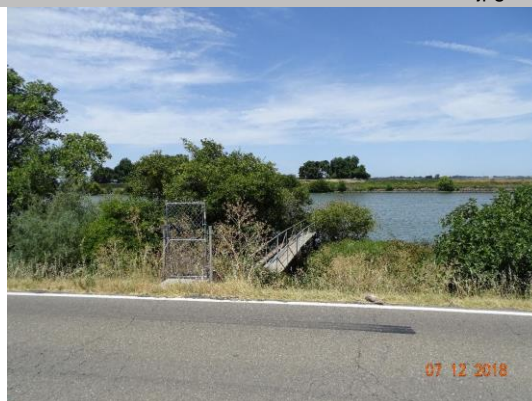
Photo 2 of 3 : UCIP_SP_2021_52689_77596.jpg

View of a bridge to pump platform on WS.

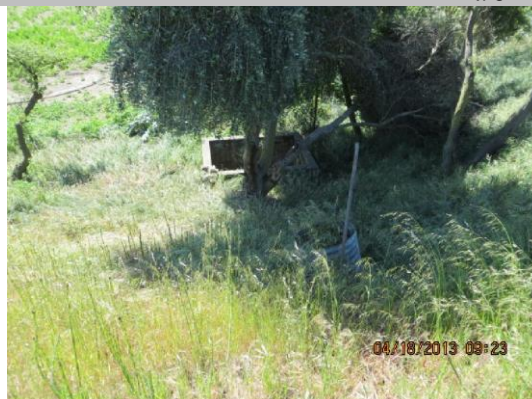
Photo 3 of 3 : UCIP_SP_2021_52689_19722.jpg

Siphon breaker and Concrete distribution box on LS.

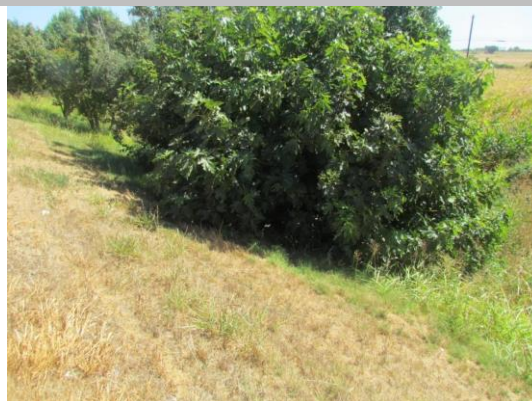
Photo 1 of 1 : SP_2021_NA0002_63_97_20210226_00037.jpg

LM Start	0.72	Rating **	U	Issue No.	97
LM End	0.72	Issue Type +	Ma	Location *	LS
Category	Earthen Levee			GPS Latitude/Longitude	
				Start	End
Item	Trim / Thin Trees			38.187102 °	38.187102 °
				-121.579463 °	-121.579463 °
DWR ID	DWR_NA0002_02_f _ 2018_97				
Comment Code					
T1 : Trim trees to at least five feet above ground level.					
Inspector Comment					
Fig tree on the landside toe.

Looking east at untrimmed fig tree at landward toe.

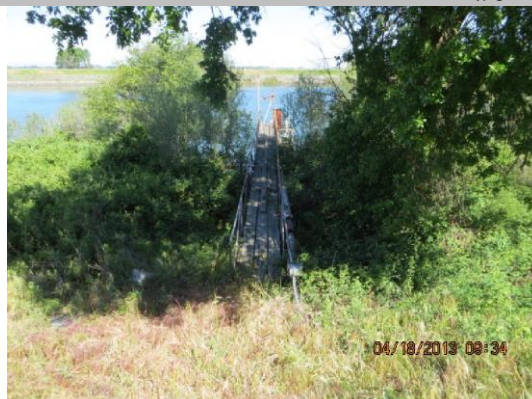
Photo 1 of 3 : UCIP_SP_2021_12164_19726.jpg

Comment Code						
Inspector Comment						
FS_ID:12164 DS_ID:21868 EP_NO: 1173 Repair Type: Non-Urgent Crossing Status: Found UCIP Comments: Several patches on pipe, walkway in disrepair and 24-inch standpipe for siphon breaker on LS slope has been dislodged from the LS slope and rests at LS toe. Pipe appears to be failing at multiple places due to corrosion. FIELD_STRUCT_DESC: 2 of 4: 12-inch irrigation pipe of an unknown material through the levee, 7 feet below the crown. Pump on pile structure with a walkway in the river. Siphon breaker in 24-inch corrugated metal riser unit on the landside (LS) slope with a 7-foot by 9-foot concrete distribution box on the LS toe. Service pole on the LS slope with a 1.5-inch galvanized iron electrical conduit at the same location. (Permit No. 1173, 1947 - Reclamation District No. 556). [Additional Reference(s): DWR Levee Log, 2005. USACE Sacramento O&M Manual 103, June 1954, (Station ""H"" 52+21) steel pipe listed, Drawing No. 50-4-2277]. FS Date: 4/18/2013

Pump on pile structure with walkway on WS berm.

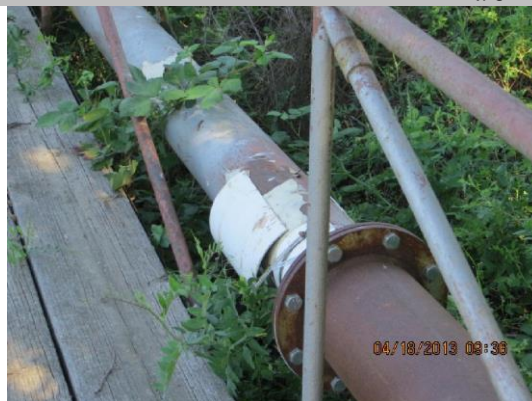
Photo 3 of 3 : UCIP_SP_2021_12164_19724.jpg

Multiple patches on Pipe along WS berm.

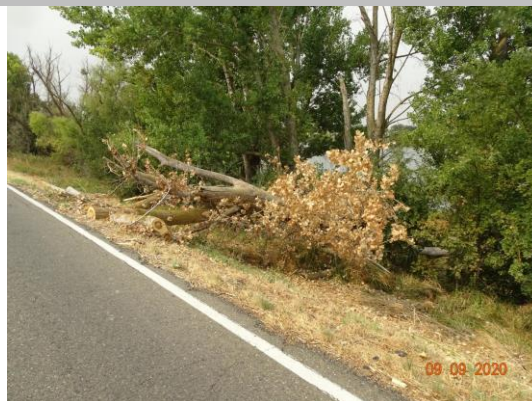
Photo 1 of 1 : SP_2021_NA0002_63_47_20210226_00011.jpg

LM Start	1.08	Rating **	U	Issue No.	47
LM End	1.08	Issue Type +	Ma	Location *	WS
Category	Earthen Levee			GPS Latitude/Longitude	
				Start	End
Item	Encroachments			38.183458 °	38.183458 °
				-121.584065 °	-121.584065 °
DWR ID	DWR_NA0002_02_f _ 2020_47				
Comment Code					
TR : Tree or limb					
Inspector Comment					
Remove down tree within 20' of waterside shoulder.

View looking downstream at down tree on the waterside slope (Fall 2020).

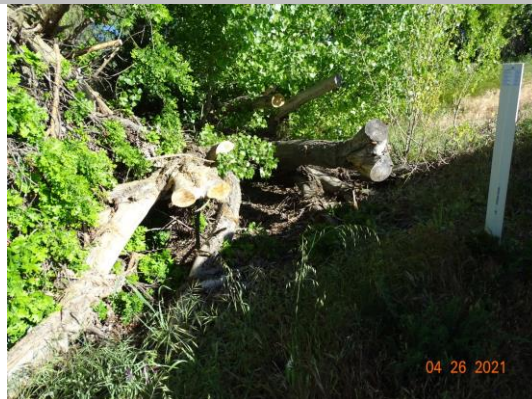
Photo 1 of 1 : SP_2021_NA0002_63_81_20210426_00146.jpg

LM Start	1.33	Rating **	M	Issue No.	81
LM End	1.33	Issue Type +	Ma	Location *	WS
Category	Earthen Levee			GPS Latitude/Longitude	
				Start	End
Item	Encroachments			38.180472 °	38.180472 °
				-121.586510 °	-121.586510 °
DWR ID	DWR_NA0002_02_s_2018_81				
Comment Code					
TR : Tree or limb					
Inspector Comment					
Large fallen tree has been significantly reduced on waterside slope.

View of fallen tree on waterside slope that has been significantly reduced since Fall 2020 (Spring 2021).

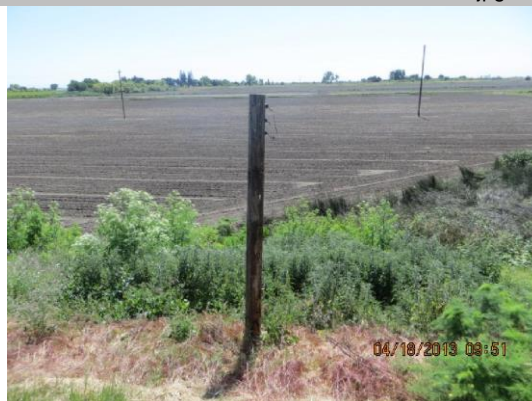
Photo 1 of 3 : UCIP_SP_2021_12165_19731.jpg

Comment Code						
Inspector Comment						
FS_ID:12165 DS_ID:21869 EP_NO: 11261 Repair Type: Non-Urgent Crossing Status: Found UCIP Comments: Pipe abandoned and should be done so properly. Pipe open on WS. FIELD_STRUCT_DESC: 8-inch irrigation pipe of an unknown material through the levee, 6.5 feet below the crown. Pump in pump house on berm. 7-foot by 9-foot concrete distribution box on the landside (LS) toe. Service poles on the LS slope with a 1.5-inch galvanized steel electrical conduit at same location. (Automatic Board Order (ABO) issued as Permit No. 11261, 1975 - Anthony and John Correia). [Additional Reference(s): DWR Levee Log, 2005. USACE Sacramento O&M Manual 103, June 1954, (Station ""H"" 42+33) steel pipe listed, Drawing No. 50-4-2277]. FS Date: 4/18/2013

JP on LS slope.

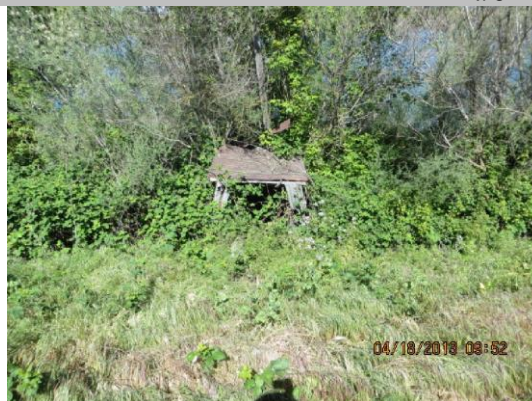
Photo 2 of 3 : UCIP_SP_2021_12165_19730.jpg

Pipe and pumphouse on WS berm.

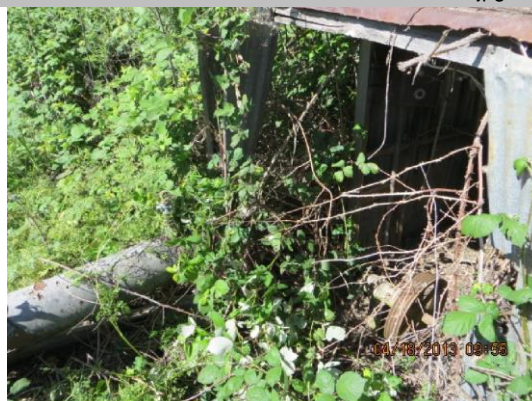
Photo 3 of 3 : UCIP_SP_2021_12165_19729.jpg

Pipe at pumphouse has been disconnected from pump and is open.

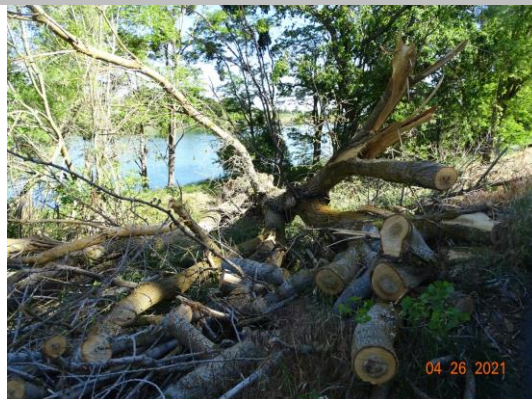
Photo 1 of 1 : SP_2021_NA0002_63_52_20210426_00147.jpg

LM Start	1.46	Rating **	U	Issue No.	52
LM End	1.46	Issue Type +	Ma	Location *	WS
Category	Earthen Levee			GPS Latitude/Longitude	
				Start	End
Item	Encroachments			38.178865 °	38.178865 °
				-121.587763 °	-121.587763 °
DWR ID	DWR_NA0002_02_s_2021_52				
Comment Code					
TR : Tree or limb					
Inspector Comment					
Remove large fallen tree on waterside slope.

View of downed tree and limbs on waterside slope (Spring 2021).

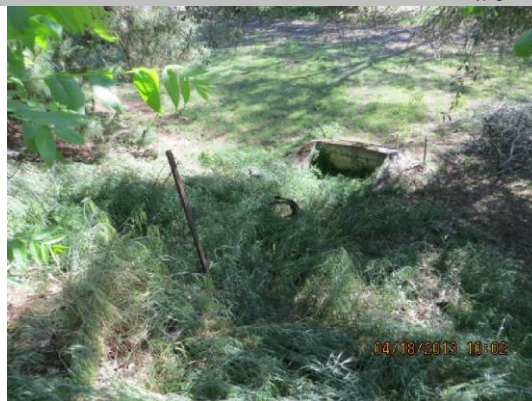
Photo 1 of 3 : UCIP_SP_2021_12183_19742.jpg

LM Start	1.61	Rating **	M	Issue No.	4	
LM End	1.61	Issue Type +	En	Location *		
Category	Supplemental			GPS Latitude/Longitude		
				Start	End	
Item	DWR UCIP Field Study			38.176874 °	38.176874 °	
				-121.589200 °	-121.589200 °	
DWR ID	21870					
Comment Code						
Inspector Comment						
FS_ID:12183						
DS_ID:21870						
EP_NO: N/A						
Repair Type: Non-Urgent						
Crossing Status: Found						
UCIP Comments: Pipe appears abandoned and should be done so properly.						
FIELD_STRUCT_DESC: 6-inch steel irrigation pipe through the levee, 5.8 feet below the crown. 3-foot by 3-foot concrete distribution box at the landside (LS) toe. Polyvinyl chloride standpipe at the waterside (WS) toe. Hose bib attachment on pipe at the LS toe.						
FS Date: 4/18/2013

Concrete distribution box on LS toe.

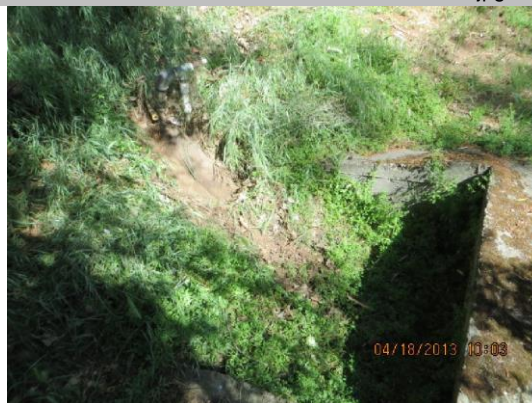
Photo 2 of 3 : UCIP_SP_2021_12183_19741.jpg

Distribution box and hose bib on LS toe.

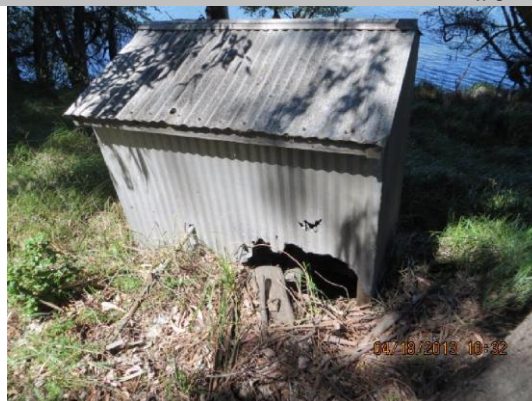
Photo 1 of 3 : UCIP_SP_2021_12185_19751.jpg

Comment Code						
Inspector Comment						
FS_ID:12185 DS_ID:21872 EP_NO: 11294 Repair Type: Non-Urgent Crossing Status: Found UCIP Comments: Pipe abandoned on both sides. Pipe should be abandoned properly. FIELD_STRUCT_DESC: 6-inch irrigation pipe of an unknown material through the levee, 6.5 feet below the crown. Pump in pump house on the waterside (WS) slope. 1-inch galvanized iron steel electrical conduit at same location. (Automatic Board Order (ABO) issued as Permit No. 11294, 1975 - Hubert Vandermaele). [Additional Reference(s): DWR Levee Log, 2005. USACE Sacramento O&M Manual 103, June 1954, (Station ""H"" 8+72) steel pipe listed, Drawing No. 50-4-2277]. FS Date: 4/18/2013

Pumphouse on WS slope.

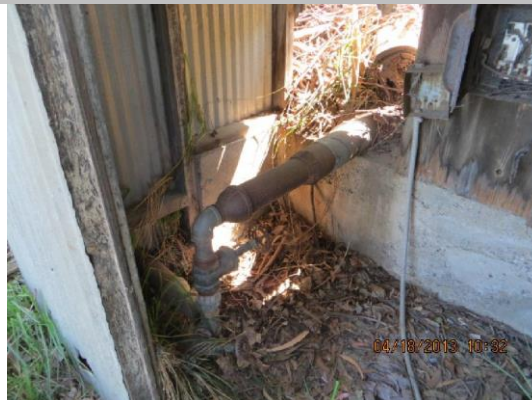
Photo 2 of 3 : UCIP_SP_2021_12185_19750.jpg

Pipe and shutoff valve at pumphouse on WS slope.

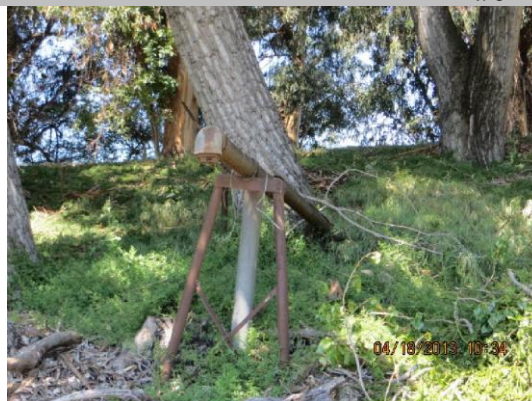
Photo 3 of 3 : UCIP_SP_2021_12185_19749.jpg

Pipe at LS slope (open).

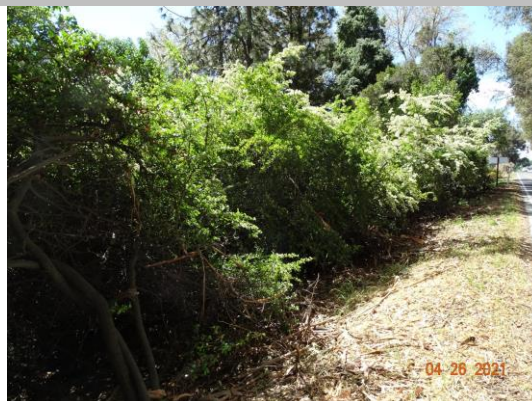
Photo 1 of 1 : SP_2021_NA0002_63_12_20210426_00160.jpg

LM Start	1.91	Rating **	U	Issue No.	12
LM End	1.94	Issue Type +	En	Location *	LS
Category	Earthen Levee			GPS Latitude/Longitude	
				Start	End
Item	Vegetation			38.173030 °	38.172598 °
				-121.591624 °	-121.591853 °
DWR ID	DWR_NA0002_02_s_2012_12				
Comment Code					
V6 : Landscaping					
Inspector Comment					
Dense landscaping vegetation is on the landside slope.

View looking downstream at landscaping on the landside slope (Spring 2021).

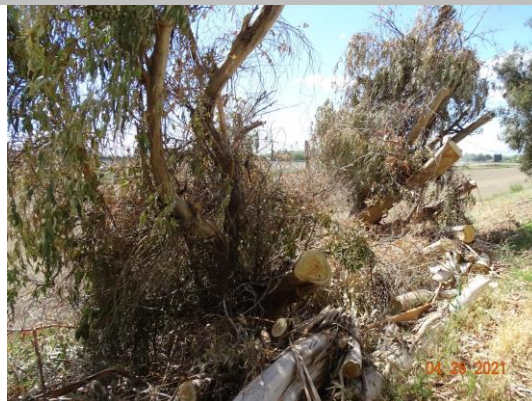
Photo 1 of 1 : SP_2021_NA0002_63_95_20210426_00159.jpg

LM Start	1.99	Rating **	U	Issue No.	95
LM End	1.99	Issue Type +	Ma	Location *	LS
Category	Earthen Levee			GPS Latitude/Longitude	
				Start	End
Item	Encroachments			38.171939 °	38.171939 °
				-121.592337 °	-121.592337 °
DWR ID	DWR_NA0002_02_s_2021_95				
Comment Code					
TR : Tree or limb					
Inspector Comment					
Remove down tree limbs on the landside slope.

View of down tree limbs on the landside slope (Spring 2021).

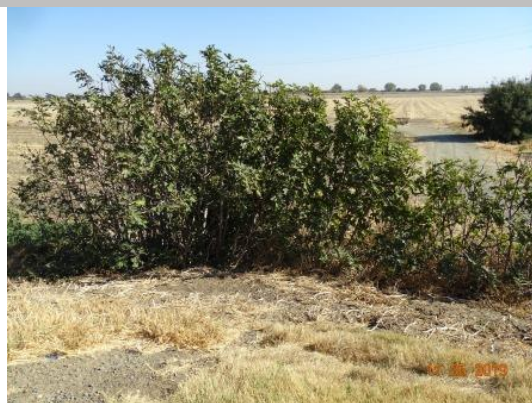
Photo 1 of 1 : SP_2021_NA0002_63_120_20210226_00048.jpg

LM Start	2.16	Rating **	M	Issue No.	120
LM End	2.16	Issue Type +	Ma	Location *	LS
Category	Earthen Levee			GPS Latitude/Longitude	
				Start	End
Item	Trim / Thin Trees			38.169853 °	38.169853 °
				-121.593828 °	-121.593828 °
DWR ID	DWR_NA0002_02_f _ 2016_120				
Comment Code					
T2 : Thin trees to allow visibility of the ground and room to flood fight.					
Inspector Comment					
Fig tree on the landside slope.

View of young fig tree on the landside slope (Fall 2019).

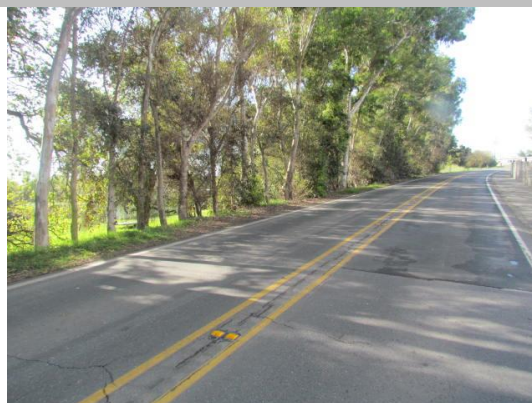
Photo 1 of 1 : SP_2021_NA0002_63_25_20210226_00005.jpg

LM Start	2.34	Rating **	M	Issue No.	25
LM End	2.38	Issue Type +	Ma	Location *	LS
Category	Earthen Levee			GPS Latitude/Longitude	
				Start	End
Item	Trim / Thin Trees			38.167627 °	38.167152 °
				-121.595538 °	-121.595997 °
DWR ID	DWR_NA0002_02_s_2012_25				
Comment Code					
T2 : Thin trees to allow visibility of the ground and room to flood fight.					
Inspector Comment

Looking southeast at trees at landward shoulder. (Spring 2015)

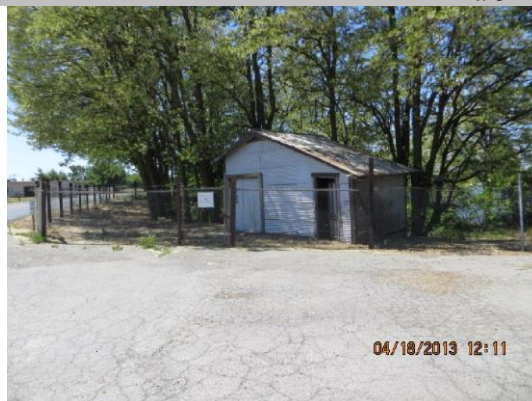
Photo 1 of 3 : UCIP_SP_2021_12211_19770.jpg

Comment Code						
Inspector Comment						
FS_ID:12211 DS_ID:21878 EP_NO: 11263 Repair Type: Non-Urgent Crossing Status: Indicator Found UCIP Comments: Further investigation to determine location of pipe should be done. Pumphouse needs to be unlocked to gather additional information. FIELD_STRUCT_DESC: 8-inch irrigation pipe of an unknown material through the levee, 3.7 feet below the crown. Pump in pump house on the waterside (WS) berm. 30-inch concrete standpipe on the landside (LS). (Automatic Board Order (ABO) issued as Permit No. 11263, 1975 - Ensher, Alexander, and Barsoon, Inc.). [Additional Reference(s): DWR Levee Log, 2005. USACE Sacramento O&M Manual 103, June 1954, (RM 18.25) welded steel pipe listed, Drawing No. 6-13-1100]. FS Date: 4/18/2013

Possible pumphouse on WS shoulder.

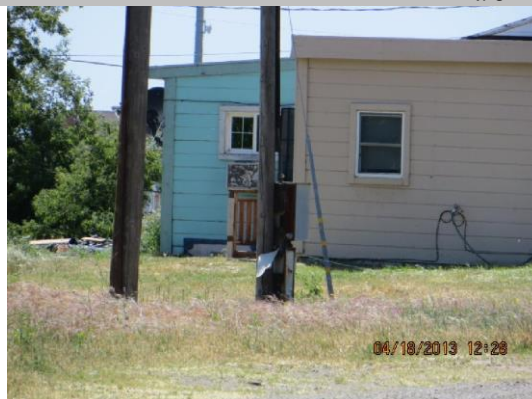
Photo 3 of 3 : UCIP_SP_2021_12211_19768.jpg

JP with a meter on pole that would be appropriate for this crossing.

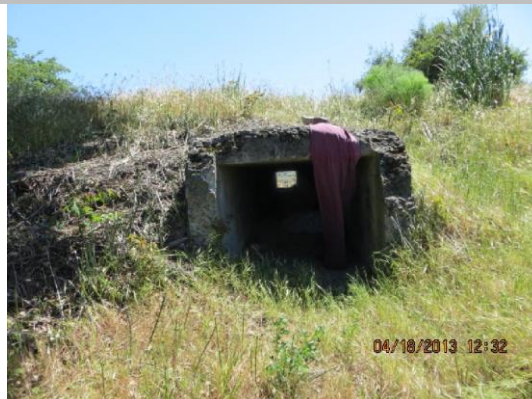
Photo 1 of 3 : UCIP_SP_2021_53389_19773.jpg

Comment Code						
Inspector Comment						
FS_ID:53389 DS_ID:21879 EP_NO: N/A Repair Type: Non-Urgent Crossing Status: Found UCIP Comments: 07/12/2018 Tunnel is open on both sides. No integrity issue observed, therefore crossing downgraded to "Non-Urgent". (O.Yakimov-DWR UCIP)10/24/2016 same as previous inspection culvert is open on both ends. WS blocked by blankets -- WS structure is being used as a shelter. (O. Magana - DWR UCIP)04/18/2013 Culvert open on both ends. Needs to be abandoned properly. (W. Wylie - DWR UCIP) FIELD_STRUCT_DESC: *ABANDONED* 42-inch by 42-inch open reinforced concrete drainage culvert through the levee, 6 feet below the crown. [Additional Reference(s): DWR Levee Log, 2005, 3-foot by 3.5-foot culvert listed. USACE Sacramento O&M Manual 103, June 1954, (RM 18.16) Drawing No. 6-13-1100]. FS Date: 7/12/2018 2:59:33 PM

Concrete tunnel open on both ends.

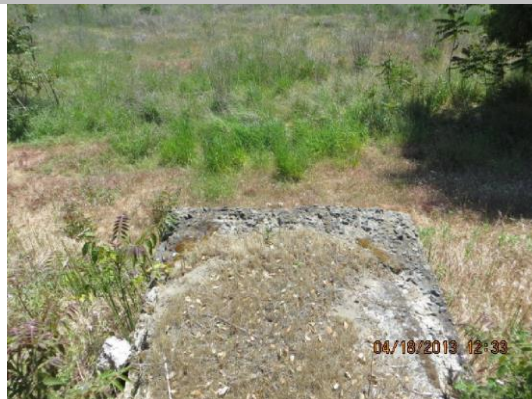
Photo 2 of 3 : UCIP_SP_2021_53389_19772.jpg

Top of concrete tunnel on LS shoulder.

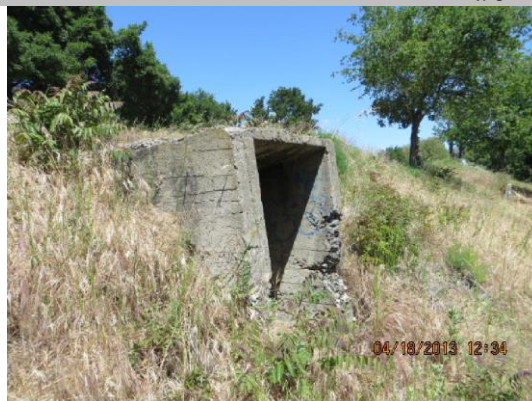
Photo 3 of 3 : UCIP_SP_2021_53389_19771.jpg

Concrete tunnel on LS shoulder.

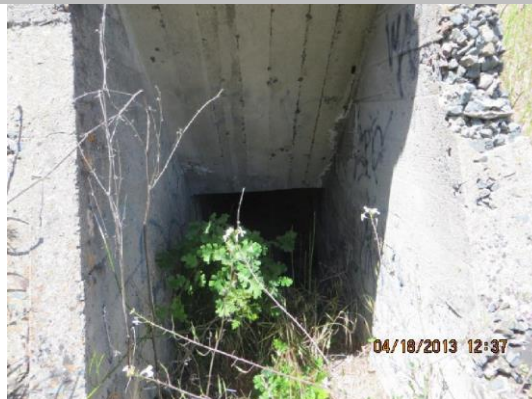
Photo 1 of 3 : UCIP_SP_2021_53513_19776.jpg

Comment Code						
Inspector Comment						
FS_ID:53513 DS_ID:21880 EP_NO: N/A Repair Type: Non-Urgent Crossing Status: Found UCIP Comments: 07/12/2018 Tunnel is open on both sides. No integrity issue observed, therefore crossing downgraded to "Non-Urgent". (O.Yakimov-DWR UCIP)10/24/2016 same as previous inspection concrete box culvert will need to be abandoned properly. (O. Magana - DWR UCIP)04/18/2013 tunnel should be abandoned properly. (W. Wylie - DWR UCIP) FIELD_STRUCT_DESC: *ABANDONED* 48-inch by 48-inch reinforced concrete drainage culvert through the levee, 6.5-inches below the crown. [Additional Reference(s): DWR Levee Log, 2005. USACE Sacramento O&M Manual 103, June 1954, (RM 18.13) 3-foot by 3-foot concrete box listed, Drawing No. 6-13-1100]. FS Date: 7/12/2018 9:05:37 AM

Tunnel open on LS shoulder.

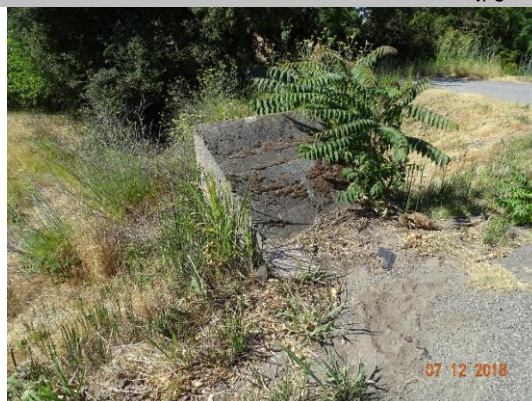
Photo 2 of 3 : UCIP_SP_2021_53513_77578.jpg

Concrete tunnel on LS shoulder.

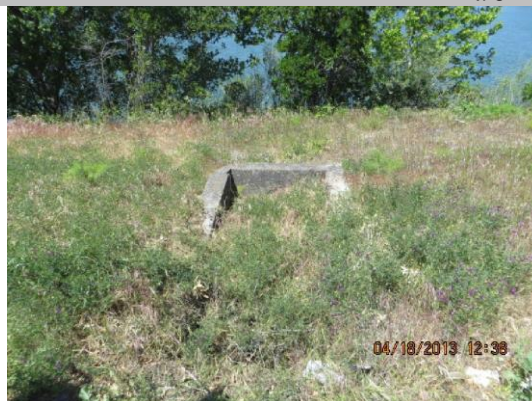
Photo 3 of 3 : UCIP_SP_2021_53513_19774.jpg

10'X5' concrete box on WS slope, filled with soil.

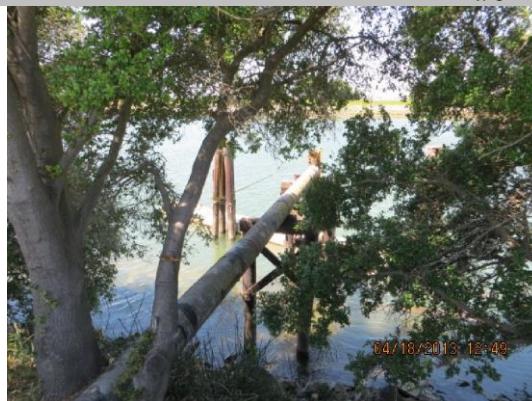
Photo 1 of 3 : UCIP_SP_2021_12214_19778.jpg

LM Start	2.75	Rating **	M	Issue No.	11	
LM End	2.75	Issue Type +	En	Location *		
Category	Supplemental			GPS Latitude/Longitude		
				Start	End	
Item	DWR UCIP Field Study			38.164432 °	38.164432 °	
				-121.601918 °	-121.601918 °	
DWR ID	21881					
Comment Code						
Inspector Comment						
FS_ID:12214						
DS_ID:21881						
EP_NO: 2005						
Repair Type: Non-Urgent						
Crossing Status: Found						
UCIP Comments: Pipe appears abandoned and rusty. It should be abandoned properly if it is no longer in use.						
FIELD_STRUCT_DESC: 18-inch steel sewer discharge line through the levee, 4 feet below the crown. Two pile dolphins in stream. Fire hydrant on the landside (LS) shoulder. (Permit No. 2005, 1954 - City of Isleton). [Additional Reference(s): DWR Levee Log, 2005].						
FS Date: 4/18/2013

Pipe, pile structure, and dolphins on WS.

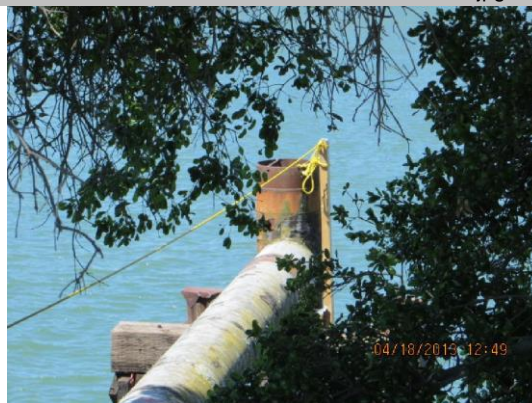
Photo 2 of 3 : UCIP_SP_2021_12214_19777.jpg

Pipe on pier at WS.

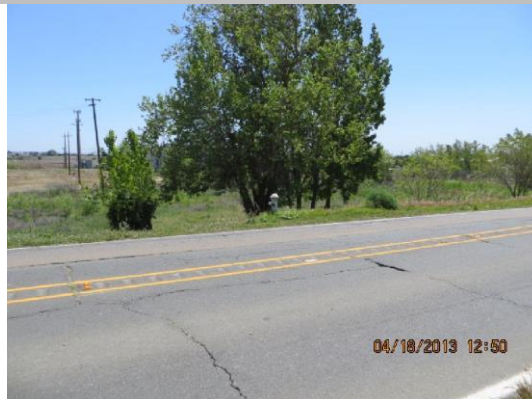
Photo 3 of 3 : UCIP_SP_2021_12214_19779.jpg

Fire hydrant on LS shoulder.

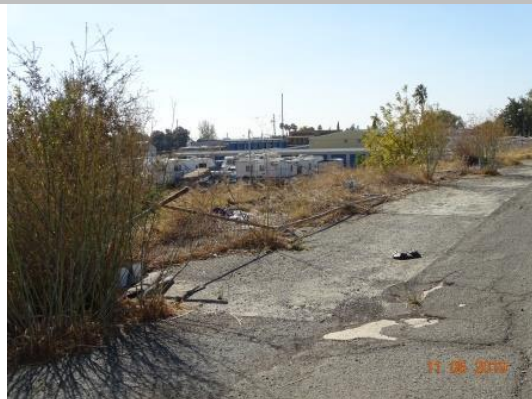
Photo 1 of 1 : SP_2021_NA0002_63_94_20210226_00036.jpg

LM Start	2.81	Rating **	M	Issue No.	94
LM End	2.81	Issue Type +	En	Location *	LS
Category	Earthen Levee			GPS Latitude/Longitude	
				Start	End
Item	Encroachments			38.164077 °	38.164077 °
				-121.602853 °	-121.602853 °
DWR ID	DWR_NA0002_02_f _ 2015_94				
Comment Code					
FE : Fence					
Inspector Comment					
Remove fallen fence on landside shoulder.

View looking at down fence on the landside shoulder (Fall 2019).

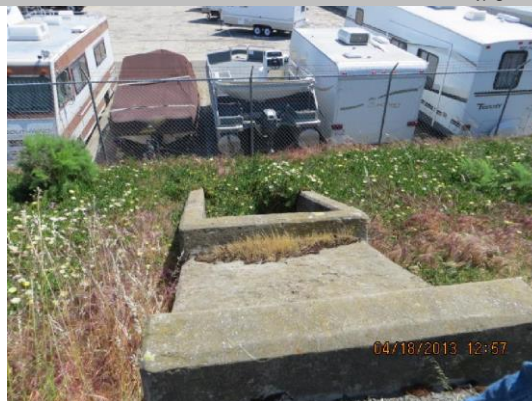
Photo 1 of 3 : UCIP_SP_2021_53514_19782.jpg

Comment Code						
Inspector Comment						
FS_ID:53514 DS_ID:21882 EP_NO: N/A Repair Type: Non-Urgent Crossing Status: Found UCIP Comments: 07/12/2018 Tunnel is open on both ends. No integrity issue observed, therefore crossing downgraded to "Non-Urgent". (O.Yakimov-DWR UCIP)10/24/2016 same as previous inspection tunnel is opened on both ends. (O. Magana - DWR UCIP)04/18/2013 Tunnel open on both ends and should be abandoned properly. (W. Wylie - DWR UCIP) FIELD_STRUCT_DESC: *ABANDONED* 48-inch by 72-inch reinforced concrete drainage culvert through the levee, 1 foot below the crown. [Additional Reference(s): DWR Levee Log, 2005, 4-foot by 4.5-foot culvert listed. USACE Sacramento O&M Manual 103, June 1954, (RM 17.89) 48-inch by 52-inch concrete box listed, Drawing No. 6-13-1100]. FS Date: 7/12/2018 9:07:49 AM

Entrance to tunnel on LS slope.

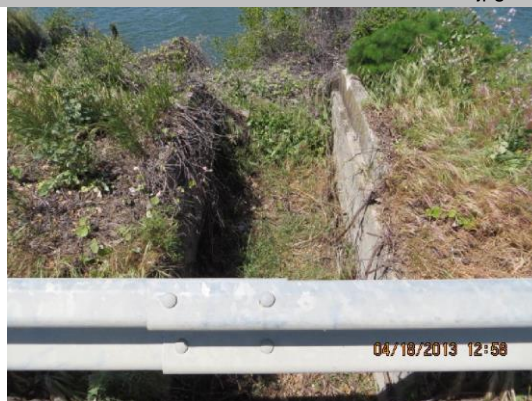
Photo 2 of 3 : UCIP_SP_2021_53514_19781.jpg

Tunnel opening on WS slope.

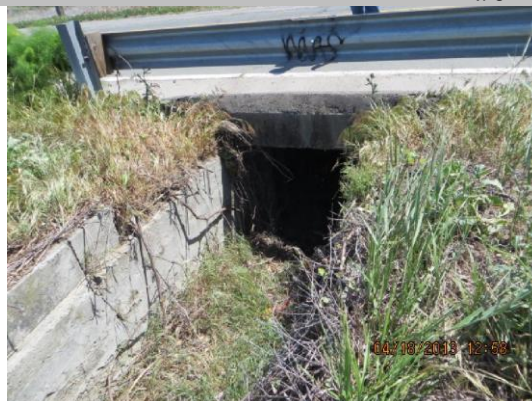
Photo 3 of 3 : UCIP_SP_2021_53514_19780.jpg

Tunnel opening on WS slope.

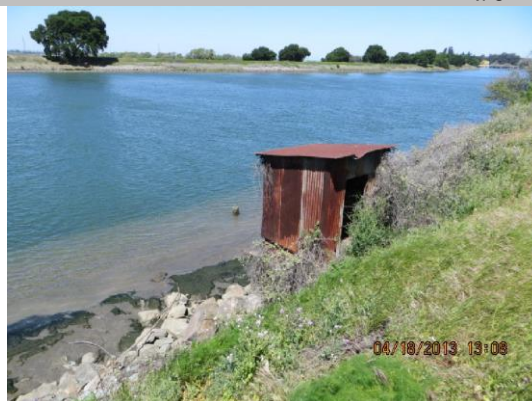
Photo 1 of 2 : UCIP_SP_2021_12217_19785.jpg

FS_ID:12217
 DS_ID:21883
 EP_NO: 11269
 Repair Type: Non-Urgent
 Crossing Status: Found
 UCIP Comments: Pipe needs to be abandoned properly if it is truly abandoned.
 FIELD_STRUCT_DESC: 8-inch irrigation pipe of an unknown material through the levee, 8.7 feet below the crown. Pump in pump house on the waterside (WS) slope. Slide gate in pump house. Pipe not visible on the landside (LS). (Automatic Board Order (ABO) issued as Permit No. 11269, 1975 - Griffin Steel and Supply Company). [Additional Reference(s): DWR Levee Log, 2005].
 FS Date: 4/18/2013

Pumphouse on WS slope.

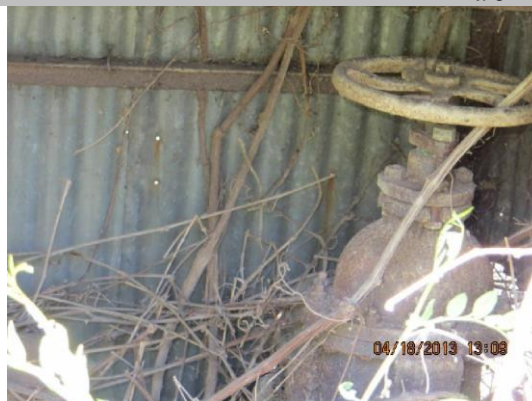
Photo 2 of 2 : UCIP_SP_2021_12217_19784.jpg

Slide gate in pumphouse on WS slope.

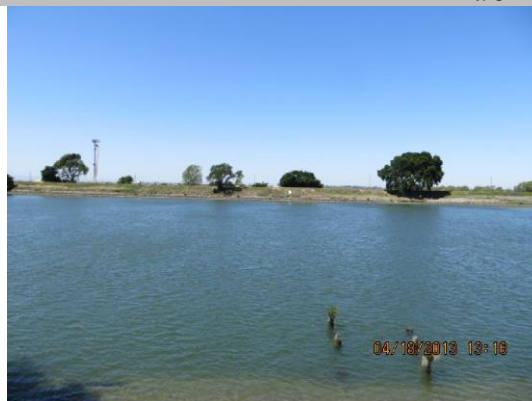
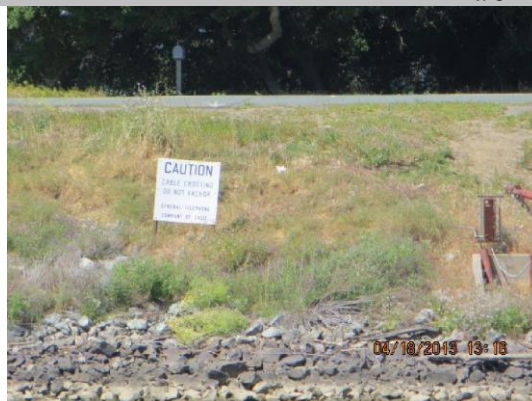
Photo 1 of 2 : UCIP_SP_2021_16005_27067.jpg

FS_ID:16005
 DS_ID:21884
 EP_NO: 14173
 Repair Type: Non-Urgent
 Crossing Status: Indicator Found
 UCIP Comments: If pipe is still in use it should be marked properly on levee.
 FIELD_STRUCT_DESC: 12-inch steel telephone conduit through the levee, 2 feet below the crown, and under the channel. Four 4-inch galvanized iron conductor pipes sleeved through 12-inch steel conduit. Sign on the waterside (WS) slope of levee across river provides location for this crossing. (Permit No. 14173, 1985 - Owner Unknown).
 [Additional Reference(s): DWR Levee Log, 2005].
 FS Date: 4/18/2013

Sign on opposite side of river provides indication of pipe location.

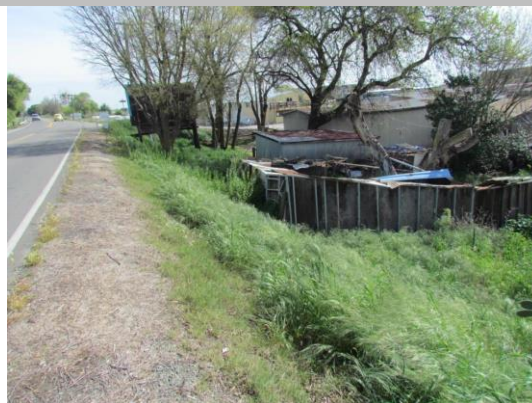
Photo 1 of 2 : SP_2021_NA0002_63_30_20210226_00007.jpg

LM Start	2.93	Rating **	U	Issue No.	30
LM End	3.12	Issue Type +	En	Location *	LS
Category	Earthen Levee			GPS Latitude/Longitude	
				Start	End
Item	Encroachments			38.163317 °	38.162707 °
				-121.604813 °	-121.608262 °
DWR ID	DWR_NA0002_02_s_2012_30				
Comment Code					
UR : Urban					
Inspector Comment					
There are several encroachments within the town limits along the landside slope.

Looking north at several encroachments along landward slope and toe.

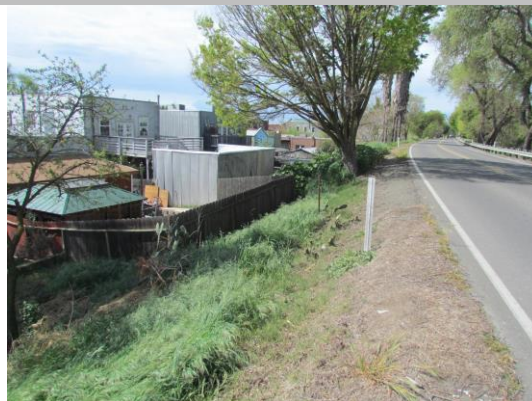
Photo 2 of 2 : SP_2021_NA0002_63_30_20210226_00008.jpg

Looking south at several encroachments along landward slope and toe.

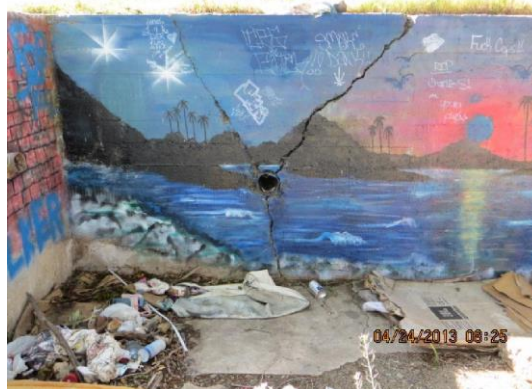
Photo 1 of 2 : UCIP_SP_2021_12724_20643.jpg

LM Start	2.99	Rating **	M	Issue No.	17	
LM End	2.99	Issue Type +	En	Location *		
Category	Supplemental			GPS Latitude/Longitude		
				Start	End	
Item	DWR UCIP Field Study			38.163063 °	38.163063 °	
				-121.605799 °	-121.605799 °	
DWR ID	21886					
Comment Code						
Inspector Comment						
FS_ID:12724 DS_ID:21886 EP_NO: N/A Repair Type: Non-Urgent Crossing Status: Found UCIP Comments: Pipe should be abandoned properly. FIELD_STRUCT_DESC: *ABANDONED* 6-inch pipe of an unknown material or purpose through levee 4.5 feet below crown. Originally included in the 1959 O&M manual. Pipe visible at foundation on WS shoulder. FS Date: 4/24/2013 10:00:00 AM

Pipe visible at concrete foundation on WS shoulder.

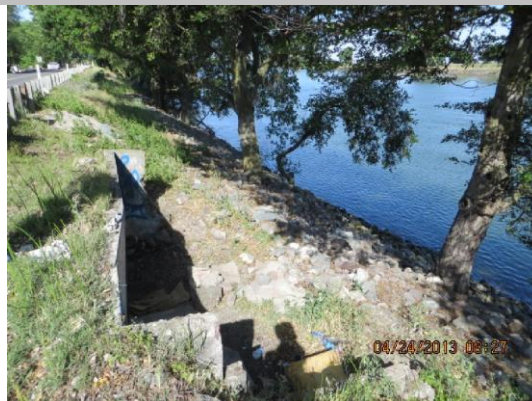
Photo 2 of 2 : UCIP_SP_2021_12724_20642.jpg

Foundation on WS shoulder.

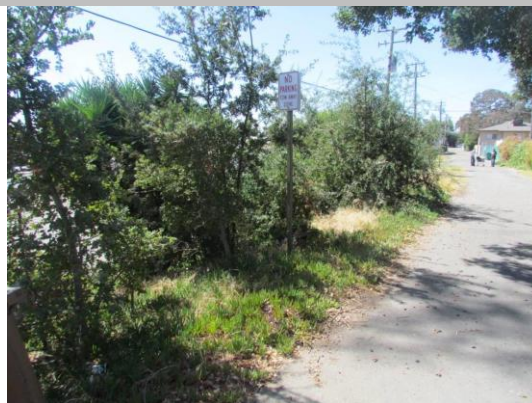
Photo 1 of 1 : SP_2021_NA0002_63_7_20210226_00001.jpg

LM Start	3.22	Rating **	U	Issue No.	7
LM End	3.22	Issue Type +	En	Location *	LS
Category	Earthen Levee			GPS Latitude/Longitude	
				Start	End
Item	Vegetation			38.162609 °	38.162609 °
				-121.609979 °	-121.609979 °
DWR ID	DWR_NA0002_02_f_2019_7				
Comment Code					
V6 : Landscaping					
Inspector Comment

Looking south at overgrown landscaping on landward slope. (Fall 2016)

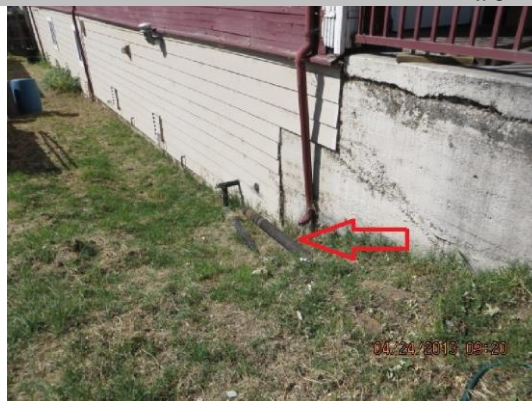
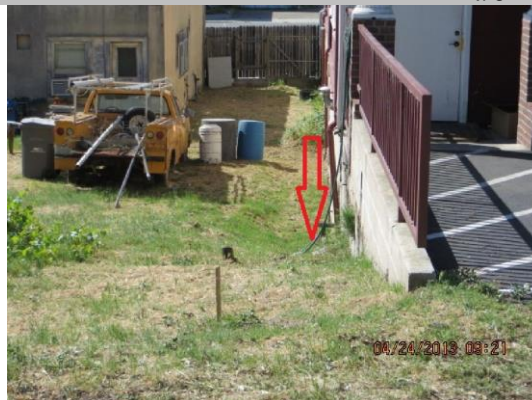
Photo 1 of 2 : UCIP_SP_2021_15966_26949.jpg

LM Start	3.29	Rating **	M	Issue No.	18
LM End	3.29	Issue Type +	En	Location *	
Category	Supplemental			GPS Latitude/Longitude	
				Start	End
Item	DWR UCIP Field Study			38.162430 °	38.162430 °
				-121.611248 °	-121.611248 °
DWR ID	23135				
Comment Code					
Inspector Comment					
FS_ID:15966 DS_ID:23135 EP_NO: N/A Repair Type: Non-Urgent Crossing Status: Found UCIP Comments: Need to determine disposition and use of pipe. FIELD_STRUCT_DESC: 4-inch cast iron drainage pipe through the levee, 8 feet below the crown. Pipe visible next to foundation on the landside (LS) toe. FS Date: 4/24/2013

Pipe visible next to foundation on LS slope.

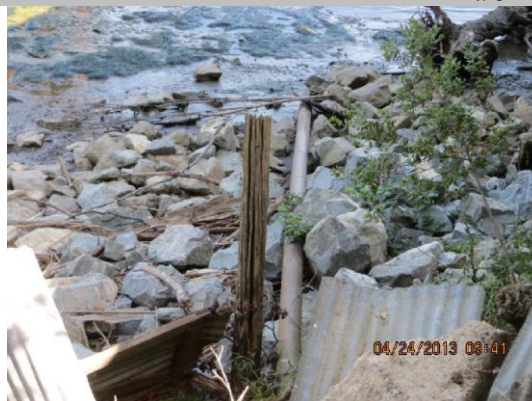
Photo 2 of 2 : UCIP_SP_2021_12745_20682.jpg

Pipe visible on WS toe.

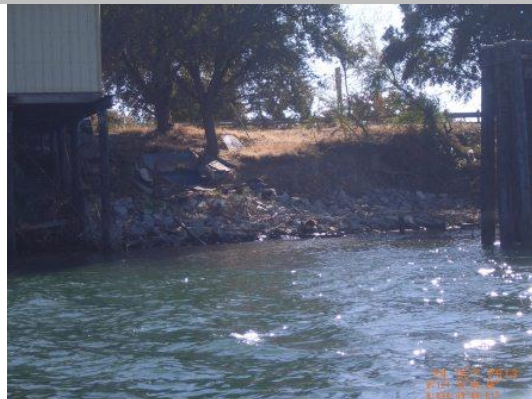
Photo 1 of 2 : SP_2021_NA0002_63_75_20210226_00023.jpg

USACE 2013 Photo #1

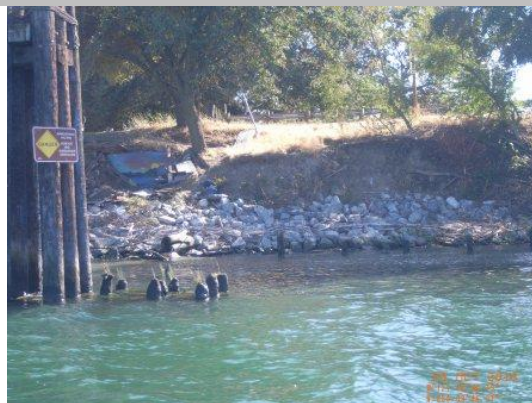
Photo 2 of 2 : SP_2021_NA0002_63_75_20210226_00024.jpg

USACE 2013 Photo #2

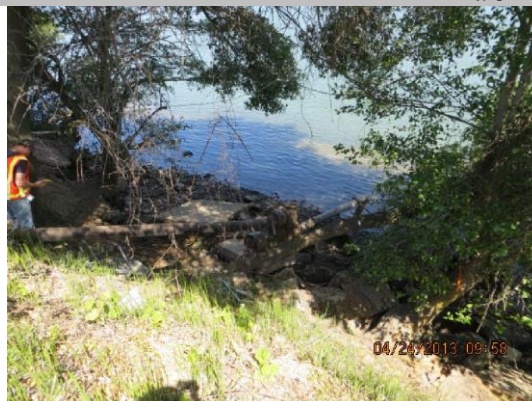
Photo 1 of 3 : UCIP_SP_2021_12746_20686.jpg

LM Start	3.44	Rating **	M	Issue No.	21	
LM End	3.44	Issue Type +	En	Location *		
Category	Supplemental			GPS Latitude/Longitude		
				Start	End	
Item	DWR UCIP Field Study			38.162473 °	38.162473 °	
				-121.613963 °	-121.613963 °	
DWR ID	21893					
Comment Code						
Inspector Comment						
FS_ID:12746 DS_ID:21893 EP_NO: 11275 Repair Type: Non-Urgent Crossing Status: Found UCIP Comments: Pipe abandoned and should be abandoned properly. Pipe open on both ends. FIELD_STRUCT_DESC: 8-inch irrigation pipe of an unknown material through the levee, 7.7 feet below the crown. Pump in pump house on the waterside (WS) slope. (Automatic Board Order (ABO) issued as Permit No. 11275, 1975 - M. R. V., Inc., Isleton Motel). [Additional Reference(s): DWR Levee Log, 2005. USACE Sacramento O&M Manual 102, April 1959, (RM 17.3) (Reclamation District No. 2067) steel pipe listed]. FS Date: 4/24/2013

Pipe and pump visible on WS slope

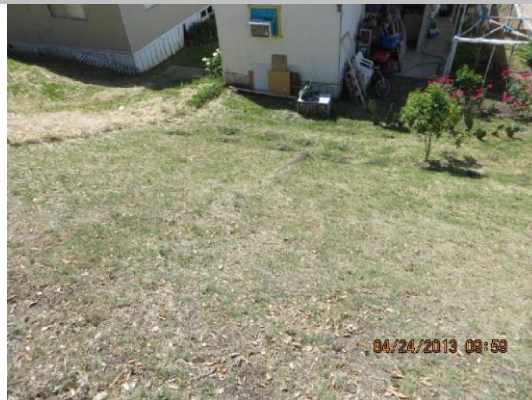
Photo 2 of 3 : UCIP_SP_2021_12746_20685.jpg

Pipe visible on LS slope near toe.

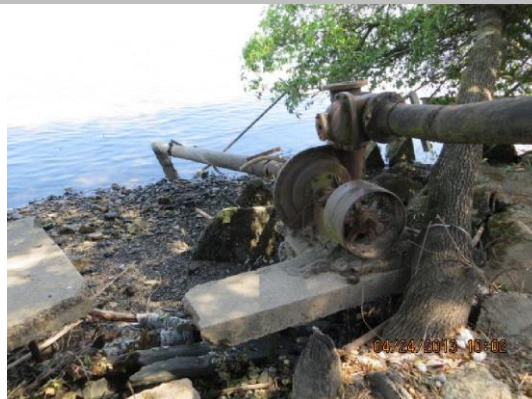
Photo 3 of 3 : UCIP_SP_2021_12746_20684.jpg

Pipe and pump on WS toe.

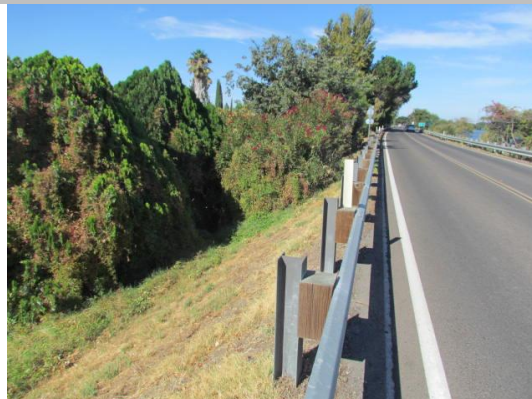
Photo 1 of 1 : SP_2021_NA0002_63_101_20210226_00040.jpg

LM Start	3.47	Rating **	M	Issue No.	101
LM End	3.53	Issue Type +	En	Location *	LS
Category	Earthen Levee			GPS Latitude/Longitude	
				Start	End
Item	Vegetation			38.162492 °	38.162600 °
				-121.614521 °	-121.615667 °
DWR ID	DWR_NA0002_02_s_2014_101				
Comment Code					
V6 : Landscaping					
Inspector Comment

Looking at dense landscaping on landward slope.

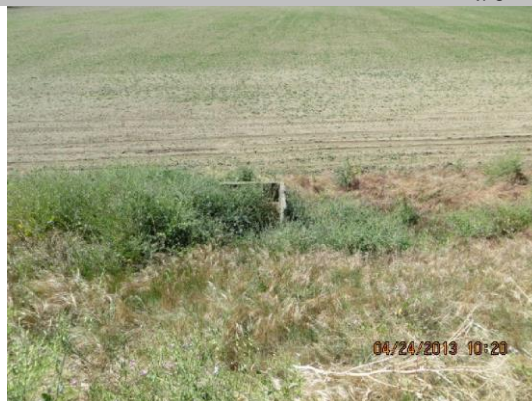
Photo 1 of 2 : UCIP_SP_2021_12748_20692.jpg

LM Start	3.70	Rating **	M	Issue No.	22
LM End	3.70	Issue Type +	En	Location *	
Category	Supplemental			GPS Latitude/Longitude	
				Start	End
Item	DWR UCIP Field Study			38.163048 °	38.163048 °
				-121.618839 °	-121.618839 °
DWR ID	21895				
Comment Code					
Inspector Comment					
FS_ID:12748 DS_ID:21895 EP_NO: 1615 Repair Type: Non-Urgent Crossing Status: Found UCIP Comments: Pipe abandoned and should be abandoned properly. FIELD_STRUCT_DESC: 8-inch irrigation pipe of an unknown material through the levee, 7.7 feet below the crown. 6-foot by 6-foot concrete distribution box on the LS toe. (Permit No. 1615, 1951 - Jones and Miller). [Additional Reference(s): DWR Levee Log, 2005. USACE Sacramento O&M Manual 102, April 1959, (RM 17.0) (Reclamation District No. 2067) steel pipe listed]. FS Date: 4/24/2013

Concrete distribution box on LS toe.

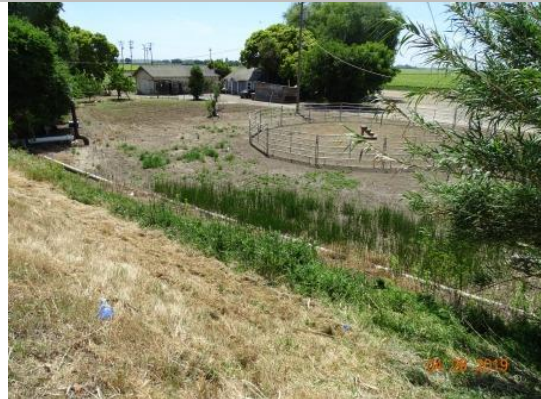
Photo 1 of 1 : SP_2021_NA0002_63_108_20210226_00042.jpg

View of irrigation pipe at landside toe (Spring 2019).

LM Start	3.92	Rating **	M	Issue No.	108
LM End	3.92	Issue Type +	En	Location *	LS
Category	Earthen Levee			GPS Latitude/Longitude	
				Start	End
Item	Encroachments			38.164020 °	38.164020 °
				-121.622641 °	-121.622641 °
DWR ID	DWR_NA0002_02_s_ 2019_108				
Comment Code					
LI : Landscape Irrigation					
Inspector Comment					
Move irrigation pipe 10 feet away from landside toe.

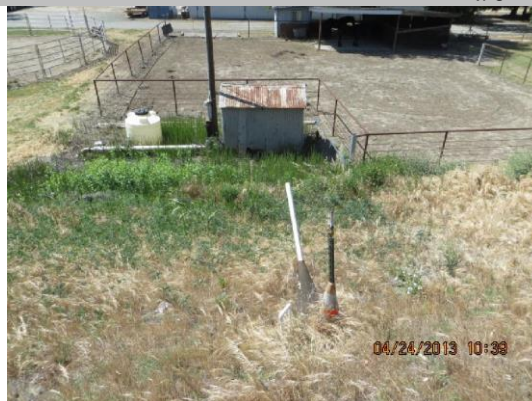
Photo 1 of 3 : UCIP_SP_2021_12752_20699.jpg

Comment Code						
Inspector Comment						
FS_ID:12752 DS_ID:21898 EP_NO: 11287 Repair Type: Non-Urgent Crossing Status: Found UCIP Comments: Aging pipe with repair on WS slope. Good candidate for vidio inspection. FIELD_STRUCT_DESC: 5-inch irrigation pipe of an unknown material through the levee, 5.5 feet below the crown. Pump in pump house on the landside (LS). Shutoff valve in pump house on the LS toe. (Automatic Board Order (ABO) issued as Permit No. 11287, 1975 - Norman Silva). [Additional Reference(s): DWR Levee Log, 2005, 6-inch pipe listed. USACE Sacramento O&M Manual 102, April 1959, (RM 16.8) (Reclamation District No. 2067) 6-inch steel pipe listed]. FS Date: 4/24/2013

Pipe and pump house on LS.

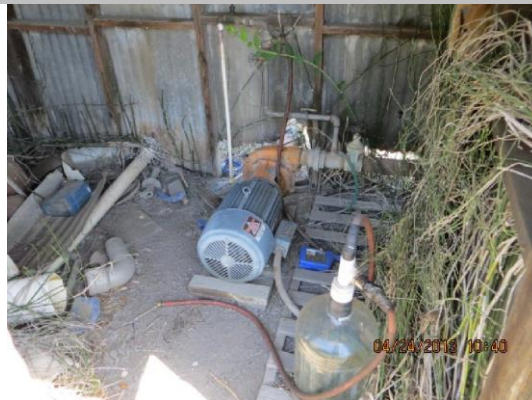
Photo 2 of 3 : UCIP_SP_2021_12752_20698.jpg

Pump and shutoff valve inside pump house on LS toe.
