**Flood Control Project Maintenance
Levee Inspections
LMA District Cover Sheet**

Brannan Andrus Levee Maintenance District

Waterway			Bank	Unit Miles
Unit No. 01 Georgiana Slough			Right	6.01
	Spring (March - May)	Summer (June - August)	(September - November) Fall	Winter (December - February)
Unit Maintenance Rating (Fall Only)				
Date of Inspection	3/17/2021 - 3/17/2021			
DWR Inspector	David Julian			
Accompanied By

Levee Inspection Report By Mile - Spring 2021

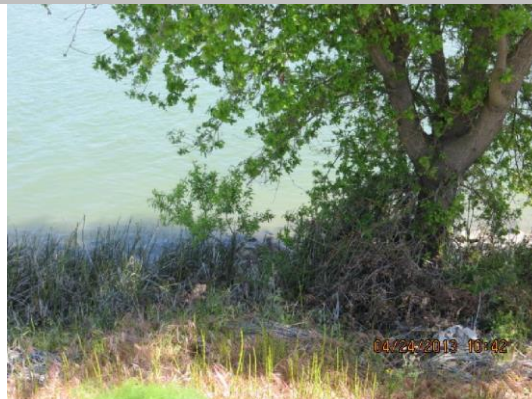
Photo 3 of 3 : UCIP_SP_2021_12752_20697.jpg

Pipe visible in water at left of tree.

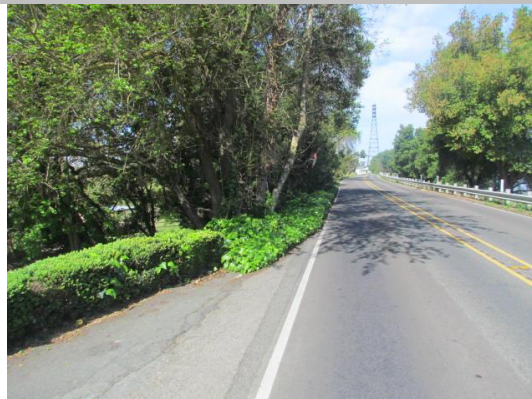
Photo 1 of 1 : SP_2021_NA0002_63_59_20210226_00014.jpg

LM Start	4.06	Rating **	U	Issue No.	59
LM End	4.13	Issue Type +	En	Location *	LS
Category	Earthen Levee			GPS Latitude/Longitude	
				Start	End
Item	Vegetation			38.164728 °	38.165167 °
				-121.624949 °	-121.626273 °
DWR ID	DWR_NA0002_02_s_ 2012_59				
Comment Code					
V6 : Landscaping					
Inspector Comment

Looking west at dense landscaping on landward slope.

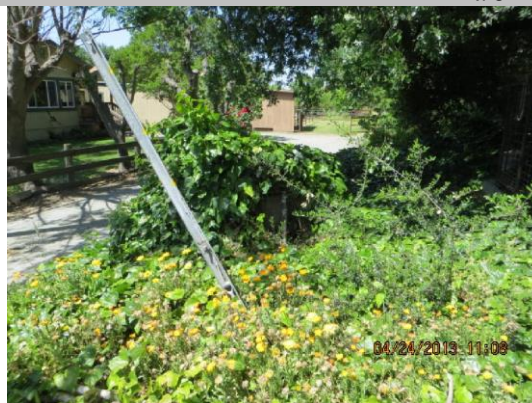
Photo 1 of 3 : UCIP_SP_2021_12768_20731.jpg

LM Start	4.11	Rating **	M	Issue No.	27	
LM End	4.11	Issue Type +	En	Location *		
Category	Supplemental			GPS Latitude/Longitude		
				Start		End
Item	DWR UCIP Field Study			38.165016 °	38.165016 °	
				-121.625834 °	-121.625834 °	
DWR ID	21904					
Comment Code						
Inspector Comment						
FS_ID:12768 DS_ID:21904 EP_NO: 787 Repair Type: Non-Urgent Crossing Status: Found UCIP Comments: Pipe may be abandoned and should be done so properly if not being used. Good candidate for video inspection. FIELD_STRUCT_DESC: 2 of 2: 14-inch steel irrigation pipe through the levee, 4.2 feet below the crown. Pump on pile structure in stream. (Permit No. 787, 1939 - J. E. Silva, et al.). [Additional Reference(s): DWR Levee Log, 2005. USACE Sacramento O&M Manual 102, April 1959, (RM 16.6) (Reclamation District No. 2067)]. FS Date: 4/24/2013

Concrete distribution box at LS toe.

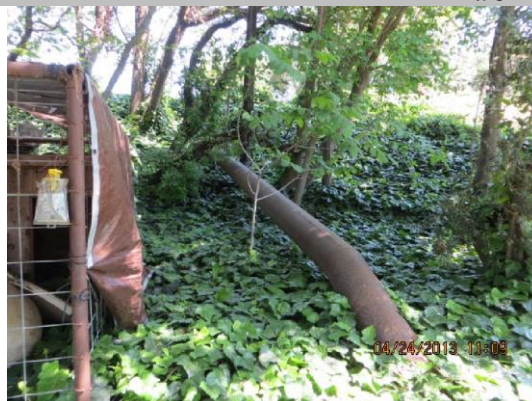
Photo 2 of 3 : UCIP_SP_2021_12768_20730.jpg

Pipe on LS slope.

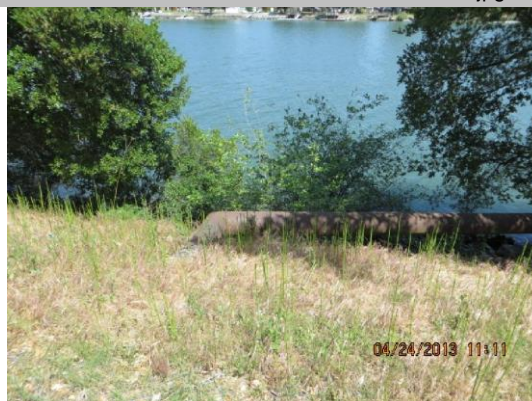
Photo 3 of 3 : UCIP_SP_2021_12768_20729.jpg

Pipe on WS slope.

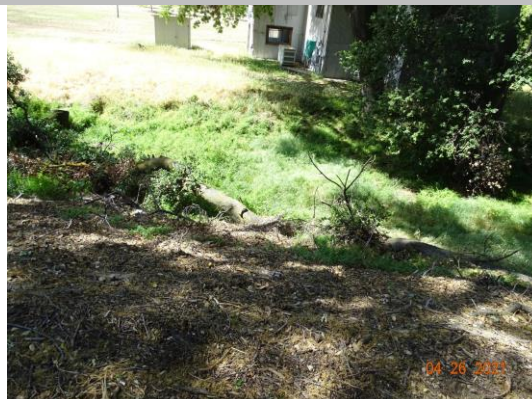
Photo 1 of 1 : SP_2021_NA0002_63_169_20210426_00158.jpg

View of down tree limb on the landside slope (Spring 2021).

LM Start	4.29	Rating **	U	Issue No.	169
LM End	4.29	Issue Type +	Ma	Location *	LS
Category	Earthen Levee			GPS Latitude/Longitude	
				Start	End
Item	Encroachments			38.166258 °	38.166258 °
				-121.628717 °	-121.628717 °
DWR ID	DWR_NA0002_02_f _ 2018_169				
Comment Code					
TR : Tree or limb					
Inspector Comment					
Remove the downed tree limb from the landside slope.

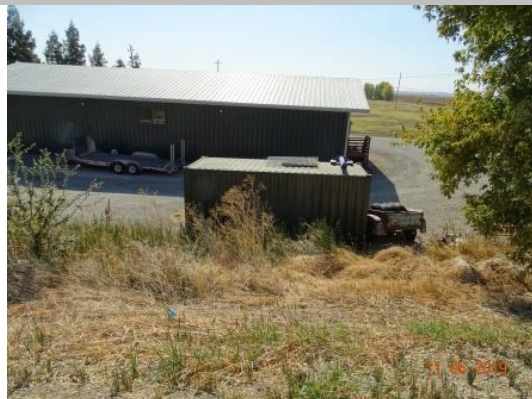
Photo 1 of 1 : SP_2021_NA0002_63_88_20210226_00033.jpg

LM Start	4.46	Rating **	U	Issue No.	88
LM End	4.46	Issue Type +	En	Location *	LS
Category	Earthen Levee			GPS Latitude/Longitude	
				Start	End
Item	Encroachments			38.167132 °	38.167132 °
				-121.631592 °	-121.631592 °
DWR ID	DWR_NA0002_02_f_2019_88				
Comment Code					
BU : Building					
Inspector Comment					
Storage container is located at the landside toe.

View of storage container at the landside toe (Fall 2019).

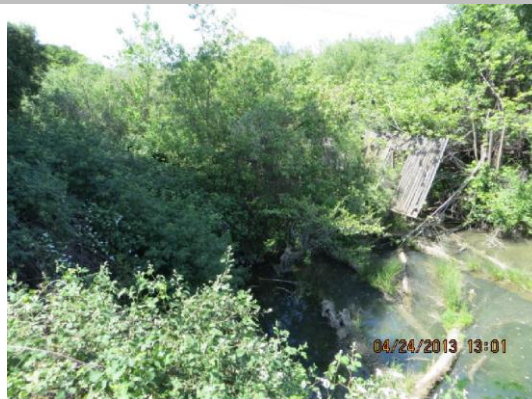
Photo 1 of 3 : UCIP_SP_2021_16010_27085.jpg

Comment Code						
Inspector Comment						
FS_ID:16010 DS_ID:21907 EP_NO: 11274 Repair Type: Non-Urgent Crossing Status: Found UCIP Comments: Pipe abandoned and should be abandoned properly if not already done so. FIELD_STRUCT_DESC: *ABANDONED* 2 of 2: 10-inch irrigation pipe of an unknown material through the levee, 6.6 feet below the crown. Pump in pump house on the landside (LS) slope. Pump house not visible, 4/24/2013. (Automatic Board Order (ABO) issued as Permit No. 11274, 1975 - Henry Martin). [Additional Reference(s): DWR Levee Log, 2005. USACE Sacramento O&M Manual 102, April 1959, (RM 16.2) (Reclamation District No. 2067) steel pipe listed]. FS Date: 4/24/2013

Possible portion of pumphouse visible off WS toe.

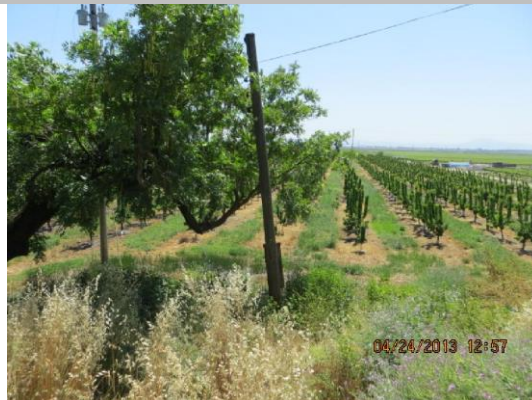
Photo 2 of 3 : UCIP_SP_2021_16010_27087.jpg

JP and meter on LS slope at location of abandoned pipe.

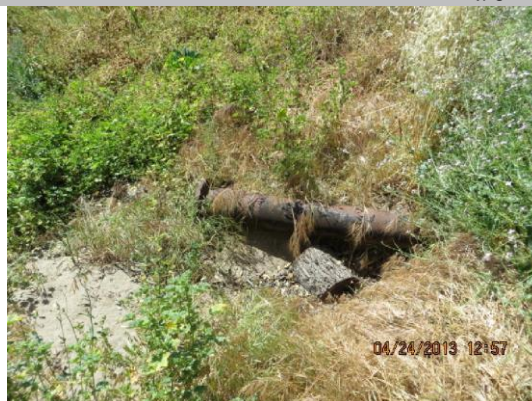
Photo 3 of 3 : UCIP_SP_2021_16010_27086.jpg

Abandoned pipe on LS slope.

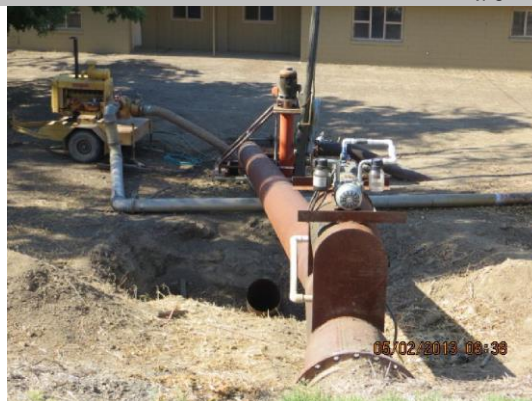
Photo 1 of 3 : UCIP_SP_2021_12773_20740.jpg

FS_ID:12773
 DS_ID:21908
 EP_NO: 11285
 Repair Type: Non-Urgent
 Crossing Status: Found
 UCIP Comments: Pit under pipe on WS shoulder - possible leak.
 Excavation of pipe on LS slope into levee prism.
 FIELD_STRUCT_DESC: 20-inch irrigation pipe of an unknown material, sleeved through a 22-inch, sleeved through a 24-inch pipe, through the levee, 3 feet below the crown. Pump on the landside (LS). Small pump on the LS shoulder and a 7-foot by 9-foot concrete sump on the LS toe.
 (Automatic Board Order (ABO) issued as Permit No. 11285, 1975 - Manuel Silva). [Additional Reference(s): DWR Levee Log, 2005. USACE Sacramento O&M Manual 102, April 1959, (RM 15.9) (Reclamation District No. 2067) steel pipe listed].
 FS Date: 5/2/2013

Small pump on LS shoulder with concrete distribution box on LS toe.

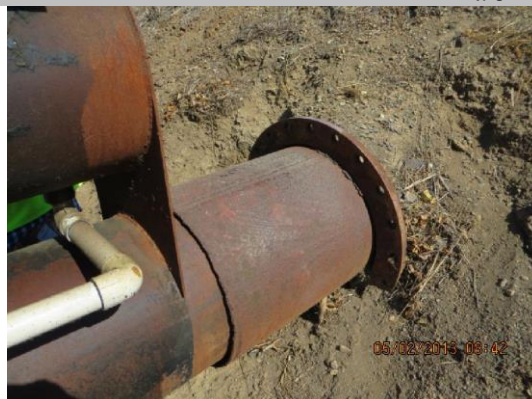
Photo 2 of 3 : UCIP_SP_2021_12773_20739.jpg

20-inch pipe sleeved through 22-inch pipe sleeved through a 24-inch steel pipe.

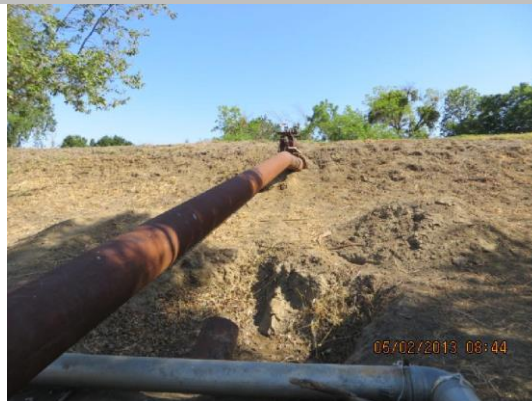
Photo 3 of 3 : UCIP_SP_2021_12773_20738.jpg

Pipe on LS slope with excavation in levee prism.

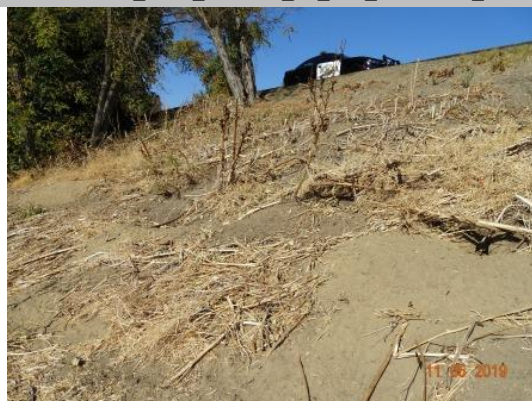
Photo 1 of 1 : SP_2021_NA0002_63_128_20210226_00051.jpg

LM Start	4.81	Rating **	U	Issue No.	128
LM End	4.99	Issue Type +	Ma	Location *	LS
Category	Earthen Levee			GPS Latitude/Longitude	
				Start	End
Item	Animal Control			38.168831 °	38.169583 °
				-121.637619 °	-121.640698 °
DWR ID	DWR_NA0002_02_f_2019_128				
Comment Code					
A1 : Exterminate rodents and backfill and compact or grout burrows.					
Inspector Comment					
Multiple large squirrel holes.

View of multiple large squirrel holes in landside slope (Fall 2019).

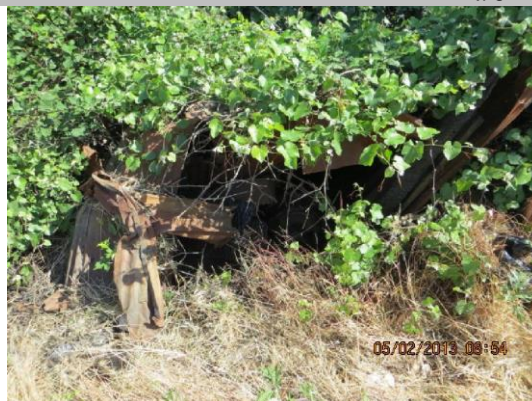
Photo 1 of 3 : UCIP_SP_2021_12774_20745.jpg

FS_ID:12774
DS_ID:21909
EP_NO: 724
Repair Type: Non-Urgent
Crossing Status: Found
UCIP Comments: Pipe open on waterside at fallen down pumphouse. Pipe abandoned. Service pole on LS slope down on ground near broken standpipe. Pipe needs to be properly abandoned.
FIELD_STRUCT_DESC: 10-inch irrigation pipe of an unknown material through the levee, 3.8 feet below the crown. Pump in pump house on the waterside (WS) slope. Service pole on the landside (LS) slope. Replaces a 10-inch pipe at approximately the same location. 32-inch concrete standpipe on the LS toe. 1.5-inch electrical conduit runs parallel to 10-inch pipe. (Permit No. 724, 1937 - California Lands, Inc., and Frank Hodapp). [Additional Reference(s): DWR Levee Log, 2005. USACE Sacramento O&M Manual 102, April 1959, (RM 15.8) (Reclamation District No. 2067) steel pipe listed].
FS Date: 5/2/2013

Broken down pumphouse on WS slope.

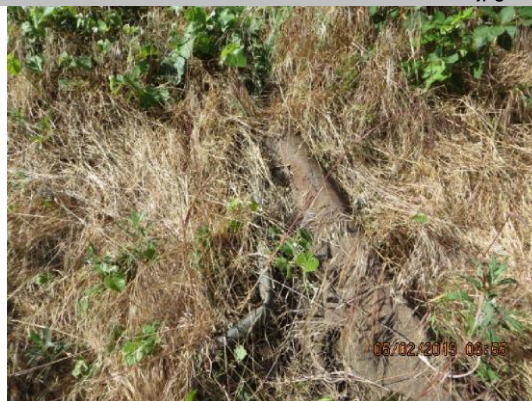
Photo 2 of 3 : UCIP_SP_2021_12774_20744.jpg

deformed and crushed pipe with 1.5-inch electrical conduit on WS slope.

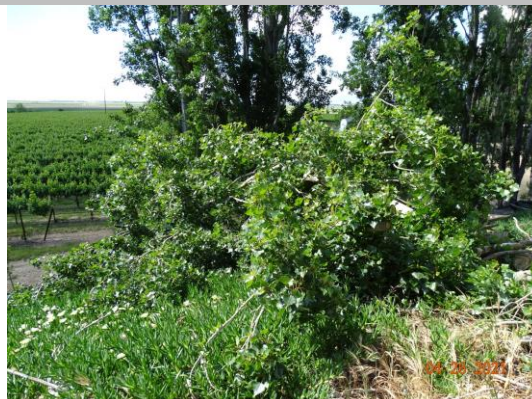
Photo 1 of 1 : SP_2021_NA0002_63_91_20210426_00157.jpg

View of large fallen tree on the landside slope (Spring 2021).

LM Start	5.32	Rating **	U	Issue No.	91
LM End	5.32	Issue Type +	En	Location *	LS
Category	Earthen Levee			GPS Latitude/Longitude	
				Start	End
Item	Encroachments			38.171866 °	38.171866 °
				-121.645684 °	-121.645684 °
DWR ID	DWR_NA0002_02_s_2021_91				
Comment Code					
TR : Tree or limb					
Inspector Comment					
Remove large fallen tree on landside slope.

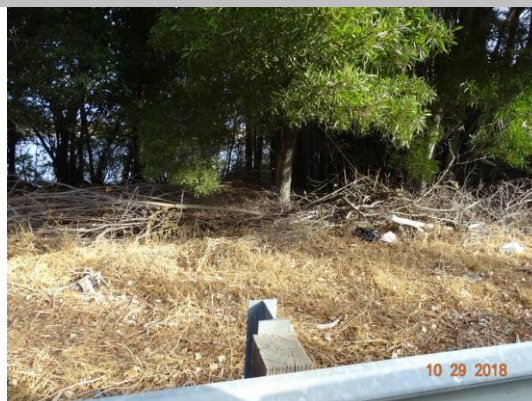
Photo 1 of 1 : SP_2021_NA0002_63_115_20210226_00045.jpg

View of prunings on the waterside slope (October 2018).

LM Start	5.36	Rating **	M	Issue No.	115
LM End	5.36	Issue Type +	Ma	Location *	WS
Category	Earthen Levee			GPS Latitude/Longitude	
				Start	End
Item	Encroachments			38.171892 °	38.171892 °
				-121.646387 °	-121.646387 °
DWR ID	DWR_NA0002_02_f _ 2018_115				
Comment Code					
PR : Prunings					
Inspector Comment					
Remove the prunings from the waterside slope.

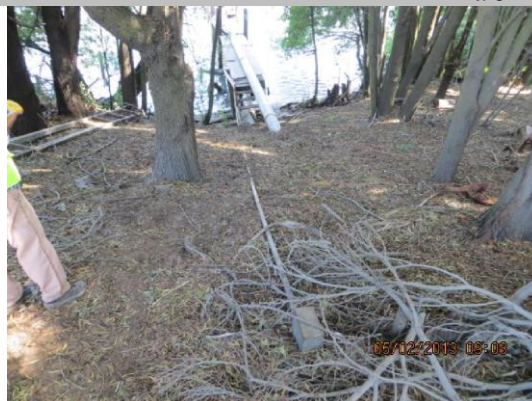
Photo 1 of 3 : UCIP_SP_2021_12776_20754.jpg

LM Start	5.41	Rating **	M	Issue No.	32
LM End	5.41	Issue Type +	En	Location *	
Category	Supplemental			GPS Latitude/Longitude	
				Start	End
Item	DWR UCIP Field Study			38.171824 °	38.171824 °
				-121.647265 °	-121.647265 °
DWR ID	21910				
Comment Code					
Inspector Comment					
FS_ID:12776 DS_ID:21910 EP_NO: 7089A Repair Type: Non-Urgent Crossing Status: Found UCIP Comments: Hole at LS toe over pipe possible sign of leakage. FIELD_STRUCT_DESC: 7-inch drainage pipe of an unknown material through the levee, 13 feet below the crown. Pump in pump house on the landside (LS). 1.5-inch galvanized steel electrical conduit at same location. 4-foot by 6-foot concrete distribution box off the LS toe next to pump house. [Additional Reference(s): DWR Levee Log, 2005. USACE Sacramento O&M Manual 102, April 1959, (RM 15.3) (Reclamation District No. 2067) steel pipe listed]. FS Date: 5/2/2013

Pipe and electrical conduit on WS slope.

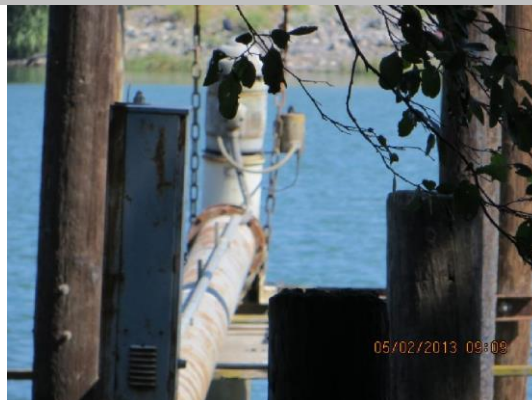
Photo 2 of 3 : UCIP_SP_2021_12776_20753.jpg

Pump on pier at WS toe.

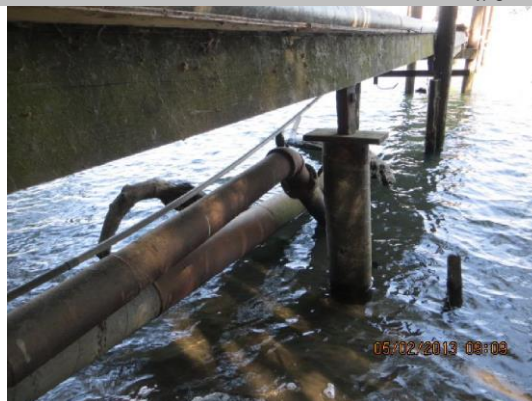
Photo 3 of 3 : UCIP_SP_2021_12776_20752.jpg

Pipe under pier.

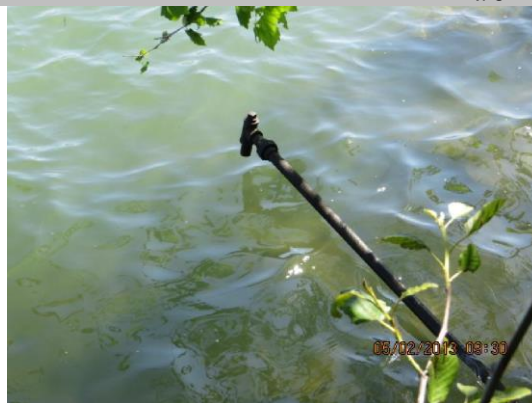
Photo 1 of 3 : UCIP_SP_2021_12778_20762.jpg

LM Start	5.77	Rating **	M	Issue No.	33	
LM End	5.77	Issue Type +	Ma	Location *		
Category	Supplemental			GPS Latitude/Longitude		
				Start		End
Item	DWR UCIP LMA Responsibility			38.172940 °		38.172940 °
				-121.653700 °		-121.653700 °
DWR ID	21912					
Comment Code						
Inspector Comment						
FS_ID:12778 DS_ID:21912 EP_NO: N/A Repair Type: Non-Urgent Crossing Status: Found UCIP Comments: Pipe abandoned. Erosion on WS slope at location where pipe should be. FIELD_STRUCT_DESC: *ABANDONED* 12-inch drainage pipe of an unknown material through the levee, 13 feet below the crown. Pump and gate valve in pump house at the landside (LS) toe. 1.5-inch electrical conduit along pipe at same location. 42-inch concrete standpipe at the LS toe. [Additional Reference(s): USACE Sacramento O&M Manual 102, April 1959, (RM 14.8) (Reclamation District No. 2067) steel pipe listed FS Date: 5/2/2013

Conduit at WS toe.

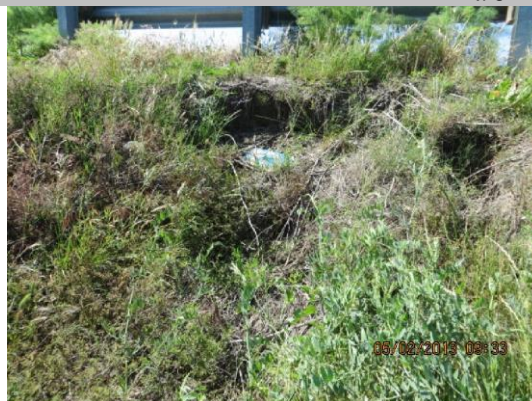
Photo 2 of 3 : UCIP_SP_2021_12778_20761.jpg

Erosion along pipe alignment at WS slope.

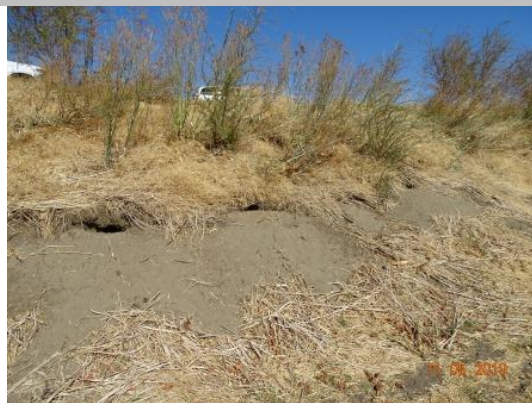
Photo 1 of 1 : SP_2021_NA0002_63_122_20210226_00049.jpg

LM Start	6.07	Rating **	U	Issue No.	122
LM End	6.07	Issue Type +	Ma	Location *	LS
Category	Earthen Levee			GPS Latitude/Longitude	
				Start	End
Item	Animal Control			38.174655 °	38.174655 °
				-121.658643 °	-121.658643 °
DWR ID	DWR_NA0002_02_f_2019_122				
Comment Code					
A1 : Exterminate rodents and backfill and compact or grout burrows.					
Inspector Comment					
Multiple large squirrel holes.

View of multiple large squirrel holes in the landside slope (Fall 2019).

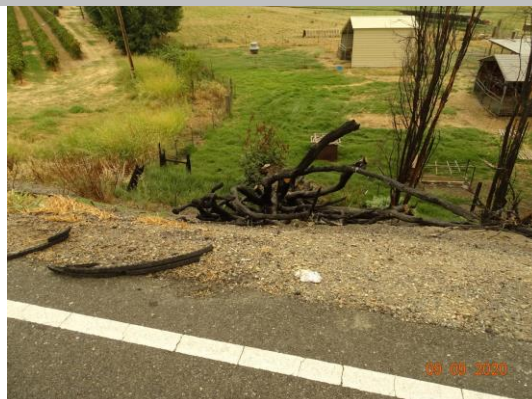
Photo 1 of 1 : SP_2021_NA0002_63_84_20210226_00032.jpg

LM Start	6.24	Rating **	M	Issue No.	84
LM End	6.24	Issue Type +	Ma	Location *	LS
Category	Earthen Levee			GPS Latitude/Longitude	
				Start	End
Item	Encroachments			38.174143 °	38.174143 °
				-121.661659 °	-121.661659 °
DWR ID	DWR_NA0002_02_f _ 2017_84				
Comment Code					
TR : Tree or limb					
Inspector Comment					
Dead tree on the landside.

View looking downslope at burned tree on the landside slope (Fall 2020).

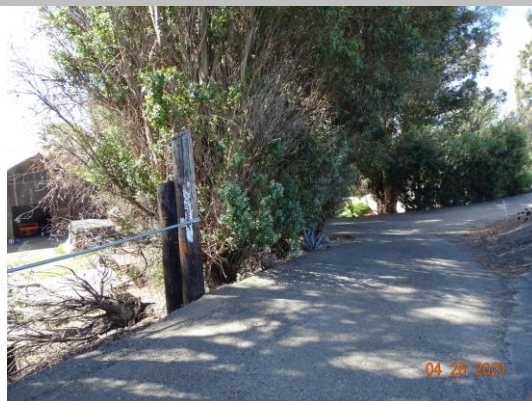
Photo 1 of 1 : SP_2021_NA0002_63_50_20210426_00156.jpg

LM Start	6.27	Rating **	M	Issue No.	50
LM End	6.29	Issue Type +	En	Location *	LS
Category	Earthen Levee			GPS Latitude/Longitude	
				Start	End
Item	Vegetation			38.173922 °	38.173832 °
				-121.662272 °	-121.662550 °
DWR ID	DWR_NA0002_02_s_2013_50				
Comment Code					
V6 : Landscaping					
Inspector Comment

View looking downstream at landscaping on the landside slope (Spring 2021).

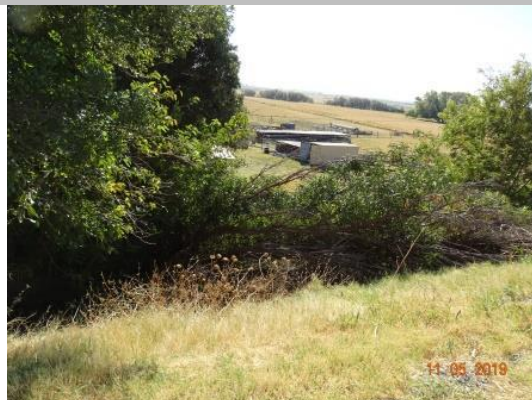
Photo 1 of 1 : SP_2021_NA0002_63_13_20210226_00004.jpg

LM Start	6.32	Rating **	U	Issue No.	13
LM End	6.32	Issue Type +	Ma	Location *	LS
Category	Earthen Levee			GPS Latitude/Longitude	
				Start	End
Item	Encroachments			38.173697 °	38.173697 °
				-121.663082 °	-121.663082 °
DWR ID	DWR_NA0002_02_s_2017_13				
Comment Code					
TR : Tree or limb					
Inspector Comment					
Fallen tree on the landside slope.

View of fallen tree on the landside slope (Fall 2019).

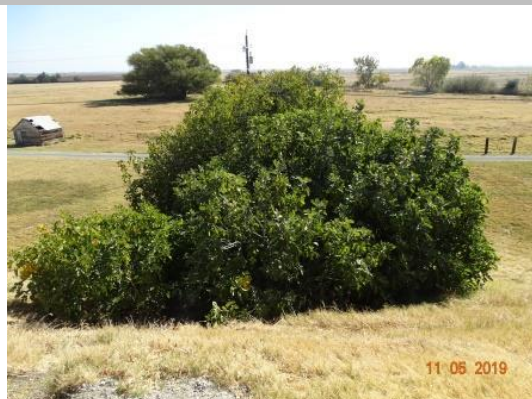
Photo 1 of 1 : SP_2021_NA0002_63_118_20210226_00046.jpg

LM Start	6.46	Rating **	M	Issue No.	118
LM End	6.46	Issue Type +	Ma	Location *	LS
Category	Earthen Levee			GPS Latitude/Longitude	
				Start	End
Item	Trim / Thin Trees			38.172678 °	38.172678 °
				-121.665280 °	-121.665280 °
DWR ID	DWR_NA0002_02_f_2019_118				
Comment Code					
T2 : Thin trees to allow visibility of the ground and room to flood fight.					
Inspector Comment

View of fig tree on the landside slope (Fall 2019).

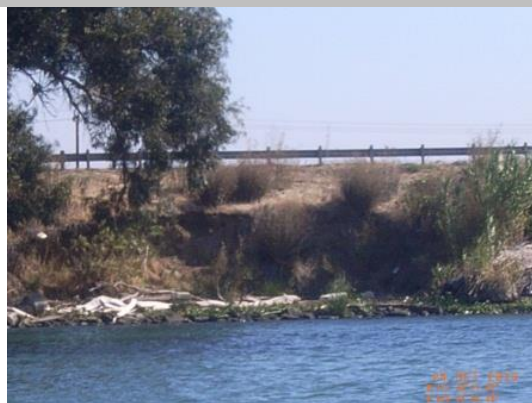
Photo 1 of 1 : SP_2021_NA0002_63_71_20210226_00022.jpg

LM Start	6.98	Rating **	U	Issue No.	71
LM End	7.04	Issue Type +	Ma	Location *	WS
Category	Supplemental			GPS Latitude/Longitude	
				Start	End
Item	2017 USACE Erosion Survey			38.166583 °	38.165794 °
				-121.670684 °	-121.671014 °
DWR ID	DWR_NA0002_02_f_2018_71				
Comment Code					
Inspector Comment					
2017 Site ID: SAC 13.6 L					
Status: Critical					
2017 Field Notes: upgraded to critical. nearly vertical face from levee hinge. trees with large root balls likely to fail.					
Site History: 2011 - Large section of bank slumped off.

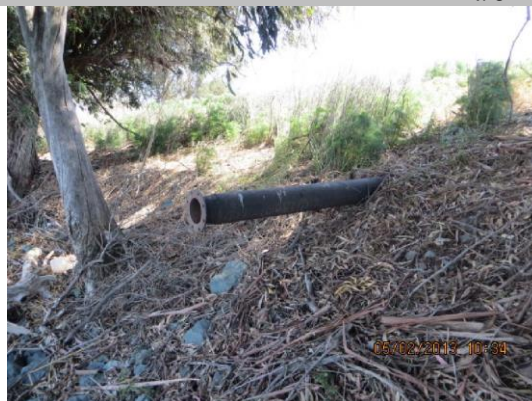
Photo 1 of 3 : UCIP_SP_2021_53390_27090.jpg

FS_ID:53390
DS_ID:21916
EP_NO: N/A
Repair Type: Urgent
Crossing Status: Found
UCIP Comments: 07/12/2018 Holes on pipe visible where it daylightes on WS, and inside of concrete box on LS. Pipe is opened on WS. Recommend internal inspection to determine pipe integrity through levee. (O.Yakimov-DWR UCIP)10/24/2016 same as previous inspection pipe is opened on the WS. The crossing remains "Urgent" due WS end open. Crossing appears abandoned--need to contact owner to determine status. If crossing is no longer in use owner will need to coordinate with the CVFPB to comply with Title 23. (O. Magana - DWR UCIP)05/02/2013 Pipe open on WS. (W. Wylie - DWR UCIP)
FIELD_STRUCT_DESC: *ABANDONED* 8-inch steel irrigation pipe through levee 8.7 feet below crown. Pipe measures 8-inch inner diameter (ID) and 10-inch outer diameter (OD). A 5-foot by 5-foot concrete distribution box is located on the landside (LS) toe. [Additional Reference(s): DWR Levee Log, 2005. USACE Sacramento O&M Manual Unit 103, June 1954, (RM 13.6)].

Pipe open on WS slope.

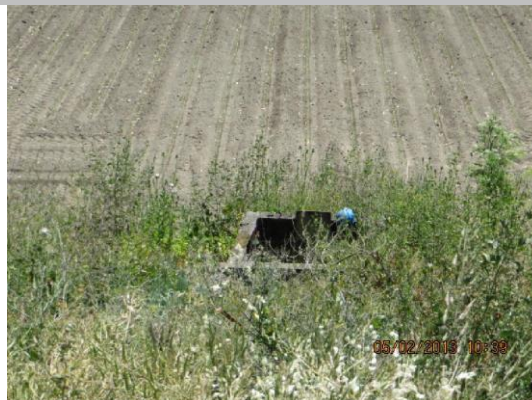
Photo 2 of 3 : UCIP_SP_2021_53390_27091.jpg

5X5 concrete distribution box at LS toe

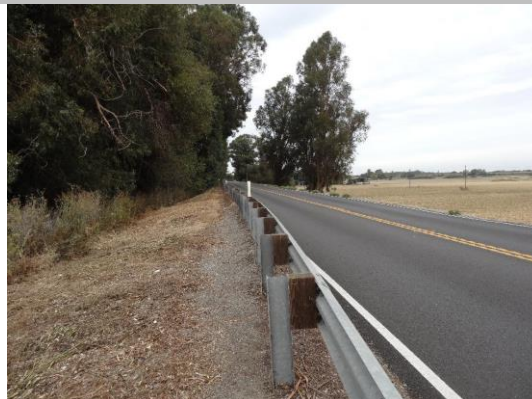
Photo 3 of 3 : UCIP_SP_2021_53390_76478.jpg

View of levee crown and WS slope at pipe crossing.

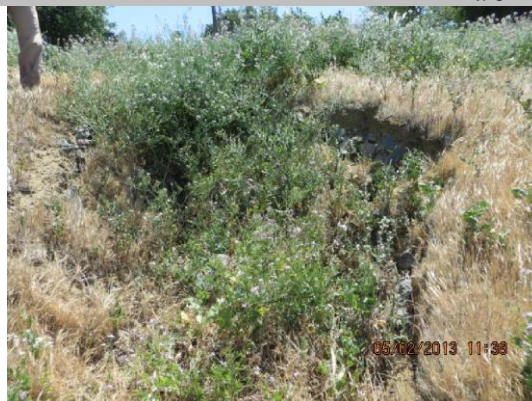
Photo 1 of 3 : UCIP_SP_2021_12814_20821.jpg

Comment Code						
Inspector Comment						
FS_ID:12814 DS_ID:21918 EP_NO: 11293 Repair Type: Non-Urgent Crossing Status: Found UCIP Comments: Erosion or sinkhole on WS shoulder. Does not appear to be an immediate threat. FIELD_STRUCT_DESC: 2 of 2: 16-inch irrigation pipe of an unknown material through the levee, 7.1 feet below the crown. Pump and service pole on the landside (LS) slope. 72-inch concrete standpipe at the landside (LS) toe. (Automatic Board Order (ABO) issued as Permit No. 11293, 1975 - John Wilcox). [Additional Reference(s): DWR Levee Log, 2005. USACE Sacramento O&M Manual 102, April 1959, (RM 13.0) (Reclamation District No. 2067) steel pipe listed]. FS Date: 5/2/2013

Erosion/sinkhole over pipe on WS slope.

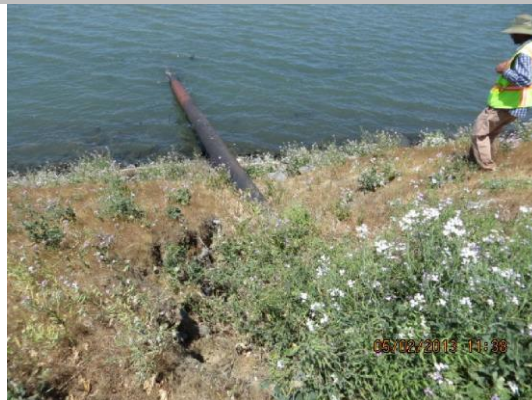
Photo 2 of 3 : UCIP_SP_2021_12814_20820.jpg

Pipe on WS slope.

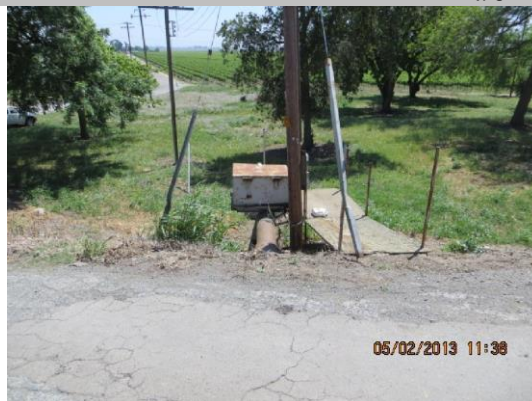
Photo 3 of 3 : UCIP_SP_2021_12814_20819.jpg

Pipe and pump on LS shoulder.

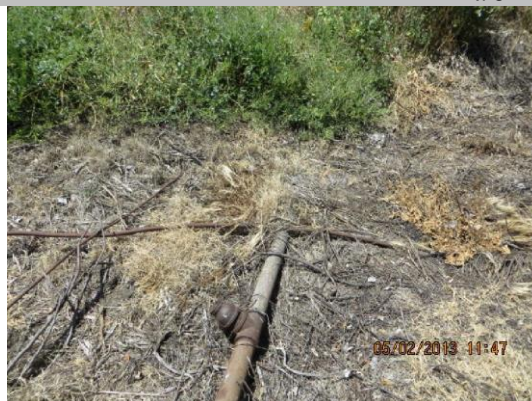
Photo 1 of 2 : UCIP_SP_2021_12817_20825.jpg

FS_ID:12817
 DS_ID:21920
 EP_NO: N/A
 Repair Type: Non-Urgent
 Crossing Status: Found
 UCIP Comments: Pipe should be abandoned properly.
 FIELD_STRUCT_DESC: 3-inch pipe of an unknown material or purpose through the levee, 7.7 feet below the crown. Inactive service pole on the landside (LS) slope. [Additional Reference(s): DWR Levee Log, 2005].
 FS Date: 5/2/2013

3.5-inch galvanized iron pipe on LS slope.

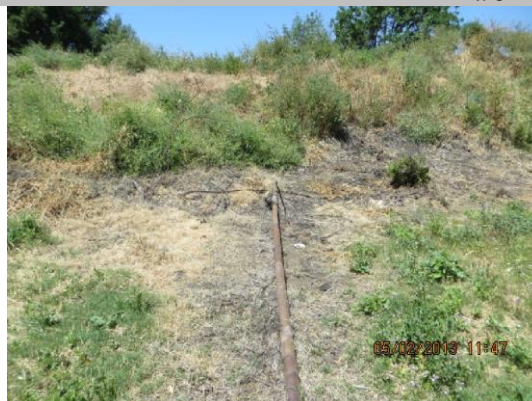
Photo 2 of 2 : UCIP_SP_2021_12817_20824.jpg

3.5-inch galvanized iron pipe on LS slope.

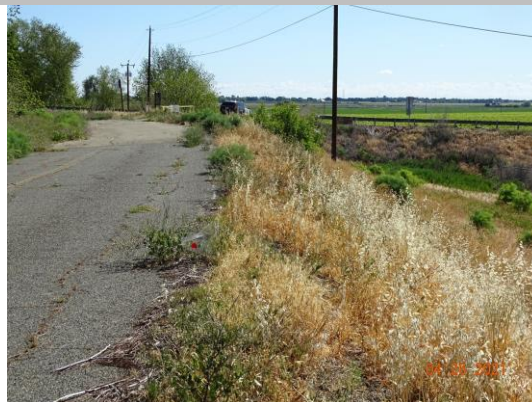
Photo 1 of 1 : SP_2021_NA0002_63_49_20210426_00152.jpg

LM Start	7.60	Rating **	U	Issue No.	49
LM End	7.82	Issue Type +	Ma	Location *	LS
Category	Earthen Levee			GPS Latitude/Longitude	
				Start	End
Item	Vegetation			38.158555 °	38.156797 °
				-121.675595 °	-121.678955 °
DWR ID	DWR_NA0002_02_f_2020_49				
Comment Code					
V1 : Control annual grass and weeds on the levee slopes and easements.					
Inspector Comment

View looking upstream at vegetation on the landside slope (Spring 2021).

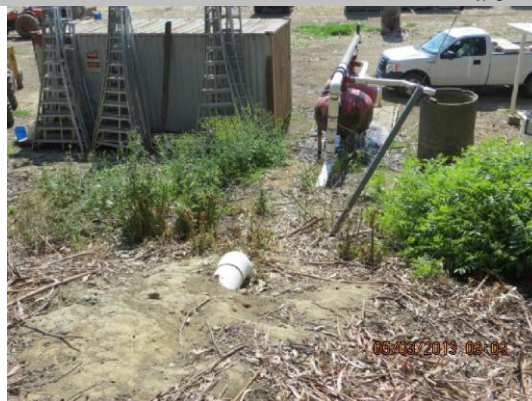
Photo 1 of 3 : UCIP_SP_2021_12869_20933.jpg

Comment Code						
Inspector Comment						
FS_ID:12869 DS_ID:21925 EP_NO: 2795 Repair Type: Non-Urgent Crossing Status: Found UCIP Comments: Annular space between PVC pipe and 12-inch steel pipe has not been sealed. FIELD_STRUCT_DESC: 20-inch irrigation pipe of an unknown material through the levee, 3 feet below the crown. 8-inch polyvinyl chloride pipe sleeved through a 12-inch pipe that is sleeved through the 20-inch. Annular space grouted between two metal pipes. Pump and butterfly valve in pump house on the waterside (WS) slope. 36-inch concrete standpipe and filters on the landside (LS) toe. (Permit No. 2795, 1958 - M. B. McKinnon). [Additional Reference(s): DWR Levee Log, 2005]. FS Date: 5/3/2013

PVC pipe, filters, and concrete standpipe on LS.

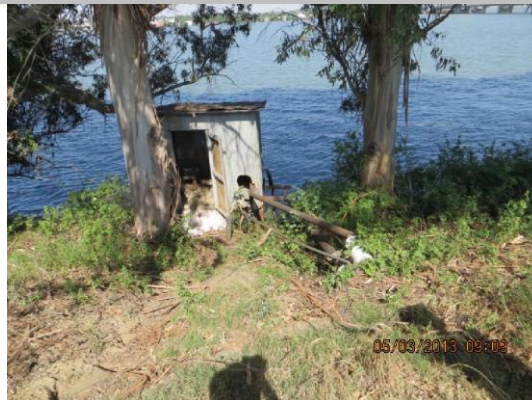
Photo 2 of 3 : UCIP_SP_2021_12869_20932.jpg

Pumphouse and pipe on WS slope.

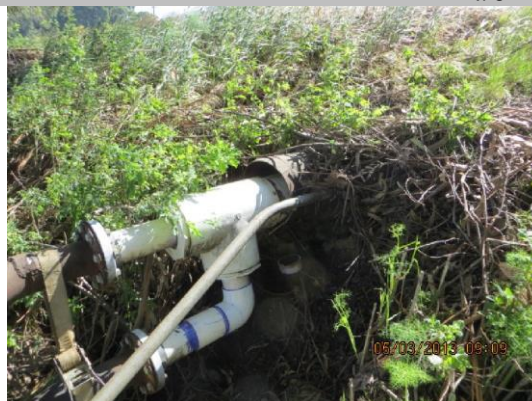
Photo 3 of 3 : UCIP_SP_2021_12869_20931.jpg

PVC pipe sleeved through 12-inch steel pipe on WS slope.

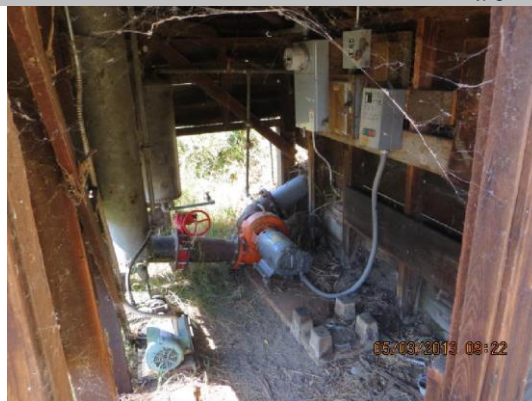
Photo 1 of 3 : UCIP_SP_2021_16143_27242.jpg

Comment Code						
Inspector Comment						
FS_ID:16143						
DS_ID:21926						
EP_NO: 8661						
Repair Type: Non-Urgent						
Crossing Status: Found						
UCIP Comments: Dip in crown over alignment of pipe. Good candidate for video inspection.						
FIELD_STRUCT_DESC: 8-inch irrigation pipe of an unknown material through the levee, 3.7 feet below the crown. Pump in pump house on the landside (LS) slope. Service pole and 30-inch concrete standpipe at the LS toe (Automatic Board Order (ABO) issued as Permit No. 8661, 1972 - Jesse Marks). [Additional Reference(s): DWR Levee Log, 2005. USACE Sacramento O&M Manual 102, April 1959, (RM 12.2) (Reclamation District No. 2067) steel pipe listed].						
FS Date: 5/3/2013

Pump and butterfly valve in pumphouse on LS toe.

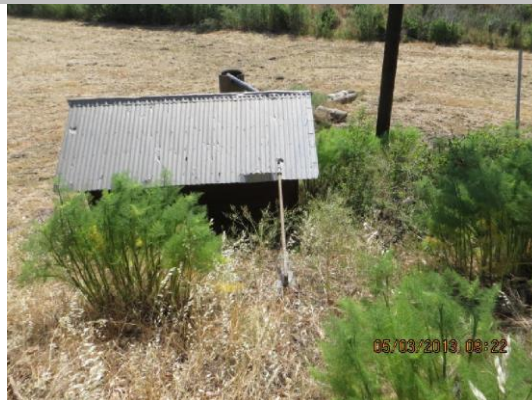
Photo 2 of 3 : UCIP_SP_2021_16143_27241.jpg

Pumphouse with concrete standpipe in background on LS toe.

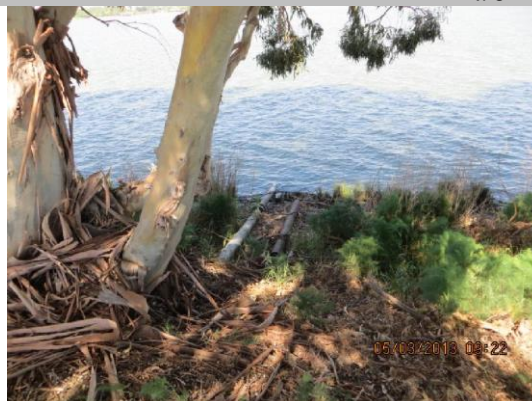
Photo 3 of 3 : UCIP_SP_2021_16143_27240.jpg

Pipe on WS slope.

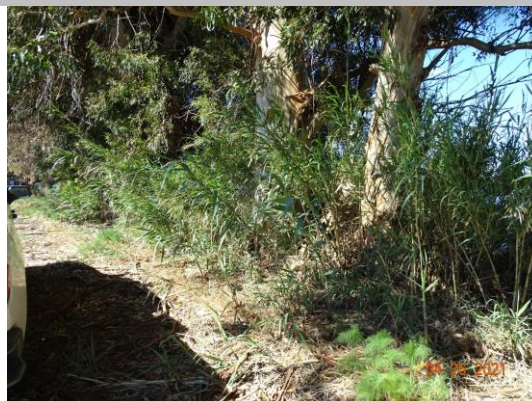
Photo 1 of 1 : SP_2021_NA0002_63_92_20210426_00154.jpg

LM Start	8.17	Rating **	U	Issue No.	92
LM End	8.17	Issue Type +	Ma	Location *	WS
Category	Earthen Levee			GPS Latitude/Longitude	
				Start	End
Item	Vegetation			38.152255 °	38.152255 °
				-121.681607 °	-121.681607 °
DWR ID	DWR_NA0002_02_f _ 2019_92				
Comment Code					
V7 : Trees / Woody Vegetation					
Inspector Comment					
Remove arundo on the waterside slope.

View of arundo on the waterside slope (Spring 2021).

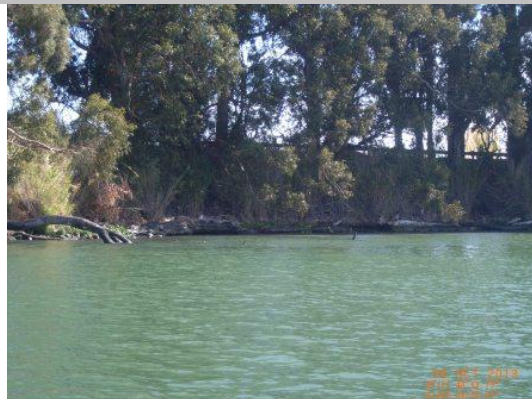
Photo 1 of 1 : SP_2021_NA0002_63_70_20210226_00021.jpg

LM Start	8.20	Rating **	U	Issue No.	70
LM End	8.42	Issue Type +	Ma	Location *	WS
Category	Supplemental			GPS Latitude/Longitude	
				Start	End
Item	2017 USACE Erosion Survey			38.151867 °	38.148711 °
				-121.682201 °	-121.682790 °
DWR ID	DWR_NA0002_02_f_2018_70				
Comment Code					
Inspector Comment					
2017 Site ID: SAC 12.1 L					
Status: Critical					
2017 Field Notes: Continues to worsen and threaten the road.					
Site History: 2010 - Small inlet area behind a man-built spit. Bank is slumping and could possibly be fixed with maintenance. 2011 - Site continues to worsen. 2015 - Upgraded to CRITICAL. 2016 - Site continues to get worse.

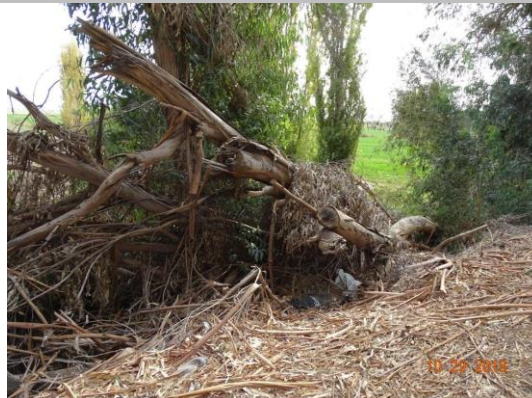
Photo 1 of 1 : SP_2021_NA0002_63_158_20210226_00056.jpg

LM Start	8.32	Rating **	U	Issue No.	158
LM End	8.35	Issue Type +	Ma	Location *	LS
Category	Earthen Levee			GPS Latitude/Longitude	
				Start	End
Item	Encroachments			38.150168 °	38.149698 °
				-121.682159 °	-121.682255 °
DWR ID	DWR_NA0002_02_f _ 2018_158				
Comment Code					
TR : Tree or limb					
Inspector Comment					
Remove the downed trees from landside slope.

View of down tree on landside slope (October 2018).

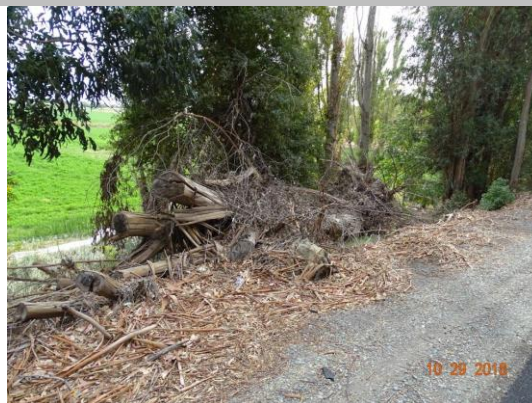
Photo 1 of 1 : SP_2021_NA0002_63_157_20210226_00055.jpg

LM Start	8.40	Rating **	U	Issue No.	157
LM End	8.40	Issue Type +	Ma	Location *	LS
Category	Earthen Levee			GPS Latitude/Longitude	
				Start	End
Item	Encroachments			38.148959 °	38.148959 °
				-121.682385 °	-121.682385 °
DWR ID	DWR_NA0002_02_f _ 2019_157				
Comment Code					
TR : Tree or limb					
Inspector Comment					
Remove the downed tree from the landside slope.

View of downed tree on landside slope (October 2018).

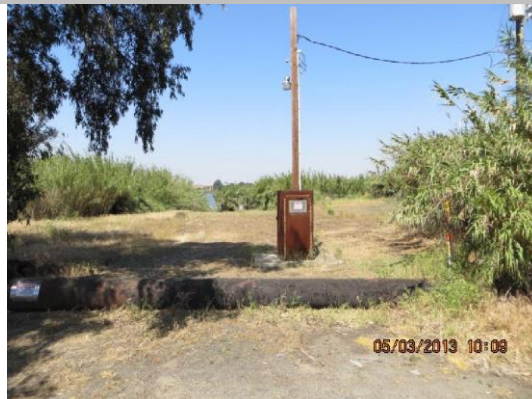
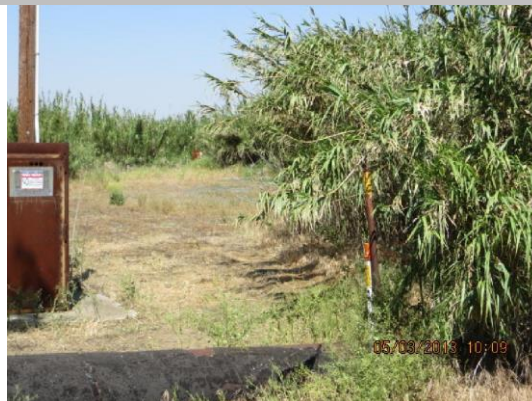
LM Start	8.55	Rating **	M	Issue No.	41
LM End	8.55	Issue Type +	En	Location *	
Category	Supplemental			GPS Latitude/Longitude	
				Start	End
Item	DWR UCIP Field Study			38.146784 °	38.146784 °
				-121.682780 °	-121.682780 °
DWR ID	21929				
Comment Code					
Inspector Comment					
FS_ID:12886 DS_ID:21929 EP_NO: 842 Repair Type: Non-Urgent Crossing Status: Indicator Found UCIP Comments: Need to determine disposition of pipe. FIELD_STRUCT_DESC: 12-inch gas pipeline of an unknown material through the levee, 3 feet below the crown. Gas line marker and vent on the waterside (WS) shoulder. (Permit No. 842, 1940 - PG&E). [Additional Reference(s): DWR Levee Log, 2005]. FS Date: 5/3/2013

Gasline marker and vent to right of JP.

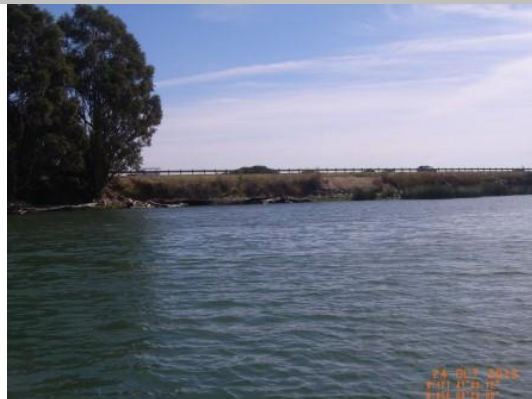
USACE 2013 Photo #1

Comment Code					
Inspector Comment					
2017 Site ID: SAC 11.2 L					
Status: Critical					
2017 Field Notes: New slump section. Erosion under the road has enlarged.					
Site History: 2008 - Erosion causing vertical bank at the highway on top of levee. The whole bank along the highway should be repaired.					
2009 - Minimal new erosion. 2011 - Bank continues to slowly erode.					
2012 - Upgrade to critical, new erosion since lat year and steeper slopes in sections. 2015 - Road foundation and cables exposed.					
Extremely large tree with exposed roots looks likely to fail and take out a significant portion of the levee. 2016 - Site continues to erode.

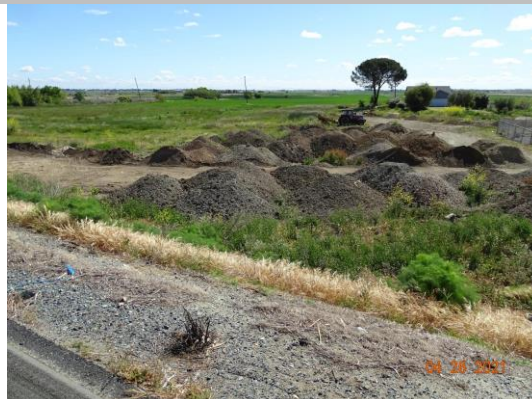
LM Start	9.06	Rating **	U	Issue No.	57
LM End	9.06	Issue Type +	En	Location *	LS
Category	Earthen Levee			GPS Latitude/Longitude	
				Start	End
Item	Encroachments			38.139722 °	38.139722 °
				-121.685524 °	-121.685524 °
DWR ID	DWR_NA0002_02_s_2021_57				
Comment Code					
DE : Debris					
Inspector Comment					
Large dirt piles at the landside toe.

View of large dirt piles within 15 feet of landside toe (Spring 2021).

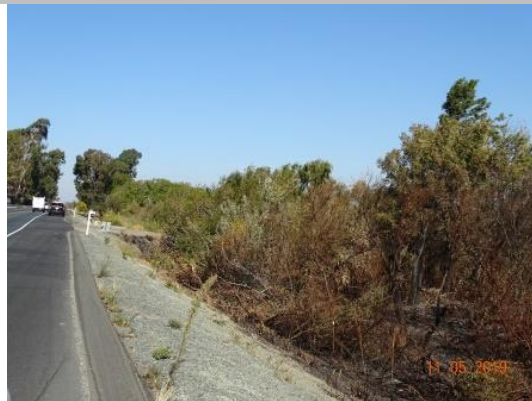
View looking upstream at vegetation on the landside slope (Fall 2019).

LM Start	9.19	Rating **	M	Issue No.	109
LM End	10.30	Issue Type +	Ma	Location *	LS
Category	Earthen Levee			GPS Latitude/Longitude	
				Start	End
Item	Vegetation			38.138038 °	38.122558 °
				-121.686165 °	-121.690739 °
DWR ID	DWR_NA0002_02_f _ 2019_109				
Comment Code					
V1 : Control annual grass and weeds on the levee slopes and easements.					
Inspector Comment

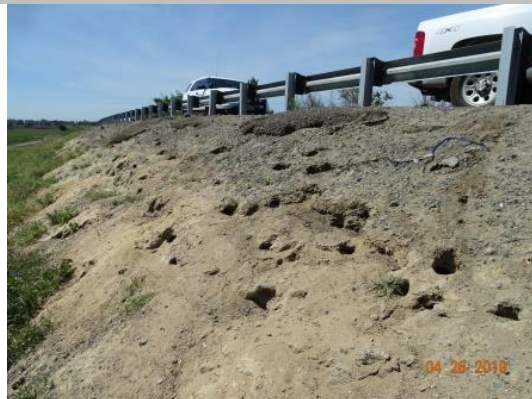
LM Start	9.36	Rating **	U	Issue No.	67
LM End	10.03	Issue Type +	Ma	Location *	LS
Category	Earthen Levee			GPS Latitude/Longitude	
				Start	End
Item	Animal Control			38.135593 °	38.126291 °
				-121.686057 °	-121.688959 °
DWR ID	DWR_NA0002_02_s_2019_67				
Comment Code					
A1 : Exterminate rodents and backfill and compact or grout burrows.					
Inspector Comment					
There is major ground squirrel burrowing activity along this stretch. The LMA is aware of rock piles near the levee toe and says that is the source of the rodents.

View looking downstream at animal holes on the landside slope (Spring 2019).

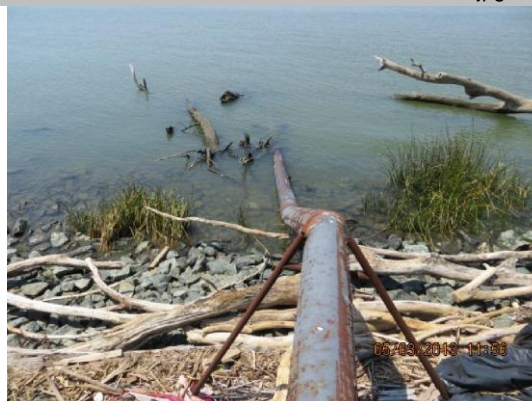
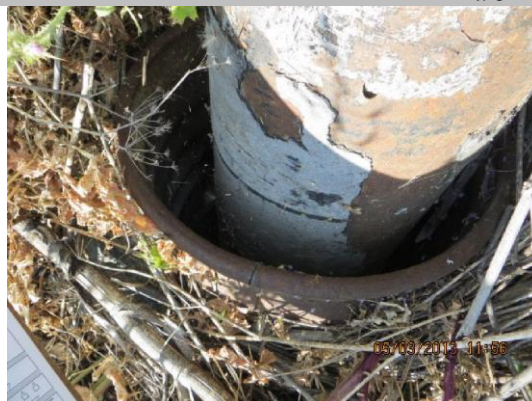
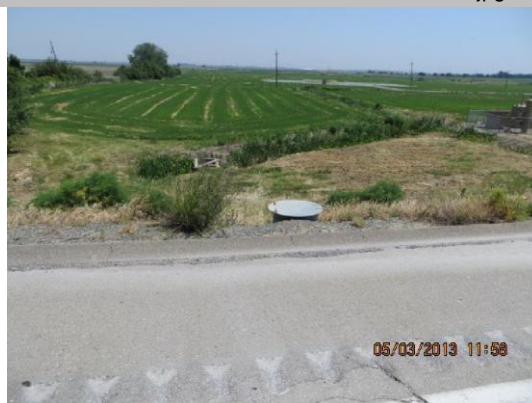
FS_ID:40528
 DS_ID:21931
 EP_NO: 16011
 Repair Type: Non-Urgent
 Crossing Status: Found
 UCIP Comments: Annular space between pipes should be grouted. IF abandoned, these pipes should be abandoned properly.
 FIELD_STRUCT_DESC: 18-inch corrugated metal conduit pipe through the levee, 4.5 feet below the crown. Inactive 12-inch pipe sleeved through 18-inch. Both ends open. Siphon breaker and air valve in 24-inch corrugated metal riser unit on the landside (LS) shoulder. 9-foot by 5-foot concrete box with slide gate off LS toe. [Additional Reference(s): DWR Levee Log, 2005. USACE Sacramento O&M Manual 102, April 1959, (RM 10.9) (Reclamation District No. 2067) steel pipe listed].
 FS Date: 5/3/2013

Pipe on WS slope.

18-inch CMP with 12-inch irrigation pipe sleeved through it.

Standpipe and concrete box at LS.

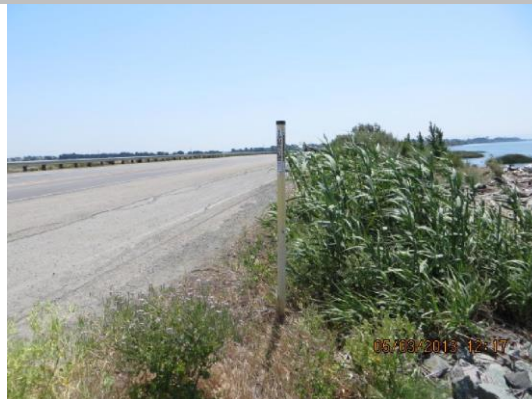
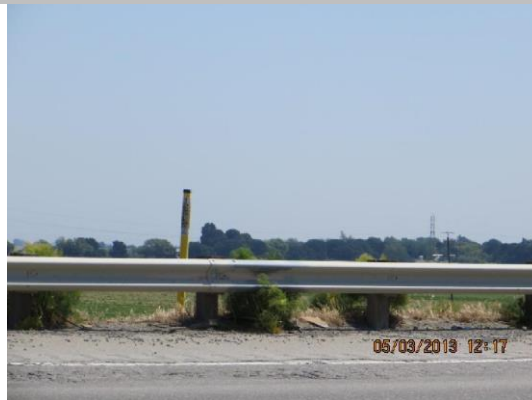
LM Start	9.50	Rating **	M	Issue No.	46
LM End	9.50	Issue Type +	En	Location *	
Category	Supplemental			GPS Latitude/Longitude	
				Start	End
Item	DWR UCIP Field Study			38.133512 °	38.133512 °
				-121.685948 °	-121.685948 °
DWR ID	23142				
Comment Code					
Inspector Comment					
FS_ID:16146 DS_ID:23142 EP_NO: N/A Repair Type: Non-Urgent Crossing Status: Indicator Found UCIP Comments: Need to determine Permit No. for this crossing. FIELD_STRUCT_DESC: Gas line markers on the landside (LS) toe and waterside (WS) shoulder. FS Date: 5/3/2013

Gasline Marker on WS shoulder

Gasline Marker on LS shoulder

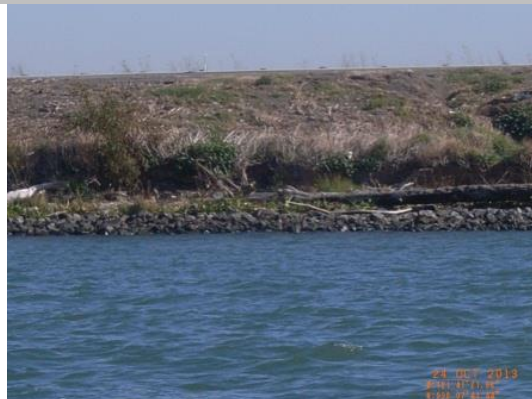
USACE 2013 Photo #1

Comment Code					
Inspector Comment					
2017 Site ID: SAC 10.8 L					
Status: Eroding					
2017 Field Notes: Lots of new woody debris recruitment.					
Site History: 2004 - Wave wash pockets approximately 100 ft long with new full bank rock between the pockets. 2005 - Spot repairs, but toe is still eroding in several places. 2006 - Low vertical bank along roadway. 2007 - A PL 84-99 repair was constructed, it cover the majority of the site with the exception of the upstream 150 to 200 ft and the downstream 250 ft, therefore it is being kept in the inventory. 2009 - Minimal new erosion. 2010 - Outboard berm looks good, but the banks are still very steep. 2011 - While the outboard berm is protecting against wave wash, bank still has slumping issues.

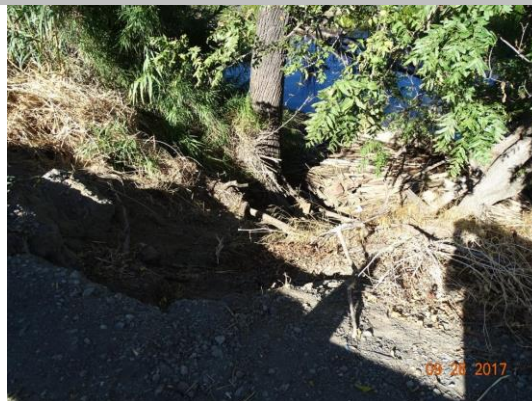
Looking northwest at the waterside slope.

LM Start	10.74	Rating **	M	Issue No.	119
LM End	10.74	Issue Type +	Ma	Location *	WS
Category	Earthen Levee			GPS Latitude/Longitude	
				Start	End
Item	Erosion / Bank Caving			38.116906 °	38.116906 °
				-121.694595 °	-121.694595 °
DWR ID	DWR_NA0002_02_f_2017_119				
Comment Code					
E2 : Schedule repair of erosion site prior to the next inspection.					
Inspector Comment
