**Flood Control Project Maintenance  
Levee Inspections  
LMA District Cover Sheet**

**Brannan Andrus Levee Maintenance District**

**Flood Control Project Maintenance  
Levee Inspections  
Unit Cover Sheet**

| Waterway | | | Bank | Unit Miles |
|--|---|---|---|---|
| Unit No. 01 Georgiana Slough | | | Right | 6.01 |

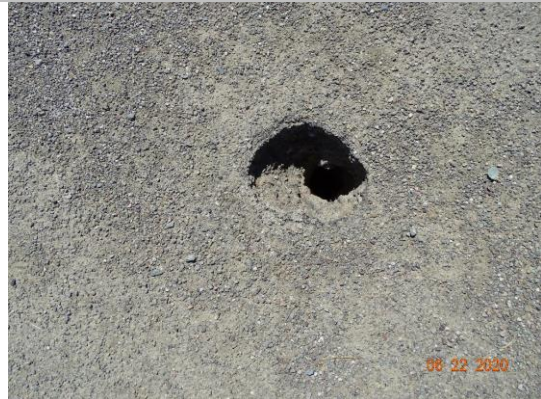
Photo 1 of 3 : UCIP\_SP\_2023\_62296\_89899.jpg

DS\_ID:21753  
FS\_ID:62296  
EP\_NO: 11232  
Repair Type: Urgent  
EVAL Issue: 2b, Levee Integrity  
Crossing Status: Found  
UCIP Comments: 06/22/2020 Record updated from Non-Urgent to Urgent. Sinkhole in the center of crown measures 8-inch in diameter and 2-feet in depth. Damaged siphon breaker pipe on landside shoulder. Vegetation on waterside limits levee inspection at this crossing. Geophysical study indicates possible presence of pipe through levee. Owner needs to coordinate with the CVFPB to remove or abandon crossing according to Title 23 requirements. No permit has been identified authorizing pipe. Need to have CVFPB review ABO and determine current owner. (O.Yakimov - DWR UCIP)  
05/16/2013 Unable to locate any appurtenances other than distribution box. Need to verify proper abandonment.  
FIELD\_STRUCT\_DESC: 12-inch steel irrigation pipe through the levee, 3.2 feet below the crown. Siphon breaker on the landside (LS) slope. Concrete distribution box located LS of the toe. 2-inch primer valve. (12-inch pipe [HLM 0.75] authorized under Automatic Board Order (ABO) issued as Permit No. 11232, 1975 - Mario Campi). [Additional Reference(s): DWR Levee Log, 2005 (HLM 0.70). USACE Sacramento O&M Manual, Unit 103, June 1954, Revised 29 December 2016, (Station 'R' 279+70), listed as 12-inch pipe. USACE As-Built Drawing No. 50-04-2631, Sheet 7, Station 279+70, March 1950].

Top of Levee: View of sinkhole in the center of crown

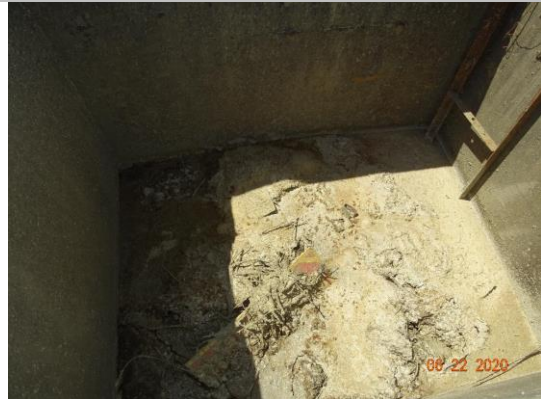
Photo 3 of 3 : UCIP\_SP\_2023\_62296\_89903.jpg

Land-Side: Silt in the bottom of CB is present inside of concrete box. Silt in the bottom of CB is present

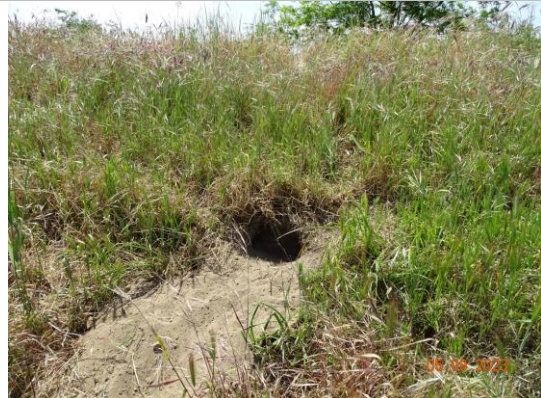
Photo 1 of 1 : SP\_2023\_NA0002\_62\_133\_20230517\_00095.jpg

| Spring 2023: Some holes have been grouted but new ones have appeared. | | | | | |

View of a new rodent hole on the LS slope (Spring 2023).

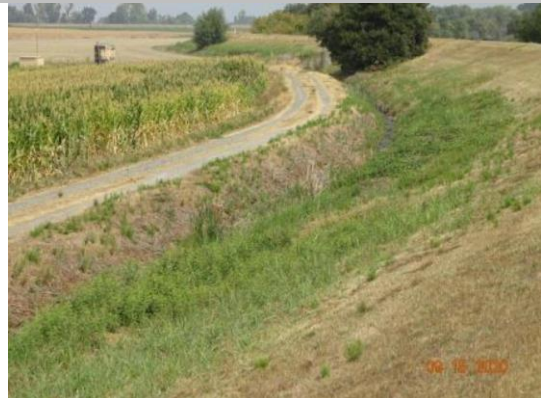
Photo 1 of 1 : SP\_2023\_NA0002\_62\_56\_20230206\_00018.jpg

| There is a ditch at the landside toe. | | | | | |

View looking upstream at ditch at the landside toe (Fall 2020).

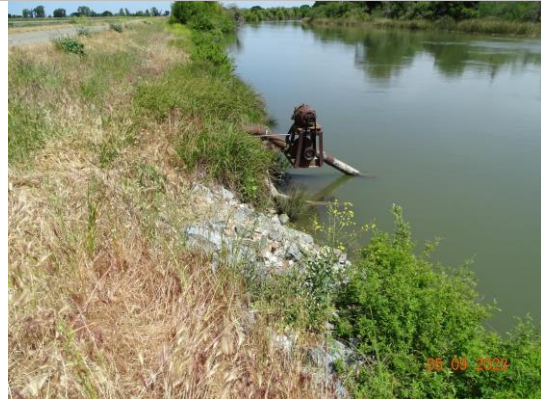
Photo 1 of 3 : SP\_2023\_NA0002\_62\_39\_20230517\_00093.jpg

| Site History: 2017 - Failed rock section, slump failure of bank to subvertical face. | | | | | |

View of the erosion on the WS (Spring 2023).

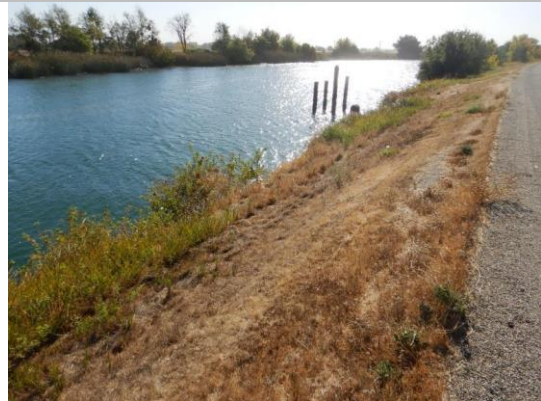
Photo 2 of 3 : SP\_2023\_NA0002\_62\_39\_20230206\_00009.jpg

USACE 2018 Erosion Photo #1

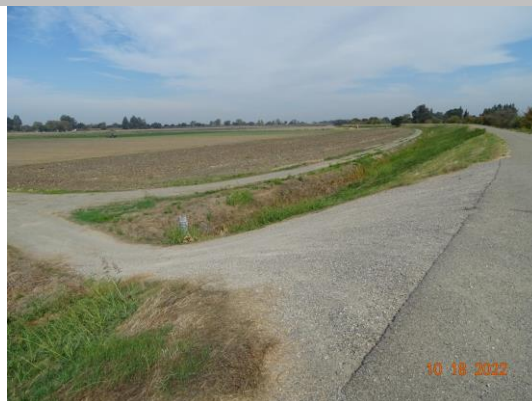
Photo 1 of 1 : SP\_2023\_NA0002\_62\_74\_20230206\_00027.jpg

| The landowner has created a gravel-covered ramp up the landside of the levee. A permit application should be submitted and the ramp should be brought up to Title 23 standards after approval. | | | | | |

View of the ramp going down the LS slope (Fall 2022).

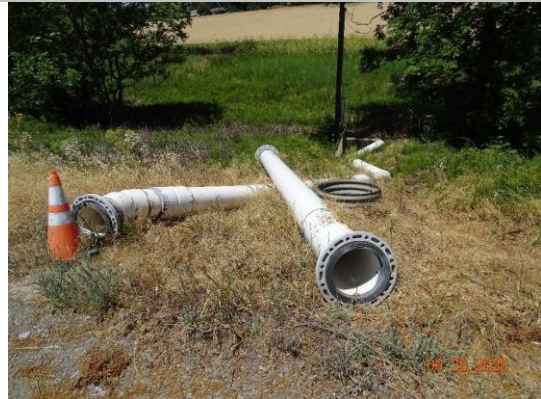
Photo 2 of 3 : UCIP\_SP\_2023\_62304\_89931.jpg

| DS_ID:21758<br>FS_ID:62304<br>EP_NO: 11252<br>Repair Type: Non-Urgent<br>EVAL Issue: 10, Unauthorized Modification or Non-Compliant Permit<br>Crossing Status: Found<br>UCIP Comments: 06/22/2020 Record remains Non-Urgent. Old pipe segment is visible inside of concrete box at landside toe. Siphon breaker is still located in CMP riser on landside levee slope. 12-inch PVC pipe is connected to pump at riverbank on one side and discharges to concrete distribution box at landside toe. Pipe is temporarily dismantled on levee crown. Unable to find a permit for modification. Unable to locate a permit to confirm original pipe removal from levee. No permit has been identified authorizing original pipe through the levee. Need to have CVFPB review ABO and determine current owner. (O.Yakimov - DWR UCIP)<br>04/06/2017 Landowner has installed a temporary pipe and removed old pipe. Photos and update courtesy of DWR Inspector, Richard Willoughby.05/16/2013 Pipe rusted through at inlet to box. Good candidate for video inspection. (G. Wylie - DWR)<br>FIELD_STRUCT_DESC: 12-inch steel pipe through the levee 4.0 feet below the crown. Slant pump on bank. Switch box on berm, conduit through levee. Siphon breaker in 24-inch CMP riser on landward slope. Power pole and electrical panel at landward toe. 7'X10' concrete distribution box on LS toe. (12-inch pipe [HLM 2.17] authorized under Automatic Board Order (ABO) issued as Permit No. 11252, 1975 - Hubert & Palmyra Vandermaele). [Additional Reference(s): DWR Levee Log, 2005 (HLM 2.17). USACE Sacramento O&M Manual, Unit 103, June 1954, Revised 29 December 2016, (Station 'R' 205+46), listed as 12-inch pipe. USACE As-Built Drawing No. 50-04-2631, Sheet 5, Station 205+46, March 1950].<br>FS Date: 6/22/2020 10:20:04 AM | | | | | | |

Land-Side: View of levee slope looking from crown. Dismantled PVC pipe on slope

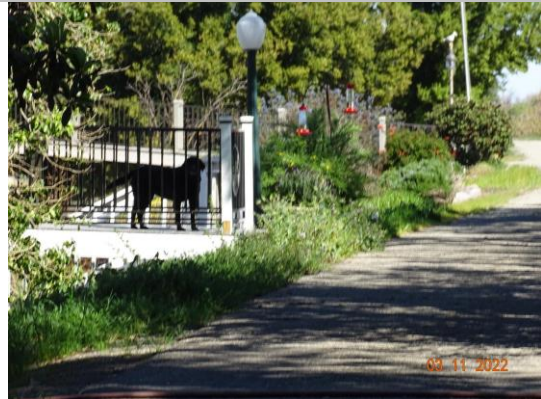
Photo 1 of 1 : SP\_2023\_NA0002\_62\_36\_20230206\_00008.jpg

| Spring 2023: Some of the landscaping has been cleared. | | | | | |

View looking upstream at landscaping on the landside slope (Spring 2022).

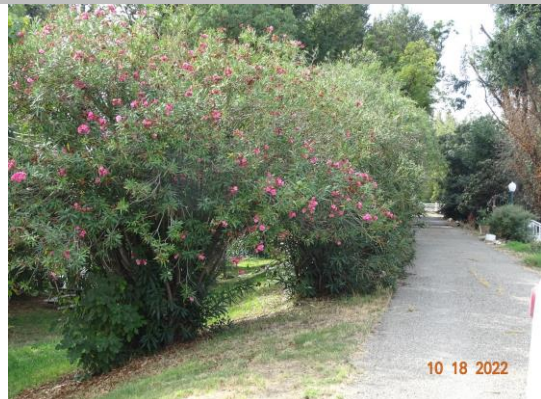
Photo 1 of 1 : SP\_2023\_NA0002\_62\_58\_20230206\_00020.jpg

View of the oleander on the WS shoulder and slope (Fall 2022).

| Remove oleanders. | | | | | |

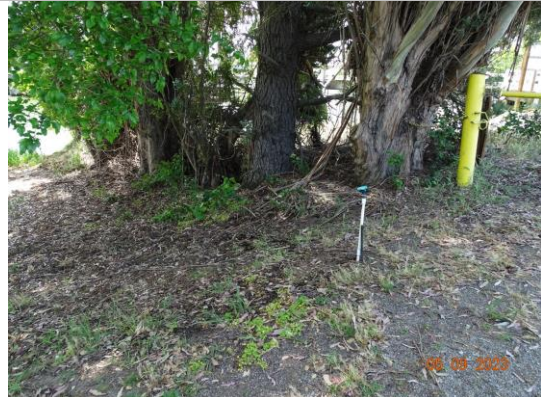
Photo 1 of 1 : SP\_2023\_NA0002\_62\_50\_20230517\_00090.jpg

| Landowner installed sprinklers along waterside slope without permit. | | | | | |

View of the sprinkler emitter on the WS slope (Spring 2023).

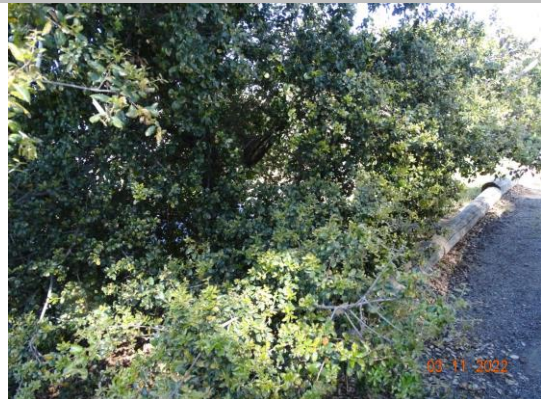
Photo 1 of 1 : SP\_2023\_NA0002\_62\_72\_20230206\_00026.jpg

View of thick tree on the landside shoulder (Spring 2022).

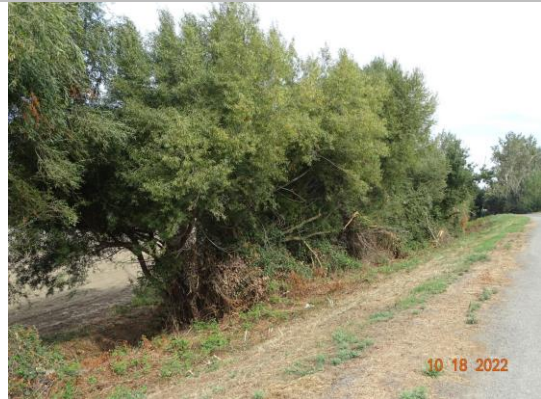
Photo 1 of 1 : SP\_2023\_NA0002\_62\_28\_20230206\_00007.jpg

| The wild roses have been removed but some dense vegetation on the toe remains. | | | | | |

View of the vegetation on the LS toe (Fall 2022).

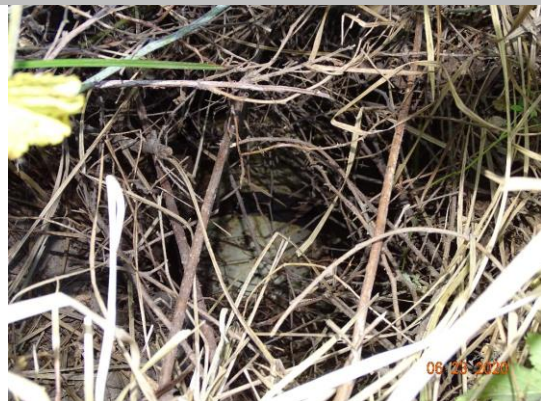
Photo 3 of 3 : UCIP\_SP\_2023\_62316\_89992.jpg

DS\_ID:21765  
FS\_ID:62316  
EP\_NO: 11238  
Repair Type: Non-Urgent  
EVAL Issue: 6, Levee Damage or Threat for Levee Damage  
Crossing Status: Found  
UCIP Comments: 06/23/2020 Record updated from Urgent to Non-Urgent. Visible cut in levee crown is due to emergency replacement of pipe section through levee crown in 2009. Erosion at riverbank within 10 feet from waterside levee toe is still present, but didn't grow in size. Dense vegetation on waterside limits inspection of levee at the crossing. No permit has been identified authorizing original pipe through the levee. Need to have CVFPB review ABO and determine current owner. (O.Yakimov - DWR UCIP)  
07/12/2018 Dense vegetation on both levee slopes. Unable to evaluate erosion on WS. Depression along pipe alignment on levee crown. Recommend internal inspection to determine pipe integrity through levee. (O.Yakimov-DWR UCIP)10/24/2016 Unable to access WS due to heavy vegetation--assume WS remains the same or erosion has progressed but not visible from levee crown. Pipe marker found on LS slope next to 12-inch irrigation pipe indicating high pressure non-odorized natural gas pipeline however, unable to confirm if line is present or if it is parallel to levee or if it goes through levee. (O. Magana - DWR UCIP)05/16/2013 Erosion along pipe at WS toe goes into levee prism. Animal activity appears to be the cause of some pretty heavy erosion damage. Some settlement along the pipe alignment on crown may indicate other problems with this pipe. (W. Wylie - DWR UCIP)

Water-Side: Pipe visible under shrubs near levee toe. Erosion around pipe is present

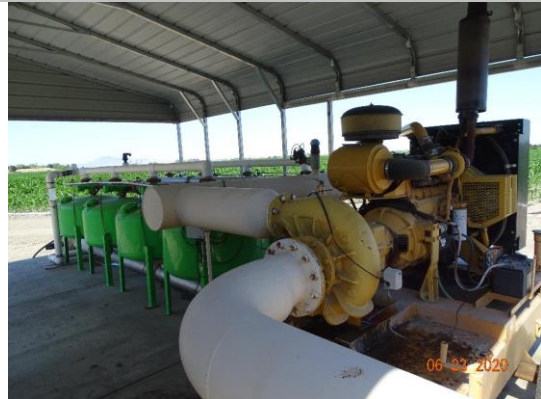
Photo 3 of 3 : UCIP\_SP\_2023\_62317\_89993.jpg

DS\_ID:21766  
FS\_ID:62317  
EP\_NO: N/A  
Repair Type: Non-Urgent  
EVAL Issue: 10, Unauthorized Modification or Non-Compliant Permit  
Crossing Status: Indicator Found  
UCIP Comments: 06/23/2020 Record remains Non-Urgent. Concrete standpipe on landside was removed. Diesel pump and media filtering facility installed on landside. Unable to find a permit for modification. Recommend owner to install a riser for siphon breaker on waterside shoulder. Pipe is running - no leaks detected. Updated coordinates of crossing. (O.Yakimov - DWR UCIP)  
05/16/2013 Appears abandoned  
FIELD\_STRUCT\_DESC: 12-inch steel irrigation pipe through the levee, at an unknown depth. 5-foot diameter concrete riser unit on the landside (LS) toe. (12-inch pipe authorized under Permit No. 13852, 1984 - A.T.J. Correia & D. Lee). [Additional Reference(s): DWR Levee Log, 2005 (HLM 2.97)].  
FS Date: 6/23/2020 11:46:59 AM

Land-Side: Diesel pump and media filtering facility off levee toe

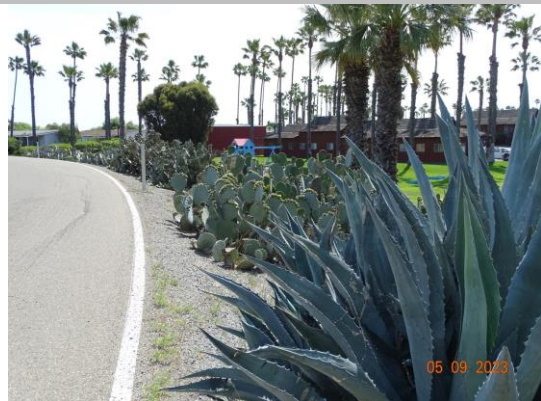
Photo 1 of 1 : SP\_2023\_NA0002\_62\_5\_20230517\_00089.jpg

View of the cactus on the WS slope (Spring 2023).

| Remove cactus from waterside slope. | | | | | |

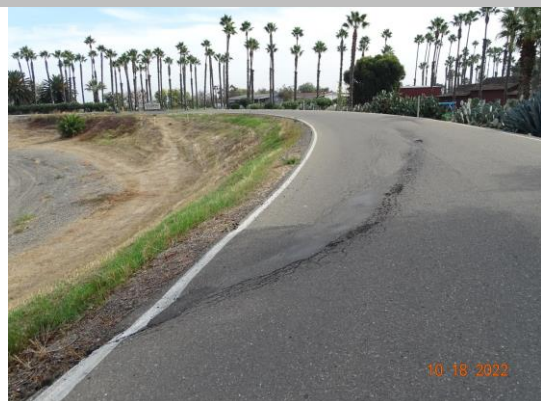
Photo 1 of 1 : SP\_2023\_NA0002\_62\_67\_20230206\_00025.jpg

| Appears to be beginning of a landside slump. LMA's Engineer (DCC) is monitoring site for movement. | | | | | |

View of the depression on the levee crown (Fall 2022).

| S1 : Repair slope instability. | | | | | |

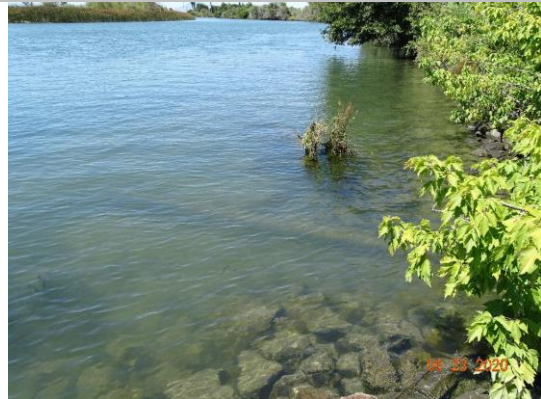
Photo 2 of 3 : UCIP\_SP\_2023\_62325\_90022.jpg

| DS_ID:21771<br>FS_ID:62325<br>EP_NO: 11238<br>Repair Type: Non-Urgent<br>EVAL Issue: 4b, Safety Issue<br>Crossing Status: Found<br>UCIP Comments: 06/23/2020 Record updated from No Action Needed<br>for avoid fall hazard. No permit has been identified authorizing<br>pipe. Need to have CVFPB review ABO and determine current owner.<br>(O.Yakimov - DWR UCIP)<br>FIELD_STRUCT_DESC: 8-inch steel irrigation pipe through the levee,<br>3.7 feet below the crown. Siphon breaker in 16-inch high-density<br>polyethylene riser unit on the landside (LS) shoulder. 36-inch diameter<br>concrete standpipe located LS of toe. (8-inch pipe [HLM 3.60]<br>authorized under Automatic Board Order (ABO) issued as Permit No.<br>11238, 1975 - Gardiner Improvement Company). [Additional<br>Reference(s): DWR Levee Log, 2005 (HLM 3.58). USACE Sacramento<br>O&M Manual, Unit 103, June 1954, Revised 29 December 2016,<br>(Station 'R' 127+98), listed as 8-inch pipe. USACE As-Built Drawing No.<br>50-04-2631, Sheet 2, Station 127+98, March 1950].<br>FS Date: 6/23/2020 4:38:39 PM | | | | | |

Water-Side: Pipe under water in the stream

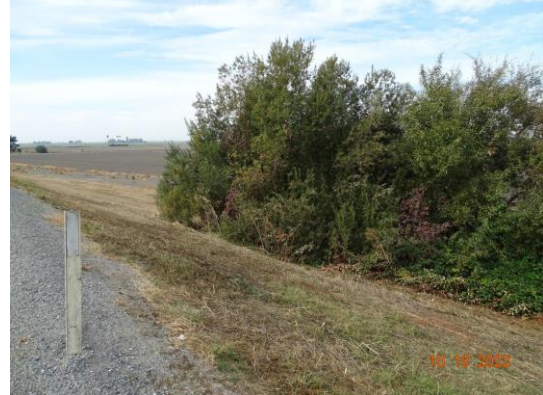
Photo 1 of 1 : SP\_2023\_NA0002\_62\_46\_20230206\_00011.jpg

View of the trees on the LS slope (Fall 2022).

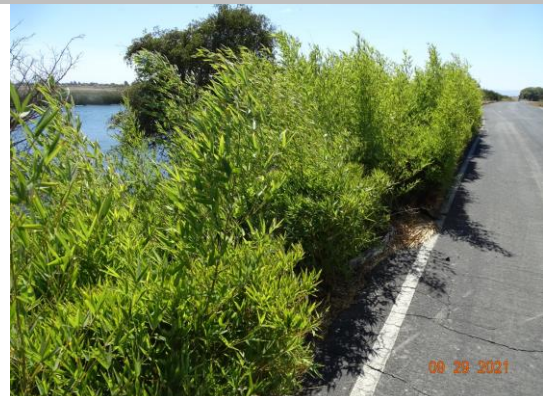
Photo 1 of 1 : SP\_2023\_NA0002\_62\_47\_20230206\_00012.jpg

View looking downstream at bamboo landscaping on the waterside slope (Fall 2021).

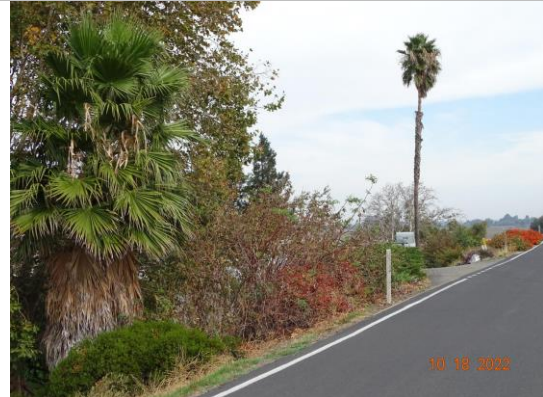
Photo 1 of 1 : SP\_2023\_NA0002\_62\_11\_20230206\_00005.jpg

View of the landscaping on the LS slope (Fall 2022).

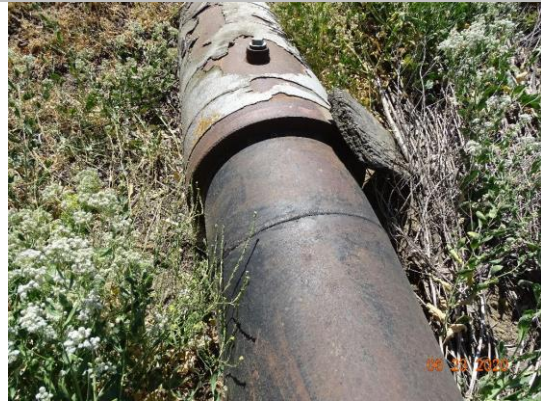
Photo 2 of 3 : UCIP\_SP\_2023\_62327\_90035.jpg

DS\_ID:21772  
 FS\_ID:62327  
 EP\_NO: 11248  
 Repair Type: Non-Urgent  
 EVAL Issue: 10, Unauthorized Modification or Non-Compliant Permit  
 Crossing Status: Found  
 UCIP Comments: 06/23/2020 Record updated from No Action Needed to Non-Urgent. 20-inch steel drainage pipe sleeved through 24-inch steel pipe. Annular space between pipes seems to be grouted. Unable to find a permit for modification. Asphalt repair patches on levee crown. No permit has been identified authorizing pipe. Need to have CVFPB review ABO and determine current owner. (O.Yakimov - DWR UCIP)  
 FIELD\_STRUCT\_DESC: 20-inch steel drainage pipe sleeved through 24-inch steel pipe through the levee, 3 feet below the crown. Siphon breaker is located on the waterside (WS) slope. Pump is located on the landside (LS). (24-inch pipe [HLM 3.99] authorized under Automatic Board Order (ABO) issued as Permit No. 11248, 1975 - Reclamation District No.407). [Additional Reference(s): DWR Levee Log, 2005 (HLM 3.99), listed as 24-inch pipe. USACE Sacramento O&M Manual, Unit 103, June 1954, Revised 29 December 2016, (Station 'R' 107+76), listed as 26-inch pipe. USACE As-Built Drawing No. 50-04-2631, Sheet 2, Station 107+76, March 1950, listed as 26-inch pipe].

Land-Side: Pipe sleeving point on levee slope

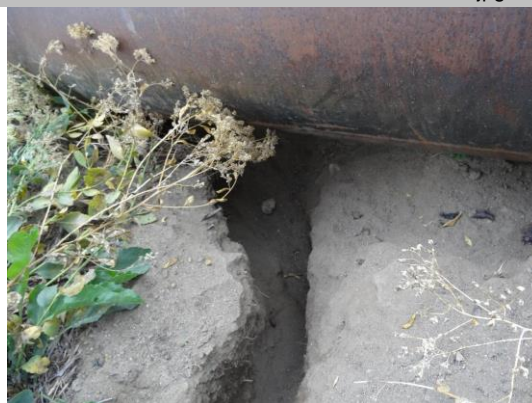
Photo 3 of 3 : UCIP\_SP\_2023\_62330\_76442.jpg

| DS_ID:21773<br>FS_ID:62330<br>EP_NO: 5534<br>Repair Type: Urgent<br>EVAL Issue: 1, Pipe Integrity<br>Crossing Status: Found<br>UCIP Comments: 06/23/2020 Record remains Urgent. Erosion site on landside shoulder has been repaired, but pipe integrity may still be compromised. Asphalt repair patches in levee crown pavement along pipe alignment. Recommend owner to perform pipe integrity test. Overgrown vegetation on landside slope limits inspection of levee at this crossing. (O.Yakimov - DWR UCIP)<br>07/12/2018 Levee crown on LS shoulder was repaved with asphalt. Dense vegetation limits visibility on LS levee slope and ability to evaluate erosion on LS. Crossing remains "Urgent". (O.Yakimov-DWR)10/24/2016 Internal erosion visible on LS where pipe daylights. LS road shoulder appears to be failing. Large sink hole patched and is visible on road/crown. Evidence of burrow activity that appear to be about 6-inches in diameter with depths greater than 3 feet. Burrow holes are located on LS hinge point just upstream of pipe and 3 holes visible on WS. Need to contact owner to address issue and recommend to stop use of crossing to avoid further damage to levee. (O. Magana - DWR UCIP)05/16/2013 Pot holes over pipe may indicate internal failure. Good candidate for video inspection. (W. Wylie - DWR UCIP) FIELD_STRUCT_DESC: 22-inch steel drainage pipe through the levee, 3 feet below the crown. Siphon breaker located on the waterside (WS) shoulder. Pump located on the landside (LS). This crossing replaces 24-inch pipe (see DSID 25663). (24-inch pipe authorized under Permit No. 5534, 1966 - Reclamation District No.407). [Additional Reference(s): DWR Levee Log, 2005 (HLM 3.99), listed as 24-inch pipe].<br>FS Date: 6/23/2020 10:47:15 AM | | | | | |

Evidence of internal erosion visible on LS.

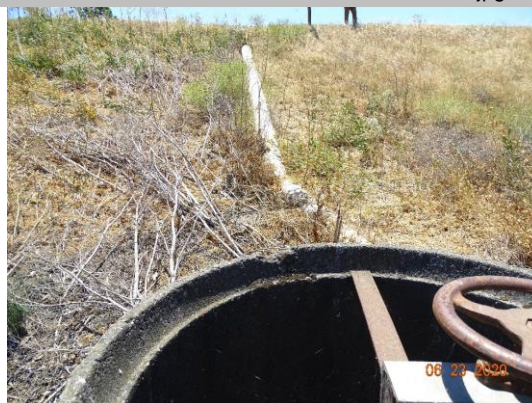
Photo 3 of 3 : UCIP\_SP\_2023\_62331\_90058.jpg

DS\_ID:21774  
 FS\_ID:62331  
 EP\_NO: 11238  
 Repair Type: Non-Urgent  
 EVAL Issue: 10, Unauthorized Modification or Non-Compliant Permit  
 Crossing Status: Found  
 UCIP Comments: 06/23/2020 Record remains Non-Urgent. Scour hole around air release pipe on waterside shoulder has been repaired, pipe is capped. Flanged coupler installed on pipe on landside levee shoulder and a new pipe put on landside levee slope to pumping plant bypassing concrete standpipe. Concrete standpipe with slide gate is abandoned. Diesel pump and media filtering facility installed on landside off levee toe. Unable to find a permit for modification. No permit has been identified authorizing pipe. Need to have CVFPB review ABO and determine current owner. (O.Yakimov - DWR UCIP)  
 10/24/2016 Unable to determine if WS primer pipe is leaking or if settling is occurring at pipe. Need to contact owner to determine when upgrades to WS were completed. (O. Magana - DWR UCIP)

Land-Side: Abandoned concrete standpipe and levee slope on background

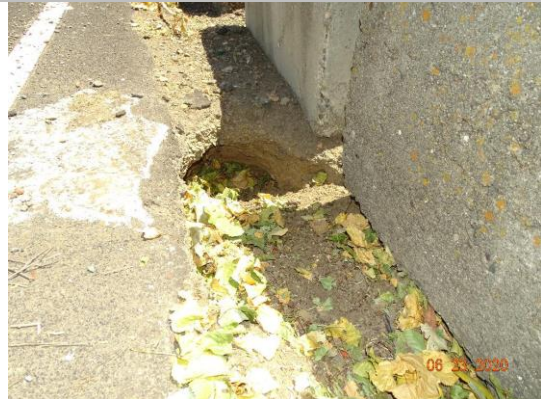
Photo 1 of 3 : UCIP\_SP\_2023\_62333\_90064.jpg

DS\_ID:21775  
FS\_ID:62333  
EP\_NO: 11238  
Repair Type: Urgent  
EVAL Issue: 2b, Levee Integrity  
Crossing Status: Found  
UCIP Comments: 06/23/2020 Record remains Urgent. Levee slope subsidence in pipe alignment on landside is more than 2-feet-deep. Sinkhole on waterside shoulder at public road pavement keeps growing and measures 3' x 2' x 0.75' deep. Missing cover on the top of vault at landside toe creates fall hazard. No permit has been identified authorizing pipe. Need to have CVFPB review ABO and determine current owner. (O.Yakimov - DWR UCIP)  
07/12/2018 Hole on LS shoulder under concrete blocks is still present, although haven't increased in size. Part of cover on concrete sump is still missing which is public safety issue. Crossing remain "Urgent" because of potential pipe failure signs. Recommend internal inspection to determine condition of pipe through levee. (DWR-O.Yakimov)  
12/30/2016 Left message with Ms. Cabral to inform her that we are working with LMA to find additional information about crossing. Spoke with Andy Giannini, LMA representative, regarding the UCIP report and Mr. Giannini believes the hole is due to ground squirrel activity. According to Mr. Giannini, the issue with ground squirrel has been resolved and the hole filled. Records indicate pipe was installed in the 1950s and authorized under Permit No. 11238 in 1975. This pipe could be about 62 years old. Crossing remains Urgent due to the uncertainty of pipe integrity through levee. Recommend having owner complete an internal inspection of the pipe through the levee to determine integrity of pipe. (O. Magana - DWR UCIP)12/28/2016 Contacted Andy Giannini, LMA representative, and provided him with UCIP report to review. (O. Magana - DWR UCIP)12/27/2016 Contacted Rebecca Cabral, property sales agent from Century 21 Farm & Ranch M&M and Associates, at 1-707-374-3900 to inquire about the property owner for this area. Mrs. Cabral was unaware of pipe through levee and has requested photos to share with client. She was not able to provide me with the current property owner information but mentioned that she will contact me next week (week ending Jan 6, 2017). (O. Magana - DWR UCIP)10/24/2016 Section of cover is still missing. Potential pipe failure through levee. Sink hole is present on LS shoulder. Need to contact owner to stop use of pipe to avoid further damage to levee. Recommend internal inspection of pipe to determine integrity of pipe wall. (O. Magana - DWR UCIP)05/08/2013 Missing cover on concrete sump is an immediate hazard and should be repaired. (W. Wylie - DWR UCIP)

Water-Side: Sinkhole on levee shoulder at the edge of road pavement

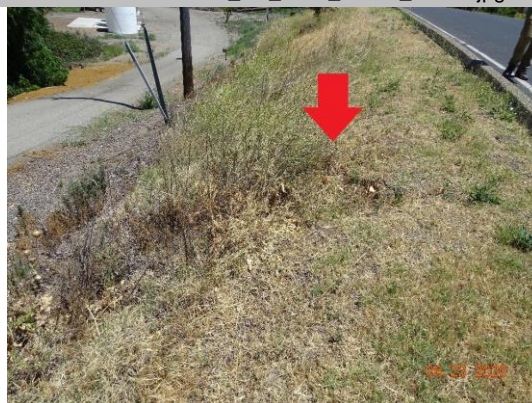
Photo 2 of 3 : UCIP\_SP\_2023\_62333\_90063.jpg

Land-Side: Subsidence on levee slope

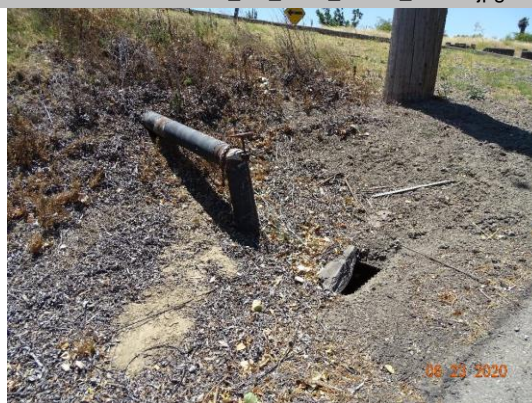
Photo 3 of 3 : UCIP\_SP\_2023\_62333\_90062.jpg

Land-Side: Open concrete spill box, pipe and levee slope

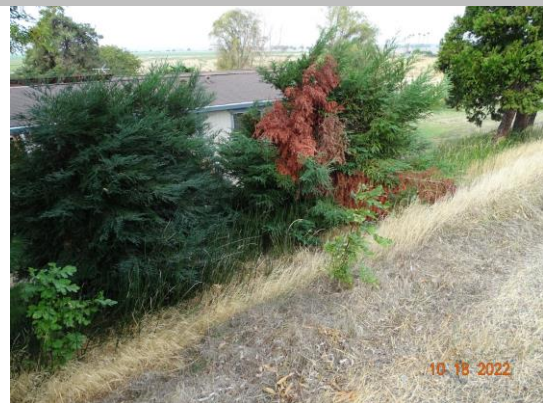
Photo 1 of 1 : SP\_2023\_NA0002\_62\_111\_20230206\_00034.jpg

View of the landscaping on the LS toe (Fall 2022).

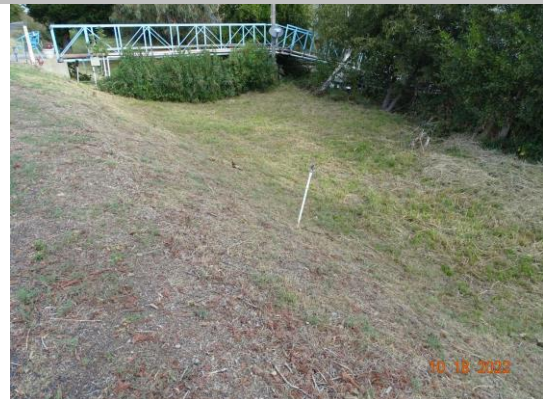
Photo 1 of 1 : SP\_2023\_NA0002\_62\_20\_20230206\_00006.jpg

| Spring 2023: The sprinkler system seems inactive and the slope is overgrown. | | | | | |

View of the sprinkler system on the WS slope (Fall 2022).

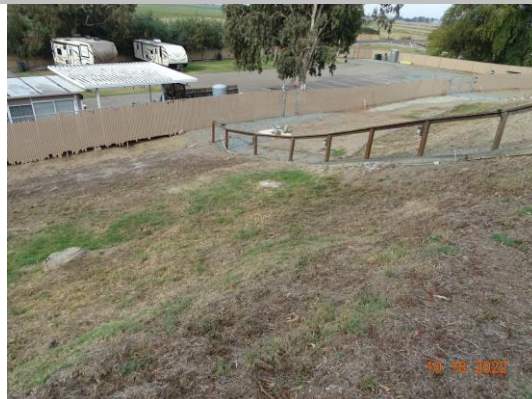
Photo 1 of 1 : SP\_2023\_NA0002\_62\_109\_20230206\_00032.jpg

| There are three tree stumps on the LS slope. | | | | | |

View of the tree stumps on the LS slope (Fall 2022).

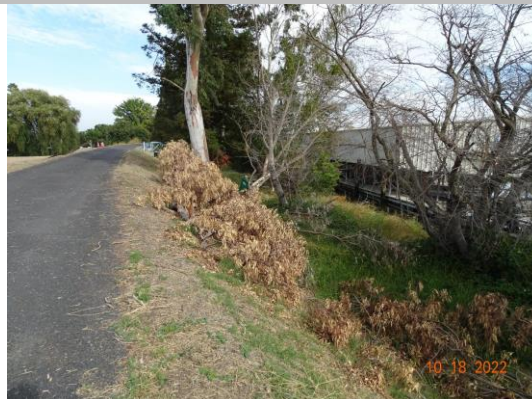
Photo 1 of 1 : SP\_2023\_NA0002\_62\_108\_20230206\_00031.jpg

| There are tree limbs on the WS slope. | | | | | |

View of the tree limbs on the WS slope (Fall 2022).

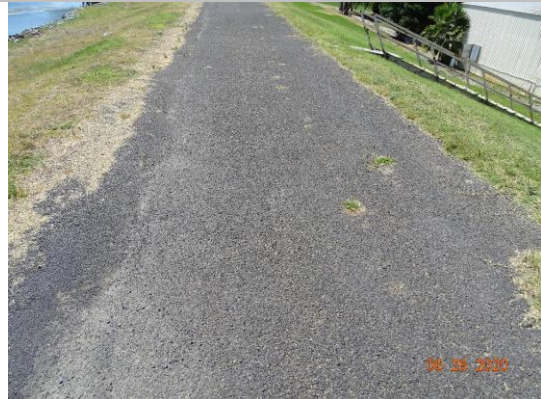
Photo 1 of 3 : UCIP\_SP\_2023\_62350\_90150.jpg

Top of Levee: View of levee crown looking downstream

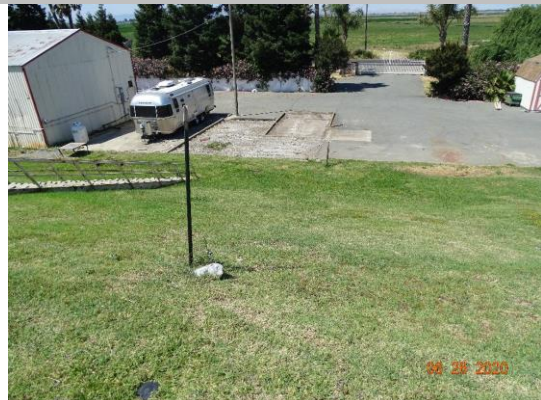
Photo 2 of 3 : UCIP\_SP\_2023\_62350\_90151.jpg

Land-Side: View of levee slope looking from crown

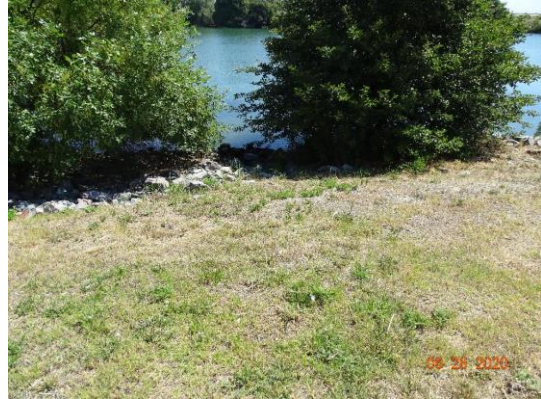
Photo 3 of 3 : UCIP\_SP\_2023\_62350\_90154.jpg

Water-Side: View of levee slope looking from crown

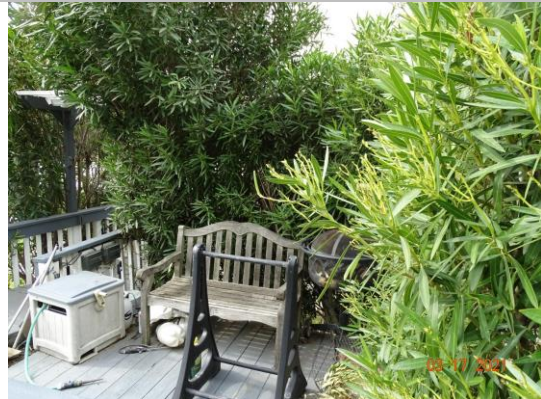
Photo 1 of 1 : SP\_2023\_NA0002\_62\_131\_20230206\_00039.jpg

| Oleanders are blocking the view down landside slope. | | | | | |

View of oleanders on the landside slope (Spring 2021).

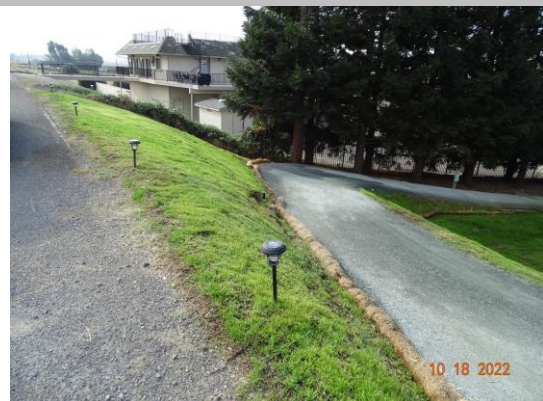
Photo 1 of 1 : SP\_2023\_NA0002\_62\_113\_20230206\_00036.jpg

| A new ramp on the LS seems to have no permit. | | | | | |

View of the ramp going down the LS slope (Fall 2022).

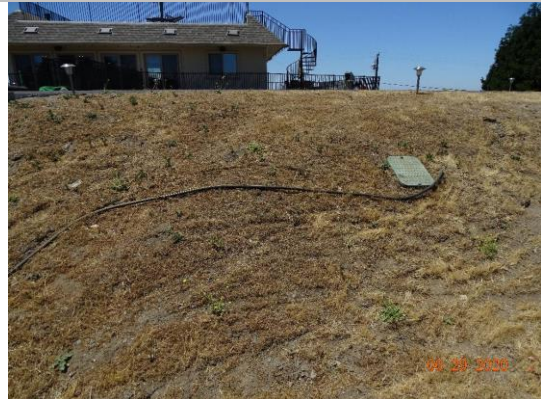
Photo 3 of 3 : UCIP\_SP\_2023\_62371\_90245.jpg

Water-Side: View of levee slope looking towards crown. Cable is exiting ground on the slope

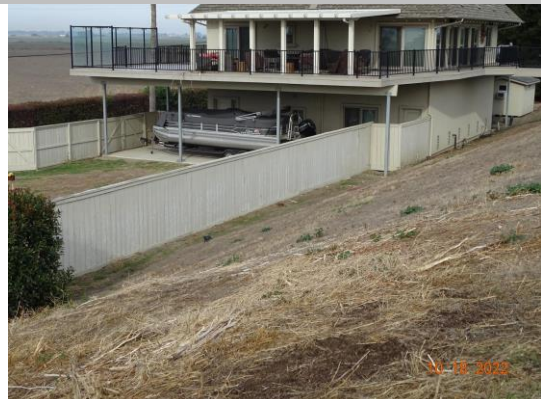
Photo 1 of 1 : SP\_2023\_NA0002\_62\_48\_20230206\_00013.jpg

| There is an unauthorized fence at the landside toe. | | | | | |

View of the fence on the LS toe (Fall 2022).

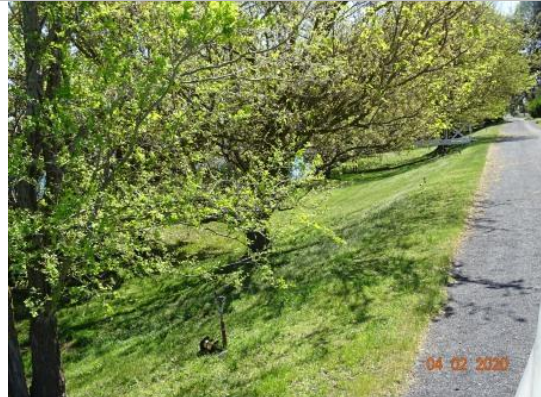
Photo 1 of 1 : SP\_2023\_NA0002\_62\_54\_20230206\_00017.jpg

| There are sprinklers on the waterside slope. | | | | | |

View looking downstream at sprinklers on the waterside slope (Spring 2020).

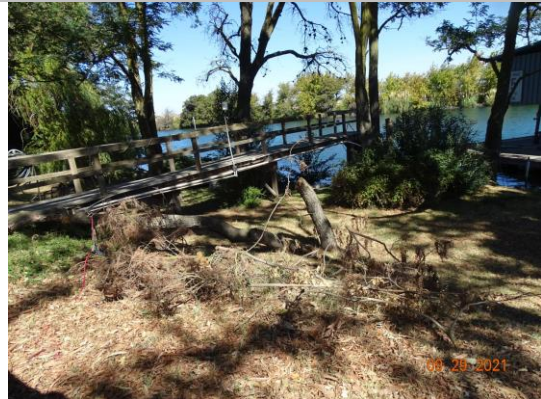
Photo 1 of 1 : SP\_2023\_NA0002\_62\_115\_20230206\_00037.jpg

| There is a tree limb on the waterside slope. | | | | | |

View of downed tree branch on the waterside slope (Fall 2021).

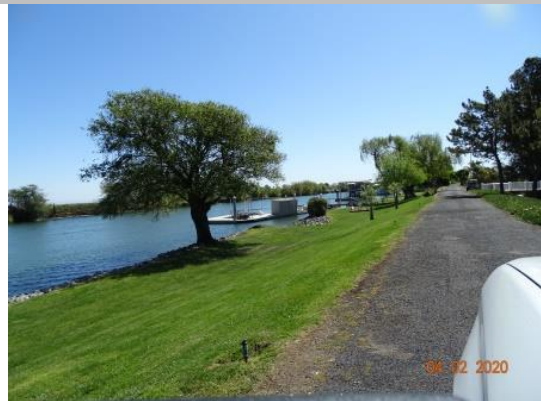
Photo 1 of 1 : SP\_2023\_NA0002\_62\_57\_20230206\_00019.jpg

| There are sprinklers on the waterside slope. | | | | | |

View looking downstream at sprinklers on the waterside slope (Spring 2020).

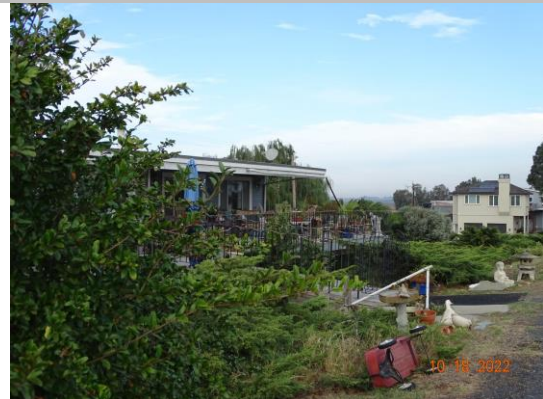
Photo 1 of 1 : SP\_2023\_NA0002\_62\_78\_20230206\_00029.jpg

| Heavy landscaping completely blocks visibility and access to landside slope and toe. | | | | | |

View of the landscaping on the LS slope (Fall 2022).

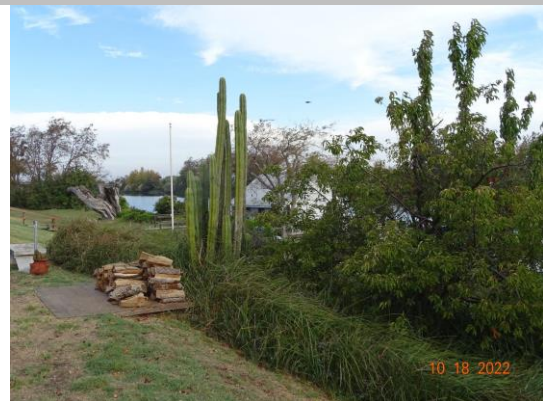
Photo 1 of 1 : SP\_2023\_NA0002\_62\_61\_20230206\_00023.jpg

| Overgrown landscaping is located on the waterside slope. | | | | | |

View of the landscaping on the WS slope (Fall 2022).

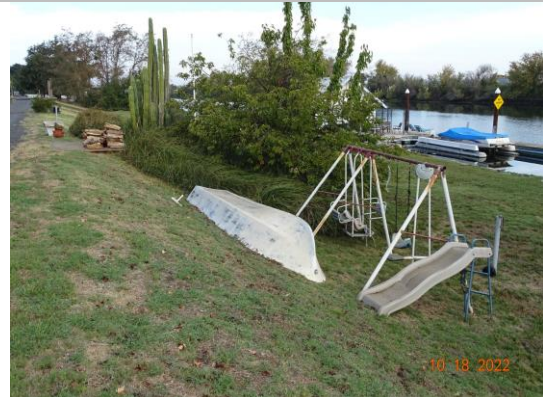
Photo 1 of 1 : SP\_2023\_NA0002\_62\_60\_20230206\_00022.jpg

| An abandoned child's swing set is located at the waterside toe. | | | | | |

View of the swing and other material on the WS slope and toe (Fall 2022).

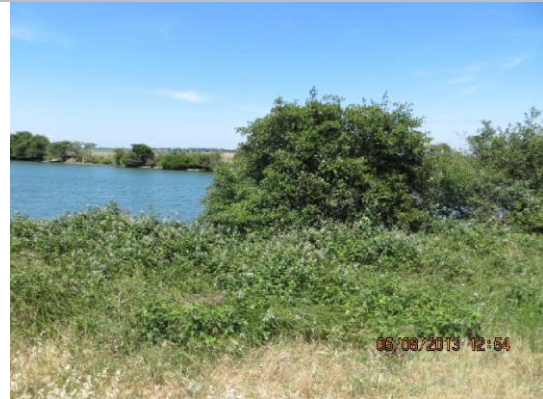
Photo 2 of 3 : UCIP\_SP\_2023\_62394\_21274.jpg

| DS_ID:21788<br>FS_ID:62394<br>EP_NO: 11245<br>Repair Type: Urgent<br>EVAL Issue: 2b, Levee Integrity<br>Crossing Status: Found<br>UCIP Comments: 07/01/2020 Record updated from No Action Needed to Urgent. Soil depression on landside slope from concrete standpipe up the slope measures 13' x 3' x 1'-deep. Overgrown vegetation on waterside limits inspection of levee at this crossing. Crossing appears abandoned. Slide gate inside of concrete standpipe not in operable condition. 1-1/2 hose connected to siphon breaker / filler pipe on landside shoulder. No permit has been identified authorizing pipe. Need to have CVFPB review ABO and determine current owner. (O.Yakimov - DWR UCIP)<br><br>FIELD_STRUCT_DESC: 10-inch steel irrigation pipe through the levee, 3.8 feet below the crown. Siphon breaker on the landside (LS) shoulder. Concrete standpipe located LS of toe. (10-inch pipe [HLM 5.55] authorized under Automatic Board Order (ABO) issued as Permit No. 11245, 1975 - Mary Nobrega & Manuel Mendes et.al). [Additional Reference(s): DWR Levee Log, 2005 (HLM 5.55). USACE Sacramento O&M Manual, Unit 103, June 1954, Revised 29 December 2016, (Station 'R' 26+25), listed as 10-inch pipe. USACE As-Built Drawing No. 50-04-2672, Sheet 3, Station 26+25, 25 January 1951].<br>FS Date: 7/1/2020 8:28:37 AM | | | | | |

Pipe visible at WS toe to left of tree in photo.

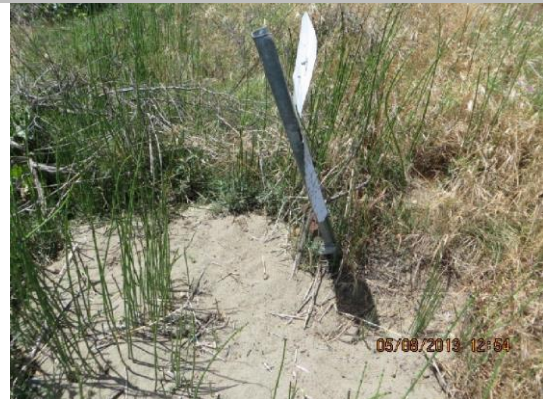
Photo 3 of 3 : UCIP\_SP\_2023\_62394\_21273.jpg

Siphon breaker next to paddle marker on LS shoulder.

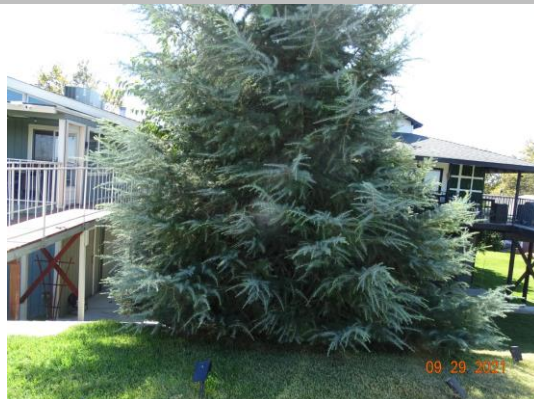
Photo 1 of 1 : SP\_2023\_NA0002\_62\_118\_20230206\_00038.jpg

View of landscaping tree on the landside slope (Fall 2021).

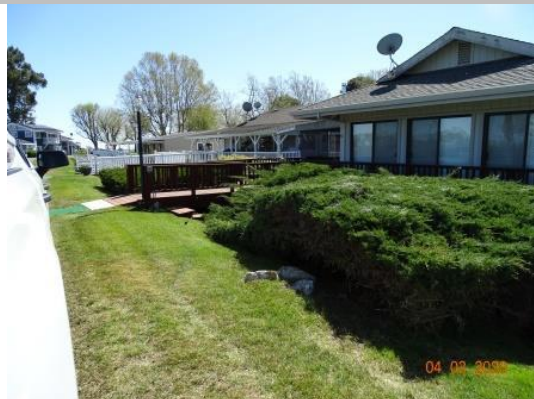
Photo 1 of 1 : SP\_2023\_NA0002\_62\_62\_20230206\_00024.jpg

View of thick landscape vegetation on the landside slope (Spring 2020).

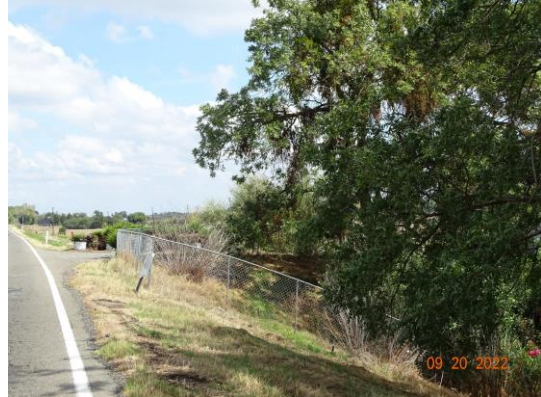
Photo 1 of 1 : SP\_2023\_NA0002\_63\_26\_20230206\_00006.jpg

View of the fence on the LS shoulder and slope (Fall 2022).

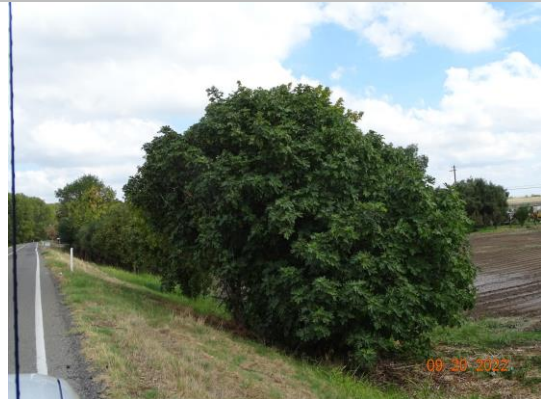
Photo 1 of 1 : SP\_2023\_NA0002\_63\_97\_20230206\_00046.jpg

| Fig tree on the landside toe needs trimming. | | | | | |

View of the fig tree on the LS slope (Fall 2022).

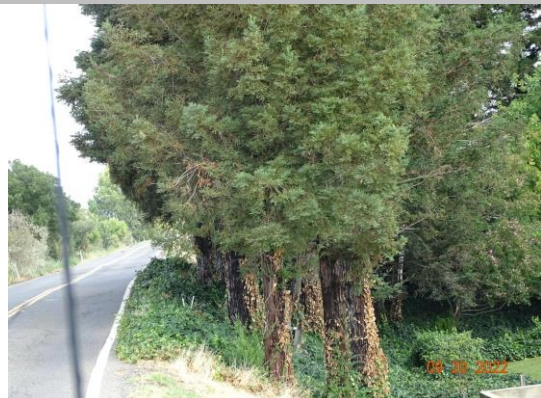
Photo 1 of 1 : SP\_2023\_NA0002\_63\_8\_20230206\_00002.jpg

View of the landscaping on the LS shoulder and slope (Fall 2022).

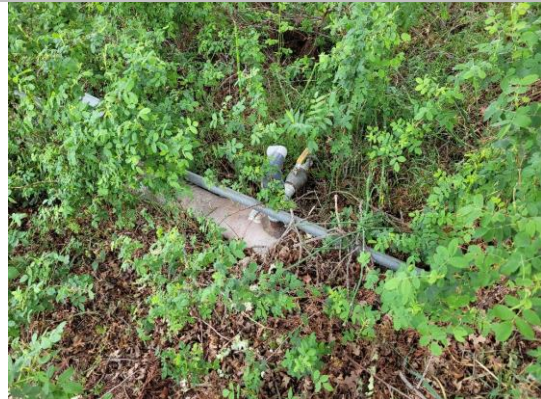
Photo 2 of 3 : UCIP\_SP\_2023\_74880\_112083.jpg

Land-Side: Air release valve and hose connection on levee shoulder

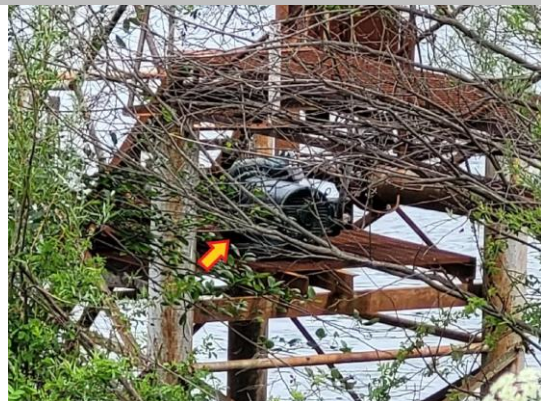
Photo 3 of 3 : UCIP\_SP\_2023\_74880\_112076.jpg

Water-Side: New pump located on pile structure in the stream

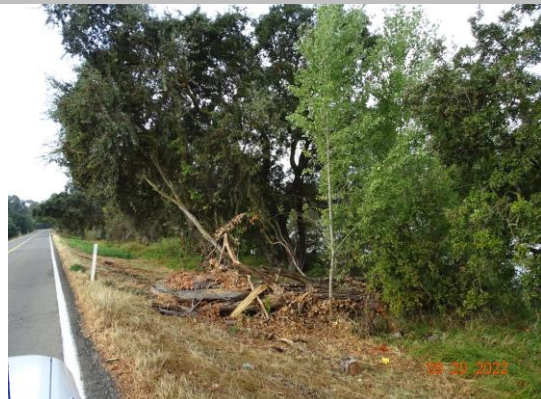
Photo 1 of 1 : SP\_2023\_NA0002\_63\_166\_20230206\_00065.jpg

| There is a fallen tree on the WS slope. | | | | | |

View of the tree on the WS slope (Fall 2022).

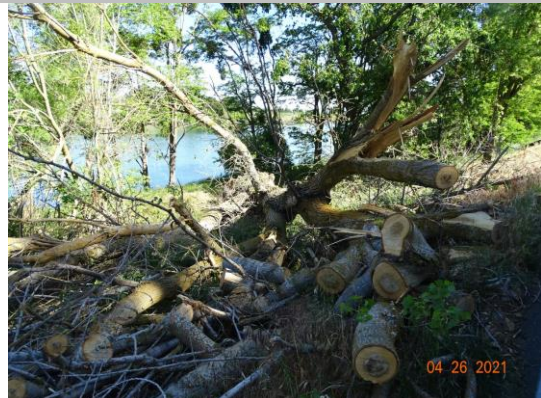
Photo 1 of 1 : SP\_2023\_NA0002\_63\_52\_20230206\_00014.jpg

View of downed tree and limbs on waterside slope (Spring 2021).

| Remove large fallen tree on waterside slope. | | | | | |

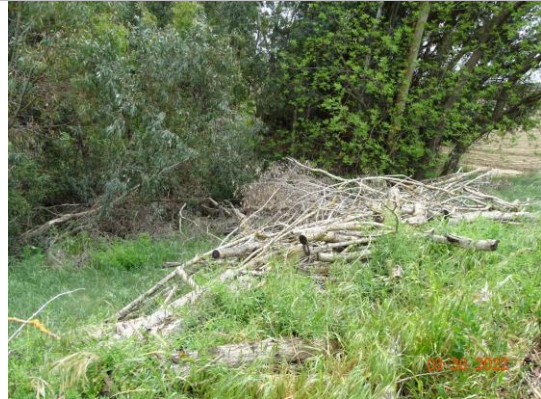
Photo 1 of 1 : SP\_2023\_NA0002\_63\_102\_20230206\_00049.jpg

View of pruned tree limbs on the landside shoulder (Spring 2022).

| Remove tree prunings on the landside slope. | | | | | |

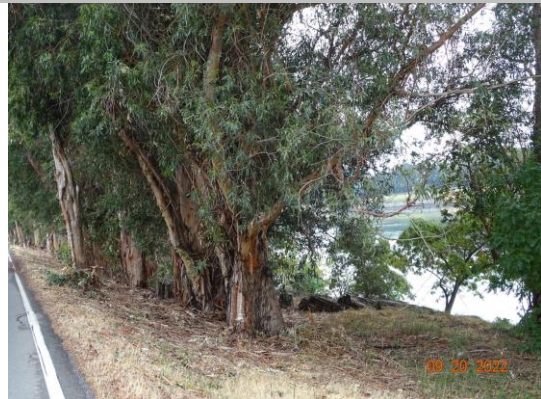
Photo 1 of 1 : SP\_2023\_NA0002\_63\_78\_20230206\_00031.jpg

View of the stump and logs on the WS slope (Fall 2022).

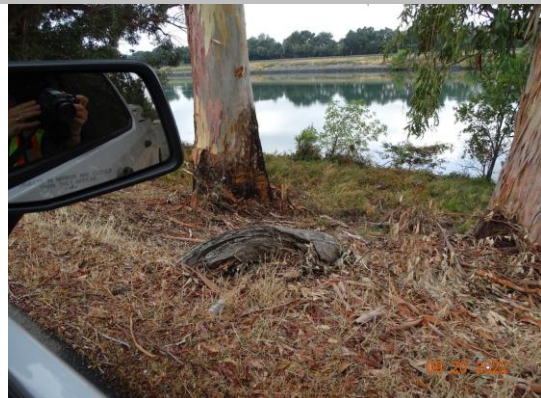
Photo 1 of 1 : SP\_2023\_NA0002\_63\_79\_20230206\_00032.jpg

View of the tree limb on the WS slope (Fall 2022).

| Remove tree limb from the waterside slope. | | | | | |

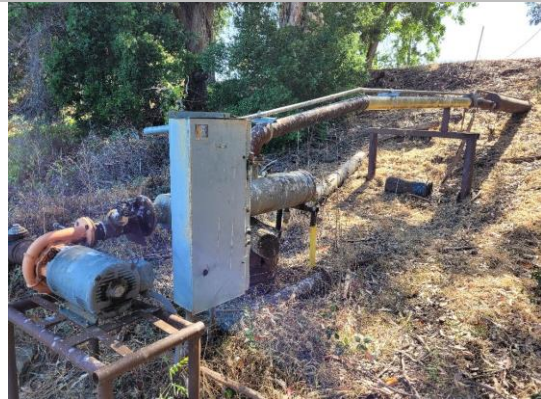
Photo 1 of 3 : UCIP\_SP\_2023\_74939\_112137.jpg

Water-Side: Pump and electrical panel on the berm

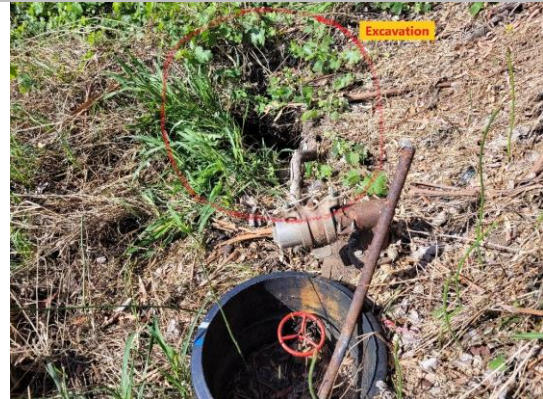
Photo 3 of 3 : UCIP\_SP\_2023\_74939\_112136.jpg

Land-Side: Corrugated Plastic Pipe (CPP) riser with air release valve and butterfly valve inside

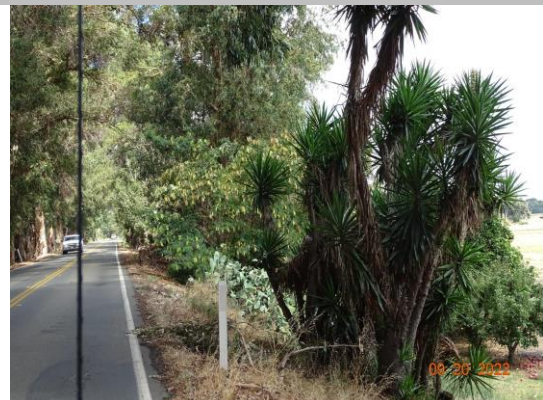
Photo 1 of 1 : SP\_2023\_NA0002\_63\_45\_20230206\_00009.jpg

| Dense vegetation and cactus are on the landside slope and toe. | | | | | |

View of the cactus and other landscaping on the LS slope (Fall 2022).

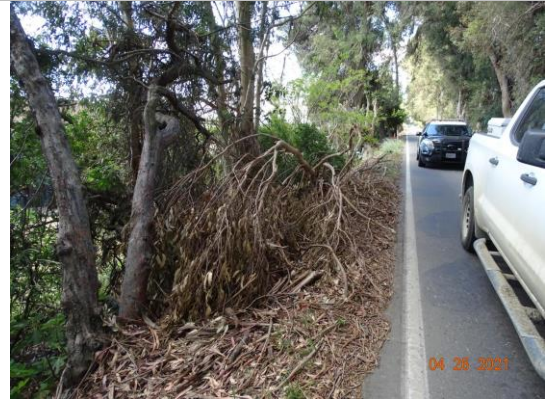
Photo 1 of 1 : SP\_2023\_NA0002\_63\_96\_20230206\_00045.jpg

Down tree limb on the landside hinge (Spring 2021).

| Remove large down tree branch on landside slope. | | | | | |

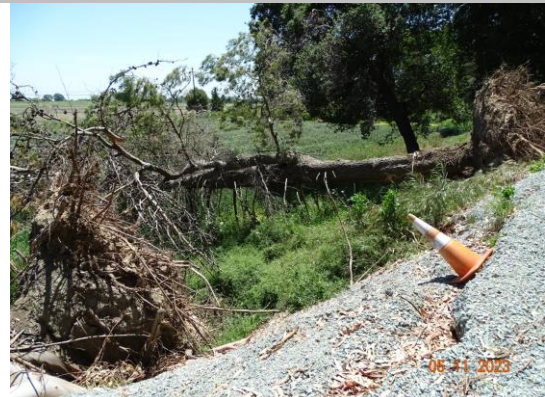
Photo 1 of 1 : SP\_2023\_NA0002\_63\_38\_20230518\_00165.jpg

| Two fallen trees with root balls on the LS slope. | | | | | |

View of the fallen trees with root balls on the LS slope (Spring 2023).

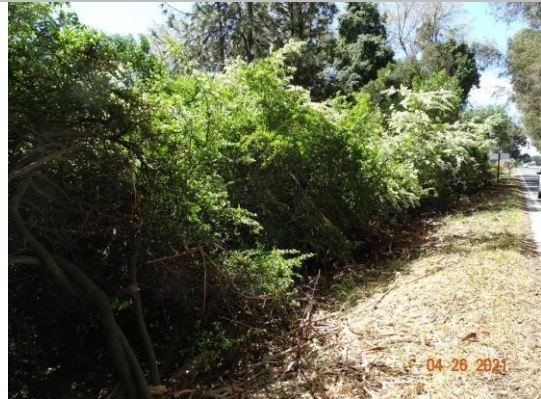
Photo 1 of 1 : SP\_2023\_NA0002\_63\_12\_20230206\_00003.jpg

| Dense landscaping vegetation is on the landside slope. | | | | | |

View looking downstream at landscaping on the landside slope (Spring 2021).

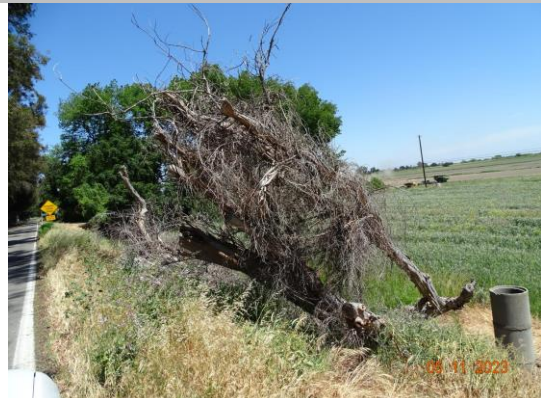
Photo 1 of 1 : SP\_2023\_NA0002\_63\_95\_20230518\_00163.jpg

View of the tree limbs on the LS slope (Spring 2023).

| Remove down tree limbs on the landside slope. | | | | | |

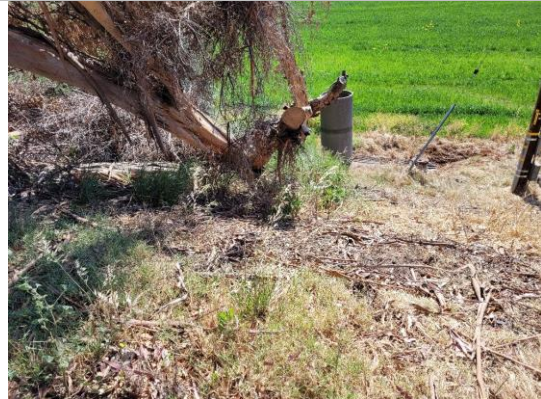
Photo 1 of 3 : UCIP\_SP\_2023\_74945\_112152.jpg

| DS_ID:21873<br>FS_ID:74945<br>EP_NO: 1173<br>Repair Type: Non-Urgent<br>EVAL Issue: 10, Unauthorized Modification or Non-Compliant Permit<br>Crossing Status: Found<br>UCIP Comments: 04/28/2022 Record updated from No Action Needed to Non-Urgent. 10-inch steel pipe sleeved through 12-inch at the pump on waterside berm. Unable to find a permit for modification. Siphone breaker and CMP riser on landside slope buried in debris. (O.Yakimov - DWR UCIP)<br>FIELD_STRUCT_DESC: 10-inch steel pipe sleeved through 12-inch steel irrigation pipe through the levee, 7 feet below the crown. Pump on the waterside (WS) berm. Siphon breaker in 24-inch corrugated metal riser unit on the landside (LS) slope. 36-inch concrete stand pipe at the LS toe. Service pole on the LS slope. (12-inch steel discharge pipe (D) authorized under Permit No. 1173, 1947 - Reclamation District No. 556). [Additional Reference(s): DWR Levee Log, 2005 (HLM 2.00), listed as 12-inch pipe. USACE Sacramento O&M Manual, Unit 103, June 1954, Revised 29 December 2016, (Station "H" 2+00), listed as 12-inch pipe. USACE As-Built Drawing No. 50-04-2277, March 1946, Sheet 1, Station 2+00 "H", listed as 12-inch pipe].<br>FS Date: 4/28/2022 11:26:22 AM | | | | | | |

Land-Side: View of levee slope looking from crown. CMP riser buried in debris on levee slope

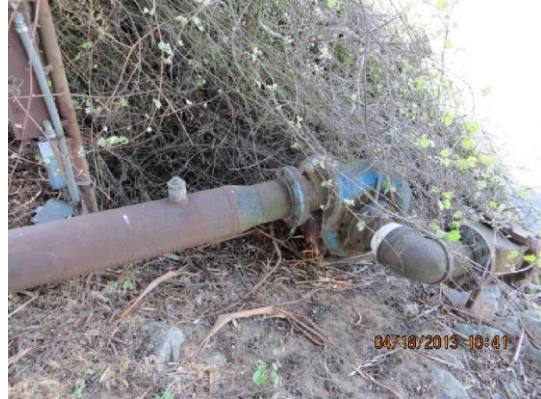
Photo 3 of 3 : UCIP\_SP\_2023\_74945\_19761.jpg

Pump on WS berm.

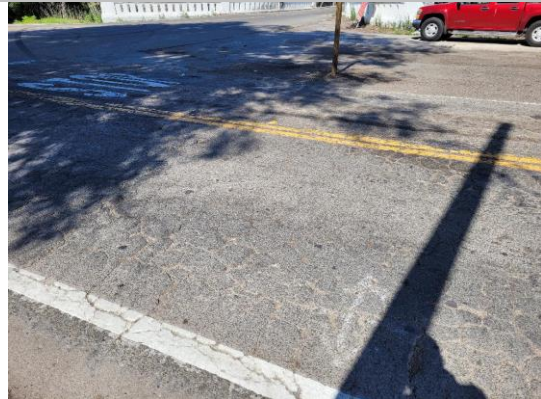
Photo 1 of 3 : UCIP\_SP\_2023\_75041\_112186.jpg

| DS_ID:23134<br>FS_ID:75041<br>EP_NO: N/A<br>Repair Type: Non-Urgent<br>EVAL Issue: 11, Maintenance Compliance Issue<br>Crossing Status: Indicator Found<br>UCIP Comments: 04/28/2022 Record updated from No Action Needed to Non-Urgent. Junction pole at landside shoulder is in failing condition due to slope stability issue. There was an attempt to stabilize the slope by placing retaining boards around the pole. No permit has been found authorizing this pipe through the levee. (O.Yakimov - DWR UCIP)<br>FIELD_STRUCT_DESC: Galvanized iron electrical conduit of an unknown size through the levee, at an unknown depth. JP and meter on the landside (LS) shoulder. Electrical connection boxes on waterside road shoulder and on upstream side of the bridge.<br>FS Date: 4/28/2022 2:07:00 PM | | | | | | |

Top of Levee: View of levee crown looking from landside

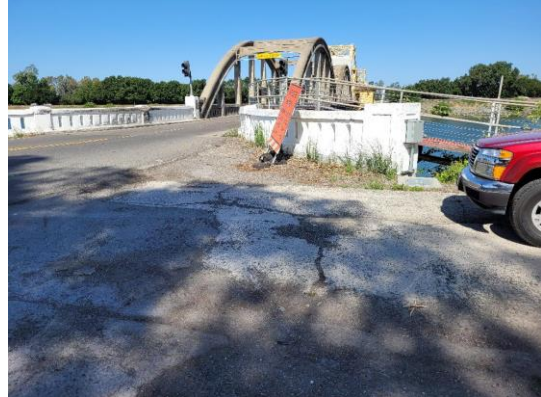
Photo 3 of 3 : UCIP\_SP\_2023\_75041\_112187.jpg

Water-Side: View of levee berm looking from crown
