**Flood Control Project Maintenance  
Levee Inspections  
LMA District Cover Sheet**

**Brannan Andrus Levee Maintenance District**

**Flood Control Project Maintenance  
Levee Inspections  
Unit Cover Sheet**

| Waterway | | | Bank | Unit Miles |
|--|---|---|---|---|
| Unit No. 01 Georgiana Slough | | | Right | 6.01 |

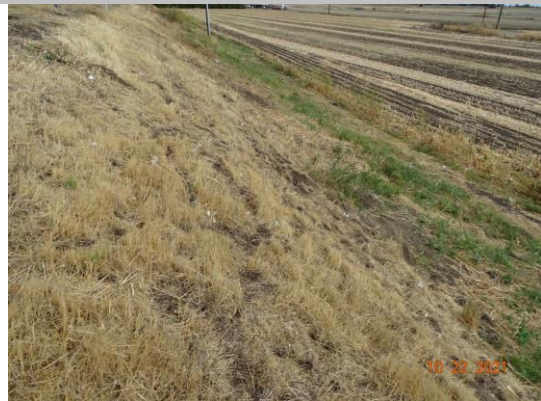
Photo 1 of 1 : SP\_2023\_NA0002\_63\_136\_20230206\_00060.jpg

View of animal holes in the landside slope (Fall 2021).

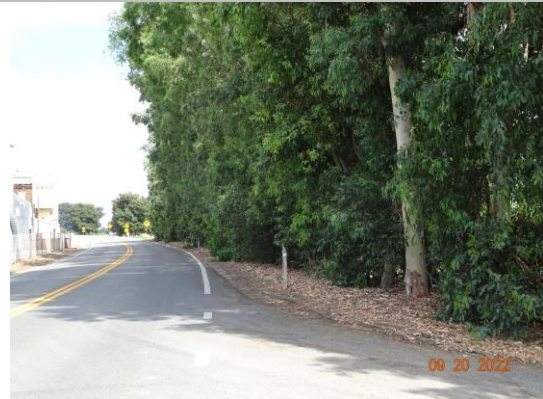
Photo 1 of 1 : SP\_2023\_NA0002\_63\_25\_20230206\_00005.jpg

View of the trees along the LS shoulder (Fall 2022).

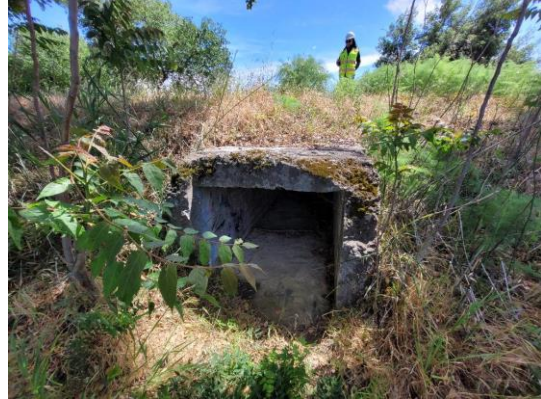
Photo 1 of 3 : UCIP\_SP\_2023\_75100\_112246.jpg

| DS_ID:21879<br>FS_ID:75100<br>EP_NO: N/A<br>Repair Type: Urgent<br>EVAL Issue: 1, Pipe Integrity<br>Crossing Status: Found<br>UCIP Comments: 04/19/2022 Record updated from Non-Urgent to Urgent. Flood risk to landside due to the tunnel is open on both ends. DMP internal video inspection has found integrity issues. LOF of crossing is between 5 and 6. Crossing will be monitored until funding becomes available to address the issues. No permit has been identified authorizing pipe. (O.Yakimov - DWR UCIP)<br>07/12/2018 Tunnel is open on both sides. No integrity issue observed, therefore crossing downgraded to "Non-Urgent". (O.Yakimov-DWR UCIP)<br>10/24/2016 same as previous inspection culvert is open on both ends. WS blocked by blankets -- WS structure is being used as a shelter. (O. Magana - DWR UCIP)<br>04/18/2013 Culvert open on both ends. Needs to be abandoned properly. (W. Wylie - DWR UCIP)<br>FIELD_STRUCT_DESC: 42-inch by 42-inch open reinforced concrete culvert through the levee, 6 feet below the crown. [Additional Reference(s): DWR Levee Log, 2005 (HLM 2.54), listed as abandoned 3-feet by 3.5-feet open concrete culvert. USACE Sacramento O&M Manual 103, June 1954, (RM 18.16) Drawing No. 6-13-1100].<br>USACE As-Built Drawing No. 06-13-1100, January 1933, Sheet 18, RM 18.16, listed as 3.5-foot by 3.5-foot concrete box].<br>FS Date: 4/19/2022 11:02:31 AM | | | | | | |

Water-Side: View of the waterward end of tunnel

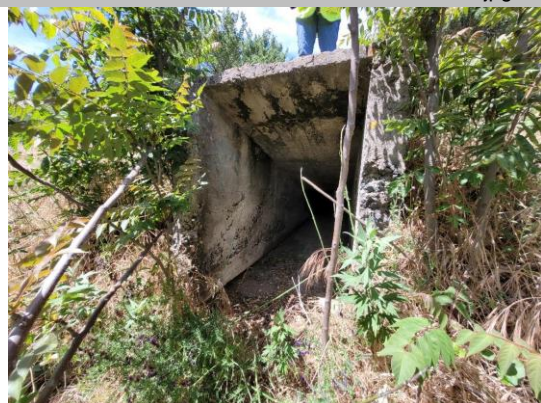
Photo 2 of 3 : UCIP\_SP\_2023\_75100\_112250.jpg

Land-Side: View of the landward end of tunnel

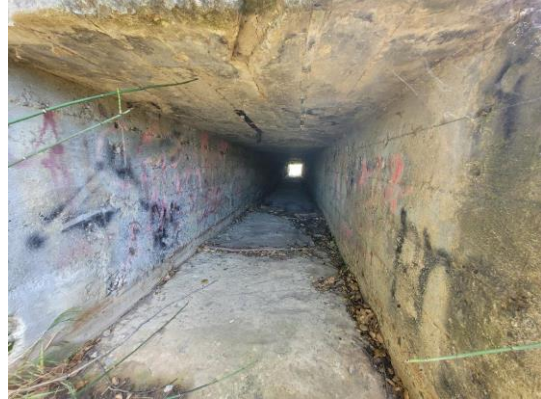
Photo 3 of 3 : UCIP\_SP\_2023\_75100\_112247.jpg

Overview of Levee: Photo taken inside of tunnel

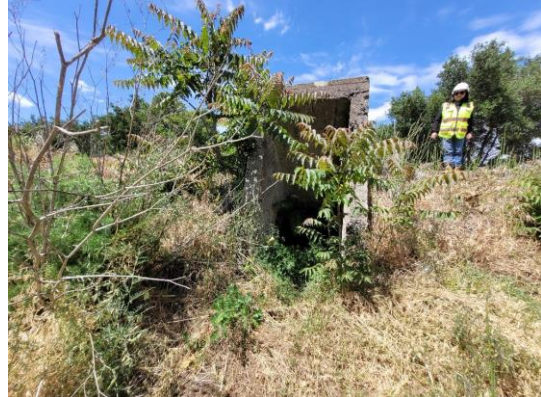
Photo 1 of 3 : UCIP\_SP\_2023\_75101\_112251.jpg

| DS_ID:21880<br>FS_ID:75101<br>EP_NO: N/A<br>Repair Type: Urgent<br>EVAL Issue: 3b, Flood Risk<br>Crossing Status: Found<br>UCIP Comments: 04/19/2022 Record updated from Non-Urgent to Urgent. Flood risk to landside due to the tunnel is open on both ends. DMP internal video inspection has found pipe integrity issues. LOF of crossing is greater than or equal to 4.1 and less than 5. Crossing will be monitored until funding becomes available for rehabilitation. No permit has been identified authorizing pipe. (O.Yakimov - DWR UCIP)<br>07/12/2018 Tunnel is open on both sides. No integrity issue observed, therefore crossing downgraded to "Non-Urgent". (O.Yakimov-DWR UCIP)<br>10/24/2016 same as previous inspection concrete box culvert will need to be abandoned properly. (O. Magana - DWR UCIP)<br>04/18/2013 tunnel should be abandoned properly. (W. Wylie - DWR UCIP)<br>FIELD_STRUCT_DESC: 48-inch by 48-inch reinforced concrete culvert through the levee, 6.5-inches below the crown. [Additional Reference(s): DWR Levee Log, 2005 (HLM 2.57), listed as abandoned 4-feet by 4-feet open concrete culvert. USACE Sacramento O&M Manual 103, June 1954, (RM 18.13) 3-foot by 3-foot concrete box listed, Drawing No. 6-13-1100].<br>USACE As-Built Drawing No. 06-13-1100, January 1933, Sheet 18, RM 18.13, listed as 3-foot by 3-foot concrete box].<br>FS Date: 4/19/2022 11:22:54 AM | | | | | | |

Land-Side: View of the landward end of tunnel

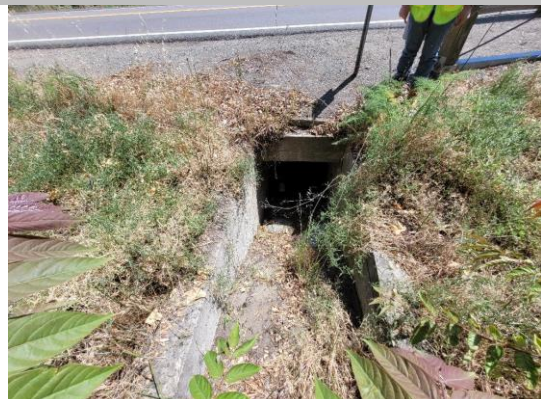
Photo 2 of 3 : UCIP\_SP\_2023\_75101\_112254.jpg

Water-Side: View of the waterward end of tunnel

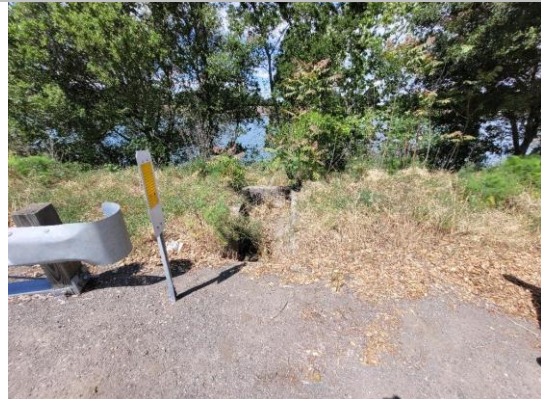
Photo 3 of 3 : UCIP\_SP\_2023\_75101\_112253.jpg

Water-Side: View of levee slope looking from crown. Concrete box on levee shoulder

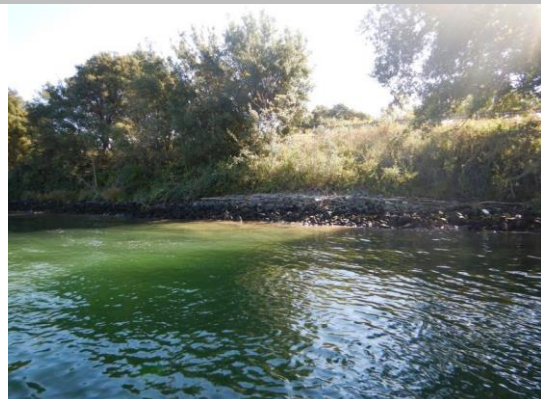
Photo 1 of 2 : SP\_2023\_NA0002\_63\_71\_20230206\_00026.jpg

2018 Site ID: SAC 18.1 L  
Status: Critical  
2018 Field Notes: Increased vegetation made it difficult to see changes.  
Site History: 2009 - Short reach of vertical bank at the toe. 2010 - Large tree is getting ready to fall in. 2015 - Freshly exposed tree roots.  
2017 - Upgraded to CRITICAL. Vertical slope face behind a tree that is likely to pop-out soon.

USACE 2018 Erosion Photo #1

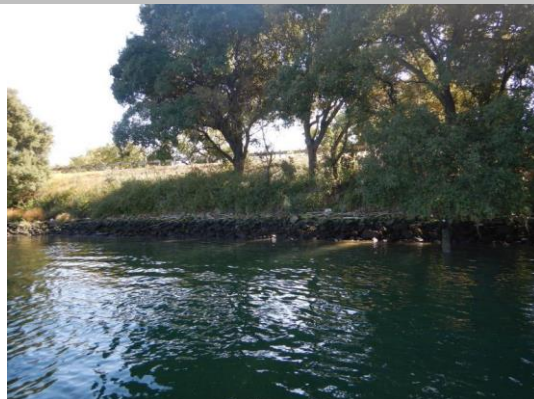
Photo 2 of 2 : SP\_2023\_NA0002\_63\_71\_20230206\_00027.jpg

USACE 2018 Erosion Photo #2

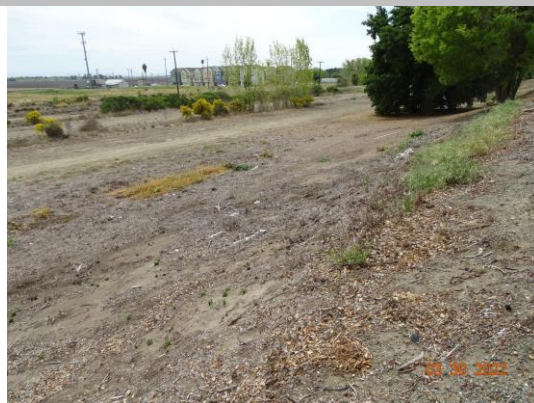
Photo 1 of 1 : SP\_2023\_NA0002\_63\_104\_20230206\_00050.jpg

View of animal holes on the landside slope (Spring 2022).

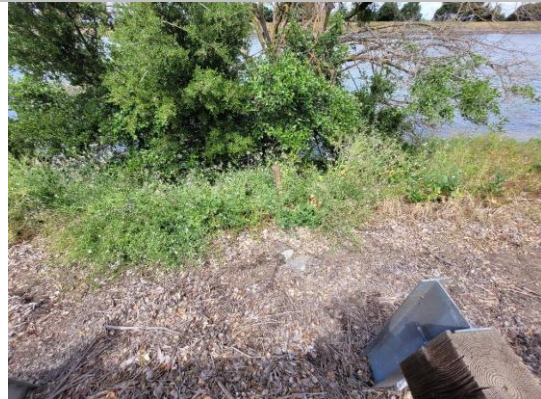
Photo 3 of 3 : UCIP\_SP\_2023\_75144\_112307.jpg

Water-Side: View of levee slope looking from crown

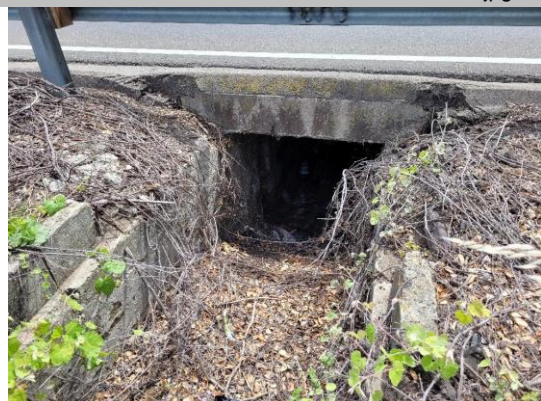
Photo 2 of 3 : UCIP\_SP\_2023\_75147\_112327.jpg

Water-Side: View of the waterward end of tunnel

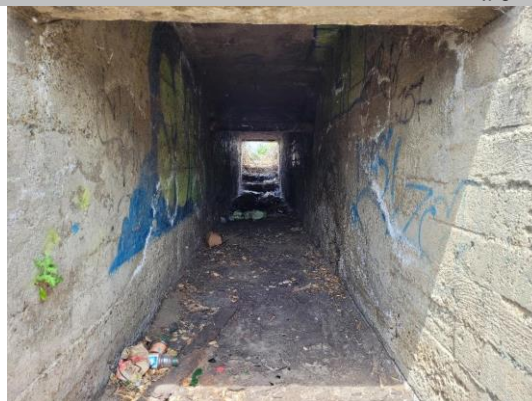
Photo 3 of 3 : UCIP\_SP\_2023\_75147\_112323.jpg

Overview of Levee: Photo taken inside of the tunnel

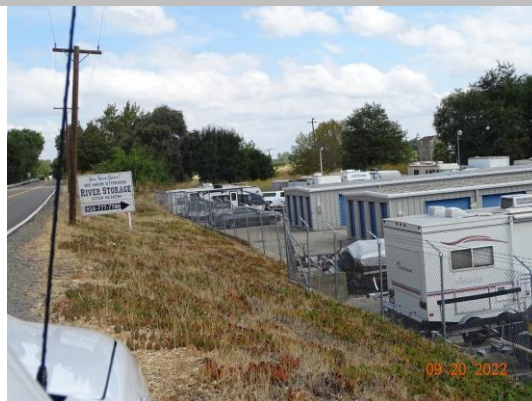
Photo 1 of 1 : SP\_2023\_NA0002\_63\_94\_20230206\_00043.jpg

| The downed fence on the LS has been re-erected. | | | | | |

View of the fence along the LS toe (Fall 2022).

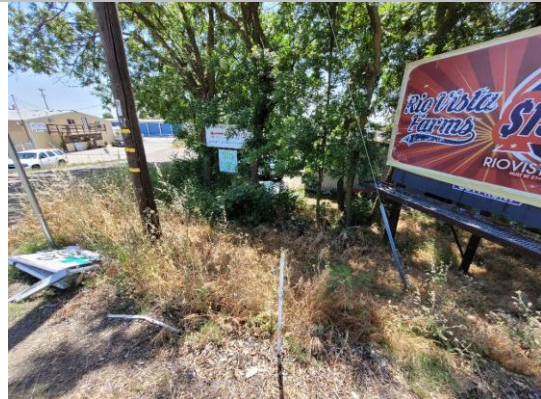
Photo 1 of 3 : UCIP\_SP\_2023\_75153\_112350.jpg

| DS_ID:21884<br>FS_ID:75153<br>EP_NO: 14173<br>Repair Type: Non-Urgent<br>EVAL Issue: 11, Maintenance Compliance Issue<br>Crossing Status: Indicator Found<br>UCIP Comments: 04/28/2022 Record remains Non-Urgent.<br>Recommend owner to install markers to show communication line alignment. (O.Yakimov - DWR UCIP)<br>04/18/2013 If pipe is still in use it should be marked properly on levee. (W.Wylie - DWR UCIP)<br>FIELD_STRUCT_DESC: 12-inch steel telephone conduit through the levee, 2 feet below the crown, and under the channel. Four 4-inch galvanized iron conductor pipes sleeved through 12-inch steel conduit. Sign on the waterside (WS) slope of levee across river provides location for this crossing. (12-inch conduit with submarine cable authorized under Permit No. 14173, 1985 - General Telephone Company of California). [Additional Reference(s): DWR Levee Log, 2005 (HLM 2.90), listed as submarine cable].<br>FS Date: 4/28/2022 2:32:50 PM | | | | | | |

Land-Side: View of levee slope looking from crown

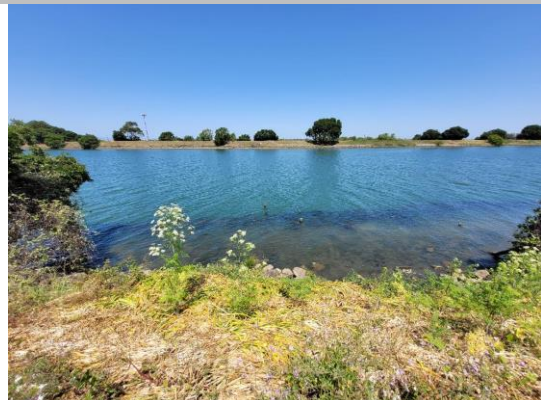
Photo 2 of 3 : UCIP\_SP\_2023\_75153\_112351.jpg

Water-Side: View of levee slope looking from crown

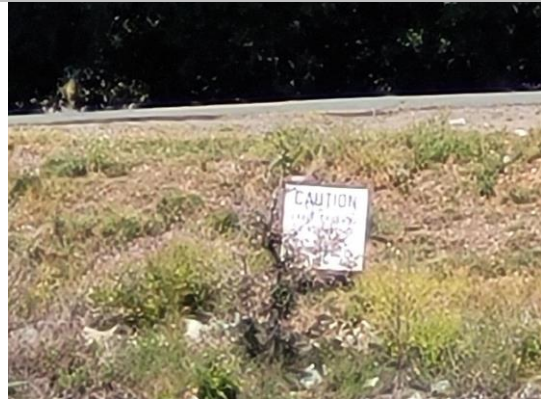
Photo 3 of 3 : UCIP\_SP\_2023\_75153\_112352.jpg

Water-Side: Caution sign on opposite side of river still in place

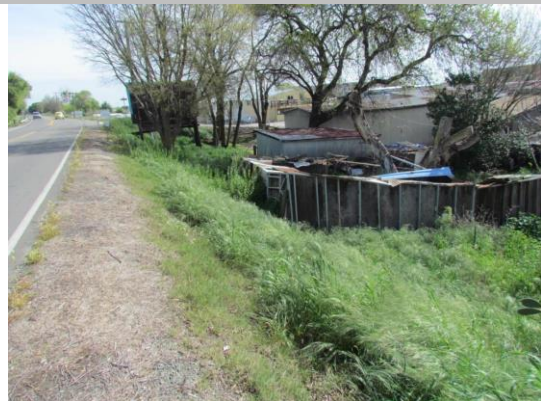
Photo 1 of 2 : SP\_2023\_NA0002\_63\_30\_20230206\_00007.jpg

| There are several encroachments within the town limits along the landside slope. | | | | | |

Looking north at several encroachments along landward slope and toe.

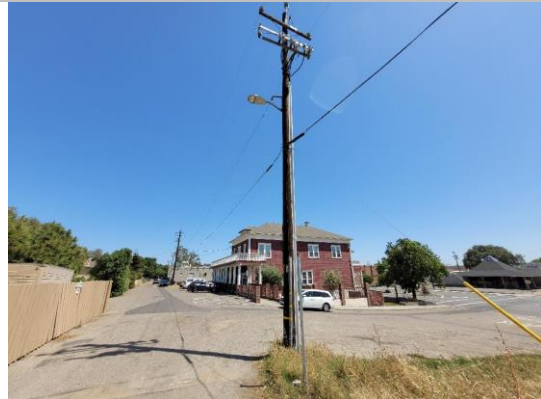
Photo 1 of 3 : UCIP\_SP\_2023\_77173\_115376.jpg

| DS_ID:25749<br>FS_ID:77173<br>EP_NO: N/A<br>Repair Type: Non-Urgent<br>EVAL Issue: 11, Maintenance Compliance Issue<br>Crossing Status: Found<br>UCIP Comments: 04/28/2022 Record is Non-Urgent. Lack of soil cover, conduit located right below crown pavement. Trench across levee is loosing pavement and getting open, recommend repaving. Fenced property on waterside. No permit has been found authorizing this pipe through the levee. (O.Yakimov - DWR UCIP)<br>FIELD_STRUCT_DESC: Unknown diameter communication conduit through levee right below the crown pavement. Junction pole with attached conduit on landside shoulder.<br>FS Date: 4/28/2022 | | | | | | |

Top of Levee: View of levee crown looking upstream. Service pole on landside shoulder

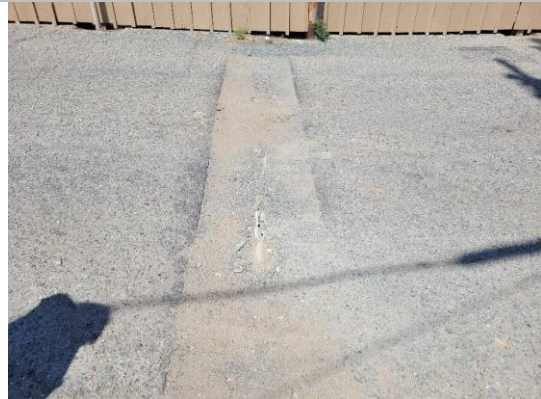
Photo 3 of 3 : UCIP\_SP\_2023\_77173\_115378.jpg

Top of Levee: Cut in pavement. Paving material is starting to come out due to the traffic

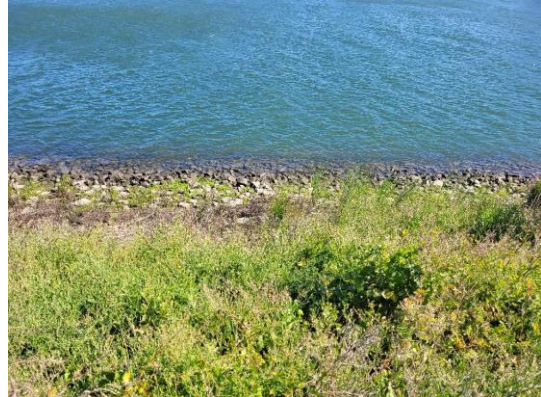
Photo 3 of 3 : UCIP\_SP\_2023\_75396\_112827.jpg

Water-Side: View of levee slope looking from crown. Pipe not found

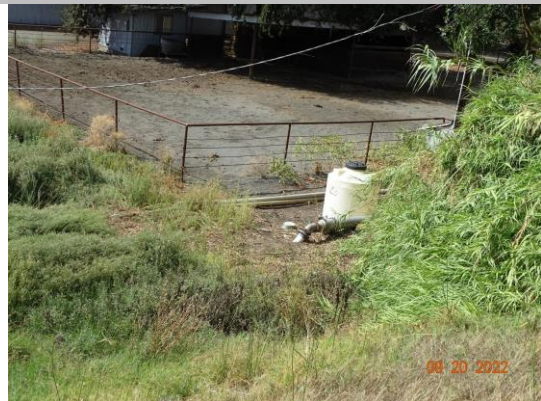
Photo 1 of 1 : SP\_2023\_NA0002\_63\_108\_20230206\_00052.jpg

View of the irrigation pipe obscured by vegetation along the LS toe (Fall 2022).

| Move irrigation pipe 10 feet away from landside toe. | | | | | |

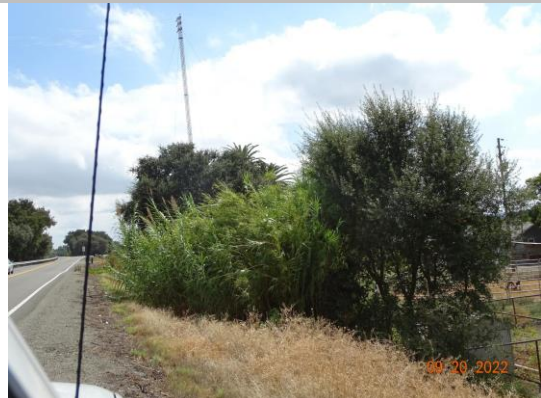
Photo 1 of 1 : SP\_2023\_NA0002\_63\_98\_20230206\_00047.jpg

View of the arundo on the LS slope (Fall 2022).

| Remove arundo from the landside slope. | | | | | |

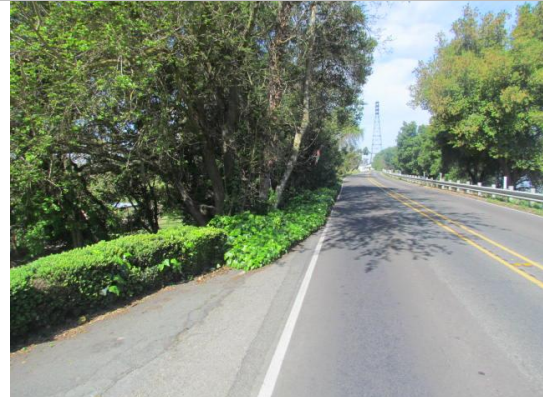
Photo 1 of 1 : SP\_2023\_NA0002\_63\_59\_20230206\_00015.jpg

Looking west at dense landscaping on landward slope.

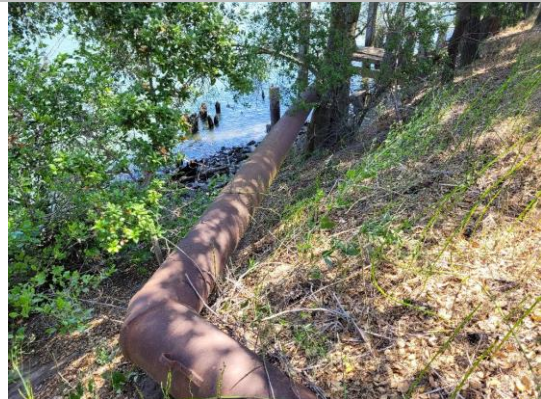
Photo 2 of 3 : UCIP\_SP\_2023\_75439\_112921.jpg

DS\_ID:21904  
FS\_ID:75439  
EP\_NO: 787  
Repair Type: Non-Urgent  
EVAL Issue: 10, Unauthorized Modification or Non-Compliant Permit  
Crossing Status: Found  
UCIP Comments: 05/03/2022 Record remains Non-Urgent. Pump is not in alignment with the pipe through levee and was added to the siphon system later (as shown in permit drawing). Concrete distribution box at LS toe instead of a sump. Unable to find a permit for modification. (O.Yakimov - DWR UCIP)  
04/24/2013 Pipe may be abandoned and should be done so properly if not being used. Good candidate for video inspection. (W.Wylie - DWR UCIP)  
FIELD\_STRUCT\_DESC: 1 of 2: 14-inch steel irrigation discharge pipe through the levee, 4.2 feet below the crown. Pump on pile structure in stream. Pipe crossing levee approximately 30 feet downstream from the location of pump. Concrete sump at landside toe - not found, instead a concrete distribution box at LS toe approximately 30 feet downstream of pump location. (14-inch siphon pipe authorized under Permit No. 787, 1939 - J. E. Silva, et al). [Additional Reference(s): DWR Levee Log, 2005 (HLM 4.11). USACE Sacramento O&M Manual, Unit 102, April 1959, Revised 29 December 2016, (RM 16.6), listed as 14-inch pipe].

Water-Side: Pipe at riverbank goes approximately 30 feet along the levee to connect pump with the pipe through levee

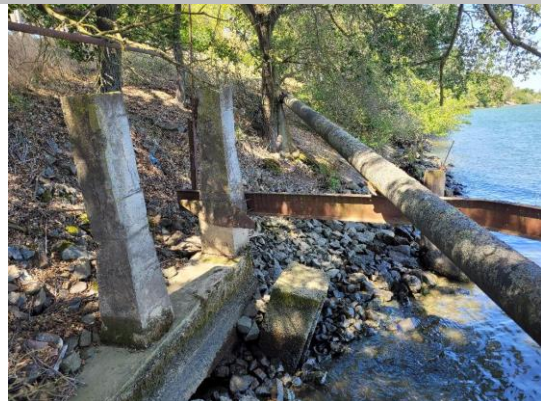
Photo 3 of 3 : UCIP\_SP\_2023\_75439\_112920.jpg

Water-Side: Pipe at riverbank goes along the levee to connect pump with the pipe through levee

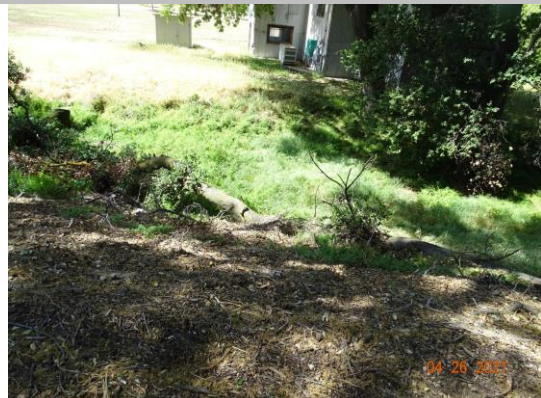
Photo 1 of 1 : SP\_2023\_NA0002\_63\_169\_20230206\_00068.jpg

View of down tree limb on the landside slope (Spring 2021).

| Remove the downed tree limb from the landside slope. | | | | | |

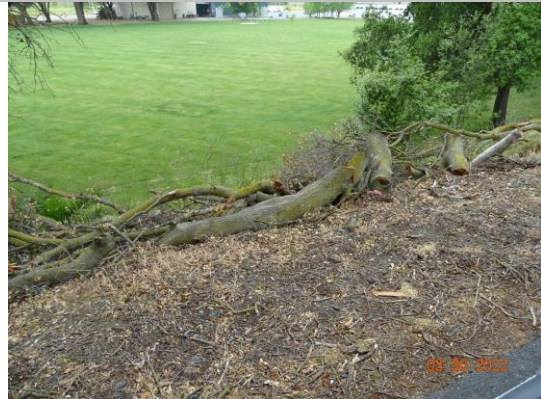
Photo 1 of 1 : SP\_2023\_NA0002\_63\_93\_20230206\_00042.jpg

View of cut up tree limbs on the landside shoulder (Spring 2022).

| Remove cut up tree limbs on landside shoulder. | | | | | |

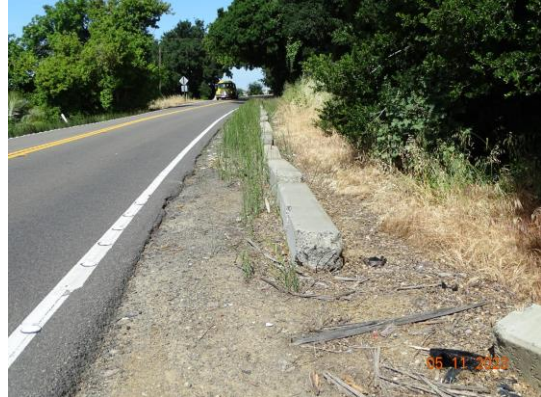
Photo 1 of 1 : SP\_2023\_NA0002\_63\_80\_20230518\_00148.jpg

| Concrete blocks placed to deter parking on waterside of crown. | | | | | |

View of the concrete blocks along the WS shoulder (Spring 2023).

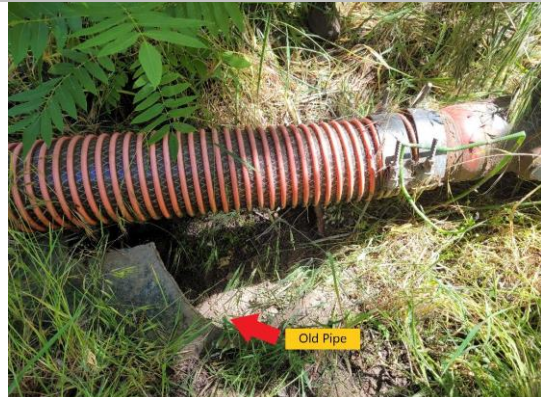
Photo 2 of 3 : UCIP\_SP\_2023\_75458\_112963.jpg

| 05/02/2013 Pit under pipe on WS shoulder - possible leak. Excavation of pipe on LS slope into levee prism. (W.Wylie - DWR UCIP) | | | | | | |

Water-Side: Pipe was cut on levee berm to install 6-inch flexible corrugated hose

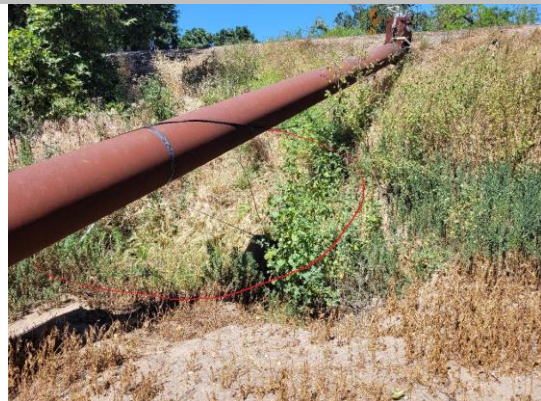
Photo 3 of 3 : UCIP\_SP\_2023\_75458\_112971.jpg

Land-Side: Excavation under pipe on levee slope. Approximate size is outlined in red

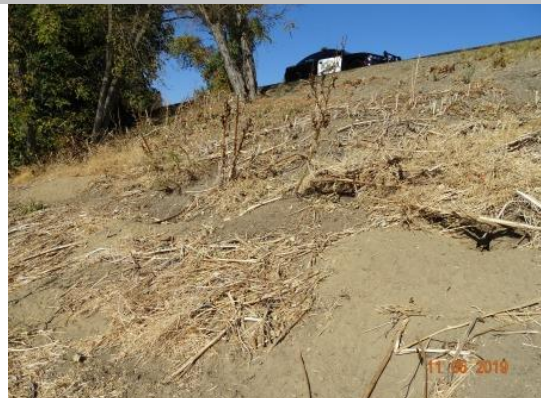
Photo 1 of 1 : SP\_2023\_NA0002\_63\_128\_20230206\_00058.jpg

| There are multiple large squirrel holes on the landside slope. | | | | | |

View of multiple large squirrel holes in landside slope (Fall 2019).

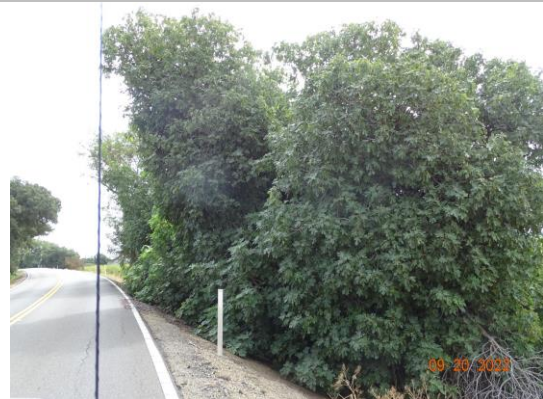
Photo 1 of 1 : SP\_2023\_NA0002\_63\_163\_20230206\_00064.jpg

View of the fig tree on the LS slope (Fall 2022).

| Trim the fig tree on the landside slope. | | | | | |

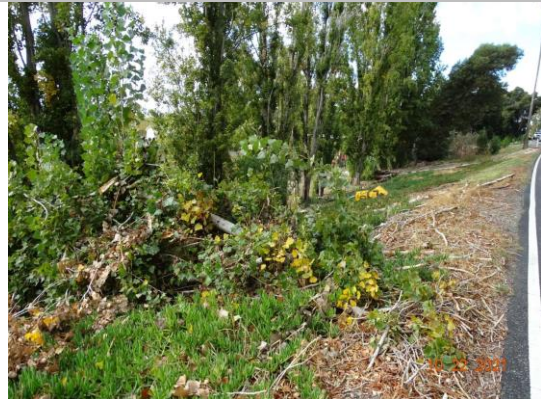
Photo 1 of 1 : SP\_2023\_NA0002\_63\_132\_20230206\_00059.jpg

View looking downstream at two down trees on the landside slope (Fall 2021).

| Remove two down trees on landside slope. | | | | | |

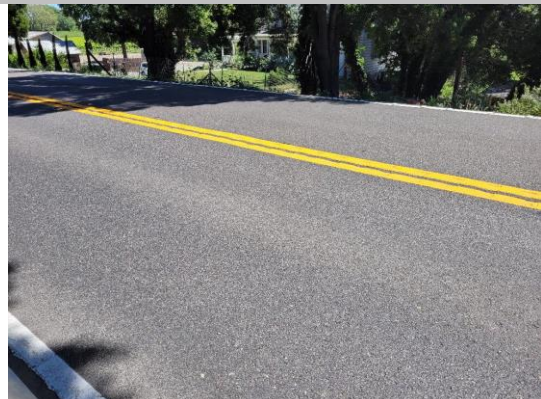
Photo 1 of 3 : UCIP\_SP\_2023\_75464\_112998.jpg

Top of Levee: View of levee crown looking towards landside

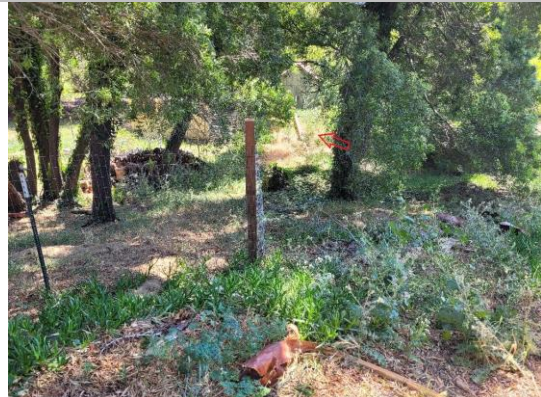
Photo 2 of 3 : UCIP\_SP\_2023\_75464\_112993.jpg

Land-Side: View of levee slope looking from crown. Pipe is visible on landside entering a shed

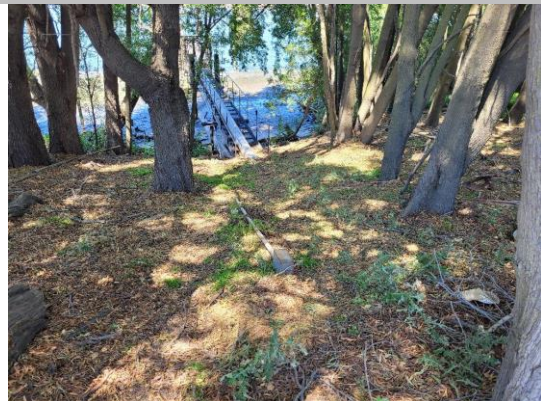
Photo 3 of 3 : UCIP\_SP\_2023\_75464\_113133.jpg

Water-Side: View of levee slope looking from crown

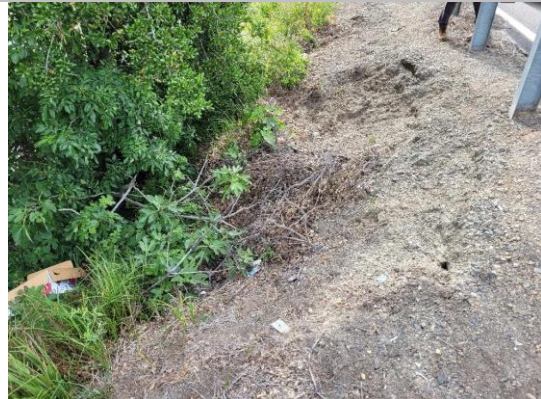
Photo 1 of 3 : UCIP\_SP\_2023\_75493\_113138.jpg

| DS_ID:21912<br>FS_ID:75493<br>EP_NO: N/A<br>Repair Type: Urgent<br>EVAL Issue: 2b, Levee Integrity<br>Crossing Status: Found<br>UCIP Comments: 05/05/2022 Record updated from Non-Urgent to Urgent. Depression on waterside slope along pipe alignment measured 13 feet wide and approximately 1.5 feet deep. Crossing appears abandoned. Abandoned centrifugal pump at landside toe with discharge pipe removed. Pipe not found on waterside. No permit has been identified authorizing pipe. Need to have CVFPB review ABO and determine current owner. (O.Yakimov - DWR UCIP)<br>05/02/2013 Pipe abandoned. Erosion on WS slope at location where pipe should be. (W.Wylie - DWR UCIP)<br>FIELD_STRUCT_DESC: 12-inch drainage pipe of an unknown material through the levee, 13 feet below the crown. Pump and gate valve at the landside (LS) toe. Pump house at LS toe removed. 1.5-inch electrical conduit along pipe at same location. 42-inch concrete standpipe at the LS toe. (12-inch pipe [HLM 5.78] authorized under Automatic Board Order (ABO) issued as Permit No. 11290, 1975 - Horace D. Towne). (Vertical pump in river channel authorized under Permit No. 1646, 1952 - H.D. Towne). [Additional Reference(s): DWR Levee Log, 1968 (HLM 5.78). USACE Sacramento O&M Manual, Unit 102, April 1959, Revised 29 December 2016, (RM 14.8), listed as 12-inch pipe].<br>FS Date: 5/5/2022 3:33:01 PM | | | | | | |

Water-Side: Another view of depression on levee slope

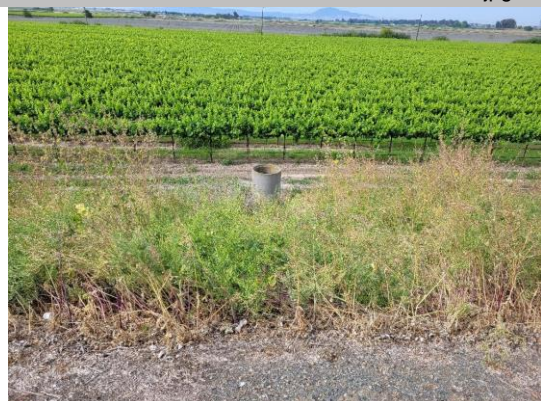
Photo 2 of 3 : UCIP\_SP\_2023\_75493\_113139.jpg

Land-Side: View of levee slope looking from crown. Concrete standpipe and abandoned pump at levee toe

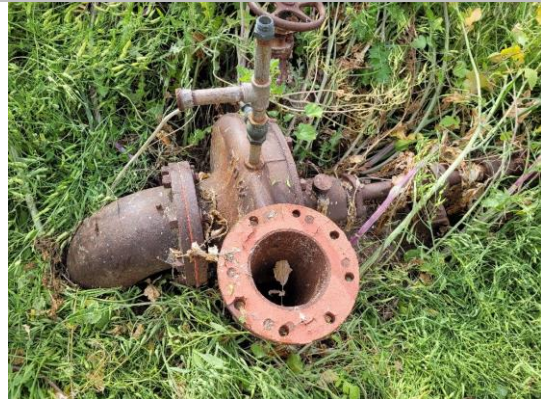
Photo 3 of 3 : UCIP\_SP\_2023\_75493\_113140.jpg

Land-Side: Abandoned pump at levee toe. Discharge pipe removed

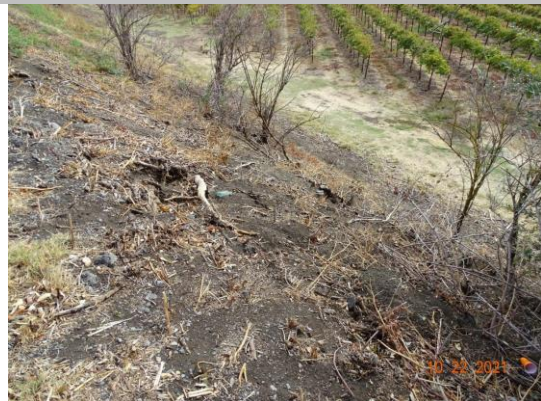
Photo 1 of 1 : SP\_2023\_NA0002\_63\_126\_20230206\_00057.jpg

| Evidence of squirrel activity. | | | | | |

View looking down slope at squirrel holes in the landside slope (Fall 2021).

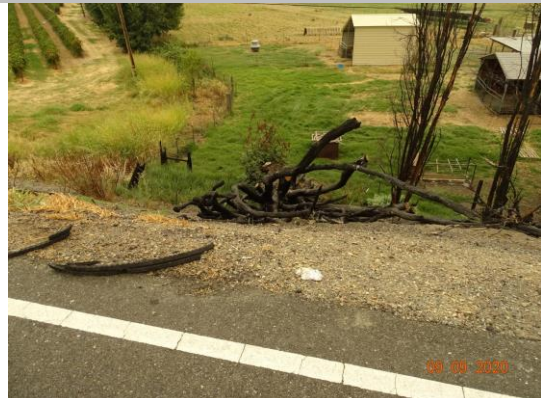
Photo 1 of 1 : SP\_2023\_NA0002\_63\_84\_20230206\_00036.jpg

| Dead tree on the landside. | | | | | |

View looking downslope at burned tree on the landside slope (Fall 2020).

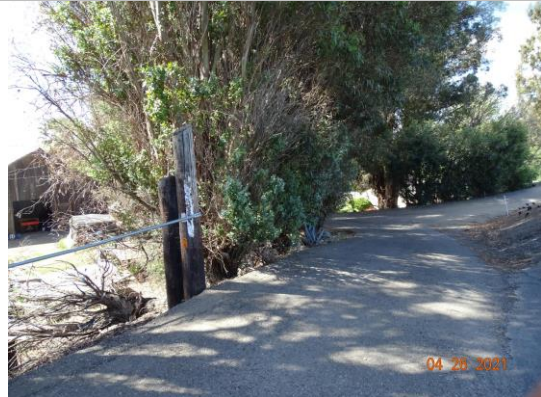
Photo 1 of 1 : SP\_2023\_NA0002\_63\_50\_20230206\_00011.jpg

View looking downstream at landscaping on the landside slope (Spring 2021).

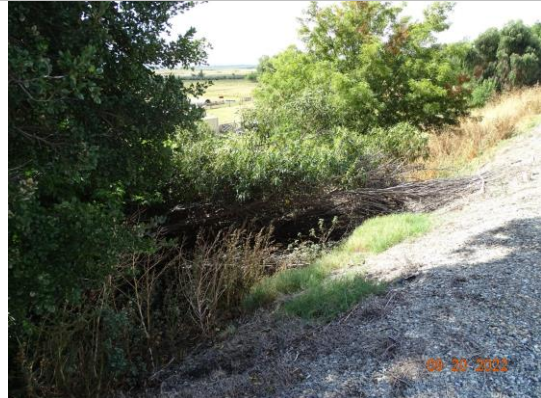
Photo 1 of 1 : SP\_2023\_NA0002\_63\_13\_20230206\_00004.jpg

| Fallen tree on the landside slope. | | | | | |

View of the fallen tree on the LS slope (Fall 2022).

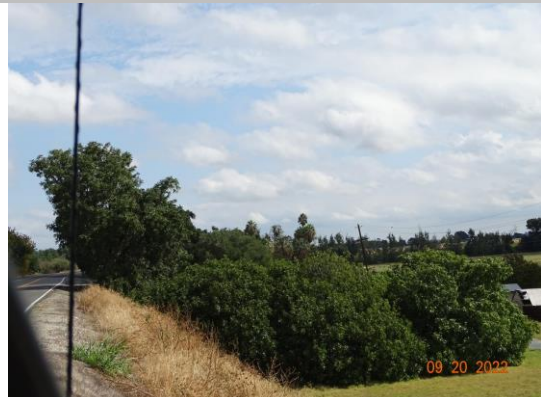
Photo 1 of 1 : SP\_2023\_NA0002\_63\_118\_20230206\_00053.jpg

View of the fig tree on the LS slope (Fall 2022).

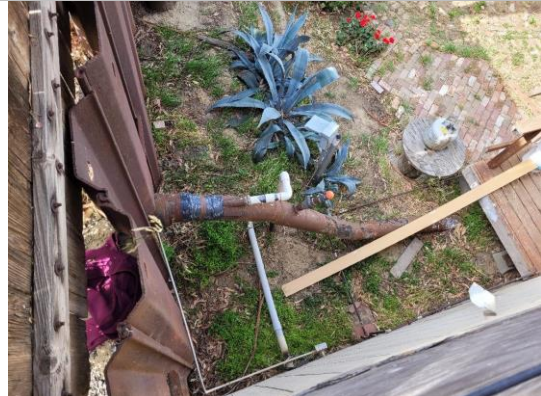
Photo 1 of 3 : UCIP\_SP\_2023\_75510\_113158.jpg

DS\_ID:21966  
FS\_ID:75510  
EP\_NO: 11278  
Repair Type: Urgent  
EVAL Issue: 3b, Flood Risk  
Crossing Status: Found  
UCIP Comments: 05/05/2022 Record updated from No Action Needed to Urgent. Multiple pipes sleeved through the original pipe with annular space not grouted that poses flood threat to the landside. Concrete distribution box and concrete standpipe are removed from landside toe and replaced with steel standpipe. Unable to find a permit for modifications. No permit has been identified authorizing pipe. Need to have CVFPB review ABO and determine current owner. (O.Yakimov - DWR UCIP)  
FIELD\_STRUCT\_DESC: 8-inch steel irrigation pipe sleeved through 9-inch steel pipe sleeved through 10-inch steel pipe through the levee, 5 feet below the crown. Pump on pier at the waterside (WS) toe. 4-foot by 5-foot concrete distribution box at the landside (LS) toe, not found. 36-inch concrete standpipe on the LS toe, not found. 1.5-inch electrical conduit at same location. (10-inch pipe [HLM 6.92] authorized under Automatic Board Order (ABO) issued as Permit No. 11278, 1975 - George J. Pestano). [Additional Reference(s): DWR Levee Log, 2005 (HLM 6.92), listed as 10-inch pipe. USACE Sacramento O&M Manual, Unit 102, April 1959, Revised 29 December 2016, (RM 13.6), listed as 10-inch pipe].

Water-Side: Pipe at the retaining wall on the property

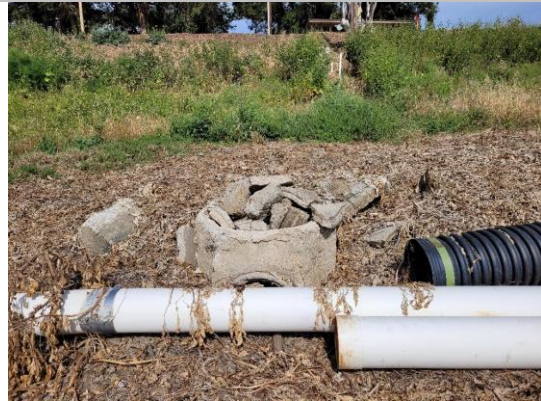
Photo 3 of 3 : UCIP\_SP\_2023\_75510\_113156.jpg

Land-Side: Concrete debris at levee toe

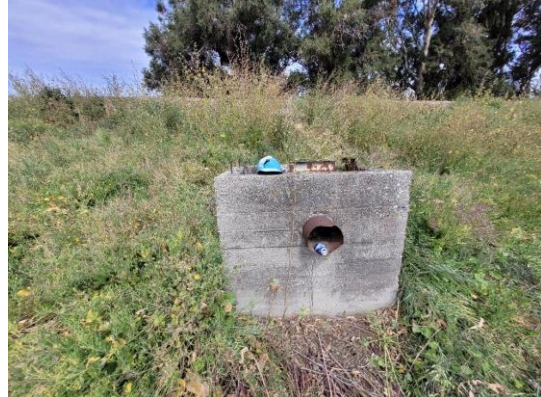
Photo 1 of 3 : UCIP\_SP\_2023\_75518\_113172.jpg

| DS_ID:21916<br>FS_ID:75518<br>EP_NO: N/A<br>Repair Type: Urgent<br>EVAL Issue: 1, Pipe Integrity<br>Crossing Status: Found<br>UCIP Comments: 05/05/2022 Record remains Urgent. Pipe located above design flood plane open on both ends. Through holes on pipe visible at riverbank. Crossing appears abandoned. Abandoned concrete distribution box at landside toe partially filled with soil. No permit has been identified authorizing pipe. (O.Yakimov - DWR UCIP)<br>07/12/2018 Holes on pipe visible where it daylights on WS, and inside of concrete box on LS. Pipe is opened on WS. Recommend internal inspection to determine pipe integrity through levee. (O.Yakimov-DWR UCIP)<br>10/24/2016 same as previous inspection pipe is opened on the WS. The crossing remains "Urgent" due WS end open. Crossing appears abandoned--need to contact owner to determine status. If crossing is no longer in use owner will need to coordinate with the CVFPB to comply with Title 23. (O. Magana - DWR UCIP)<br>05/02/2013 Pipe open on WS. (W. Wylie - DWR UCIP)<br>FIELD_STRUCT_DESC: 8-inch steel irrigation siphon pipe through levee 8.7 feet below crown. Pipe measures 8-inch inner diameter (ID) and 10-inch outer diameter (OD). A 5-foot by 5-foot concrete distribution box is located on the landside (LS) toe. [Additional Reference(s): DWR Levee Log, 2005 (HLM 7.04), listed as abandoned 8-inch pipe. USACE Sacramento O&M Manual, Unit 102, April 1959, Revised 29 December 2016, (RM 13.4), listed as 8-inch pipe].<br>FS Date: 5/5/2022 1:04:42 PM | | | | | |

Land-Side: Abandoned concrete distribution box at levee toe

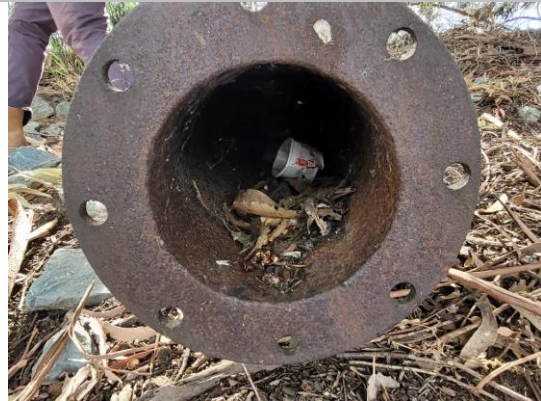
Photo 2 of 3 : UCIP\_SP\_2023\_75518\_113175.jpg

Water-Side: Open pipe end

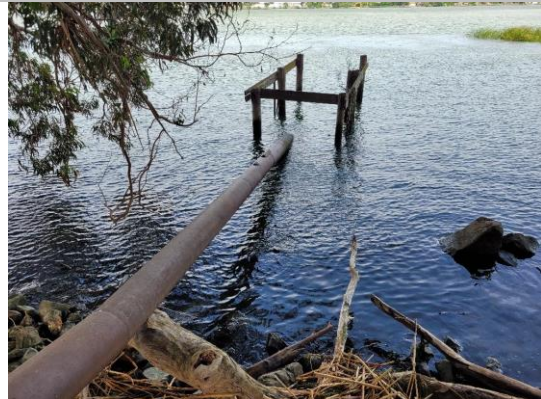
Photo 1 of 3 : UCIP\_SP\_2023\_75517\_113168.jpg

| DS_ID:21917<br>FS_ID:75517<br>EP_NO: 11293<br>Repair Type: Urgent<br>EVAL Issue: 3b, Flood Risk<br>Crossing Status: Found<br>UCIP Comments: 05/05/2022 Record updated from No Action Needed to Urgent. Pipe above flood plane open on both ends, closure device is not installed on waterside that can prevent flood to the landside. Pipe at riverbank appears replaced, concrete standpipe in the orchard on landside was replaced with corrugated plastic standpipe. Pipe diameter measured on landside slope is 12-inch. Unable to find a permit for modification. (O.Yakimov - DWR UCIP)<br>FIELD_STRUCT_DESC: 14-inch steel irrigation siphon pipe through the levee 7.1 feet below the crown. Pipe begins under broken down pier on the waterside toe and terminates in corrugated plastic standpipe on landside. Air vent on LS slope. (16-inch pipe [HLM 7.27] authorized under Automatic Board Order (ABO) issued as Permit No. 11293, 1975 - John Wilcox). [Additional Reference(s): DWR Levee Log, 2005 (HLM 7.26), listed as 16-inch pipe. USACE Sacramento O&M Manual, Unit 102, April 1959, Revised 29 December 2016, (RM 13.2), listed as 16-inch siphon pipe].<br>FS Date: 5/5/2022 10:20:46 AM | | | | | |

Water-Side: View of pipe at riverbank

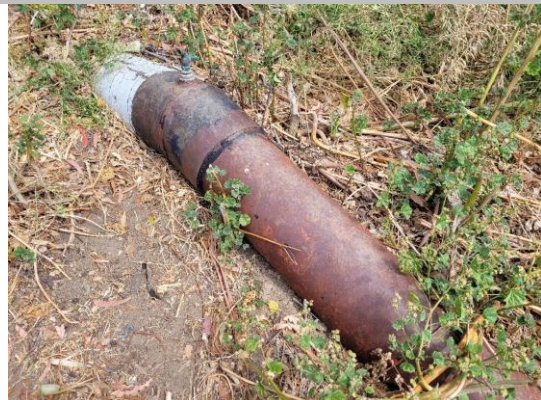
Photo 2 of 3 : UCIP\_SP\_2023\_75517\_113164.jpg

Land-Side: View of pipe on levee slope. Air vent on the top of pipe

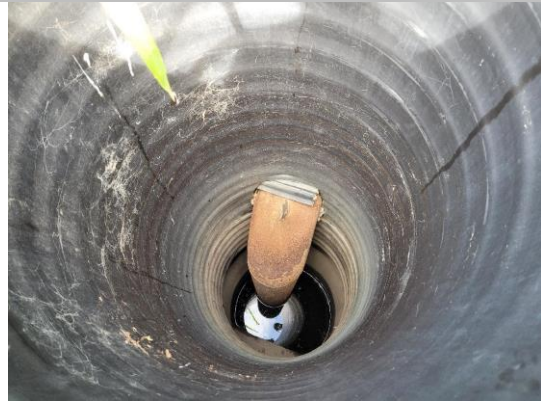
Photo 3 of 3 : UCIP\_SP\_2023\_75517\_113162.jpg

Land-Side: View of pipe inside CPP standpipe

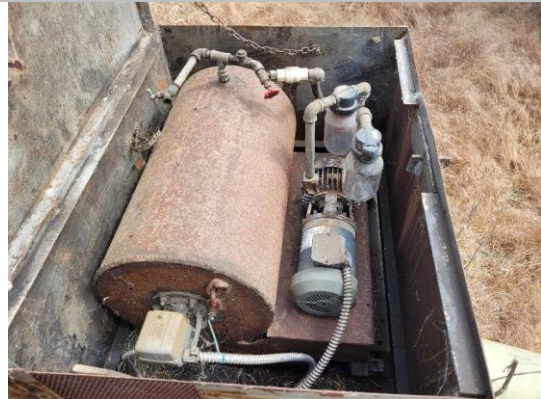
Photo 1 of 3 : UCIP\_SP\_2023\_75525\_113176.jpg

| DS_ID:21918<br>FS_ID:75525<br>EP_NO: 11293<br>Repair Type: Urgent<br>EVAL Issue: 3b, Flood Risk<br>Crossing Status: Found<br>UCIP Comments: 05/05/2022 Record updated from Non-Urgent to Urgent. 14-inch pipe sleeved through 16-inch pipe with annular space not grouted which can pose flood threat to the landside. Unable to find a permit for sleeving. Erosion on WS shoulder noted in last inspection not found. No permit has been identified authorizing pipe. (O.Yakimov - DWR UCIP)<br>05/02/2013 Erosion or sinkhole on WS shoulder. Does not appear to be an immediate threat. (W.Wylie - DWR UCIP)<br>FIELD_STRUCT_DESC: 14-inch steel irrigation siphon pipe sleeved through 16-inch steel pipe through the levee at unknown depth below the crown. Siphon filler pump and service pole on landside (LS) slope. 72-inch concrete sump at the landside (LS) toe. [Additional Reference(s): DWR Levee Log, 2005 (HLM 7.47), listed as 16-inch pipe. USACE Sacramento O&M Manual, Unit 102, April 1959, Revised 29 December 2016, (RM 13.0), listed as 16-inch pipe].<br>FS Date: 5/5/2022 2:50:39 PM | | | | | |

Land-Side: Filler pump and its equipment in service box on the top of pipe at levee shoulder

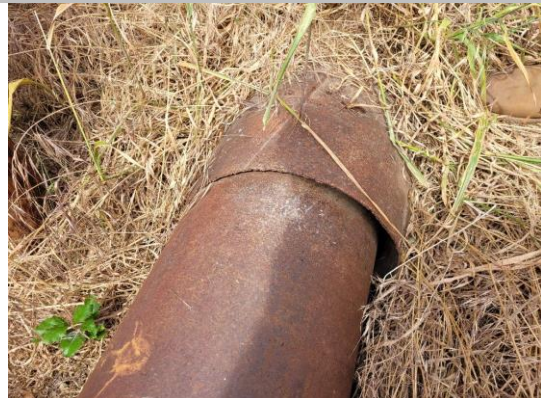
Photo 2 of 3 : UCIP\_SP\_2023\_75525\_113181.jpg

Land-Side: View of open annular space between pipes at levee shoulder

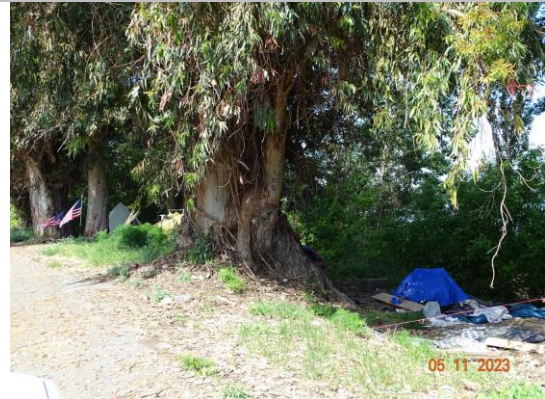
Photo 1 of 1 : SP\_2023\_NA0002\_63\_34\_20230518\_00149.jpg

| A few tents are set up on the WS slope. | | | | | |

View of the tents on the WS slope (Spring 2023).

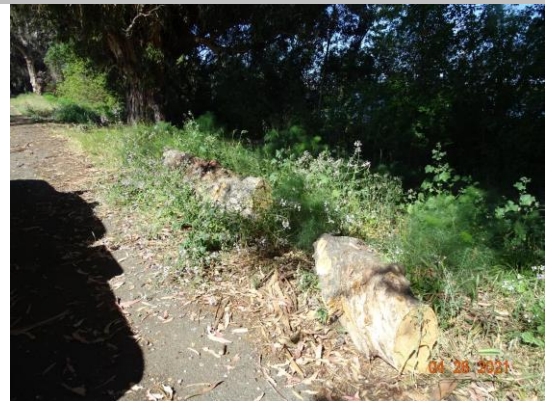
Photo 1 of 1 : SP\_2023\_NA0002\_63\_83\_20230206\_00035.jpg

| Cut up tree limb on waterside hinge. | | | | | |

View of cut-up tree limb on the waterside hinge (Spring 2021).

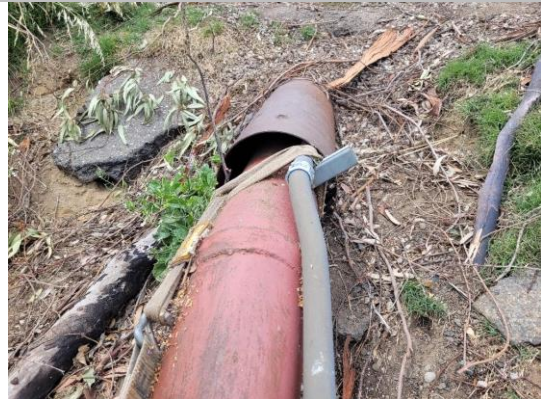
Photo 2 of 3 : UCIP\_SP\_2023\_75561\_113223.jpg

| DS_ID:21923<br>FS_ID:75561<br>EP_NO: 11272<br>Repair Type: Urgent<br>EVAL Issue: 3b, Flood Risk<br>Crossing Status: Found<br>UCIP Comments: 05/05/2022 Record updated from No Action Needed to Urgent. Annular space between pipes is not grouted that poses flood threat to the landside. 10-inch pipe sleeved through 12-inch pipe, electrical conduit is sleeved through annular space between the pipes, section of pipe on landside slope was replaced with PVC pipe. Unable to find a permit for modifications. Unauthorized encroachment recorded in Levee Log. Need to have CVFPB review ABO and determine current owner.(O.Yakimov - DWR UCIP)<br>FIELD_STRUCT_DESC: 10-inch pipe sleeved through 12-inch steel pipe through the levee 2.1 feet below the crown. Annular space not grouted. Pump on the waterside (WS) slope with butterfly valve. PVC pipe connected via coupler to steel pipe on landside (LS) slope. 1.5-inch galvanized steel electrical conduit at same location. JP and electrical panel on LS berm, electrical panel on WS slope. 36-inch standpipe at the LS toe, sand filters on landside. (10-inch pipe sleeved through 12-inch pipe [HLM 7.82] authorized under Automatic Board Order (ABO) issued as Permit No. 11272, 1975 - Ruth McKinnon). (Emergency partial replacement and extension of pipe on waterside slope authorized under Permit No. 18240, 2007 - Towne Enterprises LP). [Additional Reference(s): DWR Levee Log, 2005 (HLM 7.82), listed as 10-inch sleeved through 12-inch pipe].<br>FS Date: 5/5/2022 10:27:31 AM | | | | | | |

Land-Side: 10-inch through 12-inch pipes sleeving visible on levee shoulder

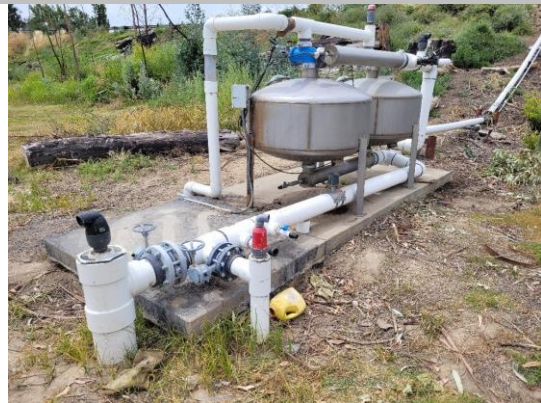
Photo 3 of 3 : UCIP\_SP\_2023\_75561\_113225.jpg

Land-Side: Sand filters off levee toe

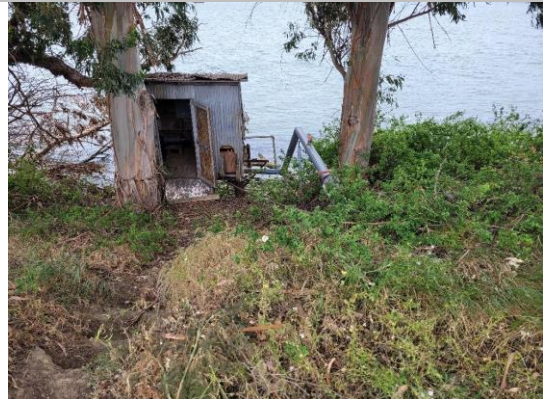
Photo 2 of 3 : UCIP\_SP\_2023\_75567\_113243.jpg

Water-Side: View of levee slope looking from crown. Pump house at riverbank

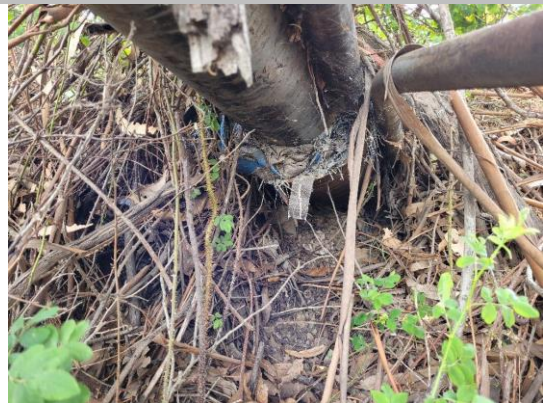
Photo 3 of 3 : UCIP\_SP\_2023\_75567\_113237.jpg

| DS_ID:21925<br>FS_ID:75567<br>EP_NO: 2795<br>Repair Type: Urgent<br>EVAL Issue: 3b, Flood Risk<br>Crossing Status: Found<br>UCIP Comments: 05/05/2022 Record updated from Non-Urgent to Urgent. Annular space between pipes plugged with tarp at waterside shoulder, this may provide flood threat to the landside. Another 2.5-inch steel pipe open on waterside end sleeved in the space between pipes through the levee. 36-inch concrete standpipe at landside toe has been removed. Unable to find a permit for modifications. Original 20-inch pipe is unauthorized encroachment recorded in Levee Log. (O.Yakimov - DWR UCIP)<br>05/03/2013 Annular space between PVC pipe and 12-inch steel pipe has not been sealed. (W.Wylie - DWR UCIP)<br>FIELD_STRUCT_DESC: 6.5-inch steel irrigation pipe sleeved through a 12-inch steel pipe that is sleeved through the 20-inch pipe of an unknown material through the levee 3 feet below the crown. Annular space not grouted between pipes. Two pumps in pump house at riverbank connected in parallel, butterfly valve on pipe on waterside (WS) slope. 36-inch concrete standpipe at landside (LS) toe, not found. Sand filters, JP and electrical panel at LS toe, 1.5-inch electrical conduit through levee at this location. (12-inch pipe through existing 20-inch pipe authorized under Permit No. 2795, 1958 - Mabel J. Ruble by M. B. McKinnon (agent)). [Additional Reference(s): DWR Levee Log, 2005 (HLM 7.96), listed as 12-inch sleeved through 20-inch pipe].<br>FS Date: 5/5/2022 11:22:20 AM | | | | | |

Water-Side: Annular space between pipes plugged with tarp at levee shoulder

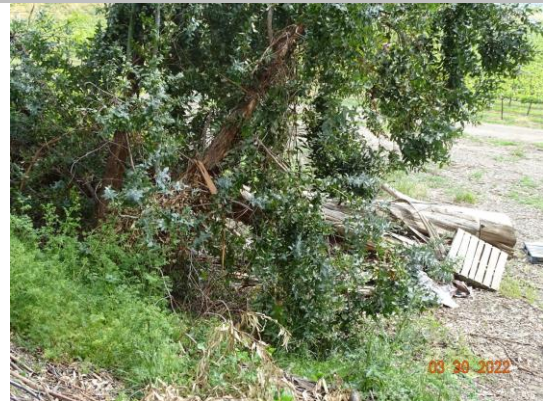
Photo 1 of 1 : SP\_2023\_NA0002\_63\_65\_20230206\_00019.jpg

View of large down tree on the landside slope (Spring 2022).

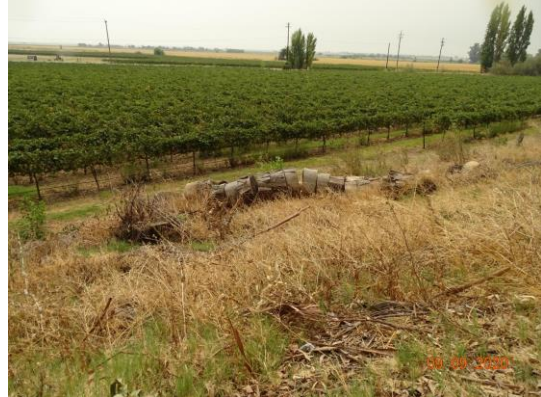
Photo 1 of 1 : SP\_2023\_NA0002\_63\_60\_20230206\_00016.jpg

| Chopped up tree trunk on the landside slope. | | | | | |

View of chopped up tree trunk on the landside slope (Fall 2020).

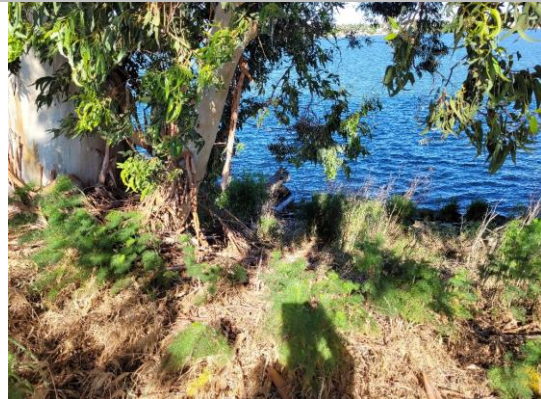
Photo 2 of 3 : UCIP\_SP\_2023\_75571\_113256.jpg

| DS_ID:21926<br>FS_ID:75571<br>EP_NO: 8661<br>Repair Type: Non-Urgent<br>EVAL Issue: 10, Unauthorized Modification or Non-Compliant Permit<br>Crossing Status: Found<br>UCIP Comments: 05/10/2022 Record remains Non-Urgent. Road pavement on the top of crown has been removed in pipe alignment. Unable to find a permit for pipe replacement or modification. No permit has been identified authorizing pipe. Need to have CVFPB review ABO and determine current owner. (O.Yakimov - DWR UCIP)<br>05/03/2013 Dip in crown over alignment of pipe. Good candidate for video inspection. (W.Wylie - DWR UCIP)<br>FIELD_STRUCT_DESC: 8-inch irrigation pipe of an unknown material through the levee, 3.7 feet below the crown. Pump in pump house on the landside (LS) slope. Service pole and 30-inch concrete standpipe at the LS toe. (8-inch pipe [HLM 8.18] authorized under Automatic Board Order (ABO) issued as Permit No. 8661, 1972 - Jesse Marks).<br>[Additional Reference(s): DWR Levee Log, 2005 (HLM 8.18). USACE Sacramento O&M Manual, Unit 102, April 1959, Revised 29 December 2016, (RM 12.2), listed as 8-inch pipe].<br>FS Date: 5/10/2022 1:34:45 PM | | | | | |

Water-Side: View of levee slope looking from crown

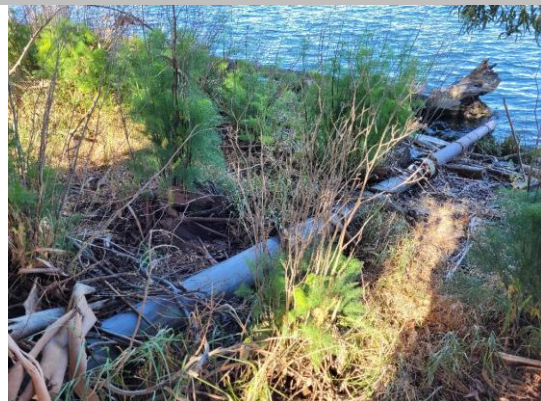
Photo 3 of 3 : UCIP\_SP\_2023\_75571\_113259.jpg

Water-Side: View of pipe at riverbank

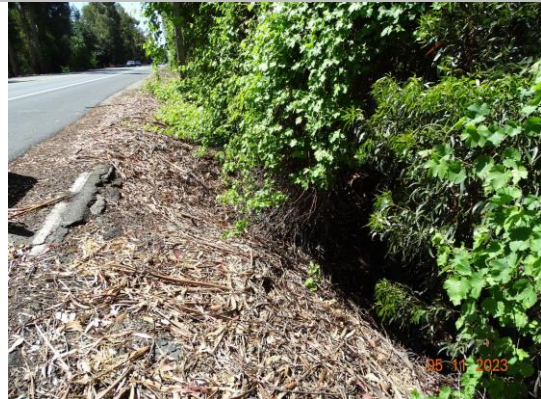
Photo 1 of 3 : SP\_2023\_NA0002\_63\_69\_20230518\_00157.jpg

Spring 2023: Noticed scour at LM 8.37 and a tree with exposed roots.  
2018 Site ID: SAC 12.1 L  
Status: Critical  
2018 Field Notes: No observed change.  
Site History: 2010 - Small inlet area behind a man-built spit. Bank is slumping and could possibly be fixed with maintenance. 2011 - Site continues to worsen. 2015 - Upgraded to CRITICAL. 2016 - Site continues to get worse. 2017 - Continues to worsen and threaten the road.

View of the scour at LM 8.37 (Spring 2023).

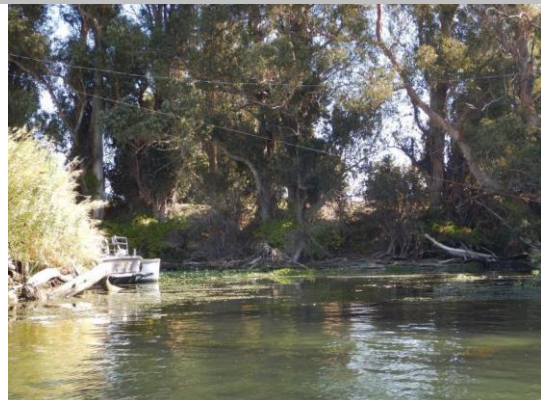
Photo 2 of 3 : SP\_2023\_NA0002\_63\_69\_20230206\_00024.jpg

USACE 2018 Erosion Photo #1

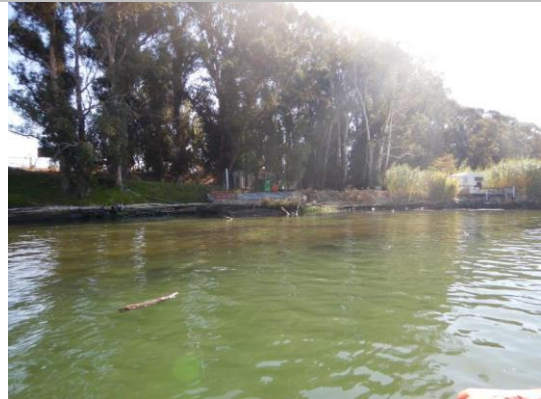
Photo 3 of 3 : SP\_2023\_NA0002\_63\_69\_20230206\_00025.jpg

USACE 2018 Erosion Photo #2

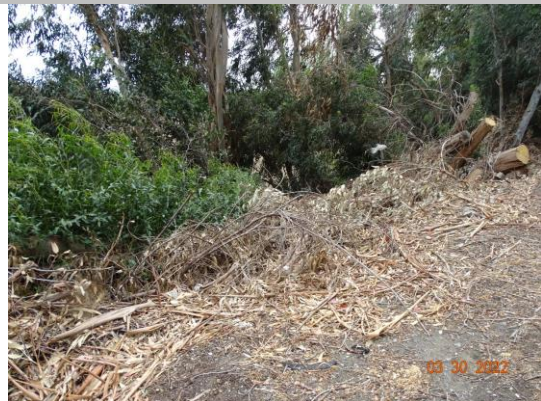
Photo 1 of 1 : SP\_2023\_NA0002\_63\_158\_20230206\_00063.jpg

View of down trees on the landside slope (Spring 2022).

| Remove the downed trees from landside slope. | | | | | |
