**Flood Control Project Maintenance  
Levee Inspections  
LMA District Cover Sheet**

**Brannan Andrus Levee Maintenance District**

**Flood Control Project Maintenance  
Levee Inspections  
Unit Cover Sheet**

| Waterway | | | Bank | Unit Miles |
|--|---|---|---|---|
| Unit No. 01 Georgiana Slough | | | Right | 6.01 |

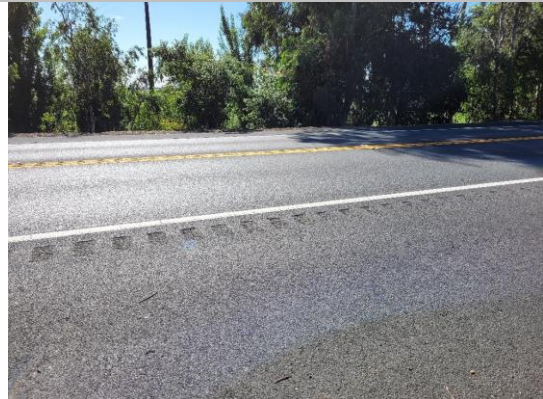
Photo 1 of 3 : UCIP\_SP\_2023\_75573\_113263.jpg

| DS_ID:21927<br>FS_ID:75573<br>EP_NO: N/A<br>Repair Type: Non-Urgent<br>EVAL Issue: 6, Levee Damage or Threat for Levee Damage<br>Crossing Status: Not Found<br>UCIP Comments: 05/10/2022 Record updated from No Action Needed to Non-Urgent. Crossing not found. Erosion or subsidence on waterside levee slope in possible pipe alignment. Geophysical results did not confirm presence of pipe through levee. Record will remain in UCIP's inspection records until future Levee Improvement Project can confirm no crossing was found through the levee. Unauthorized encroachment recorded in Levee Log. (O.Yakimov - DWR UCIP)<br>FIELD_STRUCT_DESC: 6-inch inactive pipe of an unknown material or purpose through the levee, 6.7 feet below the crown. [Additional Reference(s): DWR Levee Log, 2005 (HLM 8.41), listed as inactive 6-inch pipe].<br>FS Date: 5/10/2022 1:43:55 PM | | | | | | |

Top of Levee: View of levee crown looking towards landside

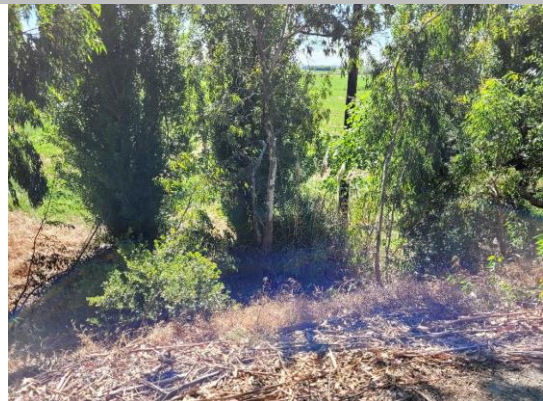
Photo 2 of 3 : UCIP\_SP\_2023\_75573\_113262.jpg

Land-Side: View of levee slope looking from crown

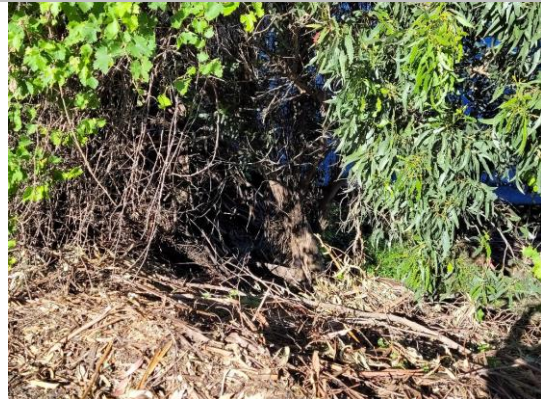
Photo 3 of 3 : UCIP\_SP\_2023\_75573\_113264.jpg

Water-Side: View of levee slope looking from crown

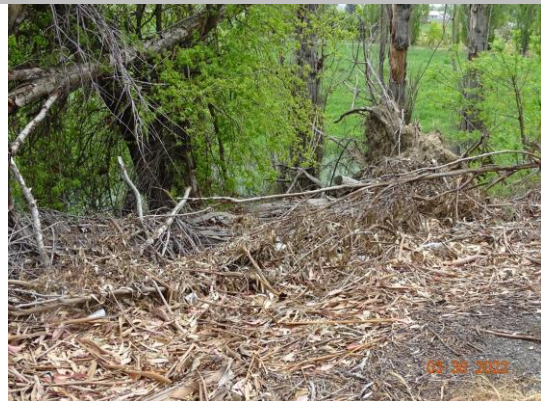
Photo 1 of 1 : SP\_2023\_NA0002\_63\_157\_20230206\_00062.jpg

View of down tree on the landside slope (Spring 2022).

| Remove the downed tree from the landside slope. | | | | | |

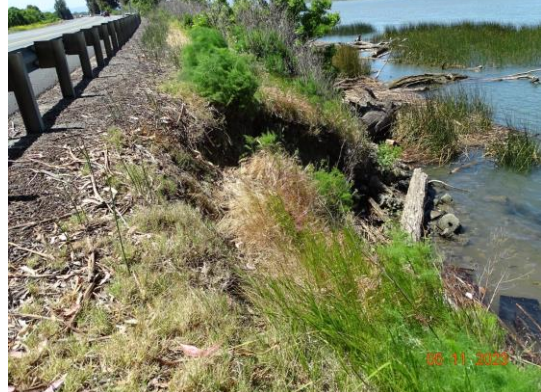
Photo 1 of 4 : SP\_2023\_NA0002\_63\_68\_20230518\_00159.jpg

View of the sloughing at LM 8.97 (Spring 2023).

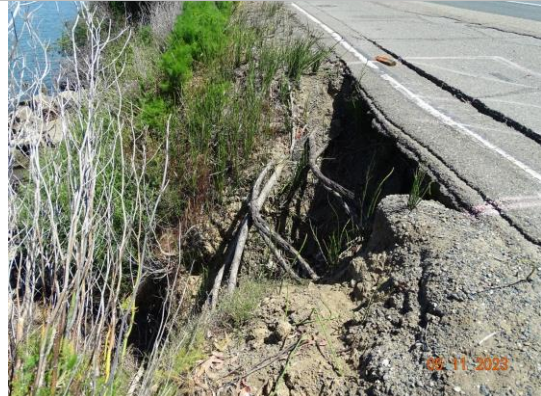
Photo 2 of 4 : SP\_2023\_NA0002\_63\_68\_20230518\_00160.jpg

Erosion at LM 9.10 by turnout (Spring 2023).

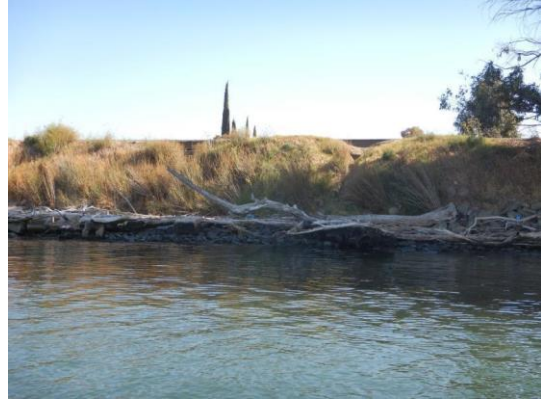
Photo 3 of 4 : SP\_2023\_NA0002\_63\_68\_20230206\_00022.jpg

USACE 2018 Erosion Photo #1

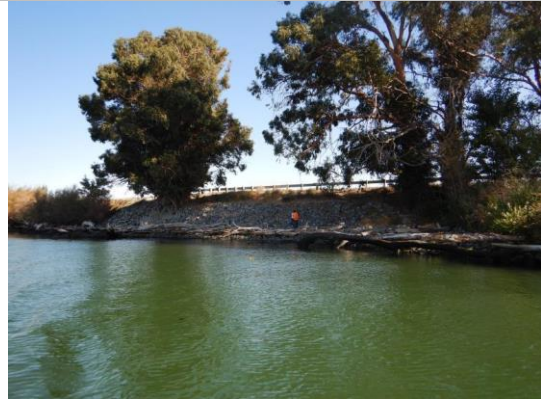
Photo 4 of 4 : SP\_2023\_NA0002\_63\_68\_20230206\_00023.jpg

| <p>Spring 2023: Noticed new, 20-ft long sloughing at LM 8.97. Two previously noticed locations of erosion/undermining both at LM 9.10 seem to not have worsened much since last fall. 2018 Site ID: SAC 11.2 L</p> <p>Status: Critical</p> <p>2018 Field Notes: Erosion is now into levee crown</p> <p>Site History: 2008 - Erosion causing vertical bank at the highway on top of levee. The whole bank along the highway should be repaired. 2009 - Minimal new erosion. 2011 - Bank continues to slowly erode. 2012 - Upgrade to CRITICAL, new erosion since lat year and steeper slopes in sections. 2015 - Road foundation and cables exposed. Extremely large tree with exposed roots looks likely to fail and take out a significant portion of the levee. 2016 - Site continues to erode. 2017 - New slump section. Erosion under the road has enlarged.</p> | | | | | |

USACE 2018 Erosion Photo #2

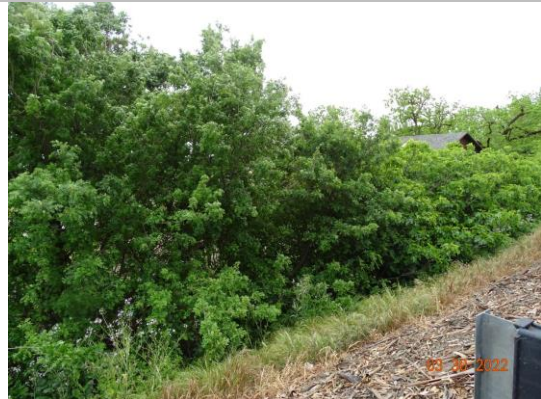
Photo 1 of 1 : SP\_2023\_NA0002\_63\_85\_20230206\_00037.jpg

View of thick trees on the landside slope (Spring 2022).

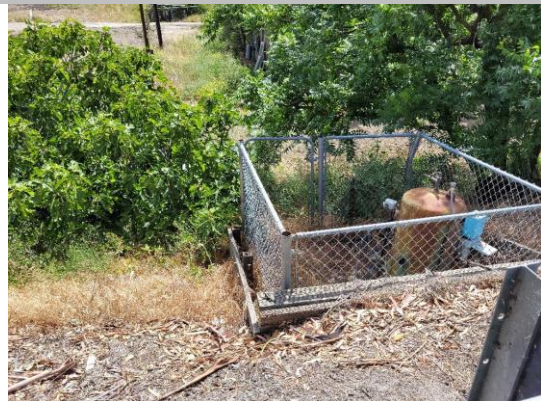
Photo 1 of 3 : UCIP\_SP\_2023\_75591\_113323.jpg

| DS_ID:21930<br>FS_ID:75591<br>EP_NO: 8006<br>Repair Type: Non-Urgent<br>EVAL Issue: 10, Unauthorized Modification or Non-Compliant Permit<br>Crossing Status: Found<br>UCIP Comments: 05/10/2022 Record updated from No Action Needed to Non-Urgent. Pumphouse has been removed from levee slope, unable to find a permit for modification. No permit has been identified authorizing original 10-inch pipe through the levee. (O.Yakimov - DWR UCIP)<br>FIELD_STRUCT_DESC: 8-inch steel irrigation pipe sleeved through 10-inch steel pipe through the levee 3.8 feet below the crown. Pump in pump house on the landside (LS), not found, slant pump on levee slope. 2-inch galvanized electrical conduit at same location. (8-inch pipe through 10-inch pipe sleeving authorized under Permit No. 8006, 1972 - Frank Emmolo). (Emergency partial replacement and extension of pipe on waterside slope authorized under Permit No. 18239, 2007 - Frank and Alba Emmolo 1995 Trust). [Additional Reference(s): DWR Levee Log, 2005 (HLM 9.26), listed as 8-inch pipe sleeved through 10-inch pipe.USACE Sacramento O&M Manual, Unit 102, April 1959, Revised 29 December 2016, (RM 11.1), listed as 10-inch siphon pipe].<br>FS Date: 5/10/2022 11:16:36 AM | | | | | | |

Land-Side: View of levee slope looking from crown

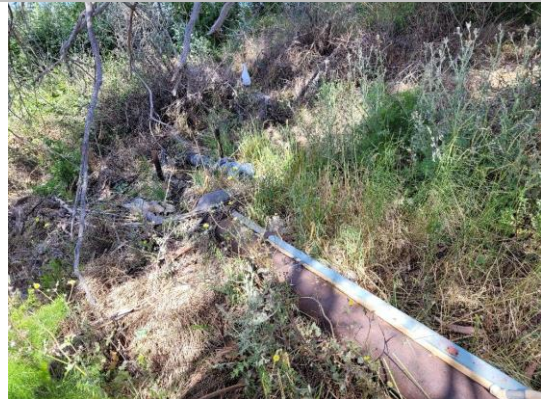
Photo 2 of 3 : UCIP\_SP\_2023\_75591\_113321.jpg

Water-Side: Pipe, electrical conduit, and pump on levee slope

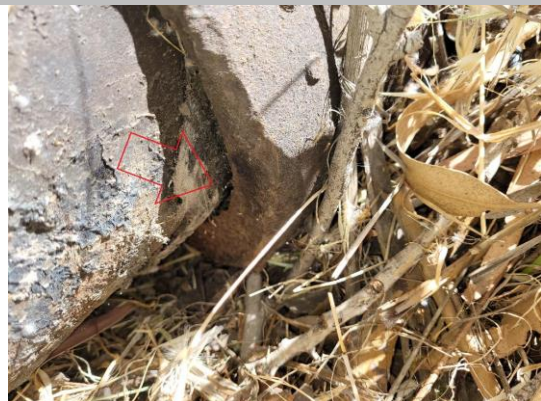
Photo 3 of 3 : UCIP\_SP\_2023\_75591\_113319.jpg

Water-Side: Sealed annular space between pipes visible on levee slope

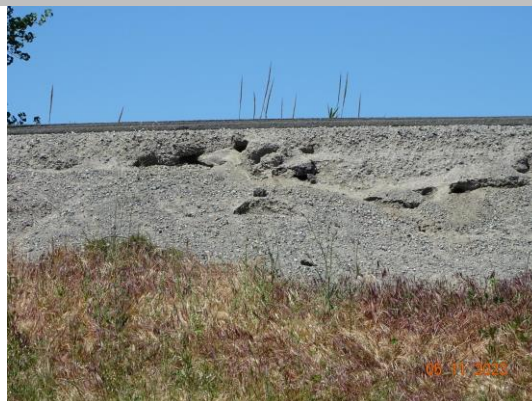
Photo 1 of 2 : SP\_2023\_NA0002\_63\_67\_20230518\_00161.jpg

| Animal holes have been backfilled but there are new holes visible along the LS slope and toe. | | | | | |

View of rodent holes on the upper LS slope (Spring 2023).

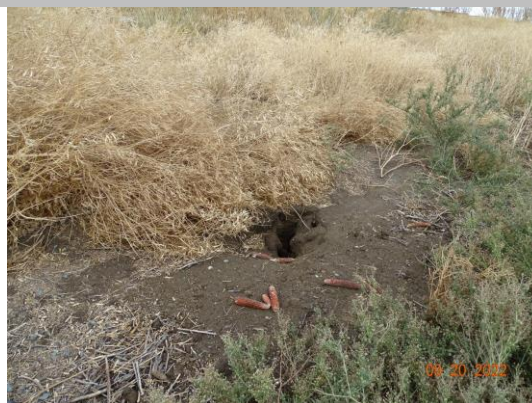
Photo 2 of 2 : SP\_2023\_NA0002\_63\_67\_20230206\_00021.jpg

View of animal hole on the LS slope (Fall 2022).

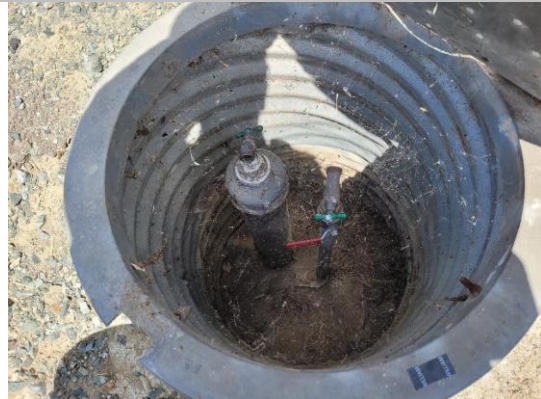
Photo 1 of 3 : UCIP\_SP\_2023\_75625\_113356.jpg

| DS_ID:21931<br>FS_ID:75625<br>EP_NO: 16011<br>Repair Type: Urgent<br>EVAL Issue: 3b, Flood Risk<br>Crossing Status: Found<br>UCIP Comments: 05/10/2022 Record updated from Non-Urgent to Urgent. Annular space between pipes is not grouted that poses flood threat to the landside. Erosion around CMP riser on landside levee shoulder of unknown source. (O.Yakimov - DWR UCIP)<br>05/03/2013 Annular space between pipes should be grouted. IF abandoned, these pipes should be abandoned properly. (W.Wylie - DWR UCIP)<br>FIELD_STRUCT_DESC: 12-inch steel irrigation siphon pipe sleeved through 18-inch corrugated metal conduit pipe through the levee 4.5 feet below the crown. Pipe measures 12 inches at the waterside toe and 14-inch on landside. Siphon breaker and air valve in 24-inch corrugated metal riser unit on the landside (LS) shoulder. 9-foot by 5-foot concrete box with slide gate off LS toe. (Two 14-inch pipes authorized under Permit No. 16011, 1993 - CA Department of Transportation). [Additional Reference(s): DWR Levee Log, 2005 (HLM 9.39), listed as inactive 12-inch pipe sleeved through 18-inch pipe].<br>FS Date: 5/10/2022 2:12:17 PM | | | | | | |

Land-Side: Filler valve and air release valve inside CMP riser

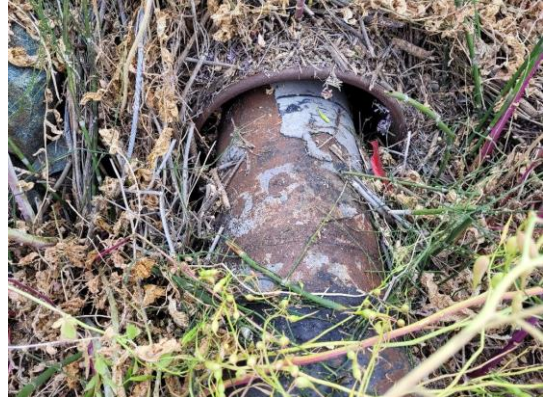
Photo 3 of 3 : UCIP\_SP\_2023\_75625\_113351.jpg

Water-Side: Not grouted annular space between pipes on levee shoulder

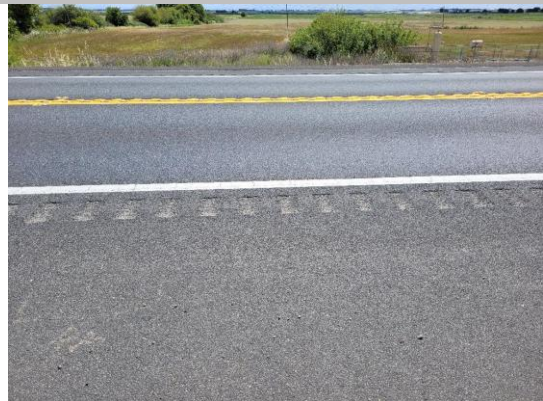
Photo 1 of 3 : UCIP\_SP\_2023\_75626\_113358.jpg

DS\_ID:21932  
FS\_ID:75626  
EP\_NO: N/A  
Repair Type: Non-Urgent  
EVAL Issue:  
Crossing Status: Not Found  
UCIP Comments: 05/10/2022 Record updated from No Action Needed to Non-Urgent. Crossing not found. Geophysical results did not confirm presence of pipe through levee. Record will remain in UCIP's inspection records until future Levee Improvement Project can confirm no crossing was found through the levee. No permit has been identified authorizing pipe. (O.Yakimov - DWR UCIP)

FIELD\_STRUCT\_DESC: 12-inch drainage pipe of an unknown material through the levee, 4 feet below the crown. Open on both ends.  
[Additional Reference(s): DWR Levee Log, 2005 (HLM 9.39). USACE Sacramento O&M Manual, Unit 102, April 1959, Revised 29 December 2016, (RM 10.9), listed as abandoned 12-inch pipe].  
FS Date: 5/10/2022 2:26:15 PM

Top of Levee: View of levee crown looking from waterside

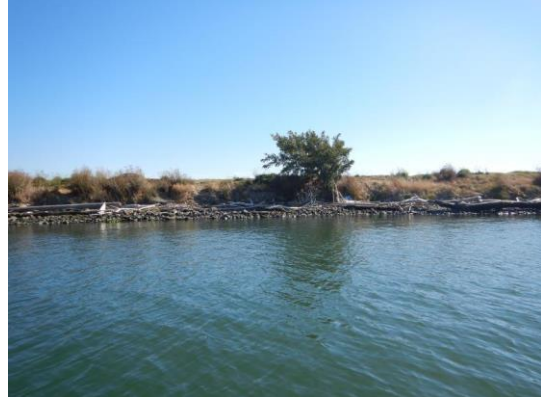
Photo 1 of 2 : SP\_2023\_NA0002\_63\_51\_20230206\_00012.jpg

Site History: 2004 - Wave wash pockets approximately 100 ft long with new full bank rock between the pockets. 2005 - Spot repairs, but toe is still eroding in several places. 2006 - Low vertical bank along roadway. 2007 - A PL 84-99 repair was constructed, it cover the majority of the site with the exception of the upstream 150 to 200 ft and the downstream 250 ft, therefore it is being kept in the inventory. 2009 - Minimal new erosion. 2010 - Outboard berm looks good, but the banks are still very steep. 2011 - While the outboard berm is protecting against wave wash, bank still has slumping issues. 2017 - Lots of new woody debris recruitment.

USACE 2018 Erosion Photo #1

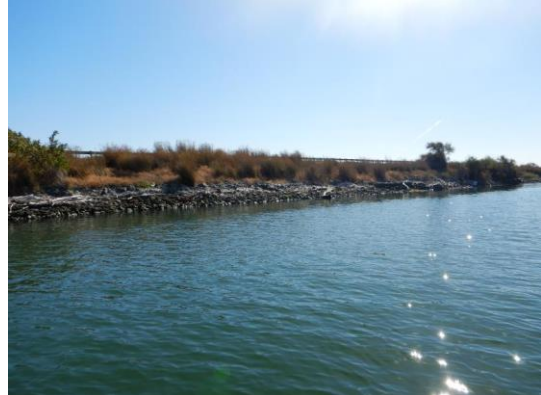
Photo 2 of 2 : SP\_2023\_NA0002\_63\_51\_20230206\_00013.jpg

USACE 2018 Erosion Photo #2

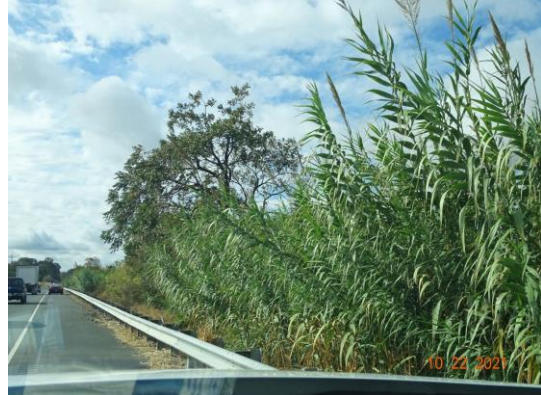
Photo 1 of 1 : SP\_2023\_NA0002\_63\_89\_20230206\_00039.jpg

View looking downstream at arundo on the waterside slope (Fall 2021).

| Trim back arundo. | | | | | |
