Flood Control Project Maintenance  
Levee Inspections  
LMA District Cover Sheet

Brannan Andrus Levee Maintenance District

**Flood Control Project Maintenance  
Levee Inspections  
Unit Cover Sheet**

Waterway			Bank	Unit Miles
Unit No. 01 Georgiana Slough			Right	6.01
	Spring (March - May)	Summer (June - August)	(September - November) Fall	Winter (December - February)
Unit Maintenance Rating (Fall Only)				
Date of Inspection	4/17/2024 - 4/17/2024			
DWR Inspector	Gregg McMillon			
Accompanied By	Emily Pappalardo DCC Engineering

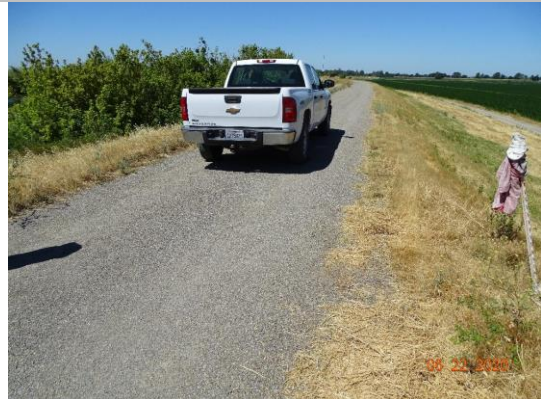
Photo 1 of 3 : UCIP\_SP\_2024\_62290\_89869.jpg

Top of Levee: View of levee crown looking downstream

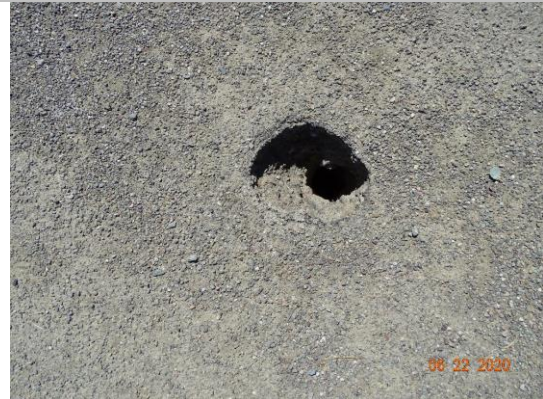
Photo 1 of 3 : UCIP\_SP\_2024\_62296\_89899.jpg

Comment Code					
Inspector Comment					
DS_ID:21753 FS_ID:62296 EP_NO: 11232 Repair Type: Urgent EVAL Issue: 2b, Levee Integrity Crossing Status: Found UCIP Comments: 06/22/2020 Record updated from Non-Urgent to Urgent. Sinkhole in the center of crown measures 8-inch in diameter and 2-feet in depth. Damaged siphon breaker pipe on landside shoulder. Vegetation on waterside limits levee inspection at this crossing. Geophysical study indicates possible presence of pipe through levee. Owner needs to coordinate with the CVFPB to remove or abandon crossing according to Title 23 requirements. No permit has been identified authorizing pipe. Need to have CVFPB review ABO and determine current owner. (O.Yakimov - DWR UCIP) 05/16/2013 Unable to locate any appurtenances other than distribution box. Need to verify proper abandonment. FIELD_STRUCT_DESC: 12-inch steel irrigation pipe through the levee, 3.2 feet below the crown. Siphon breaker on the landside (LS) slope. Concrete distribution box located LS of the toe. 2-inch primer valve. (12-inch pipe [HLM 0.75] authorized under Automatic Board Order (ABO) issued as Permit No. 11232, 1975 - Mario Campi). [Additional Reference(s): DWR Levee Log, 2005 (HLM 0.70). USACE Sacramento O&M Manual, Unit 103, June 1954, Revised 29 December 2016, (Station 'R' 279+70), listed as 12-inch pipe. USACE As-Built Drawing No. 50-04-2631, Sheet 7, Station 279+70, March 1950]. FS Date: 6/22/2020 1:33:36 PM

Top of Levee: View of sinkhole in the center of crown

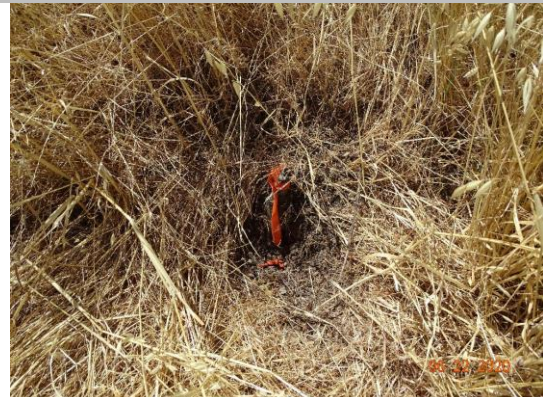
Photo 2 of 3 : UCIP\_SP\_2024\_62296\_89901.jpg

Land-Side: Damaged siphon breaker pipe on levee shoulder

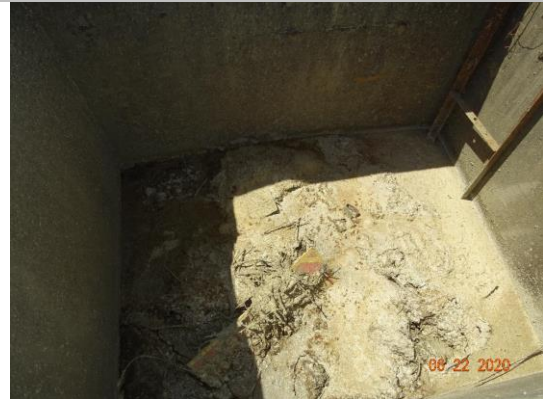
Photo 3 of 3 : UCIP\_SP\_2024\_62296\_89903.jpg

Land-Side: Silt in the bottom of CB is present inside of concrete box. Silt in the bottom of CB is present

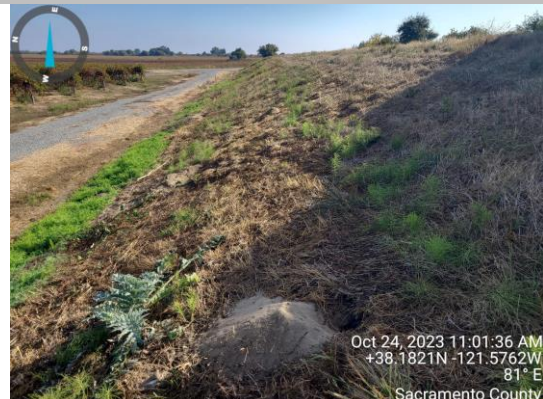
Photo 1 of 1 : SP\_2024\_NA0002\_62\_133\_20240301\_00036.jpg

LM Start	0.81	Rating **	M	Issue No.	133
LM End	0.83	Issue Type +	Ma	Location *	LS
Category	Earthen Levee			GPS Latitude/Longitude	
				Start	End
Item	Animal Control			38.182147°	38.182085°
				-121.575962°	-121.576350°
DWR ID	DWR_NA0002_01_f_2021_133				
Comment Code					
A1 : Exterminate rodents and backfill and compact or grout burrows.					
Inspector Comment					
Rodent holes on the landside slope.

View of rodent holes on the landside slope. Fall 2023.

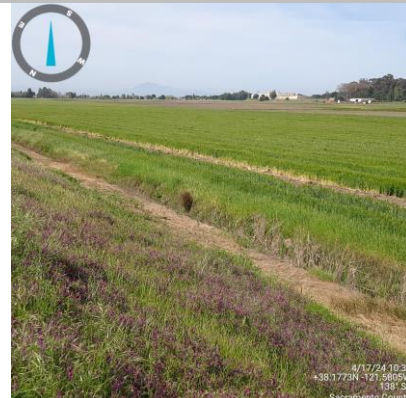
Photo 1 of 1 : SP\_2024\_NA0002\_62\_56\_20240422\_00083.jpg

LM Start	1.22	Rating **	U	Issue No.	56
LM End	2.17	Issue Type +	En	Location *	LS
Category	Earthen Levee			GPS Latitude/Longitude	
				Start	End
Item	Encroachments			38.177635°	38.164597°
				-121.580241°	-121.583921°
DWR ID	DWR_NA0002_01_s_2019_56				
Comment Code					
DT : Ditch					
Inspector Comment					
There is a ditch at the landside toe.

View of overgrown ditch at the LS toe. (Spring 2024)

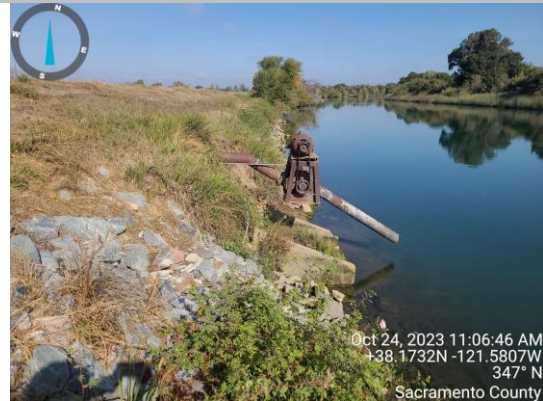
Photo 1 of 3 : SP\_2024\_NA0002\_62\_39\_20240301\_00010.jpg

LM Start	1.53	Rating **	M	Issue No.	39
LM End	1.54	Issue Type +	Ma	Location *	WS
Category	Supplemental			GPS Latitude/Longitude	
				Start	End
Item	2018 USACE Erosion Survey			38.173410°	38.173178°
				-121.580683°	-121.580622°
DWR ID	DWR_NA0002_01_s_2022_39				
Comment Code					
Inspector Comment					
2018 Site ID: GEO 5.5 R					
Status: Eroding					
2018 Field Notes: Site extended downstream.					
Site History: 2017 - Failed rock section, slump failure of bank to subvertical face.

View of erosion on the waterside slope. Fall 2023.

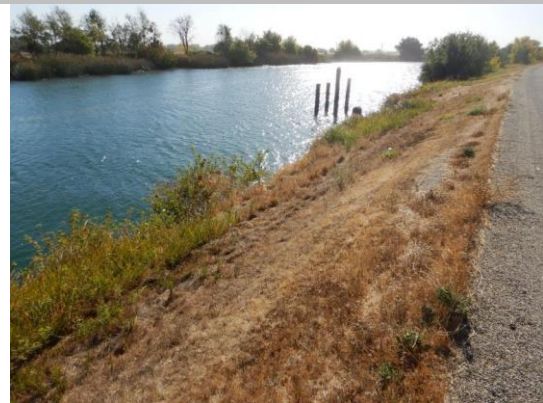
Photo 2 of 3 : SP\_2024\_NA0002\_62\_39\_20240301\_00011.jpg

USACE 2018 Erosion Photo #1

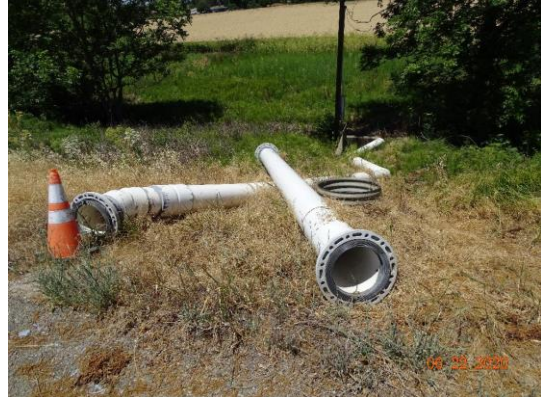
Photo 2 of 3 : UCIP\_SP\_2024\_62304\_89931.jpg

Comment Code					
Inspector Comment					
DS_ID:21758 FS_ID:62304 EP_NO: 11252 Repair Type: Non-Urgent EVAL Issue: 10, Unauthorized Modification or Non-Compliant Permit Crossing Status: Found UCIP Comments: 06/22/2020 Record remains Non-Urgent. Old pipe segment is visible inside of concrete box at landside toe. Siphon breaker is still located in CMP riser on landside levee slope. 12-inch PVC pipe is connected to pump at riverbank on one side and discharges to concrete distribution box at landside toe. Pipe is temporarily dismantled on levee crown. Unable to find a permit for modification. Unable to locate a permit to confirm original pipe removal from levee. No permit has been identified authorizing original pipe through the levee. Need to have CVFPB review ABO and determine current owner. (O.Yakimov - DWR UCIP) 04/06/2017 Landowner has installed a temporary pipe and removed old pipe. Photos and update courtesy of DWR Inspector, Richard Willoughby.05/16/2013 Pipe rusted through at inlet to box. Good candidate for video inspection. (G. Wylie - DWR) FIELD_STRUCT_DESC: 12-inch steel pipe through the levee 4.0 feet below the crown. Slant pump on bank. Switch box on berm, conduit through levee. Siphon breaker in 24-inch CMP riser on landward slope. Power pole and electrical panel at landward toe. 7'X10' concrete distribution box on LS toe. (12-inch pipe [HLM 2.17] authorized under Automatic Board Order (ABO) issued as Permit No. 11252, 1975 - Hubert & Palmyra Vandermaele). [Additional Reference(s): DWR Levee Log, 2005 (HLM 2.17). USACE Sacramento O&M Manual, Unit 103, June 1954, Revised 29 December 2016, (Station 'R' 205+46), listed as 12-inch pipe. USACE As-Built Drawing No. 50-04-2631, Sheet 5, Station 205+46, March 1950]. FS Date: 6/22/2020 10:20:04 AM

Land-Side: View of levee slope looking from crown. Dismantled PVC pipe on slope

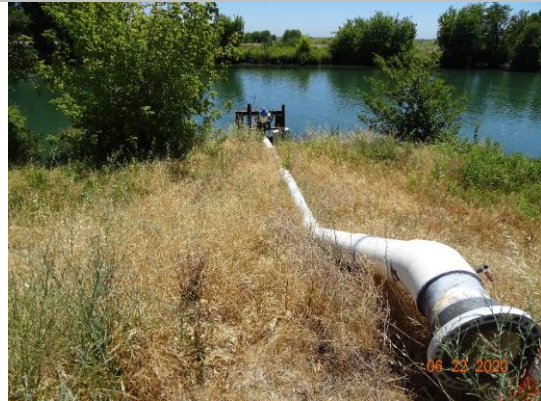
Photo 3 of 3 : UCIP\_SP\_2024\_62304\_89935.jpg

Water-Side: View of levee slope looking from crown

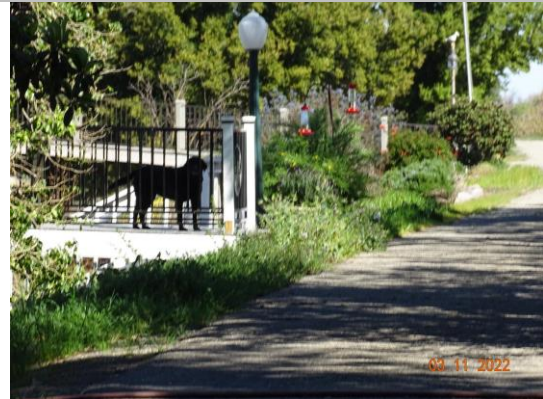
Photo 1 of 1 : SP\_2024\_NA0002\_62\_36\_20240301\_00009.jpg

LM Start	2.29	Rating **	M	Issue No.	36
LM End	2.34	Issue Type +	En	Location *	LS
Category	Earthen Levee			GPS Latitude/Longitude	
				Start	End
Item	Vegetation			38.162918°	38.162322°
				-121.584721°	-121.585081°
DWR ID	DWR_NA0002_01_s_2012_36				
Comment Code					
V6 : Landscaping					
Inspector Comment					
Some of the landscaping has been cleared but more still needs to be removed.

View looking upstream at landscaping on the landside slope (Spring 2022).

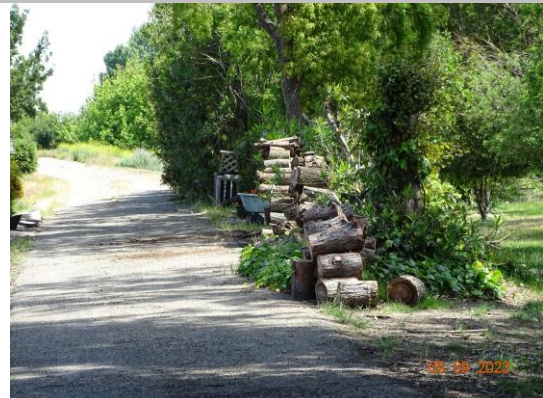
Photo 1 of 1 : SP\_2024\_NA0002\_62\_3\_20240301\_00002.jpg

LM Start	2.30	Rating **	M	Issue No.	3
LM End	2.32	Issue Type +	En	Location *	WS
Category	Earthen Levee			GPS Latitude/Longitude	
				Start	End
Item	Encroachments			38.162773°	38.162544°
				-121.584767°	-121.584909°
DWR ID	DWR_NA0002_01_s_2012_3				
Comment Code					
FW : Firewood					
Inspector Comment					
There is firewood on the waterside shoulder.

View of the firewood on the WS shoulder (Spring 2023).

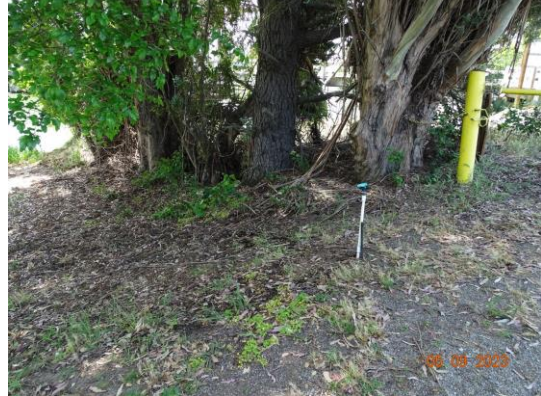
Photo 1 of 1 : SP\_2024\_NA0002\_62\_50\_20240301\_00015.jpg

LM Start	2.33	Rating **	M	Issue No.	50
LM End	2.33	Issue Type +	En	Location *	WS
Category	Earthen Levee			GPS Latitude/Longitude	
				Start	End
Item	Encroachments			38.162343°	38.162343°
				-121.585020°	-121.585020°
DWR ID	DWR_NA0002_01_f _ 2014_50				
Comment Code					
LI : Landscape Irrigation					
Inspector Comment					
Landowner installed sprinklers along waterside slope without permit.

View of the sprinkler emitter on the WS slope (Spring 2023).

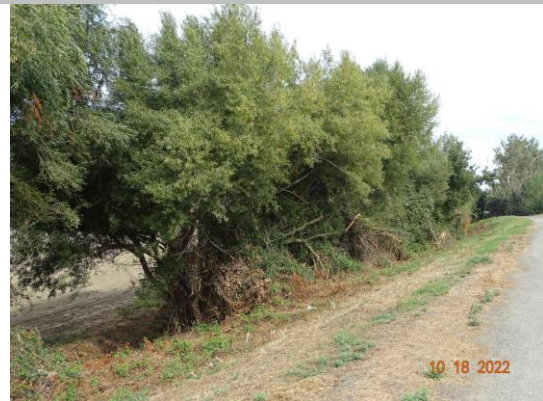
Photo 1 of 1 : SP\_2024\_NA0002\_62\_28\_20240301\_00008.jpg

LM Start	2.41	Rating **	U	Issue No.	28
LM End	2.49	Issue Type +	Ma	Location *	LS
Category	Earthen Levee			GPS Latitude/Longitude	
				Start	End
Item	Vegetation			38.161301°	38.160281°
				-121.585560°	-121.586007°
DWR ID	DWR_NA0002_01_s_2013_28				
Comment Code					
V2 : Remove the wild growth and woody vegetation other than native grasses from the levee slopes.					
Inspector Comment					
The wild roses have been removed but some dense vegetation on the toe remains.

View of the vegetation on the LS toe (Fall 2022).

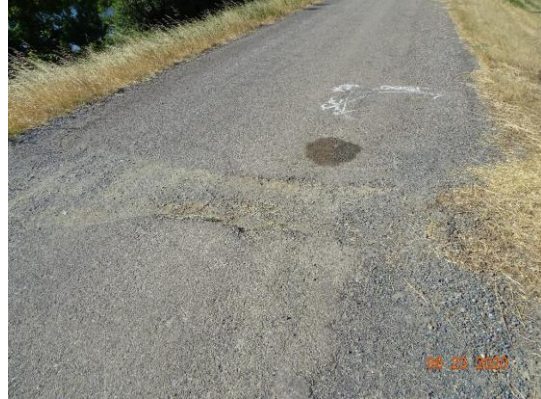
Photo 1 of 3 : UCIP\_SP\_2024\_62316\_89986.jpg

Comment Code					
Inspector Comment					
DS_ID:21765 FS_ID:62316 EP_NO: 11238 Repair Type: Non-Urgent EVAL Issue: 6, Levee Damage or Threat for Levee Damage Crossing Status: Found UCIP Comments: 06/23/2020 Record updated from Urgent to Non-Urgent. Visible cut in levee crown is due to emergency replacement of pipe section through levee crown in 2009. Erosion at riverbank within 10 feet from waterside levee toe is still present, but didn't grow in size. Dense vegetation on waterside limits inspection of levee at the crossing. No permit has been identified authorizing original pipe through the levee. Need to have CVFPB review ABO and determine current owner. (O.Yakimov - DWR UCIP) 07/12/2018 Dense vegetation on both levee slopes. Unable to evaluate erosion on WS. Depression along pipe alignment on levee crown. Recommend internal inspection to determine pipe integrity through levee. (O.Yakimov-DWR UCIP)10/24/2016 Unable to access WS due to heavy vegetation--assume WS remains the same or erosion has progressed but not visible from levee crown. Pipe marker found on LS slope next to 12-inch irrigation pipe indicating high pressure non-odorized natural gas pipeline however, unable to confirm if line is present or if it is parallel to levee or if it goes through levee. (O. Magana - DWR UCIP)05/16/2013 Erosion along pipe at WS toe goes into levee prism. Animal activity appears to be the cause of some pretty heavy erosion damage. Some settlement along the pipe alignment on crown may indicate other problems with this pipe. (W. Wylie - DWR UCIP) FIELD_STRUCT_DESC: 12-inch irrigation steel pipe through levee 4 feet below crown. Siphon breaker is located on landside (LS) shoulder. A 7-foot by 9-foot concrete distribution box is located on LS toe. (12-inch pipe [HLM 2.60] authorized under Automatic Board Order (ABO) issued as Permit No. 11238, 1975 - Gardiner Improvement Company). (Emergency replacement of 12-inch deteriorated section of pipe through levee crown was authorized under Permit 18549, 2010 - Stockton JACS LLC, and completed 07/17/2009). Pipe section was replaced with in-kind sized pipe raised within levee crown while maintaining minimum of 2-feet cover. [Additional Reference(s): DWR Levee Log, 2005 (HLM 2.55). USACE Sacramento O&M Manual, Unit 103, June 1954, Revised 29 December 2016, (Station 'R' 182+63), listed as 12-inch pipe. USACE As-Built Drawing No. 50-04-2631, Sheet 4, Station 182+63, March 1950]. FS Date: 6/23/2020 10:57:12 AM

Top of Levee: View of levee crown looking downstream

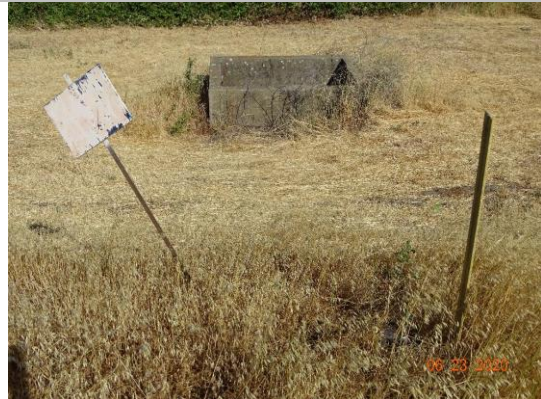
Photo 2 of 3 : UCIP\_SP\_2024\_62316\_89987.jpg

Land-Side: View of levee slope looking from crown

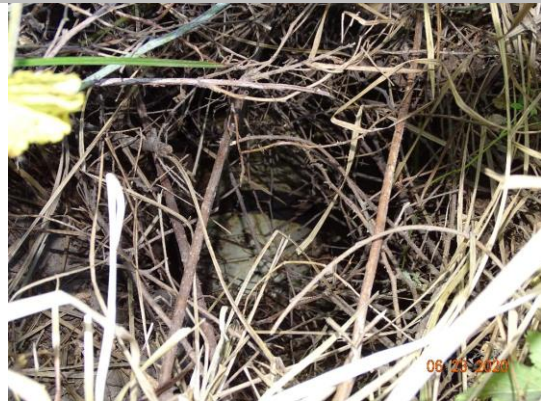
Photo 3 of 3 : UCIP\_SP\_2024\_62316\_89992.jpg

Water-Side: Pipe visible under shrubs near levee toe. Erosion around pipe is present

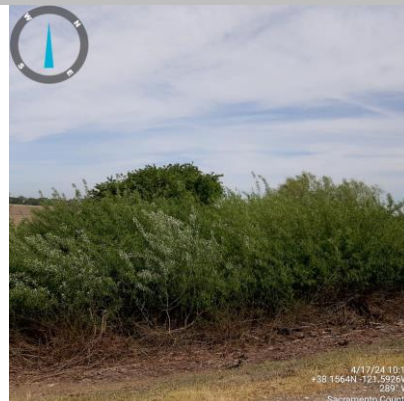
Photo 1 of 1 : SP\_2024\_NA0002\_62\_44\_20240422\_00084.jpg

LM Start	2.99	Rating **	U	Issue No.	44
LM End	3.01	Issue Type +	Ma	Location *	LS
Category	Earthen Levee			GPS Latitude/Longitude	
				Start	End
Item	Vegetation			38.156668 °	38.156361 °
				-121.592395 °	-121.592515 °
DWR ID	DWR_NA0002_01_s_2024_44				
Comment Code					
V2 : Remove the wild growth and woody vegetation other than native grasses from the levee slopes.					
Inspector Comment					
Trim or remove tall bushes on LS shoulder.

View of excessive growth on LS shoulder. (Spring 2024)

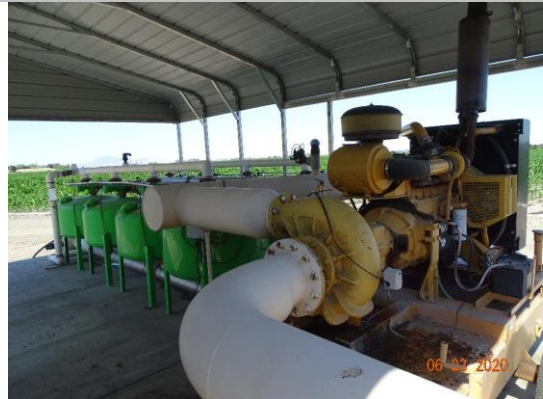
Photo 3 of 3 : UCIP\_SP\_2024\_62317\_89993.jpg

Land-Side: Diesel pump and media filtering facility off levee toe

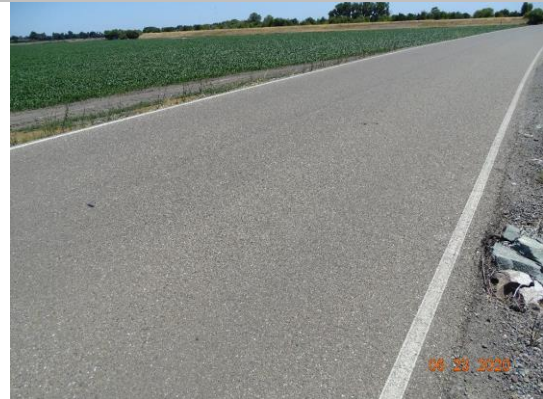
Photo 1 of 3 : UCIP\_SP\_2024\_62325\_90029.jpg

Comment Code					
Inspector Comment					
DS_ID:21771 FS_ID:62325 EP_NO: 11238 Repair Type: Non-Urgent EVAL Issue: 4b, Safety Issue Crossing Status: Found UCIP Comments: 06/23/2020 Record updated from No Action Needed to Non-Urgent. HDPE riser on landside shoulder needs a permanent cover for avoid fall hazard. No permit has been identified authorizing pipe. Need to have CVFPB review ABO and determine current owner. (O.Yakimov - DWR UCIP) FIELD_STRUCT_DESC: 8-inch steel irrigation pipe through the levee, 3.7 feet below the crown. Siphon breaker in 16-inch high-density polyethylene riser unit on the landside (LS) shoulder. 36-inch diameter concrete standpipe located LS of toe. (8-inch pipe [HLM 3.60] authorized under Automatic Board Order (ABO) issued as Permit No. 11238, 1975 - Gardiner Improvement Company). [Additional Reference(s): DWR Levee Log, 2005 (HLM 3.58). USACE Sacramento O&M Manual, Unit 103, June 1954, Revised 29 December 2016, (Station 'R' 127+98), listed as 8-inch pipe. USACE As-Built Drawing No. 50-04-2631, Sheet 2, Station 127+98, March 1950]. FS Date: 6/23/2020 4:38:39 PM

Top of Levee: View of levee crown looking upstream

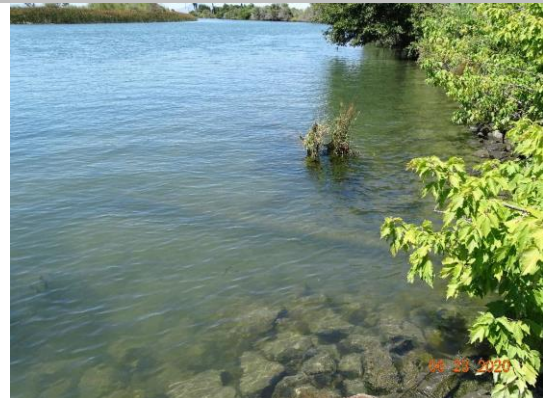
Photo 2 of 3 : UCIP\_SP\_2024\_62325\_90022.jpg

Water-Side: Pipe under water in the stream

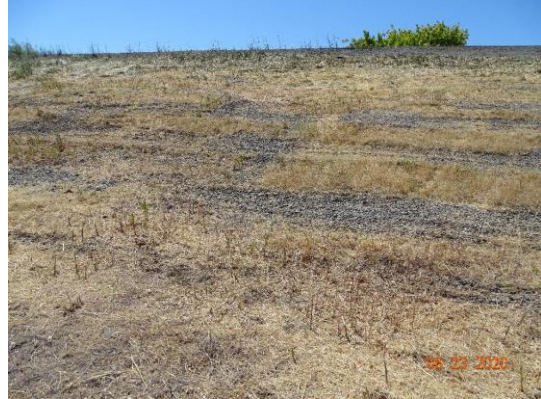
Photo 3 of 3 : UCIP\_SP\_2024\_62325\_90025.jpg

Land-Side: View of levee slope looking from toe

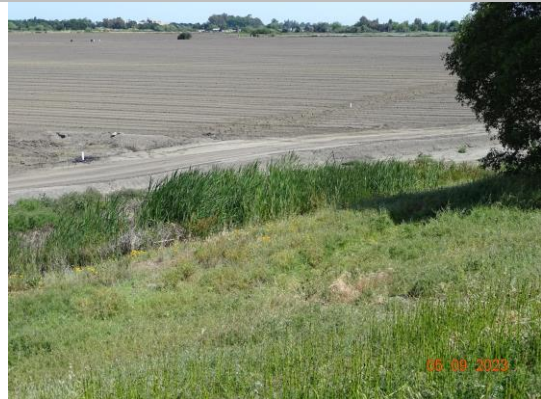
Photo 1 of 1 : SP\_2024\_NA0002\_62\_1\_20240301\_00001.jpg

LM Start	3.64	Rating **	A/W	Issue No.	1
LM End	3.64	Issue Type +	Ob	Location *	LS
Category	Earthen Levee			GPS Latitude/Longitude	
				Start	End
Item	Seepage / Sandboils			38.151786°	38.151786°
				-121.596843°	-121.596843°
DWR ID	DWR_NA0002_01_s_2020_1				
Comment Code					
SS : Seepage / Sandboils					
Inspector Comment					
45' wide continuous wet spot at the landside toe. There is a ditch next to the spot but it does not look like it is the source of the moisture.

View of the seepage site on the LS toe (Spring 2023).

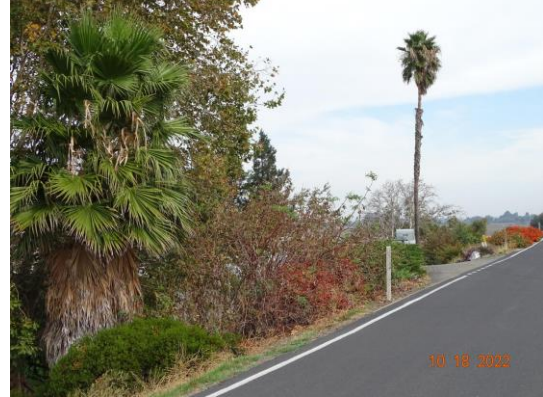
Photo 1 of 1 : SP\_2024\_NA0002\_62\_11\_20240301\_00004.jpg

LM Start	3.93	Rating **	U	Issue No.	11
LM End	3.97	Issue Type +	En	Location *	LS
Category	Earthen Levee			GPS Latitude/Longitude	
				Start	End
Item	Vegetation			38.148318°	38.147923°
				-121.599947°	-121.600245°
DWR ID	DWR_NA0002_01_s_2012_11				
Comment Code					
V6 : Landscaping					
Inspector Comment

View of the landscaping on the LS slope (Fall 2022).

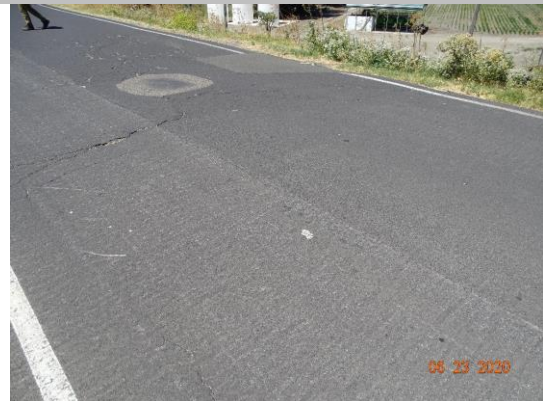
Photo 1 of 3 : UCIP\_SP\_2024\_62327\_90037.jpg

Comment Code						
Inspector Comment						
DS_ID:21772 FS_ID:62327 EP_NO: 11248 Repair Type: Non-Urgent EVAL Issue: 10, Unauthorized Modification or Non-Compliant Permit Crossing Status: Found UCIP Comments: 06/23/2020 Record updated from No Action Needed to Non-Urgent. 20-inch steel drainage pipe sleeved through 24-inch steel pipe. Annular space between pipes seems to be grouted. Unable to find a permit for modification. Asphalt repair patches on levee crown. No permit has been identified authorizing pipe. Need to have CVFPB review ABO and determine current owner. (O.Yakimov - DWR UCIP) FIELD_STRUCT_DESC: 20-inch steel drainage pipe sleeved through 24-inch steel pipe through the levee, 3 feet below the crown. Siphon breaker is located on the waterside (WS) slope. Pump is located on the landside (LS). (24-inch pipe [HLM 3.99] authorized under Automatic Board Order (ABO) issued as Permit No. 11248, 1975 - Reclamation District No.407). [Additional Reference(s): DWR Levee Log, 2005 (HLM 3.99), listed as 24-inch pipe. USACE Sacramento O&M Manual, Unit 103, June 1954, Revised 29 December 2016, (Station 'R' 107+76), listed as 26-inch pipe. USACE As-Built Drawing No. 50-04-2631, Sheet 2, Station 107+76, March 1950, listed as 26-inch pipe]. FS Date: 6/23/2020 9:27:29 AM

Top of Levee: View of levee crown looking downstream

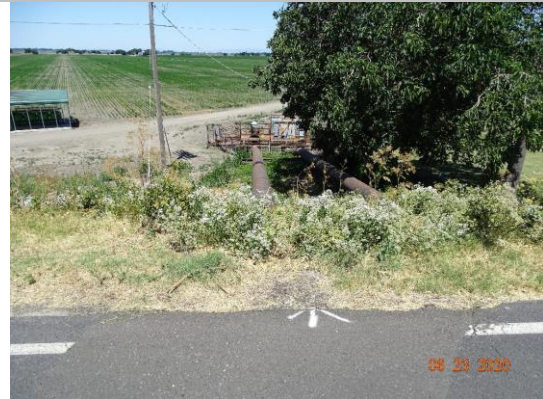
Photo 2 of 3 : UCIP\_SP\_2024\_62330\_90047.jpg

Comment Code					
Inspector Comment					
DS_ID:21773 FS_ID:62330 EP_NO: 5534 Repair Type: Urgent EVAL Issue: 1, Pipe Integrity Crossing Status: Found UCIP Comments: 06/23/2020 Record remains Urgent. Erosion site on landside shoulder has been repaired, but pipe integrity may still be compromised. Asphalt repair patches in levee crown pavement along pipe alignment. Recommend owner to perform pipe integrity test. Overgrown vegetation on landside slope limits inspection of levee at this crossing. (O.Yakimov - DWR UCIP) 07/12/2018 Levee crown on LS shoulder was repaved with asphalt. Dense vegetation limits visibility on LS levee slope and ability to evaluate erosion on LS. Crossing remains "Urgent". (O.Yakimov-DWR)10/24/2016 Internal erosion visible on LS where pipe daylights. LS road shoulder appears to be failing. Large sink hole patched and is visible on road/crown. Evidence of burrow activity that appear to be about 6-inches in diameter with depths greater than 3 feet. Burrow holes are located on LS hinge point just upstream of pipe and 3 holes visible on WS. Need to contact owner to address issue and recommend to stop use of crossing to avoid further damage to levee. (O. Magana - DWR UCIP)05/16/2013 Pot holes over pipe may indicate internal failure. Good candidate for video inspection. (W. Wylie - DWR UCIP) FIELD_STRUCT_DESC: 22-inch steel drainage pipe through the levee, 3 feet below the crown. Siphon breaker located on the waterside (WS) shoulder. Pump located on the landside (LS). This crossing replaces 24-inch pipe (see DSID 25663). (24-inch pipe authorized under Permit No. 5534, 1966 - Reclamation District No.407). [Additional Reference(s): DWR Levee Log, 2005 (HLM 3.99), listed as 24-inch pipe]. FS Date: 6/23/2020 10:47:15 AM

LM Start	3.99	Rating **	U	Issue No.	144 (cont)	
LM End	3.99	Issue Type +	En	Location *		
Category	Supplemental			GPS Latitude/Longitude		
				Start	End	
Item	DWR UCIP Field Study			38.147657°	38.147657°	
				-121.600521°	-121.600521°	
DWR ID	21773

Land-Side: View of levee slope looking from crown

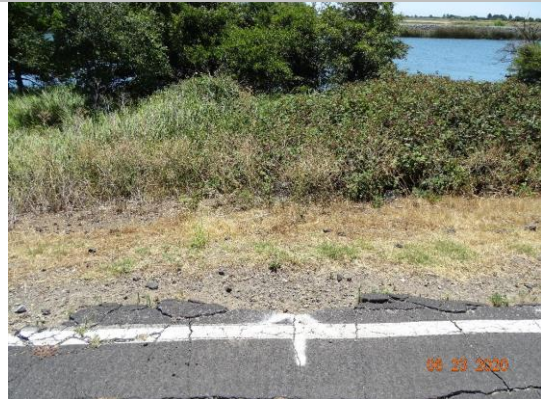
Photo 2 of 3 : UCIP\_SP\_2024\_62331\_90051.jpg

DS\_ID:21774  
FS\_ID:62331  
EP\_NO: 11238  
Repair Type: Non-Urgent  
EVAL Issue: 10, Unauthorized Modification or Non-Compliant Permit  
Crossing Status: Found  
UCIP Comments: 06/23/2020 Record remains Non-Urgent. Scour hole around air release pipe on waterside shoulder has been repaired, pipe is capped. Flanged coupler installed on pipe on landside levee shoulder and a new pipe put on landside levee slope to pumping plant bypassing concrete standpipe. Concrete standpipe with slide gate is abandoned. Diesel pump and media filtering facility installed on landside off levee toe. Unable to find a permit for modification. No permit has been identified authorizing pipe. Need to have CVFPB review ABO and determine current owner. (O.Yakimov - DWR UCIP)  
10/24/2016 Unable to determine if WS primer pipe is leaking or if settling is occurring at pipe. Need to contact owner to determine when upgrades to WS were completed. (O. Magana - DWR UCIP)

LM Start	<b>4.01</b>	Rating **	M	Issue No.	<b>145 (cont)</b>
LM End	<b>4.01</b>	Issue Type +	En	Location *	
Category	Supplemental			GPS Latitude/Longitude	
				Start	End
Item	DWR UCIP Field Study			38.147459°	38.147459°
				-121.600681°	-121.600681°
DWR ID	21774

Water-Side: View of levee slope looking from crown

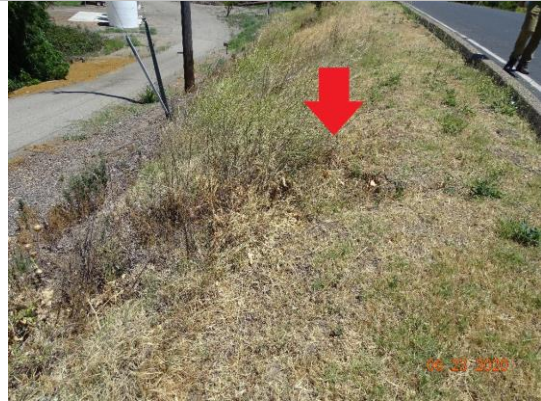
Photo 2 of 3 : UCIP\_SP\_2024\_62333\_90063.jpg

DS\_ID:21775  
FS\_ID:62333  
EP\_NO: 11238  
Repair Type: Urgent  
EVAL Issue: 2b, Levee Integrity  
Crossing Status: Found  
UCIP Comments: 06/23/2020 Record remains Urgent. Levee slope subsidence in pipe alignment on landside is more than 2-feet-deep. Sinkhole on waterside shoulder at public road pavement keeps growing and measures 3' x 2' x 0.75' deep. Missing cover on the top of vault at landside toe creates fall hazard. No permit has been identified authorizing pipe. Need to have CVFPB review ABO and determine current owner. (O.Yakimov - DWR UCIP)  
07/12/2018 Hole on LS shoulder under concrete blocks is still present, although haven't increased in size. Part of cover on concrete sump is still missing which is public safety issue. Crossing remain "Urgent" because of potential pipe failure signs. Recommend internal inspection to determine condition of pipe through levee. (DWR-O.Yakimov)  
12/30/2016 Left message with Ms. Cabral to inform her that we are working with LMA to find additional information about crossing. Spoke with Andy Giannini, LMA representative, regarding the UCIP report and Mr. Giannini believes the hole is due to ground squirrel activity. According to Mr. Giannini, the issue with ground squirrel has been resolved and the hole filled. Records indicate pipe was installed in the 1950s and authorized under Permit No. 11238 in 1975. This pipe could be about 62 years old. Crossing remains Urgent due to the uncertainty of pipe integrity through levee. Recommend having owner complete an internal inspection of the pipe through the levee to determine integrity of pipe. (O. Magana - DWR UCIP)12/28/2016 Contacted Andy Giannini, LMA representative, and provided him with UCIP report to review. (O. Magana - DWR UCIP)12/27/2016 Contacted Rebecca Cabral, property sales agent from Century 21 Farm & Ranch M&M and Associates, at 1-707-374-3900 to inquire about the property owner for this area. Mrs. Cabral was unaware of pipe through levee and has requested photos to share with client. She was not able to provide me with the current property owner information but mentioned that she will contact me next week (week ending Jan 6, 2017). (O. Magana - DWR UCIP)10/24/2016 Section of cover is still missing. Potential pipe failure through levee. Sink hole is present on LS shoulder. Need to contact owner to stop use of pipe to avoid further damage to levee. Recommend internal inspection of pipe to determine integrity of pipe wall. (O. Magana - DWR UCIP)05/08/2013 Missing cover on concrete sump is an immediate hazard and should be repaired. (W. Wylie - DWR UCIP)

Land-Side: Subsidence on levee slope

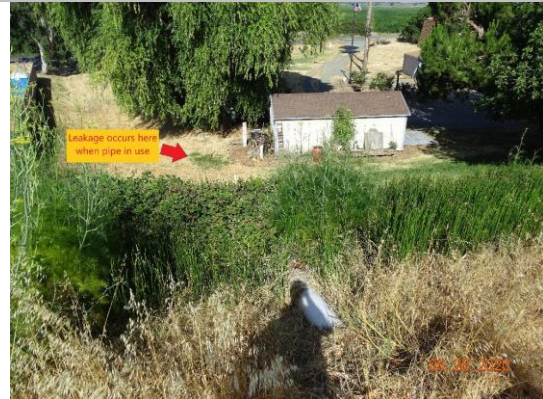
Photo 1 of 3 : UCIP\_SP\_2024\_62338\_90089.jpg

Comment Code					
Inspector Comment					
DS_ID:21813 FS_ID:62338 EP_NO: 16762 Repair Type: Urgent EVAL Issue: 1, Pipe Integrity Crossing Status: Found UCIP Comments: 06/26/2020 Record updated from No Action Needed to Urgent. Local landowner informed that leakage on landside occurs when pipe is running. Excess vegetation in pipe alignment is visible at the approximate leakage spot. Recommend pipe owner to perform pipe integrity test. (O.Yakimov - DWR UCIP) FIELD_STRUCT_DESC: 10-inch steel irrigation pipe through the levee, 2 feet below the crown. Siphon breaker on the landside (LS) shoulder. Shutoff valve at the LS toe. This crossing replaces 10-inch pipe (see DSID 21779). (12-inch pipe authorized under Permit No. 16762, 1997 - Brannan Andrus Levee Maintenance District). [Additional Reference(s): DWR Levee Log, 2005 (HLM 4.21). USACE Sacramento O&M Manual, Unit 103, June 1954, Revised 29 December 2016, (Station 'R' 95+61), listed as 8-inch pipe. USACE As-Built Drawing No. 50-04-2672, Sheet 5, Station 95+61, 25 January 1951, listed as 8-inch pipe]. FS Date: 6/26/2020 1:25:20 PM

LM Start	4.22	Rating **	U	Issue No.	147 (cont)
LM End	4.22	Issue Type +	En	Location *

Land-Side: View of levee slope looking from crown

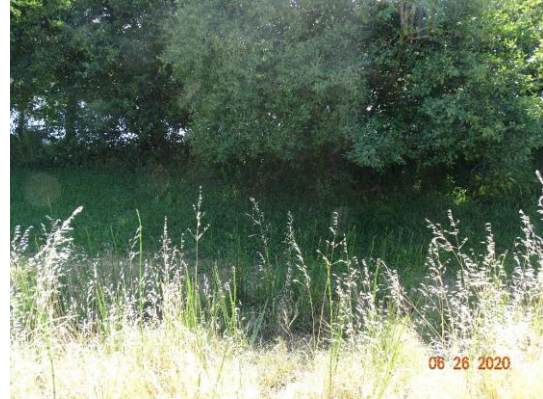
Photo 3 of 3 : UCIP\_SP\_2024\_62338\_90088.jpg

LM Start	<b>4.22</b>	Rating **	U	Issue No.	<b>147 (cont)</b>
LM End	<b>4.22</b>	Issue Type +	En	Location *	
Category	Supplemental		GPS Latitude/Longitude		
			Start	End	
Item	DWR UCIP Field Study		38.144579°	38.144579°	
			-121.601412°	-121.601412°	
DWR ID	21813

Water-Side: View of levee slope looking from crown

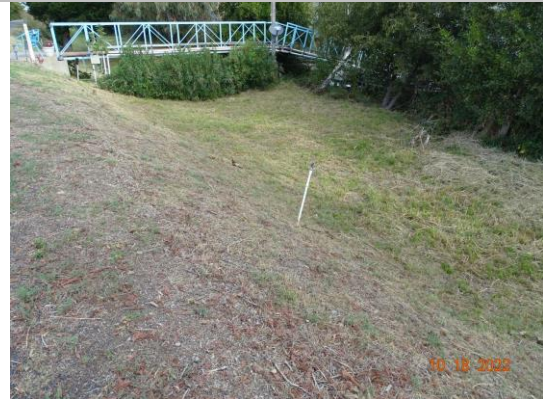
Photo 1 of 1 : SP\_2024\_NA0002\_62\_20\_20240301\_00005.jpg

LM Start	4.23	Rating **	A/W	Issue No.	20
LM End	4.29	Issue Type +	En	Location *	WS
Category	Earthen Levee			GPS Latitude/Longitude	
				Start	End
Item	Encroachments			38.144471 °	38.143652 °
				-121.601381 °	-121.600877 °
DWR ID	DWR_NA0002_01_f _ 2019_20				
Comment Code					
LI : Landscape Irrigation					
Inspector Comment					
The sprinkler system seems inactive and the slope is overgrown.

View of the sprinkler system on the WS slope (Fall 2022).

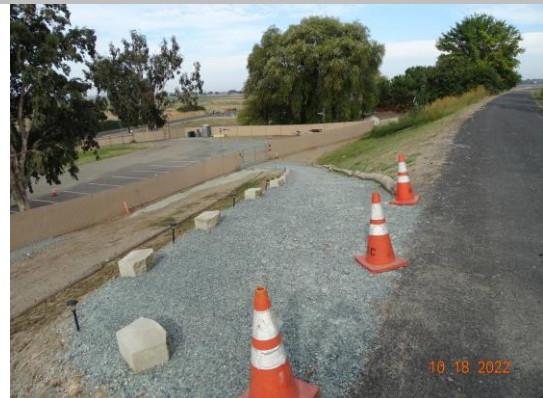
Photo 1 of 1 : SP\_2024\_NA0002\_62\_110\_20240301\_00031.jpg

LM Start	4.26	Rating **	M	Issue No.	110
LM End	4.26	Issue Type +	En	Location *	LS
Category	Earthen Levee			GPS Latitude/Longitude	
				Start	End
Item	Encroachments			38.144074°	38.144074°
				-121.601157°	-121.601157°
DWR ID	DWR_NA0002_01_f_2022_110				
Comment Code					
RA : Ramp					
Inspector Comment					
A constructed ramp on the LS seems to have no permit.

View of the ramp going down the LS slope (Fall 2022).

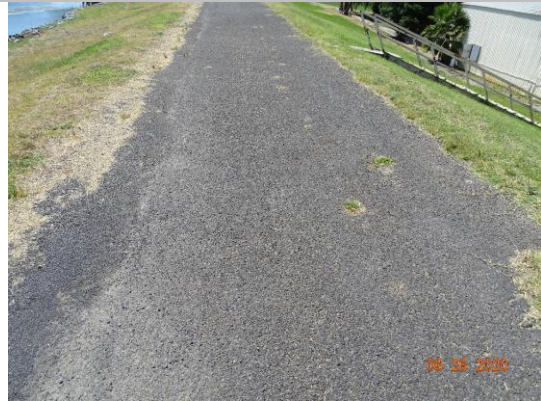
Photo 1 of 3 : UCIP\_SP\_2024\_83482\_90150.jpg

Comment Code					
Inspector Comment					
DS_ID:21780 FS_ID:83482 EP_NO: 11237 Repair Type: Urgent EVAL Issue: 2a, Levee Integrity Crossing Status: Found UCIP Comments: 05/06/2024 Pipe updated from Non-Urgent to Urgent. The landowner has installed a pipe on the levee slopes & crown and laid down a fair amount of gravel to raise the levee crown so you can drive over the pipe crossing. Other than the pipe penetration at the LS toe, it did not appear that the levee slopes/crown had been excavated to connect to the existing underground pipe. The district is working to have the pipe removed entirely. Status of pipe was brought to UCIP's attention By Gregg McMillon levee inspector from his 04/17/2024 inspection. (J. Taylor - DWR UCIP)06/26/2020 Record updated from No Action Needed to Non-Urgent. 42-inch concrete standpipe at landside levee toe has been removed. Unable to find a permit for modification. Crossing appears abandoned. No permit has been identified authorizing pipe. Need to have CVFPB review ABO and determine current owner. High water table at landside toe: water sits at approximately 1/2 feet under land surface. (O.Yakimov - DWR UCIP) FIELD_STRUCT_DESC: 12-inch steel irrigation pipe through the levee, 4 feet below the crown. Siphon breaker on the landside (LS) shoulder. 42-inch diameter concrete standpipe on the LS toe. (12-inch pipe [HLM 4.45] authorized under Automatic Board Order (ABO) issued as Permit No. 11237, 1975 - Bruna Galli). [Additional Reference(s): DWR Levee Log, 2005 (HLM 4.45). USACE Sacramento O&M Manual, Unit 103, June 1954, Revised 29 December 2016, (Station 'R' 83+60), listed as 12-inch pipe. USACE As-Built Drawing No. 50-04-2672, Sheet 5, Station 83+60, 25 January 1951]. FS Date: 5/6/2024 7:44:56 AM

Top of Levee: View of levee crown looking downstream

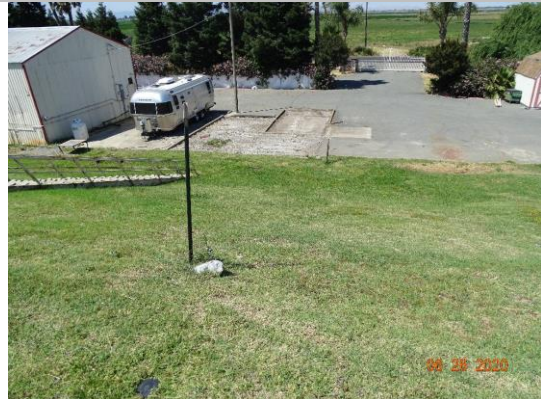
Photo 2 of 3 : UCIP\_SP\_2024\_83482\_90151.jpg

LM Start	<b>4.45</b>	Rating **	U	Issue No.	<b>148 (cont)</b>
LM End	<b>4.45</b>	Issue Type +	En	Location *	
Category	Supplemental			GPS Latitude/Longitude	
				Start	End
Item	DWR UCIP Field Study			38.141719°	38.141719°
				-121.599223°	-121.599223°
DWR ID	21780

Land-Side: View of levee slope looking from crown

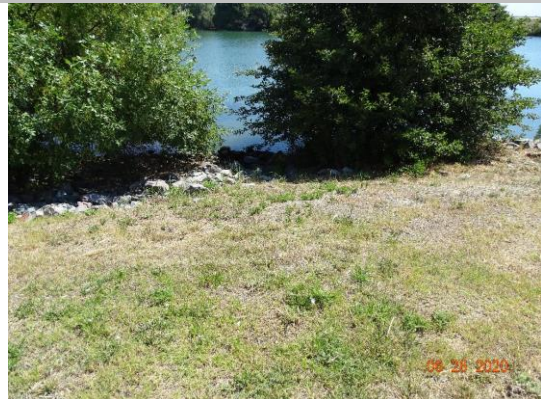
Photo 3 of 3 : UCIP\_SP\_2024\_83482\_90154.jpg

LM Start	<b>4.45</b>	Rating **	U	Issue No.	<b>148 (cont)</b>
LM End	<b>4.45</b>	Issue Type +	En	Location *

Water-Side: View of levee slope looking from crown

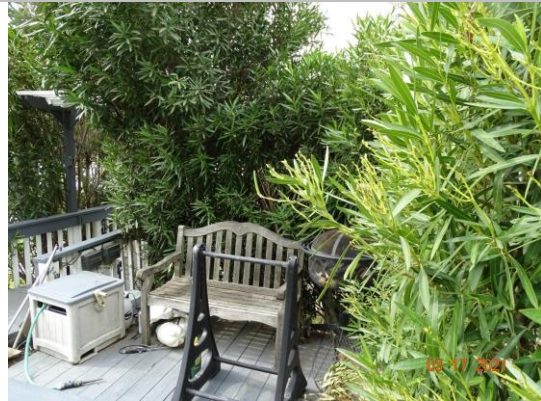
Photo 1 of 1 : SP\_2024\_NA0002\_62\_131\_20240301\_00035.jpg

LM Start	4.65	Rating **	M	Issue No.	131
LM End	4.65	Issue Type +	En	Location *	LS
Category	Earthen Levee			GPS Latitude/Longitude	
				Start	End
Item	Vegetation			38.139167°	38.139167°
				-121.597561°	-121.597561°
DWR ID	DWR_NA0002_01_s_2021_131				
Comment Code					
V6 : Landscaping					
Inspector Comment					
Oleanders are blocking the view down the landside slope.

View of oleanders on the landside slope (Spring 2021).

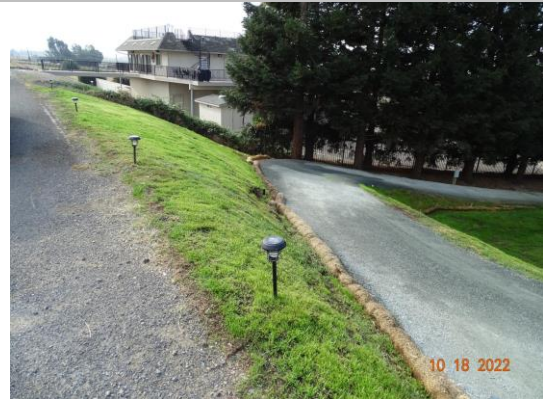
Photo 1 of 1 : SP\_2024\_NA0002\_62\_113\_20240301\_00033.jpg

LM Start	4.78	Rating **	M	Issue No.	113
LM End	4.78	Issue Type +	En	Location *	LS
Category	Earthen Levee			GPS Latitude/Longitude	
				Start	End
Item	Encroachments			38.137451°	38.137451°
				-121.596482°	-121.596482°
DWR ID	DWR_NA0002_01_f_2022_113				
Comment Code					
RA : Ramp					
Inspector Comment					
A ramp on the LS slope does not seem to have a permit.

View of the ramp going down the LS slope (Fall 2022).

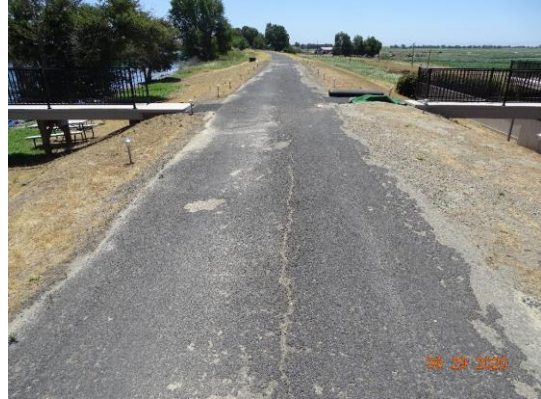
Photo 1 of 3 : UCIP\_SP\_2024\_62371\_90241.jpg

LM Start	4.80	Rating **	M	Issue No.	149
LM End	4.80	Issue Type +	En	Location *	
Category	Supplemental			GPS Latitude/Longitude	
				Start	End
Item	DWR UCIP Field Study			38.137180°	38.137180°
				-121.596268°	-121.596268°
DWR ID	21796				
Comment Code					
Inspector Comment					
DS_ID:21796 FS_ID:62371 EP_NO: 13667 Repair Type: Non-Urgent EVAL Issue: 10, Unauthorized Modification or Non-Compliant Permit Crossing Status: Found UCIP Comments: 06/29/2020 Record updated from No Action Needed to Non-Urgent. Recommend owner to install utility box and conduit to protect electrical cable on waterside. (O.Yakimov - DWR UCIP) FIELD_STRUCT_DESC: 1-inch electrical conduit of an unknown material through the levee, 2 feet below the crown. (Utility line (special condition 23) authorized under Permit No. 13667, 1983 - Ted Amlick). FS Date: 6/29/2020 1:43:47 PM

LM Start	<b>4.80</b>	Rating **	M	Issue No.	<b>149 (cont)</b>
LM End	<b>4.80</b>	Issue Type +	En	Location *

Top of Levee: View of levee crown looking downstream

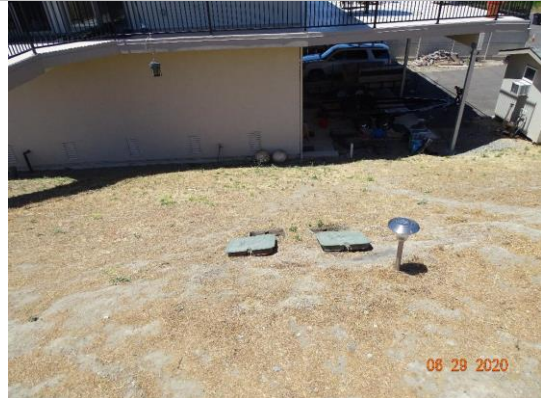
Photo 2 of 3 : UCIP\_SP\_2024\_62371\_90242.jpg

Land-Side: View of levee slope looking from crown

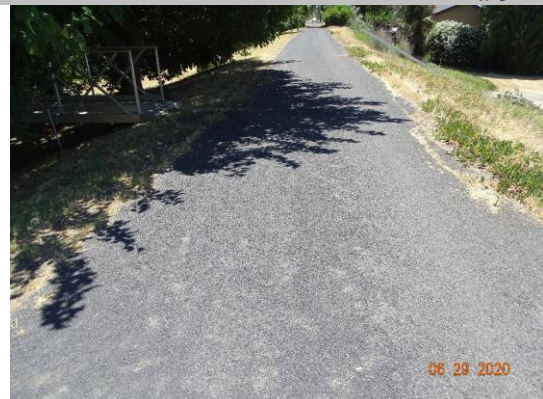
Photo 1 of 3 : UCIP\_SP\_2024\_62374\_90258.jpg

Comment Code					
Inspector Comment					
DS_ID:21841					
FS_ID:62374					
EP_NO: 5420					
Repair Type: Non-Urgent					
EVAL Issue: 10, Unauthorized Modification or Non-Compliant Permit					
Crossing Status: Found					
UCIP Comments: 06/29/2020 Record updated from No Action Needed					
to Non-Urgent. Conduit is open on waterside slope under gangway.					
Recommend owner to cap the end of the conduit. (O.Yakimov - DWR					
UCIP)					
FIELD_STRUCT_DESC: 1-inch galvanized steel electrical conduit					
through the levee, 2 feet below the crown. Visible on walkway at the					
waterside (WS) slope. (Utility conduit authorized under Permit No. 5420,					
1966 - William C. Myer). [Additional Reference(s): DWR Levee Log,					
2005 (HLM 4.98)].					
FS Date: 6/29/2020 3:09:43 PM

Top of Levee: View of levee crown looking downstream

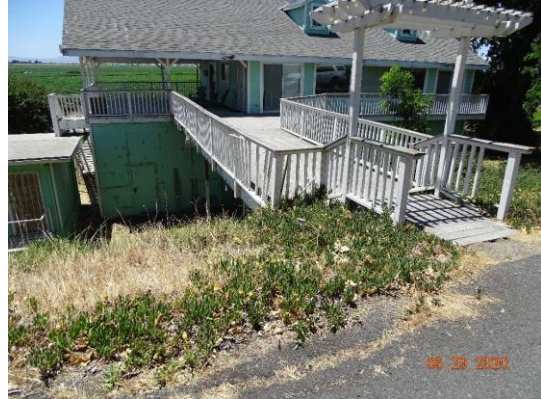
Photo 2 of 3 : UCIP\_SP\_2024\_62374\_90260.jpg

LM Start	4.98	Rating **	M	Issue No.	150 (cont)	
LM End	4.98	Issue Type +	En	Location *		
Category	Supplemental			GPS Latitude/Longitude		
				Start	End	
Item	DWR UCIP Field Study			38.135138°	38.135138°	
				-121.594176°	-121.594176°	
DWR ID	21841

Land-Side: View of levee slope looking from crown

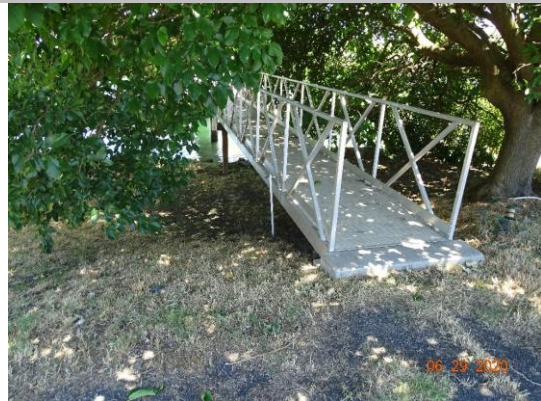
Photo 3 of 3 : UCIP\_SP\_2024\_62374\_90259.jpg

LM Start	<b>4.98</b>	Rating **	M	Issue No.	<b>150 (cont)</b>
LM End	<b>4.98</b>	Issue Type +	En	Location *

Water-Side: View of levee slope looking from crown

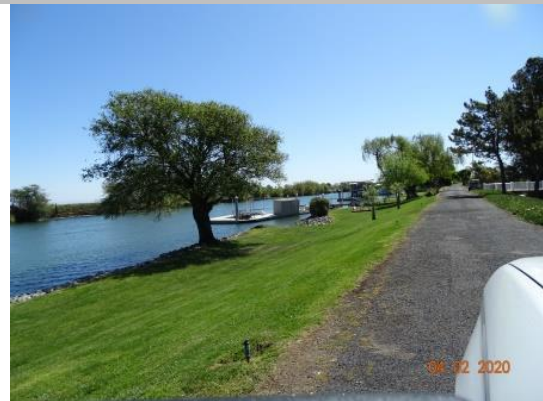
Photo 1 of 1 : SP\_2024\_NA0002\_62\_57\_20240301\_00019.jpg

LM Start	5.07	Rating **	M	Issue No.	57
LM End	5.15	Issue Type +	En	Location *	WS
Category	Earthen Levee			GPS Latitude/Longitude	
				Start	End
Item	Encroachments			38.134238 °	38.133325 °
				-121.593188 °	-121.592032 °
DWR ID	DWR_NA0002_01_s_2020_57				
Comment Code					
LI : Landscape Irrigation					
Inspector Comment					
There are sprinklers on the waterside slope.

View looking downstream at sprinklers on the waterside slope (Spring 2020).

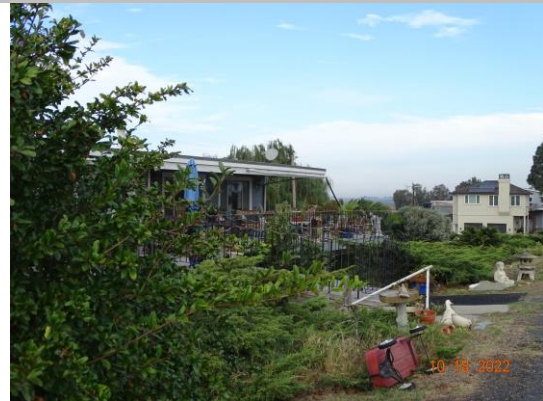
Photo 1 of 1 : SP\_2024\_NA0002\_62\_78\_20240301\_00028.jpg

LM Start	5.22	Rating **	U	Issue No.	78
LM End	5.24	Issue Type +	En	Location *	LS
Category	Earthen Levee			GPS Latitude/Longitude	
				Start	End
Item	Vegetation			38.132606°	38.132322°
				-121.591295°	-121.590989°
DWR ID	DWR_NA0002_01_s_2018_78				
Comment Code					
V6 : Landscaping					
Inspector Comment					
Heavy landscaping completely blocks visibility and access to landside slope and toe.

View of the landscaping on the LS slope (Fall 2022).

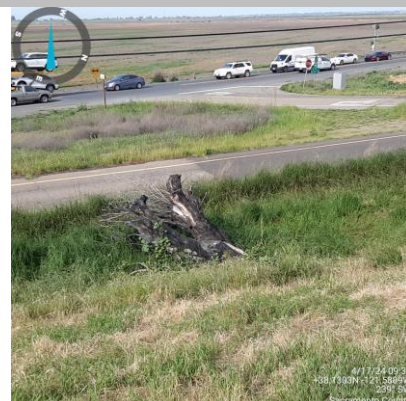
Photo 1 of 1 : SP\_2024\_NA0002\_62\_34\_20240422\_00085.jpg

LM Start	5.42	Rating **	M	Issue No.	34
LM End	5.42	Issue Type +	Ma	Location *	LS
Category	Earthen Levee			GPS Latitude/Longitude	
				Start	End
Item	Trim / Thin Trees			38.130387°	38.130387°
				-121.588962°	-121.588962°
DWR ID	DWR_NA0002_01_s_2024_34				
Comment Code					
T3 : Fallen tree with root ball.					
Inspector Comment					
Fallen, burned up tree on LS slope.

View of fallen tree to be removed from LS slope. (Spring 2024)

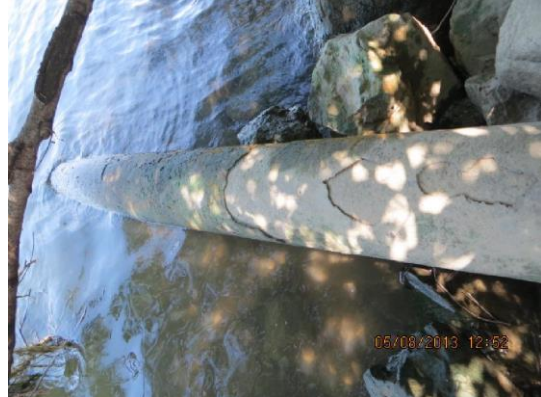
Photo 1 of 3 : UCIP\_SP\_2024\_62394\_21275.jpg

UCIP Comments: 07/01/2020 Record updated from No Action Needed to Urgent. Soil depression on landside slope from concrete standpipe up the slope measures 13' x 3' x 1'-deep. Overgrown vegetation on waterside limits inspection of levee at this crossing. Crossing appears abandoned. Slide gate inside of concrete standpipe not in operable condition. 1-1/2 hose connected to siphon breaker / filler pipe on landside shoulder. No permit has been identified authorizing pipe. Need to have CVFPB review ABO and determine current owner. (O.Yakimov - DWR UCIP)

10-inch pipe at WS toe.

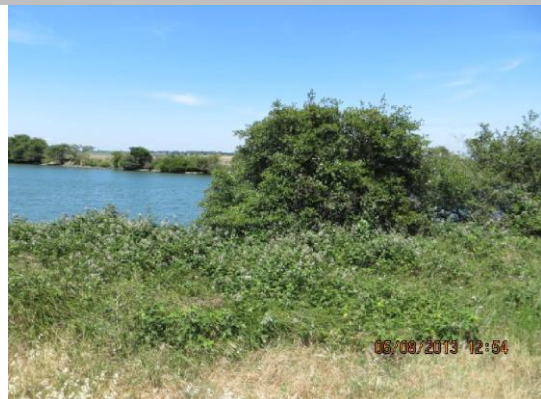
Photo 2 of 3 : UCIP\_SP\_2024\_62394\_21274.jpg

Pipe visible at WS toe to left of tree in photo.

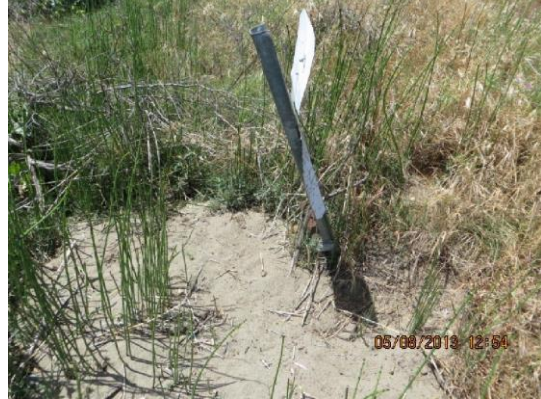
Photo 3 of 3 : UCIP\_SP\_2024\_62394\_21273.jpg

Siphon breaker next to paddle marker on LS shoulder.

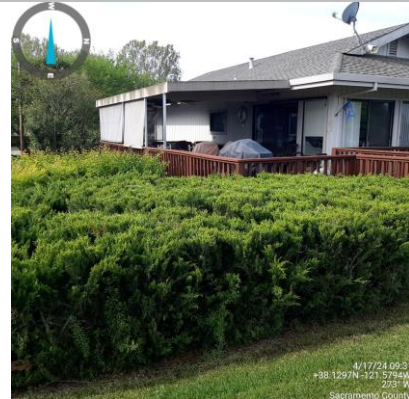
Photo 1 of 1 : SP\_2024\_NA0002\_62\_62\_20240422\_00086.jpg

LM Start	5.96	Rating **	U	Issue No.	62
LM End	5.96	Issue Type +	En	Location *	LS
Category	Earthen Levee			GPS Latitude/Longitude	
				Start	End
Item	Vegetation			38.129677°	38.129677°
				-121.579432°	-121.579432°
DWR ID	DWR_NA0002_01_s_2020_62				
Comment Code					
V6 : Landscaping					
Inspector Comment

View of thick landscape vegetation on the LS slope. (Spring 2024)

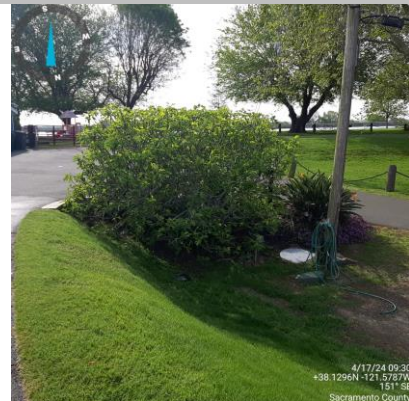
Photo 1 of 1 : SP\_2024\_NA0002\_62\_31\_20240422\_00087.jpg

LM Start	6.00	Rating **	M	Issue No.	31
LM End	6.00	Issue Type +	En	Location *	LS
Category	Earthen Levee			GPS Latitude/Longitude	
				Start	End
Item	Vegetation			38.129638°	38.129638°
				-121.578671°	-121.578671°
DWR ID	DWR_NA0002_01_s_2024_31				
Comment Code					
V6 : Landscaping					
Inspector Comment					
Owner planted bush on LS slope.

View of landscape bush to be removed from LS slope. (Spring 2024)

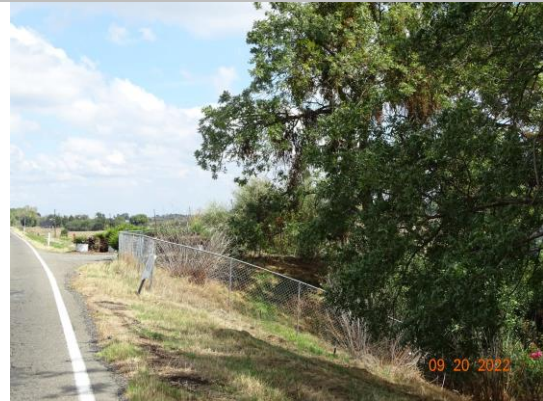
Photo 1 of 1 : SP\_2024\_NA0002\_63\_26\_20240301\_00006.jpg

LM Start	0.43	Rating **	M	Issue No.	26
LM End	0.43	Issue Type +	En	Location *	LS
Category	Earthen Levee			GPS Latitude/Longitude	
				Start	End
Item	Encroachments			38.189212°	38.189212°
				-121.574757°	-121.574757°
DWR ID	DWR_NA0002_02_s_2012_26				
Comment Code					
FE : Fence					
Inspector Comment

View of the fence on the LS shoulder and slope (Fall 2022).

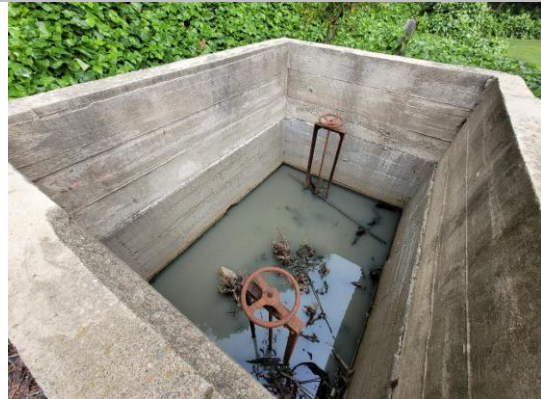
Photo 1 of 3 : UCIP\_SP\_2024\_74880\_112077.jpg

Comment Code					
Inspector Comment					
DS_ID:21868 FS_ID:74880 EP_NO: 1173 Repair Type: Non-Urgent EVAL Issue: 10, Unauthorized Modification or Non-Compliant Permit Crossing Status: Found UCIP Comments: 04/19/2022 Record remains Non-Urgent. Siphon breaker and CMP riser removed from landside slope. Air release valve and irrigation hose connection installed on waterside shoulder. Pump on pier was replaced. Unable to find a permit for modification. Pipe is running for irrigation of waterside berm via attached hose. (O.Yakimov - DWR UCIP) 04/18/2013 Several patches on pipe, walkway in disrepair and 24-inch standpipe for siphon breaker on LS slope has been dislodged from the LS slope and rests at LS toe. Pipe appears to be failing at multiple places due to corrosion. (W.Wylie - DWR UCIP) FIELD_STRUCT_DESC: 12-inch irrigation pipe of an unknown material through the levee, 7 feet below the crown. Pump on pile structure with a walkway in the river. Siphon breaker in 24-inch corrugated metal riser unit on the landside (LS) slope with a 7-foot by 9-foot concrete distribution box on the LS toe. Service pole on the LS slope with a 1.5-inch galvanized iron electrical conduit at the same location. (Six 12-inch steel discharge pipes (pipe 2 of 6) authorized under Permit No. 1173, 1947 - Reclamation District No. 556). [Additional Reference(s): DWR Levee Log, 2005 (HLM 0.82). USACE Sacramento O&M Manual, Unit 103, June 1954, Revised 29 December 2016, (Station "H" 52+21), listed as 12-inch pipe. USACE As-Built Drawing No. 50-04-2277, March 1946, Sheet 1, Station 52+21 "H"]. FS Date: 4/19/2022 8:06:58 AM

Land-Side: View inside of concrete distribution box at levee toe

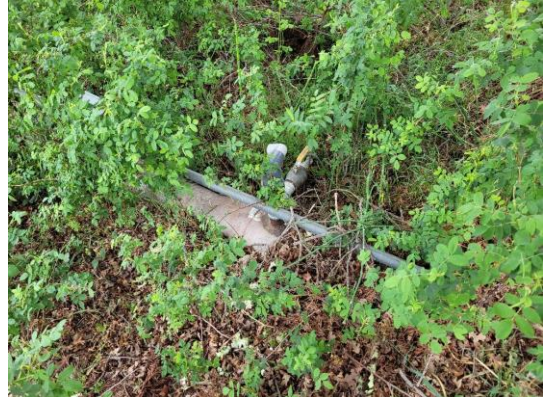
Photo 2 of 3 : UCIP\_SP\_2024\_74880\_112083.jpg

Land-Side: Air release valve and hose connection on levee shoulder

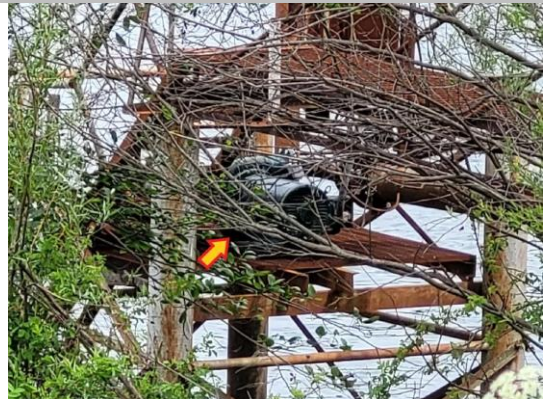
Photo 3 of 3 : UCIP\_SP\_2024\_74880\_112076.jpg

Water-Side: New pump located on pile structure in the stream

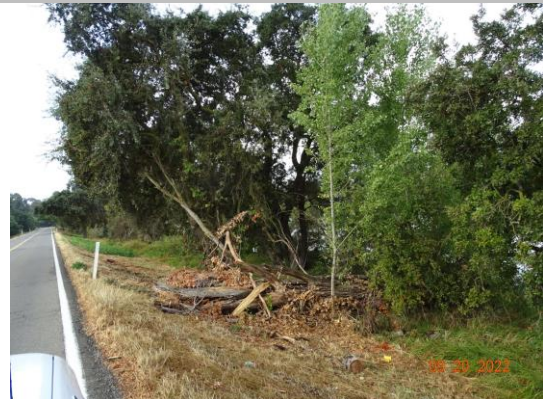
Photo 1 of 1 : SP\_2024\_NA0002\_63\_166\_20240301\_00066.jpg

LM Start	1.33	Rating **	U	Issue No.	166
LM End	1.33	Issue Type +	Ma	Location *	WS
Category	Earthen Levee			GPS Latitude/Longitude	
				Start	End
Item	Trim / Thin Trees			38.180455°	38.180455°
				-121.586522°	-121.586522°
DWR ID	DWR_NA0002_02_f_2022_166				
Comment Code					
T2 : Tree or limb.					
Inspector Comment					
There is a fallen tree on the WS slope.

View of the tree on the WS slope (Fall 2022).

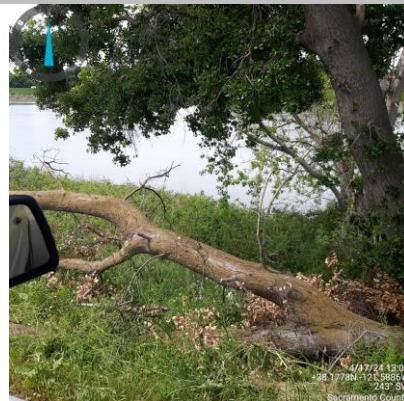
Photo 1 of 1 : SP\_2024\_NA0002\_63\_44\_20240422\_00155.jpg

LM Start	1.54	Rating **	M	Issue No.	44
LM End	1.54	Issue Type +	Ma	Location *	WS
Category	Earthen Levee			GPS Latitude/Longitude	
				Start	End
Item	Trim / Thin Trees			38.177776°	38.177776°
				-121.588644°	-121.588644°
DWR ID	DWR_NA0002_02_s_2024_44				
Comment Code					
T2 : Tree or limb.					
Inspector Comment

View of fallen tree limb on WS slope. (Spring 2024)
