Flood Control Project Maintenance  
Levee Inspections  
LMA District Cover Sheet

Brannan Andrus Levee Maintenance District

**Flood Control Project Maintenance  
Levee Inspections  
Unit Cover Sheet**

Waterway			Bank	Unit Miles
Unit No. 01 Georgiana Slough			Right	6.01
	Spring (March - May)	Summer (June - August)	(September - November) Fall	Winter (December - February)
Unit Maintenance Rating (Fall Only)				
Date of Inspection	4/17/2024 - 4/17/2024			
DWR Inspector	Gregg McMillon			
Accompanied By	Emily Pappalardo DCC Engineering

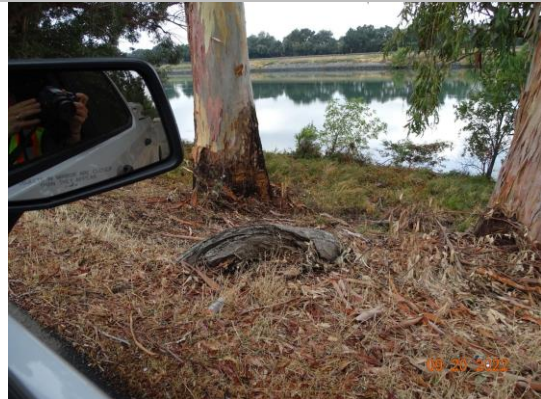
Photo 1 of 1 : SP\_2024\_NA0002\_63\_79\_20240301\_00037.jpg

LM Start	1.69	Rating **	M	Issue No.	79
LM End	1.69	Issue Type +	Ma	Location *	WS
Category	Earthen Levee			GPS Latitude/Longitude	
				Start	End
Item	Trim / Thin Trees			38.175867°	38.175867°
				-121.589884°	-121.589884°
DWR ID	DWR_NA0002_02_f_2018_79				
Comment Code					
T2 : Tree or limb.					
Inspector Comment					
Remove tree limb from the waterside slope.

View of the tree limb on the WS slope (Fall 2022).

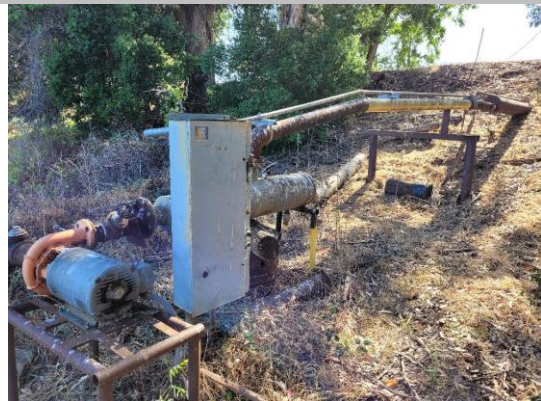
Photo 1 of 3 : UCIP\_SP\_2024\_74939\_112137.jpg

Comment Code						
Inspector Comment						
DS_ID:21871 FS_ID:74939 EP_NO: 1173 Repair Type: Urgent EVAL Issue: 2a, Levee Integrity Crossing Status: Found UCIP Comments: 04/28/2022 Record updated from No Action Needed to Urgent. Excavation at landside levee toe sized 2.5 feet diameter and 2 feet deep to connect underground 6-inch PVC pipe. 6-inch steel pipe sleeved through the 12-inch pipe as seen on waterside slope, steel plate welded to cover the annular space. Steel riser at landside toe replaced with CPP riser with air release valve and butterfly valve inside. Unable to find a permit for modifications. (O.Yakimov - DWR UCIP) FIELD_STRUCT_DESC: 6-inch steel pipe sleeved through the 12-inch steel irrigation pipe through the levee, 7 feet below the crown. Shutoff valve at pump on the waterside (WS) berm. Service pole and siphon breaker inside a steel riser unit on the landside (LS) slope. 5-inch service connection at the LS toe. 1.5-inch galvanized iron electrical conduit at the same location. (Six 12-inch steel discharge pipes (pipe 3 of 6) authorized under Permit No. 1173, 1947 - Reclamation District No. 556). [Additional Reference(s): DWR Levee Log, 2005 (HLM 1.76), listed as 12-inch pipe. USACE Sacramento O&M Manual, Unit 103, June 1954, Revised 29 December 2016, (Station "H" 14+64), listed as 12-inch pipe. USACE As-Built Drawing No. 50-04-2277, March 1946, Sheet 1, Station 14+64 "H", listed as 12-inch pipe]. FS Date: 4/28/2022 10:47:04 AM

Water-Side: Pump and electrical panel on the berm

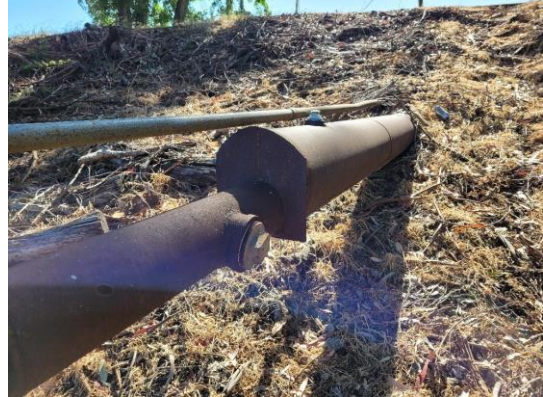
Photo 2 of 3 : UCIP\_SP\_2024\_74939\_112138.jpg

Water-Side: Sleeving point on levee slope. Annual space covered with steel plate

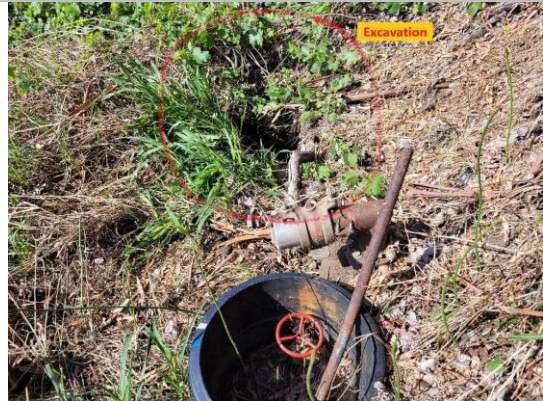
Photo 3 of 3 : UCIP\_SP\_2024\_74939\_112136.jpg

Land-Side: Corrugated Plastic Pipe (CPP) riser with air release valve and butterfly valve inside

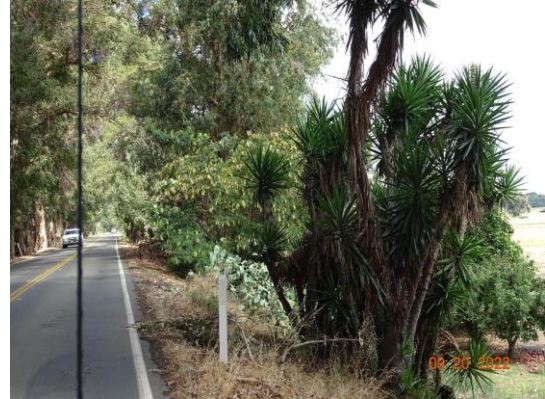
Photo 1 of 1 : SP\_2024\_NA0002\_63\_45\_20240301\_00013.jpg

LM Start	1.80	Rating **	U	Issue No.	45
LM End	1.83	Issue Type +	En	Location *	LS
Category	Earthen Levee			GPS Latitude/Longitude	
				Start	End
Item	Vegetation			38.174437°	38.174058°
				-121.590786°	-121.590978°
DWR ID	DWR_NA0002_02_f_2013_45				
Comment Code					
V6 : Landscaping					
Inspector Comment					
Dense vegetation and cactus are on the landside slope and toe.

View of the cactus and other landscaping on the LS slope (Fall 2022).

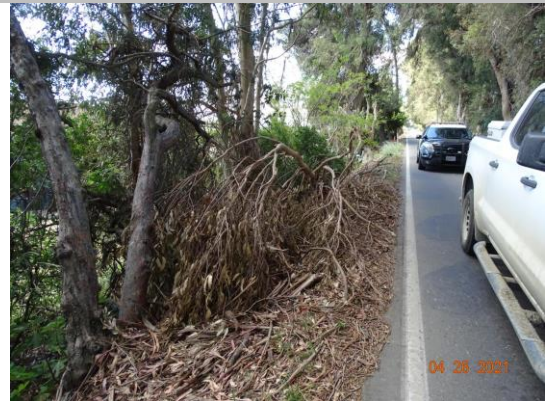
Photo 1 of 1 : SP\_2024\_NA0002\_63\_96\_20240301\_00048.jpg

LM Start	1.81	Rating **	U	Issue No.	96
LM End	1.81	Issue Type +	Ma	Location *	LS
Category	Earthen Levee			GPS Latitude/Longitude	
				Start	End
Item	Trim / Thin Trees			38.174316°	38.174316°
				-121.590830°	-121.590830°
DWR ID	DWR_NA0002_02_s_2021_96				
Comment Code					
T2 : Tree or limb.					
Inspector Comment					
Remove large downed tree branch on landside slope.

Downed tree limb on the landside hinge (Spring 2021).

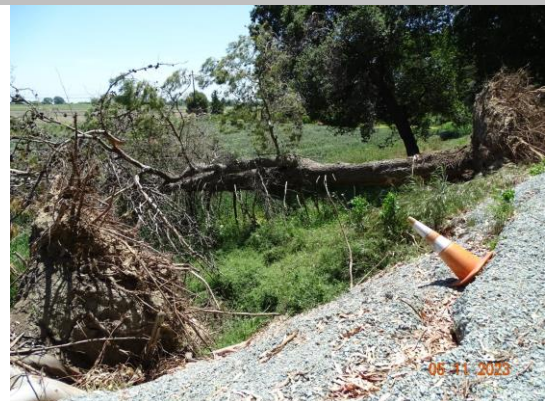
Photo 1 of 1 : SP\_2024\_NA0002\_63\_38\_20240301\_00012.jpg

LM Start	1.85	Rating **	U	Issue No.	38
LM End	1.85	Issue Type +	Ma	Location *	LS
Category	Earthen Levee			GPS Latitude/Longitude	
				Start	End
Item	Trim / Thin Trees			38.173867°	38.173867°
				-121.591099°	-121.591099°
DWR ID	DWR_NA0002_02_s_2023_38				
Comment Code					
T3 : Fallen tree with root ball.					
Inspector Comment					
Two fallen trees with root balls on the LS slope.

View of the fallen trees with root balls on the LS slope (Spring 2023).

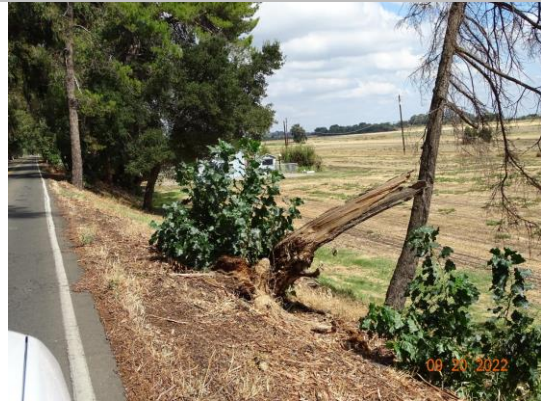
Photo 1 of 1 : SP\_2024\_NA0002\_63\_137\_20240301\_00062.jpg

LM Start	1.89	Rating **	U	Issue No.	137
LM End	1.89	Issue Type +	Ma	Location *	LS
Category	Earthen Levee			GPS Latitude/Longitude	
				Start	End
Item	Trim / Thin Trees			38.173273°	38.173273°
				-121.591468°	-121.591468°
DWR ID	DWR_NA0002_02_f _ 2021_137				
Comment Code					
T2 : Tree or limb.					
Inspector Comment					
Remove large downed tree limb on landside slope.

View of the tree on the LS slope (Fall 2022).

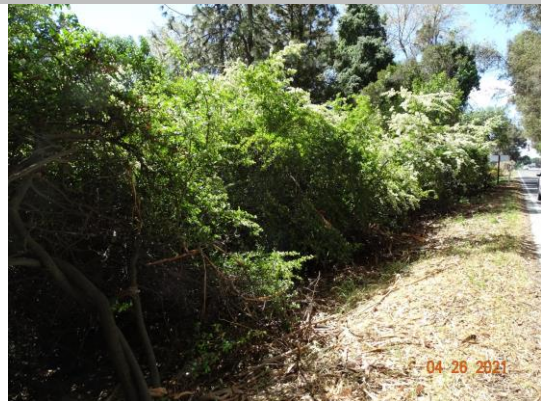
Photo 1 of 1 : SP\_2024\_NA0002\_63\_12\_20240301\_00003.jpg

LM Start	1.91	Rating **	U	Issue No.	12
LM End	1.94	Issue Type +	En	Location *	LS
Category	Earthen Levee			GPS Latitude/Longitude	
				Start	End
Item	Vegetation			38.173030°	38.172598°
				-121.591624°	-121.591853°
DWR ID	DWR_NA0002_02_s_2012_12				
Comment Code					
V6 : Landscaping					
Inspector Comment					
Dense landscaping vegetation is on the landside slope.

View looking downstream at landscaping on the landside slope (Spring 2021).

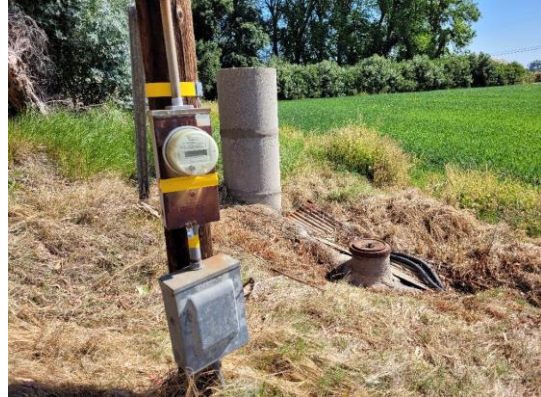
Photo 2 of 3 : UCIP\_SP\_2024\_74945\_112153.jpg

Comment Code					
Inspector Comment					
DS_ID:21873					
FS_ID:74945					
EP_NO: 1173					
Repair Type: Non-Urgent					
EVAL Issue: 10, Unauthorized Modification or Non-Compliant Permit					
Crossing Status: Found					
UCIP Comments: 04/28/2022 Record updated from No Action Needed to Non-Urgent. 10-inch steel pipe sleeved through 12-inch at the pump on waterside berm. Unable to find a permit for modification. Siphon breaker and CMP riser on landside slope buried in debris. (O.Yakimov - DWR UCIP)					
FIELD_STRUCT_DESC: 10-inch steel pipe sleeved through 12-inch steel irrigation pipe through the levee, 7 feet below the crown. Pump on the waterside (WS) berm. Siphon breaker in 24-inch corrugated metal riser unit on the landside (LS) slope. 36-inch concrete stand pipe at the LS toe. Service pole on the LS slope. (Six 12-inch steel discharge pipes (pipe 4 of 6) authorized under Permit No. 1173, 1947 - Reclamation District No. 556). [Additional Reference(s): DWR Levee Log, 2005 (HLM 2.00), listed as 12-inch pipe. USACE Sacramento O&M Manual, Unit 103, June 1954, Revised 29 December 2016, (Station "H" 2+00), listed as 12-inch pipe. USACE As-Built Drawing No. 50-04-2277, March 1946, Sheet 1, Station 2+00 "H", listed as 12-inch pipe].

Land-Side: Service pole with electrical panel and concrete standpipe at levee toe

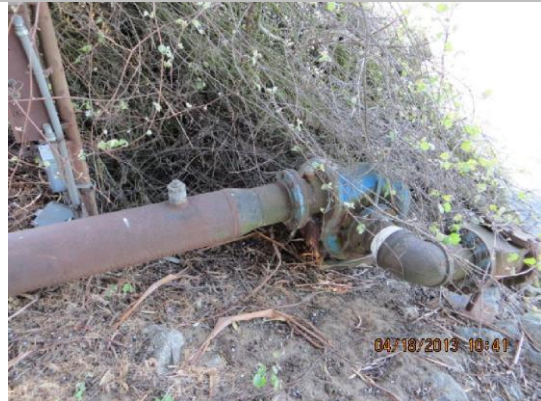
Photo 3 of 3 : UCIP\_SP\_2024\_74945\_19761.jpg

Pump on WS berm.

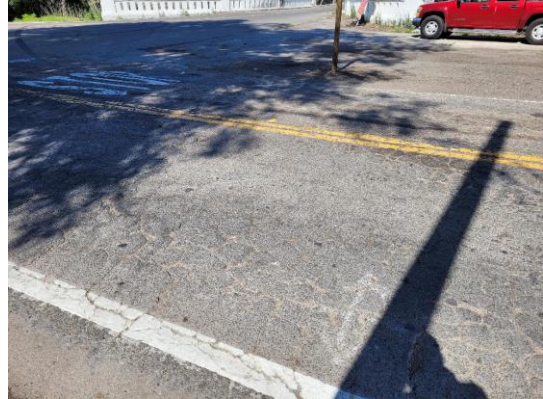
Photo 1 of 3 : UCIP\_SP\_2024\_75041\_112186.jpg

Comment Code					
Inspector Comment					
DS_ID:23134 FS_ID:75041 EP_NO: N/A Repair Type: Non-Urgent EVAL Issue: 11, Maintenance Compliance Issue Crossing Status: Indicator Found UCIP Comments: 04/28/2022 Record updated from No Action Needed to Non-Urgent. Junction pole at landside shoulder is in failing condition due to slope stability issue. There was an attempt to stabilize the slope by placing retaining boards around the pole. No permit has been found authorizing this pipe through the levee. (O.Yakimov - DWR UCIP) FIELD_STRUCT_DESC: Galvanized iron electrical conduit of an unknown size through the levee, at an unknown depth. JP and meter on the landside (LS) shoulder. Electrical connection boxes on waterside road shoulder and on upstream side of the bridge. FS Date: 4/28/2022 2:07:00 PM

Top of Levee: View of levee crown looking from landside

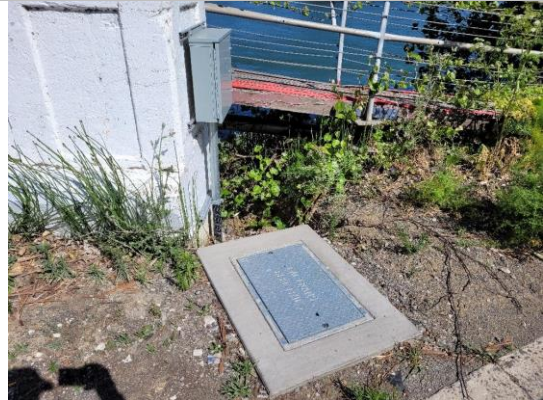
Photo 2 of 3 : UCIP\_SP\_2024\_75041\_112188.jpg

Water-Side: Electrical boxes on upstream side of bridge

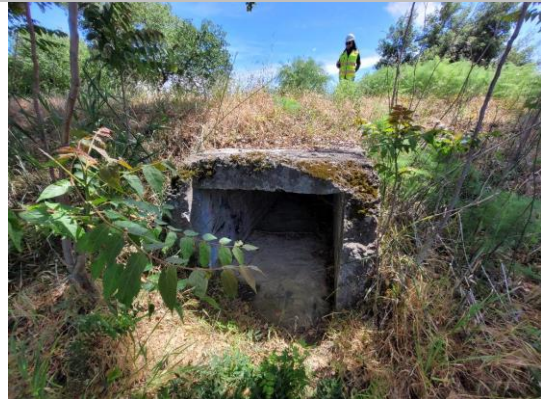
Photo 1 of 3 : UCIP\_SP\_2024\_75100\_112246.jpg

Comment Code					
Inspector Comment					
DS_ID:21879 FS_ID:75100 EP_NO: N/A Repair Type: Urgent EVAL Issue: 1, Pipe Integrity Crossing Status: Found UCIP Comments: 04/19/2022 Record updated from Non-Urgent to Urgent. Flood risk to landside due to the tunnel is open on both ends. DMP internal video inspection has found integrity issues. LOF of crossing is between 5 and 6. Crossing will be monitored until funding becomes available to address the issues. No permit has been identified authorizing pipe. (O.Yakimov - DWR UCIP) 07/12/2018 Tunnel is open on both sides. No integrity issue observed, therefore crossing downgraded to "Non-Urgent". (O.Yakimov-DWR UCIP) 10/24/2016 same as previous inspection culvert is open on both ends. WS blocked by blankets -- WS structure is being used as a shelter. (O. Magana - DWR UCIP) 04/18/2013 Culvert open on both ends. Needs to be abandoned properly. (W. Wylie - DWR UCIP) FIELD_STRUCT_DESC: 42-inch by 42-inch open reinforced concrete tunnel through the levee, 6 feet below the crown. [Additional Reference(s): DWR Levee Log, 2005 (HLM 2.54), listed as abandoned 3-feet by 3.5-feet open concrete culvert. USACE Sacramento O&M Manual 103, June 1954, (RM 18.16). USACE As-Built Drawing No. 06-13-1100, January 1933, Sheet 18, RM 18.16, listed as 3.5-foot by 3.5-foot concrete box]. FS Date: 4/19/2022 11:02:31 AM

Water-Side: View of the waterward end of tunnel

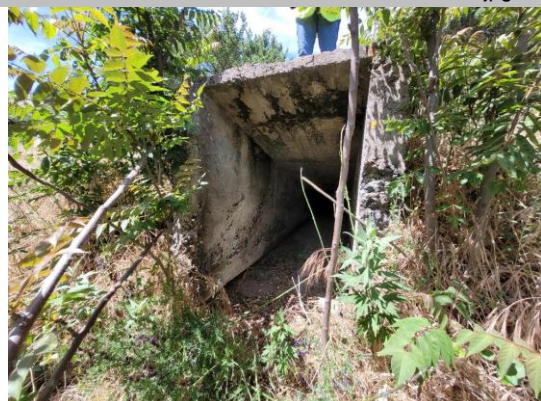
Photo 2 of 3 : UCIP\_SP\_2024\_75100\_112250.jpg

Land-Side: View of the landward end of tunnel

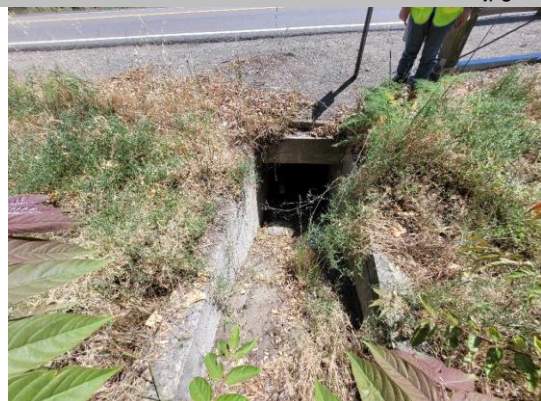
Photo 2 of 3 : UCIP\_SP\_2024\_75101\_112254.jpg

Water-Side: View of the waterward end of tunnel

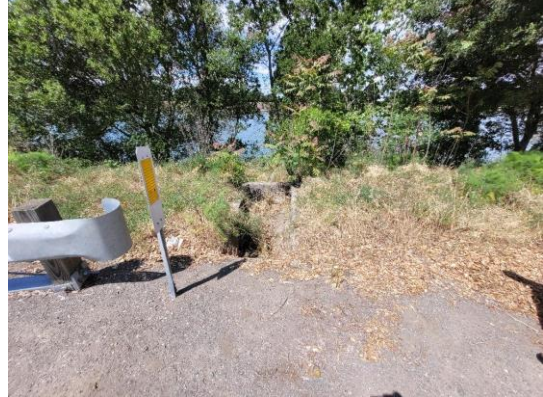
Photo 3 of 3 : UCIP\_SP\_2024\_75101\_112253.jpg

Water-Side: View of levee slope looking from crown. Concrete box on levee shoulder

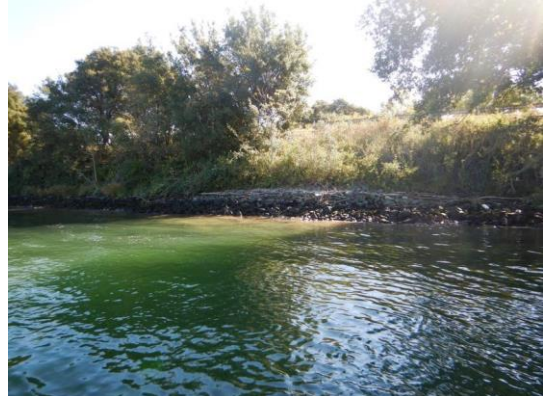
Photo 1 of 2 : SP\_2024\_NA0002\_63\_71\_20240301\_00032.jpg

LM Start	2.58	Rating **	U	Issue No.	71
LM End	2.63	Issue Type +	Ma	Location *	WS
Category	Supplemental			GPS Latitude/Longitude	
				Start	End
Item	2018 USACE Erosion Survey			38.165945°	38.165498°
				-121.599345°	-121.600080°
DWR ID	DWR_NA0002_02_s_2022_71				
Comment Code					
Inspector Comment					
2018 Site ID: SAC 18.1 L					
Status: Critical					
2018 Field Notes: Increased vegetation made it difficult to see changes.					
Site History: 2009 - Short reach of vertical bank at the toe. 2010 - Large tree is getting ready to fall in. 2015 - Freshly exposed tree roots.					
2017 - Upgraded to CRITICAL. Vertical slope face behind a tree that is likely to pop-out soon.

USACE 2018 Erosion Photo #1

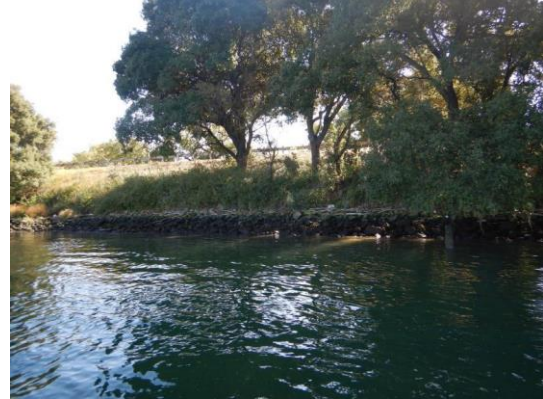
Photo 2 of 2 : SP\_2024\_NA0002\_63\_71\_20240301\_00033.jpg

USACE 2018 Erosion Photo #2

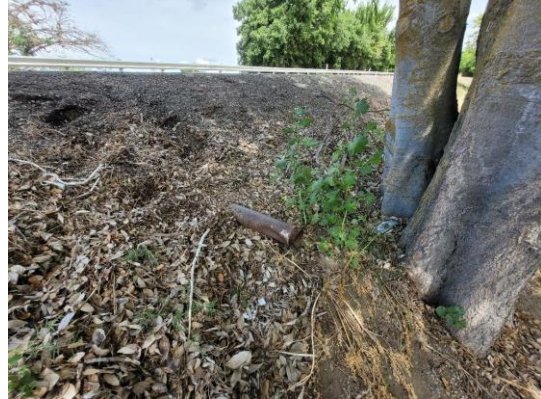
Photo 1 of 3 : UCIP\_SP\_2024\_75144\_112311.jpg

Comment Code					
Inspector Comment					
DS_ID:21955 FS_ID:75144 EP_NO: N/A Repair Type: Urgent EVAL Issue: 3b, Flood Risk Crossing Status: Found UCIP Comments: 04/19/2022 Record updated from No Action Needed to Urgent. Pipe is open on both ends. No permit has been identified authorizing pipe. (O.Yakimov - DWR UCIP) FIELD_STRUCT_DESC: 4-inch pipe of an unknown material or purpose through the levee, at an unknown depth. Steel tank on the landside (LS). [Additional Reference(s): USACE Sacramento O&M Manual 103, June 1954, (RM 17.93) steel pipe listed, Drawing No. 6-13-1100]. USACE As-Built Drawing No. 06-13-1100, January 1933, Sheet 18, RM 17.93]. FS Date: 4/19/2022 1:54:30 PM

Land-Side: Open pipe end next to the tree

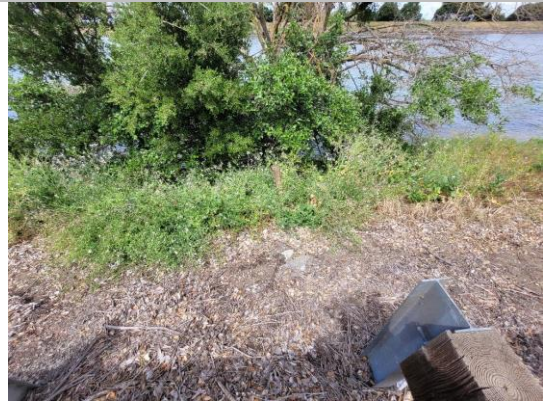
Photo 3 of 3 : UCIP\_SP\_2024\_75144\_112307.jpg

Water-Side: View of levee slope looking from crown

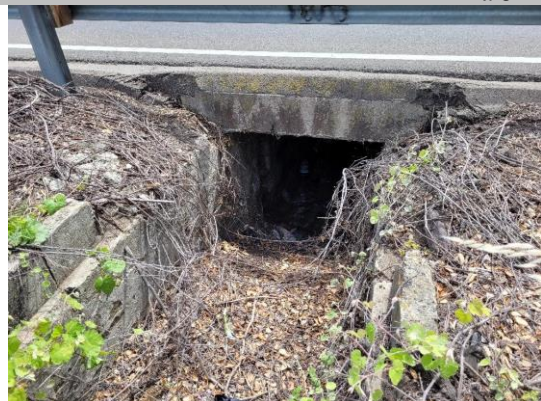
Photo 2 of 3 : UCIP\_SP\_2024\_75147\_112327.jpg

Water-Side: View of the waterward end of tunnel

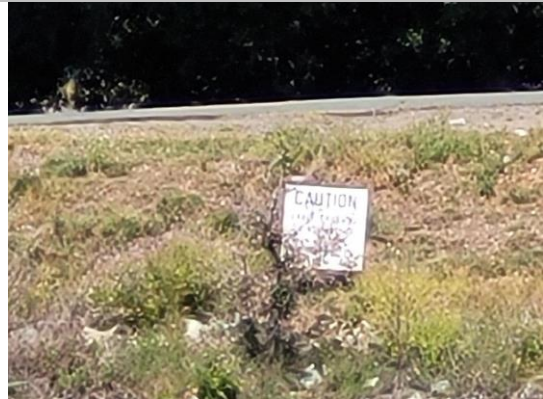
Photo 3 of 3 : UCIP\_SP\_2024\_75153\_112352.jpg

Water-Side: Caution sign on opposite side of river still in place

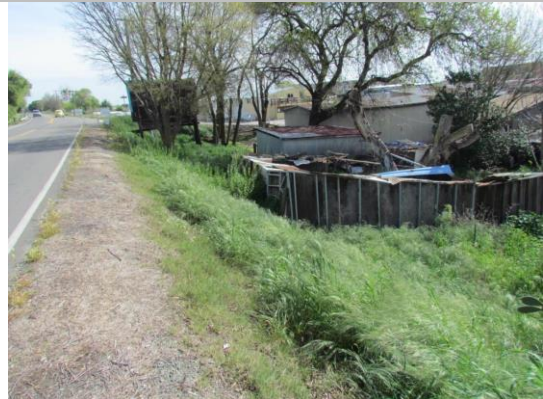
Photo 1 of 2 : SP\_2024\_NA0002\_63\_30\_20240301\_00007.jpg

LM Start	2.93	Rating **	U	Issue No.	30
LM End	3.12	Issue Type +	En	Location *	LS
Category	Earthen Levee			GPS Latitude/Longitude	
				Start	End
Item	Encroachments			38.163317°	38.162707°
				-121.604813°	-121.608262°
DWR ID	DWR_NA0002_02_s_2012_30				
Comment Code					
UR : Urban					
Inspector Comment					
There are several encroachments within the town limits along the landside slope.

Looking north at several encroachments along landward slope and toe.

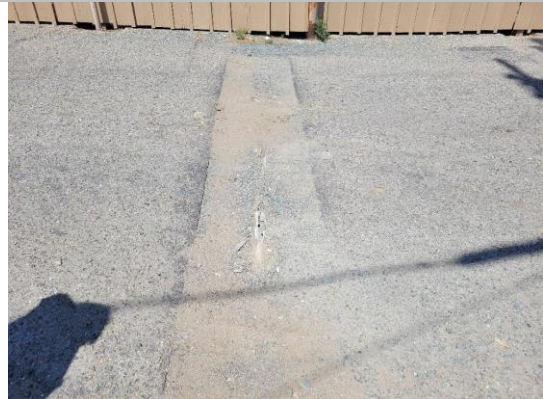
Photo 3 of 3 : UCIP\_SP\_2024\_77173\_115378.jpg

Top of Levee: Cut in pavement. Paving material is starting to come out due to the traffic

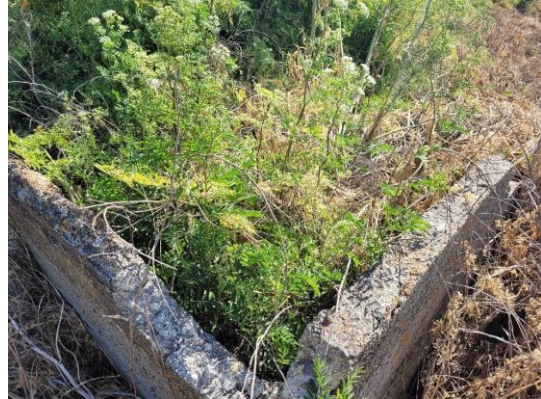
Photo 1 of 3 : UCIP\_SP\_2024\_75396\_112826.jpg

Comment Code					
Inspector Comment					
DS_ID:21895 FS_ID:75396 EP_NO: 1615 Repair Type: Urgent EVAL Issue: 2b, Levee Integrity Crossing Status: Found UCIP Comments: 05/03/2022 Record updated from Non-Urgent to Urgent. 9-feet wide and 1.5-feet deep depression on landside slope along pipe alignment. Crossing appears abandoned. Abandoned, falling apart concrete distribution box at landside toe. Pipe not found on waterside. No permit has been identified authorizing original 8-inch pipe. (O.Yakimov - DWR UCIP) 04/24/2013 Pipe abandoned and should be abandoned properly. (W.Wylie - DWR UCIP) FIELD_STRUCT_DESC: 6-inch irrigation pipe through 8-inch pipe of an unknown material through the levee, 5 feet below the crown. 6-foot by 6-foot concrete distribution box on the LS toe. (Sleeving 6-inch pipe through existing 8-inch pipe and alterations to pump authorized under Permit No. 1615, 1951 - Jones and Miller). [Additional Reference(s): DWR Levee Log, 2005 (HLM 3.71). USACE Sacramento O&M Manual, Unit 102, April 1959, Revised 29 December 2016, (RM 17.0), listed as 8-inch pipe]. FS Date: 5/3/2022 11:08:33 AM

Land-Side: Concrete distribution box at levee toe missing parts of walls, filled with dirt

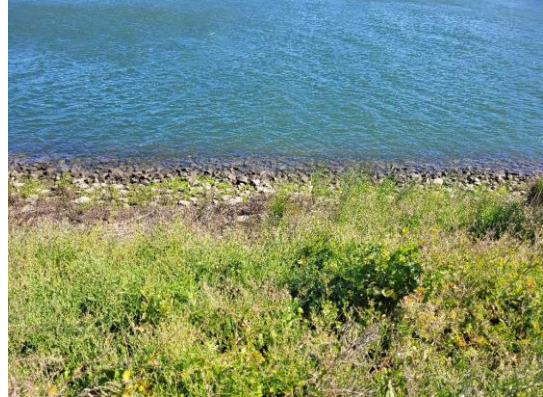
Photo 3 of 3 : UCIP\_SP\_2024\_75396\_112827.jpg

Water-Side: View of levee slope looking from crown. Pipe not found

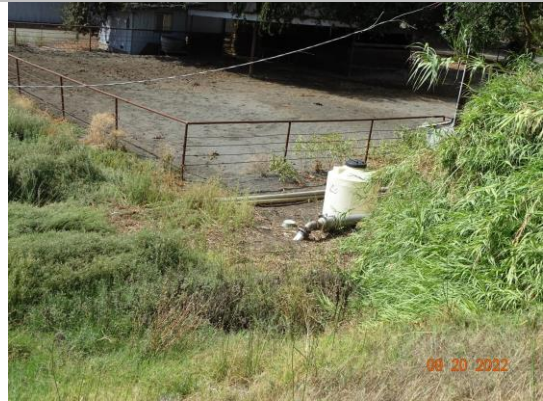
Photo 1 of 1 : SP\_2024\_NA0002\_63\_108\_20240301\_00054.jpg

View of the irrigation pipe obscured by vegetation along the LS toe (Fall 2022).

LM Start	3.92	Rating **	M	Issue No.	108
LM End	3.92	Issue Type +	En	Location *	LS
Category	Earthen Levee			GPS Latitude/Longitude	
				Start	End
Item	Encroachments			38.164020 °	38.164020 °
				-121.622641 °	-121.622641 °
DWR ID	DWR_NA0002_02_s_2019_108				
Comment Code					
LI : Landscape Irrigation					
Inspector Comment					
Move irrigation pipe 10 feet away from landside toe.

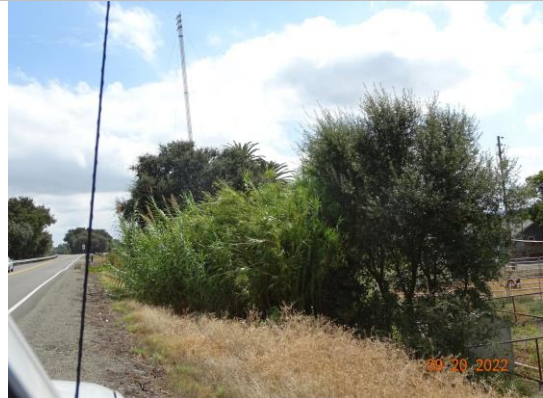
Photo 1 of 1 : SP\_2024\_NA0002\_63\_98\_20240301\_00050.jpg

View of the arundo on the LS slope (Fall 2022).

LM Start	3.92	Rating **	U	Issue No.	98
LM End	3.92	Issue Type +	Ma	Location *	LS
Category	Earthen Levee			GPS Latitude/Longitude	
				Start	End
Item	Trim / Thin Trees			38.164019°	38.164019°
				-121.622642°	-121.622642°
DWR ID	DWR_NA0002_02_s_2019_98				
Comment Code					
T1 : Trim and thin trees to at least five feet above ground level to allow visibility of the ground and room to flood fight.					
Inspector Comment					
Remove arundo from the landside slope.

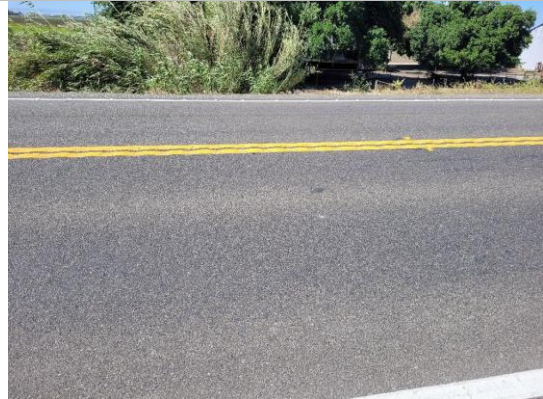
Photo 1 of 3 : UCIP\_SP\_2024\_75408\_112875.jpg

Comment Code					
Inspector Comment					
DS_ID:21898 FS_ID:75408 EP_NO: 11287 Repair Type: Non-Urgent EVAL Issue: 5, Pipe Damage Crossing Status: Found UCIP Comments: 02/08/2023 PACP internal video inspection has found moderate pipe defects. Crossing will be monitored until funding becomes available for rehabilitation. (O.Yakimov - DWR UCIP) 05/03/2022 Record remains Non-Urgent. No permit has been identified authorizing pipe. (O.Yakimov - DWR UCIP) 04/24/2013 Aging pipe with repair on WS slope. Good candidate for video inspection. (W.Wylie - DWR UCIP) FIELD_STRUCT_DESC: 5-inch irrigation pipe of an unknown material through the levee, 5.5 feet below the crown. Pump in pump house on the landside (LS). Shutoff valve in pump house on the LS toe. (6-inch pipe [HLM 3.94] authorized under Automatic Board Order (ABO) issued as Permit No. 11287, 1975 - Norman Silva). [Additional Reference(s): DWR Levee Log, 2005 (HLM 3.94), listed as 6-inch pipe. USACE Sacramento O&M Manual, Unit 102, April 1959, Revised 29 December 2016, (RM 16.8), listed as 6-inch pipe]. FS Date: 5/3/2022 1:32:05 PM

Top of Levee: View of levee crown looking from waterside

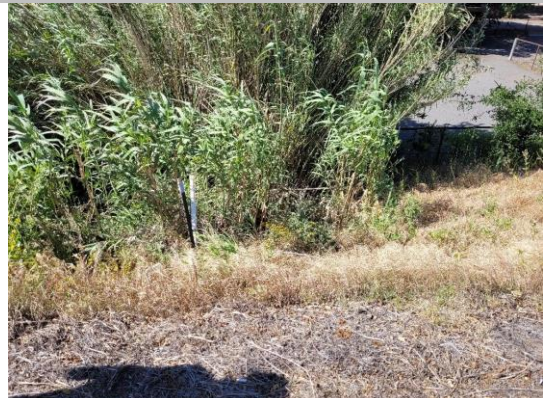
Photo 2 of 3 : UCIP\_SP\_2024\_75408\_112877.jpg

Land-Side: View of levee slope looking from crown. Pumphouse at levee toe

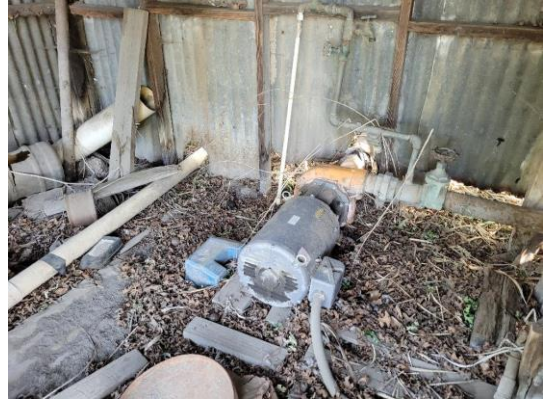
Photo 3 of 3 : UCIP\_SP\_2024\_75408\_112879.jpg

Land-Side: Pump inside the pumphouse

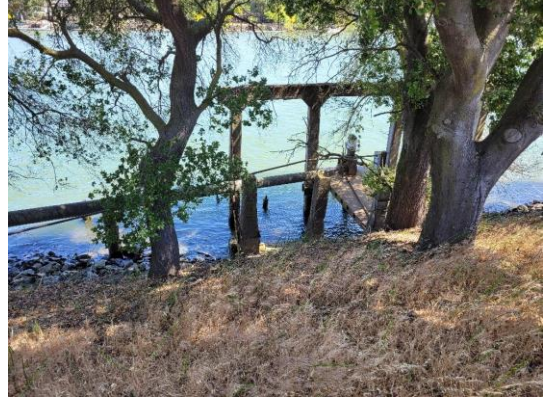
Photo 1 of 3 : UCIP\_SP\_2024\_75439\_112924.jpg

Comment Code					
Inspector Comment					
DS_ID:21904 FS_ID:75439 EP_NO: 787 Repair Type: Non-Urgent EVAL Issue: 10, Unauthorized Modification or Non-Compliant Permit Crossing Status: Found UCIP Comments: 05/03/2022 Record remains Non-Urgent. Pump is not in alignment with the pipe through levee and was added to the siphon system later (as shown in permit drawing). Concrete distribution box at LS toe instead of a sump. Unable to find a permit for modification. (O.Yakimov - DWR UCIP) 04/24/2013 Pipe may be abandoned and should be done so properly if not being used. Good candidate for video inspection. (W.Wylie - DWR UCIP) FIELD_STRUCT_DESC: 1 of 2: 14-inch steel irrigation discharge pipe through the levee, 4.2 feet below the crown. Pump on pile structure in stream. Pipe crosses levee approximately 30 feet downstream from the location of pump. Concrete sump at landside toe - not found, instead a concrete distribution box at LS toe approximately 30 feet downstream of pump location. (14-inch siphon pipe authorized under Permit No. 787, 1939 - J. E. Silva, et al). [Additional Reference(s): DWR Levee Log, 2005 (HLM 4.11). USACE Sacramento O&M Manual, Unit 102, April 1959, Revised 29 December 2016, (RM 16.6), listed as 14-inch pipe]. FS Date: 5/3/2022 3:11:49 PM

Water-Side: View of levee slope looking from crown. Pump on pier

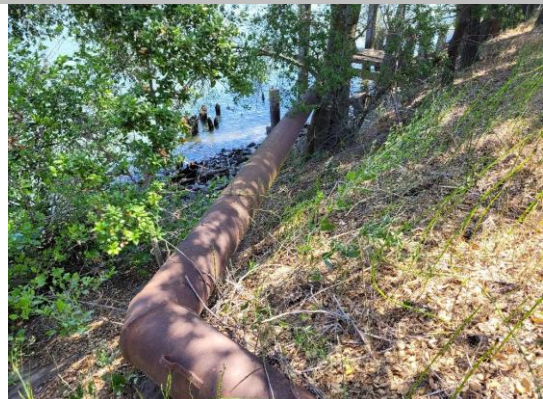
Photo 2 of 3 : UCIP\_SP\_2024\_75439\_112921.jpg

Water-Side: Pipe at riverbank goes approximately 30 feet along the levee to connect pump with the pipe through levee

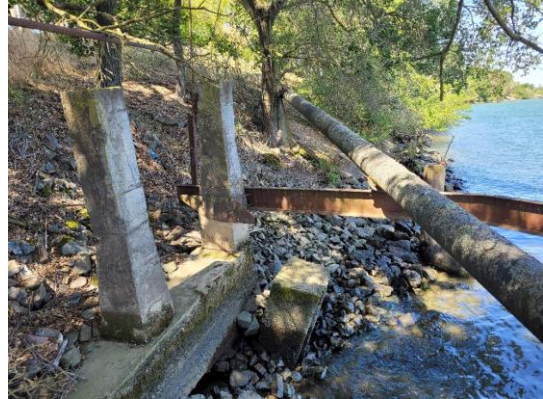
Photo 3 of 3 : UCIP\_SP\_2024\_75439\_112920.jpg

Water-Side: Pipe at riverbank goes along the levee to connect pump with the pipe through levee

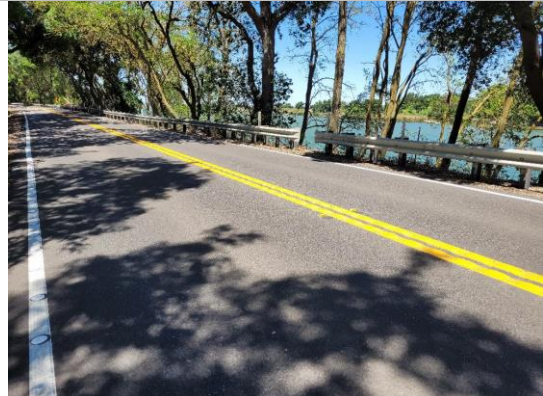
Photo 1 of 3 : UCIP\_SP\_2024\_78969\_112949.jpg

DS\_ID:21906  
FS\_ID:78969  
EP\_NO: 11274  
Repair Type: Urgent  
EVAL Issue: 1, Pipe Integrity  
Crossing Status: Found  
UCIP Comments: 02/08/2023 Record updated from Non-Urgent to Urgent. PACP internal video inspection has found severe pipe defects. Crossing will be monitored until funding becomes available to address the issues. (O.Yakimov - DWR UCIP)  
05/03/2022 Record updated from No Action Needed to Non-Urgent. Crossing appears abandoned. Pump in pumphouse at landside toe looks abandoned, damaged steel riser on landside slope filled with soil. No permit has been identified authorizing pipe. Need to have CVFPB review ABO and determine current owner. (O.Yakimov - DWR UCIP)  
FIELD\_STRUCT\_DESC: 10-inch irrigation pipe of an unknown material through the levee, 6.6 feet below the crown. Pump on pump house at the landside (LS) toe. Service pole with electric meter at LS toe. 1-inch electrical conduit buried in landside slope. (10-inch pipe [HLM 4.28] authorized under Automatic Board Order (ABO) issued as Permit No. 11274, 1975 - Henry Martin). [Additional Reference(s): DWR Levee Log, 2005 (HLM 4.28). USACE Sacramento O&M Manual, Unit 102, April 1959, Revised 29 December 2016, (RM 16.4), listed as 10-inch pipe].

Top of Levee: View of levee crown looking downstream

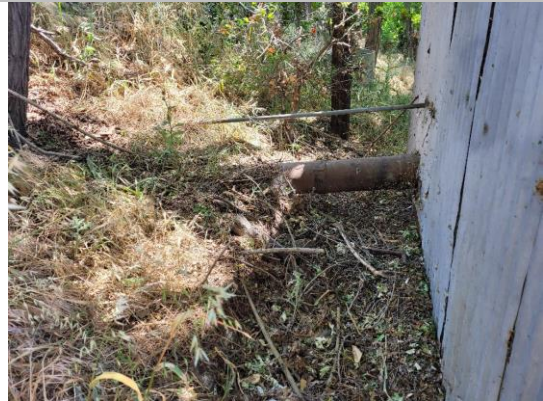
Photo 3 of 3 : UCIP\_SP\_2024\_78969\_112953.jpg

Land-Side: Pipe and electrical conduit at levee toe

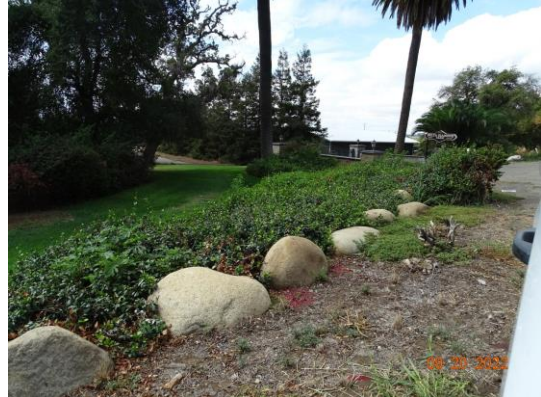
Photo 1 of 1 : SP\_2024\_NA0002\_63\_123\_20240301\_00057.jpg

LM Start	4.42	Rating **	M	Issue No.	123
LM End	4.42	Issue Type +	En	Location *	LS
Category	Earthen Levee			GPS Latitude/Longitude	
				Start	End
Item	Vegetation			38.167027°	38.167027°
				-121.630916°	-121.630916°
DWR ID	DWR_NA0002_02_s_2020_123				
Comment Code					
V6 : Landscaping					
Inspector Comment

View of the landscaping on the LS slope (Fall 2022).

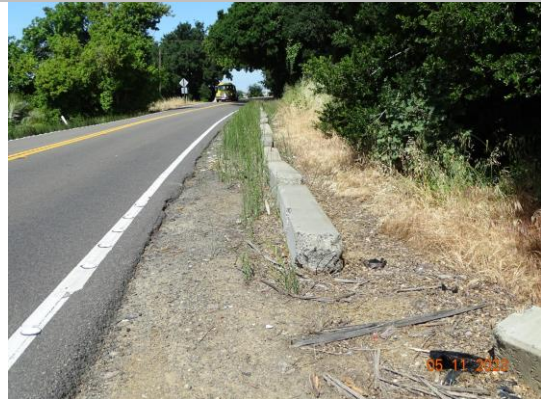
Photo 1 of 1 : SP\_2024\_NA0002\_63\_80\_20240301\_00038.jpg

LM Start	4.43	Rating **	A/W	Issue No.	80
LM End	4.47	Issue Type +	En	Location *	WS
Category	Earthen Levee			GPS Latitude/Longitude	
				Start	End
Item	Encroachments			38.167094°	38.167171°
				-121.631101°	-121.631693°
DWR ID	DWR_NA0002_02_s_2020_80				
Comment Code					
DE : Debris					
Inspector Comment					
Concrete blocks placed to deter parking on waterside of crown.

View of the concrete blocks along the WS shoulder (Spring 2023).

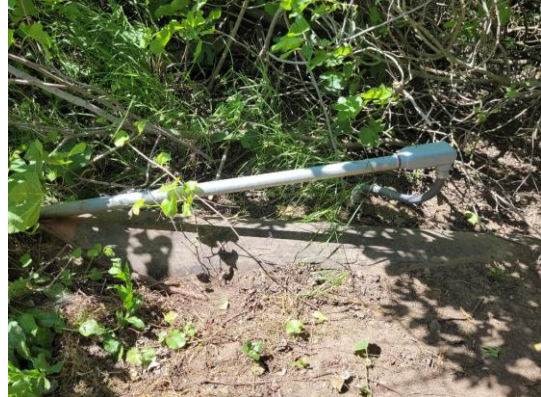
Photo 1 of 3 : UCIP\_SP\_2024\_75458\_112962.jpg

Comment Code					
Inspector Comment					
DS_ID:21908 FS_ID:75458 EP_NO: 11285 Repair Type: Urgent EVAL Issue: 2a, Levee Integrity Crossing Status: Found UCIP Comments: 05/03/2022 Record updated from Non-Urgent to Urgent. Excavation on landside (LS) slope under the pipe measured 25-foot wide and 4-feet deep. Unable to confirm that annular space between multiple sleeved pipes was properly grouted that otherwise could lead to flooding on LS. Pipe appears originally designed as a siphon and now converted to waterside (WS) pump irrigation pipe. Electrical conduit was sleeved in the space between pipes to provide power to WS. Pipe was cut on WS berm, butterfly valve installed on pipe end, 6-inch flexible corrugated hose connected to the valve. The hose continues through low flow channel. Unable to find a permit for modification. Pit under pipe on WS shoulder recorded in previous inspection didn't progress and now filled with soil. No permit has been identified authorizing pipe. Need to have CVFPB review ABO and determine current owner. (O.Yakimov - DWR UCIP) 05/02/2013 Pit under pipe on WS shoulder - possible leak. Excavation of pipe on LS slope into levee prism. (W.Wylie - DWR UCIP) FIELD_STRUCT_DESC: 20-inch siphon irrigation pipe of an unknown material, sleeved through a 22-inch, sleeved through a 24-inch pipe, through the levee, 3 feet below the crown. Pipe discharges into a 7-foot by 9-foot concrete sump off landside (LS) toe. Pump on the top of sump is not related to this crossing. Siphon filler pump above the pipe on the LS shoulder. Electrical conduit sleeved through the annular space between 20-inch and 22-inch pipes at this location. (20-inch pipe [HLM 4.79] authorized under Automatic Board Order (ABO) issued as Permit No. 11285, 1975 - Manuel Silva). [Additional Reference(s): DWR Levee Log, 2005 (HLM 4.79). USACE Sacramento O&M Manual, Unit 102, April 1959, Revised 29 December 2016, (RM 15.9), listed as 20-inch siphon pipe]. FS Date: 5/3/2022 1:51:06 PM

Water-Side: Electrical conduit comes out on levee slope

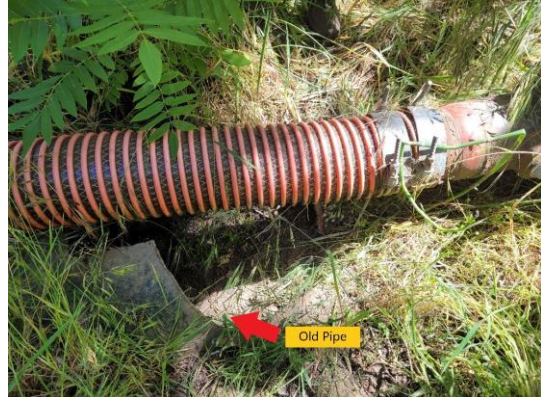
Photo 2 of 3 : UCIP\_SP\_2024\_75458\_112963.jpg

Water-Side: Pipe was cut on levee berm to install 6-inch flexible corrugated hose

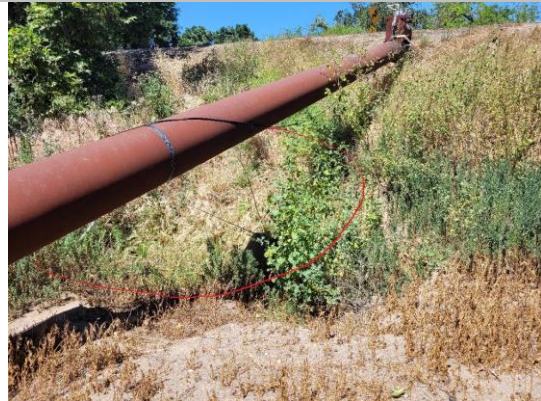
Photo 3 of 3 : UCIP\_SP\_2024\_75458\_112971.jpg

Land-Side: Excavation under pipe on levee slope. Approximate size is outlined in red

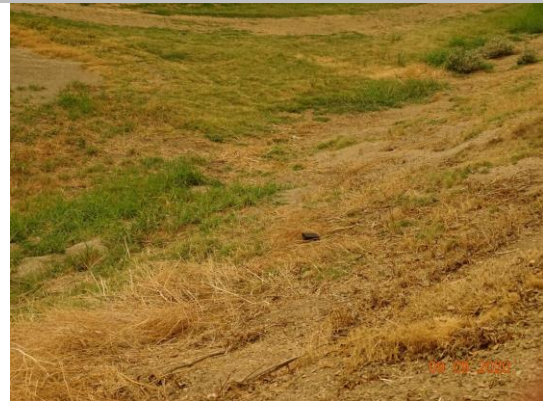
Photo 1 of 1 : SP\_2024\_NA0002\_63\_124\_20240301\_00058.jpg

LM Start	5.25	Rating **	U	Issue No.	124
LM End	5.29	Issue Type +	Ma	Location *	LS
Category	Earthen Levee			GPS Latitude/Longitude	
				Start	End
Item	Animal Control			38.171928°	38.171873°
				-121.644455°	-121.645082°
DWR ID	DWR_NA0002_02_f_2017_124				
Comment Code					
A1 : Exterminate rodents and backfill and compact or grout burrows.					
Inspector Comment					
Multiple active rodent holes on the landside slope.

View looking downstream at animal holes in the landside slope (Fall 2020).

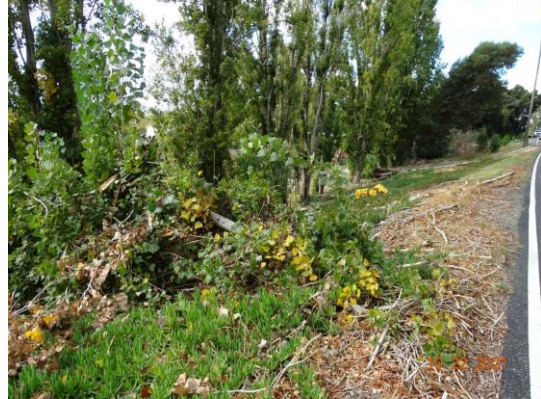
Photo 1 of 1 : SP\_2024\_NA0002\_63\_132\_20240301\_00060.jpg

View looking downstream at two downed trees on the landside slope (Fall 2021).

LM Start	5.32	Rating **	U	Issue No.	132
LM End	5.35	Issue Type +	Ma	Location *	LS
Category	Earthen Levee			GPS Latitude/Longitude	
				Start	End
Item	Trim / Thin Trees			38.171844°	38.171839°
				-121.645718°	-121.646163°
DWR ID	DWR_NA0002_02_f _ 2021_132				
Comment Code					
T3 : Fallen tree with root ball.					
Inspector Comment					
Remove two downed trees on landside slope.

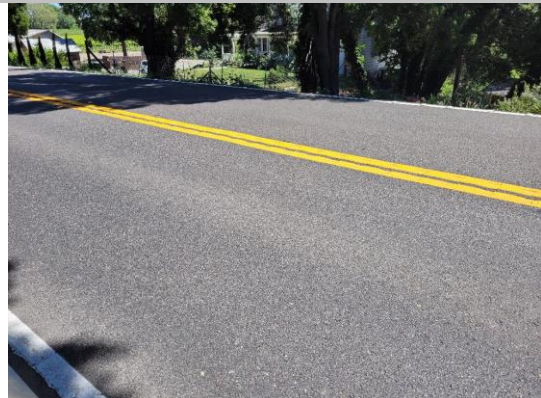
Photo 1 of 3 : UCIP\_SP\_2024\_75464\_112998.jpg

Comment Code						
Inspector Comment						
DS_ID:23138						
FS_ID:75464						
EP_NO: N/A						
Repair Type: Non-Urgent						
EVAL Issue: 11, Maintenance Compliance Issue						
Crossing Status: Found						
UCIP Comments: 05/03/2022 Record updated from No Action Needed to Non-Urgent. No permit has been found authorizing this pipe through the levee. Pipe is running, a leak through a hole in the pipe detected on walkway in the stream. (O.Yakimov - DWR UCIP)						
FIELD_STRUCT_DESC: 12-inch steel irrigation pipe through the levee, at an unknown depth. Pipe visible on the top of walkway to the pump located at the end of pier in the channel. 1.5-inch galvanized steel electrical conduit at same location. Pipe enters a shed at landside toe.						
FS Date: 5/3/2022 4:55:30 PM

Top of Levee: View of levee crown looking towards landside

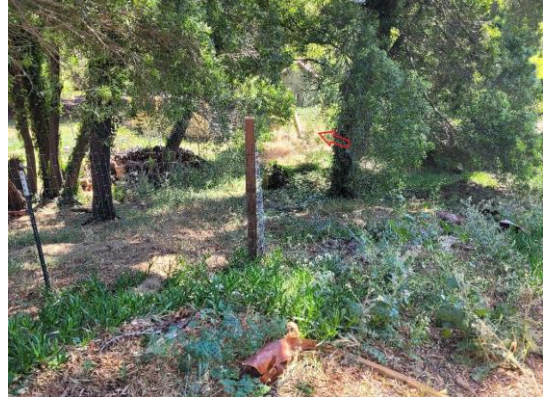
Photo 2 of 3 : UCIP\_SP\_2024\_75464\_112993.jpg

Land-Side: View of levee slope looking from crown. Pipe is visible on landside entering a shed

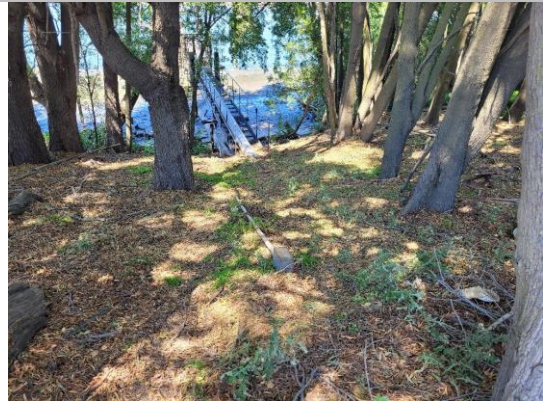
Photo 3 of 3 : UCIP\_SP\_2024\_75464\_113133.jpg

Water-Side: View of levee slope looking from crown

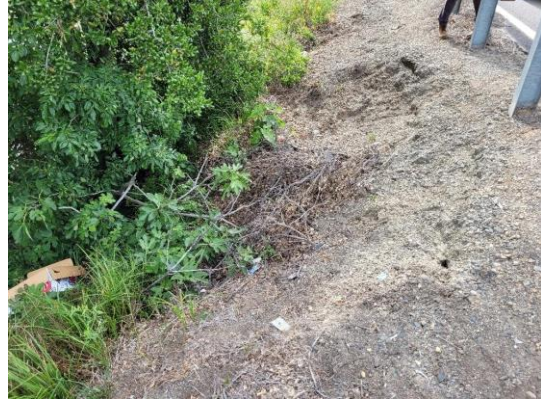
Photo 1 of 3 : UCIP\_SP\_2024\_75493\_113138.jpg

DS\_ID:21912  
FS\_ID:75493  
EP\_NO: N/A  
Repair Type: Urgent  
EVAL Issue: 2b, Levee Integrity  
Crossing Status: Found  
UCIP Comments: 05/05/2022 Record updated from Non-Urgent to Urgent. Depression on waterside slope along pipe alignment measured 13 feet wide and approximately 1.5 feet deep. Crossing appears abandoned. Abandoned centrifugal pump at landside toe with discharge pipe removed. Pipe not found on waterside. No permit has been identified authorizing pipe. Need to have CVFPB review ABO and determine current owner. (O.Yakimov - DWR UCIP)  
05/02/2013 Pipe abandoned. Erosion on WS slope at location where pipe should be. (W.Wylie - DWR UCIP)  
FIELD\_STRUCT\_DESC: 12-inch irrigation pipe of an unknown material through the levee, 13 feet below the crown. Pump and gate valve at the landside (LS) toe. Pump house at LS toe removed. 1.5-inch electrical conduit along pipe at same location. 42-inch concrete standpipe at the LS toe. (12-inch pipe [HLM 5.78] authorized under Automatic Board Order (ABO) issued as Permit No. 11290, 1975 - Horace D. Towne). (Vertical pump in river channel authorized under Permit No. 1646, 1952 - H.D. Towne). [Additional Reference(s): DWR Levee Log, 1968 (HLM 5.78). USACE Sacramento O&M Manual, Unit 102, April 1959, Revised 29 December 2016, (RM 14.8), listed as 12-inch pipe].

Water-Side: Another view of depression on levee slope

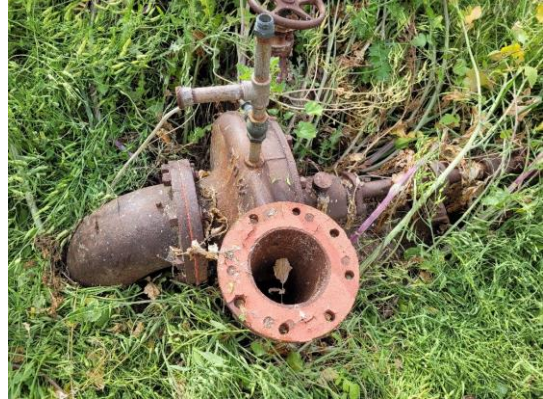
Photo 3 of 3 : UCIP\_SP\_2024\_75493\_113140.jpg

Land-Side: Abandoned pump at levee toe. Discharge pipe removed

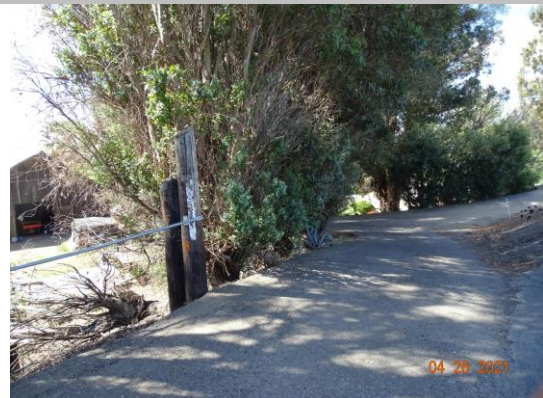
Photo 1 of 1 : SP\_2024\_NA0002\_63\_50\_20240301\_00015.jpg

LM Start	6.27	Rating **	M	Issue No.	50
LM End	6.29	Issue Type +	En	Location *	LS
Category	Earthen Levee			GPS Latitude/Longitude	
				Start	End
Item	Vegetation			38.173922°	38.173832°
				-121.662272°	-121.662550°
DWR ID	DWR_NA0002_02_s_2013_50				
Comment Code					
V6 : Landscaping					
Inspector Comment

View looking downstream at landscaping on the landside slope (Spring 2021).

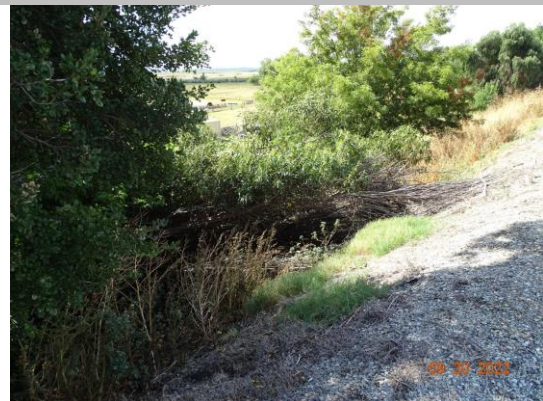
Photo 1 of 1 : SP\_2024\_NA0002\_63\_13\_20240301\_00004.jpg

LM Start	6.32	Rating **	U	Issue No.	13
LM End	6.32	Issue Type +	Ma	Location *	LS
Category	Earthen Levee			GPS Latitude/Longitude	
				Start	End
Item	Trim / Thin Trees			38.173697°	38.173697°
				-121.663082°	-121.663082°
DWR ID	DWR_NA0002_02_s_2017_13				
Comment Code					
T2 : Tree or limb.					
Inspector Comment					
Fallen tree on the landside slope.

View of the fallen tree on the LS slope (Fall 2022).

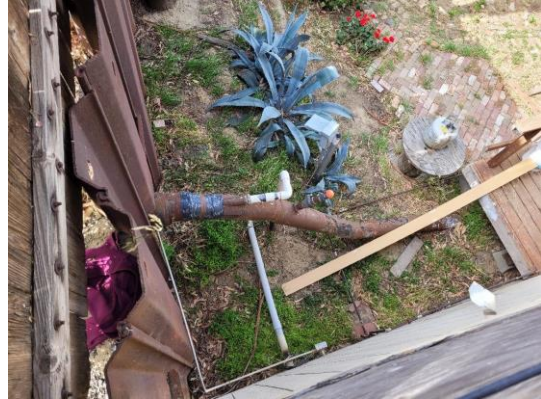
Photo 1 of 3 : UCIP\_SP\_2024\_75510\_113158.jpg

Comment Code						
Inspector Comment						
DS_ID:21966 FS_ID:75510 EP_NO: 11278 Repair Type: Urgent EVAL Issue: 3b, Flood Risk Crossing Status: Found UCIP Comments: 05/05/2022 Record updated from No Action Needed to Urgent. Multiple pipes sleeved through the original pipe with annular space not grouted that poses flood threat to the landside. Concrete distribution box and concrete standpipe are removed from landside toe and replaced with steel standpipe. Unable to find a permit for modifications. No permit has been identified authorizing pipe. Need to have CVFPB review ABO and determine current owner. (O.Yakimov - DWR UCIP) FIELD_STRUCT_DESC: 8-inch steel irrigation pipe sleeved through 9-inch steel pipe sleeved through 10-inch steel pipe through the levee, 5 feet below the crown. Pump on pier at the waterside (WS) toe. 4-foot by 5-foot concrete distribution box at the landside (LS) toe, not found. 36-inch concrete standpipe on the LS toe, not found. 1.5-inch electrical conduit at same location. (10-inch pipe [HLM 6.92] authorized under Automatic Board Order (ABO) issued as Permit No. 11278, 1975 - Goerge J. Pestano). [Additional Reference(s): DWR Levee Log, 2005 (HLM 6.92), listed as 10-inch pipe. USACE Sacramento O&M Manual, Unit 102, April 1959, Revised 29 December 2016, (RM 13.6), listed as 10-inch pipe]. FS Date: 5/5/2022 9:41:49 AM

Water-Side: Pipe at the retaining wall on the property

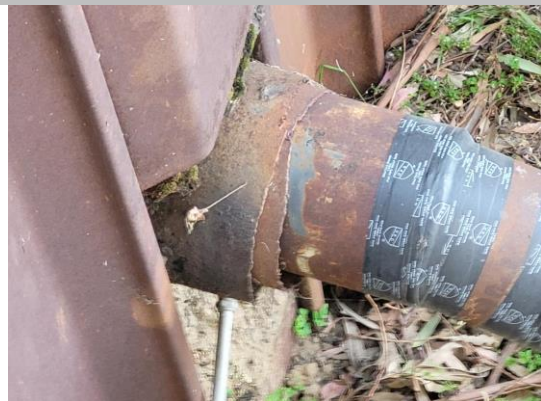
Photo 2 of 3 : UCIP\_SP\_2024\_75510\_113159.jpg

Water-Side: View of double sleeving at the retaining wall

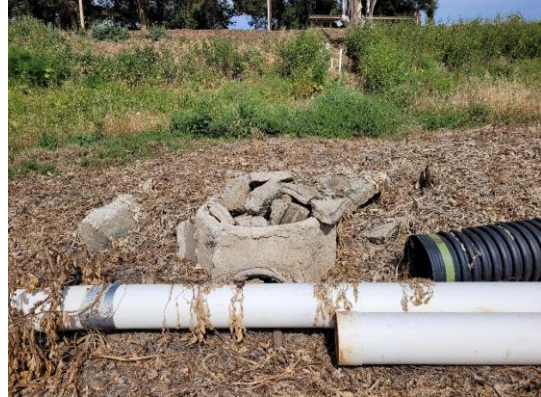
Photo 3 of 3 : UCIP\_SP\_2024\_75510\_113156.jpg

Land-Side: Concrete debris at levee toe

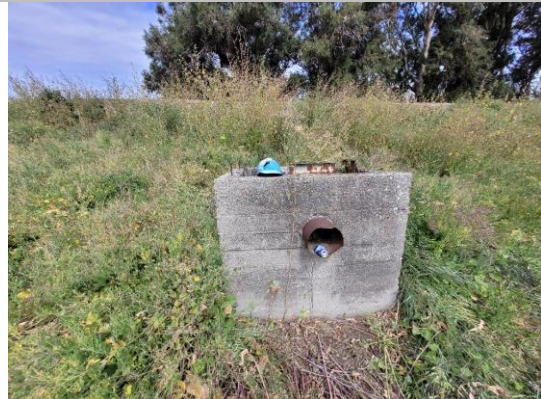
Photo 1 of 3 : UCIP\_SP\_2024\_75518\_113172.jpg

Comment Code					
Inspector Comment					
DS_ID:21916 FS_ID:75518 EP_NO: N/A Repair Type: Urgent EVAL Issue: 1, Pipe Integrity Crossing Status: Found UCIP Comments: 05/05/2022 Record remains Urgent. Pipe located above design flood plane open on both ends. Through holes on pipe visible at riverbank. Crossing appears abandoned. Abandoned concrete distribution box at landside toe partially filled with soil. No permit has been identified authorizing pipe. (O.Yakimov - DWR UCIP) 07/12/2018 Holes on pipe visible where it daylights on WS, and inside of concrete box on LS. Pipe is opened on WS. Recommend internal inspection to determine pipe integrity through levee. (O.Yakimov-DWR UCIP) 10/24/2016 same as previous inspection pipe is opened on the WS. The crossing remains "Urgent" due WS end open. Crossing appears abandoned--need to contact owner to determine status. If crossing is no longer in use owner will need to coordinate with the CVFPB to comply with Title 23. (O. Magana - DWR UCIP) 05/02/2013 Pipe open on WS. (W. Wylie - DWR UCIP) FIELD_STRUCT_DESC: 8-inch steel irrigation siphon pipe through levee 8.7 feet below crown. Pipe measures 8-inch inner diameter (ID) and 10-inch outer diameter (OD). A 5-foot by 5-foot concrete distribution box is located on the landside (LS) toe. [Additional Reference(s): DWR Levee Log, 2005 (HLM 7.04), listed as abandoned 8-inch pipe. USACE Sacramento O&M Manual, Unit 102, April 1959, Revised 29 December 2016, (RM 13.4), listed as 8-inch pipe]. FS Date: 5/5/2022 1:04:42 PM

Land-Side: Abandoned concrete distribution box at levee toe

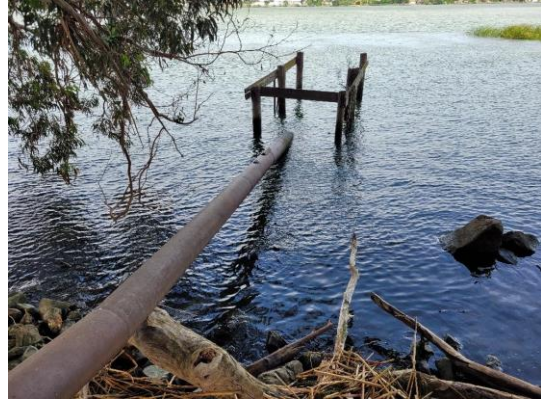
Photo 1 of 3 : UCIP\_SP\_2024\_75517\_113168.jpg

Comment Code					
Inspector Comment					
DS_ID:21917 FS_ID:75517 EP_NO: 11293 Repair Type: Urgent EVAL Issue: 3b, Flood Risk Crossing Status: Found UCIP Comments: 05/05/2022 Record updated from No Action Needed to Urgent. Pipe above flood plane open on both ends, closure device is not installed on waterside that can prevent flood to the landside. Pipe at riverbank appears replaced, concrete standpipe in the orchard on landside was replaced with corrugated plastic standpipe. Pipe diameter measured on landside slope is 12-inch. Unable to find a permit for modification. (O.Yakimov - DWR UCIP) FIELD_STRUCT_DESC: 14-inch steel irrigation siphon pipe through the levee 7.1 feet below the crown. Pipe begins under broken down pier on the waterside toe and terminates in a corrugated plastic standpipe on landside. Air vent on LS slope. (16-inch pipe [HLM 7.27] authorized under Automatic Board Order (ABO) issued as Permit No. 11293, 1975 - John Wilcox). [Additional Reference(s): DWR Levee Log, 2005 (HLM 7.26), listed as 16-inch pipe. USACE Sacramento O&M Manual, Unit 102, April 1959, Revised 29 December 2016, (RM 13.2), listed as 16-inch siphon pipe]. FS Date: 5/5/2022 10:20:46 AM

Water-Side: View of pipe at riverbank

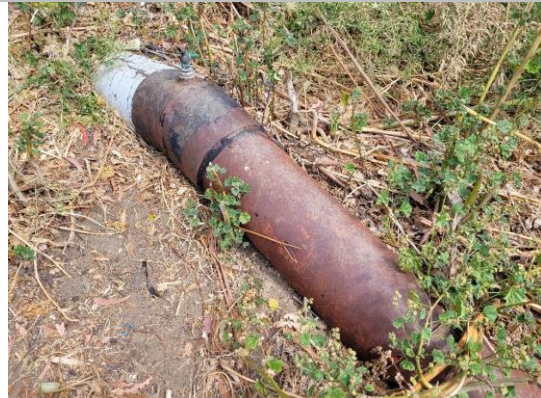
Photo 2 of 3 : UCIP\_SP\_2024\_75517\_113164.jpg

Land-Side: View of pipe on levee slope. Air vent on the top of pipe

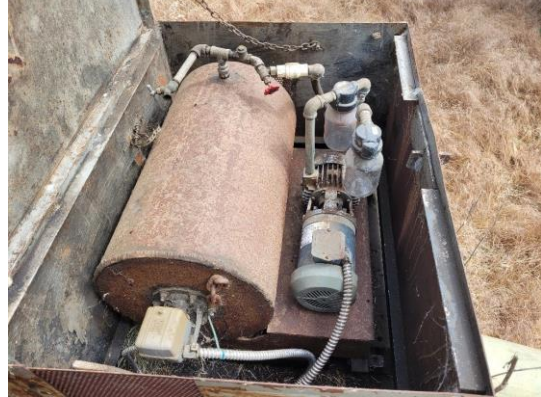
Photo 1 of 3 : UCIP\_SP\_2024\_75525\_113176.jpg

Comment Code					
Inspector Comment					
DS_ID:21918 FS_ID:75525 EP_NO: 11293 Repair Type: Urgent EVAL Issue: 3b, Flood Risk Crossing Status: Found UCIP Comments: 05/05/2022 Record updated from Non-Urgent to Urgent. 14-inch pipe sleeved through 16-inch pipe with annular space not grouted which can pose flood threat to the landside. Unable to find a permit for sleeving. Erosion on WS shoulder noted in last inspection not found. No permit has been identified authorizing pipe. (O.Yakimov - DWR UCIP) 05/02/2013 Erosion or sinkhole on WS shoulder. Does not appear to be an immediate threat. (W.Wylie - DWR UCIP) FIELD_STRUCT_DESC: 14-inch steel irrigation siphon pipe sleeved through 16-inch steel pipe through the levee at unknown depth below the crown. Siphon filler pump and service pole on landside (LS) slope. 72-inch concrete sump at the landside (LS) toe. [Additional Reference(s): DWR Levee Log, 2005 (HLM 7.47), listed as 16-inch pipe. USACE Sacramento O&M Manual, Unit 102, April 1959, Revised 29 December 2016, (RM 13.0), listed as 16-inch pipe]. FS Date: 5/5/2022 2:50:39 PM

Land-Side: Filler pump and its equipment in service box on the top of pipe at levee shoulder

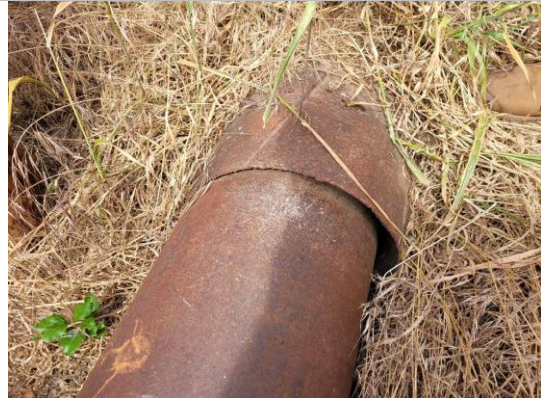
Photo 2 of 3 : UCIP\_SP\_2024\_75525\_113181.jpg

Land-Side: View of open annular space between pipes at levee shoulder

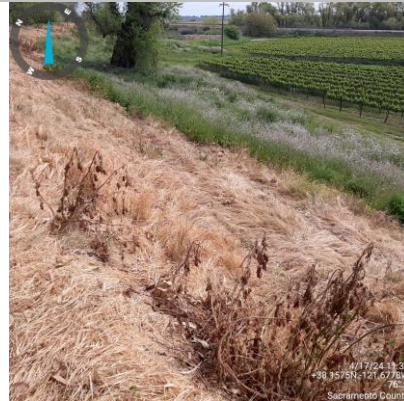
Photo 1 of 1 : SP\_2024\_NA0002\_63\_61\_20240422\_00156.jpg

LM Start	7.74	Rating **	A/W	Issue No.	61
LM End	7.74	Issue Type +	En	Location *	LS
Category	Earthen Levee			GPS Latitude/Longitude	
				Start	End
Item	Encroachments			38.157591°	38.157591°
				-121.677830°	-121.677830°
DWR ID	DWR_NA0002_02_s_2024_61				
Comment Code					
RA : Ramp					
Inspector Comment					
Vehicle tracks through existing vegetation. Monitor for future erosion.

View of vehicle tracks through the vegetation on LS slope. (Spring 2024)
