Flood Control Project Maintenance  
Levee Inspections  
LMA District Cover Sheet

Brannan Andrus Levee Maintenance District

**Flood Control Project Maintenance  
Levee Inspections  
Unit Cover Sheet**

Waterway			Bank	Unit Miles
Unit No. 01 Georgiana Slough			Right	6.01
	Spring (March - May)	Summer (June - August)	(September - November) Fall	Winter (December - February)
Unit Maintenance Rating (Fall Only)				
Date of Inspection	4/17/2024 - 4/17/2024			
DWR Inspector	Gregg McMillon			
Accompanied By	Emily Pappalardo DCC Engineering

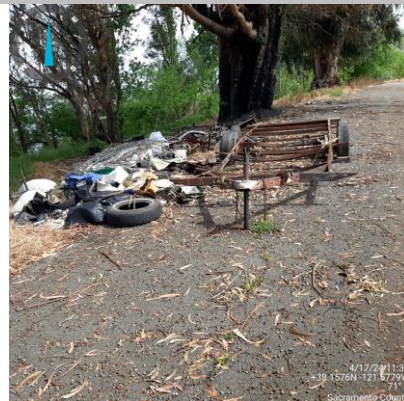
Photo 1 of 1 : SP\_2024\_NA0002\_63\_58\_20240422\_00154.jpg

LM Start	7.74	Rating **	U	Issue No.	58
LM End	7.74	Issue Type +	En	Location *	CR
Category	Earthen Levee			GPS Latitude/Longitude	
				Start	End
Item	Encroachments			38.157569°	38.157569°
				-121.677872°	-121.677872°
DWR ID	DWR_NA0002_02_s_2024_58				
Comment Code					
DE : Debris					
Inspector Comment					
Burnt trailer and other trash on levee crown.

View of burnt trailer and other garbage on levee crown. (Spring 2024)

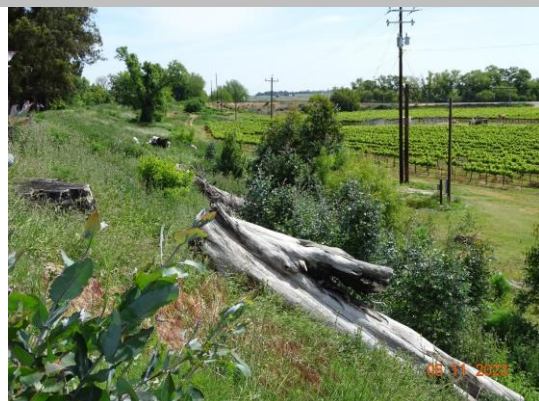
Photo 1 of 1 : SP\_2024\_NA0002\_63\_62\_20240301\_00021.jpg

LM Start	7.77	Rating **	U	Issue No.	62
LM End	7.78	Issue Type +	Ma	Location *	LS
Category	Earthen Levee			GPS Latitude/Longitude	
				Start	End
Item	Trim / Thin Trees			38.157286°	38.157201°
				-121.678223°	-121.678374°
DWR ID	DWR_NA0002_02_f_2021_62				
Comment Code					
T2 : Tree or limb.					
Inspector Comment					
Remove large downed tree trunks from landside slope.

View of the tree limbs on the LS slope (Spring 2023).

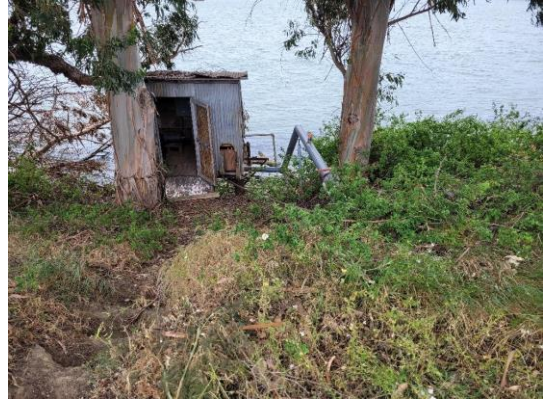
Photo 2 of 3 : UCIP\_SP\_2024\_75567\_113243.jpg

Comment Code					
Inspector Comment					
DS_ID:21925 FS_ID:75567 EP_NO: 2795 Repair Type: Urgent EVAL Issue: 3b, Flood Risk Crossing Status: Found UCIP Comments: 05/05/2022 Record updated from Non-Urgent to Urgent. Annular space between pipes plugged with tarp at waterside shoulder, this may provide flood threat to the landside. Another 2.5-inch steel pipe open on waterside end sleeved in the space between pipes through the levee. 36-inch concrete standpipe at landside toe has been removed. Unable to find a permit for modifications. Original 20-inch pipe is unauthorized encroachment recorded in Levee Log. (O.Yakimov - DWR UCIP) 05/03/2013 Annular space between PVC pipe and 12-inch steel pipe has not been sealed. (W.Wylie - DWR UCIP) FIELD_STRUCT_DESC: 6.5-inch steel irrigation pipe sleeved through a 12-inch steel pipe that is sleeved through the 20-inch pipe of an unknown material through the levee 3 feet below the crown. Annular space not grouted between pipes. Two pumps in pump house at riverbank connected in parallel, butterfly valve on pipe on waterside (WS) slope. 36-inch concrete standpipe at landside (LS) toe, not found. Sand filters, JP and electrical panel at LS toe, 1.5-inch electrical conduit through levee at this location. (12-inch pipe through existing 20-inch pipe authorized under Permit No. 2795, 1958 - Mabel J. Ruble by M. B. McKinnon (agent)). [Additional Reference(s): DWR Levee Log, 2005 (HLM 7.96), listed as 12-inch sleeved through 20-inch pipe]. FS Date: 5/5/2022 11:22:20 AM

Water-Side: View of levee slope looking from crown. Pump house at riverbank

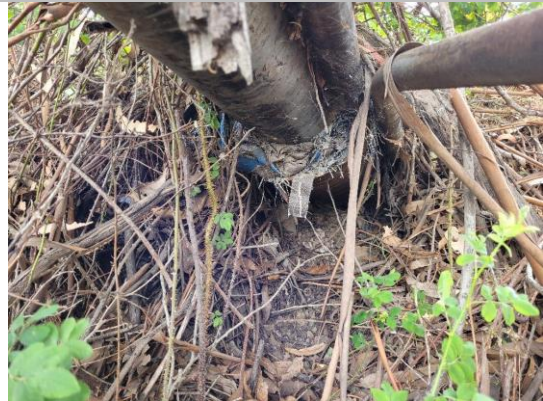
Photo 3 of 3 : UCIP\_SP\_2024\_75567\_113237.jpg

Water-Side: Annular space between pipes plugged with tarp at levee shoulder

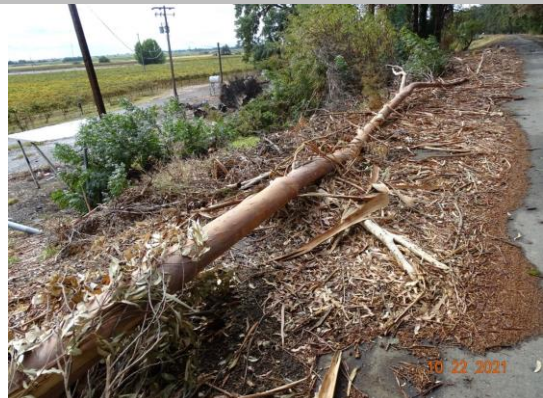
Photo 1 of 1 : SP\_2024\_NA0002\_63\_72\_20240301\_00034.jpg

LM Start	7.93	Rating **	U	Issue No.	72
LM End	7.93	Issue Type +	Ma	Location *	LS
Category	Earthen Levee			GPS Latitude/Longitude	
				Start	End
Item	Trim / Thin Trees			38.155487°	38.155487°
				-121.679997°	-121.679997°
DWR ID	DWR_NA0002_02_f_2021_72				
Comment Code					
T2 : Tree or limb.					
Inspector Comment

View of large downed tree limb on the landside hinge (Fall 2021).

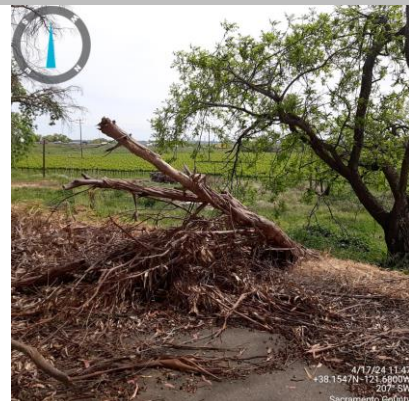
Photo 1 of 1 : SP\_2024\_NA0002\_63\_74\_20240422\_00157.jpg

LM Start	7.99	Rating **	M	Issue No.	74
LM End	7.99	Issue Type +	Ma	Location *	CR
Category	Earthen Levee			GPS Latitude/Longitude	
				Start	End
Item	Trim / Thin Trees			38.154729°	38.154729°
				-121.680439°	-121.680439°
DWR ID	DWR_NA0002_02_s_2024_74				
Comment Code					
T2 : Tree or limb.					
Inspector Comment					
Remove tree limbs from the crown LS shoulder.

View of fallen tree limbs on the crown LS shoulder. (Spring 2024)

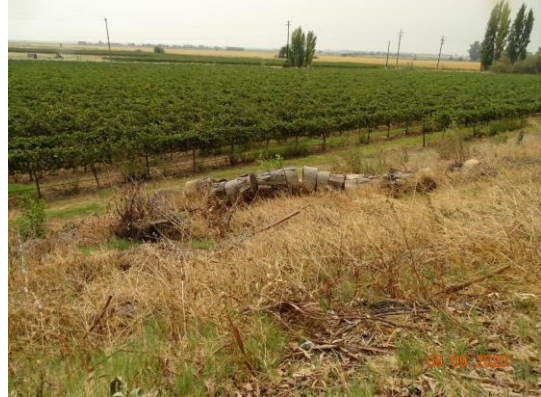
Photo 1 of 1 : SP\_2024\_NA0002\_63\_60\_20240301\_00020.jpg

LM Start	8.03	Rating **	U	Issue No.	60
LM End	8.03	Issue Type +	En	Location *	LS
Category	Earthen Levee			GPS Latitude/Longitude	
				Start	End
Item	Trim / Thin Trees			38.154176°	38.154176°
				-121.680721°	-121.680721°
DWR ID	DWR_NA0002_02_f_2020_60				
Comment Code					
T2 : Tree or limb.					
Inspector Comment					
Chopped up tree trunk on the landside slope.

View of chopped up tree trunk on the landside slope (Fall 2020).

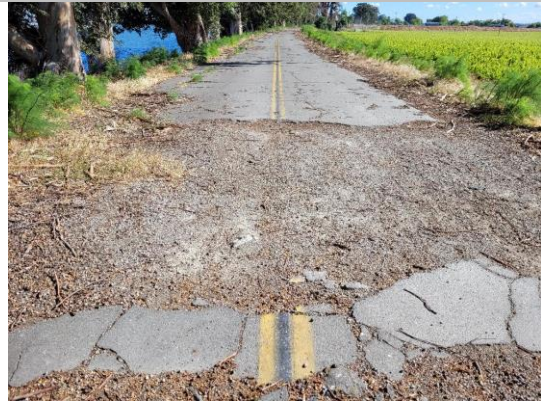
Photo 1 of 3 : UCIP\_SP\_2024\_75571\_113254.jpg

Comment Code					
Inspector Comment					
DS_ID:21926 FS_ID:75571 EP_NO: 8661 Repair Type: Non-Urgent EVAL Issue: 10, Unauthorized Modification or Non-Compliant Permit Crossing Status: Found UCIP Comments: 05/10/2022 Record remains Non-Urgent. Road pavement on the top of crown has been removed in pipe alignment. Unable to find a permit for pipe replacement or modification. No permit has been identified authorizing pipe. Need to have CVFPB review ABO and determine current owner. (O.Yakimov - DWR UCIP) 05/03/2013 Dip in crown over alignment of pipe. Good candidate for video inspection. (W.Wylie - DWR UCIP) FIELD_STRUCT_DESC: 8-inch irrigation pipe of an unknown material through the levee, 3.7 feet below the crown. Pump in pump house on the landside (LS) slope. Service pole and 30-inch concrete standpipe at the LS toe. (8-inch pipe [HLM 8.18] authorized under Automatic Board Order (ABO) issued as Permit No. 8661, 1972 - Jesse Marks). [Additional Reference(s): DWR Levee Log, 2005 (HLM 8.18). USACE Sacramento O&M Manual, Unit 102, April 1959, Revised 29 December 2016, (RM 12.2), listed as 8-inch pipe]. FS Date: 5/10/2022 1:34:45 PM

Top of Levee: View of levee crown looking upstream. Removed pavement from the top of crown in pipe alignment

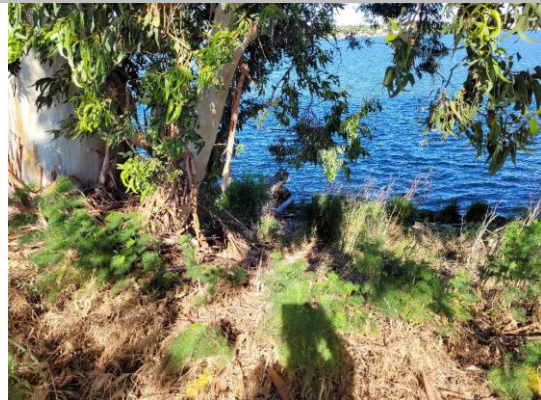
Photo 2 of 3 : UCIP\_SP\_2024\_75571\_113256.jpg

Water-Side: View of levee slope looking from crown

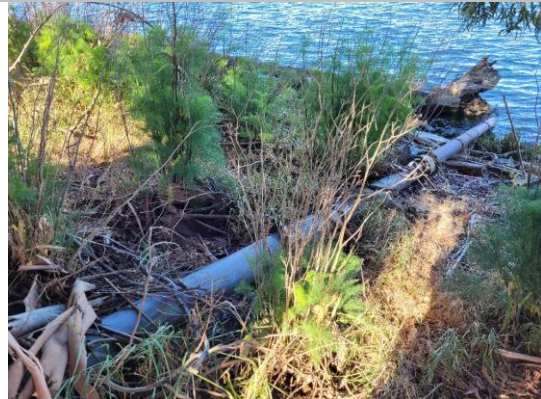
Photo 3 of 3 : UCIP\_SP\_2024\_75571\_113259.jpg

Water-Side: View of pipe at riverbank

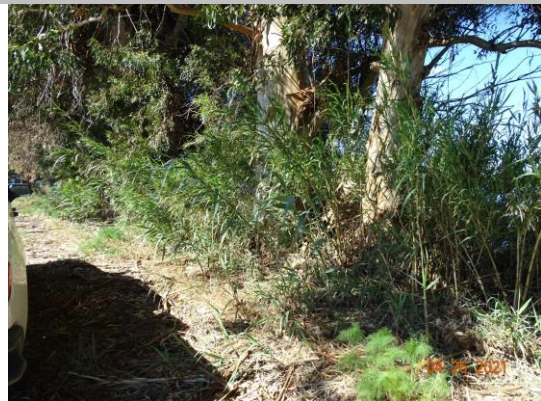
Photo 1 of 1 : SP\_2024\_NA0002\_63\_92\_20240301\_00045.jpg

LM Start	8.17	Rating **	M	Issue No.	92
LM End	8.17	Issue Type +	Ma	Location *	WS
Category	Earthen Levee			GPS Latitude/Longitude	
				Start	End
Item	Vegetation			38.152255°	38.152255°
				-121.681607°	-121.681607°
DWR ID	DWR_NA0002_02_f_2019_92				
Comment Code					
V2 : Remove the wild growth and woody vegetation other than native grasses from the levee slopes.					
Inspector Comment					
Remove arundo on the waterside slope.

View of arundo on the waterside slope (Spring 2021).

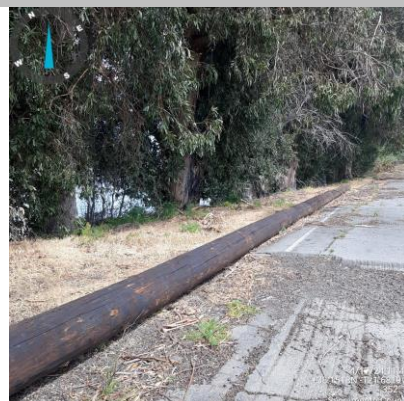
Photo 1 of 1 : SP\_2024\_NA0002\_63\_64\_20240422\_00158.jpg

LM Start	8.20	Rating **	M	Issue No.	64
LM End	8.20	Issue Type +	En	Location *	CR
Category	Earthen Levee			GPS Latitude/Longitude	
				Start	End
Item	Encroachments			38.151853°	38.151853°
				-121.681866°	-121.681866°
DWR ID	DWR_NA0002_02_s_2024_64				
Comment Code					
PO : Pole					
Inspector Comment					
Utility pole was placed on the crown's WS shoulder.

View of utility pole placed on the crown. (Spring 2024)

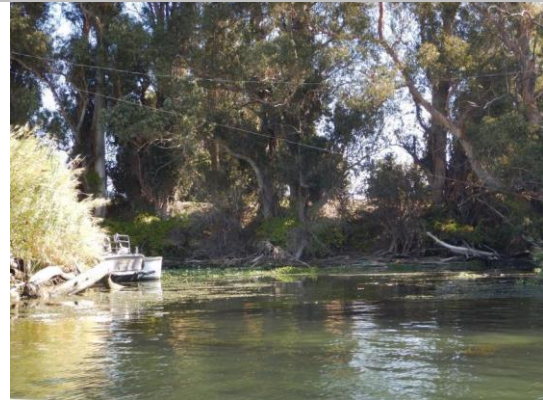
Photo 2 of 3 : SP\_2024\_NA0002\_63\_69\_20240301\_00030.jpg

Noticed scour at LM 8.37 and a tree with exposed roots. 2018 Site ID: SAC 12.1 L  
Status: Critical  
2018 Field Notes: No observed change.  
Site History: 2010 - Small inlet area behind a man-built spit. Bank is slumping and could possibly be fixed with maintenance. 2011 - Site continues to worsen. 2015 - Upgraded to CRITICAL. 2016 - Site continues to get worse. 2017 - Continues to worsen and threaten the road.

USACE 2018 Erosion Photo #1

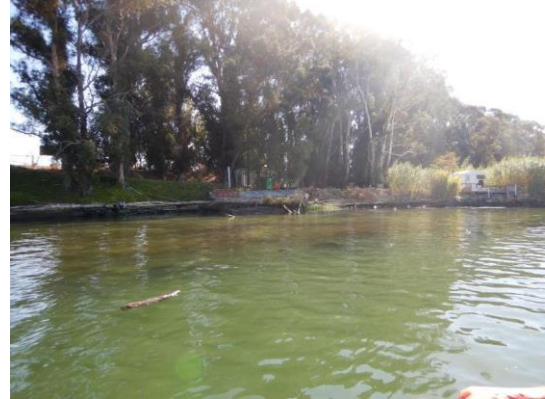
Photo 3 of 3 : SP\_2024\_NA0002\_63\_69\_20240301\_00031.jpg

LM Start	8.20	Rating **	U	Issue No.	69 (cont)
LM End	8.42	Issue Type +	Ma	Location *	WS
Category	Supplemental			GPS Latitude/Longitude	
				Start	End
Item	2018 USACE Erosion Survey			38.151867°	38.148711°
				-121.682201°	-121.682790°
DWR ID	DWR_NA0002_02_s_ 2022_69

USACE 2018 Erosion Photo #2

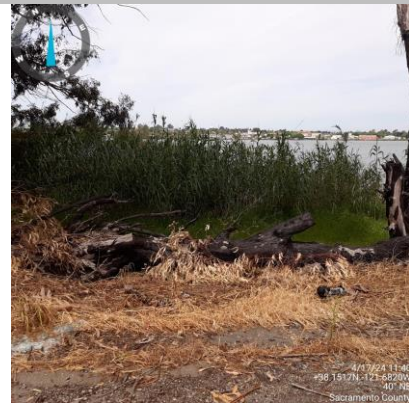
Photo 1 of 1 : SP\_2024\_NA0002\_63\_63\_20240422\_00159.jpg

LM Start	8.21	Rating **	M	Issue No.	63
LM End	8.21	Issue Type +	Ma	Location *	WS
Category	Earthen Levee			GPS Latitude/Longitude	
				Start	End
Item	Trim / Thin Trees			38.151680°	38.151680°
				-121.681896°	-121.681896°
DWR ID	DWR_NA0002_02_s_ 2024_63				
Comment Code					
T3 : Fallen tree with root ball.					
Inspector Comment					
Remove fallen tree from crown.

View of fallen tree to be removed. (Spring 2024)

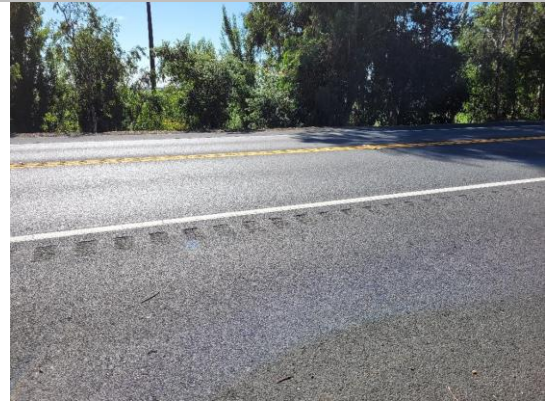
Photo 1 of 3 : UCIP\_SP\_2024\_75573\_113263.jpg

Comment Code					
Inspector Comment					
DS_ID:21927 FS_ID:75573 EP_NO: N/A Repair Type: Non-Urgent EVAL Issue: 6, Levee Damage or Threat for Levee Damage Crossing Status: Not Found UCIP Comments: 05/10/2022 Record updated from No Action Needed to Non-Urgent. Crossing not found. Erosion or subsidence on waterside levee slope in possible pipe alignment. Geophysical results did not confirm presence of pipe through levee. Record will remain in UCIP's inspection records until future Levee Improvement Project can confirm no crossing was found through the levee. Unauthorized encroachment recorded in Levee Log. (O.Yakimov - DWR UCIP) FIELD_STRUCT_DESC: 6-inch inactive pipe of an unknown material or purpose through the levee, 6.7 feet below the crown. [Additional Reference(s): DWR Levee Log, 2005 (HLM 8.41), listed as inactive 6-inch pipe]. FS Date: 5/10/2022 1:43:55 PM

Top of Levee: View of levee crown looking towards landside

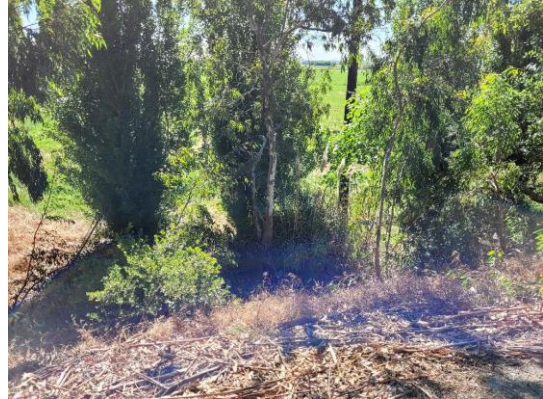
Photo 2 of 3 : UCIP\_SP\_2024\_75573\_113262.jpg

Land-Side: View of levee slope looking from crown

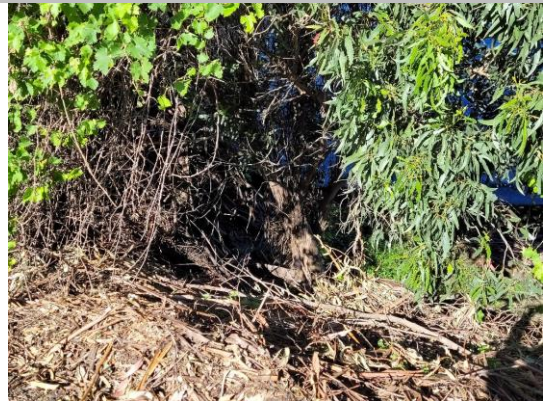
Photo 3 of 3 : UCIP\_SP\_2024\_75573\_113264.jpg

Water-Side: View of levee slope looking from crown

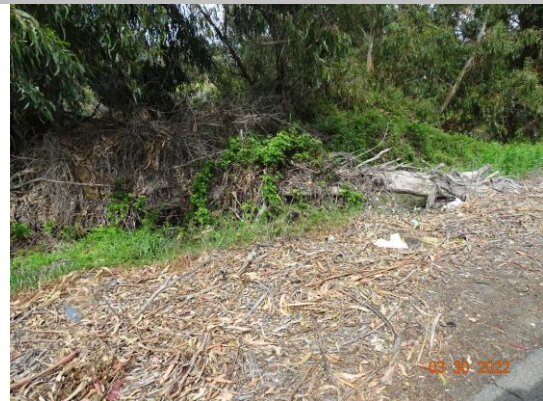
Photo 1 of 1 : SP\_2024\_NA0002\_63\_77\_20240301\_00035.jpg

LM Start	8.44	Rating **	M	Issue No.	77
LM End	8.44	Issue Type +	Ma	Location *	WS
Category	Earthen Levee			GPS Latitude/Longitude	
				Start	End
Item	Trim / Thin Trees			38.148405°	38.148405°
				-121.682580°	-121.682580°
DWR ID	DWR_NA0002_02_s_2022_77				
Comment Code					
T3 : Fallen tree with root ball.					
Inspector Comment

View of downed trees needing removal on the waterside slope (Spring 2022).

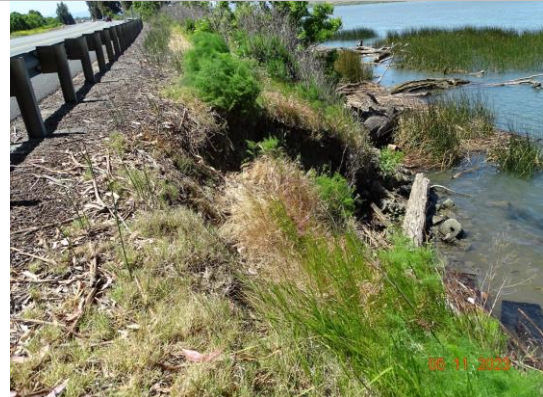
Photo 1 of 4 : SP\_2024\_NA0002\_63\_68\_20240301\_00025.jpg

Comment Code					
Inspector Comment					
Spring 2023: Noticed new, 20-ft long sloughing at LM 8.97. Two previously noticed locations of erosion/undermining both at LM 9.10 seem to not have worsened much since last fall. 2018 Site ID: SAC 11.2 L					
Status: Critical					
2018 Field Notes: Erosion is now into levee crown					
Site History: 2008 - Erosion causing vertical bank at the highway on top of levee. The whole bank along the highway should be repaired. 2009 - Minimal new erosion. 2011 - Bank continues to slowly erode. 2012 - Upgrade to CRITICAL, new erosion since lat year and steeper slopes in sections. 2015 - Road foundation and cables exposed. Extremely large tree with exposed roots looks likely to fail and take out a significant portion of the levee. 2016 - Site continues to erode. 2017 - New slump section. Erosion under the road has enlarged.

View of the sloughing at LM 8.97 (Spring 2023).

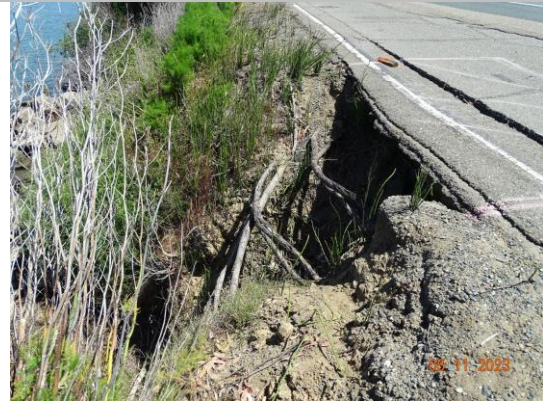
Photo 2 of 4 : SP\_2024\_NA0002\_63\_68\_20240301\_00026.jpg

Erosion at LM 9.10 by turnout (Spring 2023).

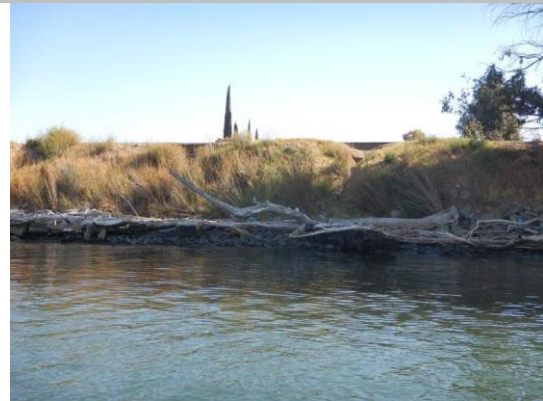
Photo 3 of 4 : SP\_2024\_NA0002\_63\_68\_20240301\_00027.jpg

USACE 2018 Erosion Photo #1

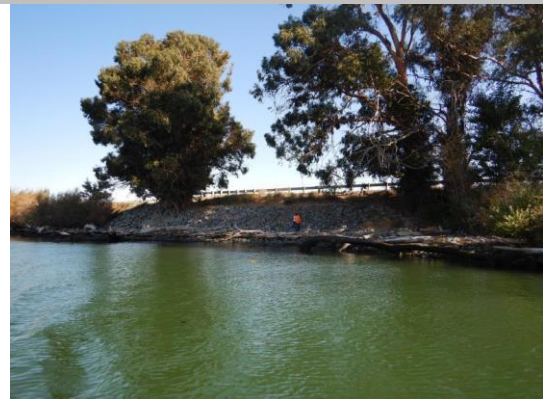
Photo 4 of 4 : SP\_2024\_NA0002\_63\_68\_20240301\_00028.jpg

USACE 2018 Erosion Photo #2

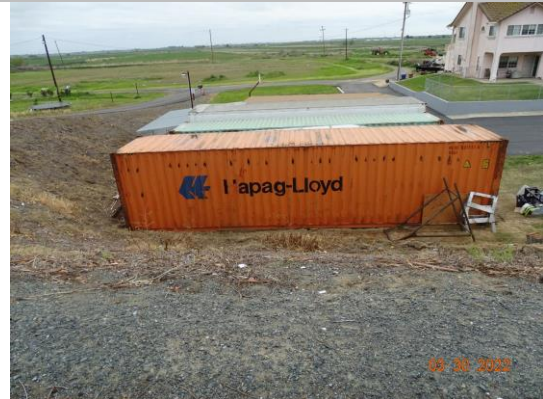
Photo 1 of 1 : SP\_2024\_NA0002\_63\_87\_20240301\_00042.jpg

LM Start	9.14	Rating **	M	Issue No.	87
LM End	9.14	Issue Type +	En	Location *	LS
Category	Earthen Levee			GPS Latitude/Longitude	
				Start	End
Item	Encroachments			38.138718°	38.138718°
				-121.685925°	-121.685925°
DWR ID	DWR_NA0002_02_s_2022_87				
Comment Code					
BU : Building					
Inspector Comment					
Shipping container at landside toe.

View of shipping container placed at landside toe (Spring 2022).

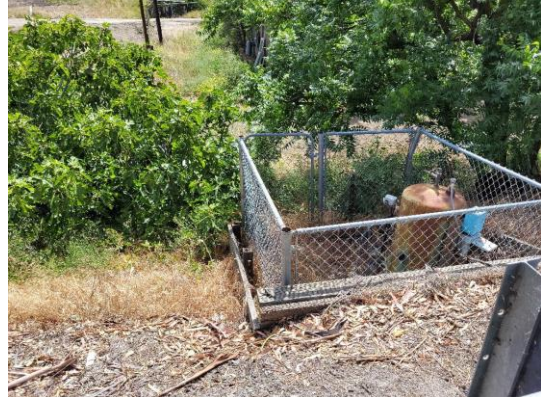
Photo 1 of 3 : UCIP\_SP\_2024\_75591\_113323.jpg

Comment Code					
Inspector Comment					
DS_ID:21930 FS_ID:75591 EP_NO: 8006 Repair Type: Non-Urgent EVAL Issue: 10, Unauthorized Modification or Non-Compliant Permit Crossing Status: Found UCIP Comments: 05/10/2022 Record updated from No Action Needed to Non-Urgent. Pumphouse has been removed from levee slope, unable to find a permit for modification. No permit has been identified authorizing original 10-inch pipe through the levee. (O.Yakimov - DWR UCIP) FIELD_STRUCT_DESC: 8-inch steel irrigation pipe sleeved through 10-inch steel pipe through the levee 3.8 feet below the crown. Pump in pump house on the landside (LS), not found, slant pump on levee slope. 2-inch galvanized electrical conduit at same location. (8-inch pipe through 10-inch pipe sleeving authorized under Permit No. 8006, 1972 - Frank Emmolo). (Emergency partial replacement and extension of pipe on waterside slope authorized under Permit No. 18239, 2007 - Frank and Alba Emmolo 1995 Trust). [Additional Reference(s): DWR Levee Log, 2005 (HLM 9.26), listed as 8-inch pipe sleeved through 10-inch pipe.USACE Sacramento O&M Manual, Unit 102, April 1959, Revised 29 December 2016, (RM 11.1), listed as 10-inch siphon pipe]. FS Date: 5/10/2022 11:16:36 AM

Land-Side: View of levee slope looking from crown

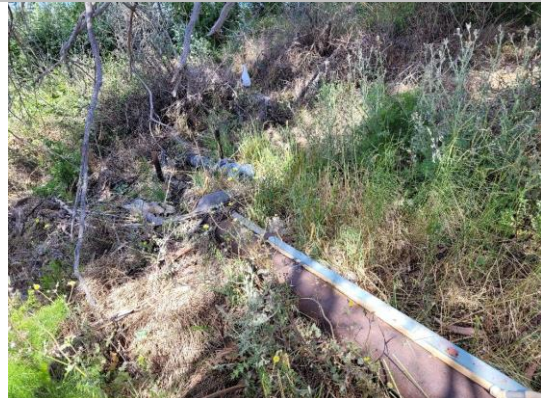
Photo 2 of 3 : UCIP\_SP\_2024\_75591\_113321.jpg

Water-Side: Pipe, electrical conduit, and pump on levee slope

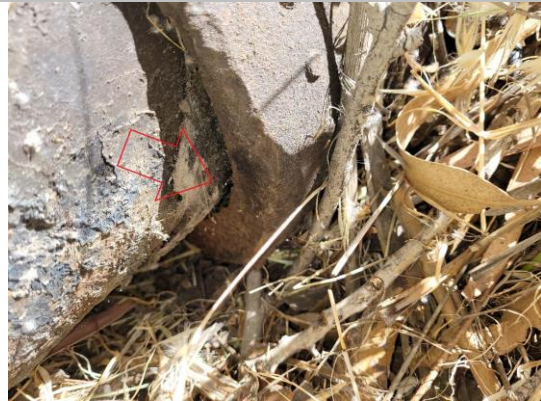
Photo 3 of 3 : UCIP\_SP\_2024\_75591\_113319.jpg

Water-Side: Sealed annular space between pipes visible on levee slope

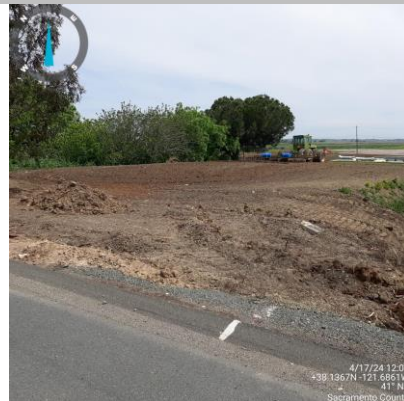
Photo 1 of 1 : SP\_2024\_NA0002\_63\_36\_20240422\_00160.jpg

LM Start	9.27	Rating **	U	Issue No.	36
LM End	9.27	Issue Type +	En	Location *	LS
Category	Earthen Levee			GPS Latitude/Longitude	
				Start	End
Item	Encroachments			38.136794°	38.136794°
				-121.686156°	-121.686156°
DWR ID	DWR_NA0002_02_s_2023_36				
Comment Code					
MA : Material					
Inspector Comment					
Grading activities on the LS encroaching onto lower slope and toe.

View of the fill material on the LS slope and toe. (Spring 2024)

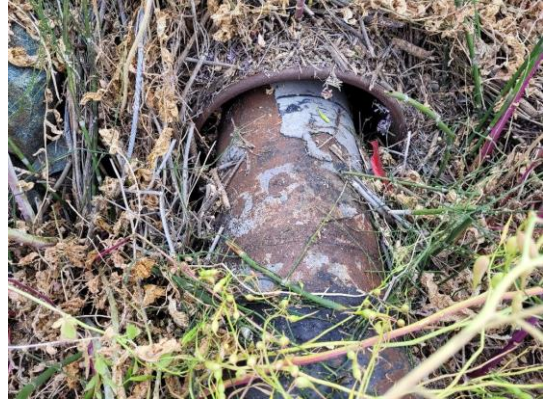
Photo 3 of 3 : UCIP\_SP\_2024\_75625\_113351.jpg

Water-Side: Not grouted annular space between pipes on levee shoulder

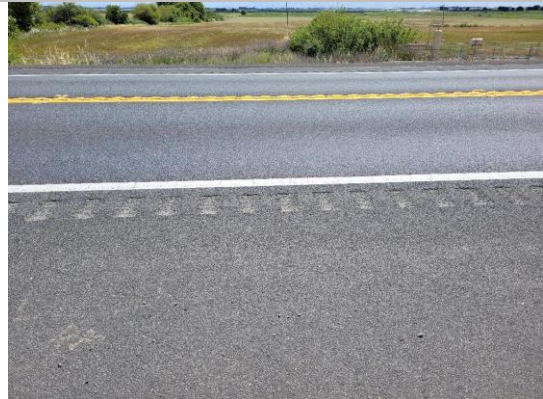
Photo 1 of 3 : UCIP\_SP\_2024\_75626\_113358.jpg

DS\_ID:21932  
FS\_ID:75626  
EP\_NO: N/A  
Repair Type: Non-Urgent  
EVAL Issue:  
Crossing Status: Not Found  
UCIP Comments: 05/10/2022 Record updated from No Action Needed to Non-Urgent. Crossing not found. Geophysical results did not confirm presence of pipe through levee. Record will remain in UCIP's inspection records until future Levee Improvement Project can confirm no crossing was found through the levee. No permit has been identified authorizing pipe. (O.Yakimov - DWR UCIP)

FIELD\_STRUCT\_DESC: 12-inch drainage pipe of an unknown material through the levee, 4 feet below the crown. Open on both ends.  
[Additional Reference(s): DWR Levee Log, 2005 (HLM 9.39). USACE Sacramento O&M Manual, Unit 102, April 1959, Revised 29 December 2016, (RM 10.9), listed as abandoned 12-inch pipe].  
FS Date: 5/10/2022 2:26:15 PM

Top of Levee: View of levee crown looking from waterside

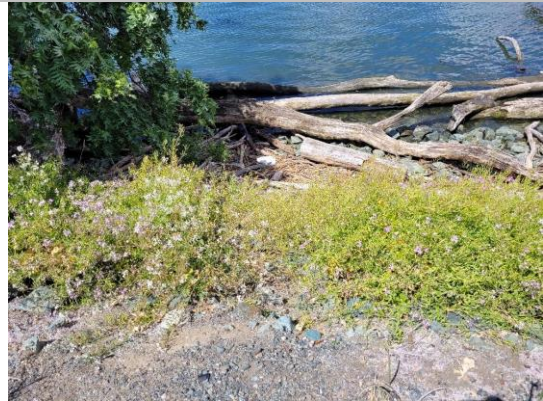
Photo 2 of 3 : UCIP\_SP\_2024\_75626\_113357.jpg

Water-Side: View of levee slope looking from crown

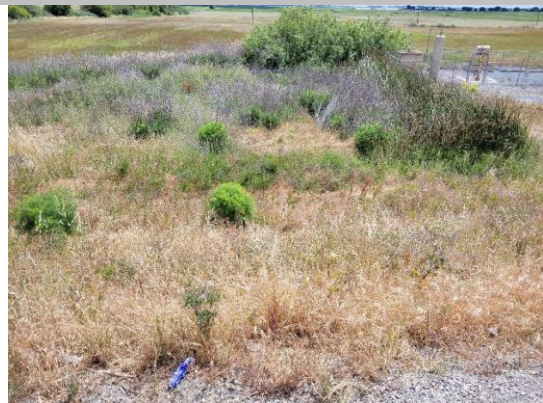
Photo 3 of 3 : UCIP\_SP\_2024\_75626\_113359.jpg

Land-Side: View of levee slope looking from crown

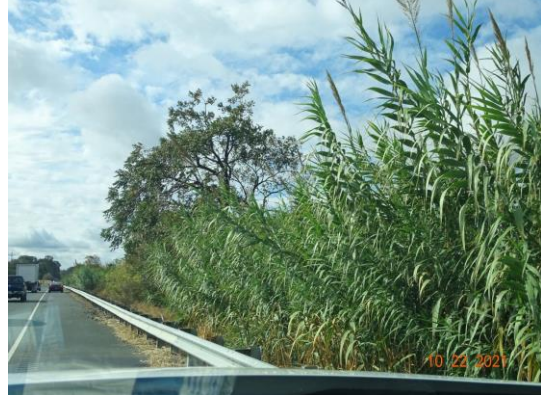
Photo 1 of 1 : SP\_2024\_NA0002\_63\_89\_20240301\_00043.jpg

View looking downstream at arundo on the waterside slope (Fall 2021).

LM Start	10.54	Rating **	U	Issue No.	89
LM End	10.95	Issue Type +	Ma	Location *	WS
Category	Earthen Levee			GPS Latitude/Longitude	
				Start	End
Item	Vegetation			38.119445°	38.114375°
				-121.692811°	-121.696559°
DWR ID	DWR_NA0002_02_f_2021_89				
Comment Code					
V2 : Remove the wild growth and woody vegetation other than native grasses from the levee slopes.					
Inspector Comment					
Trim back arundo.
