**Flood Control Project Maintenance  
Levee Inspections**

## Maintenance Issue Types Only, Levee Inspection Report By Mile - Spring 2015

### Brannan Andrus Levee Maintenance District

Waterway	Bank	Unit Miles	Inspection Start/End	Inspector
Unit No. 01 Georgiana Slough	Right	6.01	03/11/2015 03/11/2015	Richard Willoughby

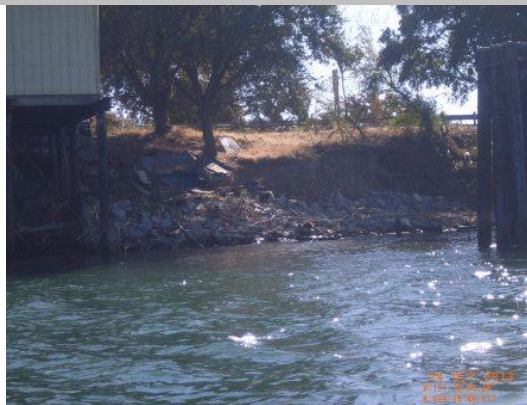
Photo 1 of 2 : SP\_2015\_NA0002\_63\_37\_20150309\_00032.jpg

LM Start	3.37	Rating **	U	Issue No.	37
LM End	3.56	Issue Type +	Ma	Location *	WS
Category	Supplemental			GPS Latitude/Longitude	
				Start	End
Item	USACE Erosion Survey			38.162641 °	38.162828 °
				-121.612800 °	-121.612623 °
DWR ID	DWR_NA0002_02_f _ 2014_37				
Action/Comments					
Inspector Comments: 2009 - Fluvial erosion, into the levee slope, close to vertical bank with roadway on top. Pilings that were once at the bankline are now 30 ft out. 2010 - Very steep slope with slumps and overturned trees. 2011 - Upgraded to CRITICAL. Sections of vertical slope with highway on top. Heavy vegetation in front of most of the erosion pockets. Structures built into the levee on the upstream end. 2012 - Site continues to worsen. 2013: Some rock added on the upstream end, but site remains critical. [2013 Site ID: SAC_17-2_L]

USACE 2013 Photo #1

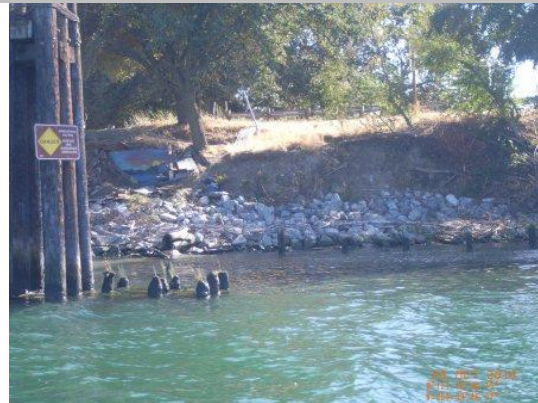
Photo 2 of 2 : SP\_2015\_NA0002\_63\_37\_20150309\_00033.jpg

LM Start	3.37	Rating **	U	Issue No.	37 (cont)
LM End	3.56	Issue Type +	Ma	Location *	WS
Category	Supplemental			GPS Latitude/Longitude	
				Start	End
Item	USACE Erosion Survey			38.162641 °	38.162828 °
				-121.612800 °	-121.616263 °
DWR ID	DWR_NA0002_02_f_2014_37				
Action/Comments					
Inspector Comments: 2009 - Fluvial erosion, into the levee slope, close to vertical bank with roadway on top. Pilings that were once at the bankline are now 30 ft out. 2010 - Very steep slope with slumps and overturned trees. 2011 - Upgraded to CRITICAL. Sections of vertical slope with highway on top. Heavy vegetation in front of most of the erosion pockets. Structures built into the levee on the upstream end. 2012 - Site continues to worsen. 2013: Some rock added on the upstream end, but site remains critical. [2013 Site ID: SAC_17-2_L]

USACE 2013 Photo #2

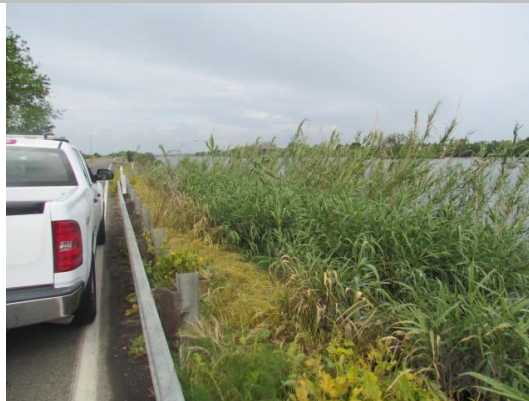
Photo 1 of 1 : SP\_2015\_NA0002\_63\_11\_20150309\_00011.jpg

LM Start	5.65	Rating **	A/W	Issue No.	11
LM End	5.69	Issue Type +	Ma	Location *	WS
Category	Earthen Levee			GPS Latitude/Longitude	
				Start	End
Item	Vegetation			38.172308 °	38.172497 °
				-121.651552 °	-121.652243 °
DWR ID	DWR_NA0002_02_s _ 2012_11				
Action/Comments					
Remove the wild growth other than native grasses from the levee slopes.					
Inspector Comments: Bamboo on waterward slope.

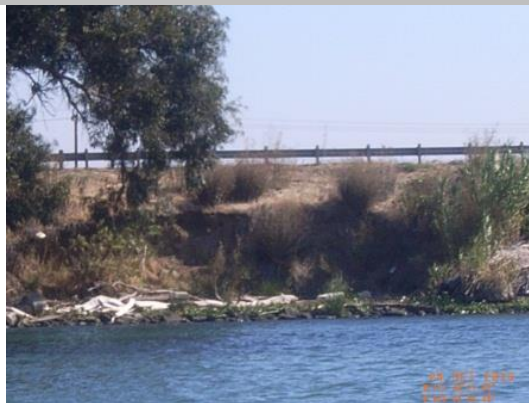
Photo 1 of 1 : SP\_2015\_NA0002\_63\_20\_20150309\_00020.jpg

LM Start	6.98	Rating **	M	Issue No.	20
LM End	7.04	Issue Type +	Ma	Location *	WS
Category	Supplemental			GPS Latitude/Longitude	
				Start	End
Item	USACE Erosion Survey			38.166583 °	38.165794 °
				-121.670684 °	-121.671014 °
DWR ID	DWR_NA0002_02_f_2014_20				
Action/Comments					
Inspector Comments: 2011 - Large section of bank slumped off. 2013: No observed changes. [2013 Site ID: SAC_13-6_L]

USACE 2013 Photo #1

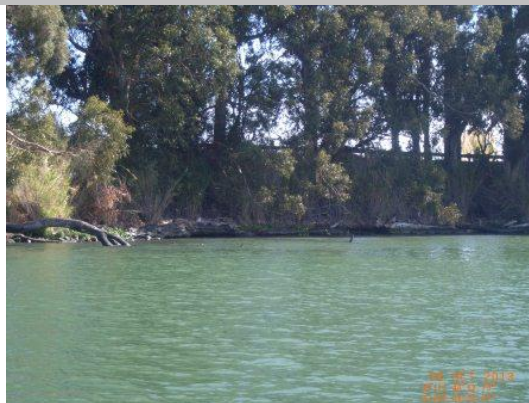
Photo 1 of 1 : SP\_2015\_NA0002\_63\_19\_20150309\_00019.jpg

LM Start	8.20	Rating **	M	Issue No.	19
LM End	8.42	Issue Type +	Ma	Location *	WS
Category	Supplemental			GPS Latitude/Longitude	
				Start	End
Item	USACE Erosion Survey			38.151867 °	38.148711 °
				-121.682201 °	-121.682790 °
DWR ID	DWR_NA0002_02_f_2014_19				
Action/Comments					
Inspector Comments: 2010 - Small inlet area behind a man-built spit. Bank is slumping and could possibly be fixed with maintenance. 2011 - Site continues to worsen. 2013: No observed changes. [2013 Site ID: SAC_12-1_L]

USACE 2013 Photo #1

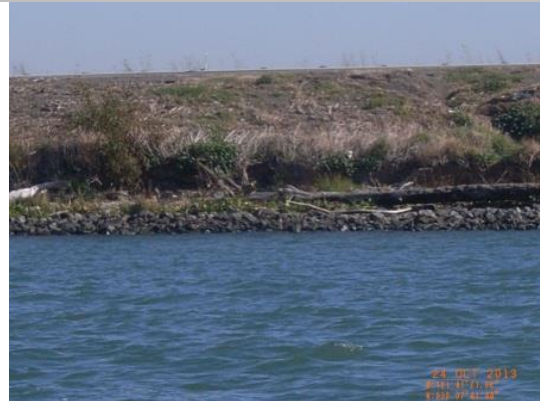
Photo 1 of 1 : SP\_2015\_NA0002\_63\_17\_20150309\_00017.jpg

LM Start	9.78	Rating **	M	Issue No.	17
LM End	9.93	Issue Type +	Ma	Location *	WS
Category	Supplemental			GPS Latitude/Longitude	
				Start	End
Item	USACE Erosion Survey			38.129722 °	38.127672 °
				-121.687468 °	-121.688646 °
DWR ID	DWR_NA0002_02_f_2014_17				
Action/Comments					
Inspector Comments: 2004 - Wave wash pockets approximately 100 ft long with new full bank rock between the pockets. 2005 - Spot repairs, but toe is still eroding in several places. 2006 - Low vertical bank along roadway. 2007 - A PL 84-99 repair was constructed, it cover the majority of the site with the exception of the upstream 150 to 200 ft and the downstream 250 ft, therefore it is being kept in the inventory. 2009 - Minimal new erosion. 2010 - Outboard berm looks good, but the banks are still very steep. 2011 - While the outboard berm is protecting against wave wash, bank still has slumping issues. 2013: No observed changes. [2013 Site ID: SAC_10-8_L]

USACE 2013 Photo #1
