**Flood Control Project Maintenance
Levee Inspections**

Maintenance Issue Types Only, Levee Inspection Report By Mile - Spring 2016

Brannan Andrus Levee Maintenance District

Waterway	Bank	Unit Miles	Inspection Start/End	Inspector
Unit No. 01 Georgiana Slough	Right	6.01	03/22/2016 03/22/2016	Richard Willoughby

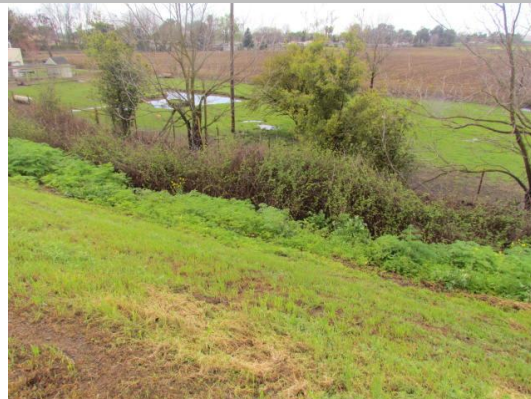
Photo 2 of 2 : SP_2016_NA0002_62_26_20160308_00028.jpg

LM Start	2.20	Rating **	M	Issue No.	26 (cont)	
LM End	2.22	Issue Type +	Ma	Location *	LS	
Category	Earthen Levee			GPS Latitude/Longitude		
				Start		End
Item	Vegetation			38.164138 °		38.163797 °
				-121.584078 °		-121.584225 °
DWR ID	DWR_NA0002_01_s _ 2013_26					
Comment Code						
V2 : Remove the wild growth other than native grasses from the levee slopes.						
Inspector Comment						
Control wild growth at landside toe.

Looking southwest at dense vegetation at landward toe.

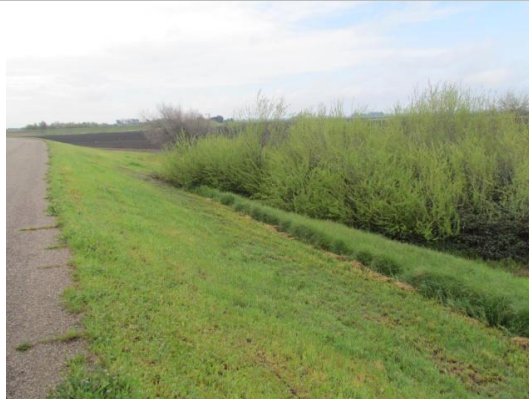
Photo 2 of 4 : SP_2016_NA0002_62_55_20160308_00049.jpg

LM Start	3.00	Rating **	U	Issue No.	55 (cont)
LM End	3.00	Issue Type +	Ma	Location *	LS

Looking southwest at dense vegetation at landward toe. (Spring 2015)

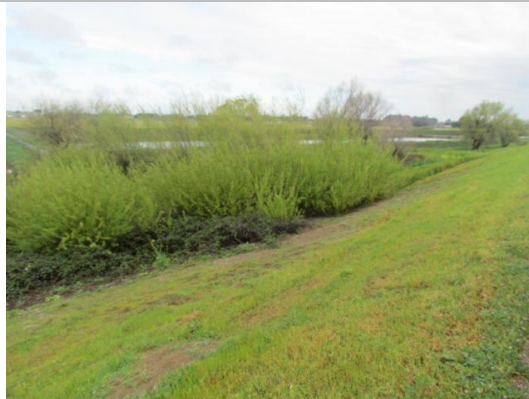
Photo 3 of 4 : SP_2016_NA0002_62_55_20160308_00050.jpg

Looking north at dense vegetation withing fifteen feet of landward toe.

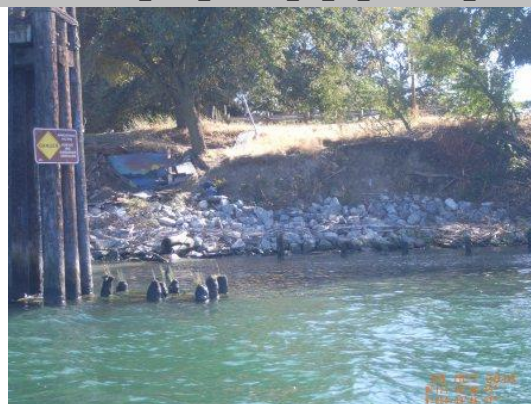
Photo 2 of 2 : SP_2016_NA0002_63_34_20160308_00033.jpg

USACE 2013 Photo #2

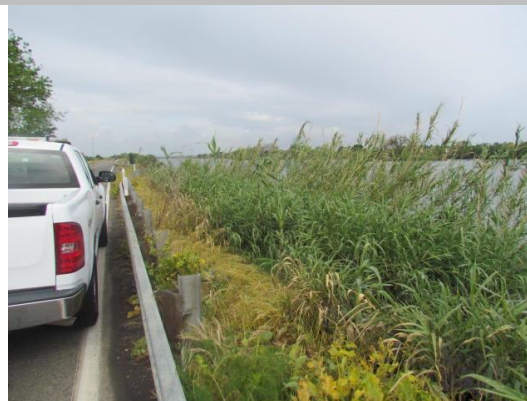
Photo 1 of 1 : SP_2016_NA0002_63_11_20160308_00011.jpg

LM Start	5.65	Rating **	M	Issue No.	11
LM End	5.69	Issue Type +	Ma	Location *	WS
Category	Earthen Levee			GPS Latitude/Longitude	
				Start	End
Item	Vegetation			38.172308 °	38.172497 °
				-121.651552 °	-121.652243 °
DWR ID	DWR_NA0002_02_s _ 2012_11				
Comment Code					
V2 : Remove the wild growth other than native grasses from the levee slopes.					
Inspector Comment					
Bamboo on waterward slope.

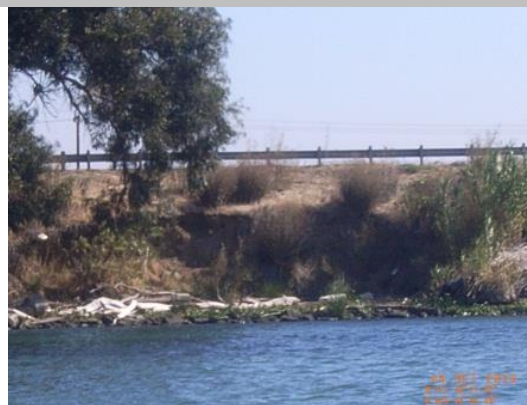
Photo 1 of 1 : SP_2016_NA0002_63_23_20160308_00022.jpg

LM Start	6.98	Rating **	M	Issue No.	23
LM End	7.04	Issue Type +	Ma	Location *	WS
Category	Supplemental			GPS Latitude/Longitude	
				Start	End
Item	2015 USACE Erosion Survey, DRAFT			38.166583 °	38.165794 °
				-121.670684 °	-121.671014 °
DWR ID	DWR_NA0002_02_s _ 2016_23				
Comment Code					
Inspector Comment					
2011 - Large section of bank slumped off. 2015: No observed changes. [2015 Site ID: SAC_13-6_L]

USACE 2013 Photo #1

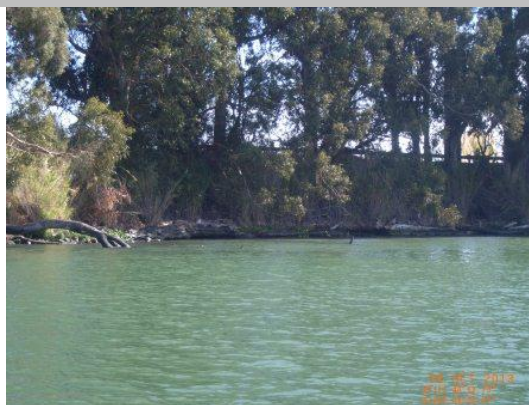
Photo 1 of 1 : SP_2016_NA0002_63_17_20160308_00017.jpg

LM Start	8.20	Rating **	U	Issue No.	17
LM End	8.42	Issue Type +	Ma	Location *	WS
Category	Supplemental			GPS Latitude/Longitude	
				Start	End
Item	2015 USACE Erosion Survey, DRAFT			38.151867 °	38.148711 °
				-121.682201 °	-121.682790 °
DWR ID	DWR_NA0002_02_s_2016_17				
Comment Code					
Inspector Comment					
2010 - Small inlet area behind a man-built spit. Bank is slumping and could possibly be fixed with maintenance. 2011 - Site continues to worsen. 2015: Upgraded to Critical [2015 Site ID: SAC_12-1_L]

USACE 2013 Photo #1

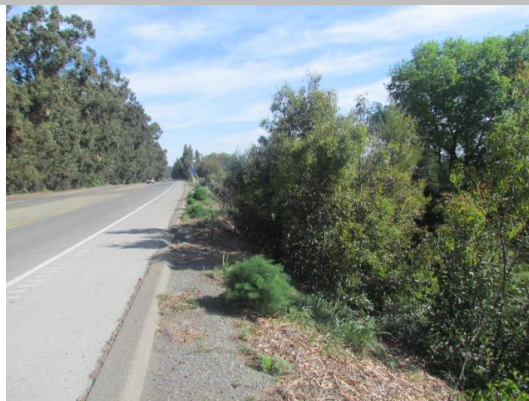
Photo 2 of 2 : SP_2016_NA0002_63_48_20160308_00045.jpg

LM Start	8.65	Rating **	U	Issue No.	48 (cont)	
LM End	8.86	Issue Type +	Ma	Location *	LS	
Category	Earthen Levee			GPS Latitude/Longitude		
				Start		End
Item	Trim / Thin Trees			38.145368 °		38.142430 °
				-121.683072 °		-121.683978 °
DWR ID	DWR_NA0002_02_s _ 2013_48					
Comment Code						
T1 : Trim trees to at least five feet above ground level.						
Inspector Comment

Looking north at dense trees on landward slope and toe.

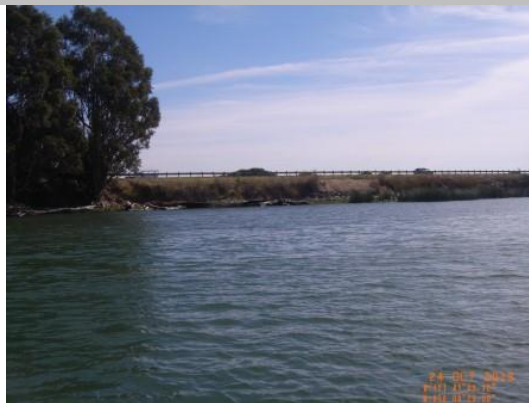
Photo 1 of 1 : SP_2016_NA0002_63_19_20160308_00018.jpg

LM Start	8.96	Rating **	U	Issue No.	19
LM End	9.18	Issue Type +	Ma	Location *	WS
Category	Supplemental			GPS Latitude/Longitude	
				Start	End
Item	2015 USACE Erosion Survey, DRAFT			38.141399 °	38.138158 °
				-121.685346 °	-121.686531 °
DWR ID	DWR_NA0002_02_s _ 2016_19				
Comment Code					
Inspector Comment					
2008 - Erosion causing vertical bank at the highway on top of levee. The whole bank along the highway should be repaired. 2009 - Minimal new erosion. 2011 - Bank continues to slowly erode. 2012 - Upgrade to critical, new erosion since lat year and steeper slopes in sections. 2015: Road foundation and cables exposed. Extremely large tree with exposed roots looks likely to fail and take out a significant portion of the levee. [2015 Site ID: SAC_11-2_L]

USACE 2013 Photo #1

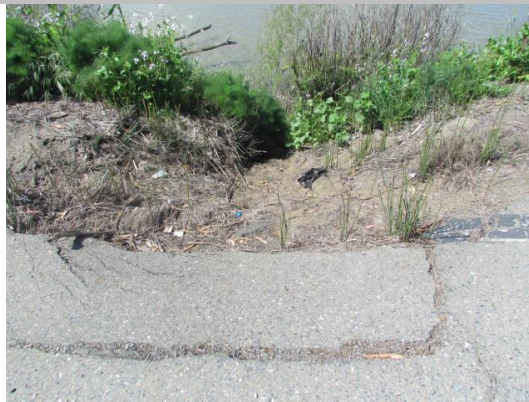
Photo 1 of 3 : SP_2016_NA0002_63_115_20160323_00175.jpg

LM Start	9.15	Rating **	M	Issue No.	115
LM End	9.15	Issue Type +	Ma	Location *	WS
Category	Earthen Levee			GPS Latitude/Longitude	
				Start	End
Item	Erosion / Bank Caving			38.138510 °	38.138510 °
				-121.686124 °	-121.686124 °
DWR ID	DWR_NA0002_02_s _ 2016_115				
Comment Code					
E1 : Note and monitor erosion site.					
Inspector Comment					
Erosion on waterward shoulder along highway appears to be foot erosion. But should be monitored.

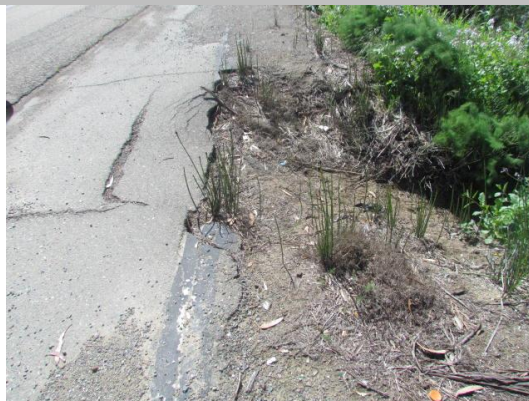
Photo 2 of 3 : SP_2016_NA0002_63_115_20160323_00174.jpg

LM Start	9.15	Rating **	M	Issue No.	115 (cont)	
LM End	9.15	Issue Type +	Ma	Location *	WS	
Category	Earthen Levee			GPS Latitude/Longitude		
				Start		End
Item	Erosion / Bank Caving			38.138510 °		38.138510 °
				-121.686124 °		-121.686124 °
DWR ID	DWR_NA0002_02_s _ 2016_115					
Comment Code						
E1 : Note and monitor erosion site.						
Inspector Comment						
Erosion on waterward shoulder along highway appears to be foot erosion. But should be monitored.

Looking north at erosion on waterward shoulder.

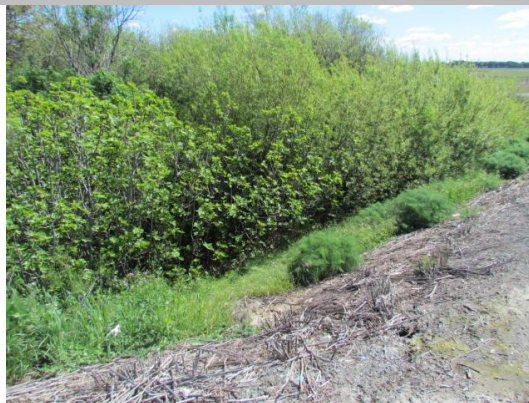
Photo 2 of 2 : SP_2016_NA0002_63_116_20160323_00178.jpg

LM Start	9.32	Rating **	U	Issue No.	116 (cont)	
LM End	9.35	Issue Type +	Ma	Location *	LS	
Category	Earthen Levee			GPS Latitude/Longitude		
				Start		End
Item	Vegetation			38.136024 °		38.135699 °
				-121.686206 °		-121.686170 °
DWR ID	DWR_NA0002_02_s _ 2016_116					
Comment Code						
V2 : Remove the wild growth other than native grasses from the levee slopes.						
Inspector Comment						
Dense vegetation on landward slope and toe.

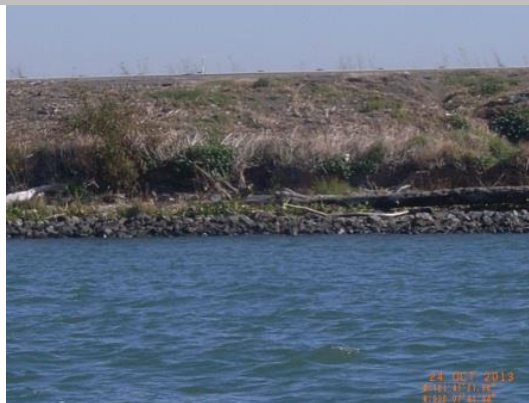
Photo 1 of 1 : SP_2016_NA0002_63_21_20160308_00020.jpg

Comment Code					
Inspector Comment					
2004 - Wave wash pockets approximately 100 ft long with new full bank rock between the pockets. 2005 - Spot repairs, but toe is still eroding in several places. 2006 - Low vertical bank along roadway. 2007 - A PL 84-99 repair was constructed, it cover the majority of the site with the exception of the upstream 150 to 200 ft and the downstream 250 ft, therefore it is being kept in the inventory. 2009 - Minimal new erosion. 2010 - Outboard berm looks good, but the banks are still very steep. 2011 - While the outboard berm is protecting against wave wash, bank still has slumping issues. 2015: No observed changes. [2015 Site ID: SAC_10-8_L]

USACE 2013 Photo #1

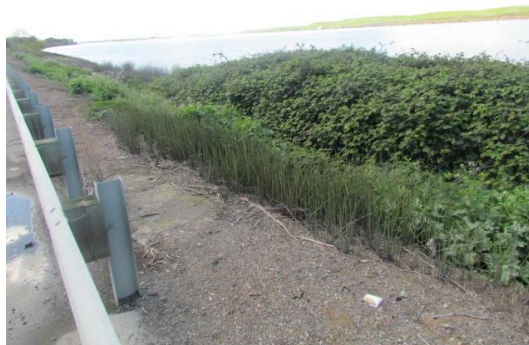
Photo 2 of 2 : SP_2016_NA0002_63_117_20160323_00180.jpg

LM Start	10.17	Rating **	U	Issue No.	117 (cont)	
LM End	10.19	Issue Type +	Ma	Location *	WS	
Category	Earthen Levee			GPS Latitude/Longitude		
				Start		End
Item	Vegetation			38.124372 °		38.124097 °
				-121.690045 °		-121.690186 °
DWR ID	DWR_NA0002_02_s_2016_117					
Comment Code						
V2 : Remove the wild growth other than native grasses from the levee slopes.						
Inspector Comment						
Dense vegetation (vines) on waterward slope.
