**Flood Control Project Maintenance
Levee Inspections**

Maintenance Issue Types Only, Levee Inspection Report By Mile - Spring 2017

Brannan Andrus Levee Maintenance District

Waterway	Bank	Unit Miles	Inspection Start/End	Inspector
Unit No. 01 Georgiana Slough	Right	6.01	03/21/2017 03/21/2017	Richard Willoughby

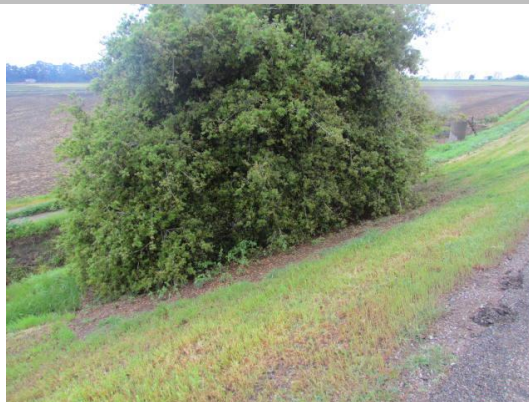
Photo 1 of 3 : SP_2017_NA0002_62_25_20170314_00020.jpg

Looking northwest at untrimmed tree at landward toe. (Spring 2015)

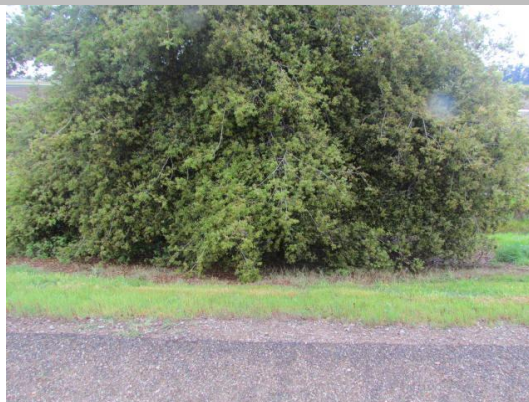
Photo 2 of 3 : SP_2017_NA0002_62_25_20170314_00021.jpg

Looking west at untrimmed tree at landward toe. (Spring 2015)

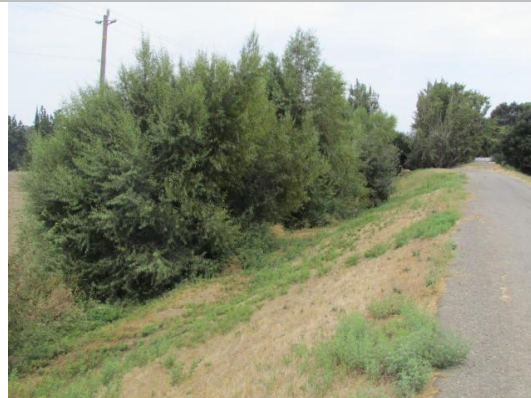
Photo 1 of 2 : SP_2017_NA0002_62_28_20170314_00025.jpg

LM Start	2.45	Rating **	U	Issue No.	28
LM End	2.49	Issue Type +	Ma	Location *	LS
Category	Earthen Levee			GPS Latitude/Longitude	
				Start	End
Item	Vegetation			38.160805 °	38.160281 °
				-121.585782 °	-121.586007 °
DWR ID	DWR_NA0002_01_s _ 2013_28				
Comment Code					
V2 : Remove the wild growth other than native grasses from the levee slopes.					
Inspector Comment					
Dense vegetation and wild roses on landside slope and toe.

Look west at dense vegetation at landward toe. (Spring 2016)

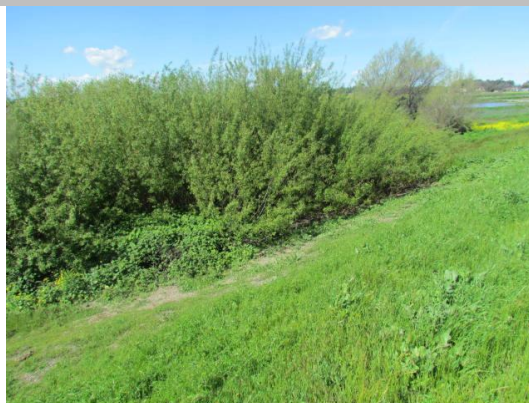
Photo 1 of 4 : SP_2017_NA0002_62_55_20170314_00041.jpg

Looking northwest at dense vegetation at landward toe. (Spring 2016)

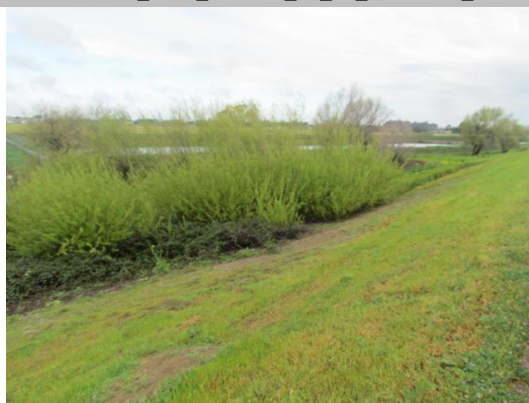
Photo 3 of 4 : SP_2017_NA0002_62_55_20170314_00043.jpg

Looking north at dense vegetation withing fifteen feet of landward toe.

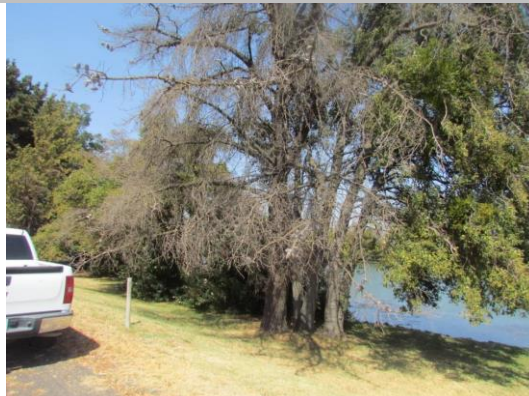
Photo 1 of 2 : SP_2017_NA0002_62_62_20170314_00049.jpg

LM Start	5.06	Rating **	U	Issue No.	62
LM End	5.06	Issue Type +	Ma	Location *	WS
Category	Earthen Levee			GPS Latitude/Longitude	
				Start	End
Item	Encroachments			38.134275 °	38.134275 °
				-121.593213 °	-121.593213 °
DWR ID	DWR_NA0002_01_f_2016_62				
Comment Code					
TR : Tree or limb					
Inspector Comment					
Dead Pine tree on waterward berm.

Looking upstream at dead pine tree on waterward berm.

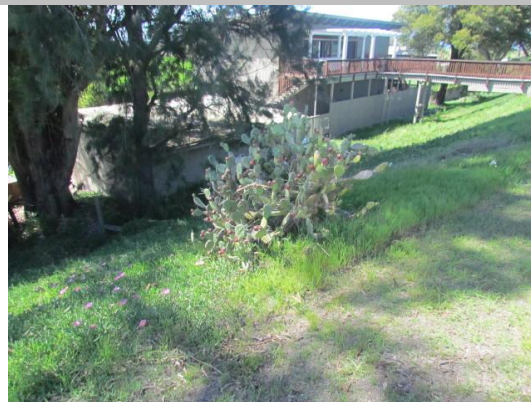
Photo 1 of 1 : SP_2017_NA0002_62_65_20170314_00051.jpg

LM Start	5.12	Rating **	M	Issue No.	65
LM End	5.12	Issue Type +	Ma	Location *	LS
Category	Earthen Levee			GPS Latitude/Longitude	
				Start	End
Item	Vegetation			38.133695 °	38.133695 °
				-121.592516 °	-121.592516 °
DWR ID	DWR_NA0002_01_s _ 2016_65				
Comment Code					
V2 : Remove the wild growth other than native grasses from the levee slopes.					
Inspector Comment					
Remove cactus from landward slope.

Looking at cactus on landward slope.

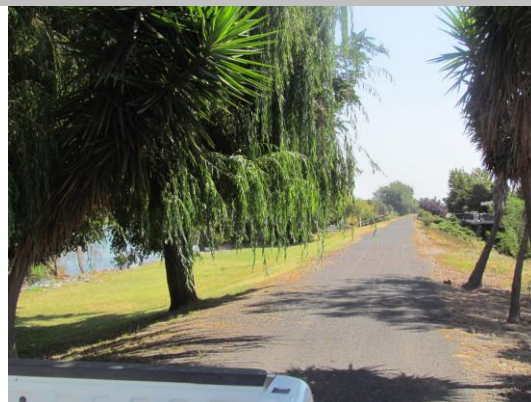
Photo 1 of 1 : SP_2017_NA0002_62_31_20170314_00027.jpg

Looking southeast at tree over levee crown.

LM Start	5.17	Rating **	M	Issue No.	31
LM End	5.17	Issue Type +	Ma	Location *	WS
Category	Earthen Levee			GPS Latitude/Longitude	
				Start	End
Item	Trim / Thin Trees			38.133145 °	38.133145 °
				-121.591895 °	-121.591895 °
DWR ID	DWR_NA0002_01_s _ 2013_31				
Comment Code					
T4 : Trim trees over roadway to at least 12 feet above ground level.					
Inspector Comment

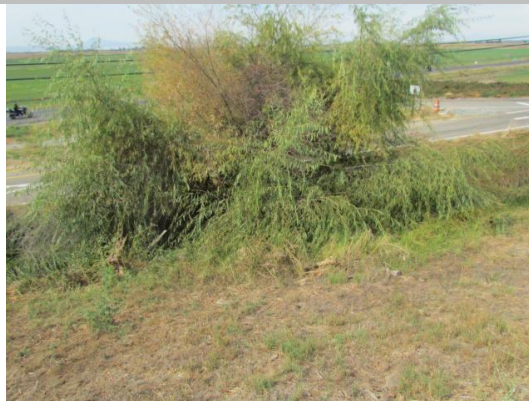
Photo 1 of 1 : SP_2017_NA0002_62_54_20170314_00040.jpg

Looking at dense trees at landward toe.

LM Start	5.42	Rating **	M	Issue No.	54
LM End	5.42	Issue Type +	Ma	Location *	LS
Category	Earthen Levee			GPS Latitude/Longitude	
				Start	End
Item	Trim / Thin Trees			38.130335 °	38.130335 °
				-121.588920 °	-121.588920 °
DWR ID	DWR_NA0002_01_s _ 2014_54				
Comment Code					
T1 : Trim trees to at least five feet above ground level.					
Inspector Comment

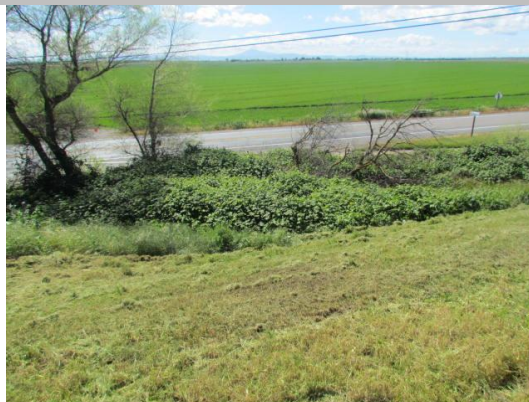
Photo 1 of 6 : SP_2017_NA0002_62_23_20170314_00013.jpg

LM Start	5.43	Rating **	U	Issue No.	23
LM End	5.54	Issue Type +	Ma	Location *	LS
Category	Earthen Levee			GPS Latitude/Longitude	
				Start	End
Item	Vegetation			38.130253 °	38.129451 °
				-121.588822 °	-121.587062 °
DWR ID	DWR_NA0002_01_s _ 2012_23				
Comment Code					
V2 : Remove the wild growth other than native grasses from the levee slopes.					
Inspector Comment					
Control vegetation at landside toe.

Looking south at vegetation at landward toe. (Spring 2016)

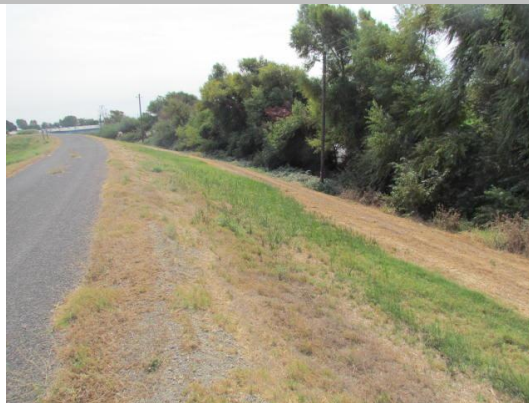
Photo 3 of 6 : SP_2017_NA0002_62_23_20170314_00015.jpg

Looking east at dense vegetation at landward toe.

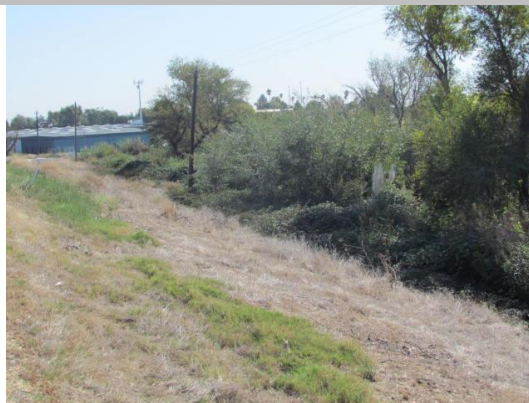
Photo 4 of 6 : SP_2017_NA0002_62_23_20170314_00016.jpg

Looking east at dense vegetation on landward toe.

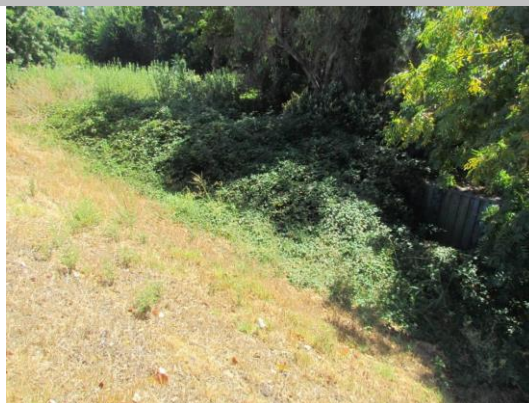
Photo 1 of 1 : SP_2017_NA0002_63_40_20170314_00043.jpg

LM Start	0.49	Rating **	U	Issue No.	40
LM End	0.49	Issue Type +	Ma	Location *	LS
Category	Earthen Levee			GPS Latitude/Longitude	
				Start	End
Item	Vegetation			38.188871 °	38.188871 °
				-121.575775 °	-121.575775 °
DWR ID	DWR_NA0002_02_f_2013_40				
Comment Code					
V2 : Remove the wild growth other than native grasses from the levee slopes.					
Inspector Comment					
Dense Berryvines at landward toe.

Looking east at berryvines at landward toe.

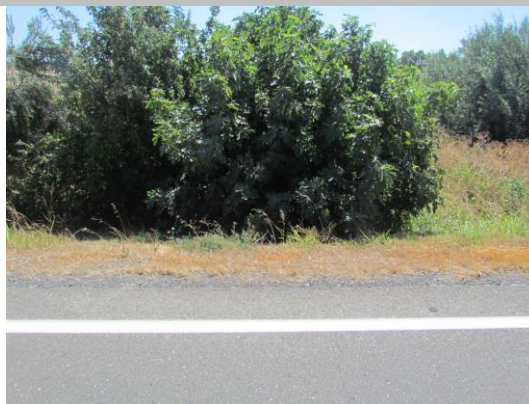
Photo 1 of 2 : SP_2017_NA0002_63_97_20170314_00063.jpg

LM Start	0.72	Rating **	U	Issue No.	97
LM End	0.72	Issue Type +	Ma	Location *	LS
Category	Earthen Levee			GPS Latitude/Longitude	
				Start	End
Item	Trim / Thin Trees			38.187102 °	38.187102 °
				-121.579463 °	-121.579463 °
DWR ID	DWR_NA0002_02_f_2016_97				
Comment Code					
T1 : Trim trees to at least five feet above ground level.					
Inspector Comment					
Untrimmed fig tree on landward toe.

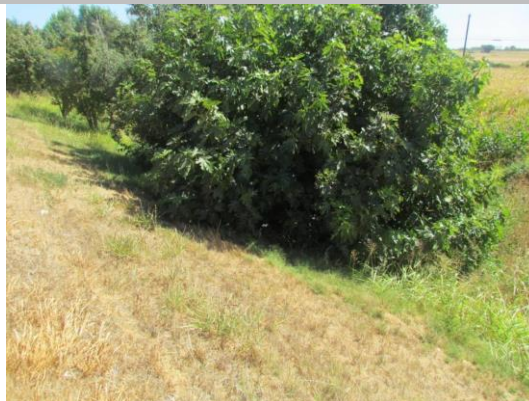
Photo 2 of 2 : SP_2017_NA0002_63_97_20170314_00064.jpg

LM Start	0.72	Rating **	U	Issue No.	97 (cont)	
LM End	0.72	Issue Type +	Ma	Location *	LS	
Category	Earthen Levee			GPS Latitude/Longitude		
				Start		End
Item	Trim / Thin Trees			38.187102 °		38.187102 °
				-121.579463 °		-121.579463 °
DWR ID	DWR_NA0002_02_f_2016_97					
Comment Code						
T1 : Trim trees to at least five feet above ground level.						
Inspector Comment						
Untrimmed fig tree on landward toe.

Looking east at untrimmed fig tree at landward toe.

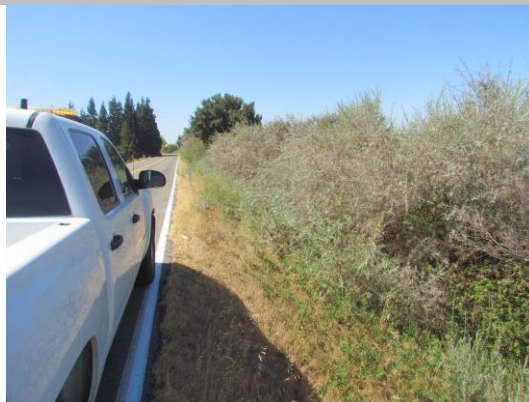
Photo 1 of 1 : SP_2017_NA0002_63_108_20170314_00075.jpg

LM Start	0.73	Rating **	U	Issue No.	108
LM End	0.79	Issue Type +	Ma	Location *	WS
Category	Earthen Levee			GPS Latitude/Longitude	
				Start	End
Item	Vegetation			38.187031 °	38.186511 °
				-121.579588 °	-121.580470 °
DWR ID	DWR_NA0002_02_f_2016_108				
Comment Code					
V2 : Remove the wild growth other than native grasses from the levee slopes.					
Inspector Comment					
Dense willows on waterward slope.

Looking southwest at dense willow trees on waterward slope.

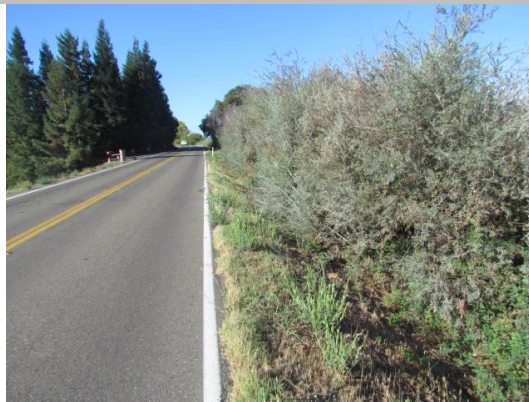
Photo 1 of 1 : SP_2017_NA0002_63_2_20170314_00002.jpg

LM Start	0.79	Rating **	U	Issue No.	2
LM End	0.84	Issue Type +	Ma	Location *	WS
Category	Earthen Levee			GPS Latitude/Longitude	
				Start	End
Item	Trim / Thin Trees			38.186535 °	38.186103 °
				-121.580395 °	-121.581127 °
DWR ID	DWR_NA0002_02_s_2012_2				
Comment Code					
T2 : Thin trees to allow visibility of the ground and room to flood fight.					
Inspector Comment					
Untrimmed trees within twenty foot zone on waterward slope.

Looking southwest at dense willows and trees on waterward slope.

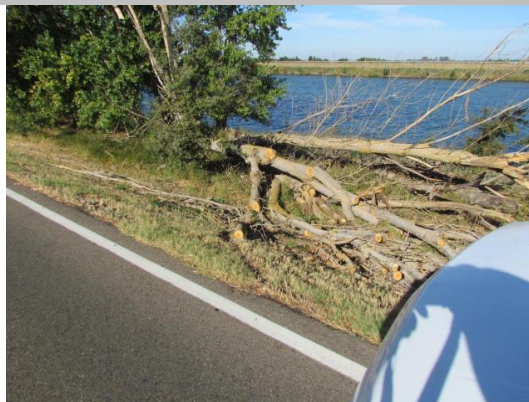
Photo 2 of 2 : SP_2017_NA0002_63_91_20170314_00055.jpg

Looking west at fallen tree on waterward slope and berm.

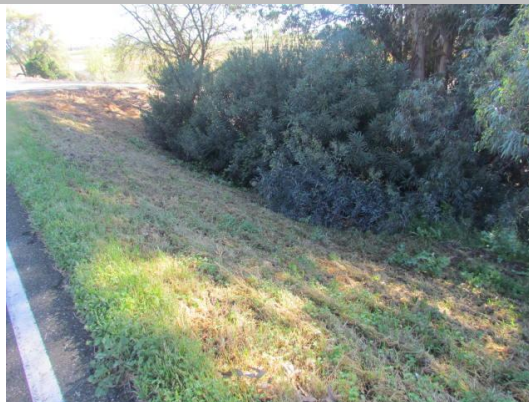
Photo 1 of 4 : SP_2017_NA0002_63_27_20170314_00029.jpg

LM Start	1.45	Rating **	U	Issue No.	27
LM End	1.47	Issue Type +	Ma	Location *	LS
Category	Earthen Levee			GPS Latitude/Longitude	
				Start	End
Item	Trim / Thin Trees			38.178950 °	38.178950 °
				-121.587717 °	-121.587717 °
DWR ID	DWR_NA0002_02_s_2012_27				
Comment Code					
T1 : Trim trees to at least five feet above ground level.					
Inspector Comment					
Dense vegetation should be trimmed back fifteen feet from landward toe.

Looking east at dense vegetation at landward toe.

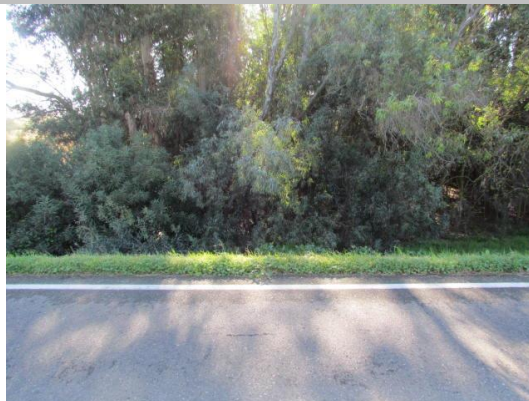
Photo 2 of 4 : SP_2017_NA0002_63_27_20170314_00030.jpg

Looking east at dense vegetation at landward toe.

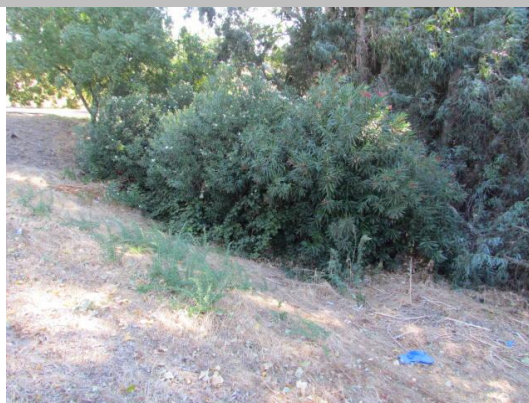
Photo 3 of 4 : SP_2017_NA0002_63_27_20170314_00031.jpg

Looking east at dense vegetation on landward toe.

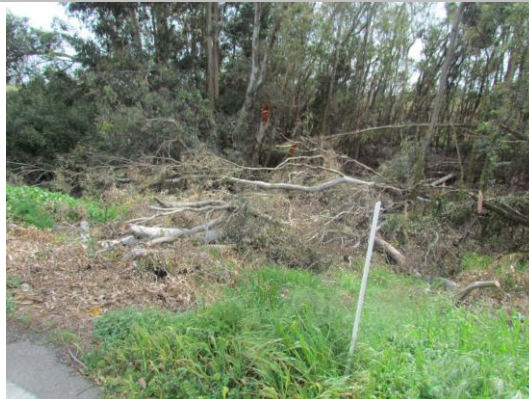
Photo 1 of 2 : SP_2017_NA0002_63_109_20170324_00183.jpg

LM Start	1.46	Rating **	U	Issue No.	109
LM End	1.46	Issue Type +	Ma	Location *	WS
Category	Earthen Levee			GPS Latitude/Longitude	
				Start	End
Item	Encroachments			38.178805 °	38.178805 °
				-121.587850 °	-121.587850 °
DWR ID	DWR_NA0002_02_s_2016_109				
Comment Code					
TR : Tree or limb					
Inspector Comment					
Downed tree branches and limbs on landward slope.

Looking southwest at fallen tree on waterward slope.

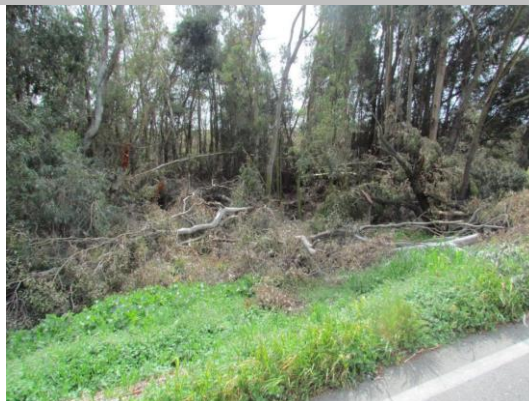
Photo 2 of 2 : SP_2017_NA0002_63_109_20170324_00184.jpg

Looking west at fallen tree on waterward slope.

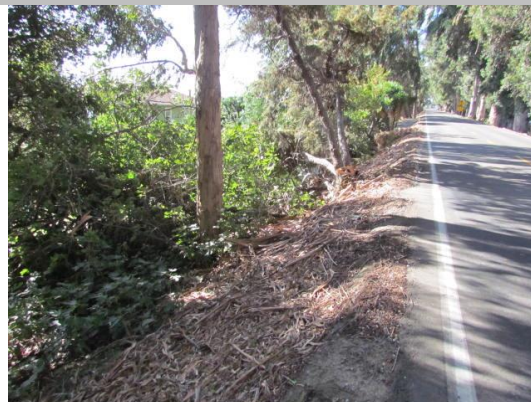
Photo 1 of 2 : SP_2017_NA0002_63_45_20170314_00045.jpg

LM Start	1.80	Rating **	U	Issue No.	45
LM End	1.82	Issue Type +	Ma	Location *	LS
Category	Earthen Levee			GPS Latitude/Longitude	
				Start	End
Item	Vegetation			38.174437 °	38.174153 °
				-121.590786 °	-121.590980 °
DWR ID	DWR_NA0002_02_f_2013_45				
Comment Code					
V2 : Remove the wild growth other than native grasses from the levee slopes.					
Inspector Comment					
Dense vegetation on landward slope and toe

Looking southwest at dense vegetation on landward slope.

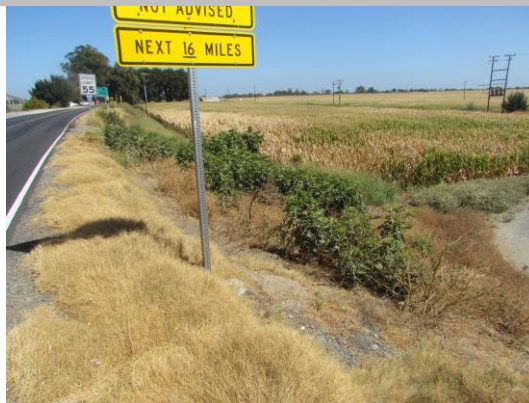
Photo 1 of 1 : SP_2017_NA0002_63_120_20170314_00090.jpg

LM Start	2.16	Rating **	M	Issue No.	120
LM End	2.16	Issue Type +	Ma	Location *	LS
Category	Earthen Levee			GPS Latitude/Longitude	
				Start	End
Item	Vegetation			38.169814 °	38.169814 °
				-121.593951 °	-121.593951 °
DWR ID	DWR_NA0002_02_f_2016_120				
Comment Code					
V2 : Remove the wild growth other than native grasses from the levee slopes.					
Inspector Comment					
Fig tree saplings on landward slope.

Looking northeast at fig tree saplings at landward toe.

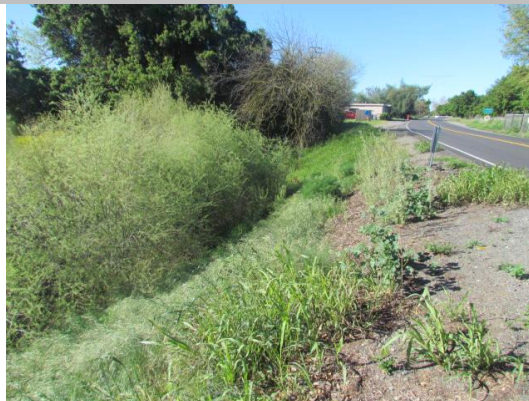
Photo 2 of 2 : SP_2017_NA0002_63_99_20170314_00066.jpg

LM Start	2.42	Rating **	U	Issue No.	99 (cont)	
LM End	2.42	Issue Type +	Ma	Location *	LS	
Category	Earthen Levee			GPS Latitude/Longitude		
				Start		End
Item	Vegetation			38.166772 °		38.166772 °
				-121.596667 °		-121.596667 °
DWR ID	DWR_NA0002_02_s _ 2014_99					
Comment Code						
V2 : Remove the wild growth other than native grasses from the levee slopes.						
Inspector Comment						
Dense willows on landward slope.

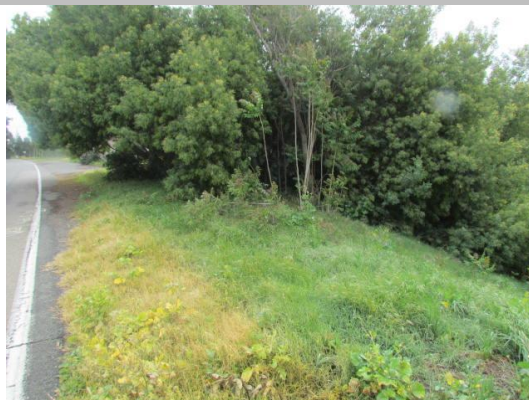
Photo 1 of 2 : SP_2017_NA0002_63_29_20170314_00034.jpg

Looking northeast at dense vegetation on landward slope.

LM Start	2.48	Rating **	U	Issue No.	29
LM End	2.48	Issue Type +	Ma	Location *	LS
Category	Earthen Levee			GPS Latitude/Longitude	
				Start	End
Item	Trim / Thin Trees			38.166378 °	38.166378 °
				-121.597570 °	-121.597570 °
DWR ID	DWR_NA0002_02_s _ 2012_29				
Comment Code					
T1 : Trim trees to at least five feet above ground level.					
Inspector Comment

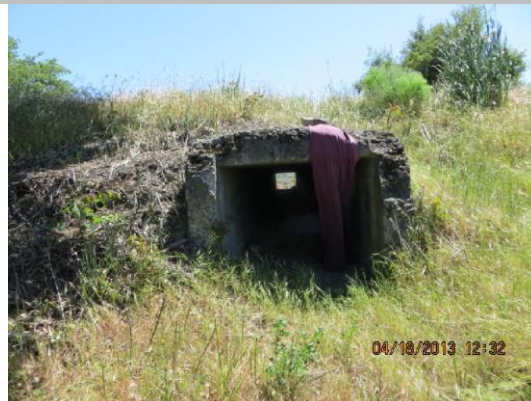
Photo 1 of 3 : UCIP_SP_2017_51314_19773.jpg

Concrete tunnel open on both ends.

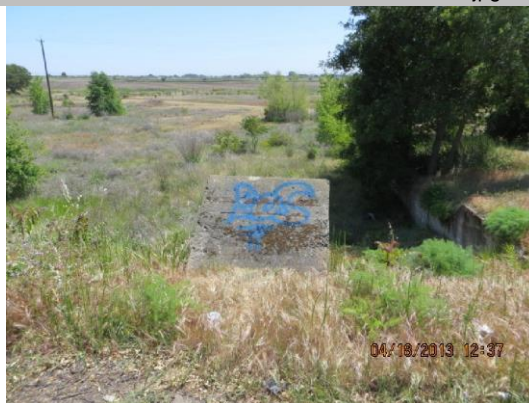
Photo 2 of 3 : UCIP_SP_2017_51315_19775.jpg

LM Start	2.57	Rating **	U	Issue No.	130 (cont)
LM End	2.57	Issue Type +	Ma	Location *	LS

Concrete tunnel on LS shoulder.

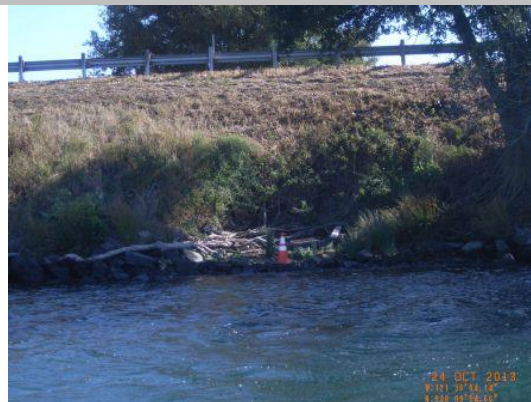
Photo 1 of 2 : SP_2017_NA0002_63_37_20170314_00040.jpg

LM Start	2.66	Rating **	M	Issue No.	37
LM End	2.74	Issue Type +	Ma	Location *	WS
Category	Supplemental			GPS Latitude/Longitude	
				Start	End
Item	2015 USACE Erosion Survey, DRAFT			38.165303 °	38.164682 °
				-121.600477 °	-121.601804 °
DWR ID	DWR_NA0002_02_s _ 2016_37				
Comment Code					
Inspector Comment					
2009 - Large scallop from rotational failure. One fallen tree and one large tree with half of its root structure exposed. 2015: Large tree expected to pop out within next couple of years, will take very large chunk of levee out. [2015 Site ID: SAC_18-0_L]

USACE 2013 Photo #1

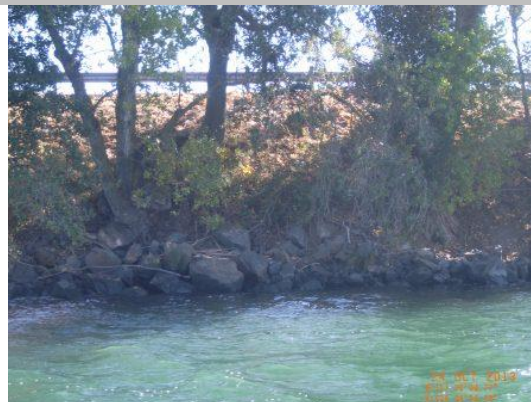
Photo 2 of 2 : SP_2017_NA0002_63_37_20170314_00041.jpg

USACE 2013 Photo #2

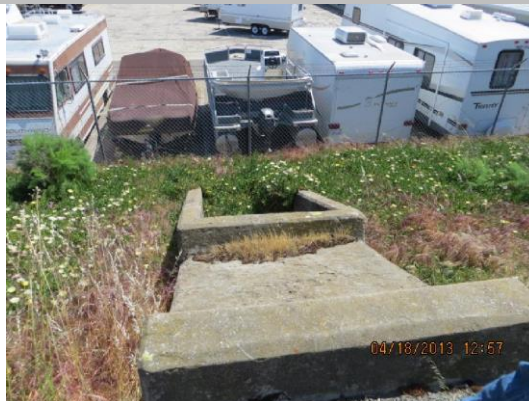
Photo 1 of 3 : UCIP_SP_2017_51316_19782.jpg

FS_ID:51316
DS_ID:21882
EP_NO: N/A
Repair Type: Urgent
Crossing Status: Found
UCIP Comments: 10/24/2016 same as previous inspection tunnel is opened on both ends. (O. Magana - DWR UCIP)04/18/2013 Tunnel open on both ends and should be abandoned properly. (W. Wylie - DWR UCIP)
FIELD_STRUCT_DESC: *ABANDONED* 4-foot by 6-foot drainage concrete culvert through levee 1 foot below the crown. [Additional Reference(s): DWR Levee Log, 2005. USACE Sacramento O&M Manual Unit 103, June 1954, (RM 17.89), Drawing No. 6-13-1100].
FS Date: 10/24/2016

Entrance to tunnel on LS slope.

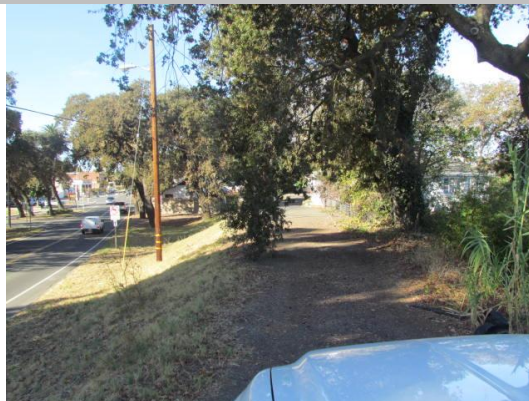
Photo 1 of 2 : SP_2017_NA0002_63_5_20170314_00003.jpg

Looking west at overhanging tree on waterward shoulder. (Fall 2014)

LM Start	3.17	Rating **	M	Issue No.	5
LM End	3.17	Issue Type +	Ma	Location *	WS
Category	Earthen Levee			GPS Latitude/Longitude	
				Start	End
Item	Trim / Thin Trees			38.162638 °	38.162638 °
				-121.609068 °	-121.609068 °
DWR ID	DWR_NA0002_02_s_2012_5				
Comment Code					
T4 : Trim trees over roadway to at least 12 feet above ground level.					
Inspector Comment

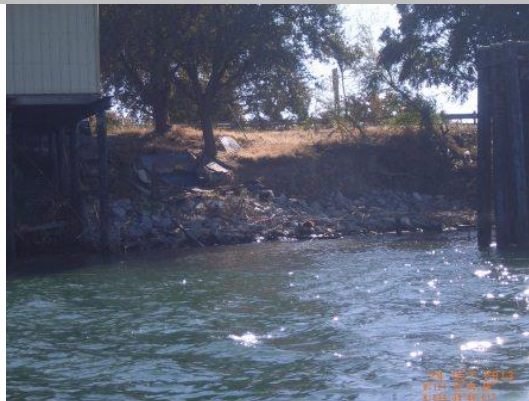
Photo 1 of 2 : SP_2017_NA0002_63_34_20170314_00038.jpg

LM Start	3.37	Rating **	U	Issue No.	34 (cont)
LM End	3.56	Issue Type +	Ma	Location *	WS

USACE 2013 Photo #1

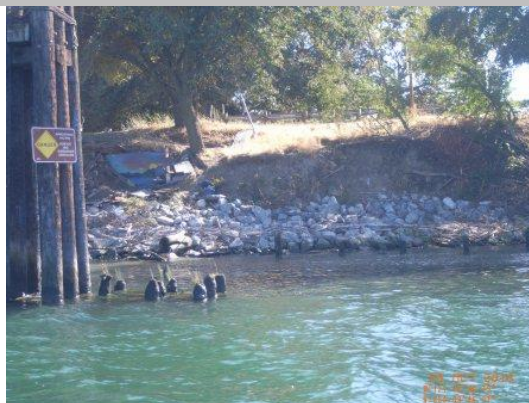
Photo 2 of 2 : SP_2017_NA0002_63_34_20170314_00039.jpg

USACE 2013 Photo #2

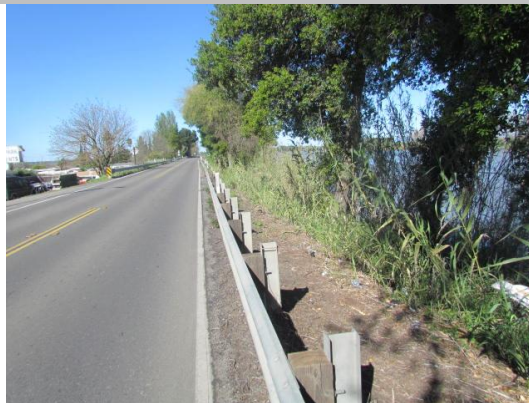
Photo 1 of 1 : SP_2017_NA0002_63_100_20170314_00067.jpg

LM Start	3.39	Rating **	M	Issue No.	100
LM End	3.42	Issue Type +	Ma	Location *	WS
Category	Earthen Levee			GPS Latitude/Longitude	
				Start	End
Item	Vegetation			38.162394 °	38.162432 °
				-121.613146 °	-121.613637 °
DWR ID	DWR_NA0002_02_s _ 2014_100				
Comment Code					
V2 : Remove the wild growth other than native grasses from the levee slopes.					
Inspector Comment					
Bamboo on waterward slope.

Looking southwest at vegetation (bamboo) on waterward slope.

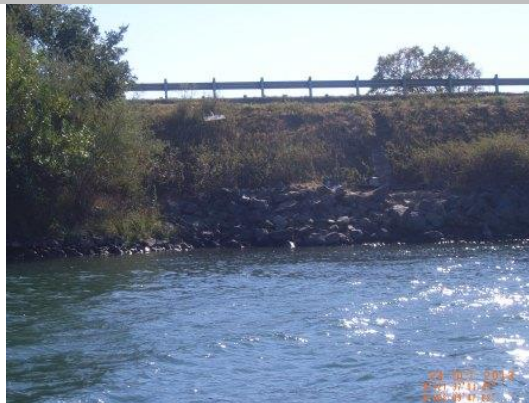
Photo 1 of 1 : SP_2017_NA0002_63_20_20170314_00023.jpg

LM Start	3.62	Rating **	U	Issue No.	20
LM End	3.73	Issue Type +	Ma	Location *	WS
Category	Supplemental			GPS Latitude/Longitude	
				Start	End
Item	2015 USACE Erosion Survey, DRAFT			38.162959 °	38.163334 °
				-121.617323 °	-121.619312 °
DWR ID	DWR_NA0002_02_s _ 2016_20				
Comment Code					
Inspector Comment					
2008 - Overstepped levee section with pocket erosion. Plans for repair currently in the design phase. 2010 - Very steep slope with slumps, longitudinal cracking, and overturned trees. 2011 - Upgraded to CRITICAL. Sections of vertical slope with highway on top. Heavy vegetation in front of most of the erosion pockets. 2015: New rock placed on the levee slope for most of the downstream end, but bad spots still remain. [2015 Site ID: SAC_16-8_L]

USACE 2013 Photo #1

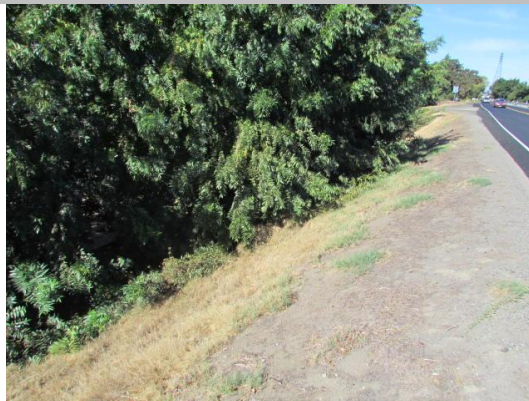
Photo 1 of 1 : SP_2017_NA0002_63_102_20170314_00069.jpg

LM Start	3.96	Rating **	U	Issue No.	102
LM End	3.96	Issue Type +	Ma	Location *	LS
Category	Earthen Levee			GPS Latitude/Longitude	
				Start	End
Item	Trim / Thin Trees			38.164246 °	38.164246 °
				-121.623272 °	-121.623272 °
DWR ID	DWR_NA0002_02_s _ 2014_102				
Comment Code					
T1 : Trim trees to at least five feet above ground level.					
Inspector Comment					
Untrimmed tree blocking landward slope and toe.

Looking west at dense trees on landward slope and toe.

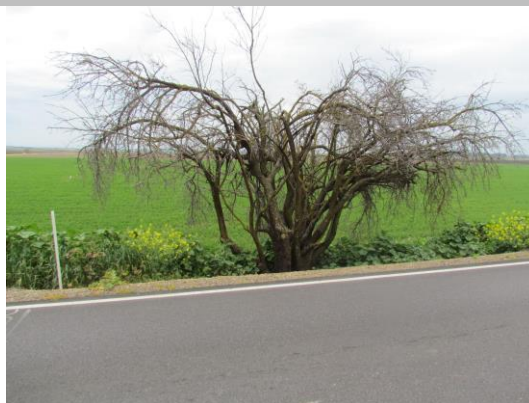
Photo 1 of 1 : SP_2017_NA0002_63_88_20170324_00187.jpg

LM Start	4.92	Rating **	M	Issue No.	88
LM End	4.92	Issue Type +	Ma	Location *	LS
Category	Earthen Levee			GPS Latitude/Longitude	
				Start	End
Item	Encroachments			38.169262 °	38.169262 °
				-121.639497 °	-121.639497 °
DWR ID	DWR_NA0002_02_s_2017_88				
Comment Code					
TR : Tree or limb					
Inspector Comment					
Remove dead tree on landward slope.

Looking east at dead tree on landward slope and toe.

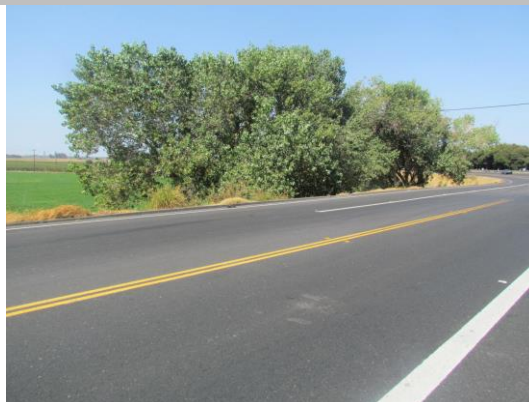
Photo 1 of 1 : SP_2017_NA0002_63_95_20170314_00061.jpg

LM Start	5.16	Rating **	U	Issue No.	95
LM End	5.16	Issue Type +	Ma	Location *	LS
Category	Earthen Levee			GPS Latitude/Longitude	
				Start	End
Item	Trim / Thin Trees			38.171318 °	38.171318 °
				-121.643001 °	-121.643001 °
DWR ID	DWR_NA0002_02_f_2015_95				
Comment Code					
T1 : Trim trees to at least five feet above ground level.					
Inspector Comment

Looking west at untrimmed trees on landward slope.

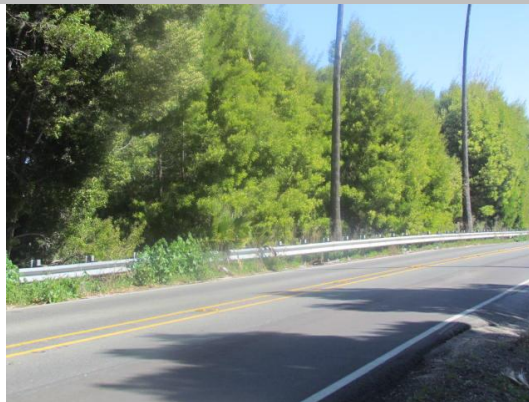
Photo 1 of 3 : SP_2017_NA0002_63_9_20170314_00010.jpg

LM Start	5.23	Rating **	U	Issue No.	9
LM End	5.42	Issue Type +	Ma	Location *	WS
Category	Earthen Levee			GPS Latitude/Longitude	
				Start	End
Item	Trim / Thin Trees			38.171942 °	38.171800 °
				-121.643975 °	-121.647447 °
DWR ID	DWR_NA0002_02_s_2012_9				
Comment Code					
T2 : Thin trees to allow visibility of the ground and room to flood fight.					
Inspector Comment

Looking northeast at dense trees on waterside slope and toe.

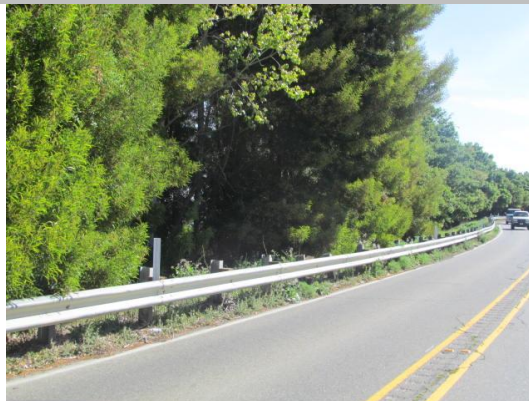
Photo 2 of 3 : SP_2017_NA0002_63_9_20170314_00011.jpg

LM Start	5.23	Rating **	U	Issue No.	9 (cont)	
LM End	5.42	Issue Type +	Ma	Location *	WS	
Category	Earthen Levee			GPS Latitude/Longitude		
				Start		End
Item	Trim / Thin Trees			38.171942°		38.171800°
				-121.643975°		-121.647447°
DWR ID	DWR_NA0002_02_s_2012_9					
Comment Code						
T2 : Thin trees to allow visibility of the ground and room to flood fight.						
Inspector Comment

Looking east at dense trees on waterward shoulder and slope.

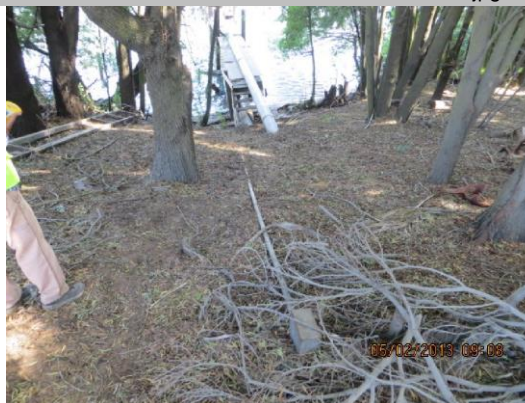
Photo 1 of 3 : UCIP_SP_2017_12776_20754.jpg

FS_ID:12776
DS_ID:21910
EP_NO: 7089A
Repair Type: Non-Urgent
Crossing Status: Found
UCIP Comments: Hole at LS toe over pipe possible sign of leakage.
FIELD_STRUCT_DESC: 7-inch pipe through levee 13.0 feet below crown. Pump in pump house on the landward side. 1.5-inch galvanized steel electrical conduit at same location. 4'X6' concrete distribution box off LS toe next to pumphouse. Originally included in the 1959 O&M manual.
FS Date: 5/2/2013

Pipe and electrical conduit on WS slope.

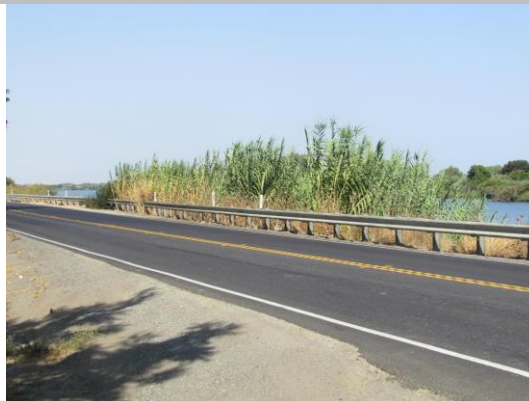
Photo 1 of 2 : SP_2017_NA0002_63_11_20170314_00013.jpg

LM Start	5.65	Rating **	U	Issue No.	11 (cont)
LM End	5.69	Issue Type +	Ma	Location *	WS

Looking northwest at bambao on waterward slope. (Fall 2016)

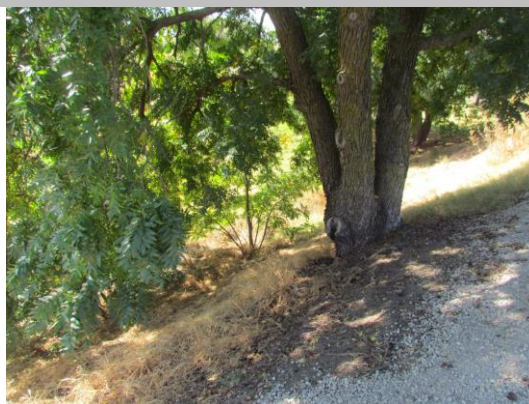
Photo 1 of 2 : SP_2017_NA0002_63_14_20170314_00017.jpg

LM Start	6.36	Rating **	U	Issue No.	14
LM End	6.36	Issue Type +	Ma	Location *	LS
Category	Earthen Levee			GPS Latitude/Longitude	
				Start	End
Item	Trim / Thin Trees			38.173406 °	38.173406 °
				-121.663815 °	-121.663815 °
DWR ID	DWR_NA0002_02_s _ 2012_14				
Comment Code					
T1 : Trim trees to at least five feet above ground level.					
Inspector Comment

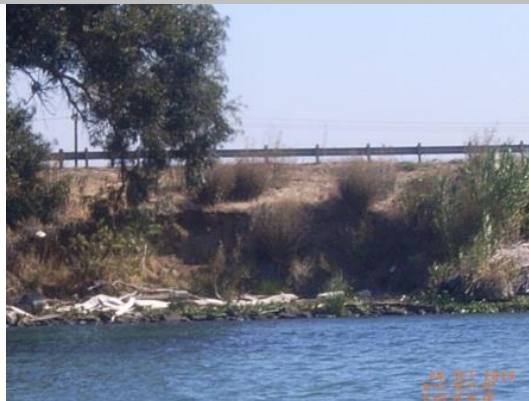
Photo 1 of 1 : SP_2017_NA0002_63_23_20170314_00026.jpg

LM Start	6.98	Rating **	M	Issue No.	23
LM End	7.04	Issue Type +	Ma	Location *	WS
Category	Supplemental			GPS Latitude/Longitude	
				Start	End
Item	2015 USACE Erosion Survey, DRAFT			38.166583 °	38.165794 °
				-121.670684 °	-121.671014 °
DWR ID	DWR_NA0002_02_s_2016_23				
Comment Code					
Inspector Comment					
2011 - Large section of bank slumped off. 2015: No observed changes. [2015 Site ID: SAC_13-6_L]

USACE 2013 Photo #1

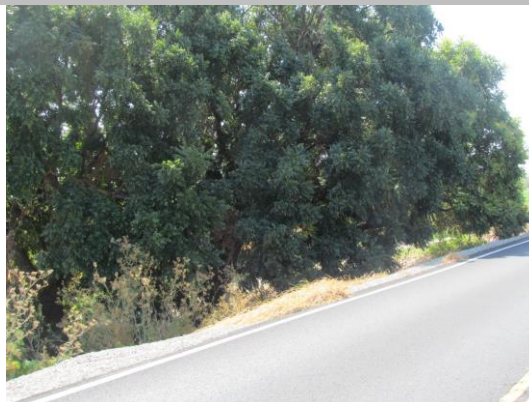
Photo 1 of 1 : SP_2017_NA0002_63_112_20170314_00080.jpg

LM Start	7.13	Rating **	U	Issue No.	112
LM End	7.13	Issue Type +	Ma	Location *	LS
Category	Earthen Levee			GPS Latitude/Longitude	
				Start	End
Item	Trim / Thin Trees			38.164465 °	38.164465 °
				-121.671292 °	-121.671292 °
DWR ID	DWR_NA0002_02_f_2015_112				
Comment Code					
T1 : Trim trees to at least five feet above ground level.					
Inspector Comment

Looking south at untrimmed trees on landward slope.

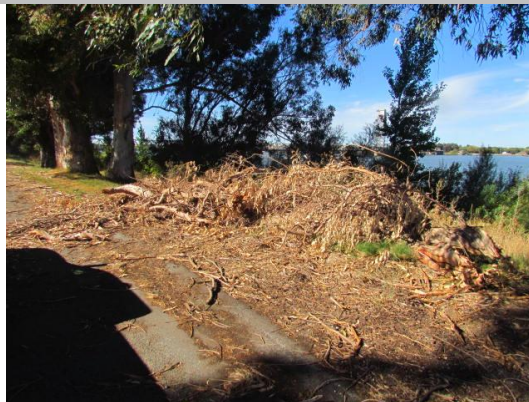
Photo 1 of 1 : SP_2017_NA0002_63_105_20170314_00072.jpg

LM Start	7.71	Rating **	M	Issue No.	105
LM End	7.71	Issue Type +	Ma	Location *	WS
Category	Earthen Levee			GPS Latitude/Longitude	
				Start	End
Item	Encroachments			38.157841 °	38.157841 °
				-121.677510 °	-121.677510 °
DWR ID	DWR_NA0002_02_f_2014_105				
Comment Code					
TR : Tree or limb					
Inspector Comment					
Tree limbs on waterward shoulder.

Looking southwest at tree limbs on waterward shoulder.

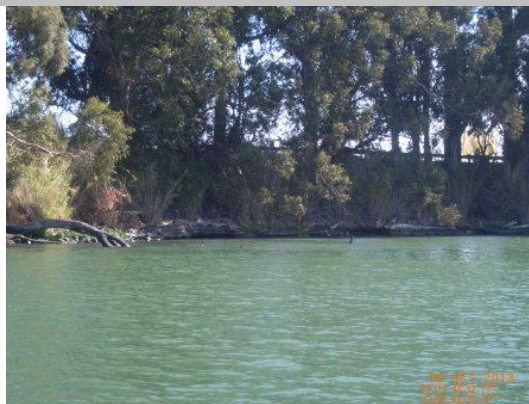
Photo 1 of 1 : SP_2017_NA0002_63_17_20170314_00021.jpg

LM Start	8.20	Rating **	U	Issue No.	17
LM End	8.42	Issue Type +	Ma	Location *	WS
Category	Supplemental			GPS Latitude/Longitude	
				Start	End
Item	2015 USACE Erosion Survey, DRAFT			38.151867 °	38.148711 °
				-121.682201 °	-121.682790 °
DWR ID	DWR_NA0002_02_s_2016_17				
Comment Code					
Inspector Comment					
2010 - Small inlet area behind a man-built spit. Bank is slumping and could possibly be fixed with maintenance. 2011 - Site continues to worsen. 2015: Upgraded to Critical [2015 Site ID: SAC_12-1_L]

USACE 2013 Photo #1

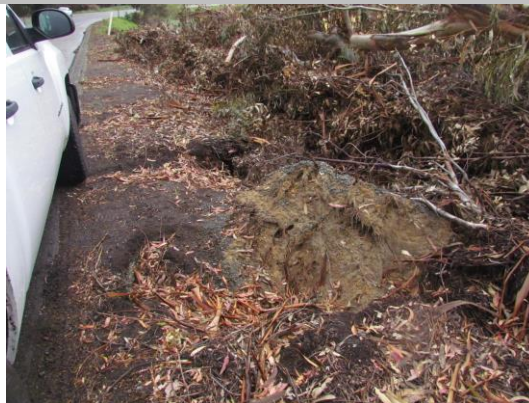
Photo 2 of 4 : SP_2017_NA0002_63_106_20170324_00193.jpg

LM Start	8.31	Rating **	U	Issue No.	106 (cont)	
LM End	8.31	Issue Type +	Ma	Location *	LS	
Category	Earthen Levee			GPS Latitude/Longitude		
				Start	End	
Item	Encroachments			38.150208 °	38.150208 °	
				-121.682130 °	-121.682130 °	
DWR ID	DWR_NA0002_02_s_2017_106					
Comment Code						
TR : Tree or limb						
Inspector Comment						
Several fallen trees and prunings on landward slope. Tree left hole on landward slope.

Looking north at hole on left by fallen tree on landward shoulder and slope.

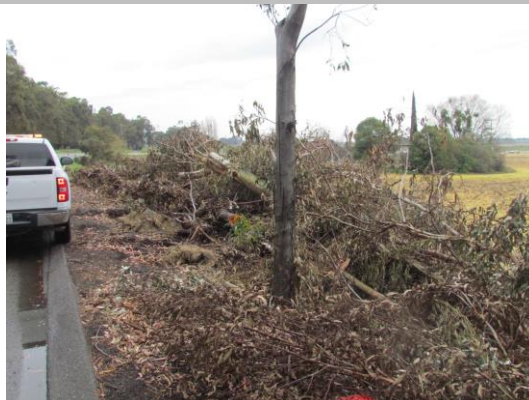
Photo 3 of 4 : SP_2017_NA0002_63_106_20170324_00194.jpg

LM Start	8.31	Rating **	U	Issue No.	106 (cont)
LM End	8.31	Issue Type +	Ma	Location *	LS

Looking north at fallen tree prunings on landward slope.

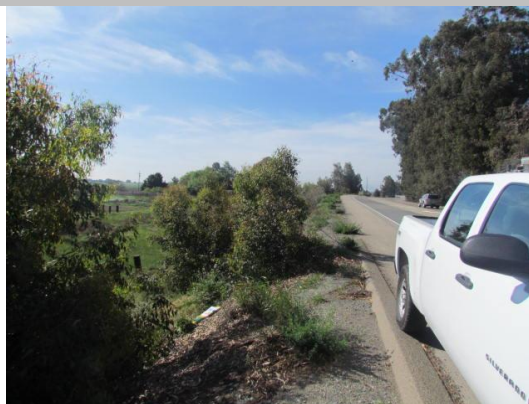
Photo 1 of 2 : SP_2017_NA0002_63_48_20170314_00047.jpg

LM Start	8.65	Rating **	M	Issue No.	48
LM End	8.86	Issue Type +	Ma	Location *	LS
Category	Earthen Levee			GPS Latitude/Longitude	
				Start	End
Item	Trim / Thin Trees			38.145368 °	38.142430 °
				-121.683072 °	-121.683978 °
DWR ID	DWR_NA0002_02_s _ 2013_48				
Comment Code					
T1 : Trim trees to at least five feet above ground level.					
Inspector Comment

Looking south at trees on landward slope.

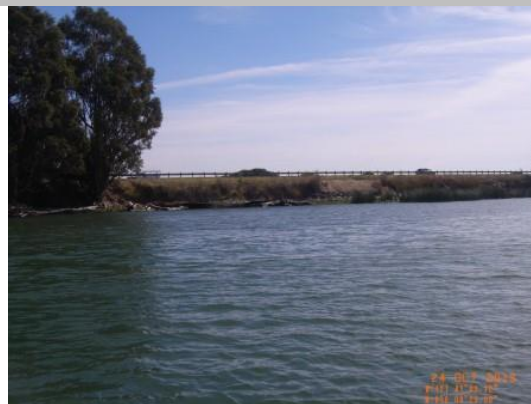
Photo 1 of 1 : SP_2017_NA0002_63_19_20170314_00022.jpg

LM Start	8.96	Rating **	U	Issue No.	19
LM End	9.18	Issue Type +	Ma	Location *	WS
Category	Supplemental			GPS Latitude/Longitude	
				Start	End
Item	2015 USACE Erosion Survey, DRAFT			38.141399 °	38.138158 °
				-121.685346 °	-121.686531 °
DWR ID	DWR_NA0002_02_s _ 2016_19				
Comment Code					
Inspector Comment					
2008 - Erosion causing vertical bank at the highway on top of levee. The whole bank along the highway should be repaired. 2009 - Minimal new erosion. 2011 - Bank continues to slowly erode. 2012 - Upgrade to critical, new erosion since lat year and steeper slopes in sections. 2015: Road foundation and cables exposed. Extremely large tree with exposed roots looks likely to fail and take out a significant portion of the levee. [2015 Site ID: SAC_11-2_L]

USACE 2013 Photo #1

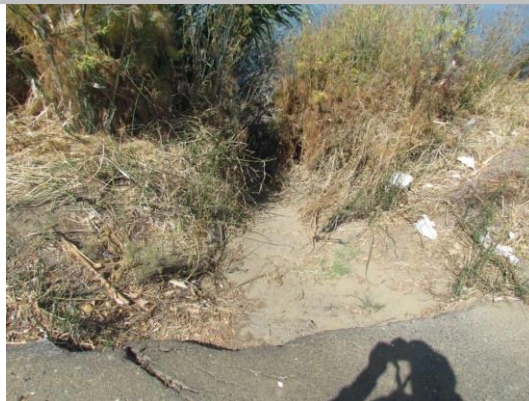
Photo 1 of 4 : SP_2017_NA0002_63_115_20170314_00082.jpg

LM Start	9.15	Rating **	U	Issue No.	115
LM End	9.15	Issue Type +	Ma	Location *	WS
Category	Earthen Levee			GPS Latitude/Longitude	
				Start	End
Item	Erosion / Bank Caving			38.138510 °	38.138510 °
				-121.686124 °	-121.686124 °
DWR ID	DWR_NA0002_02_s_2016_115				
Comment Code					
E1 : Note and monitor erosion site.					
Inspector Comment					
Erosion on waterward shoulder along highway appears to be foot erosion.

Looking west at foot erosion on waterward slope. (Fall 2016)

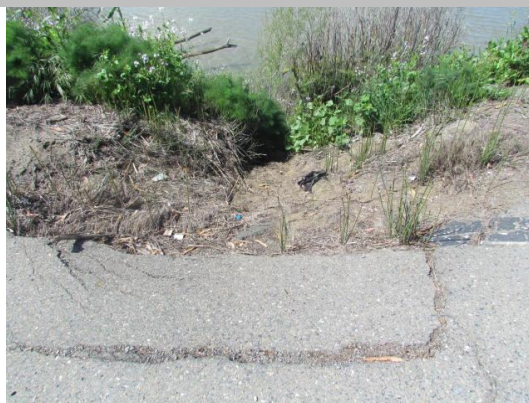
Photo 2 of 4 : SP_2017_NA0002_63_115_20170314_00083.jpg

Looking west at foot erosion on waterward slope.

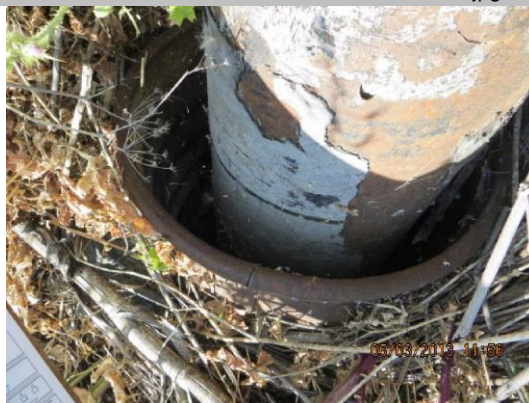
Photo 2 of 3 : UCIP_SP_2017_40528_21001.jpg

FS_ID:40528
DS_ID:21931
EP_NO: 16011
Repair Type: Non-Urgent
Crossing Status: Found
UCIP Comments: Annular space between pipes should be grouted. IF abandoned, these pipes should be abandoned properly.
FIELD_STRUCT_DESC: 18-inch corrugated metal conduit pipe through the levee 4.5 feet below the crown. Inactive 12-inch pipe sleeved through 18-inch. Both ends open. Siphon breaker and air valve in 24-inch CMP riser on LS shoulder. 9'X5' concrete box with slide gate off LS toe. Originally included in the 1959 O&M manual.
FS Date: 5/3/2013

18-inch CMP with 12-inch irrigation pipe sleeved through it.

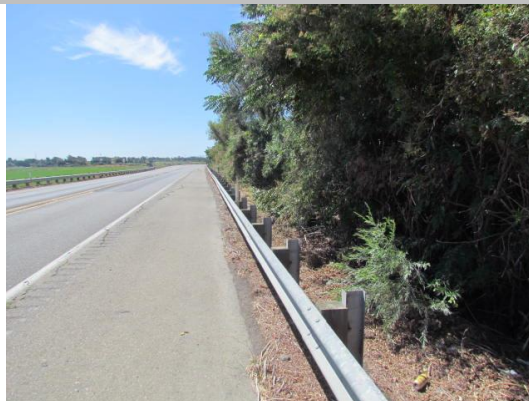
Photo 1 of 2 : SP_2017_NA0002_63_16_20170314_00019.jpg

Looking south at dense vegetation (trees) on waterward slope.

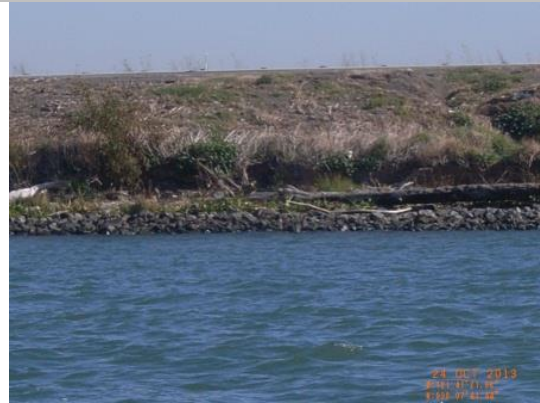
Photo 1 of 1 : SP_2017_NA0002_63_21_20170314_00024.jpg

Comment Code					
Inspector Comment					
2004 - Wave wash pockets approximately 100 ft long with new full bank rock between the pockets. 2005 - Spot repairs, but toe is still eroding in several places. 2006 - Low vertical bank along roadway. 2007 - A PL 84-99 repair was constructed, it cover the majority of the site with the exception of the upstream 150 to 200 ft and the downstream 250 ft, therefore it is being kept in the inventory. 2009 - Minimal new erosion. 2010 - Outboard berm looks good, but the banks are still very steep. 2011 - While the outboard berm is protecting against wave wash, bank still has slumping issues. 2015: No observed changes. [2015 Site ID: SAC_10-8_L]
