**Flood Control Project Maintenance
Levee Inspections**

Maintenance Issue Types Only, Levee Inspection Report By Mile - Spring 2018

Brannan Andrus Levee Maintenance District

Waterway	Bank	Unit Miles	Inspection Start/End	Inspector
Unit No. 01 Georgiana Slough	Right	6.01	04/05/2018 04/05/2018	Keith Millard

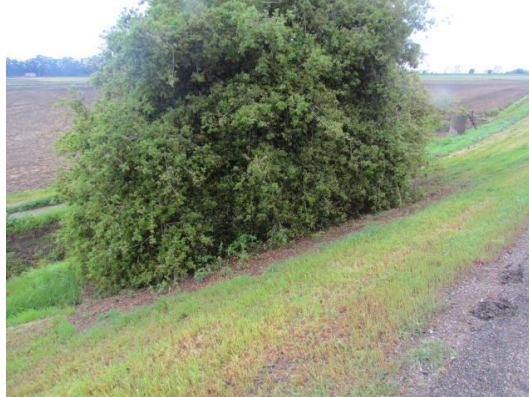
Photo 2 of 3 : SP_2018_NA0002_62_25_20180305_00022.jpg

LM Start	1.56	Rating **	U	Issue No.	25 (cont)	
LM End	1.56	Issue Type +	Ma	Location *	LS	
Category	Earthen Levee			GPS Latitude/Longitude		
				Start		End
Item	Trim / Thin Trees			38.172869 °		38.172869 °
				-121.580681 °		-121.580681 °
DWR ID	DWR_NA0002_01_s _ 2012_25					
Comment Code						
T1 : Trim trees to at least five feet above ground level.						
Inspector Comment						
Tree blocking landside toe.

Looking northwest at untrimmed tree at landward toe. (Spring 2015)

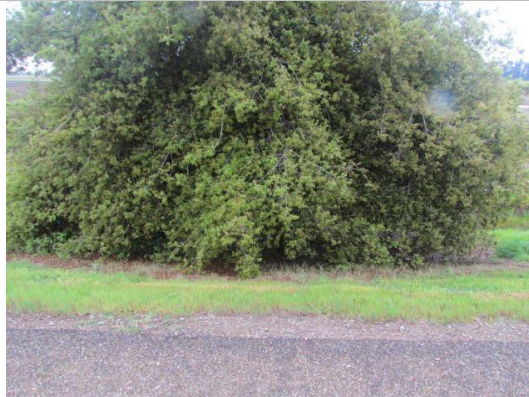
Photo 3 of 3 : SP_2018_NA0002_62_25_20180305_00023.jpg

Looking west at untrimmed tree at landward toe. (Spring 2015)

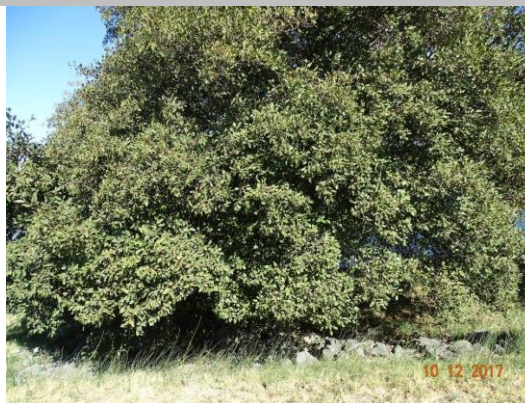
Photo 1 of 1 : SP_2018_NA0002_62_21_20180305_00013.jpg

LM Start	4.36	Rating **	M	Issue No.	21
LM End	4.36	Issue Type +	Ma	Location *	WS
Category	Earthen Levee			GPS Latitude/Longitude	
				Start	End
Item	Trim / Thin Trees			38.142838 °	38.142838 °
				-121.600163 °	-121.600163 °
DWR ID	DWR_NA0002_01_s_2012_21				
Comment Code					
T1 : Trim trees to at least five feet above ground level.					
Inspector Comment

Looking northeast at the waterside slope.

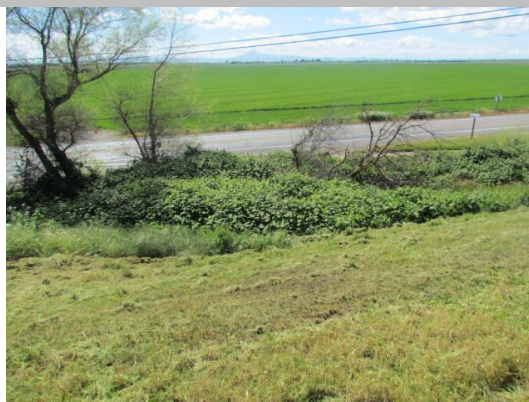
Photo 1 of 6 : SP_2018_NA0002_62_23_20180305_00014.jpg

LM Start	5.43	Rating **	U	Issue No.	23
LM End	5.57	Issue Type +	Ma	Location *	LS
Category	Earthen Levee			GPS Latitude/Longitude	
				Start	End
Item	Vegetation			38.130253 °	38.129359 °
				-121.588822 °	-121.586487 °
DWR ID	DWR_NA0002_01_s _ 2012_23				
Comment Code					
V2 : Remove the wild growth other than native grasses from the levee slopes.					
Inspector Comment					
Control vegetation at landside toe.

Looking south at vegetation at landward toe. (Spring 2016)

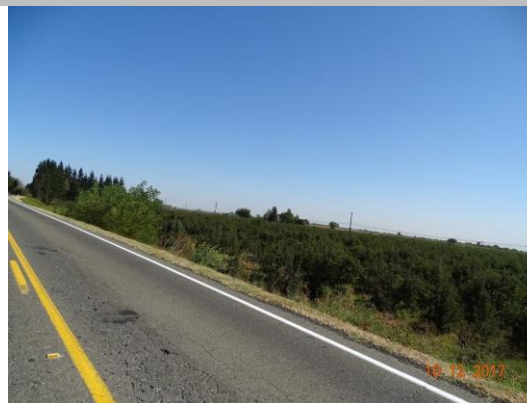
Photo 1 of 1 : SP_2018_NA0002_63_108_20180305_00084.jpg

LM Start	0.85	Rating **	M	Issue No.	108
LM End	1.33	Issue Type +	Ma	Location *	LS
Category	Earthen Levee			GPS Latitude/Longitude	
				Start	End
Item	Vegetation			38.186021 °	38.180473 °
				-121.581267 °	-121.586507 °
DWR ID	DWR_NA0002_02_f_2017_108				
Comment Code					
V2 : Remove the wild growth other than native grasses from the levee slopes.					
Inspector Comment

Looking northeast at the landside slope.

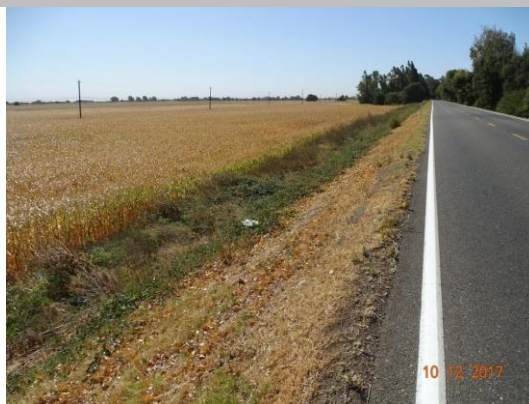
Photo 1 of 1 : SP_2018_NA0002_63_134_20180305_00100.jpg

LM Start	1.23	Rating **	M	Issue No.	134
LM End	1.26	Issue Type +	Ma	Location *	LS
Category	Earthen Levee			GPS Latitude/Longitude	
				Start	End
Item	Vegetation			38.181617 °	38.181265 °
				-121.585589 °	-121.585863 °
DWR ID	DWR_NA0002_02_f_2017_134				
Comment Code					
V2 : Remove the wild growth other than native grasses from the levee slopes.					
Inspector Comment					
Dense wild berry vines at landside toe.

Looking southwest at the landside slope.

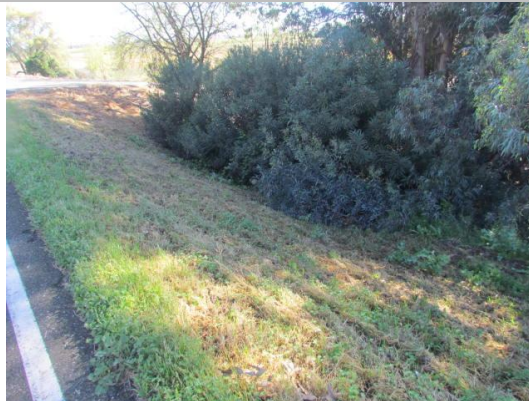
Photo 1 of 4 : SP_2018_NA0002_63_27_20180305_00031.jpg

LM Start	1.45	Rating **	U	Issue No.	27 (cont)
LM End	1.47	Issue Type +	Ma	Location *	LS

Looking east at dense vegetation at landward toe.

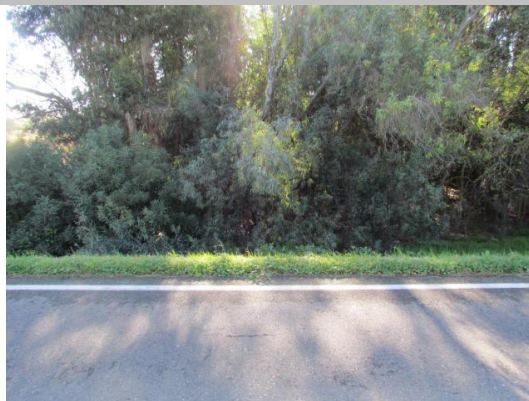
Photo 2 of 4 : SP_2018_NA0002_63_27_20180305_00032.jpg

Looking east at dense vegetation at landward toe.

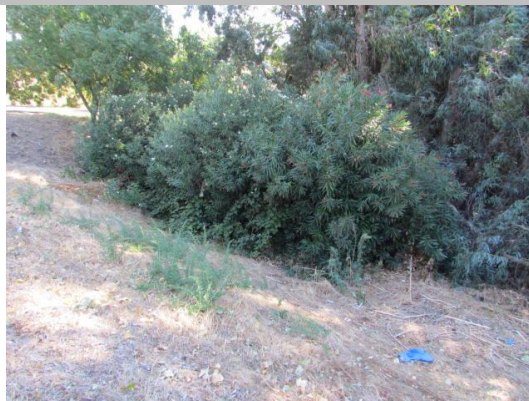
Photo 3 of 4 : SP_2018_NA0002_63_27_20180305_00033.jpg

Looking east at dense vegetation on landward toe.

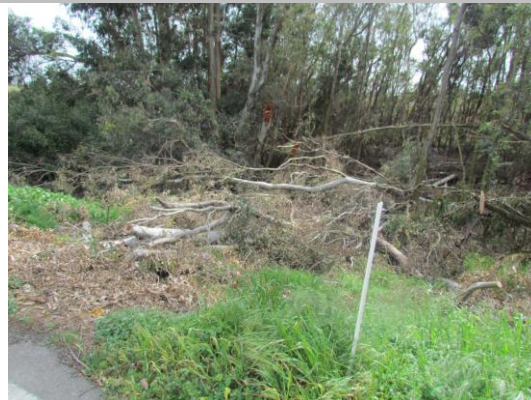
Photo 1 of 2 : SP_2018_NA0002_63_109_20180305_00085.jpg

LM Start	1.46	Rating **	U	Issue No.	109
LM End	1.46	Issue Type +	Ma	Location *	WS
Category	Earthen Levee			GPS Latitude/Longitude	
				Start	End
Item	Encroachments			38.178805 °	38.178805 °
				-121.587850 °	-121.587850 °
DWR ID	DWR_NA0002_02_s _ 2016_109				
Comment Code					
TR : Tree or limb					
Inspector Comment					
Downed tree branches and limbs on landside slope.

Looking southwest at fallen tree on waterward slope.

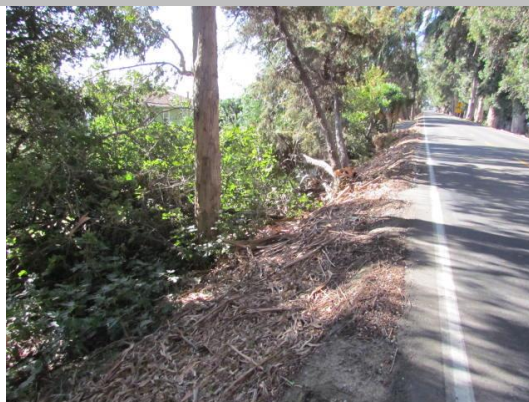
Photo 1 of 2 : SP_2018_NA0002_63_45_20180305_00047.jpg

LM Start	1.80	Rating **	U	Issue No.	45
LM End	1.82	Issue Type +	Ma	Location *	LS
Category	Earthen Levee			GPS Latitude/Longitude	
				Start	End
Item	Vegetation			38.174437 °	38.174153 °
				-121.590786 °	-121.590980 °
DWR ID	DWR_NA0002_02_f_2013_45				
Comment Code					
V2 : Remove the wild growth other than native grasses from the levee slopes.					
Inspector Comment					
Dense vegetation on landside slope and toe

Looking southwest at dense vegetation on landward slope.

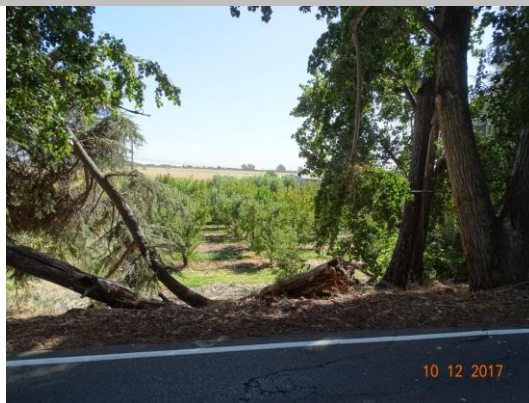
Photo 1 of 1 : SP_2018_NA0002_63_138_20180305_00101.jpg

LM Start	1.89	Rating **	M	Issue No.	138
LM End	1.89	Issue Type +	Ma	Location *	LS
Category	Earthen Levee			GPS Latitude/Longitude	
				Start	End
Item	Encroachments			38.173272 °	38.173272 °
				-121.591509 °	-121.591509 °
DWR ID	DWR_NA0002_02_f_2017_138				
Comment Code					
TR : Tree or limb					
Inspector Comment

Looking southeast at the landside slope.

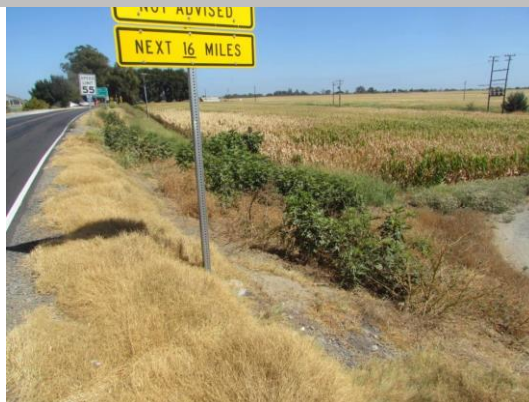
Photo 1 of 1 : SP_2018_NA0002_63_120_20180305_00098.jpg

LM Start	2.16	Rating **	M	Issue No.	120
LM End	2.16	Issue Type +	Ma	Location *	LS
Category	Earthen Levee			GPS Latitude/Longitude	
				Start	End
Item	Vegetation			38.169814 °	38.169814 °
				-121.593951 °	-121.593951 °
DWR ID	DWR_NA0002_02_f_2016_120				
Comment Code					
V2 : Remove the wild growth other than native grasses from the levee slopes.					
Inspector Comment					
Fig tree saplings on landside slope.

Looking northeast at fig tree saplings at landward toe.

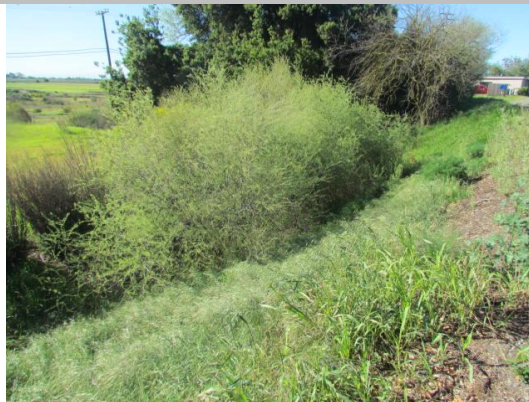
Photo 1 of 2 : SP_2018_NA0002_63_99_20180305_00072.jpg

LM Start	2.42	Rating **	U	Issue No.	99
LM End	2.42	Issue Type +	Ma	Location *	LS
Category	Earthen Levee			GPS Latitude/Longitude	
				Start	End
Item	Vegetation			38.166772 °	38.166772 °
				-121.596667 °	-121.596667 °
DWR ID	DWR_NA0002_02_s _ 2014_99				
Comment Code					
V2 : Remove the wild growth other than native grasses from the levee slopes.					
Inspector Comment					
Dense willows on landside slope.

Looking southwest at vegetation (willows) on landward slope and toe.

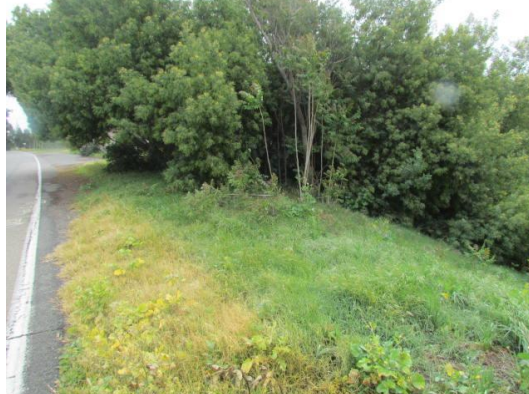
Photo 1 of 2 : SP_2018_NA0002_63_29_20180305_00036.jpg

LM Start	2.48	Rating **	U	Issue No.	29
LM End	2.48	Issue Type +	Ma	Location *	LS
Category	Earthen Levee			GPS Latitude/Longitude	
				Start	End
Item	Trim / Thin Trees			38.166378 °	38.166378 °
				-121.597570 °	-121.597570 °
DWR ID	DWR_NA0002_02_s_2012_29				
Comment Code					
T1 : Trim trees to at least five feet above ground level.					
Inspector Comment

Looking northeast at dense vegetation on landward slope.

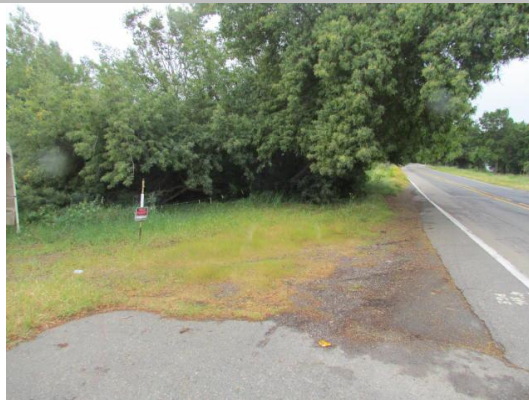
Photo 2 of 2 : SP_2018_NA0002_63_29_20180305_00037.jpg

Looking southwest at dense vegetation on landward slope.

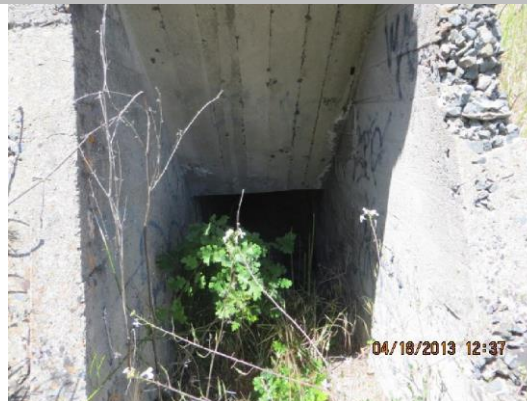
Photo 1 of 3 : UCIP_SP_2018_51315_19776.jpg

Tunnel open on LS shoulder.

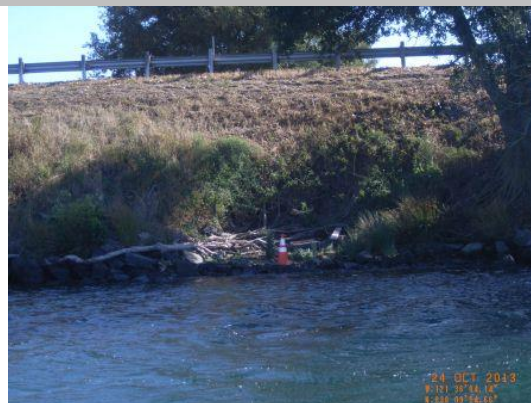
Photo 1 of 2 : SP_2018_NA0002_63_37_20180305_00042.jpg

LM Start	2.66	Rating **	M	Issue No.	37
LM End	2.74	Issue Type +	Ma	Location *	WS
Category	Supplemental			GPS Latitude/Longitude	
				Start	End
Item	2015 USACE Erosion Survey, DRAFT			38.165303 °	38.164682 °
				-121.600477 °	-121.601804 °
DWR ID	DWR_NA0002_02_s_2016_37				
Comment Code					
Inspector Comment					
2009 - Large scallop from rotational failure. One fallen tree and one large tree with half of its root structure exposed. 2015: Large tree expected to pop out within next couple of years, will take very large chunk of levee out. [2015 Site ID: SAC_18-0_L]

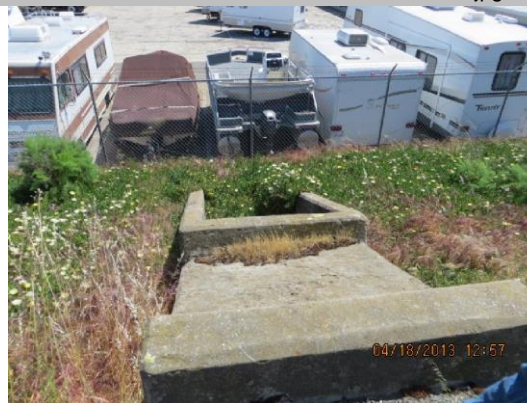
Photo 1 of 3 : UCIP_SP_2018_51316_19782.jpg

Entrance to tunnel on LS slope.

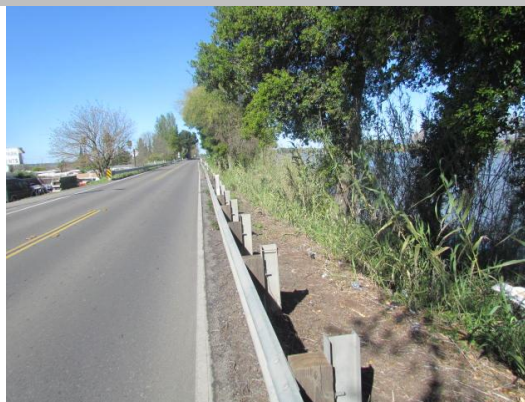
Photo 1 of 1 : SP_2018_NA0002_63_100_20180305_00074.jpg

LM Start	3.39	Rating **	M	Issue No.	100
LM End	3.42	Issue Type +	Ma	Location *	WS
Category	Earthen Levee			GPS Latitude/Longitude	
				Start	End
Item	Vegetation			38.162394 °	38.162432 °
				-121.613146 °	-121.613637 °
DWR ID	DWR_NA0002_02_s_2014_100				
Comment Code					
V2 : Remove the wild growth other than native grasses from the levee slopes.					
Inspector Comment					
Bamboo on waterside slope.

Looking southwest at vegetation (bamboo) on waterward slope.

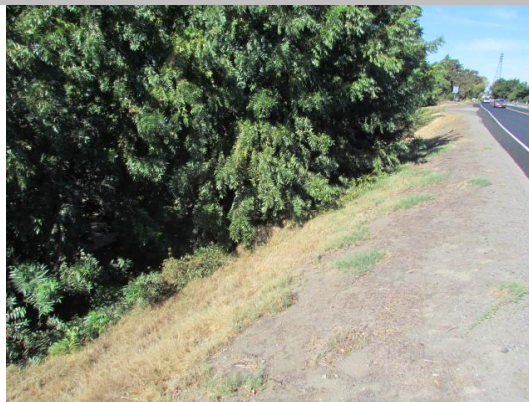
Photo 1 of 1 : SP_2018_NA0002_63_102_20180305_00076.jpg

LM Start	3.96	Rating **	U	Issue No.	102
LM End	3.96	Issue Type +	Ma	Location *	LS
Category	Earthen Levee			GPS Latitude/Longitude	
				Start	End
Item	Trim / Thin Trees			38.164246 °	38.164246 °
				-121.623272 °	-121.623272 °
DWR ID	DWR_NA0002_02_s _ 2014_102				
Comment Code					
T1 : Trim trees to at least five feet above ground level.					
Inspector Comment					
Untrimmed tree blocking landside slope and toe.

Looking west at dense trees on landward slope and toe.

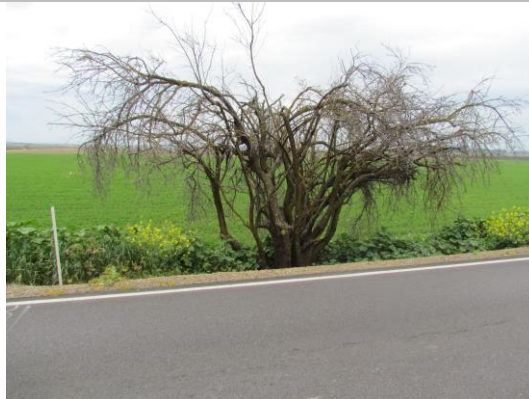
Photo 1 of 1 : SP_2018_NA0002_63_88_20180305_00058.jpg

LM Start	4.92	Rating **	M	Issue No.	88
LM End	4.92	Issue Type +	Ma	Location *	LS
Category	Earthen Levee			GPS Latitude/Longitude	
				Start	End
Item	Encroachments			38.169262 °	38.169262 °
				-121.639497 °	-121.639497 °
DWR ID	DWR_NA0002_02_s_2017_88				
Comment Code					
TR : Tree or limb					
Inspector Comment					
Remove dead tree on landside slope.

Looking east at dead tree on landward slope and toe.

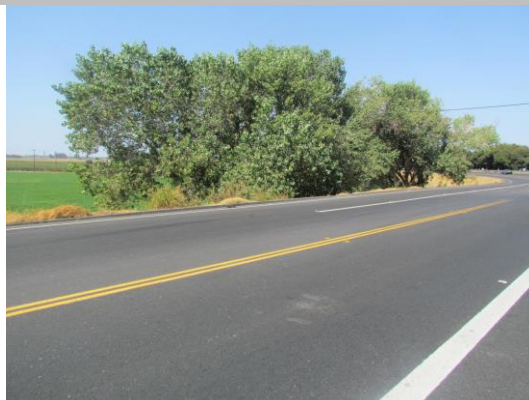
Photo 1 of 1 : SP_2018_NA0002_63_95_20180305_00067.jpg

LM Start	5.16	Rating **	U	Issue No.	95	
LM End	5.16	Issue Type +	Ma	Location *	LS	
Category	Earthen Levee			GPS Latitude/Longitude		
				Start		End
Item	Trim / Thin Trees			38.171318 °		38.171318 °
				-121.643001 °		-121.643001 °
DWR ID	DWR_NA0002_02_f_2015_95					
Comment Code						
T1 : Trim trees to at least five feet above ground level.						
Inspector Comment

Looking west at untrimmed trees on landward slope.

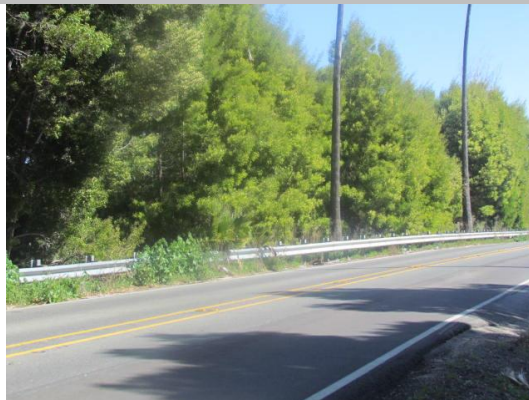
Photo 1 of 3 : SP_2018_NA0002_63_9_20180305_00012.jpg

LM Start	5.23	Rating **	U	Issue No.	9
LM End	5.42	Issue Type +	Ma	Location *	WS
Category	Earthen Levee			GPS Latitude/Longitude	
				Start	End
Item	Trim / Thin Trees			38.171942 °	38.171800 °
				-121.643975 °	-121.647447 °
DWR ID	DWR_NA0002_02_s_2012_9				
Comment Code					
T2 : Thin trees to allow visibility of the ground and room to flood fight.					
Inspector Comment

Looking northeast at dense trees on waterside slope and toe.

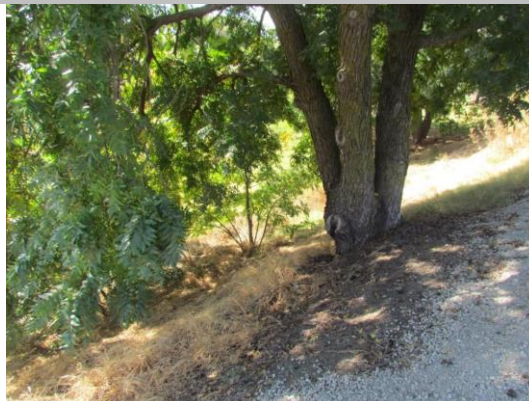
Photo 1 of 2 : SP_2018_NA0002_63_14_20180305_00020.jpg

LM Start	6.36	Rating **	U	Issue No.	14
LM End	6.36	Issue Type +	Ma	Location *	LS
Category	Earthen Levee			GPS Latitude/Longitude	
				Start	End
Item	Trim / Thin Trees			38.173406 °	38.173406 °
				-121.663815 °	-121.663815 °
DWR ID	DWR_NA0002_02_s_2012_14				
Comment Code					
T1 : Trim trees to at least five feet above ground level.					
Inspector Comment

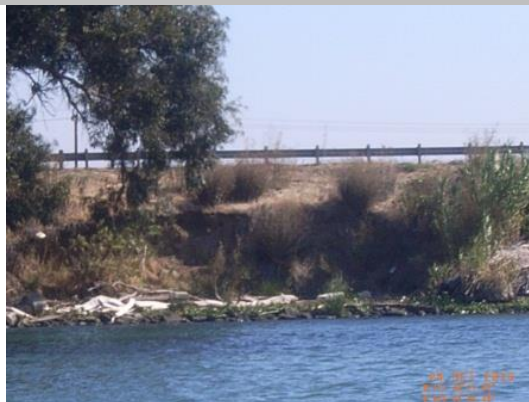
Photo 1 of 1 : SP_2018_NA0002_63_23_20180305_00028.jpg

LM Start	6.98	Rating **	M	Issue No.	23
LM End	7.04	Issue Type +	Ma	Location *	WS
Category	Supplemental			GPS Latitude/Longitude	
				Start	End
Item	2015 USACE Erosion Survey, DRAFT			38.166583°	38.165794°
				-121.670684°	-121.671014°
DWR ID	DWR_NA0002_02_s_2016_23				
Comment Code					
Inspector Comment					
2011 - Large section of bank slumped off. 2015: No observed changes. [2015 Site ID: SAC_13-6_L]

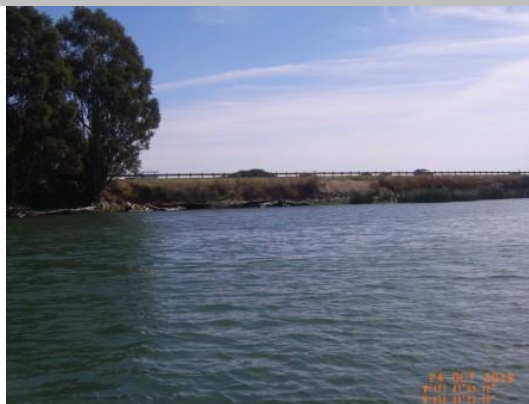
Photo 1 of 1 : SP_2018_NA0002_63_19_20180305_00025.jpg

LM Start	8.96	Rating **	U	Issue No.	19
LM End	9.18	Issue Type +	Ma	Location *	WS
Category	Supplemental			GPS Latitude/Longitude	
				Start	End
Item	2015 USACE Erosion Survey, DRAFT			38.141399 °	38.138158 °
				-121.685346 °	-121.686531 °
DWR ID	DWR_NA0002_02_s_2016_19				
Comment Code					
Inspector Comment					
2008 - Erosion causing vertical bank at the highway on top of levee. The whole bank along the highway should be repaired. 2009 - Minimal new erosion. 2011 - Bank continues to slowly erode. 2012 - Upgrade to critical, new erosion since lat year and steeper slopes in sections. 2015: Road foundation and cables exposed. Extremely large tree with exposed roots looks likely to fail and take out a significant portion of the levee. [2015 Site ID: SAC_11-2_L]

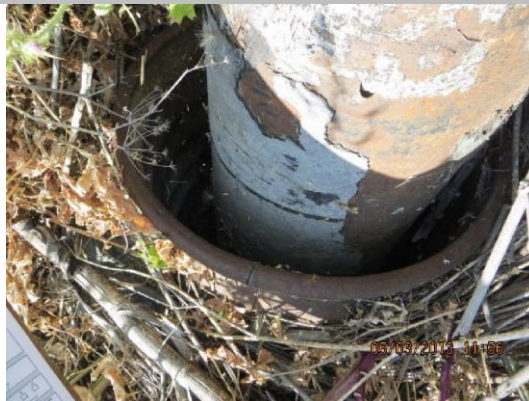
Photo 2 of 3 : UCIP_SP_2018_40528_21001.jpg

FS_ID:40528
DS_ID:21931
EP_NO: 16011
Repair Type: Non-Urgent
Crossing Status: Found
UCIP Comments: Annular space between pipes should be grouted. IF abandoned, these pipes should be abandoned properly.
FIELD_STRUCT_DESC: 18-inch corrugated metal conduit pipe through the levee, 4.5 feet below the crown. Inactive 12-inch pipe sleeved through 18-inch. Both ends open. Siphon breaker and air valve in 24-inch corrugated metal riser unit on the landside (LS) shoulder. 9-foot by 5-foot concrete box with slide gate off LS toe. [Additional Reference(s): DWR Levee Log, 2005. USACE Sacramento O&M Manual 102, April 1959, (RM 10.9) (Reclamation District No. 2067) steel pipe listed].
FS Date: 5/3/2013

18-inch CMP with 12-inch irrigation pipe sleeved through it.

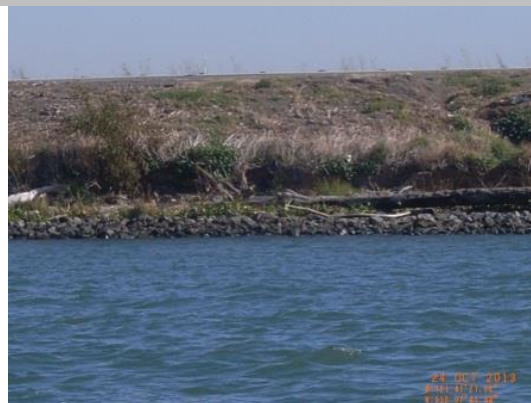
Photo 1 of 1 : SP_2018_NA0002_63_21_20180305_00027.jpg

Comment Code					
Inspector Comment					
2004 - Wave wash pockets approximately 100 ft long with new full bank rock between the pockets. 2005 - Spot repairs, but toe is still eroding in several places. 2006 - Low vertical bank along roadway. 2007 - A PL 84-99 repair was constructed, it cover the majority of the site with the exception of the upstream 150 to 200 ft and the downstream 250 ft, therefore it is being kept in the inventory. 2009 - Minimal new erosion. 2010 - Outboard berm looks good, but the banks are still very steep. 2011 - While the outboard berm is protecting against wave wash, bank still has slumping issues. 2015: No observed changes. [2015 Site ID: SAC_10-8_L]

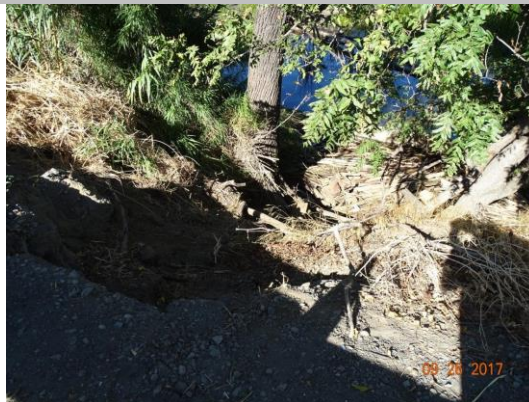
Photo 1 of 1 : SP_2018_NA0002_63_119_20180305_00097.jpg

LM Start	10.74	Rating **	M	Issue No.	119
LM End	10.74	Issue Type +	Ma	Location *	WS
Category	Earthen Levee			GPS Latitude/Longitude	
				Start	End
Item	Erosion / Bank Caving			38.116906 °	38.116906 °
				-121.694595 °	-121.694595 °
DWR ID	DWR_NA0002_02_f_2017_119				
Comment Code					
E2 : Schedule repair of erosion site prior to the next inspection.					
Inspector Comment

Looking northwest at the waterside slope.
