**Flood Control Project Maintenance  
Levee Inspections**

## Maintenance Issue Types Only, Levee Inspection Report By Mile - Spring 2019

### Brannan Andrus Levee Maintenance District

Waterway	Bank	Unit Miles	Inspection Start/End	Inspector
Unit No. 01 Georgiana Slough	Right	6.01	04/23/2019 04/23/2019	David Julian

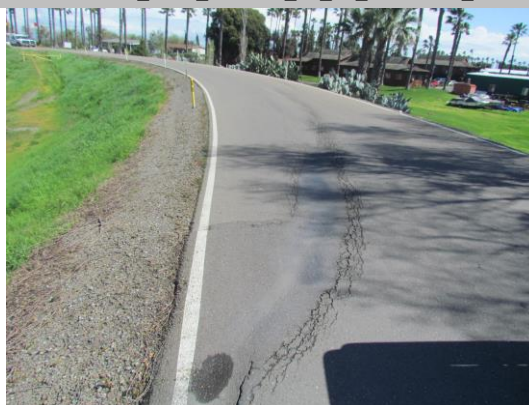
Photo 2 of 3 : SP\_2019\_NA0002\_62\_67\_20190311\_00043.jpg

LM Start	3.38	Rating **	A/W	Issue No.	67
LM End	3.40	Issue Type +	Ma	Location *	CR
Category	Earthen Levee			GPS Latitude/Longitude	
				Start	End
Item	Slope Stability			38.151430 °	38.151390 °
				-121.592085 °	-121.592517 °
DWR ID	DWR_NA0002_01_s_2017_67				
Comment Code					
S1 : Repair slope instability.					
Inspector Comment					
Appears to be beginning of a landside slump. LMA's Engineer (DCC) is monitoring site for movement.

Looking east at possible sloughing on landward shoulder.

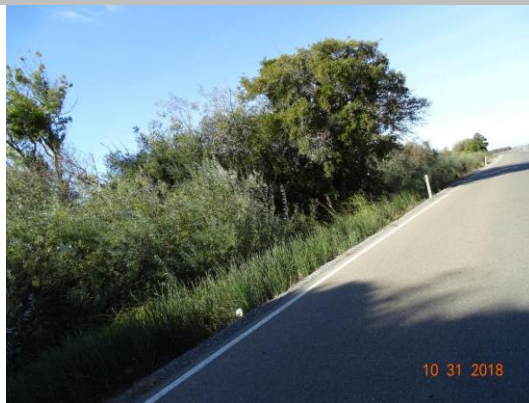
Photo 1 of 1 : SP\_2019\_NA0002\_62\_59\_20190311\_00036.jpg

LM Start	3.43	Rating **	U	Issue No.	59
LM End	3.95	Issue Type +	Ma	Location *	WS
Category	Earthen Levee			GPS Latitude/Longitude	
				Start	End
Item	Vegetation			38.151448 °	38.145753 °
				-121.592898 °	-121.601660 °
DWR ID	DWR_NA0002_01_f_2018_59				
Comment Code					
V2 : Remove the wild growth other than native grasses from the levee slopes.					
Inspector Comment

View looking downstream at vegetation on the water side slope (October 2018).

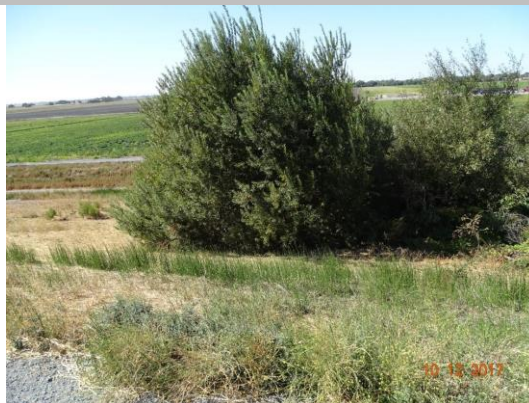
Photo 1 of 1 : SP\_2019\_NA0002\_62\_46\_20190311\_00028.jpg

LM Start	3.74	Rating **	M	Issue No.	46
LM End	3.74	Issue Type +	Ma	Location *	LS
Category	Earthen Levee			GPS Latitude/Longitude	
				Start	End
Item	Trim / Thin Trees			38.150841 °	38.150841 °
				-121.598161 °	-121.598161 °
DWR ID	DWR_NA0002_01_f_2017_46				
Comment Code					
T1 : Trim trees to at least five feet above ground level.					
Inspector Comment

Looking southwest at the landside slope.

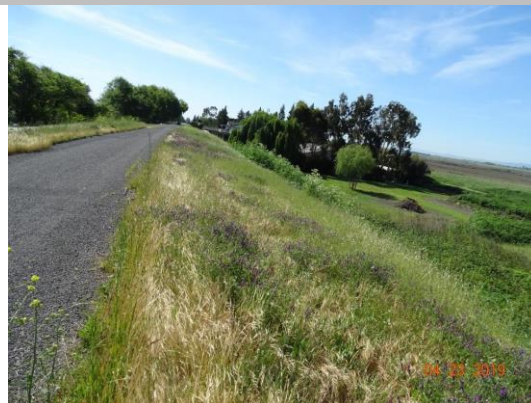
Photo 1 of 1 : SP\_2019\_NA0002\_62\_69\_20190423\_00105.jpg

LM Start	4.55	Rating **	U	Issue No.	69
LM End	4.55	Issue Type +	Ma	Location *	LS
Category	Earthen Levee			GPS Latitude/Longitude	
				Start	End
Item	Vegetation			38.140402 °	38.140402 °
				-121.598276 °	-121.598276 °
DWR ID	DWR_NA0002_01_s_2019_69				
Comment Code					
V1 : Control annual grass and weeds on the levee slopes and easements.					
Inspector Comment

View looking downstream at annual vegetation on the landside slope (Spring 2019).

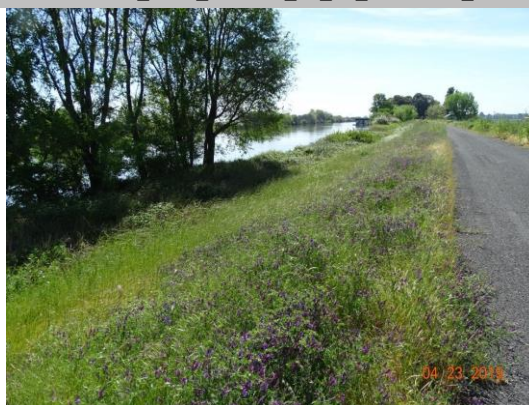
Photo 1 of 1 : SP\_2019\_NA0002\_62\_87\_20190423\_00107.jpg

LM Start	4.83	Rating **	U	Issue No.	87	
LM End	4.95	Issue Type +	Ma	Location *	WS	
Category	Earthen Levee			GPS Latitude/Longitude		
				Start		End
Item	Vegetation			38.136882 °		38.135516 °
				-121.596015 °		-121.594597 °
DWR ID	DWR_NA0002_01_s_2019_87					
Comment Code						
V1 : Control annual grass and weeds on the levee slopes and easements.						
Inspector Comment						
Maintain annual vegetation

View looking downstream at annual vegetation on the waterside slope (Spring 2019).

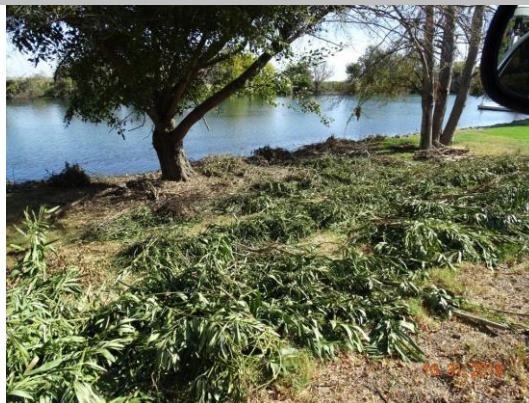
Photo 1 of 1 : SP\_2019\_NA0002\_62\_80\_20190311\_00048.jpg

LM Start	5.05	Rating **	M	Issue No.	80
LM End	5.05	Issue Type +	Ma	Location *	WS
Category	Earthen Levee			GPS Latitude/Longitude	
				Start	End
Item	Encroachments			38.134380 °	38.134380 °
				-121.593338 °	-121.593338 °
DWR ID	DWR_NA0002_01_f_2018_80				
Comment Code					
PR : Prunings					
Inspector Comment					
Remove prunings

View of prunings on the water side slope (October 2018).

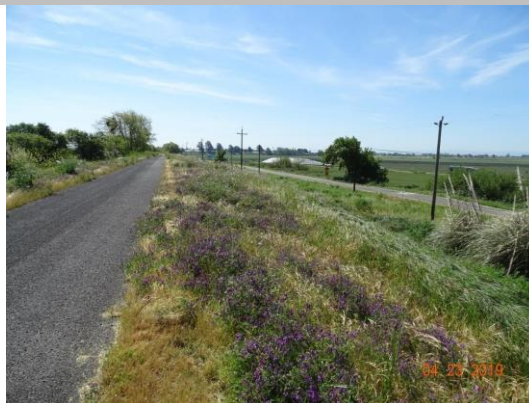
Photo 1 of 1 : SP\_2019\_NA0002\_62\_89\_20190423\_00110.jpg

LM Start	5.26	Rating **	U	Issue No.	89
LM End	5.83	Issue Type +	Ma	Location *	LS
Category	Earthen Levee			GPS Latitude/Longitude	
				Start	End
Item	Vegetation			38.132089 °	38.129643 °
				-121.590746 °	-121.581769 °
DWR ID	DWR_NA0002_01_s_2019_89				
Comment Code					
V1 : Control annual grass and weeds on the levee slopes and easements.					
Inspector Comment

View looking downstream at annual vegetation on the landside slope (Spring 2019).

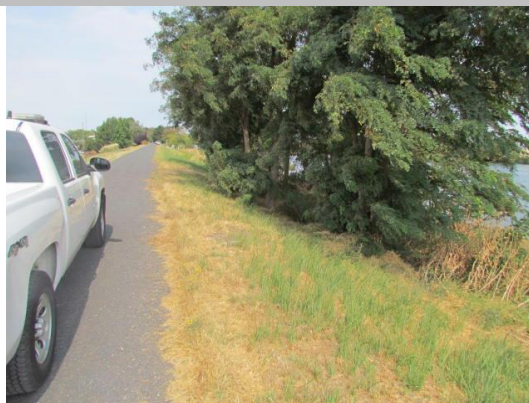
Photo 1 of 1 : SP\_2019\_NA0002\_62\_2\_20190311\_00001.jpg

LM Start	5.33	Rating **	M	Issue No.	2
LM End	5.33	Issue Type +	Ma	Location *	WS
Category	Earthen Levee			GPS Latitude/Longitude	
				Start	End
Item	Trim / Thin Trees			38.131327 °	38.131327 °
				-121.589980 °	-121.589980 °
DWR ID	DWR_NA0002_01_s_2012_2				
Comment Code					
T1 : Trim trees to at least five feet above ground level.					
Inspector Comment

Looking at untrimmed trees on waterward slope.

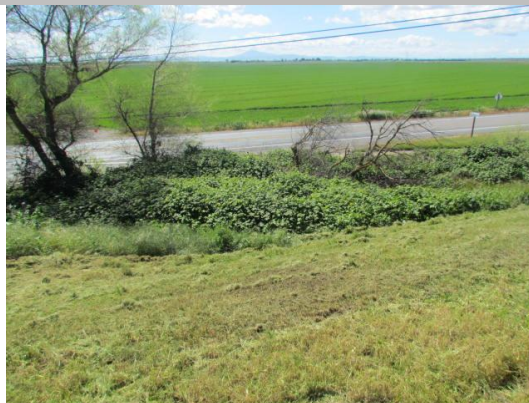
Photo 1 of 3 : SP\_2019\_NA0002\_62\_23\_20190311\_00012.jpg

LM Start	<b>5.43</b>	Rating **	U	Issue No.	<b>23 (cont)</b>
LM End	<b>5.57</b>	Issue Type +	Ma	Location *	LS

Looking south at vegetation at landward toe. (Spring 2016)

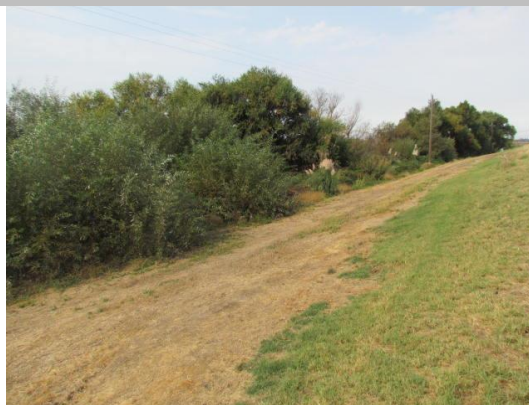
Photo 2 of 3 : SP\_2019\_NA0002\_62\_23\_20190311\_00013.jpg

Looking west at dense vegetation at landward toe.

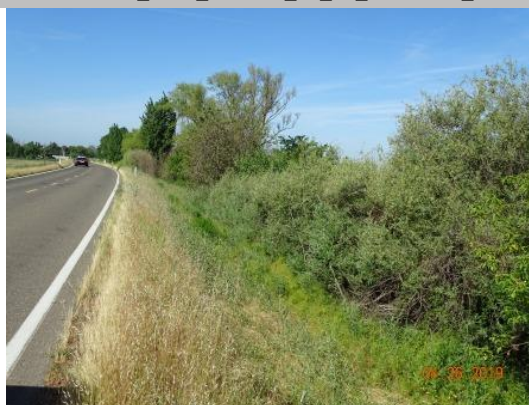
Photo 1 of 1 : SP\_2019\_NA0002\_63\_57\_20190429\_00193.jpg

LM Start	0.04	Rating **	M	Issue No.	57
LM End	2.07	Issue Type +	Ma	Location *	WS
Category	Earthen Levee			GPS Latitude/Longitude	
				Start	End
Item	Vegetation			38.191675 °	38.170978 °
				-121.568377 °	-121.593159 °
DWR ID	DWR_NA0002_02_s_2019_57				
Comment Code					
V1 : Control annual grass and weeds on the levee slopes and easements.					
Inspector Comment					
Maintain the annual vegetation.

View looking downstream at annual vegetation on the waterside slope (Spring 2019).

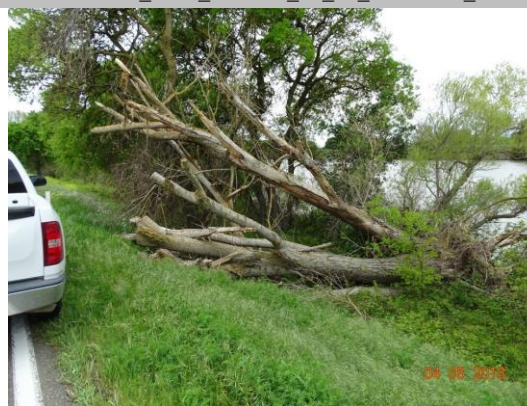
Photo 1 of 1 : SP\_2019\_NA0002\_63\_81\_20190311\_00042.jpg

LM Start	1.33	Rating **	M	Issue No.	81
LM End	1.33	Issue Type +	Ma	Location *	WS
Category	Earthen Levee			GPS Latitude/Longitude	
				Start	End
Item	Encroachments			38.180472 °	38.180472 °
				-121.586510 °	-121.586510 °
DWR ID	DWR_NA0002_02_s_2018_81				
Comment Code					
TR : Tree or limb					
Inspector Comment					
Remove large fallen tree on waterside slope.

View of fallen tree on the waterside.

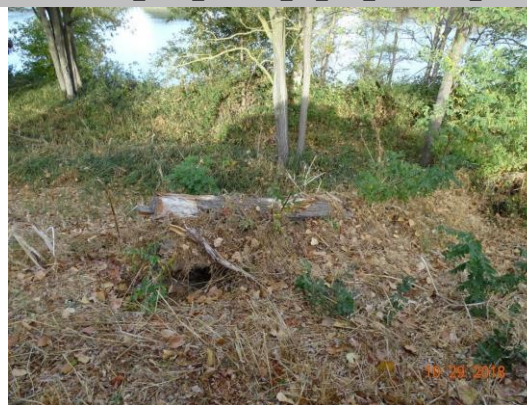
Photo 1 of 1 : SP\_2019\_NA0002\_63\_135\_20190311\_00079.jpg

LM Start	1.43	Rating **	M	Issue No.	135
LM End	1.43	Issue Type +	Ma	Location *	WS
Category	Earthen Levee			GPS Latitude/Longitude	
				Start	End
Item	Encroachments			38.179169 °	38.179169 °
				-121.587511 °	-121.587511 °
DWR ID	DWR_NA0002_02_f_2017_135				
Comment Code					
TR : Tree or limb					
Inspector Comment					
Remove downed tree limbs on waterside slope.

View of tree limbs on the water side slope (October 2018).

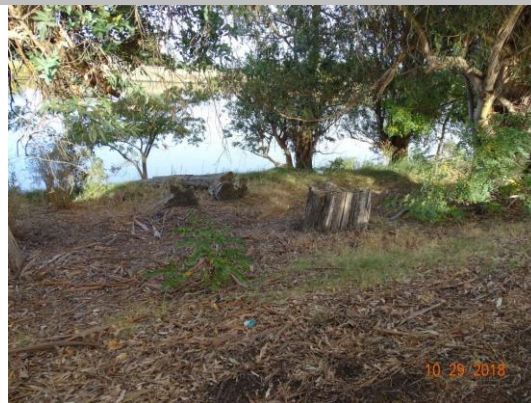
Photo 1 of 1 : SP\_2019\_NA0002\_63\_78\_20190311\_00039.jpg

LM Start	1.65	Rating **	N	Issue No.	78
LM End	1.65	Issue Type +	Ma	Location *	WS
Category	Earthen Levee			GPS Latitude/Longitude	
				Start	End
Item	Trim / Thin Trees			38.176455 °	38.176455 °
				-121.589515 °	-121.589515 °
DWR ID	DWR_NA0002_02_f_2018_78				
Comment Code					
T5 : Tree stumps.					
Inspector Comment

View of tree stump on the waterside slope (October 2018).

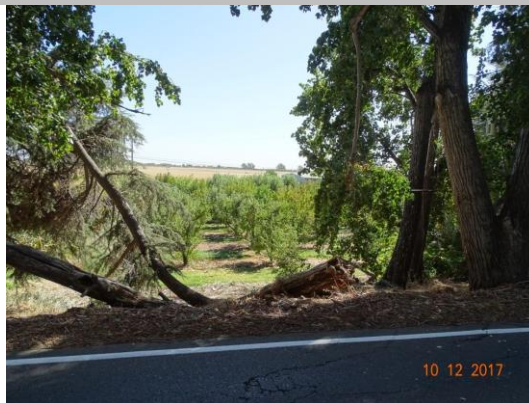
Photo 1 of 1 : SP\_2019\_NA0002\_63\_138\_20190311\_00081.jpg

LM Start	1.89	Rating **	M	Issue No.	138
LM End	1.89	Issue Type +	Ma	Location *	LS
Category	Earthen Levee			GPS Latitude/Longitude	
				Start	End
Item	Encroachments			38.173272 °	38.173272 °
				-121.591509 °	-121.591509 °
DWR ID	DWR_NA0002_02_f_2017_138				
Comment Code					
TR : Tree or limb					
Inspector Comment

Looking southeast at the landside slope.

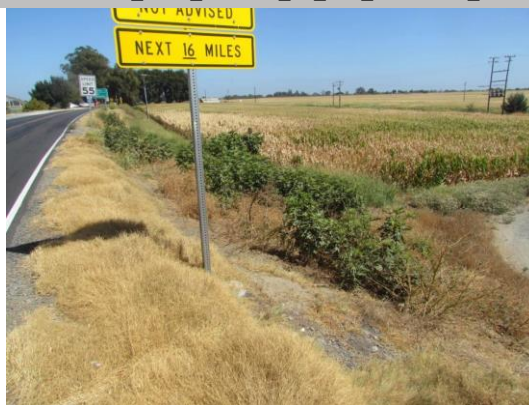
Photo 1 of 1 : SP\_2019\_NA0002\_63\_120\_20190311\_00074.jpg

LM Start	2.16	Rating **	M	Issue No.	120
LM End	2.16	Issue Type +	Ma	Location *	LS
Category	Earthen Levee			GPS Latitude/Longitude	
				Start	End
Item	Vegetation			38.169814 °	38.169814 °
				-121.593951 °	-121.593951 °
DWR ID	DWR_NA0002_02_f_2016_120				
Comment Code					
V2 : Remove the wild growth other than native grasses from the levee slopes.					
Inspector Comment					
Fig tree saplings are on the landside slope.

Looking northeast at fig tree saplings at landward toe.

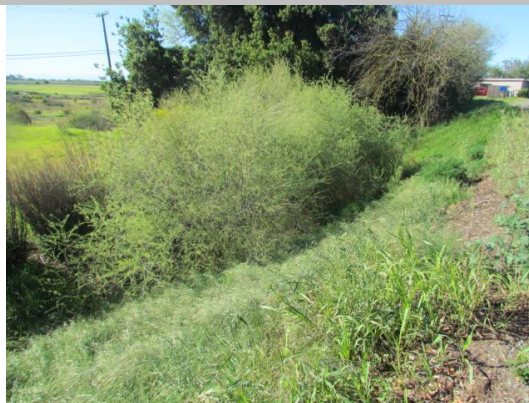
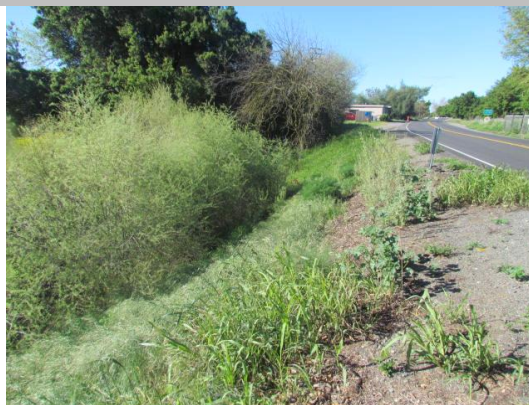
Photo 1 of 2 : SP\_2019\_NA0002\_63\_99\_20190311\_00058.jpg

LM Start	<b>2.42</b>	Rating **	U	Issue No.	<b>99 (cont)</b>
LM End	<b>2.42</b>	Issue Type +	Ma	Location *	LS

Looking southwest at vegetation (willows) on landward slope and toe.

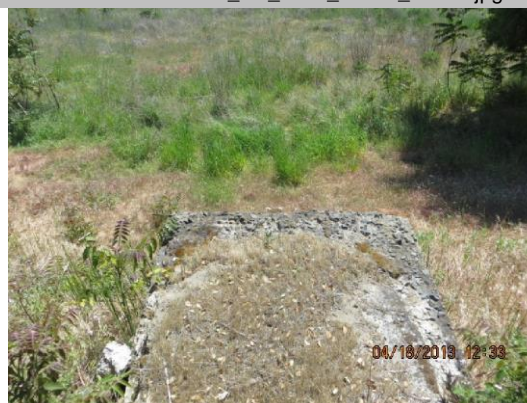
Photo 2 of 3 : UCIP\_SP\_2019\_53389\_19772.jpg

Comment Code						
Inspector Comment						
FS_ID:53389 DS_ID:21879 EP_NO: N/A Repair Type: Non-Urgent Crossing Status: Found UCIP Comments: 07/12/2018 Tunnel is open on both sides. No integrity issue observed, therefore crossing downgraded to "Non-Urgent". (O.Yakimov-DWR UCIP)10/24/2016 same as previous inspection culvert is open on both ends. WS blocked by blankets -- WS structure is being used as a shelter. (O. Magana - DWR UCIP)04/18/2013 Culvert open on both ends. Needs to be abandoned properly. (W. Wylie - DWR UCIP) FIELD_STRUCT_DESC: *ABANDONED* 42-inch by 42-inch open reinforced concrete drainage culvert through the levee, 6 feet below the crown. [Additional Reference(s): DWR Levee Log, 2005, 3-foot by 3.5-foot culvert listed. USACE Sacramento O&M Manual 103, June 1954, (RM 18.16) Drawing No. 6-13-1100]. FS Date: 7/12/2018 2:59:33 PM

Top of concrete tunnel on LS shoulder.

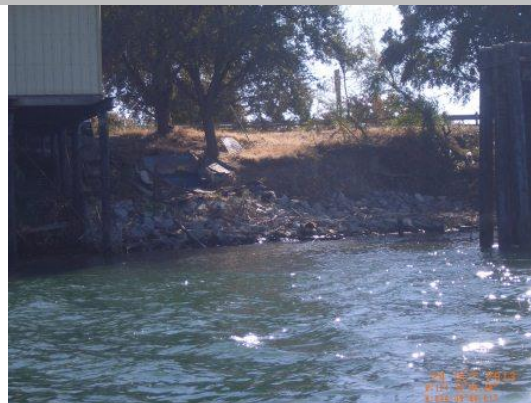
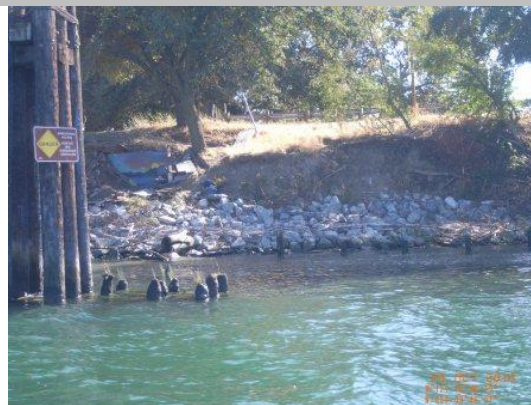
Photo 1 of 2 : SP\_2019\_NA0002\_63\_75\_20190311\_00035.jpg

Comment Code					
Inspector Comment					
2017 Site ID: SAC 17.2 L					
Status: Critical					
2017 Field Notes: More rock has been placed in spots along the toe, but it is still insufficient.					
Site History: 2009 - Fluvial erosion, into the levee slope, close to vertical bank with roadway on top. Pilings that were once at the bankline are now 30 ft out. 2010 - Very steep slope with slumps and overturned trees. 2011 - Upgraded to CRITICAL. Sections of vertical slope with highway on top. Heavy vegetation in front of most of the erosion pockets. Structures built into the levee on the upstream end. 2012 - Site continues to worsen. 2013 - Some rock added on the upstream end, but site remains critical.					
2018: Site with erosion almost into roadway still there. Keep as critical.

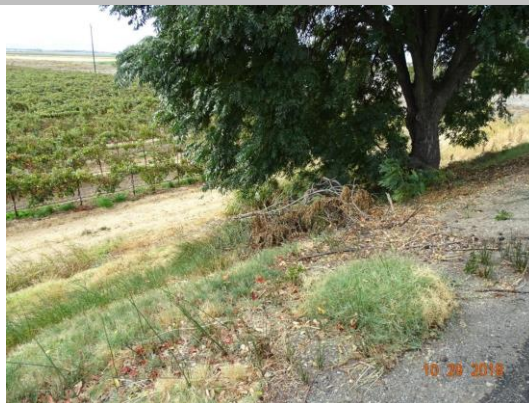
Photo 1 of 1 : SP\_2019\_NA0002\_63\_166\_20190311\_00099.jpg

LM Start	4.58	Rating **	M	Issue No.	166
LM End	4.58	Issue Type +	Ma	Location *	LS
Category	Earthen Levee			GPS Latitude/Longitude	
				Start	End
Item	Encroachments			38.167637 °	38.167637 °
				-121.633727 °	-121.633727 °
DWR ID	DWR_NA0002_02_f_2018_166				
Comment Code					
PR : Prunings					
Inspector Comment					
Remove the prunings from the landside slope.

View of prunings on the landside slope (October 2018).

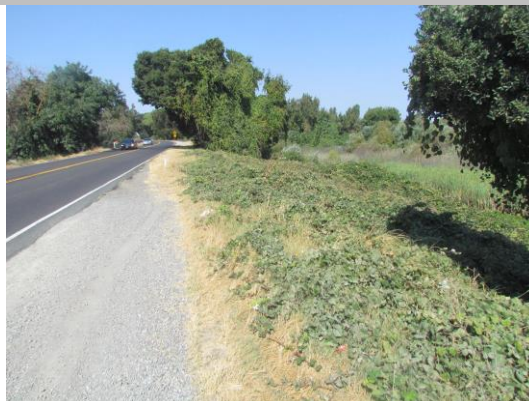
Photo 1 of 1 : SP\_2019\_NA0002\_63\_123\_20190311\_00075.jpg

LM Start	4.70	Rating **	U	Issue No.	123
LM End	4.72	Issue Type +	Ma	Location *	WS
Category	Earthen Levee			GPS Latitude/Longitude	
				Start	End
Item	Vegetation			38.168348 °	38.168456 °
				-121.635726 °	-121.636125 °
DWR ID	DWR_NA0002_02_f_2016_123				
Comment Code					
V2 : Remove the wild growth other than native grasses from the levee slopes.					
Inspector Comment					
There are dense grapevines on waterside slope.

Looking west at dense vines on waterward slope and toe.

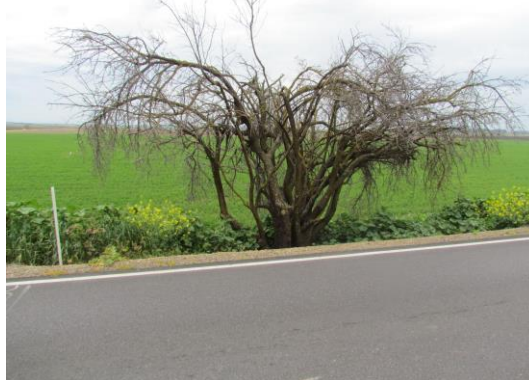
Photo 1 of 1 : SP\_2019\_NA0002\_63\_88\_20190311\_00047.jpg

LM Start	4.92	Rating **	M	Issue No.	88
LM End	4.92	Issue Type +	Ma	Location *	LS
Category	Earthen Levee			GPS Latitude/Longitude	
				Start	End
Item	Encroachments			38.169262 °	38.169262 °
				-121.639497 °	-121.639497 °
DWR ID	DWR_NA0002_02_s_2017_88				
Comment Code					
TR : Tree or limb					
Inspector Comment					
Remove dead tree on landside slope.

Looking east at dead tree on landward slope and toe.

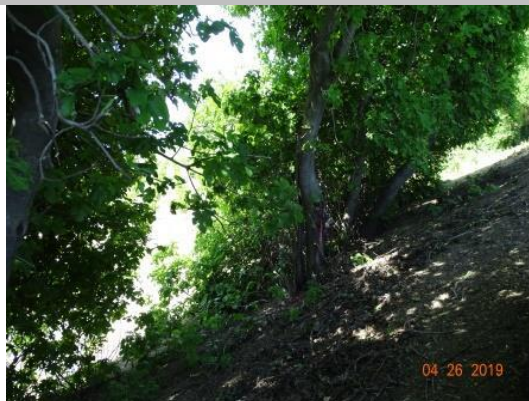
Photo 1 of 1 : SP\_2019\_NA0002\_63\_163\_20190429\_00206.jpg

LM Start	5.01	Rating **	U	Issue No.	163	
LM End	5.01	Issue Type +	Ma	Location *	LS	
Category	Earthen Levee			GPS Latitude/Longitude		
				Start		End
Item	Trim / Thin Trees			38.169750 °		38.169750 °
				-121.641107 °		-121.641107 °
DWR ID	DWR_NA0002_02_f_2018_163					
Comment Code						
T2 : Thin trees to allow visibility of the ground and room to flood fight.						
Inspector Comment						
Trim the fig tree on the landside slope.

View looking downstream at fig tree on the landside slope (Spring 2019).

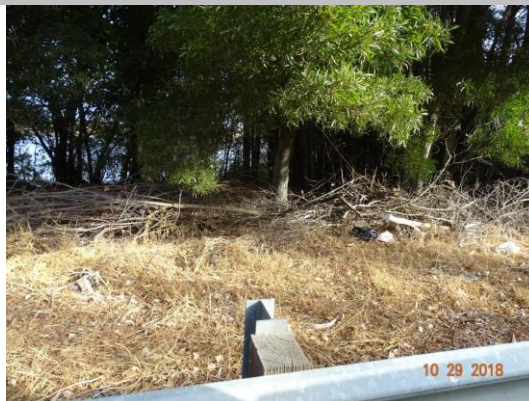
Photo 1 of 1 : SP\_2019\_NA0002\_63\_115\_20190311\_00070.jpg

LM Start	5.36	Rating **	M	Issue No.	115
LM End	5.36	Issue Type +	Ma	Location *	WS
Category	Earthen Levee			GPS Latitude/Longitude	
				Start	End
Item	Encroachments			38.171892 °	38.171892 °
				-121.646387 °	-121.646387 °
DWR ID	DWR_NA0002_02_f_2018_115				
Comment Code					
PR : Prunings					
Inspector Comment					
Remove the prunings from the waterside slope.

View of prunings on the waterside slope (October 2018).

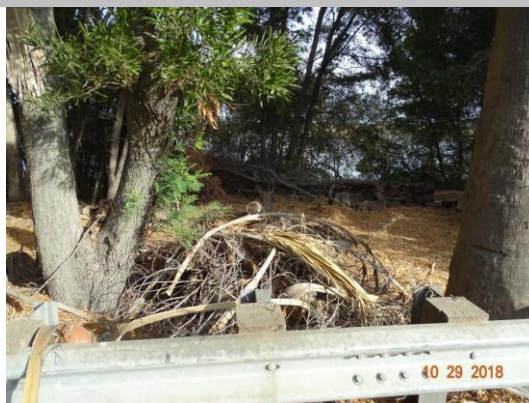
Photo 1 of 1 : SP\_2019\_NA0002\_63\_116\_20190311\_00071.jpg

LM Start	5.38	Rating **	M	Issue No.	116	
LM End	5.38	Issue Type +	Ma	Location *	WS	
Category	Earthen Levee			GPS Latitude/Longitude		
				Start	End	
Item	Encroachments			38.171858 °	38.171858 °	
				-121.646832 °	-121.646832 °	
DWR ID	DWR_NA0002_02_f_2018_116					
Comment Code						
PR : Prunings						
Inspector Comment						
Remove the prunings from the waterside slope.

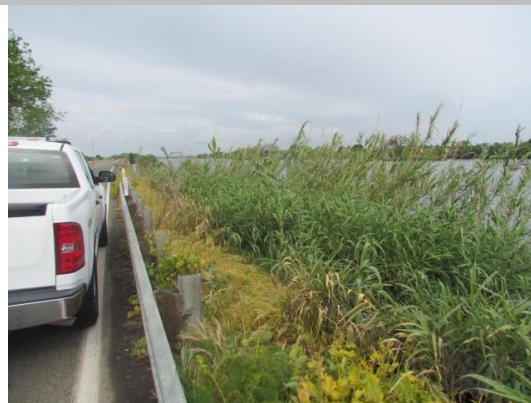
Photo 2 of 2 : SP\_2019\_NA0002\_63\_11\_20190311\_00011.jpg

LM Start	5.65	Rating **	U	Issue No.	11 (cont)	
LM End	5.69	Issue Type +	Ma	Location *	WS	
Category	Earthen Levee			GPS Latitude/Longitude		
				Start		End
Item	Vegetation			38.172308 °	38.172497 °	
				-121.651552 °	-121.652243 °	
DWR ID	DWR_NA0002_02_s _ 2012_11					
Comment Code						
V2 : Remove the wild growth other than native grasses from the levee slopes.						
Inspector Comment						
Remove arundo on the waterside slope.

Looking west at arundo on waterward slope. (Spring 2016)

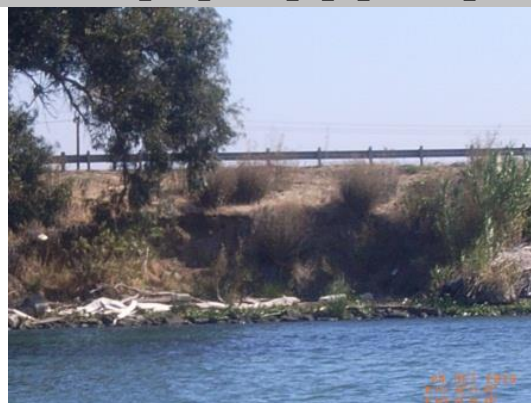
Photo 1 of 1 : SP\_2019\_NA0002\_63\_71\_20190311\_00034.jpg

LM Start	6.98	Rating **	U	Issue No.	71
LM End	7.04	Issue Type +	Ma	Location *	WS
Category	Supplemental			GPS Latitude/Longitude	
				Start	End
Item	2017 USACE Erosion Survey, DRAFT			38.166583 °	38.165794 °
				-121.670684 °	-121.671014 °
DWR ID	DWR_NA0002_02_f_2018_71				
Comment Code					
Inspector Comment					
2017 Site ID: SAC 13.6 L					
Status: Critical					
2017 Field Notes: upgraded to critical. nearly vertical face from levee hinge. trees with large root balls likely to fail.					
Site History: 2011 - Large section of bank slumped off.					
2018: Site should stay critical

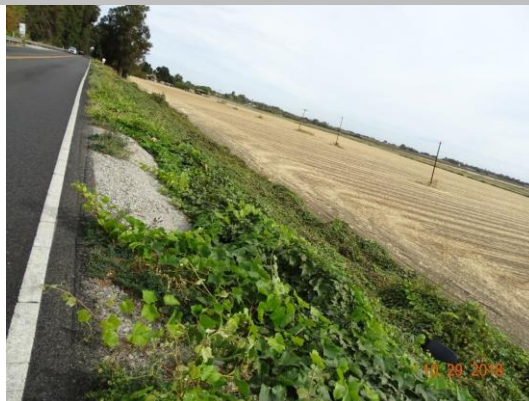
Photo 1 of 1 : SP\_2019\_NA0002\_63\_159\_20190311\_00095.jpg

LM Start	7.04	Rating **	M	Issue No.	159
LM End	7.11	Issue Type +	Ma	Location *	LS
Category	Earthen Levee			GPS Latitude/Longitude	
				Start	End
Item	Vegetation			38.165755 °	38.164730 °
				-121.670675 °	-121.671105 °
DWR ID	DWR_NA0002_02_f_2018_159				
Comment Code					
V2 : Remove the wild growth other than native grasses from the levee slopes.					
Inspector Comment					
Remove the ground cover on the landside slope.

View looking upstream at ivy on the landside slope (October 2018).

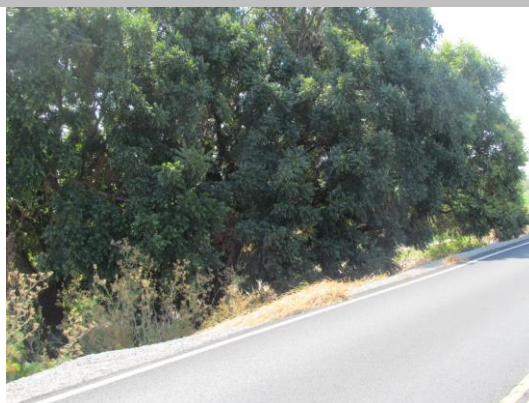
Photo 1 of 1 : SP\_2019\_NA0002\_63\_112\_20190311\_00068.jpg

LM Start	7.13	Rating **	M	Issue No.	112
LM End	7.13	Issue Type +	Ma	Location *	LS
Category	Earthen Levee			GPS Latitude/Longitude	
				Start	End
Item	Trim / Thin Trees			38.164465 °	38.164465 °
				-121.671292 °	-121.671292 °
DWR ID	DWR_NA0002_02_f_2015_112				
Comment Code					
T1 : Trim trees to at least five feet above ground level.					
Inspector Comment

Looking south at untrimmed trees on landward slope.

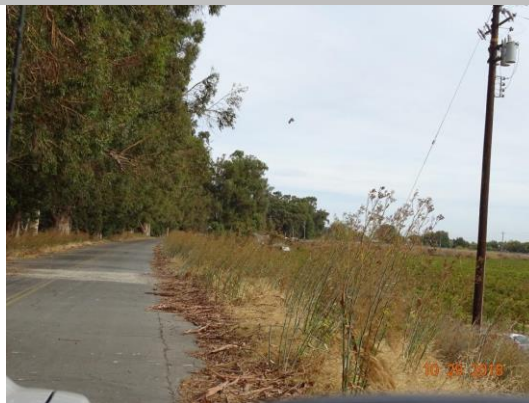
Photo 1 of 1 : SP\_2019\_NA0002\_63\_145\_20190311\_00087.jpg

LM Start	8.06	Rating **	U	Issue No.	145
LM End	8.17	Issue Type +	Ma	Location *	LS
Category	Earthen Levee			GPS Latitude/Longitude	
				Start	End
Item	Vegetation			38.153760 °	38.152197 °
				-121.680967 °	-121.681713 °
DWR ID	DWR_NA0002_02_f_2018_145				
Comment Code					
V1 : Control annual grass and weeds on the levee slopes and easements.					
Inspector Comment					
Maintain vegetation on the landside slope.

View looking upstream at vegetation on the landside shoulder and slope (October 2018).

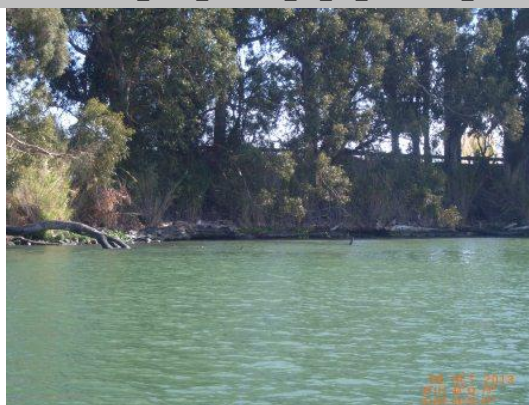
Photo 1 of 1 : SP\_2019\_NA0002\_63\_70\_20190311\_00033.jpg

LM Start	8.20	Rating **	U	Issue No.	70
LM End	8.42	Issue Type +	Ma	Location *	WS
Category	Supplemental			GPS Latitude/Longitude	
				Start	End
Item	2017 USACE Erosion Survey, DRAFT			38.151867 °	38.148711 °
				-121.682201 °	-121.682790 °
DWR ID	DWR_NA0002_02_f_2018_70				
Comment Code					
Inspector Comment					
2017 Site ID: SAC 12.1 L					
Status: Critical					
2017 Field Notes: Continues to worsen and threaten the road.					
Site History: 2010 - Small inlet area behind a man-built spit. Bank is slumping and could possibly be fixed with maintenance. 2011 - Site continues to worsen. 2015 - Upgraded to CRITICAL. 2016 - Site continues to get worse.					
2018: Still threatening roadway. Remain critical

USACE 2013 Photo #1

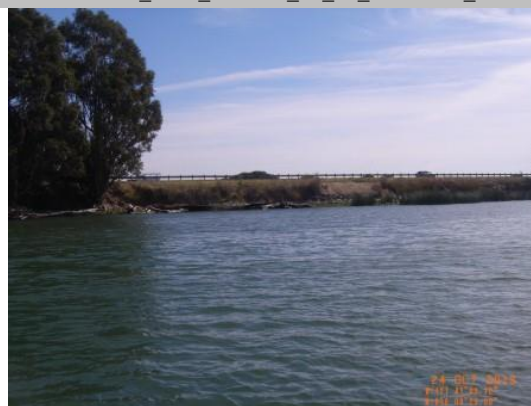
Photo 1 of 1 : SP\_2019\_NA0002\_63\_69\_20190311\_00032.jpg

Comment Code					
Inspector Comment					
2017 Site ID: SAC 11.2 L					
Status: Critical					
2017 Field Notes: New slump section. Erosion under the road has enlarged.					
Site History: 2008 - Erosion causing vertical bank at the highway on top of levee. The whole bank along the highway should be repaired. 2009 - Minimal new erosion. 2011 - Bank continues to slowly erode. 2012 - Upgrade to critical, new erosion since lat year and steeper slopes in sections. 2015 - Road foundation and cables exposed. Extremely large tree with exposed roots looks likely to fail and take out a significant portion of the levee. 2016 - Site continues to erode.

USACE 2013 Photo #1

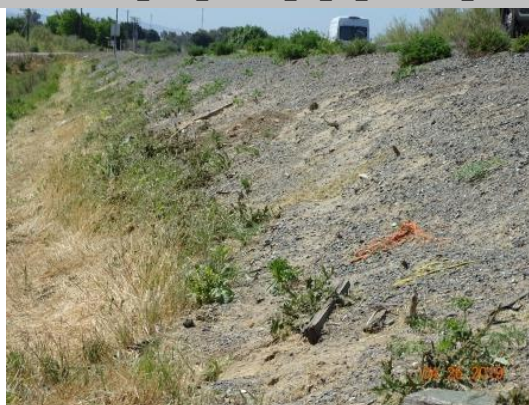
Photo 1 of 2 : SP\_2019\_NA0002\_63\_67\_20190429\_00199.jpg

LM Start	9.27	Rating **	U	Issue No.	67
LM End	10.03	Issue Type +	Ma	Location *	LS
Category	Earthen Levee			GPS Latitude/Longitude	
				Start	End
Item	Animal Control			38.136815 °	38.126291 °
				-121.686161 °	-121.688959 °
DWR ID	DWR_NA0002_02_s_2019_67				
Comment Code					
A1 : Exterminate rodents and backfill and compact or grout burrows.					
Inspector Comment					
There is major ground squirrel burrowing activity along this stretch. The LMA is aware of rock piles near the levee toe and says that is the source of the rodents.

View looking downstream at animal holes on the landside slope (Spring 2019).

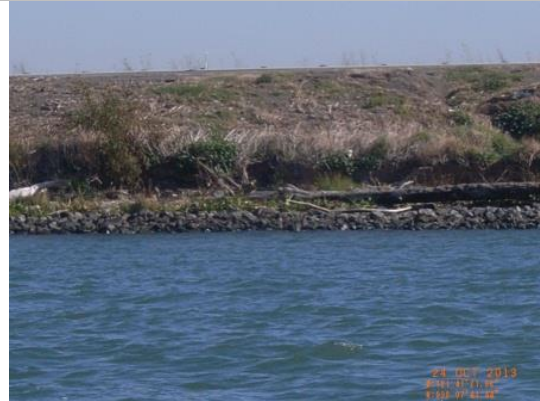
Photo 1 of 1 : SP\_2019\_NA0002\_63\_68\_20190311\_00031.jpg

Comment Code					
Inspector Comment					
2017 Site ID: SAC 10.8 L					
Status: Eroding					
2017 Field Notes: Lots of new woody debris recruitment.					
Site History: 2004 - Wave wash pockets approximately 100 ft long with new full bank rock between the pockets. 2005 - Spot repairs, but toe is still eroding in several places. 2006 - Low vertical bank along roadway. 2007 - A PL 84-99 repair was constructed, it cover the majority of the site with the exception of the upstream 150 to 200 ft and the downstream 250 ft, therefore it is being kept in the inventory. 2009 - Minimal new erosion. 2010 - Outboard berm looks good, but the banks are still very steep. 2011 - While the outboard berm is protecting against wave wash, bank still has slumping issues.

USACE 2013 Photo #1
