**Flood Control Project Maintenance
Levee Inspections**

Maintenance Issue Types Only, Levee Inspection Report By Mile - Spring 2020

Brannan Andrus Levee Maintenance District

Waterway	Bank	Unit Miles	Inspection Start/End	Inspector
Unit No. 01 Georgiana Slough	Right	6.01	04/02/2020 04/02/2020	David Julian

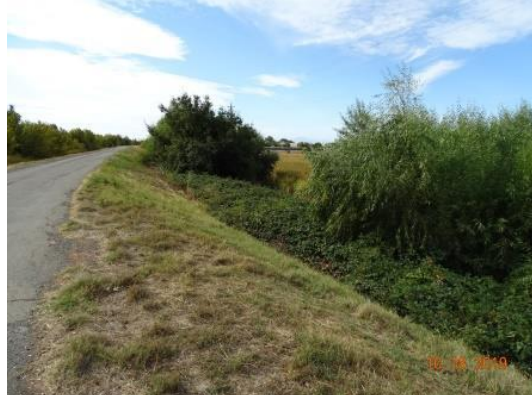
Photo 1 of 1 : SP_2020_NA0002_62_28_20200304_00008.jpg

LM Start	2.41	Rating **	U	Issue No.	28
LM End	2.49	Issue Type +	Ma	Location *	LS
Category	Earthen Levee			GPS Latitude/Longitude	
				Start	End
Item	Vegetation			38.161301 °	38.160281 °
				-121.585560 °	-121.586007 °
DWR ID	DWR_NA0002_01_s_2013_28				
Comment Code					
V2 : Remove the wild growth other than native grasses from the levee slopes.					
Inspector Comment					
Dense vegetation and wild roses on landside slope and toe.

View looking downstream at thick vegetation on the landside slope (Fall 2019).

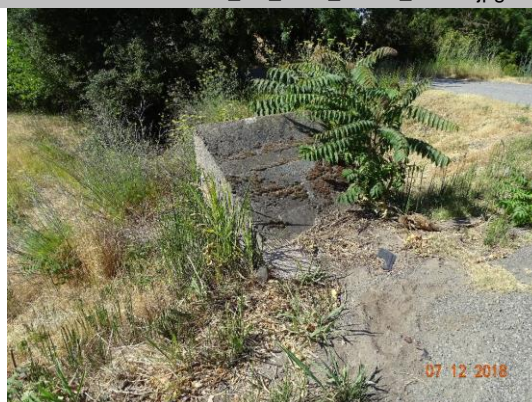
Photo 2 of 3 : UCIP_SP_2020_53513_77578.jpg

Comment Code						
Inspector Comment						
DS_ID:21880 FS_ID:53513 EP_NO: N/A Repair Type: Non-Urgent Crossing Status: Found UCIP Comments: 07/12/2018 Tunnel is open on both sides. No integrity issue observed, therefore crossing downgraded to "Non-Urgent". (O.Yakimov-DWR UCIP)10/24/2016 same as previous inspection concrete box culvert will need to be abandoned properly. (O. Magana - DWR UCIP)04/18/2013 tunnel should be abandoned properly. (W. Wylie - DWR UCIP) FIELD_STRUCT_DESC: *ABANDONED* 48-inch by 48-inch reinforced concrete drainage culvert through the levee, 6.5-inches below the crown. [Additional Reference(s): DWR Levee Log, 2005. USACE Sacramento O&M Manual 103, June 1954, (RM 18.13) 3-foot by 3-foot concrete box listed, Drawing No. 6-13-1100]. FS Date: 7/12/2018 9:05:37 AM

Concrete tunnel on LS shoulder.

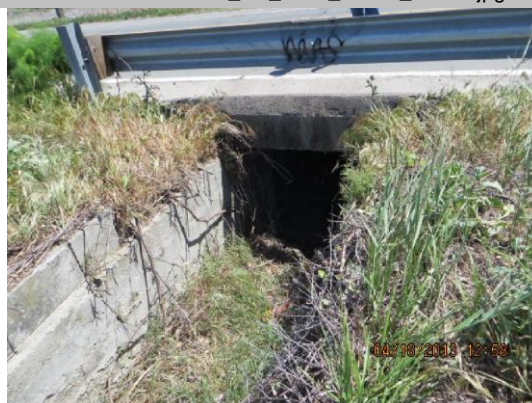
Photo 3 of 3 : UCIP_SP_2020_53514_19780.jpg

Tunnel opening on WS slope.

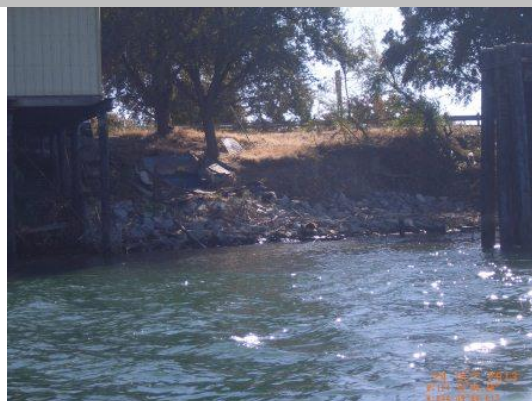
Photo 1 of 2 : SP_2020_NA0002_63_75_20200304_00039.jpg

USACE 2013 Photo #1

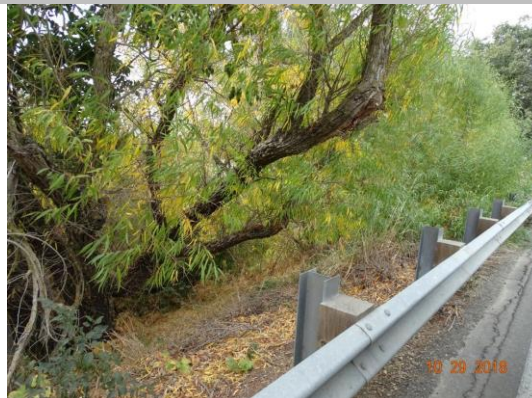
Photo 1 of 1 : SP_2020_NA0002_63_171_20200304_00091.jpg

LM Start	3.53	Rating **	M	Issue No.	171
LM End	3.56	Issue Type +	Ma	Location *	LS
Category	Earthen Levee			GPS Latitude/Longitude	
				Start	End
Item	Vegetation			38.162600 °	38.162658 °
				-121.615664 °	-121.616295 °
DWR ID	DWR_NA0002_02_f_2018_171				
Comment Code					
V2 : Remove the wild growth other than native grasses from the levee slopes.					
Inspector Comment

View looking upstream at thick vegetation on the landside slope (October 2018).

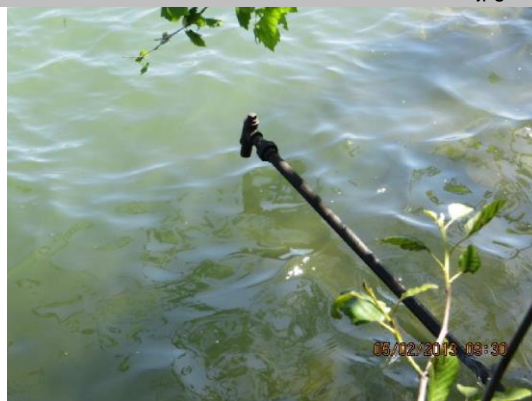
Photo 1 of 3 : UCIP_SP_2020_12778_20762.jpg

LM Start	5.77	Rating **	M	Issue No.	200	
LM End	5.77	Issue Type +	Ma	Location *		
Category	Supplemental			GPS Latitude/Longitude		
				Start		End
Item	DWR UCIP LMA Responsibility			38.172940 °		38.172940 °
				-121.653700 °		-121.653700 °
DWR ID	21912					
Comment Code						
Inspector Comment						
DS_ID:21912 FS_ID:12778 EP_NO: N/A Repair Type: Non-Urgent Crossing Status: Found UCIP Comments: Pipe abandoned. Erosion on WS slope at location where pipe should be. FIELD_STRUCT_DESC: *ABANDONED* 12-inch drainage pipe of an unknown material through the levee, 13 feet below the crown. Pump and gate valve in pump house at the landside (LS) toe. 1.5-inch electrical conduit along pipe at same location. 42-inch concrete standpipe at the LS toe. [Additional Reference(s): USACE Sacramento O&M Manual 102, April 1959, (RM 14.8) (Reclamation District No. 2067) steel pipe listed FS Date: 5/2/2013

Conduit at WS toe.

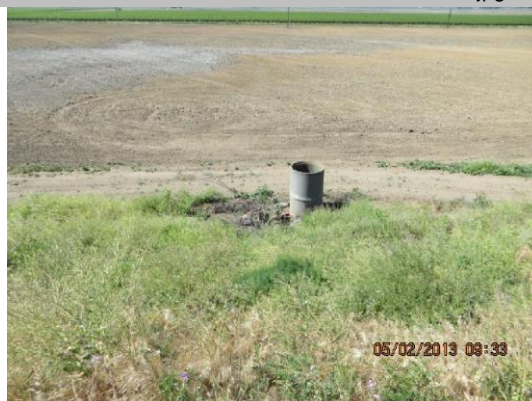
Photo 3 of 3 : UCIP_SP_2020_12778_20760.jpg

Concrete standpipe and pump on LS toe.

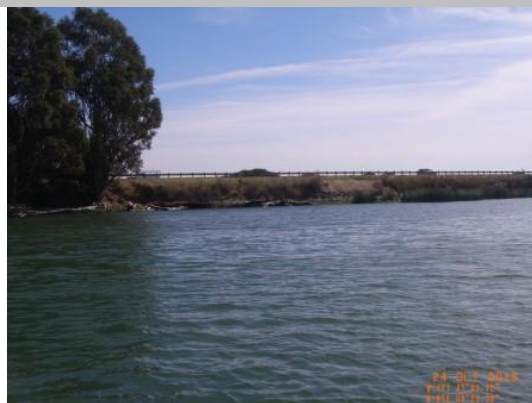
Photo 1 of 1 : SP_2020_NA0002_63_69_20200304_00035.jpg

Comment Code					
Inspector Comment					
2017 Site ID: SAC 11.2 L					
Status: Critical					
2017 Field Notes: New slump section. Erosion under the road has enlarged.					
Site History: 2008 - Erosion causing vertical bank at the highway on top of levee. The whole bank along the highway should be repaired.					
2009 - Minimal new erosion. 2011 - Bank continues to slowly erode.					
2012 - Upgrade to critical, new erosion since lat year and steeper slopes in sections. 2015 - Road foundation and cables exposed.					
Extremely large tree with exposed roots looks likely to fail and take out a significant portion of the levee. 2016 - Site continues to erode.

USACE 2013 Photo #1

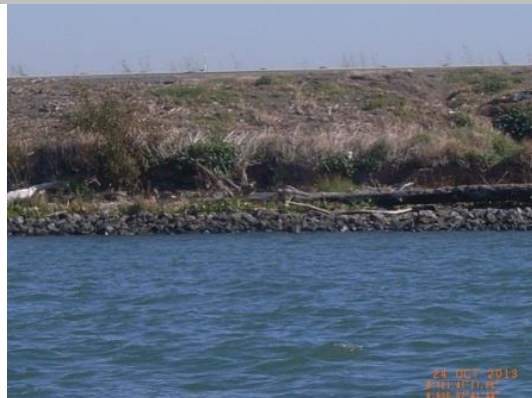
Photo 1 of 1 : SP_2020_NA0002_63_68_20200304_00034.jpg

Comment Code					
Inspector Comment					
2017 Site ID: SAC 10.8 L					
Status: Eroding					
2017 Field Notes: Lots of new woody debris recruitment.					
Site History: 2004 - Wave wash pockets approximately 100 ft long with new full bank rock between the pockets. 2005 - Spot repairs, but toe is still eroding in several places. 2006 - Low vertical bank along roadway. 2007 - A PL 84-99 repair was constructed, it cover the majority of the site with the exception of the upstream 150 to 200 ft and the downstream 250 ft, therefore it is being kept in the inventory. 2009 - Minimal new erosion. 2010 - Outboard berm looks good, but the banks are still very steep. 2011 - While the outboard berm is protecting against wave wash, bank still has slumping issues.

USACE 2013 Photo #1

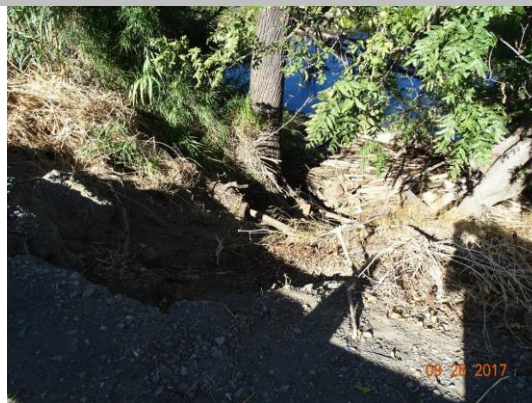
Photo 1 of 1 : SP_2020_NA0002_63_119_20200304_00072.jpg

LM Start	10.74	Rating **	M	Issue No.	119
LM End	10.74	Issue Type +	Ma	Location *	WS
Category	Earthen Levee			GPS Latitude/Longitude	
				Start	End
Item	Erosion / Bank Caving			38.116906 °	38.116906 °
				-121.694595 °	-121.694595 °
DWR ID	DWR_NA0002_02_f_2017_119				
Comment Code					
E2 : Schedule repair of erosion site prior to the next inspection.					
Inspector Comment

Looking northwest at the waterside slope.
