**Flood Control Project Maintenance  
Levee Inspections**

**Maintenance Issue Types Only, Levee Inspection Report By Mile - Spring 2021**

**Brannan Andrus Levee Maintenance District**

Waterway	Bank	Unit Miles	Inspection Start/End	Inspector
Unit No. 01 Georgiana Slough	Right	6.01	03/17/2021 03/17/2021	David Julian

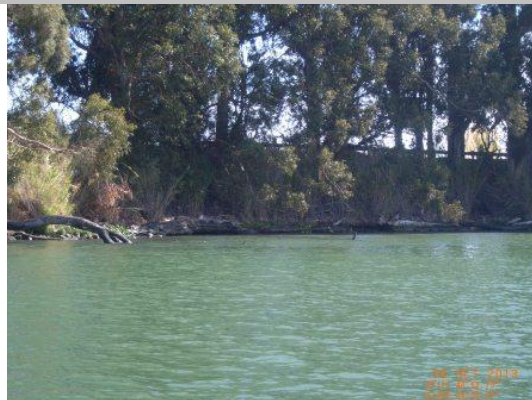
Photo 1 of 1 : SP\_2021\_NA0002\_63\_70\_20210226\_00021.jpg

LM Start	8.20	Rating **	U	Issue No.	70
LM End	8.42	Issue Type +	Ma	Location *	WS
Category	Supplemental			GPS Latitude/Longitude	
				Start	End
Item	2017 USACE Erosion Survey			38.151867 °	38.148711 °
				-121.682201 °	-121.682790 °
DWR ID	DWR_NA0002_02_f_2018_70				
Comment Code					
Inspector Comment					
2017 Site ID: SAC 12.1 L					
Status: Critical					
2017 Field Notes: Continues to worsen and threaten the road.					
Site History: 2010 - Small inlet area behind a man-built spit. Bank is slumping and could possibly be fixed with maintenance. 2011 - Site continues to worsen. 2015 - Upgraded to CRITICAL. 2016 - Site continues to get worse.

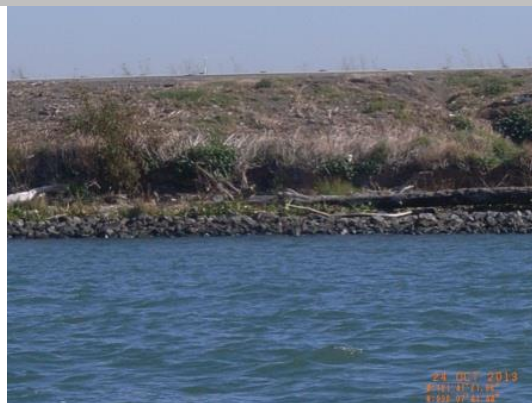
Photo 1 of 1 : SP\_2021\_NA0002\_63\_68\_20210226\_00019.jpg

2017 Site ID: SAC 10.8 L  
 Status: Eroding  
 2017 Field Notes: Lots of new woody debris recruitment.  
 Site History: 2004 - Wave wash pockets approximately 100 ft long with new full bank rock between the pockets. 2005 - Spot repairs, but toe is still eroding in several places. 2006 - Low vertical bank along roadway. 2007 - A PL 84-99 repair was constructed, it cover the majority of the site with the exception of the upstream 150 to 200 ft and the downstream 250 ft, therefore it is being kept in the inventory. 2009 - Minimal new erosion. 2010 - Outboard berm looks good, but the banks are still very steep. 2011 - While the outboard berm is protecting against wave wash, bank still has slumping issues.
