**Flood Control Project Maintenance
Levee Inspections**

Maintenance Issue Types Only, Levee Inspection Report By Mile - Spring 2022

Brannan Andrus Levee Maintenance District

Waterway	Bank	Unit Miles	Inspection Start/End	Inspector
Unit No. 01 Georgiana Slough	Right	6.01	03/11/2022 03/11/2022	David Julian

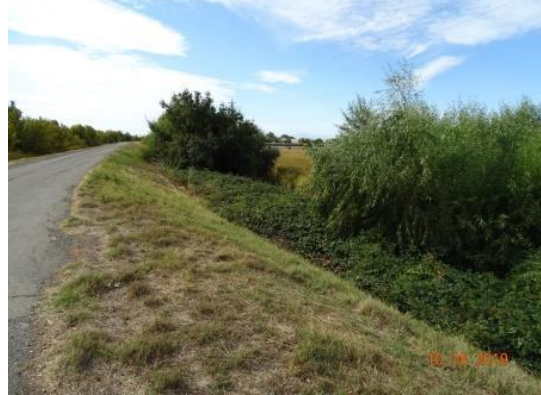
Photo 1 of 1 : SP_2022_NA0002_62_28_20220310_00009.jpg

LM Start	2.41	Rating **	U	Issue No.	28
LM End	2.49	Issue Type +	Ma	Location *	LS
Category	Earthen Levee			GPS Latitude/Longitude	
				Start	End
Item	Vegetation			38.161301 °	38.160281 °
				-121.585560 °	-121.586007 °
DWR ID	DWR_NA0002_01_s_2013_28				
Comment Code					
V2 : Remove the wild growth and woody vegetation other than native grasses from the levee slopes.					
Inspector Comment					
Dense vegetation and wild roses on landside slope and toe.

View looking downstream at thick vegetation on the landside slope (Fall 2019).

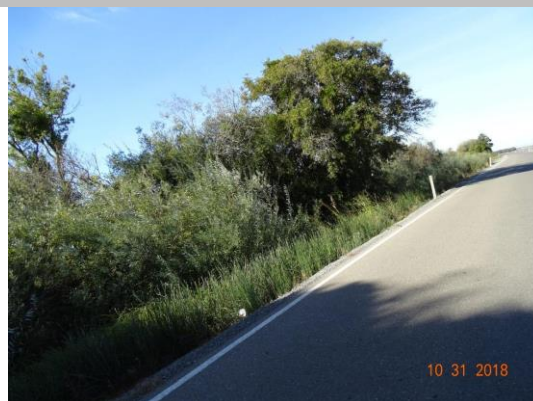
Photo 1 of 1 : SP_2022_NA0002_62_59_20220310_00022.jpg

LM Start	3.43	Rating **	U	Issue No.	59
LM End	3.82	Issue Type +	Ma	Location *	WS
Category	Earthen Levee			GPS Latitude/Longitude	
				Start	End
Item	Vegetation			38.151448 °	38.149783 °
				-121.592898 °	-121.598948 °
DWR ID	DWR_NA0002_01_f_2018_59				
Comment Code					
V2 : Remove the wild growth and woody vegetation other than native grasses from the levee slopes.					
Inspector Comment

View looking downstream at vegetation on the waterside slope (October 2018).

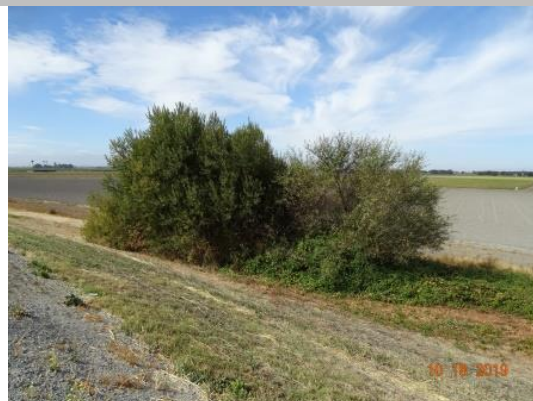
Photo 1 of 1 : SP_2022_NA0002_62_46_20220310_00013.jpg

LM Start	3.74	Rating **	U	Issue No.	46
LM End	3.74	Issue Type +	Ma	Location *	LS
Category	Earthen Levee			GPS Latitude/Longitude	
				Start	End
Item	Trim / Thin Trees			38.150841 °	38.150841 °
				-121.598161 °	-121.598161 °
DWR ID	DWR_NA0002_01_f_2017_46				
Comment Code					
T1 : Trim and thin trees to at least five feet above ground level to allow visibility of the ground and room to flood fight.					
Inspector Comment

View looking downstream at thick tree on the landside slope (Fall 2019).

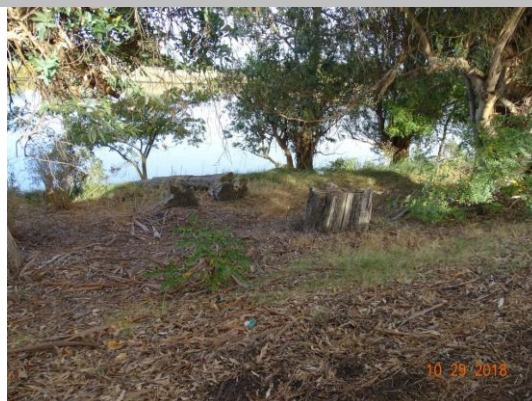
Photo 1 of 1 : SP_2022_NA0002_63_78_20220329_00031.jpg

LM Start	1.64	Rating **	N	Issue No.	78
LM End	1.64	Issue Type +	Ma	Location *	WS
Category	Earthen Levee			GPS Latitude/Longitude	
				Start	End
Item	Trim / Thin Trees			38.176532 °	38.176532 °
				-121.589478 °	-121.589478 °
DWR ID	DWR_NA0002_02_f_2018_78				
Comment Code					
T5 : Tree stumps.					
Inspector Comment

View of tree stump on the waterside slope (October 2018).

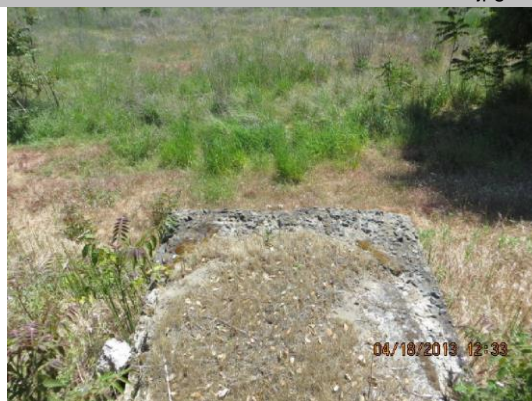
Photo 2 of 3 : UCIP_SP_2022_53389_19772.jpg

LM Start	2.54	Rating **	U	Issue No.	9 (cont)
LM End	2.54	Issue Type +	Ma	Location *	
Category	Supplemental			GPS Latitude/Longitude	
				Start	End
Item	DWR UCIP LMA Responsibility			38.165980 °	38.165980 °
				-121.598520 °	-121.598520 °
DWR ID	21879

Top of concrete tunnel on LS shoulder.

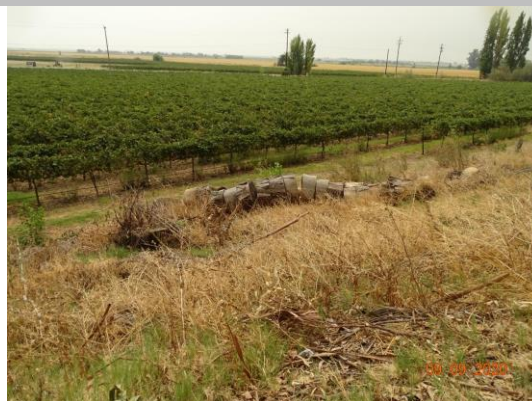
Photo 1 of 1 : SP_2022_NA0002_63_60_20220329_00019.jpg

LM Start	8.03	Rating **	U	Issue No.	60
LM End	8.03	Issue Type +	Ma	Location *	LS
Category	Earthen Levee			GPS Latitude/Longitude	
				Start	End
Item	Encroachments			38.154176 °	38.154176 °
				-121.680721 °	-121.680721 °
DWR ID	DWR_NA0002_02_f_2020_60				
Comment Code					
TR : Tree or limb					
Inspector Comment					
Chopped up tree trunk on the landside slope.

View of chopped up tree trunk on the landside slope (Fall 2020).

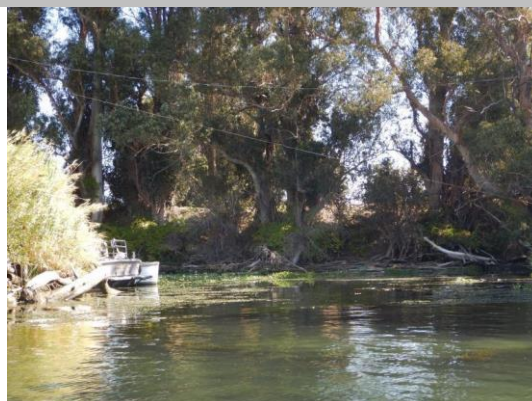
Photo 1 of 2 : SP_2022_NA0002_63_69_20220329_00026.jpg

LM Start	8.20	Rating **	U	Issue No.	69 (cont)
LM End	8.42	Issue Type +	Ma	Location *	WS

USACE 2018 Erosion Photo #1

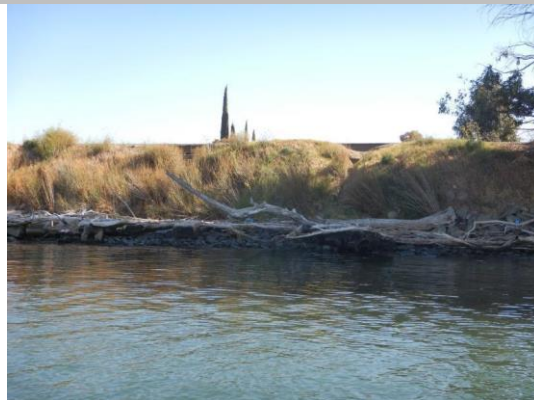
Photo 1 of 2 : SP_2022_NA0002_63_68_20220329_00024.jpg

LM Start	8.96	Rating **	U	Issue No.	68 (cont)
LM End	9.31	Issue Type +	Ma	Location *	WS

USACE 2018 Erosion Photo #1

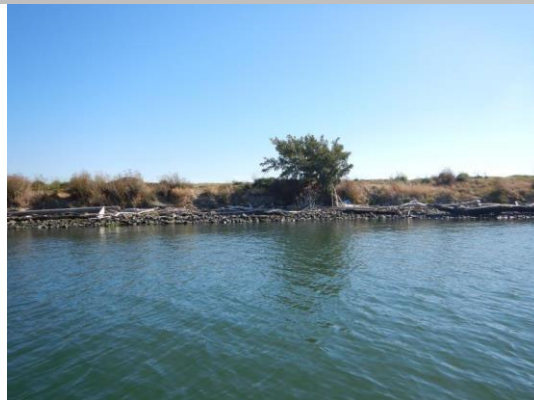
Photo 1 of 2 : SP_2022_NA0002_63_51_20220329_00012.jpg

LM Start	9.78	Rating **	M	Issue No.	51 (cont)
LM End	9.93	Issue Type +	Ma	Location *	WS

USACE 2018 Erosion Photo #1
