**Flood Control Project Maintenance
Levee Inspections**

Maintenance Issue Types Only, Levee Inspection Report By Mile - Spring 2023

Brannan Andrus Levee Maintenance District

Waterway	Bank	Unit Miles	Inspection Start/End	Inspector
Unit No. 01 Georgiana Slough	Right	6.01	05/09/2023 05/09/2023	Saskia Donovan

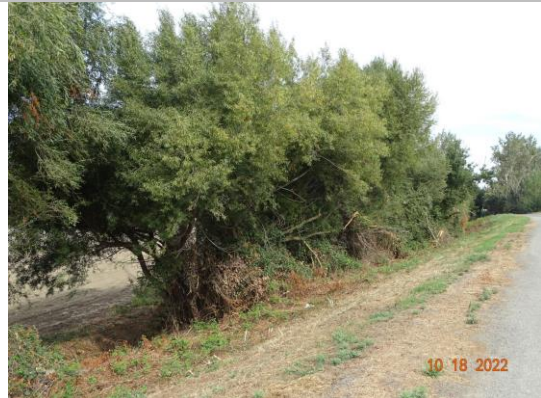
Photo 1 of 1 : SP_2023_NA0002_62_28_20230206_00007.jpg

LM Start	2.41	Rating **	U	Issue No.	28
LM End	2.49	Issue Type +	Ma	Location *	LS
Category	Earthen Levee			GPS Latitude/Longitude	
				Start	End
Item	Vegetation			38.161301°	38.160281°
				-121.585560°	-121.586007°
DWR ID	DWR_NA0002_01_s_2013_28				
Comment Code					
V2 : Remove the wild growth and woody vegetation other than native grasses from the levee slopes.					
Inspector Comment					
The wild roses have been removed but some dense vegetation on the toe remains.

View of the vegetation on the LS toe (Fall 2022).

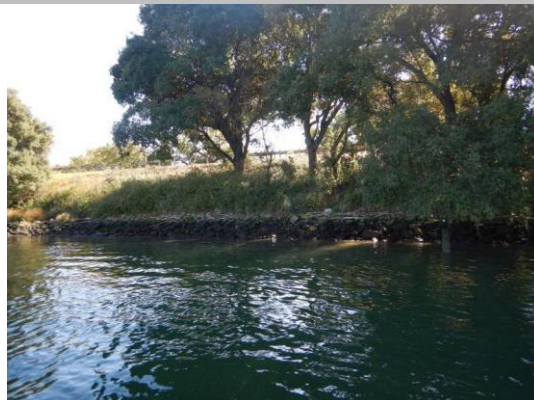
Photo 2 of 2 : SP_2023_NA0002_63_71_20230206_00027.jpg

USACE 2018 Erosion Photo #2

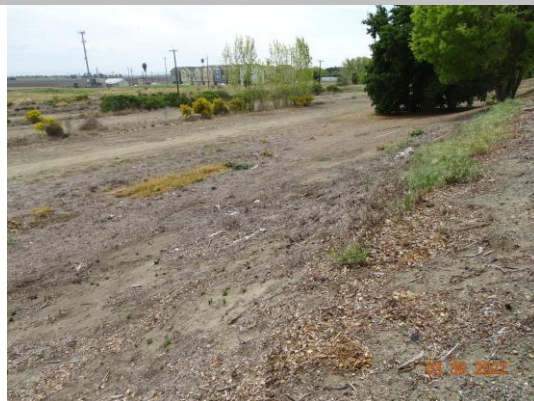
Photo 1 of 1 : SP_2023_NA0002_63_104_20230206_00050.jpg

LM Start	2.63	Rating **	U	Issue No.	104
LM End	2.66	Issue Type +	Ma	Location *	LS
Category	Earthen Levee			GPS Latitude/Longitude	
				Start	End
Item	Animal Control			38.165310°	38.165068°
				-121.599987°	-121.600445°
DWR ID	DWR_NA0002_02_s_2022_104

View of animal holes on the landside slope (Spring 2022).

Comment Code					
A1 : Exterminate rodents and backfill and compact or grout burrows.					
Inspector Comment

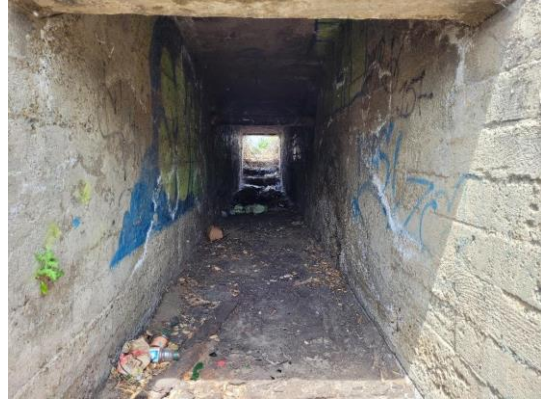
Photo 3 of 3 : UCIP_SP_2023_75147_112323.jpg

LM Start	2.84	Rating **	U	Issue No.	10 (cont)
LM End	2.84	Issue Type +	Ma	Location *	
Category	Supplemental			GPS Latitude/Longitude	
				Start	End
Item	DWR UCIP LMA Responsibility			38.163850°	38.163850°
				-121.603317°	-121.603317°
DWR ID	21882

Overview of Levee: Photo taken inside of the tunnel

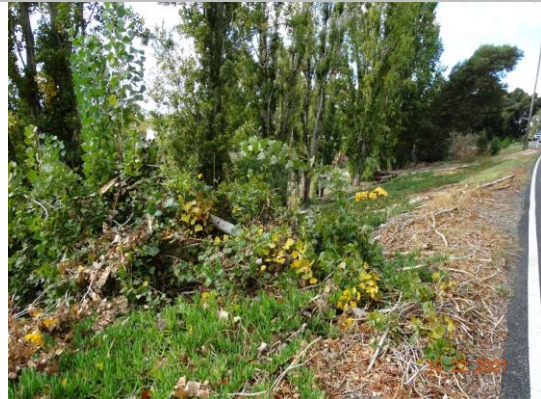
Photo 1 of 1 : SP_2023_NA0002_63_132_20230206_00059.jpg

LM Start	5.32	Rating **	U	Issue No.	132
LM End	5.35	Issue Type +	Ma	Location *	LS
Category	Earthen Levee			GPS Latitude/Longitude	
				Start	End
Item	Trim / Thin Trees			38.171844°	38.171839°
				-121.645718°	-121.646163°
DWR ID	DWR_NA0002_02_f_2021_132				
Comment Code					
T3 : Fallen tree with root ball.					
Inspector Comment					
Remove two down trees on landside slope.

View looking downstream at two down trees on the landside slope (Fall 2021).

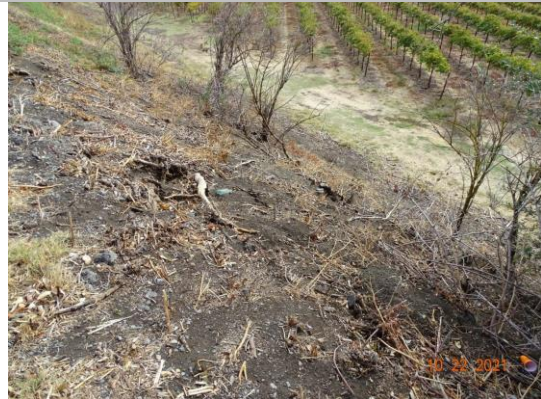
Photo 1 of 1 : SP_2023_NA0002_63_126_20230206_00057.jpg

LM Start	6.16	Rating **	M	Issue No.	126
LM End	6.16	Issue Type +	Ma	Location *	LS
Category	Earthen Levee			GPS Latitude/Longitude	
				Start	End
Item	Animal Control			38.174466°	38.174466°
				-121.660322°	-121.660322°
DWR ID	DWR_NA0002_02_f _ 2021_126				
Comment Code					
A1 : Exterminate rodents and backfill and compact or grout burrows.					
Inspector Comment					
Evidence of squirrel activity.

View looking down slope at squirrel holes in the landside slope (Fall 2021).

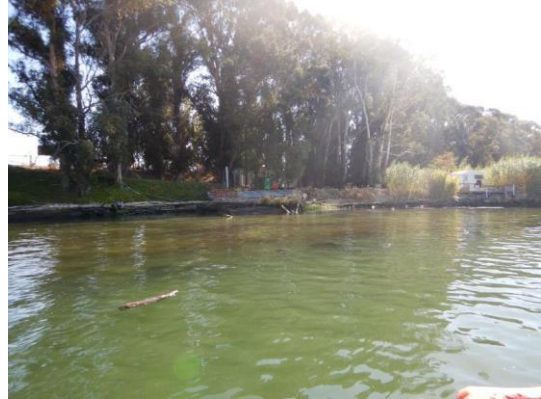
Photo 3 of 3 : SP_2023_NA0002_63_69_20230206_00025.jpg

LM Start	8.20	Rating **	U	Issue No.	69 (cont)
LM End	8.42	Issue Type +	Ma	Location *	WS
Category	Supplemental			GPS Latitude/Longitude	
				Start	End
Item	2018 USACE Erosion Survey			38.151867°	38.148711°
				-121.682201°	-121.682790°
DWR ID	DWR_NA0002_02_s _ 2022_69

USACE 2018 Erosion Photo #2

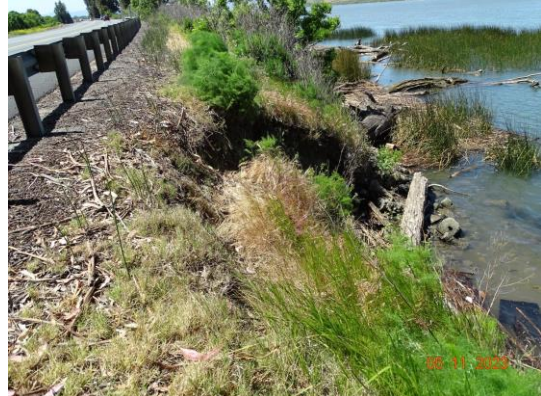
Photo 1 of 4 : SP_2023_NA0002_63_68_20230518_00159.jpg

LM Start	8.96	Rating **	U	Issue No.	68 (cont)
LM End	9.31	Issue Type +	Ma	Location *	WS

View of the sloughing at LM 8.97 (Spring 2023).

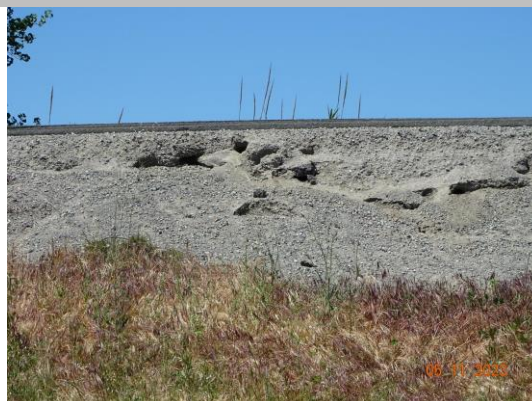
Photo 1 of 2 : SP_2023_NA0002_63_67_20230518_00161.jpg

LM Start	9.36	Rating **	M	Issue No.	67
LM End	9.61	Issue Type +	Ma	Location *	LS
Category	Earthen Levee			GPS Latitude/Longitude	
				Start	End
Item	Animal Control			38.135593°	38.131921°
				-121.686057°	-121.686240°
DWR ID	DWR_NA0002_02_s_2019_67				
Comment Code					
A1 : Exterminate rodents and backfill and compact or grout burrows.					
Inspector Comment					
Animal holes have been backfilled but there are new holes visible along the LS slope and toe.

View of rodent holes on the upper LS slope (Spring 2023).

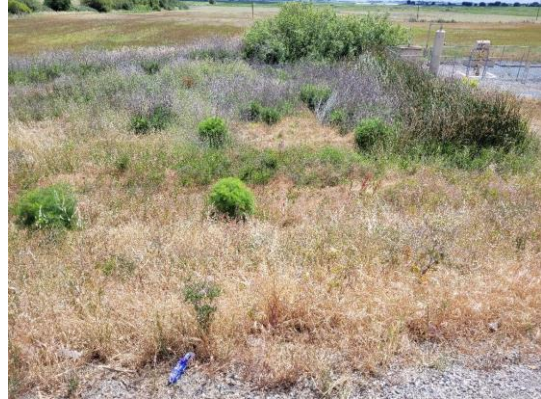
Photo 3 of 3 : UCIP_SP_2023_75626_113359.jpg

LM Start	9.37	Rating **	M	Issue No.	33 (cont)	
LM End	9.37	Issue Type +	Ma	Location *		
Category	Supplemental			GPS Latitude/Longitude		
				Start	End	
Item	DWR UCIP LMA Responsibility			38.135348°	38.135348°	
				-121.686086°	-121.686086°	
DWR ID	21932

Land-Side: View of levee slope looking from crown
