**Flood Control Project Maintenance
Levee Inspections**

Maintenance Issue Types Only, Levee Inspection Report By Mile - Spring 2024

Brannan Andrus Levee Maintenance District

Waterway	Bank	Unit Miles	Inspection Start/End	Inspector
Unit No. 01 Georgiana Slough	Right	6.01	04/17/2024 04/17/2024	Gregg McMillon

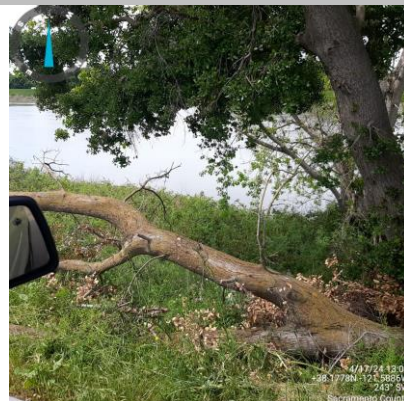
Photo 1 of 1 : SP_2024_NA0002_63_44_20240422_00155.jpg

LM Start	1.54	Rating **	M	Issue No.	44
LM End	1.54	Issue Type +	Ma	Location *	WS
Category	Earthen Levee			GPS Latitude/Longitude	
				Start	End
Item	Trim / Thin Trees			38.177776°	38.177776°
				-121.588644°	-121.588644°
DWR ID	DWR_NA0002_02_s_2024_44				
Comment Code					
T2 : Tree or limb.					
Inspector Comment

View of fallen tree limb on WS slope. (Spring 2024)

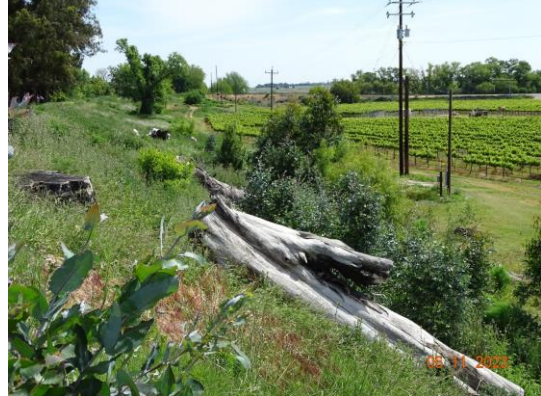
Photo 1 of 1 : SP_2024_NA0002_63_62_20240301_00021.jpg

View of the tree limbs on the LS slope (Spring 2023).

LM Start	7.77	Rating **	U	Issue No.	62
LM End	7.78	Issue Type +	Ma	Location *	LS
Category	Earthen Levee			GPS Latitude/Longitude	
				Start	End
Item	Trim / Thin Trees			38.157286°	38.157201°
				-121.678223°	-121.678374°
DWR ID	DWR_NA0002_02_f_2021_62				
Comment Code					
T2 : Tree or limb.					
Inspector Comment					
Remove large downed tree trunks from landside slope.

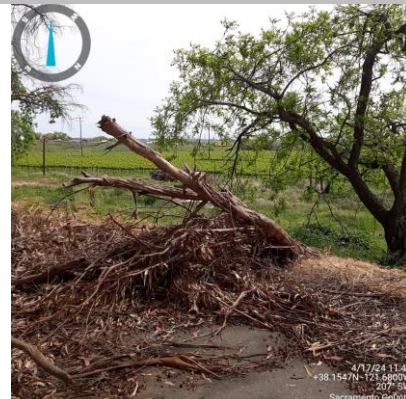
Photo 1 of 1 : SP_2024_NA0002_63_74_20240422_00157.jpg

View of fallen tree limbs on the crown LS shoulder. (Spring 2024)

LM Start	7.99	Rating **	M	Issue No.	74
LM End	7.99	Issue Type +	Ma	Location *	CR
Category	Earthen Levee			GPS Latitude/Longitude	
				Start	End
Item	Trim / Thin Trees			38.154729°	38.154729°
				-121.680439°	-121.680439°
DWR ID	DWR_NA0002_02_s_2024_74				
Comment Code					
T2 : Tree or limb.					
Inspector Comment					
Remove tree limbs from the crown LS shoulder.

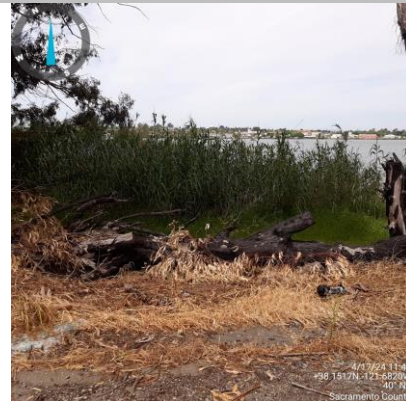
Photo 1 of 1 : SP_2024_NA0002_63_63_20240422_00159.jpg

View of fallen tree to be removed. (Spring 2024)

LM Start	8.21	Rating **	M	Issue No.	63
LM End	8.21	Issue Type +	Ma	Location *	WS
Category	Earthen Levee			GPS Latitude/Longitude	
				Start	End
Item	Trim / Thin Trees			38.151680°	38.151680°
				-121.681896°	-121.681896°
DWR ID	DWR_NA0002_02_s_2024_63				
Comment Code					
T3 : Fallen tree with root ball.					
Inspector Comment					
Remove fallen tree from crown.

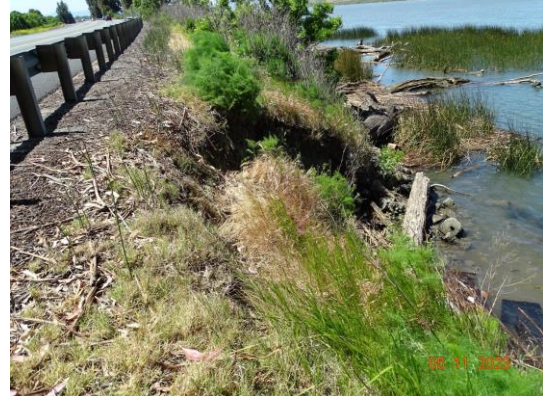
Photo 1 of 4 : SP_2024_NA0002_63_68_20240301_00025.jpg

LM Start	8.96	Rating **	U	Issue No.	68 (cont)
LM End	9.31	Issue Type +	Ma	Location *	WS

View of the sloughing at LM 8.97 (Spring 2023).
