**Flood Control Project Maintenance  
Levee Inspections**

**Fall 2015 Levee Maintenance Deficiency Summary Report**

**Sacramento River Basin**

**Butte County Department of Public Works**

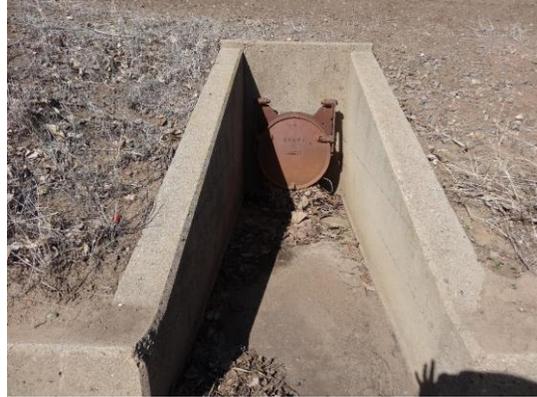
Photo 3 of 3 : UCIP\_FA\_2015\_3888.jpg

LM Start	<b>1.00</b>	Rating **	M	Issue No.	<b>34 (cont)</b>
LM End	<b>1.00</b>	Issue Type +	En	Location *	N/A
Category	Supplemental			GPS Latitude/Longitude	
				Start	End
Item	DWR UCIP Field Study			39.739268 °	39.739268 °
				-121.931891 °	-121.931891 °
DWR ID					
Action/Comments					
Inspector Comments: FS_ID:32044 DS_ID:19211 EP_NO: N/A FS_HLM: 1.021 Repair Type: Non-Urgent Crossing Status: Found

WS view: U typed concrete headwall, pipe, and flapgate on levee slope.

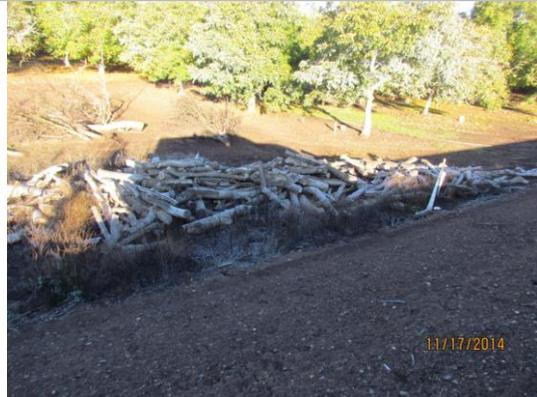
Photo 1 of 2 : FA\_2015\_NA0003\_64\_23\_20150910\_00006.jpg

LM Start	<b>1.29</b>	Rating **	M	Issue No.	<b>23</b>
LM End	<b>1.29</b>	Issue Type +	En	Location *	N/A
Category	Earthen Levee			GPS Latitude/Longitude	
				Start	End
Item	Encroachments			39.741277 °	39.741277 °
				-121.927485 °	-121.927485 °
DWR ID	DWR_NA0003_01_f_2014_23				
Action/Comments					
Firewood Inspector Comments: Remove the firewood from the landside toe.

View of the firewood along the landside toe.

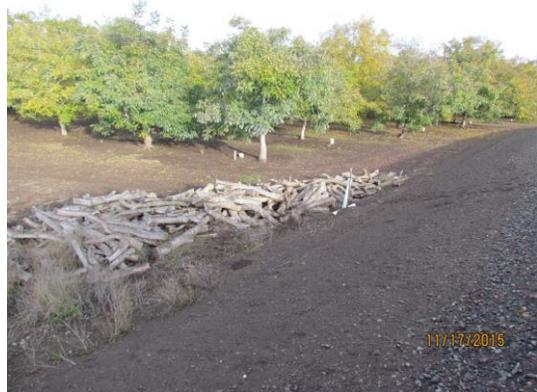
Photo 2 of 2 : FA\_2015\_NA0003\_64\_23\_20151118\_00012.jpg

View of the firewood along the landside toe.

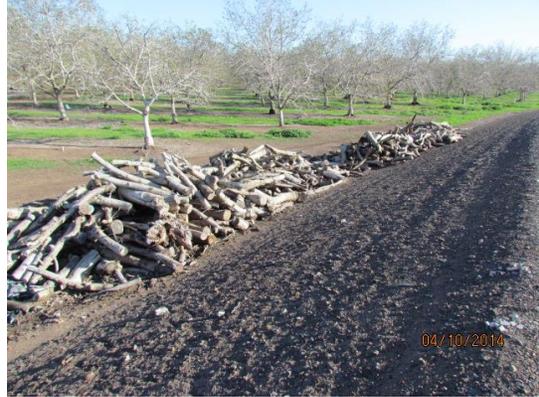
Photo 1 of 2 : FA\_2015\_NA0003\_64\_15\_20150910\_00004.jpg

LM Start	<b>1.69</b>	Rating **	M	Issue No.	<b>15</b>
LM End	<b>1.69</b>	Issue Type +	En	Location *	LS
Category	Earthen Levee		GPS Latitude/Longitude		
			Start	End	
Item	Encroachments		39.745718 °	39.745718 °	
			-121.923124 °	-121.923124 °	
DWR ID	DWR_NA0003_01_s_2014_15				
Action/Comments					
Firewood Inspector Comments: Remove the firewood from the landside toe

View of the firewood along the landside toe.

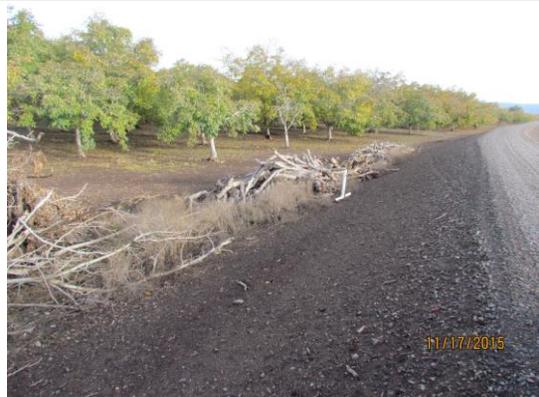
Photo 2 of 2 : FA\_2015\_NA0003\_64\_15\_20151118\_00013.jpg

View of the firewood along the landside toe.

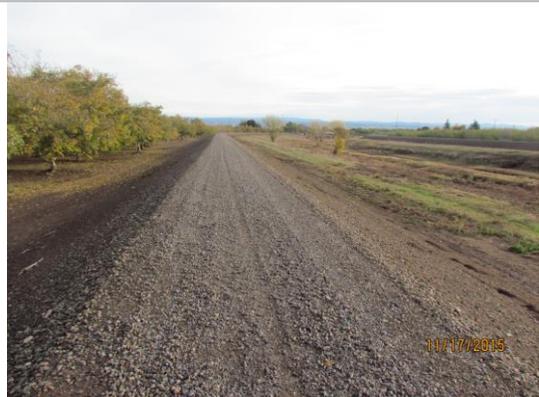
Photo 1 of 1 : FA\_2015\_NA0003\_64\_28\_20151118\_00014.jpg

LM Start	<b>1.73</b>	Rating **	A	Issue No.	<b>28</b>
LM End	<b>1.73</b>	Issue Type +	Ma	Location *	CR
Category	Earthen Levee		GPS Latitude/Longitude		
			Start	End	
Item	Crown Surface / Depressions / Rutting		39.746098 °	39.746098 °	
			-121.922672 °	-121.922672 °	
DWR ID	DWR_NA0003_01_f_2015_28				
Action/Comments					
Add appropriate material and re-grade the levee to bring the crown above the design elevation. Inspector Comments: Butte County placed new gravel the crown roadway.

View of the new gravel on the crown roadway.

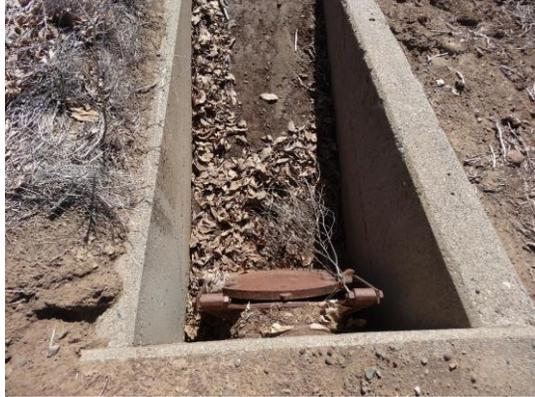
Photo 3 of 3 : UCIP\_FA\_2015\_4568.jpg

LM Start	<b>1.90</b>	Rating **	<b>U</b>	Issue No.	<b>35 (cont)</b>
LM End	<b>1.90</b>	Issue Type +	<b>En</b>	Location *	<b>CR</b>
Category	Supplemental			GPS Latitude/Longitude	
				Start	End
Item	DWR UCIP Field Study			39.747563 °	39.747563 °
				-121.920170 °	-121.920170 °
DWR ID					
Action/Comments					
Inspector Comments: FS_ID:41767 DS_ID:19212 EP_NO: N/A FS_HLM: 1.944 Repair Type: Urgent Crossing Status: Found

WS view: U type concrete headwall, flapgate on levee slope. Gate was not fully closed.

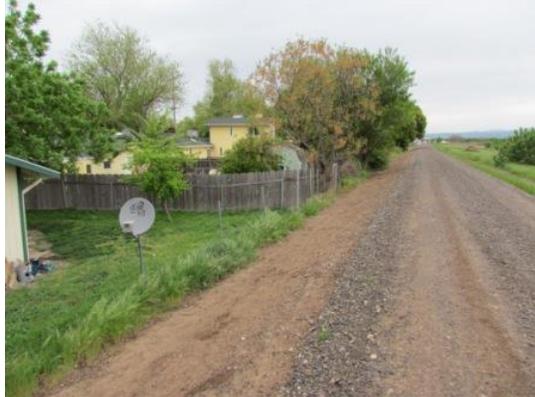
Photo 1 of 1 : FA\_2015\_NA0003\_64\_3\_20150910\_00002.jpg

LM Start	<b>2.00</b>	Rating **	<b>U</b>	Issue No.	<b>3</b>
LM End	<b>2.04</b>	Issue Type +	<b>En</b>	Location *	<b>LS</b>
Category	Earthen Levee			GPS Latitude/Longitude	
				Start	End
Item	Encroachments			39.748330 °	39.748867 °
				-121.918685 °	-121.918533 °
DWR ID	DWR_NA0003_01_s_2012_3				
Action/Comments					
Fence

View of the fences along the L/S toe.

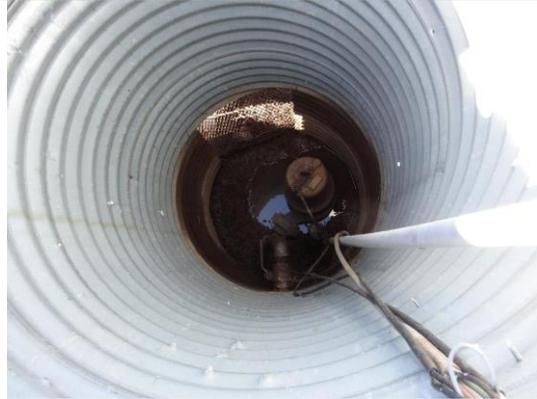
Photo 1 of 3 : UCIP\_FA\_2015\_4171.jpg

Item	DWR UCIP Field Study			39.757445 °	39.757445 °
				-121.913654 °	-121.913654 °
DWR ID					
Action/Comments					
Inspector Comments: FS_ID:30291 DS_ID:19230 EP_NO: 16633 FS_HLM: 2.7801 Repair Type: Non-Urgent Crossing Status: Indicator Found UCIP Comments: A concrete water control box on landside shoulder.It needs confirmation and more info from LMA and/or DWR Inspector. FIELD_STRUCT_DESC: A 2-inch diameter storm water discharge pipeline through the right bank and landward levee toe of Mud Creek. Used a 2-inch coated & wrapped steel pipe. Submerged pump in 36 inch dia CMP casing approx 10 ft from landside toe. Drainage ditch, up to 4 ft wide, runs perpendicular to levee alignment starting at CMP riser and running away from levee. (App. No. 16633) FS Date: 02/20/2014

LS view: inside view of CMP riser. Pipe, gate valve, air vent, and submersible pump in the riser.

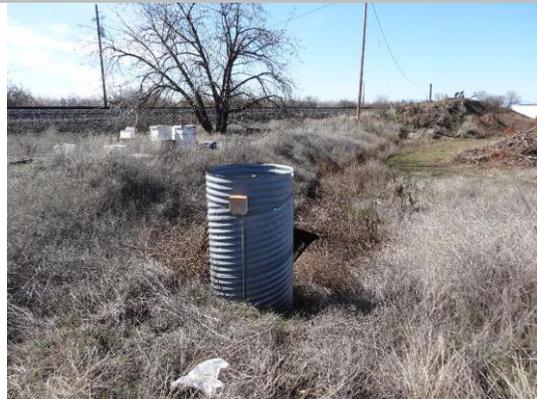
Photo 2 of 3 : UCIP\_FA\_2015\_4172.jpg

LS view: CMP riser on levee toe and drainage ditch perpendicular to the levee.

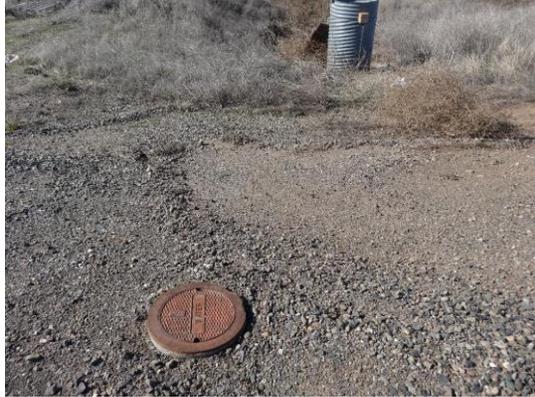
Photo 3 of 3 : UCIP\_FA\_2015\_4173.jpg

LS view: CMP riser on levee toe (top) and control box on levee shoulder (bottom).

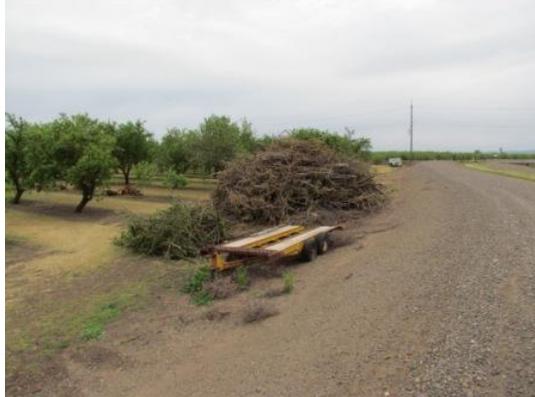
Photo 1 of 1 : FA\_2015\_NA0003\_64\_1\_20150910\_00001.jpg

LM Start	2.93	Rating **	M	Issue No.	1
LM End	2.93	Issue Type +	En	Location *	LS
Category	Earthen Levee			GPS Latitude/Longitude	
				Start	End
Item	Encroachments			39.759755 °	39.759755 °
				-121.911160 °	-121.911160 °
DWR ID	DWR_NA0003_01_s_2012_1				
Action/Comments					
Prunings

View of the pruning pile along the L/S toe.

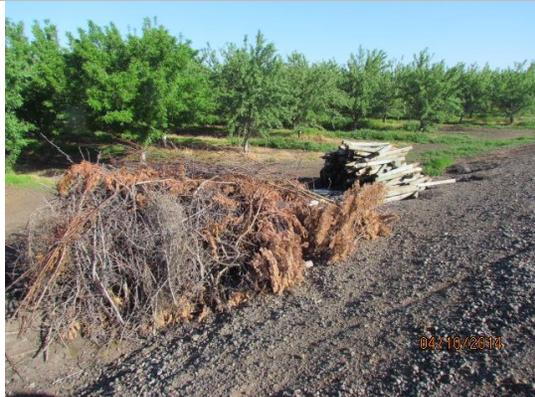
Photo 1 of 1 : FA\_2015\_NA0003\_64\_25\_20150910\_00007.jpg

LM Start	3.02	Rating **	M	Issue No.	25
LM End	3.02	Issue Type +	En	Location *	LS
Category	Earthen Levee			GPS Latitude/Longitude	
				Start	End
Item	Encroachments			39.761085 °	39.761085 °
				-121.911048 °	-121.911048 °
DWR ID	DWR_NA0003_01_s_2012_25				
Action/Comments					
Prunings

View of the prunings along the landside toe.

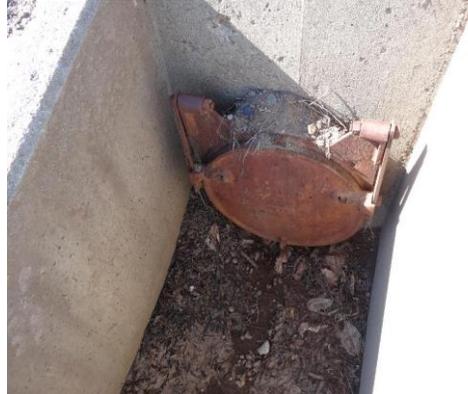
Photo 2 of 2 : UCIP\_FA\_2015\_4175.jpg

WS view: U type concrete headwall, flapgate on levee slope.

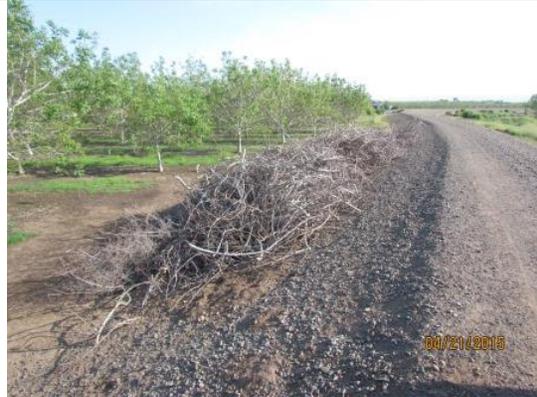
Photo 1 of 2 : FA\_2015\_NA0003\_64\_31\_20150910\_00011.jpg

LM Start	<b>3.15</b>	Rating **	M	Issue No.	<b>31</b>
LM End	<b>3.15</b>	Issue Type +	En	Location *	LS
Category	Earthen Levee		GPS Latitude/Longitude		
			Start	End	
Item	Encroachments		39.762565 °	39.762565 °	
			-121.909873 °	-121.909873 °	
DWR ID	DWR_NA0003_01_s_2015_31				
Action/Comments					
Prunings Inspector Comments: Remove the prunings from the landside slope.

View of the prunings along the landside slope.

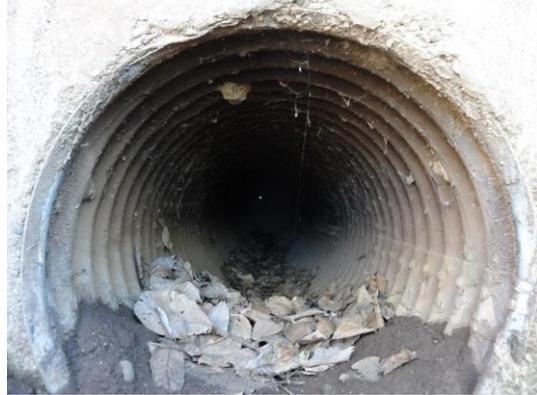
Photo 1 of 3 : UCIP\_FA\_2015\_4508.jpg

Inspector Comments: FS\_ID:30310  
 DS\_ID:19218  
 EP\_NO: N/A  
 FS\_HLM: 3.4763  
 Repair Type: Non-Urgent  
 Crossing Status: Found  
 UCIP Comments: Needs cleaning and clearing of debris.  
 FIELD\_STRUCT\_DESC: 24-inch CM pipe through the levee, 10.0 feet below the crown. Flap gate on the waterward end. Concrete "U" headwalls on both ends. Grouted riprap apron on the landward end. Grouted riprap spillway on the waterward end. O&M Manual Sac 504, May 1965.  
 FS Date: 02/20/2014

LS view: inside view of CMP on levee slope. Needs cleaning and clearing.

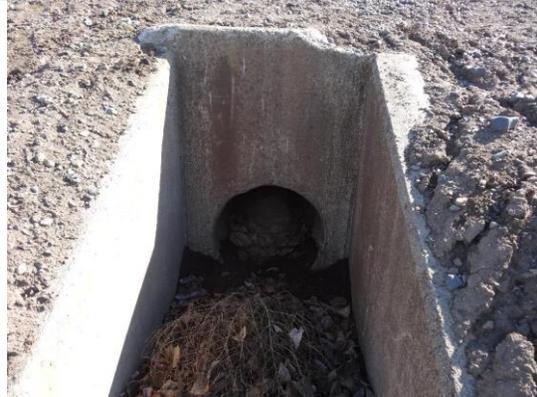
Photo 2 of 3 : UCIP\_FA\_2015\_4509.jpg

LS view: U type concrete headwall and CMP on levee slope.

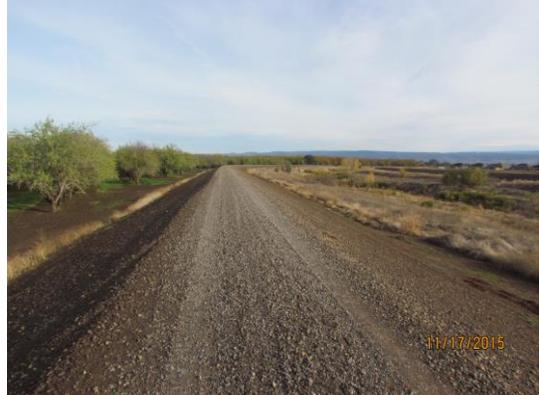
Photo 1 of 1 : FA\_2015\_NA0003\_64\_30\_20151118\_00016.jpg

LM Start	<b>3.72</b>	Rating **	A	Issue No.	<b>30</b>
LM End	<b>3.72</b>	Issue Type +	Ma	Location *	LS
Category	Earthen Levee			GPS Latitude/Longitude	
				Start	End
Item	Vegetation			39.768155 °	39.768155 °
				-121.902420 °	-121.902420 °
DWR ID	DWR_NA0003_01_f_2015_30				
Action/Comments					
Control annual grass and weeds on the levee slopes and easements. Inspector Comments: Butte County sprayed the vegetation and dragged both the slopes.

View of no vegetation on both slopes.

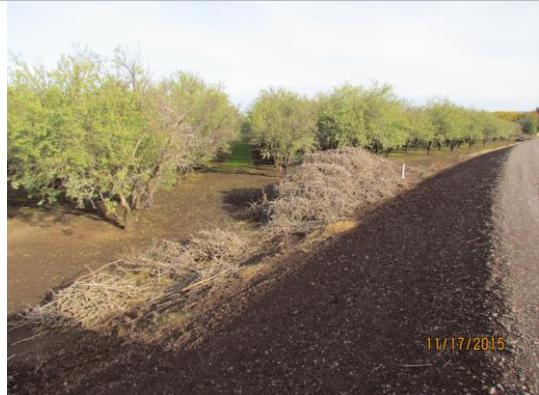
Photo 1 of 1 : FA\_2015\_NA0003\_64\_32\_20151118\_00017.jpg

LM Start	<b>3.88</b>	Rating **	M	Issue No.	<b>32</b>
LM End	<b>3.88</b>	Issue Type +	En	Location *	LS
Category	Earthen Levee			GPS Latitude/Longitude	
				Start	End
Item	Encroachments			39.770292 °	39.770292 °
				-121.901428 °	-121.901428 °
DWR ID	DWR_NA0003_01_f_2015_32				
Action/Comments					
Prunings Inspector Comments: Remove the prunings from the landside toe.

View of the prunings along the landside toe.

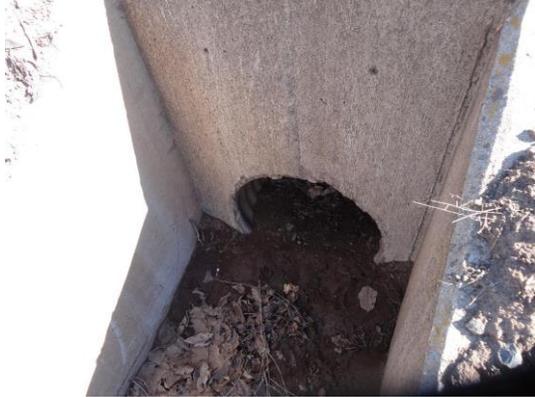
Photo 1 of 2 : UCIP\_FA\_2015\_4511.jpg

LM Start	<b>3.97</b>	Rating **	M	Issue No.	<b>40</b>
LM End	<b>3.97</b>	Issue Type +	En	Location *	LS
Category	Supplemental			GPS Latitude/Longitude	
				Start	End
Item	DWR UCIP Field Study			39.771293 °	39.771293 °
				-121.900247 °	-121.900247 °
DWR ID					
<b>Action/Comments</b>					
Inspector Comments: FS_ID:30311 DS_ID:19219 EP_NO: N/A FS_HLM: 4.07 Repair Type: Non-Urgent Crossing Status: Found UCIP Comments: Needs cleaning and clearing of debris in both ends of the pipe. FIELD_STRUCT_DESC: 24-inch CM pipe through the levee, 9.0 feet below the crown. Flap gate on the waterward end. Concrete "U" headwalls on both ends. Grouted riprap apron on the landward end. Grouted riprap spillway on the waterward end. O&M Manual Sac 504, May 1965. FS Date: 02/20/2014

LS view: U type concrete headwall and CMP on levee slope.

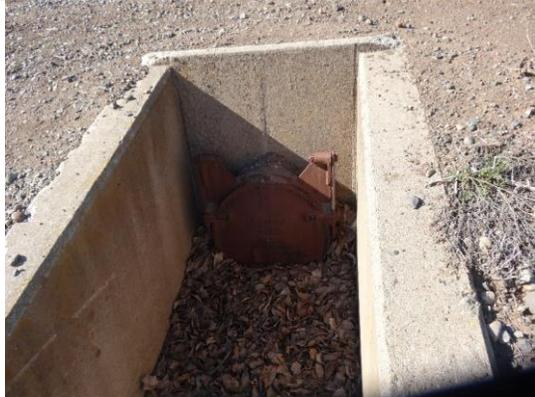
Photo 2 of 2 : UCIP\_FA\_2015\_4512.jpg

WS view: U type concrete headwall, pipe, and flapgata on levee slope. Vegetation debris blocking outlet.

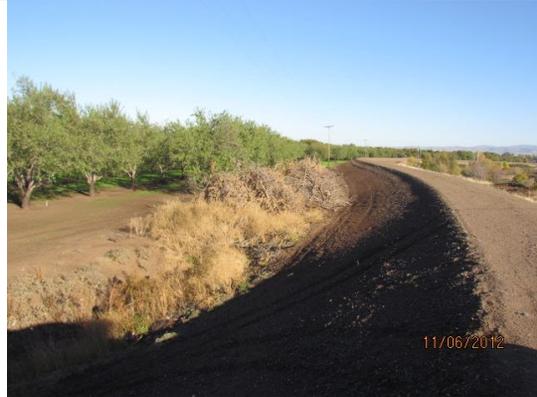
Photo 1 of 1 : FA\_2015\_NA0003\_64\_21\_20150910\_00005.jpg

LM Start	<b>4.46</b>	Rating **	M	Issue No.	<b>21</b>
LM End	<b>4.46</b>	Issue Type +	En	Location *	LS
Category	Earthen Levee		GPS Latitude/Longitude		
			Start	End	
Item	Encroachments		39.775908 °	39.775908 °	
			-121.893947 °	-121.893947 °	
DWR ID	DWR_NA0003_01_s_2012_21				
Action/Comments					
Prunings

View of the brush pile along landside toe.

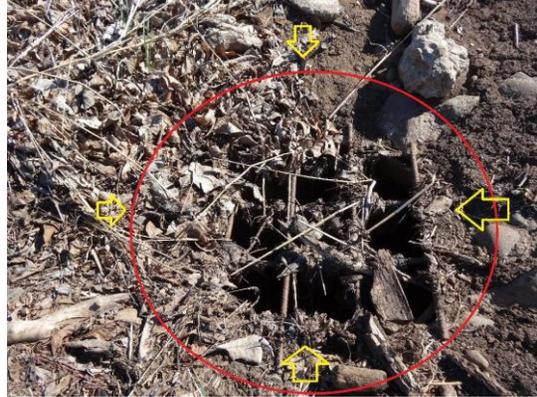
Photo 1 of 2 : UCIP\_FA\_2015\_4569.jpg

Item	DWR UCIP Field Study			39.780244 °	39.780244 °
DWR ID				-121.891267 °	-121.891267 °
Action/Comments					
Inspector Comments: FS_ID:30388 DS_ID:19221 EP_NO: N/A FS_HLM: 4.93 Repair Type: Non-Urgent Crossing Status: Found UCIP Comments: CM Standpipe intake. Intake pipe with air vent. Steel rib-bar grit cover on the standpipe on landside levee toe. Needs cleaning and clearing on both ends of the pipe. FIELD_STRUCT_DESC: 24-inch CM pipe through the levee, 15.0 feet below the crown. Flap gate on the waterward end. Concrete "U" headwalls on waterside ends. Grouted riprap spillway on the waterward end. CM Standpipe intake. Intake pipe with air vent. Steel rib-bar grit cover on the standpipe on landside levee toe. O&M Manual Sac 504, May 1965. FS Date: 02/20/2014

LS view: Underground CM standpipe intake with steel grit on levee toe.

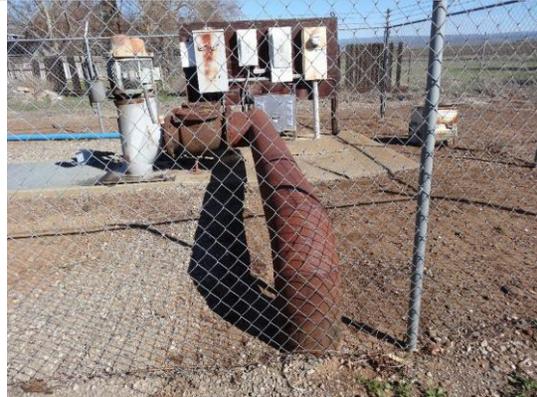
Photo 1 of 3 : UCIP\_FA\_2015\_4515.jpg

LM Start	<b>5.30</b>	Rating **	M	Issue No.	<b>44</b>
LM End	<b>5.30</b>	Issue Type +	En	Location *	LS
Category	Supplemental			GPS Latitude/Longitude	
				Start	End
Item	DWR UCIP Field Study			39.784739 °	39.784739 °
				-121.884860 °	-121.884860 °
DWR ID					
Action/Comments					
Inspector Comments: FS_ID:30368 DS_ID:19223 EP_NO: N/A FS_HLM: 5.4284 Repair Type: Non-Urgent Crossing Status: Found UCIP Comments: 12-inch steel pipe about 14 ft below the crown. FIELD_STRUCT_DESC: 12-inch steel pipeline through levee, 14-ft below the crown. Slide gate in concrete box on waterward slope. Flap gate on waterward side. Grouted rock revetment on waterward slope. Three pumps on concrete pad on landside. FS Date: 02/24/2014

LS view: pipe, pumps, power boxes, concrete vault on landside.

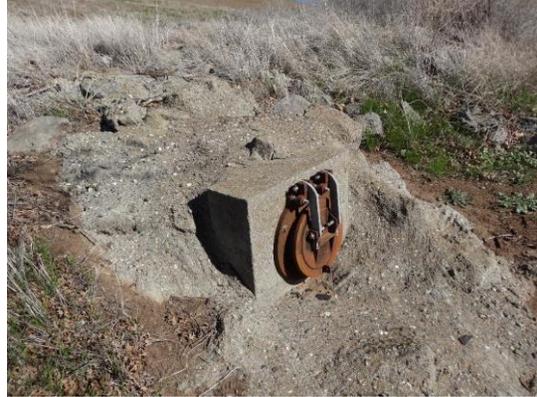
Photo 2 of 3 : UCIP\_FA\_2015\_4516.jpg

WS view: concrete headwall and flapgate on levee slope.

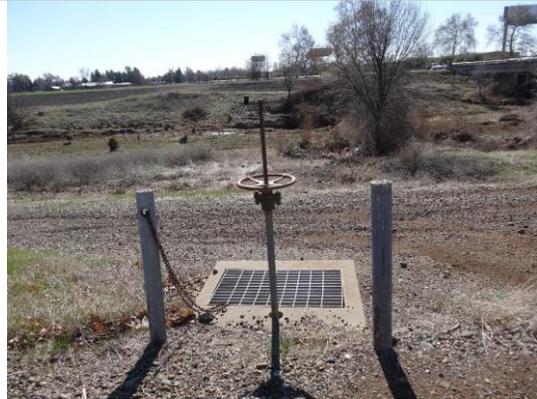
Photo 3 of 3 : UCIP\_FA\_2015\_4517.jpg

WS view: slide gate in concrete box on levee slope.

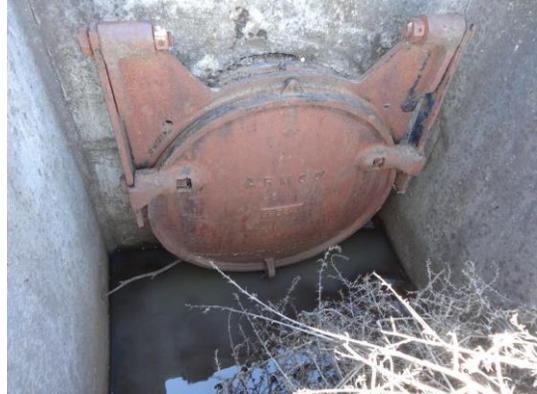
Photo 2 of 3 : UCIP\_FA\_2015\_3213.jpg

WS view: U type concrete headwall, pipe, and flapgate on levee slope. Vegetation debris on outlet box.

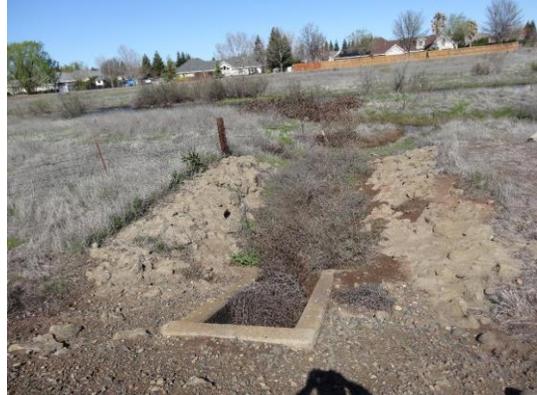
Photo 3 of 3 : UCIP\_FA\_2015\_3214.jpg

WS view: CMP culvert with U type concrete headwall. Vegetation debris blocking outlet box.

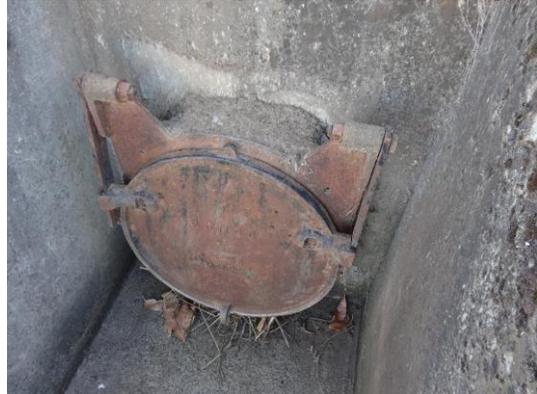
Photo 3 of 3 : UCIP\_FA\_2015\_4655.jpg

WS view: U type concrete headwall, pipe, and flapgate on levee slope.

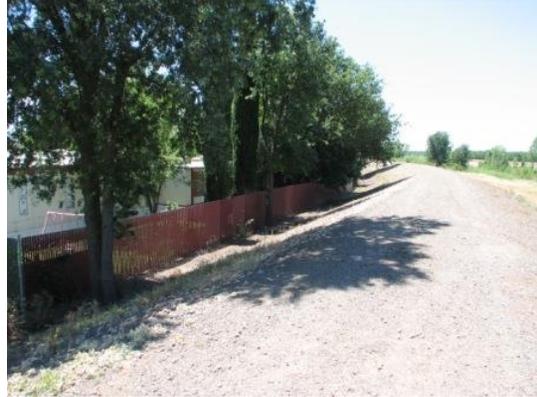
Photo 1 of 1 : FA\_2015\_NA0003\_65\_3\_20150910\_00002.jpg

LM Start	<b>1.49</b>	Rating **	U	Issue No.	<b>3</b>
LM End	<b>1.81</b>	Issue Type +	En	Location *	LS
Category	Earthen Levee		GPS Latitude/Longitude		
			Start	End	
Item	Encroachments		39.782773 °	39.778972 °	
			-121.888178 °	-121.891563 °	
DWR ID	DWR_NA0003_02_s_2012_3				
Action/Comments					
Fence Inspector Comments: The fence is within the easement.

View of the fence along the landside toe of the levee.

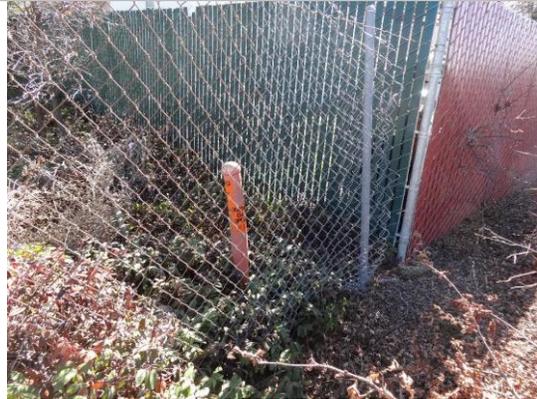
Photo 1 of 1 : UCIP\_FA\_2015\_4526.jpg

LS view: gasline marker on levee toe.

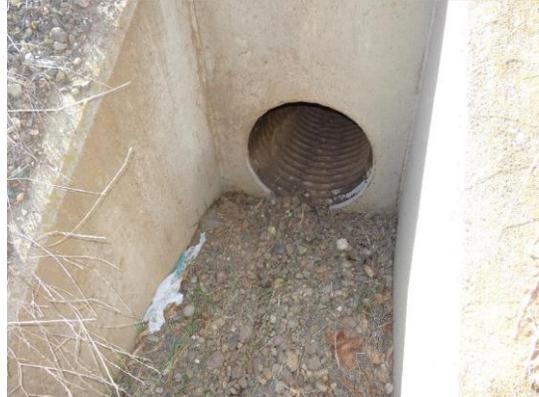
Photo 1 of 3 : UCIP\_FA\_2015\_4527.jpg

**Action/Comments**  
 Inspector Comments: FS\_ID:41375  
 DS\_ID:19238  
 EP\_NO: 12619A  
 FS\_HLM: 2.113  
 Repair Type: Non-Urgent  
 Crossing Status: Found  
 UCIP Comments: - 24-inch CM pipe.- inlet and spillway may need cleaning and clearing.  
 FIELD\_STRUCT\_DESC: 24-inch CM pipe through the levee, 11.0 feet below the crown. Flap gate on the waterward end. Concrete "U" headwall on both ends. Grouted riprap apron on the landward end. Grouted riprap spillway on the waterward end. (App. 12619 - Vermillion). Replaced 24-inch pipe with 36-inch pipe. 3/79 (App.12619A)  
 FS Date: 02/24/2014

LS view: U type concrete headwall and CMP on levee slope.

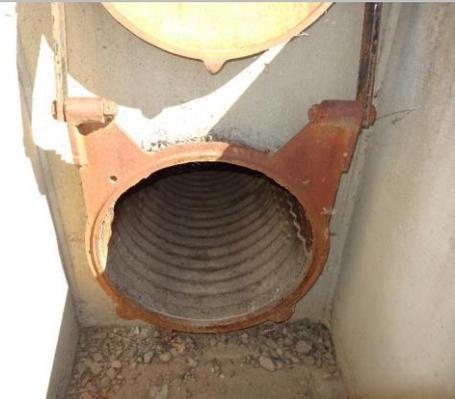
Photo 2 of 3 : UCIP\_FA\_2015\_4528.jpg

WS view: U type concrete headwall, pipe, and flapgate on levee slope.

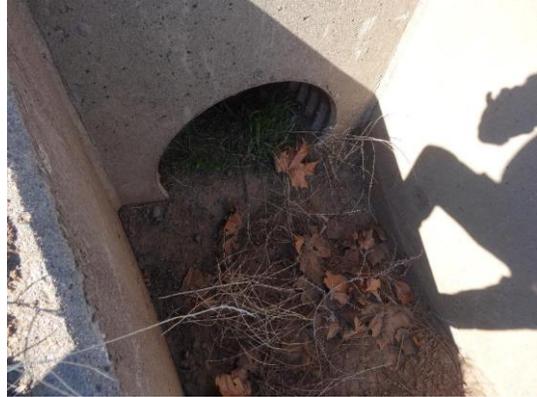
Photo 2 of 3 : UCIP\_FA\_2015\_4531.jpg

LS view: U type concrete headwall and CMP on levee slope.

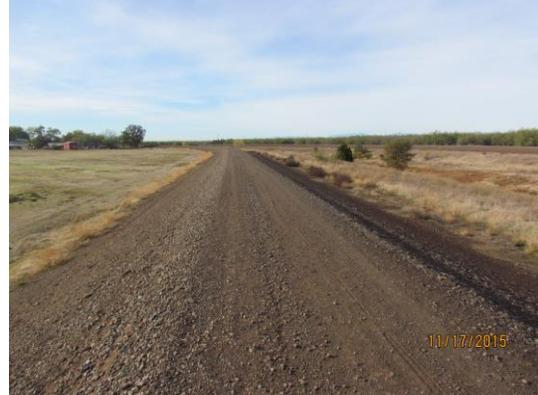
Photo 1 of 1 : FA\_2015\_NA0003\_65\_9\_20151118\_00006.jpg

LM Start	<b>2.57</b>	Rating **	A	Issue No.	<b>9</b>
LM End	<b>2.57</b>	Issue Type +	Ma	Location *	LS
Category	Earthen Levee		GPS Latitude/Longitude		
			Start	End	
Item	Vegetation		39.770788 °	39.770788 °	
			-121.899552 °	-121.899552 °	
DWR ID	DWR_NA0003_02_f_2015_9				
Action/Comments					
Control annual grass and weeds on the levee slopes and easements. Inspector Comments: Butte County sprayed and dragged both slope.

View of the no vegetation on both slopes.

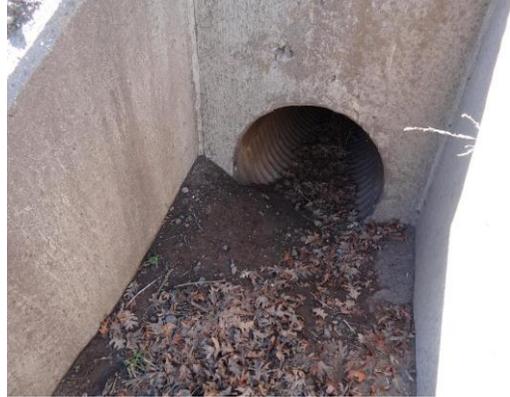
Photo 2 of 3 : UCIP\_FA\_2015\_4633.jpg

LS view: U type concrete headwall and CMP on levee slope. Debris and soil in inlet box.

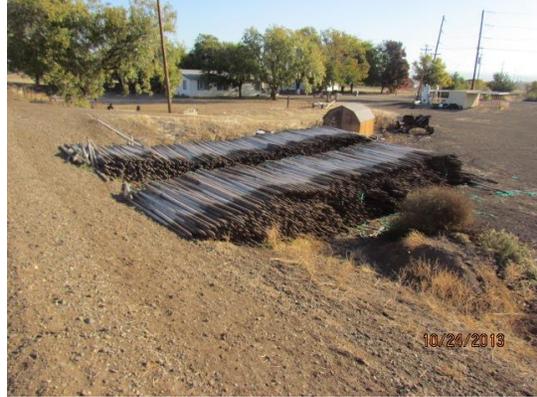
Photo 1 of 1 : FA\_2015\_NA0003\_65\_1\_20150910\_00001.jpg

LM Start	<b>2.80</b>	Rating **	M	Issue No.	<b>1</b>
LM End	<b>2.80</b>	Issue Type +	En	Location *	LS
Category	Earthen Levee			GPS Latitude/Longitude	
				Start	End
Item	Encroachments			39.767841 °	39.767841 °
				-121.901534 °	-121.901534 °
DWR ID	DWR_NA0003_02_f_2013_1				
Action/Comments					
Material

View of the tree stakes along the landside slope and toe.

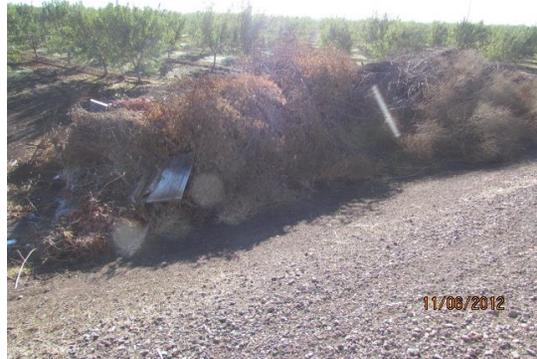
Photo 1 of 1 : FA\_2015\_NA0003\_65\_5\_20150910\_00003.jpg

LM Start	<b>3.31</b>	Rating **	M	Issue No.	<b>5</b>
LM End	<b>3.31</b>	Issue Type +	En	Location *	LS
Category	Earthen Levee			GPS Latitude/Longitude	
				Start	End
Item	Encroachments			39.763208 °	39.763208 °
				-121.908517 °	-121.908517 °
DWR ID	DWR_NA0003_02_f_2012_5				
Action/Comments					
Prunings

View of the brush pile along landside toe.

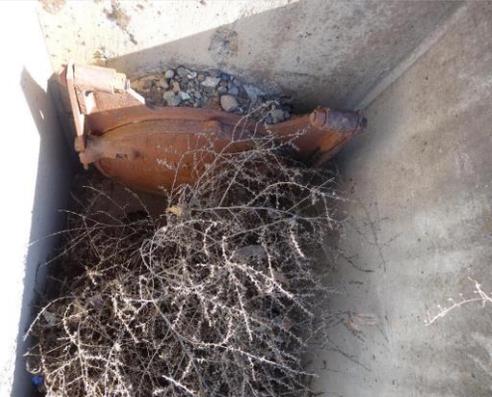
Photo 3 of 3 : UCIP\_FA\_2015\_4662.jpg

WS view: U type concrete headwall, pipe, and flapgate on levee slope. Vegetation debris and soil blocking outlet.

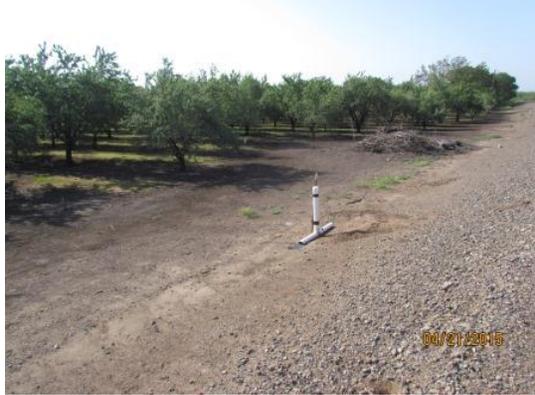
Photo 1 of 2 : FA\_2015\_NA0003\_65\_8\_20150910\_00005.jpg

LM Start	<b>4.55</b>	Rating **	A/W	Issue No.	<b>8</b>
LM End	<b>4.55</b>	Issue Type +	Ma	Location *	LS
Category	Earthen Levee		GPS Latitude/Longitude		
			Start	End	
Item	Animal Control		39.749639 °	39.749639 °	
			-121.917188 °	-121.917188 °	
DWR ID	DWR_NA0003_02_f_2013_8				
Action/Comments					
Exterminate rodents and backfill and compact or grout burrows. Inspector Comments: Butte County has been grouting the rodent holes.

View of the bait station placed by the rodent hole.

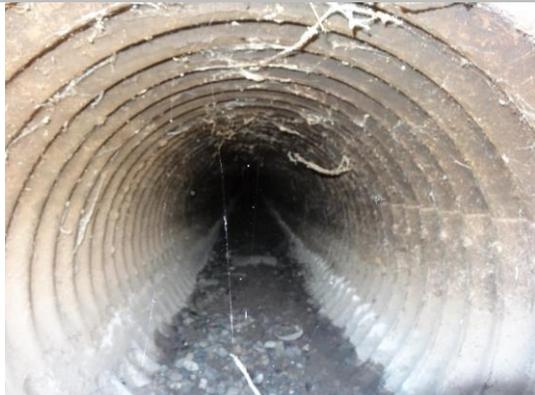
Photo 1 of 3 : UCIP\_FA\_2015\_4663.jpg

LS view: inside view of CMP on levee slope. Needs cleaning and clearing.

Inspector Comments: FS\_ID:31028  
 DS\_ID:19245  
 EP\_NO: N/A  
 FS\_HLM: 4.7749  
 Repair Type: Non-Urgent  
 Crossing Status: Found  
 UCIP Comments: Needs cleaning and clearing of debris.  
 FIELD\_STRUCT\_DESC: 24-inch CM pipe through the levee, 10.0 feet below the crown. Flap gate on the waterward end. Concrete "U" headwalls on both ends. Grouted riprap apron on the landward end. Grouted riprap spillway on the waterward end. O&M Manual Sac 504, May 1965.  
 FS Date: 02/25/2014

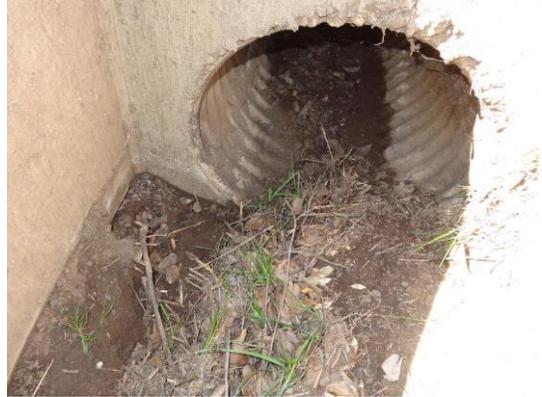
Photo 2 of 3 : UCIP\_FA\_2015\_4664.jpg

LS view: U type concrete headwall and CMP on levee slope.

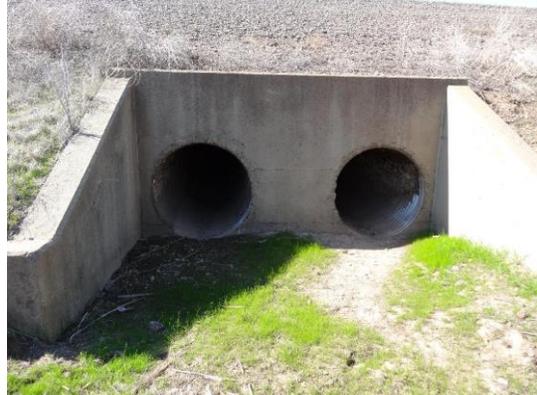
Photo 1 of 3 : UCIP\_FA\_2015\_4669.jpg

LS view: U type concrete headwall and CMPs on levee slope. Soil/mud on inlet box.

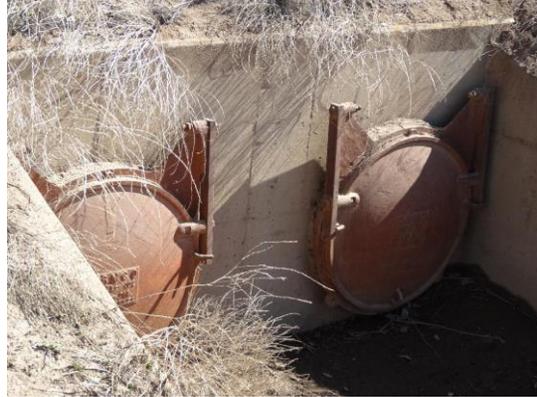
Photo 2 of 3 : UCIP\_FA\_2015\_4670.jpg

LM Start	6.09	Rating **	M	Issue No.	23 (cont)
LM End	6.09	Issue Type +	En	Location *	LS
Category	Supplemental			GPS Latitude/Longitude	
				Start	End
Item	DWR UCIP Field Study			39.733297 °	39.733297 °
				-121.930411 °	-121.930411 °
DWR ID					
Action/Comments					
Inspector Comments: FS_ID:41376 DS_ID:19248 EP_NO: N/A FS_HLM: 6.289 Repair Type: Non-Urgent Crossing Status: Found UCIP Comments: Needs cleaning and clearing of debris. FIELD_STRUCT_DESC: 1 of 2: Two 42-inch CM pipes through the levee, 16.0 feet below the crown. Flap gates on the waterward end. Slide gates in CM pipe riser on the waterward slope. Concrete "U" headwalls on both ends. Grouted riprap apron and rock revetment on the landward end. Channel Slough drainage structure. O&M Manual Sac 504, May 1965. FS Date: 02/25/2014

WS view: U type concrete headwall, pipes, and flapgates on levee slope. Vegetation debris on outlet box.

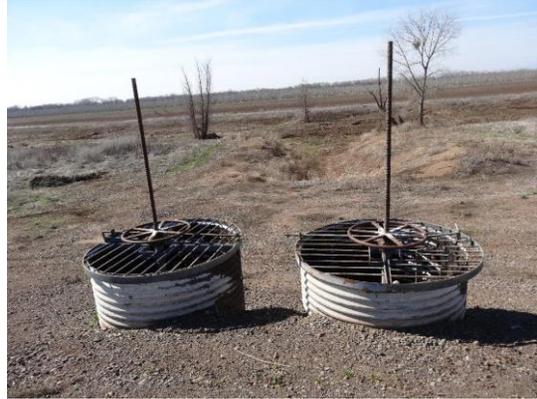
Photo 3 of 3 : UCIP\_FA\_2015\_4671.jpg

WS view: slide gates in CMP risers on levee slope.

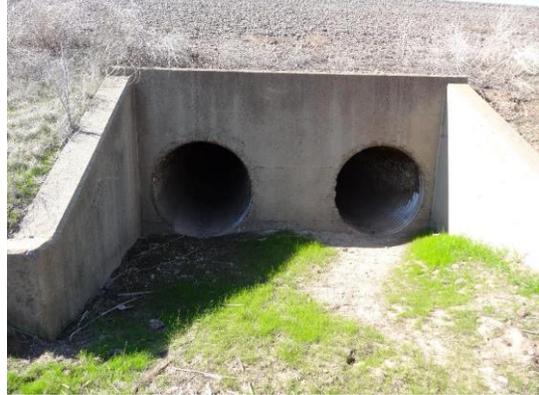
Photo 1 of 3 : UCIP\_FA\_2015\_4672.jpg

LM Start	<b>6.09</b>	Rating **	M	Issue No.	<b>24</b>
LM End	<b>6.09</b>	Issue Type +	En	Location *	LS
Category	Supplemental			GPS Latitude/Longitude	
				Start	End
Item	DWR UCIP Field Study			39.733280 °	39.733280 °
				-121.930409 °	-121.930409 °
DWR ID					
Action/Comments					
Inspector Comments: FS_ID:41377 DS_ID:19259 EP_NO: N/A FS_HLM: 6.29 Repair Type: Non-Urgent Crossing Status: Found

LS view: U type concrete headwall and CMPs on levee slope. Soil/mud on inlet box.

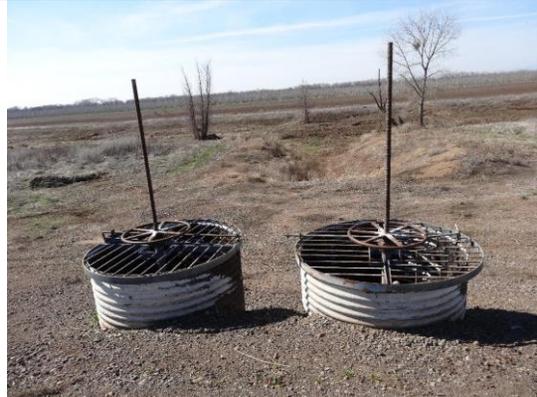
Photo 3 of 3 : UCIP\_FA\_2015\_4674.jpg

WS view: slide gates in CMP risers on levee slope.

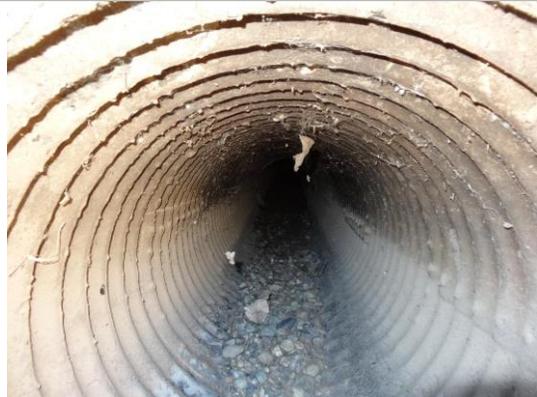
Photo 1 of 3 : UCIP\_FA\_2015\_4675.jpg

LM Start	<b>6.15</b>	Rating **	M	Issue No.	<b>25</b>
LM End	<b>6.15</b>	Issue Type +	En	Location *	LS
Category	Supplemental			GPS Latitude/Longitude	
				Start	End
Item	DWR UCIP Field Study			39.732515 °	39.732515 °
				-121.930373 °	-121.930373 °
DWR ID					
Action/Comments					
Inspector Comments: FS_ID:31034 DS_ID:19249 EP_NO: N/A FS_HLM: 6.34 Repair Type: Non-Urgent Crossing Status: Found UCIP Comments: Needs cleaning and clearing of debris. FIELD_STRUCT_DESC: 24-inch CM pipe through the levee, 12.0 feet below the crown. Flap gate on the waterward end. Concrete "U" headwalls on both ends. Grouted riprap apron on the landward end. Grouted riprap spillway on the waterward end. O&M Manual Sac 504, May 1965. FS Date: 02/25/2014

LS view: inside view of CMP on levee slope. Needs cleaning and clearing.

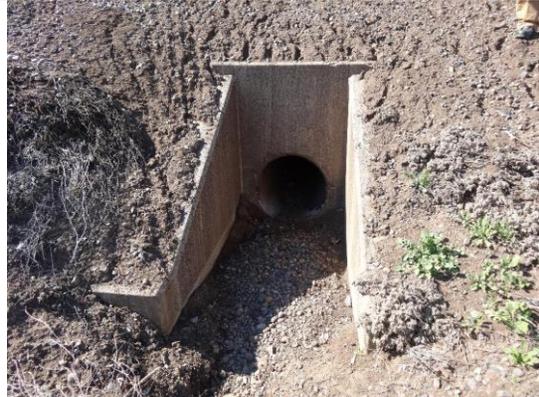
Photo 2 of 3 : UCIP\_FA\_2015\_4676.jpg

LS view: U type concrete headwall and CMP on levee slope.

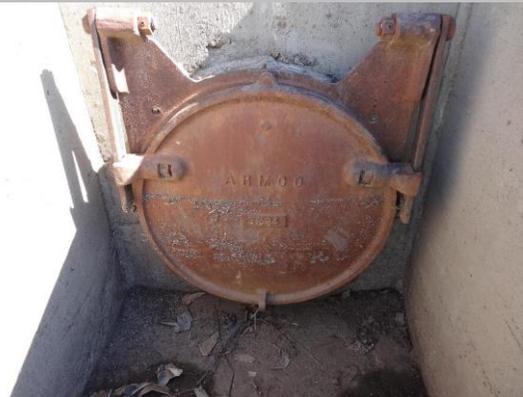
Photo 3 of 3 : UCIP\_FA\_2015\_4677.jpg

WS view: U type concrete headwall, pipe, and flapgate on levee slope.

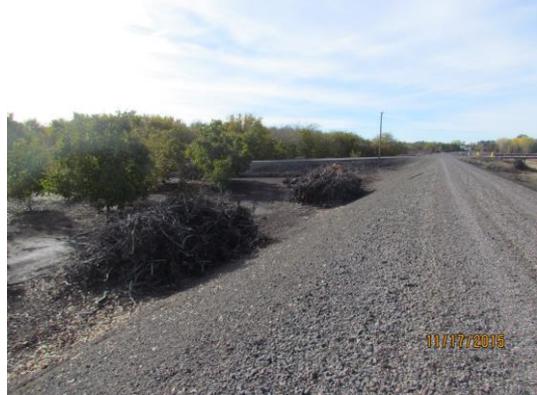
Photo 1 of 1 : FA\_2015\_NA0003\_65\_12\_20151118\_00010.jpg

View of the prunings along the landside toe.

LM Start	<b>6.36</b>	Rating **	M	Issue No.	<b>12</b>
LM End	<b>6.36</b>	Issue Type +	En	Location *	LS
Category	Earthen Levee		GPS Latitude/Longitude		
			Start	End	
Item	Encroachments		39.729663 °	39.729663 °	
			-121.931883 °	-121.931883 °	
DWR ID	DWR_NA0003_02_f_2015_12				
Action/Comments					
Prunings Inspector Comments: Remove the prunings from the landside toe.

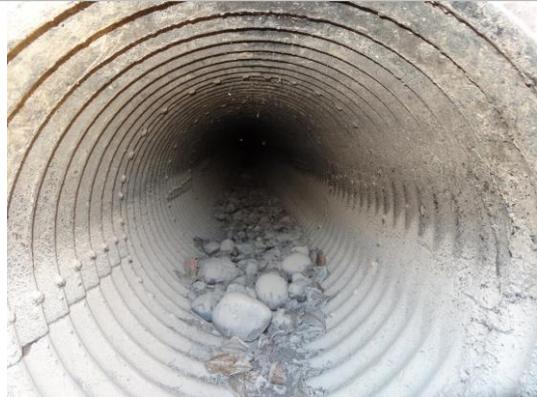
Photo 1 of 3 : UCIP\_FA\_2015\_3303.jpg

LM Start	<b>6.43</b>	Rating **	M	Issue No.	<b>26</b>
LM End	<b>6.43</b>	Issue Type +	En	Location *	LS
Category	Supplemental		GPS Latitude/Longitude		
			Start	End	
Item	DWR UCIP Field Study		39.728812 °	39.728812 °	
			-121.932623 °	-121.932623 °	
DWR ID					
Action/Comments					
Inspector Comments: FS_ID:31085 DS_ID:19251 EP_NO: N/A FS_HLM: 6.6354 Repair Type: Non-Urgent Crossing Status: Found UCIP Comments: Needs cleaning and clearing of debris. FIELD_STRUCT_DESC: 24-inch CM pipe through the levee, 15.5 feet below the crown. Flap gate on the waterward end. Concrete "U" headwalls on both ends. Grouted riprap apron on the landward end. Grouted riprap spillway on the waterward end. O&M Manual Sac 504, May 1965. FS Date: 02/25/2014

LS view: inside view of CMP on levee slope. Needs cleaning and clearing.

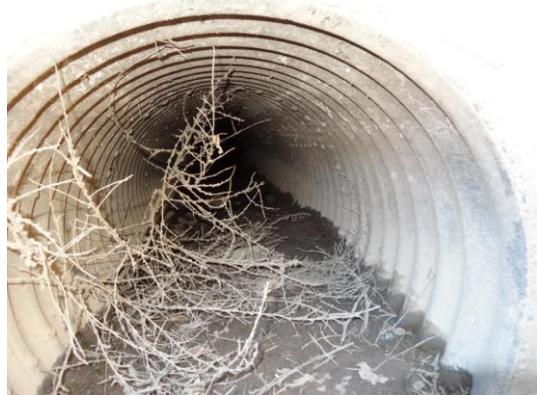
Photo 1 of 3 : UCIP\_FA\_2015\_3306.jpg

LM Start	<b>6.94</b>	Rating **	M	Issue No.	<b>27</b>
LM End	<b>6.94</b>	Issue Type +	En	Location *	LS
Category	Supplemental			GPS Latitude/Longitude	
				Start	End
Item	DWR UCIP Field Study			39.722798 °	39.722798 °
				-121.937828 °	-121.937828 °
DWR ID					
Action/Comments					
Inspector Comments: FS_ID:31103 DS_ID:19252 EP_NO: N/A FS_HLM: 7.15 Repair Type: Non-Urgent Crossing Status: Found

LS view: inside view of CMP on levee slope. Needs cleaning and clearing.

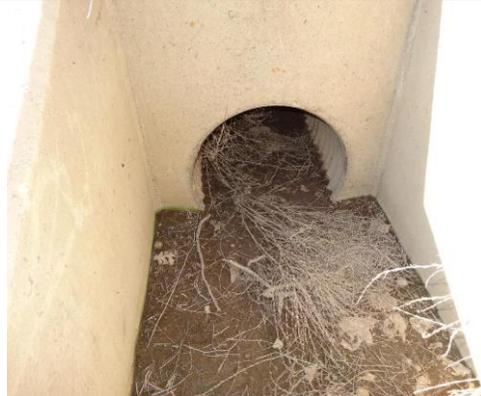
Photo 2 of 3 : UCIP\_FA\_2015\_3307.jpg

LS view: U type concrete headwall and CMP on levee slope. Soil/mud on inlet box.

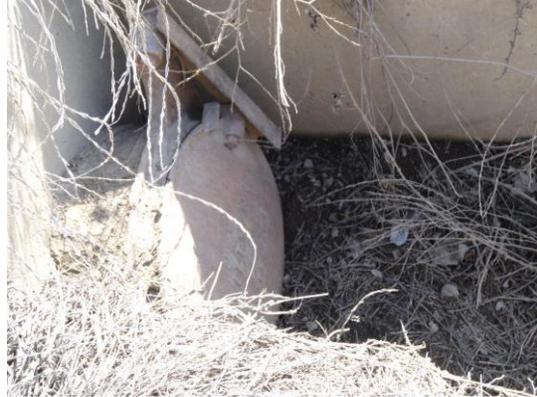
Photo 3 of 3 : UCIP\_FA\_2015\_3308.jpg

WS view: U type concrete headwall, pipe, and flapgates on levee slope. Soil/mud on outlet box. Vegetation debris blocking outlet box

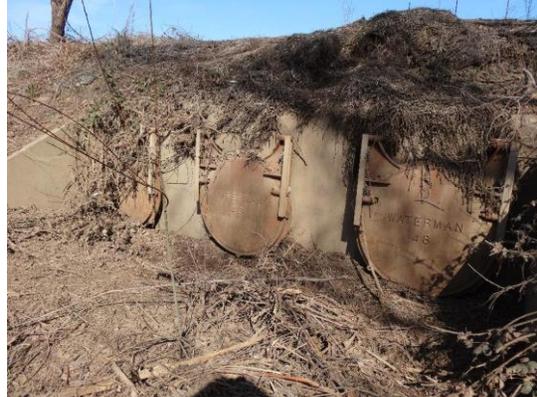
Photo 1 of 2 : UCIP\_FA\_2015\_3819.jpg

LM Start	<b>7.22</b>	Rating **	M	Issue No.	<b>28</b>
LM End	<b>7.22</b>	Issue Type +	En	Location *	LS
Category	Supplemental			GPS Latitude/Longitude	
				Start	End
Item	DWR UCIP Field Study			39.718882 °	39.718882 °
				-121.937602 °	-121.937602 °
DWR ID					
Action/Comments					
Inspector Comments: FS_ID:32085 DS_ID:19253 EP_NO: N/A FS_HLM: 7.445 Repair Type: Non-Urgent Crossing Status: Found UCIP Comments: Slide gates in CMP risers on waterside shoulder. Needs cleaning and clearing of debris. FIELD_STRUCT_DESC: 1 of 3: Three 48-inch CM pipes through levee, 18.0 feet below crown. Flap gate on the waterward end. Slide gate in CMP riser on waterside shoulder. Concrete "U" headwalls on both ends. Grouted riprap apron on the landward end. Grouted riprap spillway on the waterward end. O&M Manual Sac 504, May 1965. FS Date: 02/25/2014

WS view: U type concrete headwall, pipes, and flapgates on levee slope. Soil/mud on outlet box. Vegetation debris blocking outlet box

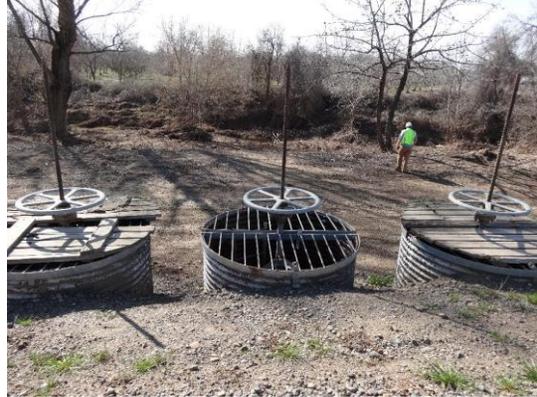
Photo 2 of 2 : UCIP\_FA\_2015\_3820.jpg

WS view: slide gates in CMP risers on waterside shoulder.

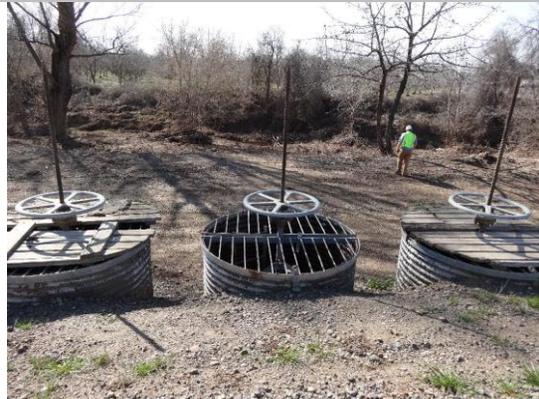
Photo 3 of 3 : UCIP\_FA\_2015\_3162.jpg

WS view: slide gates in CMP risers on waterside shoulder.

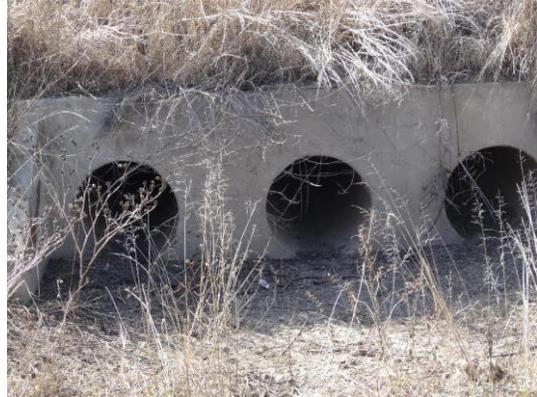
Photo 1 of 3 : UCIP\_FA\_2015\_3163.jpg

LM Start	<b>7.23</b>	Rating **	M	Issue No.	<b>30</b>
LM End	<b>7.23</b>	Issue Type +	En	Location *	LS
Category	Supplemental			GPS Latitude/Longitude	
				Start	End
Item	DWR UCIP Field Study			39.718849 °	39.718849 °
				-121.937580 °	-121.937580 °
DWR ID					
Action/Comments					
Inspector Comments: FS_ID:32087 DS_ID:19261 EP_NO: N/A FS_HLM: 7.448 Repair Type: Non-Urgent Crossing Status: Found

LS view: U type concrete headwall and CMPs on levee slope. Soil/mud on inlet box.

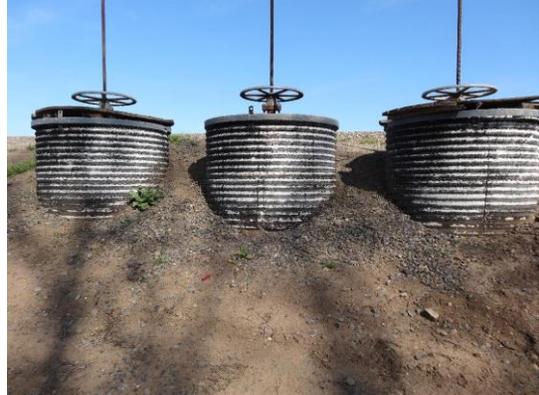
Photo 3 of 3 : UCIP\_FA\_2015\_3165.jpg

WS view: slide gates in CMP risers on waterside shoulder.

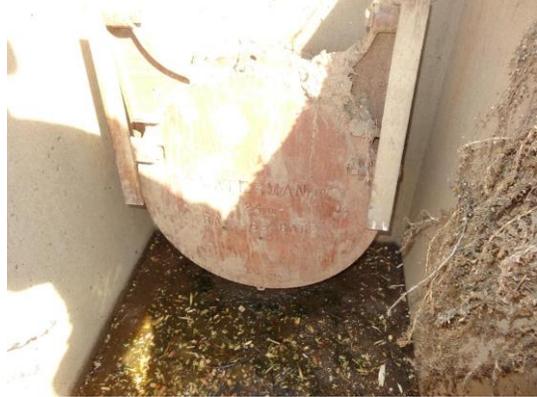
Photo 2 of 2 : UCIP\_FA\_2015\_3310.jpg

**Action/Comments**  
 Inspector Comments: FS\_ID:31129  
 DS\_ID:19254  
 EP\_NO: N/A  
 FS\_HLM: 8.0015  
 Repair Type: Non-Urgent  
 Crossing Status: Found  
 UCIP Comments: Debris in inlet pipe, needs cleaning and clearing.  
 FIELD\_STRUCT\_DESC: 24-inch CM pipe through the levee, 18.0 feet below the crown. Flap gate on the waterward end. Concrete "U" headwalls on both ends. Grouted riprap apron on the landward end. Grouted riprap spillway on the waterward end. O&M Manual Sac 504, May 1965.  
 FS Date: 02/25/2014

WS view: U type concrete headwall, pipe, and flapgate on levee slope. Soil/mud on outlet box.

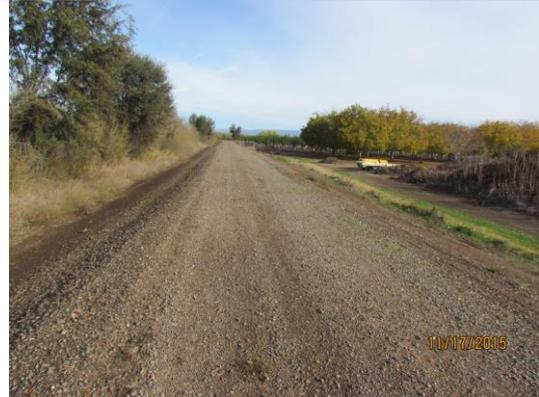
Photo 1 of 1 : FA\_2015\_NA0003\_66\_17\_20151118\_00001.jpg

LM Start	<b>0.11</b>	Rating **	A	Issue No.	<b>17</b>
LM End	<b>0.11</b>	Issue Type +	Ma	Location *	LS
Category	Earthen Levee			GPS Latitude/Longitude	
				Start	End
Item	Vegetation			39.734465 °	39.734465 °
				-121.929417 °	-121.929417 °
DWR ID	DWR_NA0003_02A_f_2015_17				
Action/Comments					
Control annual grass and weeds on the levee slopes and easements. Inspector Comments: Butte County sprayed and dragged both slopes.

View of no vegetation on both slopes.

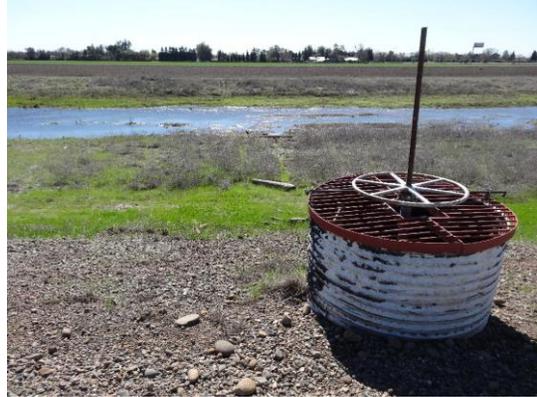
Photo 1 of 3 : UCIP\_FA\_2015\_3166.jpg

LM Start	<b>0.10</b>	Rating **	M	Issue No.	<b>14</b>
LM End	<b>0.10</b>	Issue Type +	En	Location *	WS
Category	Supplemental			GPS Latitude/Longitude	
				Start	End
Item	DWR UCIP Field Study			39.786195 °	39.786195 °
				-121.881325 °	-121.881325 °
DWR ID					
Action/Comments					
Inspector Comments: FS_ID:32103 DS_ID:19262 EP_NO: N/A FS_HLM: 0.078 Repair Type: Non-Urgent Crossing Status: Found UCIP Comments: Slide gate in CMP riser on waterside. The culvert was working during field inspection. FIELD_STRUCT_DESC: 42-inch CM pipe through the levee, 14 feet below the crown. Flap gate on the waterward end. Slid gate in CM riser on the waterward slope. Concrete "U" headwalls on both ends. Grouted riprap apron on the landward end. Grouted riprap spillway on the waterward end. O&M Manual Sac 504, May 1965. FS Date: 03/11/2014

WS view: slide gate in CMP riser on waterside shoulder.

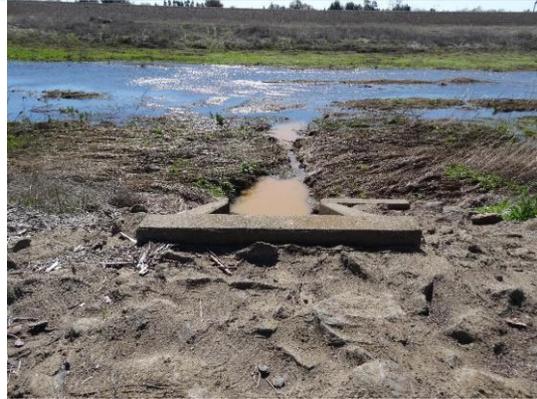
Photo 2 of 3 : UCIP\_FA\_2015\_3947.jpg

WS view: U type concrete headwall of CMP culvert on levee slope. Grouted riprap levee slope and spillway.

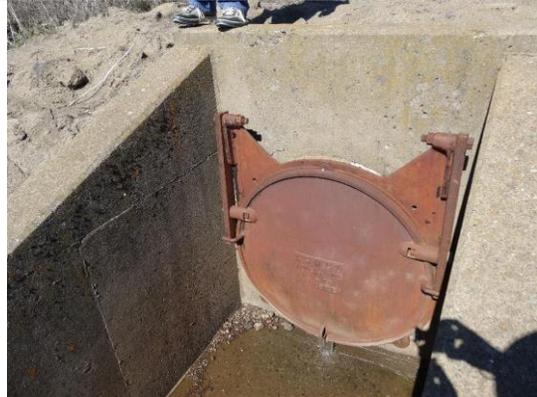
Photo 3 of 3 : UCIP\_FA\_2015\_3948.jpg

WS view: U type concrete headwall, pipe, and flapgate on levee slope.

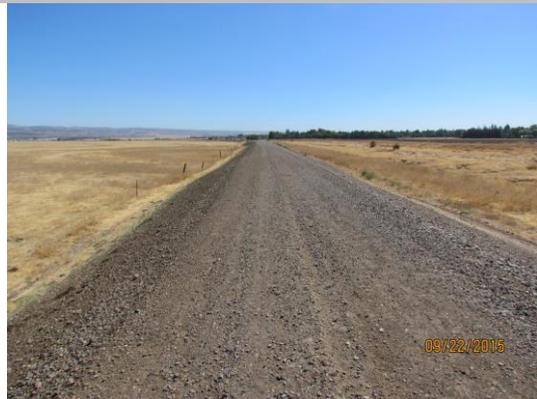
Photo 1 of 1 : FA\_2015\_NA0003\_67\_13\_20151013\_00004.jpg

LM Start	<b>1.11</b>	Rating **	A	Issue No.	<b>13</b>
LM End	<b>1.11</b>	Issue Type +	Ma	Location *	LS
Category	Earthen Levee			GPS Latitude/Longitude	
				Start	End
Item	Vegetation			39.780317 °	39.780317 °
				-121.865255 °	-121.865255 °
DWR ID	DWR_NA0003_03_f_2015_13				
Action/Comments					
Control annual grass and weeds on the levee slopes and easements. Inspector Comments: Butte Co. sprayed and dragged both slopes.

View of both slopes with acceptable vegetation.

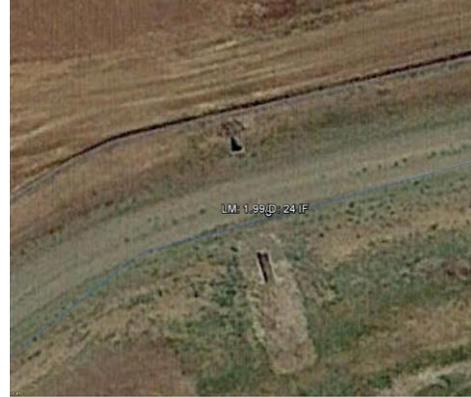
Photo 1 of 1 : UCIP\_FA\_2015\_3883.jpg

LM Start	<b>1.96</b>	Rating **	M	Issue No.	<b>15</b>
LM End	<b>1.96</b>	Issue Type +	En	Location *	LS
Category	Supplemental			GPS Latitude/Longitude	
				Start	End
Item	DWR UCIP Field Study			39.781714 °	39.781714 °
				-121.850868 °	-121.850868 °
DWR ID					
<b>Action/Comments</b>					
Inspector Comments: FS_ID:31900 DS_ID:19266 EP_NO: N/A FS_HLM: 1.99 Repair Type: Non-Urgent Crossing Status: Indicator Found UCIP Comments: Needs location confirmation, GPS reading has not taken due to access problem. FIELD_STRUCT_DESC: 24-inch CM pipe through the levee, 8.0 feet below the crown. Flap gate on the waterward end. Concrete "U" headwalls on both ends. Grouted riprap apron on the landward end. Grouted riprap spillway on the waterward end. O&M Manual Sac 504, May 1965. FS Date: 03/11/2014

Bird's eye view: concrete headwall visible on both sides of the levee. Grouted riprap spillway on waterside.

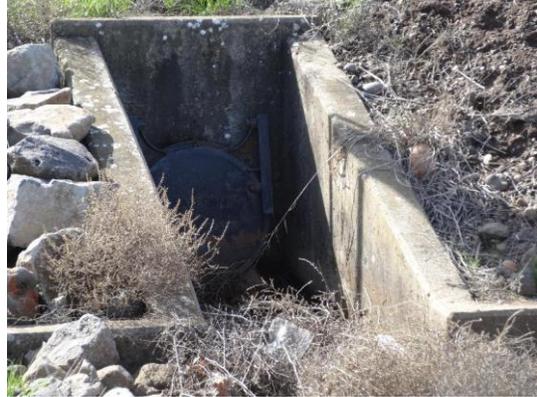
Photo 2 of 2 : UCIP\_FA\_2015\_3950.jpg

WS view: concrete headwall, pipe, and flapgate on levee slope. Vegetation and mud on outlet box.

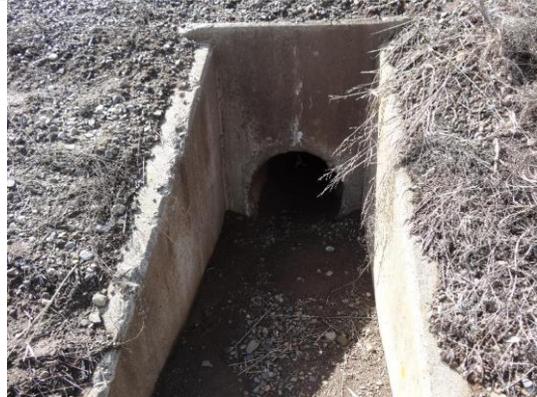
Photo 1 of 2 : UCIP\_FA\_2015\_3884.jpg

Inspector Comments: FS\_ID:31901  
 DS\_ID:19269  
 EP\_NO: N/A  
 FS\_HLM: 3.14  
 Repair Type: Non-Urgent  
 Crossing Status: Found  
 UCIP Comments: Needs cleaning and clearing the culvert.  
 FIELD\_STRUCT\_DESC: 24-inch CM pipe through the levee, 11.0 feet below the crown. Flap gate on the waterward end. Concrete "U" headwalls on both ends. Grouted riprap apron on the landward end. Grouted riprap spillway on the waterward end. O&M Manual Sac 504, May 1965.  
 FS Date: 03/07/2014

LS view: U type concrete headwall and CMP on levee slope. Soil/mud on inlet box.

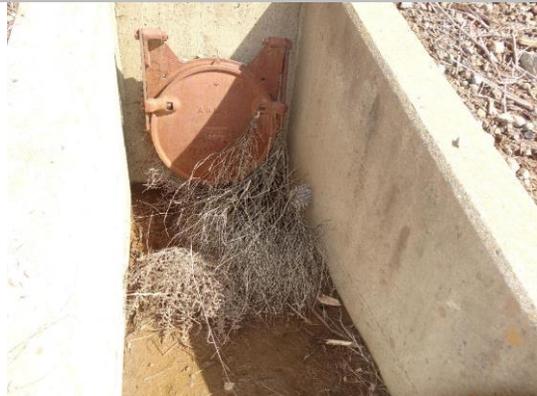
Photo 2 of 2 : UCIP\_FA\_2015\_3885.jpg

WS view: U type concrete headwall, flapgate, and CMP on levee slope. Needs cleaning and clearing.
